Wolfson Report No 2702 - Assessment of keel and associated structure of the sailing vessel
Tyger of London

Report No. 2702

Date : 4th June 2018
Compiled By : [REDACTED]
Verified By : [REDACTED]

Assessment of Keel and associated structure of Sailing Vessel ‘Tyger of London’

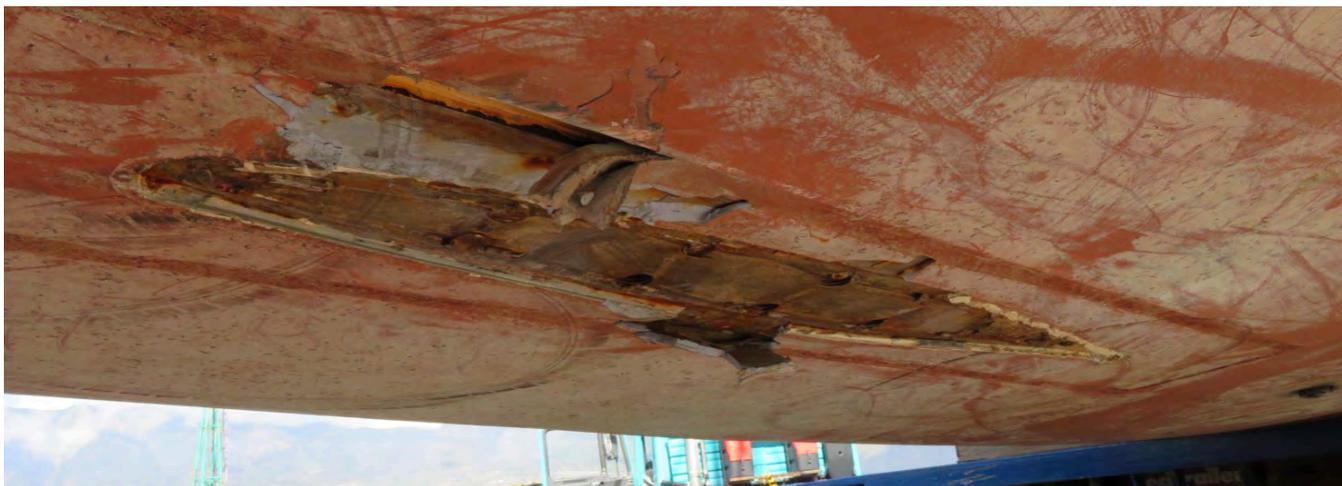
Figure 1: Showing plate still attached to hull as the yacht was removed from the water, image supplied by MAIB.

The keel design includes a rectangular shaped 'top plate', the edge of which contains 16 bolts to attach to the yacht frame. Within the centre of the top plate are 12 threaded holes following the aerofoil shape of the keel. When in-service the mass of the keel hung from 12 rods threaded into the top plate, and partially welded. When the vessel was recovered it was noted that the top plate had remained attached to the yacht, it was also noted that 8 of the 12 rods had fractured within the plate, and 4 threaded holes (centrally located) had been stripped and were empty.

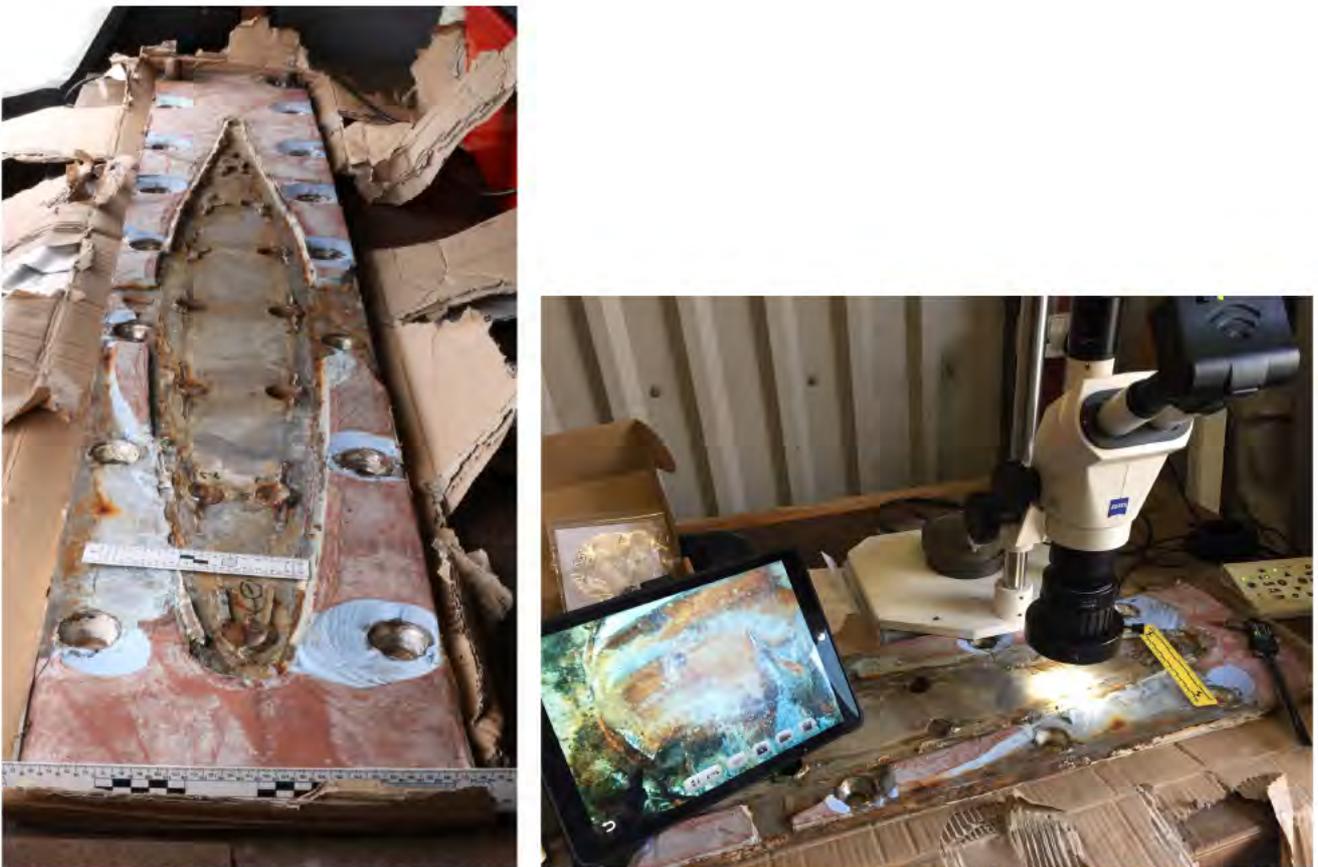
Figure 2: Showing examination conditions. Left: view of plate looking aftward. Right: microscope set-up. ROIs were examined using a Zeiss microscope and documented with a digital camera.

The as-received examination of the plate (shown in Figure 2) confirmed what had been previously reported by MAIB: all twelve fixing points had failed. Eight remnants of rod were present at positions 1, 2, 3, 4, 8, 10, 11 and 12. Within the center of the plate four positions were empty of any large rod remnants (5, 6, 7 and 9). Note 1 was at the FWD end and even numbered positions along the port side.
