Rail Accident Investigation Branch

Investigating organisational factors in the Bradford Interchange runaway

Runaway at Bradford Interchange

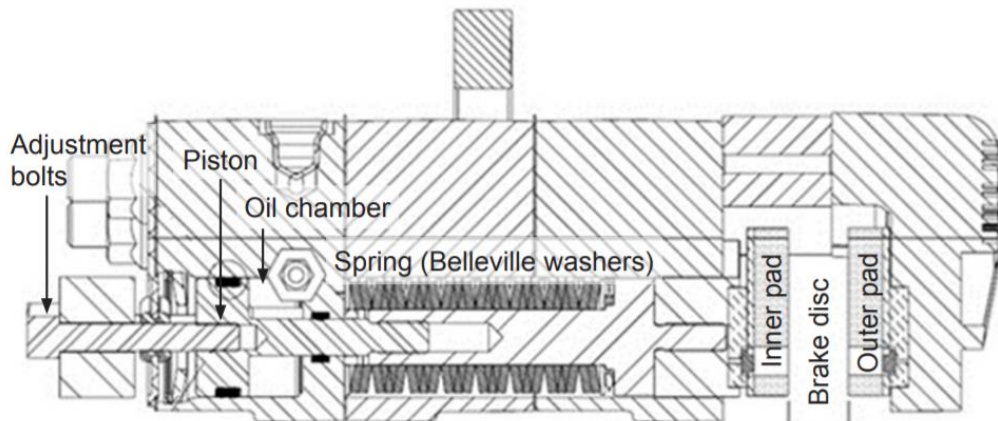
Fitters not maintaining the DRWB in accordance with OEM instructions

- Competent to the relevant Rail Plant Association assessment modules (2-yr cycle)
- Had been provided with relevant OEM instructions and forms created by employers to complete
- Were routinely not following the OEM instructions and just ticking the forms
