Rail Accident Investigation Branch

# Rail Accident Report

## Passenger injury at Ashton-under-Lyne tram stop 12 March 2019

Report 15/2019  
November 2019

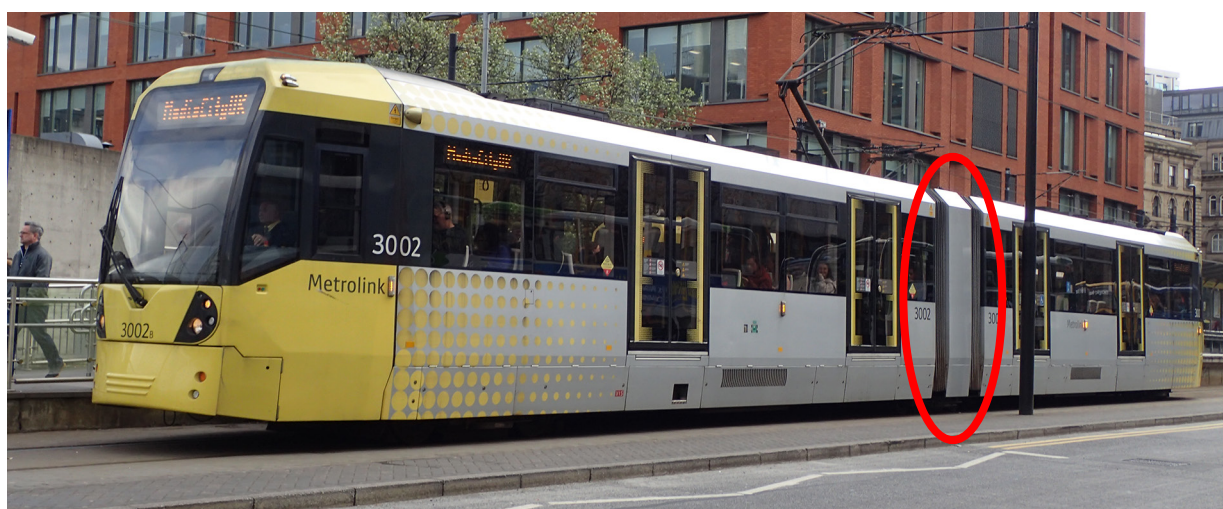
Figure 4: Photo of an M5000 tram similar to that involved in the accident, with the articulation section indicated

- 13 The tram involved was a Bombardier M5000 vehicle (figure 4), number 3040. It was operating a series of journeys collectively known as Run 38. The journey it was running at the time of the accident had started at Eccles (figure 2).

- 27 At 22:55 hrs, the tram started to move. At that moment, the passenger was standing on the platform, leaning on the side of the tram. When the tram initially started to move, the passenger moved slightly away from the tram. However, once the articulation section of the tram (figure 4) had passed him, the passenger moved back towards the tram and once again came into contact with its bodyside.
- 28 Once the tram had passed the passenger, he was no longer supported by the side of the tram and he fell from the platform (a height of 905 mm, paragraph 6) and landed on the track (figure 5). Tram stop CCTV shows the passenger lying motionless thereafter.

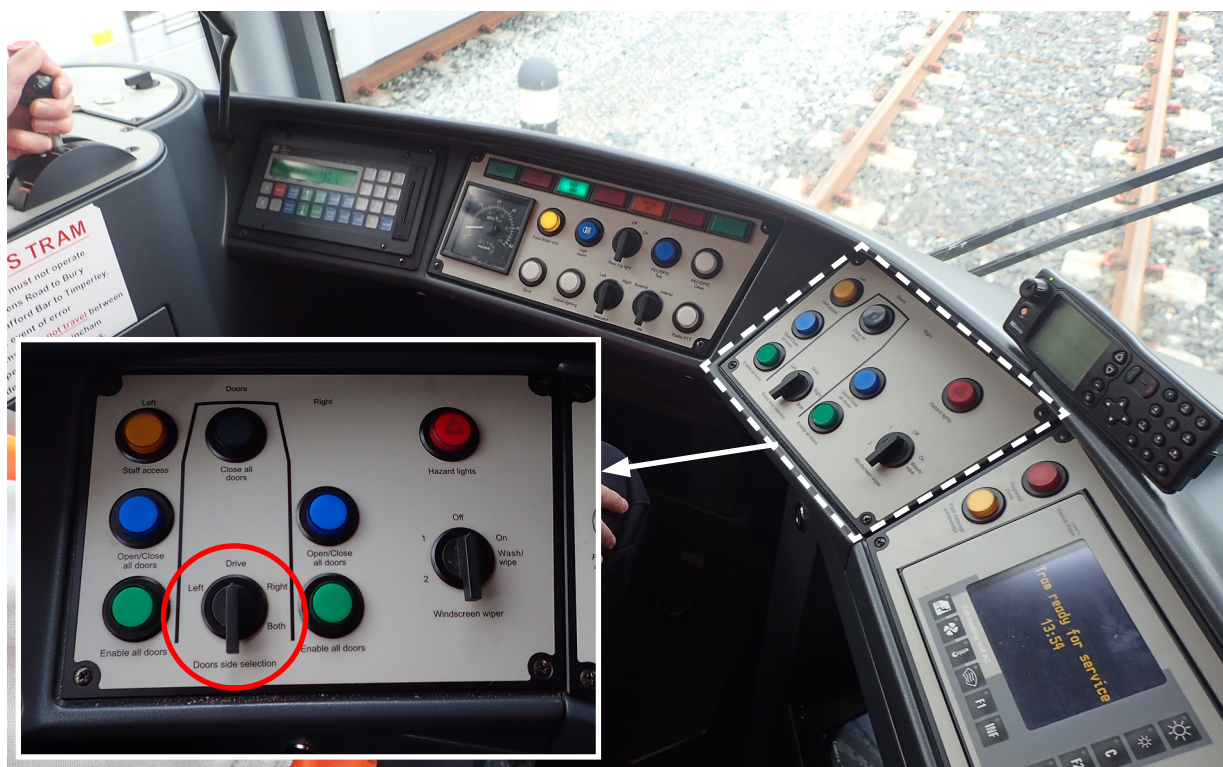
Figure 7: The door side selector switch on the driver's console

- 35 When the door side selector switch is in the central 'drive' position, the two CCTV screens provide images from cameras located on the side of the tram looking backwards. Each screen provides the rear-facing view from the camera on the respective side of the vehicle. The CCTV screens therefore provide the same type of view as door-mounted rear-view mirrors would on a motor vehicle. The provision of rear-view mirrors, or an alternative provided by CCTV, is a legal requirement<sup>5</sup> for the operation of trams which can operate on streets with road traffic. For this reason, the door selector switch must be placed into the central 'drive' position before a tram departs from a tram stop.

- 36 When a tram is at a tram stop, the driver uses the door side selector switch to choose which side of the vehicle the doors will be opened. The doors are opened and closed using separate push buttons. Changing the position of the selector switch causes the CCTV image, on the selected side, to be split vertically (figure 6). The split screen shows:
- on the left side, the view from the front camera looking along the side of the tram towards the rear; and
  - on the right side, the view from a camera at the rear of the vehicle looking along the same side of the tram towards the front.
