Report on the investigation of the fatal accident
while boarding the tug

Millgarth

at the north oil stage

on 27 January 2019

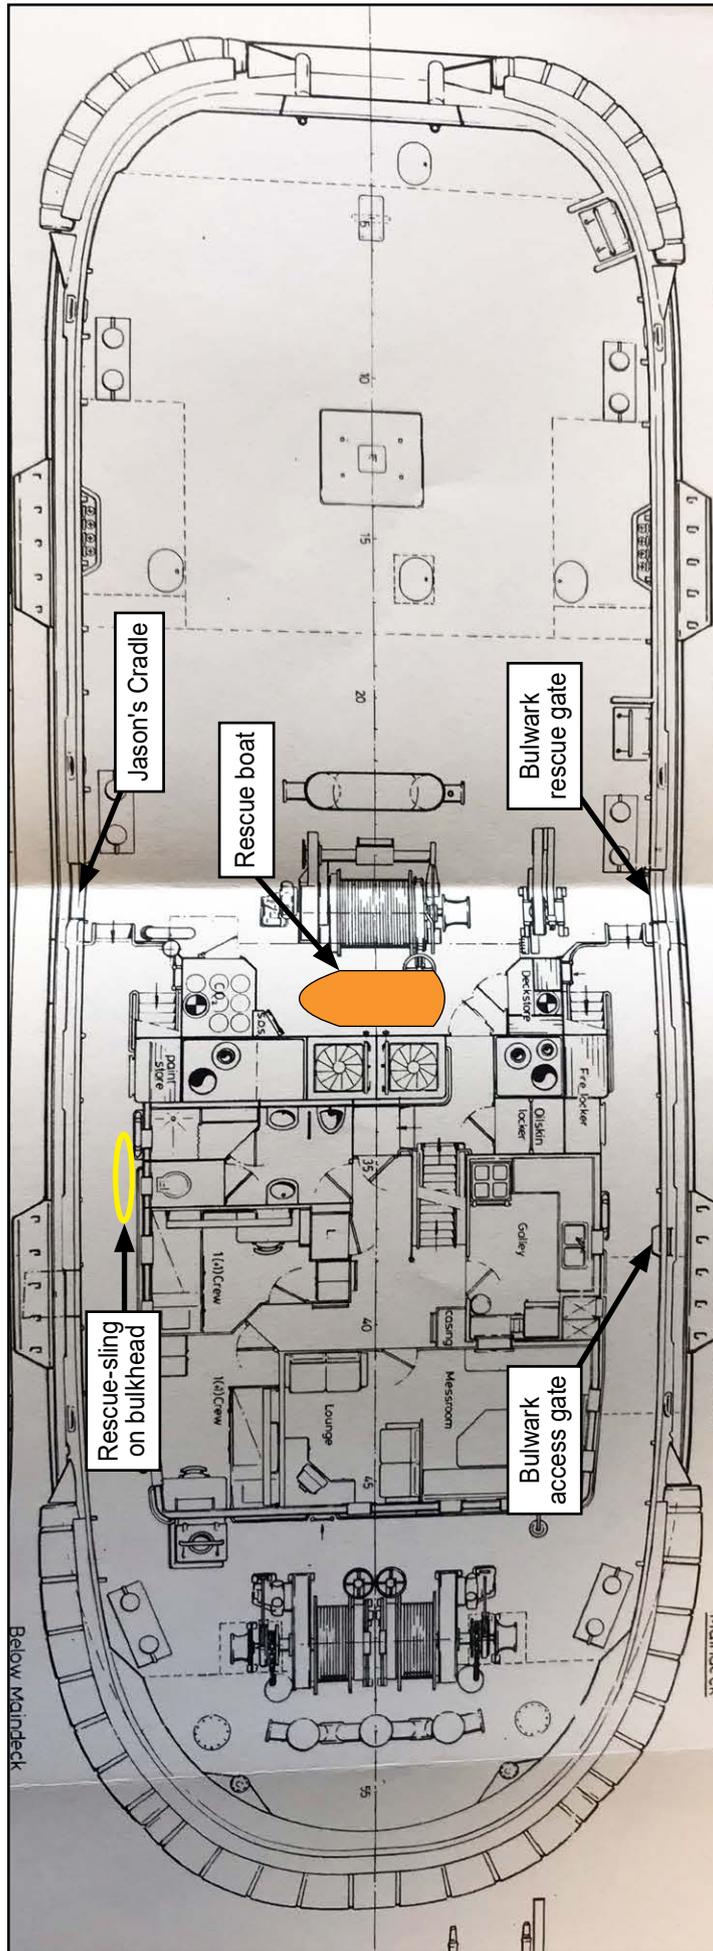
Figure 6: General arrangement

The master came down from the wheelhouse and asked the crew to get the manoverboard (MOB) rescue-sling, which was stored on the bulkhead on the starboard side of the main deck (**Figure 6**). The crew positioned the rescue-sling under the chief engineer's arms and tried to lift him using its aluminium telescopic extension pole. They managed to pull him out of the water to his waist level but were unable to lift him further. The master left the two crewmen in charge and went back into the wheelhouse to control the vessel. He maintained communication with Mersey VTS, who informed him that the rescue boat *Marine Fire Rescue 1 (MFR1)*, based at the port's Pier Head Landing Stage in Liverpool, was on its way.

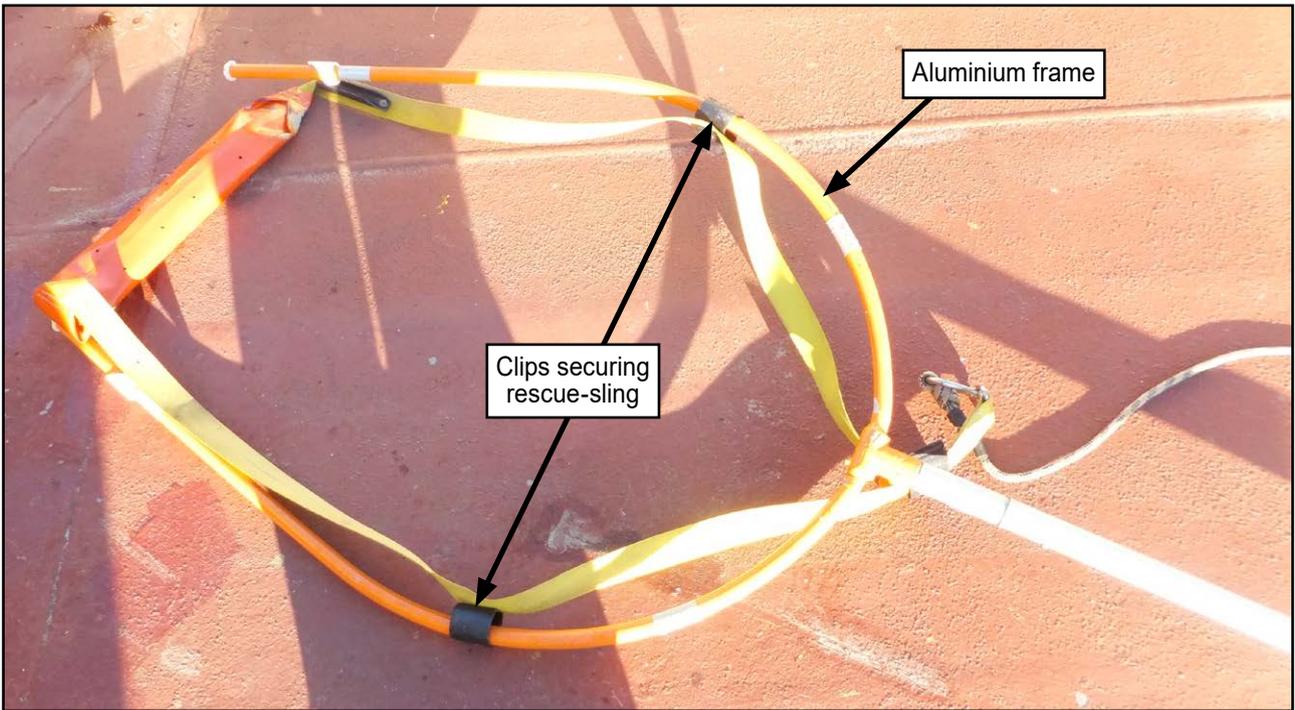
Figure 7a: SB rescue-sling

The SB rescue-sling was attached to a 12mm plaited polyester line and was clipped to a 1.2m long open-ended aluminium frame to form an open loop (**Figure 7a**). The frame was attached to a 1.7m telescopic pole that could be extended to 4m (**Figure 7b**). The procedure for recovering a person from the water was:

The SB rescue-sling on board *Millgarth* was stored in its fully assembled condition and was not subjected to the 3-yearly load test. The crews had not been trained in the use of this equipment and operating instructions for its intended use were not available on board.

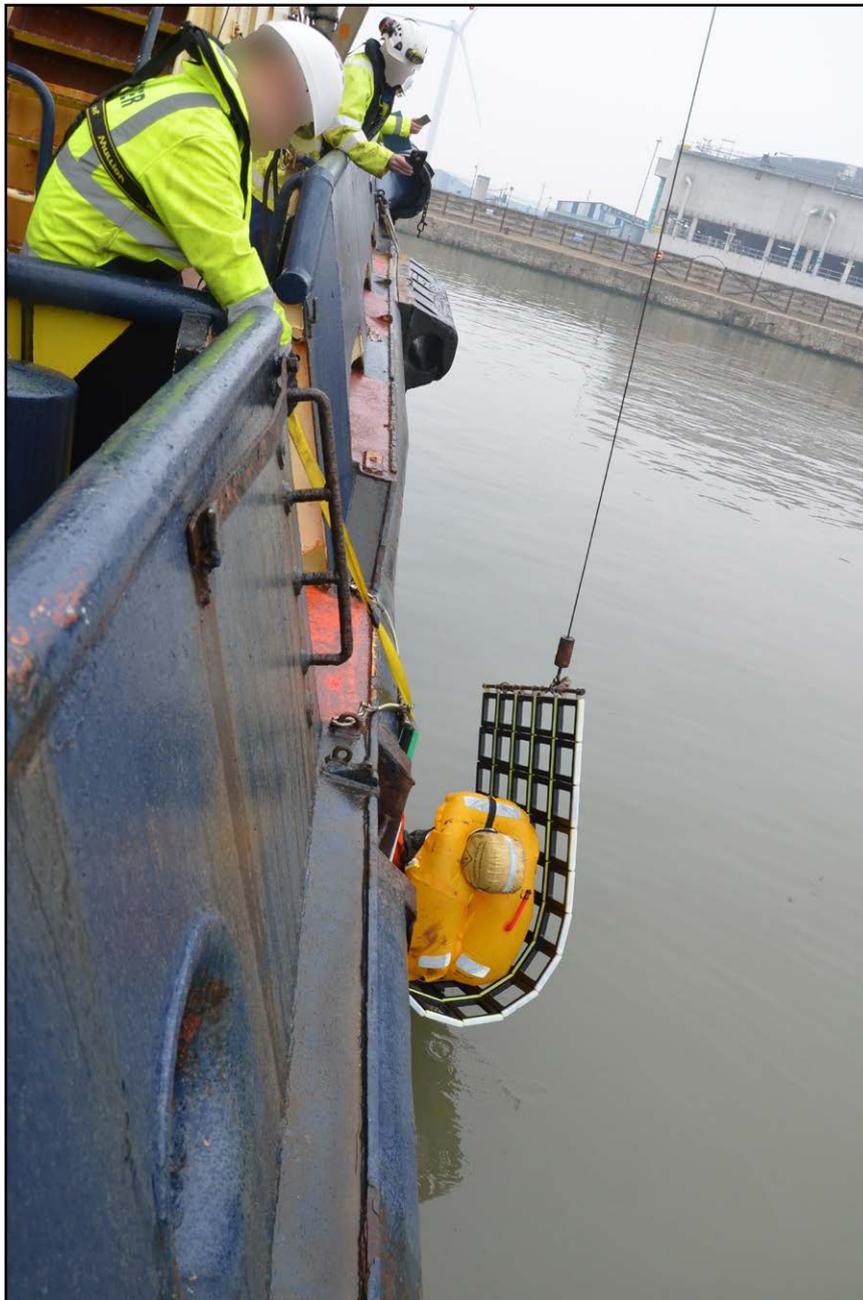
Figure 8: Jason's Cradle equipment being used during a drill

Jason's Cradle is the trade name of an MOB recovery device manufactured by Land and Marine Products Limited and was designed for use on vessels with freeboards up to 5m. It is a non-collapsible scoop, one end of which is fixed to a rigid structure such as the bulwark. In operation, its free end is hooked onto a winch and then flipped over into the water. The casualty is positioned in the scoop and then heaved out of the water and recovered on board in a horizontal position using the winch (**Figure 8**).

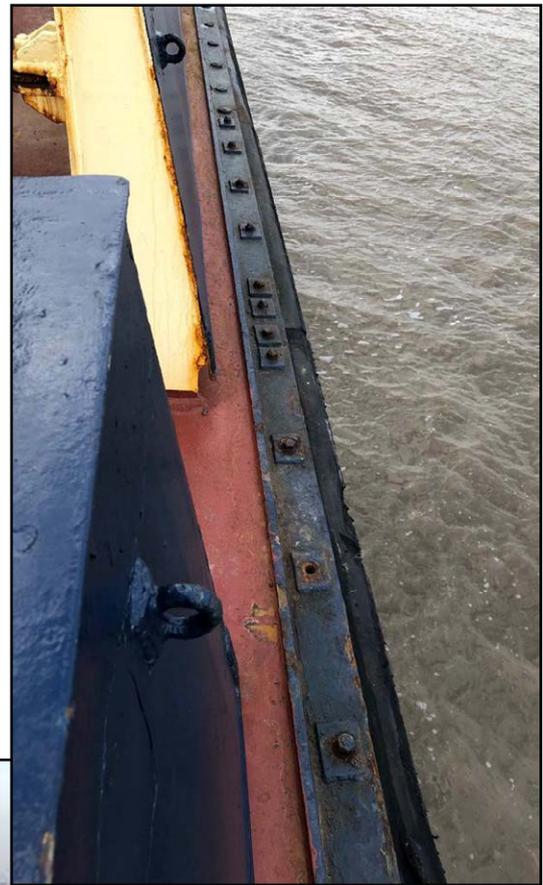
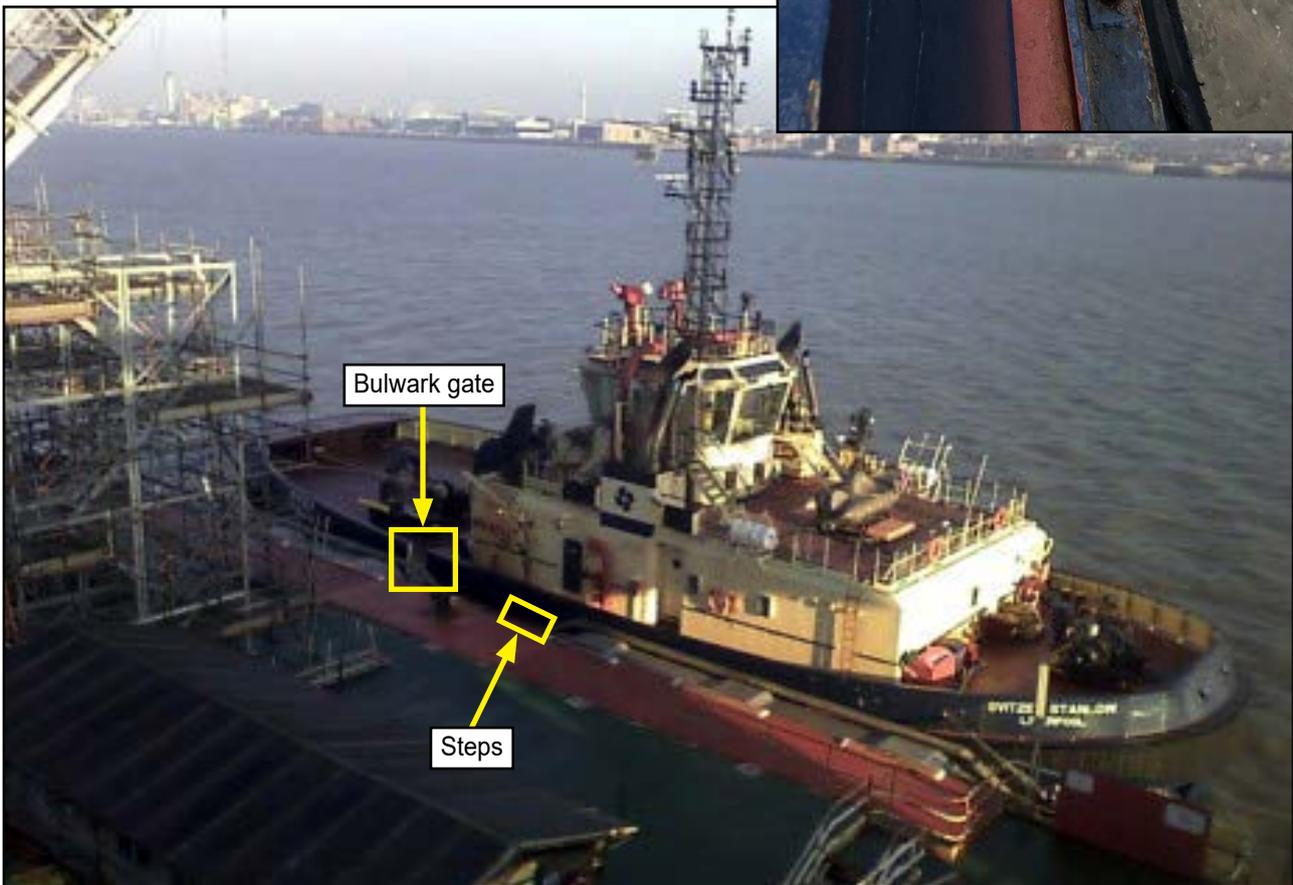
Figure 12: *Svitzer Stanlow* (inset: *Svitzer Stanlow*'s 'rubber iron' outside the bulwark)

Subsequently, it was established that cutting a new door would interfere with the fire deluge system¹⁰ on *Svitzer Stanlow*, and no further action was taken. The observation in the audit report remained with the 'completed' status. This issue, highlighted on *Svitzer Stanlow*, was not applicable to all stand-by tugs in Liverpool (**Figure 12** and inset).
