Rail Accident Investigation Branch

Rail Accident Investigation: Interim Report

**Track workers struck by a train at Margam,
South Wales
3 July 2019**

Report IR1/2019
December 2019

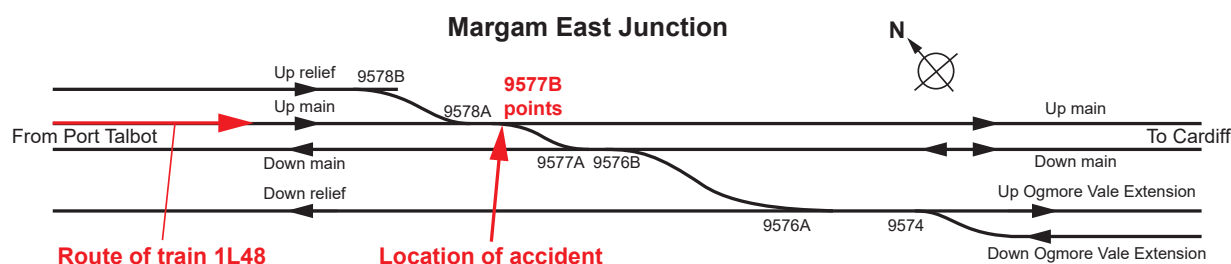
Figure 2: Track layout

- The points involved, numbered 9577B, form part of a crossover between the up and down main lines (figure 2). The crossover forms part of the route between the up relief line, which is on the north-east side of the main lines and terminates at Margam East Junction, and the up and down Ogmore Vale Extension (OVE) lines, which are on the south-west side of the main lines and give access to a number of freight destinations including Margam Abbey (Port Talbot) steelworks.
