First Monitoring Report for 4 Low-Volume Sealed Roads in Kenya

Final Report

Prepared for Kenya Materials Testing and Research Department (MTRD)

AFCAP Project – KEN2043C

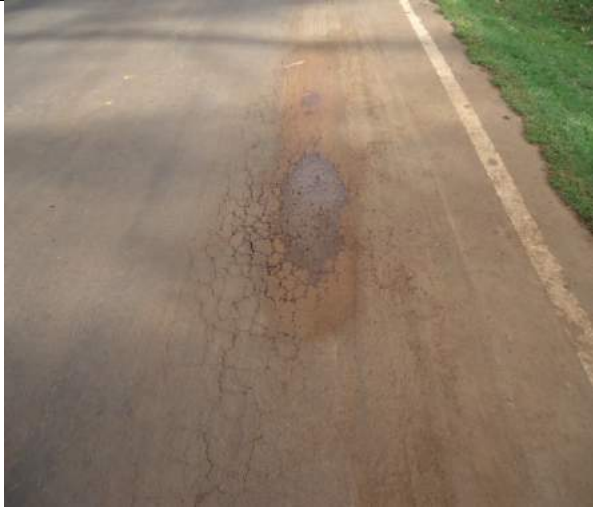
A photograph showing a paved road on the right with a white edge line. To the left of the road is a grassy shoulder with some sparse, low-lying vegetation. In the background, there are trees and a clear sky.
Fig10	Km 0+600-0+650 RHS	-Edge subsidence -Ponding of water in the rut.

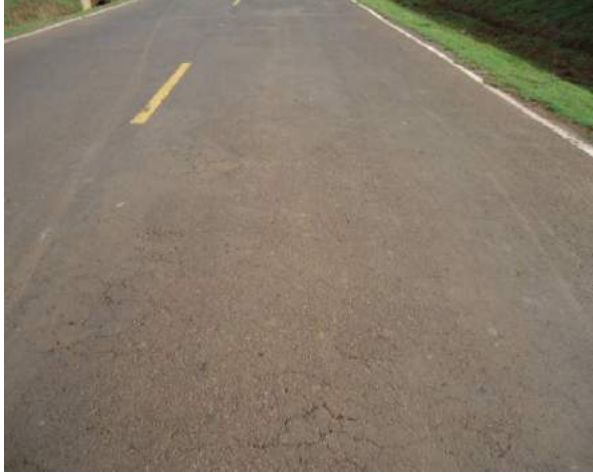
A close-up photograph of a road surface. A yellow dashed line is visible on the left. The road surface shows a deep rut with a small pool of water in the center. The surrounding pavement appears slightly uneven and aged.
Fig 11	Km 0+650 – 0+800	-Fatigue cracks and deformation

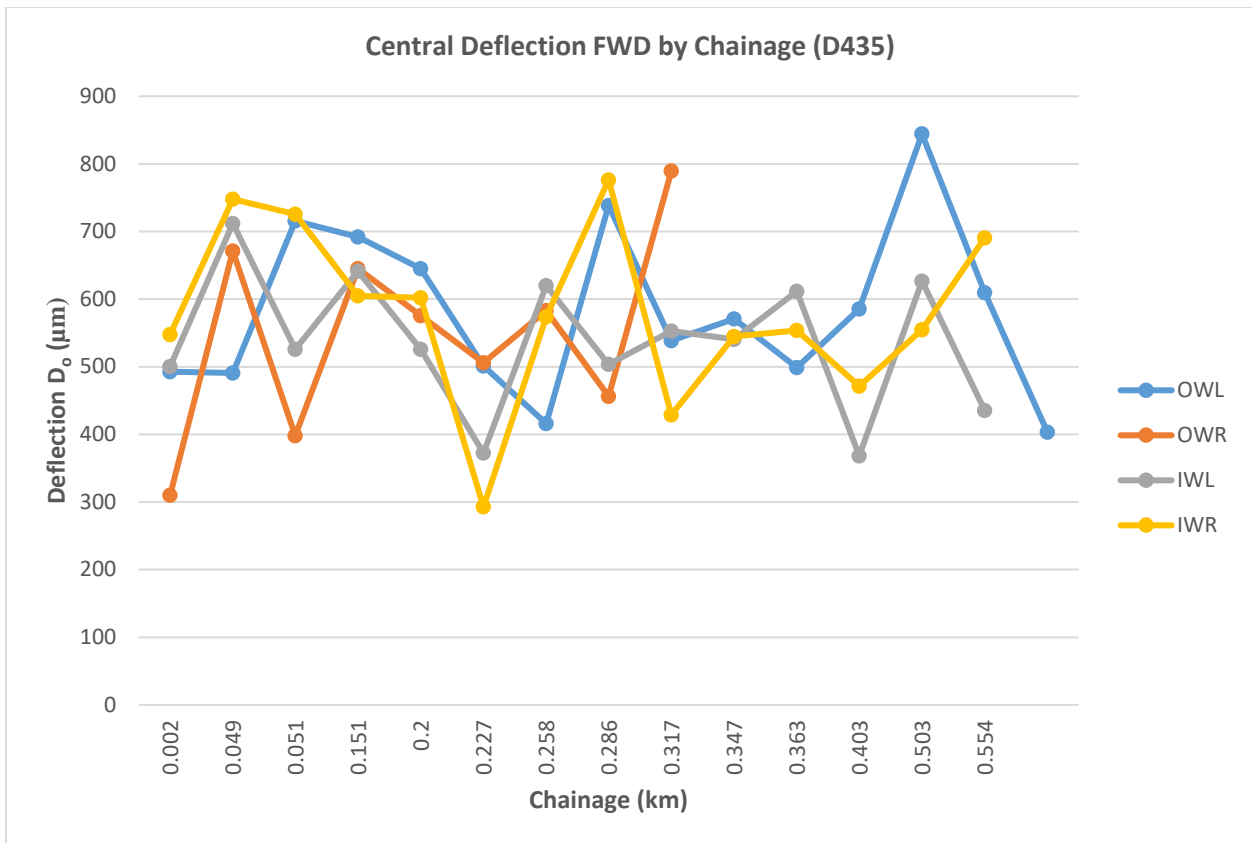
Figure 5-3: Central deflection by chainage (D435)

All the deflection outputs from the FWD for all the sensors (D_0 up to D_6) for all the test locations are presented in the Appendix section of the report as Annex 1-5. Figure 5-3 shows a plot of the central deflection by chainage along the road.

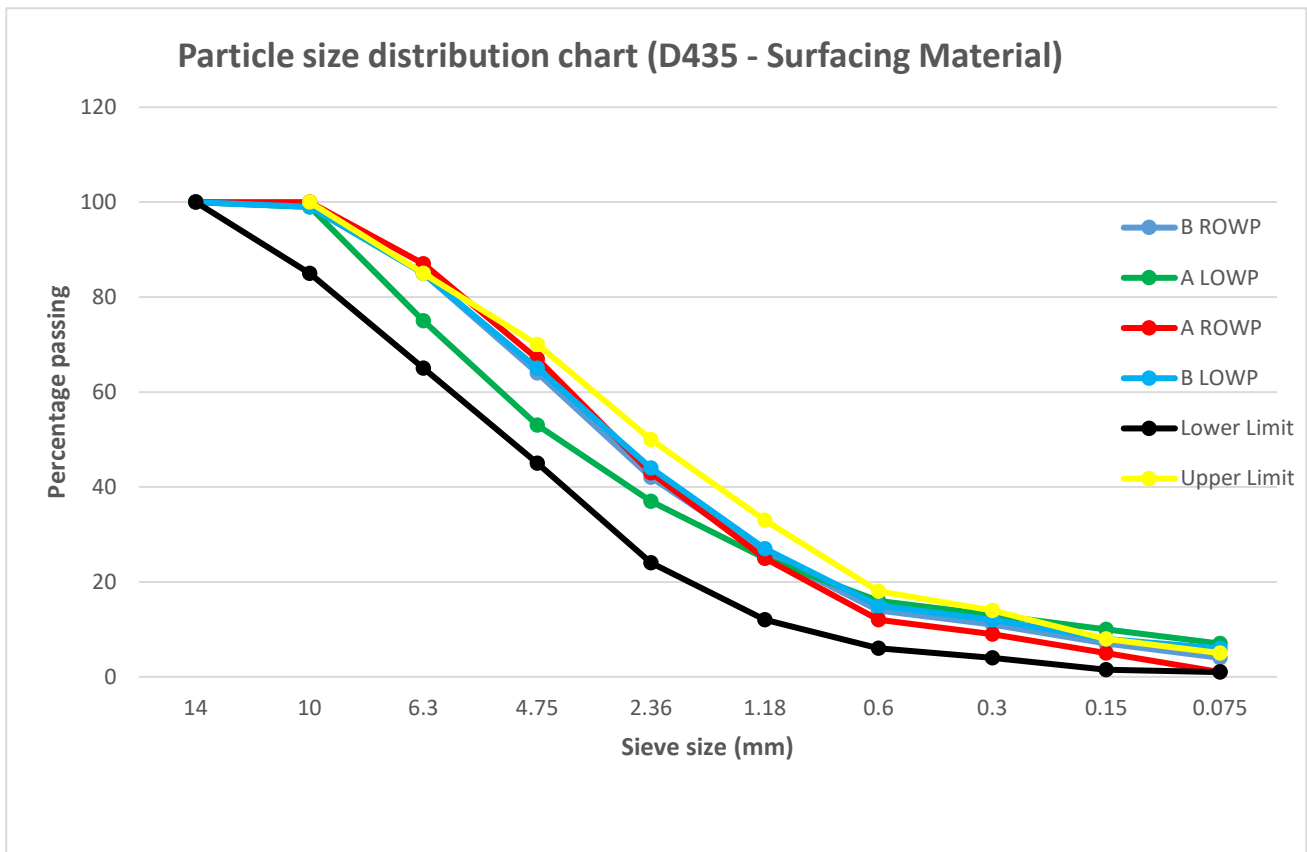
Figure 5-5: Particle size distribution for base material (D435)

The plots in Figure 5-5 show the particle size distribution for the surface layer. The surfacing materials lie within the specification envelope. The specification is obtained from LVSR Pavement Design Guidelines.

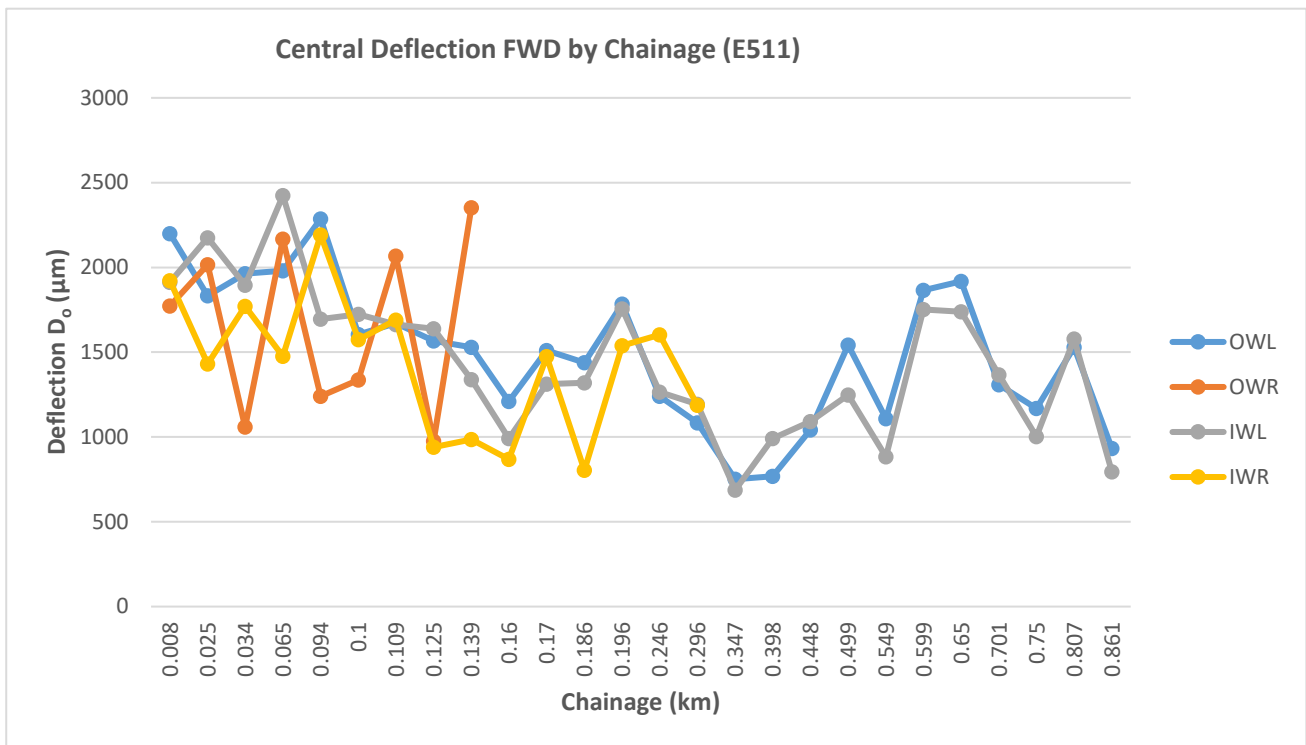
Figure 6-3: Central deflection by chainage (E511)

The entire deflection outputs from the FWD for all the sensors (D_0 up to D_6) for all the test locations are presented in the Appendix section of the report as Annex 1-5. Figure 6-3 shows the central deflection for each wheel path along the road section. The values are highly variable. The deflection behaves in almost a similar manner as noted from the values which were obtained in the baseline survey.

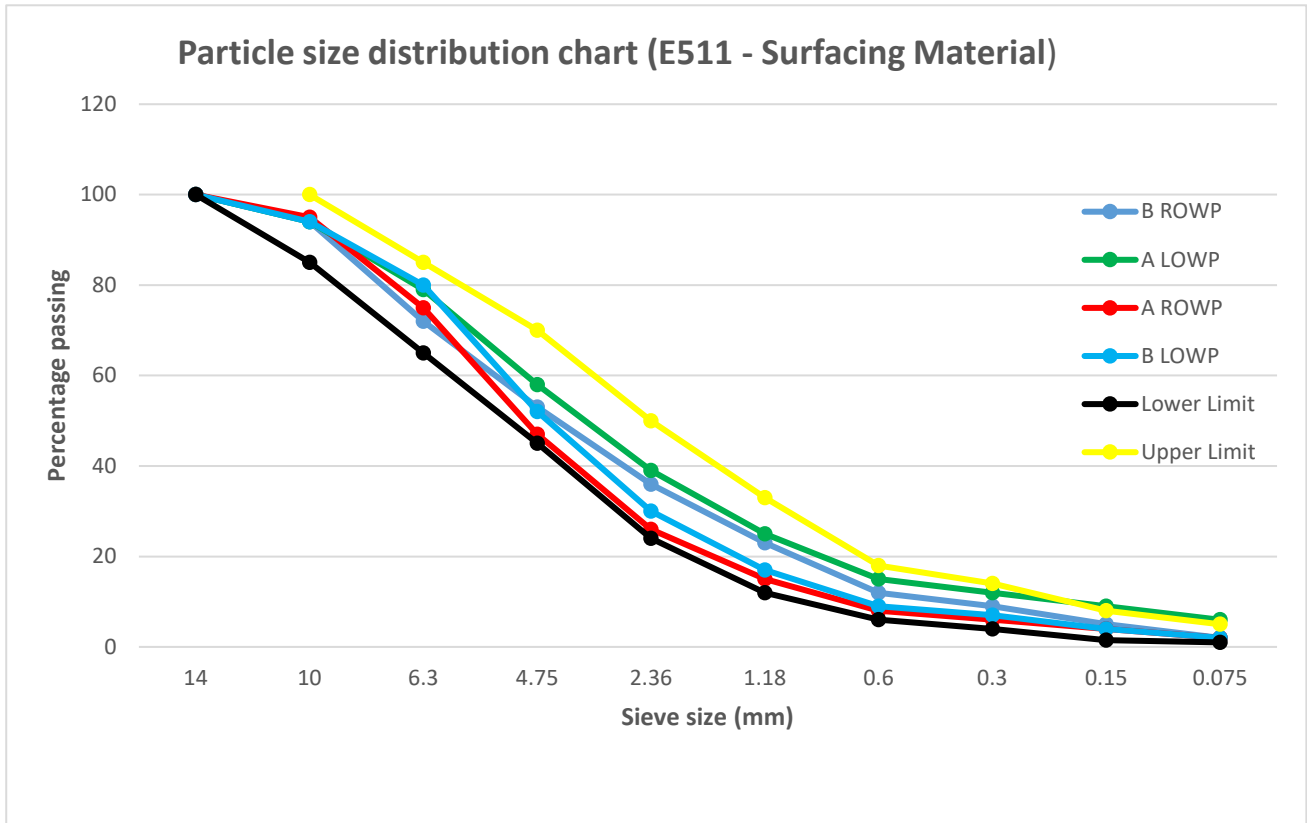
Figure 6-5: Particle size distribution for base material (E511)

The plots in Figure 6-5 show the particle size distribution for the surface layer. The surfacing materials fit within specification envelope. The specification is obtained from LVSR Pavement Design Guidelines.
