# AIRCRAFT ACCIDENT REPORT 1/2020

Report on the accident to  
**Piper PA-46-310P Malibu, N264DB**  
22 nm north-north-west of Guernsey  
on 21 January 2019

## Air Accidents Investigation Branch

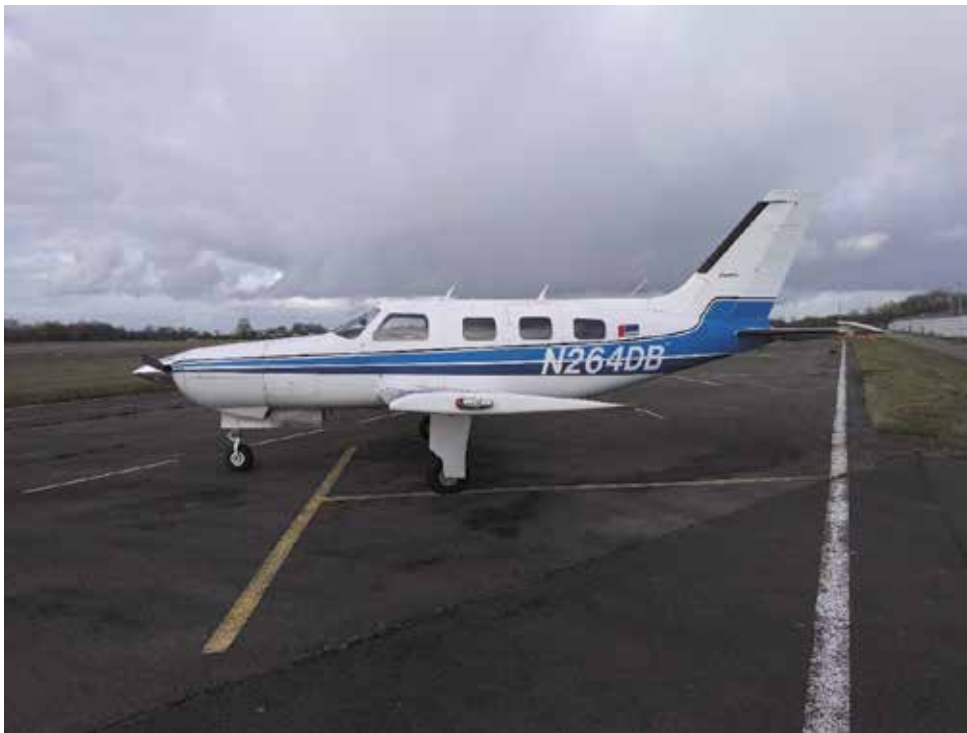
**Figure 1**

N264DB on the ground at Nantes prior to the flight

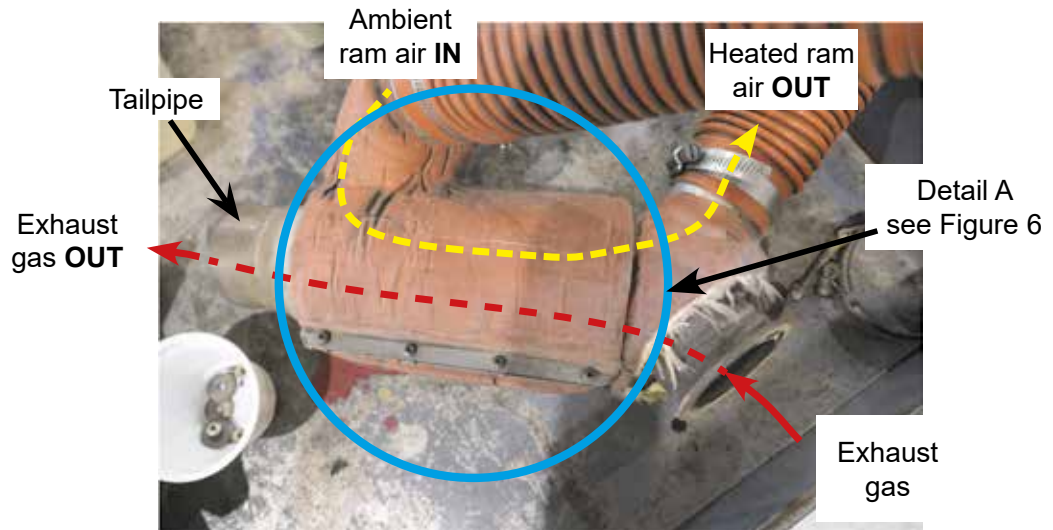
**Figure 5**

A heater muff is attached via spot welds to the right exhaust tailpipe. Ram air ducting and a removable shroud are placed over the heater muff to provide hot air for cabin conditioning (Figure 5). The shroud is secured in place by four fasteners. Figure 6 shows another tailpipe from a PA-46-310P aircraft with the shroud unfastened and slid to the end of the tailpipe to allow it to be inspected. The 'heated ram air out' and 'exhaust gas in' ducts are spot welded and brazed onto the tailpipe and covered with a fixed cover.

Right tailpipe and heater assembly removed from a PA-46-310P aircraft

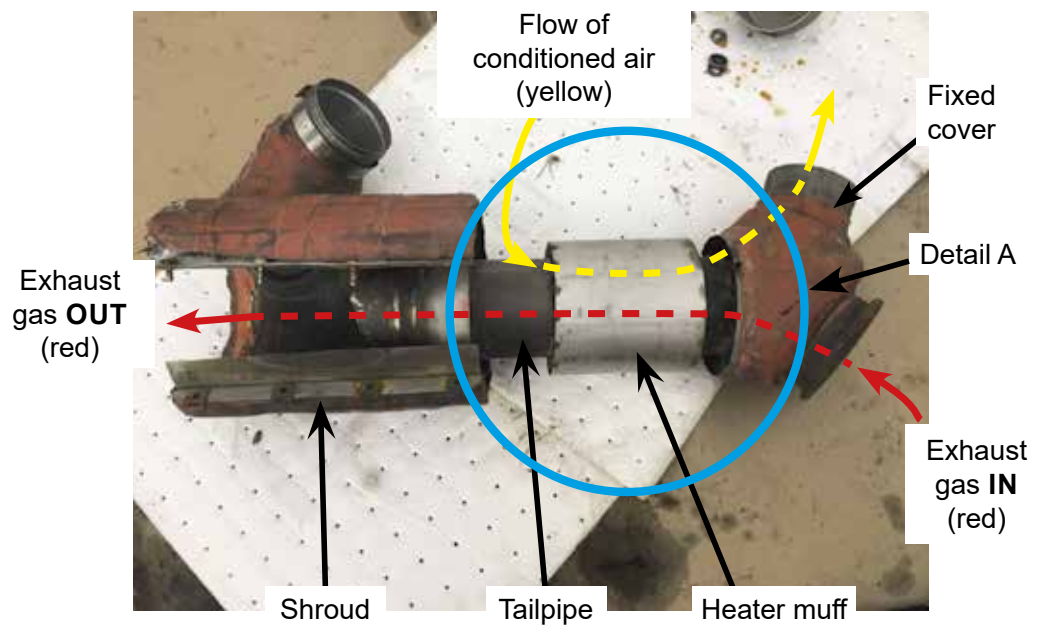
**Figure 6**

Ram air shroud removed from exhaust tailpipe / heater muff from a PA-46-310P tailpipe

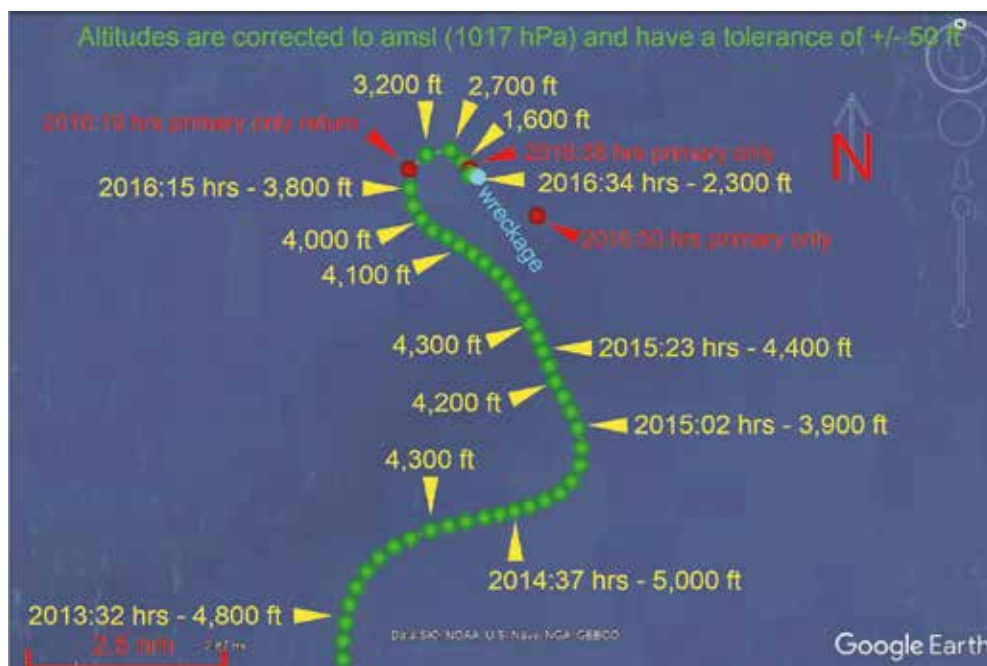
**Figure 12**

Radar track of final section of flight  
(created from a combination of data from  
Jersey (Les Platons) and Guernsey radars)

During the right and left turns which started at 2013:32 hrs (Figure 12), it was calculated that the aircraft's roll attitude reached maximums of about 36° right and 56° left. The pitch attitude reached about 10° nose up as the aircraft initially climbed at up to 3,000 fpm, and about 15° nose down as it descended at up to 5,000 fpm. The calculated airspeed also varied between about 150 KIAS and 200 KIAS during these manoeuvres.

At 2012 hrs, when the aircraft was about 11 nm north of Guernsey, ATC gave permission for the pilot to descend below FL50, and this was the last communication with him. Shortly afterwards (Figure 12), a right, followed by left turn was flown, during which the bank angle reached about 56°, while the aircraft descended, climbed and then descended again at a vertical speed of about 5,000 fpm. This series of turns lasted about 90 seconds, and it was likely that they were flown to remain in, or regain VMC, but they resulted in a flightpath that was unstable and inconsistent with normal cruise flight or with use of the autopilot. The investigation concluded that the aircraft was being flown manually during this period, which was shortly before it entered the final descending turn to the right.

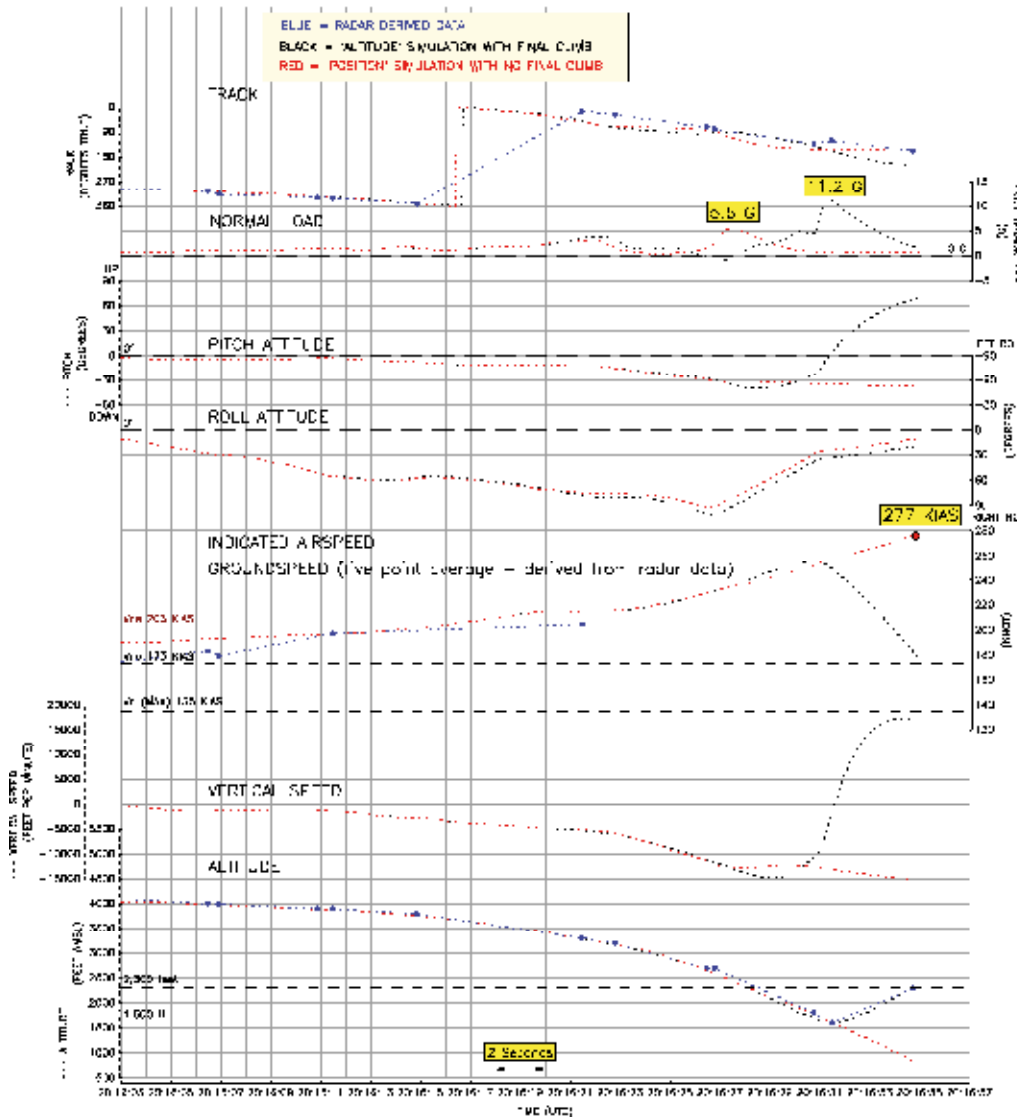
**Figure 22**

Estimated normal loads from simulations of final manoeuvre (commencing at 2016:03 hrs)

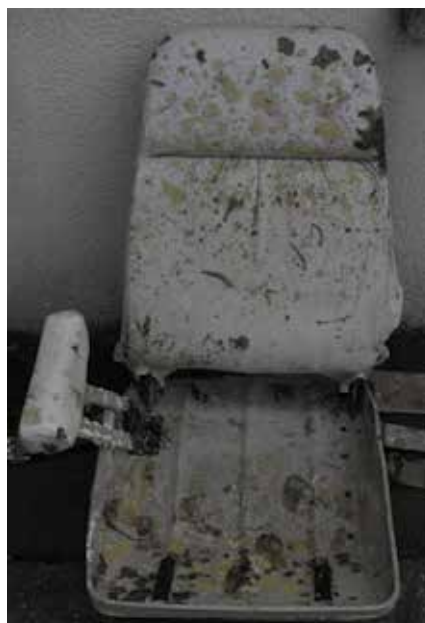
**Figure B-2**

On 26 September 2019, the crew of a trawler informed the French authorities that they had brought up what they believed to be an aircraft seat while conducting a trawl approximately 7 km to the west of the location of the main wreckage site. The seat was assessed by the AAIB as the left middle passenger seat from N264DB (Figure B-2).

Passenger seat from N264DB

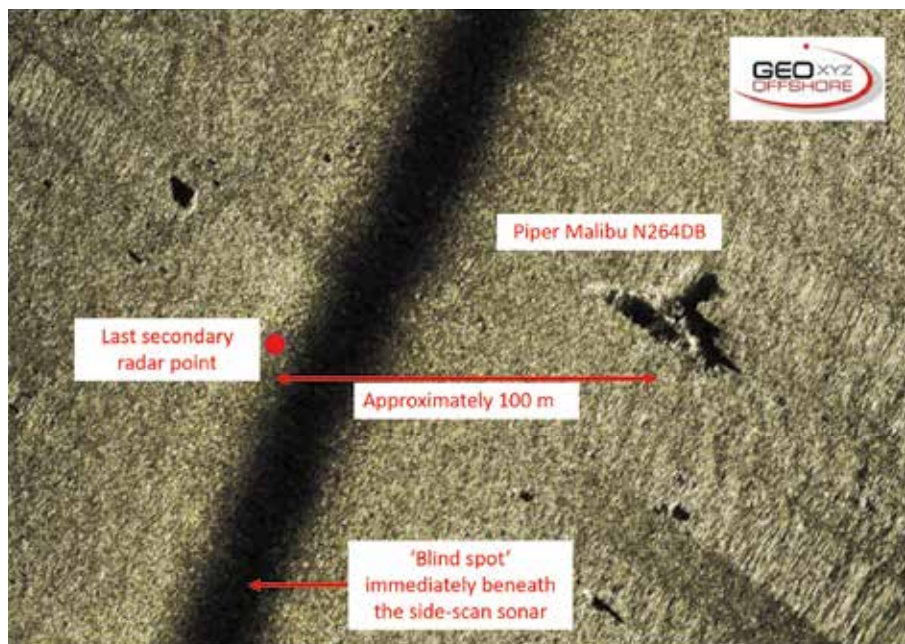
**Figure B-5**

Both vessels began their side-scan survey of the seabed on the morning of 3 February 2019. Early in the search, the FPV Morven identified an object of interest at a depth of approximately 68 m and cleared the immediate area. The Geo Ocean III subsequently used its own side-scan sonar to observe the object (Figure B-5).

Side-scan sonar image of N264DB

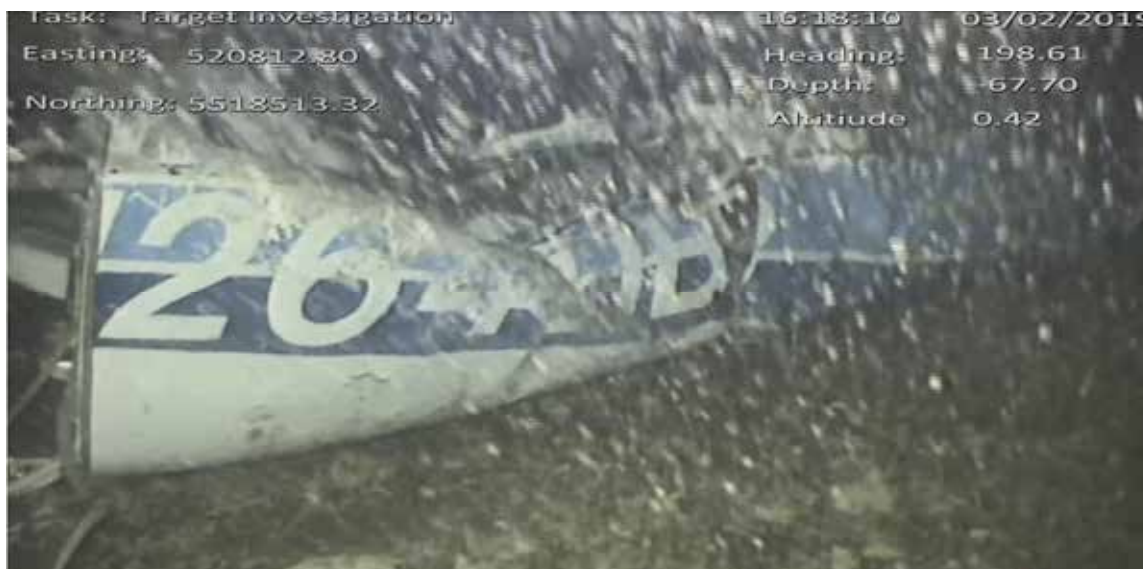
**Figure B-6**

The Geo Ocean III began a search of the seabed near the object of interest using its ROV, which was equipped with a video camera, and the object was identified as the wreckage of N264DB (Figure B-6).

Tail section of N264DB on seabed at a depth of 68 m

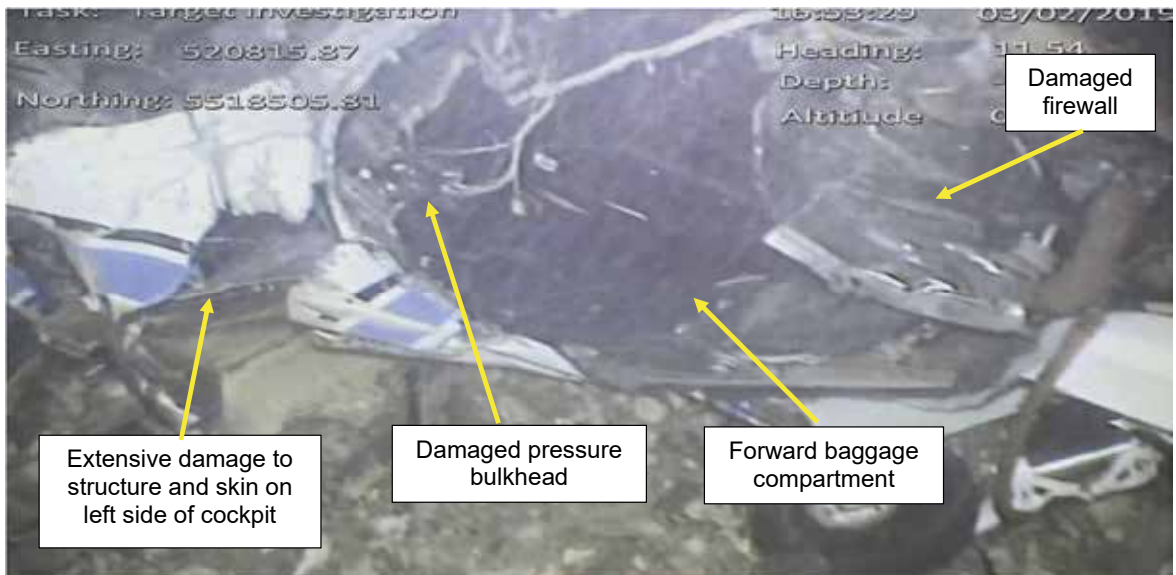
Figure B-9  
Forward of cockpit
