Report on the investigation of the collision between
the container vessel
ANL Wyong
and the gas carrier
King Arthur
in the approaches to Algeciras, Spain
on 4 August 2018

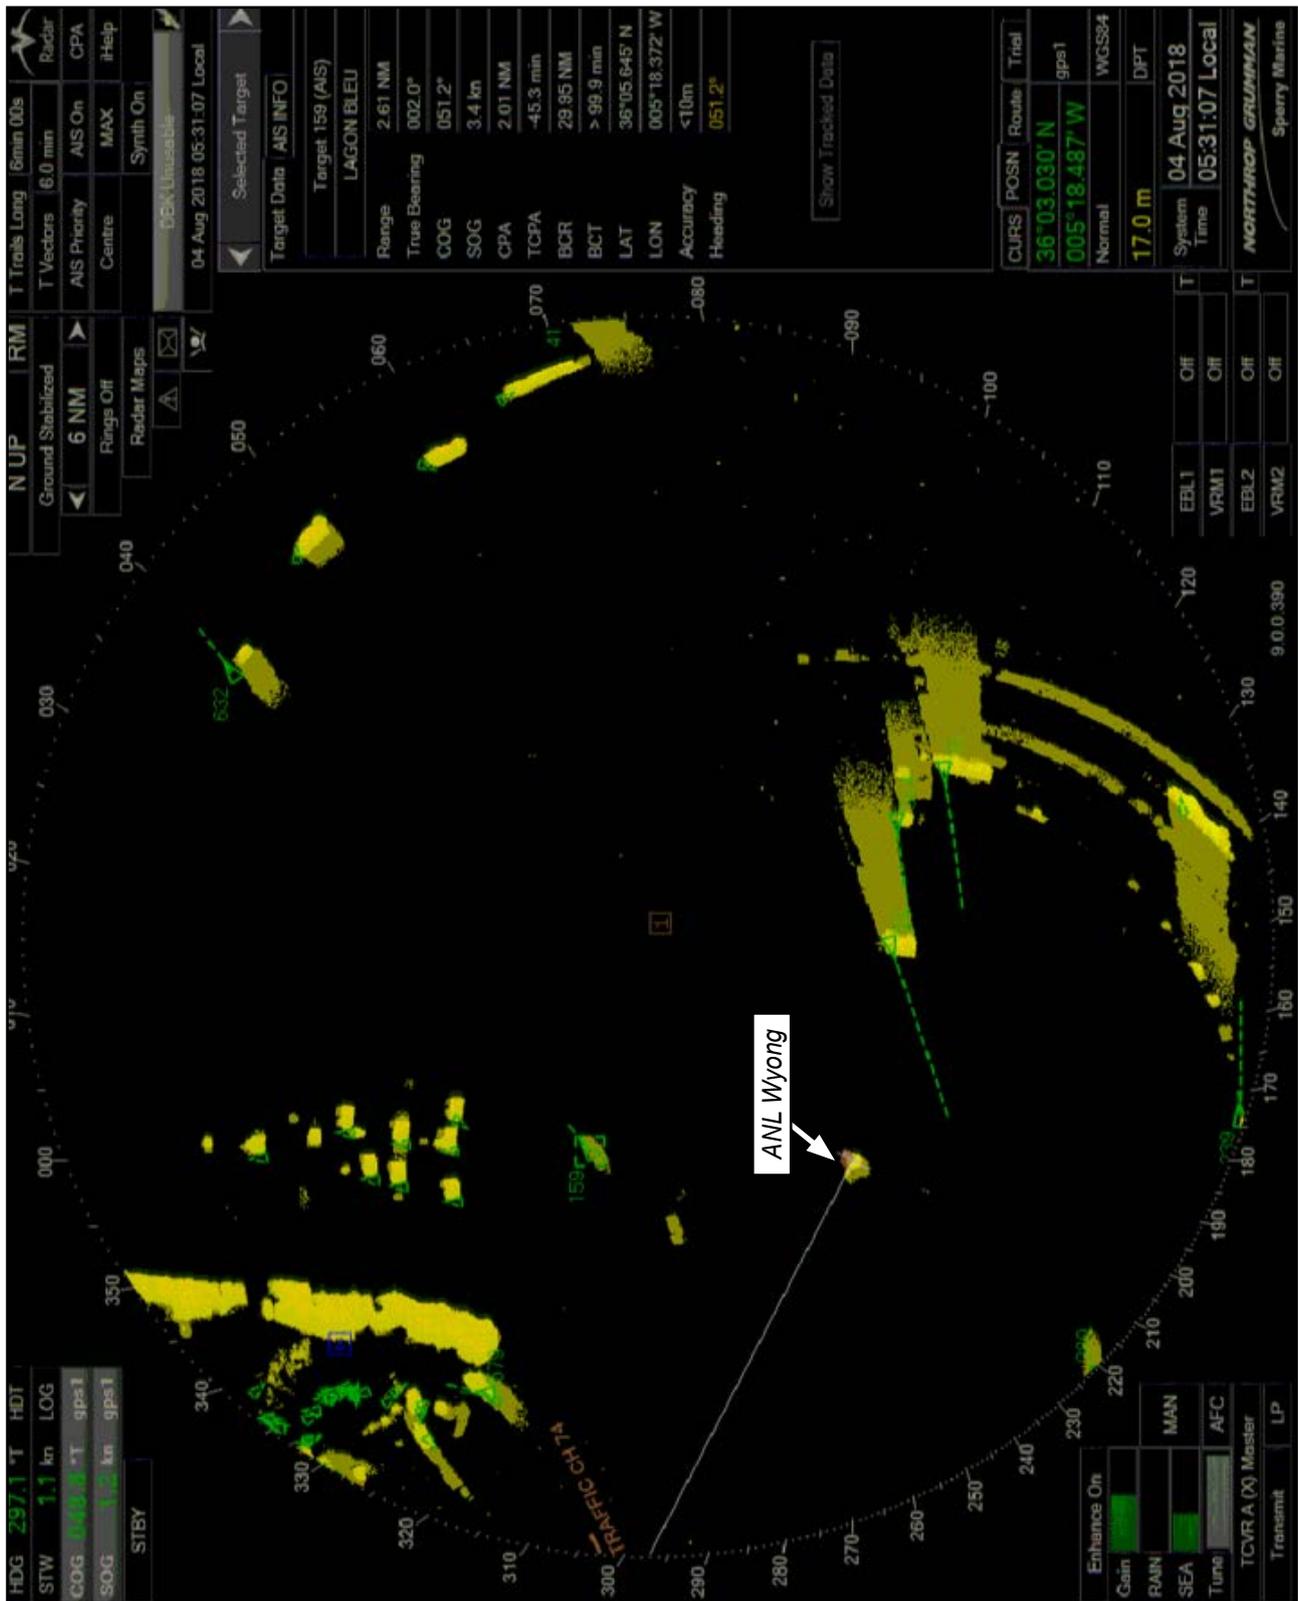
ANL Wyong arrived at the waiting position at 0521; the engine was then stopped but remained at immediate notice, upper deck lighting was switched on and the con was passed back to the OOW. In the waiting position, the traffic level was assessed as moderate with westbound shipping passing to the south. *ANL Wyong*'s radar picture at 0531 is at **Figure 3**; at this time, the vessel's heading was north-westerly,

Figure 3: *ANL Wyong*'s starboard radar display at 0531 showing shipping traffic levels prior to the master leaving the bridge

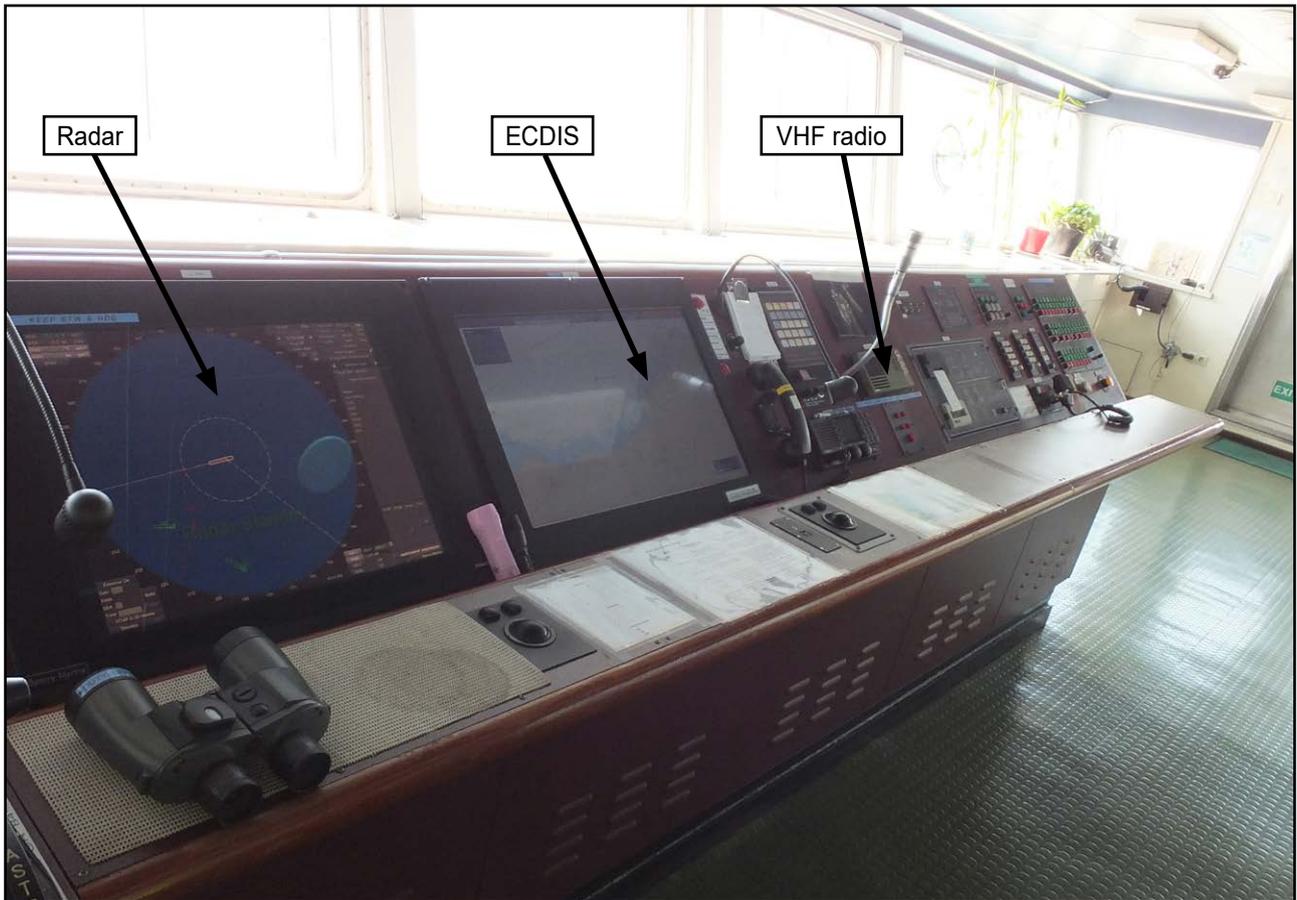
Figure 4: The starboard side of ANL Wyong's bridge console showing the radar and ECDIS displays in use by the OOW

ANL *Wyong*'s bridge console included two radar and two ECDIS displays. At the time of the accident, the OOW was monitoring the situation from the starboard side of the main console (**Figure 4**). The radar system was capable of analysing target data using both AIS and automatic radar plotting aid (ARPA) information; the OOW's radar display was set to prioritise AIS information.

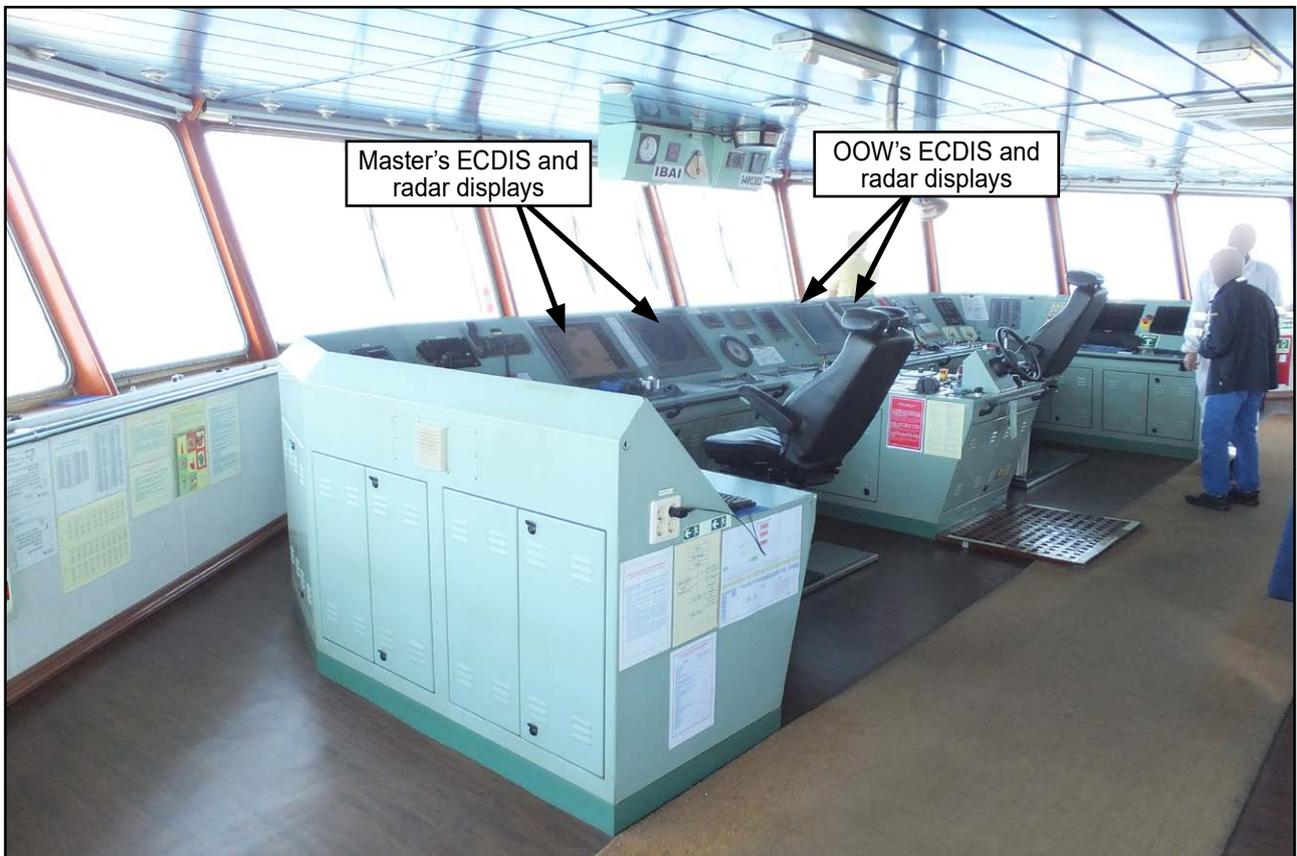
Figure 5: King Arthur's bridge horseshoe arrangement showing the displays in use by the master and OOW

King Arthur's bridge layout was a horseshoe arrangement (**Figure 5**) with a central console for propulsion controls and two independent radar and ECDIS displays either side; both radars integrated ARPA and AIS data. The master was conning from the port side of the horseshoe and the chief officer was monitoring on the starboard side. *King Arthur's* voyage data recorder (VDR) only recorded the radar picture on the starboard side of the bridge. Consequently, only the settings of

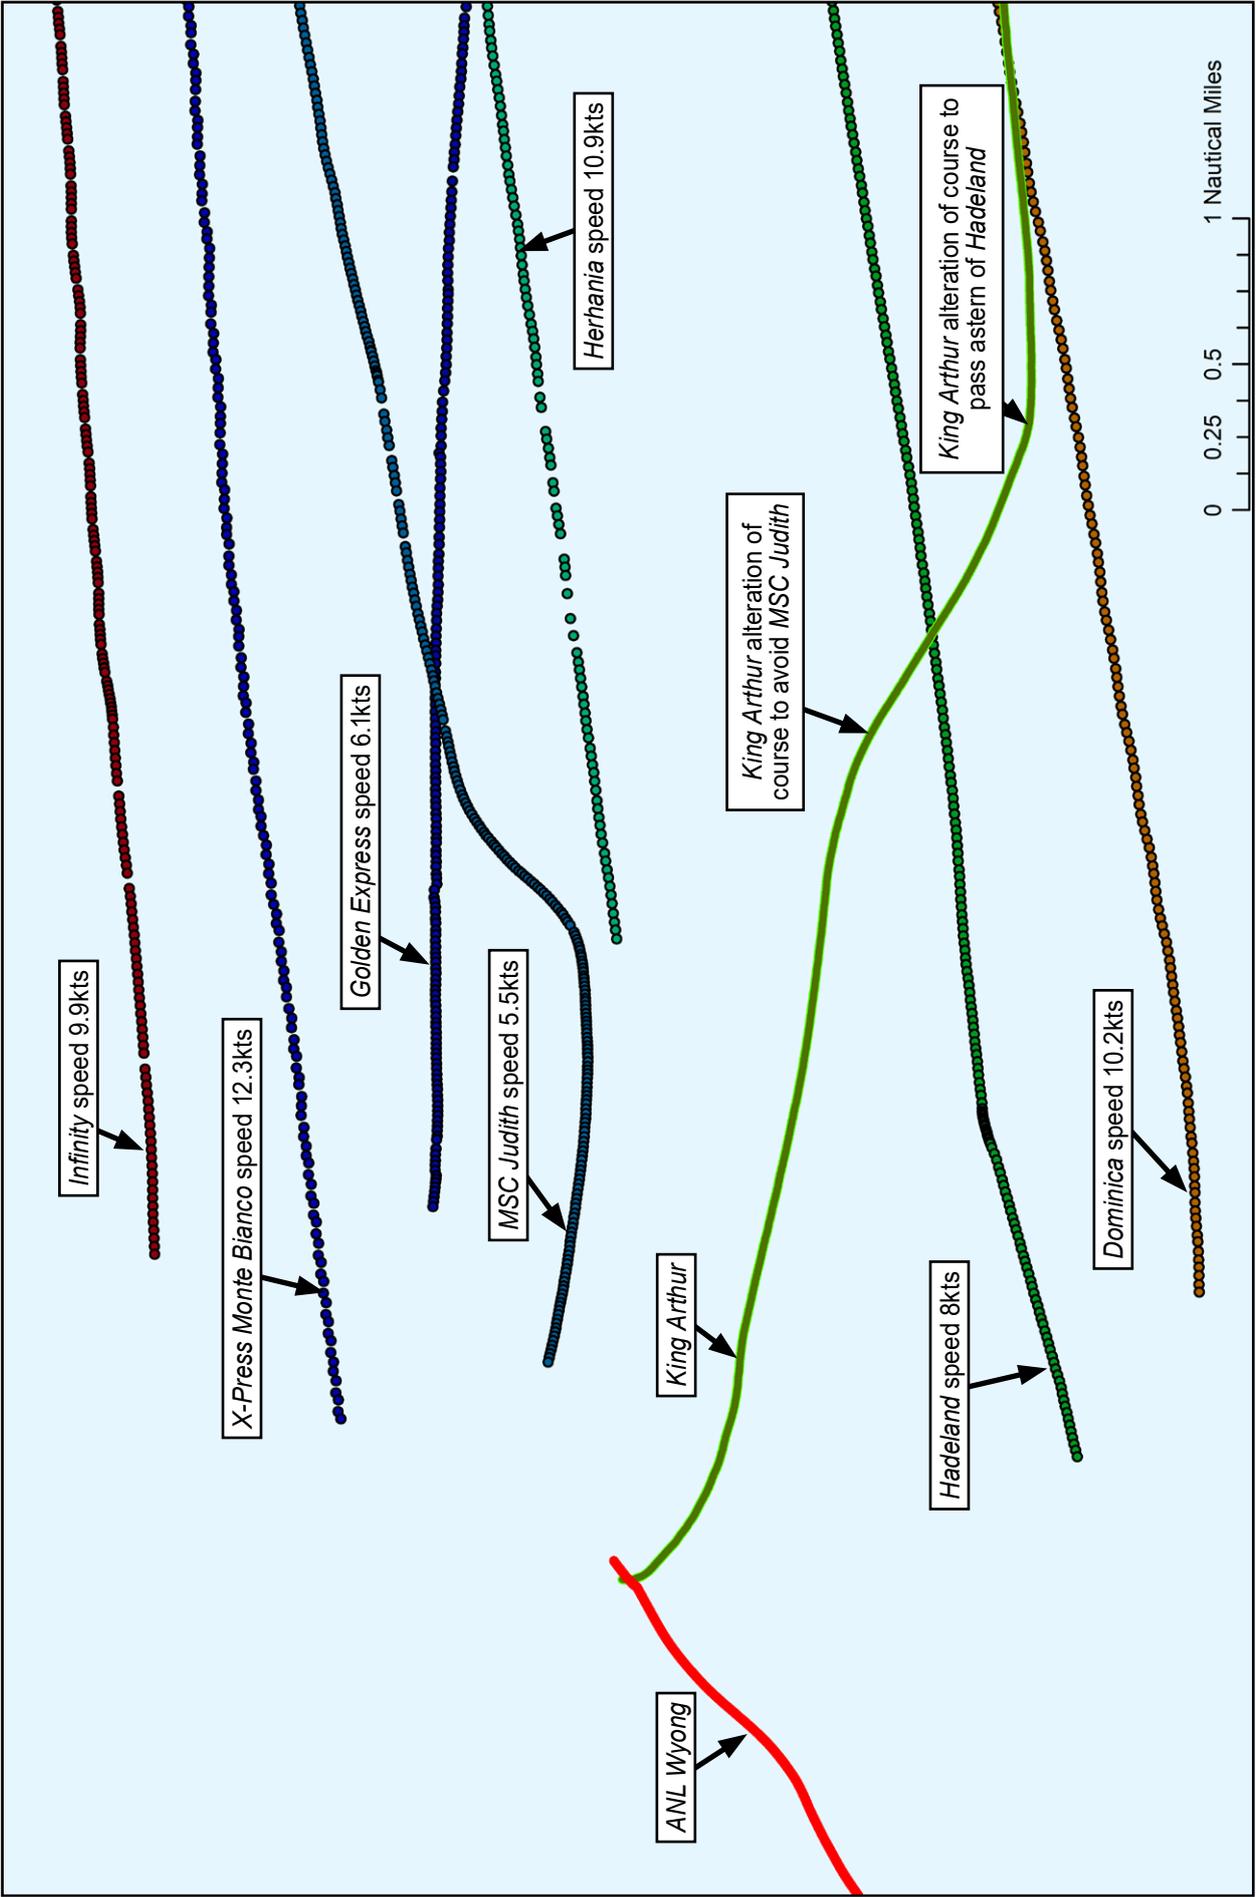
During this conversation, *King Arthur's* master commenced a slow turn to port with the vessel settling on a new heading of 275°; the aim of this alteration was to keep clear of *MSC Judith* (**Figure 6**).

Figure 6: Tracks of eight closest vessels proceeding towards ANL Wyong and showing King Arthur's heading alterations

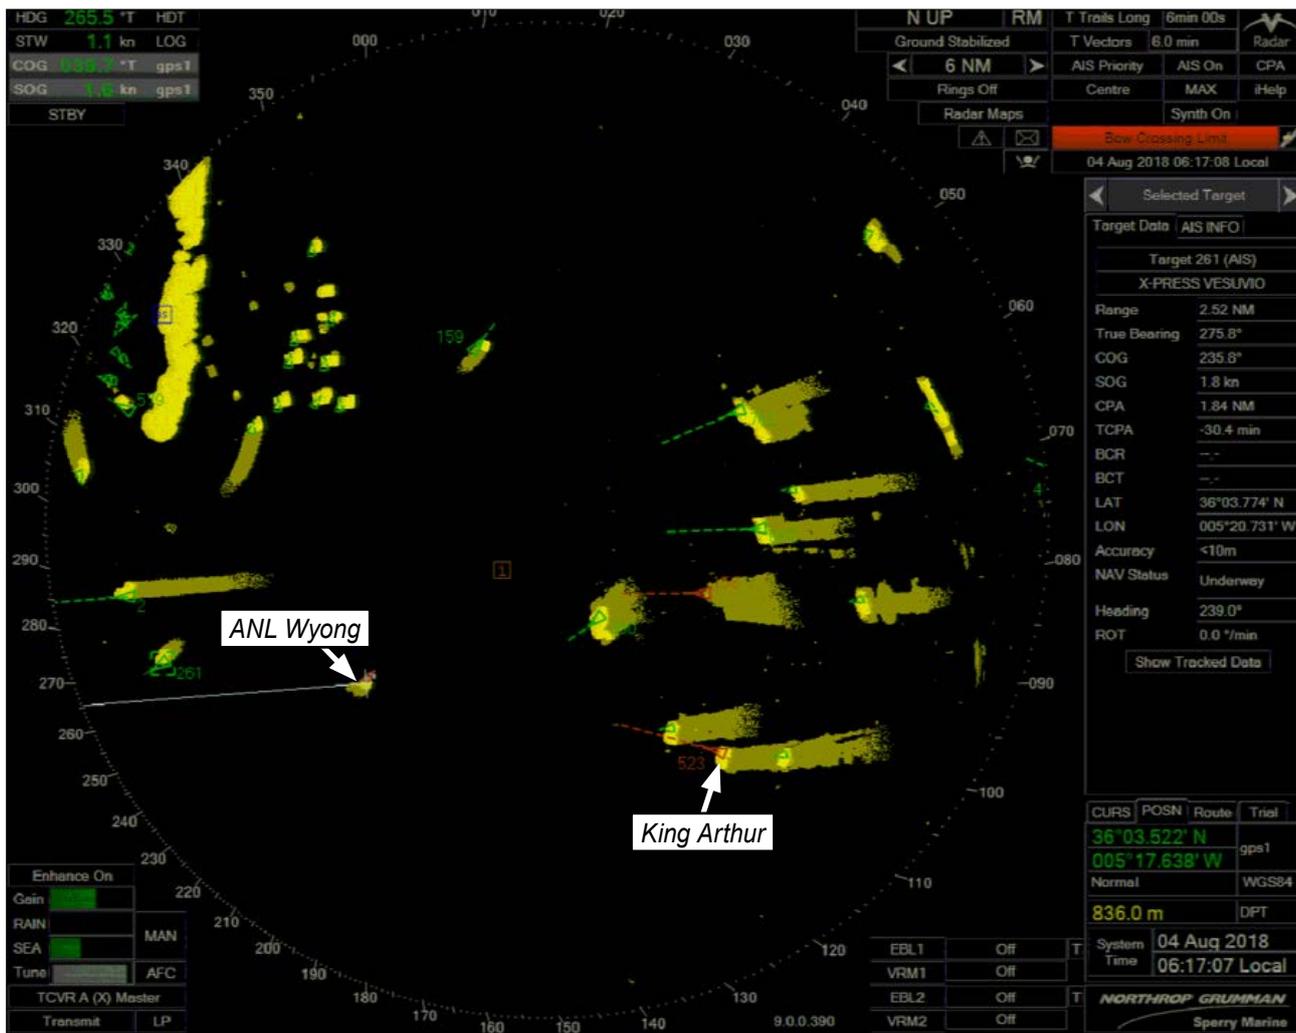
Figure 7: ANL Wyong's starboard radar display at 0617 showing nine radar contacts approaching from the east

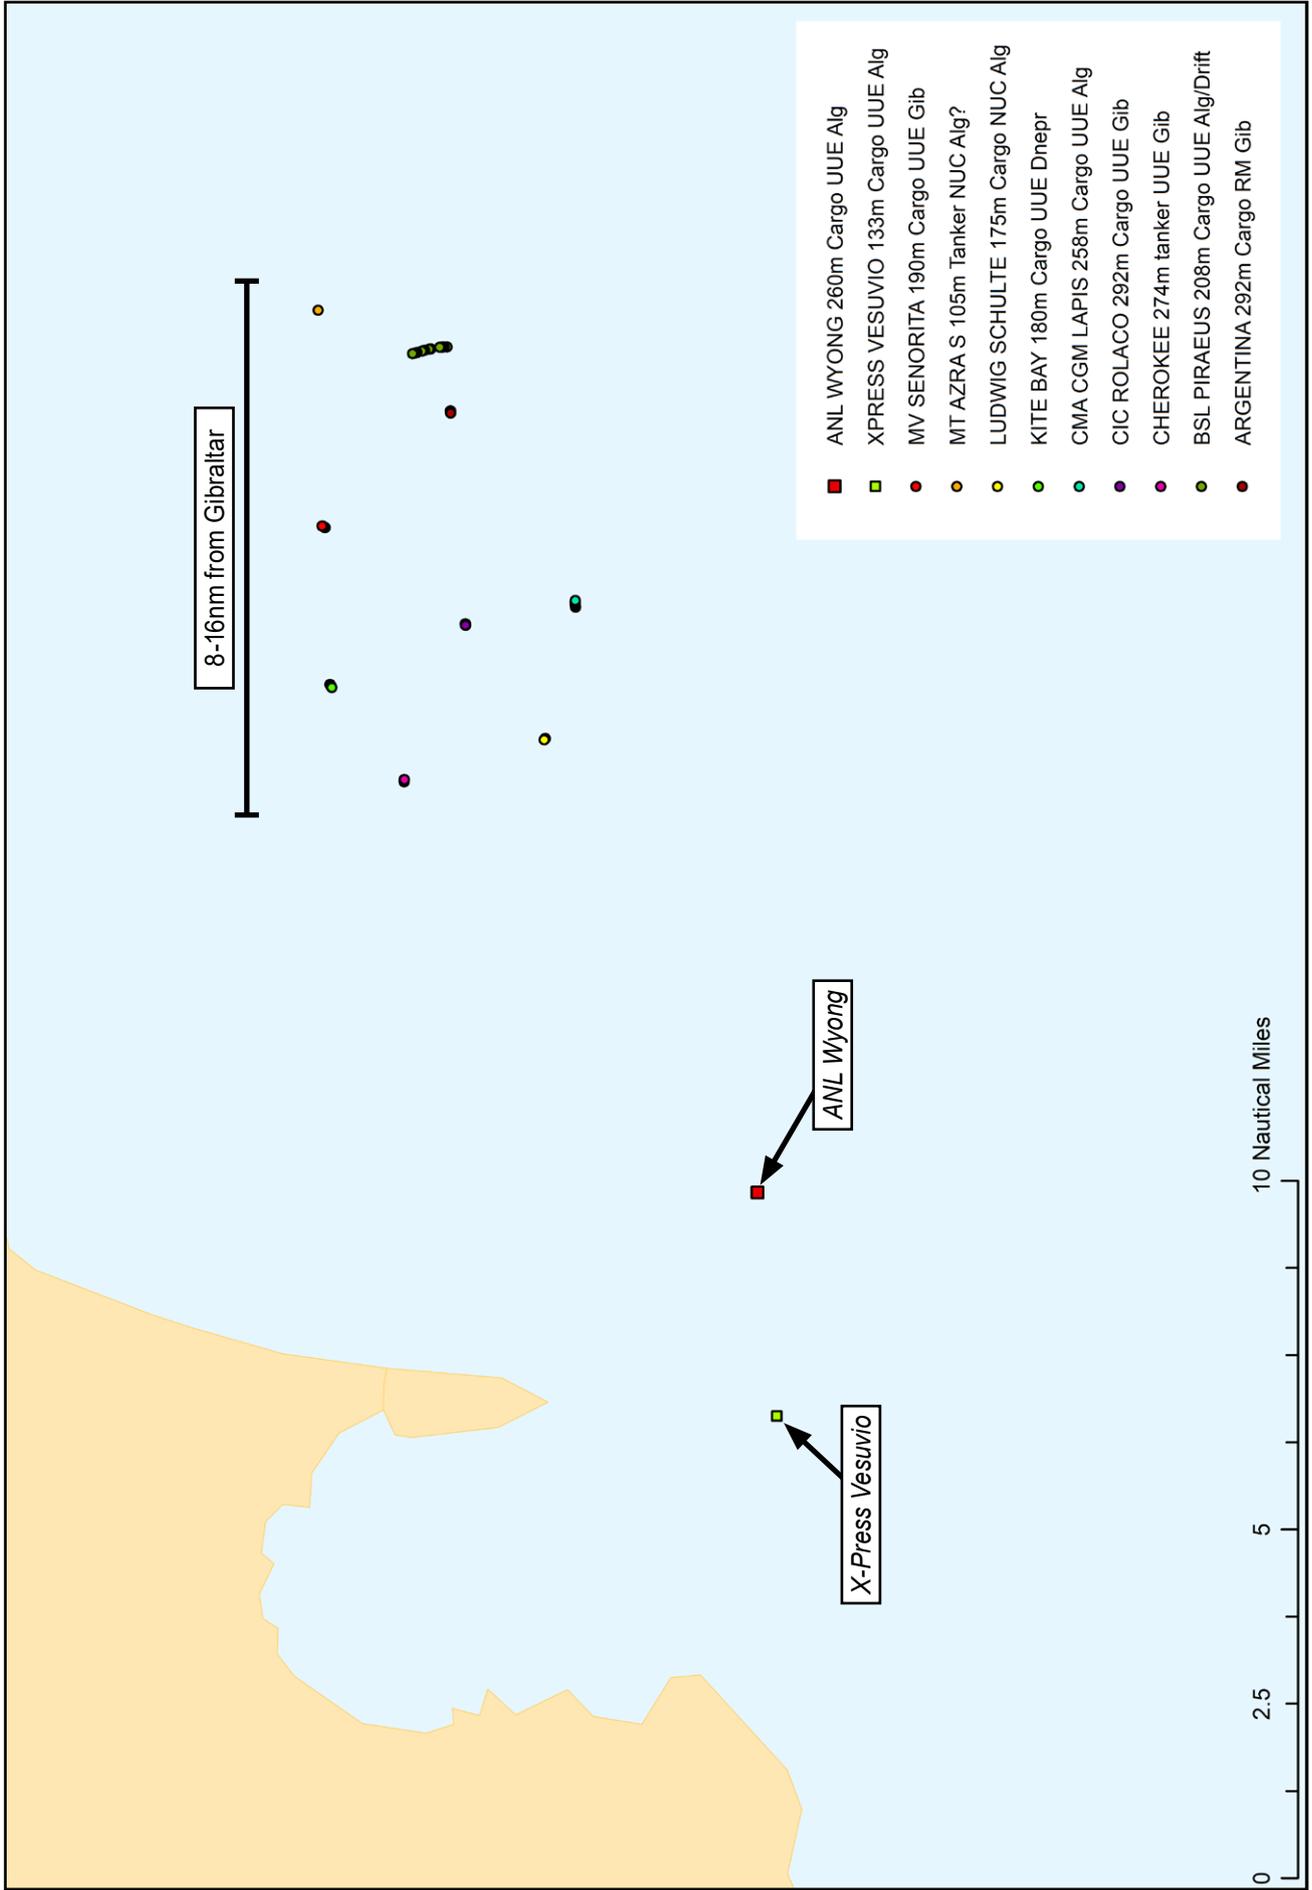
At the time of the accident, AIS data showed that there were 11 vessels outside Gibraltar Bay waiting to enter either Algeciras or Gibraltar (**Figure 15**). The majority of these vessels were between 8nm and 16nm east of Gibraltar and one vessel, the container ship *Xpress Vesuvio*, was nearby *ANL Wyong*. The AIS information being transmitted by these vessels is at **Table 4**.

Figure 15: AIS data for 11 vessels waiting outside Gibraltar Bay at the time of the accident
