MARINE ACCIDENT INVESTIGATION BRANCH

Summary of Investigations No 1/92

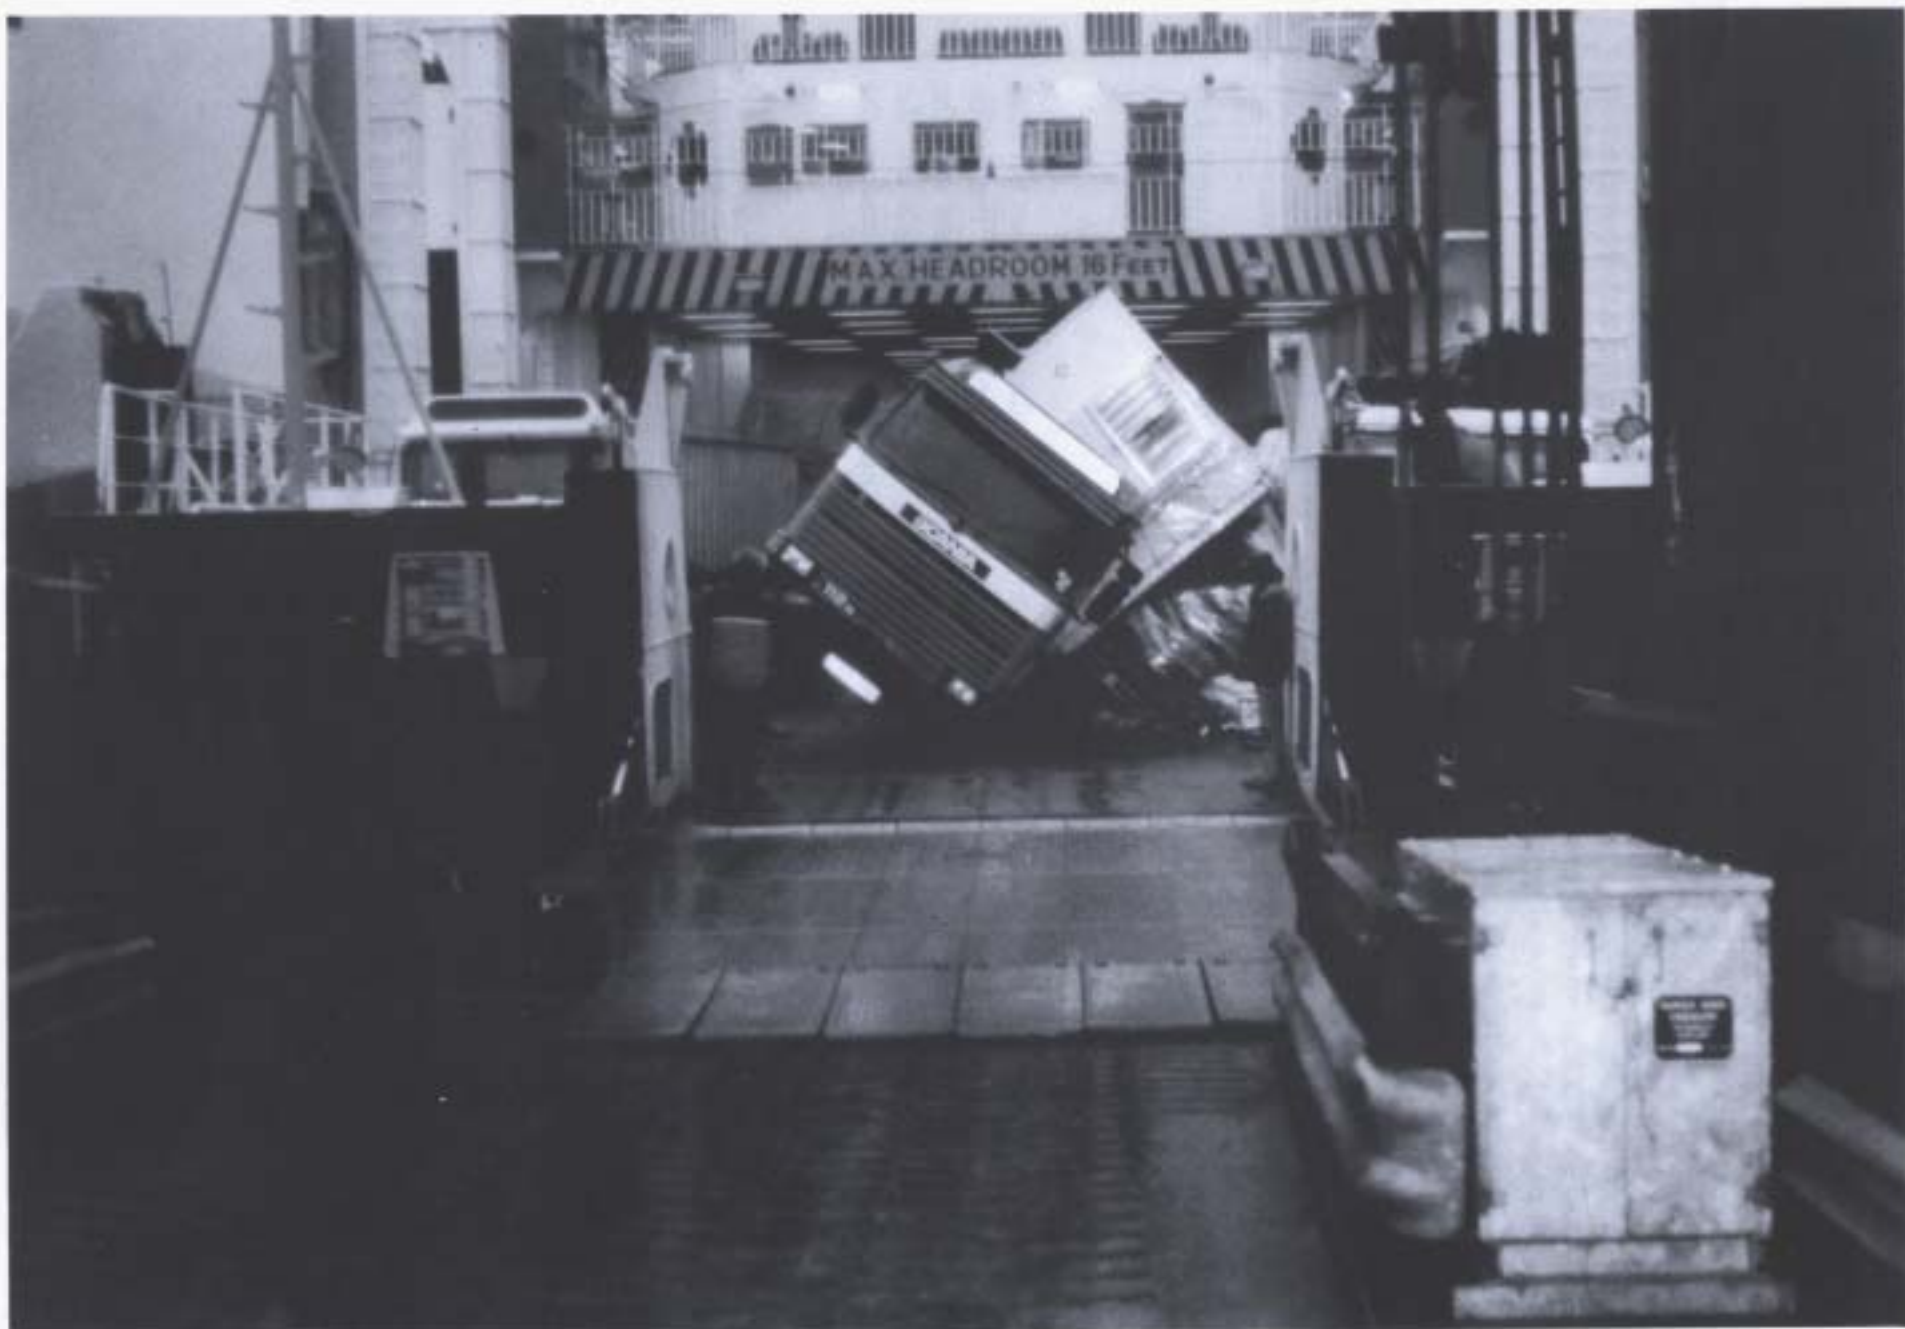
5. The Code recommends that when carrying cargo on flats, it is effectively secured, preferably with chains or webbing fitted with tightening devices; rope is not recommended.

6. The correct declaration of cargo is essential to ensure that proper securing arrangements are made.

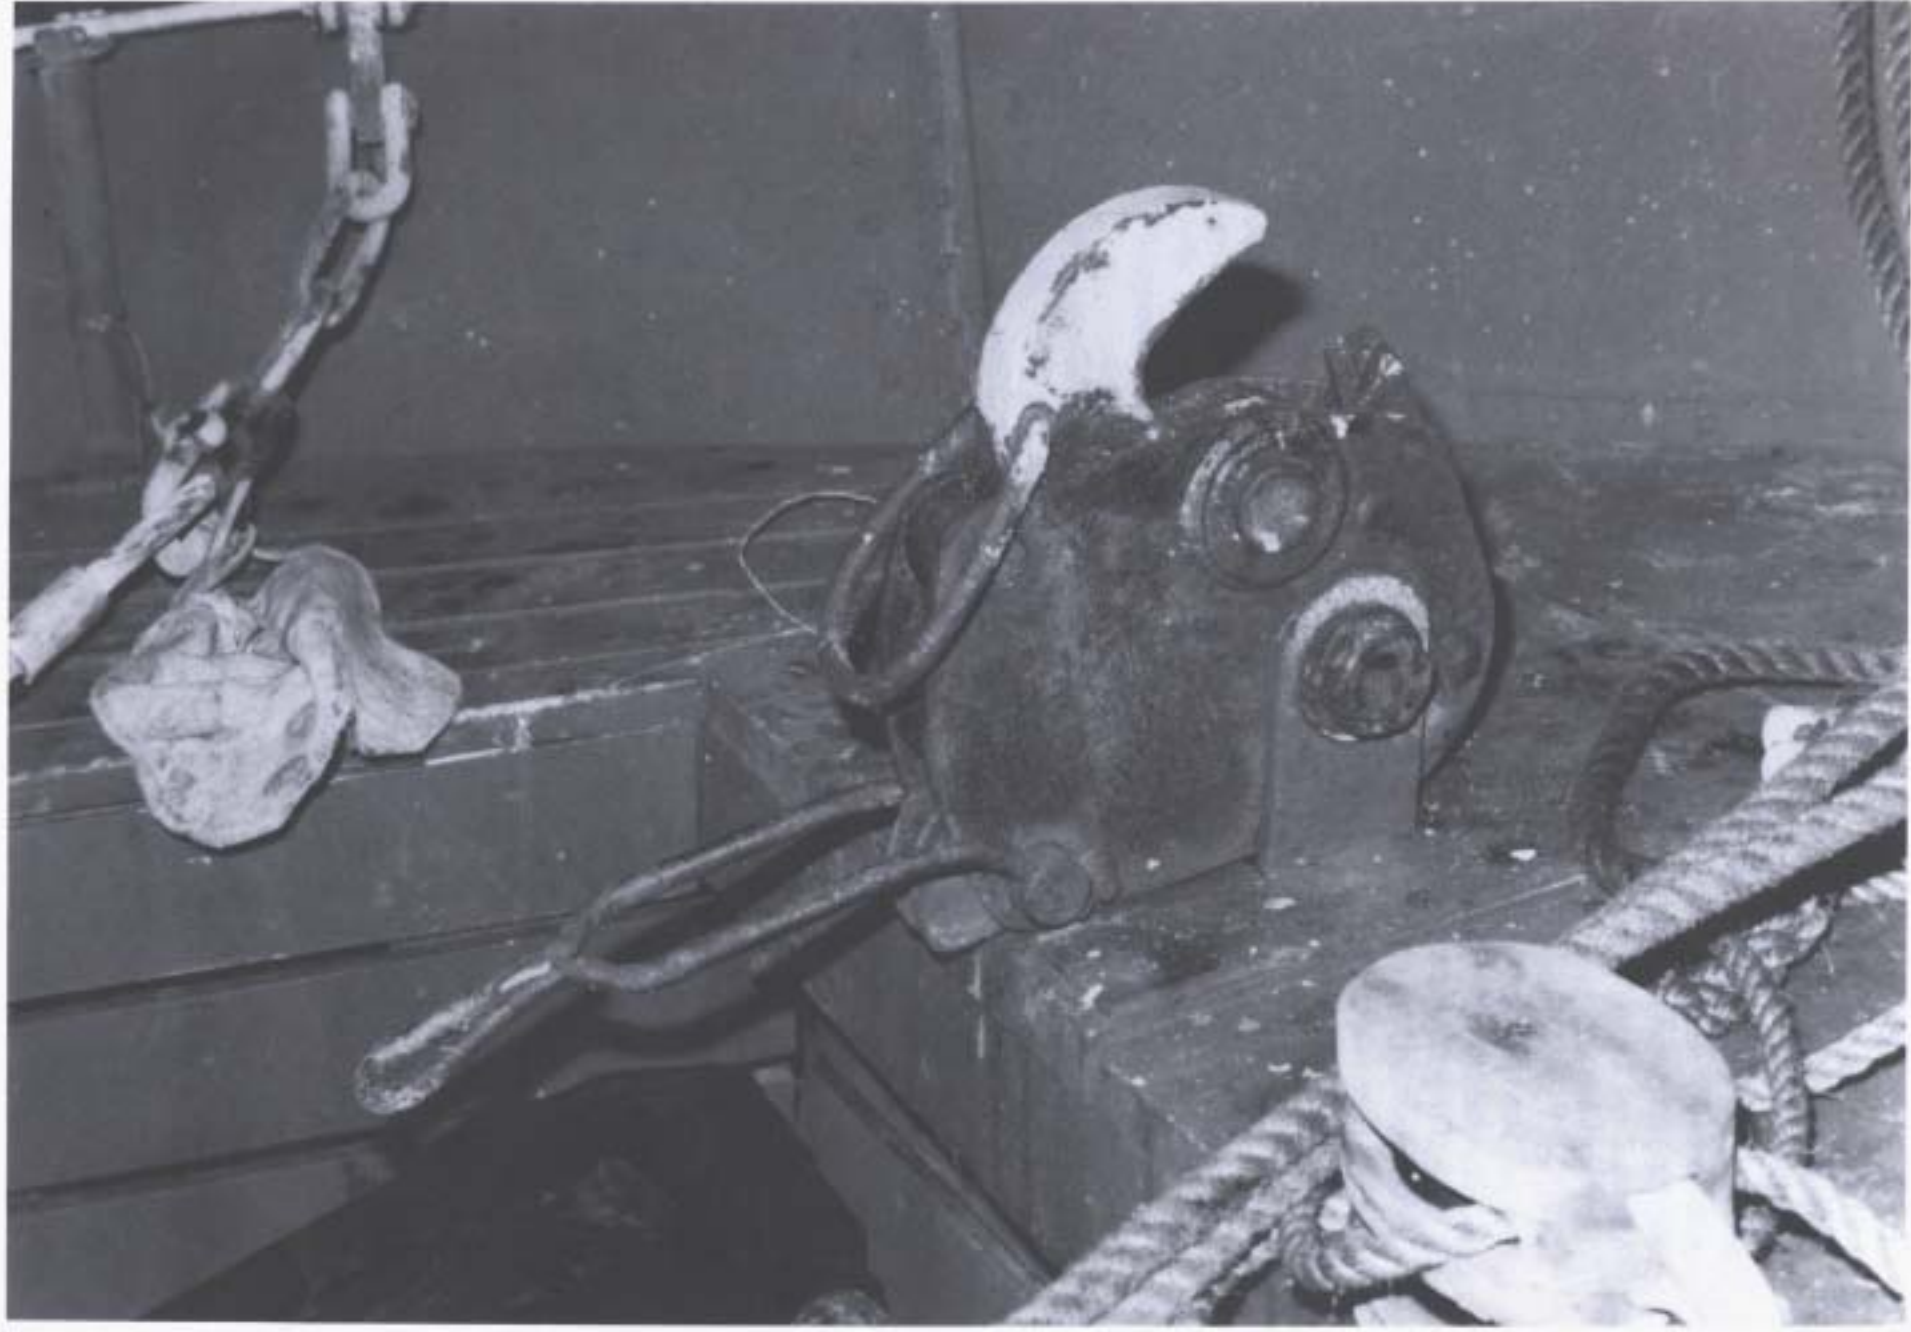
Only disengaging gears approved by the Marine Directorate of the Department of Transport as detailed under Merchant Shipping Notice No M.1440 should be installed. This allows disengaging gear approved directly by the Department of Transport or other gear if it can be shown that it has been approved by an Administration or recognised Classification Society in accordance with the requirements of the 1983 Amendments to the 1974 SOLAS Convention.

Instructions for the safe operation of disengaging gears should be available on board.

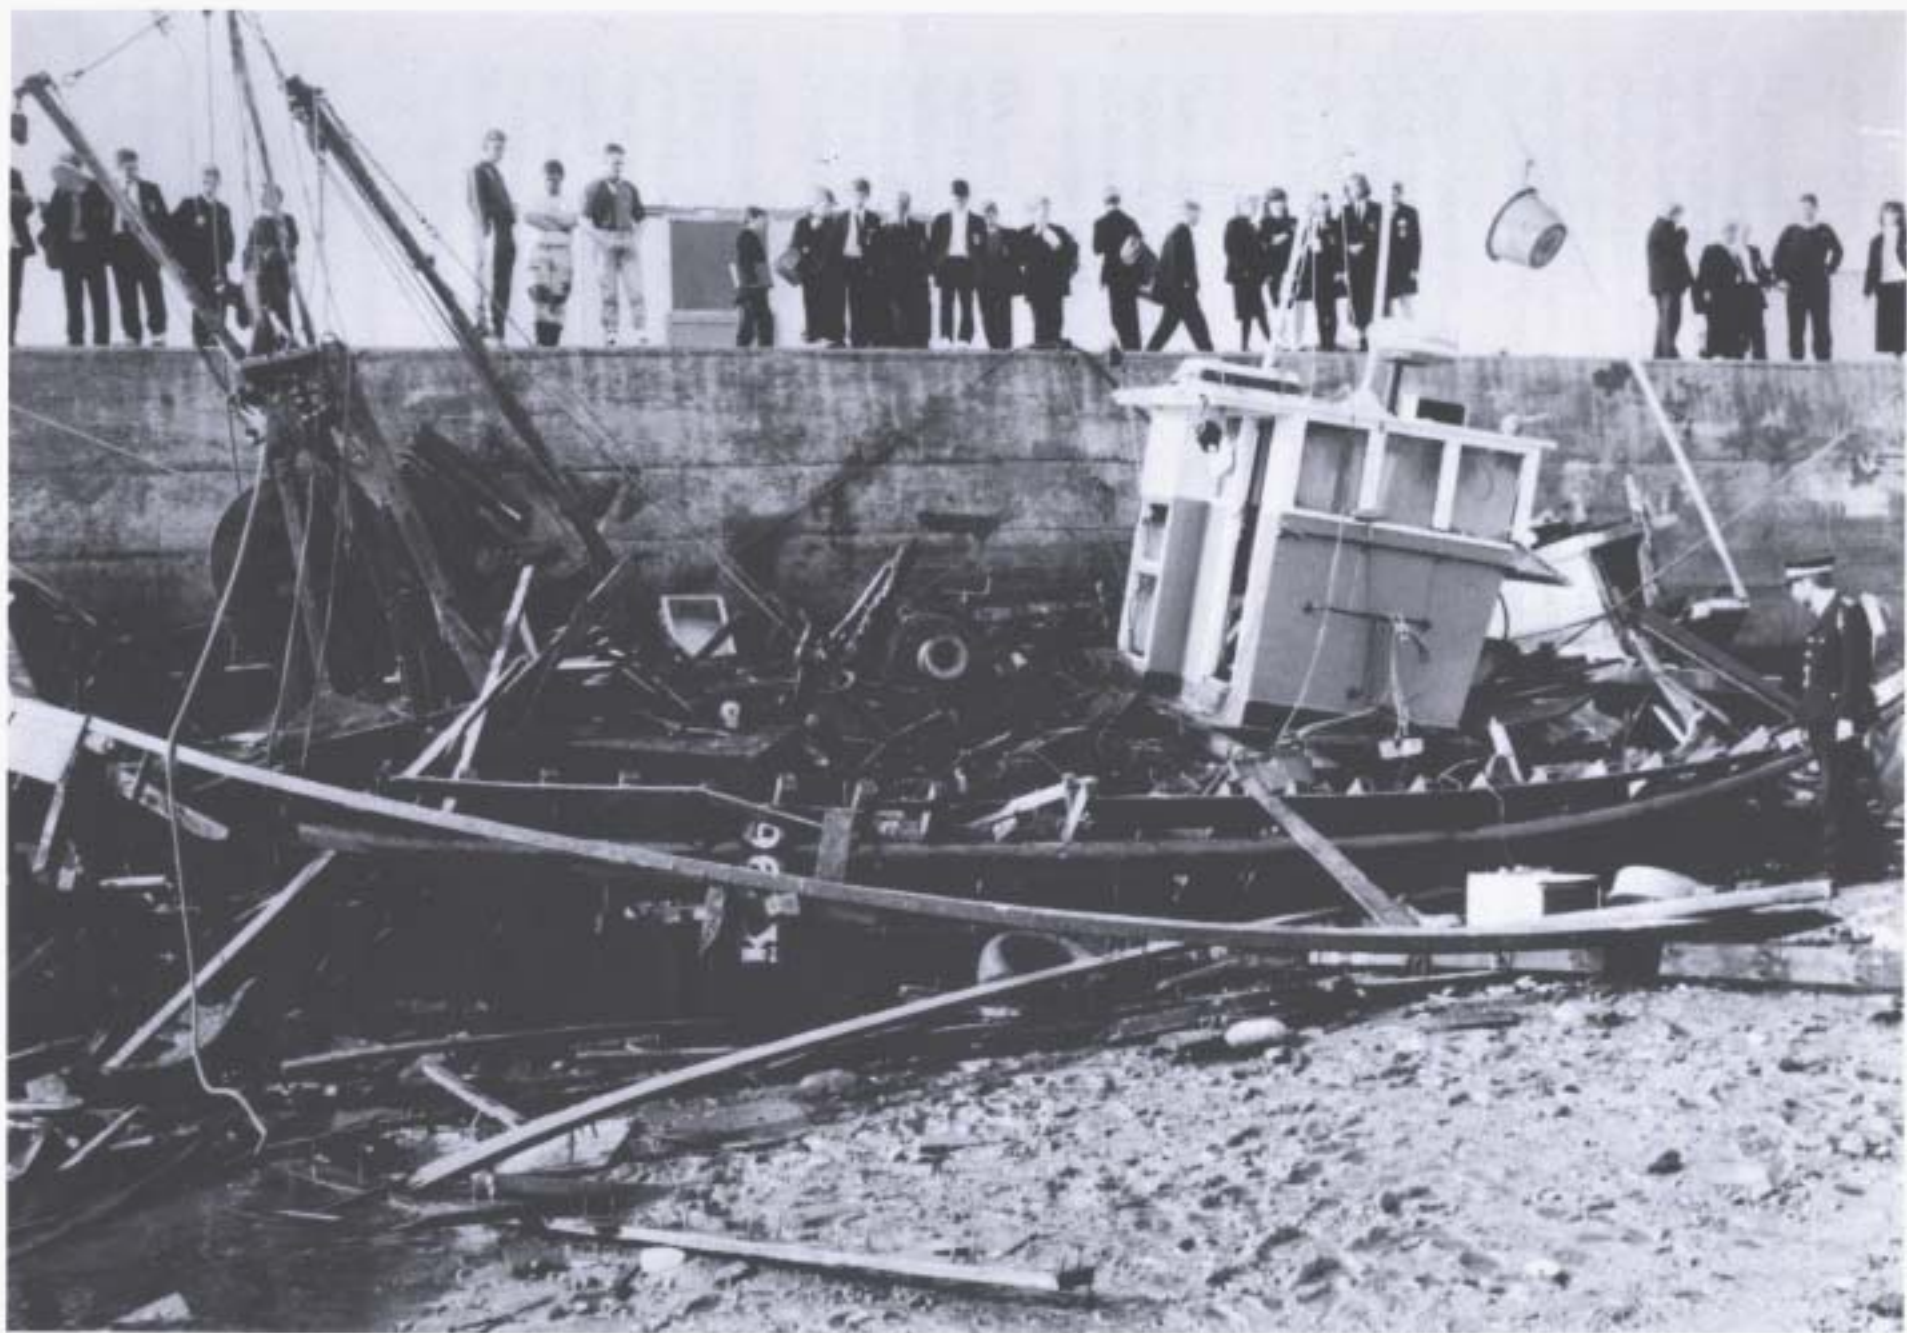
1. This type of incident well illustrates the dangers inherent in LPG domestic installations onboard vessels. Advice on the use of LPG and general comments on system installations is given in Merchant Shipping Notice No M.984. Additional advice is available in the DTp 1986 publication "Fishermen and Safety" - a guide to safe working practices for fisherman.
2. Routine inspection of the system pipework, the installation of a suitable gas detection unit and the use of the regulator isolation valve might have prevented this incident and the destruction of the vessel.
