# **MARINE ACCIDENT INVESTIGATION BRANCH**

## **Summary of Investigations No 3/94**

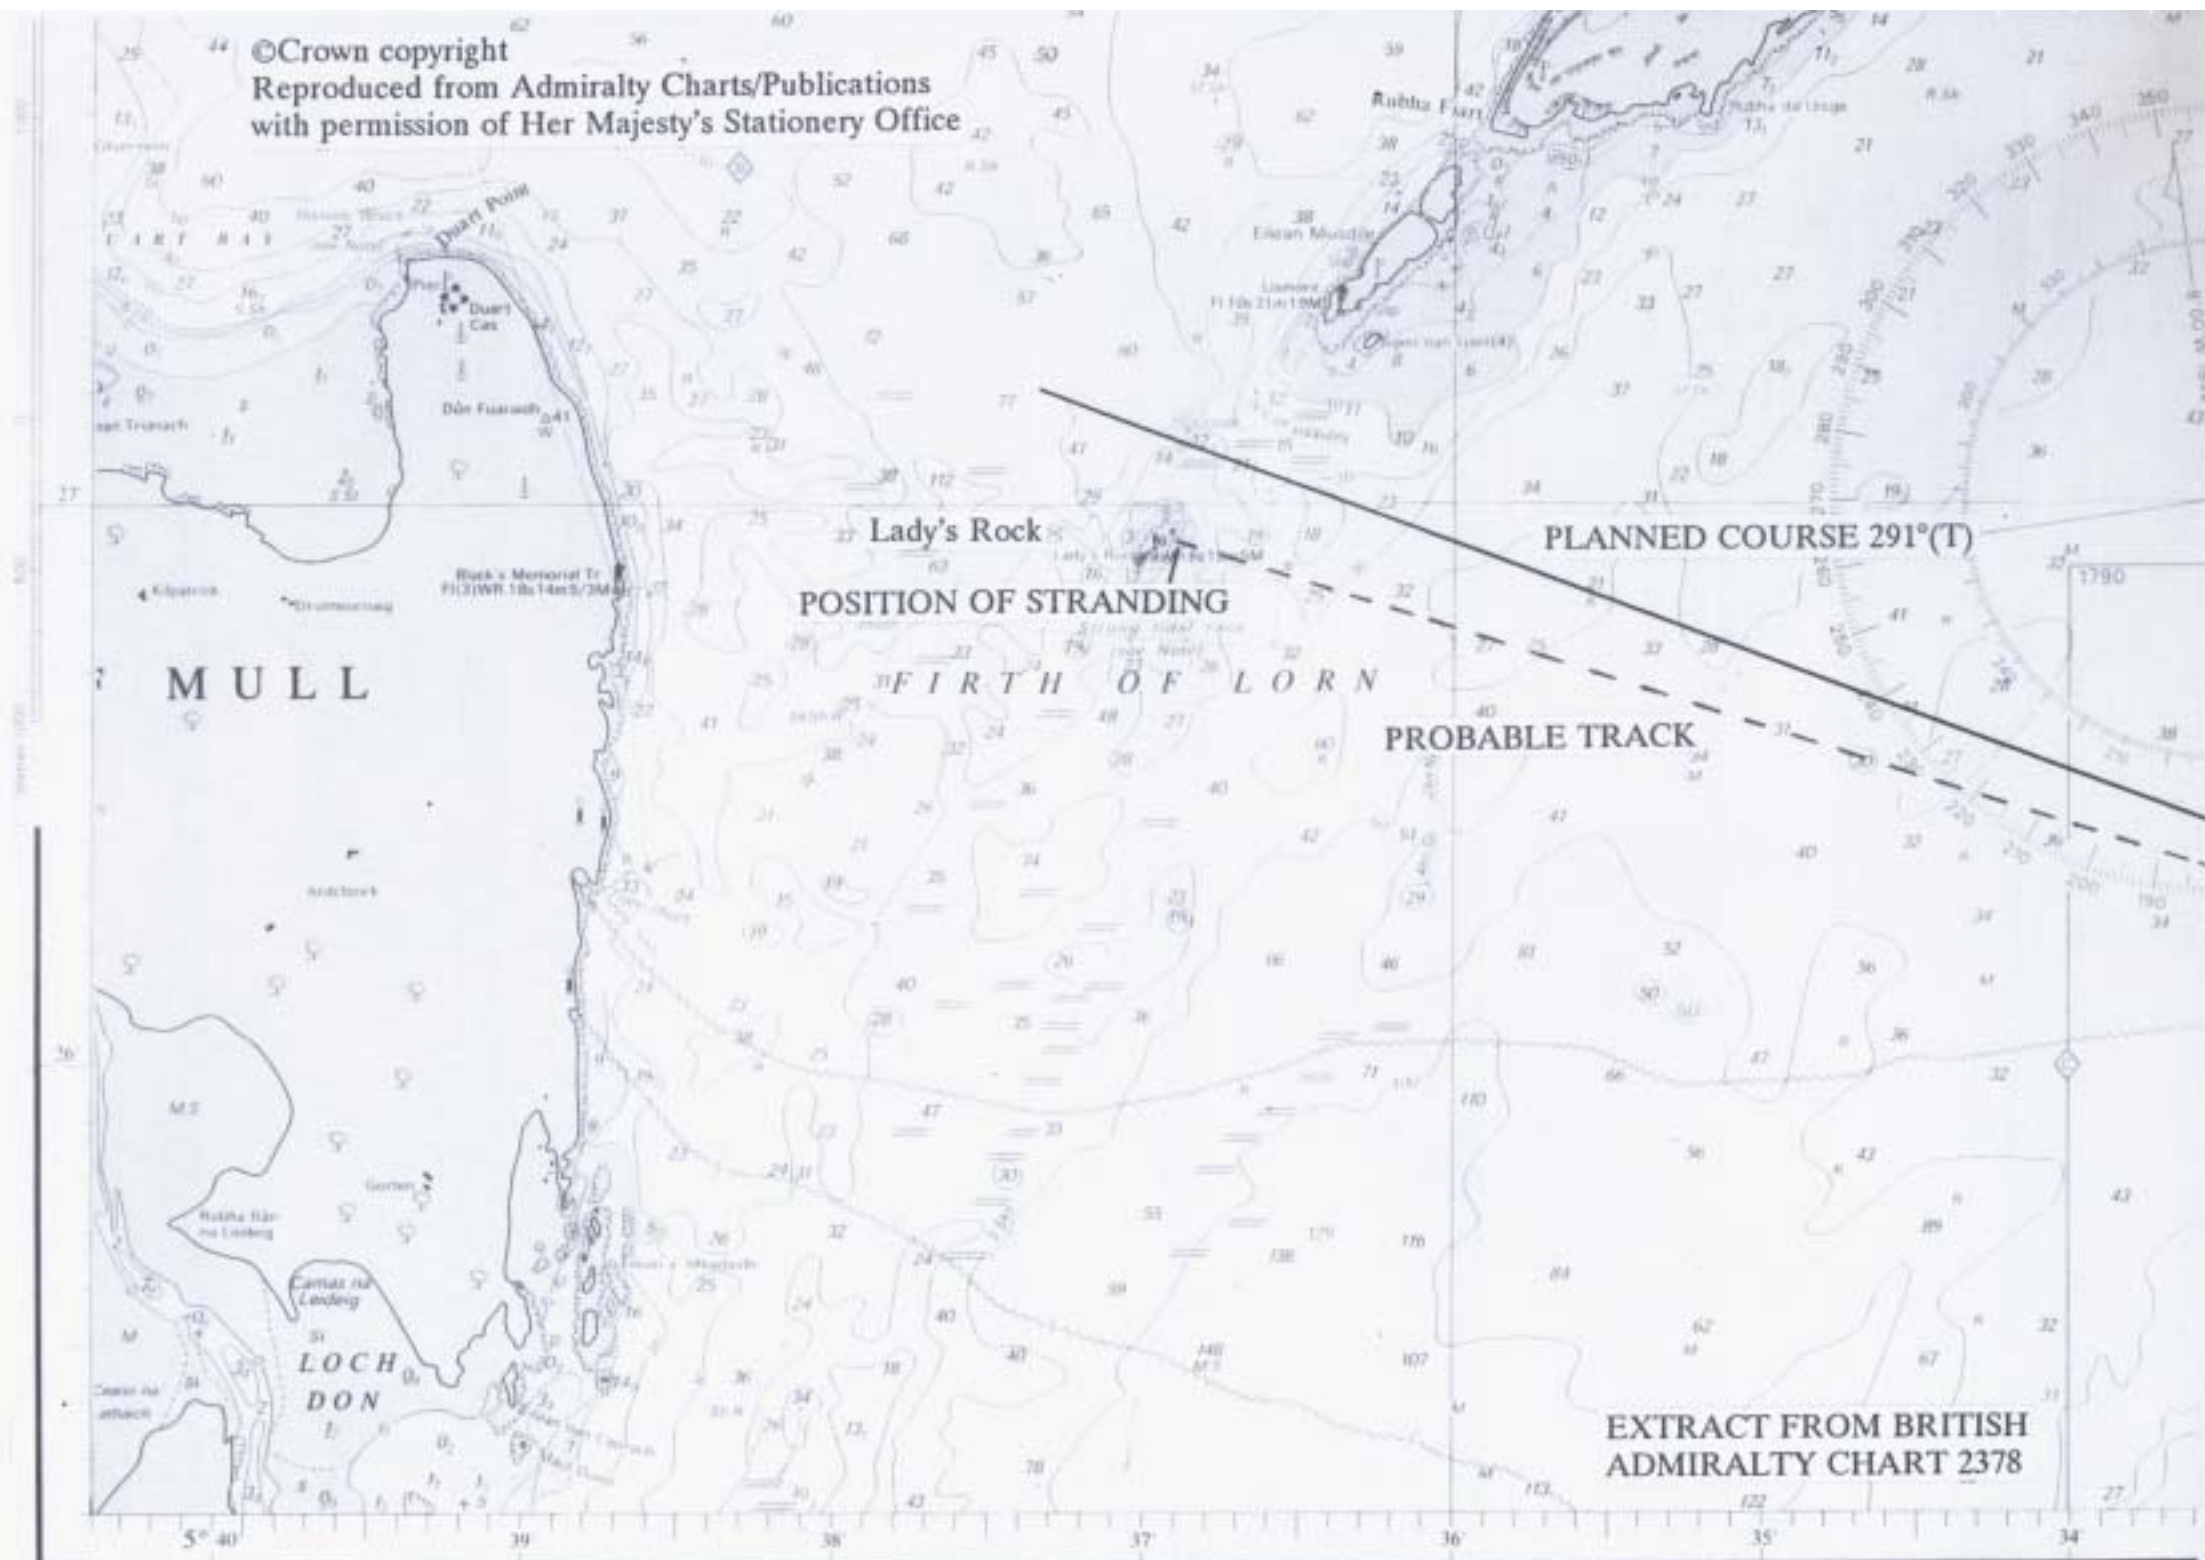
Soon after the Skipper left the wheelhouse the visibility deteriorated in heavy rain showers. This badly affected the radar picture but the lights apparently remained visible. As the vessel proceeded towards the entrance to the Sound the deckhand, using the video plotter, discovered that the vessel was being set to port and so course was altered to starboard to compensate for this. The Skipper was called when the vessel was just under one mile off Lady's Rock and again when the vessel was less than half a mile off it. When the Skipper reached the wheelhouse he realised that the vessel was to the south-west of the intended track and very close to Lady's Rock. He attempted to alter course to starboard but was unable to avoid a stranding.

PLANNED COURSE 291°(T)

Lady's Rock  
POSITION OF STRANDING
