# Safety Digest 3/2003

## **Marine Accident Investigation Branch**

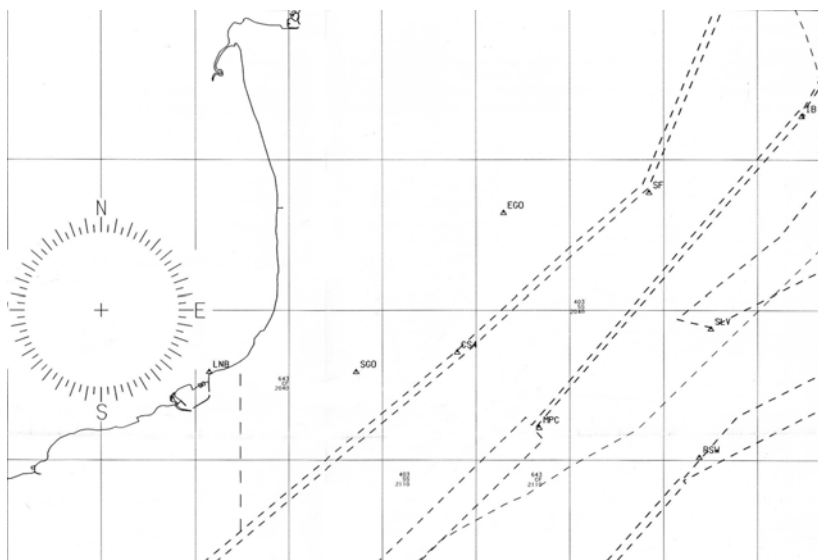
The tanker's OOW misinterpreted the predicted clearance, and was satisfied that a risk of collision did not exist. The ferry's OOW, however, interpreted that a risk of collision did exist and, at about 3 miles range, gave a series of flashes to prompt the tanker to take avoiding action. He then attempted to contact the tanker by VHF radio and gave another series of flashes before deciding to take avoiding action himself by altering course to port.

The tanker's OOW maintained course and speed, and the ferry passed down the tanker's starboard side at a range of about 0.25 mile.

Extract from CNIS Plot showing the respective tracks of the tanker and the ferry

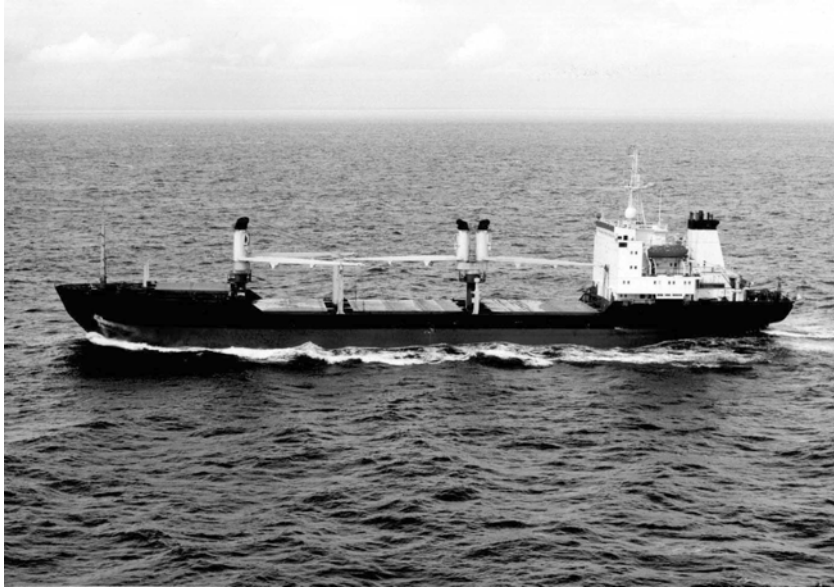
**Cargo vessel at sea**

A ship carrying just over 10,000m<sup>3</sup> of timber packages, of which about one third was stowed on deck, encountered a severe gale and high seas while on passage in the English Channel. Proceeding directly into the wind and sea caused her to pound, which made it unsafe for her crew to check and tighten the wire lashings securing the deck cargo. Although speed was reduced from about 12 knots to 8 knots through the water, large amounts of water were shipped on to the deck cargo.

About 2 hours after darkness had fallen, loud bangs were heard from the cargo deck as two of the wooden uprights used to help secure the stow were broken. The master realised the deck cargo had started to shift and altered course to port to close the French coast; the nearest place of safety. Speed was also increased to 12 knots. On the new course, the sea was now about 35° on the starboard bow, and the ship started to roll more heavily. About 20 minutes later, she rolled heavily to port. This caused the deck cargo to shift about 0.5m across the deck and to break all of the remaining uprights on the port side. The ship immediately listed to between 10° and 15° to port.

**1. It is not a coincidence that nearly all timber cargo shifts occur during bad weather. In such conditions, a deck cargo can be hit with great force by considerable amounts of water taken over the bow, large amounts of water can get under tarpaulin covers and among the cargo, and pounding and rolling can generate tremendous shock loading on the cargo and its lashings. Obviously, bad weather should be avoided if at all possible, even if this means deviating from the passage plan and sheltering for several hours. When this is not an option, however, each course and speed alteration must be carefully judged, bearing in mind the vulnerability of the deck cargo at all times. As the relevant IMO Code of Practice advises:**

**2. During the course of a voyage, vibration causes a timber deck cargo to settle, which results in its wire lashings loosening, and leaving little else but the timber's own weight to keep it in place. This problem is usually overcome by checking and tightening the lashings on at least a daily basis when at sea. It is sod's law, however, that when in rough seas and a cargo shift is most likely to occur, this is not always possible. It certainly cannot be done safely unless guard wires or lifelines are rigged to provide safe access to the turnbuckles.**

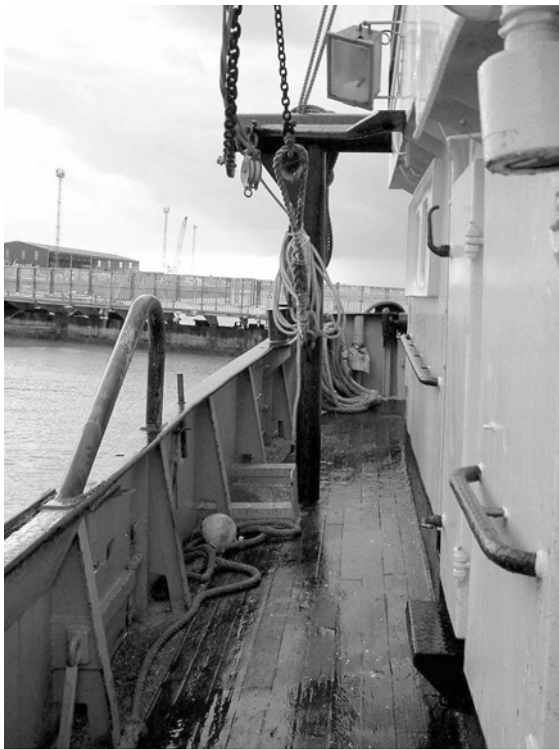
Two deckhands proceeded forward and started raising the derricks; the third went aft. When the derricks had been raised, one of the forward deckhands threw a line to the deckhand aft, who then tied it to a cleat attached to a stanchion on the starboard quarter.

Stanchion on the starboard side

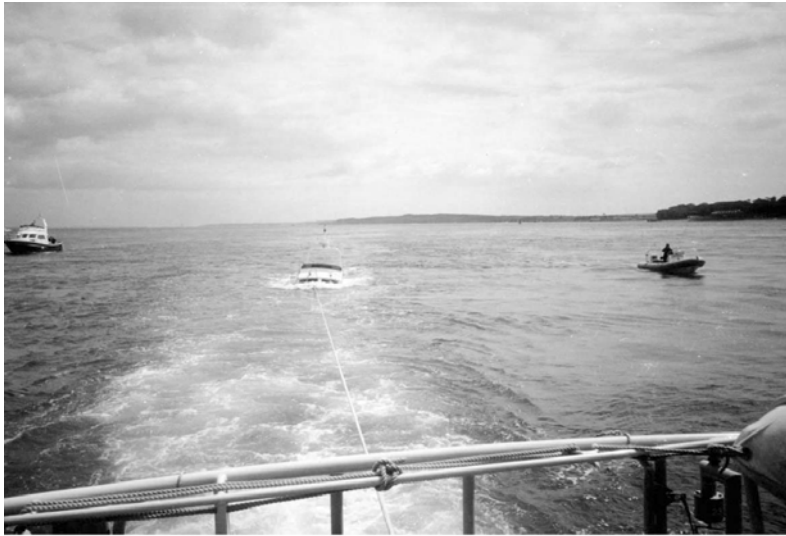
Just minutes before the vessel sank by the stern, the divers and crew were rescued. The liferaft, still in its canister, floated off the wheelhouse top and was retrieved. As the vessel sank, a towline was

attached to the bow. Once she had sunk to the bottom, the lifeboat slowly towed the casualty along, and she rose to the surface and was able to be beached and salvaged on the next tide.

Under tow after sinking
