SAFETY DIGEST

Lessons from Marine Accident Reports 3/2005

MAIB

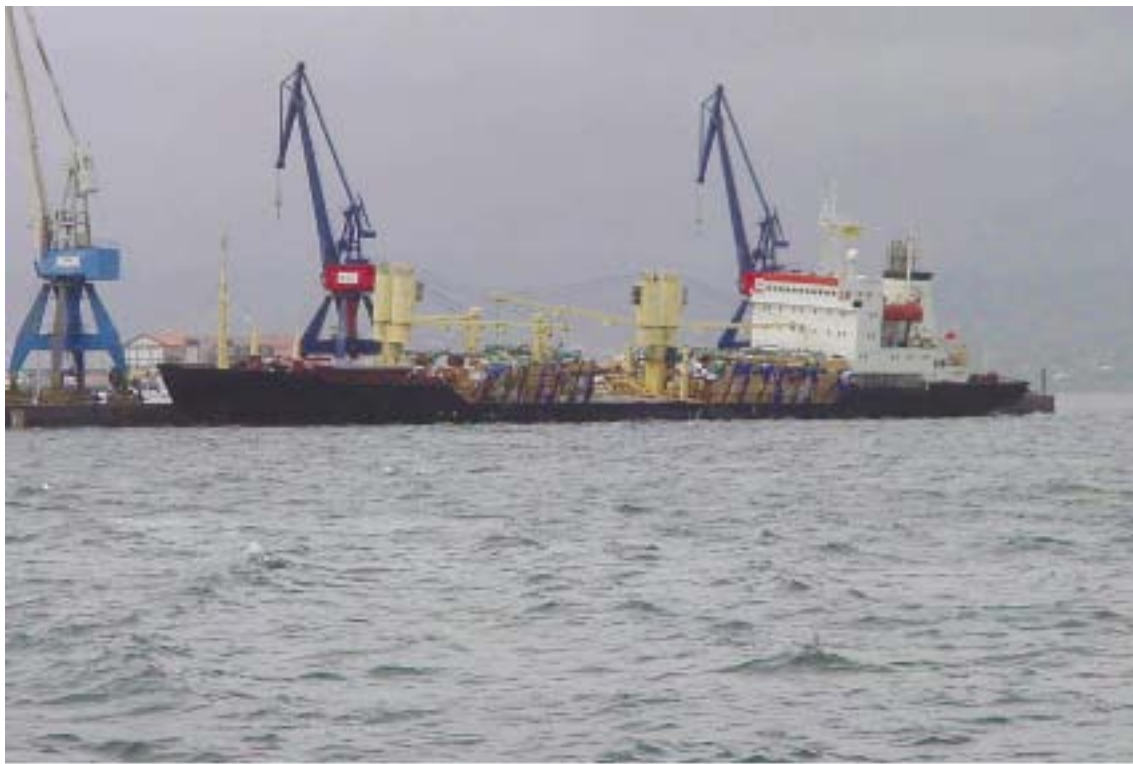
Figure 5

There was a substantial overhang of packages on the port side (Figure 4), but the ship arrived safely (Figure 5) having sustained only minor damage and no injuries to any crew members.

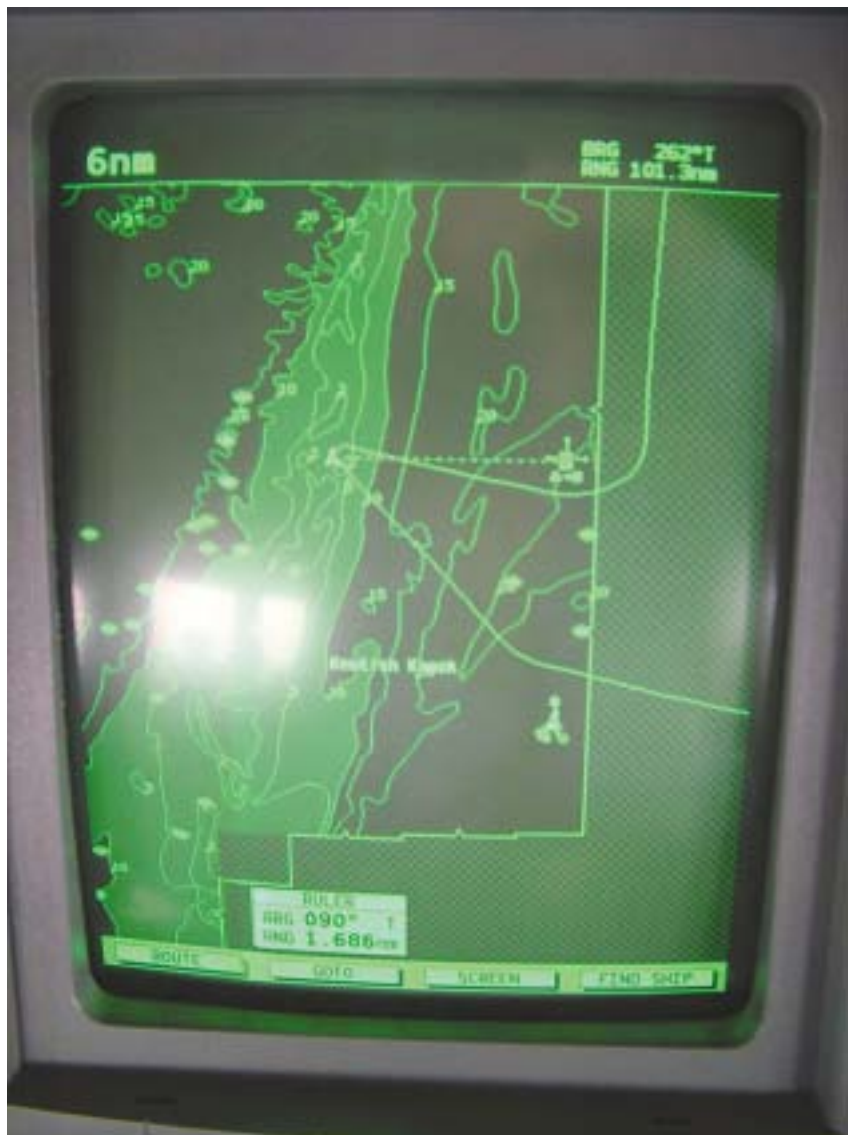
Photograph showing the video plotter in use

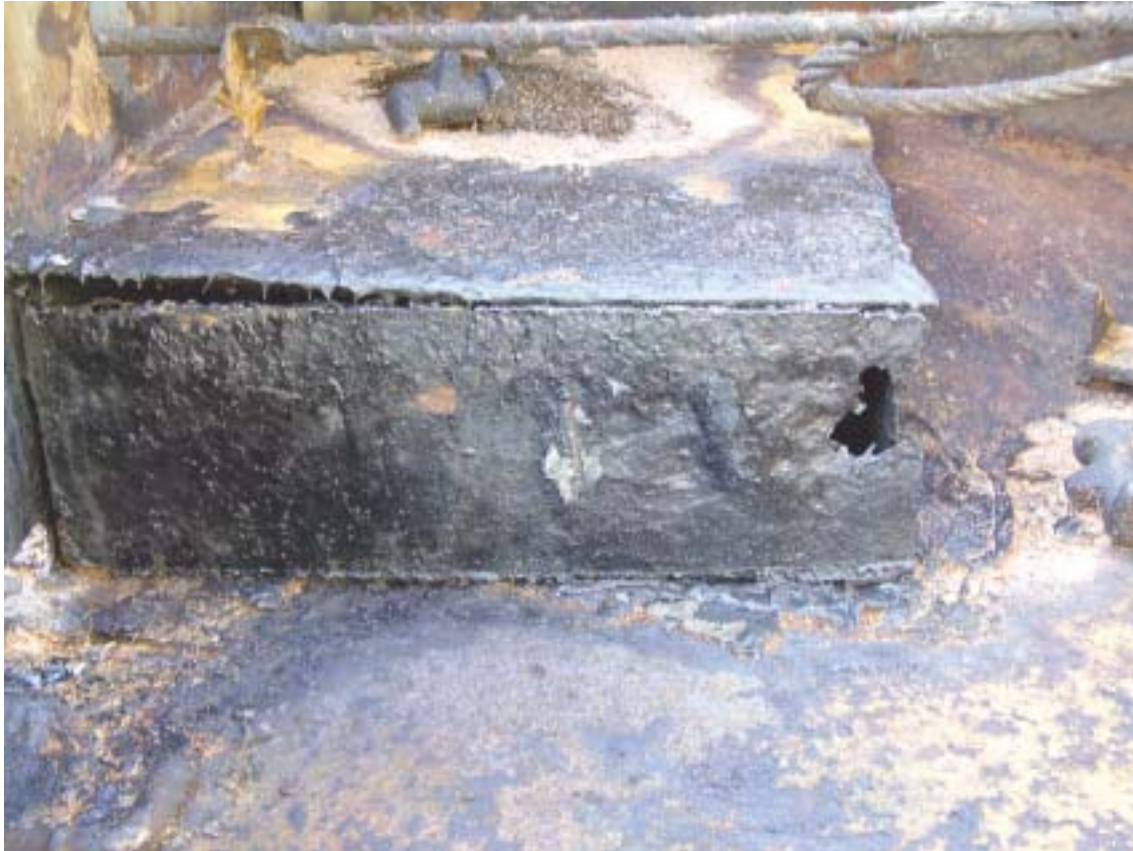
Plate in position

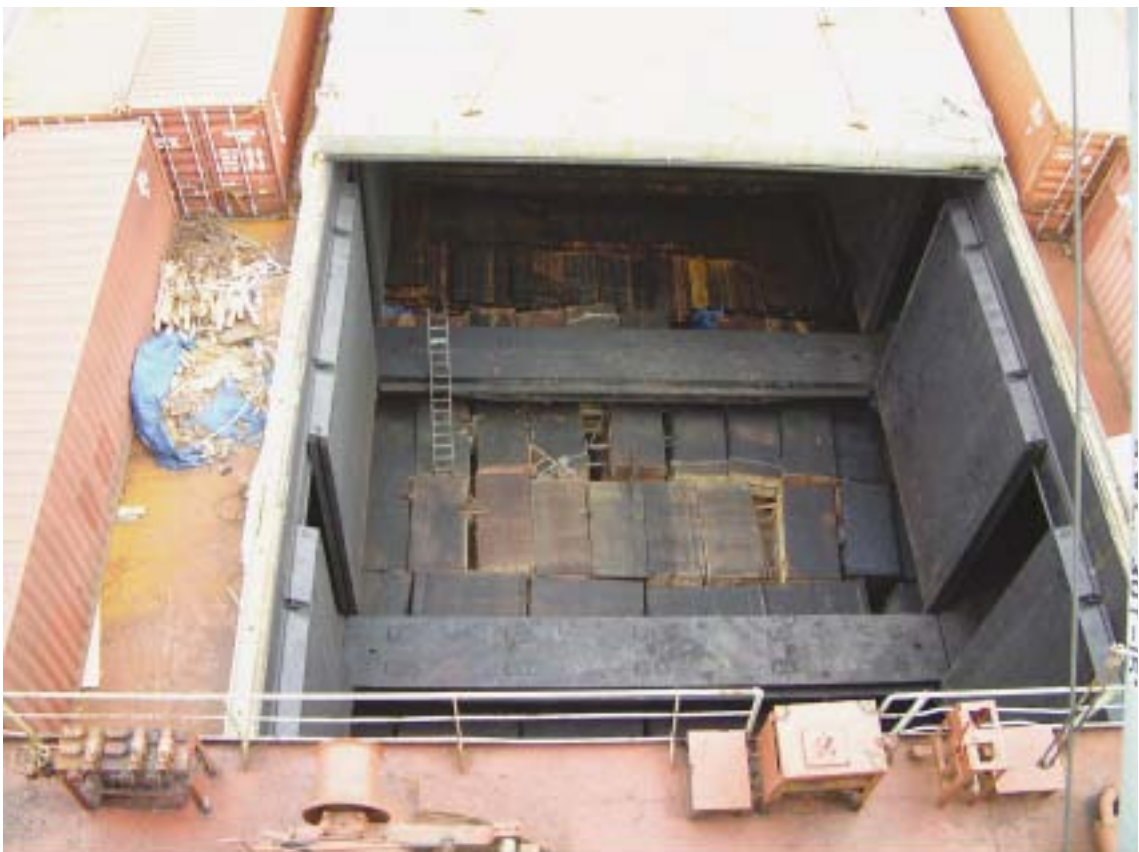
View into lower hold from bridge

As burning progressed, molten steel fell into the hold and ignited the plywood stowed immediately under the box section. At about 1500, the fitter noticed smoke issuing from the (now open) box section. He poured the bucket of water into the hold and ran to inform the bosun, who was working in No 1 hold. The bosun hurried to the bridge to collect the fire locker key and to inform the OOW. Meanwhile, the deck crew set up hoses for boundary cooling.

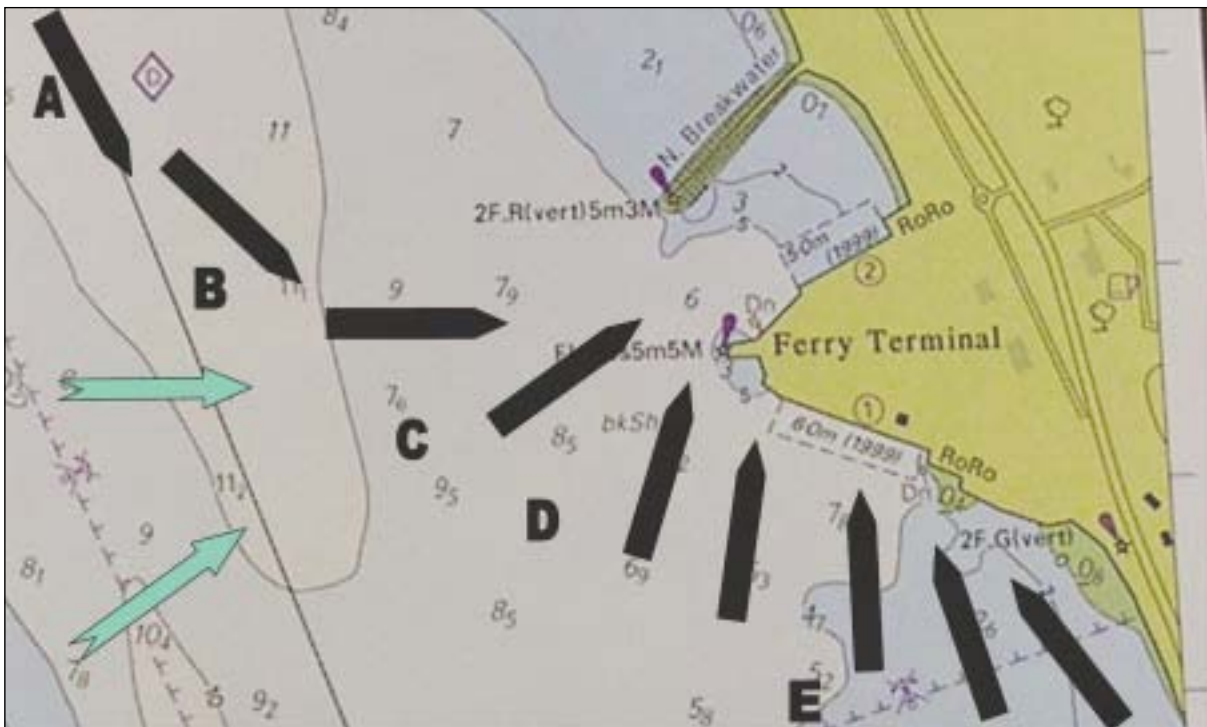
Sequence of Events

A – The master began swinging the vessel to port, unaware that the wind had veered from the south-west to the west.

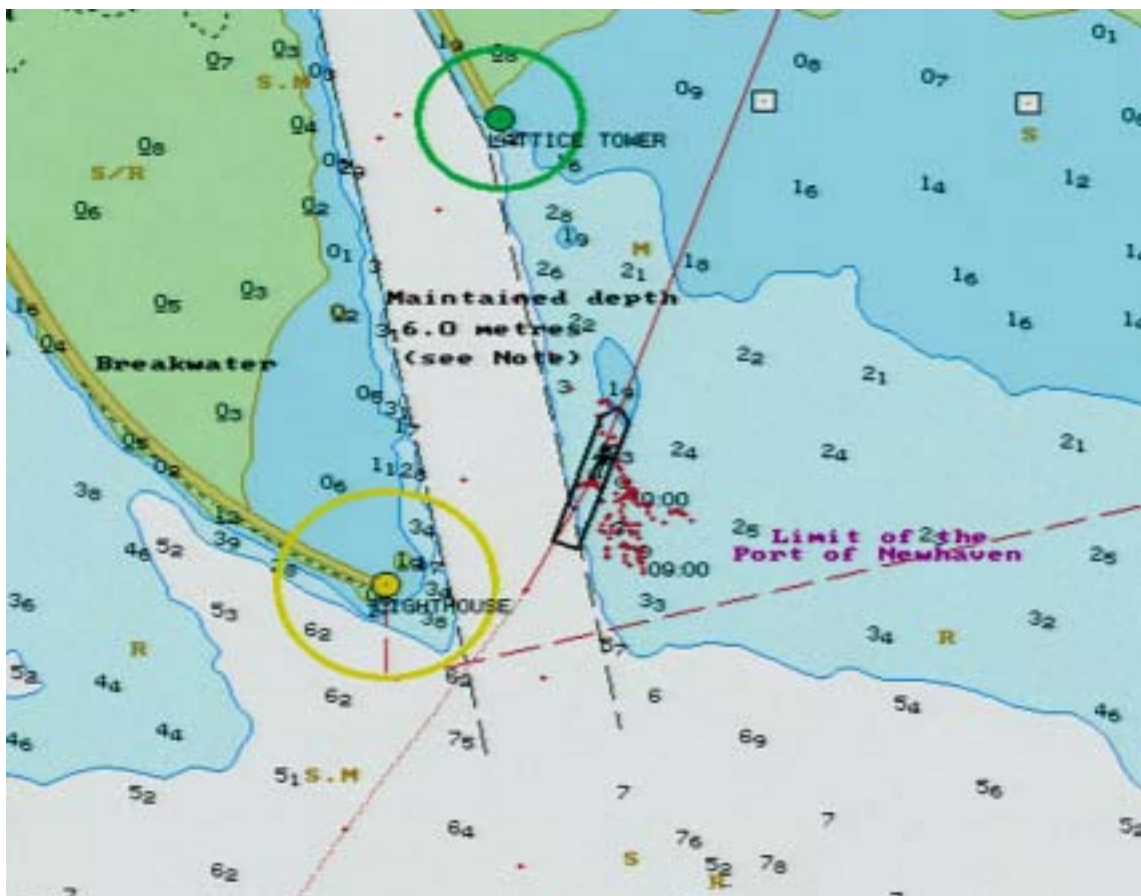
As the bridge of the ship came abeam of the end of the breakwater, the master ordered "port 20". The helmsman replied "port 20" but put the wheel to starboard. This error was not noticed, and when the ship failed to start swinging to port, the master ordered "hard-to-port". Again, the helmsman repeated the order, but put the wheel "hard-to starboard". With the ship still not swinging to port, the bow thruster was used at full power to attempt to bring the bow to port. These efforts had no effect, and the ship maintained her heading.

As the ship passed the limits of the opposite side of the channel, it was finally noted that the rudder was to starboard, and not to port, and the order was given to reverse the direction of the rudder. Shortly afterwards, the engines were put to full astern to minimise the impact of the – now inevitable – grounding.

Screenshot from ship's ECDIS replay

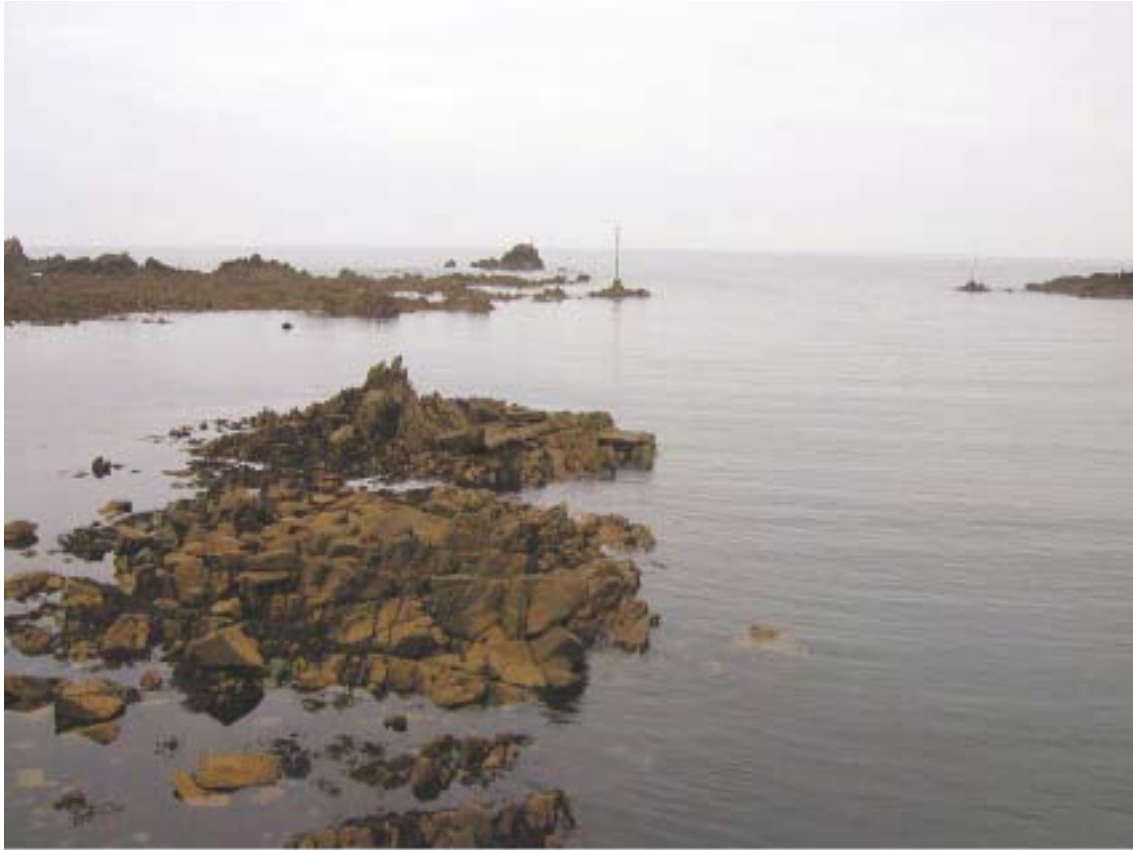
The reason for the fishing vessel veering to port was thought to have been the failure to turn on the electrically-driven hydraulic steering pump when the autopilot was engaged. This was a mistake that had been made before, but not while in the confines of a narrow channel.

Harbour entrance channel at low water

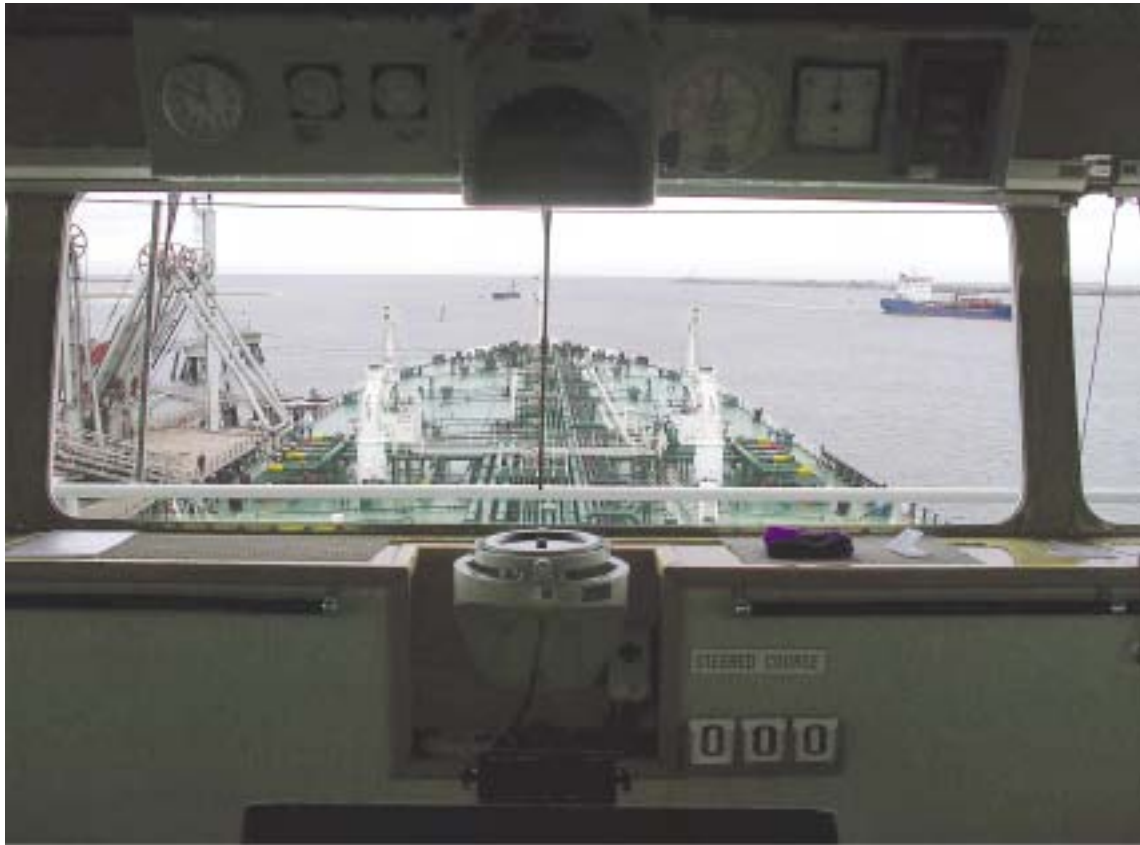
The tanker, meanwhile, was heading nearly due south at about 13 knots. Her bridge team consisted of the chief officer and a lookout. The chief officer saw the lights of a vessel at between 30° and 40° on the port bow, and the radar indicated that she was at a distance of about 5.5 miles and on a collision course. As they approached, he could see through his binoculars that the other vessel was a fishing vessel on passage. Under the collision regulations, his was the stand-on vessel, so he expected the trawler to alter course and give way. It did not.

View from bridge of tanker

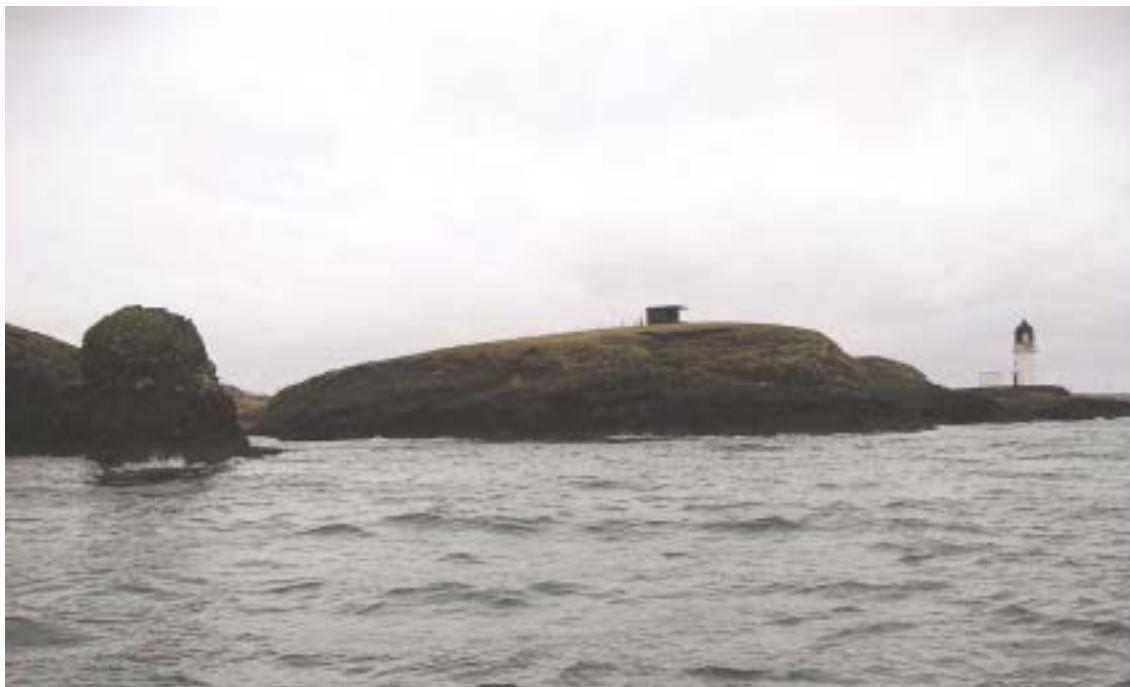
Location of grounding

Usually, when the vessel made its way out to sea, the skipper would engage the automatic helm at the entrance to the harbour. Perhaps on this occasion, he believed he had set the course on the automatic helm, and had engaged it, but had not actually done so. He might then have become distracted with the chart plotter. It is possible that with no steering, the left-handed propeller then caused the vessel to turn to starboard and towards the shore.
