MARINE ACCIDENT
INVESTIGATION BRANCH

SAFETY DIGEST

Lessons from Marine Accident Reports 1/2005

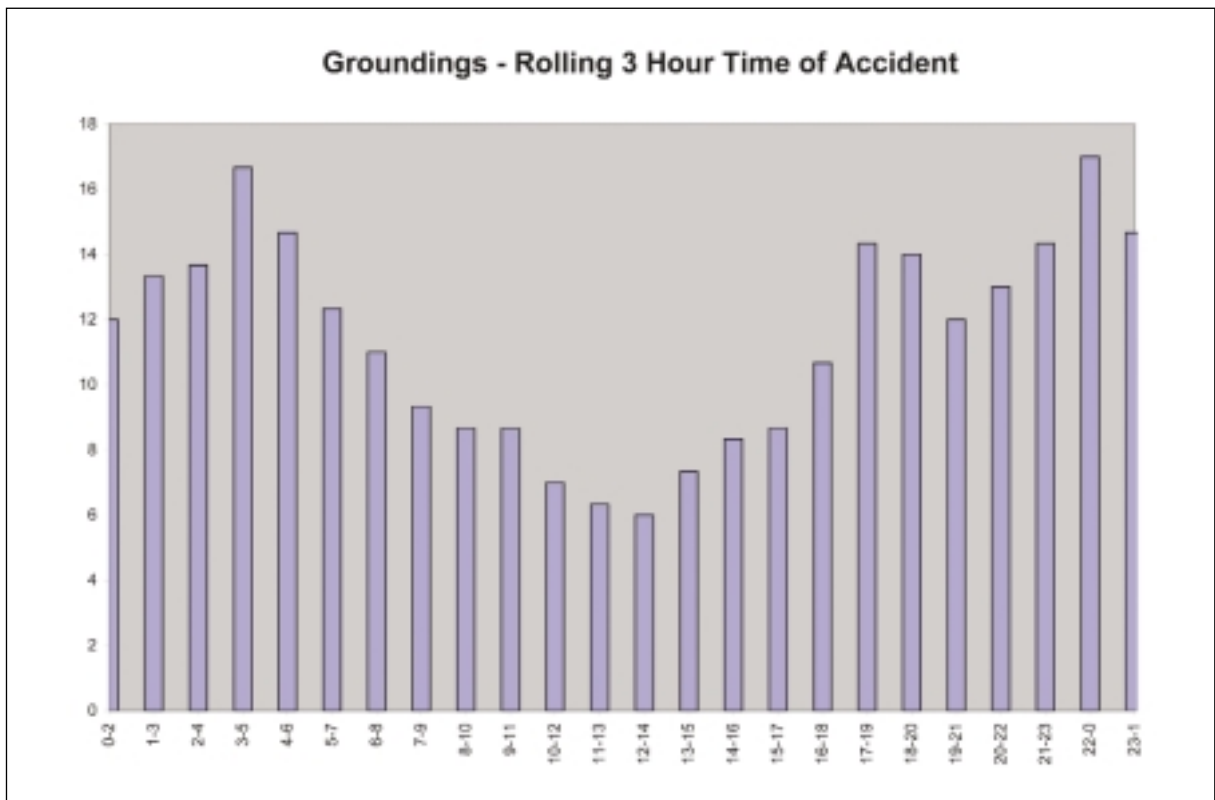
The above figure, which uses data from all groundings in UK waters that were reported to MAIB over a 10-year period, and which involved a merchant vessel of over 500gt, shows that groundings are much more likely to occur at night. It can also be seen that they are much more likely to happen towards the end of a watch. The most common times being 0400 to 0500, 1700 to 1900 and at about 2300. This clearly indicates that fatigue is likely to be a factor.

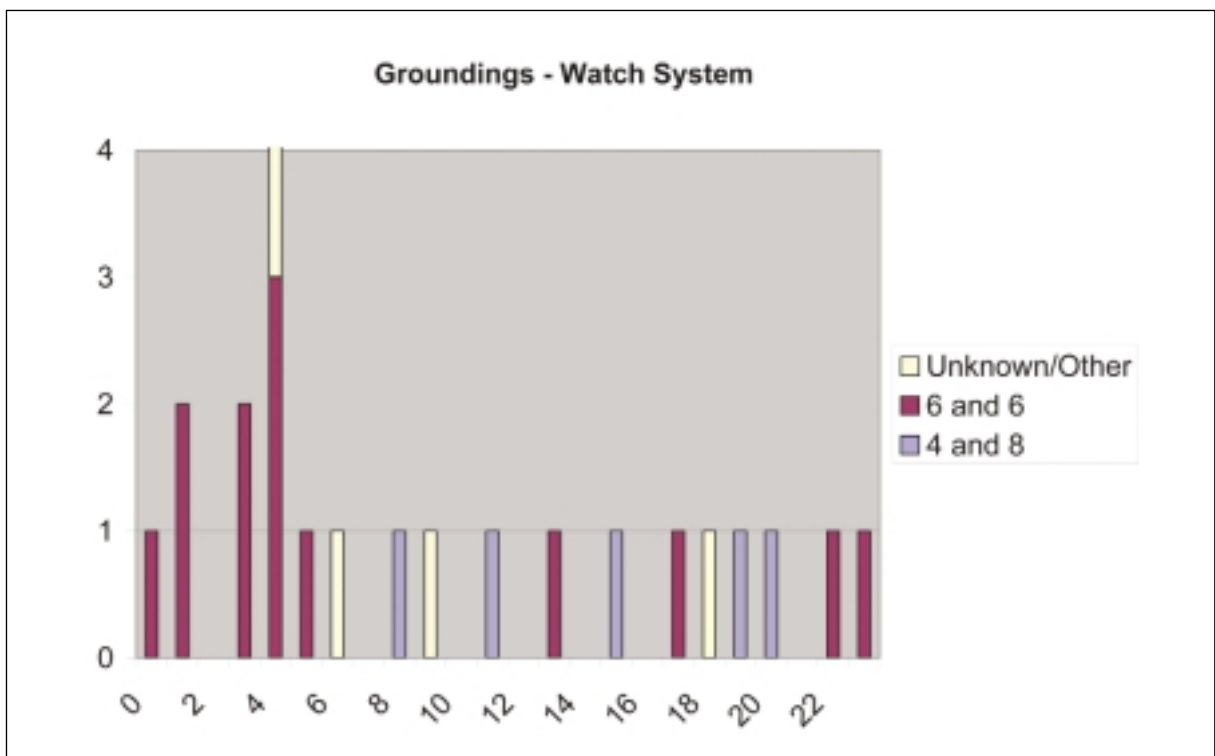
There were 23 groundings considered in detail in the study. The above diagram shows the watchkeeping arrangements in each of those groundings. The link between 6-on 6-off watchkeeping, and groundings that occur at night, can be clearly deduced.

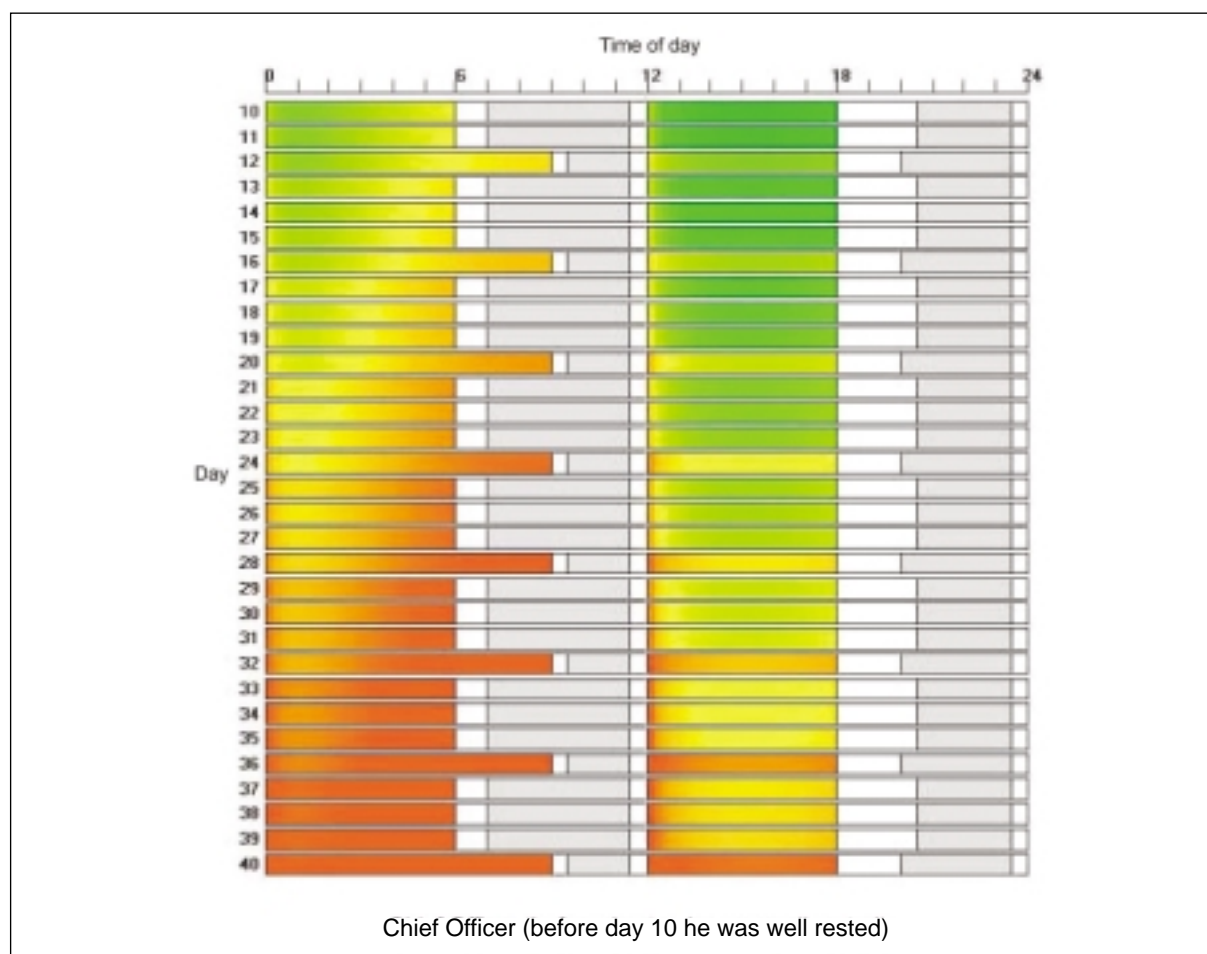
It can be seen that the chief officer appears to begin to get dangerously tired after about 3 weeks of this routine. However, no allowance is made for the **quality** of rest which is assumed to be good. To test the effectiveness of days off in port, a rest day was introduced into the programme at every second port call. It was found that these rest days did not make an appreciable difference to the levels of fatigue indicated.

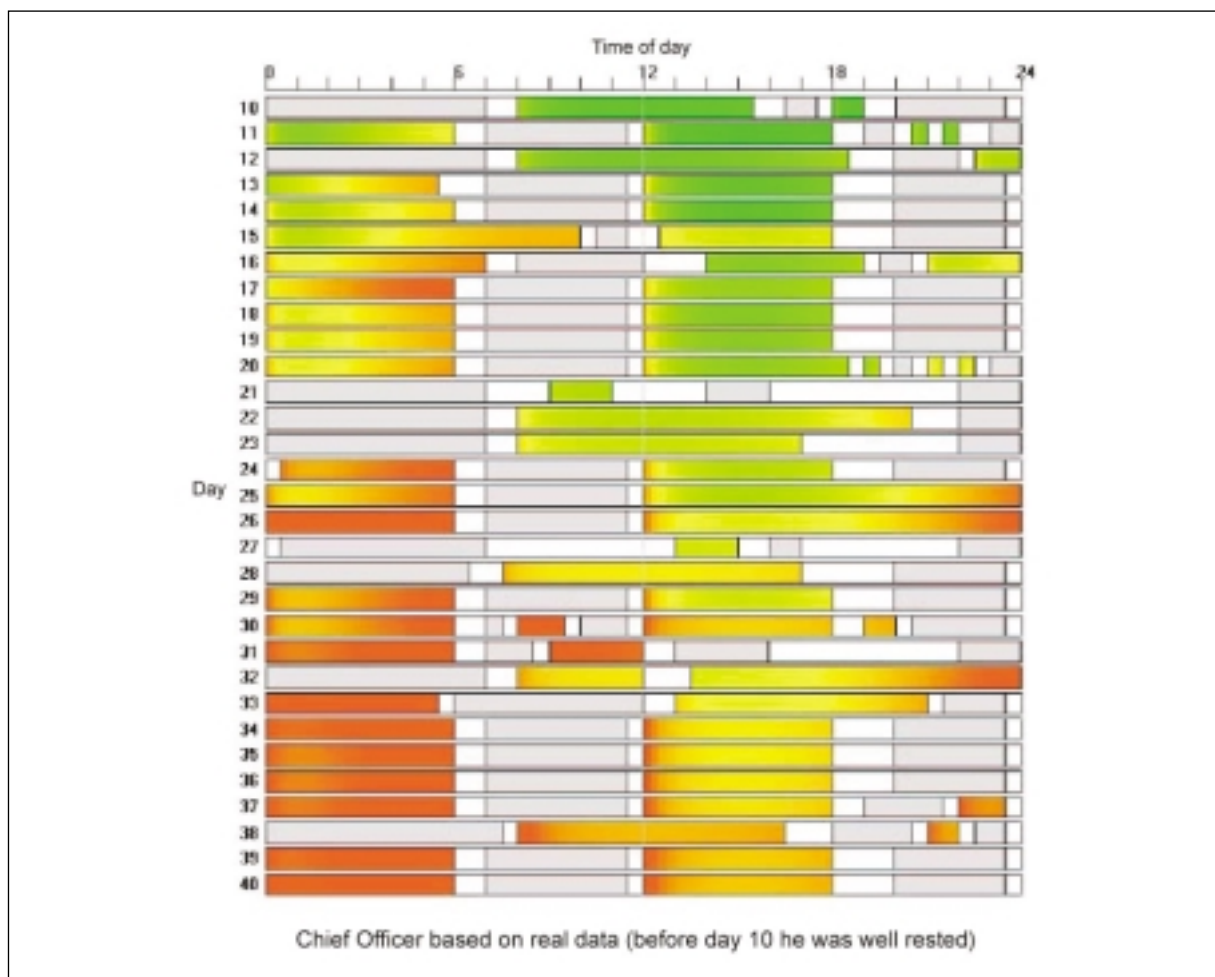
It can be seen that, despite the chief officer getting several nights in port, the programme indicates that dangerous levels of fatigue are likely to exist after 2 or 3 weeks in the routine. The most dangerous times appear to occur towards the end of the midnight to 0600 watch, which ties in closely with the results shown in figures 1 and 2.

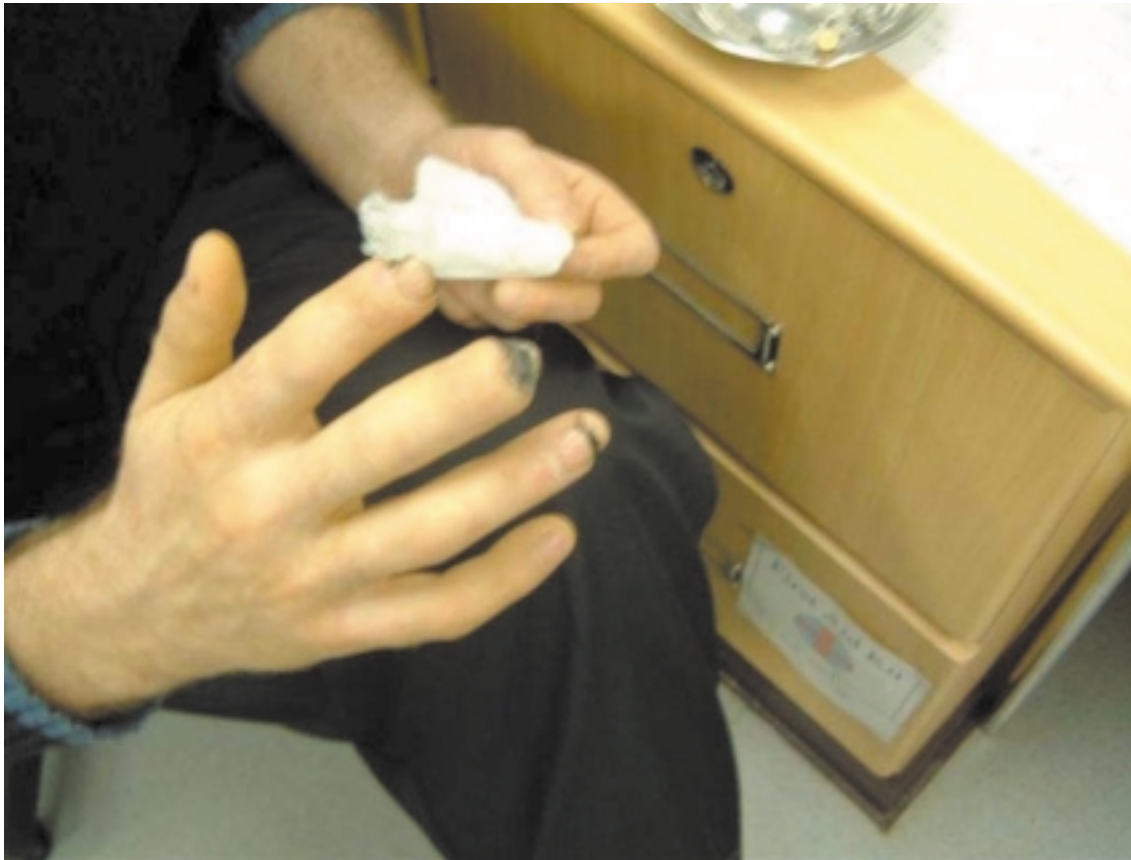
Figure 2: Motor fan unit and vee belts

Unable to react quickly enough, the fingers of the engineer's right hand were drawn into, and became trapped between the vee belts and the electric motor pulley (**Figure 2**).

1. If you are required to work on rotating or other moving equipment, ensure that all precautions are taken to isolate and prove that it cannot restart unexpectedly. By issuing warning notices, locking off starter controls, removing fuses, and fitting locking devices on the plant, you will be reducing the opportunity for an unexpected, and probably very painful, accident to take place.

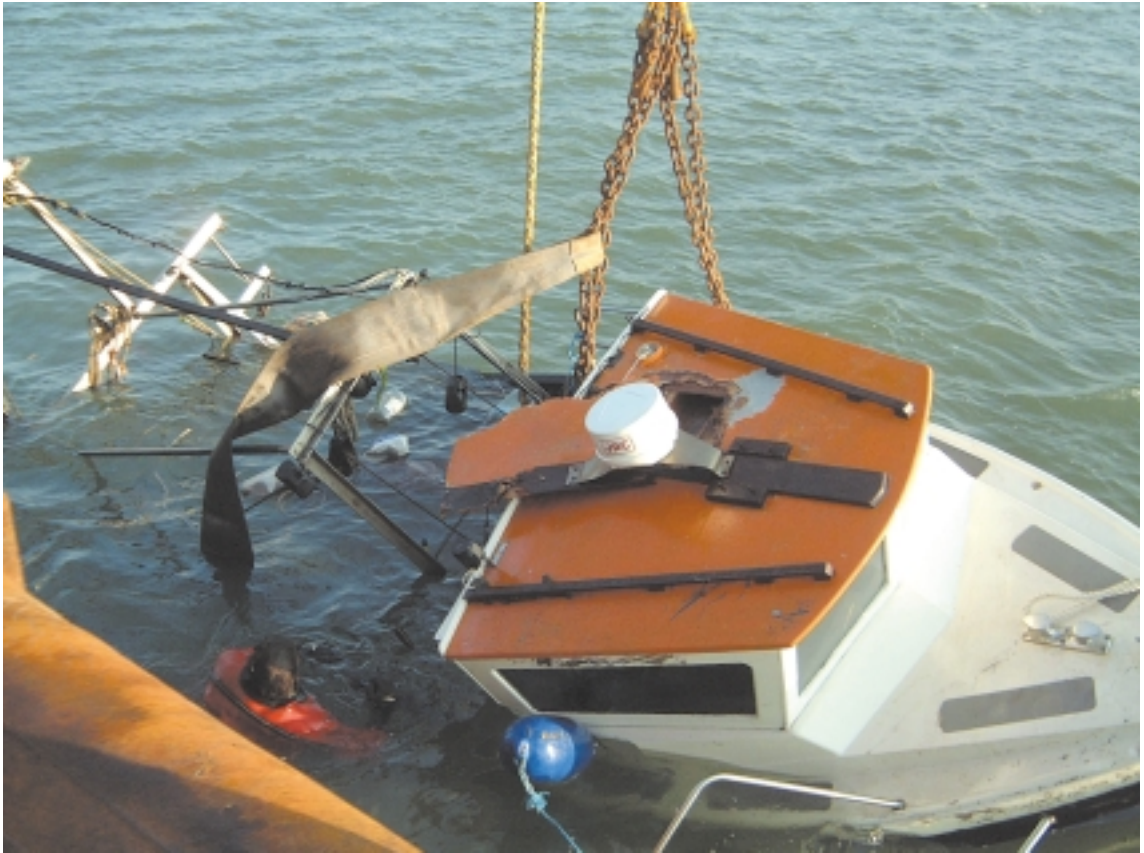
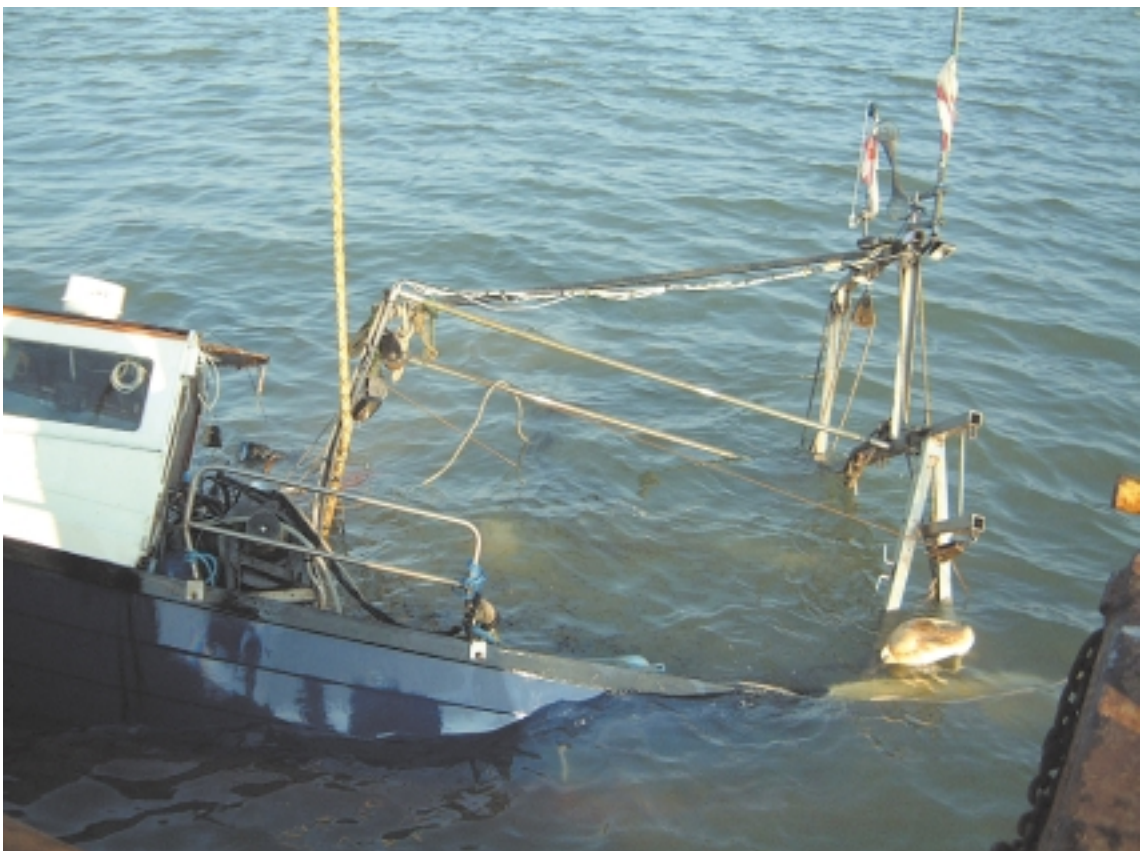
A salvage operation performed the following day located the vessel on its second attempt. After a 6 hour operation, the trawls were cut and the vessel raised, pumped out and safely returned to her mooring. Divers were not able to identify the nature of the obstruction due to poor visibility.

Photographs taken during the salvage operation

1. All too often, the MAIB finds in its investigations that the wearing of lifejackets has been ignored; this case was no exception. The wearing of lifejackets had not been considered at any time since the vessel left her mooring, even though two young people were onboard. Occasionally, lifejackets can be cumbersome when handling fishing gear, however once this vessel was disabled it should have been evident to the skipper that lifejackets were a sensible precaution and could only have assisted with the rescue operation.
