**MARINE ACCIDENT
INVESTIGATION BRANCH**

SAFETY DIGEST

**Lessons from Marine
Accident Reports
3/2006**

No 3/2006

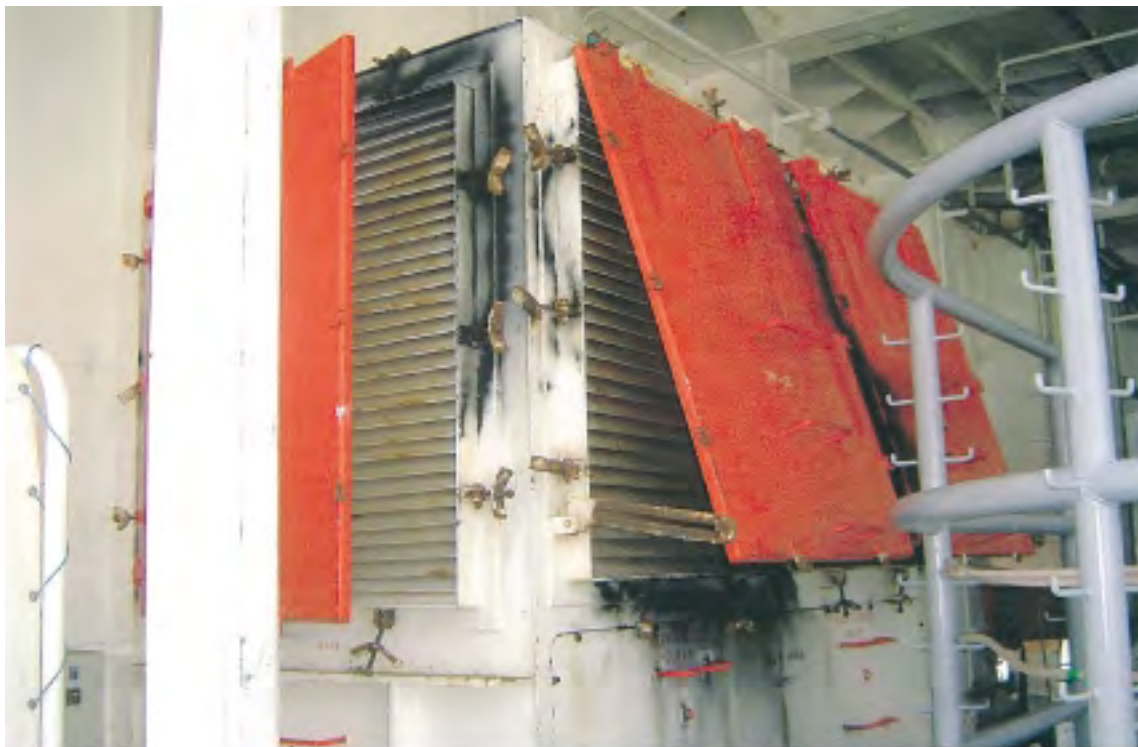
Figure 1 – Engine room vents

Subsequent examination revealed the cause of the fire to be a fractured fuel gauge pipe

1. Pipework support brackets must be examined regularly to ensure they are well designed, secure and adequate for their intended purpose.
2. Capillary gauge pipeworks are always vulnerable to breakage or leakages, particularly over a period of time. Alternative monitoring systems do exist, in the form of electrical transducer systems which remove the need for the use of susceptible capillary pipework. Use of such monitoring equipment should be considered, particularly for older, more vulnerable designs of engines on systems carrying flammable fluids such as fuel and lubricating oils. Alternatively, if such electrical monitoring is deemed inappropriate, for local monitoring, consideration should be given to fitting isolation cocks or valves in the capillary pipework at, or close to, the entablature (or pump casing) which can be kept closed under normal operation and opened only for sufficient time to read the gauges, when required.

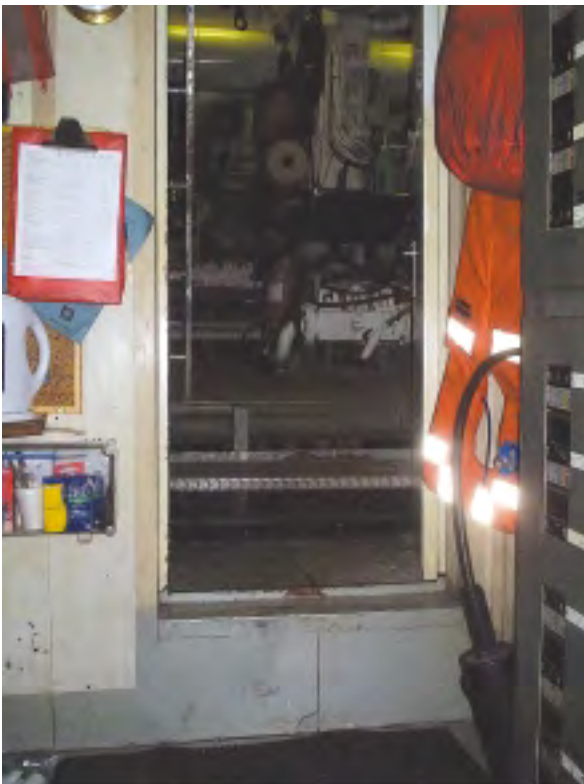
Figure 1

The rapid escape of gas caused the cylinder to “fly” into the control room, where it hit the switchboard and tripped a breaker, causing a blackout. Two crew members were injured; one was detained in hospital with bone fractures.

1. Manual handling of large gas cylinders is hazardous in a number of ways:
 - They are heavy: lifting 123kg in an awkward space is likely to cause physical injury, either by over straining or by dropping the cylinder. Consider using a correct cylinder trolley which has wheels and lifting points, and can make the task of moving a heavy cylinder in a restricted space considerably less arduous.

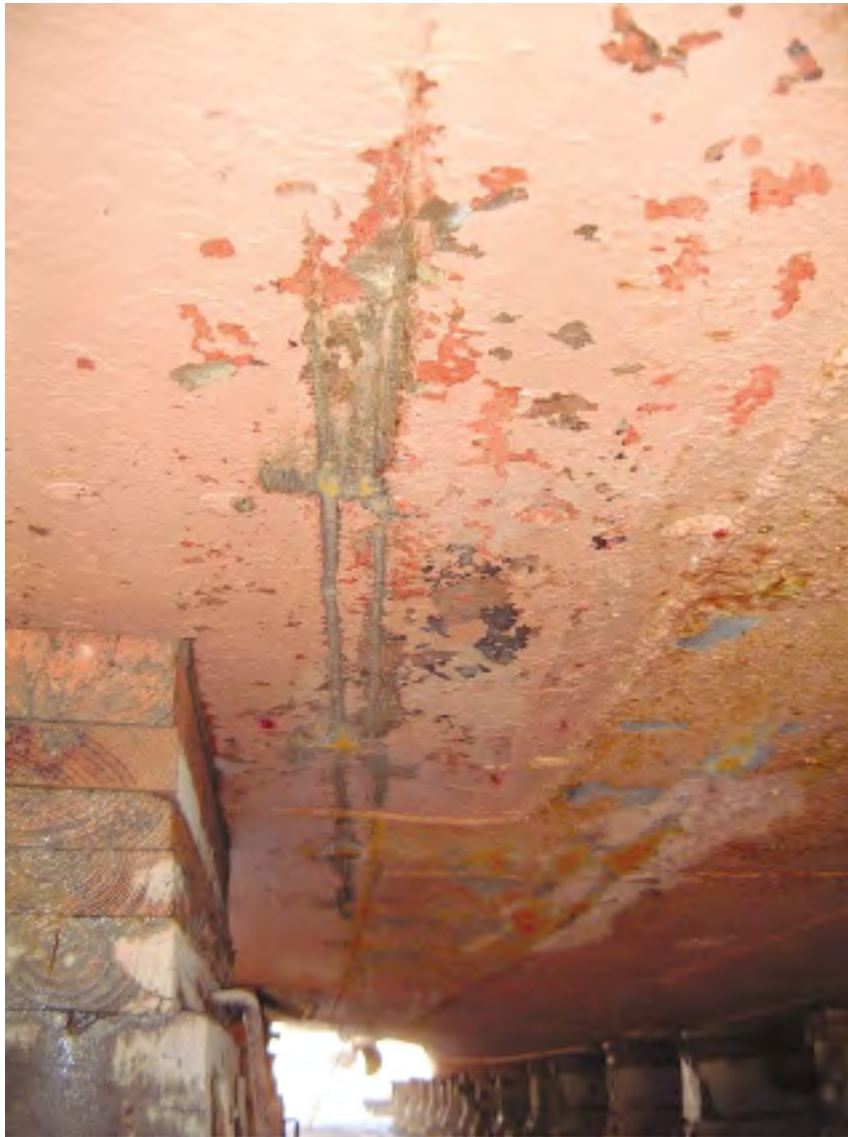
Note: Plate cut out in ship repair yard

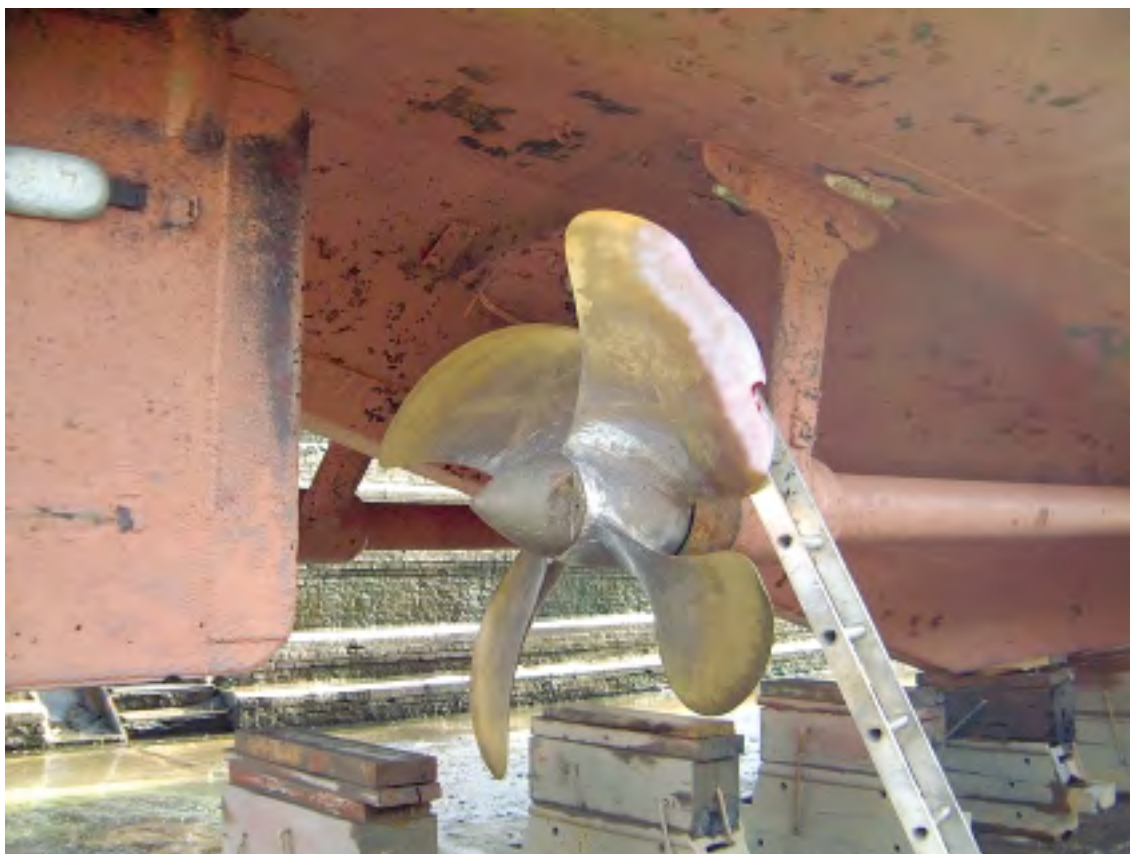
The vessel berthed minutes later, when assistance was provided by the emergency services and contractors appointed by the company. Inspection showed that, had the damage been sustained 1 metre further aft, the main engine room would have been breached, possibly resulting in a substantially different outcome.

1. Although the final starboard hand mark was passed on the correct side, close inspection of the chart showed that the mark was positioned outside of the main channel boundaries in a shallow water area. By aiming for the buoy, the master had taken the vessel outside of the channel and into an area of shallow water.

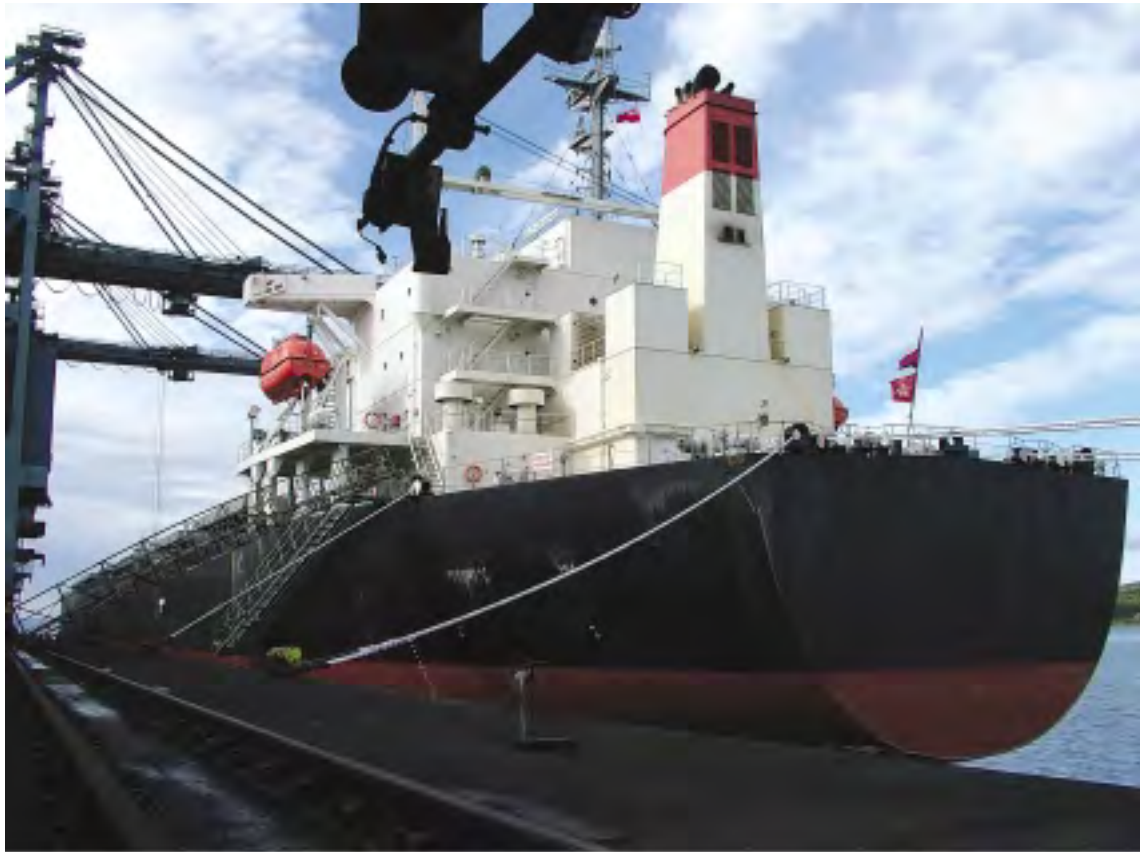
Figure 1

The crew did not follow the requirements for handling a cargo of coal, as specified in the BC Code, because the holds were kept ventilated for the entire passage. When the ship arrived in the UK, she anchored until the discharge berth became free. The weather deteriorated while at the anchorage, and the ventilators were closed as a result. The daily gas measurements showed a substantial rise in CO, but the master and mate did not appreciate the significance of this and the port authorities were not told.

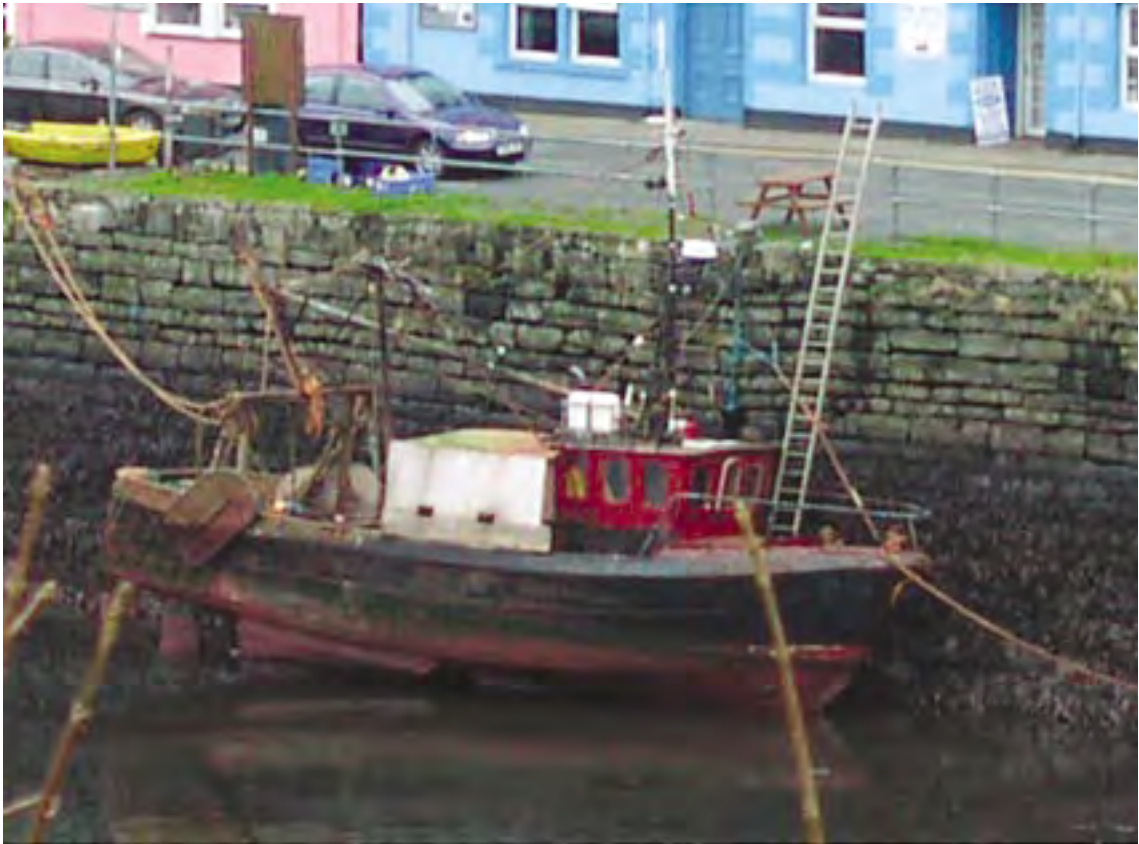
Figure 1

Over the years, some attempts had been made to carry out patch repairs to the deck. But these had to be frequently abandoned because of the lack of parent metal to weld to and could be considered as only temporary measures. Perhaps this was because permanent repairs would have been too costly and burdensome for a commercial venture that was, at best, marginal. Although regarded as a capable skipper, those who knew him, found it extremely difficult to balance this with his ambivalent attitude towards the condition of his vessel.

1. Skippers and owners of fishing vessels must ensure their vessels are safe to proceed to sea. This means that watertight hatches and doors should, indeed, be watertight and the structure should be in a seaworthy condition. Do not delay repairs – the situation will only get worse.
2. The condition of a ship's hull will inevitably deteriorate over time. However, ensuring that the paint preservation is intact and regularly touched up, is one, relatively cheap and effective way of protecting structure against corrosion. In this particular vessel, it was difficult to find evidence of any external paint coatings.
3. Regularly examine upper deck, non-watertight hatch arrangements. The risk of downflooding through fish hold hatches that are fitted with boards can be much reduced by fitting tarpaulin covers over them.

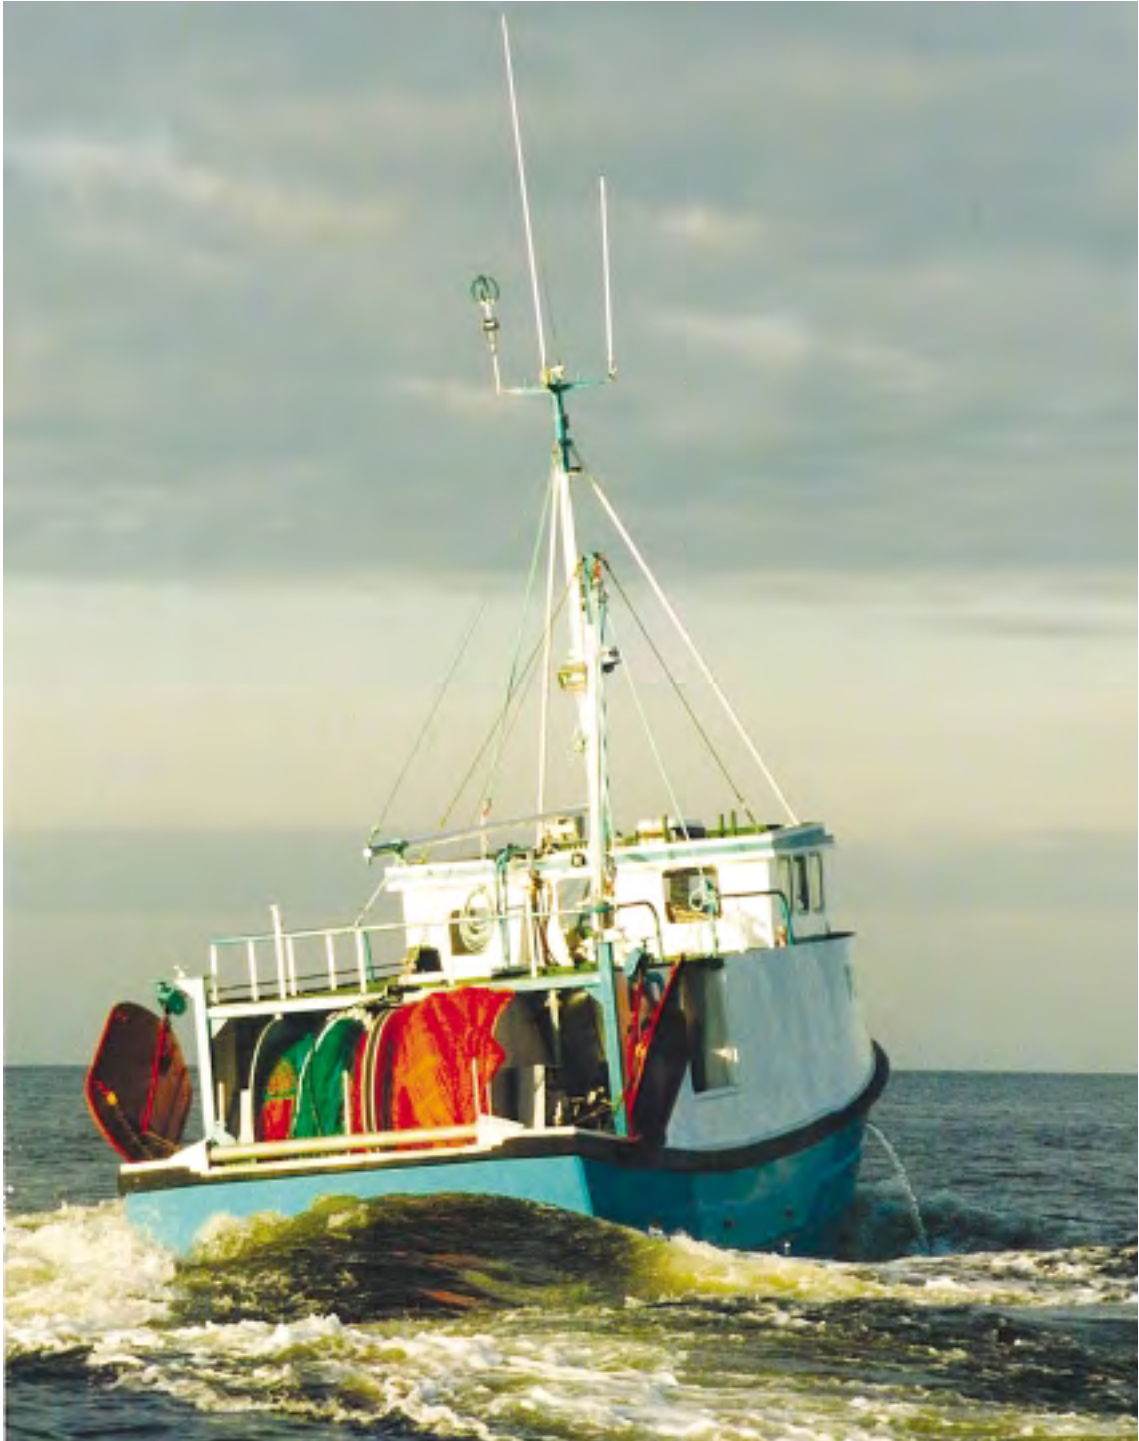
Loss of “Rulebeater” With Poor Freeboard

A 9.8m long fishing vessel (photograph) with two people on board was swamped by a wave which came over her stern while her trawl was snagged on a seabed obstruction. Floodwater

There was no minimum freeboard requirement for a fishing vessel of this size, but there was for an equivalent sized workboat. If the workboat standard had been applied to this vessel, she would have been about 5 tonnes too heavy. She was overloaded with equipment and fittings, and her freeboard and buoyancy were inadequate as a result.

3. The area of freeing ports on this vessel did not meet the basic minimum guidance. When the effect of the shelter was taken into account, her freeing ports were woefully inadequate. Trapped water on a vessel can easily cause capsize, and adequate means for water to quickly escape should be provided. If your vessel has a shelter which could trap water on the after deck, try to avoid operating while stationary and stern-to the sea waves.

1. The commercial advantages to be gained by “rulebeaters” like this one must be weighed against any resultant reductions in safety-critical areas like freeboard. The builders and first owners of this vessel had no idea that she was dangerous under certain conditions. Research is currently being carried out which will probably lead to new regulations on minimum freeboard. In the meantime, owners of “rulebeaters” similar to this one should carefully consider whether the amount of freeboard on their vessel is appropriate and safe.
2. The standard for workboats provides useful guidance. A fishing vessel with a continuous watertight weather deck and

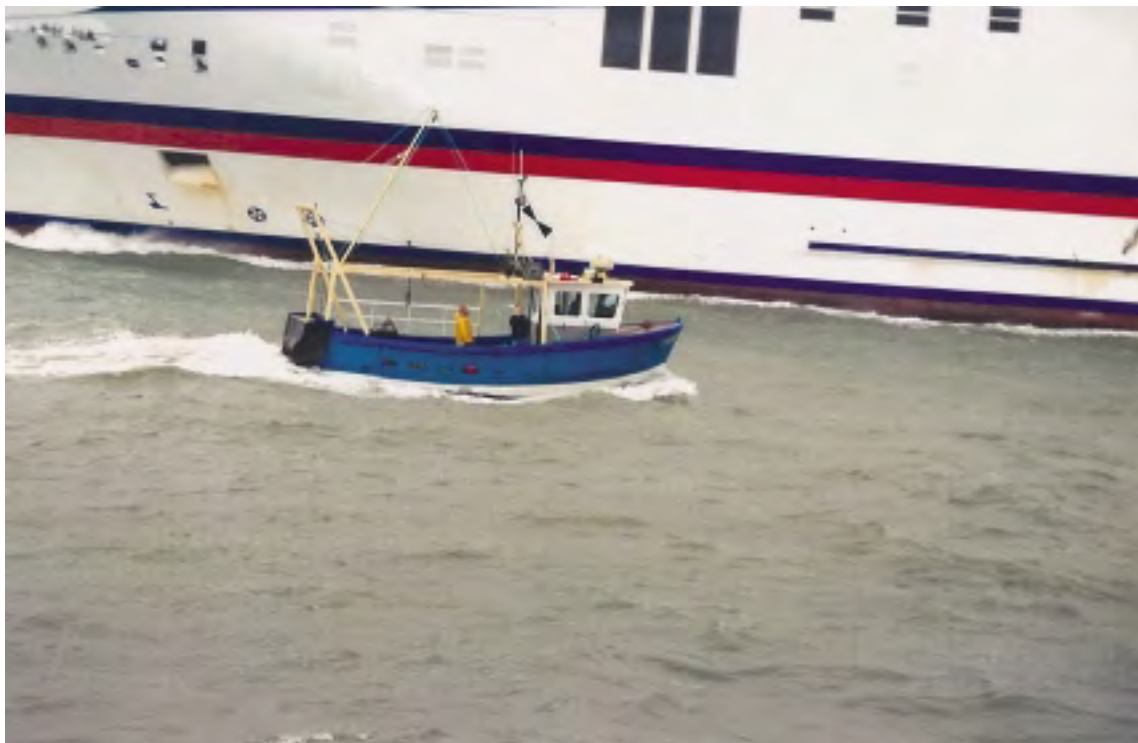
Aggregate Bags Sink Mussel Dredger

Over the years, fishermen have thought of many ideas to reduce time spent alongside and unloading the catch. Recently, some fishermen have taken to loading their shellfish catch into 1 cubic metre aggregate bags, which are more commonly used in the building industry by builders' merchants. These bags are stowed on the open deck and unloaded quickly by crane.

The vessel, with a crew of three, had a successful day's fishing, and was heading back to port with a good catch when the weather deteriorated unexpectedly and she experienced strong winds and large seas. As the vessel closed her home port, her engine failed and she began rolling heavily and shipping seas which started to fill the bags on deck.

1. Both the owner and skipper failed to notice the serious stability implications of the bags having no means of drainage. Using these bags had the same effect as blocking the vessel's freeing ports, because water could not escape. Be aware of the dangers of water trapped on deck. It can happen quickly and unexpectedly. Always ensure that freeing ports are kept clear, and that containers on deck have adequate drainage holes.
2. Fishermen on small vessels should consider wearing constant wear buoyancy aids all the time at sea. The MAIB frequently comes across accidents where vessels capsize suddenly, with little or no warning. In such a circumstance, it is *too late* to scramble around to find the lifejackets which are often stowed in the most inaccessible location.
