MARINE ACCIDENT
INVESTIGATION BRANCH

SAFETY DIGEST

**Lessons from Marine
Accident Reports
1/2007**

No 1/2007

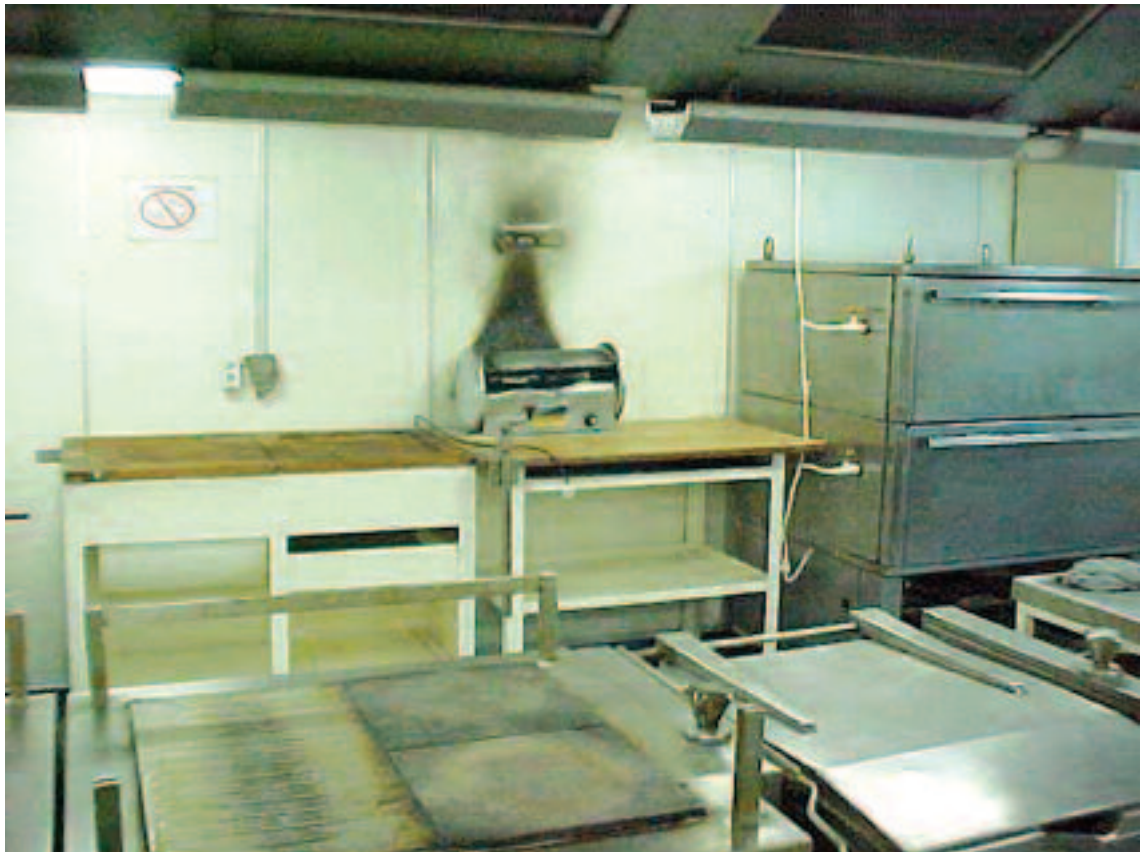
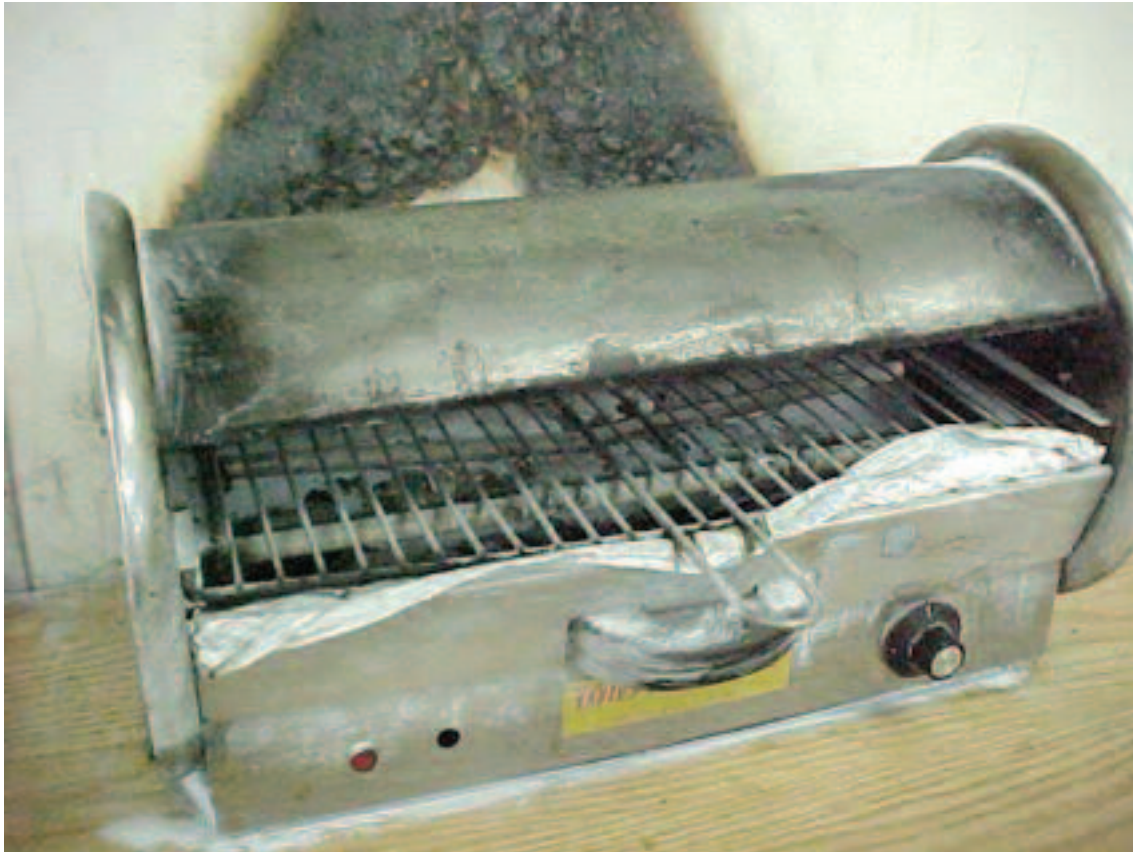
A popping noise was heard from the galley, and was investigated by the off-duty catering staff. They found a grill unit and the bulkhead behind it on fire.

Food, which had been left on the grill cooking and unattended, had ignited and set fire to the bulkhead. The 15-minute grill timer was checked and found to be working correctly and no other faults were found on the grill.

Subsequently, the procedure for shutting down the galley in the evening, including locking the access doors, was reinforced.

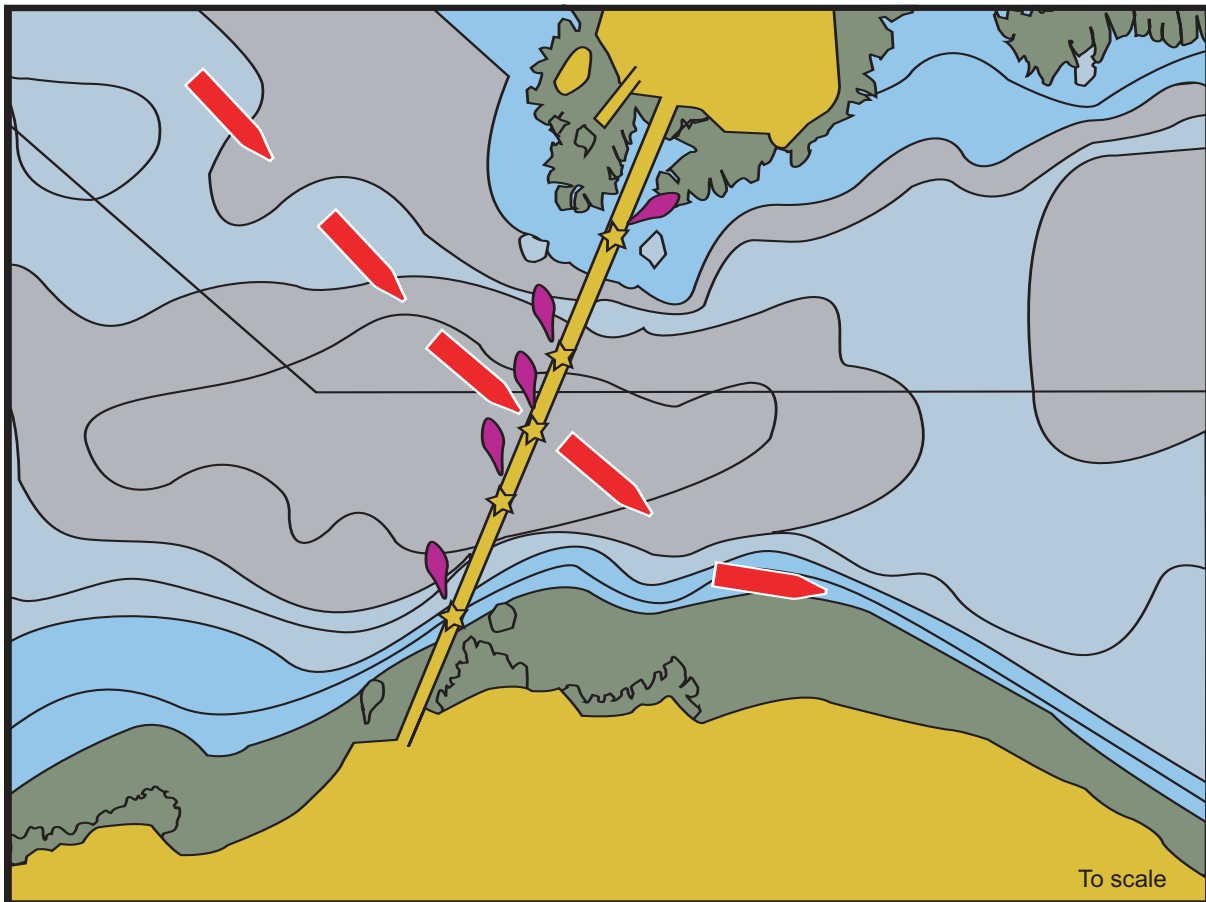
As the vessel passed under the centre of the bridge, the master used 10° of port helm to bring her around 40° to the required heading for the passage. No allowance, mental or otherwise, had been made for the vessel's advance and, unsurprisingly, she grounded on the southern edge of the channel.

The vessel sustained significant hull damage. She was holed in one segregated ballast tank but, fortunately, there was no pollution as a result of the incident.

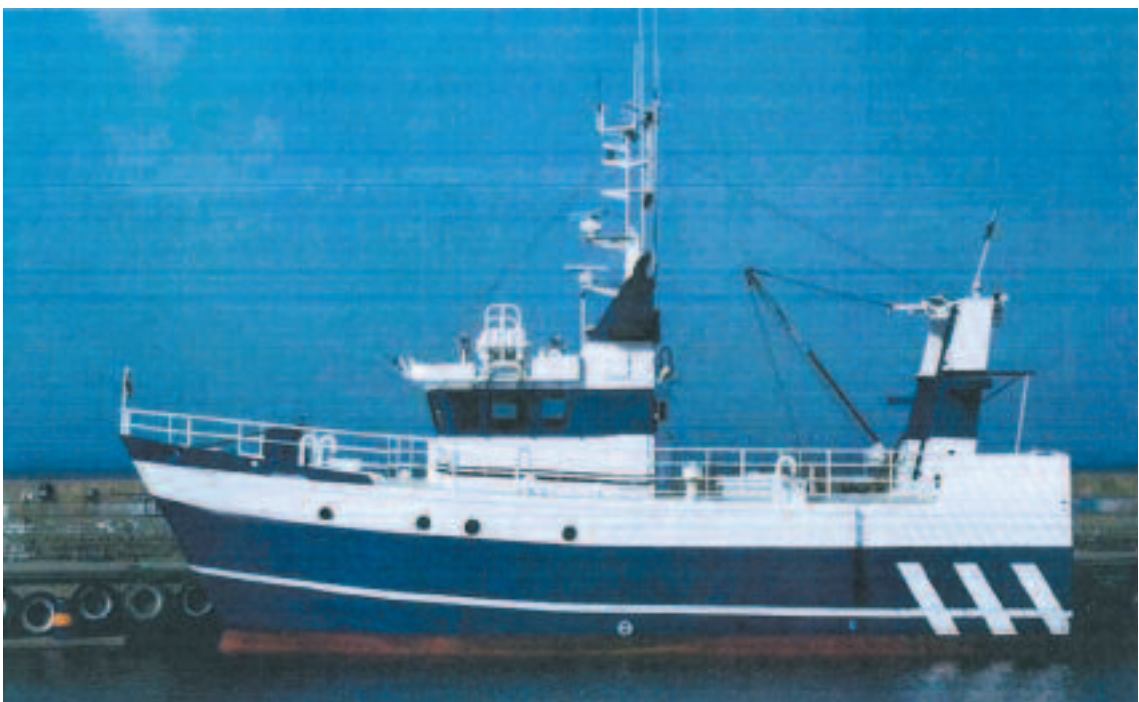
The container vessel's master emerged from the toilet in time to see the fishing vessel's lights close by and on the starboard beam. He had not felt any impact so, despite the protestations on the VHF from the angry and frightened fishermen, he continued on voyage. Although the container vessel was only superficially damaged, its ice strengthened bow

had seriously damaged the fishing vessel. Fortunately, the fishing vessel was able to limp into harbour without further incident, although the master was unaware of this at the time.

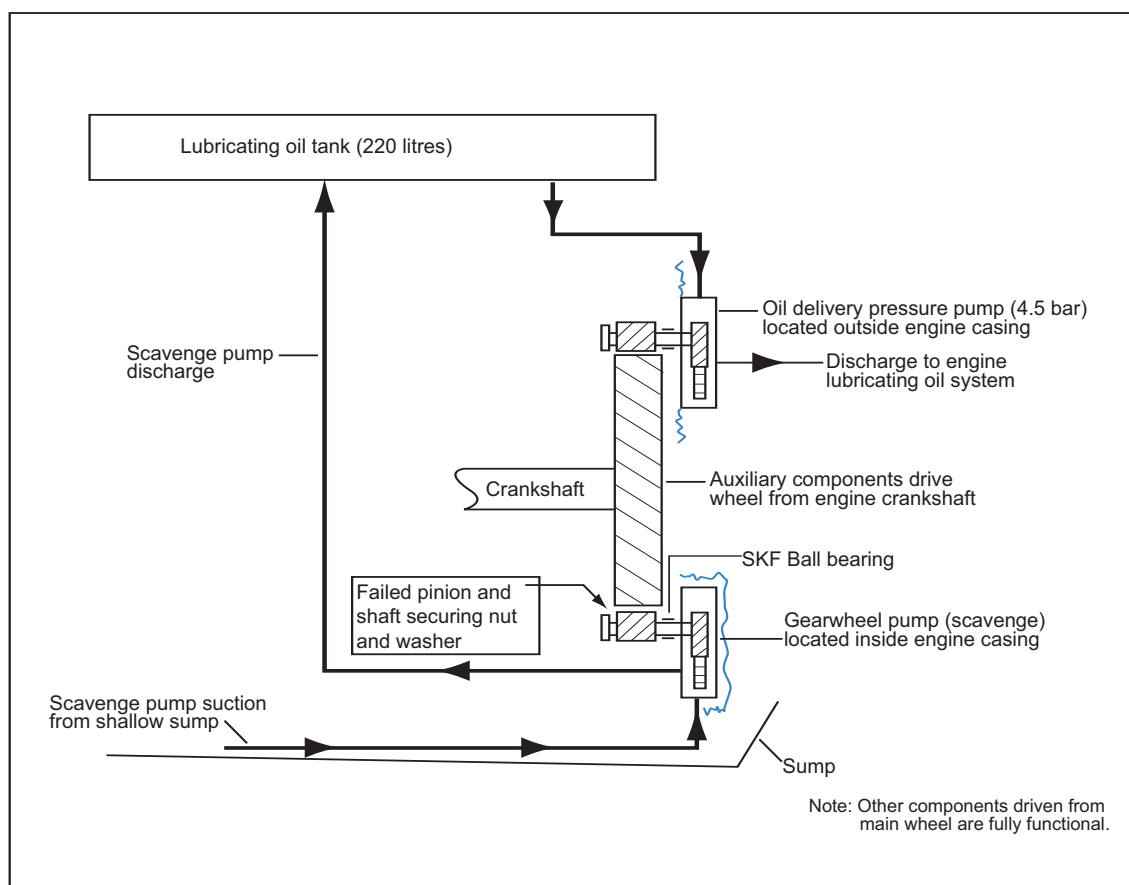
Figure 1 - Schematic of engine lubrication oil system

The chief engineer's peace was soon disturbed. At 1450, the engine room alarm panel repeater sounded in his cabin, so he immediately ran the short distance to the engine room access where the panel was situated. There, he found the main engine lubricating oil, low level warning in alarm. As he checked the level in the engine oil tank the engine low lubricating oil pressure alarm sounded. With no level on the dipstick, it was clear that the 220 litre oil charge was being lost or was not being returned from the sump by the oil scavenge pump (Figure 1).

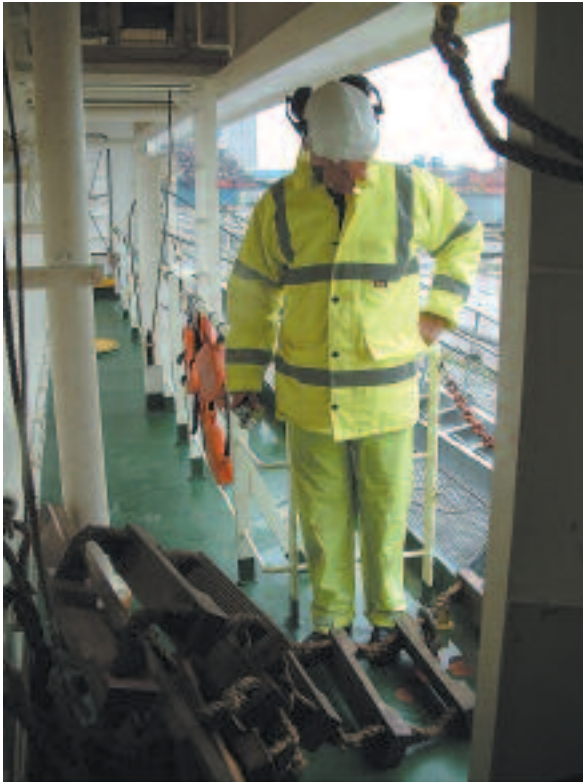
Space available for rigging the pilot ladder

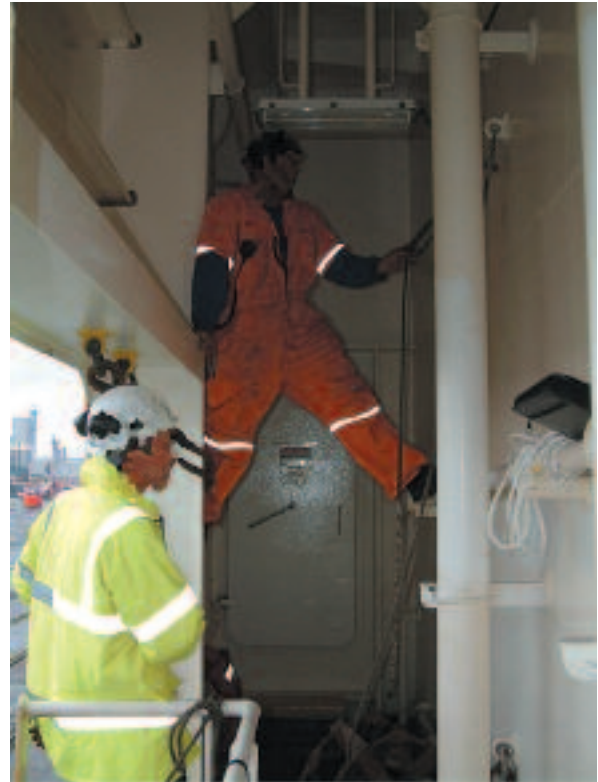
Position of crew for lowering pilot ladder overboard

the bosun's mate to slack back and, as he did so, the weight came off the rung, causing the bosun to lose his balance. His body weight then carried him overboard.

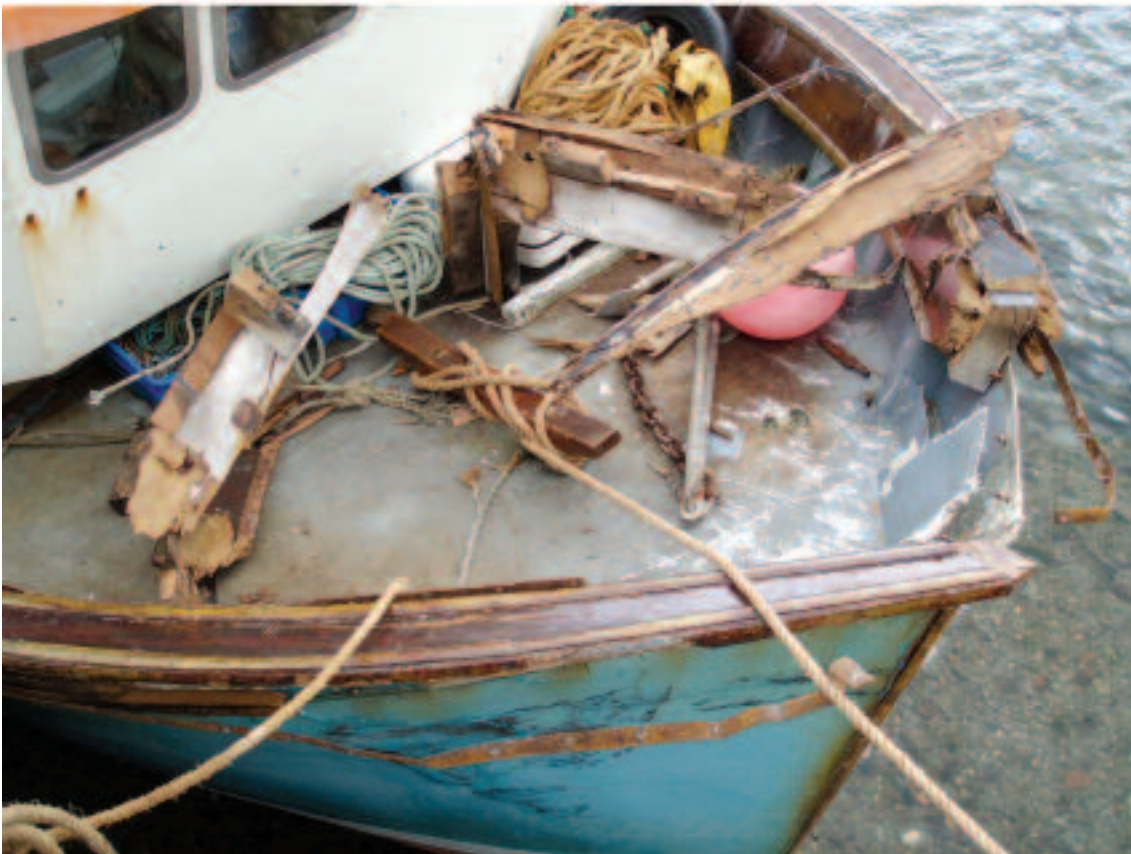
Photographs showing bow damage

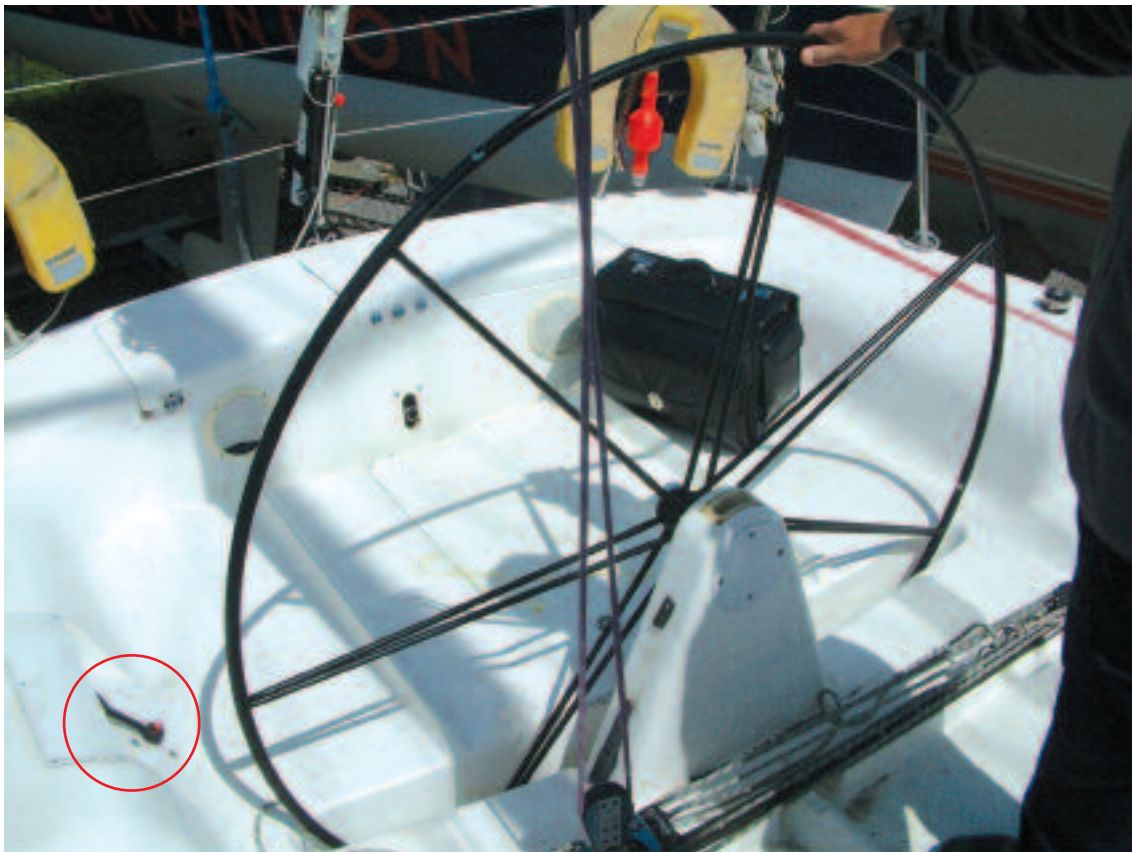
Figure 1 – Position of engine control lever

At 1426 the yacht was tacked back up the channel. The skipper then asked the Day Skipper to start the engine. The Day Skipper unclipped his safety line as he prepared to check that the engine control was in neutral, but he found the lever to be seized (Figure 1). He spent the next 2 minutes releasing it; he then moved in front of the wheel to go down below to start the engine, but he was brought to an abrupt halt. His foot became entangled in the traveller because his safety line became taut (Figure 2). His line had not been released as first thought. The skipper, now distracted, turned round to release the safety line and, at the same time, the yacht conducted an

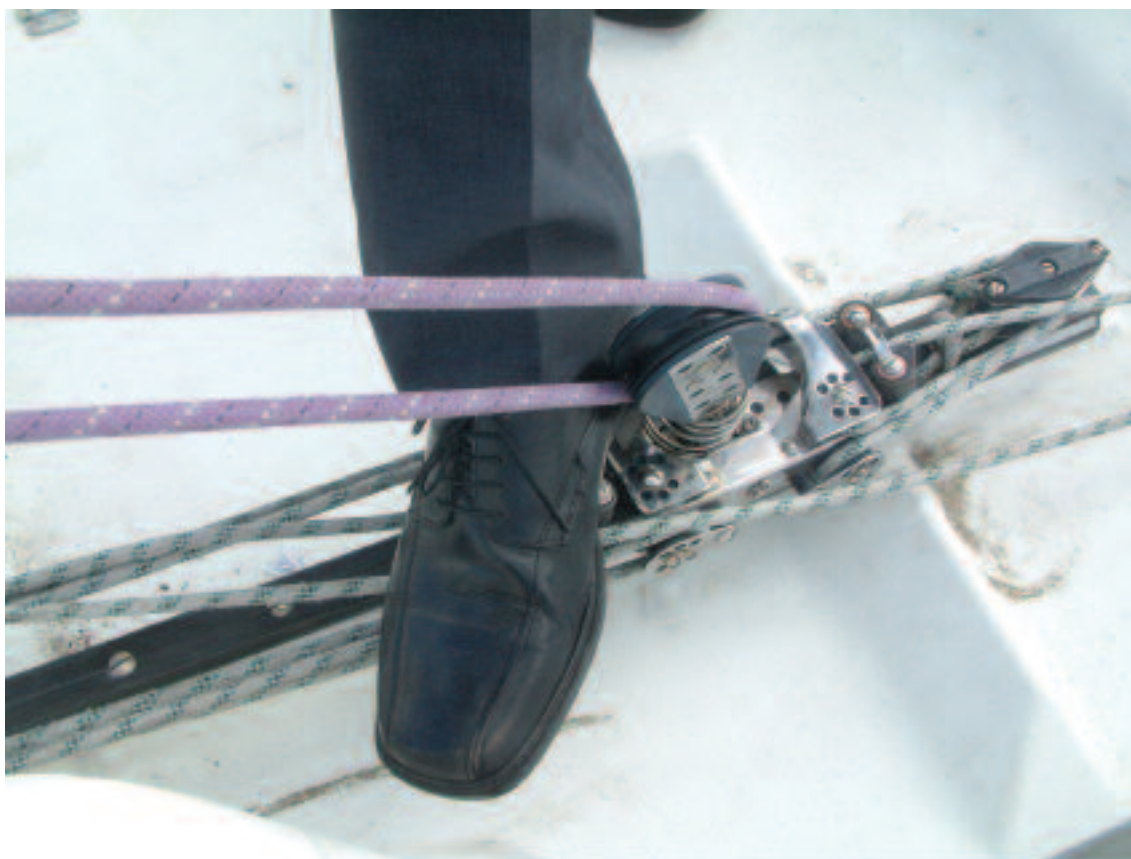
Figure 2 – Day skipper's leg position on the traveller rig

inadvertent gybe. The boom moved rapidly from starboard to port, trapping the Day Skipper's leg with the mainsheet, causing multiple fractures to his right leg. The boom immediately returned to the starboard side.

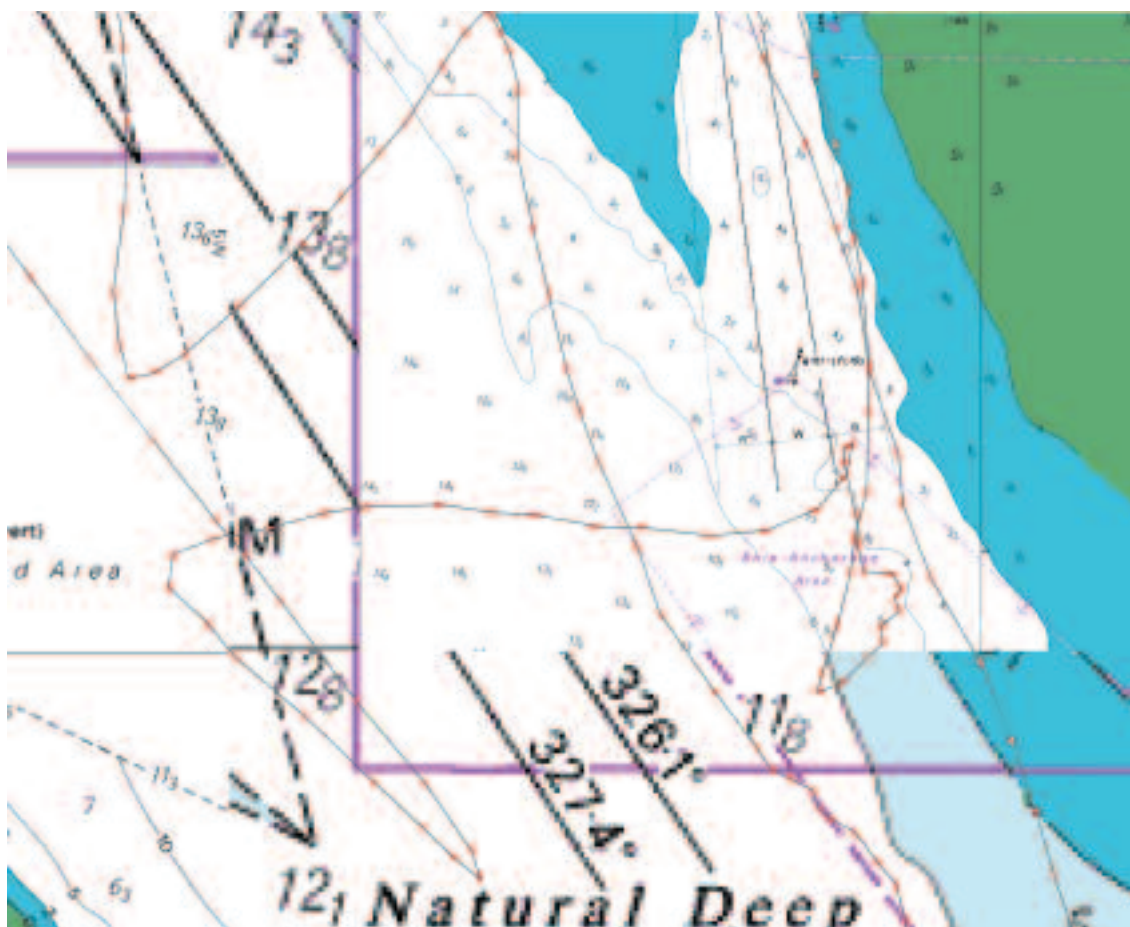
Figure 3 – Detailed GPS track showing key accident points

back inboard. Bleeding profusely from her ears, nose and mouth, her situation was potentially life threatening. The skipper now busied himself in trying to get the sail down. A GPS track identifying the accident points is at Figure 3.
