MARINE ACCIDENT
INVESTIGATION BRANCH

SAFETY DIGEST

**Lessons from Marine
Accident Reports
2/2006**

No 2/2006

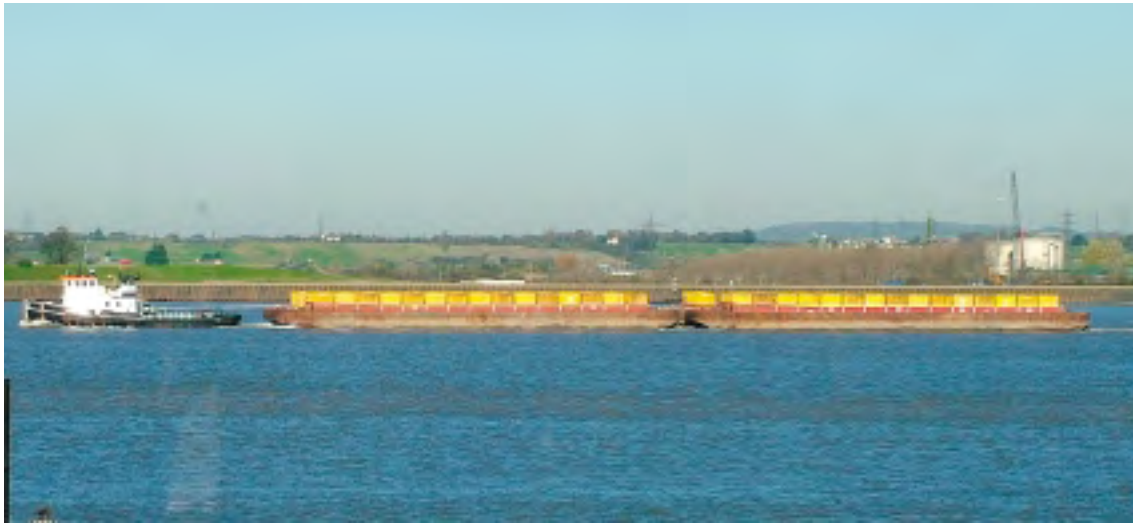
Figure 2

starboard and trimming by the head. Subsequent soundings found four ballast tanks had been opened to the sea (Figures 2 and 3).

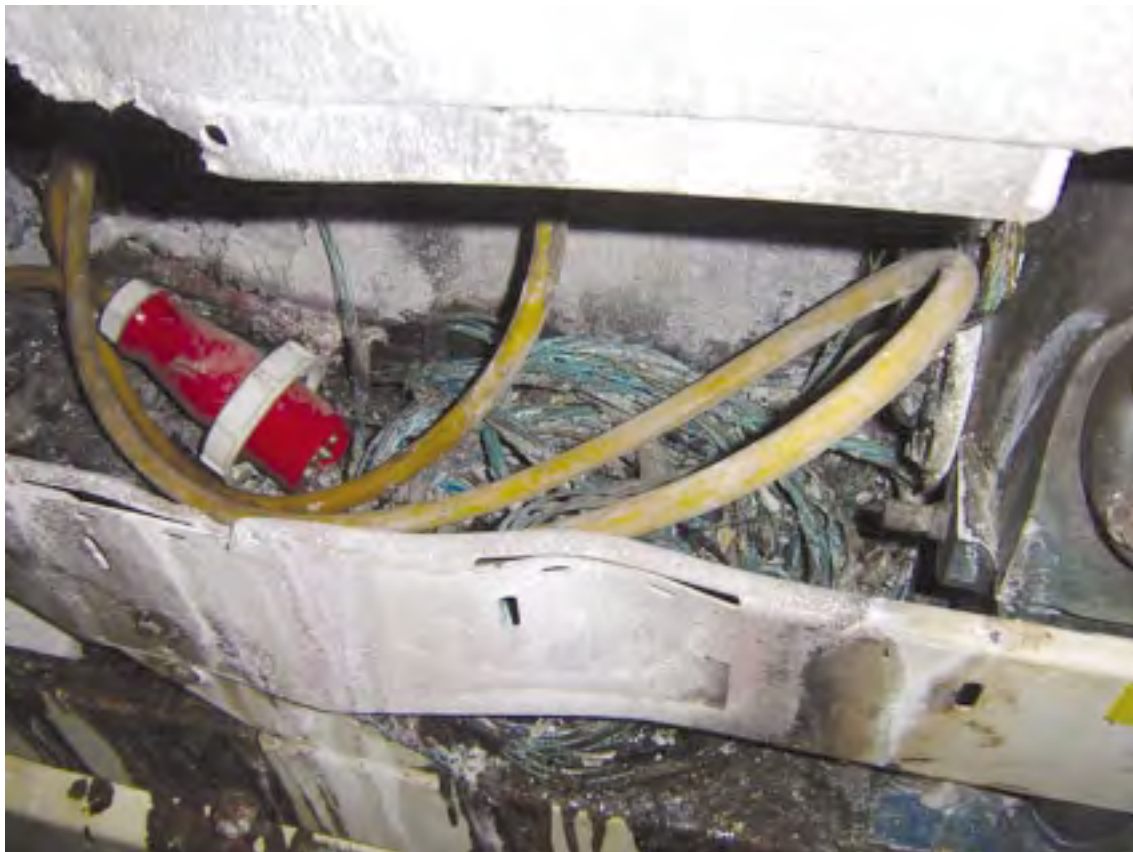
Ventilation was then restarted and the smoke cleared. An examination found the fire was probably started by the overheating of a coiled power supply cable to a refrigerated container (see Figure). This was probably aggravated by it being next to the discharge, and therefore hot side, of the unit's compressor.

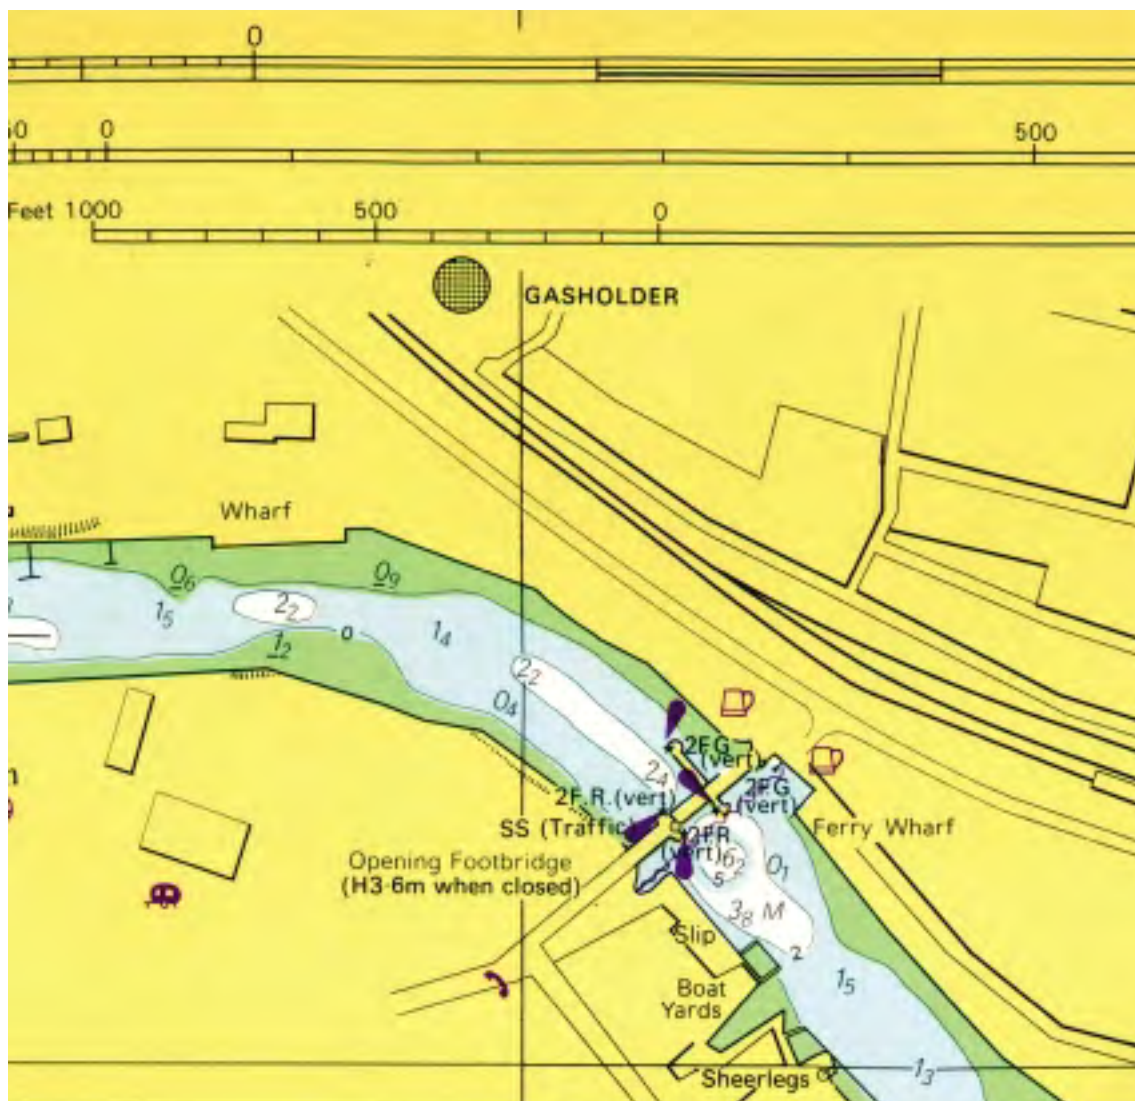
seemed to understand. As the vessel neared a bridge, which was situated near the berth, the pilot repeatedly asked the master to slow down. On each occasion, the master replied "yes", and he appeared to obey the instructions although he was having trouble keeping steerage way (Figure 1 [chartlet]).

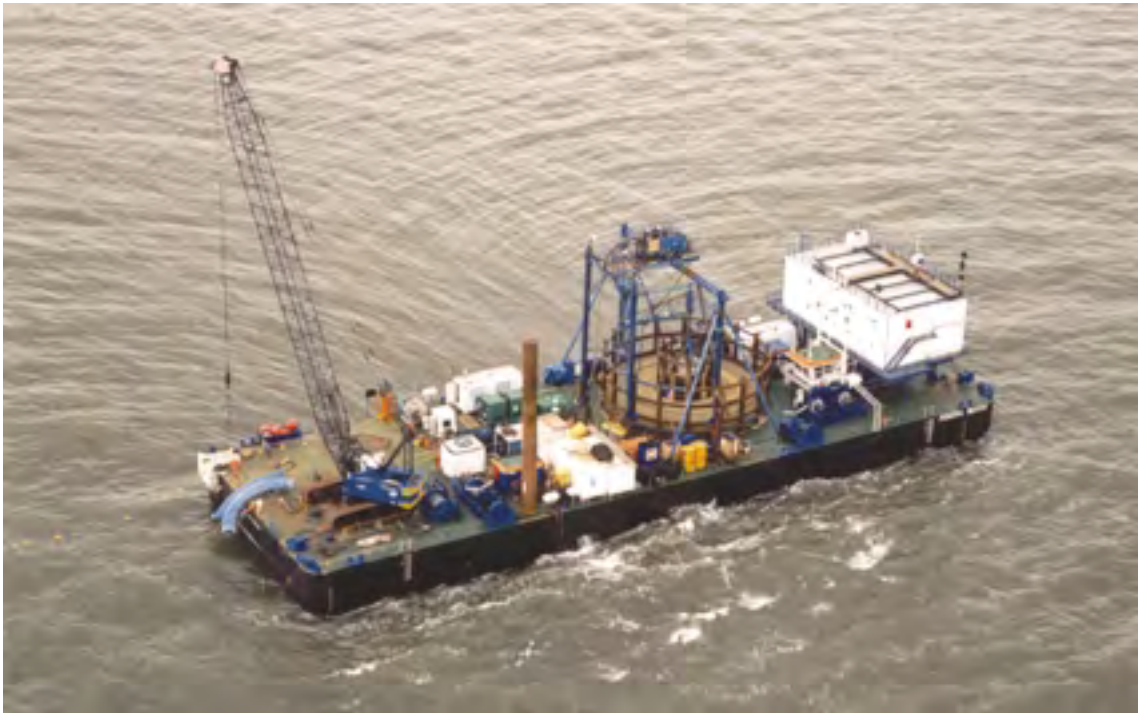
At the time of the accident, the able seaman was not wearing a safety helmet, although they were supplied and ready for use on board.

1. Personal Protective Equipment (PPE), including safety helmets, was supplied on board, but it was up to the individual to ensure his or her own safety by wearing them. The crew member was wearing no safety helmet and was working in full view of the master, yet nothing was said. It is likely that a helmet would have made little or no difference to the injuries sustained, but the issue does indicate a lax safety management system.
2. All hazardous operations, such as the transfer of wires and anchors at sea, should be risk assessed and, if necessary, a detailed written operations procedure should be completed. A risk assessment in this case should have highlighted the dangers associated with not securing the vessels together before transferring items of equipment.

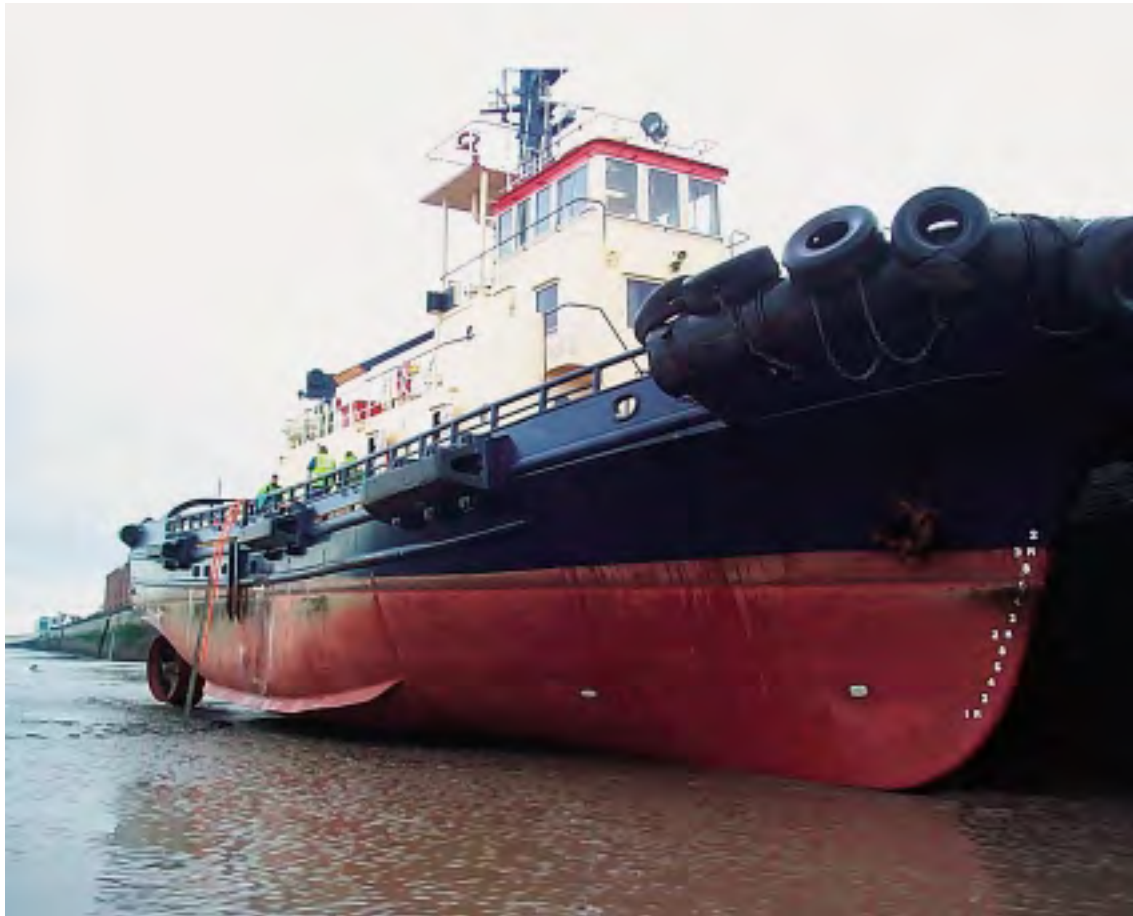
Figure 4 – Vessel beached for repairs

An ambulance was called by mobile telephone, and the engineer taken to hospital. Crew from the other tugs assisted in damage control efforts, and after contacting the company managers, it was decided to beach the tug to effect temporary repairs (Figure 4). These were carried out and the tug was successfully re-floated on the next tide.

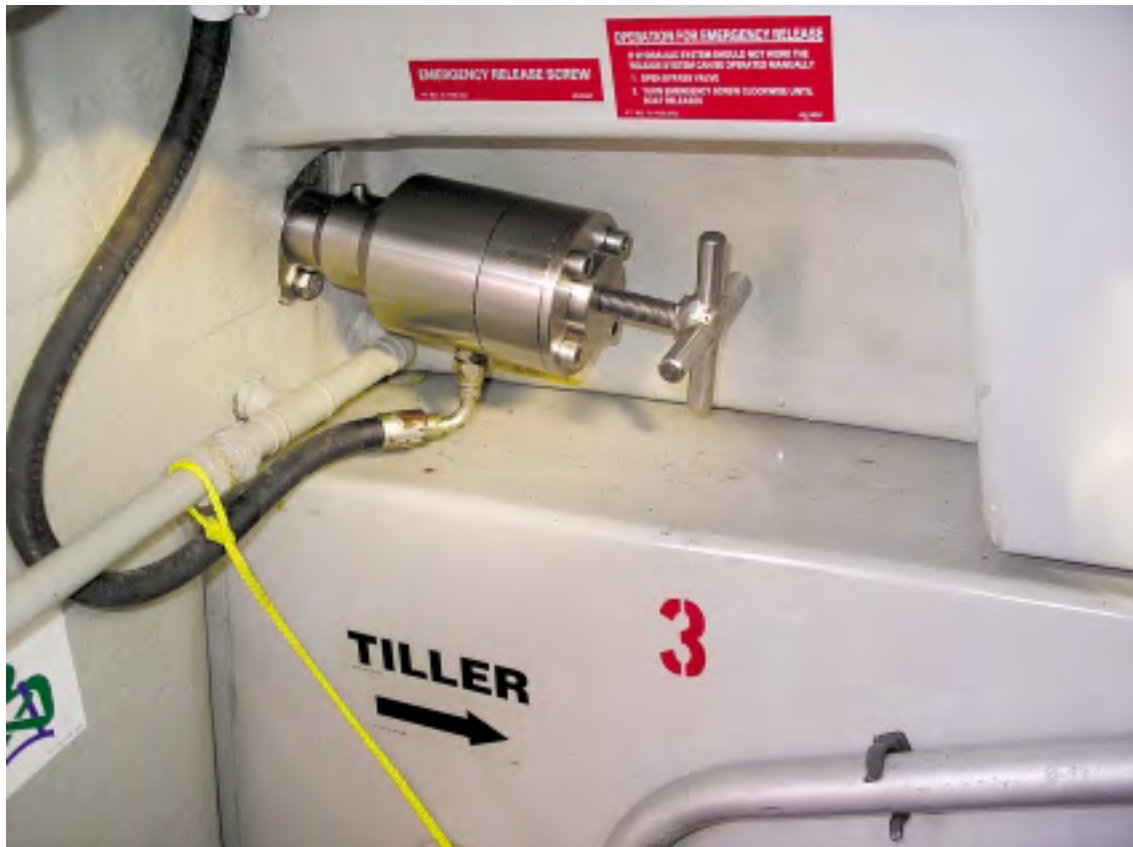
Figure 2 – Signage adjacent to manual release

The weight of the lifeboat was taken by the "A" frame hanging chains, allowing the release hook to be safely operated. The chief officer did not explain the purpose of the drill, nor did he describe the system or the methods of release. Despite this, one of the ABs was instructed to enter the lifeboat and operate the manual release hand wheel. However, neither the AB, nor the chief officer checked that the hydraulic by pass valve was open, as clearly required by the instructions next to the hand wheel (Figure 2).

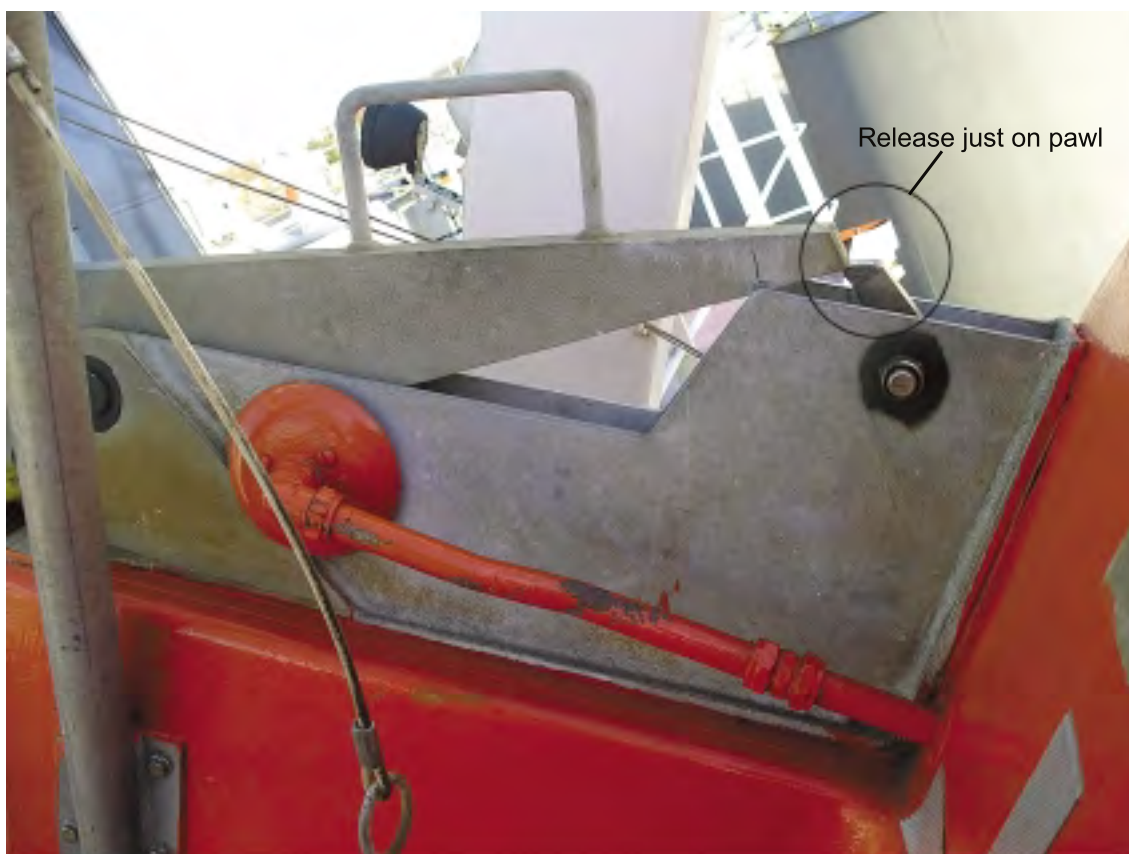
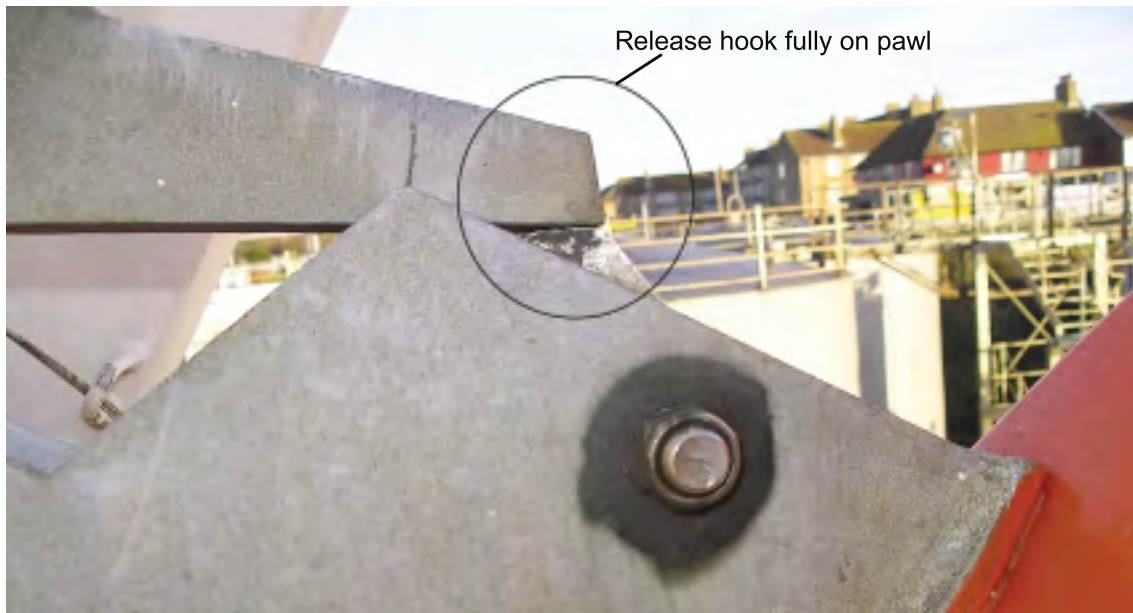
Following the drill, the hydraulic system by pass valve was left in the shut position. This was considered to be the normal standby position, but was contrary to the operating instructions posted in the lifeboat. Although there were no formal checks for the standby condition of the lifeboat, the chief officer confirmed the release hook chain was in position, but no checks were made on the correct position of the release pawl (Figures 4 and 5).

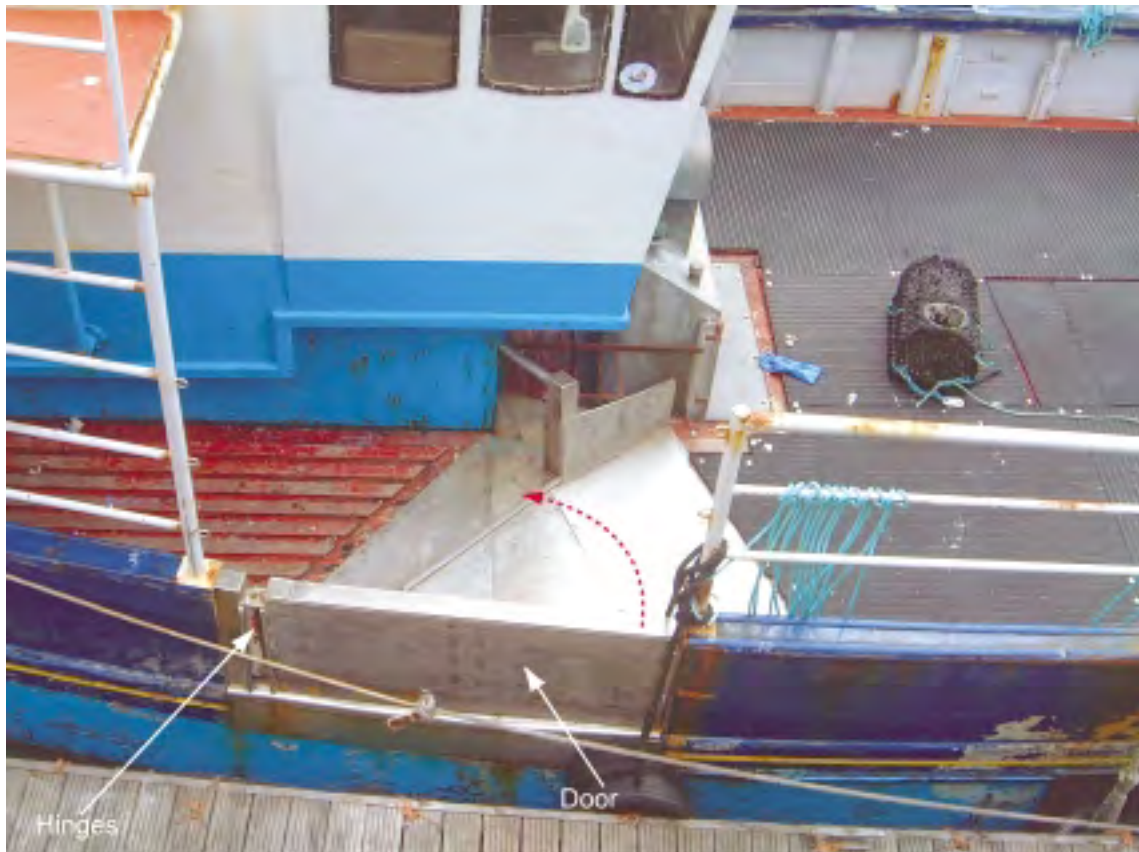
To avoid the hazard of a bight around an ankle, it was decided to move the crewman handling the pots well away from any lines on the deck. This was done by putting a hinged door in the bulwark at one side of the deck which, when opened, allowed the pots to be drawn across the deck by the vessel's forward motion, with only limited intervention from the crew (see Figure).

1. The owner's risk assessment did not extend to considering the hazards associated with the modifications, namely the dangers of the open shooting door.
2. Whenever a risk assessment suggests modifications to equipment or procedures might be beneficial, the hazards associated with the changes should be run through a new risk assessment. Only if the level of risk is reduced by the proposed changes are those changes worthwhile.
3. The practice of blocking off a second access route between the working deck and the wheelhouse forced this crew to walk past the shooting door, which was a substantial hazard when open.
4. Once in the water, the crewman was unable to stay afloat because he was not wearing a lifejacket or other buoyancy aid. His loss from the vessel had been noticed so quickly that, had he been able to remain afloat, for even a few minutes, he might have been safely recovered.

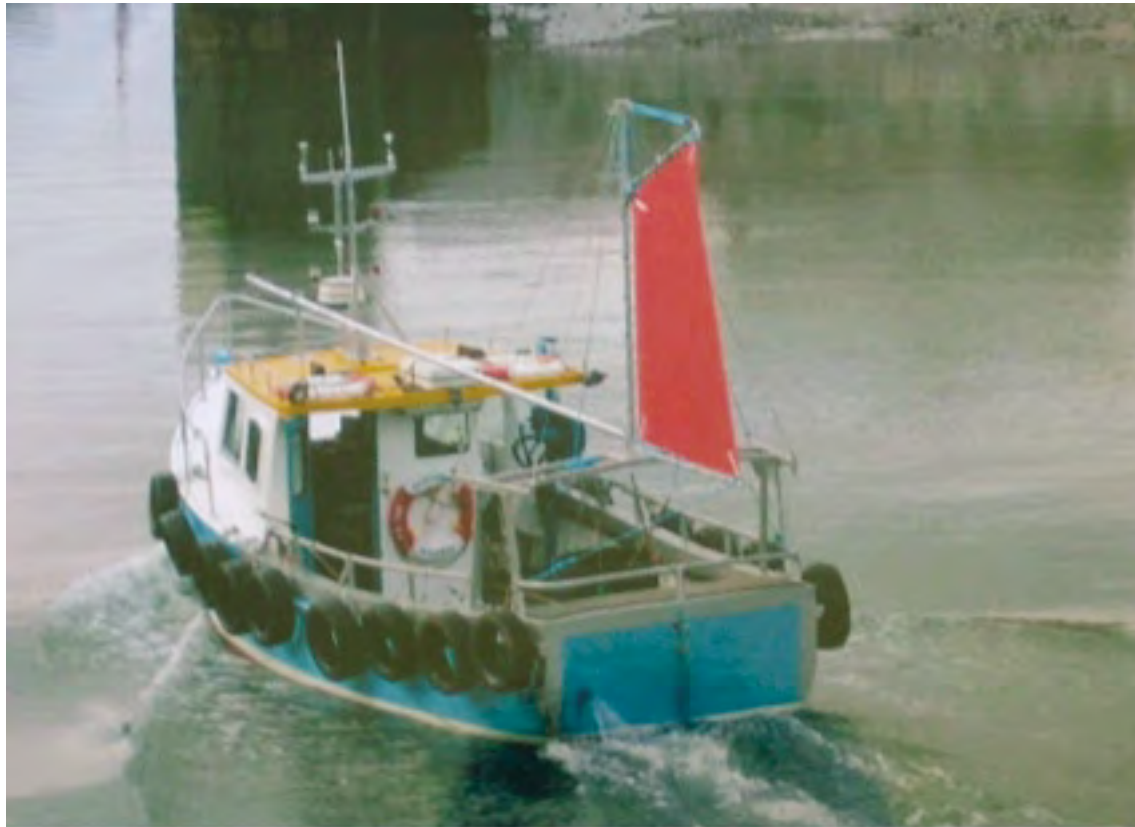
Figure 2

slow speed to give the crew time to tail the prawns before reaching port. The other fishing vessel was a potter (Figure 2), and had broken down when on passage to her grounds.

3. It is possible that the liferaft on the potter failed to deploy because it had been incorrectly fitted or poorly sited. The free issue of liferafts is an excellent safety initiative, but they must be installed correctly. Fishermen who fit liferafts should follow the instructions very carefully. If there is any doubt about the correct procedure, assistance from an experienced seafarer such as a lifeboat man or harbourmaster should be sought.

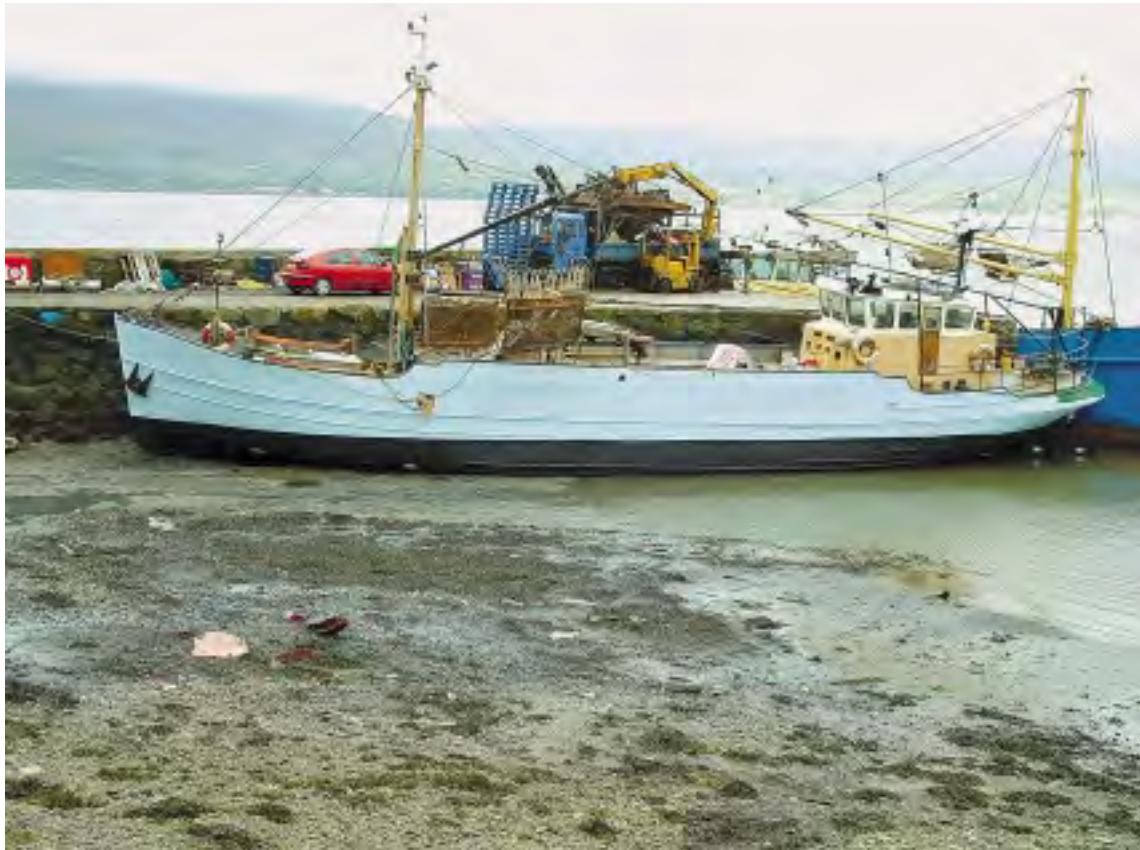
Figure 1 – General view of vessel

A 26 metre mussel dredger (Figure 1) converted from a Dutch river barge, built in 1908, was flagged into the UK register in 2002 having been inclined and surveyed. An MCA approved stability book was produced, setting out loading conditions, but it was not normal practice to hold it on board. Modifications, which added weight to the vessel, were made following inclining, but the MCA was not notified.

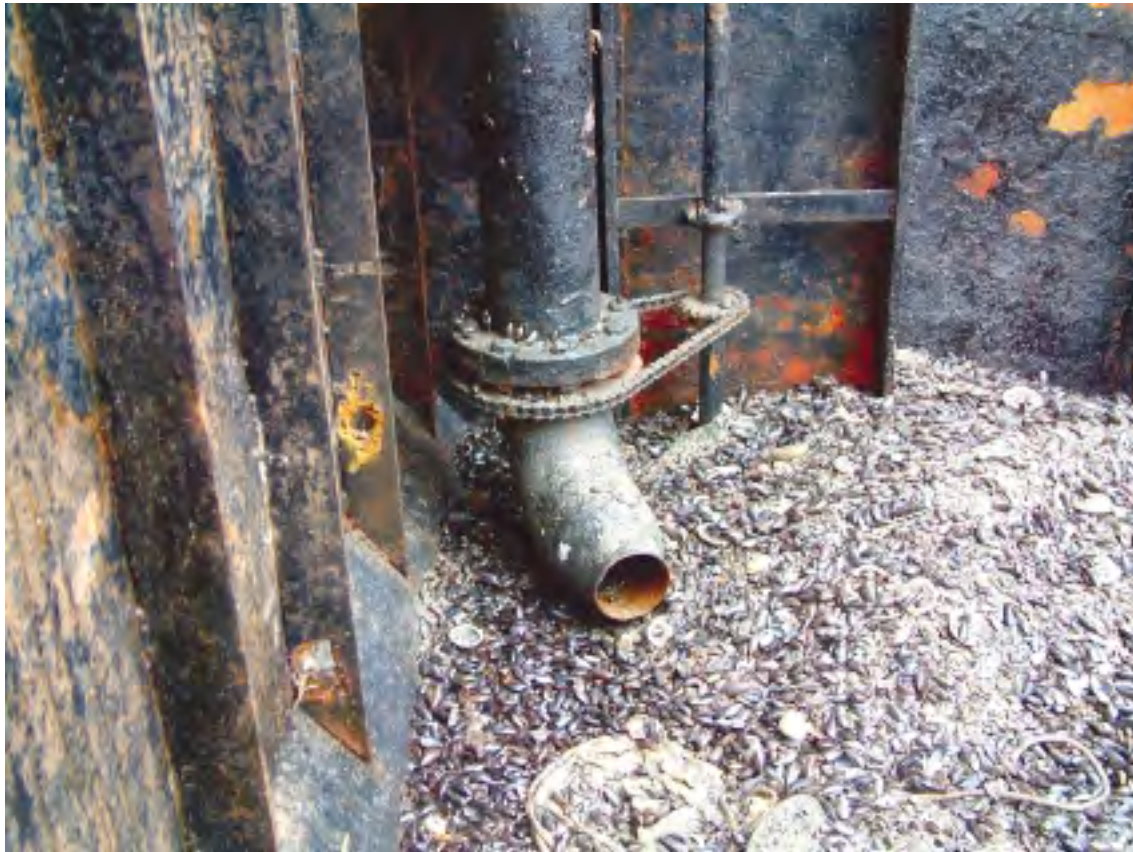
Figure 2 – Slusher jet

pressure salt water “slusher” pump used to drive the mussels out of the seeding hatch using the directional “slusher” jet (Figure 2).

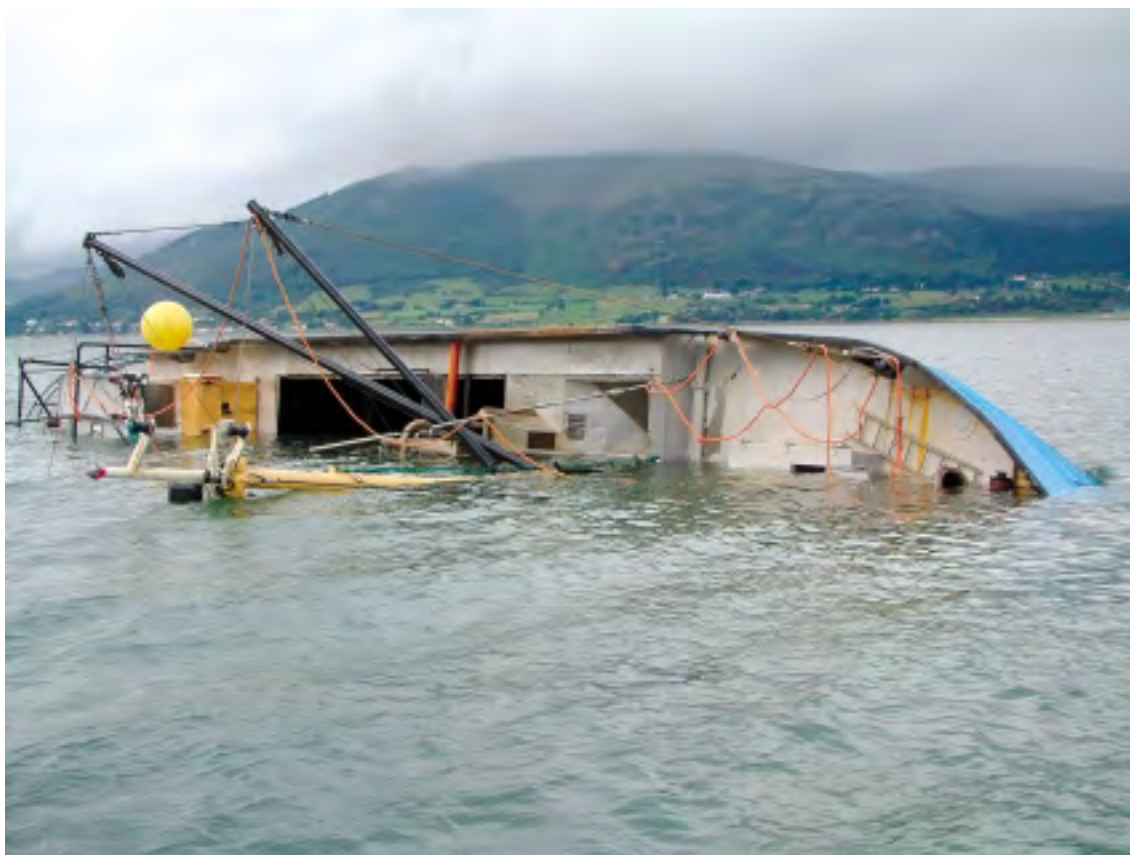
Figure 3 – Vessel capsized

During the accident investigation, it was found that the double bottom “tell tale” pipe isolating valve was blocked. Once cleared, water gushed out, proving that the double bottom was flooded. The cause of ingress was found to be plate corrosion in the after hold bilge suction well (Figure 4). Now this is not a big problem if the double remains pressed full, but the slight drainage into the engine room removed some water, which resulted in a large free surface effect.

Following remodelling of the stability of the vessel, it was found that the probable cause of capsize was an obstructed seeding hatch. This led to an increase in the water level in the after hold, coupled with free surface in the double bottom and a cargo shift.

3. If water is seen to be leaking from a “tell tale” system it should be investigated without delay. The investigation does not end there: the cause of water ingress must be determined and rectified. Your life could depend on it.

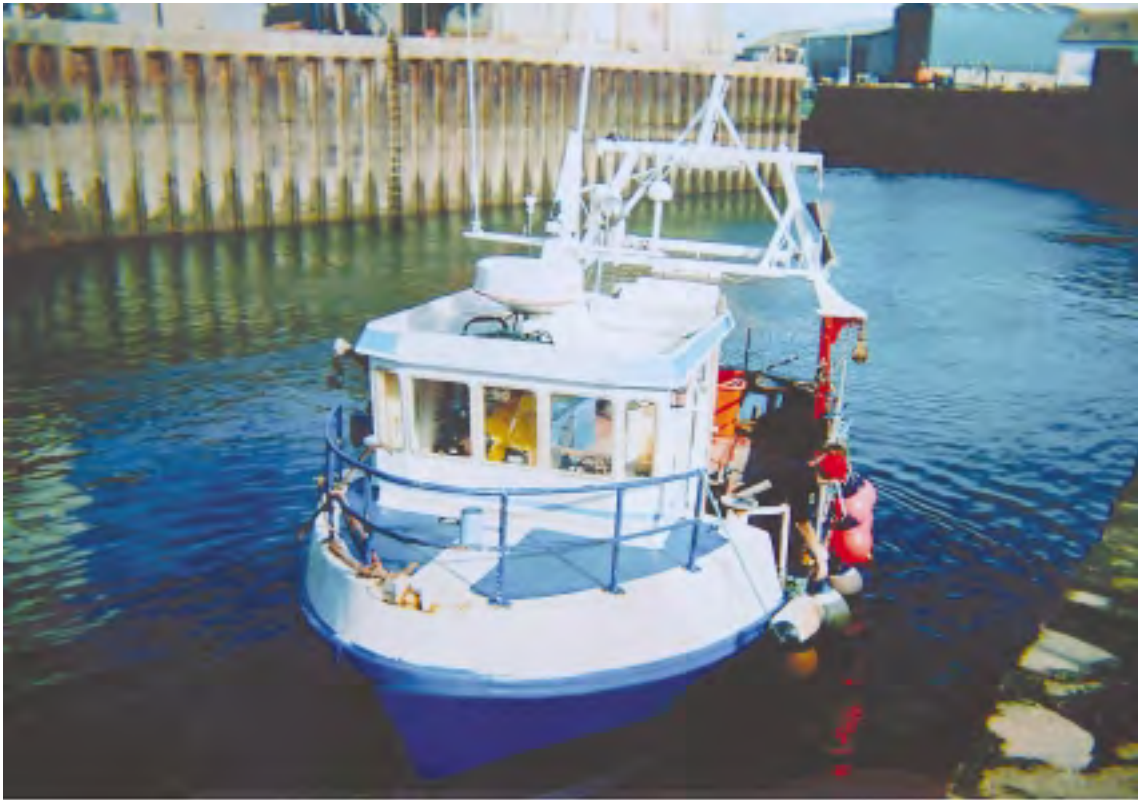
Figure 1

An 8.7m potting vessel (Figure 1) capsized rapidly and without warning while starting out on passage back to her home port at the end of a day's fishing. The two crew members were thrown into the sea; neither was wearing a lifejacket. The vessel righted herself, and the deckhand returned to the partially submerged hull and was able to release the liferaft. He managed to inflate it, and board it from the water. The skipper, who had been seen on the surface, was lost from view before the deckhand could paddle the liferaft to him and was not seen again. The vessel sank shortly afterwards.

Analysis of the evidence indicated that flooding of the engine space, caused by a failure in the salt water cooling system, probably led to the loss. The vessel was not fitted with an operational bilge alarm, and there was no other warning that flooding was taking place. The engine space extended the

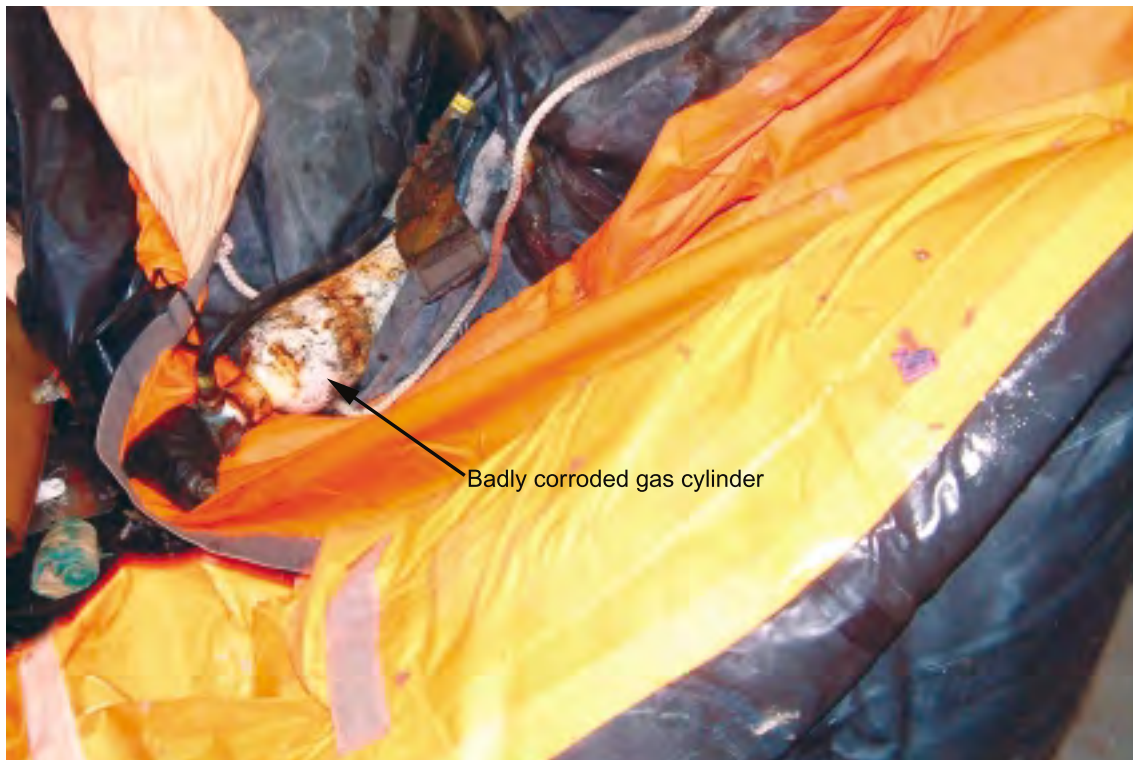
Figure 2

The liferaft had not been serviced for many years (more than 12), and it was fortunate that it inflated when the deckhand pulled the painter, particularly as the gas cylinder was badly corroded (Figure 2). The condition of the liferaft fabric and equipment was also very poor, resulting in the deckhand spending a very uncomfortable night in it. The flares, torch and liferaft lights did not work, and no reflective tape was fitted to the canopy.

3. A fishing vessel of this size does not have to carry a liferaft, although the benefit of having one has been dramatically demonstrated by this accident. Government agencies in many parts of the country now issue liferafts free of charge, so if you own a small fishing vessel, you should take advantage of this initiative if it is available. Once a liferaft is installed, it should be serviced in accordance with the manufacturer's instructions.

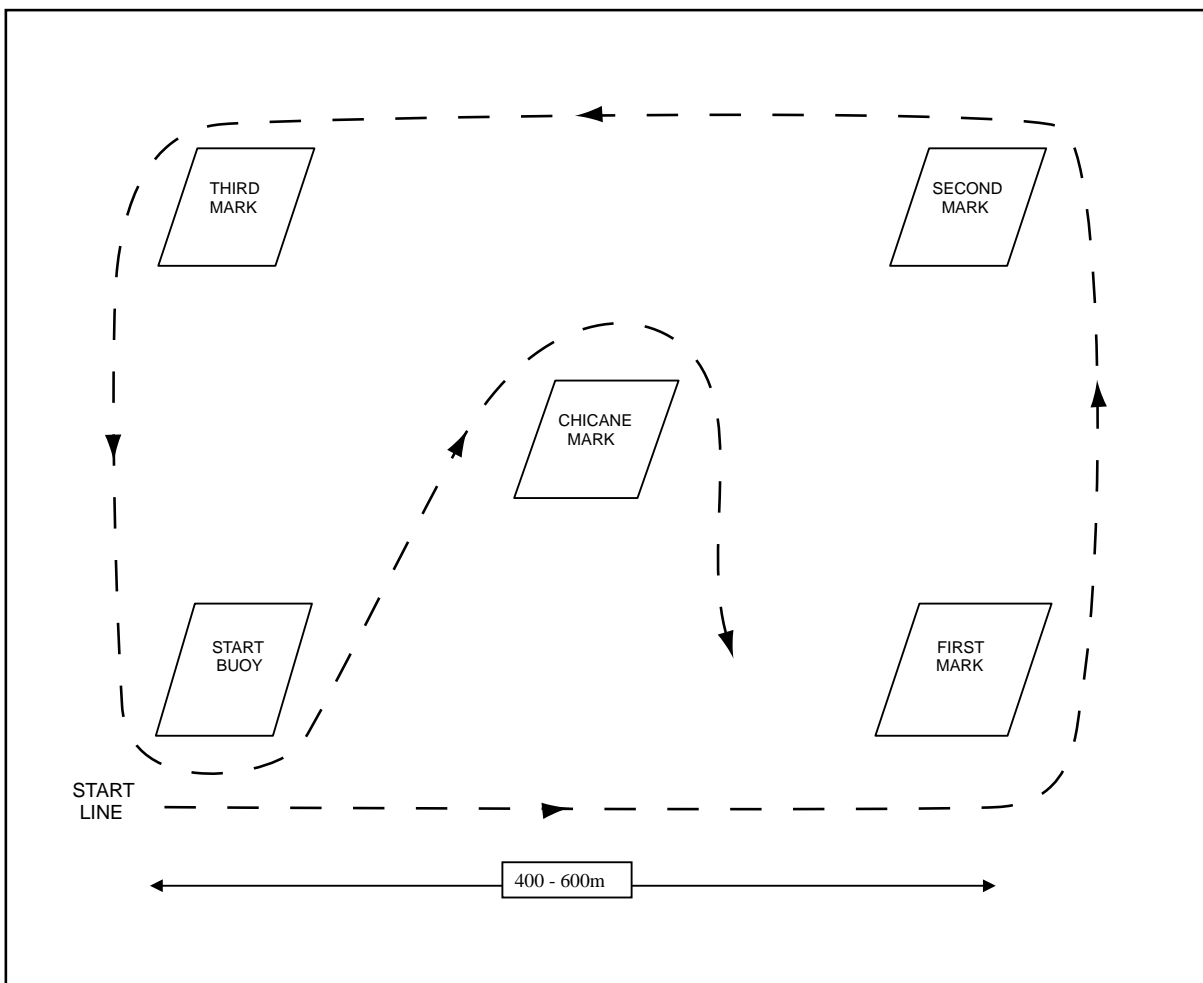
Figure 2 – Typical course

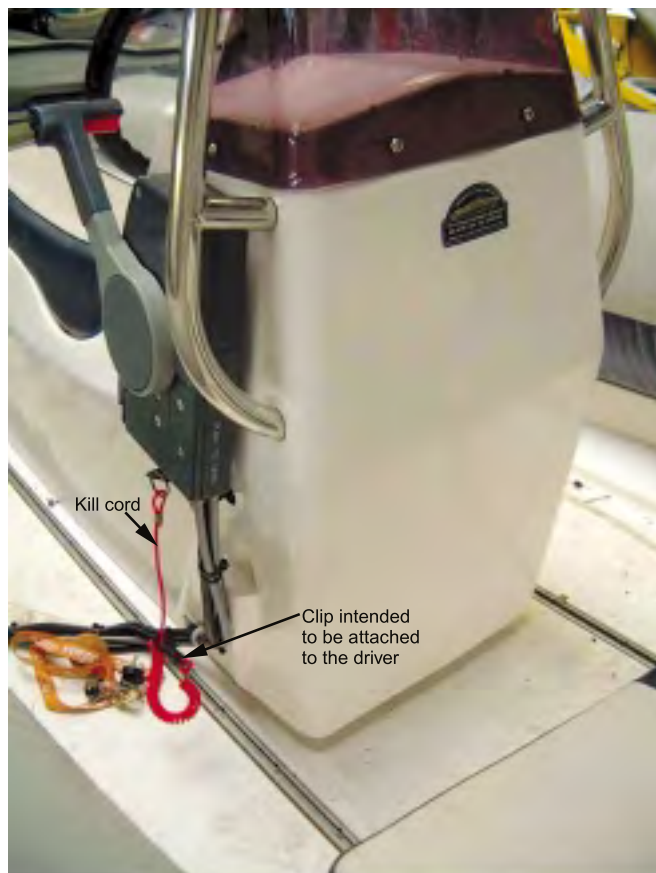
Figure 1 – Photograph showing console and kill cord

1. Had the kill-cord fitted to the RIB been used, the injuries caused by the propeller would have been avoided. A RIB driver does not expect to be thrown from his or her boat, and therefore it is not difficult to see why some drivers might see the wearing of kill-cords as unnecessary, or even as an insult to their ability. However, this accident shows that the unexpected does happen, and that people do get seriously injured as a consequence. It is common sense to use the kill-cord; it is foolish not to.

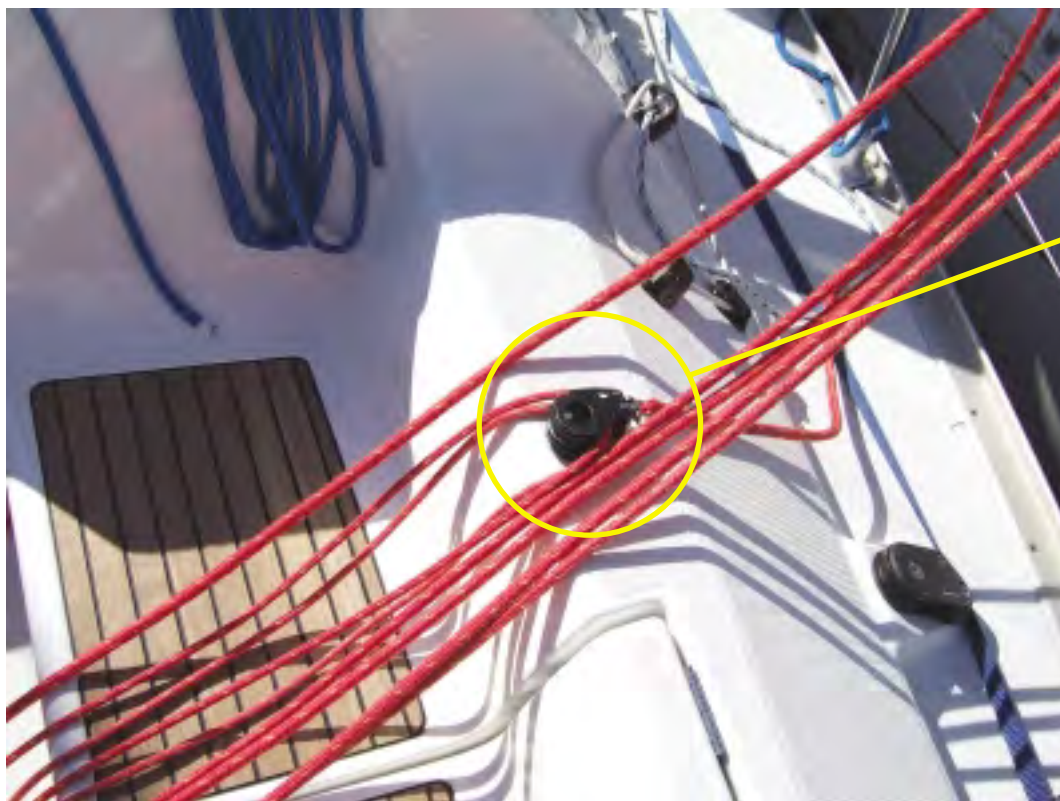
Figure 1

Fine tuning block
