MARINE ACCIDENT
INVESTIGATION BRANCH

SAFETY DIGEST

**Lessons from Marine
Accident Reports
1/2008**

No 1/2008

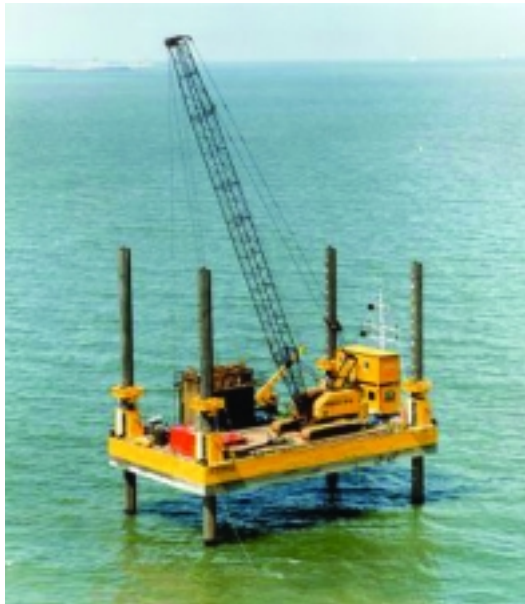
Figure 1: Jack-up barge in position

Shortly after altering course, and half an hour after low water, the barge grounded on the forward two, of her four, legs. The force of the grounding caused some of the barge personnel to fall; however, no one was injured.

The jack-up barge refloated 40 minutes after the grounding and was returned to harbour. All four legs were found to be damaged, with the damage to the barge costing an estimated £1m to repair. The delay in returning the barge to her destination also resulted in extensive delays to the project when the seabed frame, constructed during the previous installation stage, collapsed in the strong tides.

3. When using electronic charts, source data can be hard to find or, once found, interpret:
 - ECDIS equipment uses Category of Zone of Confidence (CATZOC)

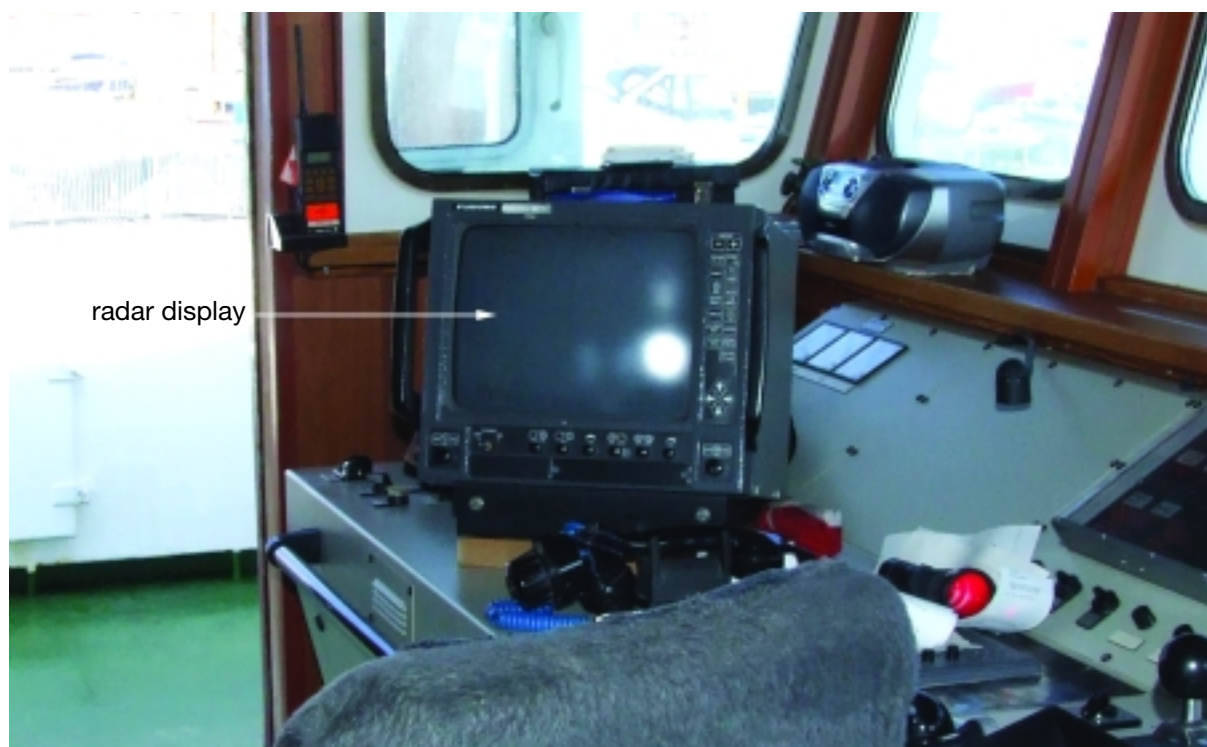
Figure 1

The cargo ship was holed above the waterline (see Figure 2) and diverted to a nearby port for survey and repair, but the trawler sustained only superficial damage and continued fishing.

4. Given the limited manoeuvrability of vessels engaged in fishing, it is in their interests to keep a proper lookout, to ensure dangerous situations caused by other vessels not keeping clear are spotted in time to allow successful avoiding action to be taken. This cannot be achieved unless at least one person is looking out of the window and at the radar display.

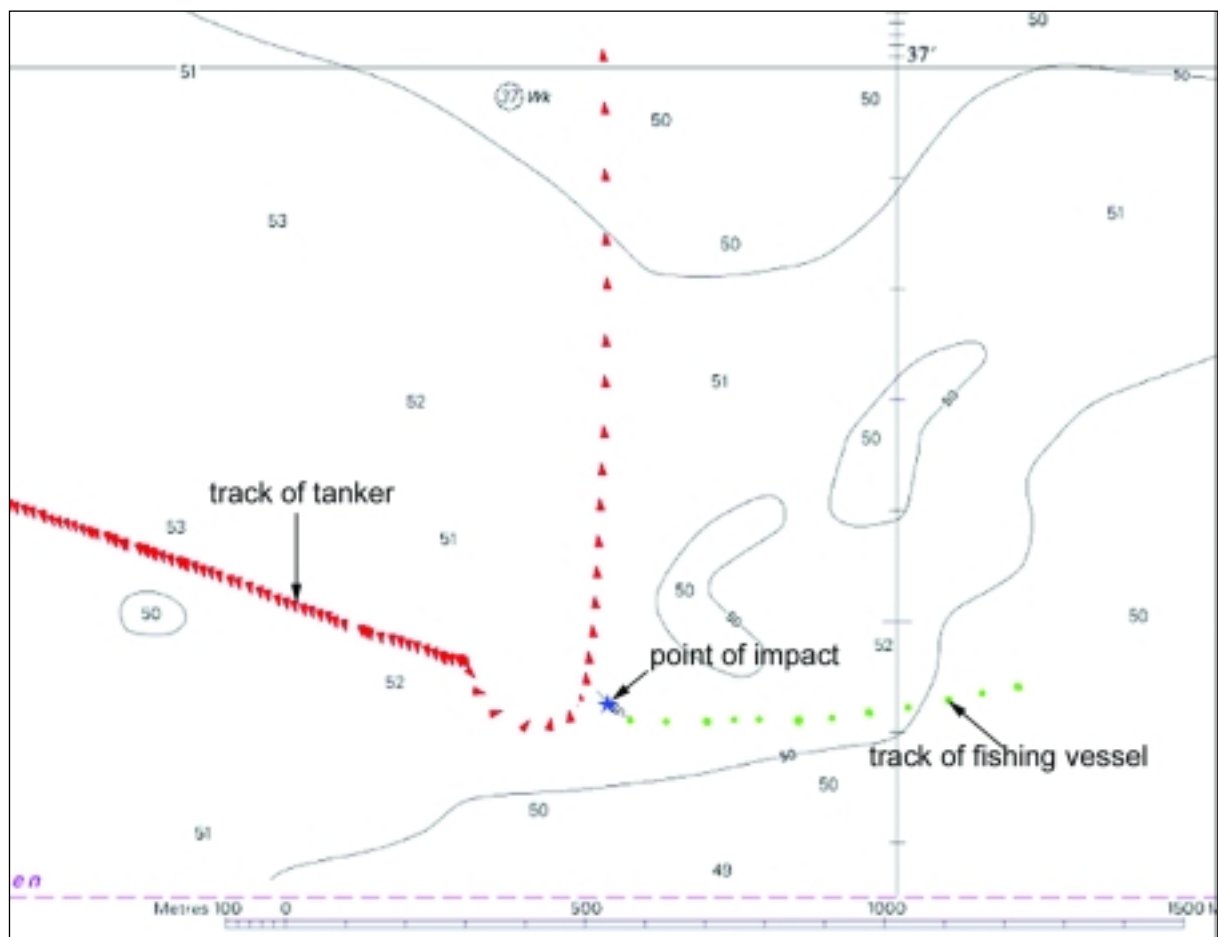
Tracks of the vessels

At about 0848 UTC the master of the tanker received a call from the pilot advising him to meet him at a position 2 miles to the north. He plotted his position at 0850 UTC and manoeuvred his vessel to head north with the use of helm and engines, acquiring a speed of about 3 knots in so doing (see Plot). At the time, the bridge was manned by the master and a seaman.

After laying some of her pots in the eastern approaches to the port, the fishing vessel headed off in a westerly direction at a speed of about 6 knots. The skipper was using a track recorder in conjunction with a separate echo sounder to record the positions of his pots. To monitor the traffic on radar, the skipper had to switch between the echo sounder and radar modes on his multifunction navigational instrument. The range set on the fishing vessel's radar was only 0.125nm which, in effect, gave the skipper 1 minute's worth of view ahead, but he was not fully aware of this fact. He had been switching to monitor the radar occasionally, and was about to do so when the skipper sighted the tanker's hull. By that time it was too late to take effective action to prevent the collision which occurred at 0851 UTC. The precise time and position of the collision are known because the skipper was thrown forwards onto the control console,

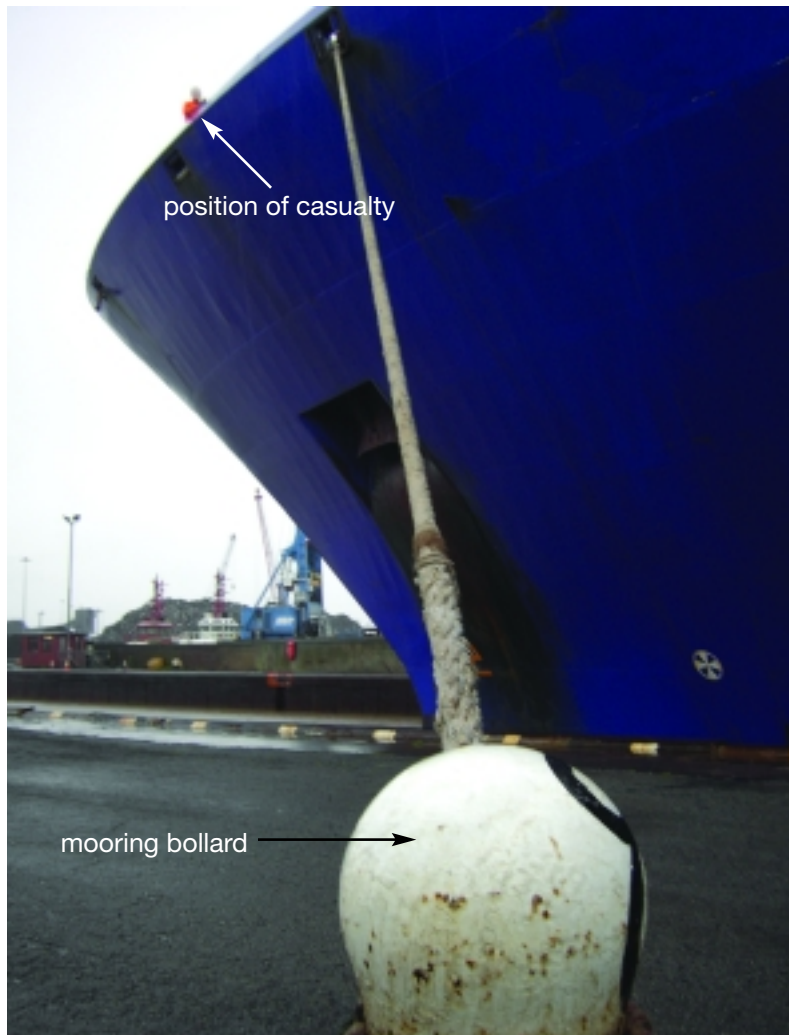
Figure 1: Mooring arrangements at the time of incident

snapped back, and struck the leading hand in the face, causing lacerations and fractures to his cheek bone and nose. He had not been wearing a safety helmet.

2. It is essential that all personnel involved in mooring operations are provided with, and wear, personal protective equipment.
3. Complacency is a killer, and it is vital that ships' staff keep alert to the potential risks involved in mooring operations at all times.

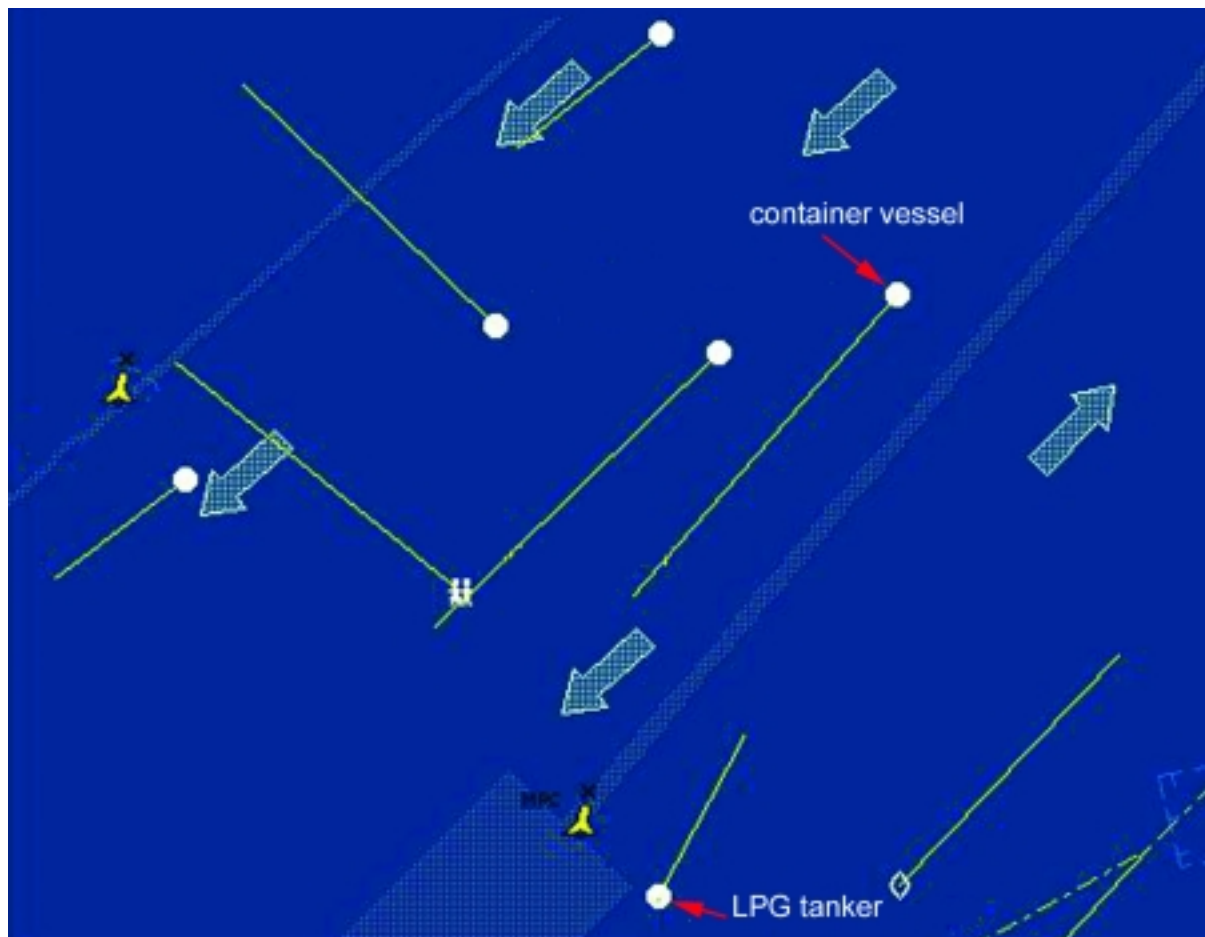
Figure 1: Initial position of vessels

A target was sighted on the port bow of the LPG tanker at 10 nm and acquired on the vessel's ARPA radar. When the vector was settled, the OOW performed a trial manoeuvre check which indicated that if the tanker altered course at the MPC buoy, as planned, they would pass 1 mile ahead of the target vessel.

There was a strong tidal stream running from the north-east, so the vessel was a little later arriving at the MPC buoy than expected. At the MPC buoy the lookout took the wheel and, on instruction, altered course to cross the south-west lane. After steadying on the new course the OOW fixed the position using a visual bearing and radar distance, and plotted it on the chart in the chart room. He recalls seeing the target vessel, a container ship, broad on

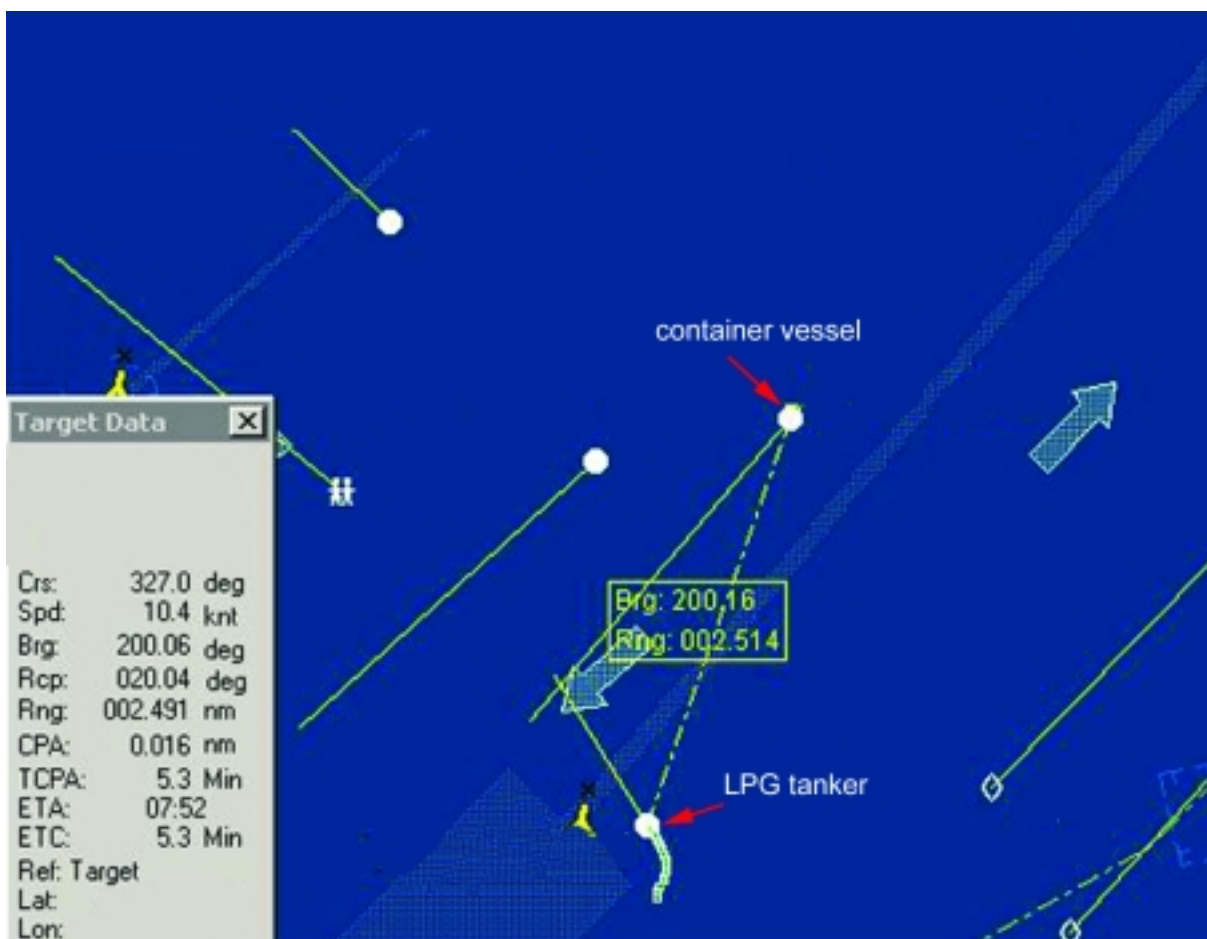
Figure 2: Vessel positions after LPG tanker's change of course

Shortly after starting the turn to port he contacted the other vessel to request that they went to port as well; this was declined by the master, who stated that they would alter to starboard.

The combination of these two actions resulted in a collision being narrowly avoided.

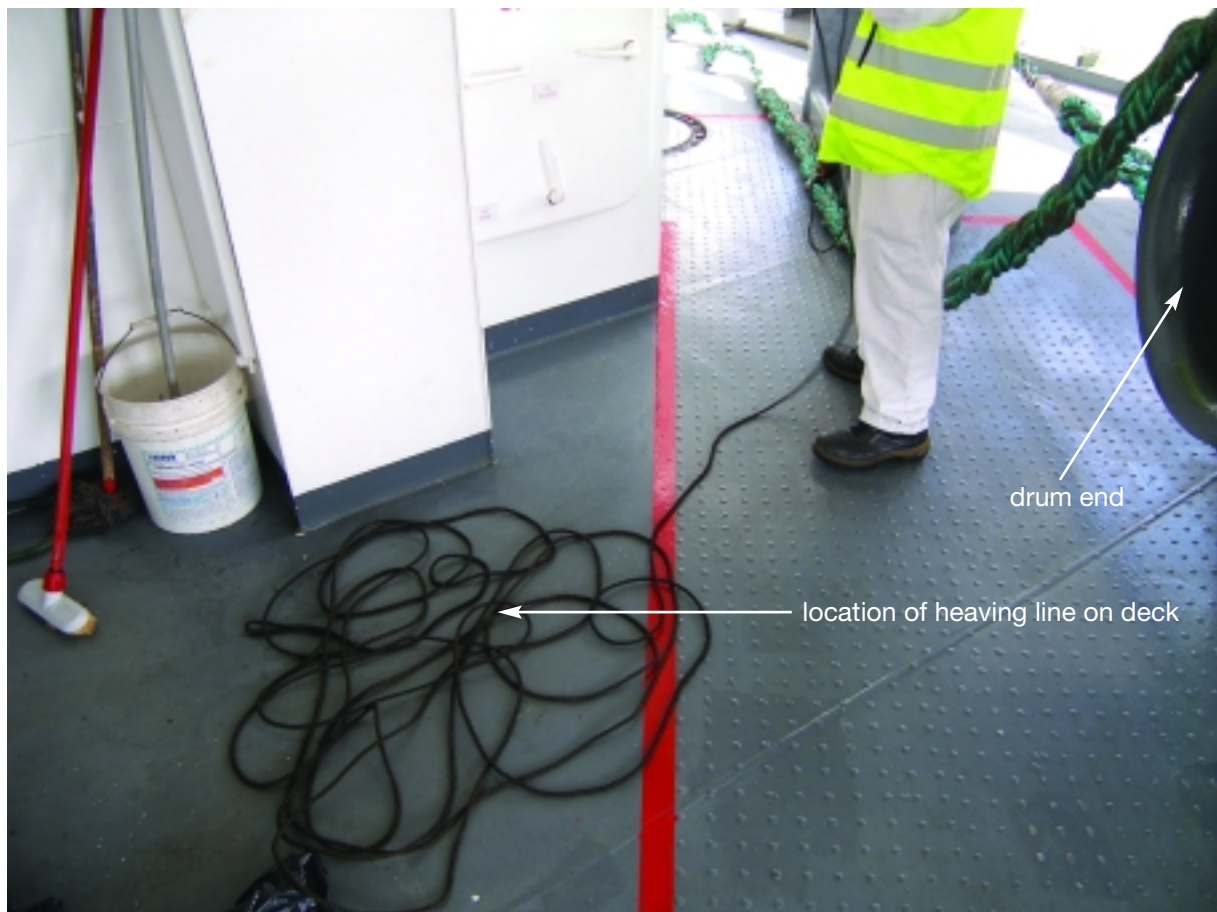
Figure 1: Position of the casualty in relation to the heaving line

A container feeder vessel, with a pilot on board, was on its regular weekly visit to a port situated on a river. He took over the ship's controls just off the port. He then held the ship stationary, stemming the 3-4 knot flood tide, with the port's entrance lock on his starboard beam. The weather conditions were good with only a light breeze.

2. Making a tug line fast to a ship presents a significant hazard to both ship and tug crews. It is important to remember that tugs, operating in the wash of a ship can, and do, occasionally lose control temporarily, causing them to move off station. Ships' crews must be prepared for this, and must be able to respond quickly and effectively to reduce the risk of serious injury.

4. Good communication is the key to safe operations between tugs and ships. On this occasion, there was little communication between the tug and the aft deck of the container ship, or between the tug's bridge and aft deck. It is vital that clear visual communications are maintained between tugs and ships, as well as between tug crew members to ensure operations are carried out as safely as possible.

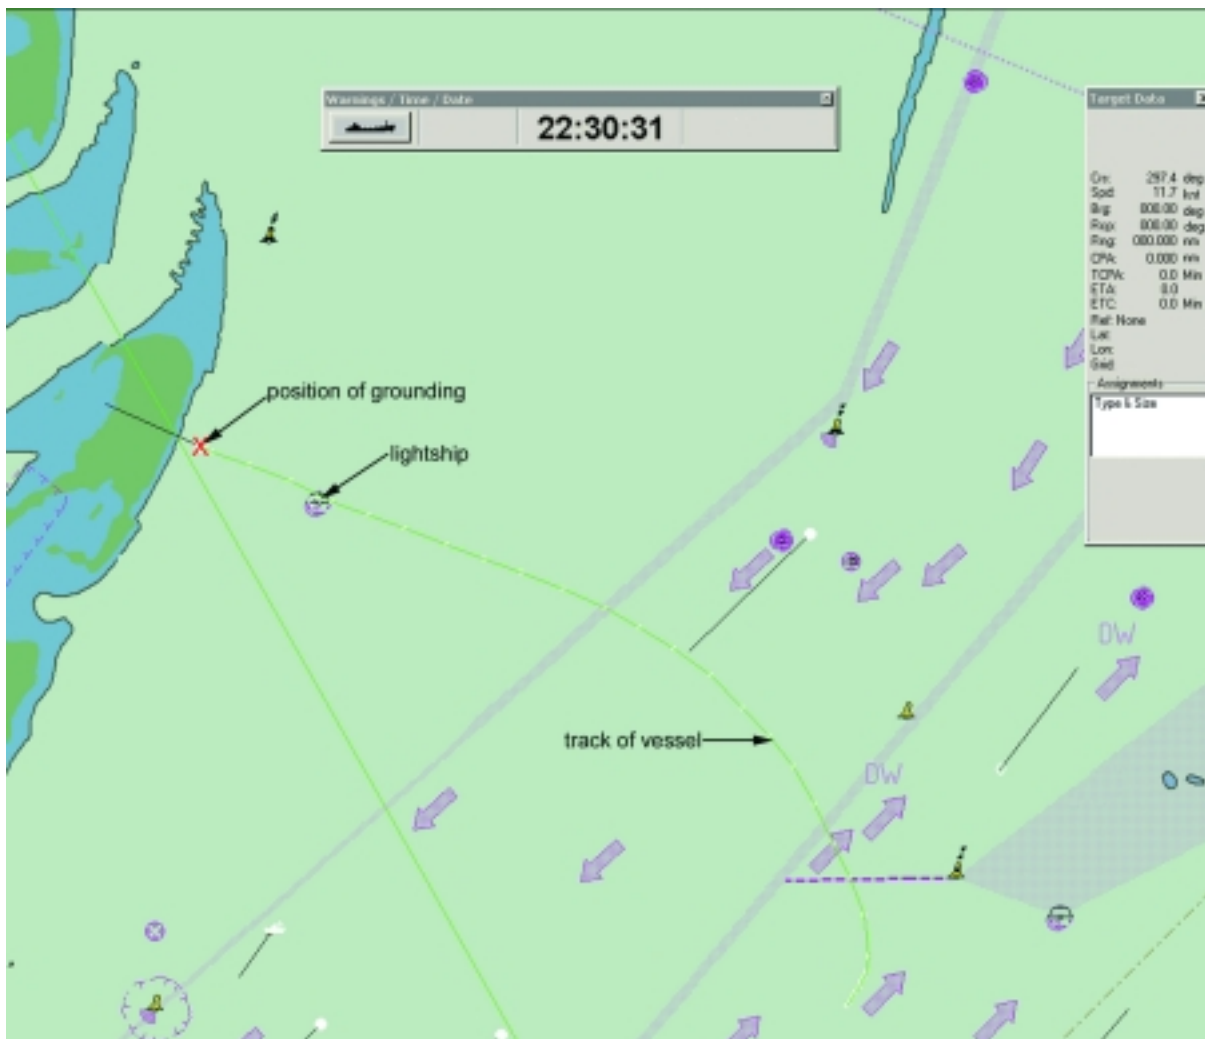
Vessel track until grounding at 2230

Once the vessel had been checked for damage and her DP informed, she resumed her passage, with the bridge watchkeeping duties shared between the chief and second officers.

3. Following a major accident, such as a collision or grounding, the alerting of the crew by the use of the general alarm, and of the coastguard by radio or DSC, are both important actions intended to minimise the risks to a vessel and those on board. It is therefore safer to ensure these actions are taken as soon as possible rather than to wait and discover that some of the crew are missing or that external assistance is required. It might be too late by then.

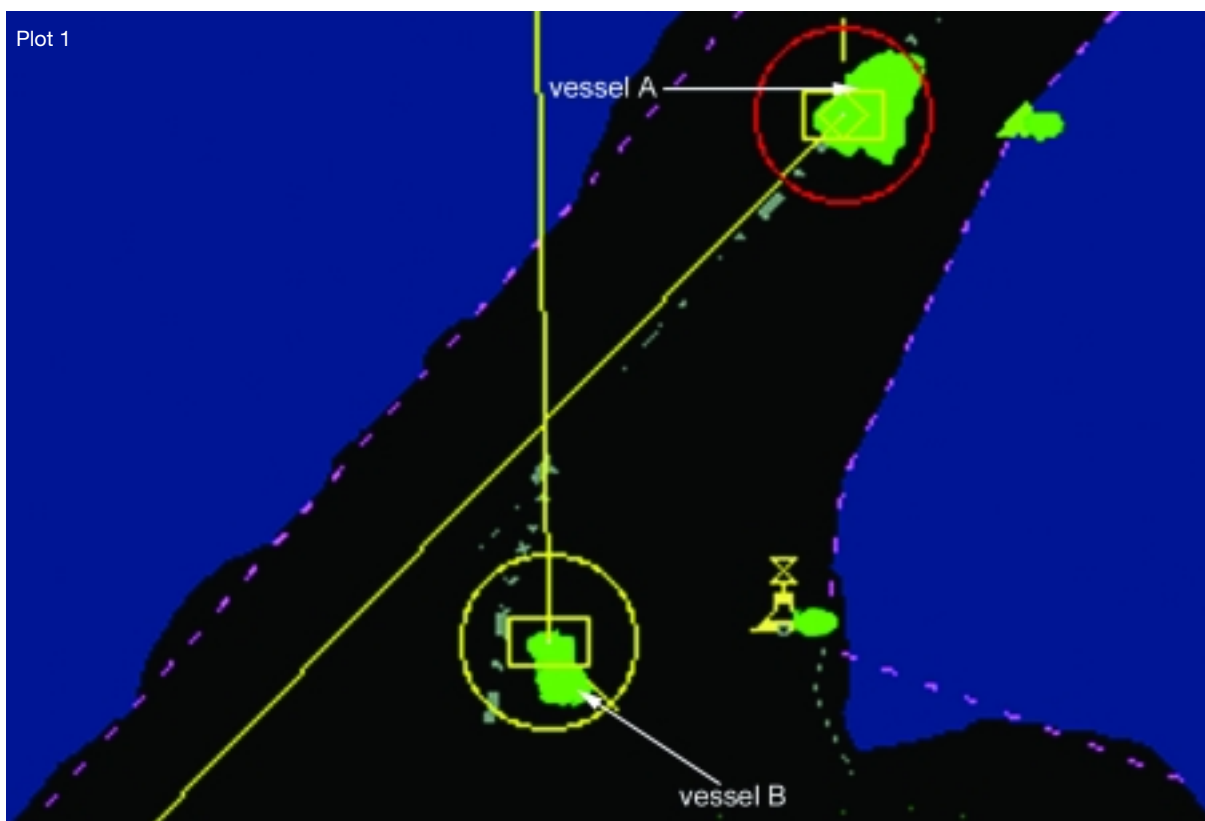
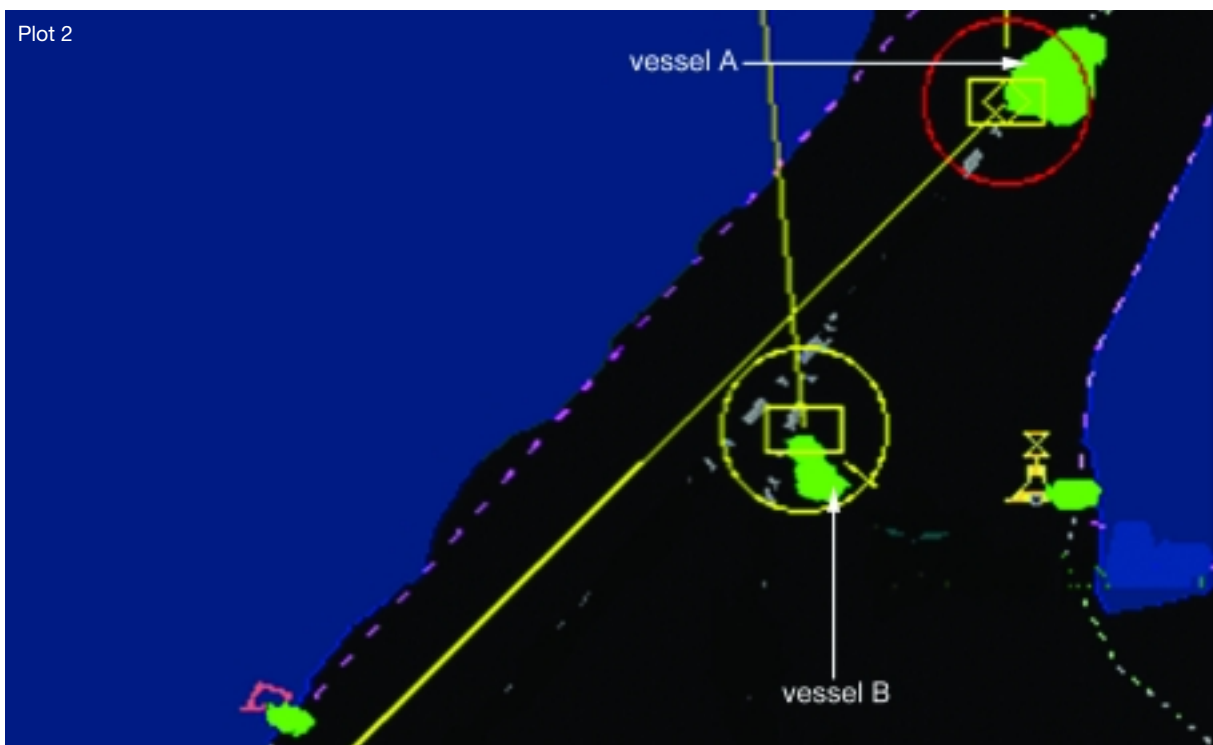
Unaware of the actions of the AB and, in view of the relative aspects of the two vessels, the master of Vessel B assessed that Vessel A must have altered course to port. Consequently, he grabbed the helm and went hard to port (plot 2).

The master of Vessel A was also surprised to see a starboard aspect of Vessel B, and used his forward speed and his side thrusters to slide his vessel away to cushion the effect of the imminent collision. Vessel A suffered minor damage to her hull above the water line and there was paint damage and slight indentation to the bow of Vessel B. Luckily there were no injuries or pollution.

1. This is not the first time a helmsman has put the helm the wrong way in pilotage waters, and it won't be the last. However, such a mistake need not result in an accident, providing it is spotted immediately. Regardless of the experience of those involved, this can only be achieved by the good seamanship practice of habitually checking the rudder angle repeater after each helm order has been given. It will often be too late to rectify the error if the movement of the ship's head is relied upon, particularly in restricted visibility where there are no visual references.

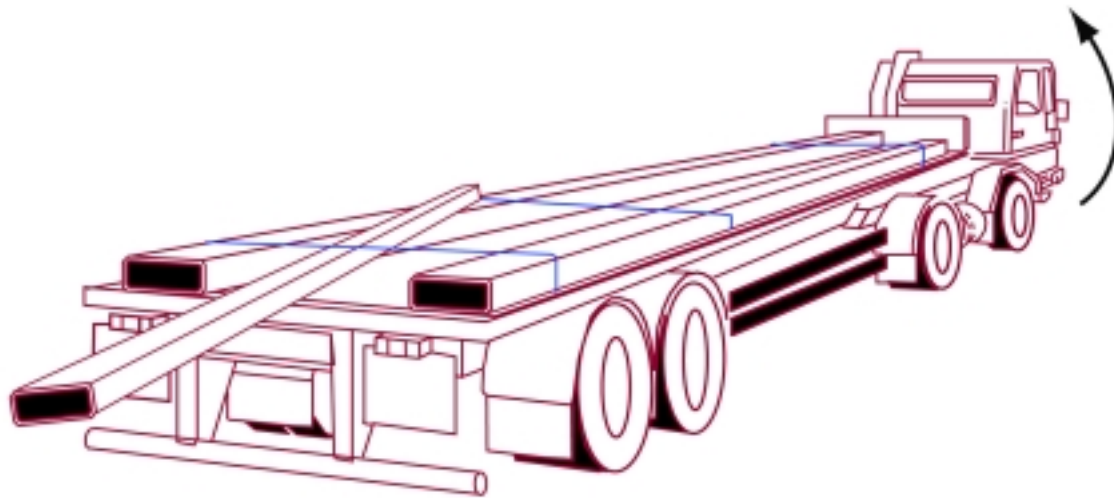
An unaccompanied 12.2m HGV flatbed trailer carrying steel box-sections was being unloaded by a tugmaster from a ro-ro vessel. Deck lashings were removed and crew stood by to remove the support trestle at the front of the trailer. The tugmaster connected to the trailer and lifted the front clear of the trestle, tipping up the flatbed slightly.

1. Crew working on vehicle decks should be aware of the correct lashing methods used to secure common loads to trailers. Advice is freely available from Government Departments and Industry Associations on best practice.
2. Trailers should be inspected where possible to ensure that both the load and the trailer are secured when they are loaded on board the vessel.
3. Personnel should keep clear of the area around vehicle trailers when they are being lifted or moved, to minimise the hazard should any items fall.

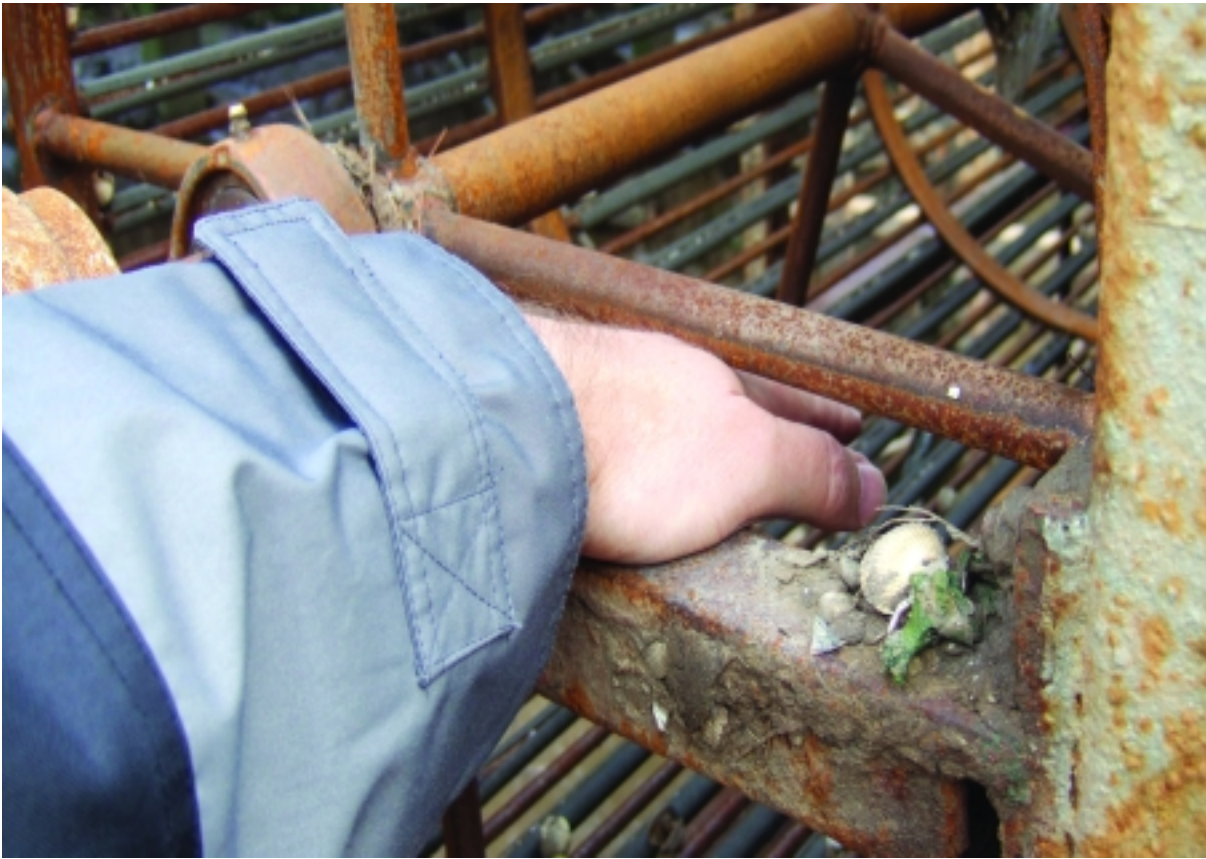
Figure 3

enough space for his hand to grip the support and be clear of the rotating inner drum. There was not (Figure 3). The riddle's rotating drum caught his thumb, fractured his wrist and pulled his arm into the riddle when his left elbow fractured and the skin was removed from his inner arm.

1. Dangerous machinery like this must have protective guards in place to stop operators unintentionally getting caught in the moving parts. This is particularly important at sea, where the movement of the vessel may unbalance the crewman and cause him to fall into the machinery.

2. The construction and location of the riddle created a significant “shear trap” risk to the crew working adjacent to this unguarded machinery. The usual crew accommodated the risk of personal injury when working close to the riddle in their normal operations, but they had not identified that the shear trap posed a significant danger to an inexperienced crewman on board. While the dangers associated with fishing may be blatantly obvious to experienced hands, they might not be recognised by new crewmen. A risk assessment would have identified the hazard from the riddle earlier, and the machine could have been guarded properly, thus protecting all the crew from the shear trap risk.

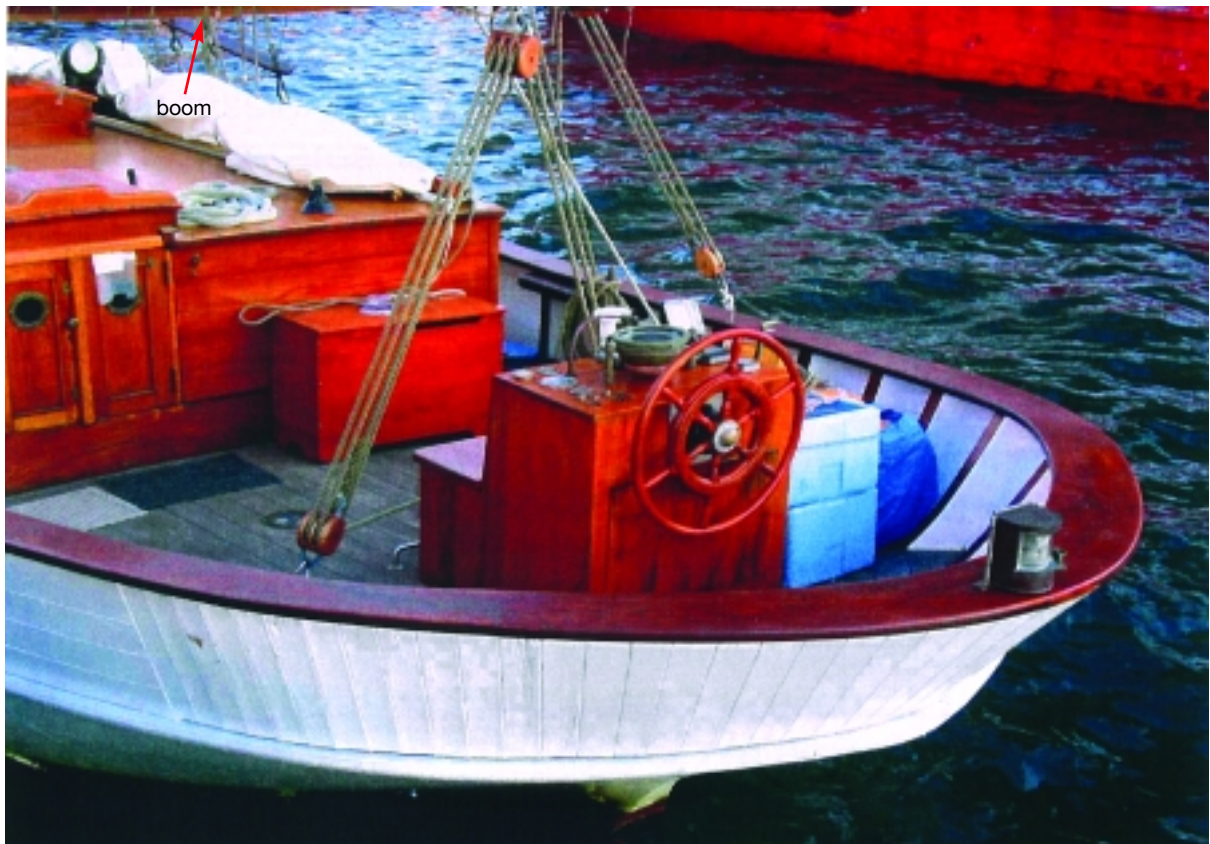
Rear of the vessel

Needing to make a course alteration the crew prepared for a gybe. Two crew members were required to pull in the mainsheet so that the boom was close to the centreline. The sheet was then made off on a cleat. At that point, the gaff gybed across to the starboard side and the force of this caused the sheet to break free, and the boom swung violently to starboard. As a result of this, one crew member was swept over the side.

1. This accident highlighted the importance of being able to carry out a manoverboard recovery manoeuvre under a variety of conditions. The attempts to recover the man who was lost were hampered by the fact that the approaches were made too fast for a line or a boathook to be used properly. When the casualty was still conscious he caught hold of the line that was thrown, but he let go of it under load.

2. The crew were relatively inexperienced and no proper safety briefing had taken place before sailing. Neither the skipper, nor his three crew were wearing lifejackets at the time of the accident. This additional buoyancy would have helped the casualty to keep his head clear of the water, thus substantially increasing his likely survival time. He would also have been able to conserve more strength to assist with his recovery.

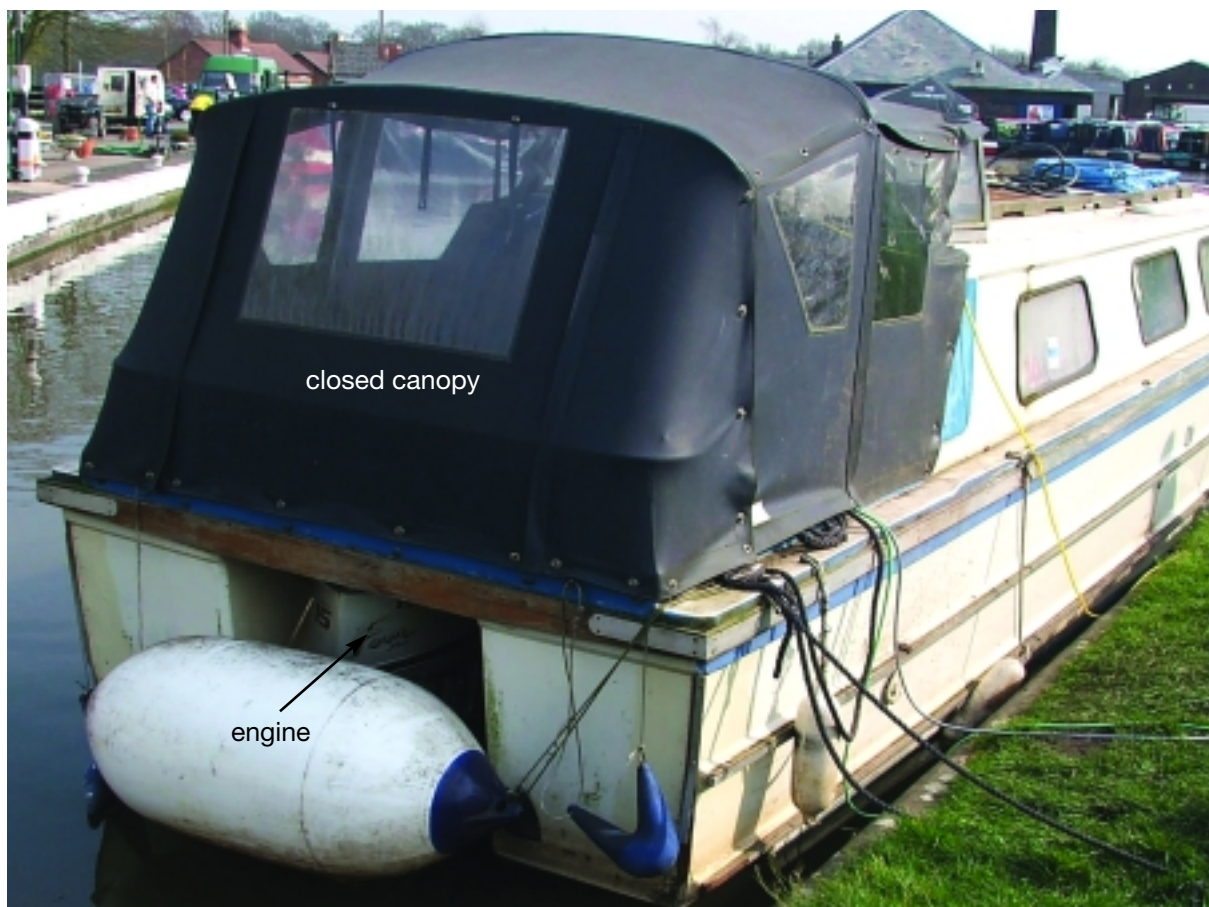
A couple were living on board a 1980s built, 4 berth, 8.2 metre inland waterway cruiser which was moored on a canal. It was winter. The 11kW (15hp) outboard engine was mounted on the transom stern, which was partially enclosed by the structure of the vessel. The engine space was separated from the cockpit above by removable wooden panels, which were not gas tight. The canopy over the cockpit was closed. A large fender had been secured across the vessel's stern and immediately aft of the outboard engine space.

- The three cabin roof plastic mushroom type ventilators had been sealed off with masking tape; only the stainless steel ventilator was found to be open.
- The ventilators at the bottom of the two doors that led from the cockpit to the cabin had been covered with masking tape on the inside.
- The heater and the cooker had been switched off. However, the gas supply to the cooker was leaking.
- The 12 Volt battery, which provided power to the cabin lights through the vessel's electrical system, gave a reading of just over 1 Volt.
- The outboard engine drove a small alternator which provided a trickle charge to the battery.

2. Taping over high and low level ventilators prevents air from circulating freely in cabin spaces, and could allow inadvertent leakage of carbon monoxide and/or domestic bottled gas to accumulate to dangerous levels. Minimum ventilation requirements are set out in the Boat Safety Scheme Standards.
3. Careful thought should be given to the prevailing conditions when running an engine continuously. Exhaust fumes should be allowed to ventilate freely to atmosphere and be prevented, so far as is reasonably practicable, from permeating into living and/or working spaces.

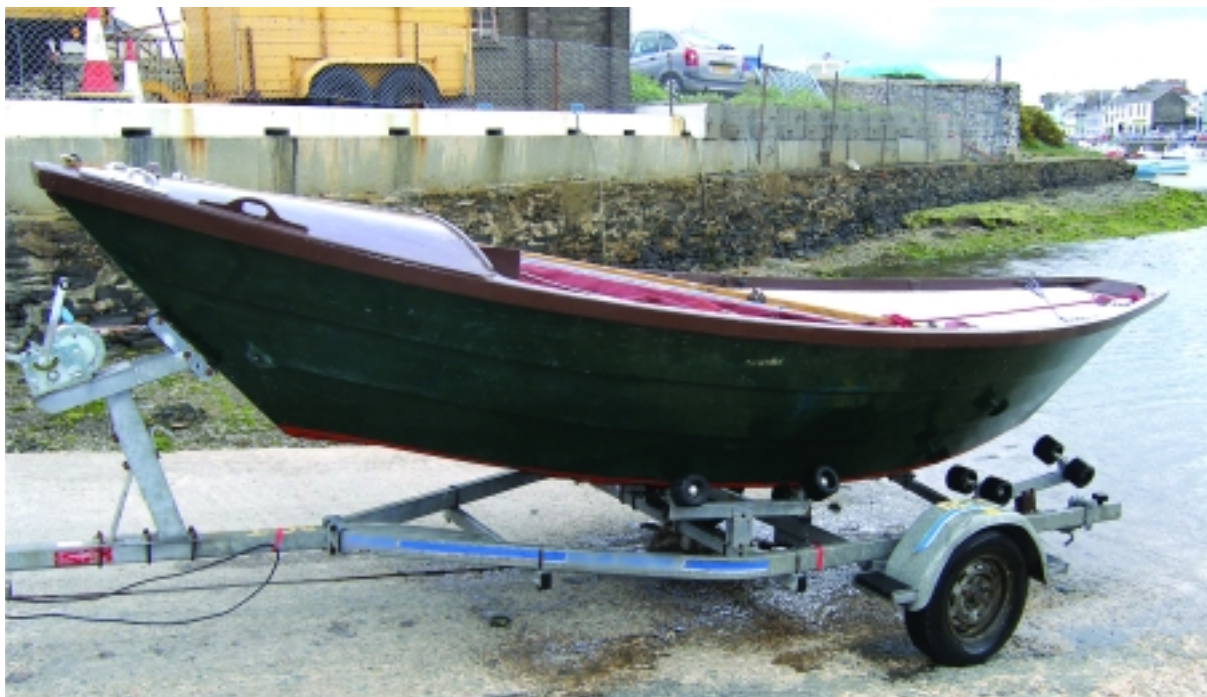
Figure 1: 5.5m open sailing boat

When the boat was recovered, a line was found secured over the dagger-board slot, indicating the dagger-board, which remains missing, probably dropped out of the bottom of the boat prior to its capsize.

2. The age of this boat was unable to be determined, and there was no documentation or builder's plate. If you purchase a boat second-hand, make sure you receive this information, if available, so that you can determine the maximum loading and sea conditions for which the boat is intended.

4. Consider the weather and sea conditions carefully in conjunction with your own experience before setting out on a voyage. Plan escape routes and ports of refuge if the weather deteriorates, and be prepared for the weather to be worse than forecast.

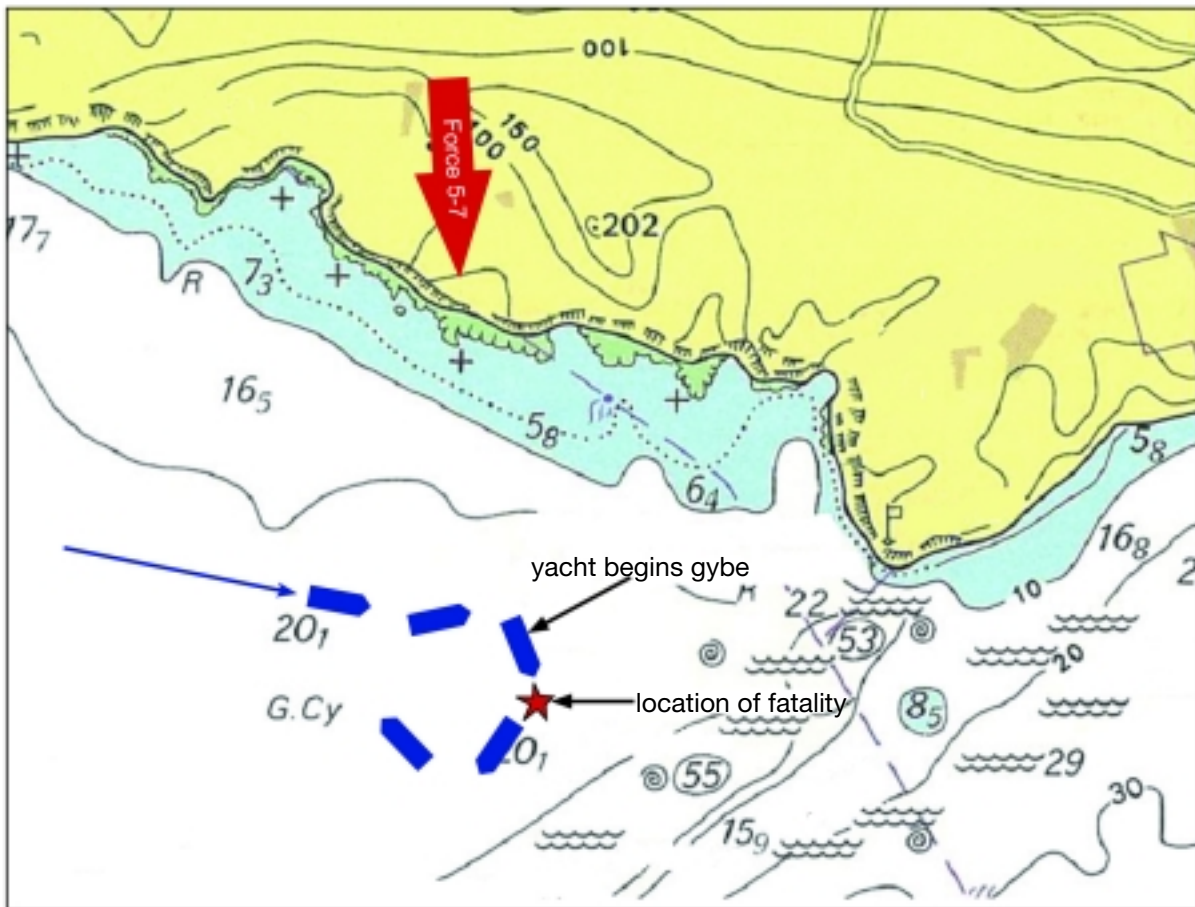
Figure 2: Movement of the vessel through the gybe

broach to windward. The helm was put hard over to starboard to counteract this until it was on full-lock. The rudder stalled and the boat failed to respond to the helm. After a short time the gust subsided, but with the helm still hard over, the yacht quickly came round to starboard and continued into a rapid and uncontrolled gybe until the boat settled close to head to wind (Figure 2).

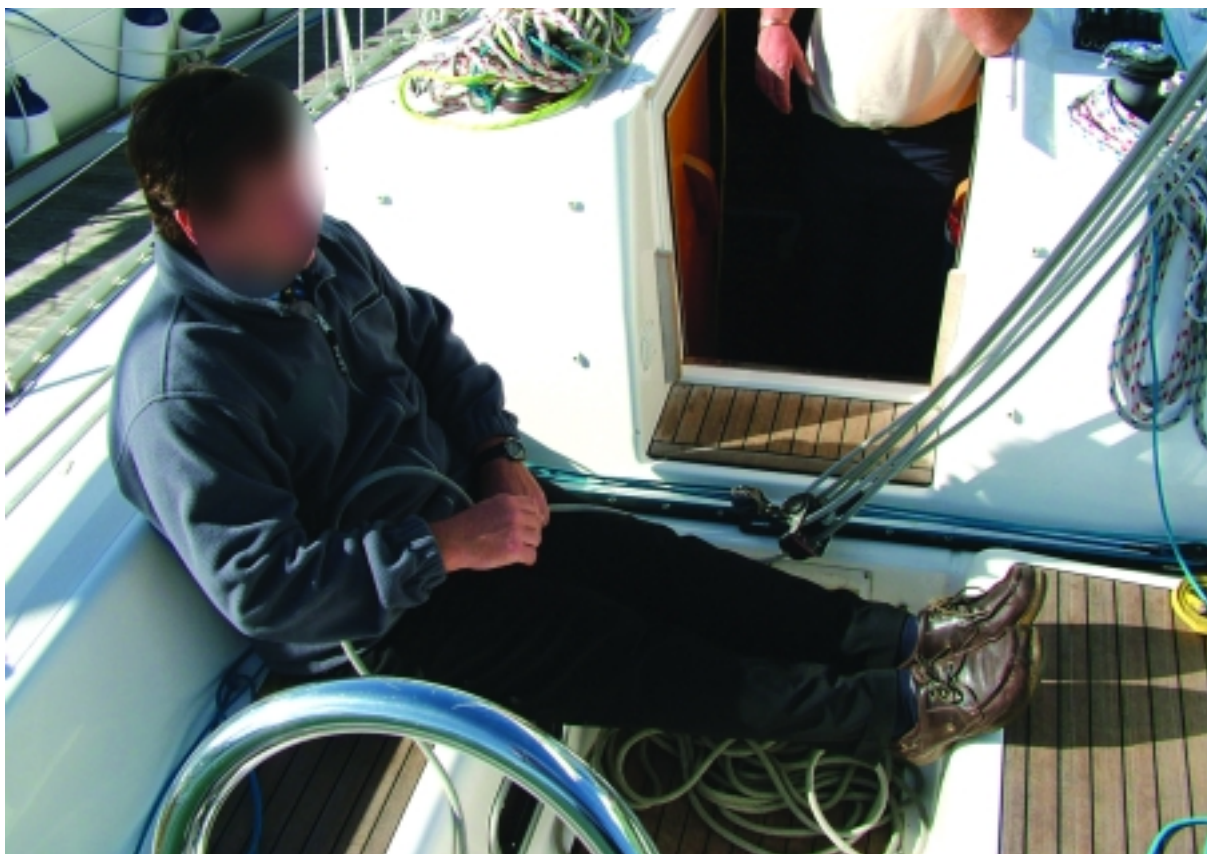
As the boom crashed across, the sheets caught the mate, who was sitting in the cockpit just aft of the traveller (Figure 3) and threw him forward, against the top edge of the coachroof. He sustained fatal head injuries.

Figure 3: Location of casualty when caught by the sheet
