MARINE ACCIDENT  
INVESTIGATION BRANCH

# SAFETY DIGEST

**Lessons from Marine  
Accident Reports  
2/2008**

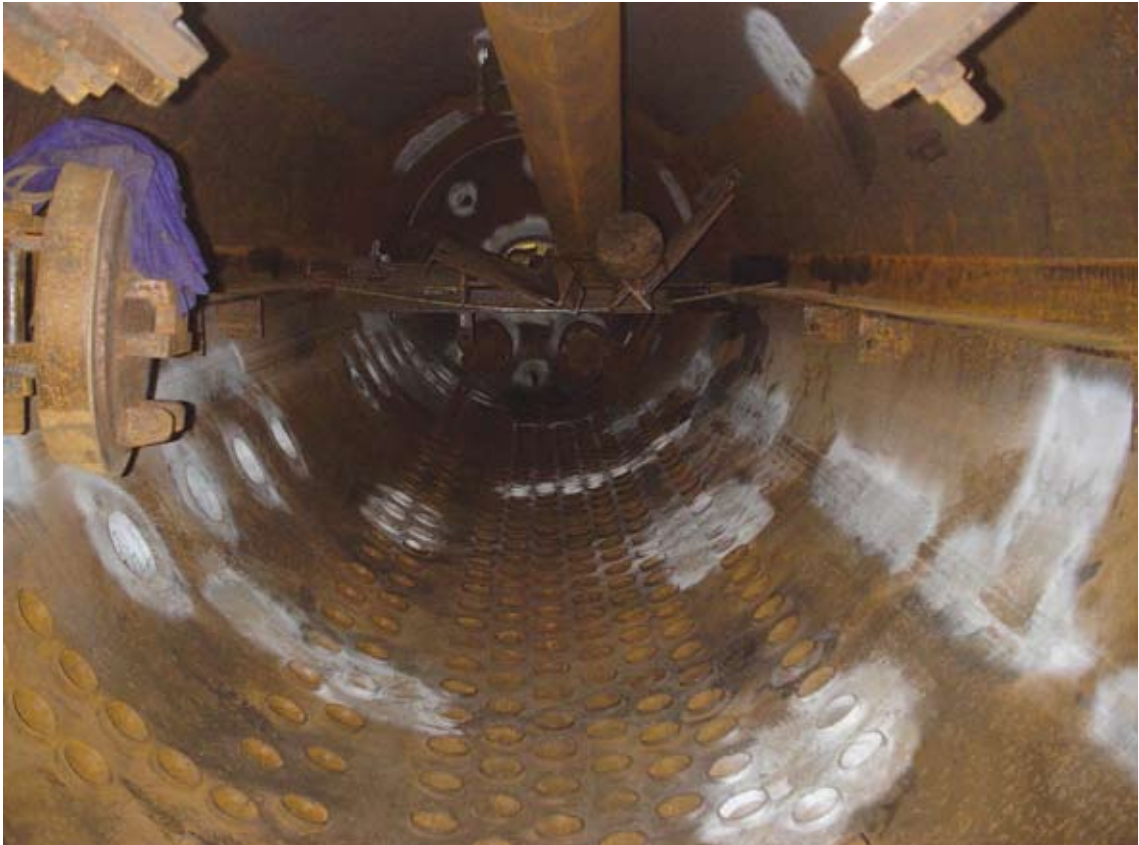
Figure 2

By 2100 things had rapidly changed. Tests indicated that the boiler steel was being attacked by the sulphamic acid. The UK expert was rather sceptical about the interpretation of the test results because he had expected to circulate the water/acid mixture for a few more hours. However, he agreed to stop circulating the water/acid mixture and reconfigured the system to pump the mixture into a shore-side bowser. In the meantime, he asked the repair contractor to arrange for the after door of the starboard boiler steam drum to be opened (Figure 2) so that the internal surfaces of the boiler could be inspected.

At about 2145 the steam drum door was opened, and as the contractors pushed the door into the drum there was a noticeable suction as the seal was broken. The workers also moved a non-intrinsically safe halogen lamp to a handrail near to the steam drum.

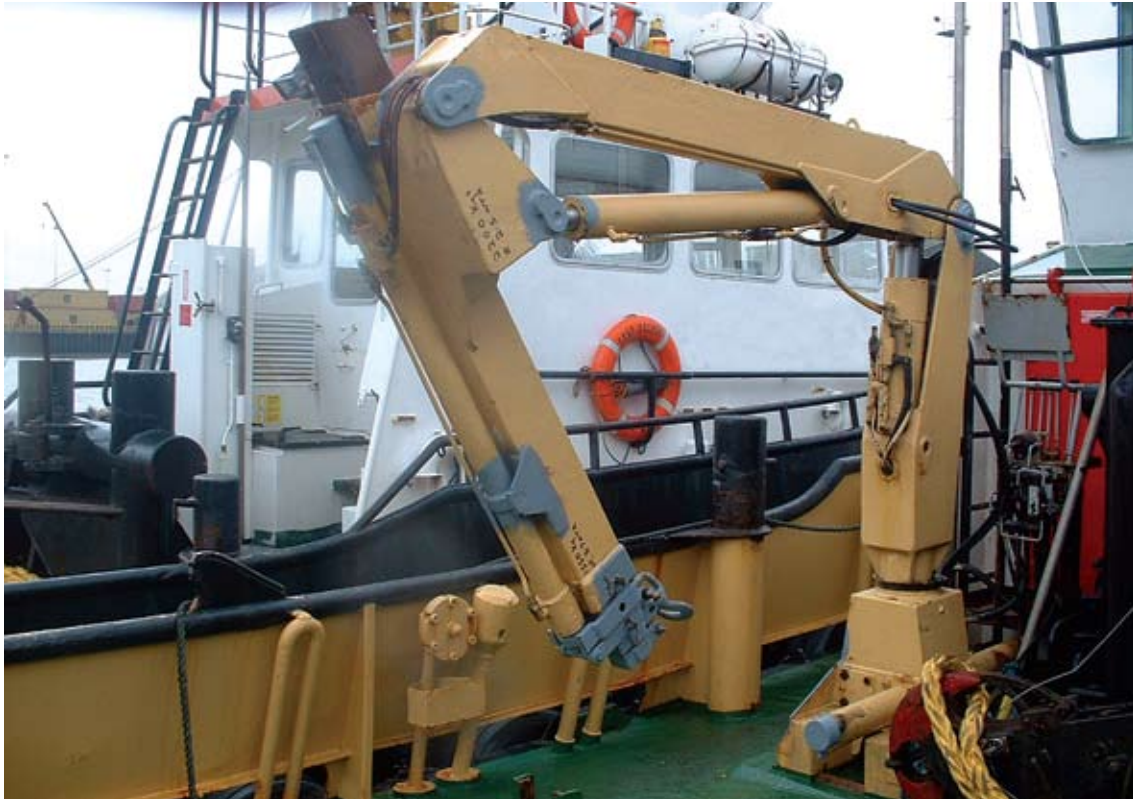
Telescopic folding jib

The engineering supervisor heard the shout and rushed to operate the controls to retract the telescopic section. He then freed the injured engineer and laid him on the deck. Meanwhile, the crew from another tug, moored alongside, jumped on board to assist. The alarm was raised immediately, and port paramedics were quickly on scene. The injured engineer was stabilised before he was flown to hospital. Sadly, although attempts were made to save his lower leg, it had to be amputated below the knee.

A subsequent inspection was unable to identify any significant fault with the crane or its controls. It is believed the injured engineer might have inadvertently moved the jib controls as he climbed down from the operator's position.

1. Treat hydraulically powered equipment with care and respect. It is extremely powerful and can inflict terrible injuries, as demonstrated by this accident.
2. Since 24 November 2006, equipment such as the crane in this accident must comply with the Merchant Shipping PUWER<sup>1</sup> and LOLER<sup>2</sup> regulations. As an employer, ensure you are aware of these requirements for work equipment and lifting equipment.

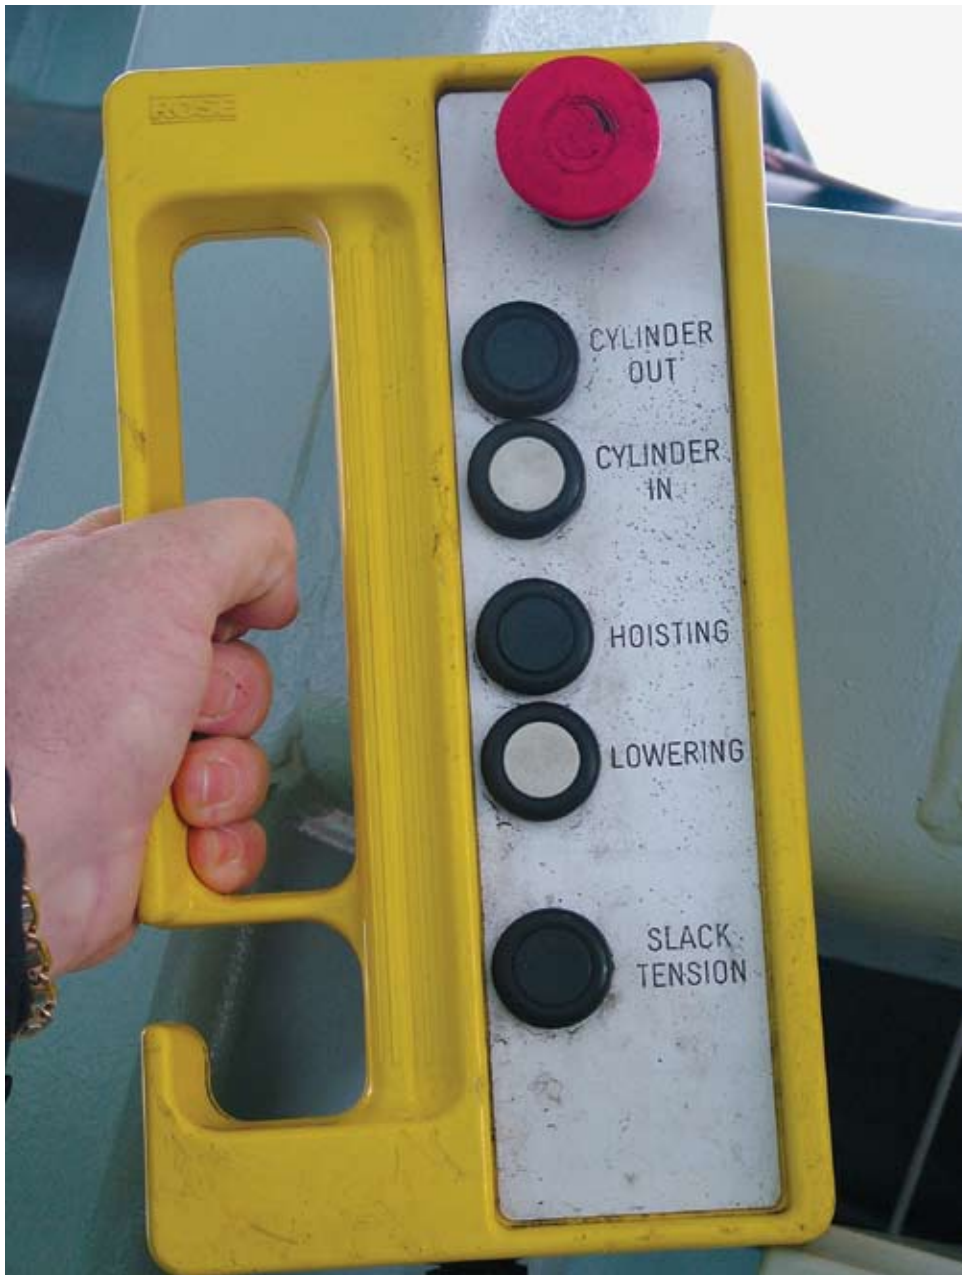
Figure 3 – FRC winch controller

Still restrained by the fall wire, the FRC turned to port, away from the ship, and listed heavily to starboard. The crew jumped clear of the boat as it was pulled on its side through the water.

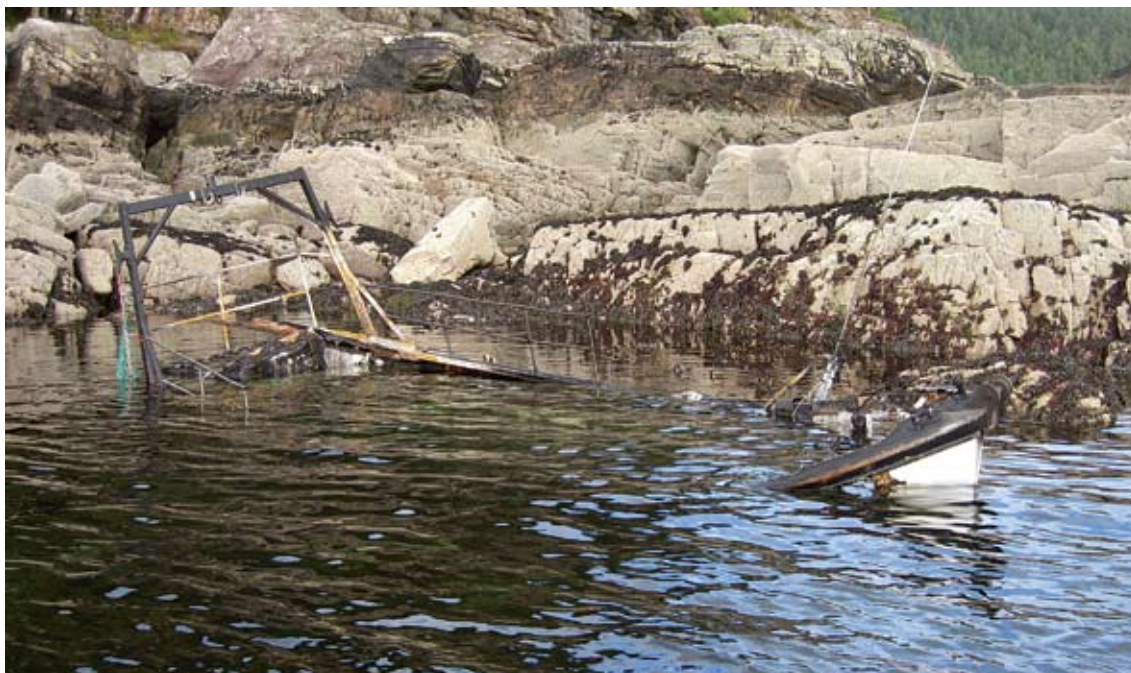
Figure 2

In the morning, the skipper and his crew tried to locate the boat, but were unable to do so. They believed that it was probably dragged out to sea by the tides and had sunk. However, they continued to search the inlets and eventually found it at low tide resting on rocks. The wheelhouse, deck and most of the hull had been consumed by the fire.

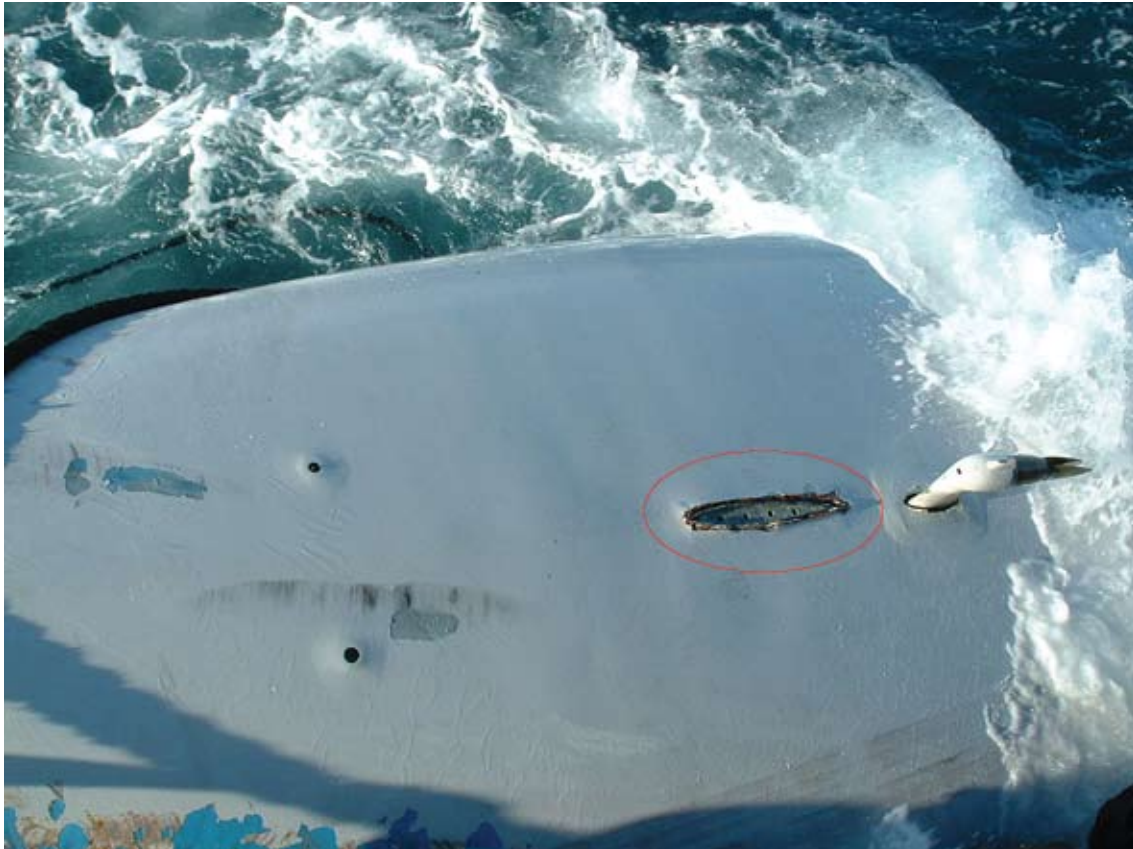
Figure 1

Investigations found that the fabricated steel keel had failed just below the fillet weld connecting the fin to the taper box (see Figure 1). Laboratory metallurgical analysis confirmed that the keel had suffered fatigue failure due to reverse bending stresses. Defects were also found in the keel taper box welds, and two of the three keel bolts had also failed.

It was further discovered that the boat builder had sub-contracted the hollow keel construction to a steel fabricator who had no marine experience. The fabricator changed the original design, and incorporated a fillet weld in a critical area. He did so to ease manufacture and reduce costs, but without the supporting calculations to assess the stresses to which the keel would be subjected. He did not consult with the designer on the changes. In 2005, 160kg of lead was added to the keel bulb for racing optimisation reasons. Once again there were no supporting calculations, nor were there detailed checks made against the “original” or “as built” designs to ensure that the modification was safe.

It was found that none of the designs achieved the required Safety Factor of 2. The addition of

the extra bulb weight exacerbated the problem and the keel was unable to withstand the “in service” bending stresses, and this led to the conditions of failure.

Seek expert advice – you may need to use non-destructive procedures to check that the keel structure is sound. Also, regularly check the tightness of keel bolts and thoroughly investigate the cause of any failures. ***Remember***, action at this stage could save your life.

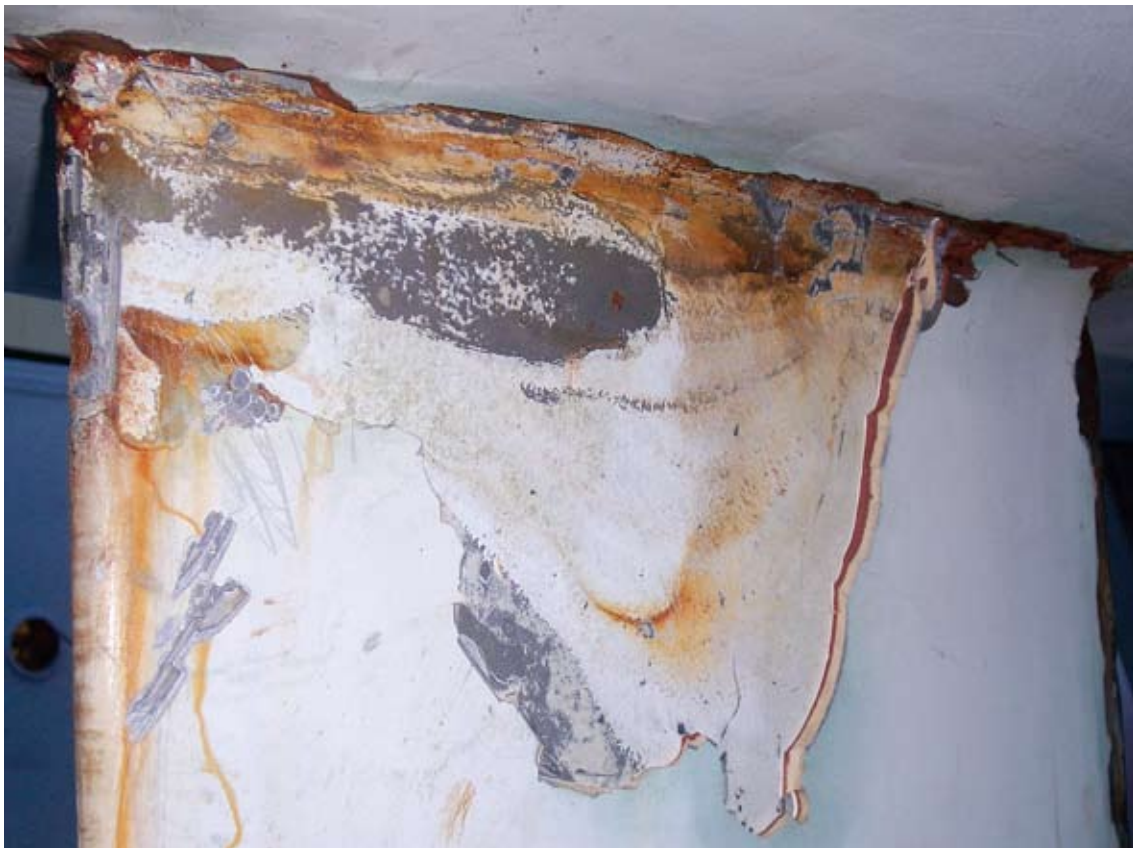
Figure 2

considerable detachment of the keel’s epoxy filler and anti-fouling was found (see Figure 2). There was also evidence of the likelihood of fine cracking in the steel adjacent to the fillet weld, but this went undetected by the repairer, so the last chance to prevent the accident was missed.

3. Do not dismiss the importance of keel coating detachment, or evidence of cracking of the coatings at the keel to hull interface; this may indicate more deep seated keel structural problems.
