SAFETY DIGEST

Lessons from Marine Accident Reports

No 2/2007

MARINE ACCIDENT INVESTIGATION BRANCH

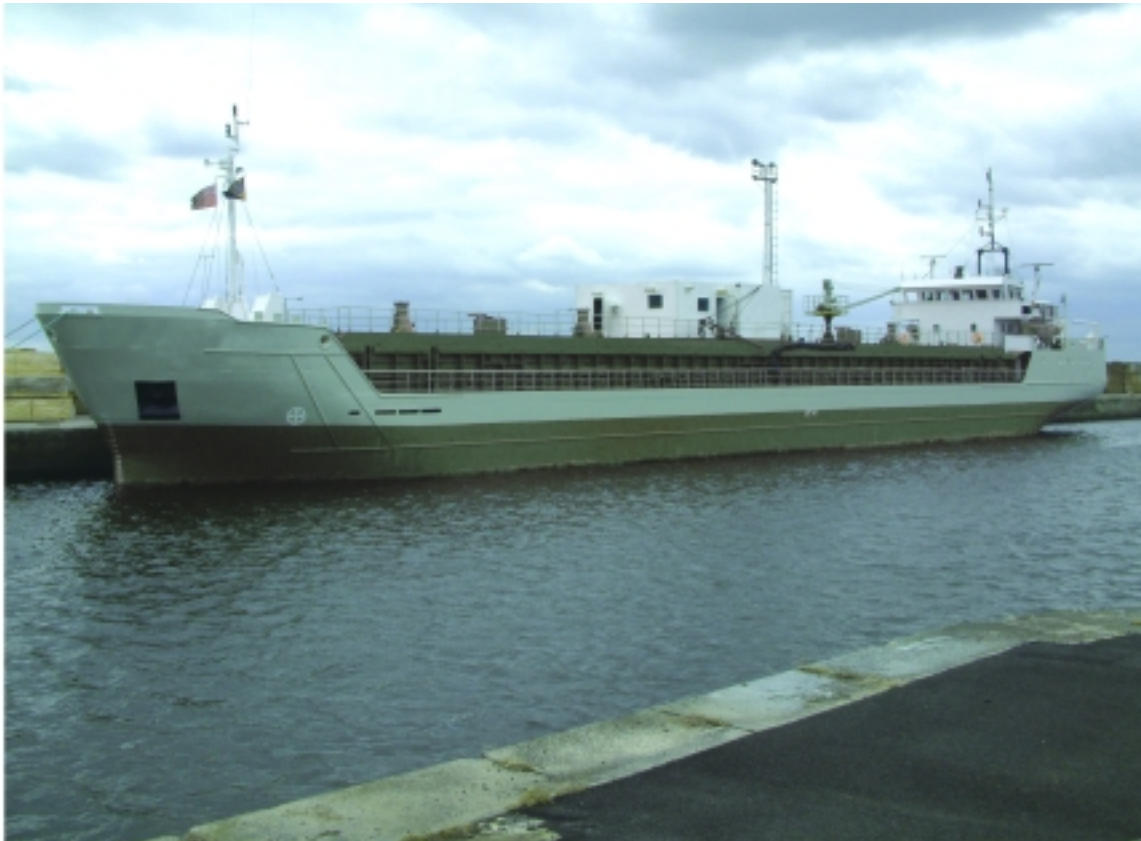
Figure 1

The master of a single screw, 1850 tons cement carrier (Figure 1) had prepared his ship to enter port. The engines, steering gear and navigation equipment had been thoroughly tested as required by his ISM documentation. All proved satisfactory, and he settled back to await the imminent arrival of the pilot.

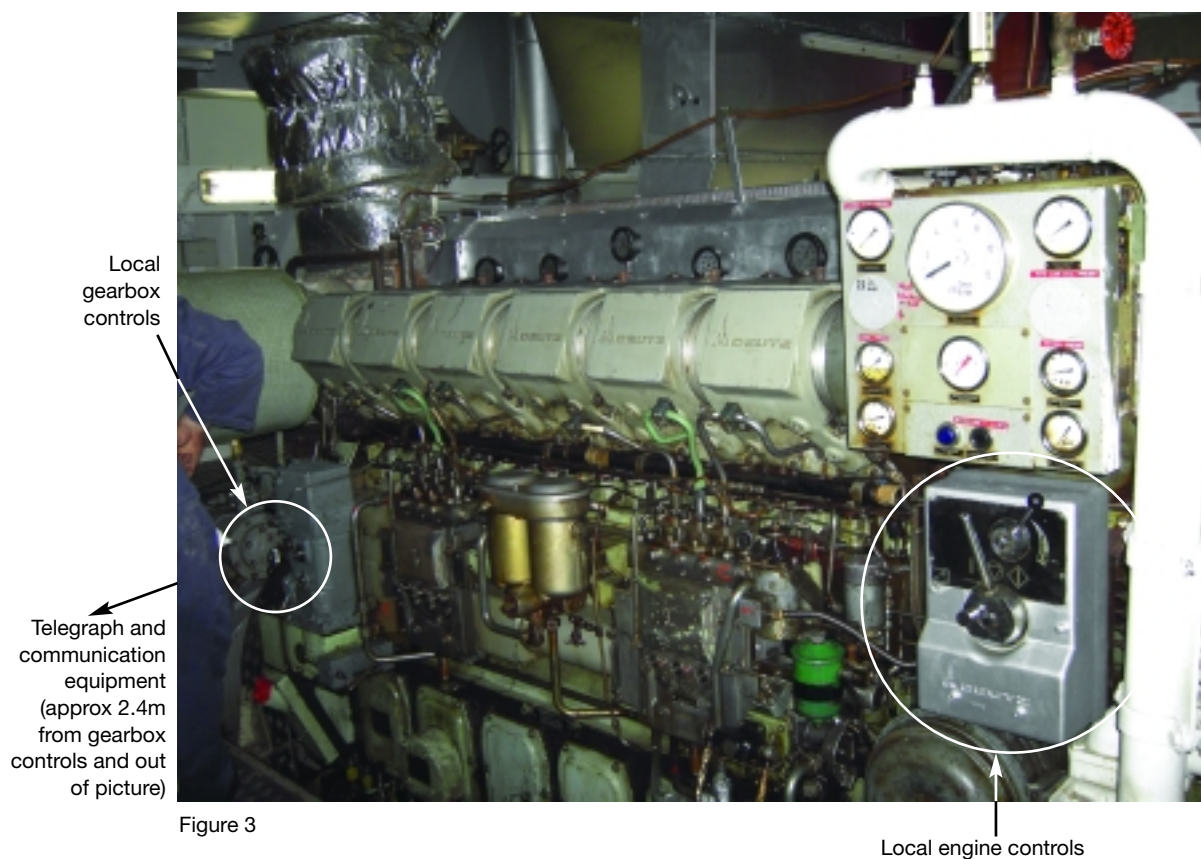
Unfortunately, the local engine and gearbox controls, telegraph switches and bridge communication equipment are separated by some distance, making it very difficult for one person to take local control (Figure 3). Had control failure drills been conducted, this limitation would have been identified and could have been addressed. Despite the well managed training regime, this important safety drill had been overlooked.

1. It is important that the ship's team is fully conversant and practised with the routines to assume local control of propulsion systems.
2. Do consider the need to supplement the engineering staff if the disposition of equipment makes it difficult for a person working alone to assume local control.
3. Consider the "what ifs" no matter how unlikely they may appear to be. For example, consider how to maintain propulsion control and steering should both fail during a tight navigational situation.

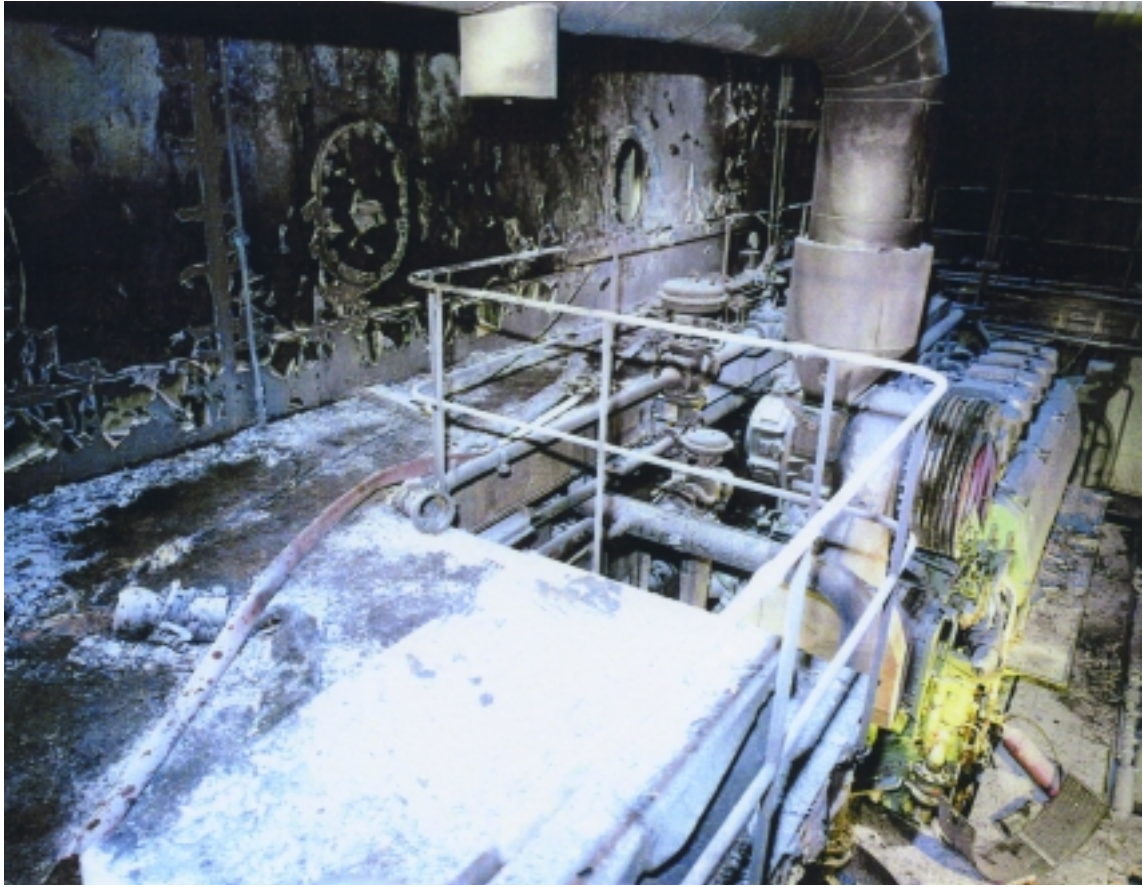
Figure 1

Tank entry for the tank cleaners and the suction hose was through a manhole located in the engine room at an upper level (Figure 1).

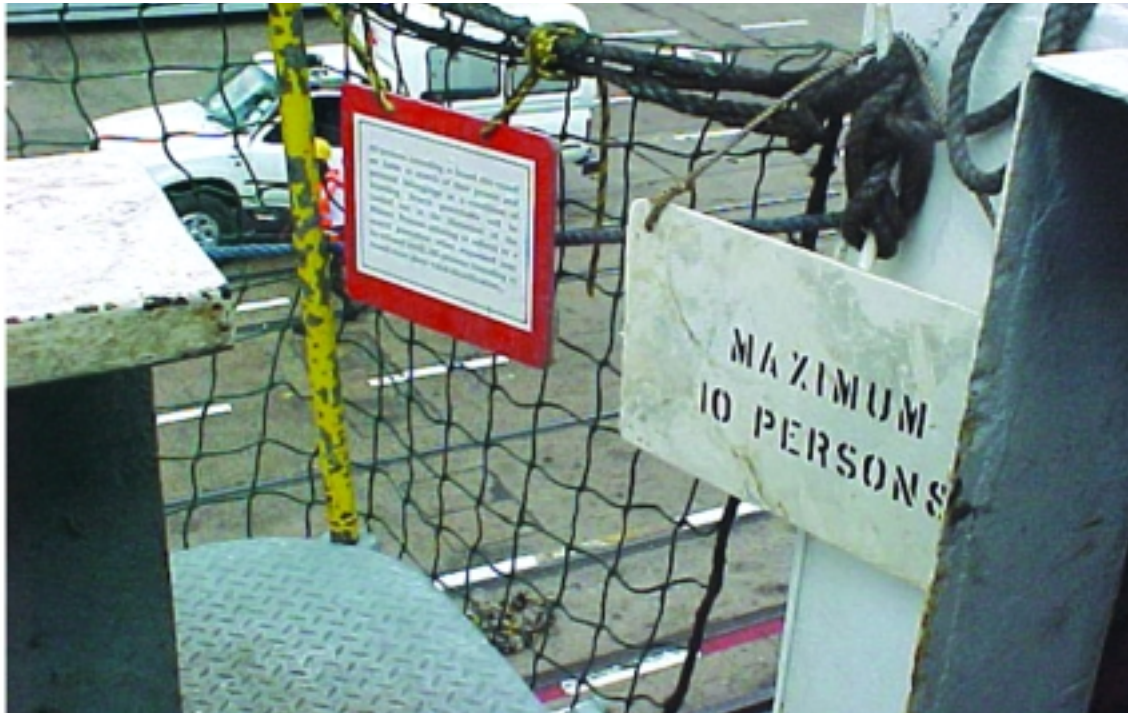
Figure 3

The gangway then dropped because the lowering wires had been slackened to allow for the movement of the vessel during cargo operations. The ship's duty officer and gangway watchmen were positioned at the top of the gangway, where a sign indicating that the maximum number of persons allowed on the gangway was 10, was sited (Figure 3).

4. For a variety of practical reasons, gangways cannot always be rigged or used as designed. However, they can frequently still be safely used in such situations providing the risks involved are carefully considered, and additional precautions, such as the reduction of its maximum loading, and increased vigilance, are implemented.

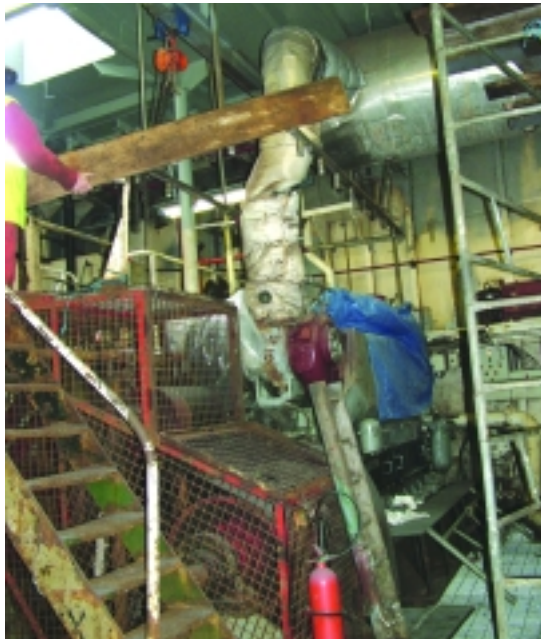
Figure 1

engineer from a permanent access landing (2.1M) which, although fenced off, had a staircase leading down to the main deck (see Figures 1 and 2). Just as the AB was about to hand the last board up to the chief engineer, the chief engineer told him to 'hold on' so that he could reposition himself. This probably disrupted the work rhythm of the AB, who stepped backwards onto the staircase, missed her footing and fell backwards down eight steps.

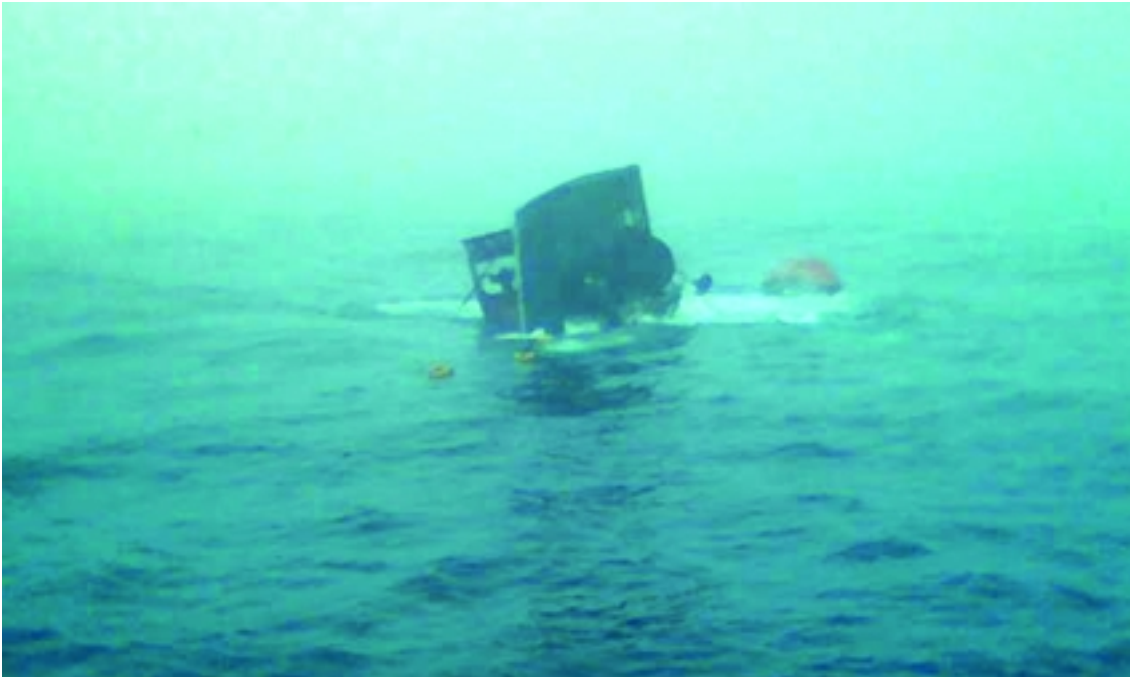
On board the supply ship, the master arrived on the bridge fewer than 30 seconds after the impact. Noting that the fishing boat was alongside, and that the towing wire was leading under his vessel, he de-clutched the thrusters so that they did not become

entangled in the wire. As the tension eased in the wire, it cleared from under his vessel, and he decided to move his vessel clear and standby to offer assistance. Meanwhile, other members of the crew were preparing the FRC and checking their own ship for damage. Apart from some denting and scrapes to the ship's

side, damage was limited to a hole above the waterline in the forepeak tank.

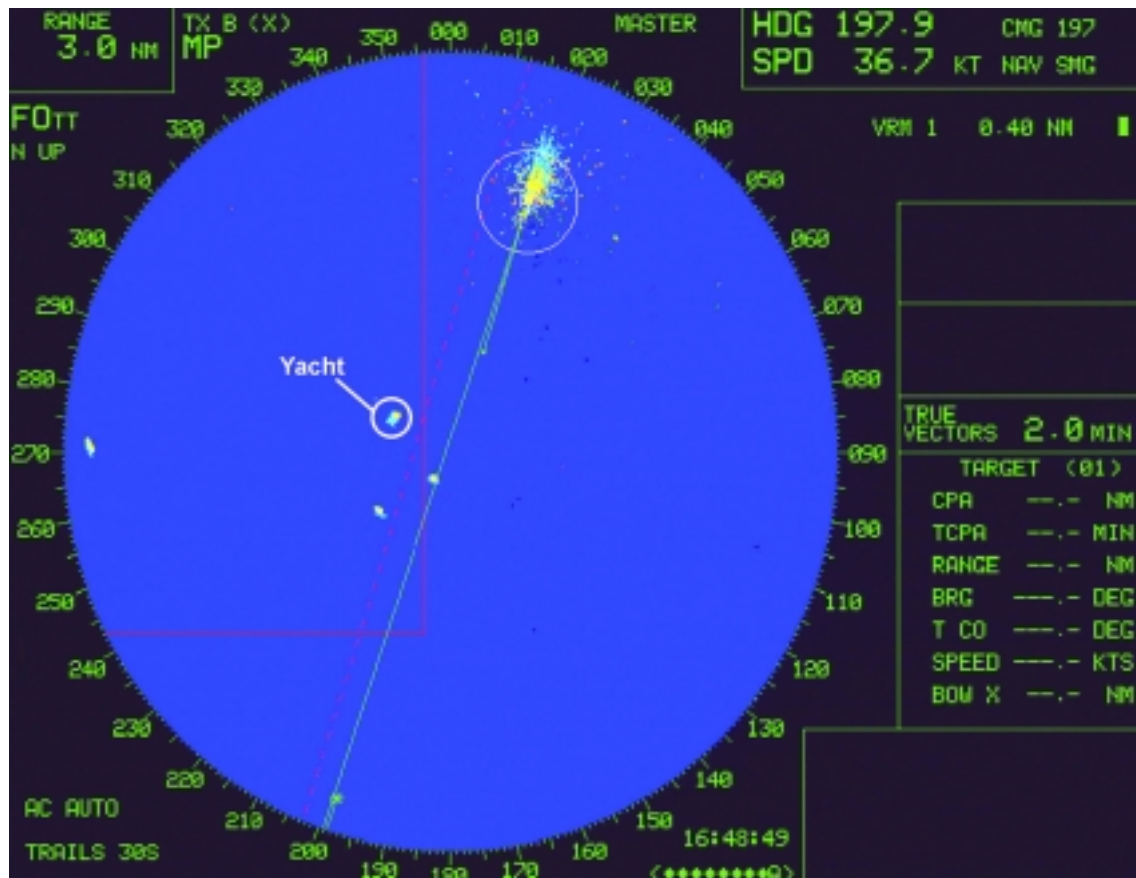
Figure 1: VDR extract of HSC

The motor yacht was first sighted at about 10 degrees on the starboard bow at a distance of about 3.5nm (Figure 1) and appeared to be crossing and on a collision course. The master of the HSC, being the give way vessel, decided to alter course 15 degrees to starboard which, by the time he had done so, put the motor yacht 1.6nm away and fine on his port bow (Figure 2).

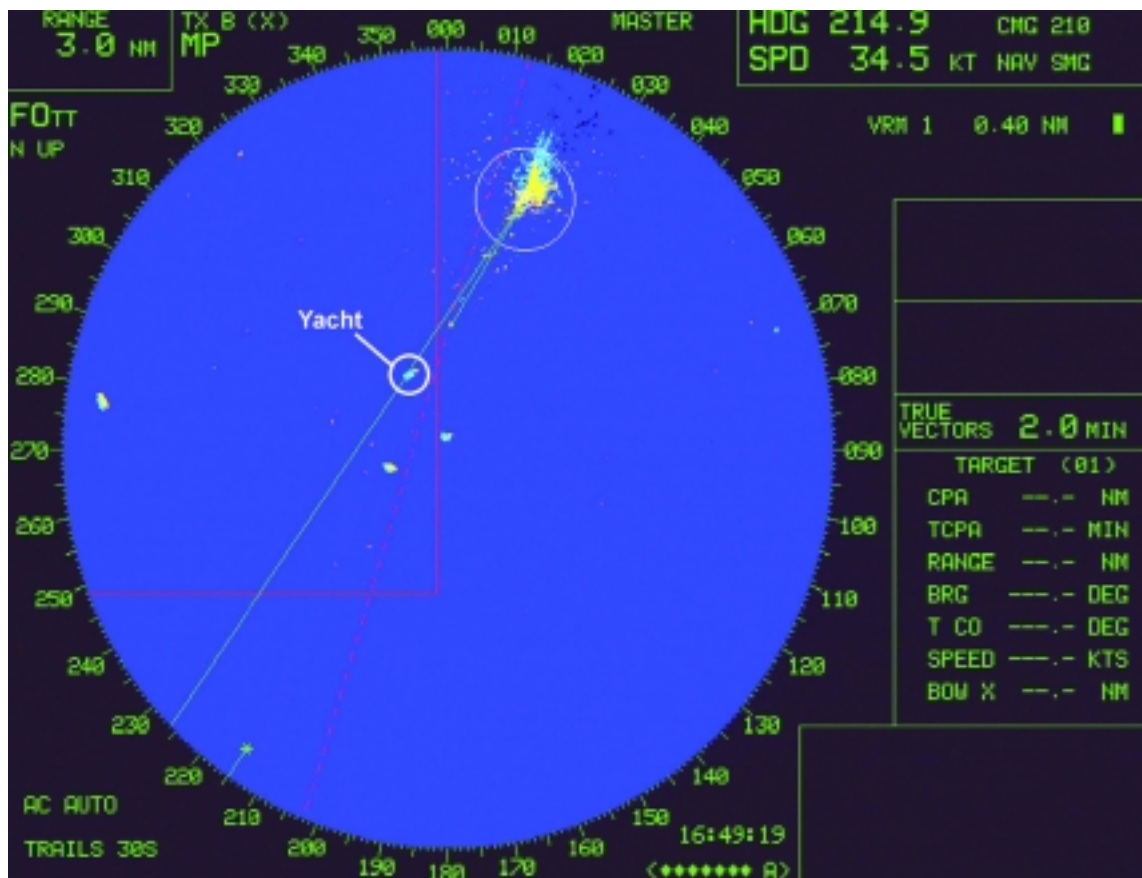
Figure 2: VDR extract of HSC

The master of the HSC was unaware that his last minute change of plan had caused so much upset on the yacht. He believed he had the situation under control. The yacht skipper reported the incident to the MAIB and, consequently, the Voyage Data Recorder (VDR)

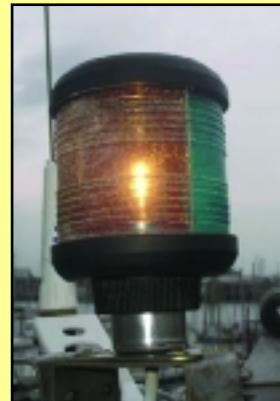
- ii. The lamps (bulbs) fitted to the navigation lights used on *Ouzo* can easily be inadvertently replaced with lamps of a lower rating.
 - iii. It is quite common for replacement lamps for yacht navigation lights to have damaged filaments, which cause an intermittent fault.

- iv. If the yacht heels more than 5° the horizontal intensity of her navigation lights may be decreased.

Yacht owners should make every effort to ensure that their navigation lights are fully effective, and their characteristics understood.
