MARINE ACCIDENT  
INVESTIGATION BRANCH

# SAFETY DIGEST

**Lessons from Marine  
Accident Reports  
3/2008**

**No 3/2008**

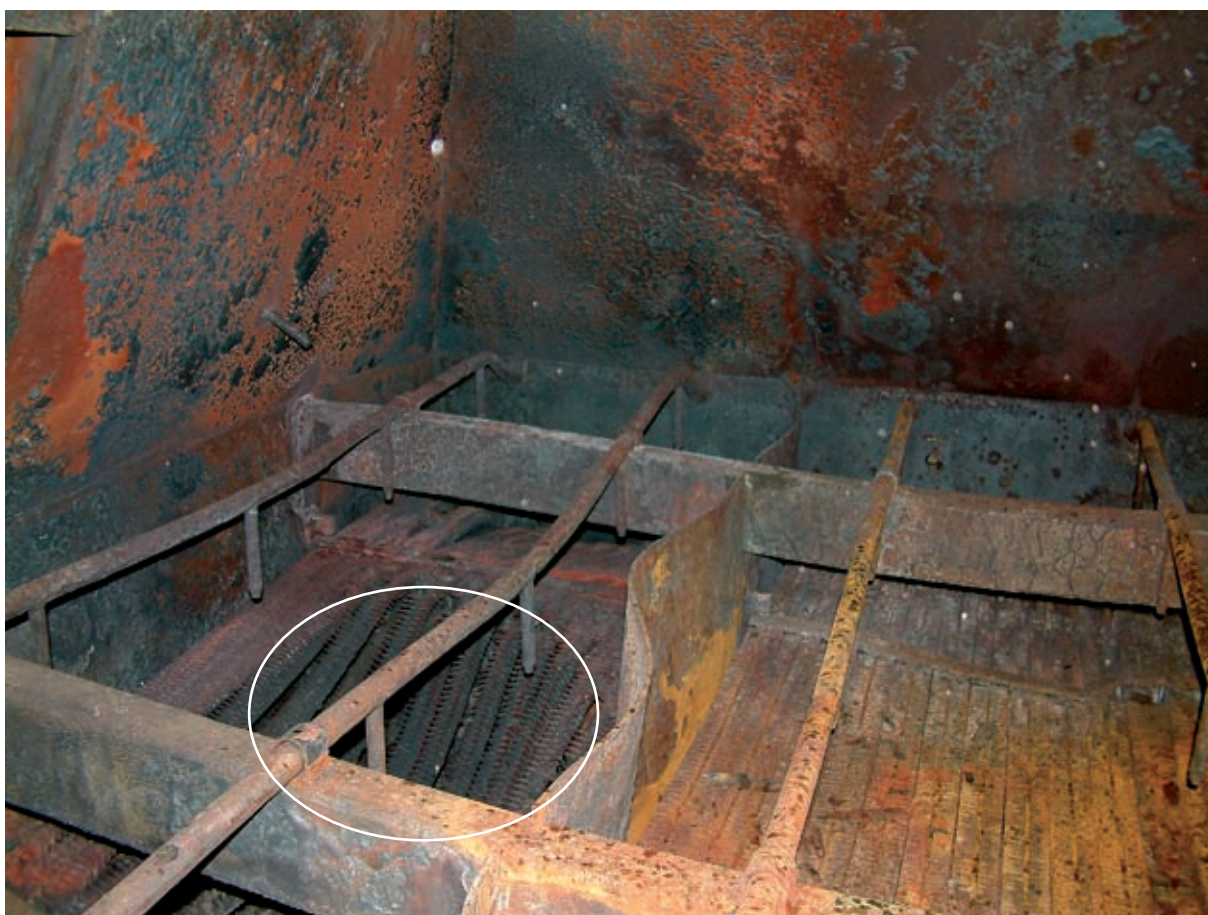
A rapid rise in the temperature of the EGE was noticed, and the chief engineer realised there was a fire inside the EGE casing. The bridge and nearby crew were alerted and the emergency alarm was activated. Radiant heat

A new fire tube was fitted to the auxiliary boiler, but the EGE was damaged beyond repair. Repairs delayed the vessel by 2 weeks, spoiling perishable cargo and incurring further penalties.

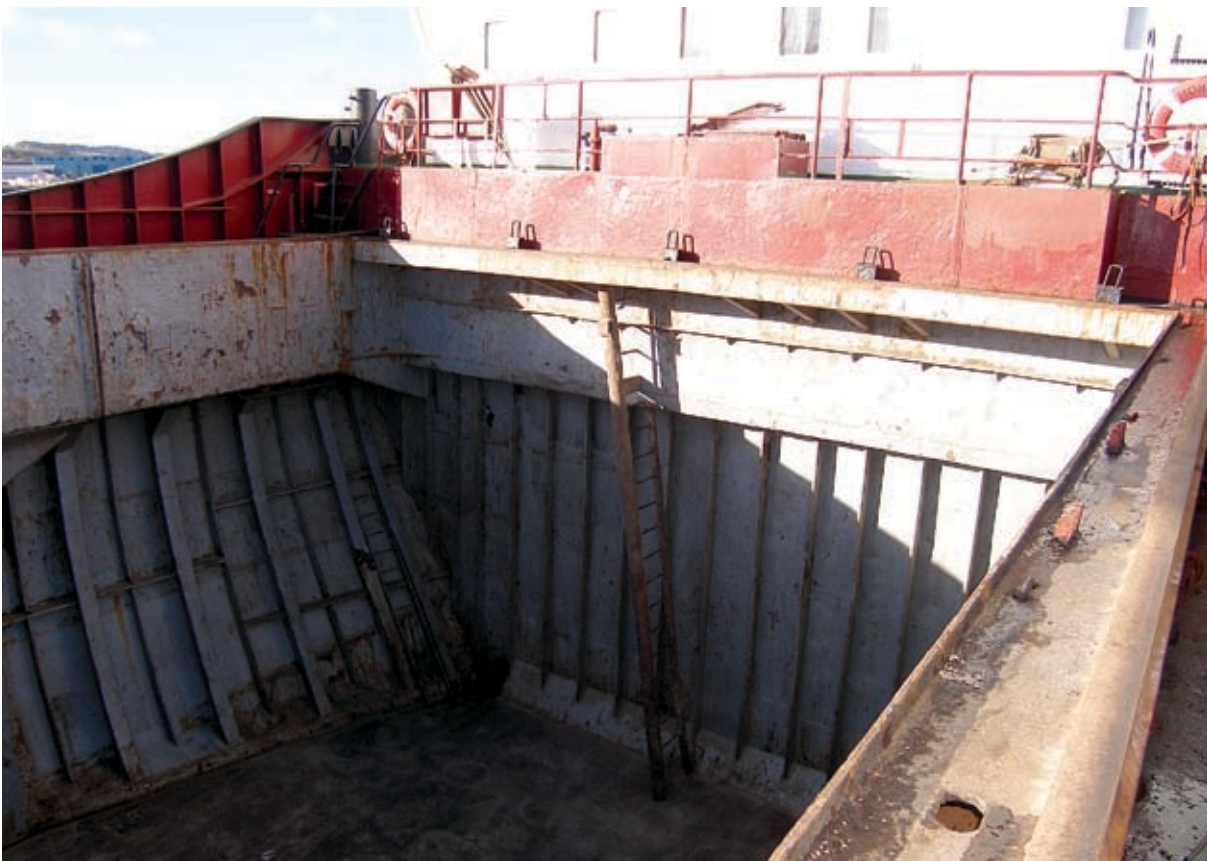
Figure 1: Cargo hold

When the vessel arrived at the port, the fumigator appointed to meet the vessel found a very high concentration of phosphine gas in the deceased crewman's cabin and in the compartment next door. Both these spaces were adjacent to the aft bulkhead of the hold, and the cabin deck overlapped into the hold by 0.5m. No obvious leakage path for the fumigant gas was located, even after smoke testing the hold and stripping back the bulkhead linings. However, following de-scaling of the area, some pin holes were discovered in the underside of the cabin deck that overhung the cargo hold.

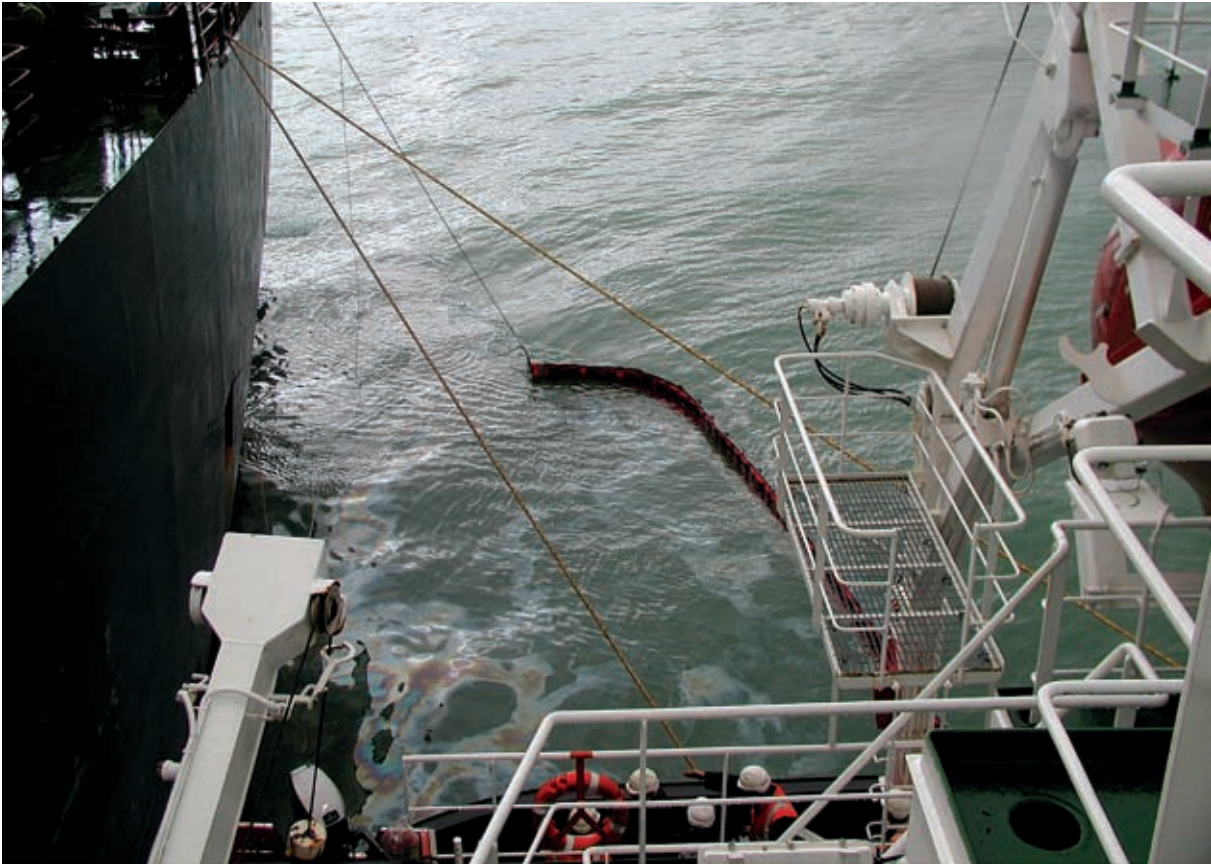
Figure 1

Pumping was immediately stopped, and the ship's crew attempted to absorb the fuel with the oil spill equipment. However, about 100 litres of fuel flowed from the scuppers into the sea. The local port's oil spillage plan was activated, booms were laid (Figures 1 and 2), chemicals were sprayed onto the fuel, and over the next 2 hours the fuel dispersed.

1. Where remote valve indicators are defective, ensure that a visual check on the actual valve is made to determine its true position.
2. Rectify remote indication defects promptly, and prove actual valve positions against those indicated at the remote position.
3. Scupper blanking arrangements should be regularly checked to ensure that they are tight. Their integrity can be proven by a simple water test.
4. It is useful to include oil spillage exercises as part of the emergency drill schedule.

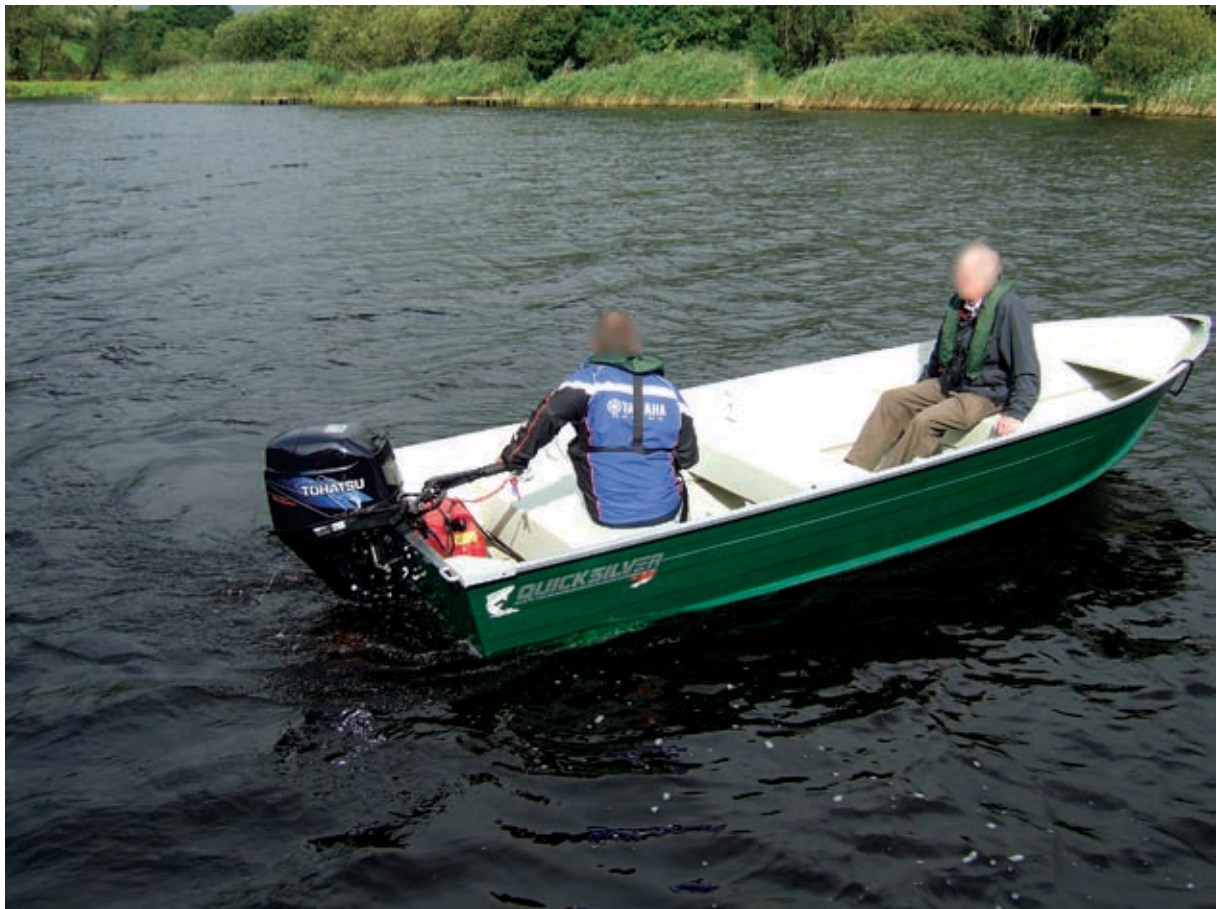
Similar aluminium angling boat
