MARINE ACCIDENT  
INVESTIGATION BRANCH

# SAFETY DIGEST

**Lessons from Marine  
Accident Reports  
3/2009**

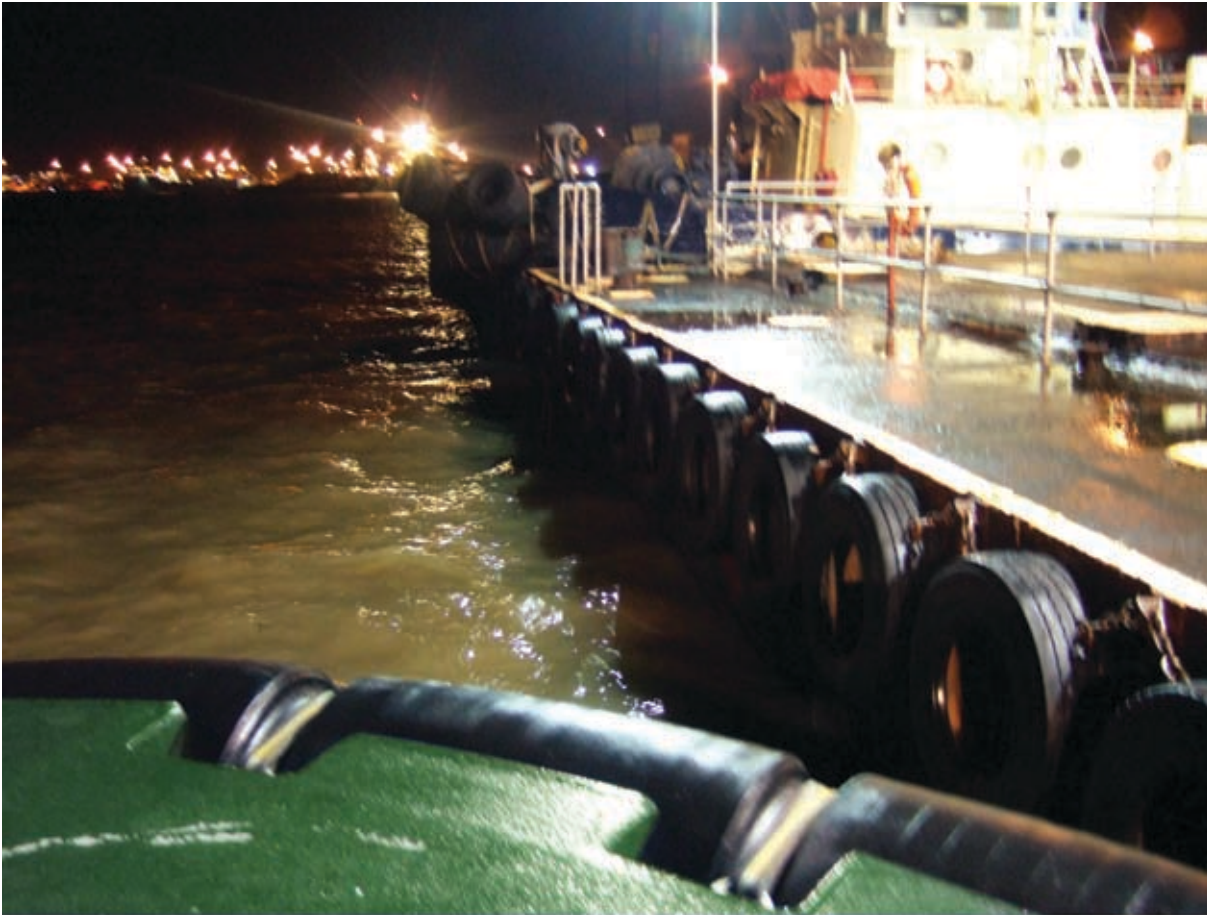
Figure 2: Pontoon and tyre fendering

instead. As he did so, the bow pitched up, rode over the fender, and then pitched down again, trapping the man's lower leg between the pontoon and the boat's hull.

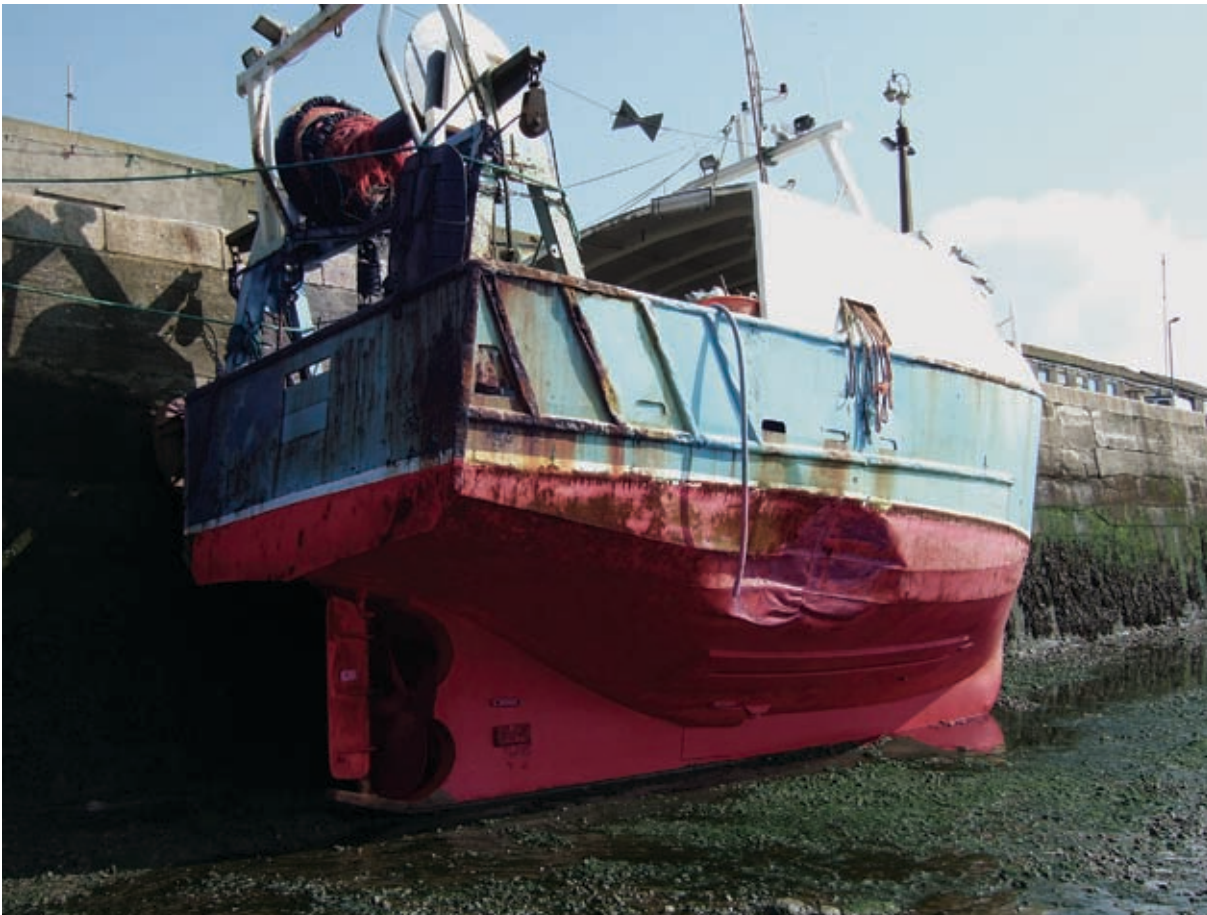
Seconds before the collision, the fishing vessel crewman looked up, and saw an approaching wall of water. By now too late to take avoiding action, the vessels collided. The fishing vessel sustained significant damage, with her deck

Figure 1: Small fishing vessel involved in the collision

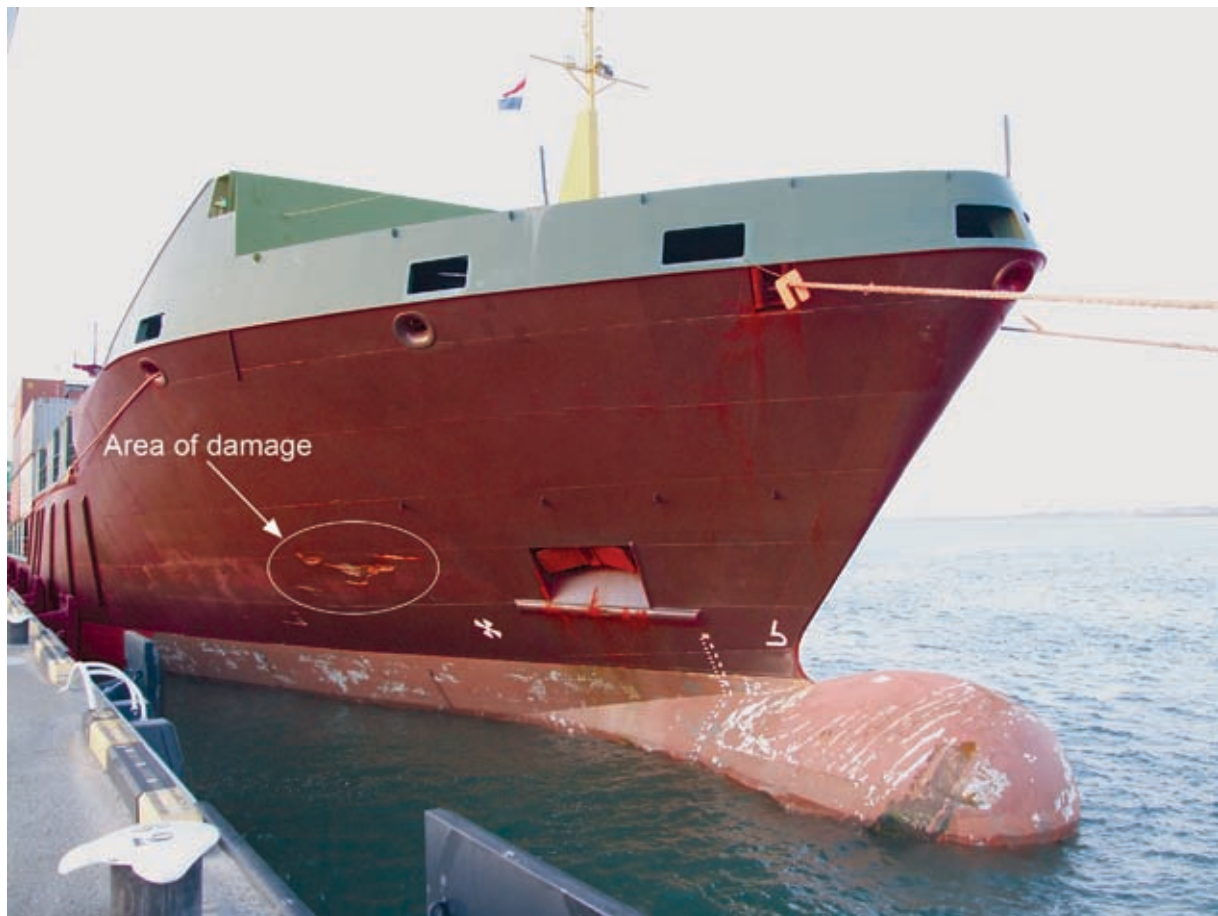
Figure 2: The container vessel involved in the collision

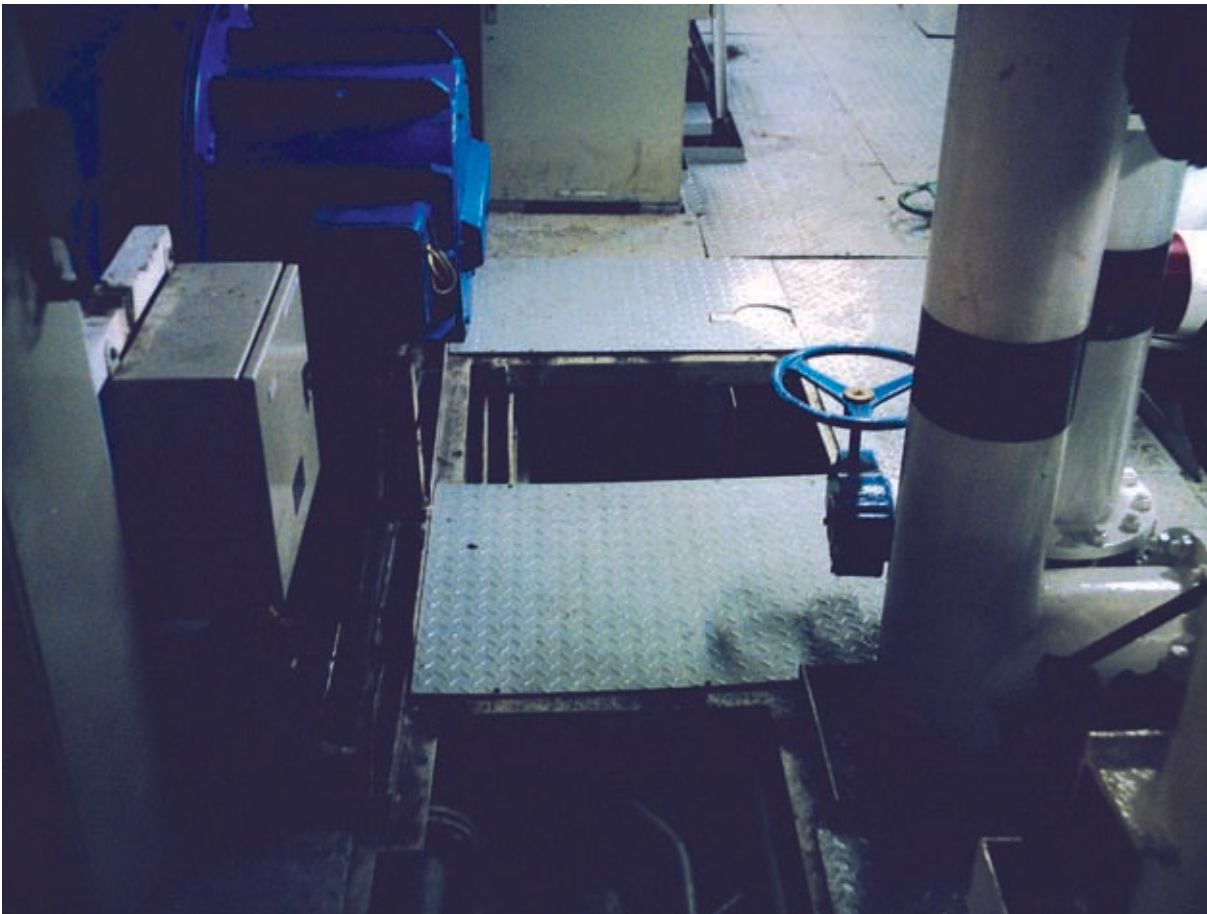
A short time later, copious amounts of smoke billowed up from under the floor plates (Figure 1). The second engineer, who was in the engine room at the time, raised the alarm, and the chief officer contacted the shore Fire and Rescue Service. In the meantime the engine room was evacuated and personnel were accounted for.

Figure 1: Welding area

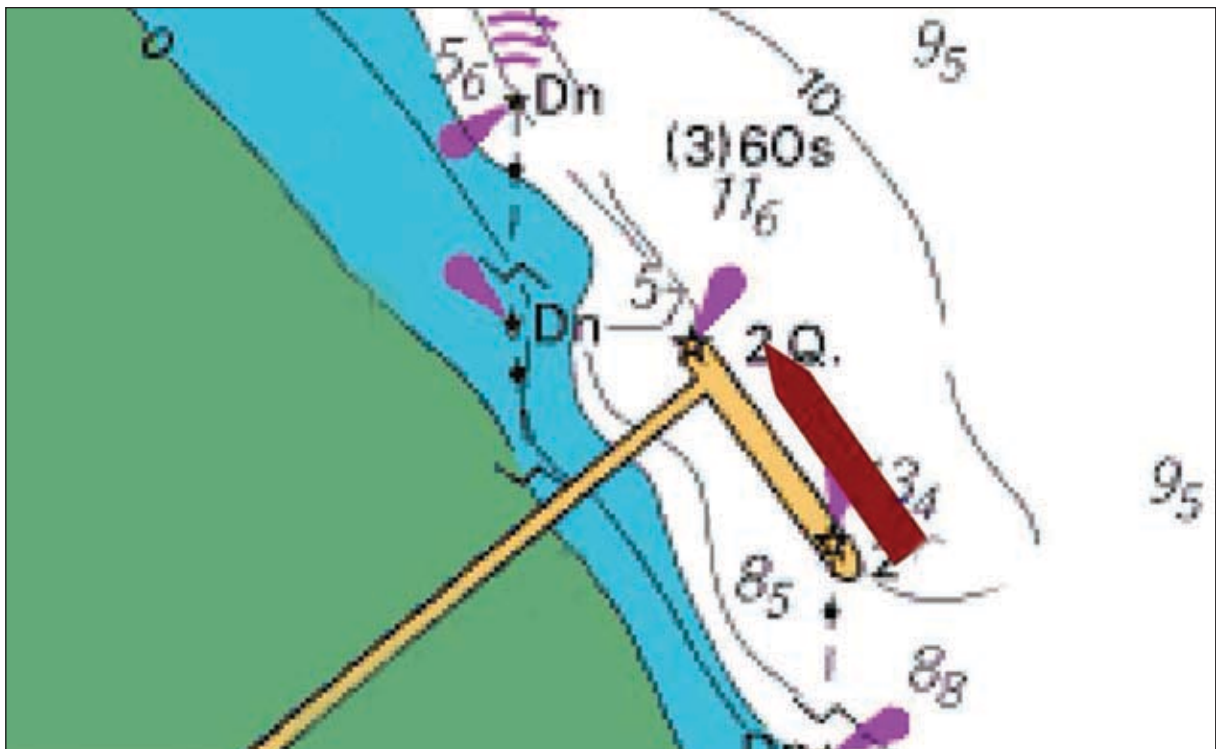
Figure 1: Vessel at beginning of manoeuvre

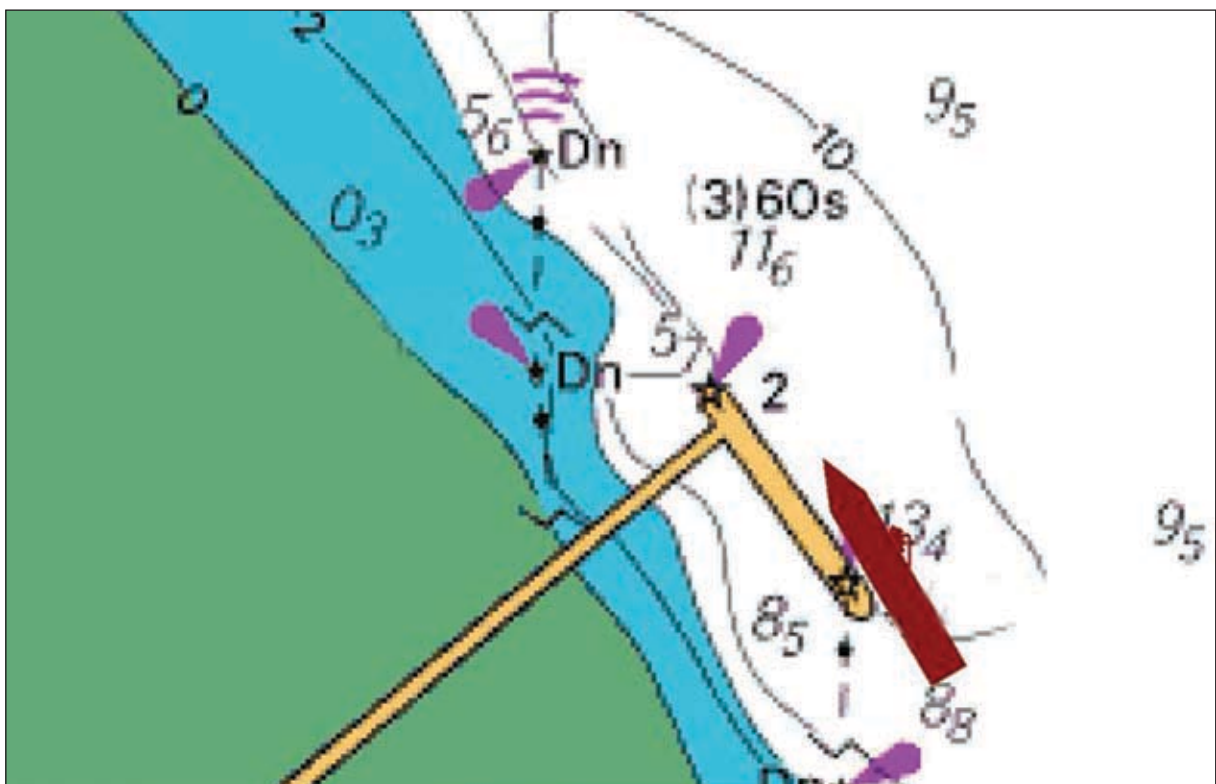
Figure 2: Vessel moving astern

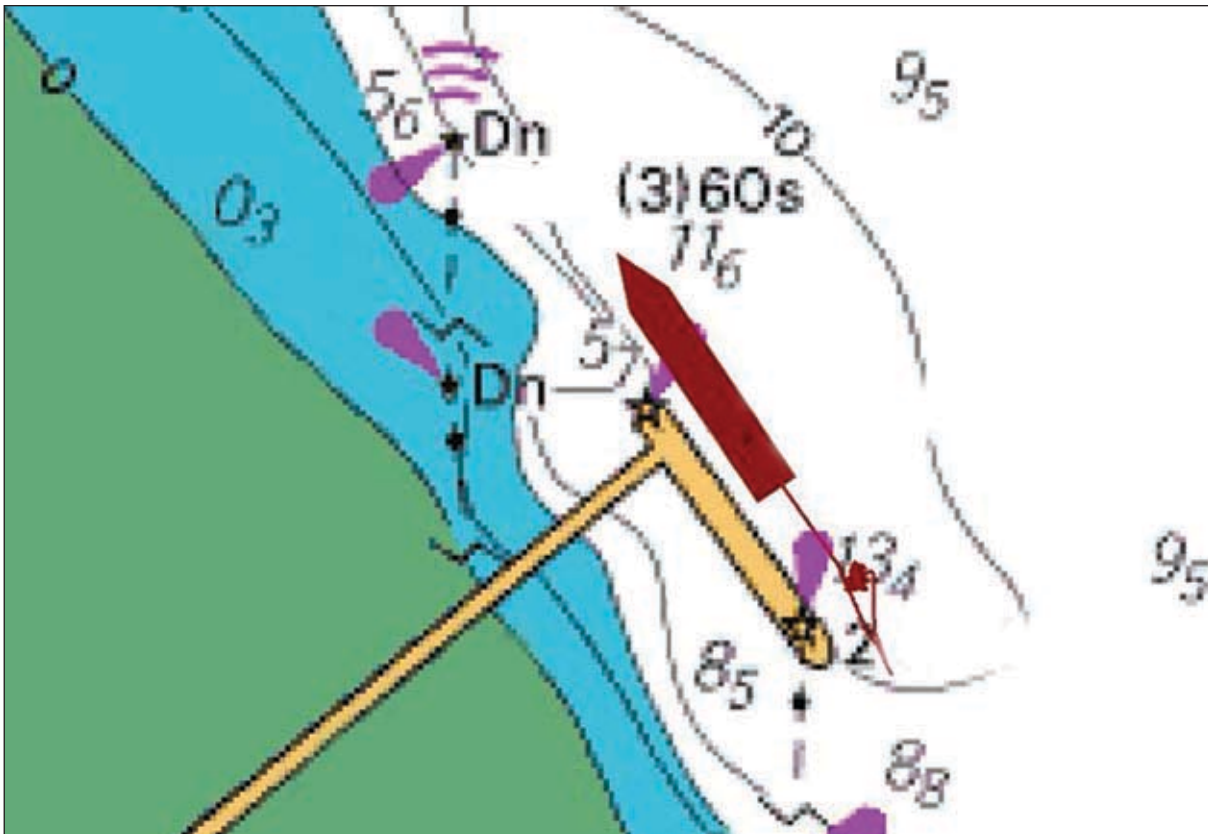
Figure 3: Vessel moving off the jetty

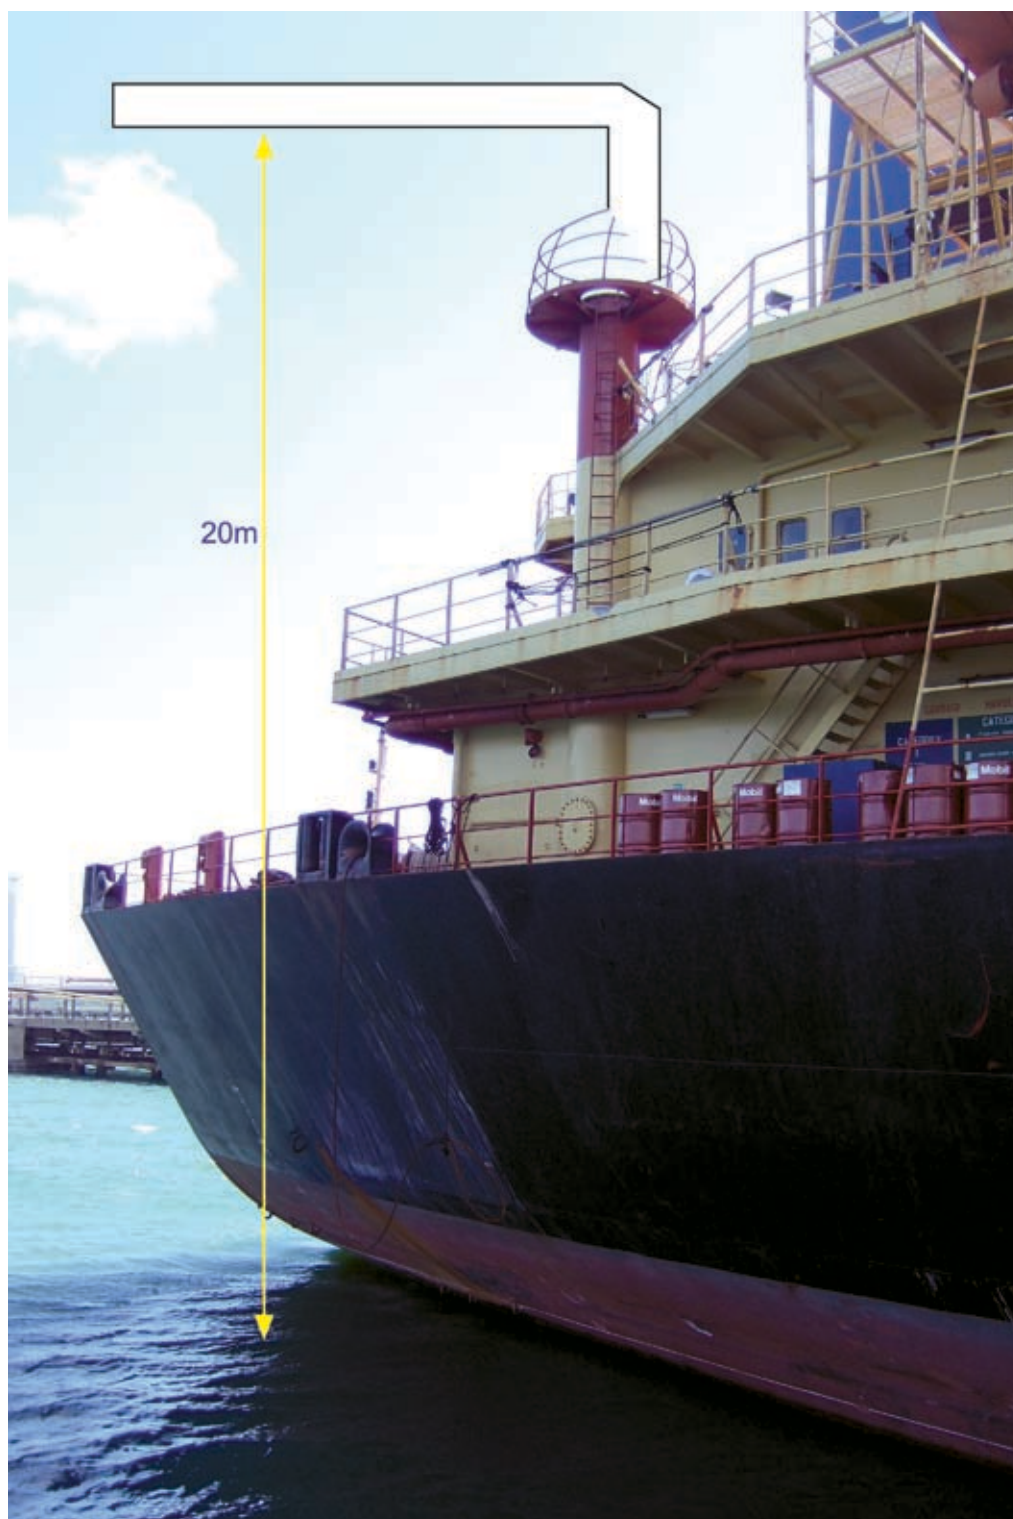
Position of the crane at time of accident

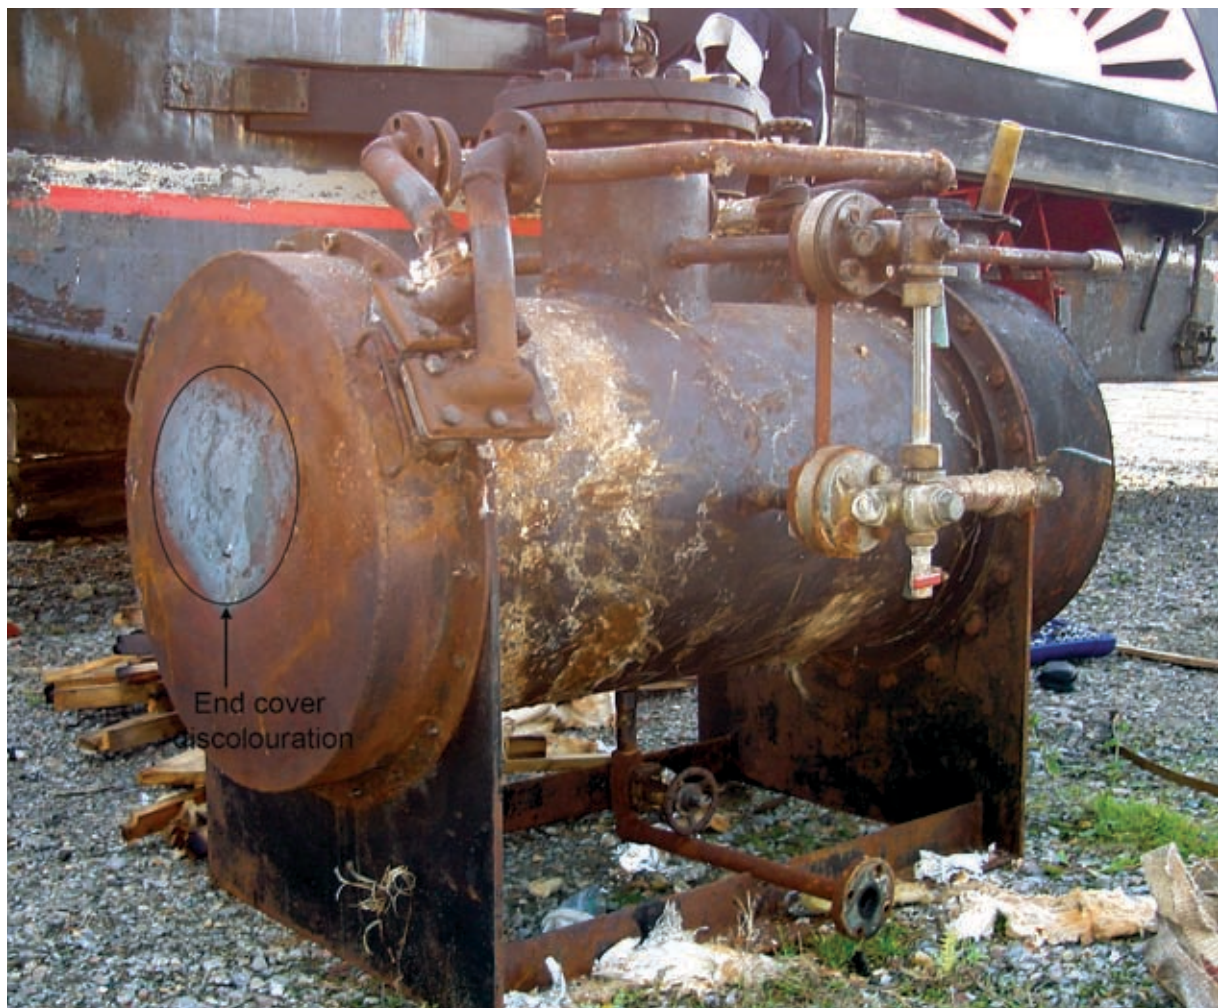
After removing the boiler lagging, the boiler rear casing was found to be severely discoloured. Further investigation identified that the superheater coil fitted behind the rear casing was too large for the boiler design. The continued expansion and contraction of the coil destroyed the insulation refractory lining

Figure 1: The boiler

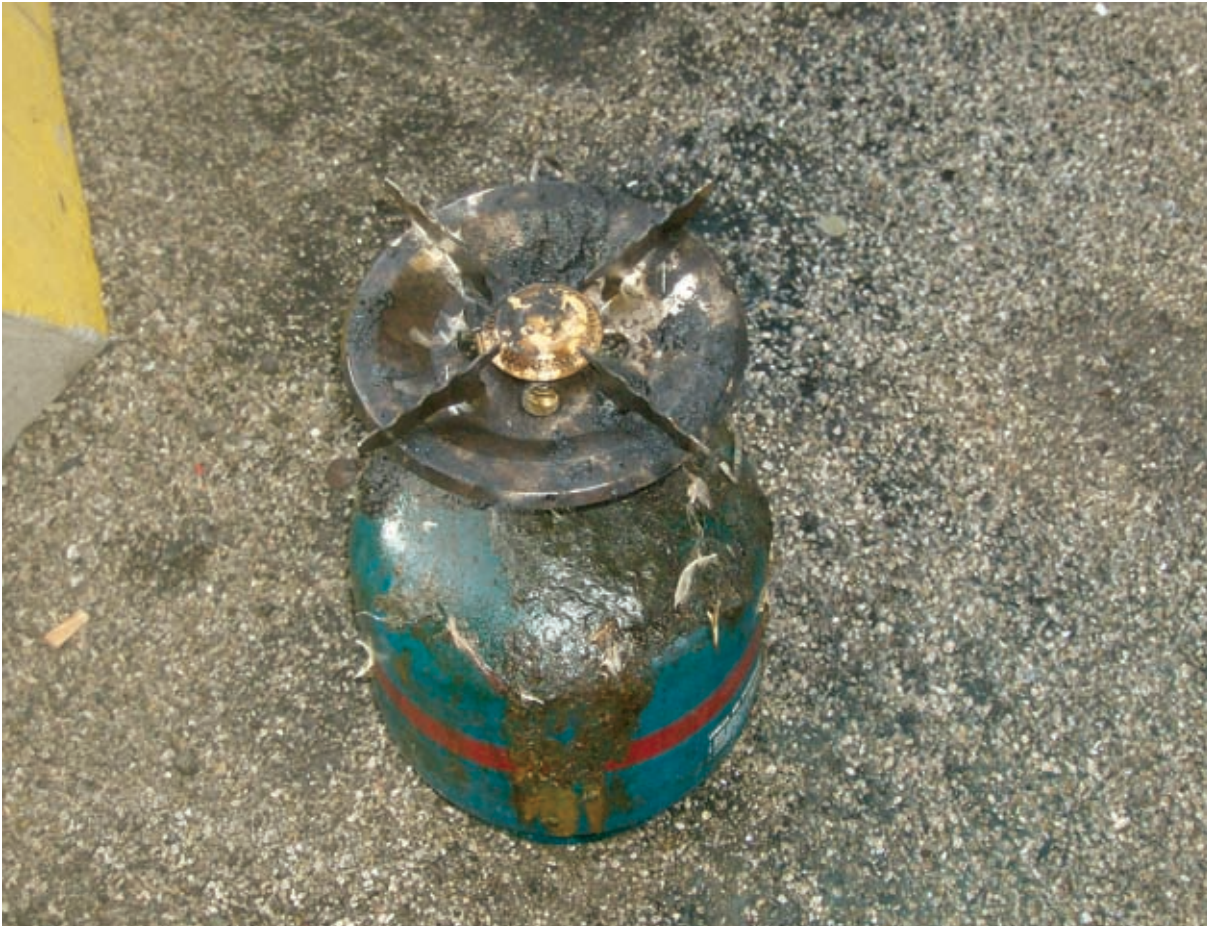
Figure 2: Camping stove

the main broadcast alarm and the fire party assembled. With the fire hoses providing protection, the cab side window was smashed and water directed into the cab. At 1648 the fire was declared to be extinguished. The contents of the cab, which included bedding, personal effects and a camping stove (Figure 2) were removed and doused with water.

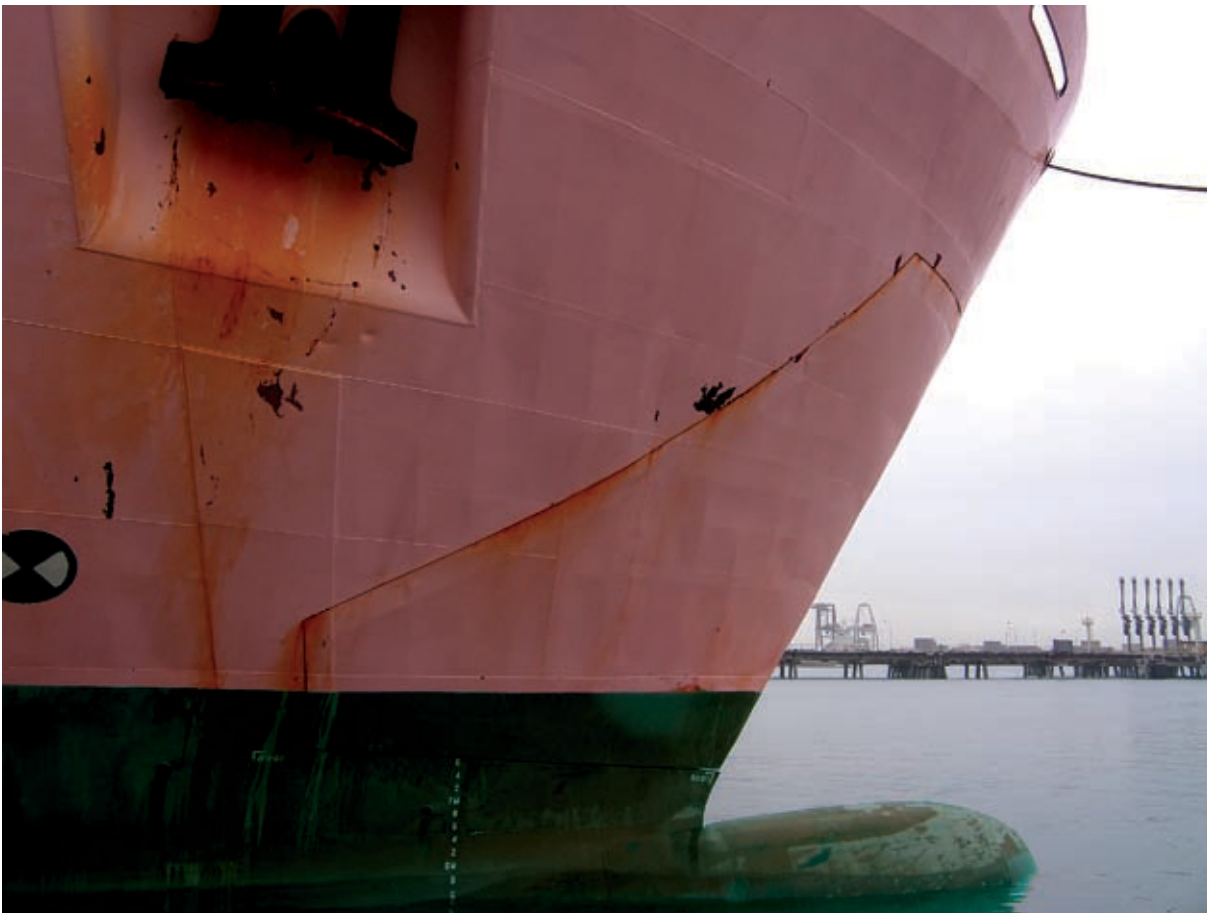
The master switched back to sea mode and altered course and speed to bring the prevailing weather on to the ferry's stern. The chief engineer went to the car deck to investigate the problem. Once the water in the bow door space had drained out and the ship was on a comfortable course, the small watertight access hatch into the bow door space from the car deck was unbolted. The chief engineer had a look inside. He found most of the visible cleats and bolts disengaged.

Figure 1: Bow door in closed position

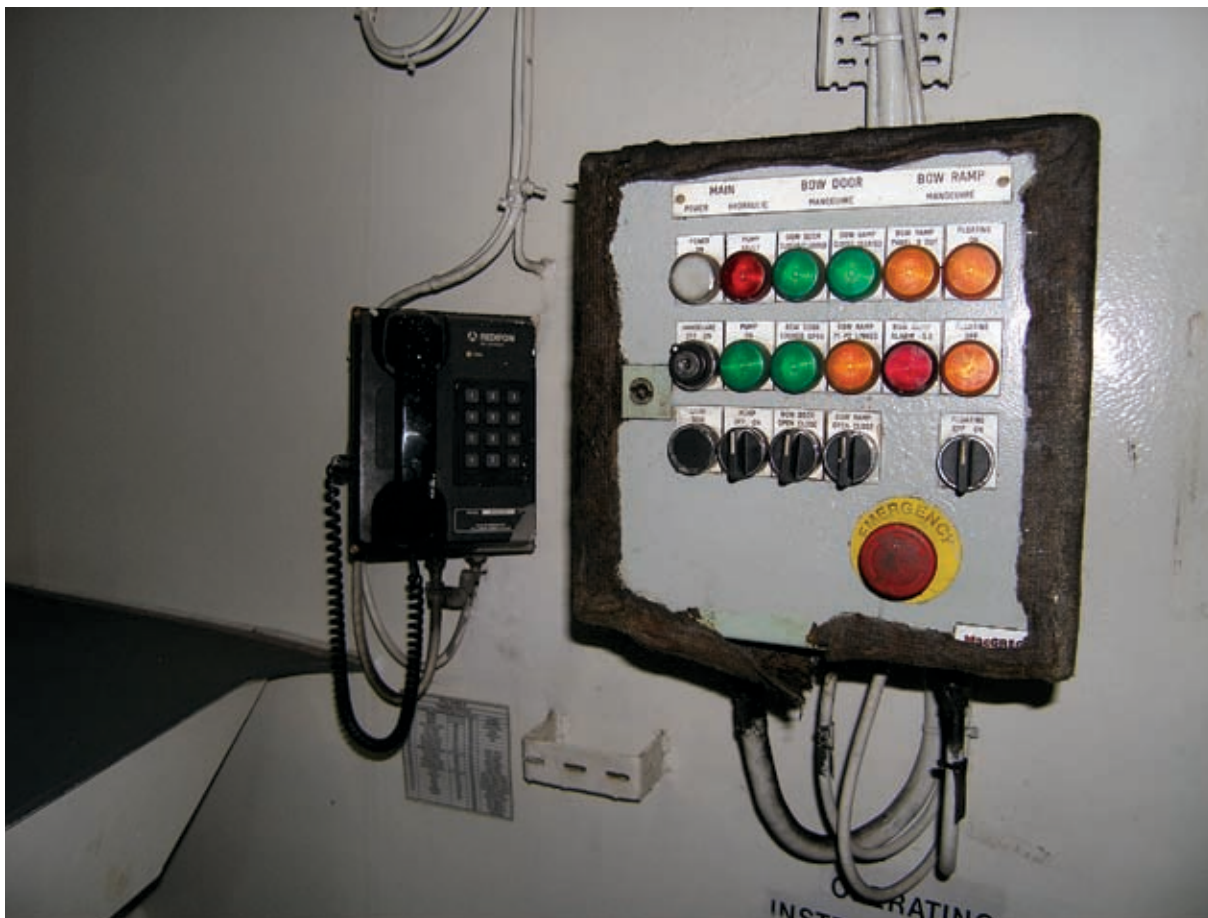
The chief engineer proceeded to the solenoid room and followed the emergency instructions for closure of the door, which required manually activating the hydraulic solenoid

Figure 2: Bow door operating panel on car deck

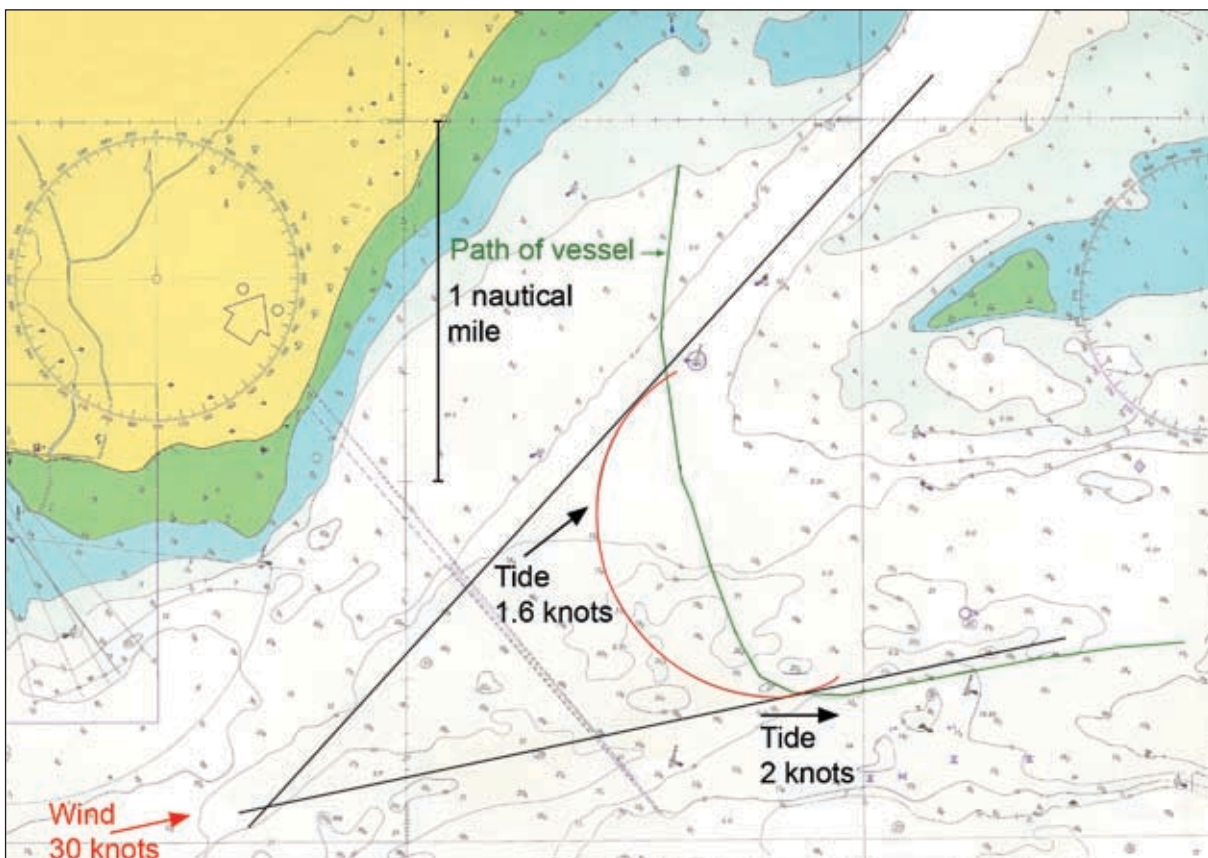
due to the large superstructure, and this was uppermost in the bridge team’s minds as the order for “wheel over” was given to initiate the turn. Due to the opposing directions of the ship and the wind and stream, the ship’s head payed off the wind very rapidly once “wheel over” was ordered and, driven on by her forward momentum she continued to swing, with an increasing rate of turn. This resulted in the ship being out of position to complete the turn into a narrow navigable channel, between two shallows.

Route taken by the vessel, showing “rate of turn” calculations

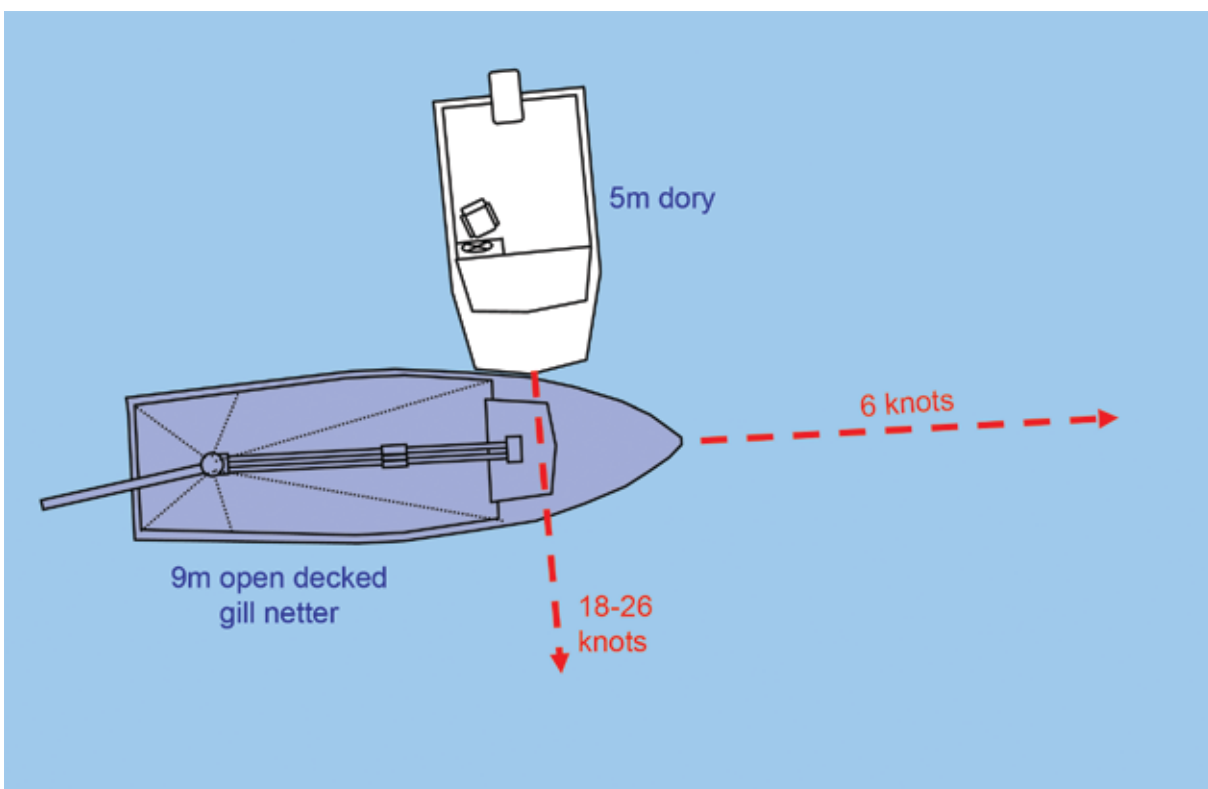
Figure 2: Relative positions on impact

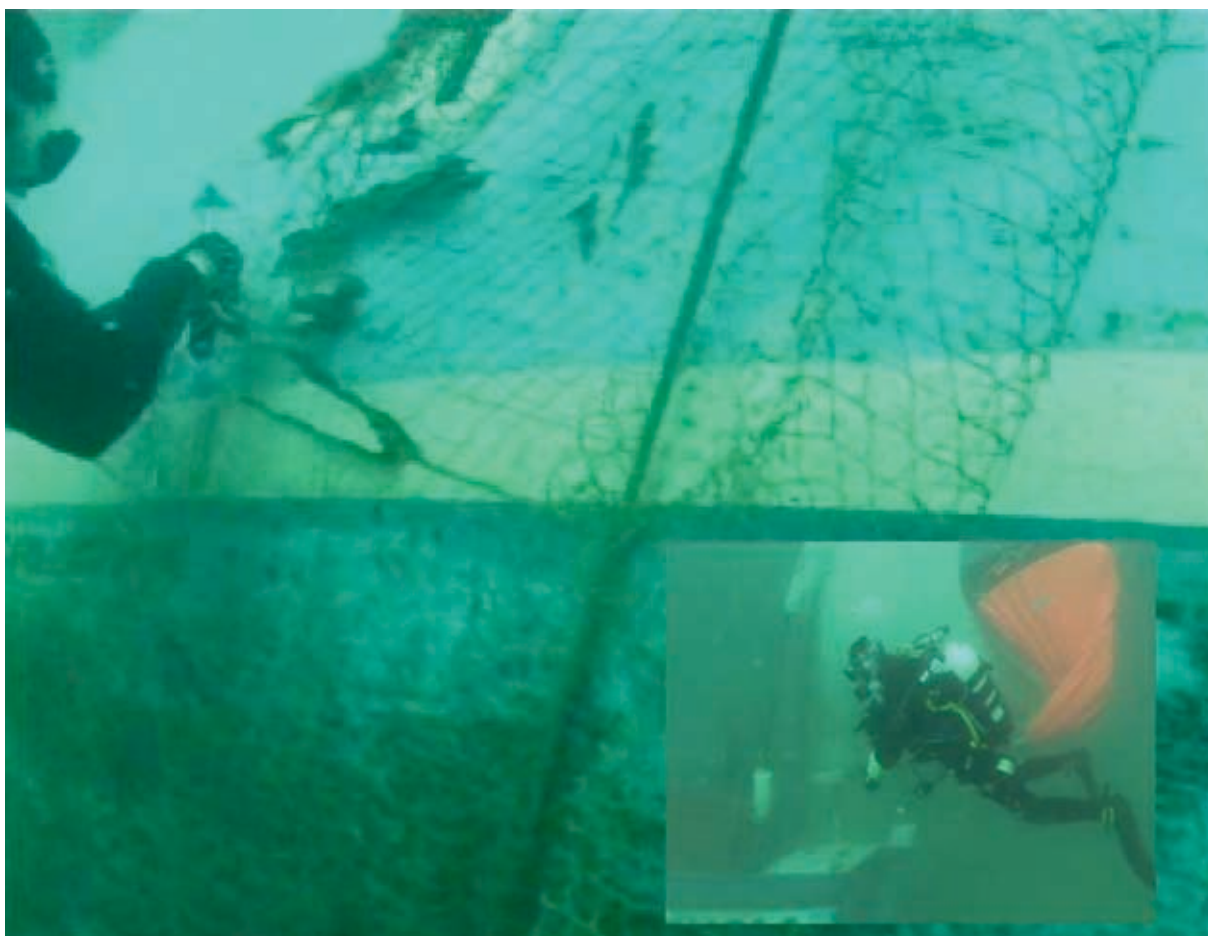
Figure 4: Gill netter diving survey

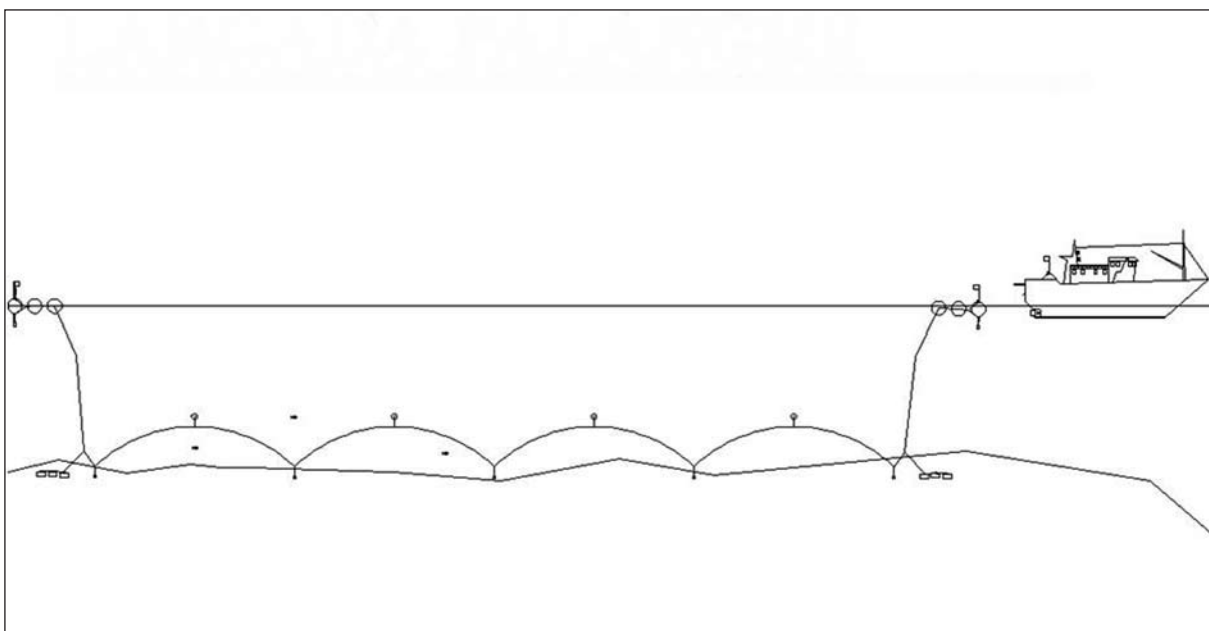
It is likely that the deckhand had stood in a bight of the connecting rope and was thrown overboard when weight came onto the rope between the dhan buoys and the marker buoy.

Figure 1: Diagram showing the long-line on the seabed

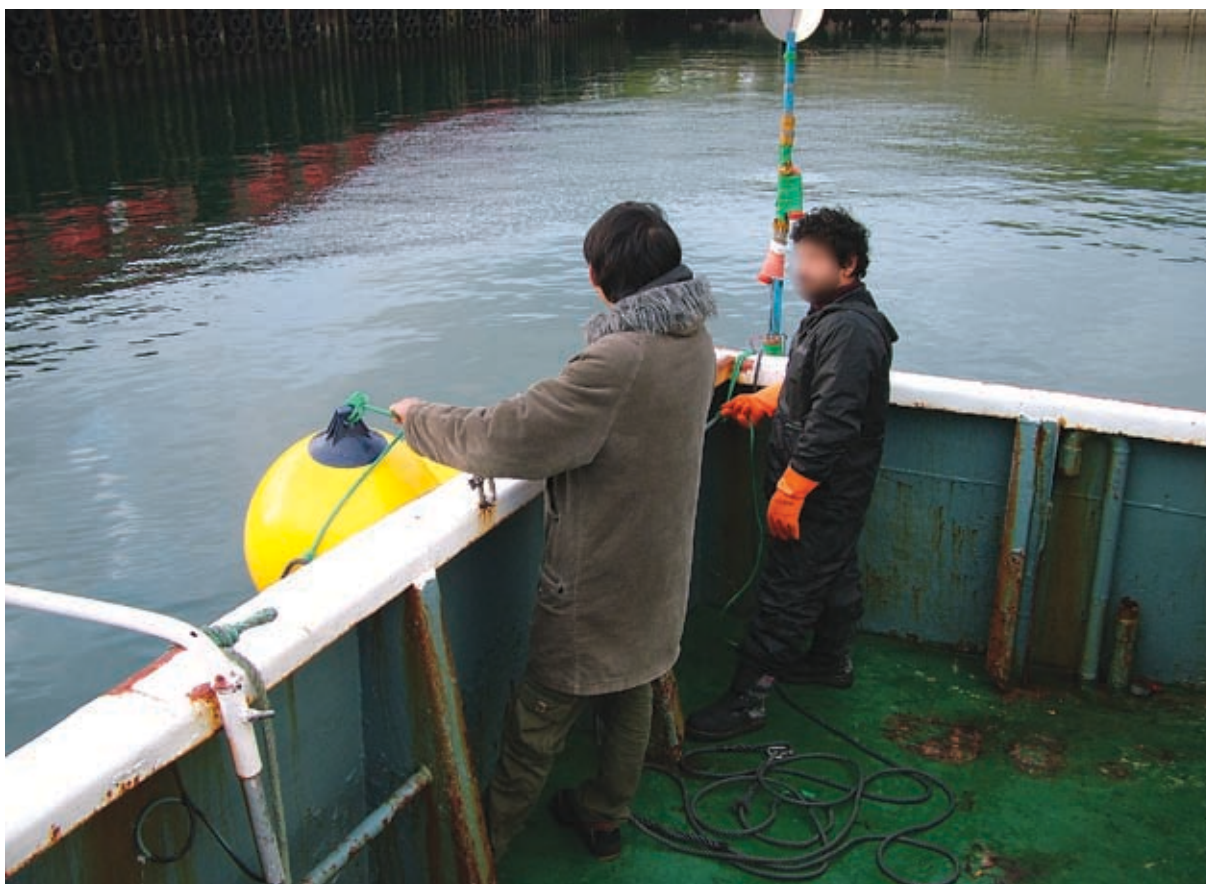
Figure 2: Two fishermen showing the point of letting go of the dhan buoy

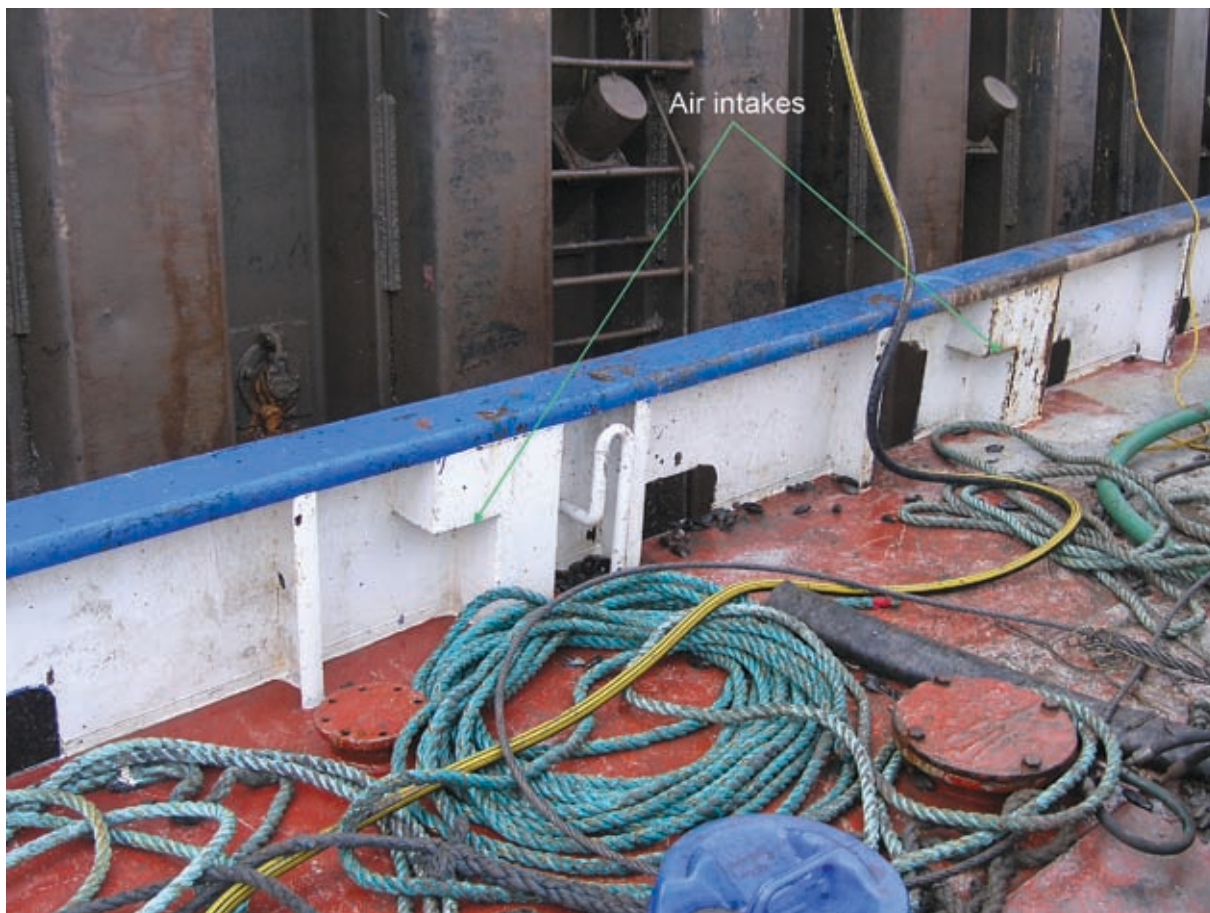
Despite the skipper's efforts, he was unable to free the dredge or correct the heel before downflooding occurred into the engine room via the vents sited under the bulwark. As the vessel capsized to starboard, the two crewmen on deck managed to scramble on to the port side of the wheelhouse. As a result, none of the crew entered the water. The skipper, who was in the wheelhouse, called the coastguard and the accompanying fishing vessel.

Figure 1: Deck, showing engine room air intakes

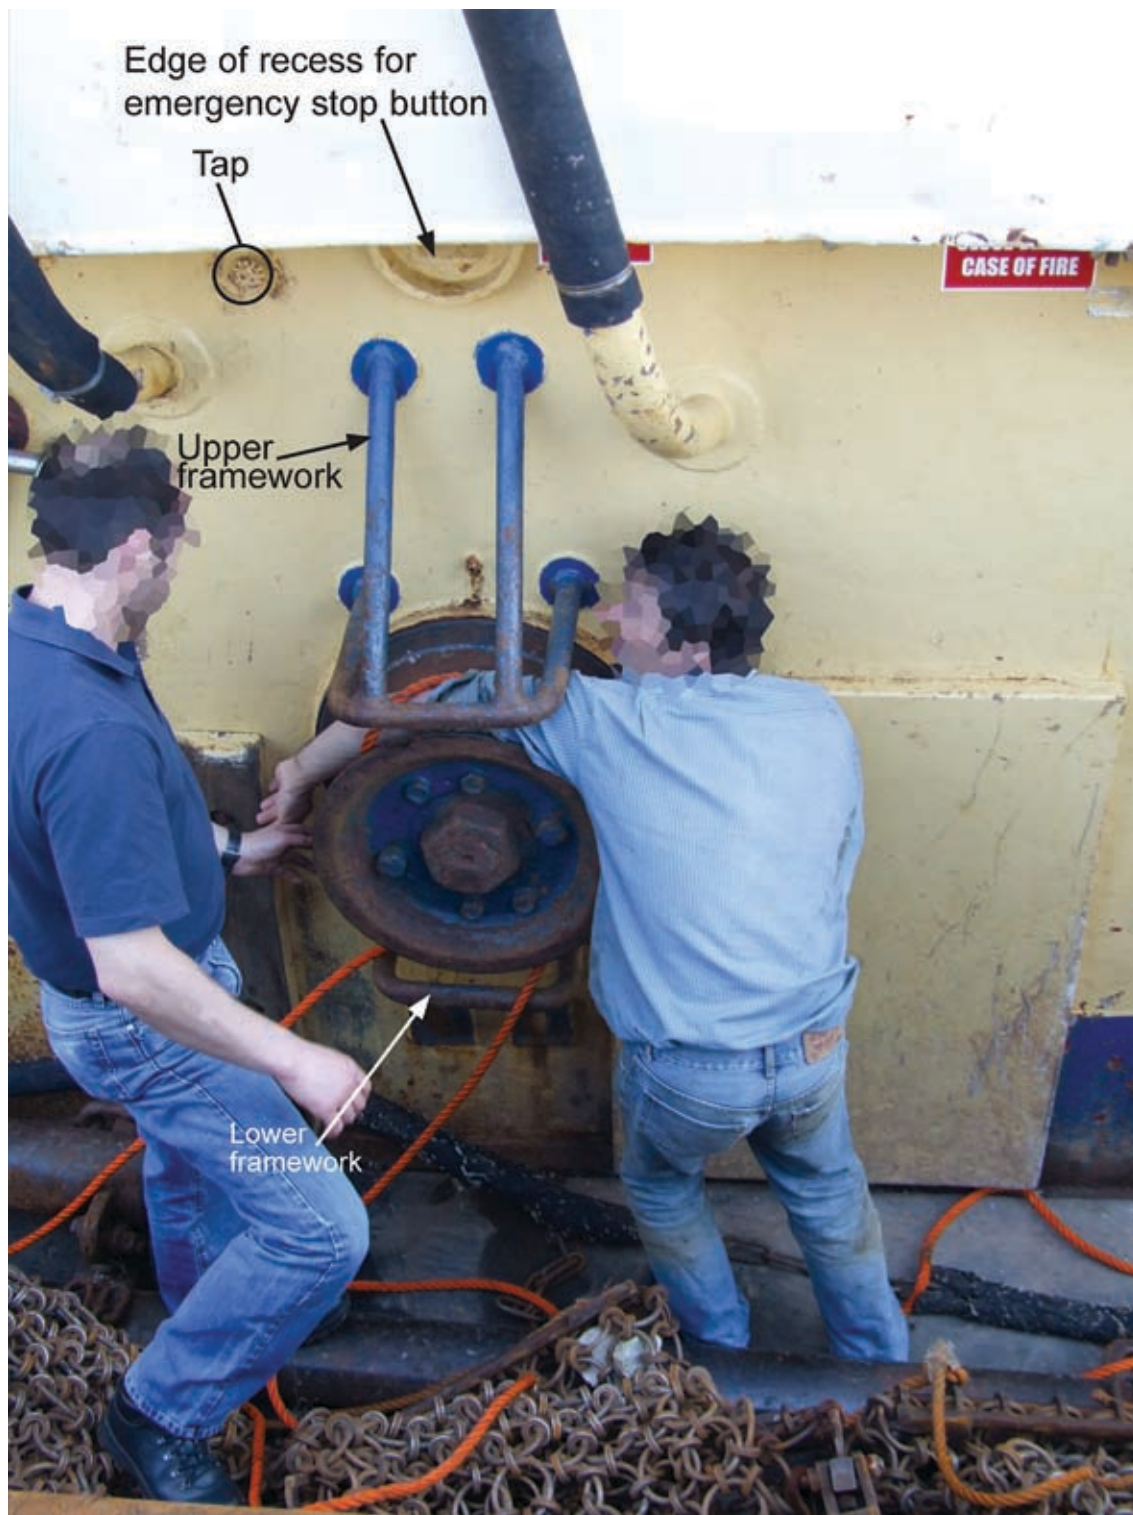
Figure 2: Demonstration of “as-found” position of deckhand, trapped in whipping drum

- The frameworks above and below the whipping drum had been fitted when the vessel changed from a beam trawler to a scalloper. They created an additional entrapment hazard and undoubtedly contributed to the very serious injuries sustained by the deckhand.

3. A new “tipping” arrangement has now been fitted to this vessel, which should remove the dangers evident from the initial working arrangement. Various alternative “tipping” configurations are available, such as automatic systems, or the use of a dedicated “tipping” winch, with a remote control. Not only will such systems offer safety benefits, but they will also lead to more efficient operations, thus saving time and money.
