MARINE ACCIDENT  
INVESTIGATION BRANCH

# SAFETY DIGEST

**Lessons from Marine  
Accident Reports  
3/2009**

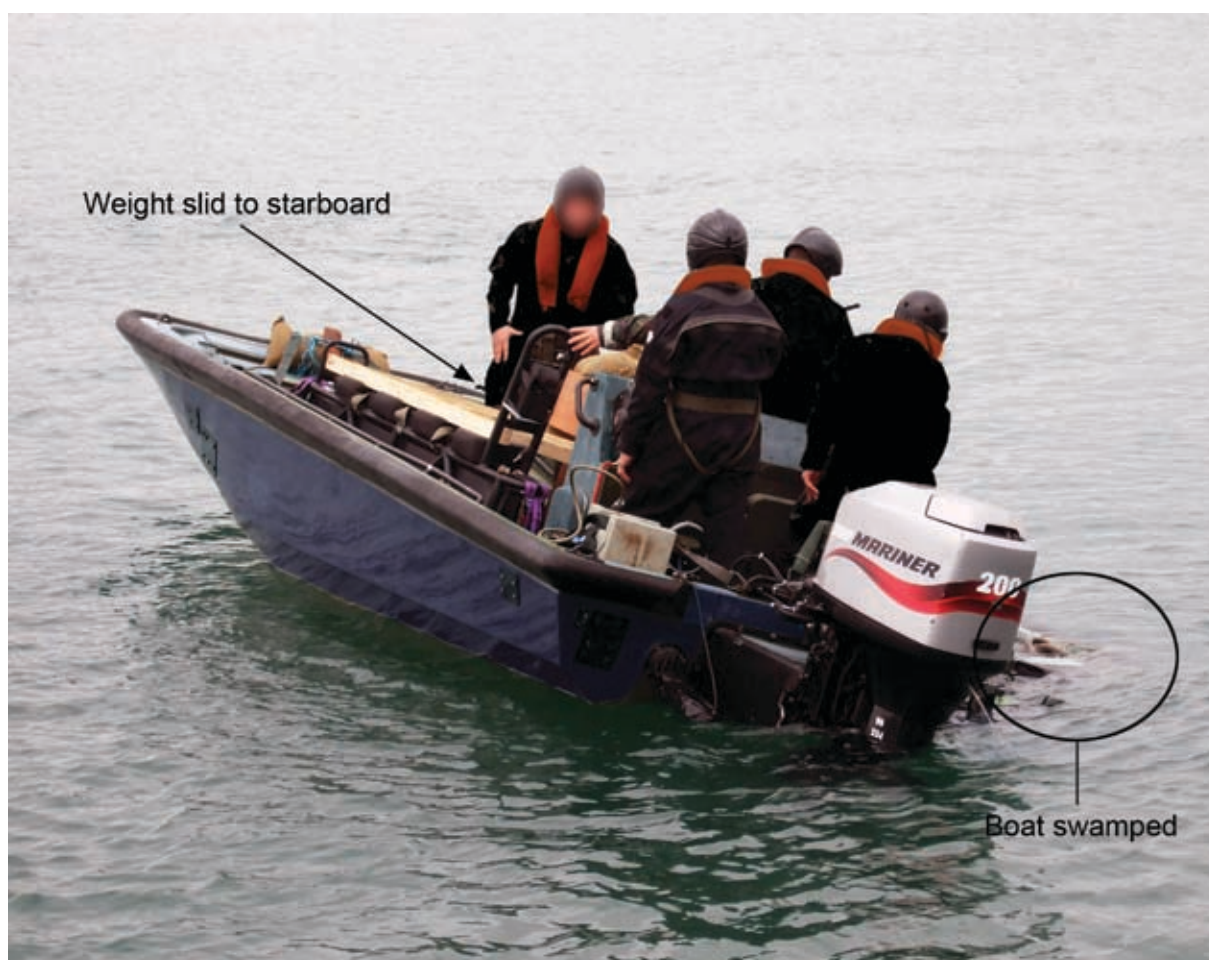
The boat started taking on water over its bow and sides, which then accumulated on the deck and caused the boat to loll to port. To address the problem, the instructor in charge turned his boat into the sea and stopped. The '*elephant's trunk*<sup>1</sup>' on the port side of the aft transom was lowered. Speed was then increased and a turn to starboard was commenced. As the boat started to turn, the teenagers seated on the port side of the boat were instructed to transfer to the starboard side. As they moved, the boat heeled to starboard and capsized.

Capsize trial illustrating weight shift and boat swamping

2. The accumulation of water on the decks of any boat is dangerous, and can quickly lead to the loss of stability where it is able to move freely from one side of a vessel to the other. Prevention is easier than cure, and the use of 'elephant's trunks', self-bailers, freeing ports and bilge pumps is usually very effective, even in rough conditions. However, once water has accumulated and can move unchecked, great care must be taken not to counter any apparent list with the movement of people or weights. This is unlikely to have the desired effect and can result in capsizing. Limiting the movement of people on the boat and getting rid of the water by all means available is the safest and simplest solution.

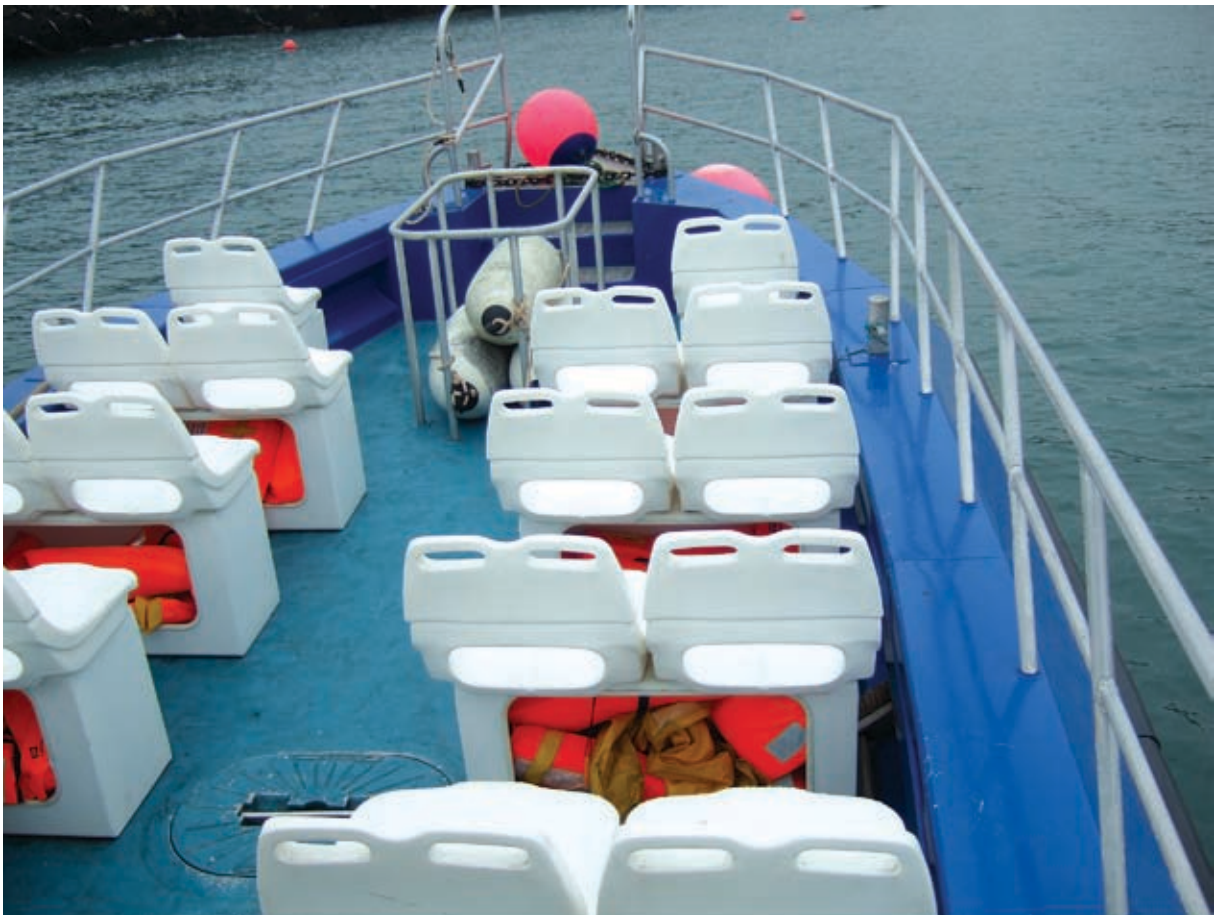
Figure 1: Rear view of the high speed vessel

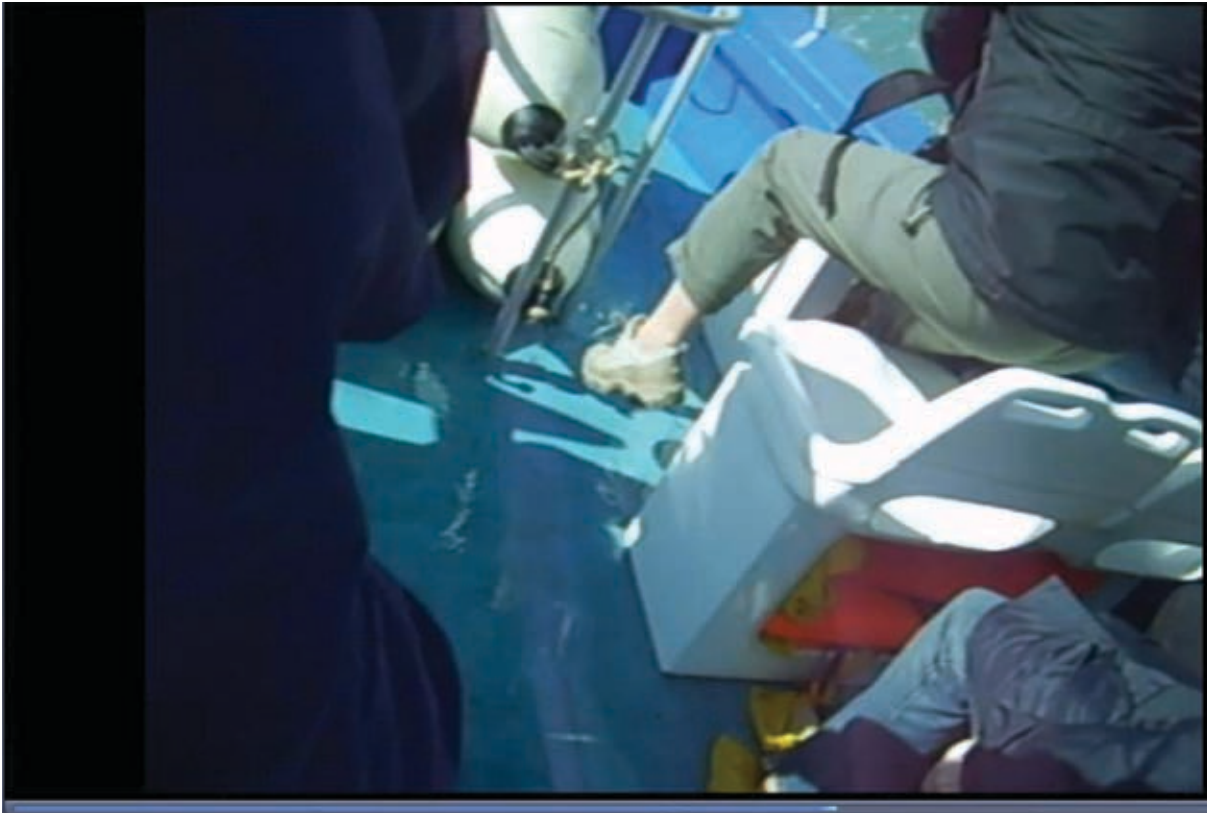
While the boat was in the channel, a single steep wave, roughly 2m in height, rose up immediately ahead of it. Despite the skipper's best efforts, he was unable to stop the vessel slamming heavily as it dropped off the back of the wave. The passengers landed heavily on

Figure 2: Photograph of a passenger being lifted from her seat by a wave

4. Prior to a trip, identifying anyone with a condition that could place them at greater risk, for example if they have a pre-existing back problem, are infirm or are pregnant, and determining whether the trip is suitable for them.
5. Ensuring helmsmen are alert to the risks to people from slamming, and that they drive their vessels appropriately. This should be emphasised where the helmsman is positioned behind the passengers, and is exposed to less violent motion.
6. Considering the suitability of the vessel for the intended trips. Planing hulls with 22-28 degrees of deadrise angle at the transom will provide a reasonable ride in moderate waves. In general, the shallower a vessel's deadrise, the greater its propensity to slam in steep or confused seas.
