**Lessons from Marine
Accident Reports
2/2010**

SAFETY DIGEST
Lessons from Marine Accidents
No 2/2010

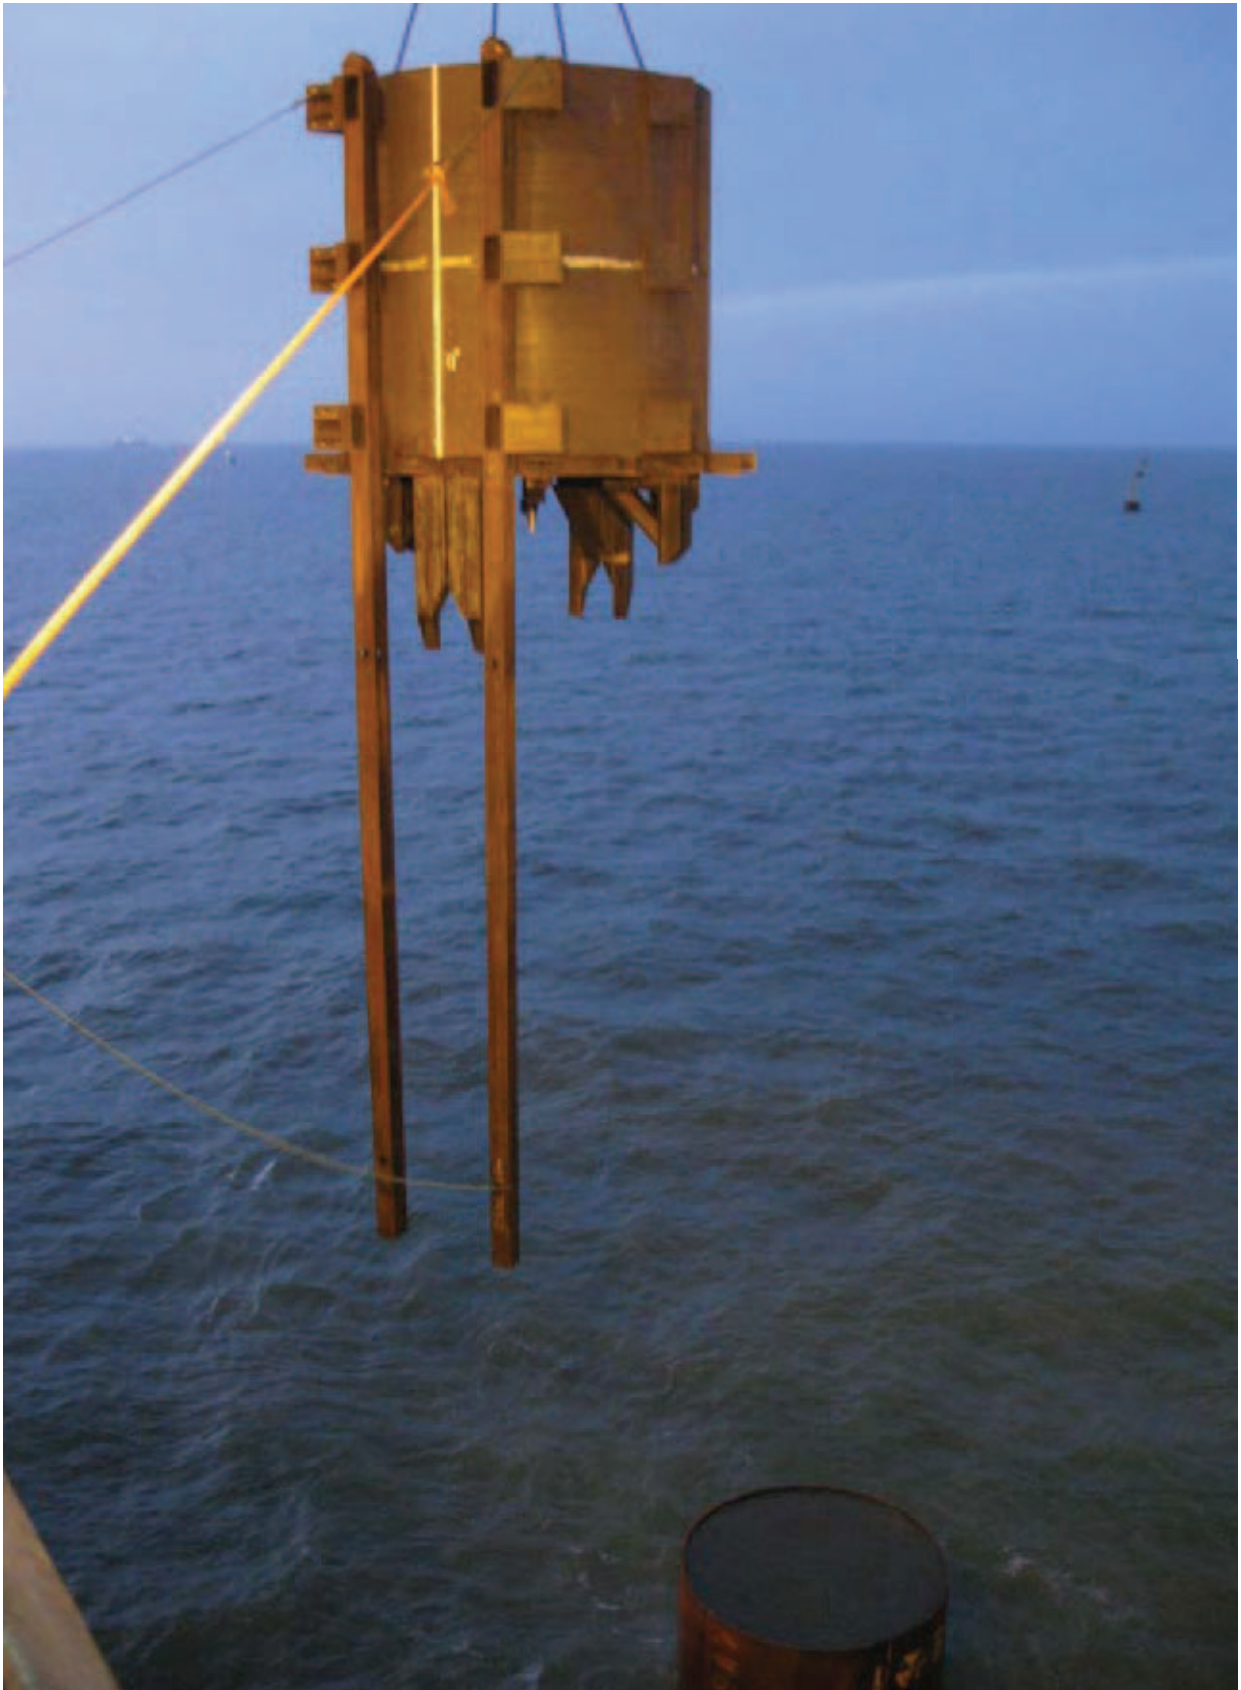
Figure 1: Wind turbine tower alignment tool

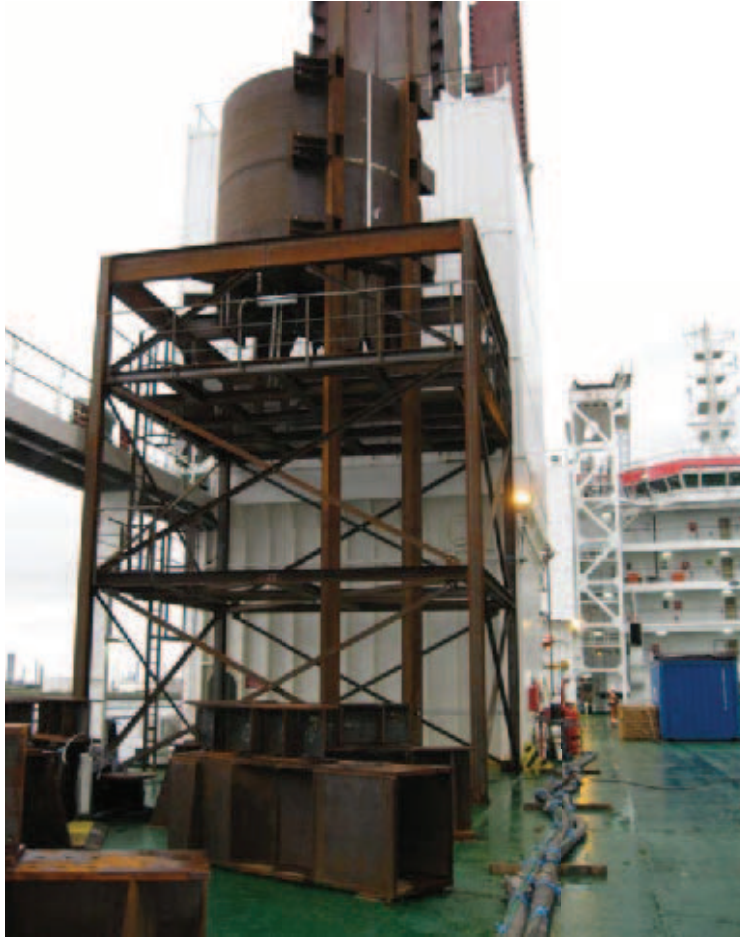
Figure 2: Alignment tool secured in its stowage

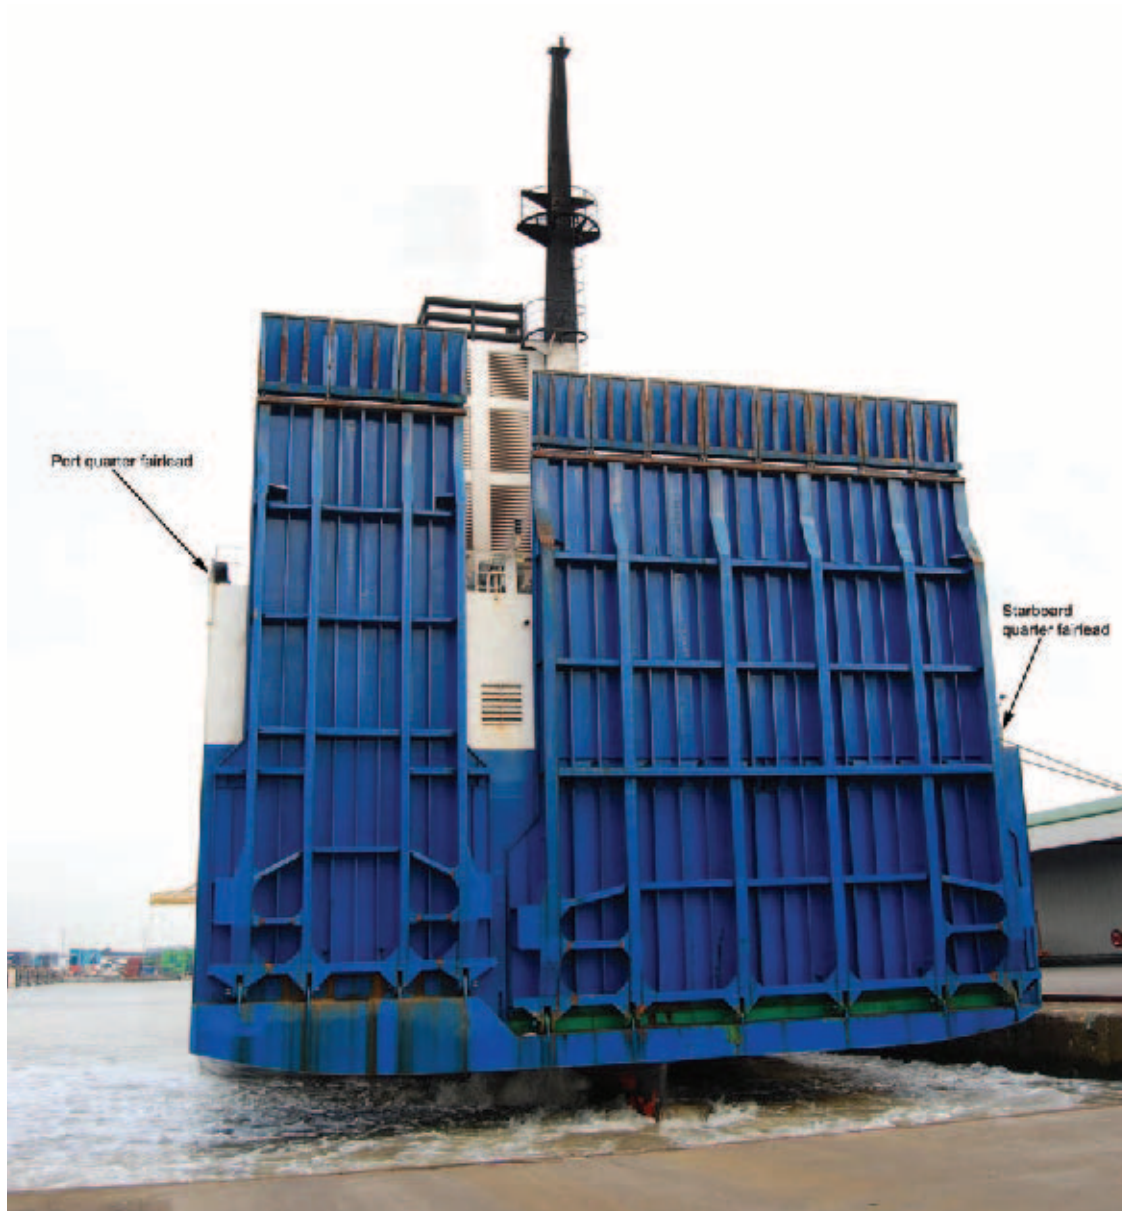
Figure 1: Stern view of cargo vessel showing fairlead positions

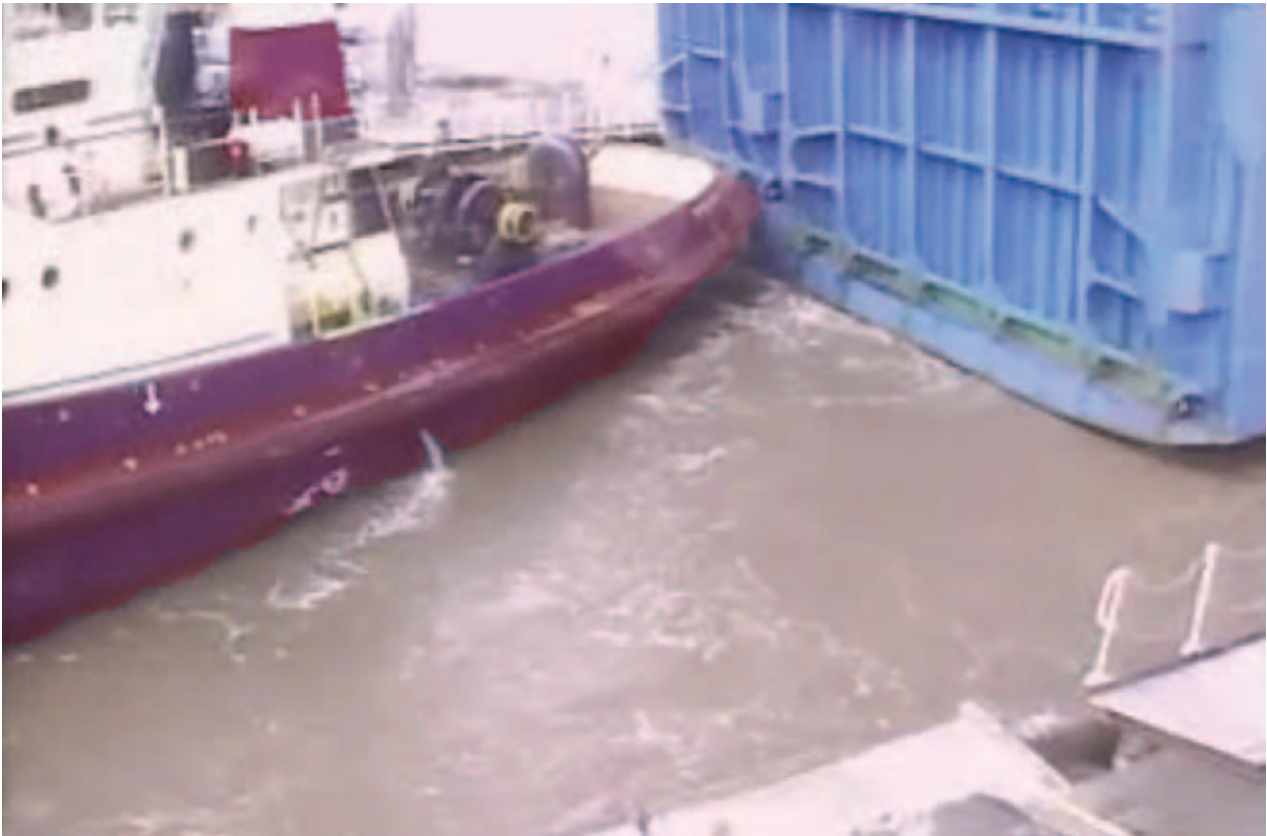
Figure 2: Tug pushing onto cargo vessel's transom

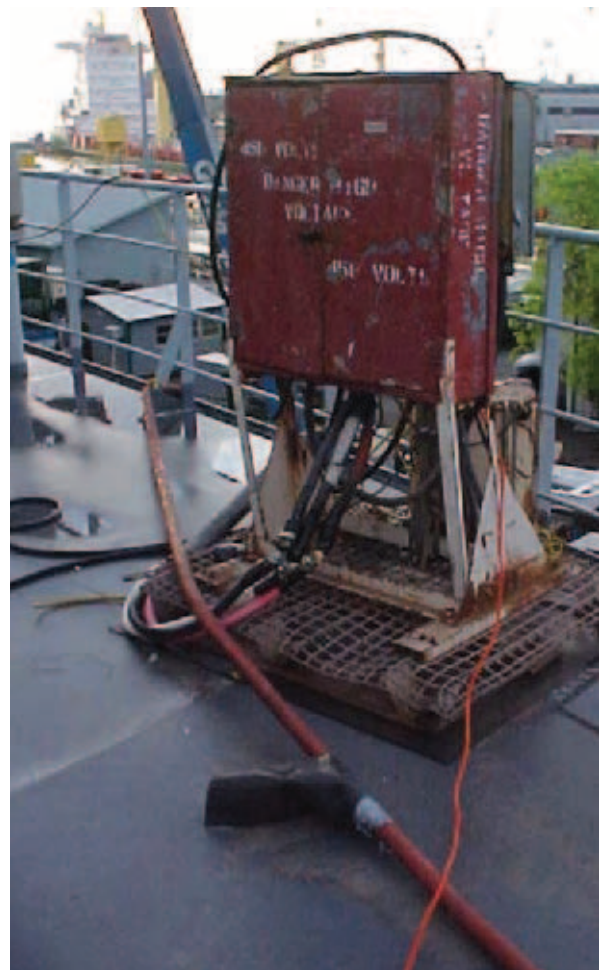
A few days later, the crew heard an explosion in the shipyard, following which shore electrical supplies were lost and the vessel suffered a blackout. Investigation showed that this time, one phase of the shore power had failed due to a poor mechanical connection, causing the remaining two phases to overload, resulting in significant damage to the supply cables before the breakers operated. Electric motors on board the ship were found to have been single phasing, and some were damaged as a result.

Figure 1: Shore services box

1. **Trust no one:** safety standards can vary enormously in different parts of the world.
2. Always ensure that appropriately qualified staff have properly checked connections on shore electrical supplies before they are made live.

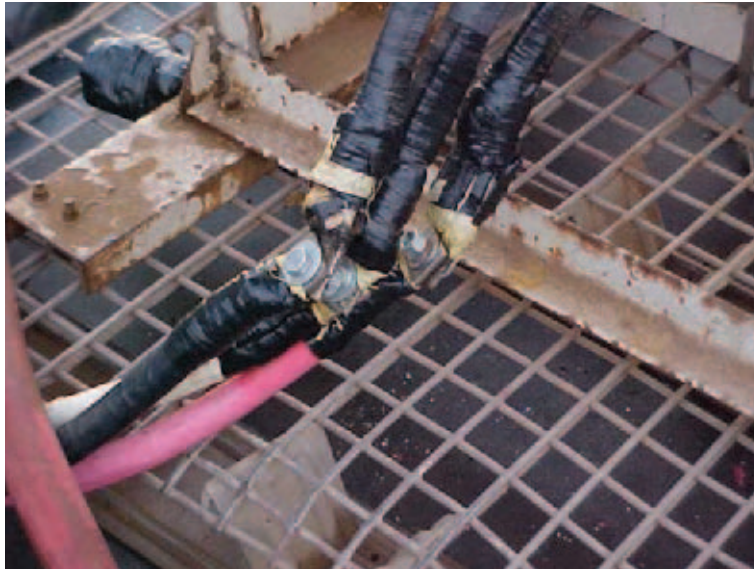
Figure 2: Shore services supply cable

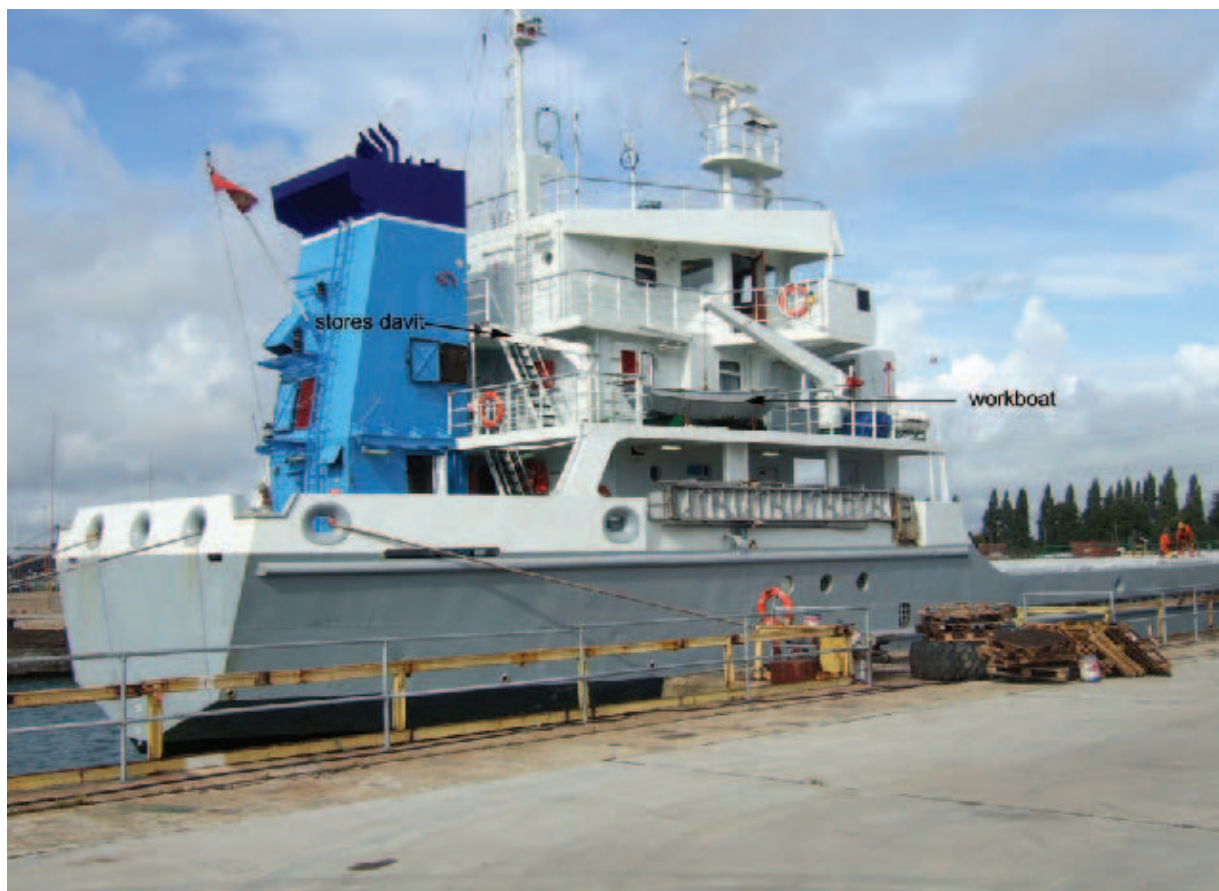
After the boat had descended about 2m the wire parted, close to the hook, and the boat and both occupants fell around 8m to the water. Both suffered serious injuries, but were able to climb out of the boat and up the vertical ladder on to the dockside, from where they were taken to hospital by the emergency services. Both required a lengthy time off work to recuperate.

Figure 1: The vessel involved in the incident

3. The wire was heavily corroded and was incapable of supporting the weight of the workboat and the crew.
 - a) The stores davit was not included in the list of maintainable items, so effective maintenance and testing was not carried out.

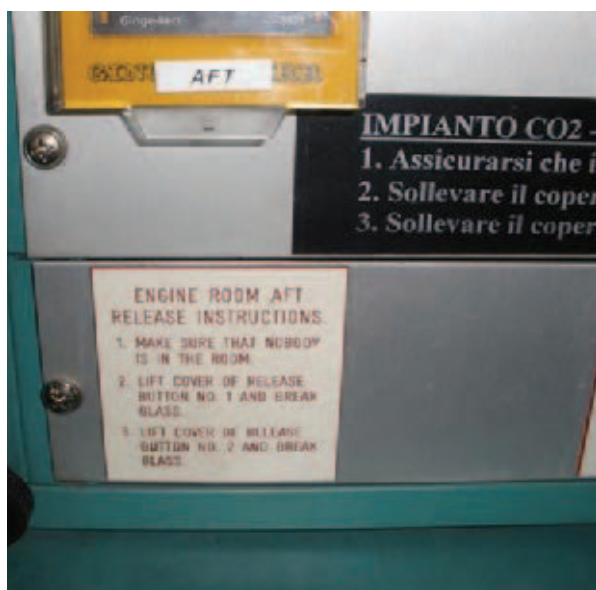
Figure 1: Safety instructions at the control positions

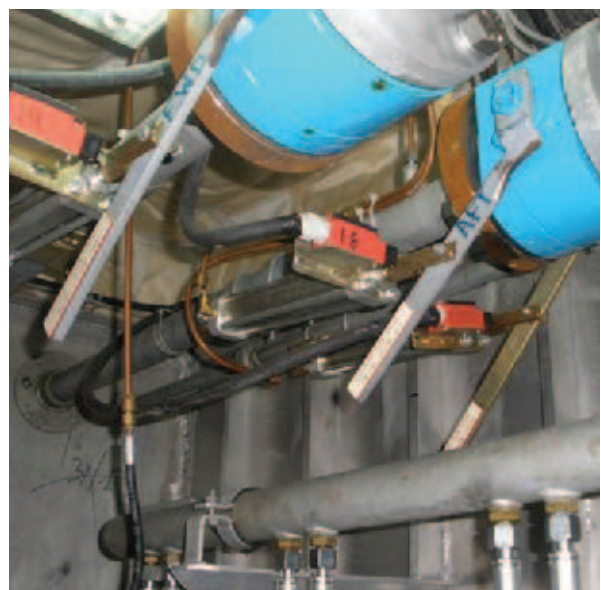
Figure 2

The chief engineer in the forward engine room was familiar with the system, however the other chief engineer, who was on the bridge, was not as well versed in it. The two stage CO₂ systems, supplying the forward and after engine room and the emergency generator room, could be activated from the bridge and also locally in the CO₂ room in accordance with the instructions posted at the control positions (Figure 1). The first stage required the glass panel to be broken, and depressing the button activated the selected space visual and audio alarm, stopped the ventilation fans and shut the ventilation dampers; it also stopped the fuel pumps. The push button also activated a solenoid pilot valve. This opened the CO₂ gas bottle valves which then pressurised the manifold up to the main distribution valve. When the second stage button was depressed the appropriate distribution valve (Figure 2) opened after a 90 second delay, allowing CO₂ gas to enter the selected space.

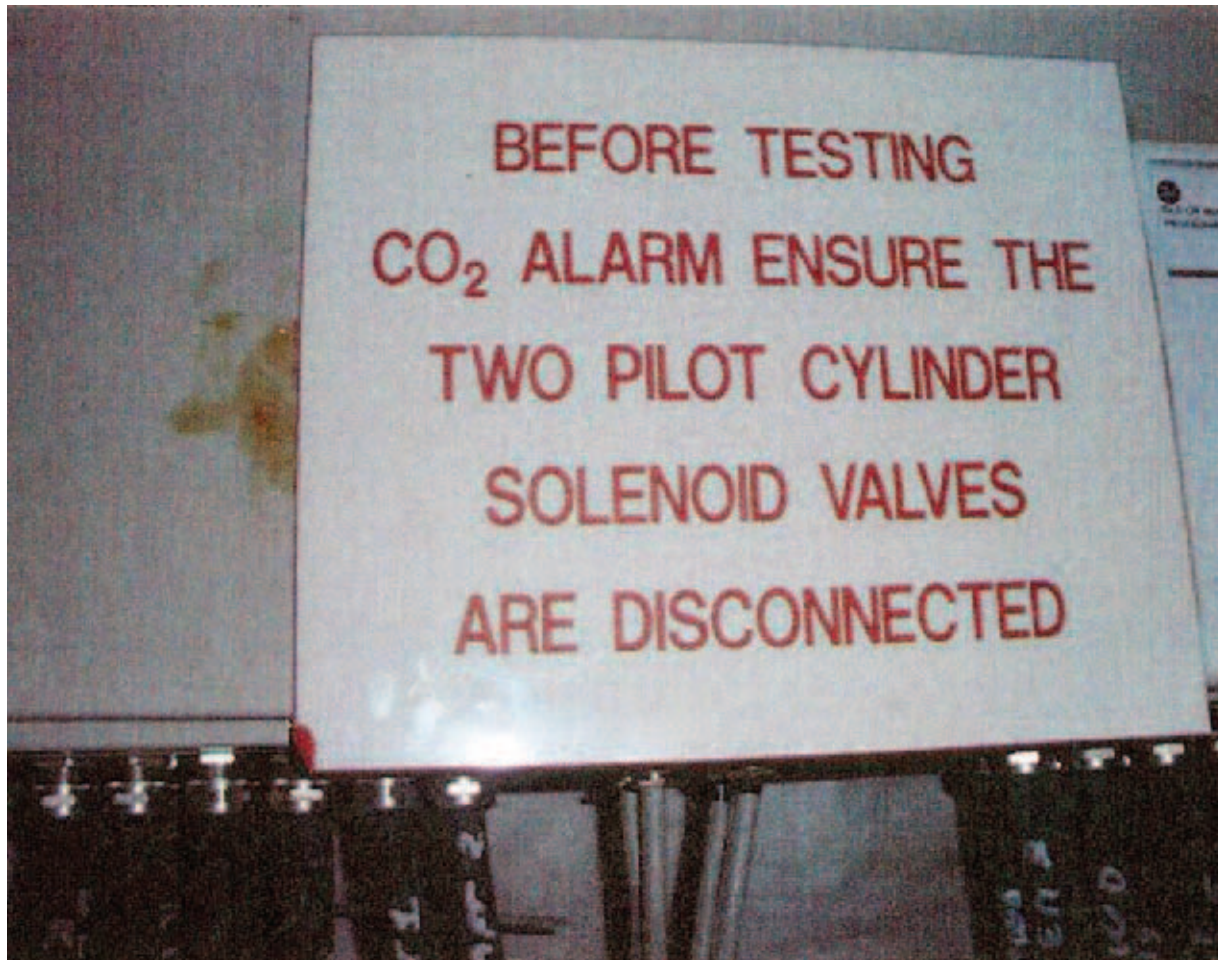
Figure 3

On receiving the request to test the alarms, the chief engineer on the bridge broke the glass and depressed the stage one button. The alarm sounded to the satisfaction of the surveyors. No reference was made to the maintenance system, which specified the correct test procedure or to the precautions detailed in the CO₂ room (Figure 3).

After lunch the survey group entered the CO₂ room. They found that a number of the gas bottles had frosted up and there was a gas leak from a pipe-screwed connection on the pilot valve, and the line up to the distribution cylinder was pressurised.

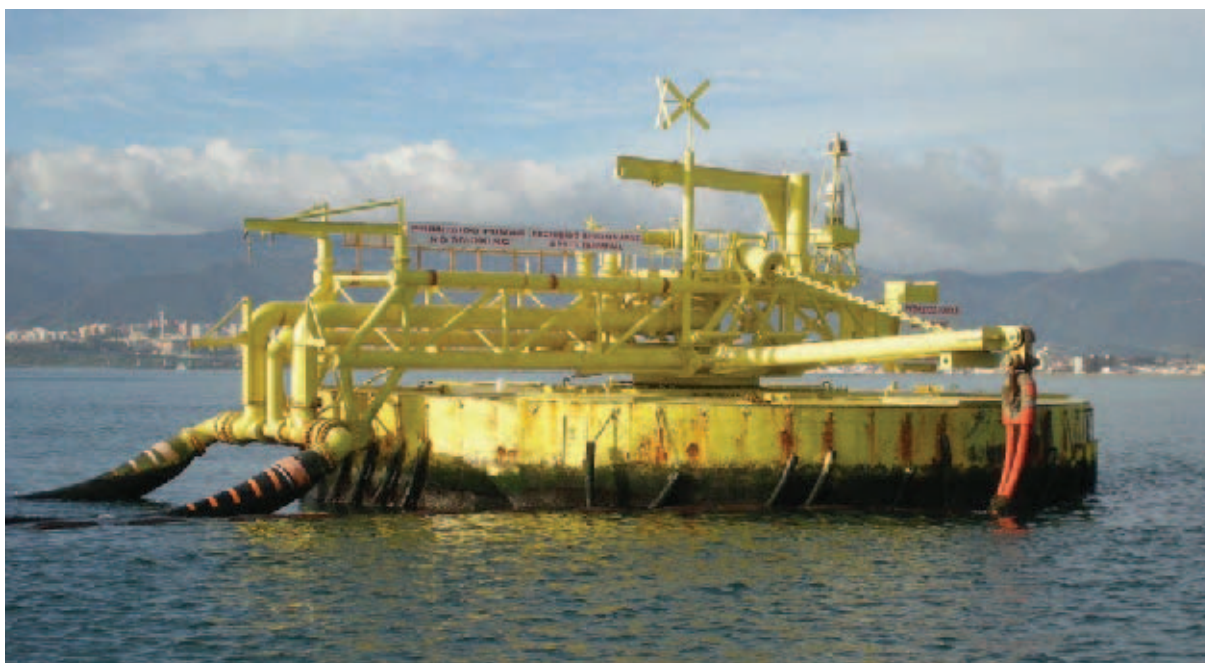
Underwater surveys showed that the buoy had suffered only minor denting, but the ship was holed in two places below the waterline in way of a void space.

Figure 1: Monobuoy

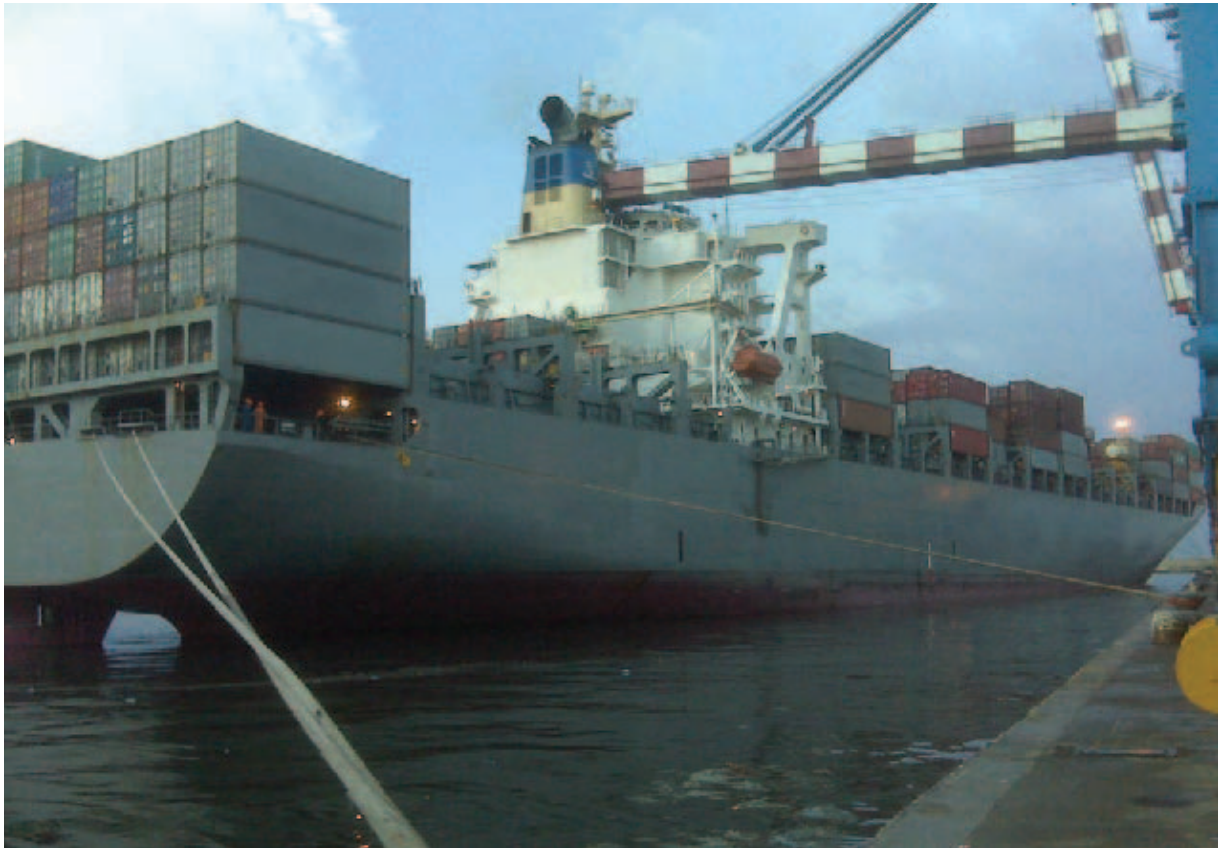
Figure 1: The container vessel made contact with the shore container gantry crane

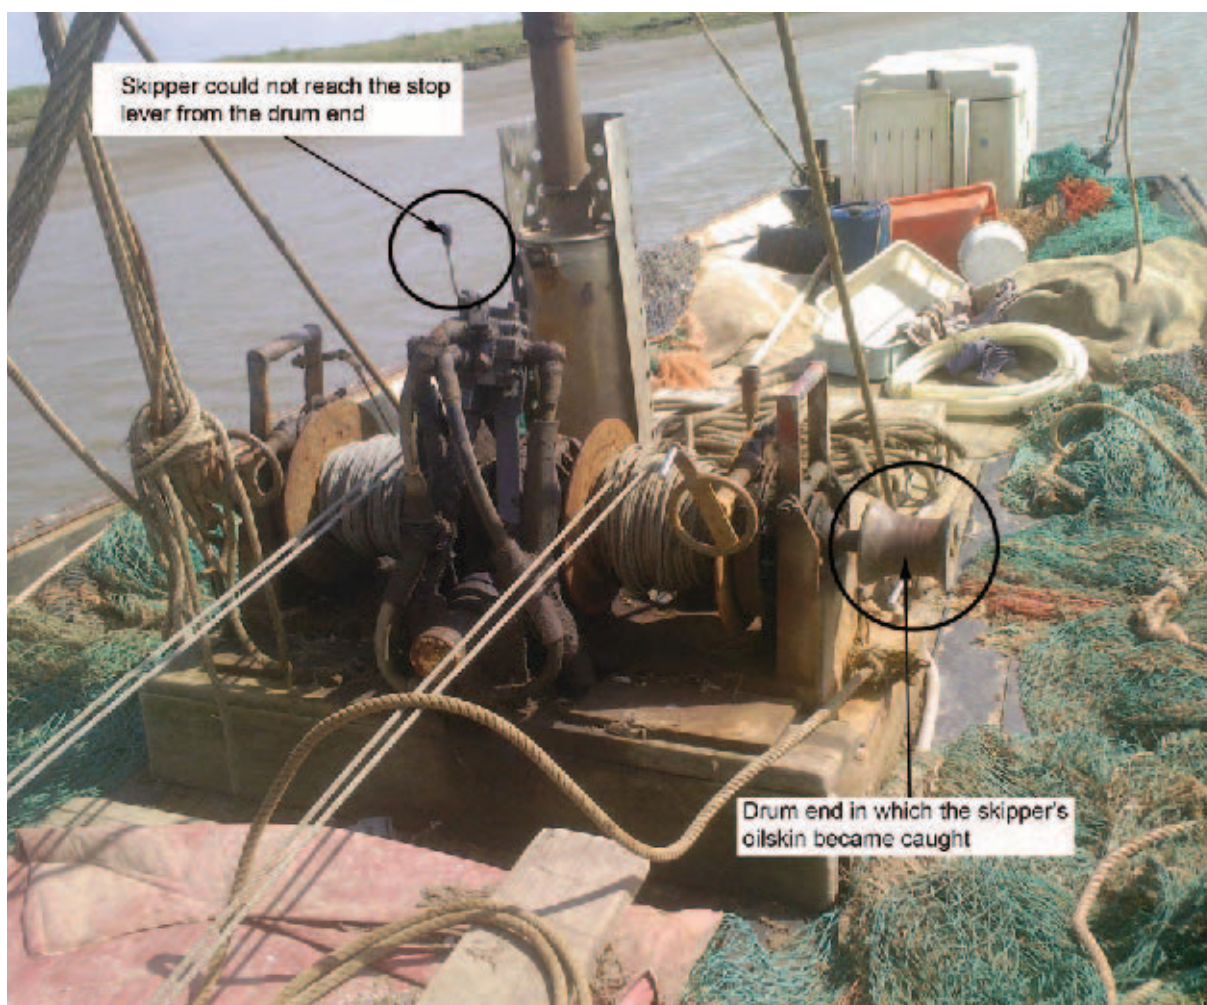
Fortunately, there was a crewman on board the vessel that day, which was unusual as the skipper normally worked single handed. The crewman was able to stop the winch before the skipper was taken around the drum again. However, the skipper was already badly injured, having fractured his leg in three places as well as injuring his back and thigh.

Figure 1: View of the working deck where the accident occurred

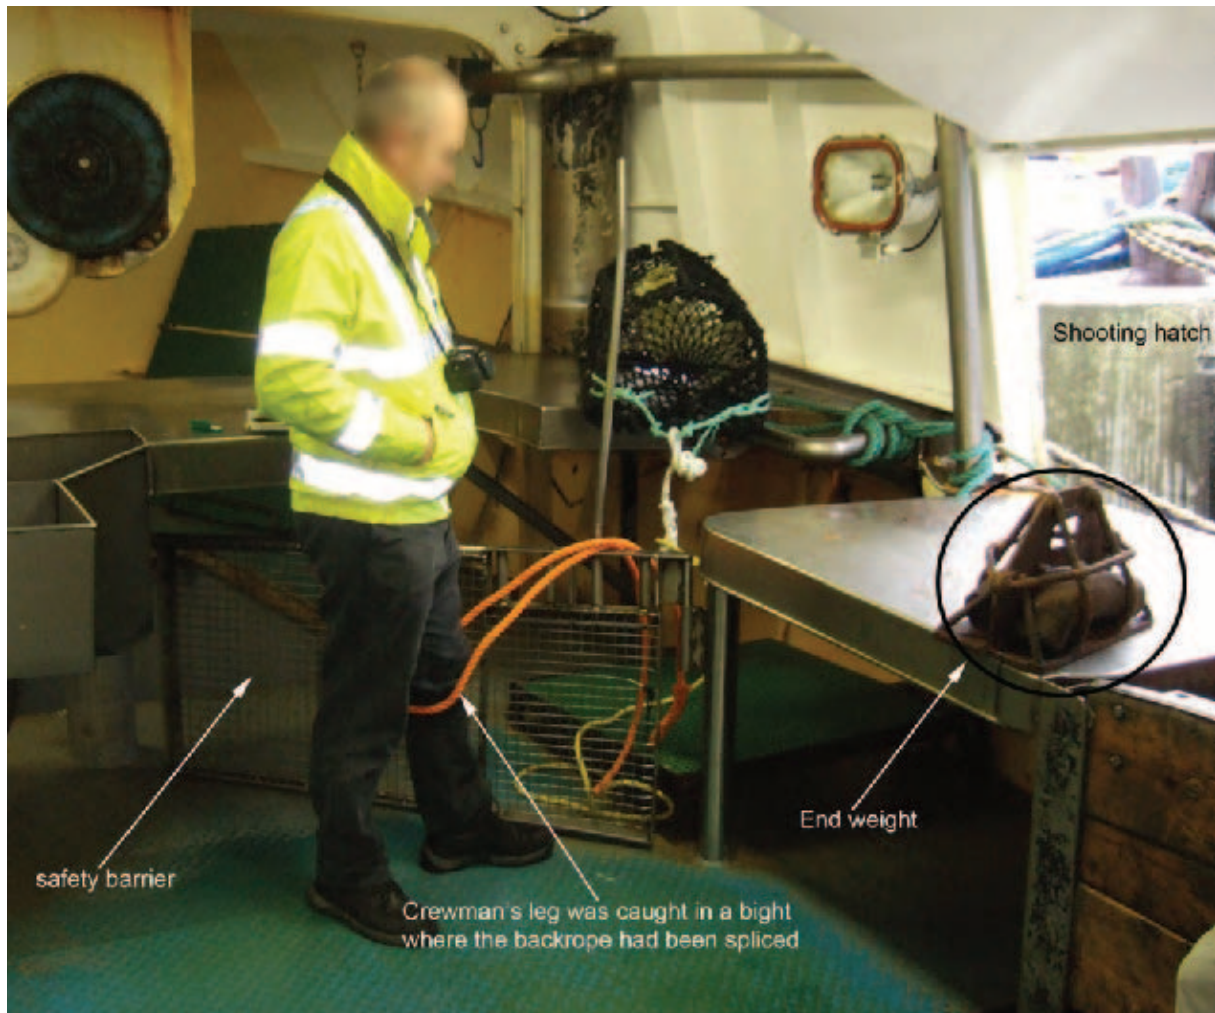
Demonstration of where crewman was standing immediately before the incident

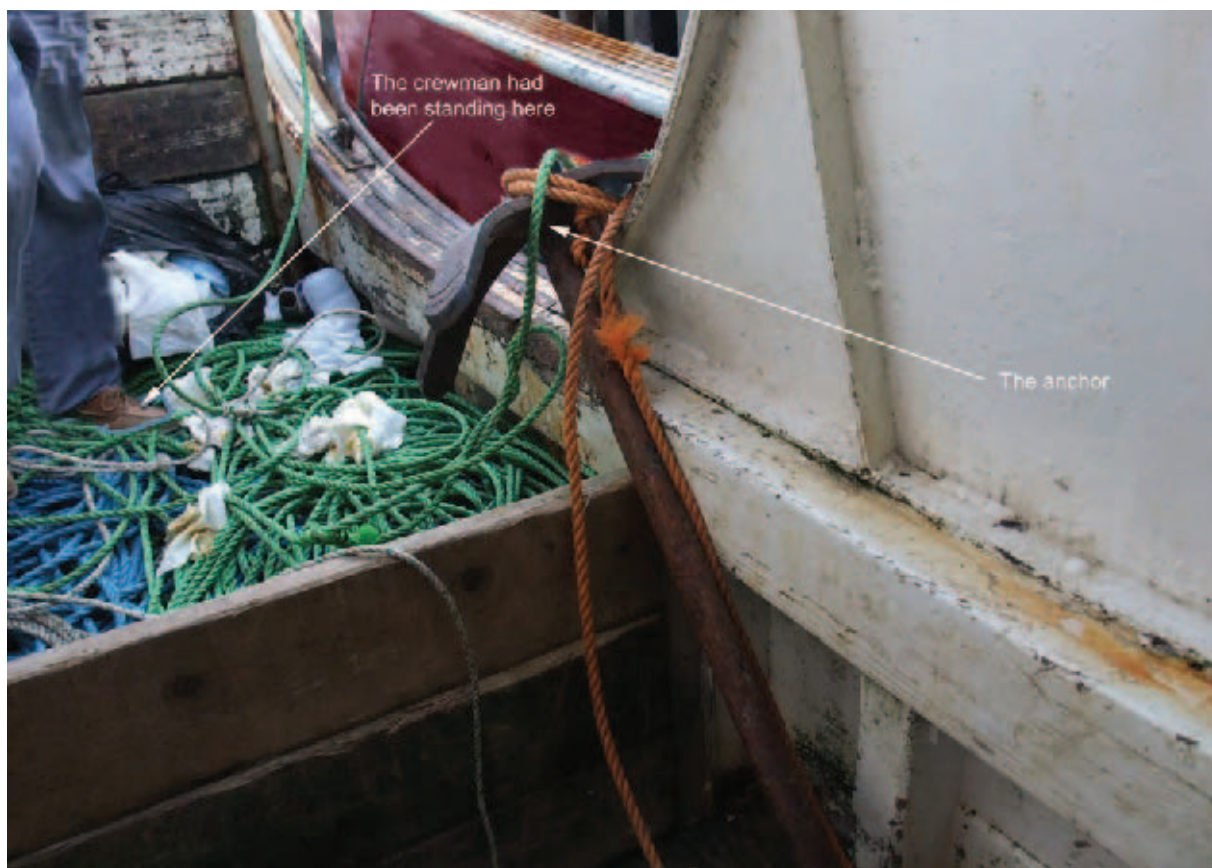
The position of the fisherman immediately before the incident

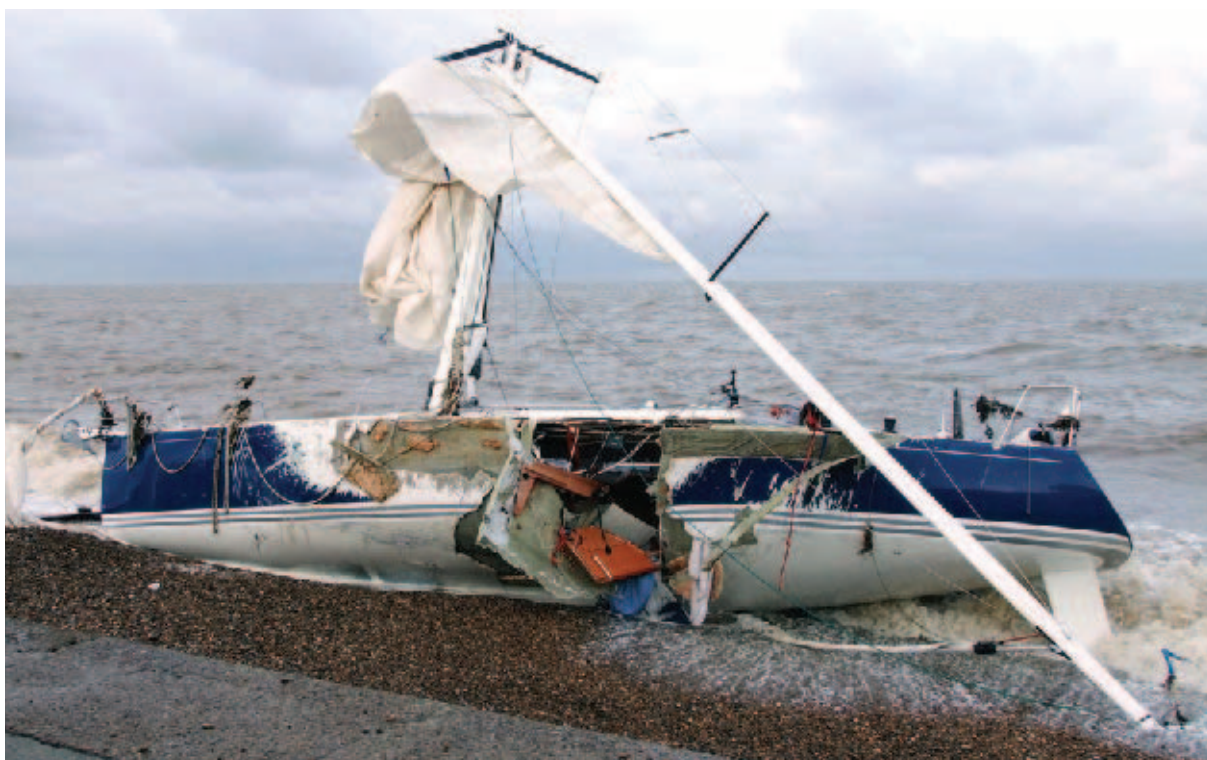
The owner and crew were considering what to do next, when the keel detached and the boat capsized suddenly. Fortunately, it remained afloat with the mast and rigging in the water, and both crew were able to climb up the deck and hold onto the guardrails. A rescue helicopter had been standing by, and it recovered both the owner and his crew.

The yacht involved in the incident

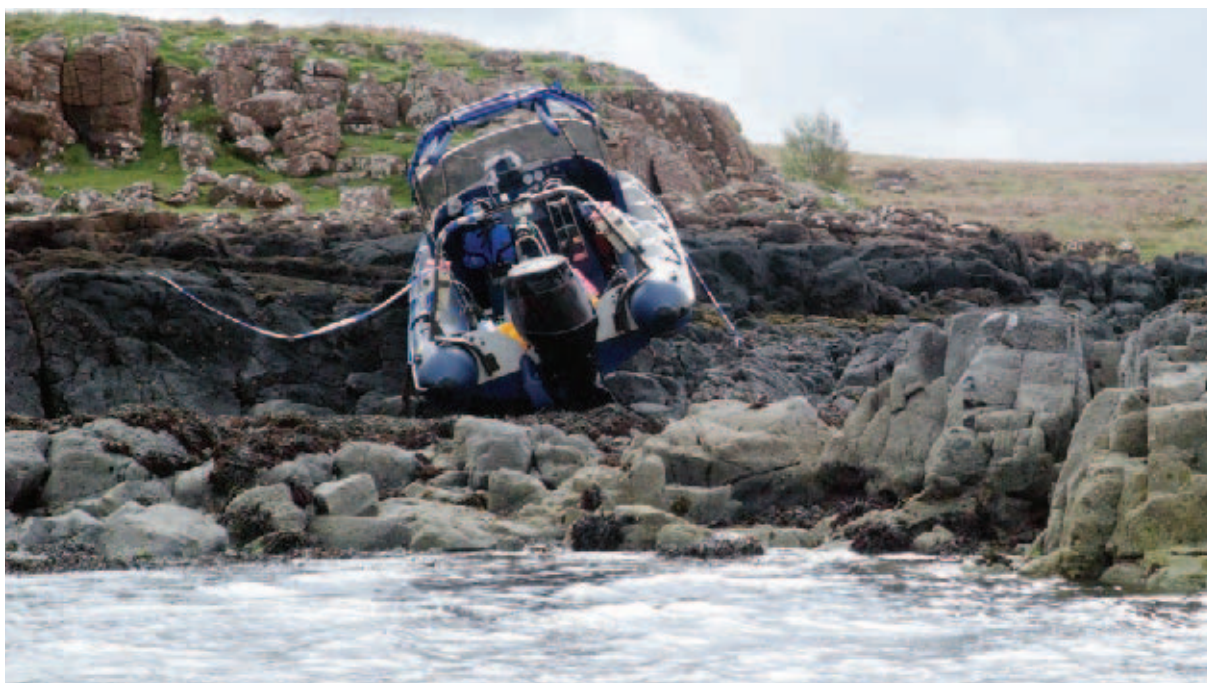
Alcohol impairs performance and, more often than not results in a greater willingness to take risks, regardless of how experienced, qualified or skilled a boat driver may be. In this case, its consumption led to the RIB being navigated into the darkness at speed, without a passage plan, the use of the GPS mapper or a proper lookout. Ultimately, this cost one of the boat's occupants his life. The principle of a designated driver limiting his or her alcohol consumption is a sensible precaution, which is as relevant to water craft as it is to road vehicles.

The RIB aground on the rocks

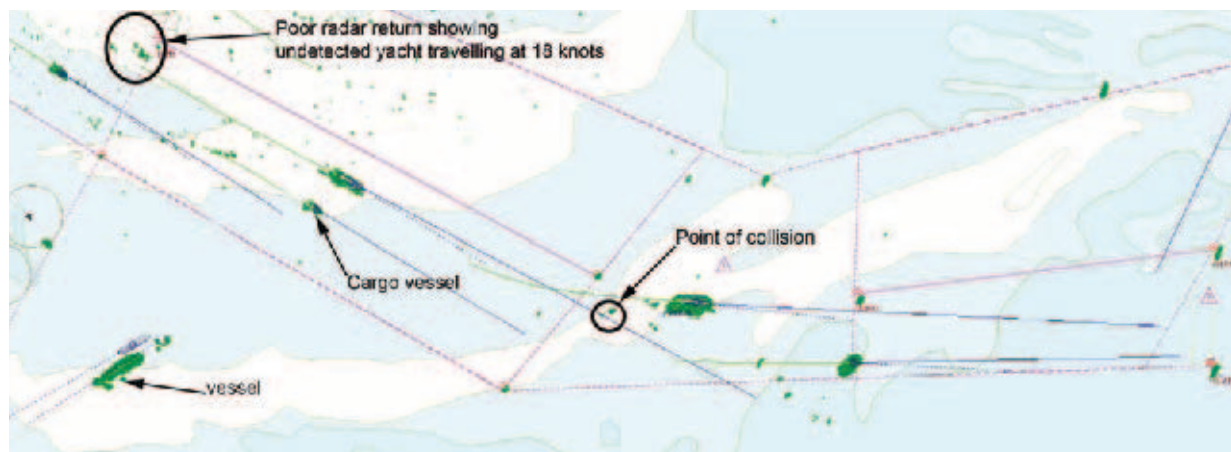
The yacht was not fitted with AIS and only presented an intermittent radar target, so neither the VTS operator nor the bridge team on the cargo vessel noticed its presence. As no traffic was expected in that position, the yacht's approach remained undetected. On board the yacht, the skipper was using his radar for navigation, but was not plotting tracks of other vessels in the area.

VTS shot showing the poor radar return of the yacht involved in the collision

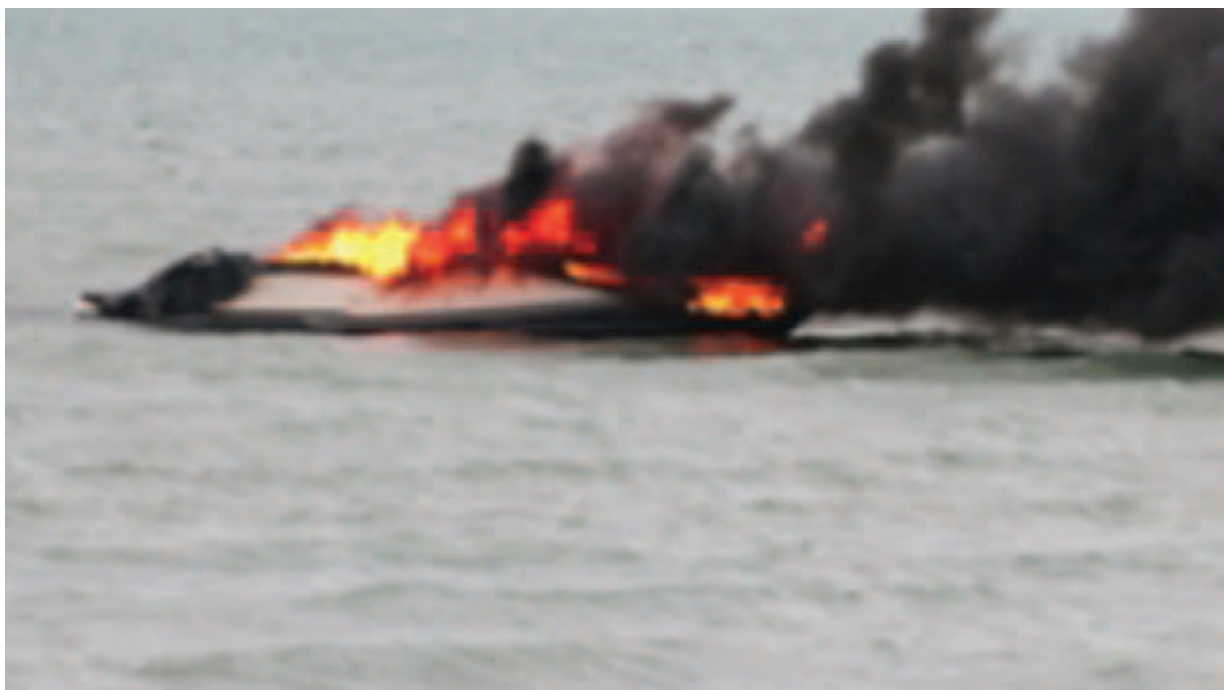
The fire disabled the VHF radio, and flames were coming out of the locker next to the lazarette. Fortunately, when the skipper had placed his liferaft on board, he had temporarily stowed it on the aft deck. He dragged the raft to the transom gate. By this time the fire was coming out of the engine compartment and was hot enough to melt the crewman’s jacket and singe his hair.

The two friends managed to board the liferaft, but their flares, lifejackets and portable VHF were in the saloon, and inaccessible. As the yacht was still close inshore, they were seen by several people ashore, who contacted HM Coastguard. The survivors were soon rescued, but within minutes the yacht was completely consumed by fire.

The motor cruiser on fire after the passengers had been rescued

1. **Lifejackets: Useless unless worn!**
A lifejacket will buy you vital time in the water and could save your life, but only if you are wearing it. Get into the habit of wearing a lifejacket at all times when afloat, because it means you'll be familiar with your particular lifejacket and how to operate it in an emergency. It also means that it won't be burnt before you get a chance to use it.
