# Marine Accident Investigation Branch (MAIB) - Safety Digest - Fishing 2001

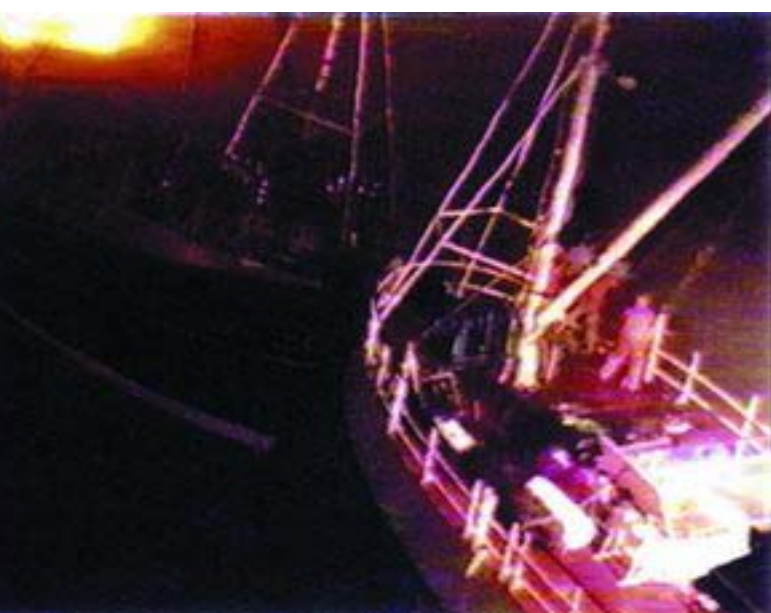
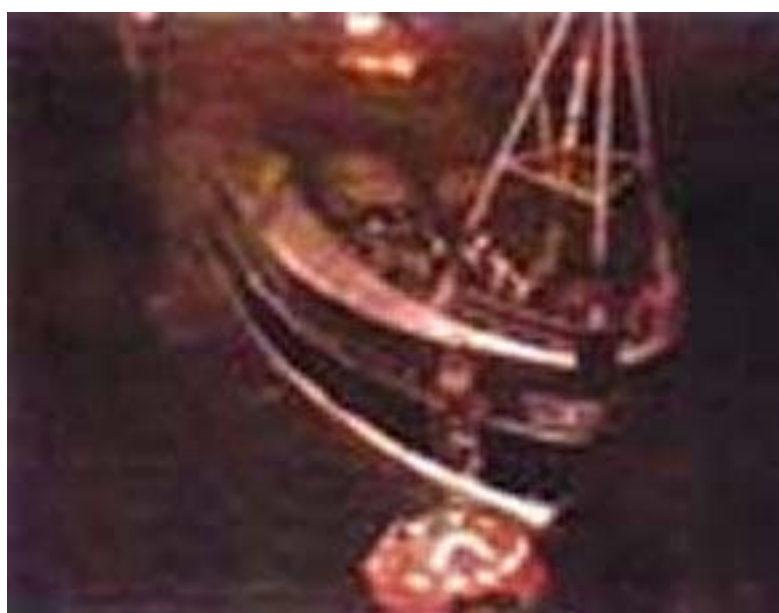
At about 0215 on Saturday morning, the vessel was slowly trawling in a southerly direction, when the mate, who was on watch, discovered a fire in the galley. The skipper and crew were called and gathered in the wheelhouse, passing the galley on their way. With the galley door secured in the open position, all saw the fire but nobody attempted to shut the door. A short abortive attempt was made to fight the fire but, by this time, the accommodation itself was starting to burn. The skipper called the coastguard on the VHF to tell them of the fire, but lost direct contact. He attempted to stop the main engine, but the controls failed to respond. Kirkwall lifeboat was launched and a rescue helicopter was airborne at 0219. Using a "Mayday" relay, local contact was made with fishing vessels in the area and contact re-established with the casualty.

*Be Ready's* crew, having realised that the fire was beyond their control, launched both liferafts. With the vessel still going ahead slowly, both liferafts became entangled with the trawl wires aft, and were lost. Lifejackets had to be retrieved from the accommodation using the emergency escape hatch. The crew of five then moved forward and waited for the rescue vessels, maintaining contact via a hand-held VHF set. Weather conditions were force 8, rough seas with wintry showers.

6. The installation of a smoke or heat detector in the galley area would have detected this fire before it became well established, and allowed it to be tackled using the vessels fire extinguishers.

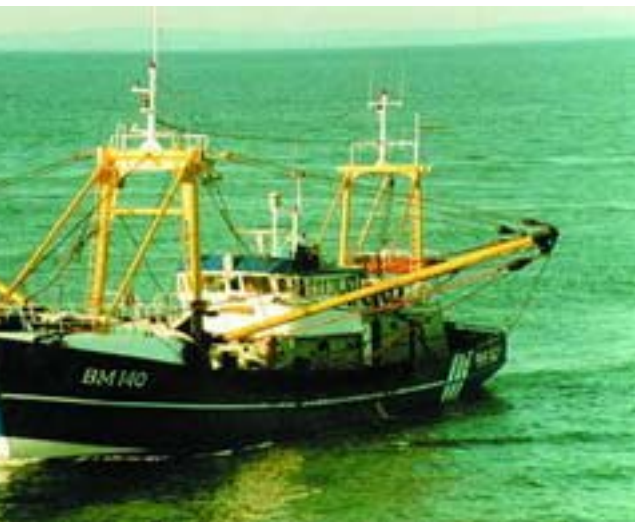
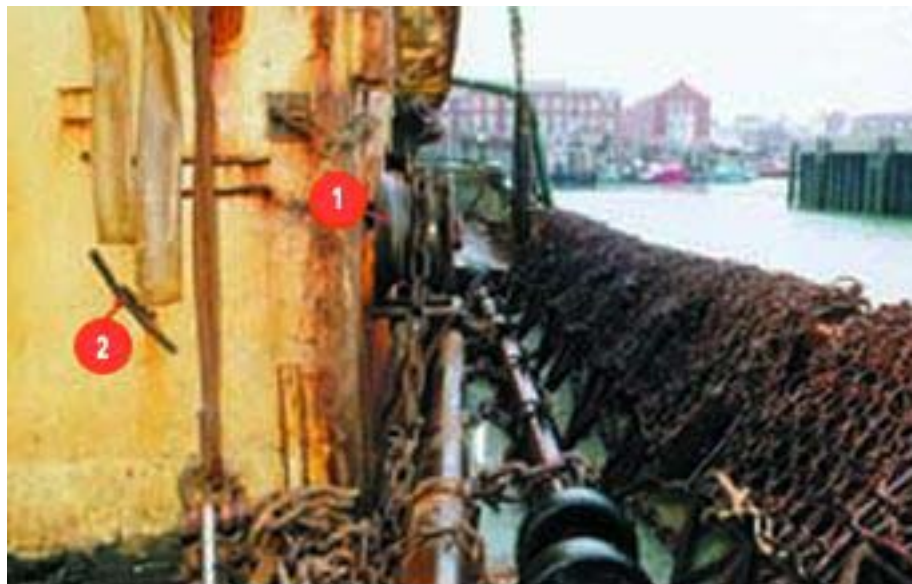
The starboard gear had just been brought inboard, and the winch operator thought that the deckhand had finished using the port whipping drum, and was stowing the pulling-in rope for the starboard gear in front of the wheelhouse, which is just inboard from the dropping zone of the port gear. The winch operator did not wait for the deckhand to move to the protected position under the whaleback. The port gear was dropped, but instead of the deckhand being just clear of the gear, he was under it.

In mitigation, the view from the wheelhouse was poor, especially for the mate who was quite short. An upturned fish box was fitted as a standing platform for the winch operator, but even with this aid the aft parts of the dropping zones could not be seen.

1. For dangerous operations, it is essential that the proper procedures are followed. If the hauling inboard had been conducted correctly, the winch operator would have been able to see that both

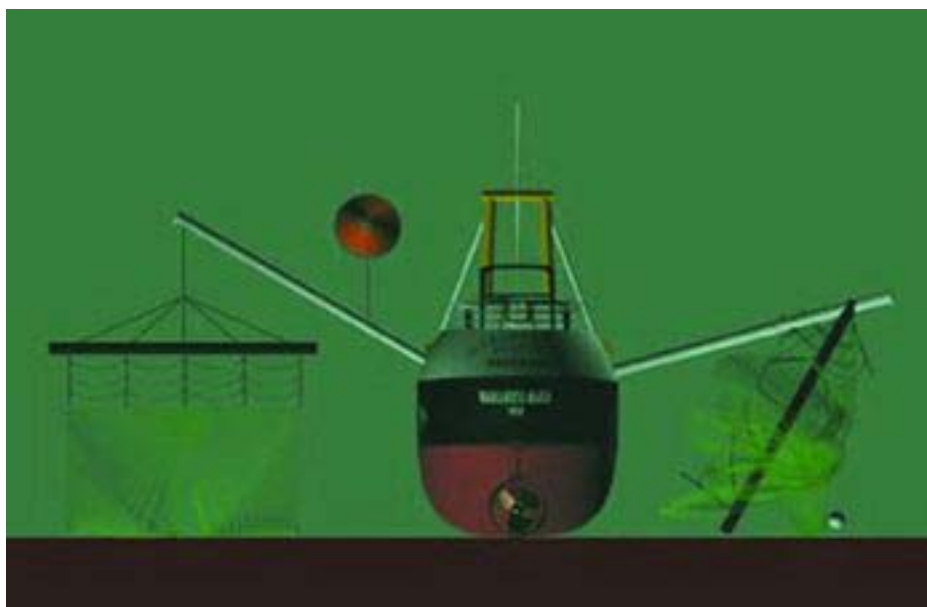
The wreck was surveyed using remotely operated vehicles (ROVs). She was found with her derricks partly topped, her beams at the derrick ends, and a large quantity of shells and sand in the cod end of one net. The other cod end was badly damaged. It was concluded that she had hauled her nets to the surface with a large amount of sand and shells in each cod end. Both derricks were then topped, but the unusually large weights in her nets, acting on the derrick ends, seriously reduced her stability. In this state she was unable to resist even small heeling forces and she rolled to port, was unable to recover due to lack of stability, and sank by the stern.

As she went down by the stern, her liferafts, which had been stowed on the aft shelter, floated free. Unfortunately they floated forward and became fouled on the derricks and netting, resulting in neither being able to float to the surface. The emergency position indicating radio beacon (EPIRB) probably suffered a similar fate, because it too had been stowed on the shelter, quite close to the liferafts.

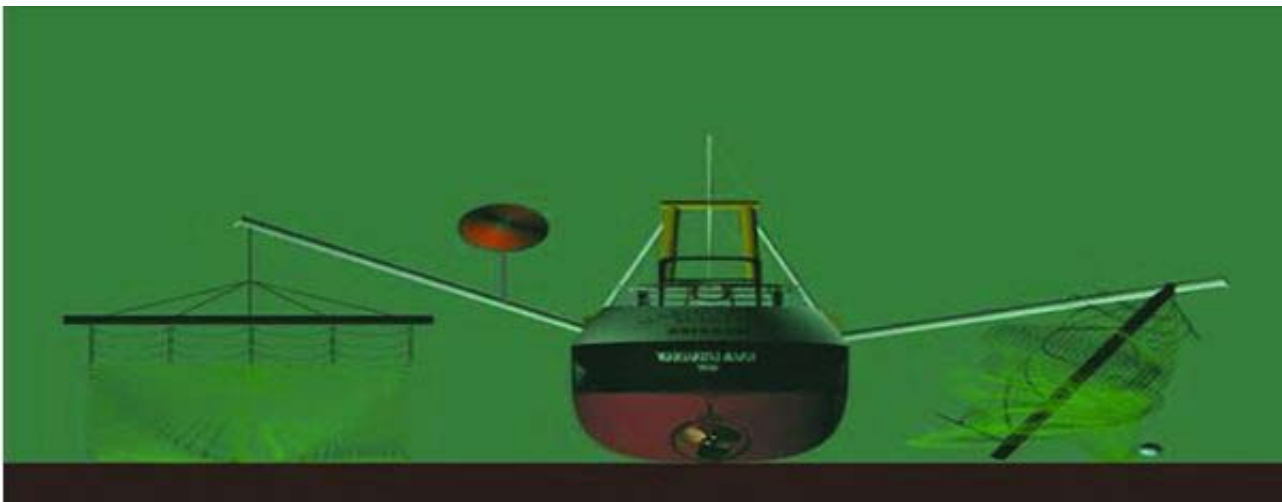
3. Fishermen are well aware of the effect of hanging weights from derrick ends. However, fishing vessels do not usually have stability data on board which attempts to place any figures on just how much stability is affected by this type of operation. The following diagrams illustrate the size of this effect on *Margaretha Maria*.

Other beam trawlers might be affected to a similar degree, depending on the weight of their gear and geometry of their derricks. The MAIB has therefore recommended that the Maritime and Coastguard Agency (MCA) makes a study of this effect on operational beam trawlers, with a view to amending stability requirements of this type of vessel.

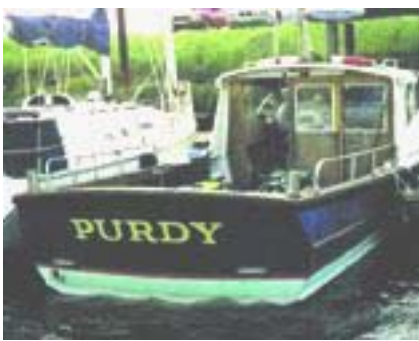
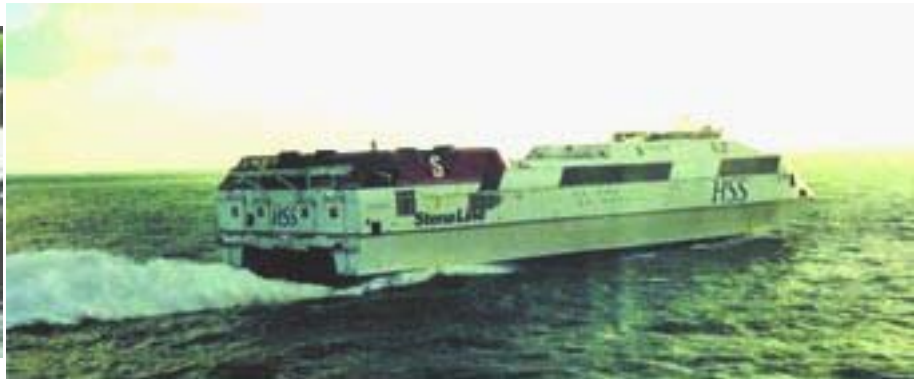
*Purdy*, a 10m long, Aquabelle angling boat with the skipper and one other person on board, was preparing to anchor and begin fishing on a shallow sandbank off the East Anglian coast when HSS Stena Discovery passed inbound for the port of Harwich. *Purdy's* skipper turned his boat towards the wash from the high-speed ferry. The conditions were fine, with a southerly wind of force 3, good visibility and a slight sea. As the first wash waves approached *Purdy*, they grew in height to 4 metres and began to break. The first wave crashed over *Purdy's* bow, swamping the vessel and washing the person, who had been sitting on the engine casing aft, overboard.

1. Even when the weather conditions appear benign it is always sensible to wear a lifejacket on the open deck of any small boat or vessel.
2. Large high-speed, high-powered vessels are capable of producing high-energy wash waves under certain critical conditions of speed and water depth.
3. Wash waves, which may have little or no effect on other vessels in deep water, can, when entering shallow water, grow dangerously high.
4. The wash producing capabilities of high-speed craft are not fully understood and, despite the operator's best attempts to minimise wash production, large waves can be produced inadvertently.
5. Small craft should stay clear of very shallow water when, and just after, a high-speed ferry passes.

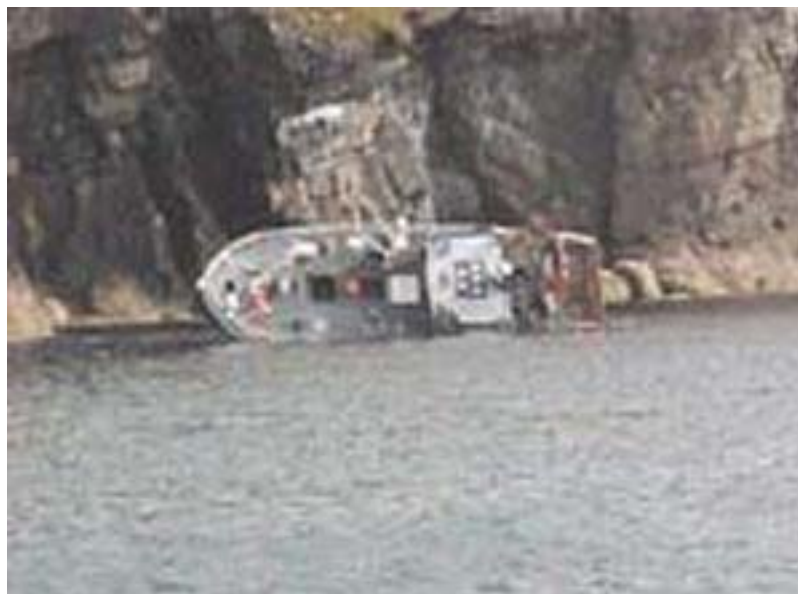
Attempts to refloat the vessel, using engines and rudder, failed and, as the vessels list and motion became increasingly unsafe, the skipper decided to abandon ship. The four crew disembarked into a liferaft and, rather than head for the nearby shore, paddled towards *Arnisdale* lying some 500 metres away. When abandoning ship, two deckhands donned personal survival suits but no lifejackets while the skipper donned a lifejacket but not his survival suit. The remaining deckhand, who had not completed a sea survival course, did neither. The crew were safely recovered and, other than suffering from shock, were unscathed. There were no injuries.

Further attempts to refloat *Betty James* were unsuccessful and she eventually became a total loss.

1. Disrupted sleep, which leads to fatigue, is an unavoidable aspect of a fisherman's life at sea, and every opportunity to catch up on lost sleep should be taken, especially when the interval between landing and sailing is as short as an hour or two.
