# Fishing 2007 Safety Digest

MARINE ACCIDENT INVESTIGATION BRANCH

This *Safety Digest* draws the attention of the marine community to some of the lessons arising from investigations into recent accidents.

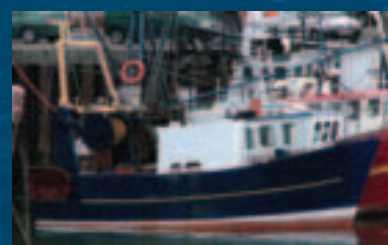
Figure 1

A prawn trawler (Figure 1) was returning to port after a night's fishing. The skipper was helping the deckhand tail prawns on the working deck, but was periodically returning to the wheelhouse to attend to the navigational watch. He saw another small fishing vessel ahead during one of the periods when he was looking out. The skipper thought that this vessel was either hauling or shooting pots, and was underway at about 2 knots, in which case he would pass well astern of her. Having made this assumption, he returned to the working deck, thinking that he was safe. But the other fishing vessel was in fact adrift, and was not under command, after having suffered an engine failure. The vessels collided about 10 minutes later.

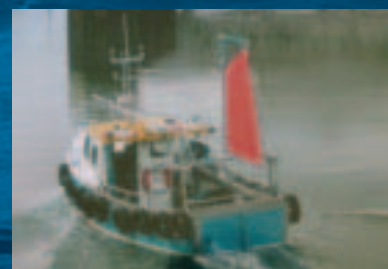
Figure 2

Both fishing vessels were a little less than 10 metres in length. The wind was force 2 and the visibility was good. The trawler was steaming at slow speed to give the crew time to tail the prawns before reaching port. The other fishing vessel was a potter (Figure 2), and had broken down when on passage to her grounds.

**3** It is possible that the liferaft on the potter failed to deploy because it had been incorrectly fitted or poorly sited. The free issue of liferafts is an excellent safety initiative, but they must be installed correctly. Fishermen who fit liferafts should follow the instructions very carefully. If there is any doubt about the correct procedure, assistance from an experienced seafarer such as a lifeboat man or harbourmaster should be sought.

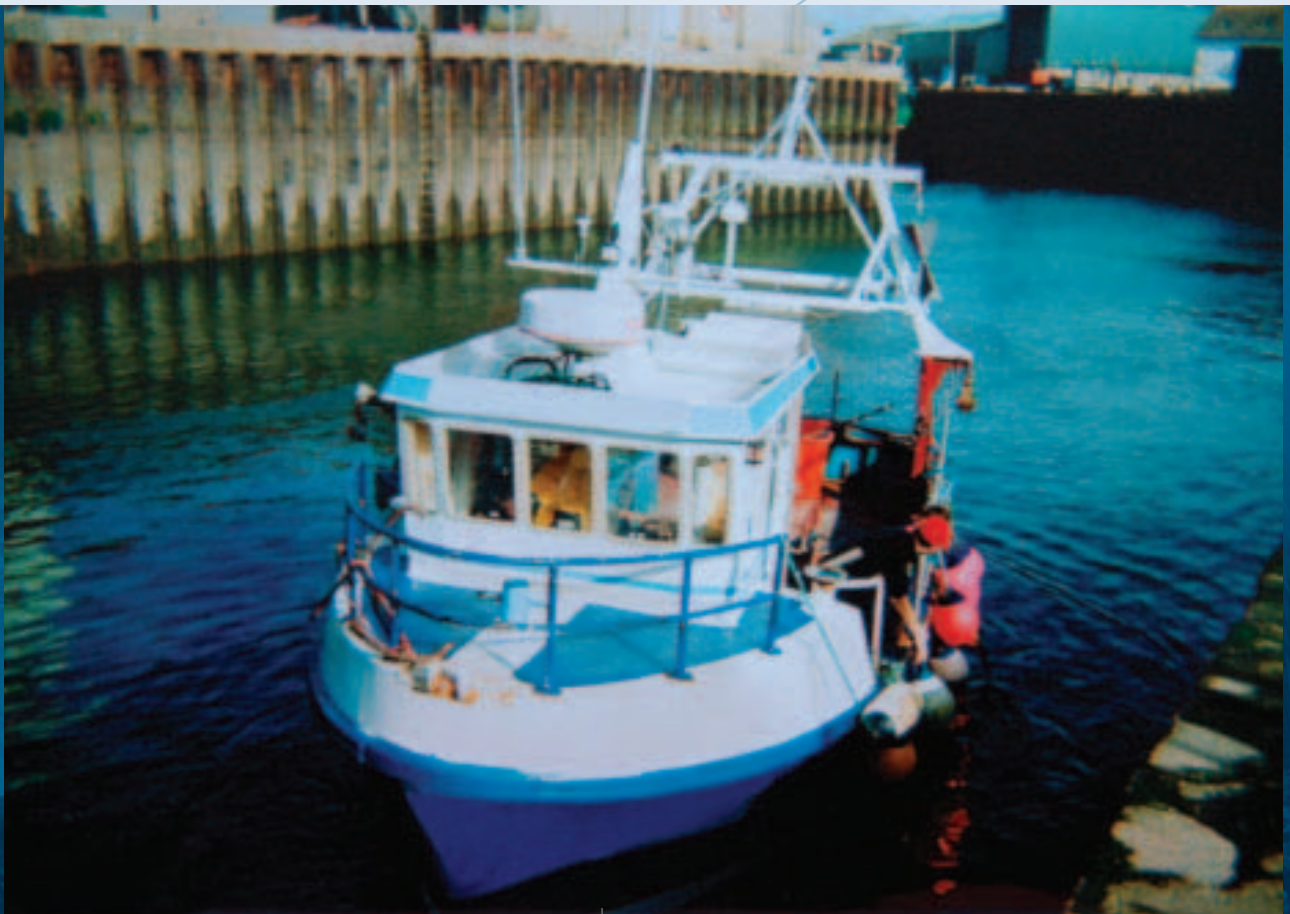
Figure 1

An 8.7m potting vessel (Figure 1) capsized rapidly and without warning while starting out on passage back to her home port at the end of a day's fishing. The two crew members were thrown into the sea; neither was wearing a lifejacket. The vessel righted herself, and the deckhand returned to the partially submerged hull and was able to release the liferaft. He managed to inflate it, and board it from the water. The skipper, who had been seen on the surface, was lost from view before the deckhand could paddle the liferaft to him and was not seen again. The vessel sank shortly afterwards.

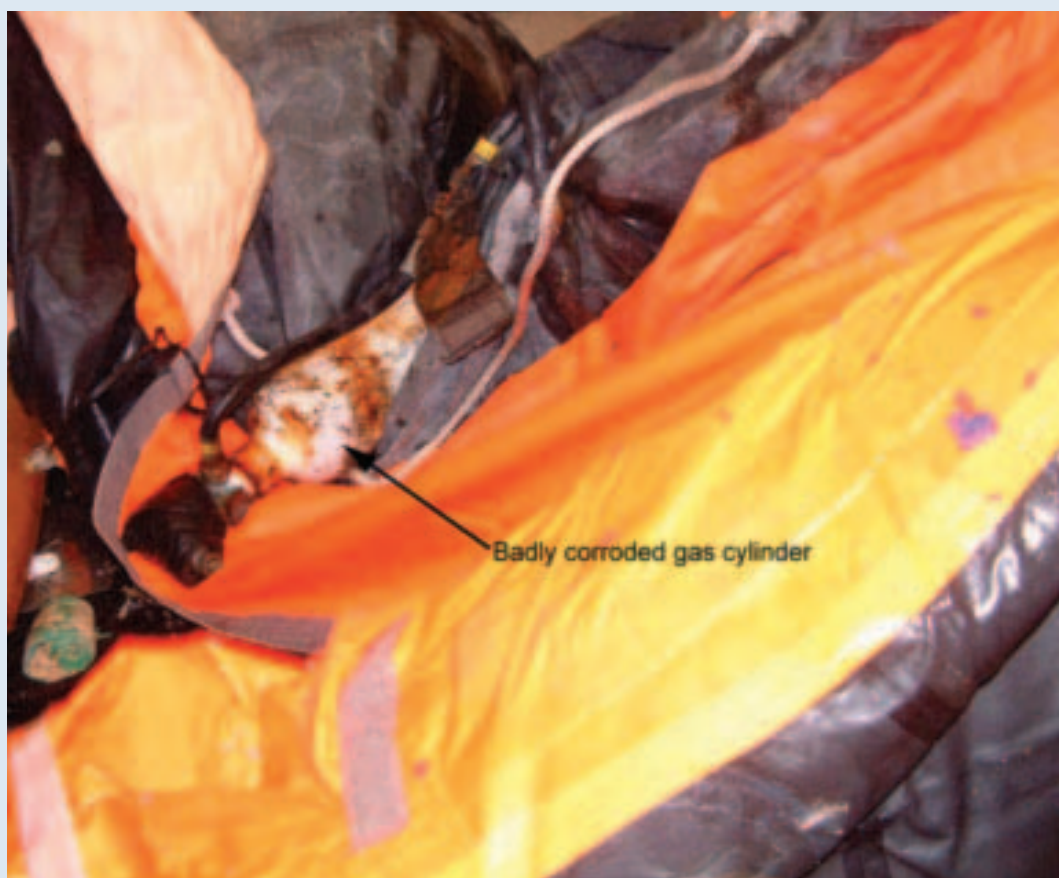
Figure 2

The liferaft had not been serviced for many years (more than 12), and it was fortunate that it inflated when the deckhand pulled the painter, particularly as the gas cylinder was badly corroded (Figure 2). The condition of the liferaft fabric and equipment was also very poor, resulting in the deckhand spending a very uncomfortable night in it. The flares, torch and liferaft lights did not work, and no reflective tape was fitted to the canopy.

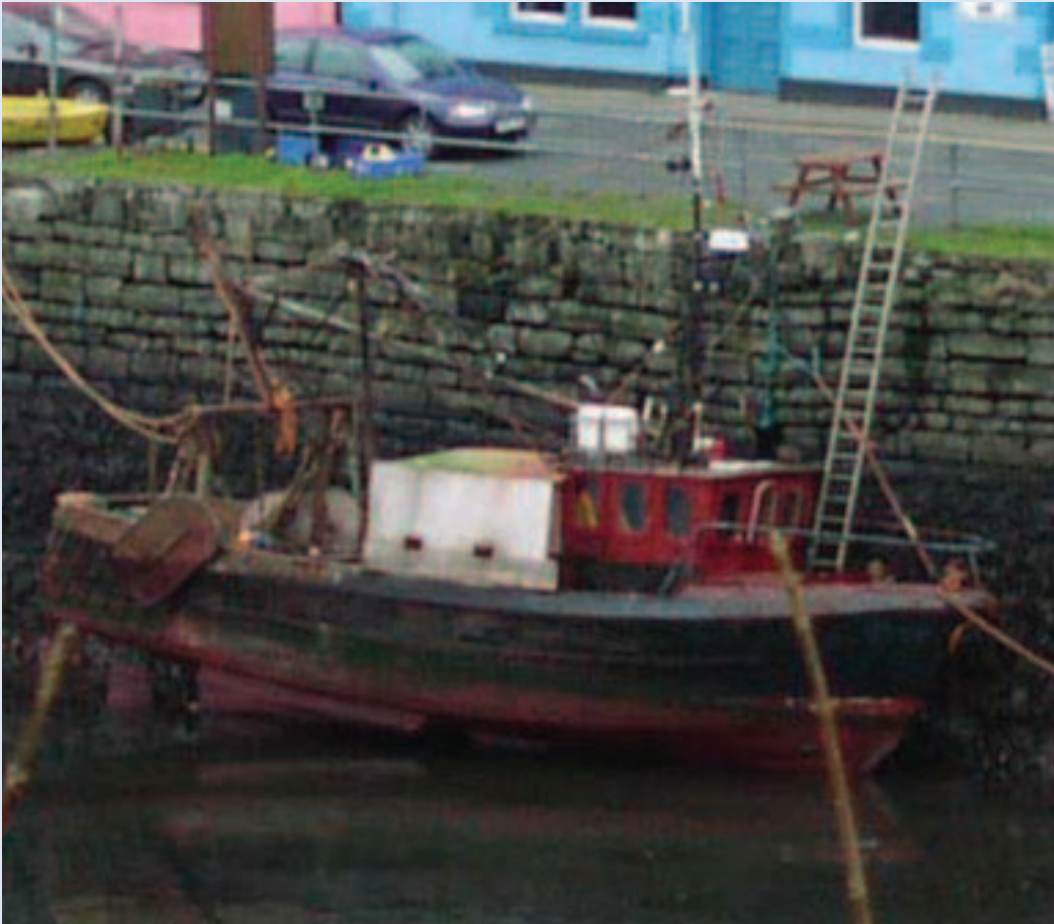
Figure 1

The skipper had mixed success at fishing, so money was fairly tight. This might help to explain the extremely poor condition of the vessel (Figure 1). On many occasions, harbour authorities and other skippers had advised him to attend to the poor – and in their view, dangerous – structural condition of his vessel. There were holes and splits in the weather and forecastle deck and bulwarks. The fish hold did not have a watertight cover or even a tarpaulin to cover

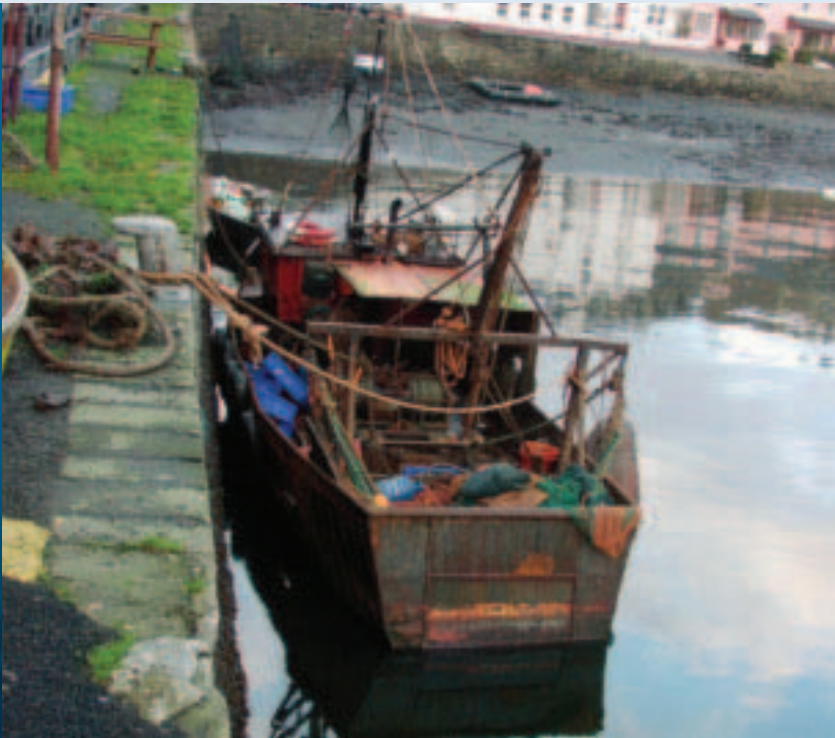
Figure 2

the hatch boards, and there was virtually no paint protection to prevent hull corrosion (Figure 2).

**3** Regularly examine upper deck, non-watertight hatch arrangements. The risk of downflooding through fish hold hatches that are fitted with boards can be much reduced by fitting tarpaulin covers over them.
