# Fishing 2006 Safety Digest

MARINE ACCIDENT INVESTIGATION BRANCH

This *Safety Digest* draws the attention of the marine community to some of the lessons arising from investigations into recent accidents.

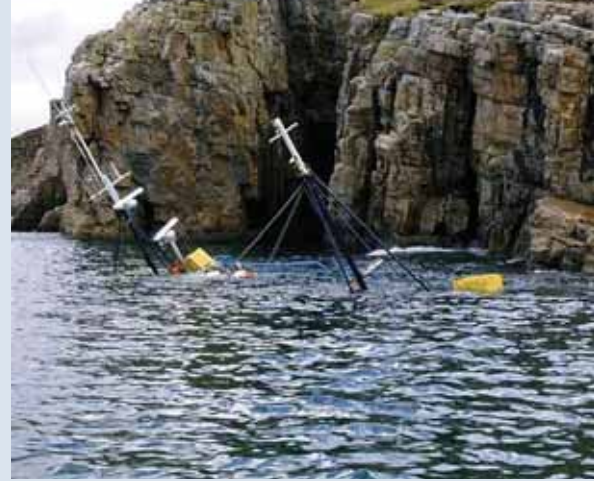
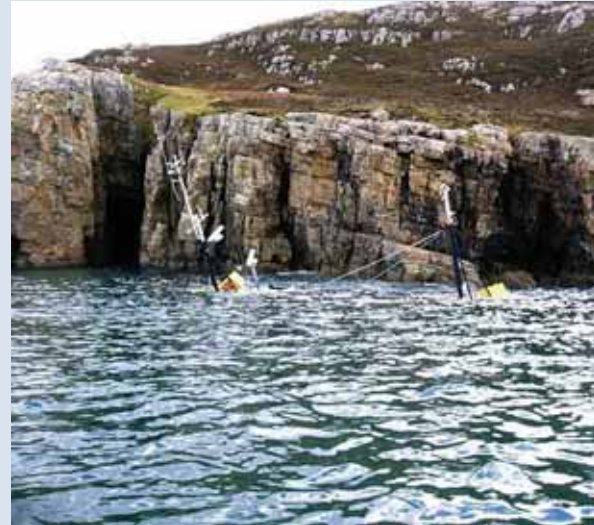
The liferaft was launched and all six men climbed in. They pushed themselves away from the stricken boat, and watched her as the engine stopped and the stern light went underwater. She was soon sitting on the bottom, with only her masts visible above water (see figures).

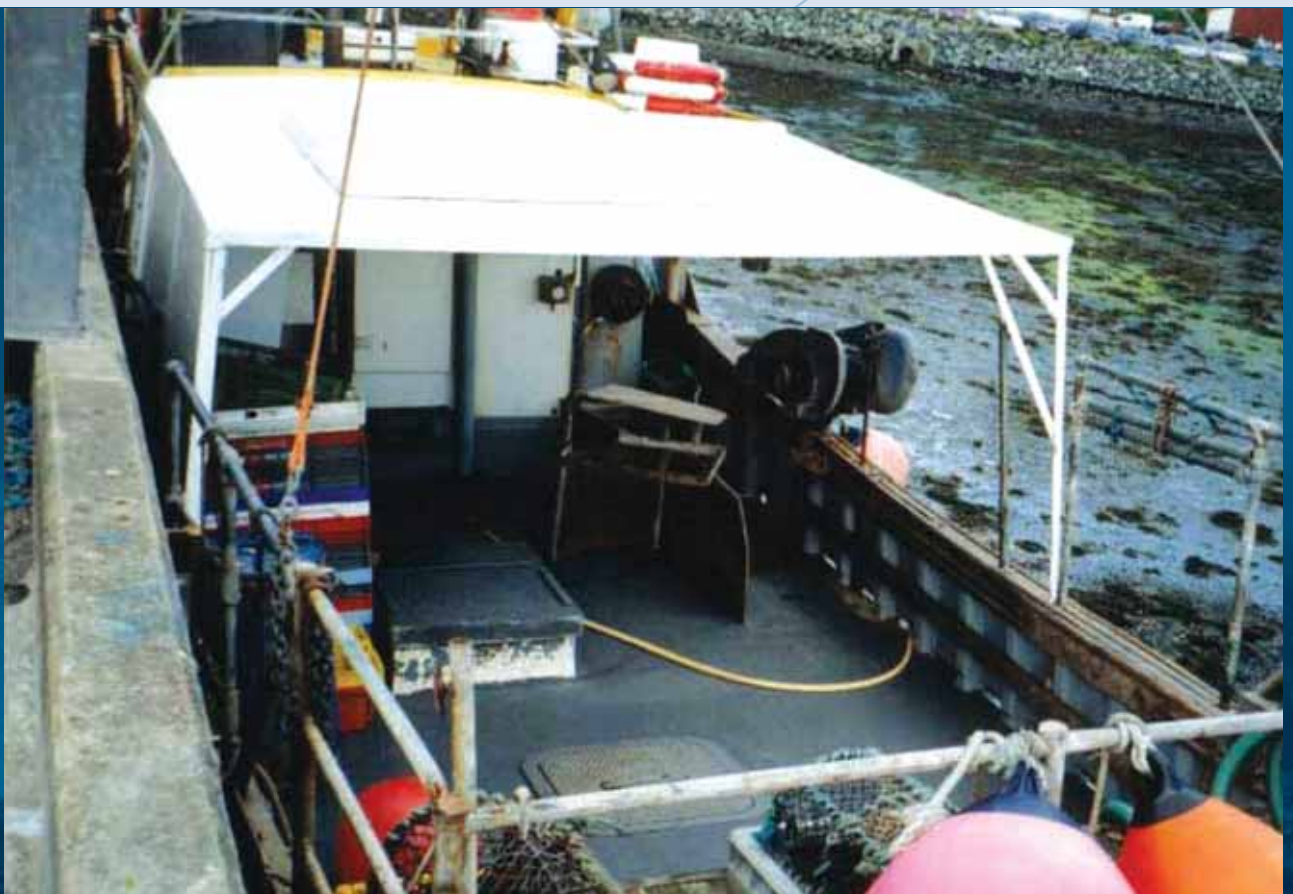
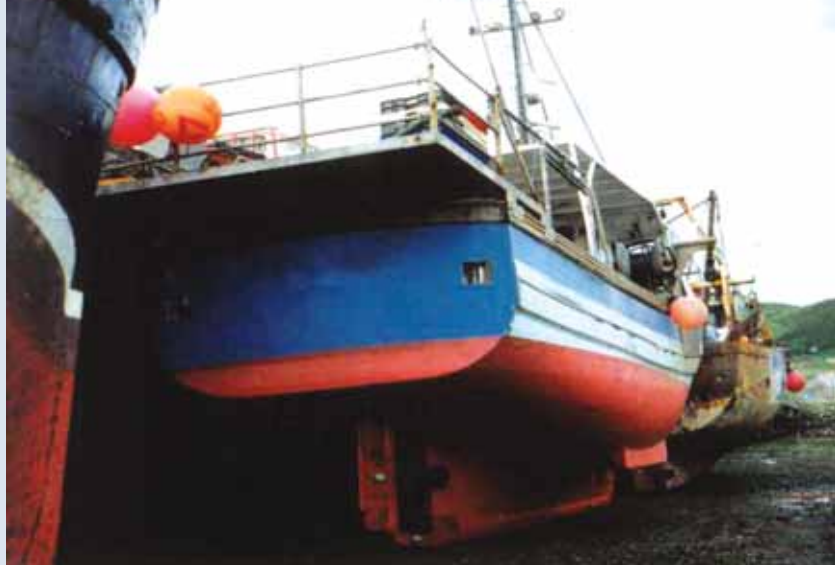
there was a fair amount of water present, so the deck wash pump suction was switched over from the sea suction to the bilge suction. The water in the bilges continued to rise, so the vivier circulating pump was started and the suction put into the bilges. At that stage, the skipper made a call to the coastguard indicating their problems - but not their position.

Shortly after that, the main engine stopped due to the amount of water in the bilges, and this stopped the deck wash pump, which was driven from this engine. The crew donned their lifejackets and launched their liferaft. The boat was feeling very sluggish and,

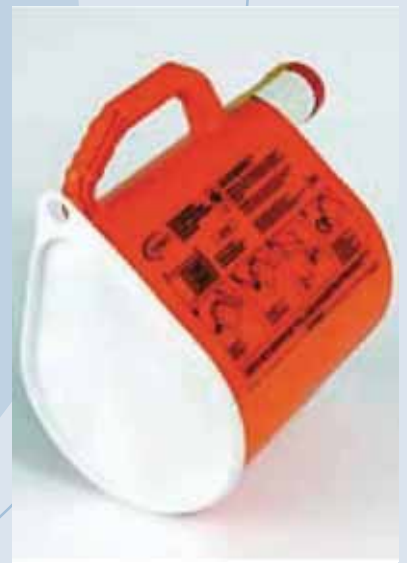
access. Shortly afterwards, the line-throwing appliance was detonated. Travelling diagonally across the accommodation, and lodging itself in the starboard aft bunk, a fire broke out immediately. After raising the alarm, the fire was quickly extinguished by the crew member, ably assisted by shore staff and the crew of an adjacent vessel.

**1** Skippers should ensure that the locker containing a vessel's pyrotechnics is located on or near the bridge in a secure, dry and readily accessible location. The locker should be clearly marked with the contents.
