# Fishing 2008 Safety Digest

MARINE ACCIDENT INVESTIGATION BRANCH

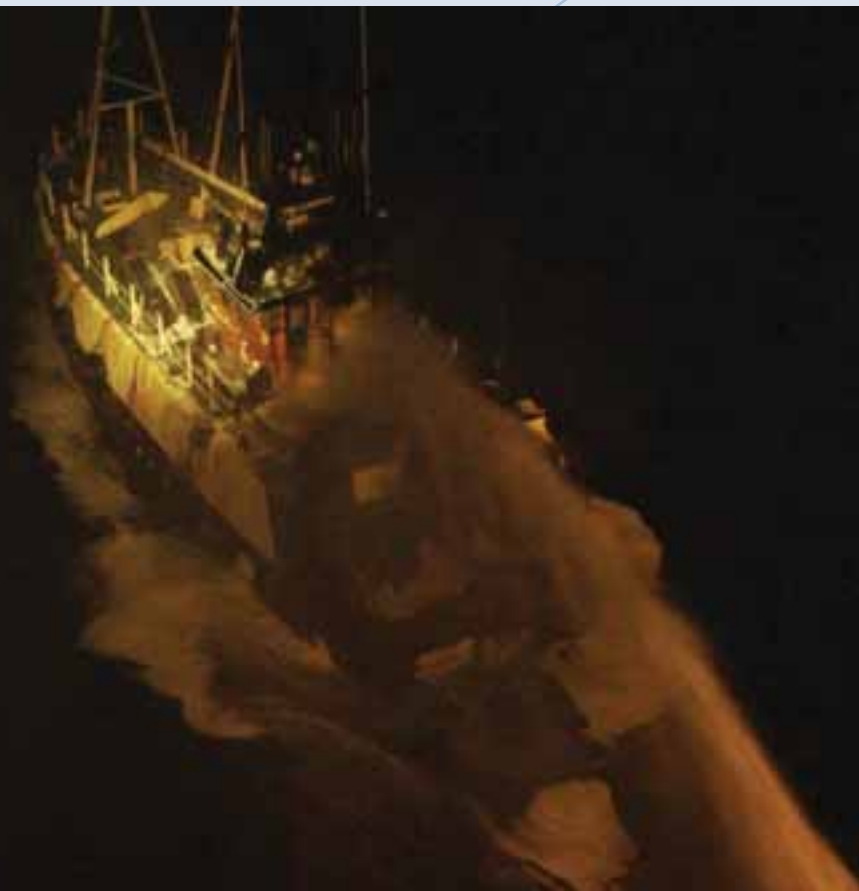
Smoke from the wheelhouse had dispersed, and down below, the galley appeared undamaged. The mate entered the cabin and saw where fire had damaged the starboard side. He went forward to the engine room door and cracked it open. Thick smoke and noxious gases escaped and the skipper pulled him clear. They waited on the upper deck for a few minutes and then returned to the engine room. The smoke had cleared, and the mate was able to enter the engine room. He heard a crackle and then saw a glow of fire in the far corner.

- 1** Electrical systems and insulation material should be checked carefully to minimise the risk of fire.
- 2** Emergency engine and fuel system shut down methods should be tested regularly and repaired if they do not operate correctly.
- 3** Engine rooms should be checked to ensure that they can be fully closed down in a fire situation to prevent smoke spreading and to give CO<sub>2</sub> drench systems the maximum chance of success.
- 4** Do not put yourself back into danger by returning to the scene of a fire too soon. Re-opening a compartment causes air to enter, which may then allow a fire to re-ignite. Engine room fires may require many hours to cool before re-entry can safely be made. Compartment re-entry should be made by properly trained firefighters with the correct fire fighting equipment and breathing apparatus.

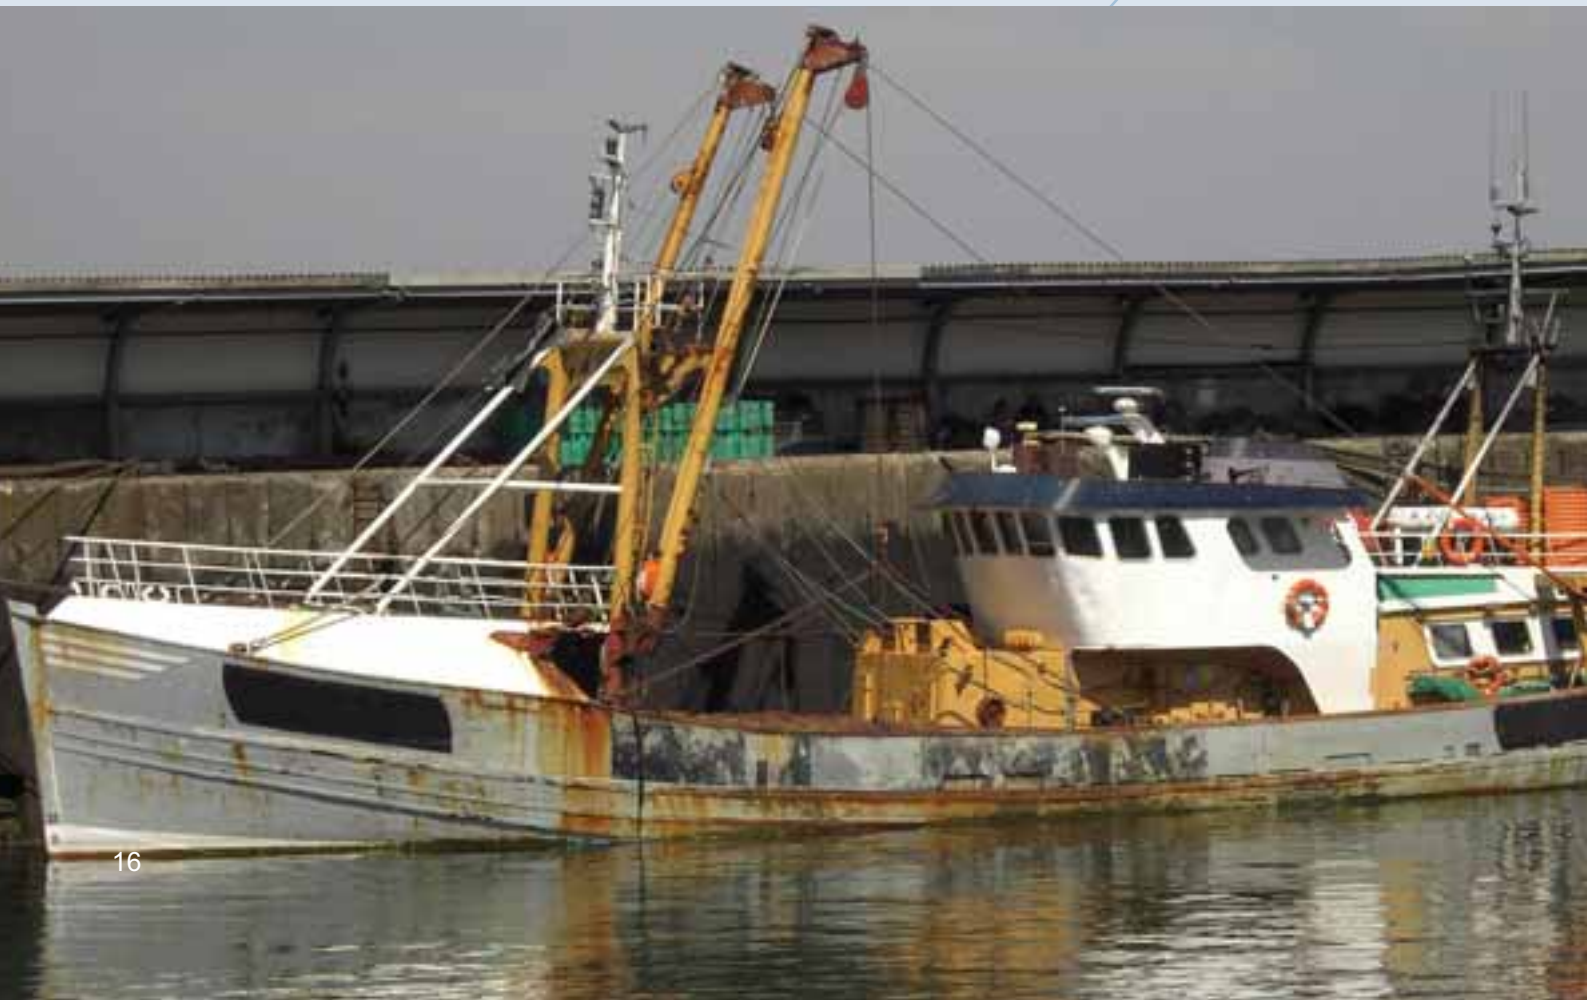
Two days later, the electric submersible pump in the forward net store failed. Using the emergency pump, which was driven by the auxiliary engine, the deckhand/engineer tried to pump out the store. However, the auxiliary engine failed because of an oil leak, which could not be repaired at sea.

The local lifeboat was launched, carrying a portable pump, and it rendezvoused with the fishing vessel. They made for the nearest port, where the fire brigade pumped out the flooded spaces. The engineer found that two wires had become detached from the electric submersible pump, so he reattached them and the pump worked satisfactorily. Later that morning, the fishing vessel returned safely to her home port, under the watch of the coastguard.

- Crew members who were designated as engineers received improved training.
- The auxiliary engine and the engine bilge pump were renewed.
- Large sections of bilge pipe system were renewed, and improved routing was introduced.
- The overboard discharge valves for the emergency and bilge pumps were raised from beneath water level to lead over the top of the deck.
- A diesel-driven, portable salvage pump was placed on board.
- A working sea trial was carried out in moderate sea conditions to test the new improvements; all were found to be satisfactory.

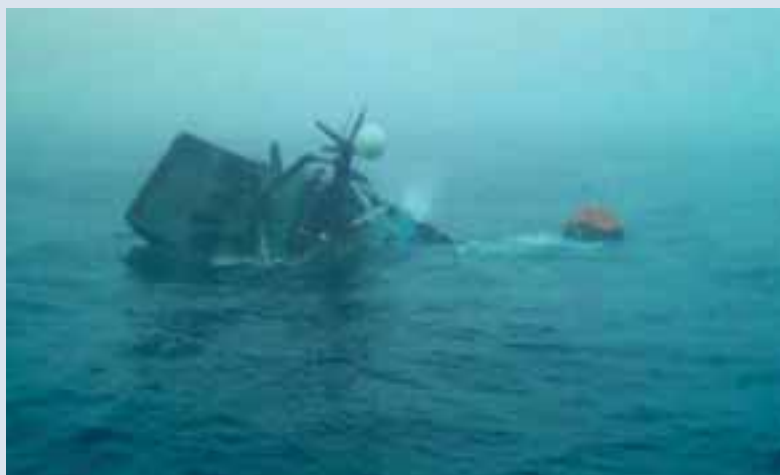
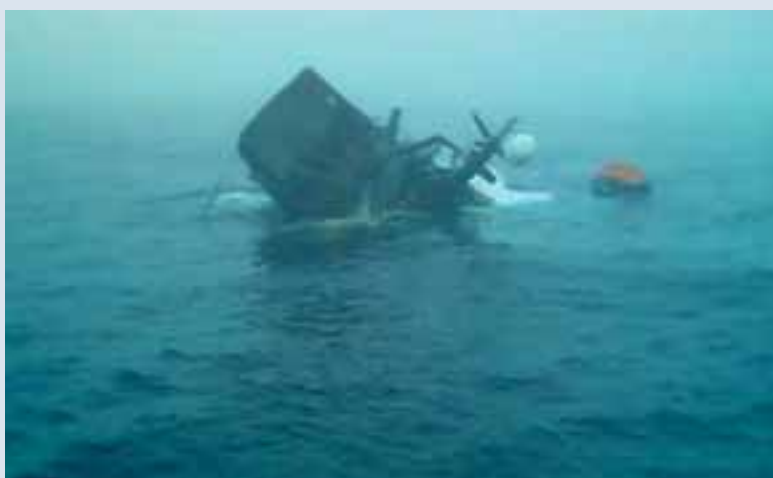
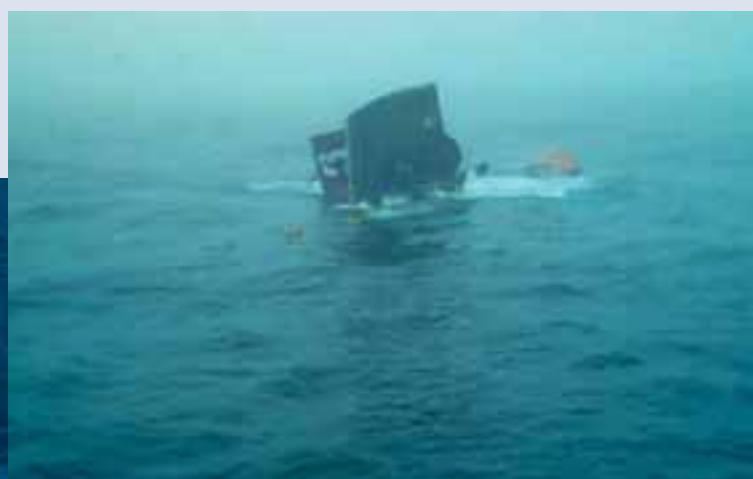
The impact rolled the port boat onto her port side, throwing the remaining crew out of their bunks. A split had been made in the hull, allowing water into the fish hold, and the bulkhead between the fish hold and engine room had been ruptured, allowing water to flow freely between the two spaces.

On board the supply ship, the master arrived on the bridge fewer than 30 seconds after the impact. Noting that the fishing boat was alongside, and that the towing wire was leading under his vessel, he de-clutched the thrusters so that they did not become entangled in the wire. As the tension eased in the wire, it cleared from under his vessel, and he decided to move his vessel clear and standby to offer assistance. Meanwhile, other members of the crew were preparing the FRC and checking their own ship for damage. Apart from some denting and scrapes to the ship's side, damage was limited to a hole above the waterline in the forepeak tank.

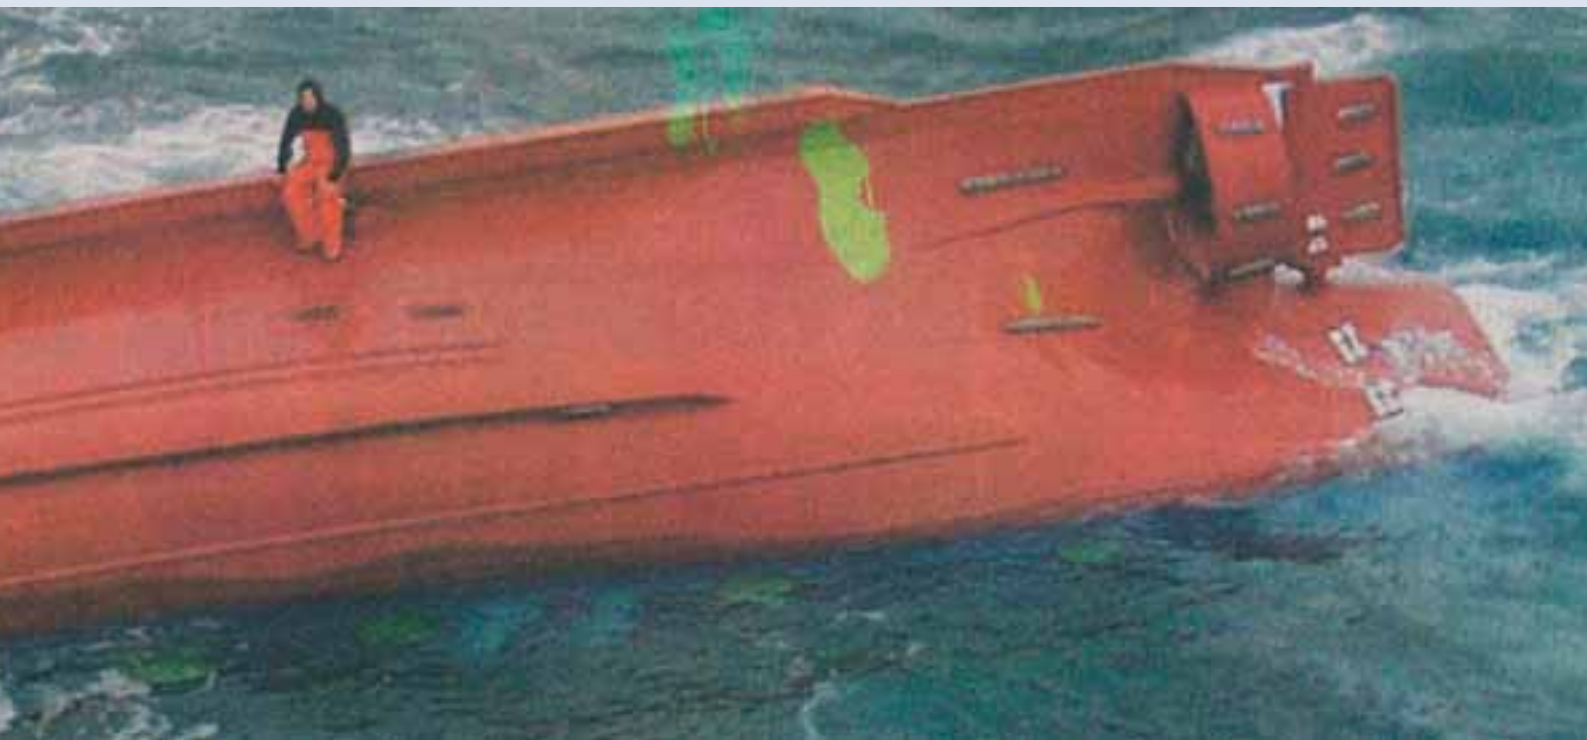
On a late winter's afternoon, in calm sea conditions, a beam trawler caught her port trawl gear on a fastener. During the ensuing attempts to free the gear the vessel listed rapidly and capsized. There was only one survivor from the four crewmen on board.

**1** The trawler met all the applicable stability conditions. However, in the situation where her port derrick was horizontal, its gear anchored to the seabed, and her starboard derrick raised to a large angle, she was extremely vulnerable, and capable of capsizing with less than 5 tons of winch force on the port side. Hauling the gear on one side, and lifting the derrick before trying to free the snagged gear on the other, is contrary to good beam trawler practice. Leaving the derrick on the opposite side horizontal will help balance the forces, and would have been a safer way of maintaining stability in this case.

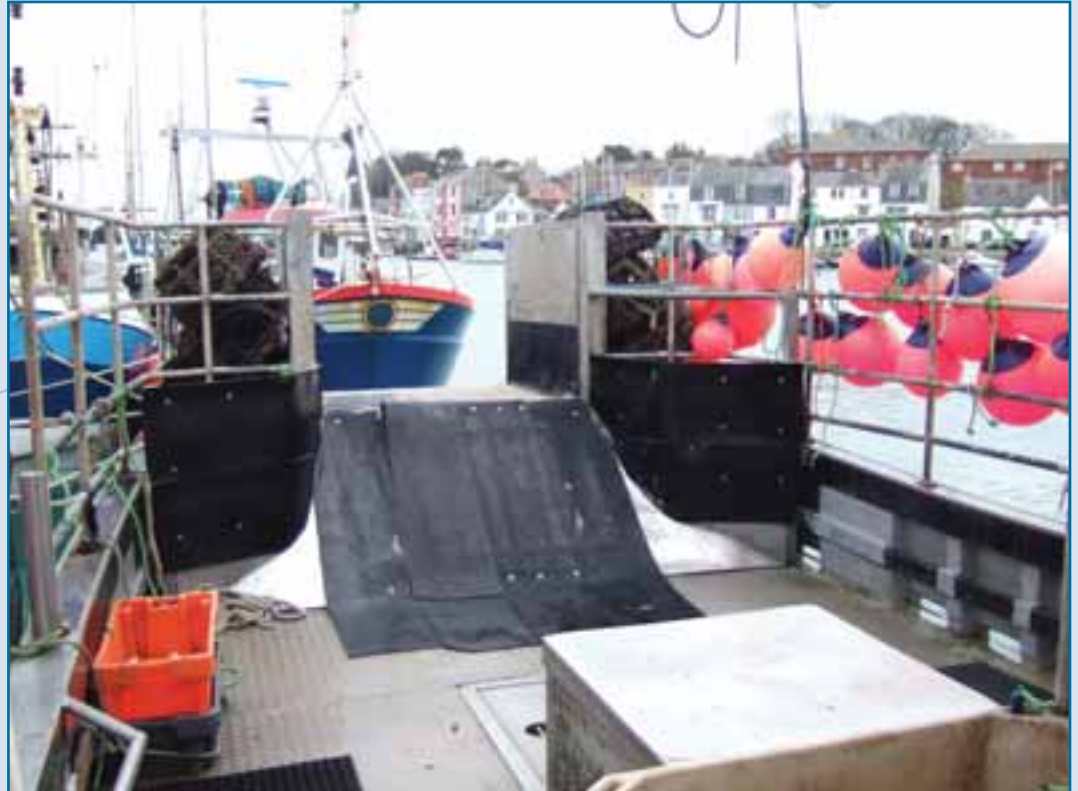
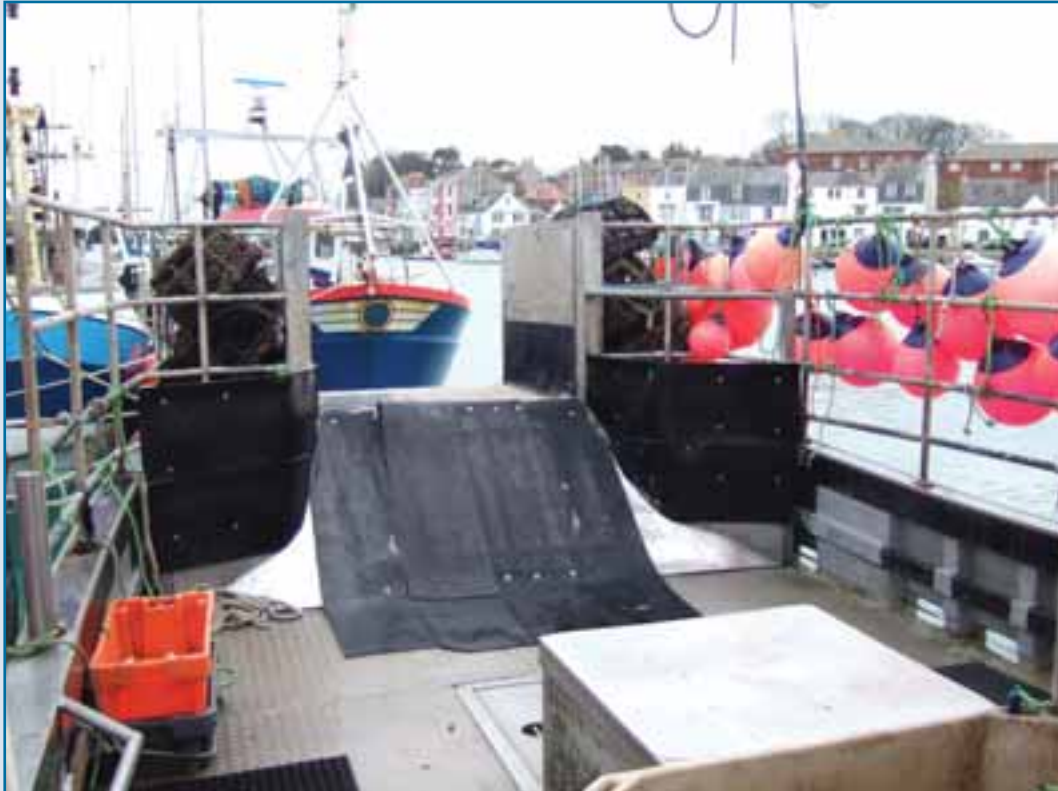
Do you notice any differences between the two photographs? – Concentrate on the ramp at the centre of the vessel's stern and imagine lines of pots being shot out through this opening. This is a common way of laying a line of pots and involves them being carefully stowed on deck, with the associated ropes, in such a manner that they are free to pass through the stern opening, without assistance from the crew, once the process has commenced.

men were trained and experienced in this type of fishing. However, in each case, the fishermen became trapped in the rope and were quickly dragged over the side and into the sea.

**1** When risk assessing any operation at sea, consider the question “What if a person does something they shouldn’t?” If you cannot ensure their safety at all times, which on the deck of a fishing vessel is unlikely, then you must consider the last resort – the provision of suitable Personal Protective Equipment: in this case a lifejacket and suitable clothing, to make the operation as safe as reasonably practicable.

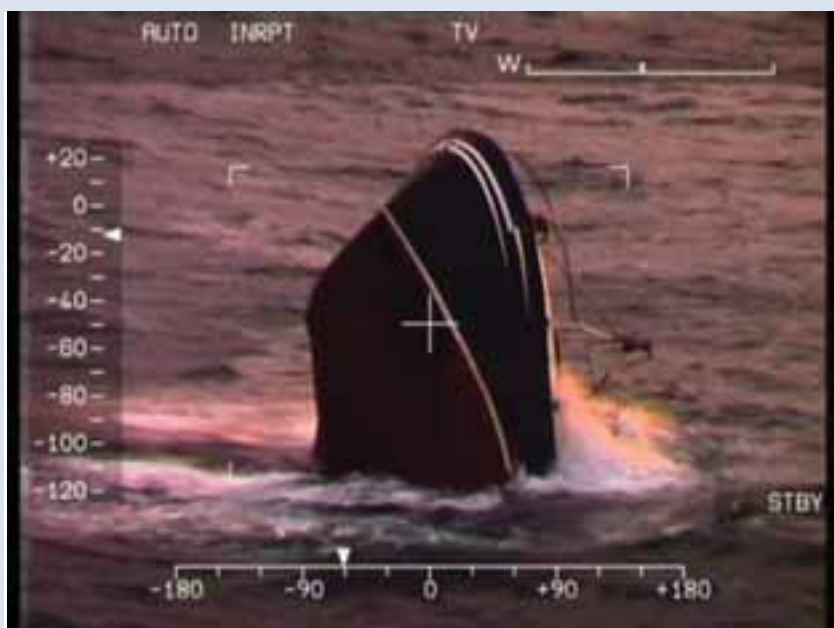
late to put a man onto the exposed deck to close the vent flaps. As the vessel trimmed further by the stern, and listed to starboard, seawater found its way into these vents and drained down below decks.

The wind decreased and the sea state improved as the vessel got closer to shore. Consequently the vessel stopped rolling and remained listed on her starboard side, and this alerted the skipper to the angle of loll developing. Aware of the worsening situation, the skipper ensured all his crew were in lifejackets and instructed them to prepare a liferaft. He stopped the vessel, which immediately settled on her side, allowing the crew to step into the liferaft, taking with them their EPIRB and portable VHF radio. Within minutes of abandoning, the crew were winched to safety by a SAR helicopter, which had been summoned earlier by the coastguards. Soon afterwards, the vessel sank by the stern.

**4** The open vent flaps allowed water to find its way below decks and subsequently sink the vessel. Seafarers should be acutely aware of the dangers of downflooding through openings, at all times, and take all due precautions where there is a possibility of this happening. Had the vents been closed early on during this emergency, it would have prevented further ingress, and allowed the crew a good margin of safety until the SAR salvage pump arrived.
