**MAIB**  
MARINE ACCIDENT INVESTIGATION BRANCH

# Safety Digest

**Fishing  
2014g**

Published May 2014

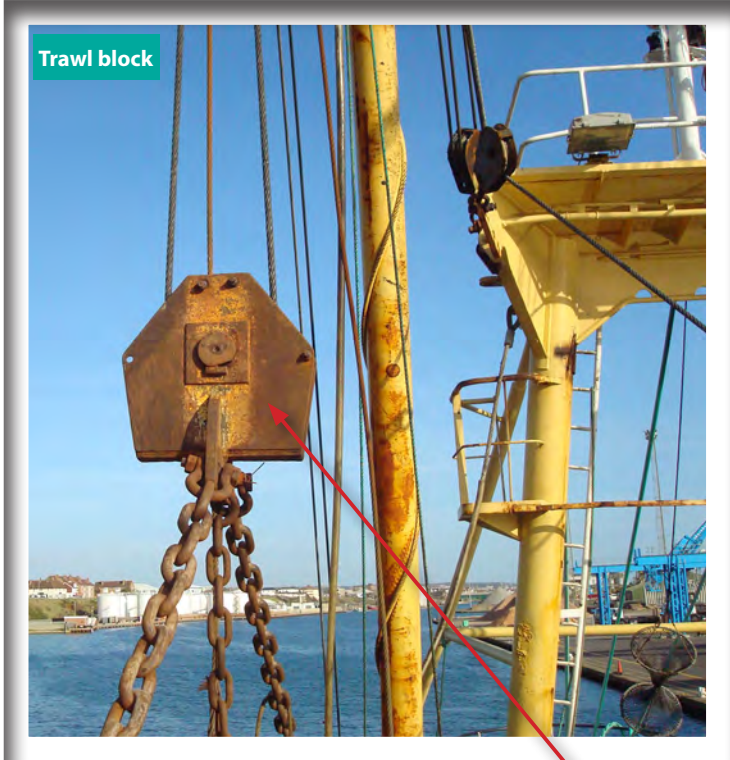
**“Regular inspection of wires, particularly those that are used heavily, such as trawl wires, is essential to ensure they are safe for use.”**

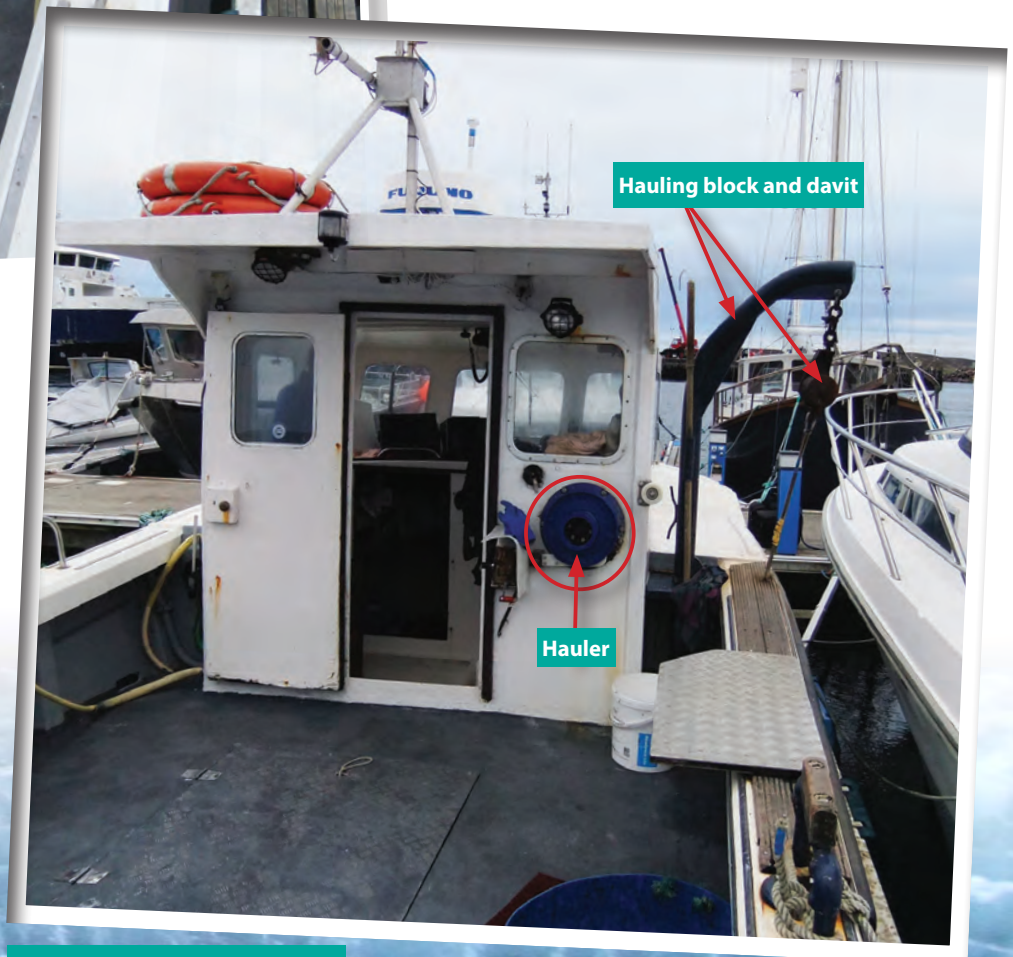
Figure 25: Stern view of potter

“ The owner did not carry a knife and there were none available for him to use to cut the back rope. Carrying a knife, or having one immediately available, could mean the difference between life and death.”

Hauling block and davit

Hauler
