MARINE ACCIDENT INVESTIGATION BRANCH

# Leisure craft

SAFETY DIGEST

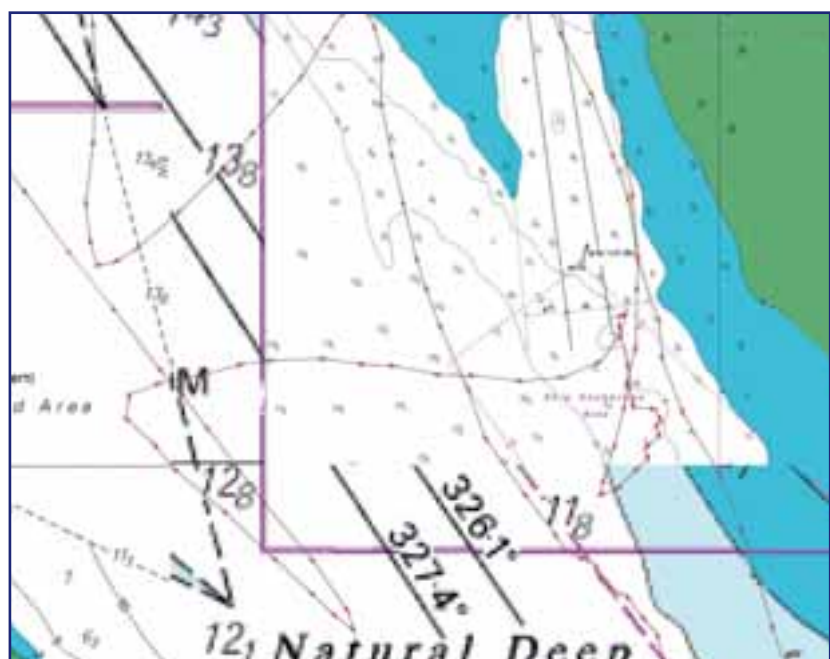
Figure 3 – Detailed GPS track showing key accident points

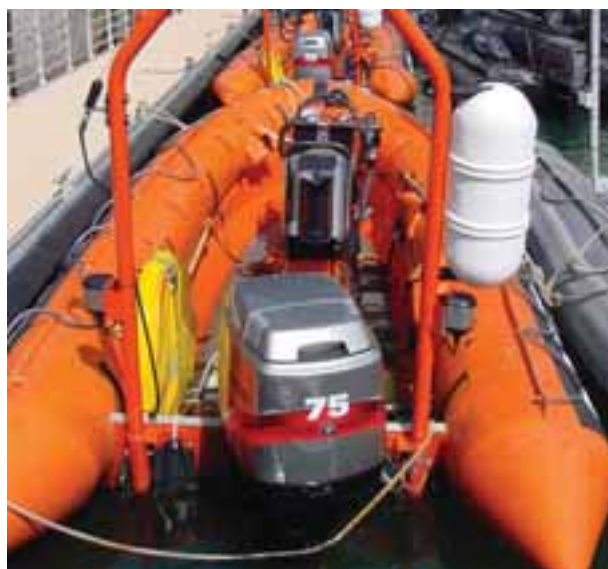
the throttle to prevent his fall. This forced the engine into gear. Although he immediately pulled the kill cord, the stern of the RIB momentarily slewed to port before the engine stopped, and the propeller struck the boy's left leg, causing serious injuries.

*Stern view of the safety boat*

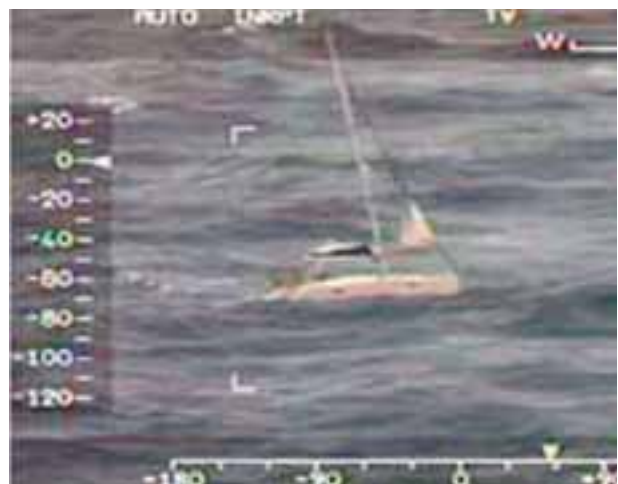
Figure 2 – Video still of yacht taken after the 3 crew were lost overboard.

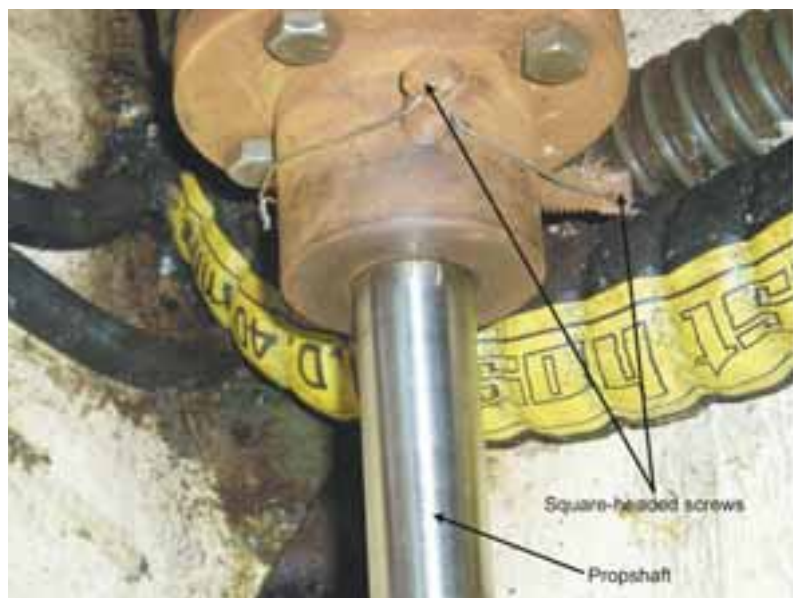
The owner's shouts were heard by his son on the helm, who promptly stopped the engine and immediately used his mobile telephone to dial 999 and ask for coastguard assistance. He then used the boat's first-aid kit to dress his father's arm, using a wooden spatula from the galley as a splint and cottonwool pads to stem the flow of blood. The injury was serious, with a length of broken bone exposed.

*Engine/propshaft coupling arrangements*

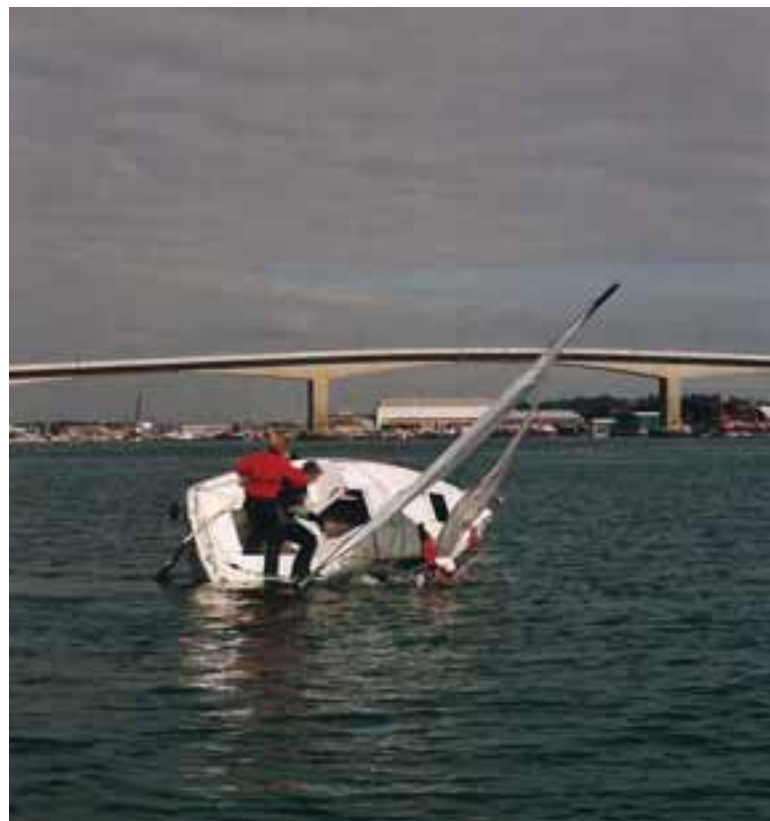
Figure 2 – Test report photograph – small trailer-sailer being capsized

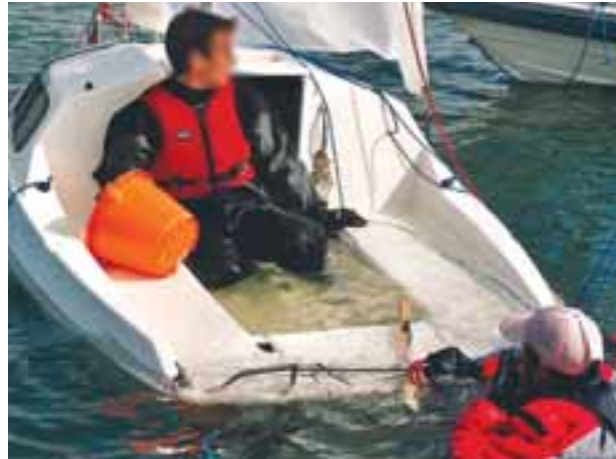
Figure 3 – Test report photograph – cockpit fully swamped

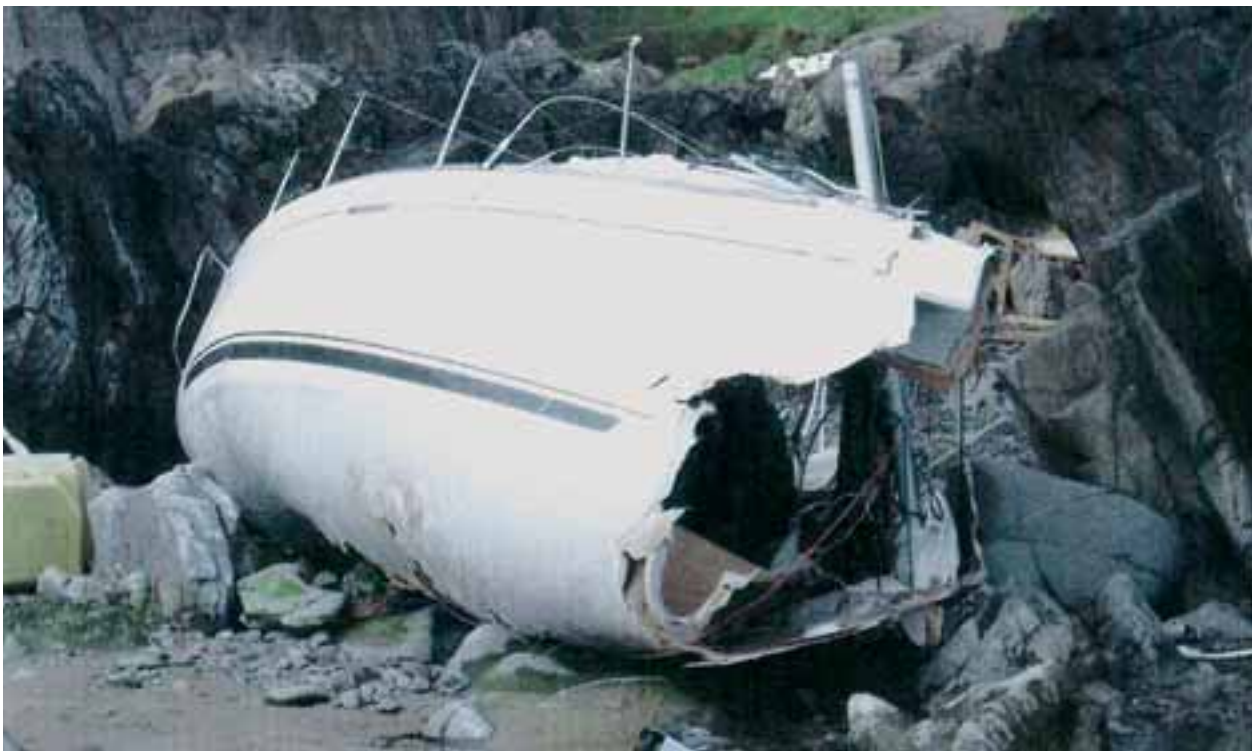
Figure 1

the genoa secured on the windward side. The crew rigged the emergency tiller, but the rudder would not budge. At this time, the depth of water was 25m, but the yacht only had 20m of anchor chain attached to the anchor.

The crew tried to investigate the steering mechanism further, but at 1350 the skipper decided to make a "Mayday" call, following which the local lifeboat and SAR helicopter were launched. The yacht drifted inshore, but once in a water depth of 15m, the jib was furled and the anchor let go. Despite using the engine to alleviate the drift, the snatching of the anchor on the bottom caused such loads that the rope connecting the bitter end of the chain to the anchor locker failed and the anchor was lost.

- 3** Ensure you have sufficient chain and rope attached to your anchor, and that it is of the correct size. For the yacht in this accident, 20m of chain was half the amount recommended. If weight is a major consideration on your yacht, then rope and chain can be used; but ensure you have sufficient chain to assist holding. The prudent mariner will also carry a kedge anchor, which can be used as a back-up in an emergency.

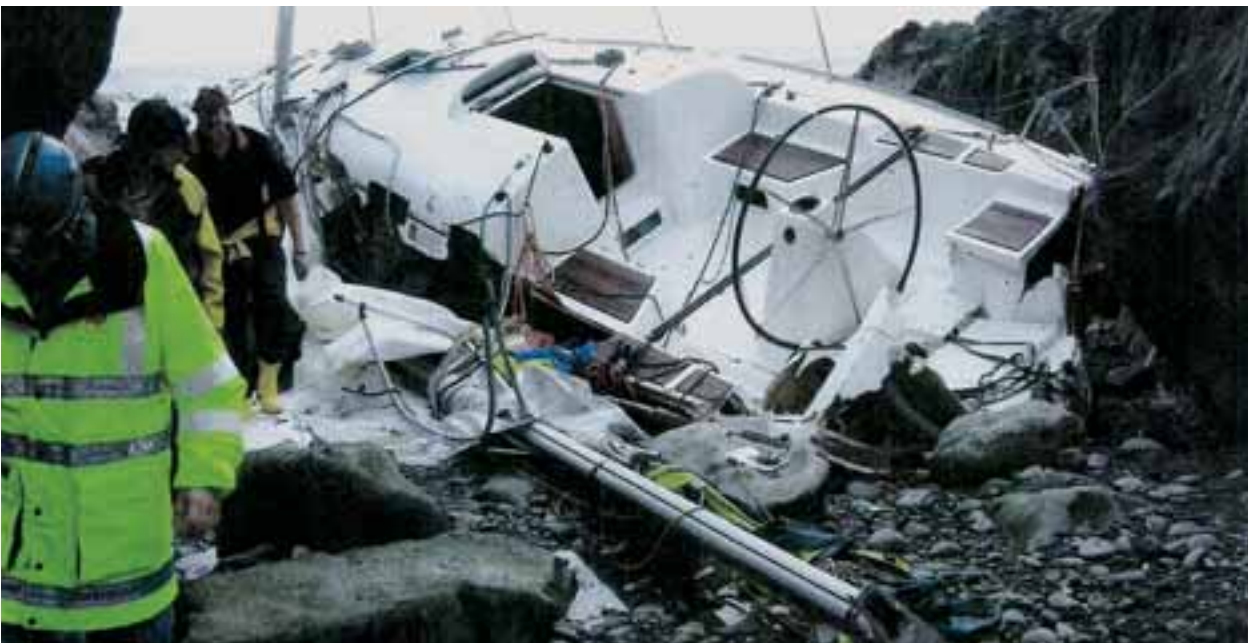
Figure 2

started to pull the yacht off the beach but, unfortunately, the line parted and the yacht beached once again.

At this stage, the lifeboat coxswain decided that the risk to the yacht's crew was too great, and they were evacuated from their vessel by helicopter. The crew suffered no injuries during their ordeal, and returned to the vessel at low tide to salvage some belongings. The yacht, however, was not able to be salvaged and became a total

- 2** Be alert to navigational dangers and, where possible, keep well clear of a lee shore. On this occasion, there was no great need to be sailing 1nm off a very rocky coast. Standing further off will give you extra breathing space to deal with emergencies and the unexpected.

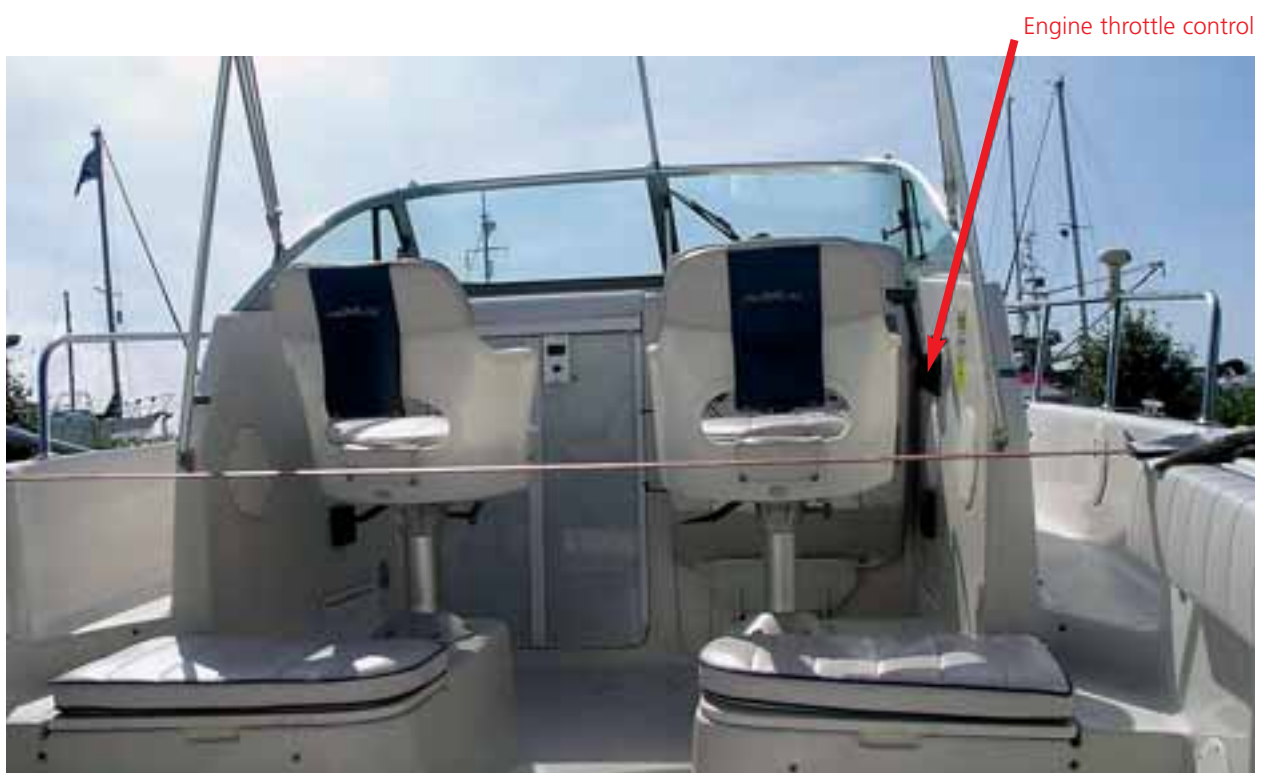
Figure 1 – A view looking forward from the stern of the cockpit area

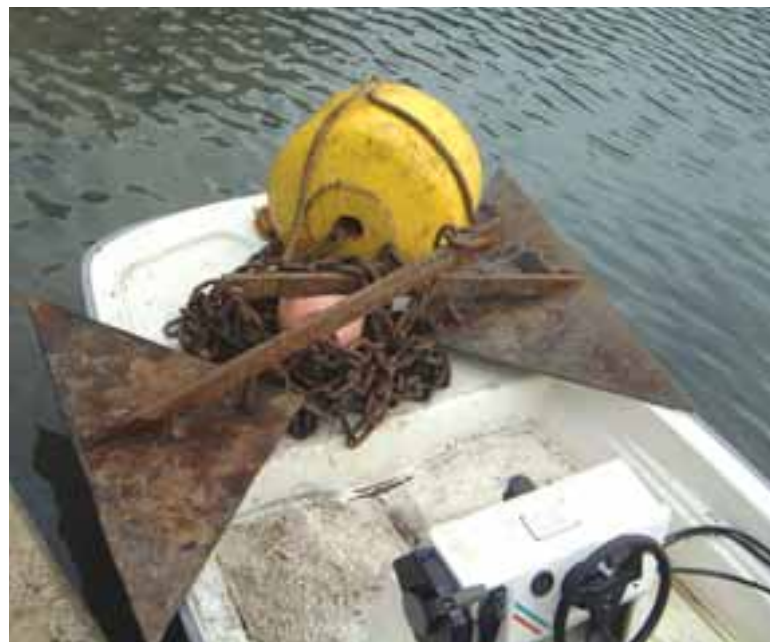
The outboard motor on the dory had failed on a number of occasions in the past and, based on its condition after the accident, it is likely that it failed as the dory was crossing the mouth of the estuary. The vessel would have been swept out into rougher water very quickly and foundered. The position in which the dory and the mooring (which was recovered from the seabed) were subsequently found supports this scenario, although it will never be known exactly what happened.

*Photograph showing the mooring placed on the bow of the dory*

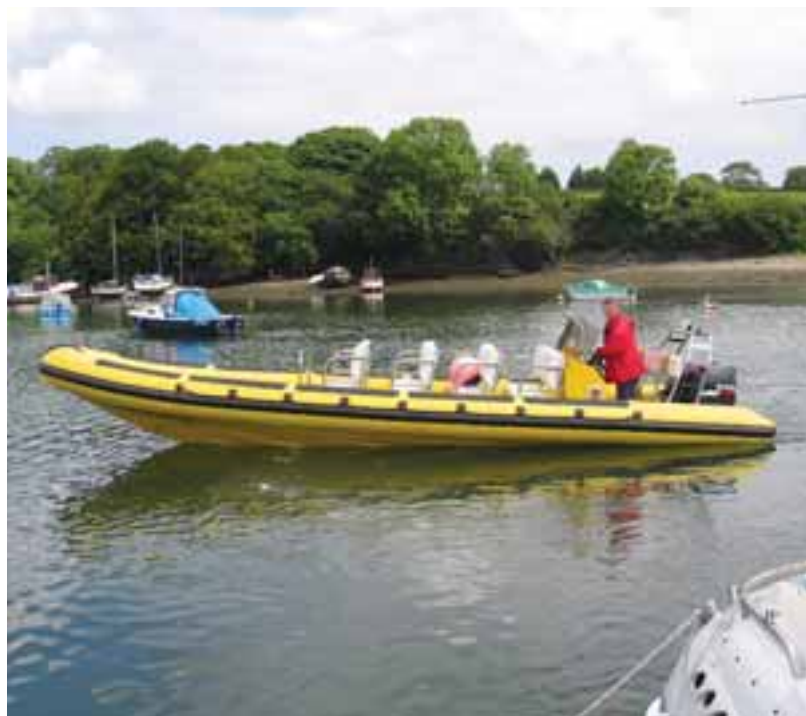
Figure 1 – Broad on, port perspective

The skipper felt the RIB's handling characteristics change. The deck heaved slightly, there was a loud crack and the forward part of the hull momentarily adopted an angle of about 45 degrees from the horizontal. The front bench seat was torn from its deck mountings, plunging two of the children into the water (Figure 2). One female passenger also trapped her legs between

the split sections of the marine ply deck before being pulled back by her husband. In the meantime, the skipper ran forward, the engines stopped as the kill cord was activated, and he dropped both his anchors and launched the lifeboat, although he was unsure how to do this. The RIB, although still afloat, had its bow section fully open to the sea, with port and starboard splits to the hull extending to over half the RIB's length (Figure 3).

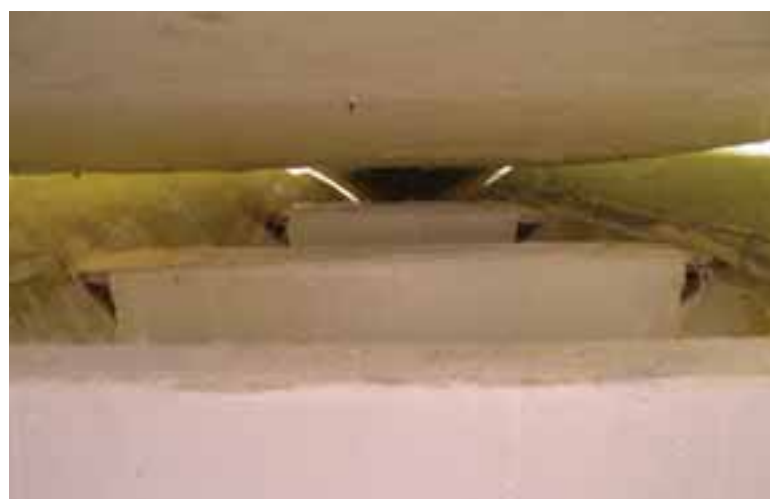
Figure 4 – Construction

The subsequent investigation found that the RIB was supposedly built to the European Craft Directive's standards, but there was no documentation to support this claim. In particular, there was no specification for the hull structure or its construction to justify its designation to cope with 4 metre seas, the structure lacked longitudinal stiffness and was of extremely light construction (Figure 4). As this vessel was used for commercial purposes, it was subjected to detailed examination under the auspices of the MCA. However, in common with many other RIBs, there was no access to the under deck areas, so it was very difficult to assess the true condition of the hull.

**3** If considering buying a re-sale boat, you will wish to check the condition of the hull structure. This is often difficult with a GRP RIB as under deck access is frequently impossible. If this is the case, the builder may well have a set of photographs taken during build. These, coupled with the information in the Technical File, will aid you and your surveyor to determine the suitability of the vessel's construction for your needs. It is also wise to check the vessel's history for any major hull repairs.

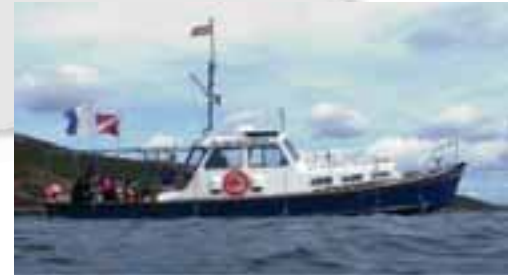
*Dive vessel displaying the Alpha flag and the American Territories flag*

At no point prior to the incident had the skipper positively identified the flags displayed by the diving vessel. As a result, the yacht passed over the top of the divers as they surfaced, blissfully unaware of the diving operations beneath them. Attempts by the Coastguard and the dive vessel to contact the yacht by VHF radio failed. Thankfully on this occasion there were no injuries sustained by any of the diving party.

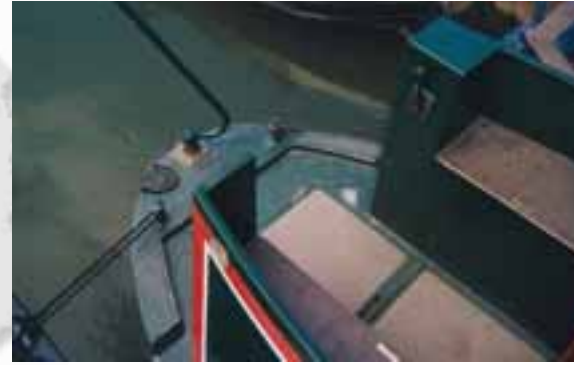
*Aft section of the narrowboat*

deploy the life-ring. The lanyard for the life-ring was wrapped around it like a yo-yo. Unfortunately, the life-ring lanyard didn't unravel as it was thrown, resulting in the life-ring dropping into the water beside the boat. The lanyard was pulled back in, and fully unravelled, before a second attempt at a throw was made. The throw did not reach the pair in the water, the lady having now managed to raise the casualty's head above water.

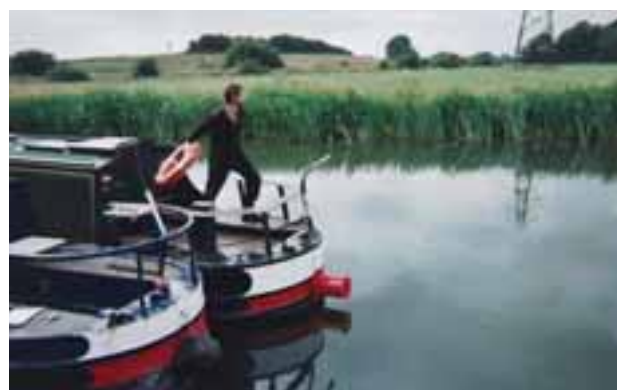
*Demonstrating use of the life-ring*
