MAIB

MARINE ACCIDENT INVESTIGATION BRANCH

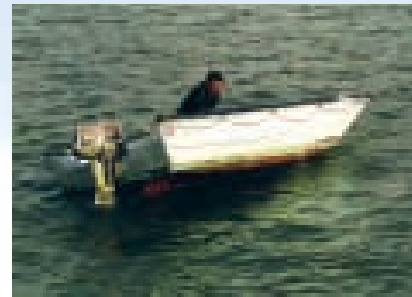
Following the accident, the boat was examined to reveal a substantial amount of water trapped in the void between the inner and outer hulls under the floor. The investigation revealed that uncontrolled movement of seawater in both the boat, and the void beneath the floor, combined to make it so unstable that she would eventually capsize. It was found that seawater had entered the void through two small holes in the bows where a towing bolt had been fastened, but had at some stage become detached.

6 Any craft likely to be used afloat must be properly maintained, regularly checked and inspected carefully before it is used. By noticing something important that a bolt is missing to leave two small holes just above the waterline, could be the difference between a few minutes delay rectifying it, and a very tragic accident.

The dory in this accident was fitted with lifelines. They greatly helped those in the water by providing them with something to hang on to. The rigging of such equipment is strongly recommended.
