Report detailing the testing of an HPL rainscreen cladding system tested in accordance with the requirement as described in British Standard 8414

CUSTOMER TEST REPORT

BS 8414-1-2015+A1-2017 Test Report

Report Reference: 101856.8414

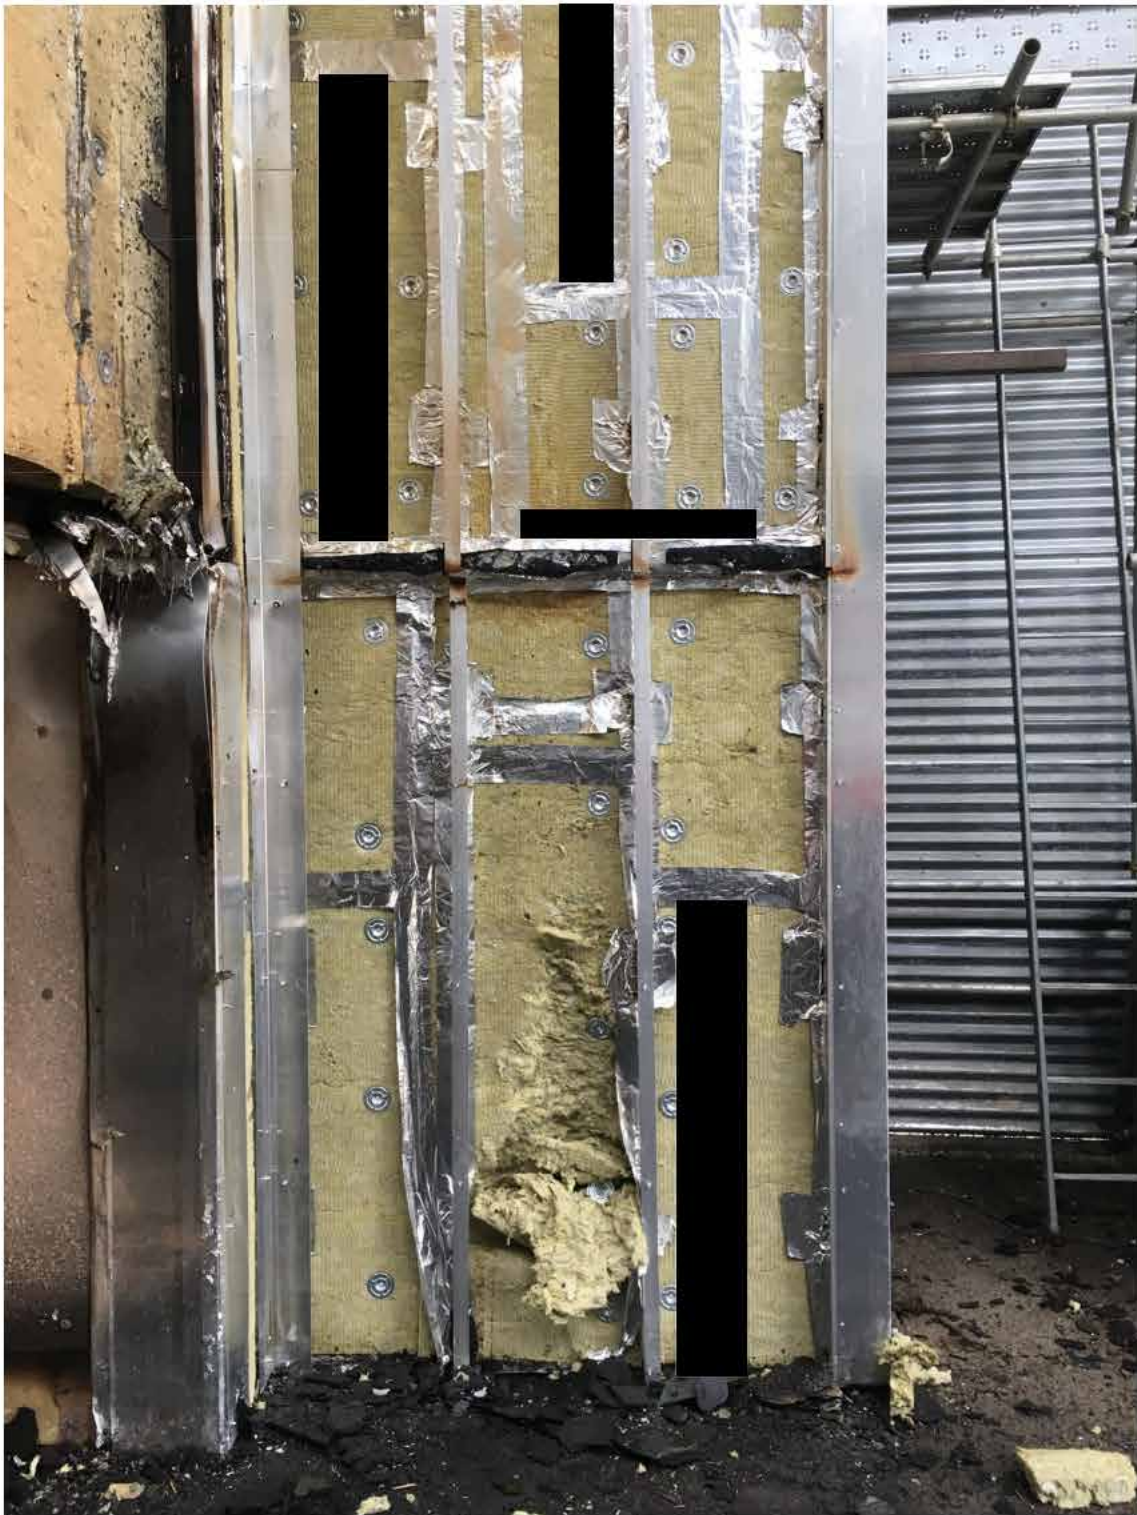
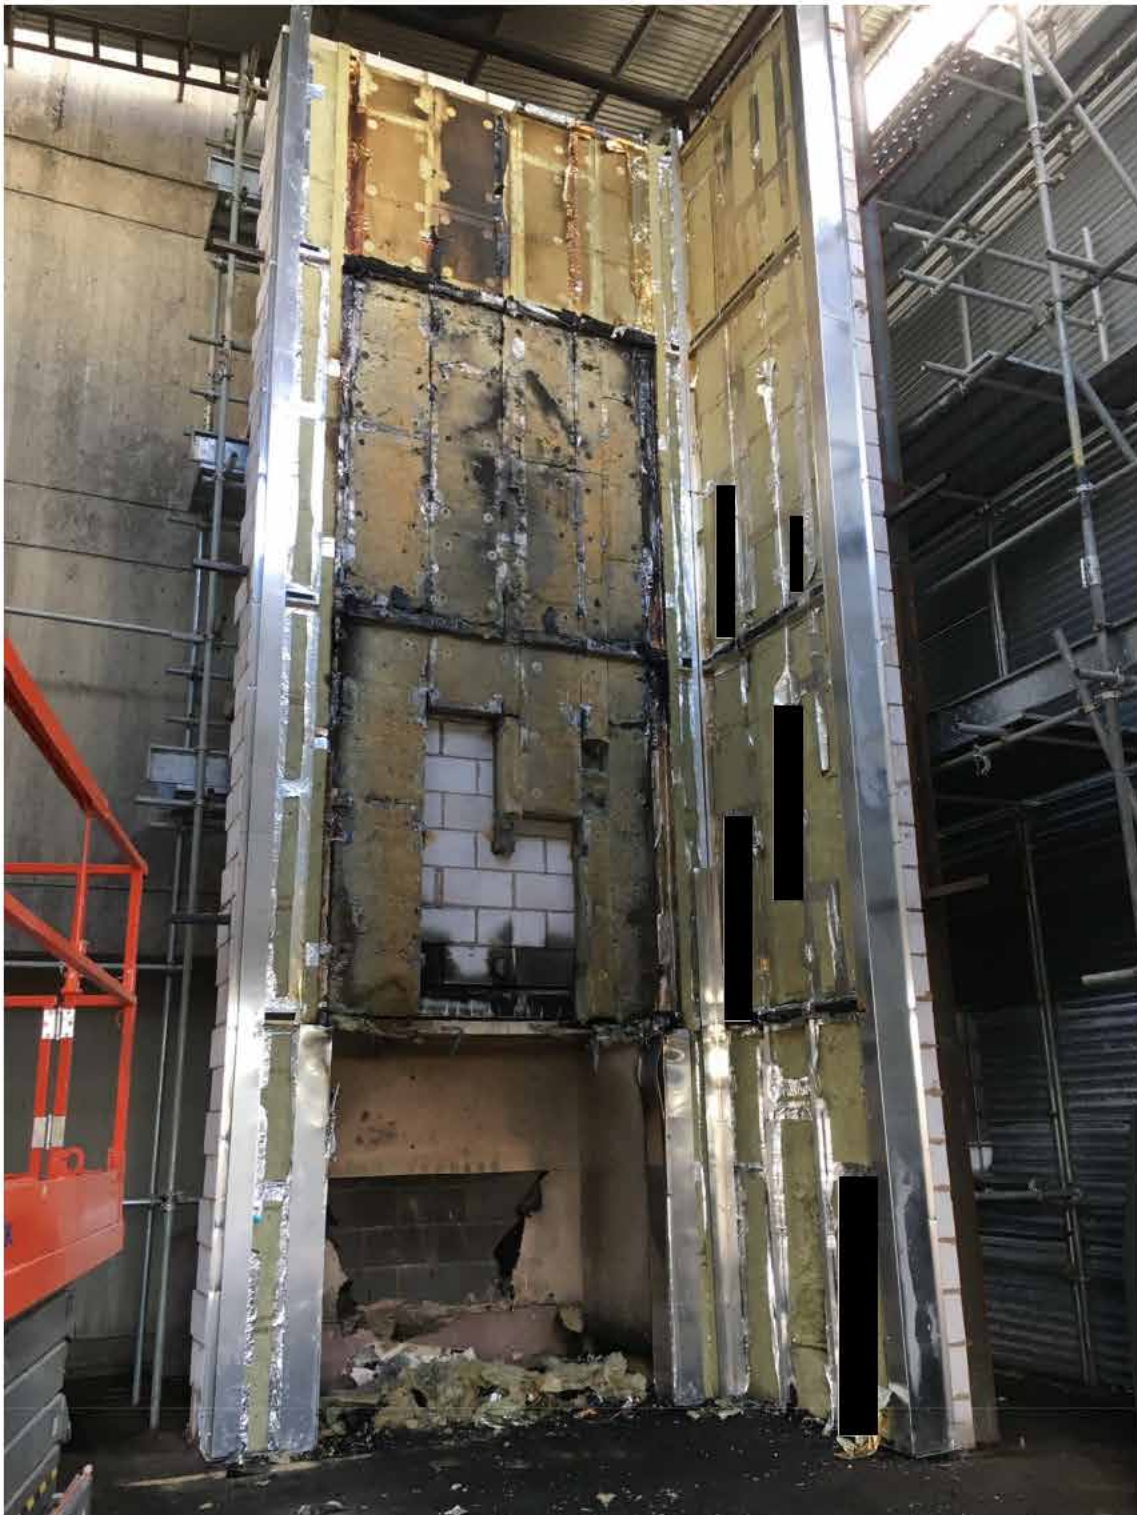
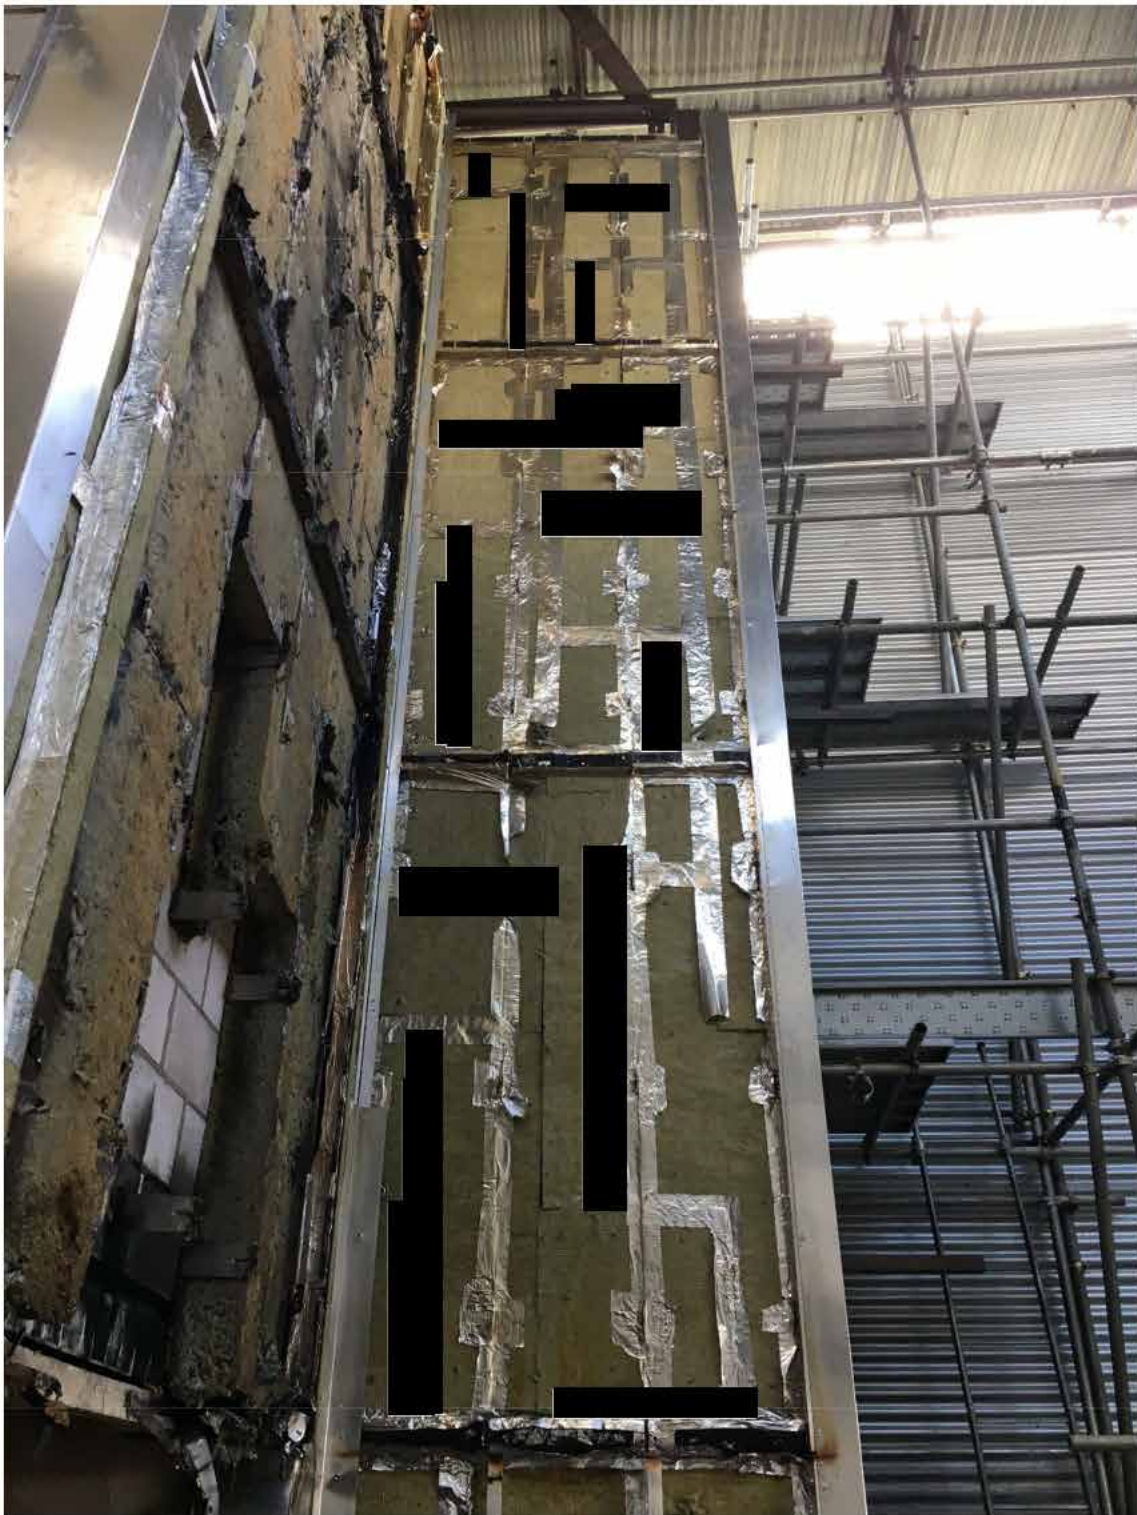
10 Appendix C – Post-test photographs

10.00	Crib lighting commences
14.00	Surface damage visible on façade panels, directly above fire
15.00	Aluminium frame begins to warp
15.30	Exterior skin of façade panels begins to blister

19.10	Aluminium frame around burn chamber fails
20.40	Small pieces of debris start to fall from fascia panels
21.50	Smoke emerging from gaps between lower panels

22.40	Lower façade panels visibly warped directly above fire
23.00	Smoke emerging from behind upper panels
24.00	Façade surface damage reaches upper panels

24.30	Façade surface damage visible on the wing panels
25.00	Surface of lower panels burnt away directly above fire
27.00	Cracks in lower panels directly above fire

32.00	Bottom of lower panels completely bunt away
33.16	Panels on wing wall warped
34.25	Large piece of debris falls from lower panel
36.40	Middle of lower panels, and bottom corners of upper panels burnt away
