Report No.: J094259
Nature of Work: Demolition Survey
Issue Date: 14/05/2018
Client Name: WYG Engineering Ltd
Geneva Building, Lake View Drive, Sherwood Business Park,
Annesley, Nottingham, NG15 0ED
Site Address: Student Union, Former City North Campus, Birmingham City
University, Perry Barr, B42 2US

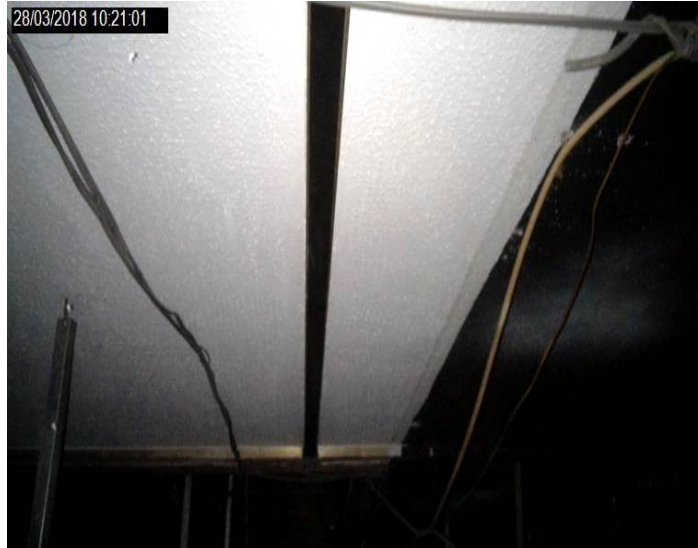
Location:	1.15 Bar Area	Block:	Commercial	Floor Level: Ground Floor
Sample No.:	DU001041	Portal Ref No.:	2

Item:	Asbestos Textured coating to concrete			
Asbestos Content:	Result Based on:			
Chrysotile	Analysis of sample using PLM			
Sample Analysed By: Reg 13(1)	Extent:	150 m ²		
Comments: Above suspended plasterboard ceiling to section of the room see plan for location

Material Assessment Total Score: 3		Likelihood of Disturbance Assessment Total Score: 4		Management Assessment Licensable: No Recommendations: Program removal Reinspection Interval: Not Applicable Overall Risk Category: C7
Product Type:	1 (Asbestos textured coating)	Location:	1 (Large rooms or well-ventilated areas)	
Condition:	1 (Minor scratches)	Accessibility:	0 (Usually inaccessible or unlikely to be disturbed)	
Surface Treatment:	0 (Composite material)			
Asbestos Type:	1 (Chrysotile)	Extent Score:	3 (>50 sq m or >50m pipe run)

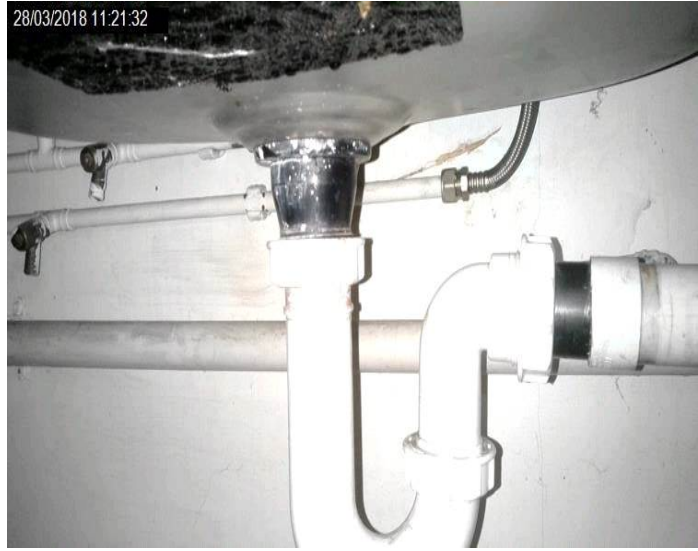
Location:	1.12 Store	Block:	Commercial	Floor Level: Ground Floor
Sample No.:	DU001044	Portal Ref No.:	26

Item:	Bitumen sink pad			
Asbestos Content:		Result Based on:		
No Asbestos Detected		Analysis of sample using PLM		
Sample Analysed By:	Reg 13(1)	Extent:	2 units	
Comments: Strip also present to drainer.

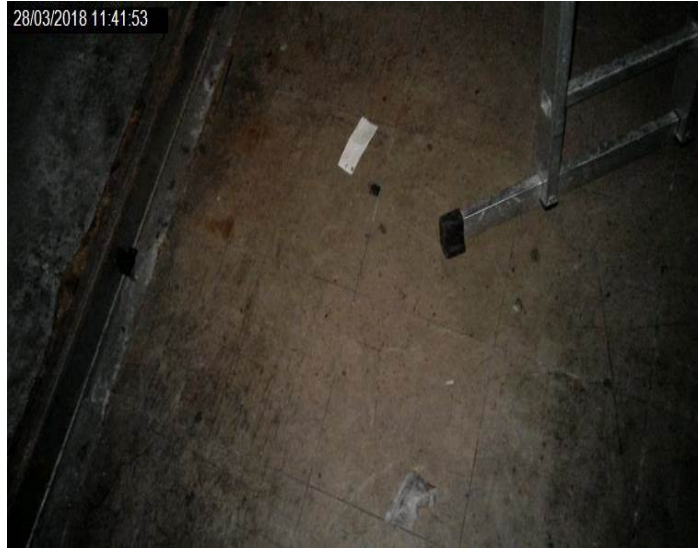
Location:	1.11 Plant Room	Block:	Commercial	Floor Level: Ground Floor
Sample No.:	DU001048	Portal Ref No.:	31

Item:	Asbestos Thermoplastic floor tiles with bitumen adhesive			
Asbestos Content:	Result Based on:			
Chrysotile in adhesive only	Analysis of sample using PLM			
Sample Analysed By: Reg 13(1)	Extent:	25 m ²		
Comments:

Material Assessment Total Score: 3		Likelihood of Disturbance Assessment Total Score: 7		Management Assessment Licensable: No Recommendations: Program removal Reinspection Interval: Not Applicable Overall Risk Category: C10
Product Type:	1 (Asbestos thermoplastic)	Location:	2 (Rooms up to 100 sq m)	
Condition:	1 (Minor scratches)	Accessibility:	3 (Routinely disturbed)	
Surface Treatment:	0 (Composite material)			
Asbestos Type:	1 (Chrysotile)	Extent Score:	2 (>10 - <50 sq m or >10m - <50m pipe run)

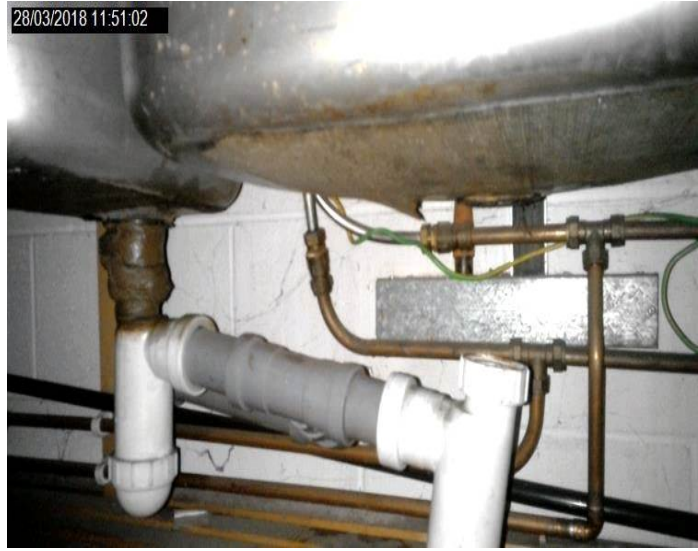
Location:	1.10 Office	Block:	Commercial	Floor Level: Ground Floor
Sample No.:	DU001050	Portal Ref No.:	33

Item:	Bitumen sink pad			
Asbestos Content:		Result Based on:		
No Asbestos Detected		Analysis of sample using PLM		
Sample Analysed By:	Reg 13(1)	Extent:	2 units	
Comments: To drainer

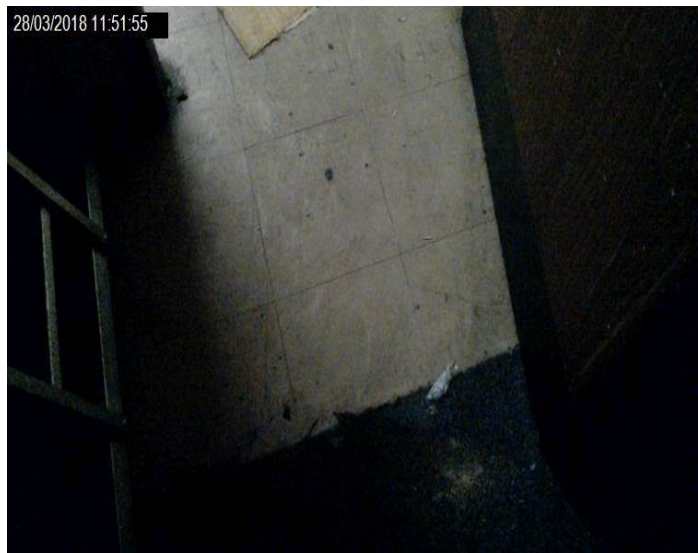
Location:	1.10 Office	Block:	Commercial	Floor Level: Ground Floor
Sample No.:	As DU001048	Portal Ref No.:	34

Item:	Asbestos Thermoplastic floor tiles with bitumen adhesive			
Asbestos Content:	Result Based on:			
Chrysotile in adhesive only	Strongly presumed			
Sample Analysed By:	Not applicable	Extent:	12 m ²	
Comments:

Material Assessment Total Score: 3		Likelihood of Disturbance Assessment Total Score: 6		Management Assessment Licensable: No Recommendations: Program removal Reinspection Interval: Not Applicable Overall Risk Category: C9
Product Type:	1 (Asbestos thermoplastic)	Location:	2 (Rooms up to 100 sq m)	
Condition:	1 (Minor scratches)	Accessibility:	2 (Easily disturbed)	
Surface Treatment:	0 (Composite material)			
Asbestos Type:	1 (Chrysotile)	Extent Score:	2 (>10 - <50 sq m or >10m - <50m pipe run)

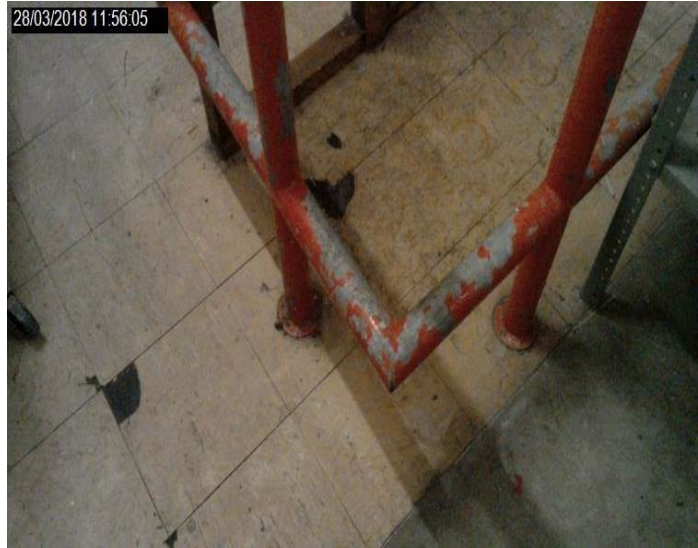
Location:	1.09 Load Area	Block:	Commercial	Floor Level: Ground Floor
Sample No.:	As DU001048	Portal Ref No.:	37

Item:	Asbestos Thermoplastic floor tiles with bitumen adhesive			
Asbestos Content:	Result Based on:			
Chrysotile in adhesive only	Strongly presumed			
Sample Analysed By:	Not applicable	Extent:	12 m ²	
Comments:

Material Assessment Total Score: 3		Likelihood of Disturbance Assessment Total Score: 7		Management Assessment Licensable: No Recommendations: Program removal Reinspection Interval: Not Applicable Overall Risk Category: C10
Product Type:	1 (Asbestos thermoplastic)	Location:	2 (Rooms up to 100 sq m)	
Condition:	1 (Minor scratches)	Accessibility:	3 (Routinely disturbed)	
Surface Treatment:	0 (Composite material)			
Asbestos Type:	1 (Chrysotile)	Extent Score:	2 (>10 - <50 sq m or >10m - <50m pipe run)

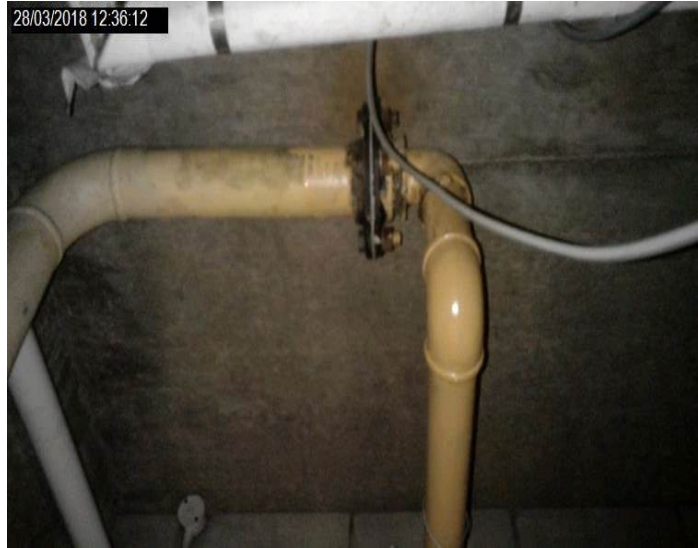
Location:	1.05 Disabled Toilet	Block:	Commercial	Floor Level: Ground Floor
Sample No.:	DU001057	Portal Ref No.:	49

Item:	Asbestos Compressed fibre gasket			
Asbestos Content:	Result Based on:			
Chrysotile	Analysis of sample using PLM			
Sample Analysed By: Reg 13(1)	Extent:	3 units		
Comments: To the yellow gas pipework

Material Assessment Total Score: 5		Likelihood of Disturbance Assessment Total Score: 2		Management Assessment Licensable: No Recommendations: Program removal Reinspection Interval: Not Applicable Overall Risk Category: C7
Product Type:	2 (Compressed asbestos fibre)	Location:	2 (Rooms up to 100 sq m)	
Condition:	1 (Minor scratches)	Accessibility:	0 (Usually inaccessible or unlikely to be disturbed)	
Surface Treatment:	1 (Unencapsulated textile/paper)			
Asbestos Type:	1 (Chrysotile)	Extent Score:	0 (Small amounts or items)

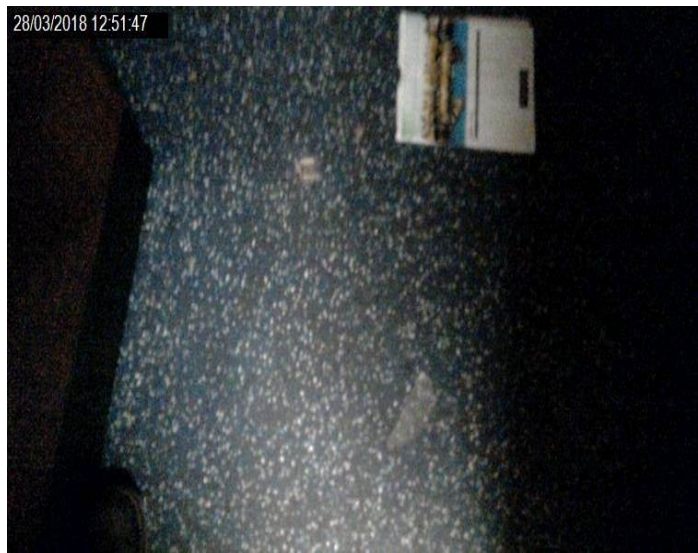
Location:	1.02 Food Store	Block:	Commercial	Floor Level: Ground Floor
Sample No.:	DU001060	Portal Ref No.:	54

Item:	Asbestos Thermoplastic floor tiles with bitumen adhesive			
Asbestos Content:	Result Based on:			
Chrysotile in adhesive only	Analysis of sample using PLM			
Sample Analysed By: Reg 13(1)	Extent:	18 m ²		
Comments: Present beneath vinyl flooring.

Material Assessment Total Score: 3		Likelihood of Disturbance Assessment Total Score: 4		Management Assessment Licensable: No Recommendations: Program removal Reinspection Interval: Not Applicable Overall Risk Category: C7
Product Type:	1 (Asbestos thermoplastic)	Location:	2 (Rooms up to 100 sq m)	
Condition:	1 (Minor scratches)	Accessibility:	0 (Usually inaccessible or unlikely to be disturbed)	
Surface Treatment:	0 (Composite material)			
Asbestos Type:	1 (Chrysotile)	Extent Score:	2 (>10 - <50 sq m or >10m - <50m pipe run)

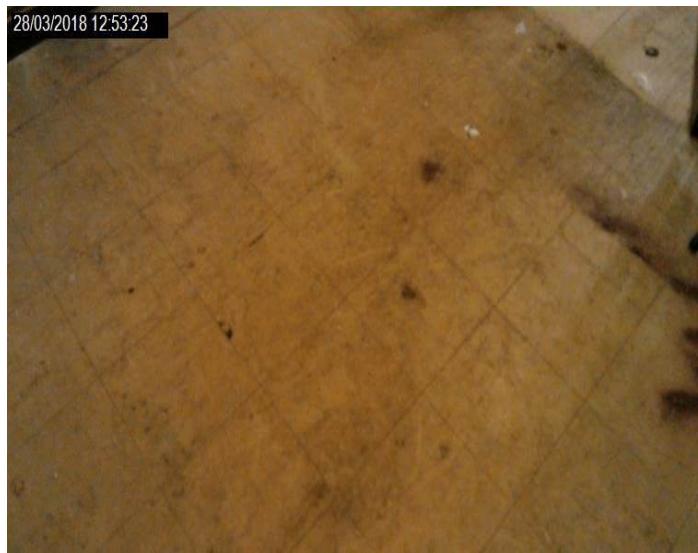
Location:	1.01 Changing Room	Block:	Commercial	Floor Level: Ground Floor
Sample No.:	As DU001060	Portal Ref No.:	55

Item:	Asbestos Thermoplastic floor tiles with bitumen adhesive			
Asbestos Content:	Result Based on:			
Chrysotile in adhesive only	Strongly presumed			
Sample Analysed By:	Not applicable	Extent:	20 m ²	
Comments:

Material Assessment Total Score: 3		Likelihood of Disturbance Assessment Total Score: 7		Management Assessment Licensable: No Recommendations: Program removal Reinspection Interval: Not Applicable Overall Risk Category: C10
Product Type:	1 (Asbestos thermoplastic)	Location:	2 (Rooms up to 100 sq m)	
Condition:	1 (Minor scratches)	Accessibility:	3 (Routinely disturbed)	
Surface Treatment:	0 (Composite material)			
Asbestos Type:	1 (Chrysotile)	Extent Score:	2 (>10 - <50 sq m or >10m - <50m pipe run)

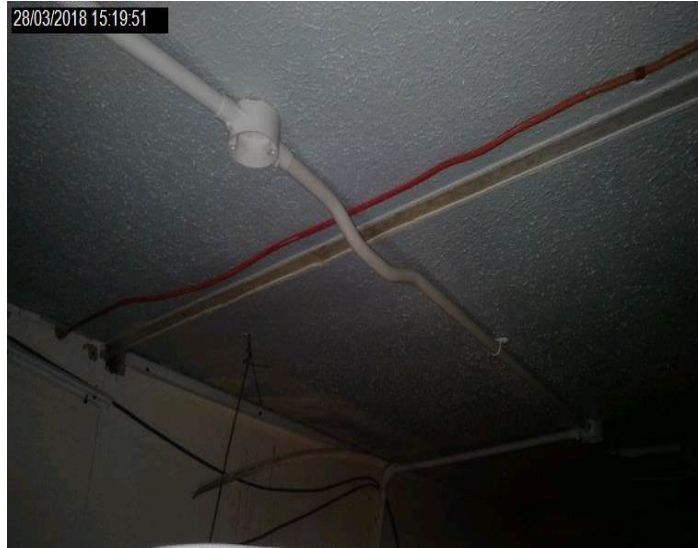
Location:	2.07 Retail Unit	Block:	Commercial	Floor Level: 1st Floor
Sample No.:	As DU001066	Portal Ref No.:	71

Item:	Asbestos Textured coating to concrete ceiling			
Asbestos Content:	Result Based on:			
Chrysotile	Strongly presumed			
Sample Analysed By:	Not applicable	Extent:	30 m ²	
Comments:

Material Assessment Total Score: 3		Likelihood of Disturbance Assessment Total Score: 5		Management Assessment Licensable: No Recommendations: Program removal Reinspection Interval: Not Applicable Overall Risk Category: C8
Product Type:	1 (Asbestos textured coating)	Location:	2 (Rooms up to 100 sq m)	
Condition:	1 (Minor scratches)	Accessibility:	1 (Occasionally likely to be disturbed)	
Surface Treatment:	0 (Composite material)			
Asbestos Type:	1 (Chrysotile)	Extent Score:	2 (>10 - <50 sq m or >10m - <50m pipe run)

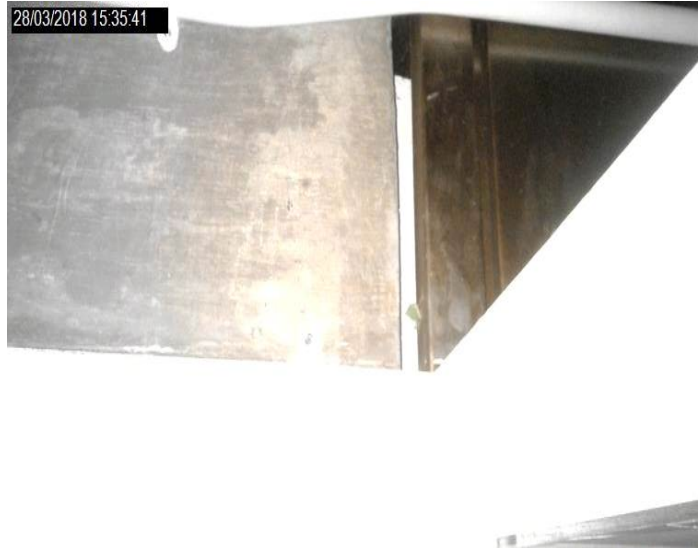
Location:	2.18 Retail unit	Block:	Commercial	Floor Level: 1st Floor
Sample No.:	DU001070	Portal Ref No.:	73

Item:	Insulating board			
Asbestos Content:		Result Based on:		
No Asbestos Detected		Analysis of sample using PLM		
Sample Analysed By:	Reg 13(1)	Extent:	1 m ²	
Comments: Behind metal panel above lift doors

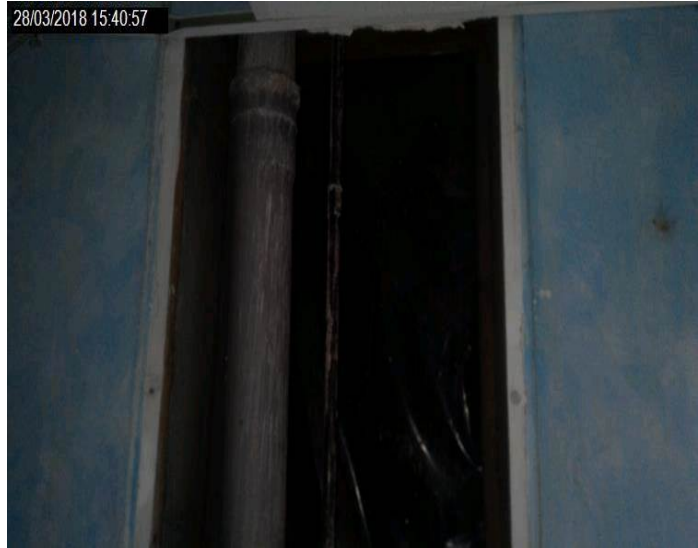
Location:	2.10 Retail Unit	Block:	Commercial	Floor Level: 1st Floor
Sample No.:	DU001071	Portal Ref No.:	74

Item:	Insulating board panel to risers			
Asbestos Content:		Result Based on:		
No Asbestos Detected		Analysis of sample using PLM		
Sample Analysed By:	Reg 13(1)	Extent:	9 m ²	
Comments: 3 sets of riser panels

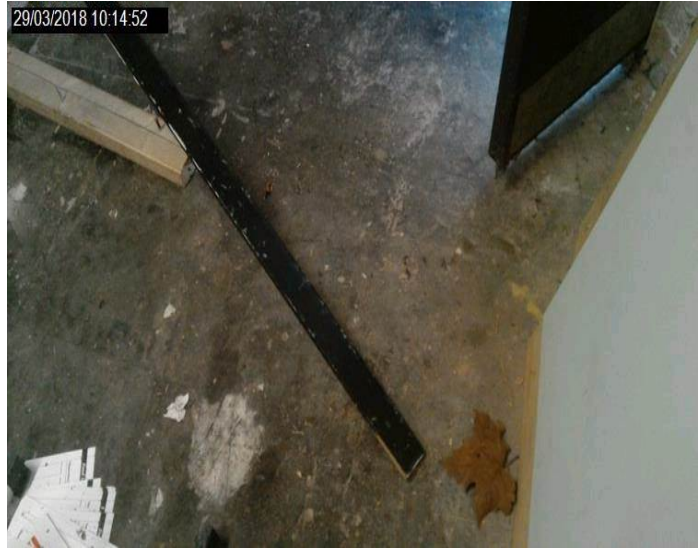
Location:	2.26 Office	Block:	Commercial	Floor Level: 1st Floor
Sample No.:	DU001077	Portal Ref No.:	84

Item:	Asbestos Bitumen adhesive			
Asbestos Content:	Result Based on:			
Chrysotile	Analysis of sample using PLM			
Sample Analysed By:	Reg 13(1)	Extent:	20 m ²	
Comments: Includes small amount of thermoplastic floor tile debris

Material Assessment Total Score: 3		Likelihood of Disturbance Assessment Total Score: 7		Management Assessment Licensable: No Recommendations: Program removal Reinspection Interval: Not Applicable Overall Risk Category: C10
Product Type:	1 (Asbestos bitumen)	Location:	2 (Rooms up to 100 sq m)	
Condition:	1 (Minor scratches)	Accessibility:	3 (Routinely disturbed)	
Surface Treatment:	0 (Composite material)			
Asbestos Type:	1 (Chrysotile)	Extent Score:	2 (>10 - <50 sq m or >10m - <50m pipe run)

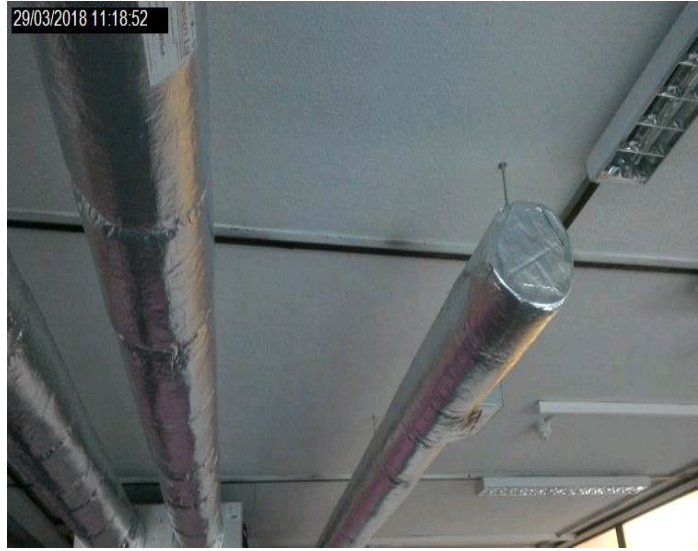
Location:	3.01 Student Area	Block:	Commercial	Floor Level: 2nd Floor
Sample No.:	As DU001080	Portal Ref No.:	95

Item:	Asbestos Textured coating to concrete ceiling			
Asbestos Content:	Result Based on:			
Chrysotile	Strongly presumed			
Sample Analysed By:	Not applicable	Extent:	60 m ²	
Comments:

Material Assessment Total Score: 3		Likelihood of Disturbance Assessment Total Score: 6		Management Assessment Licensable: No Recommendations: Program removal Reinspection Interval: Not Applicable Overall Risk Category: C9
Product Type:	1 (Asbestos textured coating)	Location:	2 (Rooms up to 100 sq m)	
Condition:	1 (Minor scratches)	Accessibility:	1 (Occasionally likely to be disturbed)	
Surface Treatment:	0 (Composite material)			
Asbestos Type:	1 (Chrysotile)	Extent Score:	3 (>50 sq m or >50m pipe run)

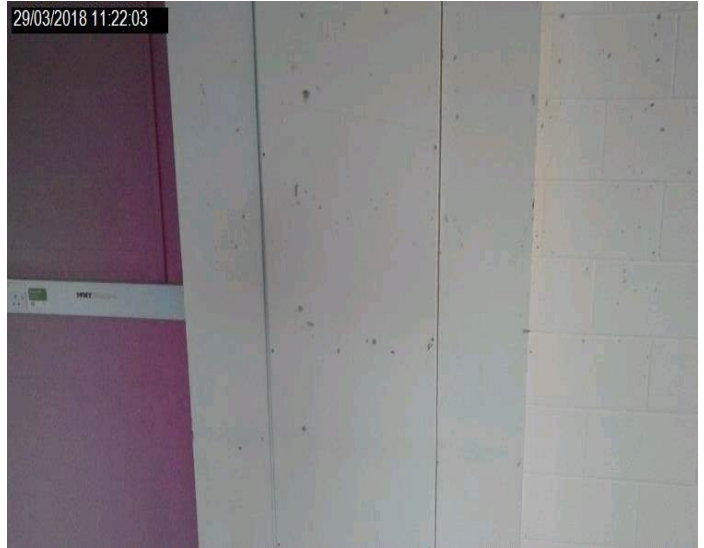
Location:	3.01 Student Area	Block:	Commercial	Floor Level: 2nd Floor
Sample No.:	As DU001082	Portal Ref No.:	97

Item:	Insulating board panel to riser			
Asbestos Content:		Result Based on:		
No Asbestos Detected		Strongly presumed		
Sample Analysed By:	Not applicable	Extent:	3 m ²	
Comments:

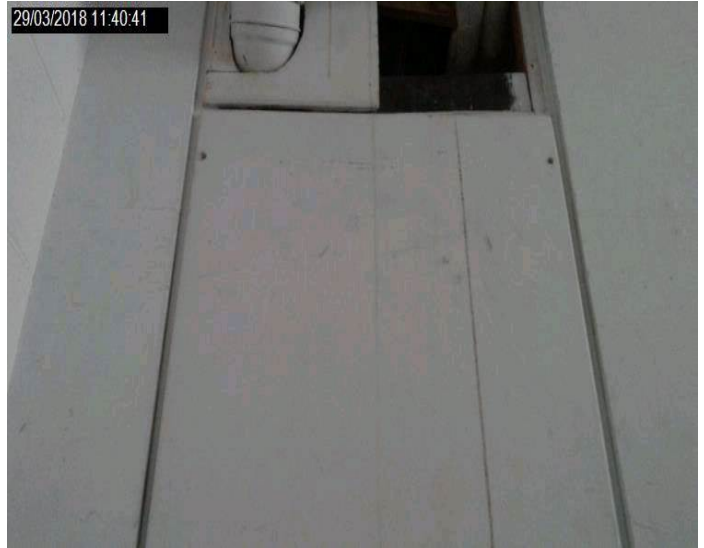
Location:	3.16 Store	Block:	Commercial	Floor Level: 2nd Floor
Sample No.:	As DU001082	Portal Ref No.:	102

Item:	Insulating board panel to riser			
Asbestos Content:		Result Based on:		
No Asbestos Detected		Strongly presumed		
Sample Analysed By:	Not applicable	Extent:	3 m ²	
Comments:

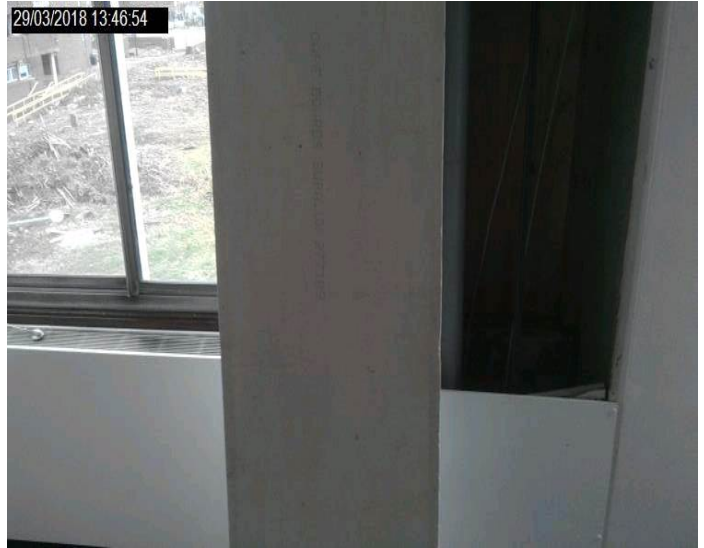
Location:	3.06 Office	Block:	Commercial	Floor Level: 2nd Floor
Sample No.:	As DU001086	Portal Ref No.:	115

Item:	Insulating board panel to riser			
Asbestos Content:		Result Based on:		
No Asbestos Detected		Strongly presumed		
Sample Analysed By:	Not applicable	Extent:	3 m ²	
Comments:

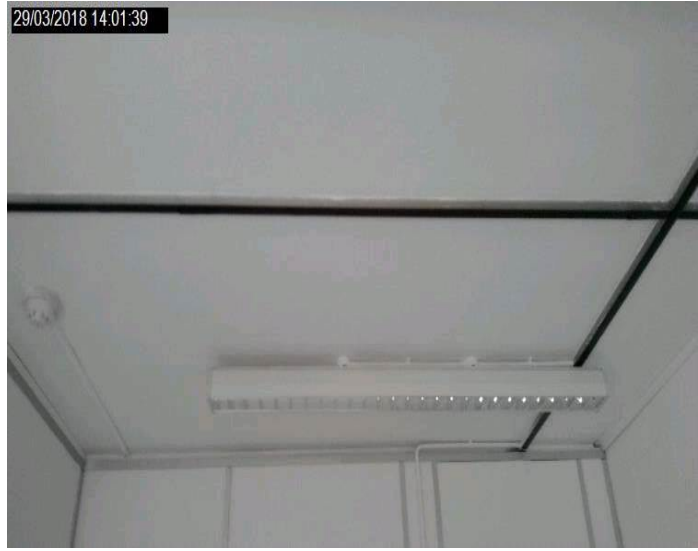
Location:	3.10 Office	Block:	Commercial	Floor Level: 2nd Floor
Sample No.:	As DU001090	Portal Ref No.:	120

Item:	Asbestos Textured coating to concrete ceiling			
Asbestos Content:	Result Based on:			
Chrysotile	Strongly presumed			
Sample Analysed By:	Not applicable	Extent:	10 m ²	
Comments:

Material Assessment Total Score: 3		Likelihood of Disturbance Assessment Total Score: 5		Management Assessment Licensable: No Recommendations: Program removal Reinspection Interval: Not Applicable Overall Risk Category: C8
Product Type:	1 (Asbestos textured coating)	Location:	2 (Rooms up to 100 sq m)	
Condition:	1 (Minor scratches)	Accessibility:	1 (Occasionally likely to be disturbed)	
Surface Treatment:	0 (Composite material)			
Asbestos Type:	1 (Chrysotile)	Extent Score:	2 (>10 - <50 sq m or >10m - <50m pipe run)

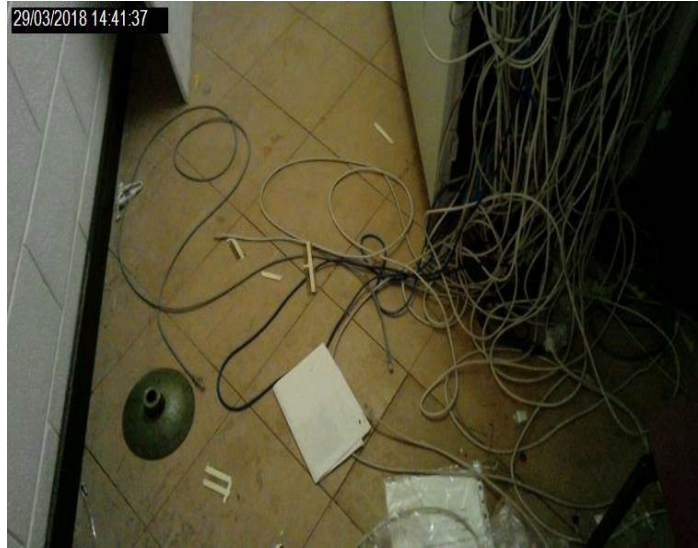
Location:	3.17 Store	Block:	Commercial	Floor Level: 2nd Floor
Sample No.:	As DU001094	Portal Ref No.:	131

Item:	Asbestos Thermoplastic floor tiles with bitumen adhesive			
Asbestos Content:	Result Based on:			
Chrysotile in adhesive only	Strongly presumed			
Sample Analysed By:	Not applicable	Extent:	6 m ²	
Comments:

Material Assessment Total Score: 3		Likelihood of Disturbance Assessment Total Score: 6		Management Assessment Licensable: No Recommendations: Program removal Reinspection Interval: Not Applicable Overall Risk Category: C9
Product Type:	1 (Asbestos thermoplastic)	Location:	2 (Rooms up to 100 sq m)	
Condition:	1 (Minor scratches)	Accessibility:	3 (Routinely disturbed)	
Surface Treatment:	0 (Composite material)			
Asbestos Type:	1 (Chrysotile)	Extent Score:	1 (<10 sq m or 10m pipe run)

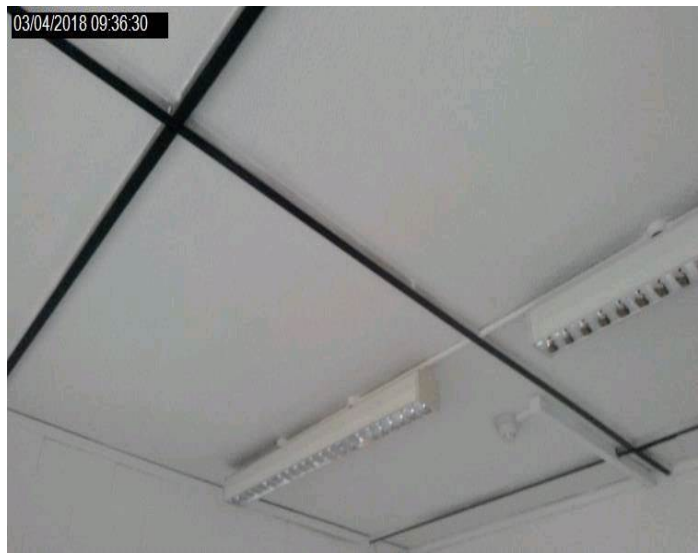
Location:	3.20 Office	Block:	Commercial	Floor Level: 2nd Floor
Sample No.:	DU001099	Portal Ref No.:	139

Item:	Asbestos Textured coating to concrete ceiling			
Asbestos Content:	Result Based on:			
Chrysotile	Analysis of sample using PLM			
Sample Analysed By:	Reg 13(1)	Extent:	20 m ²	
Comments:

Material Assessment Total Score: 3		Likelihood of Disturbance Assessment Total Score: 5		Management Assessment Licensable: No Recommendations: Program removal Reinspection Interval: Not Applicable Overall Risk Category: C8
Product Type:	1 (Asbestos textured coating)	Location:	2 (Rooms up to 100 sq m)	
Condition:	1 (Minor scratches)	Accessibility:	1 (Occasionally likely to be disturbed)	
Surface Treatment:	0 (Composite material)			
Asbestos Type:	1 (Chrysotile)	Extent Score:	2 (>10 - <50 sq m or >10m - <50m pipe run)

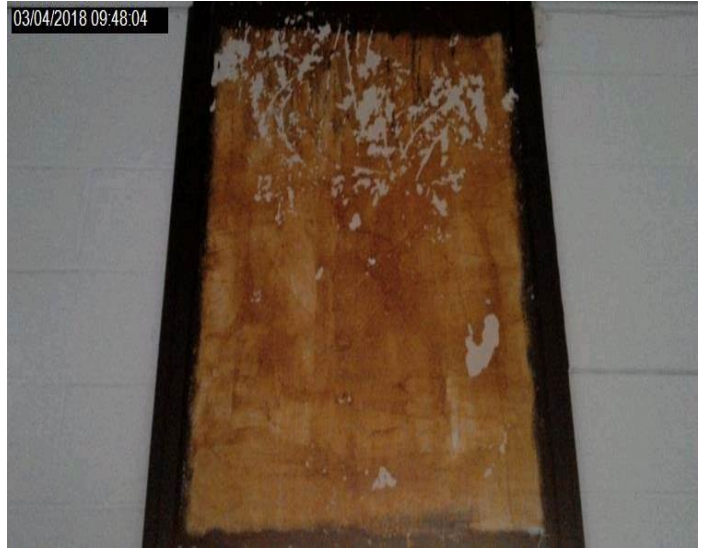
Location:	3.23 Office	Block:	Commercial	Floor Level: 2nd Floor
Sample No.:	DU001101	Portal Ref No.:	142

Item:	Insulating board door header panel			
Asbestos Content:	Result Based on:			
No Asbestos Detected	Analysis of sample using PLM			
Sample Analysed By: Reg 13(1)	Extent:	2 m ²		
Comments: Double skin

Material Assessment Total Score: 0		Likelihood of Disturbance Assessment Total Score: 0		Management Assessment Licensable: Yes Recommendations: Not Applicable Reinspection Interval: Not Applicable Overall Risk Category: E0
Product Type:	0 Not Applicable	Location:	0 Not Applicable	
Condition:	0 Not Applicable	Accessibility:	0 Not Applicable	
Surface Treatment:	0 Not Applicable			
Asbestos Type:	0 Not Applicable	Extent Score:	0 Not Applicable

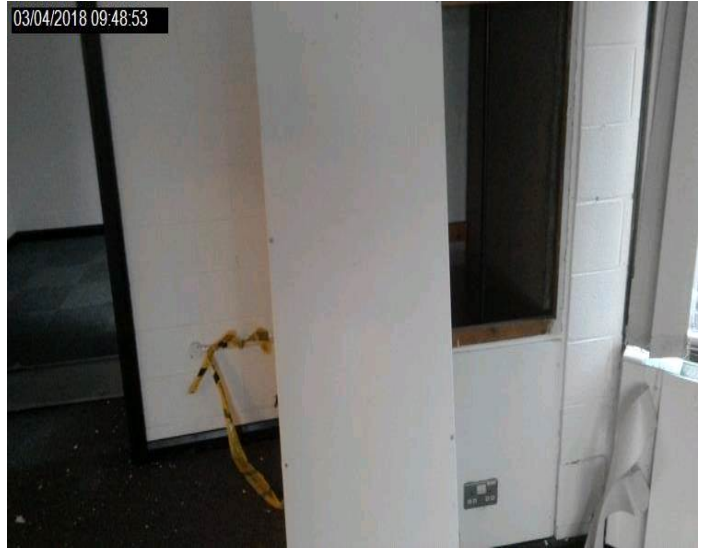
Location:	3.23 Office	Block:	Commercial	Floor Level: 2nd Floor
Sample No.:	DU001102	Portal Ref No.:	143

Item:	Insulating board panel to riser			
Asbestos Content:		Result Based on:		
No Asbestos Detected		Analysis of sample using PLM		
Sample Analysed By:	Reg 13(1)	Extent:	6 m ²	
Comments: Riser panels to two risers in the room

Material Assessment Total Score: 0		Likelihood of Disturbance Assessment Total Score: 0		Management Assessment Licensable: Yes Recommendations: Not Applicable Reinspection Interval: Not Applicable Overall Risk Category: E0
Product Type:	0 Not Applicable	Location:	0 Not Applicable	
Condition:	0 Not Applicable	Accessibility:	0 Not Applicable	
Surface Treatment:	0 Not Applicable			
Asbestos Type:	0 Not Applicable	Extent Score:	0 Not Applicable

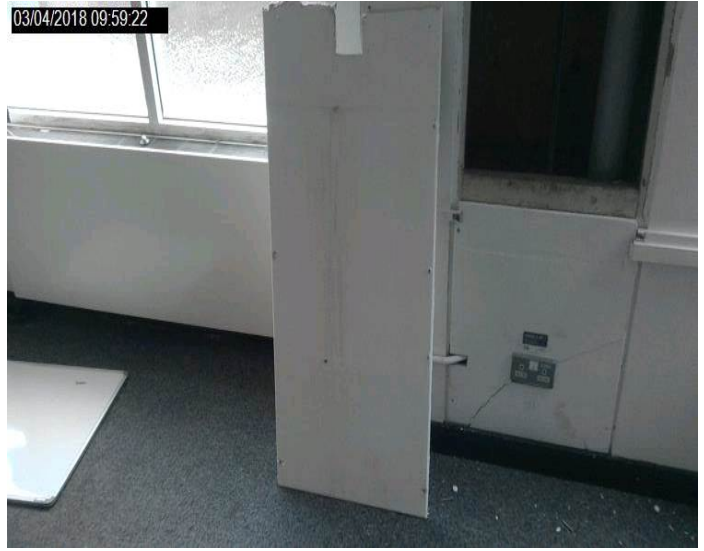
Location:	3.25 Office	Block:	Commercial	Floor Level: 2nd Floor
Sample No.:	As DU001102	Portal Ref No.:	150

Item:	Insulating board panel to riser			
Asbestos Content:		Result Based on:		
No Asbestos Detected		Strongly presumed		
Sample Analysed By:	Not applicable	Extent:	2 m ²	
Comments: Non suspect board top of riser

Material Assessment Total Score: 0		Likelihood of Disturbance Assessment Total Score: 0		Management Assessment Licensable: Yes Recommendations: Not Applicable Reinspection Interval: Not Applicable Overall Risk Category: E0
Product Type:	0 Not Applicable	Location:	0 Not Applicable	
Condition:	0 Not Applicable	Accessibility:	0 Not Applicable	
Surface Treatment:	0 Not Applicable			
Asbestos Type:	0 Not Applicable	Extent Score:	0 Not Applicable

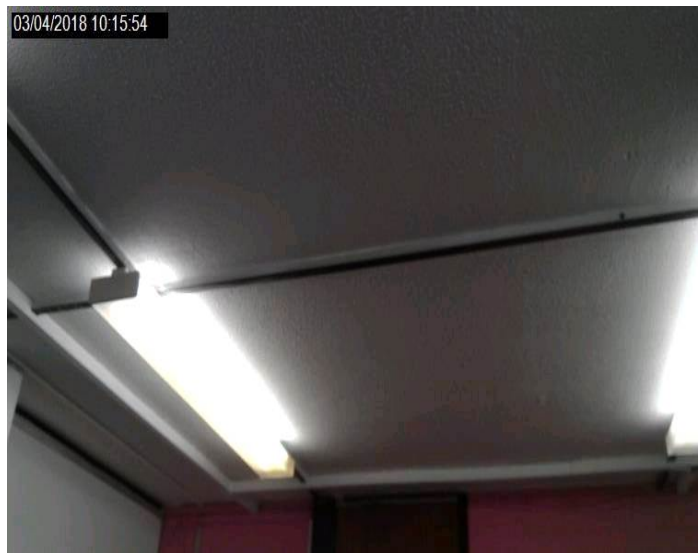
Location:	3.99C Corridor	Block:	Commercial	Floor Level: 2nd Floor
Sample No.:	As DU001099	Portal Ref No.:	152

Item:	Asbestos Textured coating to concrete ceiling			
Asbestos Content:	Result Based on:			
Chrysotile	Strongly presumed			
Sample Analysed By:	Not applicable	Extent:	30 m ²	
Comments:

Material Assessment Total Score: 3		Likelihood of Disturbance Assessment Total Score: 5		Management Assessment Licensable: No Recommendations: Program removal Reinspection Interval: Not Applicable Overall Risk Category: C8
Product Type:	1 (Asbestos textured coating)	Location:	2 (Rooms up to 100 sq m)	
Condition:	1 (Minor scratches)	Accessibility:	1 (Occasionally likely to be disturbed)	
Surface Treatment:	0 (Composite material)			
Asbestos Type:	1 (Chrysotile)	Extent Score:	2 (>10 - <50 sq m or >10m - <50m pipe run)

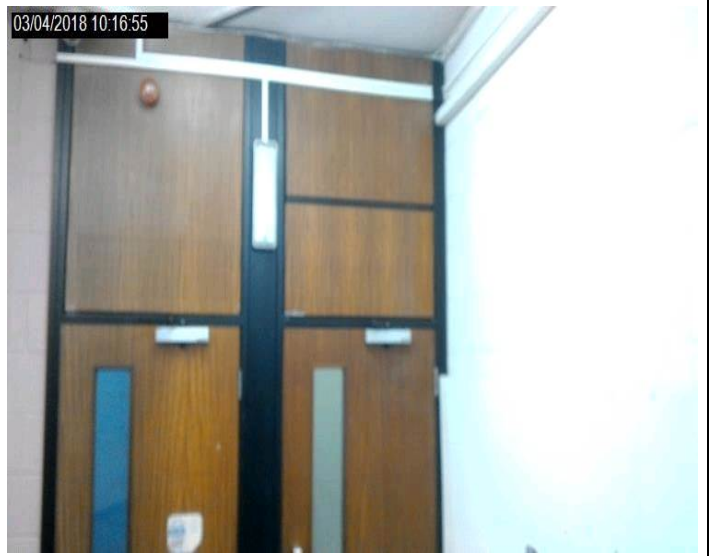
Location:	3.99C Corridor	Block:	Commercial	Floor Level: 2nd Floor
Sample No.:	DU001104	Portal Ref No.:	153

Item:	Asbestos Insulating board door header			
Asbestos Content:	Result Based on:			
Chrysotile Amosite	Analysis of sample using PLM			
Sample Analysed By: Reg 13(1)	Extent:	2 m ²		
Comments: Double skin behind timber panel, to right hand side door in the picture leading from corridor 3.99B

Material Assessment Total Score: 6		Likelihood of Disturbance Assessment Total Score: 4		Management Assessment Licensable: Yes Recommendations: Program removal Reinspection Interval: Not Applicable Overall Risk Category: C10
Product Type:	2 (Asbestos insulating board)	Location:	2 (Rooms up to 100 sq m)	
Condition:	1 (Minor scratches)	Accessibility:	1 (Occasionally likely to be disturbed)	
Surface Treatment:	1 (Enclosed asbestos insulating board)			
Asbestos Type:	2 (Chrysotile Amosite)	Extent Score:	1 (<10 sq m or 10m pipe run)

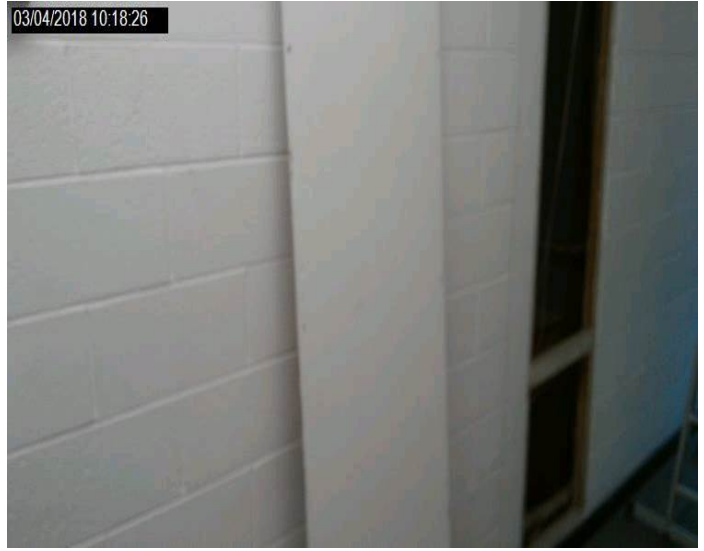
Location:	3.99C Corridor	Block:	Commercial	Floor Level: 2nd Floor
Sample No.:	DU001105	Portal Ref No.:	154

Item:	Insulating board panel to service duct			
Asbestos Content:		Result Based on:		
No Asbestos Detected		Analysis of sample using PLM		
Sample Analysed By:	Reg 13(1)	Extent:	3 m ²	
Comments:

Material Assessment Total Score: 0		Likelihood of Disturbance Assessment Total Score: 0		Management Assessment Licensable: Yes Recommendations: Not Applicable Reinspection Interval: Not Applicable Overall Risk Category: E0
Product Type:	0 Not Applicable	Location:	0 Not Applicable	
Condition:	0 Not Applicable	Accessibility:	0 Not Applicable	
Surface Treatment:	0 Not Applicable			
Asbestos Type:	0 Not Applicable	Extent Score:	0 Not Applicable

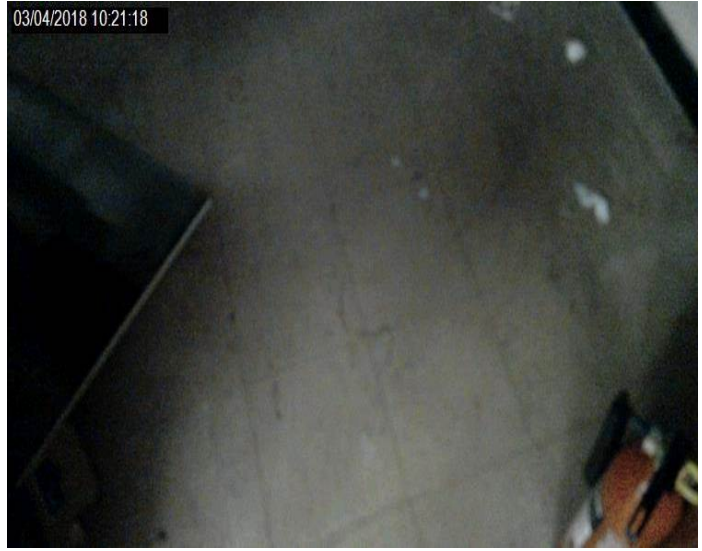
Location:	3.26 Store	Block:	Commercial	Floor Level: 2nd Floor
Sample No.:	DU001106	Portal Ref No.:	155

Item:	Asbestos Thermoplastic floor tiles with bitumen adhesive			
Asbestos Content:	Result Based on:			
Chrysotile in adhesive only	Analysis of sample using PLM			
Sample Analysed By: Reg 13(1)	Extent:	6 m ²		
Comments:

Material Assessment Total Score: 3		Likelihood of Disturbance Assessment Total Score: 6		Management Assessment Licensable: No Recommendations: Program removal Reinspection Interval: Not Applicable Overall Risk Category: C9
Product Type:	1 (Asbestos thermoplastic)	Location:	2 (Rooms up to 100 sq m)	
Condition:	1 (Minor scratches)	Accessibility:	3 (Routinely disturbed)	
Surface Treatment:	0 (Composite material)			
Asbestos Type:	1 (Chrysotile)	Extent Score:	1 (<10 sq m or 10m pipe run)

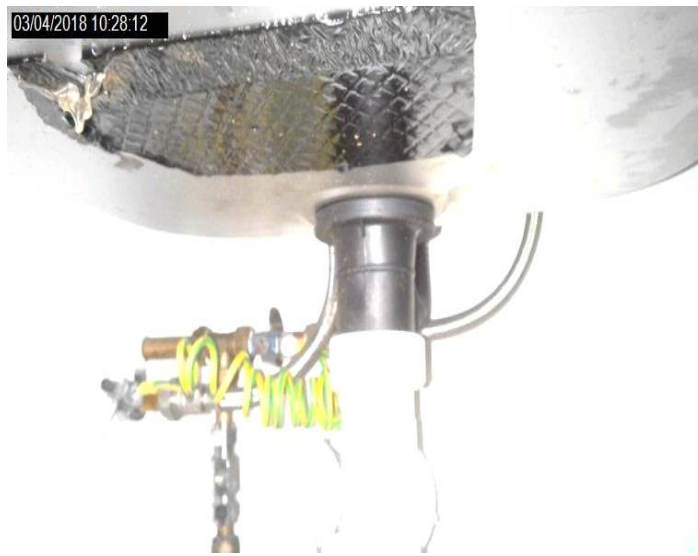
Location:	3.28 Kitchen	Block:	Commercial	Floor Level: 2nd Floor
Sample No.:	DU001107	Portal Ref No.:	156

Item:	Bitumen sink pad			
Asbestos Content:		Result Based on:		
No Asbestos Detected		Analysis of sample using PLM		
Sample Analysed By:	Reg 13(1)	Extent:	1 unit	
Comments:

Material Assessment Total Score: 0		Likelihood of Disturbance Assessment Total Score: 0		Management Assessment Licensable: No Recommendations: Not Applicable Reinspection Interval: Not Applicable Overall Risk Category: E0
Product Type:	0 Not Applicable	Location:	0 Not Applicable	
Condition:	0 Not Applicable	Accessibility:	0 Not Applicable	
Surface Treatment:	0 Not Applicable			
Asbestos Type:	0 Not Applicable	Extent Score:	0 Not Applicable

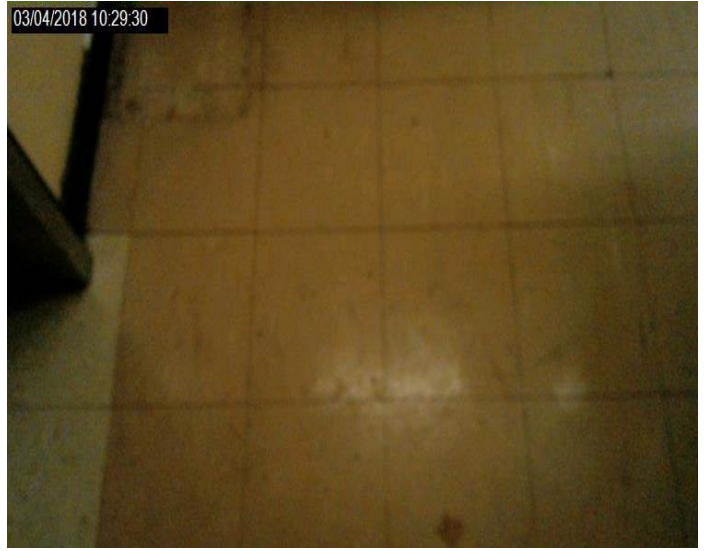
Location:	3.28 Kitchen	Block:	Commercial	Floor Level: 2nd Floor
Sample No.:	As DU001106	Portal Ref No.:	157

Item:	Asbestos Thermoplastic floor tiles with bitumen adhesive			
Asbestos Content:	Result Based on:			
Chrysotile in adhesive only	Strongly presumed			
Sample Analysed By:	Not applicable	Extent:	4 m ²	
Comments:

Material Assessment Total Score: 3		Likelihood of Disturbance Assessment Total Score: 6		Management Assessment Licensable: No Recommendations: Program removal Reinspection Interval: Not Applicable Overall Risk Category: C9
Product Type:	1 (Asbestos thermoplastic)	Location:	2 (Rooms up to 100 sq m)	
Condition:	1 (Minor scratches)	Accessibility:	3 (Routinely disturbed)	
Surface Treatment:	0 (Composite material)			
Asbestos Type:	1 (Chrysotile)	Extent Score:	1 (<10 sq m or 10m pipe run)

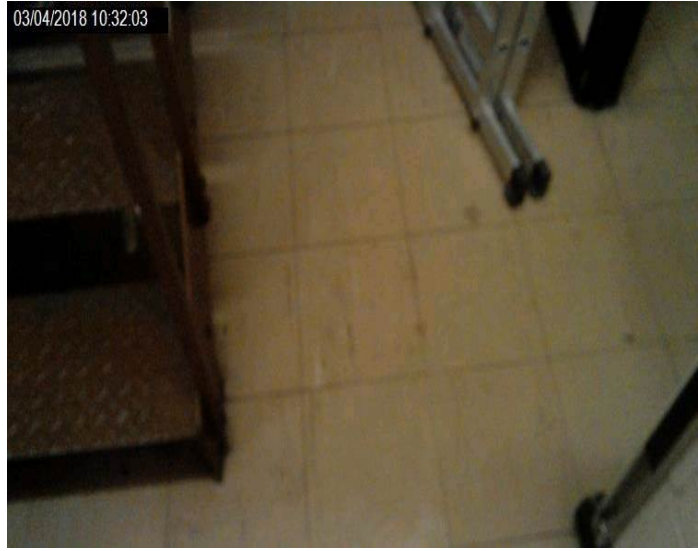
Location:	3.27 Store	Block:	Commercial	Floor Level: 2nd Floor
Sample No.:	As DU001106	Portal Ref No.:	159

Item:	Asbestos Thermoplastic floor tiles with bitumen adhesive			
Asbestos Content:	Result Based on:			
Chrysotile in adhesive only	Strongly presumed			
Sample Analysed By:	Not applicable	Extent:	4 m ²	
Comments:

Material Assessment Total Score: 3		Likelihood of Disturbance Assessment Total Score: 6		Management Assessment Licensable: No Recommendations: Program removal Reinspection Interval: Not Applicable Overall Risk Category: C9
Product Type:	1 (Asbestos thermoplastic)	Location:	2 (Rooms up to 100 sq m)	
Condition:	1 (Minor scratches)	Accessibility:	3 (Routinely disturbed)	
Surface Treatment:	0 (Composite material)			
Asbestos Type:	1 (Chrysotile)	Extent Score:	1 (<10 sq m or 10m pipe run)

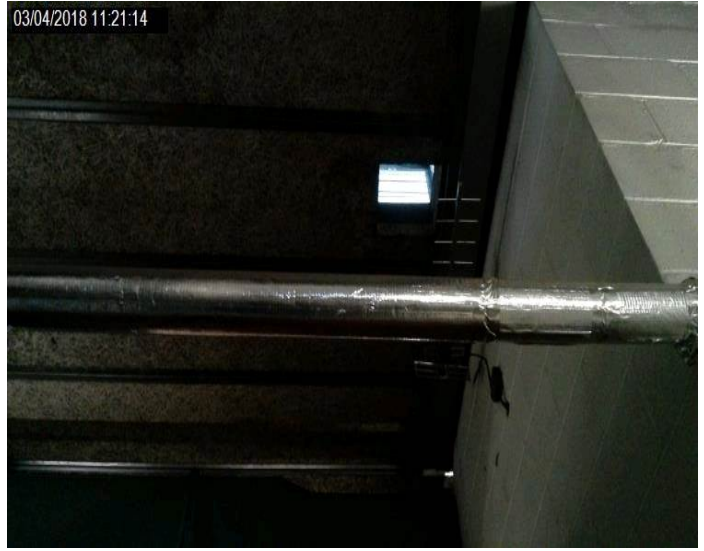
Location:	4.01 Plant Room	Block:	Commercial	Floor Level: 3rd Floor
Sample No.:	DU001110	Portal Ref No.:	161

Item:	Cement sheet to compressed straw board			
Asbestos Content:	Result Based on:			
No Asbestos Detected	Analysis of sample using PLM			
Sample Analysed By: Reg 13(1)	Extent:	30 m ²		
Comments:

Material Assessment Total Score: 0		Likelihood of Disturbance Assessment Total Score: 0		Management Assessment Licensable: No Recommendations: Not Applicable Reinspection Interval: Not Applicable Overall Risk Category: E0
Product Type:	0 Not Applicable	Location:	0 Not Applicable	
Condition:	0 Not Applicable	Accessibility:	0 Not Applicable	
Surface Treatment:	0 Not Applicable			
Asbestos Type:	0 Not Applicable	Extent Score:	0 Not Applicable

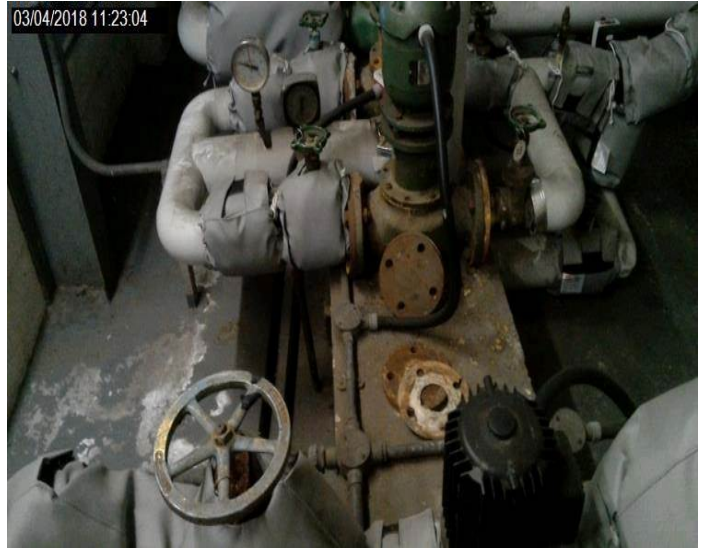
Location:	4.01 Plant Room	Block:	Commercial	Floor Level: 3rd Floor
Sample No.:	DU001112	Portal Ref No.:	163

Item:	Asbestos Compressed fibre gasket			
Asbestos Content:	Result Based on:			
Chrysotile	Analysis of sample using PLM			
Sample Analysed By: Reg 13(1)	Extent:	40 units		
Comments: To all pipework sections and lying loose

Material Assessment Total Score: 5		Likelihood of Disturbance Assessment Total Score: 4		Management Assessment Licensable: No Recommendations: Program removal Reinspection Interval: Not Applicable Overall Risk Category: C9
Product Type:	2 (Compressed asbestos fibre)	Location:	2 (Rooms up to 100 sq m)	
Condition:	1 (Minor scratches)	Accessibility:	1 (Occasionally likely to be disturbed)	
Surface Treatment:	1 (Unencapsulated textile/paper)			
Asbestos Type:	1 (Chrysotile)	Extent Score:	1 (<10 sq m or 10m pipe run)

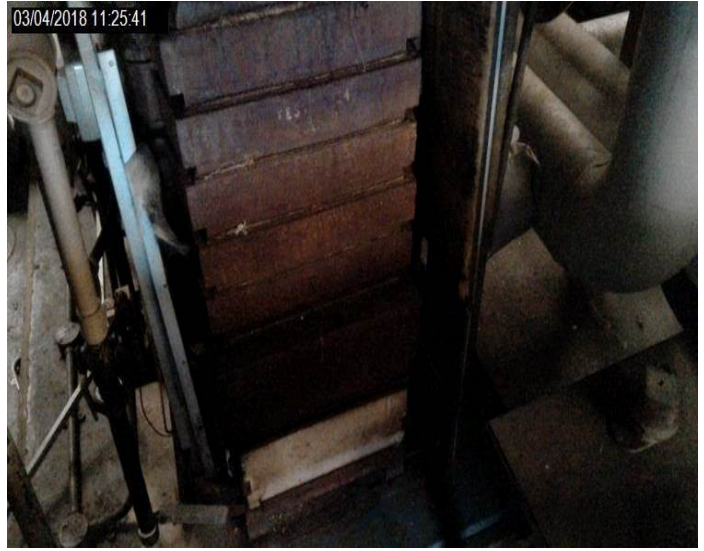
Location:	4.01 Plant Room	Block:	Commercial	Floor Level: 3rd Floor
Sample No.:	DU001113	Portal Ref No.:	164

Item:	Asbestos Textile seal to cast iron sections			
Asbestos Content:	Result Based on:			
Chrysotile	Analysis of sample using PLM			
Sample Analysed By: Reg 13(1)	Extent:	40 linear metres		
Comments: 8 boilers, 5 or 6 sections to each

Material Assessment Total Score: 6		Likelihood of Disturbance Assessment Total Score: 5		Management Assessment Licensable: No Recommendations: Program removal Reinspection Interval: Not Applicable Overall Risk Category: B11
Product Type:	2 (Asbestos textile)	Location:	2 (Rooms up to 100 sq m)	
Condition:	1 (Minor scratches)	Accessibility:	1 (Occasionally likely to be disturbed)	
Surface Treatment:	2 (Unencapsulated textile/paper)			
Asbestos Type:	1 (Chrysotile)	Extent Score:	2 (>10 - <50 sq m or >10m - <50m pipe run)

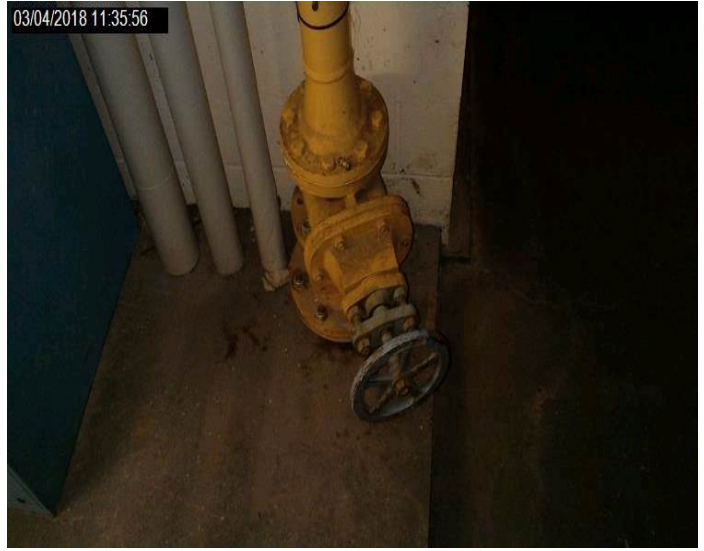
Location:	4.03	Block:	Commercial	Floor Level: 3rd Floor
Sample No.:	DU001114	Portal Ref No.:	166

Item:	Compressed fibre gaskets to pipework			
Asbestos Content:	Result Based on:			
No Asbestos Detected	Analysis of sample using PLM			
Sample Analysed By: Reg 13(1)	Extent:	4 units		
Comments: To yellow pipework

Material Assessment Total Score: 0		Likelihood of Disturbance Assessment Total Score: 0		Management Assessment Licensable: No Recommendations: Not Applicable Reinspection Interval: Not Applicable Overall Risk Category: E0
Product Type:	0 Not Applicable	Location:	0 Not Applicable	
Condition:	0 Not Applicable	Accessibility:	0 Not Applicable	
Surface Treatment:	0 Not Applicable			
Asbestos Type:	0 Not Applicable	Extent Score:	0 Not Applicable

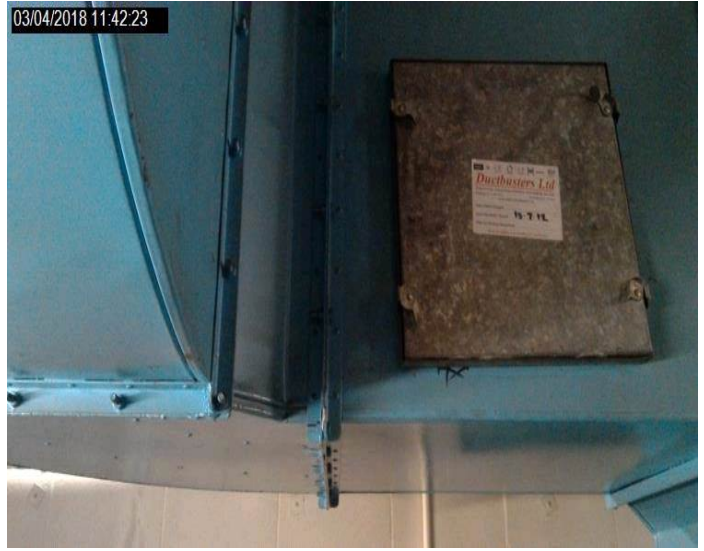
Location:	4.02	Block:	Commercial	Floor Level: 3rd Floor
Sample No.:	DU001115	Portal Ref No.:	169

Item:	Asbestos Mastic seal to metal ductwork			
Asbestos Content:	Result Based on:			
Chrysotile	Analysis of sample using PLM			
Sample Analysed By: Reg 13(1)	Extent:	20 linear metres		
Comments: Present to all joints on blue ducting.

Material Assessment Total Score: 3		Likelihood of Disturbance Assessment Total Score: 5		Management Assessment Licensable: No Recommendations: Program removal Reinspection Interval: Not Applicable Overall Risk Category: C8
Product Type:	1 (Asbestos Mastic)	Location:	2 (Rooms up to 100 sq m)	
Condition:	1 (Minor scratches)	Accessibility:	1 (Occasionally likely to be disturbed)	
Surface Treatment:	0 (Composite material)			
Asbestos Type:	1 (Chrysotile)	Extent Score:	2 (>10 - <50 sq m or >10m - <50m pipe run)

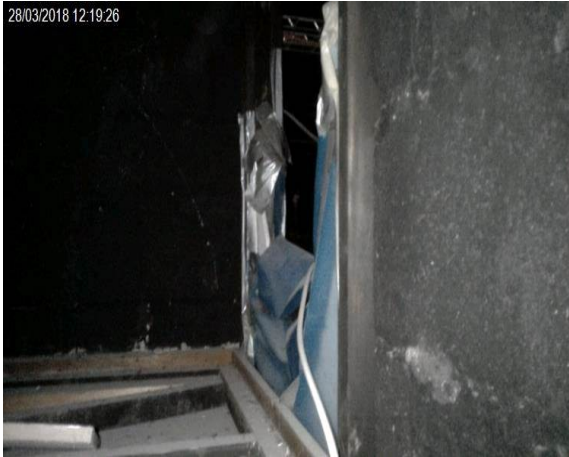
Intrusion 026 - Void runs in line with the lift shaft pre cast concrete

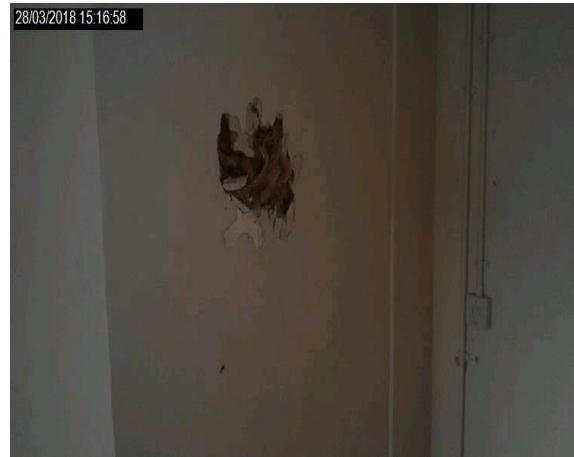
Intrusion 031 - Plasterboard to timber

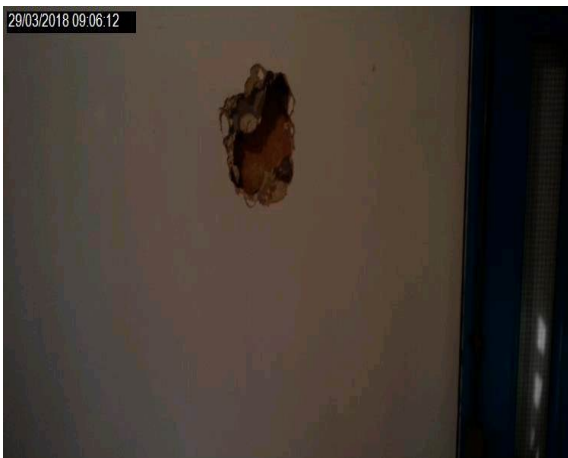
Intrusion 032 - Plasterboard to concrete pillar

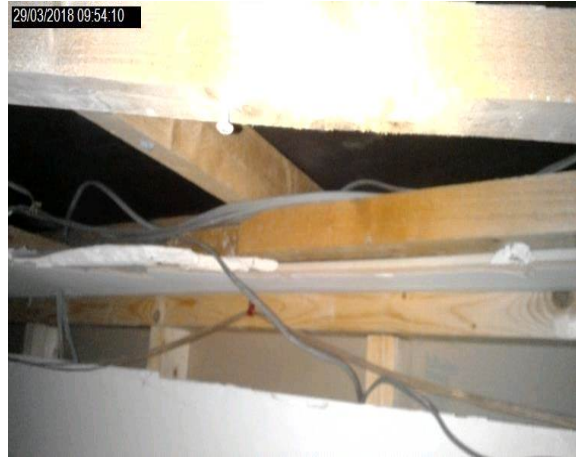
Intrusion 035 - Timber frame stage

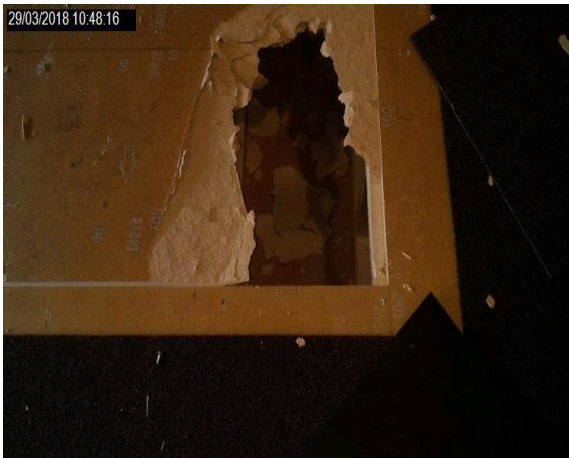
Intrusion 036 - Modern vinyl to concrete

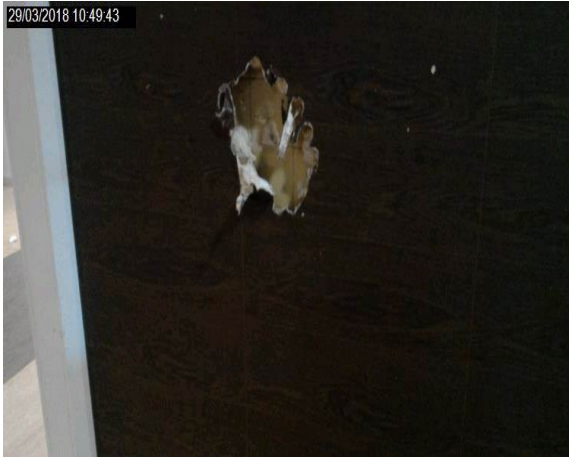
Intrusion 038 - Timber panels to block column

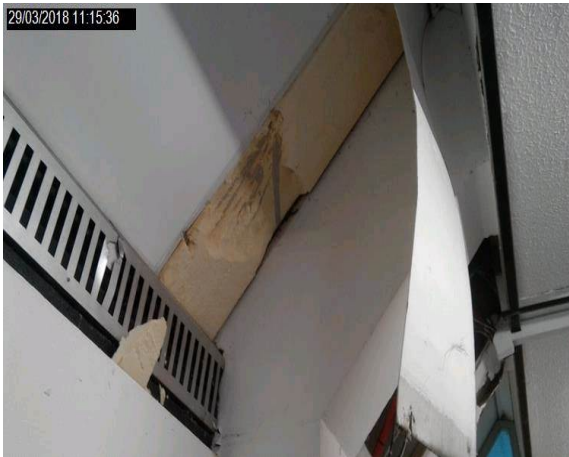
Intrusion 040 - Metal grate to heating pipes polystyrene behind to steel joists
