**Report No.:** J094042  
**Nature of Work:** Demolition Survey  
**Issue Date:** 29/05/2018  
**Client Name:** WYG Engineering Ltd  
Geneva Building, Lake View Drive, Sherwood Business Park,  
Annesley, Nottingham, NG15 0ED  
**Site Address:** Cox Building, Former City North Campus, Birmingham City  
University, Perry Barr, B42 2US

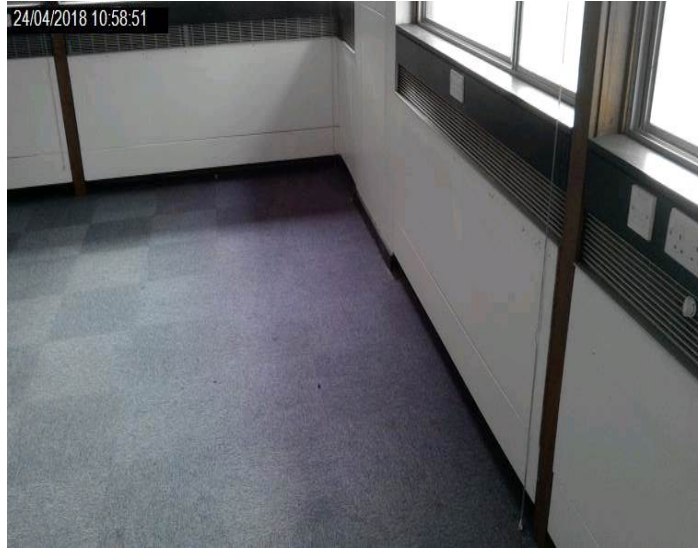
<b>Location:</b>	3.12	<b>Block:</b>	Commercial	<b>Floor Level:</b> 2nd Floor
<b>Sample No.:</b>	DU001272	<b>Portal Ref No.:</b>	6

<b>Item:</b>	Asbestos Cement shuttering			
<b>Asbestos Content:</b>	Chrysotile			
<b>Result Based on:</b>	Analysis of sample using PLM			
<b>Sample Analysed By:</b>	Reg 13(1)	<b>Extent:</b>	12 m <sup>2</sup>	
<b>Comments:</b> To ceiling of wall void, behind timber panels

<b>Material Assessment Total Score: 4</b>		<b>Likelihood of Disturbance Assessment Total Score: 5</b>		<b>Management Assessment</b>  <b>Licensable:</b> No  <b>Recommendations:</b> Program removal  <b>Reinspection Interval:</b> Not Applicable  <b>Overall Risk Category:</b> C9
<b>Product Type:</b>	1 (Asbestos cement)	<b>Location:</b>	2 (Rooms up to 100 sq m)	
<b>Condition:</b>	1 (Minor scratches)	<b>Accessibility:</b>	1 (Occasionally likely to be disturbed)	
<b>Surface Treatment:</b>	1 (Encapsulated asbestos cement)			
<b>Asbestos Type:</b>	1 (Chrysotile)	<b>Extent Score:</b>	2 (>10 - <50 sq m or >10m - <50m pipe run)

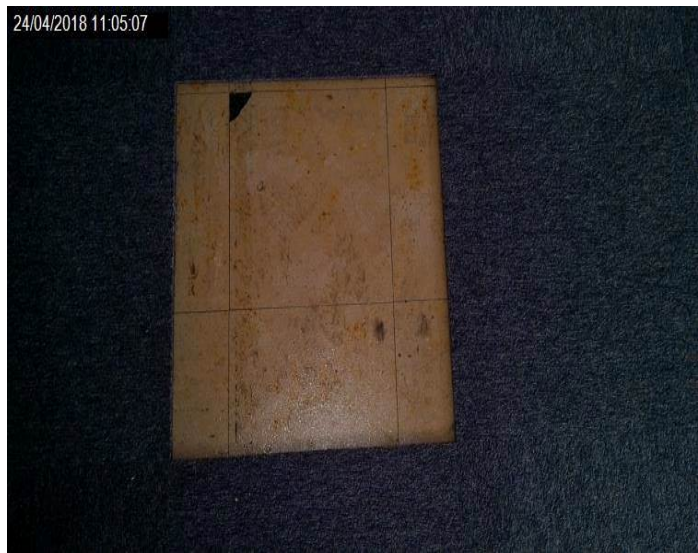
<b>Location:</b>	3.12	<b>Block:</b>	Commercial	<b>Floor Level:</b> 2nd Floor
<b>Sample No.:</b>	DU001273	<b>Portal Ref No.:</b>	7

<b>Item:</b>	Asbestos Thermoplastic floor tiles with bitumen adhesive			
<b>Asbestos Content:</b>	Result Based on:			
Chrysotile in tile and adhesive	Analysis of sample using PLM			
<b>Sample Analysed By:</b> Reg 13(1)	<b>Extent:</b>	36 m <sup>2</sup>		
<b>Comments:</b> Beneath carpet tiles

<b>Material Assessment Total Score: 3</b>		<b>Likelihood of Disturbance Assessment Total Score: 4</b>		<b>Management Assessment</b>  <b>Licensable:</b> No  <b>Recommendations:</b> Program removal  <b>Reinspection Interval:</b> Not Applicable  <b>Overall Risk Category:</b> C7
<b>Product Type:</b>	1 (Asbestos thermoplastic)	<b>Location:</b>	2 (Rooms up to 100 sq m)	
<b>Condition:</b>	1 (Minor scratches)	<b>Accessibility:</b>	0 (Usually inaccessible or unlikely to be disturbed)	
<b>Surface Treatment:</b>	0 (Composite material)			
<b>Asbestos Type:</b>	1 (Chrysotile)	<b>Extent Score:</b>	2 (>10 - <50 sq m or >10m - <50m pipe run)

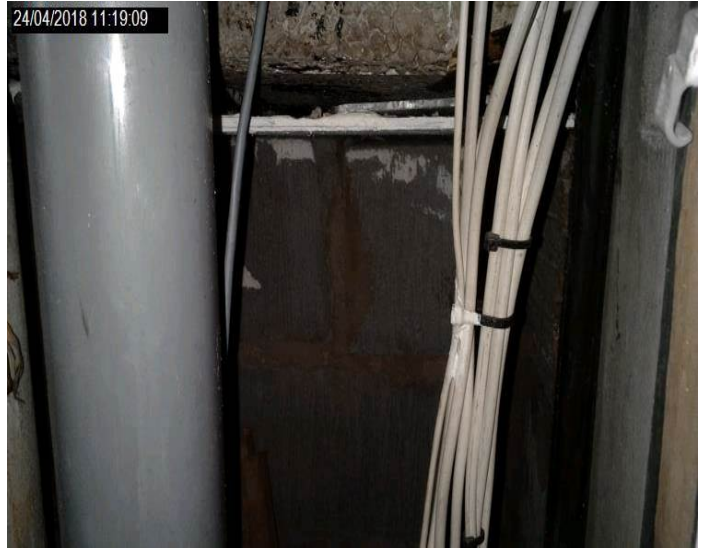
<b>Location:</b>	3.35	<b>Block:</b>	Commercial	<b>Floor Level:</b> 2nd Floor
<b>Sample No.:</b>	As DU001272	<b>Portal Ref No.:</b>	14

<b>Item:</b>	Asbestos Cement shuttering			
<b>Asbestos Content:</b>	<b>Result Based on:</b>			
Chrysotile	Strongly presumed			
<b>Sample Analysed By:</b>	Not applicable	<b>Extent:</b>	10 m <sup>2</sup>	
<b>Comments:</b> To ceiling of wall void, behind timber panels

<b>Material Assessment Total Score: 4</b>		<b>Likelihood of Disturbance Assessment Total Score: 4</b>		<b>Management Assessment</b>  <b>Licensable:</b> No  <b>Recommendations:</b> Program removal  <b>Reinspection Interval:</b> Not Applicable  <b>Overall Risk Category:</b> C8
<b>Product Type:</b>	1 (Asbestos cement)	<b>Location:</b>	2 (Rooms up to 100 sq m)	
<b>Condition:</b>	1 (Minor scratches)	<b>Accessibility:</b>	1 (Occasionally likely to be disturbed)	
<b>Surface Treatment:</b>	1 (Encapsulated asbestos cement)			
<b>Asbestos Type:</b>	1 (Chrysotile)	<b>Extent Score:</b>	1 (<10 sq m or 10m pipe run)

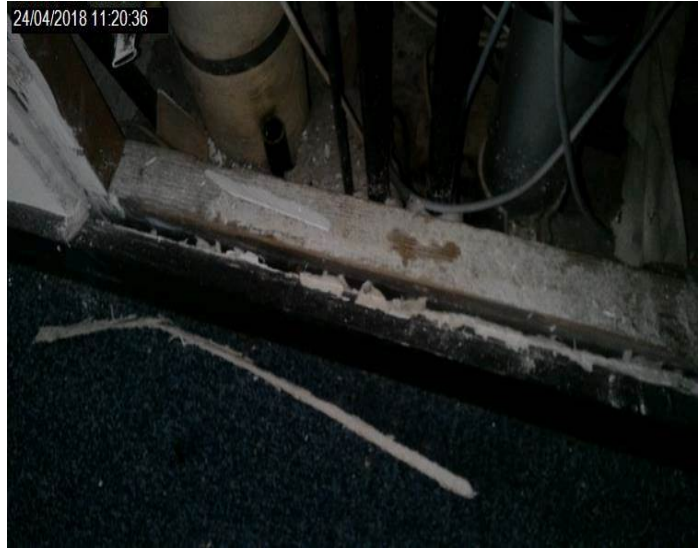
<b>Location:</b>	3.35	<b>Block:</b>	Commercial	<b>Floor Level:</b> 2nd Floor
<b>Sample No.:</b>	DU001276	<b>Portal Ref No.:</b>	19

<b>Item:</b>	Asbestos Insulating board debris to riser			
<b>Asbestos Content:</b>	Result Based on:			
Amosite	Analysis of sample using PLM			
<b>Sample Analysed By:</b> Reg 13(1)	<b>Extent:</b>	1 m <sup>2</sup>		
<b>Comments:</b> Potential for more of the item hidden within the riser

<b>Material Assessment Total Score: 9</b>		<b>Likelihood of Disturbance Assessment Total Score: 4</b>		<b>Management Assessment</b>  <b>Licensable:</b> Yes  <b>Recommendations:</b> Program removal  <b>Reinspection Interval:</b> Not Applicable  <b>Overall Risk Category:</b> B13
<b>Product Type:</b>	2 (Asbestos insulating board)	<b>Location:</b>	2 (Rooms up to 100 sq m)	
<b>Condition:</b>	3 (Significant damage)	<b>Accessibility:</b>	1 (Occasionally likely to be disturbed)	
<b>Surface Treatment:</b>	2 (Unencapsulated asbestos insulating board)			
<b>Asbestos Type:</b>	2 (Amosite)	<b>Extent Score:</b>	1 (<10 sq m or 10m pipe run)

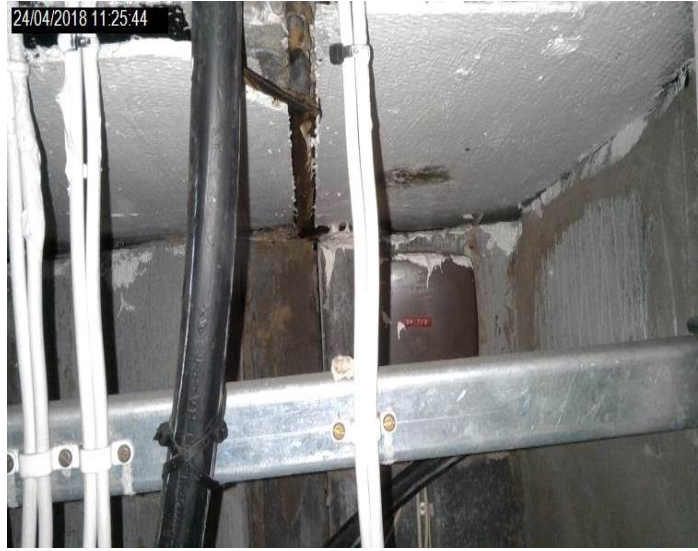
<b>Location:</b>	3.29	<b>Block:</b>	Commercial	<b>Floor Level:</b> 2nd Floor
<b>Sample No.:</b>	As DU001272	<b>Portal Ref No.:</b>	23

<b>Item:</b>	Asbestos Cement shuttering			
<b>Asbestos Content:</b>	<b>Result Based on:</b>			
Chrysotile	Strongly presumed			
<b>Sample Analysed By:</b>	Not applicable	<b>Extent:</b>	6 m <sup>2</sup>	
<b>Comments:</b> To ceiling of wall void, behind timber panels

<b>Material Assessment Total Score: 4</b>		<b>Likelihood of Disturbance Assessment Total Score: 4</b>		<b>Management Assessment</b>  <b>Licensable:</b> No  <b>Recommendations:</b> Program removal  <b>Reinspection Interval:</b> Not Applicable  <b>Overall Risk Category:</b> C8
<b>Product Type:</b>	1 (Asbestos cement)	<b>Location:</b>	2 (Rooms up to 100 sq m)	
<b>Condition:</b>	1 (Minor scratches)	<b>Accessibility:</b>	1 (Occasionally likely to be disturbed)	
<b>Surface Treatment:</b>	1 (Encapsulated asbestos cement)			
<b>Asbestos Type:</b>	1 (Chrysotile)	<b>Extent Score:</b>	1 (<10 sq m or 10m pipe run)

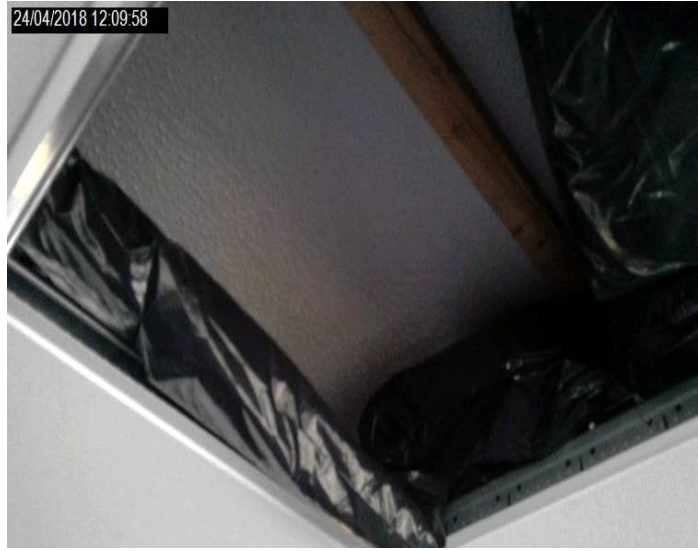
<b>Location:</b>	3.15	<b>Block:</b>	Commercial	<b>Floor Level:</b> 2nd Floor
<b>Sample No.:</b>	As DU001283	<b>Portal Ref No.:</b>	51

<b>Item:</b>	Asbestos Textured coating to concrete			
<b>Asbestos Content:</b>	<b>Result Based on:</b>			
Chrysotile	Strongly presumed			
<b>Sample Analysed By:</b>	Not applicable	<b>Extent:</b>	100 m <sup>2</sup>	
<b>Comments:</b> Above suspended tiles, and glass fibre insulation

<b>Material Assessment Total Score: 3</b>		<b>Likelihood of Disturbance Assessment Total Score: 6</b>		<b>Management Assessment</b>  <b>Licensable:</b> No  <b>Recommendations:</b> Program removal  <b>Reinspection Interval:</b> Not Applicable  <b>Overall Risk Category:</b> C9
<b>Product Type:</b>	1 (Asbestos textured coating)	<b>Location:</b>	2 (Rooms up to 100 sq m)	
<b>Condition:</b>	1 (Minor scratches)	<b>Accessibility:</b>	1 (Occasionally likely to be disturbed)	
<b>Surface Treatment:</b>	0 (Composite material)			
<b>Asbestos Type:</b>	1 (Chrysotile)	<b>Extent Score:</b>	3 (>50 sq m or >50m pipe run)

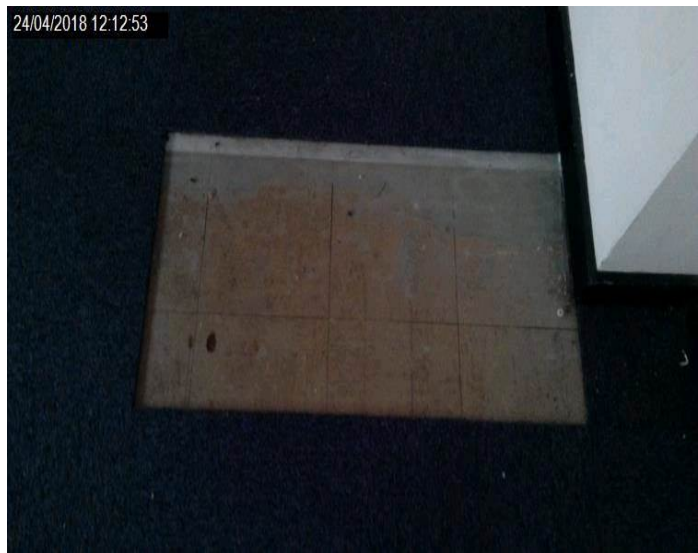
<b>Location:</b>	3.15	<b>Block:</b>	Commercial	<b>Floor Level:</b> 2nd Floor
<b>Sample No.:</b>	As DU001287	<b>Portal Ref No.:</b>	54

<b>Item:</b>	Asbestos Thermoplastic floor tiles with bitumen adhesive			
<b>Asbestos Content:</b>	<b>Result Based on:</b>			
Chrysotile in adhesive only	Strongly presumed			
<b>Sample Analysed By:</b>	Not applicable	<b>Extent:</b>	100 m <sup>2</sup>	
<b>Comments:</b> Beneath carpet tiles

<b>Material Assessment Total Score: 3</b>		<b>Likelihood of Disturbance Assessment Total Score: 5</b>		<b>Management Assessment</b>  <b>Licensable:</b> No  <b>Recommendations:</b> Program removal  <b>Reinspection Interval:</b> Not Applicable  <b>Overall Risk Category:</b> C8
<b>Product Type:</b>	1 (Asbestos thermoplastic)	<b>Location:</b>	2 (Rooms up to 100 sq m)	
<b>Condition:</b>	1 (Minor scratches)	<b>Accessibility:</b>	0 (Usually inaccessible or unlikely to be disturbed)	
<b>Surface Treatment:</b>	0 (Composite material)			
<b>Asbestos Type:</b>	1 (Chrysotile)	<b>Extent Score:</b>	3 (>50 sq m or >50m pipe run)

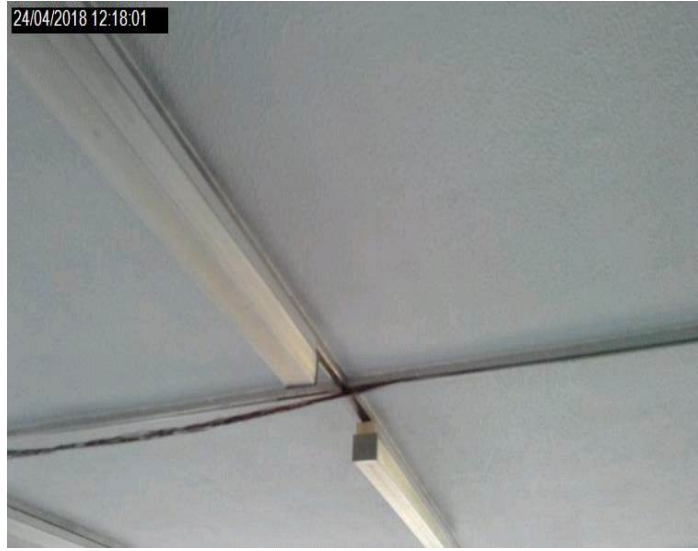
<b>Location:</b>	3.18	<b>Block:</b>	Commercial	<b>Floor Level:</b> 2nd Floor
<b>Sample No.:</b>	As DU001283	<b>Portal Ref No.:</b>	57

<b>Item:</b>	Asbestos Textured coating to concrete			
<b>Asbestos Content:</b>	<b>Result Based on:</b>			
Chrysotile	Strongly presumed			
<b>Sample Analysed By:</b>	Not applicable	<b>Extent:</b>	30 m <sup>2</sup>	
<b>Comments:</b>

<b>Material Assessment Total Score: 3</b>		<b>Likelihood of Disturbance Assessment Total Score: 5</b>		<b>Management Assessment</b>  <b>Licensable:</b> No  <b>Recommendations:</b> Program removal  <b>Reinspection Interval:</b> Not Applicable  <b>Overall Risk Category:</b> C8
<b>Product Type:</b>	1 (Asbestos textured coating)	<b>Location:</b>	2 (Rooms up to 100 sq m)	
<b>Condition:</b>	1 (Minor scratches)	<b>Accessibility:</b>	1 (Occasionally likely to be disturbed)	
<b>Surface Treatment:</b>	0 (Composite material)			
<b>Asbestos Type:</b>	1 (Chrysotile)	<b>Extent Score:</b>	2 (>10 - <50 sq m or >10m - <50m pipe run)

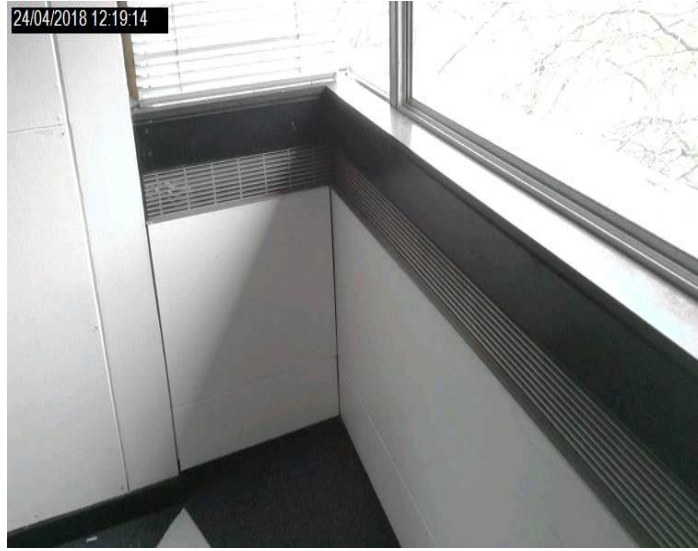
<b>Location:</b>	3.18	<b>Block:</b>	Commercial	<b>Floor Level:</b> 2nd Floor
<b>Sample No.:</b>	As DU001285	<b>Portal Ref No.:</b>	58

<b>Item:</b>	Asbestos Cement window sill			
<b>Asbestos Content:</b>	<b>Result Based on:</b>			
Chrysotile	Strongly presumed			
<b>Sample Analysed By:</b>	Not applicable	<b>Extent:</b>	11 linear metres	
<b>Comments:</b>

<b>Material Assessment Total Score: 4</b>		<b>Likelihood of Disturbance Assessment Total Score: 5</b>		<b>Management Assessment</b>  <b>Licensable:</b> No  <b>Recommendations:</b> Program removal  <b>Reinspection Interval:</b> Not Applicable  <b>Overall Risk Category:</b> C9
<b>Product Type:</b>	1 (Asbestos cement)	<b>Location:</b>	2 (Rooms up to 100 sq m)	
<b>Condition:</b>	1 (Minor scratches)	<b>Accessibility:</b>	1 (Occasionally likely to be disturbed)	
<b>Surface Treatment:</b>	1 (Encapsulated asbestos cement)			
<b>Asbestos Type:</b>	1 (Chrysotile)	<b>Extent Score:</b>	2 (>10 - <50 sq m or >10m - <50m pipe run)

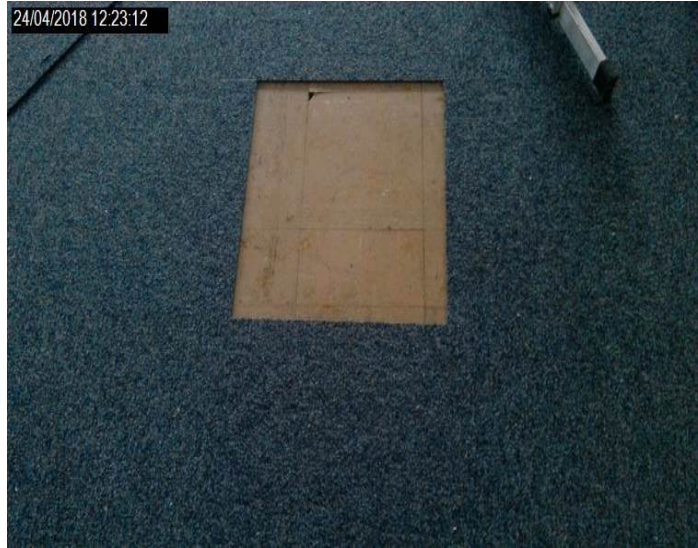
<b>Location:</b>	3.18	<b>Block:</b>	Commercial	<b>Floor Level:</b> 2nd Floor
<b>Sample No.:</b>	DU001289	<b>Portal Ref No.:</b>	60

<b>Item:</b>	Asbestos Thermoplastic floor tiles with bitumen adhesive			
<b>Asbestos Content:</b>	Result Based on:			
Chrysotile in adhesive only	Analysis of sample using PLM			
<b>Sample Analysed By:</b> Reg 13(1)	<b>Extent:</b>	30 m <sup>2</sup>		
<b>Comments:</b> Beneath carpet tiles

<b>Material Assessment Total Score: 3</b>		<b>Likelihood of Disturbance Assessment Total Score: 4</b>		<b>Management Assessment</b>  <b>Licensable:</b> No  <b>Recommendations:</b> Program removal  <b>Reinspection Interval:</b> Not Applicable  <b>Overall Risk Category:</b> C7
<b>Product Type:</b>	1 (Asbestos thermoplastic)	<b>Location:</b>	2 (Rooms up to 100 sq m)	
<b>Condition:</b>	1 (Minor scratches)	<b>Accessibility:</b>	0 (Usually inaccessible or unlikely to be disturbed)	
<b>Surface Treatment:</b>	0 (Composite material)			
<b>Asbestos Type:</b>	1 (Chrysotile)	<b>Extent Score:</b>	2 (>10 - <50 sq m or >10m - <50m pipe run)

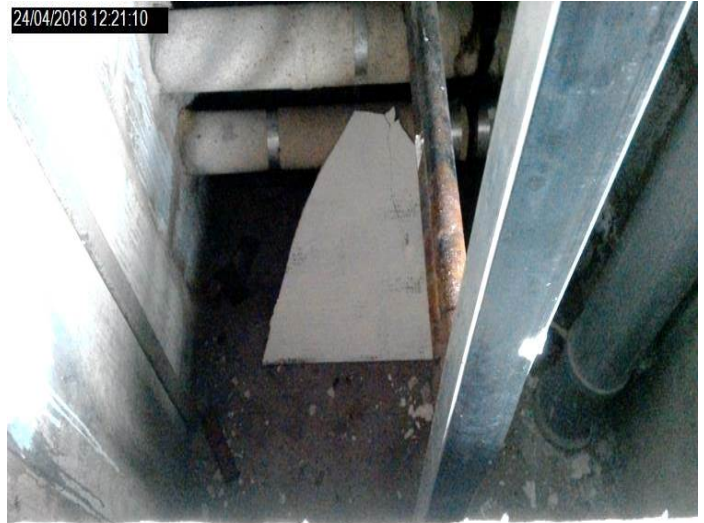
<b>Location:</b>	3.18	<b>Block:</b>	Commercial	<b>Floor Level:</b> 2nd Floor
<b>Sample No.:</b>	DU001288	<b>Portal Ref No.:</b>	62

<b>Item:</b>	Asbestos Cement shuttering debris			
<b>Asbestos Content:</b>	Result Based on:			
Chrysotile	Analysis of sample using PLM			
<b>Sample Analysed By:</b> Reg 13(1)	<b>Extent:</b>	1 m <sup>2</sup>		
<b>Comments:</b> Cement shuttering debris within riser

<b>Material Assessment Total Score: 5</b>		<b>Likelihood of Disturbance Assessment Total Score: 4</b>		<b>Management Assessment</b>  <b>Licensable:</b> No  <b>Recommendations:</b> Program removal  <b>Reinspection Interval:</b> Not Applicable  <b>Overall Risk Category:</b> C9
<b>Product Type:</b>	1 (Asbestos cement)	<b>Location:</b>	2 (Rooms up to 100 sq m)	
<b>Condition:</b>	2 (Local damage)	<b>Accessibility:</b>	1 (Occasionally likely to be disturbed)	
<b>Surface Treatment:</b>	1 (Unencapsulated asbestos cement)			
<b>Asbestos Type:</b>	1 (Chrysotile)	<b>Extent Score:</b>	1 (<10 sq m or 10m pipe run)

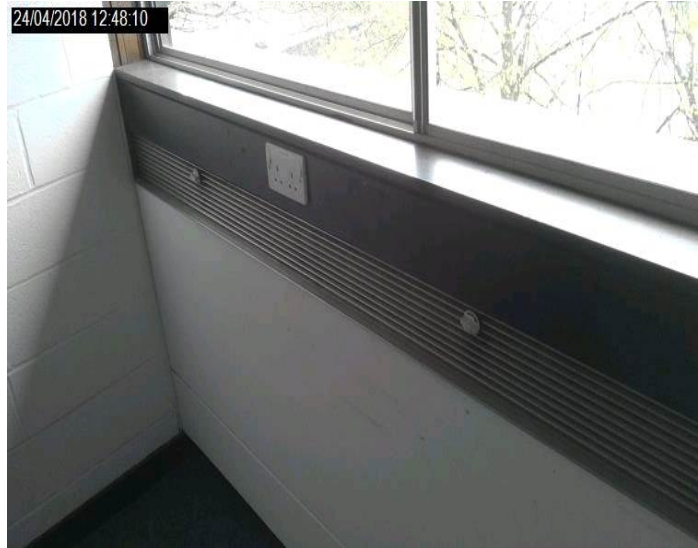
<b>Location:</b>	3.22	<b>Block:</b>	Commercial	<b>Floor Level:</b> 2nd Floor
<b>Sample No.:</b>	As DU001285	<b>Portal Ref No.:</b>	73

<b>Item:</b>	Asbestos Cement window sill			
<b>Asbestos Content:</b>	<b>Result Based on:</b>			
Chrysotile	Strongly presumed			
<b>Sample Analysed By:</b>	Not applicable	<b>Extent:</b>	2 linear metres	
<b>Comments:</b>

<b>Material Assessment Total Score: 4</b>		<b>Likelihood of Disturbance Assessment Total Score: 4</b>		<b>Management Assessment</b>  <b>Licensable:</b> No  <b>Recommendations:</b> Program removal  <b>Reinspection Interval:</b> Not Applicable  <b>Overall Risk Category:</b> C8
<b>Product Type:</b>	1 (Asbestos cement)	<b>Location:</b>	2 (Rooms up to 100 sq m)	
<b>Condition:</b>	1 (Minor scratches)	<b>Accessibility:</b>	1 (Occasionally likely to be disturbed)	
<b>Surface Treatment:</b>	1 (Encapsulated asbestos cement)			
<b>Asbestos Type:</b>	1 (Chrysotile)	<b>Extent Score:</b>	1 (<10 sq m or 10m pipe run)

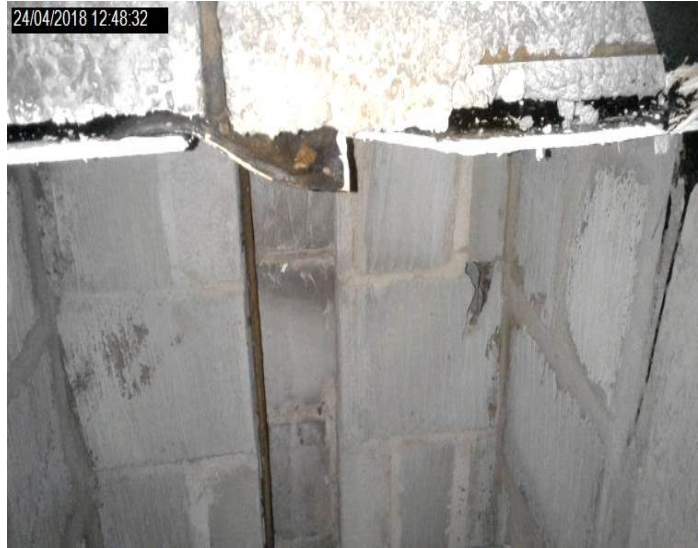
<b>Location:</b>	3.22	<b>Block:</b>	Commercial	<b>Floor Level:</b> 2nd Floor
<b>Sample No.:</b>	As DU001286	<b>Portal Ref No.:</b>	74

<b>Item:</b>	Asbestos Cement shuttering			
<b>Asbestos Content:</b>	<b>Result Based on:</b>			
Chrysotile	Strongly presumed			
<b>Sample Analysed By:</b>	Not applicable	<b>Extent:</b>	3 m <sup>2</sup>	
<b>Comments:</b> To ceiling of wall void, behind timber panels

<b>Material Assessment Total Score: 4</b>		<b>Likelihood of Disturbance Assessment Total Score: 4</b>		<b>Management Assessment</b>  <b>Licensable:</b> No  <b>Recommendations:</b> Program removal  <b>Reinspection Interval:</b> Not Applicable  <b>Overall Risk Category:</b> C8
<b>Product Type:</b>	1 (Asbestos cement)	<b>Location:</b>	2 (Rooms up to 100 sq m)	
<b>Condition:</b>	1 (Minor scratches)	<b>Accessibility:</b>	1 (Occasionally likely to be disturbed)	
<b>Surface Treatment:</b>	1 (Encapsulated asbestos cement)			
<b>Asbestos Type:</b>	1 (Chrysotile)	<b>Extent Score:</b>	1 (<10 sq m or 10m pipe run)

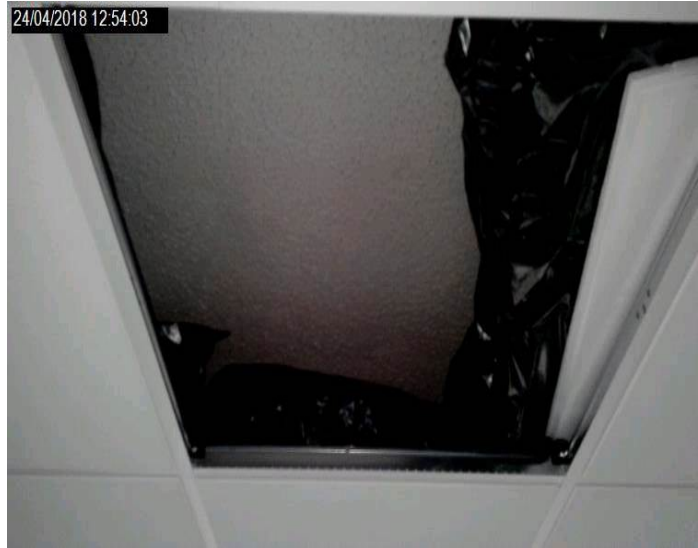
<b>Location:</b>	3.23	<b>Block:</b>	Commercial	<b>Floor Level:</b> 2nd Floor
<b>Sample No.:</b>	As DU001283	<b>Portal Ref No.:</b>	76

<b>Item:</b>	Asbestos Textured coating to concrete			
<b>Asbestos Content:</b>	<b>Result Based on:</b>			
Chrysotile	Strongly presumed			
<b>Sample Analysed By:</b>	Not applicable	<b>Extent:</b>	30 m <sup>2</sup>	
<b>Comments:</b> Above suspended ceiling tiles

<b>Material Assessment Total Score: 3</b>		<b>Likelihood of Disturbance Assessment Total Score: 5</b>		<b>Management Assessment</b>  <b>Licensable:</b> No  <b>Recommendations:</b> Program removal  <b>Reinspection Interval:</b> Not Applicable  <b>Overall Risk Category:</b> C8
<b>Product Type:</b>	1 (Asbestos textured coating)	<b>Location:</b>	2 (Rooms up to 100 sq m)	
<b>Condition:</b>	1 (Minor scratches)	<b>Accessibility:</b>	1 (Occasionally likely to be disturbed)	
<b>Surface Treatment:</b>	0 (Composite material)			
<b>Asbestos Type:</b>	1 (Chrysotile)	<b>Extent Score:</b>	2 (>10 - <50 sq m or >10m - <50m pipe run)

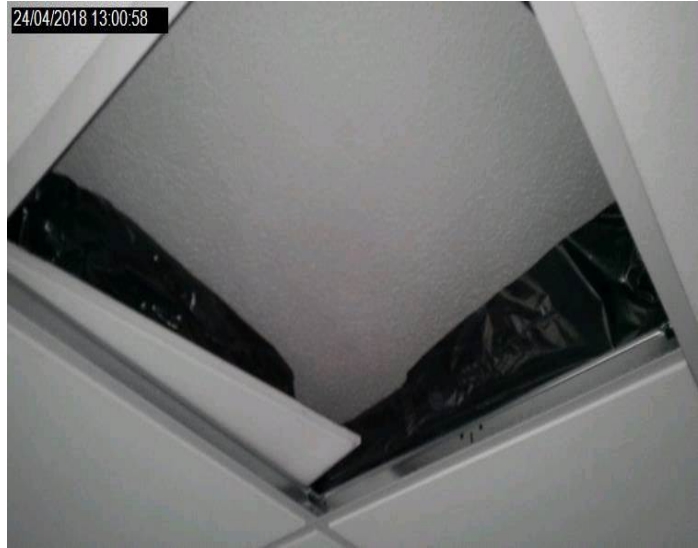
<b>Location:</b>	3.25	<b>Block:</b>	Commercial	<b>Floor Level:</b> 2nd Floor
<b>Sample No.:</b>	As DU001283	<b>Portal Ref No.:</b>	81

<b>Item:</b>	Asbestos Textured coating to concrete			
<b>Asbestos Content:</b>	<b>Result Based on:</b>			
Chrysotile	Strongly presumed			
<b>Sample Analysed By:</b>	Not applicable	<b>Extent:</b>	12 m <sup>2</sup>	
<b>Comments:</b> Above suspended ceiling tiles

<b>Material Assessment Total Score: 3</b>		<b>Likelihood of Disturbance Assessment Total Score: 5</b>		<b>Management Assessment</b>  <b>Licensable:</b> No  <b>Recommendations:</b> Program removal  <b>Reinspection Interval:</b> Not Applicable  <b>Overall Risk Category:</b> C8
<b>Product Type:</b>	1 (Asbestos textured coating)	<b>Location:</b>	2 (Rooms up to 100 sq m)	
<b>Condition:</b>	1 (Minor scratches)	<b>Accessibility:</b>	1 (Occasionally likely to be disturbed)	
<b>Surface Treatment:</b>	0 (Composite material)			
<b>Asbestos Type:</b>	1 (Chrysotile)	<b>Extent Score:</b>	2 (>10 - <50 sq m or >10m - <50m pipe run)

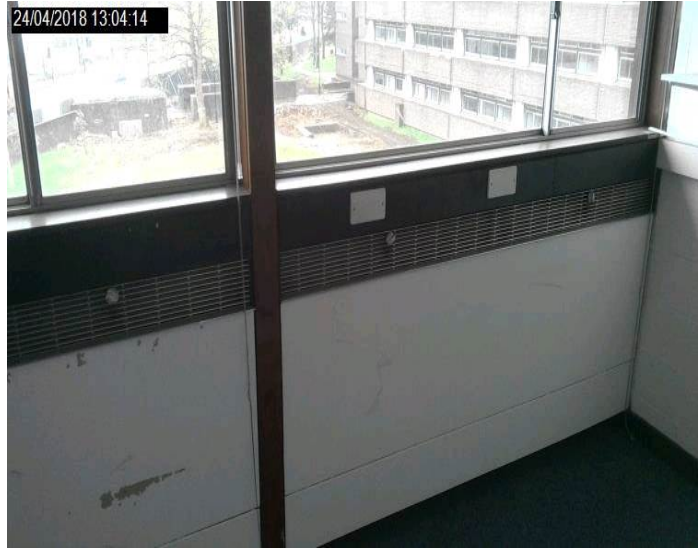
<b>Location:</b>	3.26	<b>Block:</b>	Commercial	<b>Floor Level:</b> 2nd Floor
<b>Sample No.:</b>	As DU001285	<b>Portal Ref No.:</b>	86

<b>Item:</b>	Asbestos Cement window sill			
<b>Asbestos Content:</b>	<b>Result Based on:</b>			
Chrysotile	Strongly presumed			
<b>Sample Analysed By:</b>	Not applicable	<b>Extent:</b>	5 linear metres	
<b>Comments:</b>

<b>Material Assessment Total Score: 4</b>		<b>Likelihood of Disturbance Assessment Total Score: 4</b>		<b>Management Assessment</b>  <b>Licensable:</b> No  <b>Recommendations:</b> Program removal  <b>Reinspection Interval:</b> Not Applicable  <b>Overall Risk Category:</b> C8
<b>Product Type:</b>	1 (Asbestos cement)	<b>Location:</b>	2 (Rooms up to 100 sq m)	
<b>Condition:</b>	1 (Minor scratches)	<b>Accessibility:</b>	1 (Occasionally likely to be disturbed)	
<b>Surface Treatment:</b>	1 (Encapsulated asbestos cement)			
<b>Asbestos Type:</b>	1 (Chrysotile)	<b>Extent Score:</b>	1 (<10 sq m or 10m pipe run)

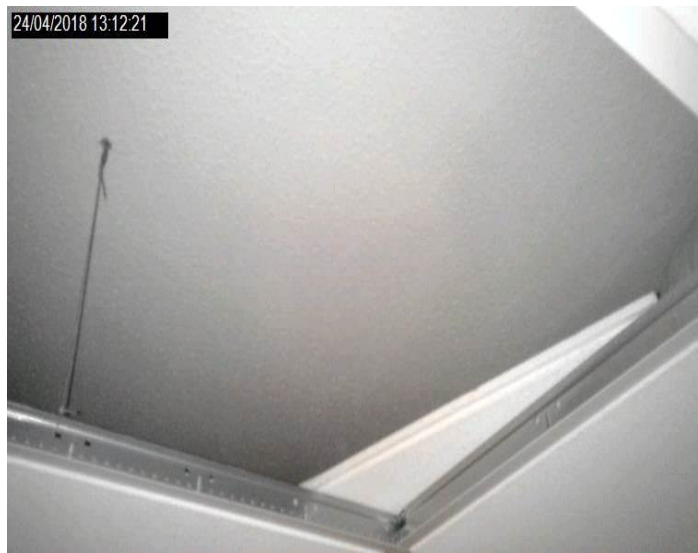
<b>Location:</b>	3.19	<b>Block:</b>	Commercial	<b>Floor Level:</b> 2nd Floor
<b>Sample No.:</b>	DU001292	<b>Portal Ref No.:</b>	89

<b>Item:</b>	Asbestos Textured coating to concrete			
<b>Asbestos Content:</b>	Result Based on:			
Chrysotile	Analysis of sample using PLM			
<b>Sample Analysed By:</b>	Reg 13(1)	<b>Extent:</b>	36 m <sup>2</sup>	
<b>Comments:</b> Above suspended tiles and glass fibre

<b>Material Assessment Total Score: 3</b>		<b>Likelihood of Disturbance Assessment Total Score: 5</b>		<b>Management Assessment</b>  <b>Licensable:</b> No  <b>Recommendations:</b> Program removal  <b>Reinspection Interval:</b> Not Applicable  <b>Overall Risk Category:</b> C8
<b>Product Type:</b>	1 (Asbestos textured coating)	<b>Location:</b>	2 (Rooms up to 100 sq m)	
<b>Condition:</b>	1 (Minor scratches)	<b>Accessibility:</b>	1 (Occasionally likely to be disturbed)	
<b>Surface Treatment:</b>	0 (Composite material)			
<b>Asbestos Type:</b>	1 (Chrysotile)	<b>Extent Score:</b>	2 (>10 - <50 sq m or >10m - <50m pipe run)

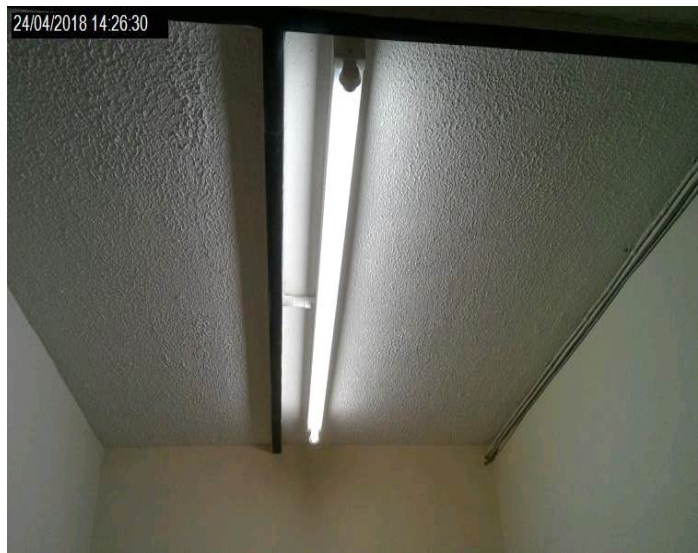
<b>Location:</b>	2.37	<b>Block:</b>	Commercial	<b>Floor Level:</b> 1st Floor
<b>Sample No.:</b>	DU001301	<b>Portal Ref No.:</b>	110

<b>Item:</b>	Asbestos Textured coating to concrete			
<b>Asbestos Content:</b>	Result Based on:			
Chrysotile	Analysis of sample using PLM			
<b>Sample Analysed By:</b> Reg 13(1)	<b>Extent:</b>	6 m <sup>2</sup>		
<b>Comments:</b>

<b>Material Assessment Total Score: 3</b>		<b>Likelihood of Disturbance Assessment Total Score: 4</b>		<b>Management Assessment</b>  <b>Licensable:</b> No  <b>Recommendations:</b> Program removal  <b>Reinspection Interval:</b> Not Applicable  <b>Overall Risk Category:</b> C7
<b>Product Type:</b>	1 (Asbestos textured coating)	<b>Location:</b>	2 (Rooms up to 100 sq m)	
<b>Condition:</b>	1 (Minor scratches)	<b>Accessibility:</b>	1 (Occasionally likely to be disturbed)	
<b>Surface Treatment:</b>	0 (Composite material)			
<b>Asbestos Type:</b>	1 (Chrysotile)	<b>Extent Score:</b>	1 (<10 sq m or 10m pipe run)

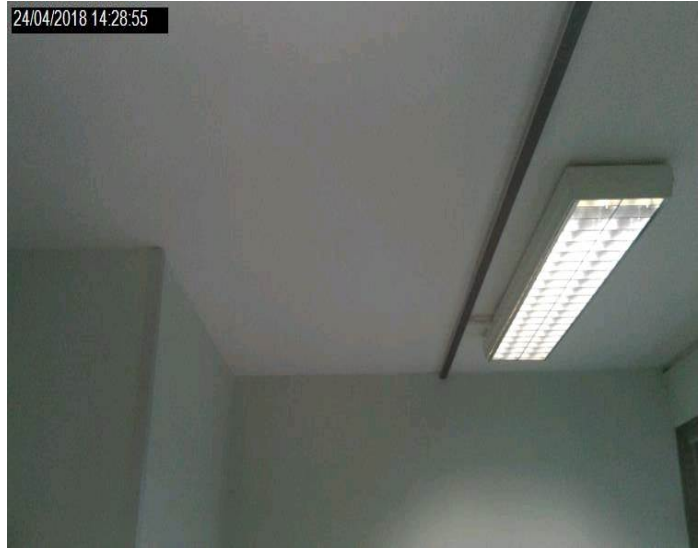
<b>Location:</b>	2.36	<b>Block:</b>	Commercial	<b>Floor Level:</b> 1st Floor
<b>Sample No.:</b>	As DU001301	<b>Portal Ref No.:</b>	111

<b>Item:</b>	Asbestos Textured coating to concrete			
<b>Asbestos Content:</b>	<b>Result Based on:</b>			
Chrysotile	Strongly presumed			
<b>Sample Analysed By:</b>	Not applicable	<b>Extent:</b>	12 m <sup>2</sup>	
<b>Comments:</b>

<b>Material Assessment Total Score: 3</b>		<b>Likelihood of Disturbance Assessment Total Score: 5</b>		<b>Management Assessment</b>  <b>Licensable:</b> No  <b>Recommendations:</b> Program removal  <b>Reinspection Interval:</b> Not Applicable  <b>Overall Risk Category:</b> C8
<b>Product Type:</b>	1 (Asbestos textured coating)	<b>Location:</b>	2 (Rooms up to 100 sq m)	
<b>Condition:</b>	1 (Minor scratches)	<b>Accessibility:</b>	1 (Occasionally likely to be disturbed)	
<b>Surface Treatment:</b>	0 (Composite material)			
<b>Asbestos Type:</b>	1 (Chrysotile)	<b>Extent Score:</b>	2 (>10 - <50 sq m or >10m - <50m pipe run)

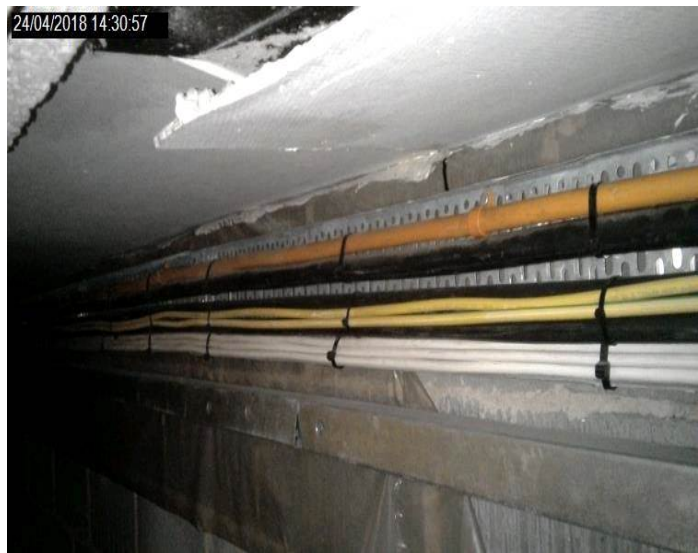
<b>Location:</b>	2.36	<b>Block:</b>	Commercial	<b>Floor Level:</b> 1st Floor
<b>Sample No.:</b>	DU001304	<b>Portal Ref No.:</b>	114

<b>Item:</b>	Asbestos Cement shuttering			
<b>Asbestos Content:</b>	Result Based on:			
Chrysotile	Analysis of sample using PLM			
<b>Sample Analysed By:</b> Reg 13(1)	<b>Extent:</b>	3 m <sup>2</sup>		
<b>Comments:</b> To the ceiling of wall void to the heating system

<b>Material Assessment Total Score: 4</b>		<b>Likelihood of Disturbance Assessment Total Score: 4</b>		<b>Management Assessment</b>  <b>Licensable:</b> No  <b>Recommendations:</b> Program removal  <b>Reinspection Interval:</b> Not Applicable  <b>Overall Risk Category:</b> C8
<b>Product Type:</b>	1 (Asbestos cement)	<b>Location:</b>	2 (Rooms up to 100 sq m)	
<b>Condition:</b>	1 (Minor scratches)	<b>Accessibility:</b>	1 (Occasionally likely to be disturbed)	
<b>Surface Treatment:</b>	1 (Encapsulated asbestos cement)			
<b>Asbestos Type:</b>	1 (Chrysotile)	<b>Extent Score:</b>	1 (<10 sq m or 10m pipe run)

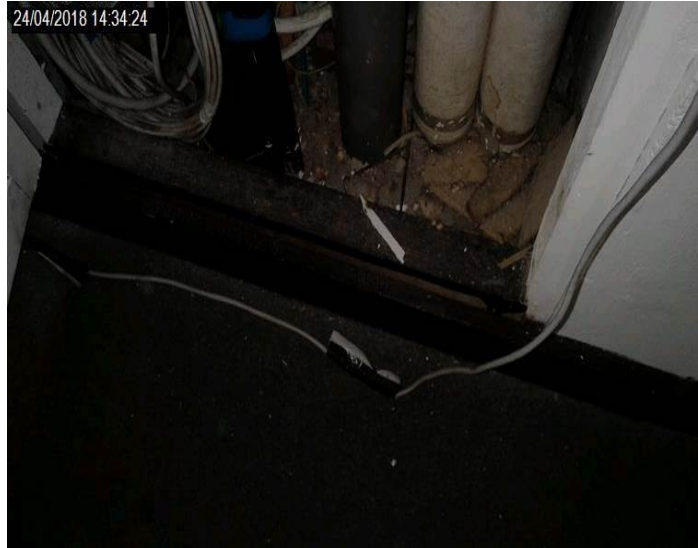
<b>Location:</b>	2.36	<b>Block:</b>	Commercial	<b>Floor Level:</b> 1st Floor
<b>Sample No.:</b>	DU001305	<b>Portal Ref No.:</b>	115

<b>Item:</b>	Asbestos Insulating board debris			
<b>Asbestos Content:</b>	<b>Result Based on:</b>			
Chrysotile Amosite	Analysis of sample using PLM			
<b>Sample Analysed By:</b> Reg 13(1)	<b>Extent:</b>	1 m <sup>2</sup>		
<b>Comments:</b> Potential for more of the item to be hidden within the riser

<b>Material Assessment Total Score: 9</b>		<b>Likelihood of Disturbance Assessment Total Score: 4</b>		<b>Management Assessment</b>  <b>Licensable:</b> Yes  <b>Recommendations:</b> Program removal  <b>Reinspection Interval:</b> Not Applicable  <b>Overall Risk Category:</b> B13
<b>Product Type:</b>	2 (Asbestos insulating board)	<b>Location:</b>	2 (Rooms up to 100 sq m)	
<b>Condition:</b>	3 (Significant damage)	<b>Accessibility:</b>	1 (Occasionally likely to be disturbed)	
<b>Surface Treatment:</b>	2 (Unencapsulated asbestos insulating board)			
<b>Asbestos Type:</b>	2 (Chrysotile Amosite)	<b>Extent Score:</b>	1 (<10 sq m or 10m pipe run)

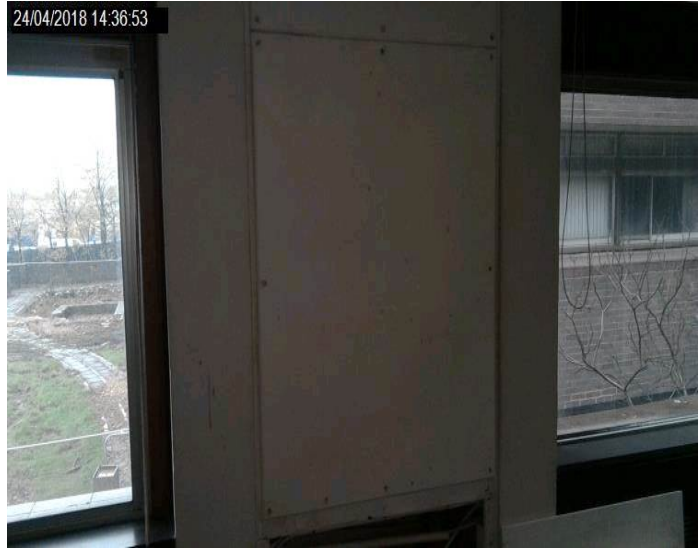
<b>Location:</b>	2.35	<b>Block:</b>	Commercial	<b>Floor Level:</b> 1st Floor
<b>Sample No.:</b>	As DU001302	<b>Portal Ref No.:</b>	118

<b>Item:</b>	Insulating board panel to riser			
<b>Asbestos Content:</b>		<b>Result Based on:</b>		
No Asbestos Detected		Strongly presumed		
<b>Sample Analysed By:</b>	Not applicable	<b>Extent:</b>	3 m <sup>2</sup>	
<b>Comments:</b>

<b>Material Assessment Total Score: 0</b>		<b>Likelihood of Disturbance Assessment Total Score: 0</b>		<b>Management Assessment</b>  <b>Licensable:</b> Yes  <b>Recommendations:</b> Not Applicable  <b>Reinspection Interval:</b> Not Applicable  <b>Overall Risk Category:</b> E0
<b>Product Type:</b>	0 Not Applicable	<b>Location:</b>	0 Not Applicable	
<b>Condition:</b>	0 Not Applicable	<b>Accessibility:</b>	0 Not Applicable	
<b>Surface Treatment:</b>	0 Not Applicable			
<b>Asbestos Type:</b>	0 Not Applicable	<b>Extent Score:</b>	0 Not Applicable

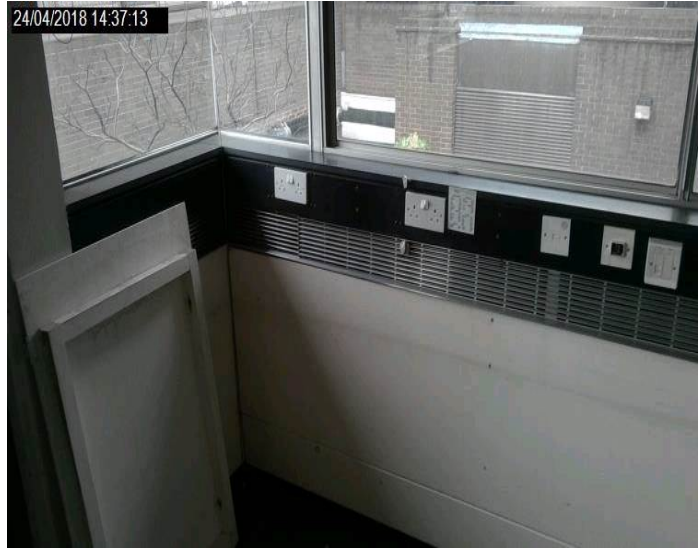
<b>Location:</b>	2.35	<b>Block:</b>	Commercial	<b>Floor Level:</b> 1st Floor
<b>Sample No.:</b>	As DU001303	<b>Portal Ref No.:</b>	119

<b>Item:</b>	Asbestos Cement window sill			
<b>Asbestos Content:</b>	<b>Result Based on:</b>			
Chrysotile Amosite	Strongly presumed			
<b>Sample Analysed By:</b>	Not applicable	<b>Extent:</b>	8 linear metres	
<b>Comments:</b>

<b>Material Assessment Total Score: 5</b>		<b>Likelihood of Disturbance Assessment Total Score: 4</b>		<b>Management Assessment</b>  <b>Licensable:</b> No  <b>Recommendations:</b> Program removal  <b>Reinspection Interval:</b> Not Applicable  <b>Overall Risk Category:</b> C9
<b>Product Type:</b>	1 (Asbestos cement)	<b>Location:</b>	2 (Rooms up to 100 sq m)	
<b>Condition:</b>	1 (Minor scratches)	<b>Accessibility:</b>	1 (Occasionally likely to be disturbed)	
<b>Surface Treatment:</b>	1 (Encapsulated asbestos cement)			
<b>Asbestos Type:</b>	2 (Chrysotile Amosite)	<b>Extent Score:</b>	1 (<10 sq m or 10m pipe run)

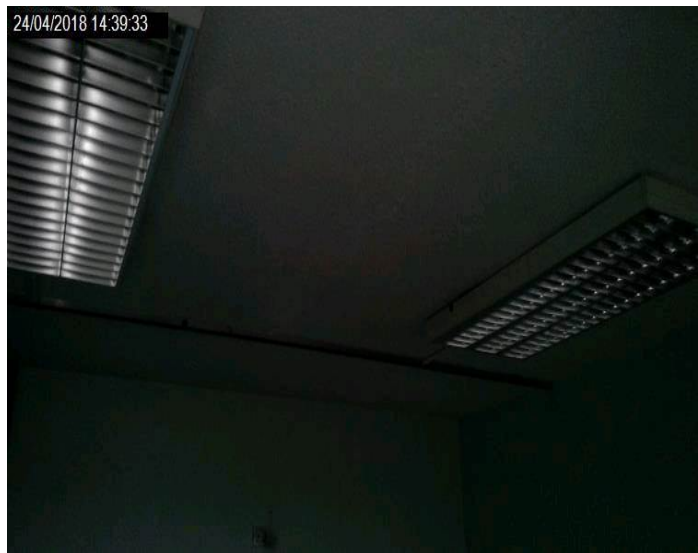
<b>Location:</b>	2.34	<b>Block:</b>	Commercial	<b>Floor Level:</b> 1st Floor
<b>Sample No.:</b>	As DU001301	<b>Portal Ref No.:</b>	122

<b>Item:</b>	Asbestos Textured coating to concrete			
<b>Asbestos Content:</b>	<b>Result Based on:</b>			
Chrysotile	Strongly presumed			
<b>Sample Analysed By:</b>	Not applicable	<b>Extent:</b>	16 m <sup>2</sup>	
<b>Comments:</b>

<b>Material Assessment Total Score: 3</b>		<b>Likelihood of Disturbance Assessment Total Score: 5</b>		<b>Management Assessment</b>  <b>Licensable:</b> No  <b>Recommendations:</b> Program removal  <b>Reinspection Interval:</b> Not Applicable  <b>Overall Risk Category:</b> C8
<b>Product Type:</b>	1 (Asbestos textured coating)	<b>Location:</b>	2 (Rooms up to 100 sq m)	
<b>Condition:</b>	1 (Minor scratches)	<b>Accessibility:</b>	1 (Occasionally likely to be disturbed)	
<b>Surface Treatment:</b>	0 (Composite material)			
<b>Asbestos Type:</b>	1 (Chrysotile)	<b>Extent Score:</b>	2 (>10 - <50 sq m or >10m - <50m pipe run)

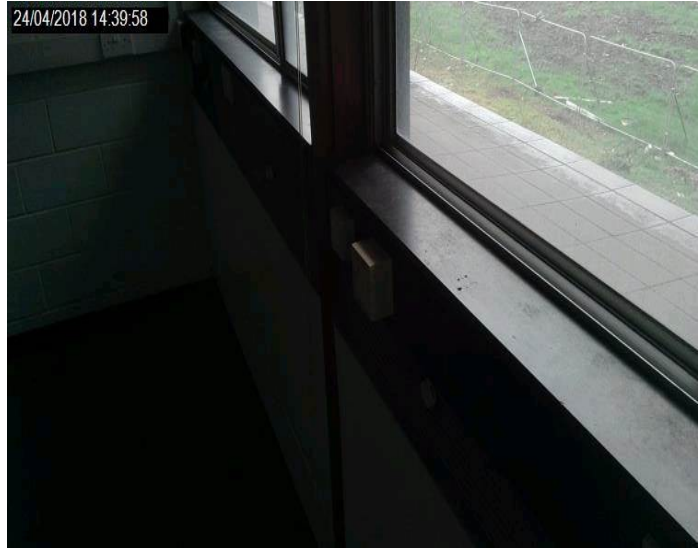
<b>Location:</b>	2.34	<b>Block:</b>	Commercial	<b>Floor Level:</b> 1st Floor
<b>Sample No.:</b>	As DU001303	<b>Portal Ref No.:</b>	124

<b>Item:</b>	Asbestos Cement window sill			
<b>Asbestos Content:</b>	<b>Result Based on:</b>			
Chrysotile Amosite	Strongly presumed			
<b>Sample Analysed By:</b>	Not applicable	<b>Extent:</b>	5 linear metres	
<b>Comments:</b>

<b>Material Assessment Total Score: 5</b>		<b>Likelihood of Disturbance Assessment Total Score: 4</b>		<b>Management Assessment</b>  <b>Licensable:</b> No  <b>Recommendations:</b> Program removal  <b>Reinspection Interval:</b> Not Applicable  <b>Overall Risk Category:</b> C9
<b>Product Type:</b>	1 (Asbestos cement)	<b>Location:</b>	2 (Rooms up to 100 sq m)	
<b>Condition:</b>	1 (Minor scratches)	<b>Accessibility:</b>	1 (Occasionally likely to be disturbed)	
<b>Surface Treatment:</b>	1 (Encapsulated asbestos cement)			
<b>Asbestos Type:</b>	2 (Chrysotile Amosite)	<b>Extent Score:</b>	1 (<10 sq m or 10m pipe run)

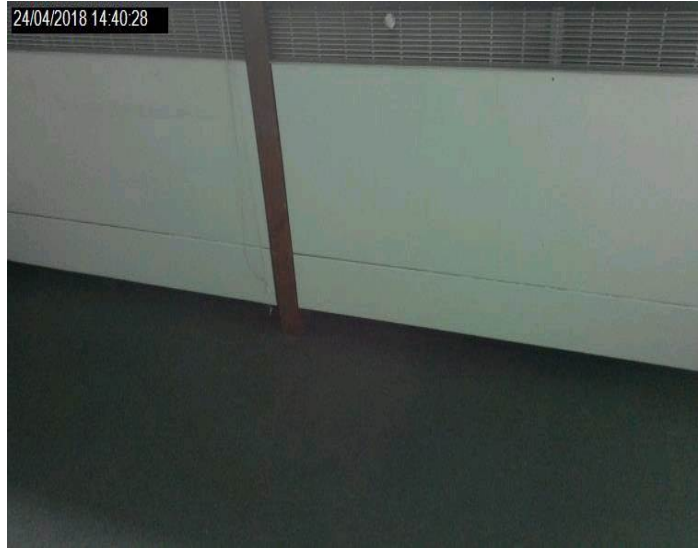
<b>Location:</b>	2.34	<b>Block:</b>	Commercial	<b>Floor Level:</b> 1st Floor
<b>Sample No.:</b>	As DU001304	<b>Portal Ref No.:</b>	125

<b>Item:</b>	Asbestos Cement shuttering			
<b>Asbestos Content:</b>	<b>Result Based on:</b>			
Chrysotile	Strongly presumed			
<b>Sample Analysed By:</b>	Not applicable	<b>Extent:</b>	5 m <sup>2</sup>	
<b>Comments:</b> To the ceiling of wall void to the heating system

<b>Material Assessment Total Score: 4</b>		<b>Likelihood of Disturbance Assessment Total Score: 4</b>		<b>Management Assessment</b>  <b>Licensable:</b> No  <b>Recommendations:</b> Program removal  <b>Reinspection Interval:</b> Not Applicable  <b>Overall Risk Category:</b> C8
<b>Product Type:</b>	1 (Asbestos cement)	<b>Location:</b>	2 (Rooms up to 100 sq m)	
<b>Condition:</b>	1 (Minor scratches)	<b>Accessibility:</b>	1 (Occasionally likely to be disturbed)	
<b>Surface Treatment:</b>	1 (Encapsulated asbestos cement)			
<b>Asbestos Type:</b>	1 (Chrysotile)	<b>Extent Score:</b>	1 (<10 sq m or 10m pipe run)

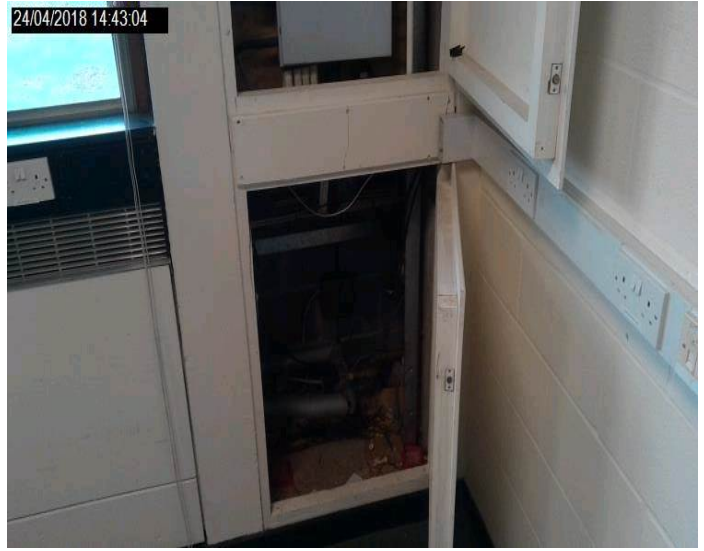
<b>Location:</b>	2.30	<b>Block:</b>	Commercial	<b>Floor Level:</b> 1st Floor
<b>Sample No.:</b>	As DU001302	<b>Portal Ref No.:</b>	127

<b>Item:</b>	Insulating board panel to riser			
<b>Asbestos Content:</b>		<b>Result Based on:</b>		
No Asbestos Detected		Strongly presumed		
<b>Sample Analysed By:</b>	Not applicable	<b>Extent:</b>	3 m <sup>2</sup>	
<b>Comments:</b>

<b>Material Assessment Total Score: 0</b>		<b>Likelihood of Disturbance Assessment Total Score: 0</b>		<b>Management Assessment</b>  <b>Licensable:</b> Yes  <b>Recommendations:</b> Not Applicable  <b>Reinspection Interval:</b> Not Applicable  <b>Overall Risk Category:</b> E0
<b>Product Type:</b>	0 Not Applicable	<b>Location:</b>	0 Not Applicable	
<b>Condition:</b>	0 Not Applicable	<b>Accessibility:</b>	0 Not Applicable	
<b>Surface Treatment:</b>	0 Not Applicable			
<b>Asbestos Type:</b>	0 Not Applicable	<b>Extent Score:</b>	0 Not Applicable

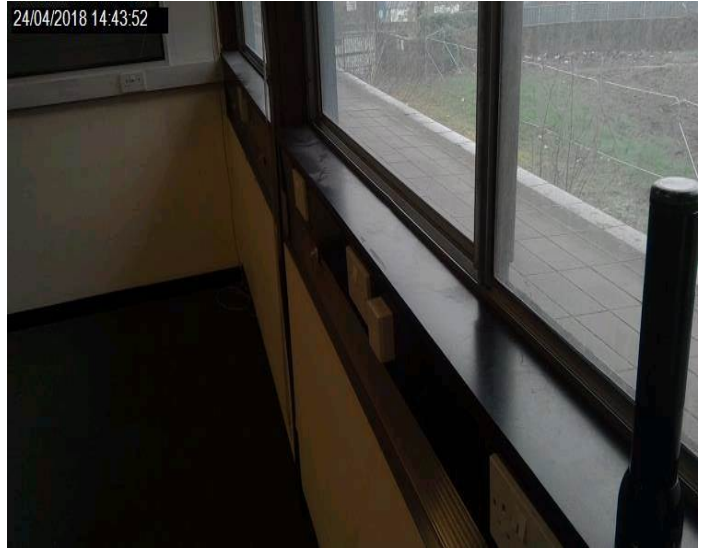
<b>Location:</b>	2.30	<b>Block:</b>	Commercial	<b>Floor Level:</b> 1st Floor
<b>Sample No.:</b>	As DU001303	<b>Portal Ref No.:</b>	128

<b>Item:</b>	Asbestos Cement window sill			
<b>Asbestos Content:</b>	<b>Result Based on:</b>			
Chrysotile Amosite	Strongly presumed			
<b>Sample Analysed By:</b>	Not applicable	<b>Extent:</b>	5 linear metres	
<b>Comments:</b>

<b>Material Assessment Total Score: 5</b>		<b>Likelihood of Disturbance Assessment Total Score: 4</b>		<b>Management Assessment</b>  <b>Licensable:</b> No  <b>Recommendations:</b> Program removal  <b>Reinspection Interval:</b> Not Applicable  <b>Overall Risk Category:</b> C9
<b>Product Type:</b>	1 (Asbestos cement)	<b>Location:</b>	2 (Rooms up to 100 sq m)	
<b>Condition:</b>	1 (Minor scratches)	<b>Accessibility:</b>	1 (Occasionally likely to be disturbed)	
<b>Surface Treatment:</b>	1 (Encapsulated asbestos cement)			
<b>Asbestos Type:</b>	2 (Chrysotile Amosite)	<b>Extent Score:</b>	1 (<10 sq m or 10m pipe run)

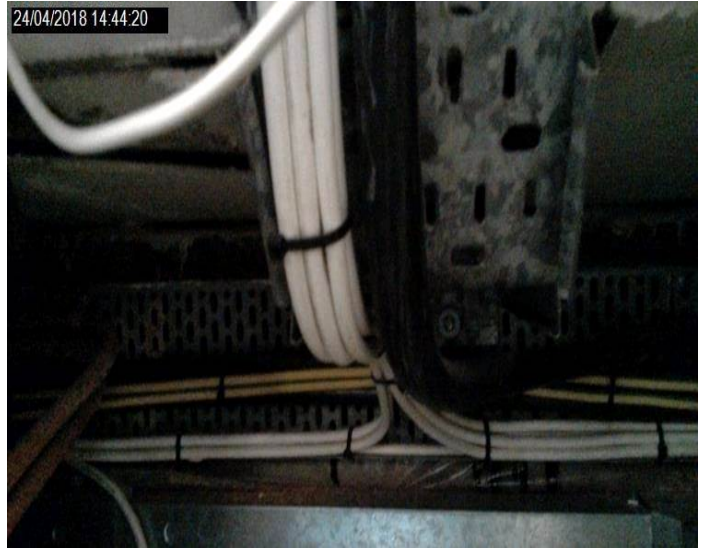
<b>Location:</b>	2.30	<b>Block:</b>	Commercial	<b>Floor Level:</b> 1st Floor
<b>Sample No.:</b>	As DU001304	<b>Portal Ref No.:</b>	129

<b>Item:</b>	Asbestos Cement shuttering			
<b>Asbestos Content:</b>	<b>Result Based on:</b>			
Chrysotile	Strongly presumed			
<b>Sample Analysed By:</b>	Not applicable	<b>Extent:</b>	6 m <sup>2</sup>	
<b>Comments:</b> To the ceiling of wall void to the heating system

<b>Material Assessment Total Score: 4</b>		<b>Likelihood of Disturbance Assessment Total Score: 4</b>		<b>Management Assessment</b>  <b>Licensable:</b> No  <b>Recommendations:</b> Program removal  <b>Reinspection Interval:</b> Not Applicable  <b>Overall Risk Category:</b> C8
<b>Product Type:</b>	1 (Asbestos cement)	<b>Location:</b>	2 (Rooms up to 100 sq m)	
<b>Condition:</b>	1 (Minor scratches)	<b>Accessibility:</b>	1 (Occasionally likely to be disturbed)	
<b>Surface Treatment:</b>	1 (Encapsulated asbestos cement)			
<b>Asbestos Type:</b>	1 (Chrysotile)	<b>Extent Score:</b>	1 (<10 sq m or 10m pipe run)

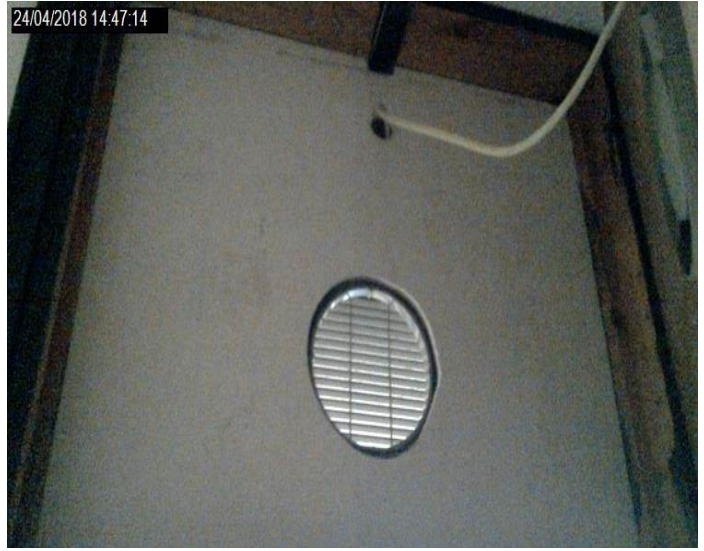
<b>Location:</b>	2.30	<b>Block:</b>	Commercial	<b>Floor Level:</b> 1st Floor
<b>Sample No.:</b>	DU001307	<b>Portal Ref No.:</b>	130

<b>Item:</b>	Insulating board door header panels			
<b>Asbestos Content:</b>		<b>Result Based on:</b>		
No Asbestos Detected		Analysis of sample using PLM		
<b>Sample Analysed By:</b>	Reg 13(1)	<b>Extent:</b>	3 m <sup>2</sup>	
<b>Comments:</b> Leading to rooms 2.31, 2.32 and leading to corridor 2.18

<b>Material Assessment Total Score: 0</b>		<b>Likelihood of Disturbance Assessment Total Score: 0</b>		<b>Management Assessment</b>  <b>Licensable:</b> Yes  <b>Recommendations:</b> Not Applicable  <b>Reinspection Interval:</b> Not Applicable  <b>Overall Risk Category:</b> E0
<b>Product Type:</b>	0 Not Applicable	<b>Location:</b>	0 Not Applicable	
<b>Condition:</b>	0 Not Applicable	<b>Accessibility:</b>	0 Not Applicable	
<b>Surface Treatment:</b>	0 Not Applicable			
<b>Asbestos Type:</b>	0 Not Applicable	<b>Extent Score:</b>	0 Not Applicable

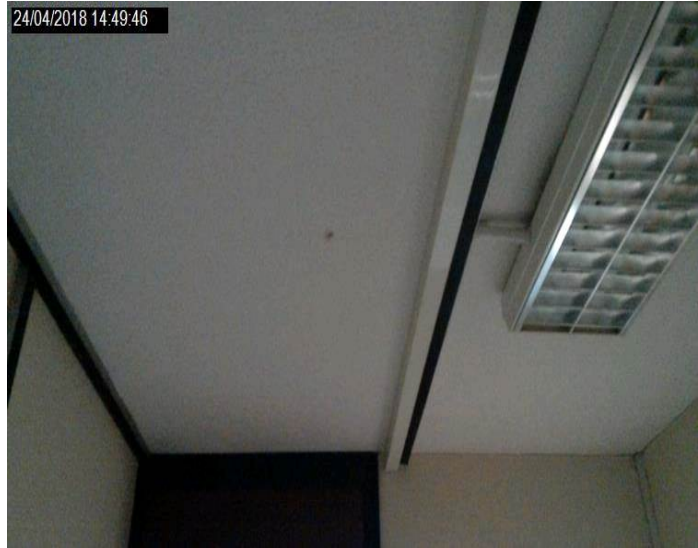
<b>Location:</b>	2.31	<b>Block:</b>	Commercial	<b>Floor Level:</b> 1st Floor
<b>Sample No.:</b>	As DU001301	<b>Portal Ref No.:</b>	131

<b>Item:</b>	Asbestos Textured coating to concrete			
<b>Asbestos Content:</b>	<b>Result Based on:</b>			
Chrysotile	Strongly presumed			
<b>Sample Analysed By:</b>	Not applicable	<b>Extent:</b>	6 m <sup>2</sup>	
<b>Comments:</b>

<b>Material Assessment Total Score: 3</b>		<b>Likelihood of Disturbance Assessment Total Score: 4</b>		<b>Management Assessment</b>  <b>Licensable:</b> No  <b>Recommendations:</b> Program removal  <b>Reinspection Interval:</b> Not Applicable  <b>Overall Risk Category:</b> C7
<b>Product Type:</b>	1 (Asbestos textured coating)	<b>Location:</b>	2 (Rooms up to 100 sq m)	
<b>Condition:</b>	1 (Minor scratches)	<b>Accessibility:</b>	1 (Occasionally likely to be disturbed)	
<b>Surface Treatment:</b>	0 (Composite material)			
<b>Asbestos Type:</b>	1 (Chrysotile)	<b>Extent Score:</b>	1 (<10 sq m or 10m pipe run)

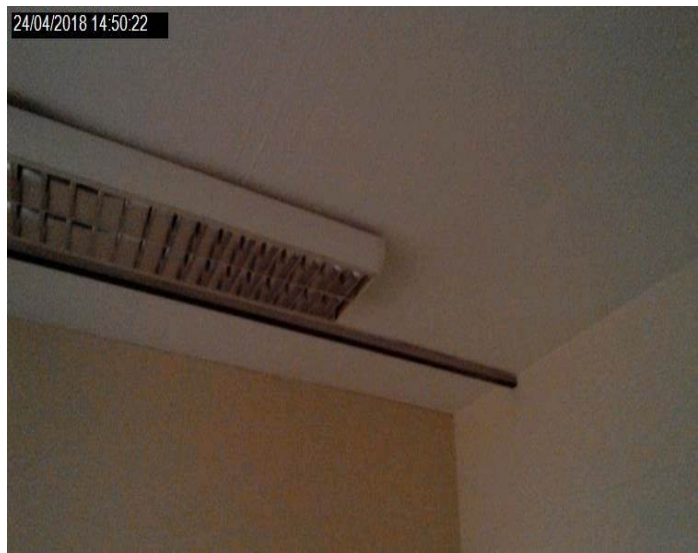
<b>Location:</b>	2.32	<b>Block:</b>	Commercial	<b>Floor Level:</b> 1st Floor
<b>Sample No.:</b>	As DU001301	<b>Portal Ref No.:</b>	132

<b>Item:</b>	Asbestos Textured coating to concrete			
<b>Asbestos Content:</b>	<b>Result Based on:</b>			
Chrysotile	Strongly presumed			
<b>Sample Analysed By:</b>	Not applicable	<b>Extent:</b>	8 m <sup>2</sup>	
<b>Comments:</b>

<b>Material Assessment Total Score: 3</b>		<b>Likelihood of Disturbance Assessment Total Score: 4</b>		<b>Management Assessment</b>  <b>Licensable:</b> No  <b>Recommendations:</b> Program removal  <b>Reinspection Interval:</b> Not Applicable  <b>Overall Risk Category:</b> C7
<b>Product Type:</b>	1 (Asbestos textured coating)	<b>Location:</b>	2 (Rooms up to 100 sq m)	
<b>Condition:</b>	1 (Minor scratches)	<b>Accessibility:</b>	1 (Occasionally likely to be disturbed)	
<b>Surface Treatment:</b>	0 (Composite material)			
<b>Asbestos Type:</b>	1 (Chrysotile)	<b>Extent Score:</b>	1 (<10 sq m or 10m pipe run)

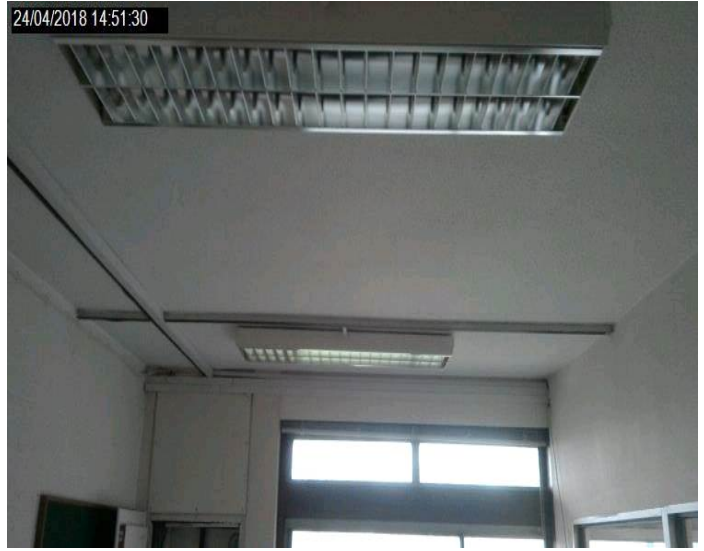
<b>Location:</b>	2.33	<b>Block:</b>	Commercial	<b>Floor Level:</b> 1st Floor
<b>Sample No.:</b>	As DU001301	<b>Portal Ref No.:</b>	133

<b>Item:</b>	Asbestos Textured coating to concrete			
<b>Asbestos Content:</b>	<b>Result Based on:</b>			
Chrysotile	Strongly presumed			
<b>Sample Analysed By:</b>	Not applicable	<b>Extent:</b>	15 m <sup>2</sup>	
<b>Comments:</b>

<b>Material Assessment Total Score: 3</b>		<b>Likelihood of Disturbance Assessment Total Score: 5</b>		<b>Management Assessment</b>  <b>Licensable:</b> No  <b>Recommendations:</b> Program removal  <b>Reinspection Interval:</b> Not Applicable  <b>Overall Risk Category:</b> C8
<b>Product Type:</b>	1 (Asbestos textured coating)	<b>Location:</b>	2 (Rooms up to 100 sq m)	
<b>Condition:</b>	1 (Minor scratches)	<b>Accessibility:</b>	1 (Occasionally likely to be disturbed)	
<b>Surface Treatment:</b>	0 (Composite material)			
<b>Asbestos Type:</b>	1 (Chrysotile)	<b>Extent Score:</b>	2 (>10 - <50 sq m or >10m - <50m pipe run)
