**Report No.:** J094042  
**Nature of Work:** Demolition Survey  
**Issue Date:** 29/05/2018  
**Client Name:** WYG Engineering Ltd  
Geneva Building, Lake View Drive, Sherwood Business Park,  
Annesley, Nottingham, NG15 0ED  
**Site Address:** Cox Building, Former City North Campus, Birmingham City  
University, Perry Barr, B42 2US

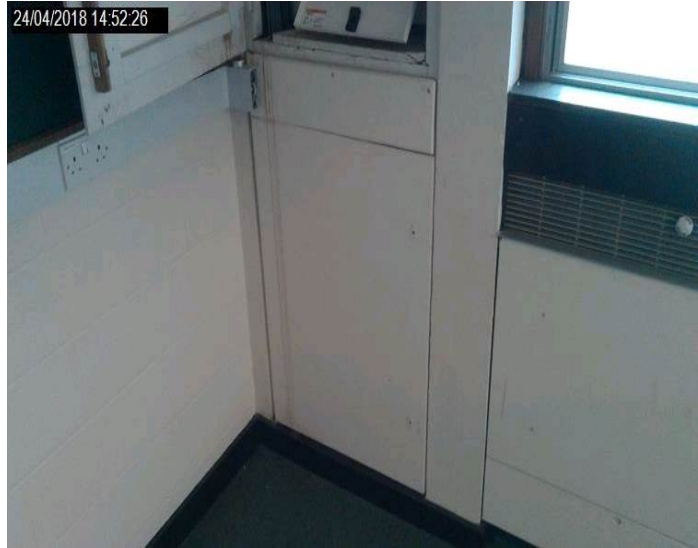
<b>Location:</b>	2.33	<b>Block:</b>	Commercial	<b>Floor Level:</b> 1st Floor
<b>Sample No.:</b>	As DU001302	<b>Portal Ref No.:</b>	134

<b>Item:</b>	Insulating board panel to riser			
<b>Asbestos Content:</b>		<b>Result Based on:</b>		
No Asbestos Detected		Strongly presumed		
<b>Sample Analysed By:</b>	Not applicable	<b>Extent:</b>	3 m <sup>2</sup>	
<b>Comments:</b>

<b>Material Assessment Total Score: 0</b>		<b>Likelihood of Disturbance Assessment Total Score: 0</b>		<b>Management Assessment</b>  <b>Licensable:</b> Yes  <b>Recommendations:</b> Not Applicable  <b>Reinspection Interval:</b> Not Applicable  <b>Overall Risk Category:</b> E0
<b>Product Type:</b>	0 Not Applicable	<b>Location:</b>	0 Not Applicable	
<b>Condition:</b>	0 Not Applicable	<b>Accessibility:</b>	0 Not Applicable	
<b>Surface Treatment:</b>	0 Not Applicable			
<b>Asbestos Type:</b>	0 Not Applicable	<b>Extent Score:</b>	0 Not Applicable

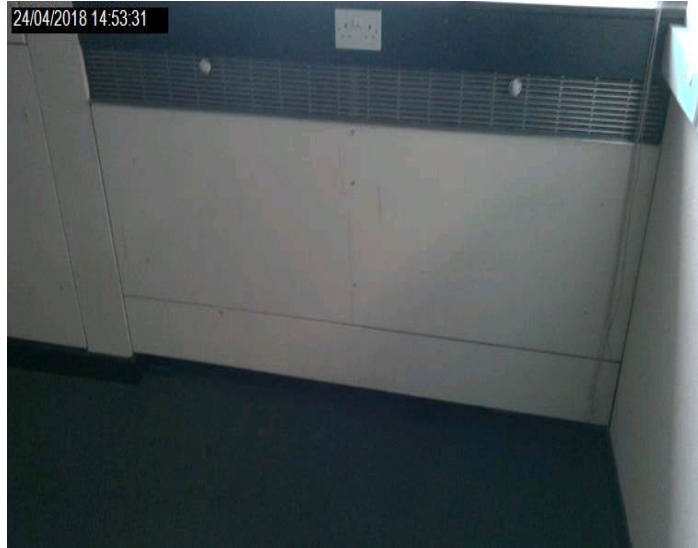
<b>Location:</b>	2.33	<b>Block:</b>	Commercial	<b>Floor Level:</b> 1st Floor
<b>Sample No.:</b>	As DU001304	<b>Portal Ref No.:</b>	136

<b>Item:</b>	Asbestos Cement shuttering			
<b>Asbestos Content:</b>	<b>Result Based on:</b>			
Chrysotile	Strongly presumed			
<b>Sample Analysed By:</b>	Not applicable	<b>Extent:</b>	3 m <sup>2</sup>	
<b>Comments:</b> To the ceiling of wall void to the heating system

<b>Material Assessment Total Score: 4</b>		<b>Likelihood of Disturbance Assessment Total Score: 4</b>		<b>Management Assessment</b>  <b>Licensable:</b> No  <b>Recommendations:</b> Program removal  <b>Reinspection Interval:</b> Not Applicable  <b>Overall Risk Category:</b> C8
<b>Product Type:</b>	1 (Asbestos cement)	<b>Location:</b>	2 (Rooms up to 100 sq m)	
<b>Condition:</b>	1 (Minor scratches)	<b>Accessibility:</b>	1 (Occasionally likely to be disturbed)	
<b>Surface Treatment:</b>	1 (Encapsulated asbestos cement)			
<b>Asbestos Type:</b>	1 (Chrysotile)	<b>Extent Score:</b>	1 (<10 sq m or 10m pipe run)

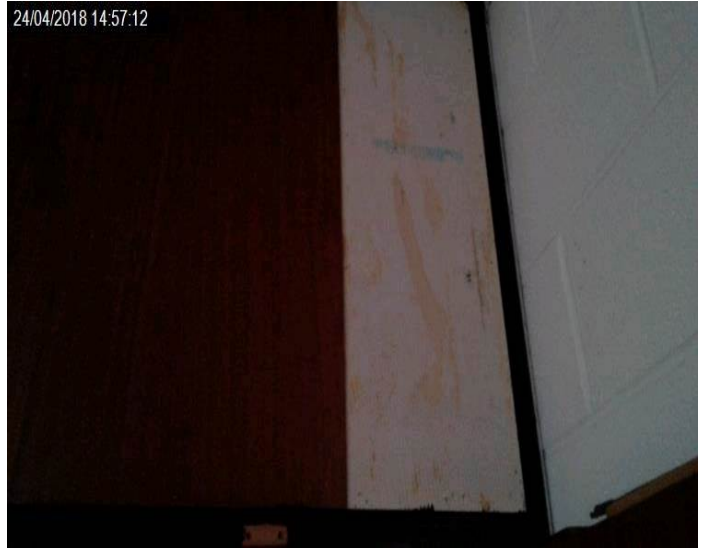
<b>Location:</b>	2.00	<b>Block:</b>	Commercial	<b>Floor Level:</b> 1st Floor
<b>Sample No.:</b>	DU001308	<b>Portal Ref No.:</b>	137

<b>Item:</b>	Insulating board door header			
<b>Asbestos Content:</b>		<b>Result Based on:</b>		
No Asbestos Detected		Analysis of sample using PLM		
<b>Sample Analysed By:</b>	Reg 13(1)	<b>Extent:</b>	4 m <sup>2</sup>	
<b>Comments:</b> Double skin, both sides of the stairwell

<b>Material Assessment Total Score: 0</b>		<b>Likelihood of Disturbance Assessment Total Score: 0</b>		<b>Management Assessment</b>  <b>Licensable:</b> Yes  <b>Recommendations:</b> Not Applicable  <b>Reinspection Interval:</b> Not Applicable  <b>Overall Risk Category:</b> E0
<b>Product Type:</b>	0 Not Applicable	<b>Location:</b>	0 Not Applicable	
<b>Condition:</b>	0 Not Applicable	<b>Accessibility:</b>	0 Not Applicable	
<b>Surface Treatment:</b>	0 Not Applicable			
<b>Asbestos Type:</b>	0 Not Applicable	<b>Extent Score:</b>	0 Not Applicable

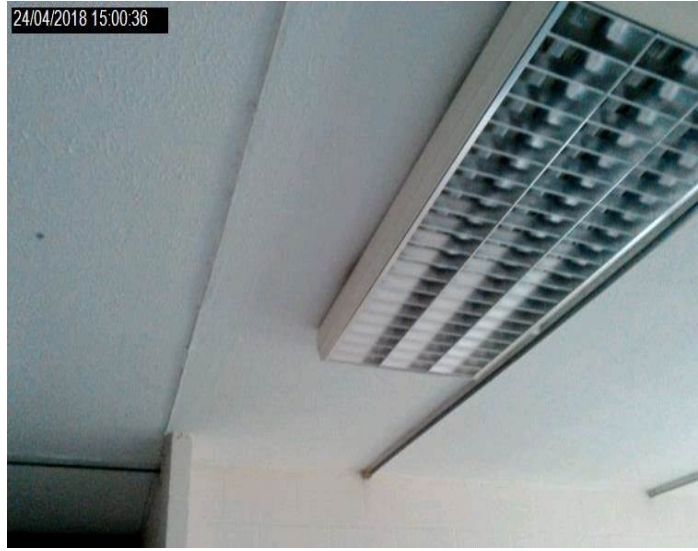
<b>Location:</b>	2.29	<b>Block:</b>	Commercial	<b>Floor Level:</b> 1st Floor
<b>Sample No.:</b>	DU001309	<b>Portal Ref No.:</b>	138

<b>Item:</b>	Asbestos Textured coating to concrete			
<b>Asbestos Content:</b>	Result Based on:			
Chrysotile	Analysis of sample using PLM			
<b>Sample Analysed By:</b>	Reg 13(1)	<b>Extent:</b>	25 m <sup>2</sup>	
<b>Comments:</b>

<b>Material Assessment Total Score: 3</b>		<b>Likelihood of Disturbance Assessment Total Score: 5</b>		<b>Management Assessment</b>  <b>Licensable:</b> No  <b>Recommendations:</b> Program removal  <b>Reinspection Interval:</b> Not Applicable  <b>Overall Risk Category:</b> C8
<b>Product Type:</b>	1 (Asbestos textured coating)	<b>Location:</b>	2 (Rooms up to 100 sq m)	
<b>Condition:</b>	1 (Minor scratches)	<b>Accessibility:</b>	1 (Occasionally likely to be disturbed)	
<b>Surface Treatment:</b>	0 (Composite material)			
<b>Asbestos Type:</b>	1 (Chrysotile)	<b>Extent Score:</b>	2 (>10 - <50 sq m or >10m - <50m pipe run)

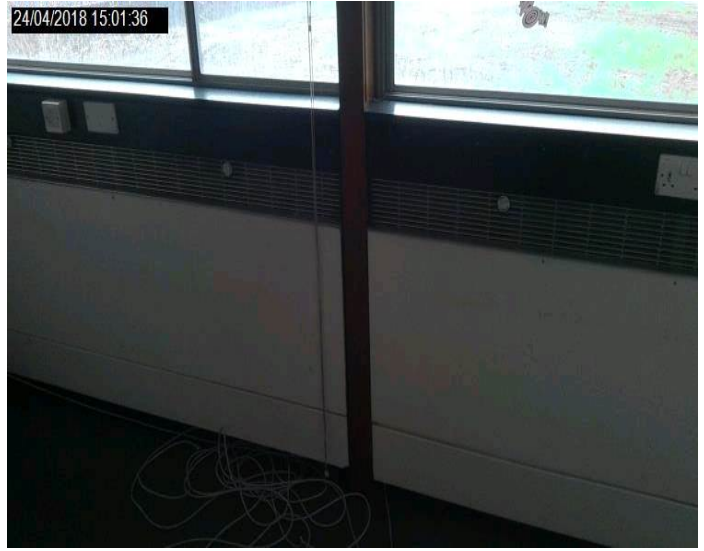
<b>Location:</b>	2.29	<b>Block:</b>	Commercial	<b>Floor Level:</b> 1st Floor
<b>Sample No.:</b>	DU001310	<b>Portal Ref No.:</b>	140

<b>Item:</b>	Asbestos Cement window sill			
<b>Asbestos Content:</b>	Result Based on:			
Chrysotile	Analysis of sample using PLM			
<b>Sample Analysed By:</b> Reg 13(1)	<b>Extent:</b>	5 linear metres		
<b>Comments:</b>

<b>Material Assessment Total Score: 4</b>		<b>Likelihood of Disturbance Assessment Total Score: 4</b>		<b>Management Assessment</b>  <b>Licensable:</b> No  <b>Recommendations:</b> Program removal  <b>Reinspection Interval:</b> Not Applicable  <b>Overall Risk Category:</b> C8
<b>Product Type:</b>	1 (Asbestos cement)	<b>Location:</b>	2 (Rooms up to 100 sq m)	
<b>Condition:</b>	1 (Minor scratches)	<b>Accessibility:</b>	1 (Occasionally likely to be disturbed)	
<b>Surface Treatment:</b>	1 (Encapsulated asbestos cement)			
<b>Asbestos Type:</b>	1 (Chrysotile)	<b>Extent Score:</b>	1 (<10 sq m or 10m pipe run)

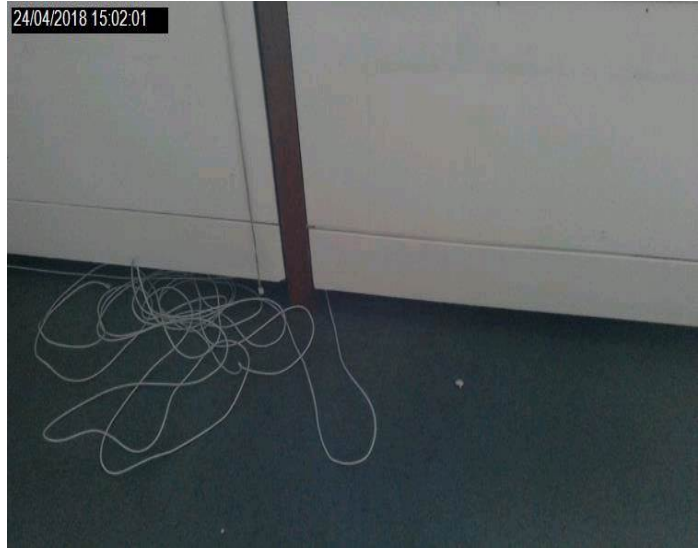
<b>Location:</b>	2.29	<b>Block:</b>	Commercial	<b>Floor Level:</b> 1st Floor
<b>Sample No.:</b>	DU001311	<b>Portal Ref No.:</b>	141

<b>Item:</b>	Asbestos Cement shuttering			
<b>Asbestos Content:</b>	Result Based on:			
Chrysotile	Analysis of sample using PLM			
<b>Sample Analysed By:</b> Reg 13(1)	<b>Extent:</b>	5 m <sup>2</sup>		
<b>Comments:</b> To the ceiling of wall void to the heating system

<b>Material Assessment Total Score: 4</b>		<b>Likelihood of Disturbance Assessment Total Score: 4</b>		<b>Management Assessment</b>  <b>Licensable:</b> No  <b>Recommendations:</b> Program removal  <b>Reinspection Interval:</b> Not Applicable  <b>Overall Risk Category:</b> C8
<b>Product Type:</b>	1 (Asbestos cement)	<b>Location:</b>	2 (Rooms up to 100 sq m)	
<b>Condition:</b>	1 (Minor scratches)	<b>Accessibility:</b>	1 (Occasionally likely to be disturbed)	
<b>Surface Treatment:</b>	1 (Encapsulated asbestos cement)			
<b>Asbestos Type:</b>	1 (Chrysotile)	<b>Extent Score:</b>	1 (<10 sq m or 10m pipe run)

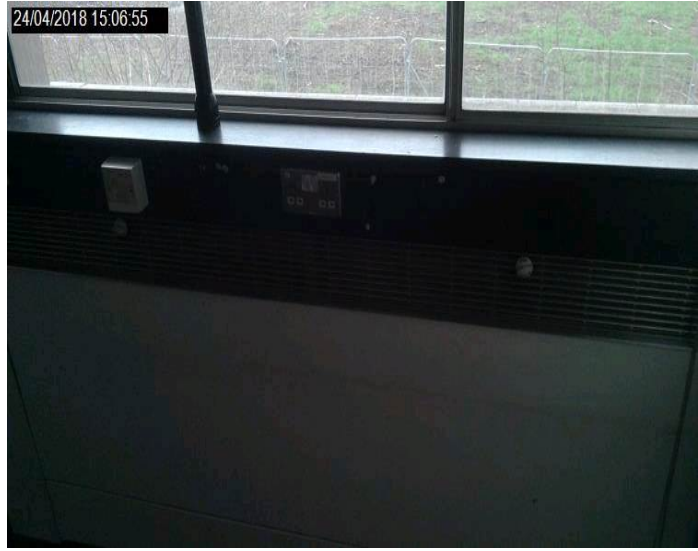
<b>Location:</b>	2.28	<b>Block:</b>	Commercial	<b>Floor Level:</b> 1st Floor
<b>Sample No.:</b>	As DU001310	<b>Portal Ref No.:</b>	143

<b>Item:</b>	Asbestos Cement window sill			
<b>Asbestos Content:</b>	<b>Result Based on:</b>			
Chrysotile	Strongly presumed			
<b>Sample Analysed By:</b>	Not applicable	<b>Extent:</b>	2 linear metres	
<b>Comments:</b>

<b>Material Assessment Total Score: 4</b>		<b>Likelihood of Disturbance Assessment Total Score: 4</b>		<b>Management Assessment</b>  <b>Licensable:</b> No  <b>Recommendations:</b> Program removal  <b>Reinspection Interval:</b> Not Applicable  <b>Overall Risk Category:</b> C8
<b>Product Type:</b>	1 (Asbestos cement)	<b>Location:</b>	2 (Rooms up to 100 sq m)	
<b>Condition:</b>	1 (Minor scratches)	<b>Accessibility:</b>	1 (Occasionally likely to be disturbed)	
<b>Surface Treatment:</b>	1 (Encapsulated asbestos cement)			
<b>Asbestos Type:</b>	1 (Chrysotile)	<b>Extent Score:</b>	1 (<10 sq m or 10m pipe run)

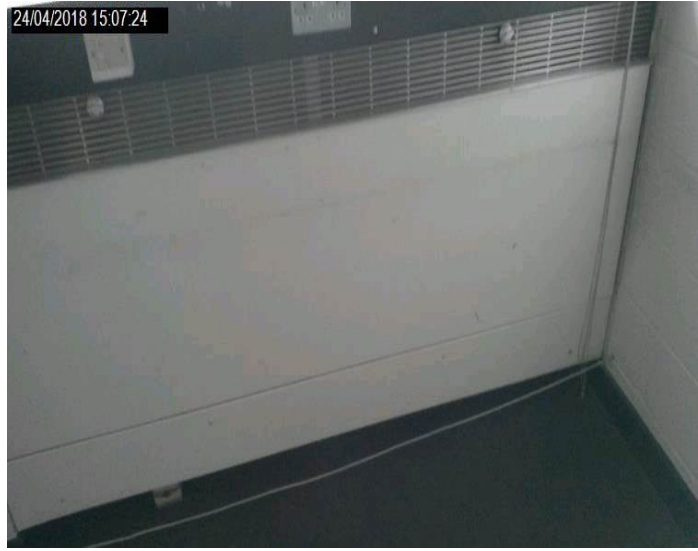
<b>Location:</b>	2.28	<b>Block:</b>	Commercial	<b>Floor Level:</b> 1st Floor
<b>Sample No.:</b>	As DU001311	<b>Portal Ref No.:</b>	144

<b>Item:</b>	Asbestos Cement shuttering			
<b>Asbestos Content:</b>	<b>Result Based on:</b>			
Chrysotile	Strongly presumed			
<b>Sample Analysed By:</b>	Not applicable	<b>Extent:</b>	3 m <sup>2</sup>	
<b>Comments:</b> To the ceiling of wall void to the heating system

<b>Material Assessment Total Score: 4</b>		<b>Likelihood of Disturbance Assessment Total Score: 4</b>		<b>Management Assessment</b>  <b>Licensable:</b> No  <b>Recommendations:</b> Program removal  <b>Reinspection Interval:</b> Not Applicable  <b>Overall Risk Category:</b> C8
<b>Product Type:</b>	1 (Asbestos cement)	<b>Location:</b>	2 (Rooms up to 100 sq m)	
<b>Condition:</b>	1 (Minor scratches)	<b>Accessibility:</b>	1 (Occasionally likely to be disturbed)	
<b>Surface Treatment:</b>	1 (Encapsulated asbestos cement)			
<b>Asbestos Type:</b>	1 (Chrysotile)	<b>Extent Score:</b>	1 (<10 sq m or 10m pipe run)

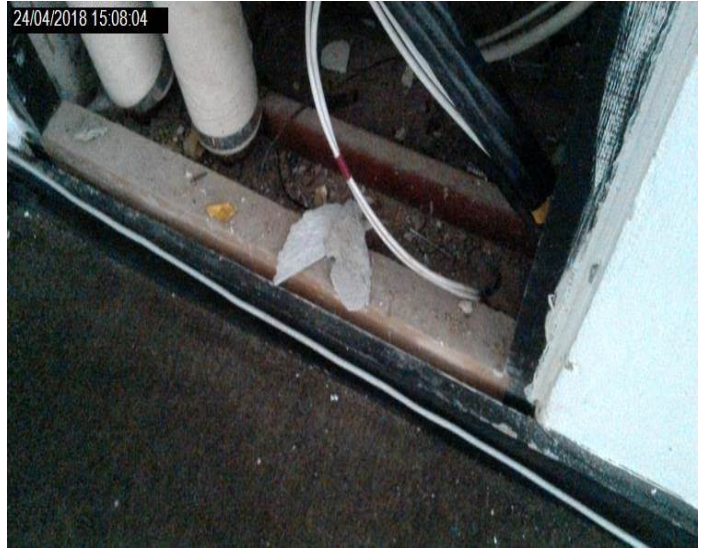
<b>Location:</b>	2.28	<b>Block:</b>	Commercial	<b>Floor Level:</b> 1st Floor
<b>Sample No.:</b>	DU001313	<b>Portal Ref No.:</b>	146

<b>Item:</b>	Asbestos Insulating board debris to base of riser			
<b>Asbestos Content:</b>	Result Based on:			
Chrysotile Amosite	Analysis of sample using PLM			
<b>Sample Analysed By:</b> Reg 13(1)	<b>Extent:</b>	1 m <sup>2</sup>		
<b>Comments:</b> Sporadic throughout base of riser

<b>Material Assessment Total Score: 9</b>		<b>Likelihood of Disturbance Assessment Total Score: 4</b>		<b>Management Assessment</b>  <b>Licensable:</b> Yes  <b>Recommendations:</b> Program removal  <b>Reinspection Interval:</b> Not Applicable  <b>Overall Risk Category:</b> B13
<b>Product Type:</b>	2 (Asbestos insulating board)	<b>Location:</b>	2 (Rooms up to 100 sq m)	
<b>Condition:</b>	3 (Significant damage)	<b>Accessibility:</b>	1 (Occasionally likely to be disturbed)	
<b>Surface Treatment:</b>	2 (Unencapsulated asbestos insulating board)			
<b>Asbestos Type:</b>	2 (Chrysotile Amosite)	<b>Extent Score:</b>	1 (<10 sq m or 10m pipe run)

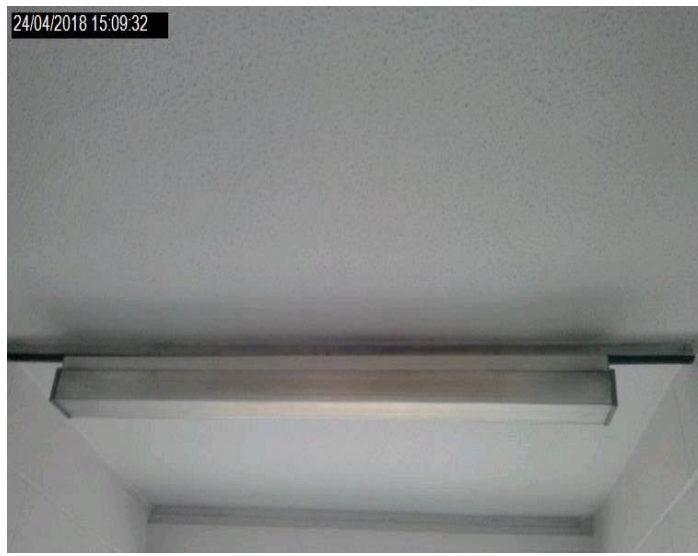
<b>Location:</b>	2.27	<b>Block:</b>	Commercial	<b>Floor Level:</b> 1st Floor
<b>Sample No.:</b>	As DU001309	<b>Portal Ref No.:</b>	147

<b>Item:</b>	Asbestos Textured coating to concrete			
<b>Asbestos Content:</b>	<b>Result Based on:</b>			
Chrysotile	Strongly presumed			
<b>Sample Analysed By:</b>	Not applicable	<b>Extent:</b>	8 m <sup>2</sup>	
<b>Comments:</b>

<b>Material Assessment Total Score: 3</b>		<b>Likelihood of Disturbance Assessment Total Score: 4</b>		<b>Management Assessment</b>  <b>Licensable:</b> No  <b>Recommendations:</b> Program removal  <b>Reinspection Interval:</b> Not Applicable  <b>Overall Risk Category:</b> C7
<b>Product Type:</b>	1 (Asbestos textured coating)	<b>Location:</b>	2 (Rooms up to 100 sq m)	
<b>Condition:</b>	1 (Minor scratches)	<b>Accessibility:</b>	1 (Occasionally likely to be disturbed)	
<b>Surface Treatment:</b>	0 (Composite material)			
<b>Asbestos Type:</b>	1 (Chrysotile)	<b>Extent Score:</b>	1 (<10 sq m or 10m pipe run)

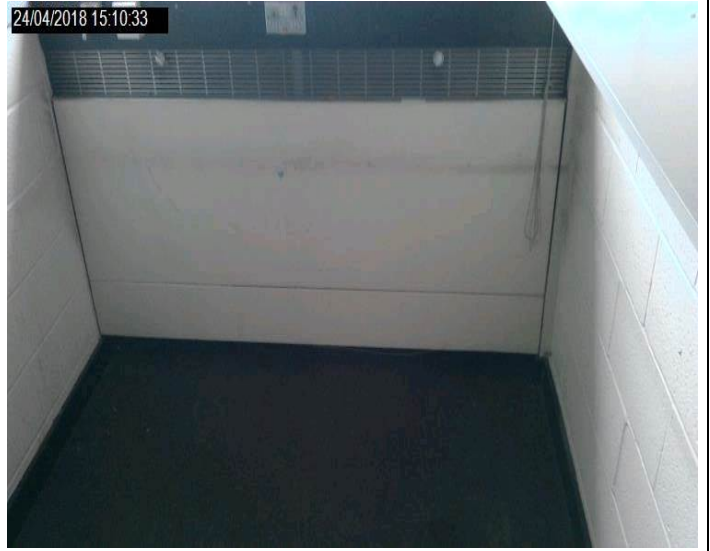
<b>Location:</b>	2.27	<b>Block:</b>	Commercial	<b>Floor Level:</b> 1st Floor
<b>Sample No.:</b>	As DU001311	<b>Portal Ref No.:</b>	149

<b>Item:</b>	Asbestos Cement shuttering			
<b>Asbestos Content:</b>	<b>Result Based on:</b>			
Chrysotile	Strongly presumed			
<b>Sample Analysed By:</b>	Not applicable	<b>Extent:</b>	2 m <sup>2</sup>	
<b>Comments:</b> To the ceiling of wall void to the heating system

<b>Material Assessment Total Score: 4</b>		<b>Likelihood of Disturbance Assessment Total Score: 4</b>		<b>Management Assessment</b>  <b>Licensable:</b> No  <b>Recommendations:</b> Program removal  <b>Reinspection Interval:</b> Not Applicable  <b>Overall Risk Category:</b> C8
<b>Product Type:</b>	1 (Asbestos cement)	<b>Location:</b>	2 (Rooms up to 100 sq m)	
<b>Condition:</b>	1 (Minor scratches)	<b>Accessibility:</b>	1 (Occasionally likely to be disturbed)	
<b>Surface Treatment:</b>	1 (Encapsulated asbestos cement)			
<b>Asbestos Type:</b>	1 (Chrysotile)	<b>Extent Score:</b>	1 (<10 sq m or 10m pipe run)

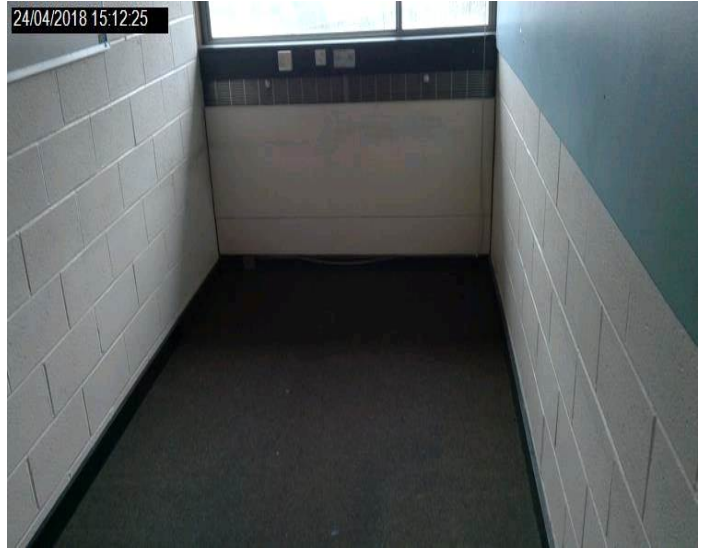
<b>Location:</b>	2.26	<b>Block:</b>	Commercial	<b>Floor Level:</b> 1st Floor
<b>Sample No.:</b>	As DU001311	<b>Portal Ref No.:</b>	152

<b>Item:</b>	Asbestos Cement shuttering			
<b>Asbestos Content:</b>	<b>Result Based on:</b>			
Chrysotile	Strongly presumed			
<b>Sample Analysed By:</b>	Not applicable	<b>Extent:</b>	2 m <sup>2</sup>	
<b>Comments:</b> To the ceiling of wall void to the heating system

<b>Material Assessment Total Score: 4</b>		<b>Likelihood of Disturbance Assessment Total Score: 4</b>		<b>Management Assessment</b>  <b>Licensable:</b> No  <b>Recommendations:</b> Program removal  <b>Reinspection Interval:</b> Not Applicable  <b>Overall Risk Category:</b> C8
<b>Product Type:</b>	1 (Asbestos cement)	<b>Location:</b>	2 (Rooms up to 100 sq m)	
<b>Condition:</b>	1 (Minor scratches)	<b>Accessibility:</b>	1 (Occasionally likely to be disturbed)	
<b>Surface Treatment:</b>	1 (Encapsulated asbestos cement)			
<b>Asbestos Type:</b>	1 (Chrysotile)	<b>Extent Score:</b>	1 (<10 sq m or 10m pipe run)

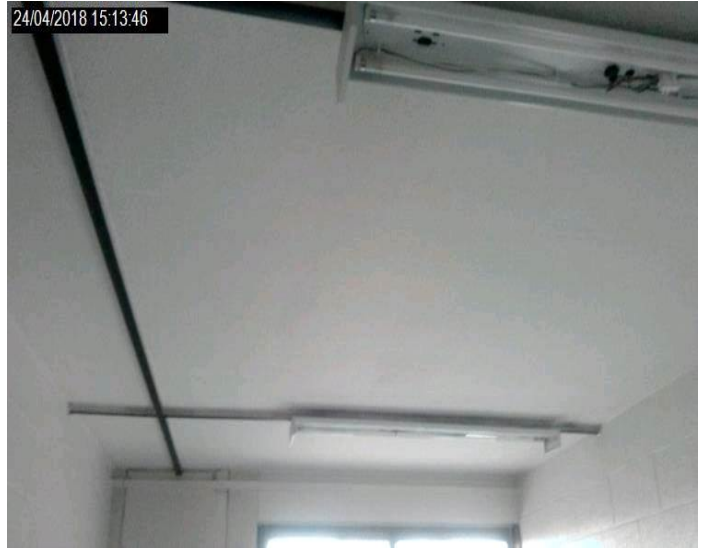
<b>Location:</b>	2.25	<b>Block:</b>	Commercial	<b>Floor Level:</b> 1st Floor
<b>Sample No.:</b>	As DU001309	<b>Portal Ref No.:</b>	153

<b>Item:</b>	Asbestos Textured coating to concrete			
<b>Asbestos Content:</b>	<b>Result Based on:</b>			
Chrysotile	Strongly presumed			
<b>Sample Analysed By:</b>	Not applicable	<b>Extent:</b>	14 m <sup>2</sup>	
<b>Comments:</b>

<b>Material Assessment Total Score: 3</b>		<b>Likelihood of Disturbance Assessment Total Score: 5</b>		<b>Management Assessment</b>  <b>Licensable:</b> No  <b>Recommendations:</b> Program removal  <b>Reinspection Interval:</b> Not Applicable  <b>Overall Risk Category:</b> C8
<b>Product Type:</b>	1 (Asbestos textured coating)	<b>Location:</b>	2 (Rooms up to 100 sq m)	
<b>Condition:</b>	1 (Minor scratches)	<b>Accessibility:</b>	1 (Occasionally likely to be disturbed)	
<b>Surface Treatment:</b>	0 (Composite material)			
<b>Asbestos Type:</b>	1 (Chrysotile)	<b>Extent Score:</b>	2 (>10 - <50 sq m or >10m - <50m pipe run)

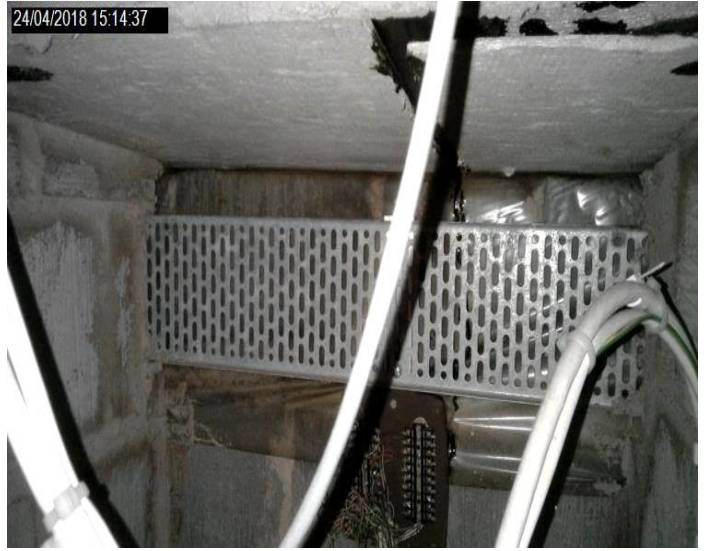
<b>Location:</b>	2.25	<b>Block:</b>	Commercial	<b>Floor Level:</b> 1st Floor
<b>Sample No.:</b>	As DU001311	<b>Portal Ref No.:</b>	155

<b>Item:</b>	Asbestos Cement shuttering			
<b>Asbestos Content:</b>	<b>Result Based on:</b>			
Chrysotile	Strongly presumed			
<b>Sample Analysed By:</b>	Not applicable	<b>Extent:</b>	3 m <sup>2</sup>	
<b>Comments:</b> To the ceiling of wall void to the heating system

<b>Material Assessment Total Score: 4</b>		<b>Likelihood of Disturbance Assessment Total Score: 4</b>		<b>Management Assessment</b>  <b>Licensable:</b> No  <b>Recommendations:</b> Program removal  <b>Reinspection Interval:</b> Not Applicable  <b>Overall Risk Category:</b> C8
<b>Product Type:</b>	1 (Asbestos cement)	<b>Location:</b>	2 (Rooms up to 100 sq m)	
<b>Condition:</b>	1 (Minor scratches)	<b>Accessibility:</b>	1 (Occasionally likely to be disturbed)	
<b>Surface Treatment:</b>	1 (Encapsulated asbestos cement)			
<b>Asbestos Type:</b>	1 (Chrysotile)	<b>Extent Score:</b>	1 (<10 sq m or 10m pipe run)

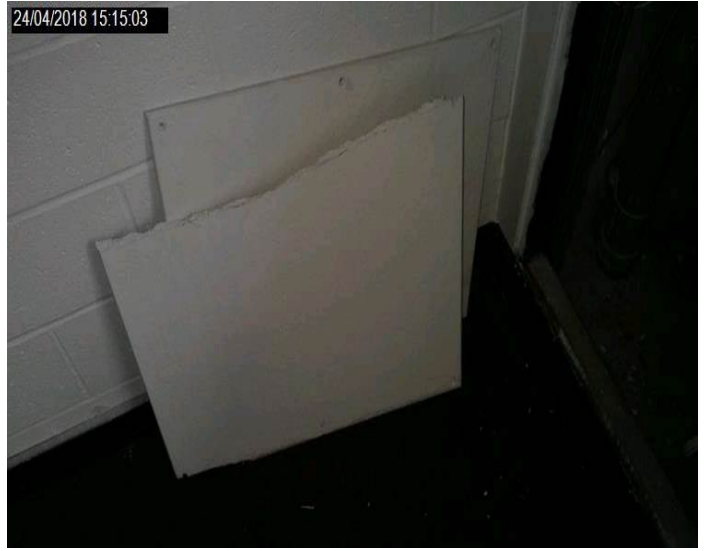
<b>Location:</b>	2.25	<b>Block:</b>	Commercial	<b>Floor Level:</b> 1st Floor
<b>Sample No.:</b>	As DU001312	<b>Portal Ref No.:</b>	156

<b>Item:</b>	Insulating board panel to riser			
<b>Asbestos Content:</b>		<b>Result Based on:</b>		
No Asbestos Detected		Strongly presumed		
<b>Sample Analysed By:</b>	Not applicable	<b>Extent:</b>	3 m <sup>2</sup>	
<b>Comments:</b>

<b>Material Assessment Total Score: 0</b>		<b>Likelihood of Disturbance Assessment Total Score: 0</b>		<b>Management Assessment</b>  <b>Licensable:</b> Yes  <b>Recommendations:</b> Not Applicable  <b>Reinspection Interval:</b> Not Applicable  <b>Overall Risk Category:</b> E0
<b>Product Type:</b>	0 Not Applicable	<b>Location:</b>	0 Not Applicable	
<b>Condition:</b>	0 Not Applicable	<b>Accessibility:</b>	0 Not Applicable	
<b>Surface Treatment:</b>	0 Not Applicable			
<b>Asbestos Type:</b>	0 Not Applicable	<b>Extent Score:</b>	0 Not Applicable

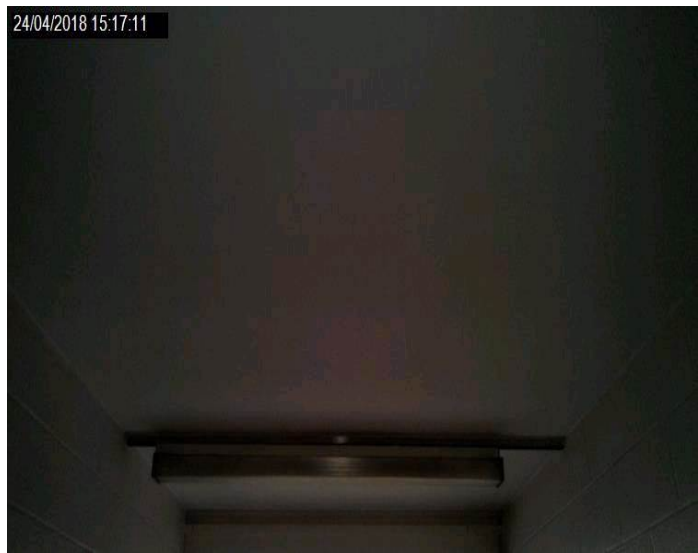
<b>Location:</b>	2.24	<b>Block:</b>	Commercial	<b>Floor Level:</b> 1st Floor
<b>Sample No.:</b>	As DU001309	<b>Portal Ref No.:</b>	157

<b>Item:</b>	Asbestos Textured coating to concrete			
<b>Asbestos Content:</b>	<b>Result Based on:</b>			
Chrysotile	Strongly presumed			
<b>Sample Analysed By:</b>	Not applicable	<b>Extent:</b>	8 m <sup>2</sup>	
<b>Comments:</b>

<b>Material Assessment Total Score: 3</b>		<b>Likelihood of Disturbance Assessment Total Score: 4</b>		<b>Management Assessment</b>  <b>Licensable:</b> No  <b>Recommendations:</b> Program removal  <b>Reinspection Interval:</b> Not Applicable  <b>Overall Risk Category:</b> C7
<b>Product Type:</b>	1 (Asbestos textured coating)	<b>Location:</b>	2 (Rooms up to 100 sq m)	
<b>Condition:</b>	1 (Minor scratches)	<b>Accessibility:</b>	1 (Occasionally likely to be disturbed)	
<b>Surface Treatment:</b>	0 (Composite material)			
<b>Asbestos Type:</b>	1 (Chrysotile)	<b>Extent Score:</b>	1 (<10 sq m or 10m pipe run)

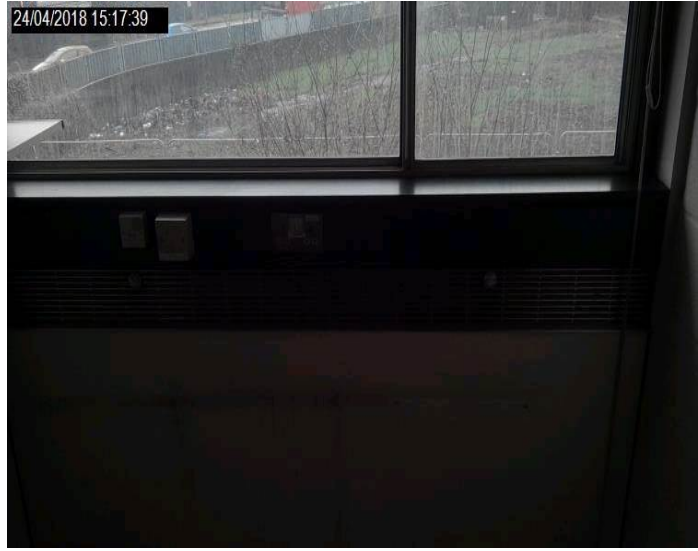
<b>Location:</b>	2.24	<b>Block:</b>	Commercial	<b>Floor Level:</b> 1st Floor
<b>Sample No.:</b>	As DU001310	<b>Portal Ref No.:</b>	158

<b>Item:</b>	Asbestos Cement window sill			
<b>Asbestos Content:</b>	<b>Result Based on:</b>			
Chrysotile	Strongly presumed			
<b>Sample Analysed By:</b>	Not applicable	<b>Extent:</b>	3 linear metres	
<b>Comments:</b>

<b>Material Assessment Total Score: 4</b>		<b>Likelihood of Disturbance Assessment Total Score: 4</b>		<b>Management Assessment</b>  <b>Licensable:</b> No  <b>Recommendations:</b> Program removal  <b>Reinspection Interval:</b> Not Applicable  <b>Overall Risk Category:</b> C8
<b>Product Type:</b>	1 (Asbestos cement)	<b>Location:</b>	2 (Rooms up to 100 sq m)	
<b>Condition:</b>	1 (Minor scratches)	<b>Accessibility:</b>	1 (Occasionally likely to be disturbed)	
<b>Surface Treatment:</b>	1 (Encapsulated asbestos cement)			
<b>Asbestos Type:</b>	1 (Chrysotile)	<b>Extent Score:</b>	1 (<10 sq m or 10m pipe run)

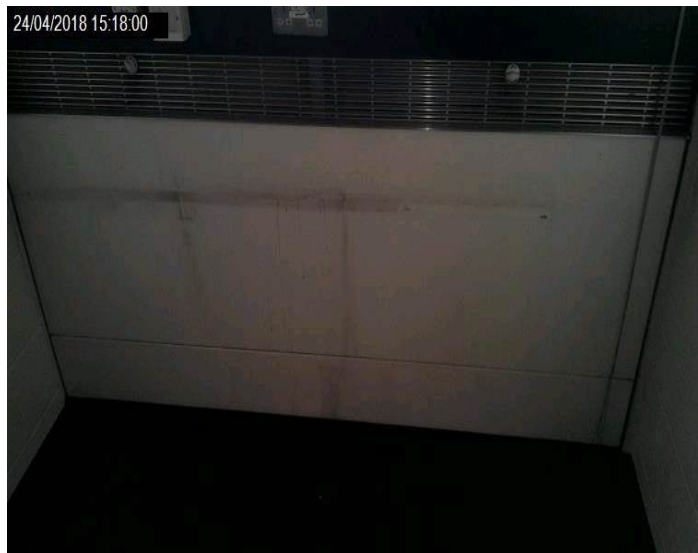
<b>Location:</b>	2.24	<b>Block:</b>	Commercial	<b>Floor Level:</b> 1st Floor
<b>Sample No.:</b>	As DU001311	<b>Portal Ref No.:</b>	159

<b>Item:</b>	Asbestos Cement shuttering			
<b>Asbestos Content:</b>	<b>Result Based on:</b>			
Chrysotile	Strongly presumed			
<b>Sample Analysed By:</b>	Not applicable	<b>Extent:</b>	3 linear metres	
<b>Comments:</b> To the ceiling of wall void to the heating system

<b>Material Assessment Total Score: 4</b>		<b>Likelihood of Disturbance Assessment Total Score: 4</b>		<b>Management Assessment</b>  <b>Licensable:</b> No  <b>Recommendations:</b> Program removal  <b>Reinspection Interval:</b> Not Applicable  <b>Overall Risk Category:</b> C8
<b>Product Type:</b>	1 (Asbestos cement)	<b>Location:</b>	2 (Rooms up to 100 sq m)	
<b>Condition:</b>	1 (Minor scratches)	<b>Accessibility:</b>	1 (Occasionally likely to be disturbed)	
<b>Surface Treatment:</b>	1 (Encapsulated asbestos cement)			
<b>Asbestos Type:</b>	1 (Chrysotile)	<b>Extent Score:</b>	1 (<10 sq m or 10m pipe run)

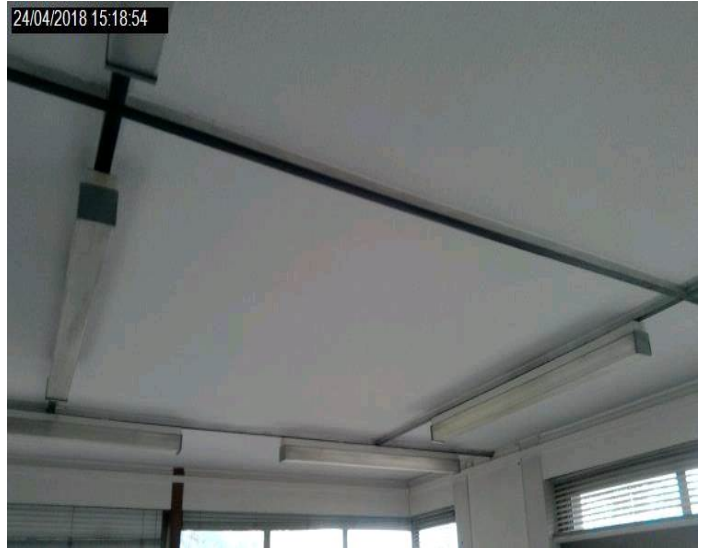
<b>Location:</b>	2.23	<b>Block:</b>	Commercial	<b>Floor Level:</b> 1st Floor
<b>Sample No.:</b>	As DU001309	<b>Portal Ref No.:</b>	160

<b>Item:</b>	Asbestos Textured coating to concrete			
<b>Asbestos Content:</b>	<b>Result Based on:</b>			
Chrysotile	Strongly presumed			
<b>Sample Analysed By:</b>	Not applicable	<b>Extent:</b>	25 m <sup>2</sup>	
<b>Comments:</b>

<b>Material Assessment Total Score: 3</b>		<b>Likelihood of Disturbance Assessment Total Score: 5</b>		<b>Management Assessment</b>  <b>Licensable:</b> No  <b>Recommendations:</b> Program removal  <b>Reinspection Interval:</b> Not Applicable  <b>Overall Risk Category:</b> C8
<b>Product Type:</b>	1 (Asbestos textured coating)	<b>Location:</b>	2 (Rooms up to 100 sq m)	
<b>Condition:</b>	1 (Minor scratches)	<b>Accessibility:</b>	1 (Occasionally likely to be disturbed)	
<b>Surface Treatment:</b>	0 (Composite material)			
<b>Asbestos Type:</b>	1 (Chrysotile)	<b>Extent Score:</b>	2 (>10 - <50 sq m or >10m - <50m pipe run)

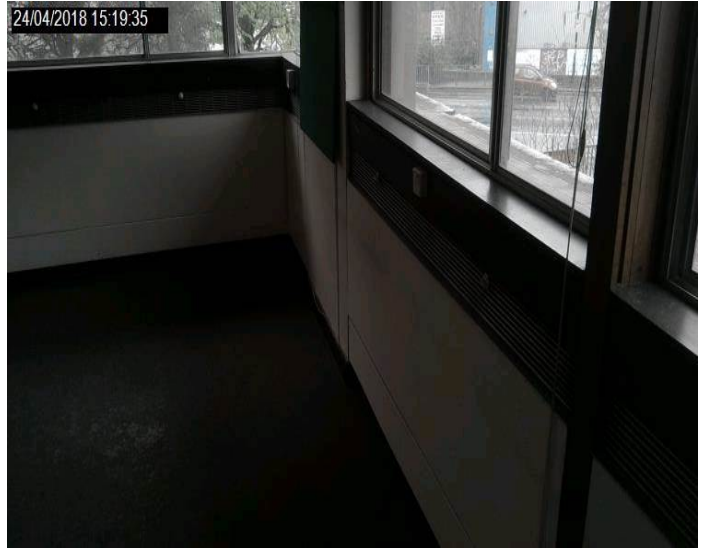
<b>Location:</b>	2.23	<b>Block:</b>	Commercial	<b>Floor Level:</b> 1st Floor
<b>Sample No.:</b>	As DU001310	<b>Portal Ref No.:</b>	161

<b>Item:</b>	Asbestos Cement window sill			
<b>Asbestos Content:</b>	<b>Result Based on:</b>			
Chrysotile	Strongly presumed			
<b>Sample Analysed By:</b>	Not applicable	<b>Extent:</b>	12 linear metres	
<b>Comments:</b>

<b>Material Assessment Total Score: 4</b>		<b>Likelihood of Disturbance Assessment Total Score: 4</b>		<b>Management Assessment</b>  <b>Licensable:</b> No  <b>Recommendations:</b> Program removal  <b>Reinspection Interval:</b> Not Applicable  <b>Overall Risk Category:</b> C8
<b>Product Type:</b>	1 (Asbestos cement)	<b>Location:</b>	2 (Rooms up to 100 sq m)	
<b>Condition:</b>	1 (Minor scratches)	<b>Accessibility:</b>	1 (Occasionally likely to be disturbed)	
<b>Surface Treatment:</b>	1 (Encapsulated asbestos cement)			
<b>Asbestos Type:</b>	1 (Chrysotile)	<b>Extent Score:</b>	1 (<10 sq m or 10m pipe run)

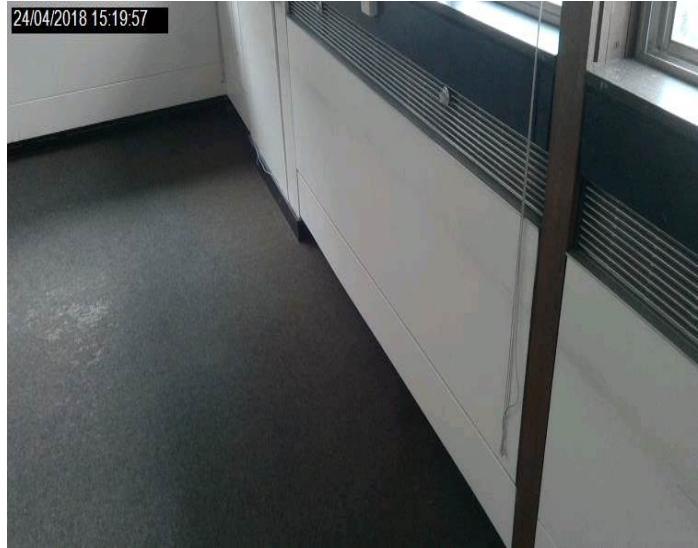
<b>Location:</b>	2.23	<b>Block:</b>	Commercial	<b>Floor Level:</b> 1st Floor
<b>Sample No.:</b>	As DU001311	<b>Portal Ref No.:</b>	162

<b>Item:</b>	Asbestos Cement shuttering			
<b>Asbestos Content:</b>	<b>Result Based on:</b>			
Chrysotile	Strongly presumed			
<b>Sample Analysed By:</b>	Not applicable	<b>Extent:</b>	12 m <sup>2</sup>	
<b>Comments:</b> To the ceiling of wall void to the heating system

<b>Material Assessment Total Score: 4</b>		<b>Likelihood of Disturbance Assessment Total Score: 5</b>		<b>Management Assessment</b>  <b>Licensable:</b> No  <b>Recommendations:</b> Program removal  <b>Reinspection Interval:</b> Not Applicable  <b>Overall Risk Category:</b> C9
<b>Product Type:</b>	1 (Asbestos cement)	<b>Location:</b>	2 (Rooms up to 100 sq m)	
<b>Condition:</b>	1 (Minor scratches)	<b>Accessibility:</b>	1 (Occasionally likely to be disturbed)	
<b>Surface Treatment:</b>	1 (Encapsulated asbestos cement)			
<b>Asbestos Type:</b>	1 (Chrysotile)	<b>Extent Score:</b>	2 (>10 - <50 sq m or >10m - <50m pipe run)

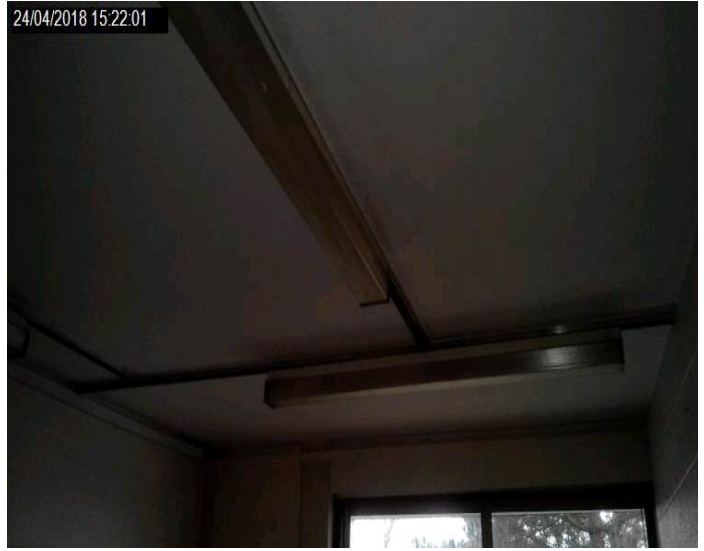
<b>Location:</b>	2.22	<b>Block:</b>	Commercial	<b>Floor Level:</b> 1st Floor
<b>Sample No.:</b>	As DU001309	<b>Portal Ref No.:</b>	164

<b>Item:</b>	Asbestos Textured coating to concrete			
<b>Asbestos Content:</b>	<b>Result Based on:</b>			
Chrysotile	Strongly presumed			
<b>Sample Analysed By:</b>	Not applicable	<b>Extent:</b>	12 m <sup>2</sup>	
<b>Comments:</b>

<b>Material Assessment Total Score: 3</b>		<b>Likelihood of Disturbance Assessment Total Score: 5</b>		<b>Management Assessment</b>  <b>Licensable:</b> No  <b>Recommendations:</b> Program removal  <b>Reinspection Interval:</b> Not Applicable  <b>Overall Risk Category:</b> C8
<b>Product Type:</b>	1 (Asbestos textured coating)	<b>Location:</b>	2 (Rooms up to 100 sq m)	
<b>Condition:</b>	1 (Minor scratches)	<b>Accessibility:</b>	1 (Occasionally likely to be disturbed)	
<b>Surface Treatment:</b>	0 (Composite material)			
<b>Asbestos Type:</b>	1 (Chrysotile)	<b>Extent Score:</b>	2 (>10 - <50 sq m or >10m - <50m pipe run)

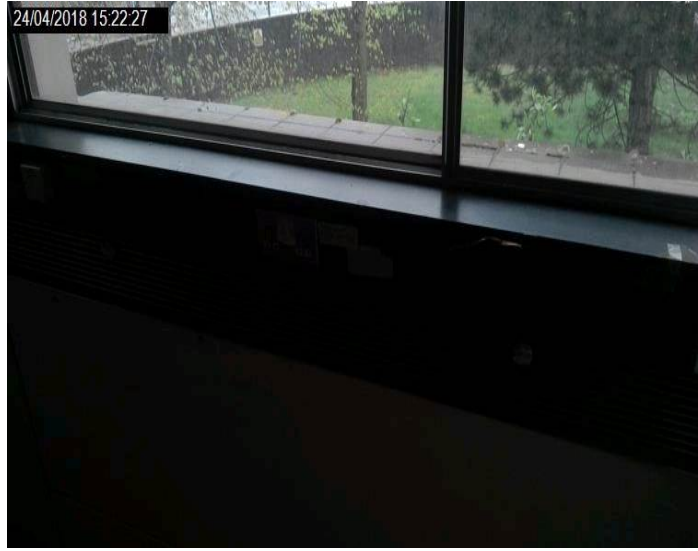
<b>Location:</b>	2.22	<b>Block:</b>	Commercial	<b>Floor Level:</b> 1st Floor
<b>Sample No.:</b>	As DU001310	<b>Portal Ref No.:</b>	165

<b>Item:</b>	Asbestos Cement window sill			
<b>Asbestos Content:</b>	<b>Result Based on:</b>			
Chrysotile	Strongly presumed			
<b>Sample Analysed By:</b>	Not applicable	<b>Extent:</b>	3 linear metres	
<b>Comments:</b>

<b>Material Assessment Total Score: 4</b>		<b>Likelihood of Disturbance Assessment Total Score: 4</b>		<b>Management Assessment</b>  <b>Licensable:</b> No  <b>Recommendations:</b> Program removal  <b>Reinspection Interval:</b> Not Applicable  <b>Overall Risk Category:</b> C8
<b>Product Type:</b>	1 (Asbestos cement)	<b>Location:</b>	2 (Rooms up to 100 sq m)	
<b>Condition:</b>	1 (Minor scratches)	<b>Accessibility:</b>	1 (Occasionally likely to be disturbed)	
<b>Surface Treatment:</b>	1 (Encapsulated asbestos cement)			
<b>Asbestos Type:</b>	1 (Chrysotile)	<b>Extent Score:</b>	1 (<10 sq m or 10m pipe run)

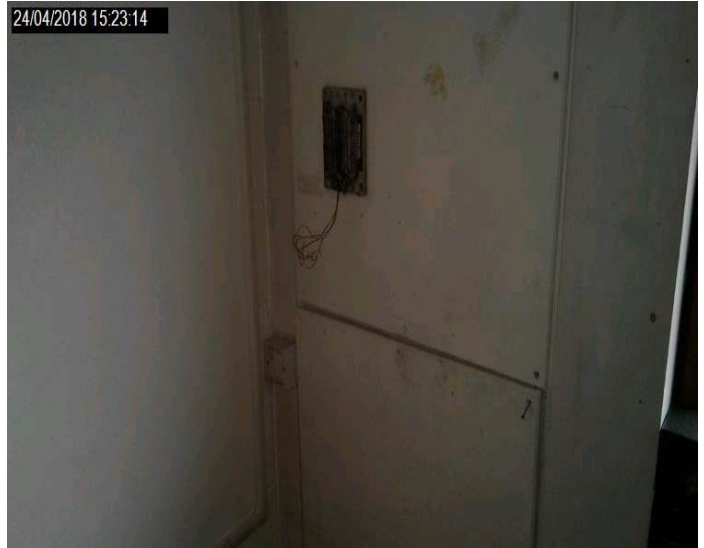
<b>Location:</b>	2.22	<b>Block:</b>	Commercial	<b>Floor Level:</b> 1st Floor
<b>Sample No.:</b>	As DU001312	<b>Portal Ref No.:</b>	167

<b>Item:</b>	Insulating board panel to riser			
<b>Asbestos Content:</b>		<b>Result Based on:</b>		
No Asbestos Detected		Strongly presumed		
<b>Sample Analysed By:</b>	Not applicable	<b>Extent:</b>	3 m <sup>2</sup>	
<b>Comments:</b>

<b>Material Assessment Total Score: 0</b>		<b>Likelihood of Disturbance Assessment Total Score: 0</b>		<b>Management Assessment</b>  <b>Licensable:</b> Yes  <b>Recommendations:</b> Not Applicable  <b>Reinspection Interval:</b> Not Applicable  <b>Overall Risk Category:</b> E0
<b>Product Type:</b>	0 Not Applicable	<b>Location:</b>	0 Not Applicable	
<b>Condition:</b>	0 Not Applicable	<b>Accessibility:</b>	0 Not Applicable	
<b>Surface Treatment:</b>	0 Not Applicable			
<b>Asbestos Type:</b>	0 Not Applicable	<b>Extent Score:</b>	0 Not Applicable

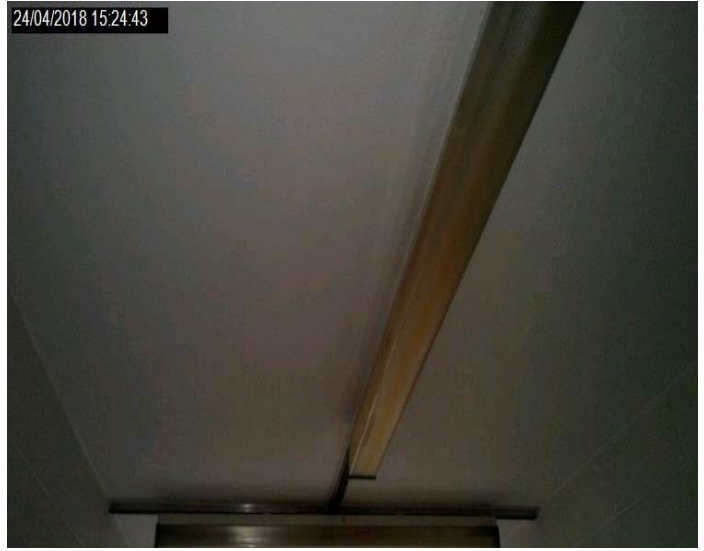
<b>Location:</b>	2.21	<b>Block:</b>	Commercial	<b>Floor Level:</b> 1st Floor
<b>Sample No.:</b>	As DU001309	<b>Portal Ref No.:</b>	168

<b>Item:</b>	Asbestos Textured coating to concrete			
<b>Asbestos Content:</b>	<b>Result Based on:</b>			
Chrysotile	Strongly presumed			
<b>Sample Analysed By:</b>	Not applicable	<b>Extent:</b>	6 m <sup>2</sup>	
<b>Comments:</b>

<b>Material Assessment Total Score: 3</b>		<b>Likelihood of Disturbance Assessment Total Score: 4</b>		<b>Management Assessment</b>  <b>Licensable:</b> No  <b>Recommendations:</b> Program removal  <b>Reinspection Interval:</b> Not Applicable  <b>Overall Risk Category:</b> C7
<b>Product Type:</b>	1 (Asbestos textured coating)	<b>Location:</b>	2 (Rooms up to 100 sq m)	
<b>Condition:</b>	1 (Minor scratches)	<b>Accessibility:</b>	1 (Occasionally likely to be disturbed)	
<b>Surface Treatment:</b>	0 (Composite material)			
<b>Asbestos Type:</b>	1 (Chrysotile)	<b>Extent Score:</b>	1 (<10 sq m or 10m pipe run)

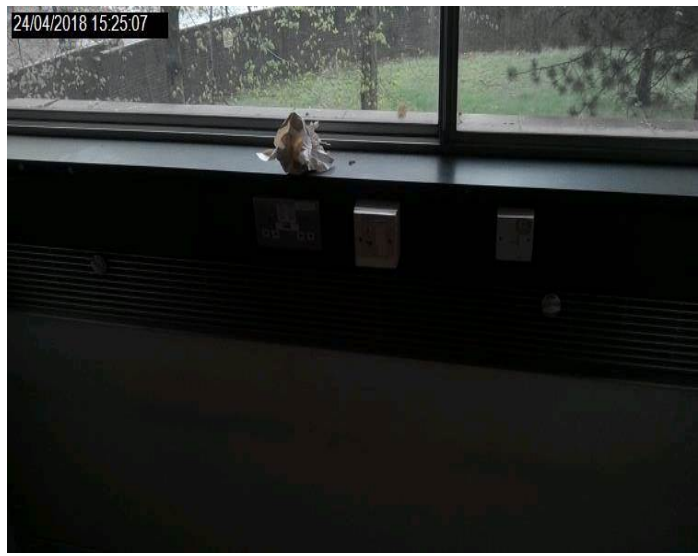
<b>Location:</b>	2.21	<b>Block:</b>	Commercial	<b>Floor Level:</b> 1st Floor
<b>Sample No.:</b>	As DU001310	<b>Portal Ref No.:</b>	169

<b>Item:</b>	Asbestos Cement window sill			
<b>Asbestos Content:</b>	<b>Result Based on:</b>			
Chrysotile	Strongly presumed			
<b>Sample Analysed By:</b>	Not applicable	<b>Extent:</b>	2 linear metres	
<b>Comments:</b>

<b>Material Assessment Total Score: 4</b>		<b>Likelihood of Disturbance Assessment Total Score: 4</b>		<b>Management Assessment</b>  <b>Licensable:</b> No  <b>Recommendations:</b> Program removal  <b>Reinspection Interval:</b> Not Applicable  <b>Overall Risk Category:</b> C8
<b>Product Type:</b>	1 (Asbestos cement)	<b>Location:</b>	2 (Rooms up to 100 sq m)	
<b>Condition:</b>	1 (Minor scratches)	<b>Accessibility:</b>	1 (Occasionally likely to be disturbed)	
<b>Surface Treatment:</b>	1 (Encapsulated asbestos cement)			
<b>Asbestos Type:</b>	1 (Chrysotile)	<b>Extent Score:</b>	1 (<10 sq m or 10m pipe run)

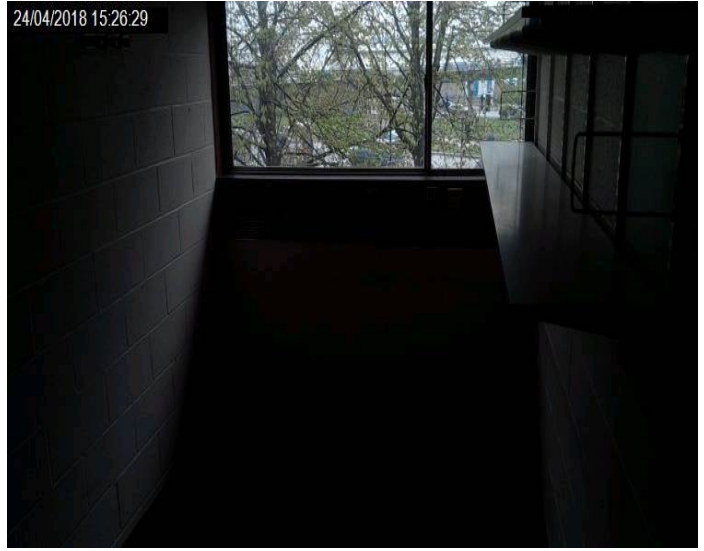
<b>Location:</b>	2.20	<b>Block:</b>	Commercial	<b>Floor Level:</b> 1st Floor
<b>Sample No.:</b>	As DU001310	<b>Portal Ref No.:</b>	172

<b>Item:</b>	Asbestos Cement window sill			
<b>Asbestos Content:</b>	<b>Result Based on:</b>			
Chrysotile	Strongly presumed			
<b>Sample Analysed By:</b>	Not applicable	<b>Extent:</b>	3 linear metres	
<b>Comments:</b>

<b>Material Assessment Total Score: 4</b>		<b>Likelihood of Disturbance Assessment Total Score: 4</b>		<b>Management Assessment</b>  <b>Licensable:</b> No  <b>Recommendations:</b> Program removal  <b>Reinspection Interval:</b> Not Applicable  <b>Overall Risk Category:</b> C8
<b>Product Type:</b>	1 (Asbestos cement)	<b>Location:</b>	2 (Rooms up to 100 sq m)	
<b>Condition:</b>	1 (Minor scratches)	<b>Accessibility:</b>	1 (Occasionally likely to be disturbed)	
<b>Surface Treatment:</b>	1 (Encapsulated asbestos cement)			
<b>Asbestos Type:</b>	1 (Chrysotile)	<b>Extent Score:</b>	1 (<10 sq m or 10m pipe run)

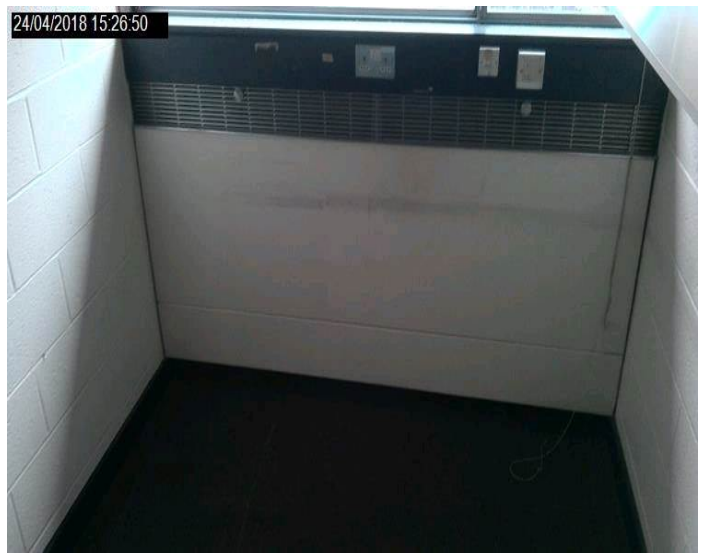
<b>Location:</b>	2.20	<b>Block:</b>	Commercial	<b>Floor Level:</b> 1st Floor
<b>Sample No.:</b>	As DU001311	<b>Portal Ref No.:</b>	173

<b>Item:</b>	Asbestos Cement shuttering			
<b>Asbestos Content:</b>	<b>Result Based on:</b>			
Chrysotile	Strongly presumed			
<b>Sample Analysed By:</b>	Not applicable	<b>Extent:</b>	3 m <sup>2</sup>	
<b>Comments:</b> To the ceiling of wall void to the heating system

<b>Material Assessment Total Score: 4</b>		<b>Likelihood of Disturbance Assessment Total Score: 4</b>		<b>Management Assessment</b>  <b>Licensable:</b> No  <b>Recommendations:</b> Program removal  <b>Reinspection Interval:</b> Not Applicable  <b>Overall Risk Category:</b> C8
<b>Product Type:</b>	1 (Asbestos cement)	<b>Location:</b>	2 (Rooms up to 100 sq m)	
<b>Condition:</b>	1 (Minor scratches)	<b>Accessibility:</b>	1 (Occasionally likely to be disturbed)	
<b>Surface Treatment:</b>	1 (Encapsulated asbestos cement)			
<b>Asbestos Type:</b>	1 (Chrysotile)	<b>Extent Score:</b>	1 (<10 sq m or 10m pipe run)

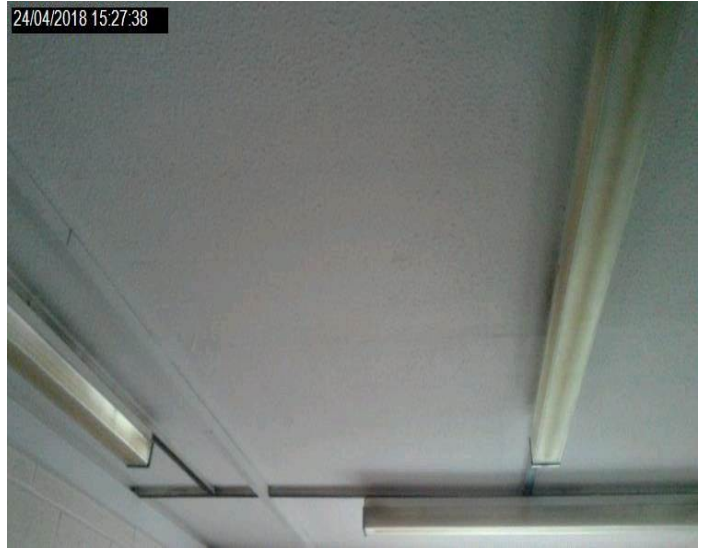
<b>Location:</b>	2.19	<b>Block:</b>	Commercial	<b>Floor Level:</b> 1st Floor
<b>Sample No.:</b>	As DU001309	<b>Portal Ref No.:</b>	174

<b>Item:</b>	Asbestos Textured coating to concrete			
<b>Asbestos Content:</b>	<b>Result Based on:</b>			
Chrysotile	Strongly presumed			
<b>Sample Analysed By:</b>	Not applicable	<b>Extent:</b>	18 m <sup>2</sup>	
<b>Comments:</b>

<b>Material Assessment Total Score: 3</b>		<b>Likelihood of Disturbance Assessment Total Score: 5</b>		<b>Management Assessment</b>  <b>Licensable:</b> No  <b>Recommendations:</b> Program removal  <b>Reinspection Interval:</b> Not Applicable  <b>Overall Risk Category:</b> C8
<b>Product Type:</b>	1 (Asbestos textured coating)	<b>Location:</b>	2 (Rooms up to 100 sq m)	
<b>Condition:</b>	1 (Minor scratches)	<b>Accessibility:</b>	1 (Occasionally likely to be disturbed)	
<b>Surface Treatment:</b>	0 (Composite material)			
<b>Asbestos Type:</b>	1 (Chrysotile)	<b>Extent Score:</b>	2 (>10 - <50 sq m or >10m - <50m pipe run)

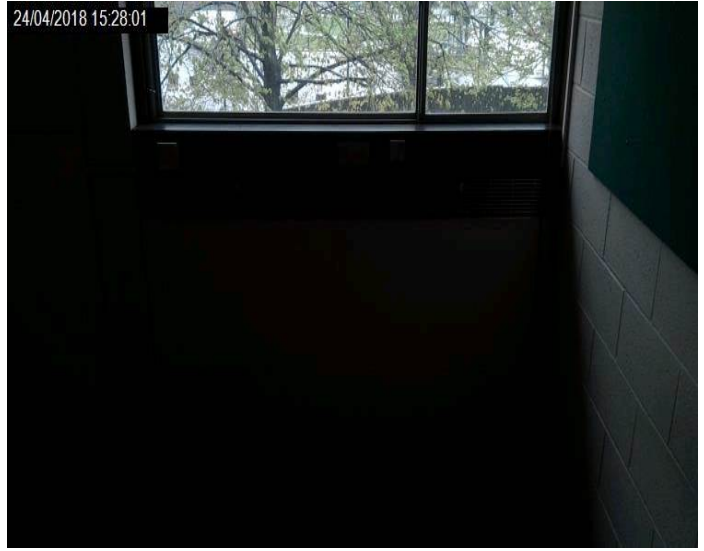
<b>Location:</b>	2.19	<b>Block:</b>	Commercial	<b>Floor Level:</b> 1st Floor
<b>Sample No.:</b>	As DU001310	<b>Portal Ref No.:</b>	175

<b>Item:</b>	Asbestos Cement window sill			
<b>Asbestos Content:</b>	<b>Result Based on:</b>			
Chrysotile	Strongly presumed			
<b>Sample Analysed By:</b>	Not applicable	<b>Extent:</b>	3 linear metres	
<b>Comments:</b>

<b>Material Assessment Total Score: 4</b>		<b>Likelihood of Disturbance Assessment Total Score: 4</b>		<b>Management Assessment</b>  <b>Licensable:</b> No  <b>Recommendations:</b> Program removal  <b>Reinspection Interval:</b> Not Applicable  <b>Overall Risk Category:</b> C8
<b>Product Type:</b>	1 (Asbestos cement)	<b>Location:</b>	2 (Rooms up to 100 sq m)	
<b>Condition:</b>	1 (Minor scratches)	<b>Accessibility:</b>	1 (Occasionally likely to be disturbed)	
<b>Surface Treatment:</b>	1 (Encapsulated asbestos cement)			
<b>Asbestos Type:</b>	1 (Chrysotile)	<b>Extent Score:</b>	1 (<10 sq m or 10m pipe run)

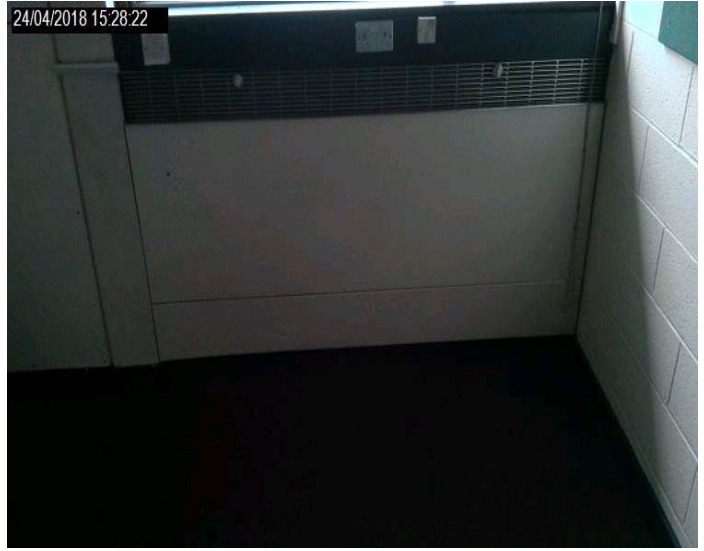
<b>Location:</b>	2.19	<b>Block:</b>	Commercial	<b>Floor Level:</b> 1st Floor
<b>Sample No.:</b>	As DU001311	<b>Portal Ref No.:</b>	176

<b>Item:</b>	Asbestos Cement shuttering			
<b>Asbestos Content:</b>	<b>Result Based on:</b>			
Chrysotile	Strongly presumed			
<b>Sample Analysed By:</b>	Not applicable	<b>Extent:</b>	3 m <sup>2</sup>	
<b>Comments:</b> To the ceiling of wall void to the heating system

<b>Material Assessment Total Score: 4</b>		<b>Likelihood of Disturbance Assessment Total Score: 4</b>		<b>Management Assessment</b>  <b>Licensable:</b> No  <b>Recommendations:</b> Program removal  <b>Reinspection Interval:</b> Not Applicable  <b>Overall Risk Category:</b> C8
<b>Product Type:</b>	1 (Asbestos cement)	<b>Location:</b>	2 (Rooms up to 100 sq m)	
<b>Condition:</b>	1 (Minor scratches)	<b>Accessibility:</b>	1 (Occasionally likely to be disturbed)	
<b>Surface Treatment:</b>	1 (Encapsulated asbestos cement)			
<b>Asbestos Type:</b>	1 (Chrysotile)	<b>Extent Score:</b>	1 (<10 sq m or 10m pipe run)

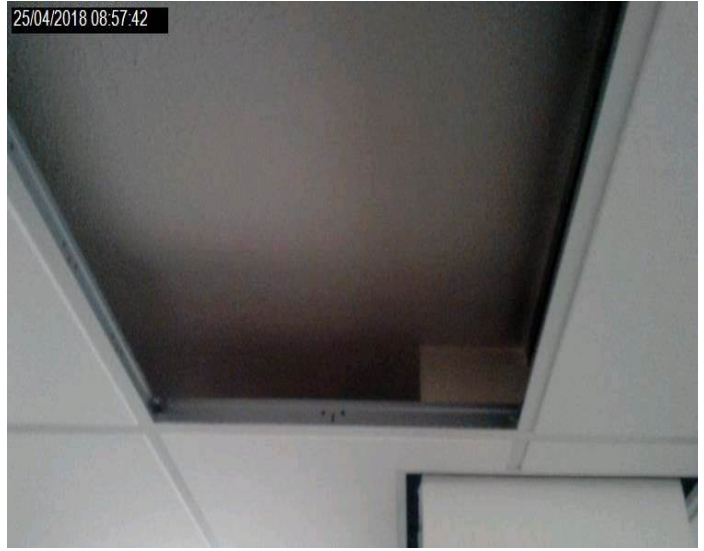
<b>Location:</b>	2.18	<b>Block:</b>	Commercial	<b>Floor Level:</b> 1st Floor
<b>Sample No.:</b>	DU001314	<b>Portal Ref No.:</b>	178

<b>Item:</b>	Asbestos Textured coating to concrete			
<b>Asbestos Content:</b>	Result Based on:			
Chrysotile	Analysis of sample using PLM			
<b>Sample Analysed By:</b> Reg 13(1)	<b>Extent:</b>	60 m <sup>2</sup>		
<b>Comments:</b> Above suspended ceiling tiles

<b>Material Assessment Total Score: 3</b>		<b>Likelihood of Disturbance Assessment Total Score: 6</b>		<b>Management Assessment</b>  <b>Licensable:</b> No  <b>Recommendations:</b> Program removal  <b>Reinspection Interval:</b> Not Applicable  <b>Overall Risk Category:</b> C9
<b>Product Type:</b>	1 (Asbestos textured coating)	<b>Location:</b>	2 (Rooms up to 100 sq m)	
<b>Condition:</b>	1 (Minor scratches)	<b>Accessibility:</b>	1 (Occasionally likely to be disturbed)	
<b>Surface Treatment:</b>	0 (Composite material)			
<b>Asbestos Type:</b>	1 (Chrysotile)	<b>Extent Score:</b>	3 (>50 sq m or >50m pipe run)

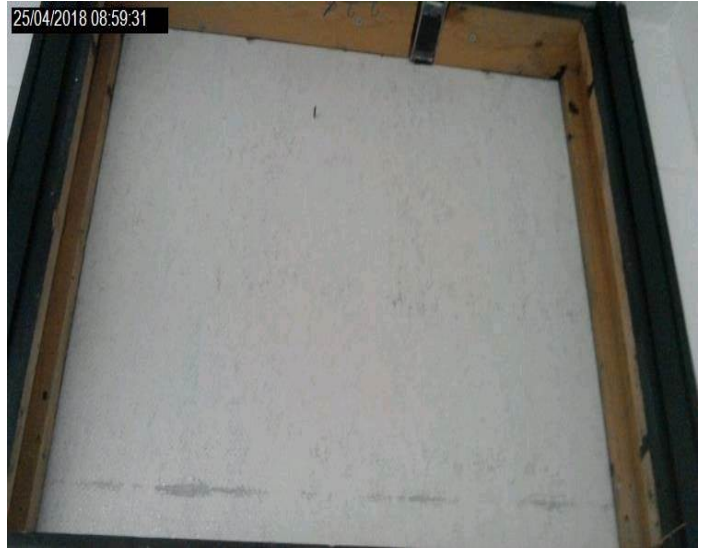
<b>Location:</b>	2.18	<b>Block:</b>	Commercial	<b>Floor Level:</b> 1st Floor
<b>Sample No.:</b>	DU001315	<b>Portal Ref No.:</b>	179

<b>Item:</b>	Insulating board door header panels			
<b>Asbestos Content:</b>		<b>Result Based on:</b>		
No Asbestos Detected		Analysis of sample using PLM		
<b>Sample Analysed By:</b>	Reg 13(1)	<b>Extent:</b>	6 m <sup>2</sup>	
<b>Comments:</b> Above doors leading to rooms 2.29, 2.28, 2.25, 2.24, 2.23 and 2.19

<b>Material Assessment Total Score: 0</b>		<b>Likelihood of Disturbance Assessment Total Score: 0</b>		<b>Management Assessment</b>  <b>Licensable:</b> Yes  <b>Recommendations:</b> Not Applicable  <b>Reinspection Interval:</b> Not Applicable  <b>Overall Risk Category:</b> E0
<b>Product Type:</b>	0 Not Applicable	<b>Location:</b>	0 Not Applicable	
<b>Condition:</b>	0 Not Applicable	<b>Accessibility:</b>	0 Not Applicable	
<b>Surface Treatment:</b>	0 Not Applicable			
<b>Asbestos Type:</b>	0 Not Applicable	<b>Extent Score:</b>	0 Not Applicable
