**Report No.:** J094042  
**Nature of Work:** Demolition Survey  
**Issue Date:** 29/05/2018  
**Client Name:** WYG Engineering Ltd  
Geneva Building, Lake View Drive, Sherwood Business Park,  
Annesley, Nottingham, NG15 0ED  
**Site Address:** Cox Building, Former City North Campus, Birmingham City  
University, Perry Barr, B42 2US

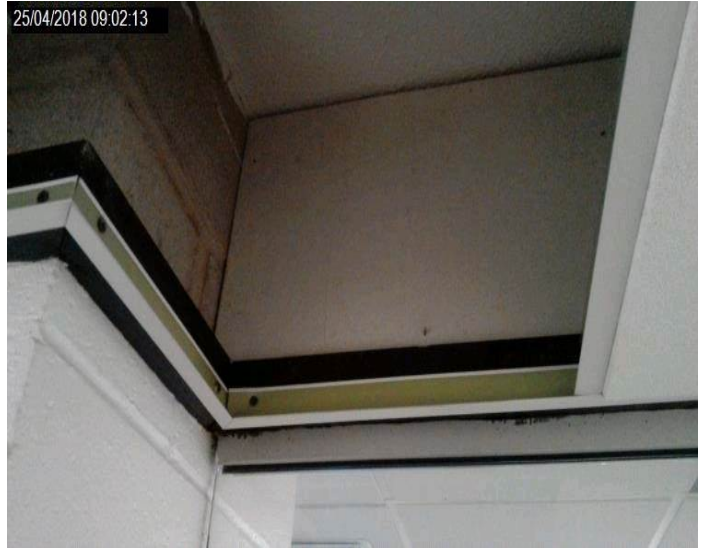
<b>Location:</b>	2.18	<b>Block:</b>	Commercial	<b>Floor Level:</b> 1st Floor
<b>Sample No.:</b>	DU001316	<b>Portal Ref No.:</b>	180

<b>Item:</b>	Insulating board panel			
<b>Asbestos Content:</b>		<b>Result Based on:</b>		
No Asbestos Detected		Analysis of sample using PLM		
<b>Sample Analysed By:</b>	Reg 13(1)	<b>Extent:</b>	4 m <sup>2</sup>	
<b>Comments:</b> Above glazed partition wall separating corridor from room

<b>Material Assessment Total Score: 0</b>		<b>Likelihood of Disturbance Assessment Total Score: 0</b>		<b>Management Assessment</b>  <b>Licensable:</b> Yes  <b>Recommendations:</b> Not Applicable  <b>Reinspection Interval:</b> Not Applicable  <b>Overall Risk Category:</b> E0
<b>Product Type:</b>	0 Not Applicable	<b>Location:</b>	0 Not Applicable	
<b>Condition:</b>	0 Not Applicable	<b>Accessibility:</b>	0 Not Applicable	
<b>Surface Treatment:</b>	0 Not Applicable			
<b>Asbestos Type:</b>	0 Not Applicable	<b>Extent Score:</b>	0 Not Applicable

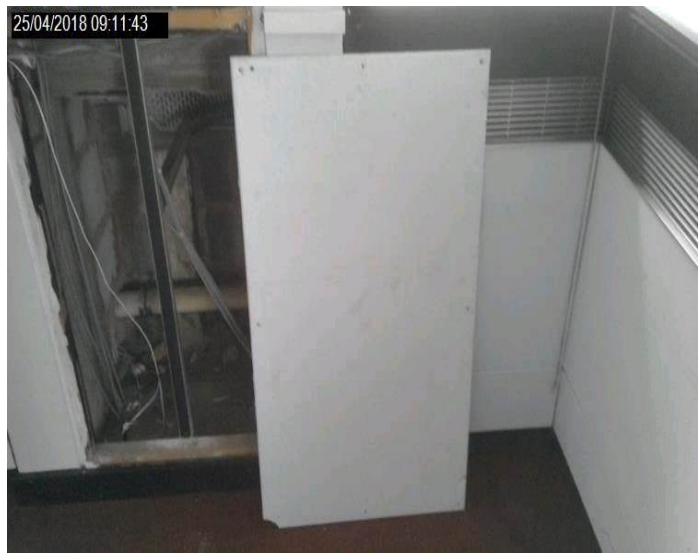
<b>Location:</b>	2.17	<b>Block:</b>	Commercial	<b>Floor Level:</b> 1st Floor
<b>Sample No.:</b>	DU001317	<b>Portal Ref No.:</b>	183

<b>Item:</b>	Insulating board panels to risers			
<b>Asbestos Content:</b>		<b>Result Based on:</b>		
No Asbestos Detected		Analysis of sample using PLM		
<b>Sample Analysed By:</b>	Reg 13(1)	<b>Extent:</b>	3 m <sup>2</sup>	
<b>Comments:</b> 1 x riser

<b>Material Assessment Total Score: 0</b>		<b>Likelihood of Disturbance Assessment Total Score: 0</b>		<b>Management Assessment</b>  <b>Licensable:</b> Yes  <b>Recommendations:</b> Not Applicable  <b>Reinspection Interval:</b> Not Applicable  <b>Overall Risk Category:</b> E0
<b>Product Type:</b>	0 Not Applicable	<b>Location:</b>	0 Not Applicable	
<b>Condition:</b>	0 Not Applicable	<b>Accessibility:</b>	0 Not Applicable	
<b>Surface Treatment:</b>	0 Not Applicable			
<b>Asbestos Type:</b>	0 Not Applicable	<b>Extent Score:</b>	0 Not Applicable

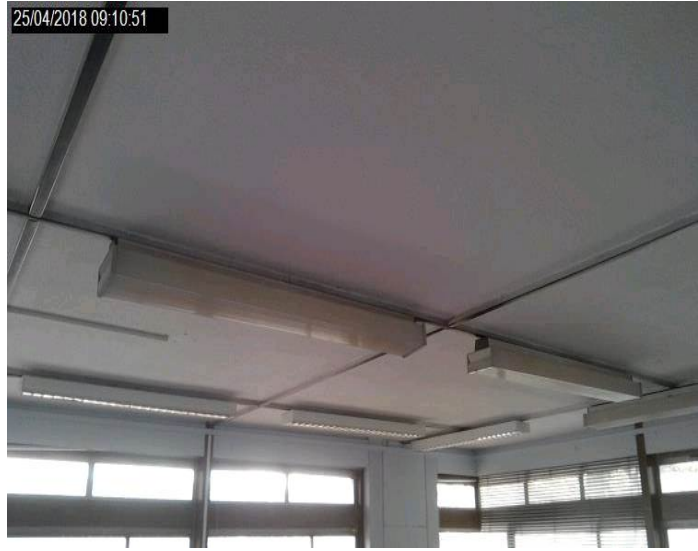
<b>Location:</b>	2.17	<b>Block:</b>	Commercial	<b>Floor Level:</b> 1st Floor
<b>Sample No.:</b>	As DU001314	<b>Portal Ref No.:</b>	184

<b>Item:</b>	Asbestos Textured coating to concrete			
<b>Asbestos Content:</b>	<b>Result Based on:</b>			
Chrysotile	Strongly presumed			
<b>Sample Analysed By:</b>	Not applicable	<b>Extent:</b>	50 m <sup>2</sup>	
<b>Comments:</b>

<b>Material Assessment Total Score: 3</b>		<b>Likelihood of Disturbance Assessment Total Score: 6</b>		<b>Management Assessment</b>  <b>Licensable:</b> No  <b>Recommendations:</b> Program removal  <b>Reinspection Interval:</b> Not Applicable  <b>Overall Risk Category:</b> C9
<b>Product Type:</b>	1 (Asbestos textured coating)	<b>Location:</b>	2 (Rooms up to 100 sq m)	
<b>Condition:</b>	1 (Minor scratches)	<b>Accessibility:</b>	1 (Occasionally likely to be disturbed)	
<b>Surface Treatment:</b>	0 (Composite material)			
<b>Asbestos Type:</b>	1 (Chrysotile)	<b>Extent Score:</b>	3 (>50 sq m or >50m pipe run)

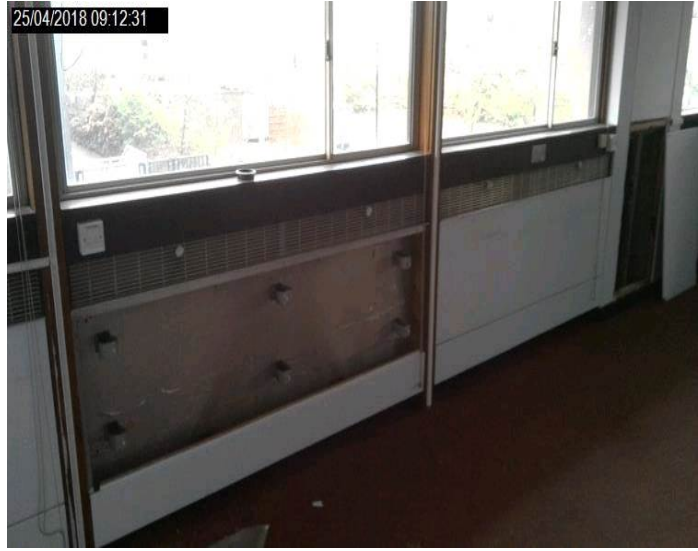
<b>Location:</b>	2.17	<b>Block:</b>	Commercial	<b>Floor Level:</b> 1st Floor
<b>Sample No.:</b>	DU001318	<b>Portal Ref No.:</b>	185

<b>Item:</b>	Asbestos Cement window sill			
<b>Asbestos Content:</b>	Result Based on:			
Chrysotile	Analysis of sample using PLM			
<b>Sample Analysed By:</b>	Reg 13(1)	<b>Extent:</b>	13 linear metres	
<b>Comments:</b>

<b>Material Assessment Total Score: 4</b>		<b>Likelihood of Disturbance Assessment Total Score: 5</b>		<b>Management Assessment</b>  <b>Licensable:</b> No  <b>Recommendations:</b> Program removal  <b>Reinspection Interval:</b> Not Applicable  <b>Overall Risk Category:</b> C9
<b>Product Type:</b>	1 (Asbestos cement)	<b>Location:</b>	2 (Rooms up to 100 sq m)	
<b>Condition:</b>	1 (Minor scratches)	<b>Accessibility:</b>	1 (Occasionally likely to be disturbed)	
<b>Surface Treatment:</b>	1 (Encapsulated asbestos cement)			
<b>Asbestos Type:</b>	1 (Chrysotile)	<b>Extent Score:</b>	2 (>10 - <50 sq m or >10m - <50m pipe run)

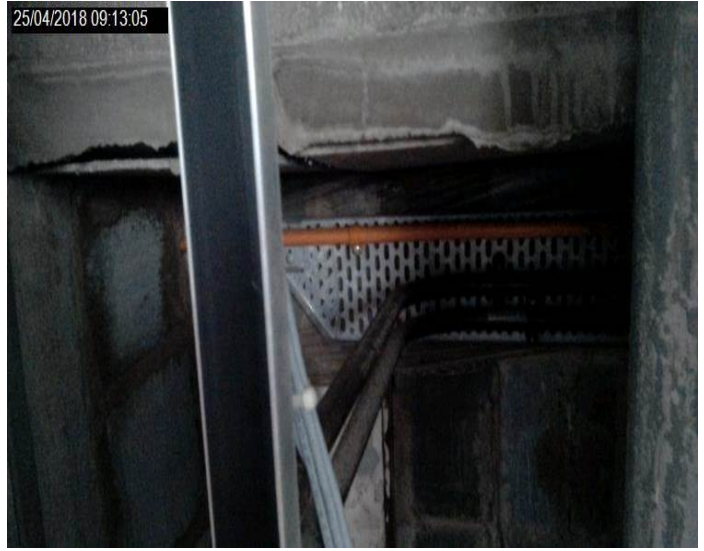
<b>Location:</b>	2.17	<b>Block:</b>	Commercial	<b>Floor Level:</b> 1st Floor
<b>Sample No.:</b>	DU001319	<b>Portal Ref No.:</b>	186

<b>Item:</b>	Asbestos Cement shuttering			
<b>Asbestos Content:</b>	Result Based on:			
Chrysotile	Analysis of sample using PLM			
<b>Sample Analysed By:</b> Reg 13(1)	<b>Extent:</b>	13 m <sup>2</sup>		
<b>Comments:</b> To ceiling of wall void, behind timber panels

<b>Material Assessment Total Score: 4</b>		<b>Likelihood of Disturbance Assessment Total Score: 5</b>		<b>Management Assessment</b>  <b>Licensable:</b> No  <b>Recommendations:</b> Program removal  <b>Reinspection Interval:</b> Not Applicable  <b>Overall Risk Category:</b> C9
<b>Product Type:</b>	1 (Asbestos cement)	<b>Location:</b>	2 (Rooms up to 100 sq m)	
<b>Condition:</b>	1 (Minor scratches)	<b>Accessibility:</b>	1 (Occasionally likely to be disturbed)	
<b>Surface Treatment:</b>	1 (Encapsulated asbestos cement)			
<b>Asbestos Type:</b>	1 (Chrysotile)	<b>Extent Score:</b>	2 (>10 - <50 sq m or >10m - <50m pipe run)

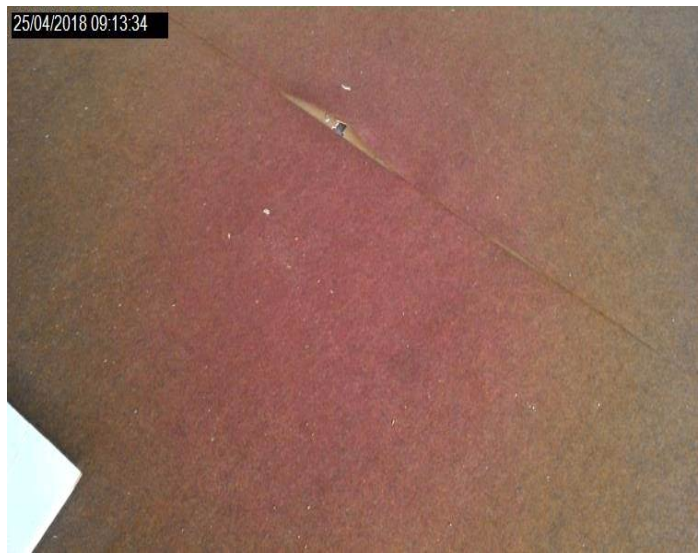
<b>Location:</b>	2.17	<b>Block:</b>	Commercial	<b>Floor Level:</b> 1st Floor
<b>Sample No.:</b>	DU001320	<b>Portal Ref No.:</b>	187

<b>Item:</b>	Asbestos Thermoplastic floor tiles with bitumen adhesive			
<b>Asbestos Content:</b>	Result Based on:			
Chrysotile in adhesive only	Analysis of sample using PLM			
<b>Sample Analysed By:</b> Reg 13(1)	<b>Extent:</b>	50 m <sup>2</sup>		
<b>Comments:</b> Beneath carpet

<b>Material Assessment Total Score: 3</b>		<b>Likelihood of Disturbance Assessment Total Score: 5</b>		<b>Management Assessment</b>  <b>Licensable:</b> No  <b>Recommendations:</b> Program removal  <b>Reinspection Interval:</b> Not Applicable  <b>Overall Risk Category:</b> C8
<b>Product Type:</b>	1 (Asbestos thermoplastic)	<b>Location:</b>	2 (Rooms up to 100 sq m)	
<b>Condition:</b>	1 (Minor scratches)	<b>Accessibility:</b>	0 (Usually inaccessible or unlikely to be disturbed)	
<b>Surface Treatment:</b>	0 (Composite material)			
<b>Asbestos Type:</b>	1 (Chrysotile)	<b>Extent Score:</b>	3 (>50 sq m or >50m pipe run)

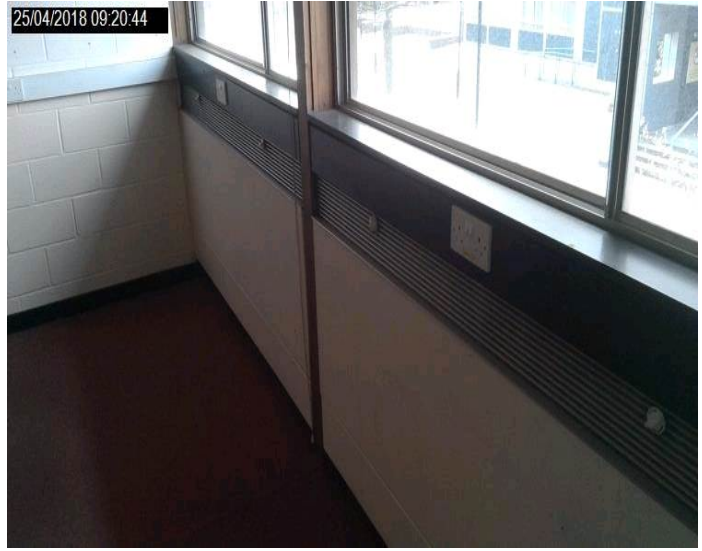
<b>Location:</b>	2.16	<b>Block:</b>	Commercial	<b>Floor Level:</b> 1st Floor
<b>Sample No.:</b>	As DU001318	<b>Portal Ref No.:</b>	191

<b>Item:</b>	Asbestos Cement window sill			
<b>Asbestos Content:</b>	<b>Result Based on:</b>			
Chrysotile	Strongly presumed			
<b>Sample Analysed By:</b>	Not applicable	<b>Extent:</b>	5 linear metres	
<b>Comments:</b>

<b>Material Assessment Total Score: 4</b>		<b>Likelihood of Disturbance Assessment Total Score: 4</b>		<b>Management Assessment</b>  <b>Licensable:</b> No  <b>Recommendations:</b> Program removal  <b>Reinspection Interval:</b> Not Applicable  <b>Overall Risk Category:</b> C8
<b>Product Type:</b>	1 (Asbestos cement)	<b>Location:</b>	2 (Rooms up to 100 sq m)	
<b>Condition:</b>	1 (Minor scratches)	<b>Accessibility:</b>	1 (Occasionally likely to be disturbed)	
<b>Surface Treatment:</b>	1 (Encapsulated asbestos cement)			
<b>Asbestos Type:</b>	1 (Chrysotile)	<b>Extent Score:</b>	1 (<10 sq m or 10m pipe run)

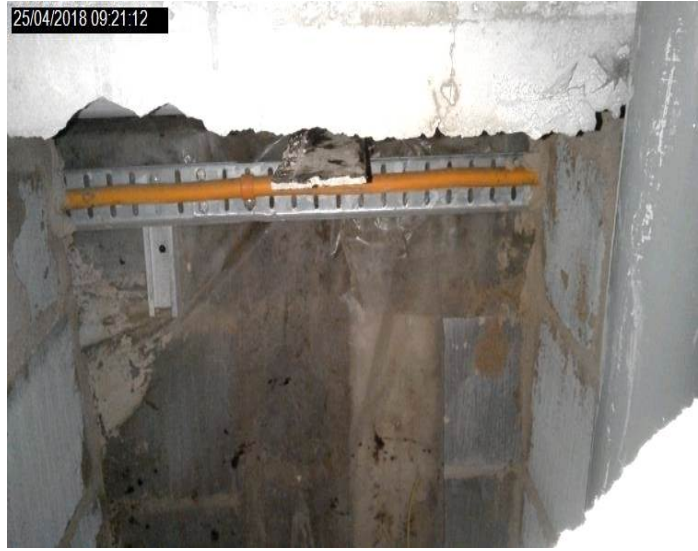
<b>Location:</b>	2.16	<b>Block:</b>	Commercial	<b>Floor Level:</b> 1st Floor
<b>Sample No.:</b>	As DU001319	<b>Portal Ref No.:</b>	192

<b>Item:</b>	Asbestos Cement shuttering			
<b>Asbestos Content:</b>	<b>Result Based on:</b>			
Chrysotile	Strongly presumed			
<b>Sample Analysed By:</b>	Not applicable	<b>Extent:</b>	6 m <sup>2</sup>	
<b>Comments:</b> To ceiling of wall void, behind timber panels

<b>Material Assessment Total Score: 4</b>		<b>Likelihood of Disturbance Assessment Total Score: 4</b>		<b>Management Assessment</b>  <b>Licensable:</b> No  <b>Recommendations:</b> Program removal  <b>Reinspection Interval:</b> Not Applicable  <b>Overall Risk Category:</b> C8
<b>Product Type:</b>	1 (Asbestos cement)	<b>Location:</b>	2 (Rooms up to 100 sq m)	
<b>Condition:</b>	1 (Minor scratches)	<b>Accessibility:</b>	1 (Occasionally likely to be disturbed)	
<b>Surface Treatment:</b>	1 (Encapsulated asbestos cement)			
<b>Asbestos Type:</b>	1 (Chrysotile)	<b>Extent Score:</b>	1 (<10 sq m or 10m pipe run)

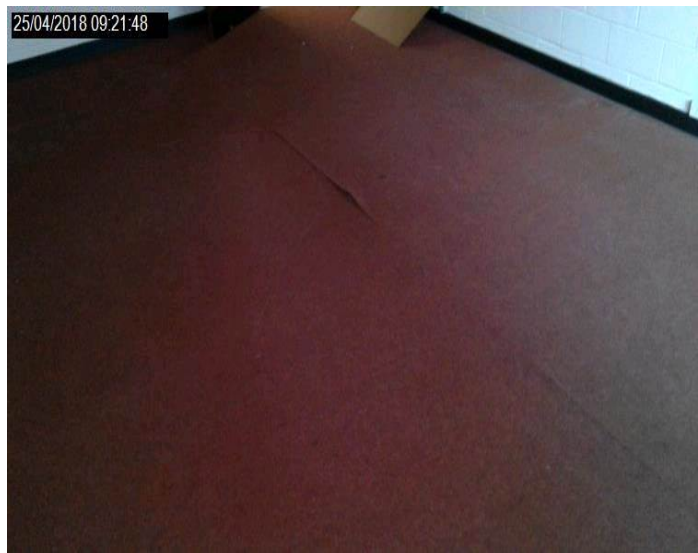
<b>Location:</b>	2.16	<b>Block:</b>	Commercial	<b>Floor Level:</b> 1st Floor
<b>Sample No.:</b>	As DU001320	<b>Portal Ref No.:</b>	193

<b>Item:</b>	Asbestos Thermoplastic floor tiles with bitumen adhesive			
<b>Asbestos Content:</b>	<b>Result Based on:</b>			
Chrysotile in adhesive only	Strongly presumed			
<b>Sample Analysed By:</b>	Not applicable	<b>Extent:</b>	36 m <sup>2</sup>	
<b>Comments:</b> Beneath carpet

<b>Material Assessment Total Score: 3</b>		<b>Likelihood of Disturbance Assessment Total Score: 4</b>		<b>Management Assessment</b>  <b>Licensable:</b> No  <b>Recommendations:</b> Program removal  <b>Reinspection Interval:</b> Not Applicable  <b>Overall Risk Category:</b> C7
<b>Product Type:</b>	1 (Asbestos thermoplastic)	<b>Location:</b>	2 (Rooms up to 100 sq m)	
<b>Condition:</b>	1 (Minor scratches)	<b>Accessibility:</b>	0 (Usually inaccessible or unlikely to be disturbed)	
<b>Surface Treatment:</b>	0 (Composite material)			
<b>Asbestos Type:</b>	1 (Chrysotile)	<b>Extent Score:</b>	2 (>10 - <50 sq m or >10m - <50m pipe run)

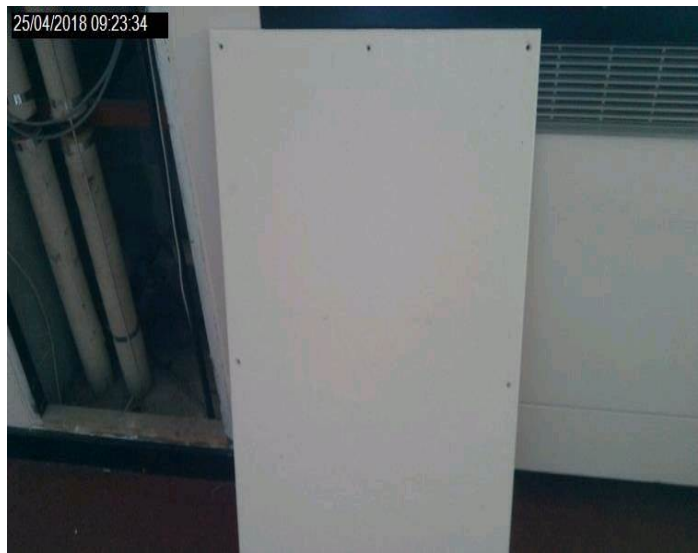
<b>Location:</b>	2.14	<b>Block:</b>	Commercial	<b>Floor Level:</b> 1st Floor
<b>Sample No.:</b>	As DU001317	<b>Portal Ref No.:</b>	194

<b>Item:</b>	Insulating board panels to risers			
<b>Asbestos Content:</b>		<b>Result Based on:</b>		
No Asbestos Detected		Strongly presumed		
<b>Sample Analysed By:</b>	Not applicable	<b>Extent:</b>	3 m <sup>2</sup>	
<b>Comments:</b> 1 x riser

<b>Material Assessment Total Score: 0</b>		<b>Likelihood of Disturbance Assessment Total Score: 0</b>		<b>Management Assessment</b>  <b>Licensable:</b> Yes  <b>Recommendations:</b> Not Applicable  <b>Reinspection Interval:</b> Not Applicable  <b>Overall Risk Category:</b> E0
<b>Product Type:</b>	0 Not Applicable	<b>Location:</b>	0 Not Applicable	
<b>Condition:</b>	0 Not Applicable	<b>Accessibility:</b>	0 Not Applicable	
<b>Surface Treatment:</b>	0 Not Applicable			
<b>Asbestos Type:</b>	0 Not Applicable	<b>Extent Score:</b>	0 Not Applicable

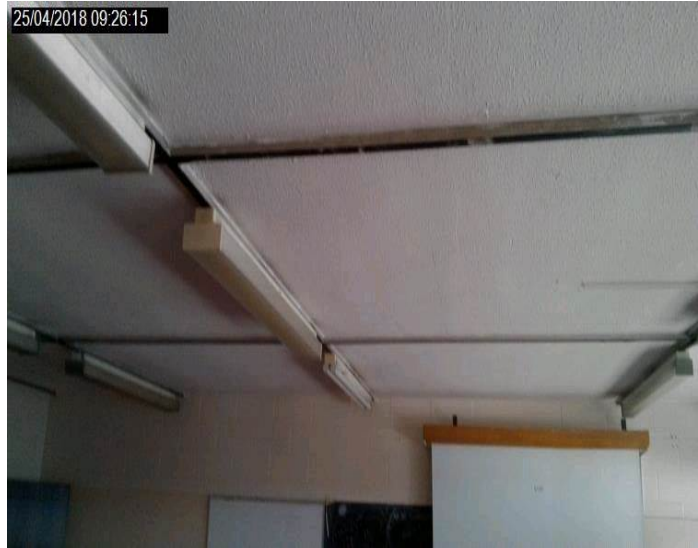
<b>Location:</b>	2.14	<b>Block:</b>	Commercial	<b>Floor Level:</b> 1st Floor
<b>Sample No.:</b>	As DU001314	<b>Portal Ref No.:</b>	195

<b>Item:</b>	Asbestos Textured coating to concrete			
<b>Asbestos Content:</b>	<b>Result Based on:</b>			
Chrysotile	Strongly presumed			
<b>Sample Analysed By:</b>	Not applicable	<b>Extent:</b>	50 m <sup>2</sup>	
<b>Comments:</b>

<b>Material Assessment Total Score: 3</b>		<b>Likelihood of Disturbance Assessment Total Score: 6</b>		<b>Management Assessment</b>  <b>Licensable:</b> No  <b>Recommendations:</b> Program removal  <b>Reinspection Interval:</b> Not Applicable  <b>Overall Risk Category:</b> C9
<b>Product Type:</b>	1 (Asbestos textured coating)	<b>Location:</b>	2 (Rooms up to 100 sq m)	
<b>Condition:</b>	1 (Minor scratches)	<b>Accessibility:</b>	1 (Occasionally likely to be disturbed)	
<b>Surface Treatment:</b>	0 (Composite material)			
<b>Asbestos Type:</b>	1 (Chrysotile)	<b>Extent Score:</b>	3 (>50 sq m or >50m pipe run)

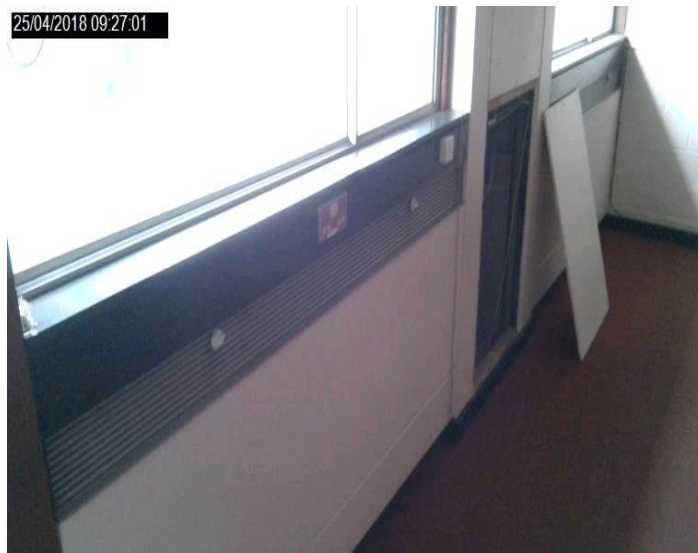
<b>Location:</b>	2.14	<b>Block:</b>	Commercial	<b>Floor Level:</b> 1st Floor
<b>Sample No.:</b>	As DU001318	<b>Portal Ref No.:</b>	196

<b>Item:</b>	Asbestos Cement window sill			
<b>Asbestos Content:</b>	<b>Result Based on:</b>			
Chrysotile	Strongly presumed			
<b>Sample Analysed By:</b>	Not applicable	<b>Extent:</b>	8 linear metres	
<b>Comments:</b>

<b>Material Assessment Total Score: 4</b>		<b>Likelihood of Disturbance Assessment Total Score: 4</b>		<b>Management Assessment</b>  <b>Licensable:</b> No  <b>Recommendations:</b> Program removal  <b>Reinspection Interval:</b> Not Applicable  <b>Overall Risk Category:</b> C8
<b>Product Type:</b>	1 (Asbestos cement)	<b>Location:</b>	2 (Rooms up to 100 sq m)	
<b>Condition:</b>	1 (Minor scratches)	<b>Accessibility:</b>	1 (Occasionally likely to be disturbed)	
<b>Surface Treatment:</b>	1 (Encapsulated asbestos cement)			
<b>Asbestos Type:</b>	1 (Chrysotile)	<b>Extent Score:</b>	1 (<10 sq m or 10m pipe run)

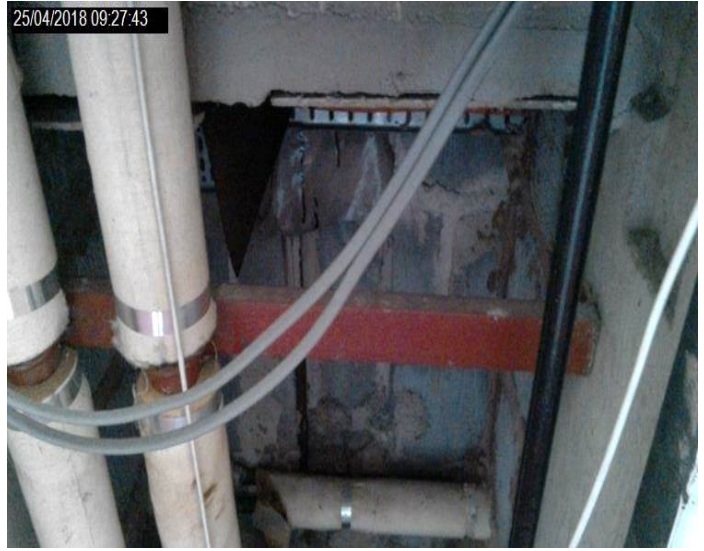
<b>Location:</b>	2.14	<b>Block:</b>	Commercial	<b>Floor Level:</b> 1st Floor
<b>Sample No.:</b>	As DU001319	<b>Portal Ref No.:</b>	197

<b>Item:</b>	Asbestos Cement shuttering			
<b>Asbestos Content:</b>	<b>Result Based on:</b>			
Chrysotile	Strongly presumed			
<b>Sample Analysed By:</b>	Not applicable	<b>Extent:</b>	9 m <sup>2</sup>	
<b>Comments:</b> To ceiling of wall void, behind timber panels

<b>Material Assessment Total Score: 4</b>		<b>Likelihood of Disturbance Assessment Total Score: 4</b>		<b>Management Assessment</b>  <b>Licensable:</b> No  <b>Recommendations:</b> Program removal  <b>Reinspection Interval:</b> Not Applicable  <b>Overall Risk Category:</b> C8
<b>Product Type:</b>	1 (Asbestos cement)	<b>Location:</b>	2 (Rooms up to 100 sq m)	
<b>Condition:</b>	1 (Minor scratches)	<b>Accessibility:</b>	1 (Occasionally likely to be disturbed)	
<b>Surface Treatment:</b>	1 (Encapsulated asbestos cement)			
<b>Asbestos Type:</b>	1 (Chrysotile)	<b>Extent Score:</b>	1 (<10 sq m or 10m pipe run)

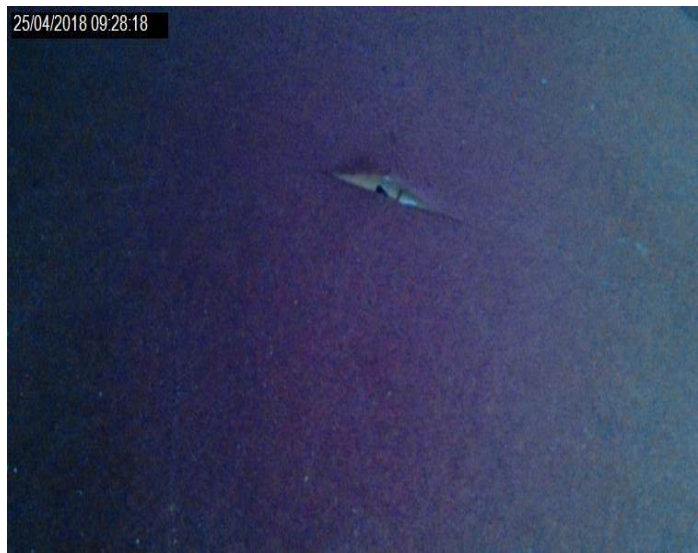
<b>Location:</b>	2.14	<b>Block:</b>	Commercial	<b>Floor Level:</b> 1st Floor
<b>Sample No.:</b>	As DU001320	<b>Portal Ref No.:</b>	198

<b>Item:</b>	Asbestos Thermoplastic floor tiles with bitumen adhesive			
<b>Asbestos Content:</b>	<b>Result Based on:</b>			
Chrysotile in adhesive only	Strongly presumed			
<b>Sample Analysed By:</b>	Not applicable	<b>Extent:</b>	50 m <sup>2</sup>	
<b>Comments:</b> Beneath carpet

<b>Material Assessment Total Score: 3</b>		<b>Likelihood of Disturbance Assessment Total Score: 5</b>		<b>Management Assessment</b>  <b>Licensable:</b> No  <b>Recommendations:</b> Program removal  <b>Reinspection Interval:</b> Not Applicable  <b>Overall Risk Category:</b> C8
<b>Product Type:</b>	1 (Asbestos thermoplastic)	<b>Location:</b>	2 (Rooms up to 100 sq m)	
<b>Condition:</b>	1 (Minor scratches)	<b>Accessibility:</b>	0 (Usually inaccessible or unlikely to be disturbed)	
<b>Surface Treatment:</b>	0 (Composite material)			
<b>Asbestos Type:</b>	1 (Chrysotile)	<b>Extent Score:</b>	3 (>50 sq m or >50m pipe run)

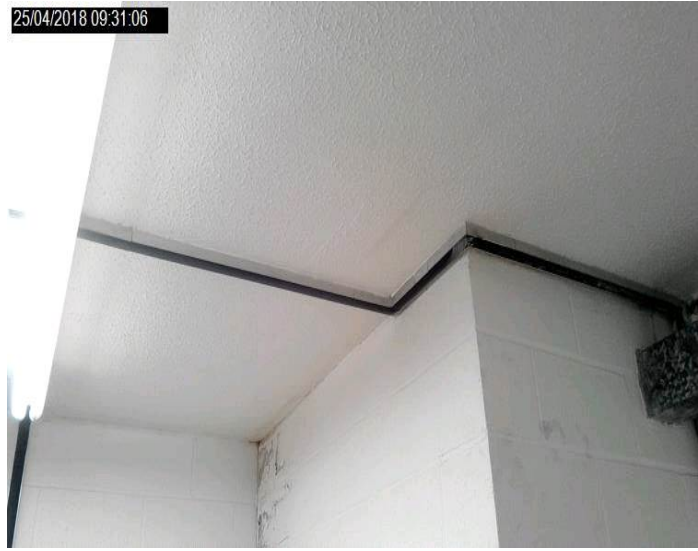
<b>Location:</b>	2.15	<b>Block:</b>	Commercial	<b>Floor Level:</b> 1st Floor
<b>Sample No.:</b>	As DU001314	<b>Portal Ref No.:</b>	200

<b>Item:</b>	Asbestos Textured coating to concrete			
<b>Asbestos Content:</b>	<b>Result Based on:</b>			
Chrysotile	Strongly presumed			
<b>Sample Analysed By:</b>	Not applicable	<b>Extent:</b>	12 m <sup>2</sup>	
<b>Comments:</b>

<b>Material Assessment Total Score: 3</b>		<b>Likelihood of Disturbance Assessment Total Score: 5</b>		<b>Management Assessment</b>  <b>Licensable:</b> No  <b>Recommendations:</b> Program removal  <b>Reinspection Interval:</b> Not Applicable  <b>Overall Risk Category:</b> C8
<b>Product Type:</b>	1 (Asbestos textured coating)	<b>Location:</b>	2 (Rooms up to 100 sq m)	
<b>Condition:</b>	1 (Minor scratches)	<b>Accessibility:</b>	1 (Occasionally likely to be disturbed)	
<b>Surface Treatment:</b>	0 (Composite material)			
<b>Asbestos Type:</b>	1 (Chrysotile)	<b>Extent Score:</b>	2 (>10 - <50 sq m or >10m - <50m pipe run)

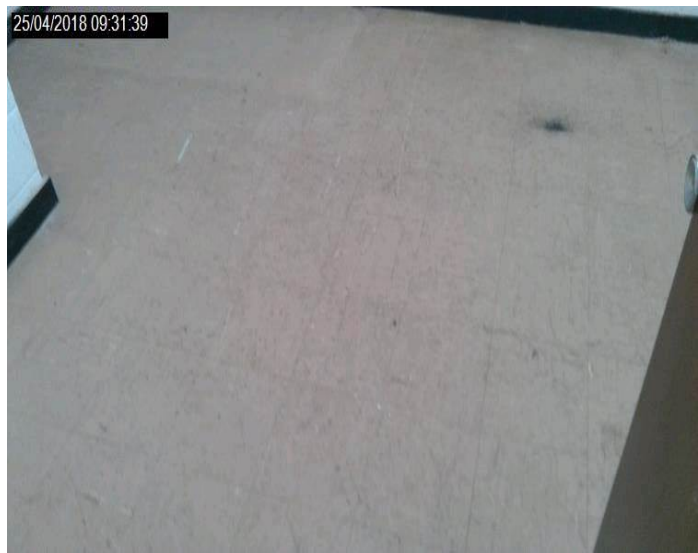
<b>Location:</b>	2.15	<b>Block:</b>	Commercial	<b>Floor Level:</b> 1st Floor
<b>Sample No.:</b>	As DU001320	<b>Portal Ref No.:</b>	203

<b>Item:</b>	Asbestos Thermoplastic floor tiles with bitumen adhesive			
<b>Asbestos Content:</b>	<b>Result Based on:</b>			
Chrysotile in adhesive only	Strongly presumed			
<b>Sample Analysed By:</b>	Not applicable	<b>Extent:</b>	12 m <sup>2</sup>	
<b>Comments:</b> Beneath carpet

<b>Material Assessment Total Score: 3</b>		<b>Likelihood of Disturbance Assessment Total Score: 7</b>		<b>Management Assessment</b>  <b>Licensable:</b> No  <b>Recommendations:</b> Program removal  <b>Reinspection Interval:</b> Not Applicable  <b>Overall Risk Category:</b> C10
<b>Product Type:</b>	1 (Asbestos thermoplastic)	<b>Location:</b>	2 (Rooms up to 100 sq m)	
<b>Condition:</b>	1 (Minor scratches)	<b>Accessibility:</b>	3 (Routinely disturbed)	
<b>Surface Treatment:</b>	0 (Composite material)			
<b>Asbestos Type:</b>	1 (Chrysotile)	<b>Extent Score:</b>	2 (>10 - <50 sq m or >10m - <50m pipe run)

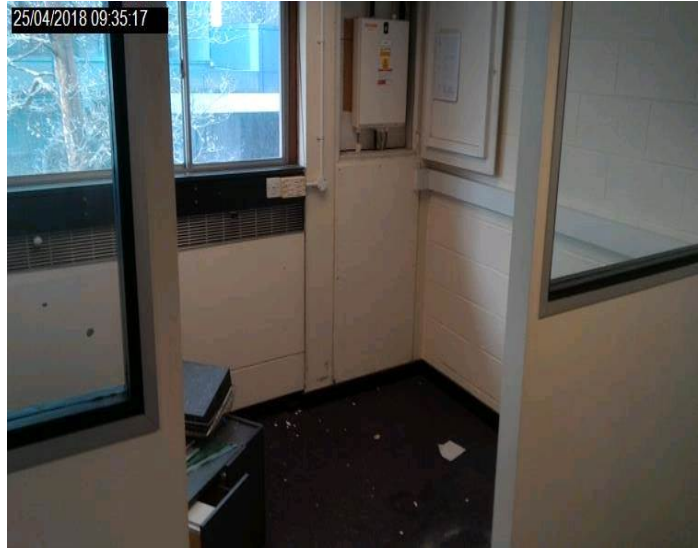
<b>Location:</b>	2.13	<b>Block:</b>	Commercial	<b>Floor Level:</b> 1st Floor
<b>Sample No.:</b>	As DU001317	<b>Portal Ref No.:</b>	204

<b>Item:</b>	Insulating board panels to risers			
<b>Asbestos Content:</b>		<b>Result Based on:</b>		
No Asbestos Detected		Strongly presumed		
<b>Sample Analysed By:</b>	Not applicable	<b>Extent:</b>	6 m <sup>2</sup>	
<b>Comments:</b> 2 x riser

<b>Material Assessment Total Score: 0</b>		<b>Likelihood of Disturbance Assessment Total Score: 0</b>		<b>Management Assessment</b>  <b>Licensable:</b> Yes  <b>Recommendations:</b> Not Applicable  <b>Reinspection Interval:</b> Not Applicable  <b>Overall Risk Category:</b> E0
<b>Product Type:</b>	0 Not Applicable	<b>Location:</b>	0 Not Applicable	
<b>Condition:</b>	0 Not Applicable	<b>Accessibility:</b>	0 Not Applicable	
<b>Surface Treatment:</b>	0 Not Applicable			
<b>Asbestos Type:</b>	0 Not Applicable	<b>Extent Score:</b>	0 Not Applicable

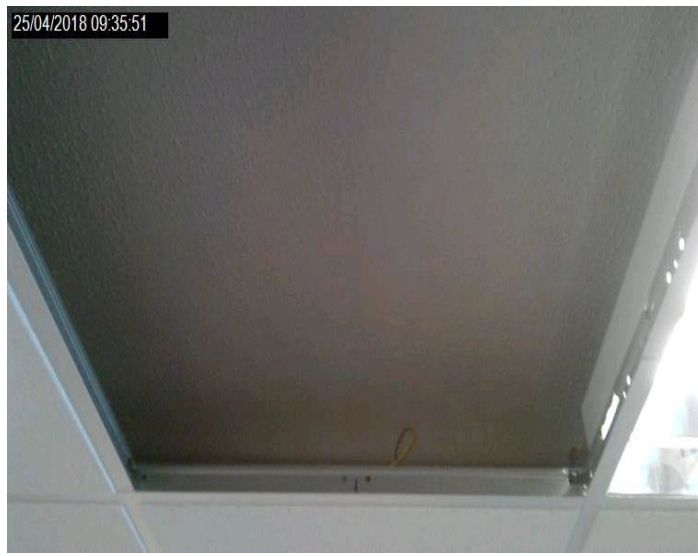
<b>Location:</b>	2.13	<b>Block:</b>	Commercial	<b>Floor Level:</b> 1st Floor
<b>Sample No.:</b>	As DU001314	<b>Portal Ref No.:</b>	205

<b>Item:</b>	Asbestos Textured coating to concrete			
<b>Asbestos Content:</b>	<b>Result Based on:</b>			
Chrysotile	Strongly presumed			
<b>Sample Analysed By:</b>	Not applicable	<b>Extent:</b>	50 m <sup>2</sup>	
<b>Comments:</b> Above suspended ceiling tiles

<b>Material Assessment Total Score: 3</b>		<b>Likelihood of Disturbance Assessment Total Score: 6</b>		<b>Management Assessment</b>  <b>Licensable:</b> No  <b>Recommendations:</b> Program removal  <b>Reinspection Interval:</b> Not Applicable  <b>Overall Risk Category:</b> C9
<b>Product Type:</b>	1 (Asbestos textured coating)	<b>Location:</b>	2 (Rooms up to 100 sq m)	
<b>Condition:</b>	1 (Minor scratches)	<b>Accessibility:</b>	1 (Occasionally likely to be disturbed)	
<b>Surface Treatment:</b>	0 (Composite material)			
<b>Asbestos Type:</b>	1 (Chrysotile)	<b>Extent Score:</b>	3 (>50 sq m or >50m pipe run)

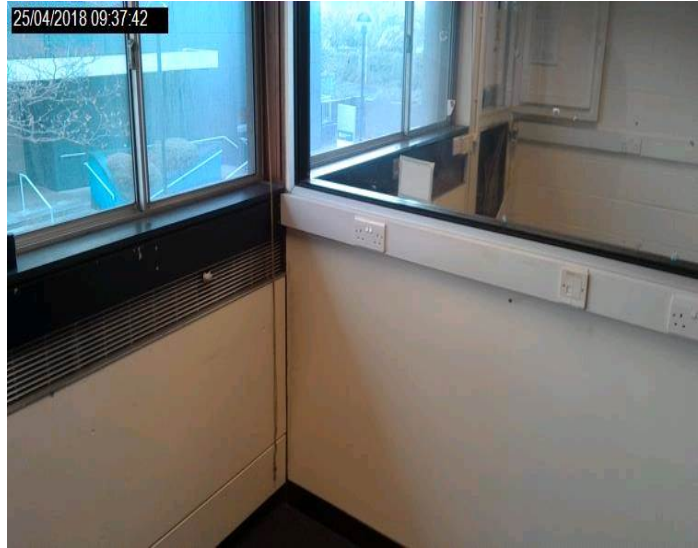
<b>Location:</b>	2.13	<b>Block:</b>	Commercial	<b>Floor Level:</b> 1st Floor
<b>Sample No.:</b>	As DU001318	<b>Portal Ref No.:</b>	206

<b>Item:</b>	Asbestos Cement window sill			
<b>Asbestos Content:</b>	<b>Result Based on:</b>			
Chrysotile	Strongly presumed			
<b>Sample Analysed By:</b>	Not applicable	<b>Extent:</b>	8 linear metres	
<b>Comments:</b>

<b>Material Assessment Total Score: 4</b>		<b>Likelihood of Disturbance Assessment Total Score: 4</b>		<b>Management Assessment</b>  <b>Licensable:</b> No  <b>Recommendations:</b> Program removal  <b>Reinspection Interval:</b> Not Applicable  <b>Overall Risk Category:</b> C8
<b>Product Type:</b>	1 (Asbestos cement)	<b>Location:</b>	2 (Rooms up to 100 sq m)	
<b>Condition:</b>	1 (Minor scratches)	<b>Accessibility:</b>	1 (Occasionally likely to be disturbed)	
<b>Surface Treatment:</b>	1 (Encapsulated asbestos cement)			
<b>Asbestos Type:</b>	1 (Chrysotile)	<b>Extent Score:</b>	1 (<10 sq m or 10m pipe run)

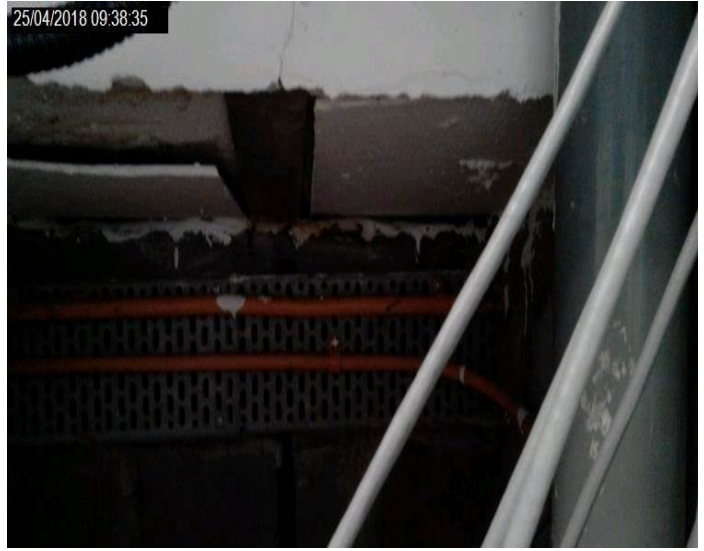
<b>Location:</b>	2.13	<b>Block:</b>	Commercial	<b>Floor Level:</b> 1st Floor
<b>Sample No.:</b>	As DU001319	<b>Portal Ref No.:</b>	207

<b>Item:</b>	Asbestos Cement shuttering			
<b>Asbestos Content:</b>	<b>Result Based on:</b>			
Chrysotile	Strongly presumed			
<b>Sample Analysed By:</b>	Not applicable	<b>Extent:</b>	8 m <sup>2</sup>	
<b>Comments:</b> To ceiling of wall void, behind timber panels

<b>Material Assessment Total Score: 4</b>		<b>Likelihood of Disturbance Assessment Total Score: 4</b>		<b>Management Assessment</b>  <b>Licensable:</b> No  <b>Recommendations:</b> Program removal  <b>Reinspection Interval:</b> Not Applicable  <b>Overall Risk Category:</b> C8
<b>Product Type:</b>	1 (Asbestos cement)	<b>Location:</b>	2 (Rooms up to 100 sq m)	
<b>Condition:</b>	1 (Minor scratches)	<b>Accessibility:</b>	1 (Occasionally likely to be disturbed)	
<b>Surface Treatment:</b>	1 (Encapsulated asbestos cement)			
<b>Asbestos Type:</b>	1 (Chrysotile)	<b>Extent Score:</b>	1 (<10 sq m or 10m pipe run)

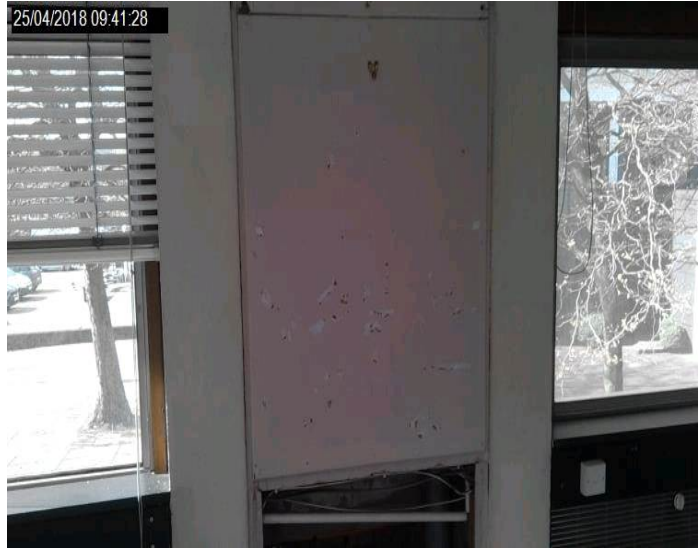
<b>Location:</b>	2.12	<b>Block:</b>	Commercial	<b>Floor Level:</b> 1st Floor
<b>Sample No.:</b>	As DU001317	<b>Portal Ref No.:</b>	209

<b>Item:</b>	Insulating board panels to risers			
<b>Asbestos Content:</b>		<b>Result Based on:</b>		
No Asbestos Detected		Strongly presumed		
<b>Sample Analysed By:</b>	Not applicable	<b>Extent:</b>	3 m <sup>2</sup>	
<b>Comments:</b> 1 x riser

<b>Material Assessment Total Score: 0</b>		<b>Likelihood of Disturbance Assessment Total Score: 0</b>		<b>Management Assessment</b>  <b>Licensable:</b> Yes  <b>Recommendations:</b> Not Applicable  <b>Reinspection Interval:</b> Not Applicable  <b>Overall Risk Category:</b> E0
<b>Product Type:</b>	0 Not Applicable	<b>Location:</b>	0 Not Applicable	
<b>Condition:</b>	0 Not Applicable	<b>Accessibility:</b>	0 Not Applicable	
<b>Surface Treatment:</b>	0 Not Applicable			
<b>Asbestos Type:</b>	0 Not Applicable	<b>Extent Score:</b>	0 Not Applicable

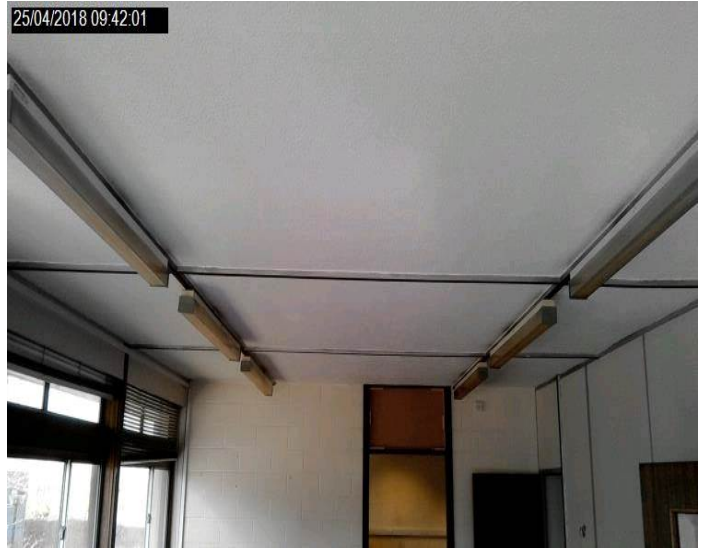
<b>Location:</b>	2.12	<b>Block:</b>	Commercial	<b>Floor Level:</b> 1st Floor
<b>Sample No.:</b>	As DU001314	<b>Portal Ref No.:</b>	210

<b>Item:</b>	Asbestos Textured coating to concrete			
<b>Asbestos Content:</b>	<b>Result Based on:</b>			
Chrysotile	Strongly presumed			
<b>Sample Analysed By:</b>	Not applicable	<b>Extent:</b>	35 m <sup>2</sup>	
<b>Comments:</b>

<b>Material Assessment Total Score: 3</b>		<b>Likelihood of Disturbance Assessment Total Score: 5</b>		<b>Management Assessment</b>  <b>Licensable:</b> No  <b>Recommendations:</b> Program removal  <b>Reinspection Interval:</b> Not Applicable  <b>Overall Risk Category:</b> C8
<b>Product Type:</b>	1 (Asbestos textured coating)	<b>Location:</b>	2 (Rooms up to 100 sq m)	
<b>Condition:</b>	1 (Minor scratches)	<b>Accessibility:</b>	1 (Occasionally likely to be disturbed)	
<b>Surface Treatment:</b>	0 (Composite material)			
<b>Asbestos Type:</b>	1 (Chrysotile)	<b>Extent Score:</b>	2 (>10 - <50 sq m or >10m - <50m pipe run)

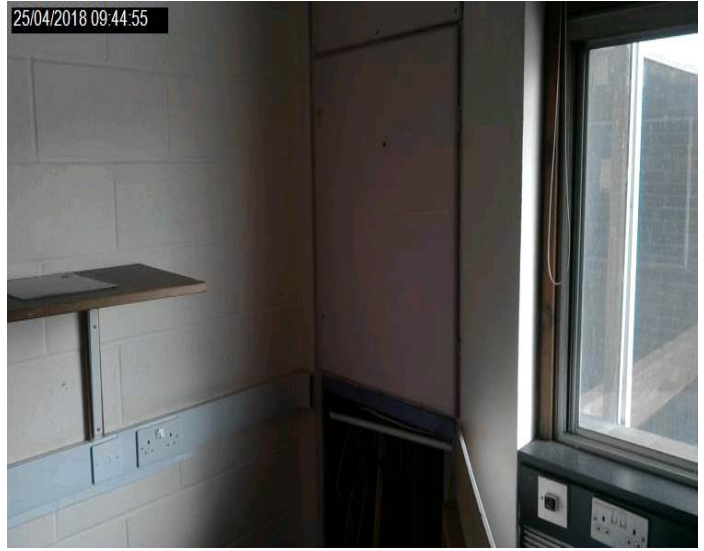
<b>Location:</b>	2.11	<b>Block:</b>	Commercial	<b>Floor Level:</b> 1st Floor
<b>Sample No.:</b>	As DU001317	<b>Portal Ref No.:</b>	214

<b>Item:</b>	Insulating board panels to risers			
<b>Asbestos Content:</b>		<b>Result Based on:</b>		
No Asbestos Detected		Strongly presumed		
<b>Sample Analysed By:</b>	Not applicable	<b>Extent:</b>	3 m <sup>2</sup>	
<b>Comments:</b> 1 x riser

<b>Material Assessment Total Score: 0</b>		<b>Likelihood of Disturbance Assessment Total Score: 0</b>		<b>Management Assessment</b>  <b>Licensable:</b> Yes  <b>Recommendations:</b> Not Applicable  <b>Reinspection Interval:</b> Not Applicable  <b>Overall Risk Category:</b> E0
<b>Product Type:</b>	0 Not Applicable	<b>Location:</b>	0 Not Applicable	
<b>Condition:</b>	0 Not Applicable	<b>Accessibility:</b>	0 Not Applicable	
<b>Surface Treatment:</b>	0 Not Applicable			
<b>Asbestos Type:</b>	0 Not Applicable	<b>Extent Score:</b>	0 Not Applicable

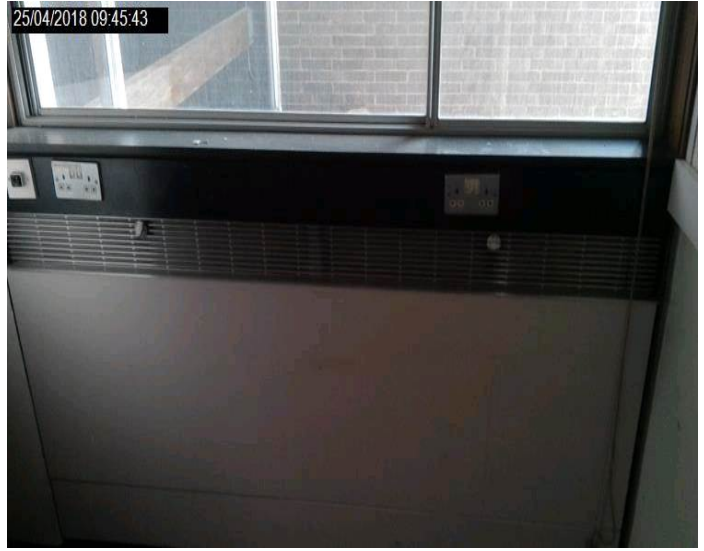
<b>Location:</b>	2.11	<b>Block:</b>	Commercial	<b>Floor Level:</b> 1st Floor
<b>Sample No.:</b>	As DU001318	<b>Portal Ref No.:</b>	216

<b>Item:</b>	Asbestos Cement window sill			
<b>Asbestos Content:</b>	<b>Result Based on:</b>			
Chrysotile	Strongly presumed			
<b>Sample Analysed By:</b>	Not applicable	<b>Extent:</b>	2 linear metres	
<b>Comments:</b>

<b>Material Assessment Total Score: 4</b>		<b>Likelihood of Disturbance Assessment Total Score: 4</b>		<b>Management Assessment</b>  <b>Licensable:</b> No  <b>Recommendations:</b> Program removal  <b>Reinspection Interval:</b> Not Applicable  <b>Overall Risk Category:</b> C8
<b>Product Type:</b>	1 (Asbestos cement)	<b>Location:</b>	2 (Rooms up to 100 sq m)	
<b>Condition:</b>	1 (Minor scratches)	<b>Accessibility:</b>	1 (Occasionally likely to be disturbed)	
<b>Surface Treatment:</b>	1 (Encapsulated asbestos cement)			
<b>Asbestos Type:</b>	1 (Chrysotile)	<b>Extent Score:</b>	1 (<10 sq m or 10m pipe run)

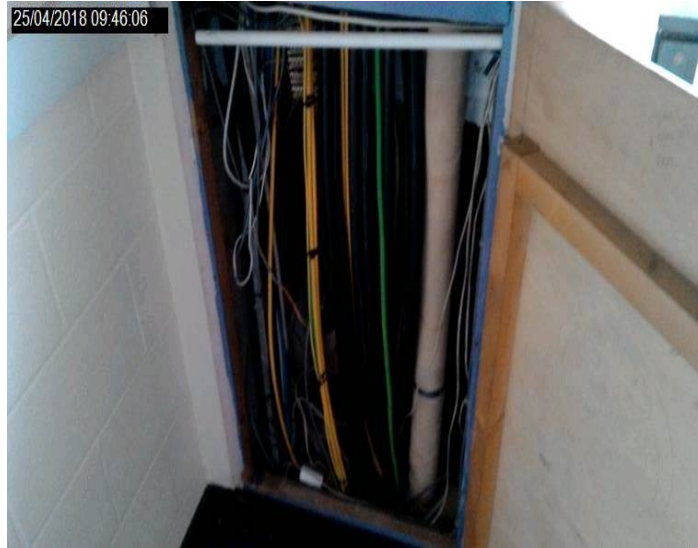
<b>Location:</b>	2.11	<b>Block:</b>	Commercial	<b>Floor Level:</b> 1st Floor
<b>Sample No.:</b>	As DU001319	<b>Portal Ref No.:</b>	217

<b>Item:</b>	Asbestos Cement shuttering			
<b>Asbestos Content:</b>	<b>Result Based on:</b>			
Chrysotile	Strongly presumed			
<b>Sample Analysed By:</b>	Not applicable	<b>Extent:</b>	3 m <sup>2</sup>	
<b>Comments:</b> To ceiling of wall void, behind timber panels, also to the front face of the riser concrete

<b>Material Assessment Total Score: 4</b>		<b>Likelihood of Disturbance Assessment Total Score: 4</b>		<b>Management Assessment</b>  <b>Licensable:</b> No  <b>Recommendations:</b> Program removal  <b>Reinspection Interval:</b> Not Applicable  <b>Overall Risk Category:</b> C8
<b>Product Type:</b>	1 (Asbestos cement)	<b>Location:</b>	2 (Rooms up to 100 sq m)	
<b>Condition:</b>	1 (Minor scratches)	<b>Accessibility:</b>	1 (Occasionally likely to be disturbed)	
<b>Surface Treatment:</b>	1 (Encapsulated asbestos cement)			
<b>Asbestos Type:</b>	1 (Chrysotile)	<b>Extent Score:</b>	1 (<10 sq m or 10m pipe run)

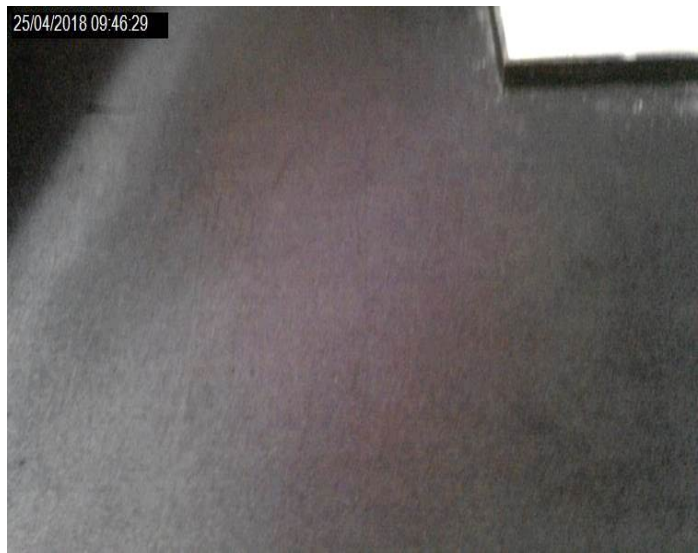
<b>Location:</b>	2.11	<b>Block:</b>	Commercial	<b>Floor Level:</b> 1st Floor
<b>Sample No.:</b>	As DU001321	<b>Portal Ref No.:</b>	218

<b>Item:</b>	Bitumen adhesive			
<b>Asbestos Content:</b>		<b>Result Based on:</b>		
No Asbestos Detected		Strongly presumed		
<b>Sample Analysed By:</b>	Not applicable	<b>Extent:</b>	18 m <sup>2</sup>	
<b>Comments:</b> Beneath carpet

<b>Material Assessment Total Score: 0</b>		<b>Likelihood of Disturbance Assessment Total Score: 0</b>		<b>Management Assessment</b>  <b>Licensable:</b> No  <b>Recommendations:</b> Not Applicable  <b>Reinspection Interval:</b> Not Applicable  <b>Overall Risk Category:</b> E0
<b>Product Type:</b>	0 Not Applicable	<b>Location:</b>	0 Not Applicable	
<b>Condition:</b>	0 Not Applicable	<b>Accessibility:</b>	0 Not Applicable	
<b>Surface Treatment:</b>	0 Not Applicable			
<b>Asbestos Type:</b>	0 Not Applicable	<b>Extent Score:</b>	0 Not Applicable

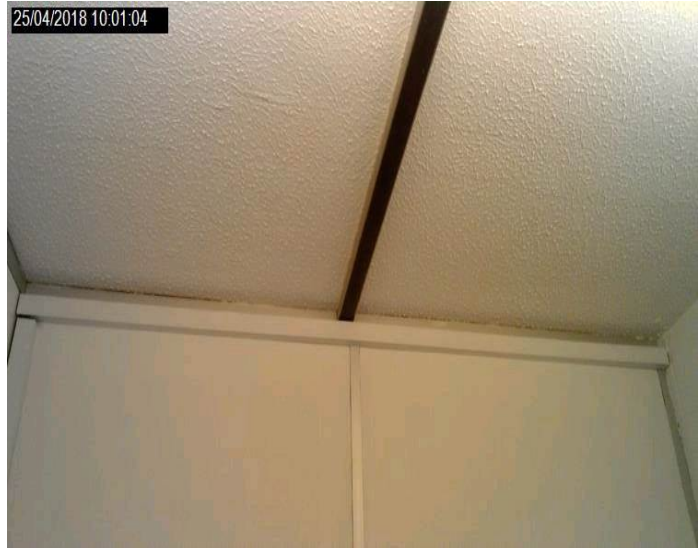
<b>Location:</b>	2.99A	<b>Block:</b>	Commercial	<b>Floor Level:</b> 1st Floor
<b>Sample No.:</b>	DU001322	<b>Portal Ref No.:</b>	220

<b>Item:</b>	Asbestos Textured coating to concrete			
<b>Asbestos Content:</b>	Result Based on:			
Chrysotile	Analysis of sample using PLM			
<b>Sample Analysed By:</b>	Reg 13(1)	<b>Extent:</b>	4 m <sup>2</sup>	
<b>Comments:</b>

<b>Material Assessment Total Score: 3</b>		<b>Likelihood of Disturbance Assessment Total Score: 4</b>		<b>Management Assessment</b>  <b>Licensable:</b> No  <b>Recommendations:</b> Program removal  <b>Reinspection Interval:</b> Not Applicable  <b>Overall Risk Category:</b> C7
<b>Product Type:</b>	1 (Asbestos textured coating)	<b>Location:</b>	2 (Rooms up to 100 sq m)	
<b>Condition:</b>	1 (Minor scratches)	<b>Accessibility:</b>	1 (Occasionally likely to be disturbed)	
<b>Surface Treatment:</b>	0 (Composite material)			
<b>Asbestos Type:</b>	1 (Chrysotile)	<b>Extent Score:</b>	1 (<10 sq m or 10m pipe run)

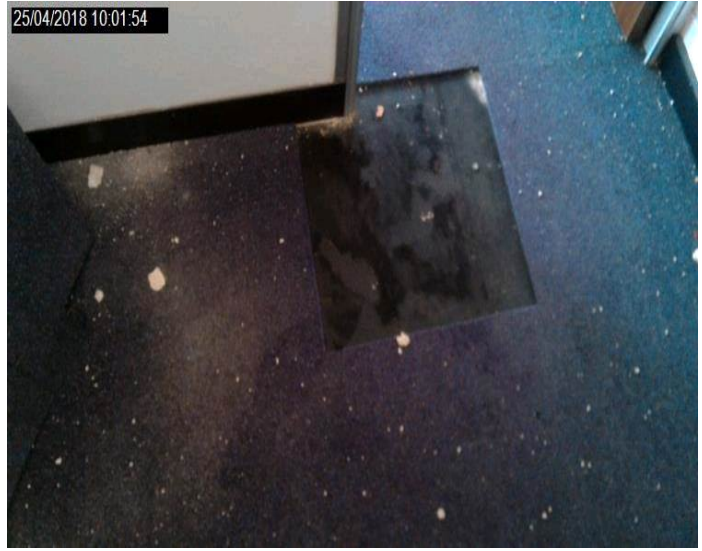
<b>Location:</b>	2.99A	<b>Block:</b>	Commercial	<b>Floor Level:</b> 1st Floor
<b>Sample No.:</b>	As DU001321	<b>Portal Ref No.:</b>	221

<b>Item:</b>	Bitumen adhesive			
<b>Asbestos Content:</b>		<b>Result Based on:</b>		
No Asbestos Detected		Strongly presumed		
<b>Sample Analysed By:</b>	Not applicable	<b>Extent:</b>	4 m <sup>2</sup>	
<b>Comments:</b> Beneath carpet tiles

<b>Material Assessment Total Score:</b> 0		<b>Likelihood of Disturbance Assessment Total Score:</b> 0		<b>Management Assessment</b>  <b>Licensable:</b> No  <b>Recommendations:</b> Not Applicable  <b>Reinspection Interval:</b> Not Applicable  <b>Overall Risk Category:</b> E0
<b>Product Type:</b>	0 Not Applicable	<b>Location:</b>	0 Not Applicable	
<b>Condition:</b>	0 Not Applicable	<b>Accessibility:</b>	0 Not Applicable	
<b>Surface Treatment:</b>	0 Not Applicable			
<b>Asbestos Type:</b>	0 Not Applicable	<b>Extent Score:</b>	0 Not Applicable

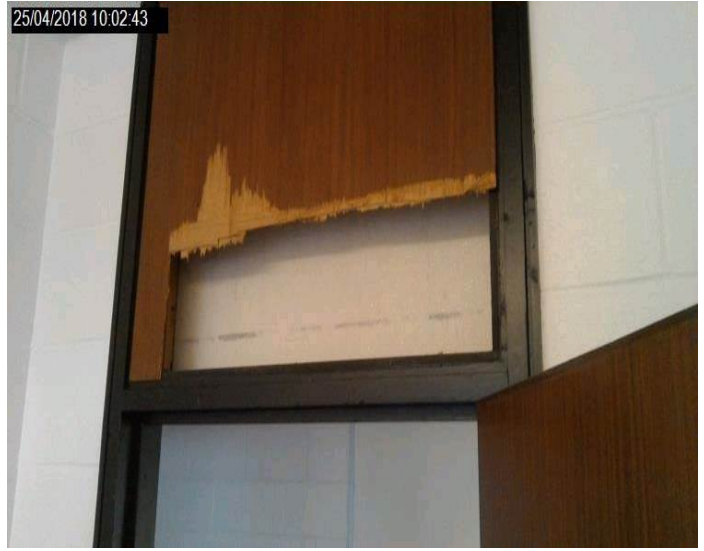
<b>Location:</b>	2.99A	<b>Block:</b>	Commercial	<b>Floor Level:</b> 1st Floor
<b>Sample No.:</b>	DU001323	<b>Portal Ref No.:</b>	222

<b>Item:</b>	Insulating board door header			
<b>Asbestos Content:</b>		<b>Result Based on:</b>		
No Asbestos Detected		Analysis of sample using PLM		
<b>Sample Analysed By:</b>	Reg 13(1)	<b>Extent:</b>	1 m <sup>2</sup>	
<b>Comments:</b>

<b>Material Assessment Total Score: 0</b>		<b>Likelihood of Disturbance Assessment Total Score: 0</b>		<b>Management Assessment</b>  <b>Licensable:</b> Yes  <b>Recommendations:</b> Not Applicable  <b>Reinspection Interval:</b> Not Applicable  <b>Overall Risk Category:</b> E0
<b>Product Type:</b>	0 Not Applicable	<b>Location:</b>	0 Not Applicable	
<b>Condition:</b>	0 Not Applicable	<b>Accessibility:</b>	0 Not Applicable	
<b>Surface Treatment:</b>	0 Not Applicable			
<b>Asbestos Type:</b>	0 Not Applicable	<b>Extent Score:</b>	0 Not Applicable

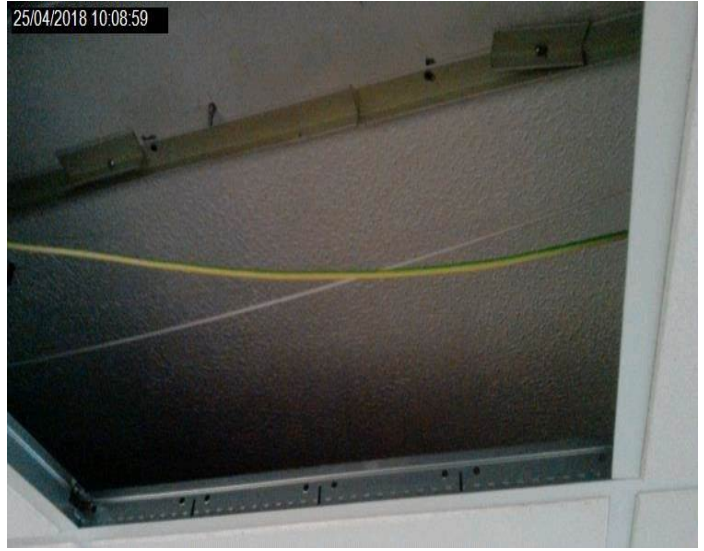
<b>Location:</b>	2.99B	<b>Block:</b>	Commercial	<b>Floor Level:</b> 1st Floor
<b>Sample No.:</b>	As DU001322	<b>Portal Ref No.:</b>	223

<b>Item:</b>	Asbestos Textured coating to concrete			
<b>Asbestos Content:</b>	<b>Result Based on:</b>			
Chrysotile	Strongly presumed			
<b>Sample Analysed By:</b>	Not applicable	<b>Extent:</b>	25 m <sup>2</sup>	
<b>Comments:</b> Above suspended ceiling tiles, partial section of the corridor ceiling

<b>Material Assessment Total Score: 3</b>		<b>Likelihood of Disturbance Assessment Total Score: 6</b>		<b>Management Assessment</b>  <b>Licensable:</b> No  <b>Recommendations:</b> Program removal  <b>Reinspection Interval:</b> Not Applicable  <b>Overall Risk Category:</b> C9
<b>Product Type:</b>	1 (Asbestos textured coating)	<b>Location:</b>	2 (Rooms up to 100 sq m)	
<b>Condition:</b>	1 (Minor scratches)	<b>Accessibility:</b>	1 (Occasionally likely to be disturbed)	
<b>Surface Treatment:</b>	0 (Composite material)			
<b>Asbestos Type:</b>	1 (Chrysotile)	<b>Extent Score:</b>	3 (>50 sq m or >50m pipe run)

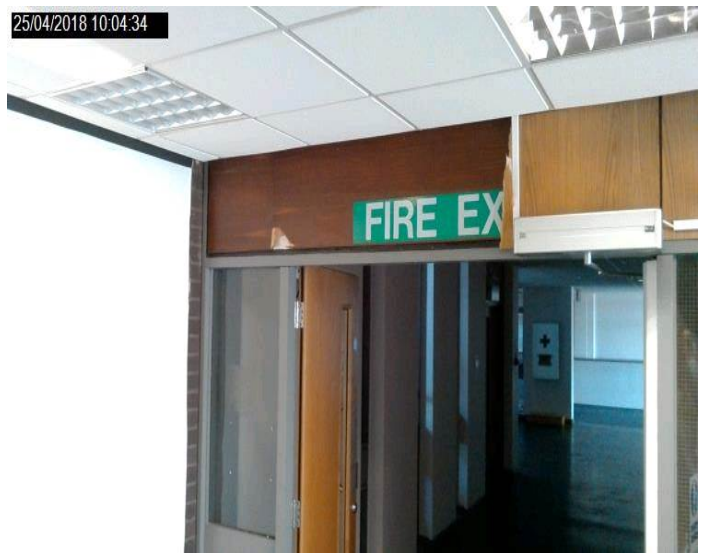
<b>Location:</b>	2.99B	<b>Block:</b>	Commercial	<b>Floor Level:</b> 1st Floor
<b>Sample No.:</b>	DU001324	<b>Portal Ref No.:</b>	225

<b>Item:</b>	Insulating board door header panels			
<b>Asbestos Content:</b>	<b>Result Based on:</b>			
No Asbestos Detected	Analysis of sample using PLM			
<b>Sample Analysed By:</b>	Reg 13(1)	<b>Extent:</b>	15 m <sup>2</sup>	
<b>Comments:</b> Leading to rooms, 2.17, 2.16, 2.14(x2), 2.15, 2.13, double doors leading to the building, 2.38, 2.36, 2.35 and 2.34

<b>Material Assessment Total Score: 0</b>		<b>Likelihood of Disturbance Assessment Total Score: 0</b>		<b>Management Assessment</b>  <b>Licensable:</b> Yes  <b>Recommendations:</b> Not Applicable  <b>Reinspection Interval:</b> Not Applicable  <b>Overall Risk Category:</b> E0
<b>Product Type:</b>	0 Not Applicable	<b>Location:</b>	0 Not Applicable	
<b>Condition:</b>	0 Not Applicable	<b>Accessibility:</b>	0 Not Applicable	
<b>Surface Treatment:</b>	0 Not Applicable			
<b>Asbestos Type:</b>	0 Not Applicable	<b>Extent Score:</b>	0 Not Applicable

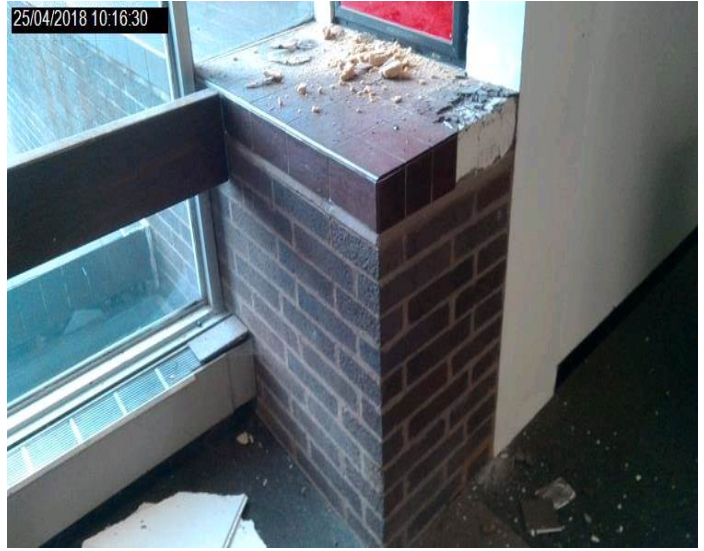
<b>Location:</b>	2.99B	<b>Block:</b>	Commercial	<b>Floor Level:</b> 1st Floor
<b>Sample No.:</b>	DU001325	<b>Portal Ref No.:</b>	226

<b>Item:</b>	Asbestos Cement shuttering			
<b>Asbestos Content:</b>	Result Based on:			
Chrysotile	Analysis of sample using PLM			
<b>Sample Analysed By:</b>	Reg 13(1)	<b>Extent:</b>	5 m <sup>2</sup>	
<b>Comments:</b> To underside of internal wall item continues into room 2.38

<b>Material Assessment Total Score: 4</b>		<b>Likelihood of Disturbance Assessment Total Score: 3</b>		<b>Management Assessment</b>  <b>Licensable:</b> No  <b>Recommendations:</b> Program removal  <b>Reinspection Interval:</b> Not Applicable  <b>Overall Risk Category:</b> C7
<b>Product Type:</b>	1 (Asbestos cement)	<b>Location:</b>	2 (Rooms up to 100 sq m)	
<b>Condition:</b>	1 (Minor scratches)	<b>Accessibility:</b>	0 (Usually inaccessible or unlikely to be disturbed)	
<b>Surface Treatment:</b>	1 (Unencapsulated asbestos cement)			
<b>Asbestos Type:</b>	1 (Chrysotile)	<b>Extent Score:</b>	1 (<10 sq m or 10m pipe run)

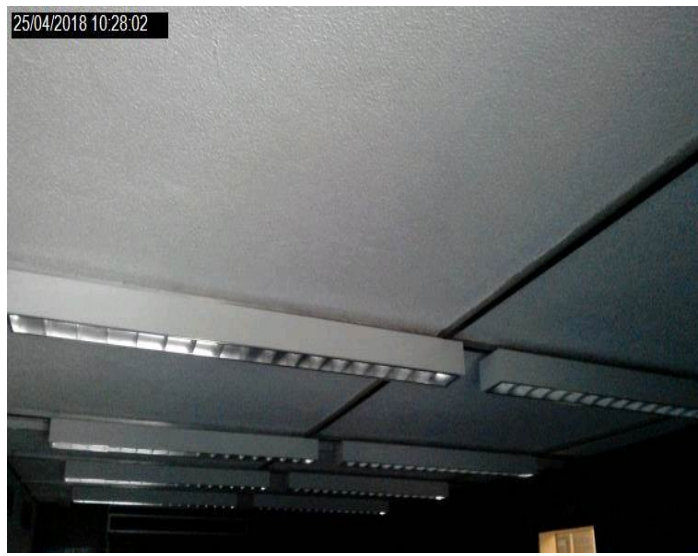
<b>Location:</b>	1.14	<b>Block:</b>	Commercial	<b>Floor Level:</b> Ground Floor
<b>Sample No.:</b>	DU001326	<b>Portal Ref No.:</b>	227

<b>Item:</b>	Asbestos Textured coating to concrete			
<b>Asbestos Content:</b>	Result Based on:			
Chrysotile	Analysis of sample using PLM			
<b>Sample Analysed By:</b>	Reg 13(1)	<b>Extent:</b>	80 m <sup>2</sup>	
<b>Comments:</b>

<b>Material Assessment Total Score: 3</b>		<b>Likelihood of Disturbance Assessment Total Score: 6</b>		<b>Management Assessment</b>  <b>Licensable:</b> No  <b>Recommendations:</b> Program removal  <b>Reinspection Interval:</b> Not Applicable  <b>Overall Risk Category:</b> C9
<b>Product Type:</b>	1 (Asbestos textured coating)	<b>Location:</b>	2 (Rooms up to 100 sq m)	
<b>Condition:</b>	1 (Minor scratches)	<b>Accessibility:</b>	1 (Occasionally likely to be disturbed)	
<b>Surface Treatment:</b>	0 (Composite material)			
<b>Asbestos Type:</b>	1 (Chrysotile)	<b>Extent Score:</b>	3 (>50 sq m or >50m pipe run)
