**Report No.:** J094042  
**Nature of Work:** Demolition Survey  
**Issue Date:** 29/05/2018  
**Client Name:** WYG Engineering Ltd  
Geneva Building, Lake View Drive, Sherwood Business Park,  
Annesley, Nottingham, NG15 0ED  
**Site Address:** Cox Building, Former City North Campus, Birmingham City  
University, Perry Barr, B42 2US

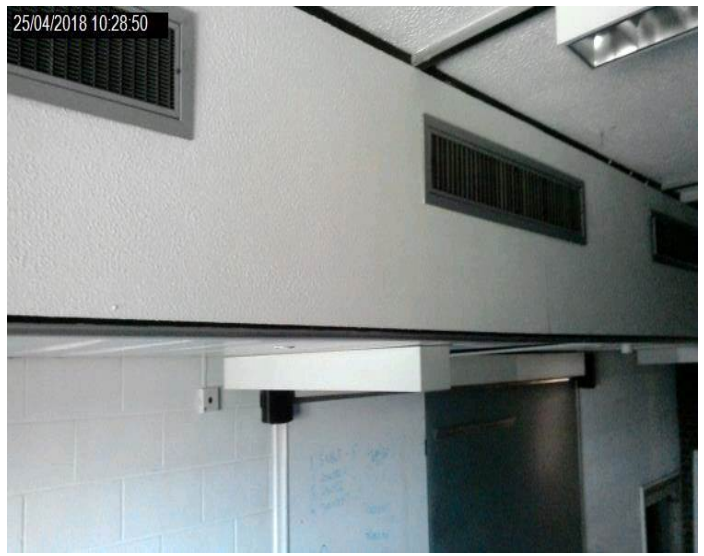
<b>Location:</b>	1.14	<b>Block:</b>	Commercial	<b>Floor Level:</b> Ground Floor
<b>Sample No.:</b>	DU001327	<b>Portal Ref No.:</b>	228

<b>Item:</b>	Asbestos Textured coating to timber upstand			
<b>Asbestos Content:</b>	Result Based on:			
Chrysotile	Analysis of sample using PLM			
<b>Sample Analysed By:</b>	Reg 13(1)	<b>Extent:</b>	12 m <sup>2</sup>	
<b>Comments:</b>

<b>Material Assessment Total Score: 3</b>		<b>Likelihood of Disturbance Assessment Total Score: 5</b>		<b>Management Assessment</b>  <b>Licensable:</b> No  <b>Recommendations:</b> Program removal  <b>Reinspection Interval:</b> Not Applicable  <b>Overall Risk Category:</b> C8
<b>Product Type:</b>	1 (Asbestos textured coating)	<b>Location:</b>	2 (Rooms up to 100 sq m)	
<b>Condition:</b>	1 (Minor scratches)	<b>Accessibility:</b>	1 (Occasionally likely to be disturbed)	
<b>Surface Treatment:</b>	0 (Composite material)			
<b>Asbestos Type:</b>	1 (Chrysotile)	<b>Extent Score:</b>	2 (>10 - <50 sq m or >10m - <50m pipe run)

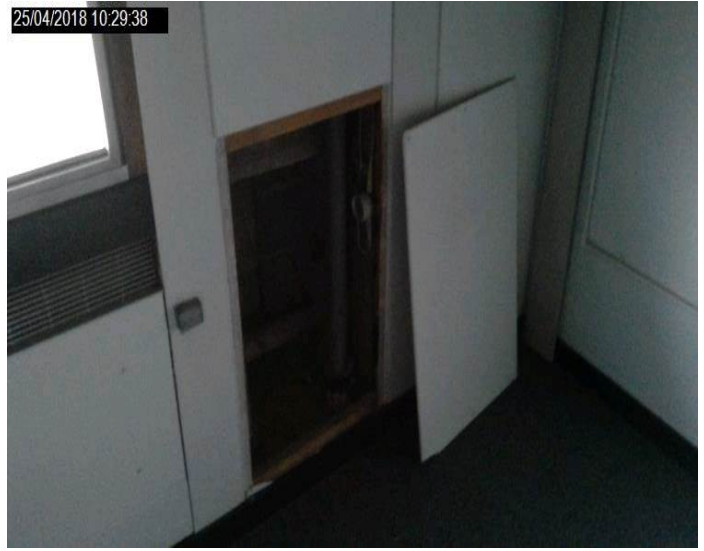
<b>Location:</b>	1.14	<b>Block:</b>	Commercial	<b>Floor Level:</b> Ground Floor
<b>Sample No.:</b>	DU001328	<b>Portal Ref No.:</b>	229

<b>Item:</b>	Insulating board panel to riser			
<b>Asbestos Content:</b>	<b>Result Based on:</b>			
No Asbestos Detected	Analysis of sample using PLM			
<b>Sample Analysed By:</b> Reg 13(1)	<b>Extent:</b>	3 m <sup>2</sup>		
<b>Comments:</b> 1 x riser

<b>Material Assessment Total Score: 0</b>		<b>Likelihood of Disturbance Assessment Total Score: 0</b>		<b>Management Assessment</b>  <b>Licensable:</b> Yes  <b>Recommendations:</b> Not Applicable  <b>Reinspection Interval:</b> Not Applicable  <b>Overall Risk Category:</b> E0
<b>Product Type:</b>	0 Not Applicable	<b>Location:</b>	0 Not Applicable	
<b>Condition:</b>	0 Not Applicable	<b>Accessibility:</b>	0 Not Applicable	
<b>Surface Treatment:</b>	0 Not Applicable			
<b>Asbestos Type:</b>	0 Not Applicable	<b>Extent Score:</b>	0 Not Applicable

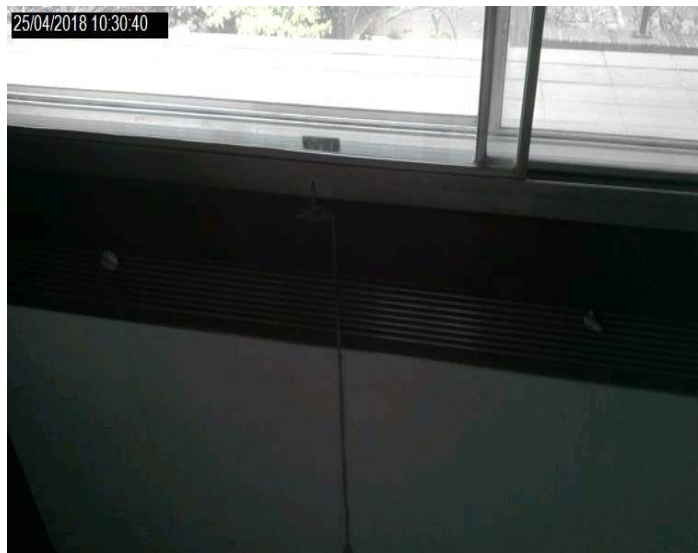
<b>Location:</b>	1.14	<b>Block:</b>	Commercial	<b>Floor Level:</b> Ground Floor
<b>Sample No.:</b>	DU001329	<b>Portal Ref No.:</b>	230

<b>Item:</b>	Asbestos Cement window sill			
<b>Asbestos Content:</b>	Result Based on:			
Chrysotile	Analysis of sample using PLM			
<b>Sample Analysed By:</b> Reg 13(1)	<b>Extent:</b>	2 linear metres		
<b>Comments:</b>

<b>Material Assessment Total Score: 4</b>		<b>Likelihood of Disturbance Assessment Total Score: 4</b>		<b>Management Assessment</b>  <b>Licensable:</b> No  <b>Recommendations:</b> Program removal  <b>Reinspection Interval:</b> Not Applicable  <b>Overall Risk Category:</b> C8
<b>Product Type:</b>	1 (Asbestos cement)	<b>Location:</b>	2 (Rooms up to 100 sq m)	
<b>Condition:</b>	1 (Minor scratches)	<b>Accessibility:</b>	1 (Occasionally likely to be disturbed)	
<b>Surface Treatment:</b>	1 (Encapsulated asbestos cement)			
<b>Asbestos Type:</b>	1 (Chrysotile)	<b>Extent Score:</b>	1 (<10 sq m or 10m pipe run)

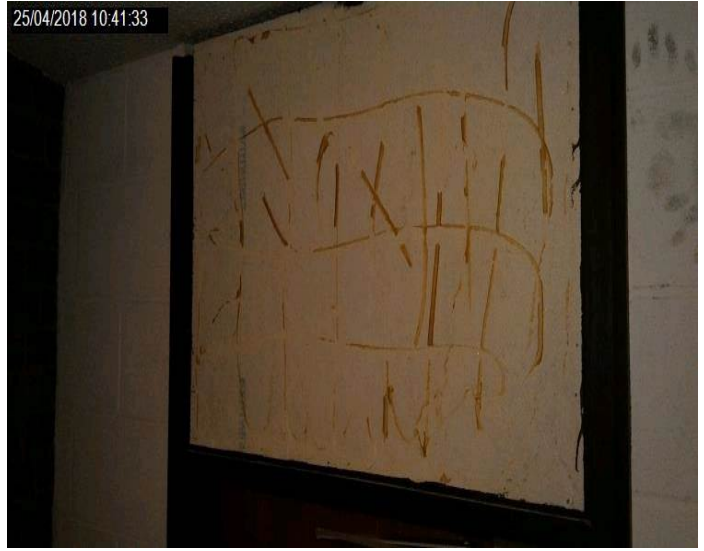
<b>Location:</b>	1.15	<b>Block:</b>	Commercial	<b>Floor Level:</b> Ground Floor
<b>Sample No.:</b>	DU001331	<b>Portal Ref No.:</b>	235

<b>Item:</b>	Insulating board door header panels			
<b>Asbestos Content:</b>		<b>Result Based on:</b>		
No Asbestos Detected		Analysis of sample using PLM		
<b>Sample Analysed By:</b>	Reg 13(1)	<b>Extent:</b>	2 m <sup>2</sup>	
<b>Comments:</b> 2 door header panels

<b>Material Assessment Total Score: 0</b>		<b>Likelihood of Disturbance Assessment Total Score: 0</b>		<b>Management Assessment</b>  <b>Licensable:</b> Yes  <b>Recommendations:</b> Not Applicable  <b>Reinspection Interval:</b> Not Applicable  <b>Overall Risk Category:</b> E0
<b>Product Type:</b>	0 Not Applicable	<b>Location:</b>	0 Not Applicable	
<b>Condition:</b>	0 Not Applicable	<b>Accessibility:</b>	0 Not Applicable	
<b>Surface Treatment:</b>	0 Not Applicable			
<b>Asbestos Type:</b>	0 Not Applicable	<b>Extent Score:</b>	0 Not Applicable

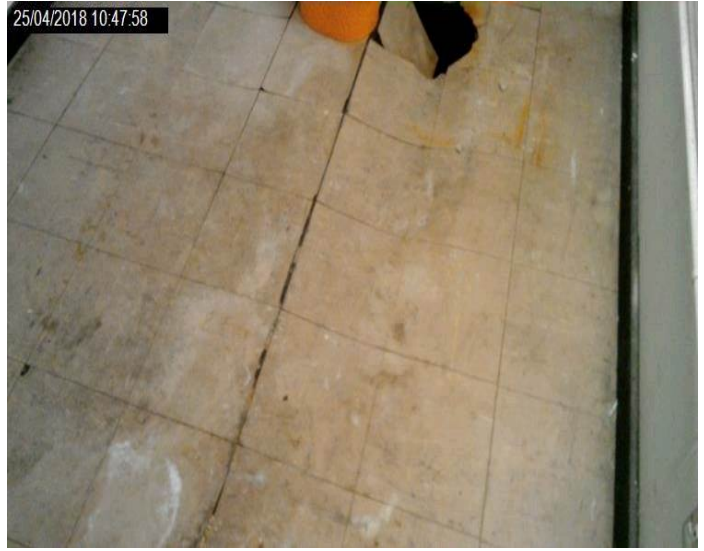
<b>Location:</b>	1.44	<b>Block:</b>	Commercial	<b>Floor Level:</b> Ground Floor
<b>Sample No.:</b>	DU001332	<b>Portal Ref No.:</b>	243

<b>Item:</b>	Asbestos Thermoplastic floor tiles with bitumen adhesive			
<b>Asbestos Content:</b>	<b>Result Based on:</b>			
Chrysotile in adhesive only	Analysis of sample using PLM			
<b>Sample Analysed By:</b> Reg 13(1)	<b>Extent:</b>	12 m <sup>2</sup>		
<b>Comments:</b>

<b>Material Assessment Total Score: 3</b>		<b>Likelihood of Disturbance Assessment Total Score: 7</b>		<b>Management Assessment</b>  <b>Licensable:</b> No  <b>Recommendations:</b> Program removal  <b>Reinspection Interval:</b> Not Applicable  <b>Overall Risk Category:</b> C10
<b>Product Type:</b>	1 (Asbestos thermoplastic)	<b>Location:</b>	2 (Rooms up to 100 sq m)	
<b>Condition:</b>	1 (Minor scratches)	<b>Accessibility:</b>	3 (Routinely disturbed)	
<b>Surface Treatment:</b>	0 (Composite material)			
<b>Asbestos Type:</b>	1 (Chrysotile)	<b>Extent Score:</b>	2 (>10 - <50 sq m or >10m - <50m pipe run)

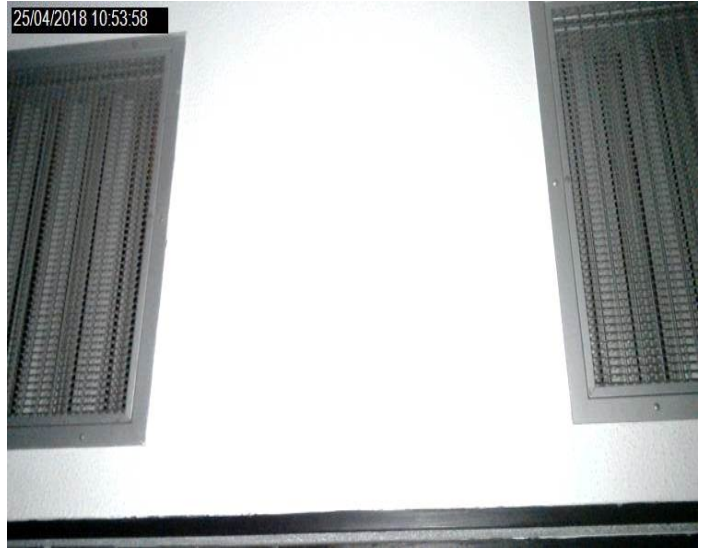
<b>Location:</b>	1.16	<b>Block:</b>	Commercial	<b>Floor Level:</b> Ground Floor
<b>Sample No.:</b>	As DU001327	<b>Portal Ref No.:</b>	245

<b>Item:</b>	Asbestos Textured coating to timber upstand			
<b>Asbestos Content:</b>	<b>Result Based on:</b>			
Chrysotile	Strongly presumed			
<b>Sample Analysed By:</b>	Not applicable	<b>Extent:</b>	12 m <sup>2</sup>	
<b>Comments:</b>

<b>Material Assessment Total Score: 3</b>		<b>Likelihood of Disturbance Assessment Total Score: 5</b>		<b>Management Assessment</b>  <b>Licensable:</b> No  <b>Recommendations:</b> Program removal  <b>Reinspection Interval:</b> Not Applicable  <b>Overall Risk Category:</b> C8
<b>Product Type:</b>	1 (Asbestos textured coating)	<b>Location:</b>	2 (Rooms up to 100 sq m)	
<b>Condition:</b>	1 (Minor scratches)	<b>Accessibility:</b>	1 (Occasionally likely to be disturbed)	
<b>Surface Treatment:</b>	0 (Composite material)			
<b>Asbestos Type:</b>	1 (Chrysotile)	<b>Extent Score:</b>	2 (>10 - <50 sq m or >10m - <50m pipe run)

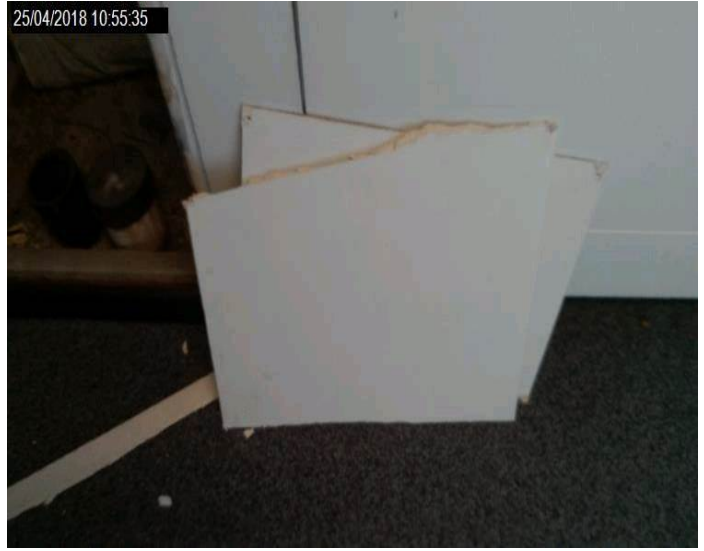
<b>Location:</b>	1.16	<b>Block:</b>	Commercial	<b>Floor Level:</b> Ground Floor
<b>Sample No.:</b>	As DU001328	<b>Portal Ref No.:</b>	246

<b>Item:</b>	Insulating board panel to riser			
<b>Asbestos Content:</b>		<b>Result Based on:</b>		
No Asbestos Detected		Strongly presumed		
<b>Sample Analysed By:</b>	Not applicable	<b>Extent:</b>	3 m <sup>2</sup>	
<b>Comments:</b> 1 x riser

<b>Material Assessment Total Score: 0</b>		<b>Likelihood of Disturbance Assessment Total Score: 0</b>		<b>Management Assessment</b>  <b>Licensable:</b> Yes  <b>Recommendations:</b> Not Applicable  <b>Reinspection Interval:</b> Not Applicable  <b>Overall Risk Category:</b> E0
<b>Product Type:</b>	0 Not Applicable	<b>Location:</b>	0 Not Applicable	
<b>Condition:</b>	0 Not Applicable	<b>Accessibility:</b>	0 Not Applicable	
<b>Surface Treatment:</b>	0 Not Applicable			
<b>Asbestos Type:</b>	0 Not Applicable	<b>Extent Score:</b>	0 Not Applicable

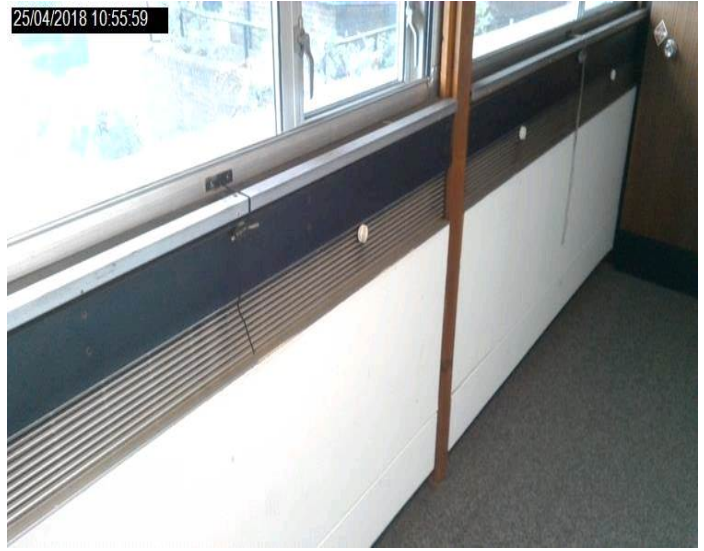
<b>Location:</b>	1.16	<b>Block:</b>	Commercial	<b>Floor Level:</b> Ground Floor
<b>Sample No.:</b>	As DU001329	<b>Portal Ref No.:</b>	247

<b>Item:</b>	Asbestos Cement window sill			
<b>Asbestos Content:</b>	<b>Result Based on:</b>			
Chrysotile	Strongly presumed			
<b>Sample Analysed By:</b>	Not applicable	<b>Extent:</b>	9 linear metres	
<b>Comments:</b>

<b>Material Assessment Total Score: 4</b>		<b>Likelihood of Disturbance Assessment Total Score: 4</b>		<b>Management Assessment</b>  <b>Licensable:</b> No  <b>Recommendations:</b> Program removal  <b>Reinspection Interval:</b> Not Applicable  <b>Overall Risk Category:</b> C8
<b>Product Type:</b>	1 (Asbestos cement)	<b>Location:</b>	2 (Rooms up to 100 sq m)	
<b>Condition:</b>	1 (Minor scratches)	<b>Accessibility:</b>	1 (Occasionally likely to be disturbed)	
<b>Surface Treatment:</b>	1 (Encapsulated asbestos cement)			
<b>Asbestos Type:</b>	1 (Chrysotile)	<b>Extent Score:</b>	1 (<10 sq m or 10m pipe run)

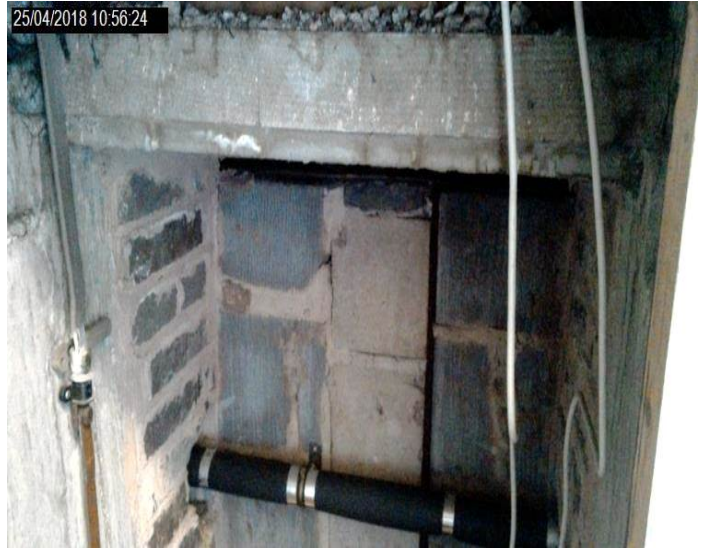
<b>Location:</b>	1.16	<b>Block:</b>	Commercial	<b>Floor Level:</b> Ground Floor
<b>Sample No.:</b>	As DU001330	<b>Portal Ref No.:</b>	248

<b>Item:</b>	Asbestos Cement shuttering			
<b>Asbestos Content:</b>	<b>Result Based on:</b>			
Chrysotile	Strongly presumed			
<b>Sample Analysed By:</b>	Not applicable	<b>Extent:</b>	9 m <sup>2</sup>	
<b>Comments:</b> To ceiling of heater wall void to external wall perimeter, also to front face of concrete in riser

<b>Material Assessment Total Score: 4</b>		<b>Likelihood of Disturbance Assessment Total Score: 3</b>		<b>Management Assessment</b>  <b>Licensable:</b> No  <b>Recommendations:</b> Program removal  <b>Reinspection Interval:</b> Not Applicable  <b>Overall Risk Category:</b> C7
<b>Product Type:</b>	1 (Asbestos cement)	<b>Location:</b>	2 (Rooms up to 100 sq m)	
<b>Condition:</b>	1 (Minor scratches)	<b>Accessibility:</b>	0 (Usually inaccessible or unlikely to be disturbed)	
<b>Surface Treatment:</b>	1 (Encapsulated asbestos cement)			
<b>Asbestos Type:</b>	1 (Chrysotile)	<b>Extent Score:</b>	1 (<10 sq m or 10m pipe run)

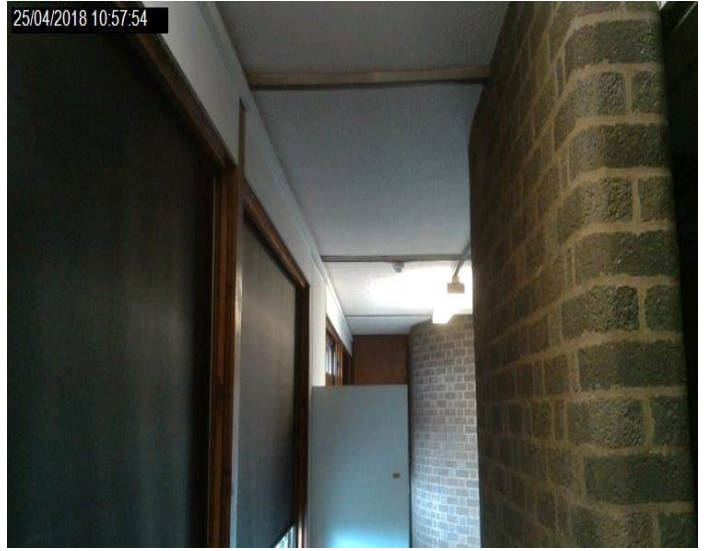
<b>Location:</b>	1.16	<b>Block:</b>	Commercial	<b>Floor Level:</b> Ground Floor
<b>Sample No.:</b>	As DU001326	<b>Portal Ref No.:</b>	249

<b>Item:</b>	Asbestos Textured coating to concrete			
<b>Asbestos Content:</b>	<b>Result Based on:</b>			
Chrysotile	Strongly presumed			
<b>Sample Analysed By:</b>	Not applicable	<b>Extent:</b>	20 m <sup>2</sup>	
<b>Comments:</b> Section of the ceiling only see plan

<b>Material Assessment Total Score: 3</b>		<b>Likelihood of Disturbance Assessment Total Score: 5</b>		<b>Management Assessment</b>  <b>Licensable:</b> No  <b>Recommendations:</b> Program removal  <b>Reinspection Interval:</b> Not Applicable  <b>Overall Risk Category:</b> C8
<b>Product Type:</b>	1 (Asbestos textured coating)	<b>Location:</b>	2 (Rooms up to 100 sq m)	
<b>Condition:</b>	1 (Minor scratches)	<b>Accessibility:</b>	1 (Occasionally likely to be disturbed)	
<b>Surface Treatment:</b>	0 (Composite material)			
<b>Asbestos Type:</b>	1 (Chrysotile)	<b>Extent Score:</b>	2 (>10 - <50 sq m or >10m - <50m pipe run)

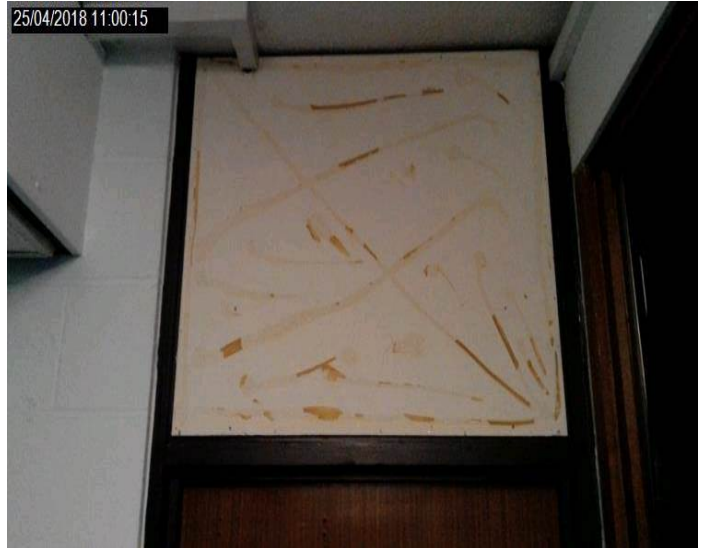
<b>Location:</b>	1.16	<b>Block:</b>	Commercial	<b>Floor Level:</b> Ground Floor
<b>Sample No.:</b>	DU001334	<b>Portal Ref No.:</b>	250

<b>Item:</b>	Insulating board door header panel			
<b>Asbestos Content:</b>		<b>Result Based on:</b>		
No Asbestos Detected		Analysis of sample using PLM		
<b>Sample Analysed By:</b>	Reg 13(1)	<b>Extent:</b>	5 m <sup>2</sup>	
<b>Comments:</b>

<b>Material Assessment Total Score: 0</b>		<b>Likelihood of Disturbance Assessment Total Score: 0</b>		<b>Management Assessment</b>  <b>Licensable:</b> Yes  <b>Recommendations:</b> Not Applicable  <b>Reinspection Interval:</b> Not Applicable  <b>Overall Risk Category:</b> E0
<b>Product Type:</b>	0 Not Applicable	<b>Location:</b>	0 Not Applicable	
<b>Condition:</b>	0 Not Applicable	<b>Accessibility:</b>	0 Not Applicable	
<b>Surface Treatment:</b>	0 Not Applicable			
<b>Asbestos Type:</b>	0 Not Applicable	<b>Extent Score:</b>	0 Not Applicable

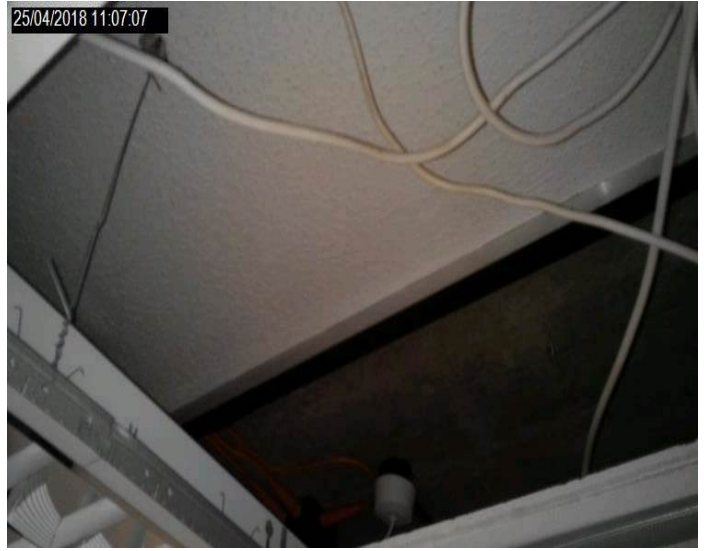
<b>Location:</b>	1.99A	<b>Block:</b>	Commercial	<b>Floor Level:</b> Ground Floor
<b>Sample No.:</b>	As DU001326	<b>Portal Ref No.:</b>	252

<b>Item:</b>	Asbestos Textured coating to concrete			
<b>Asbestos Content:</b>	<b>Result Based on:</b>			
Chrysotile	Strongly presumed			
<b>Sample Analysed By:</b>	Not applicable	<b>Extent:</b>	30 m <sup>2</sup>	
<b>Comments:</b>

<b>Material Assessment Total Score: 3</b>		<b>Likelihood of Disturbance Assessment Total Score: 5</b>		<b>Management Assessment</b>  <b>Licensable:</b> No  <b>Recommendations:</b> Program removal  <b>Reinspection Interval:</b> Not Applicable  <b>Overall Risk Category:</b> C8
<b>Product Type:</b>	1 (Asbestos textured coating)	<b>Location:</b>	2 (Rooms up to 100 sq m)	
<b>Condition:</b>	1 (Minor scratches)	<b>Accessibility:</b>	1 (Occasionally likely to be disturbed)	
<b>Surface Treatment:</b>	0 (Composite material)			
<b>Asbestos Type:</b>	1 (Chrysotile)	<b>Extent Score:</b>	2 (>10 - <50 sq m or >10m - <50m pipe run)

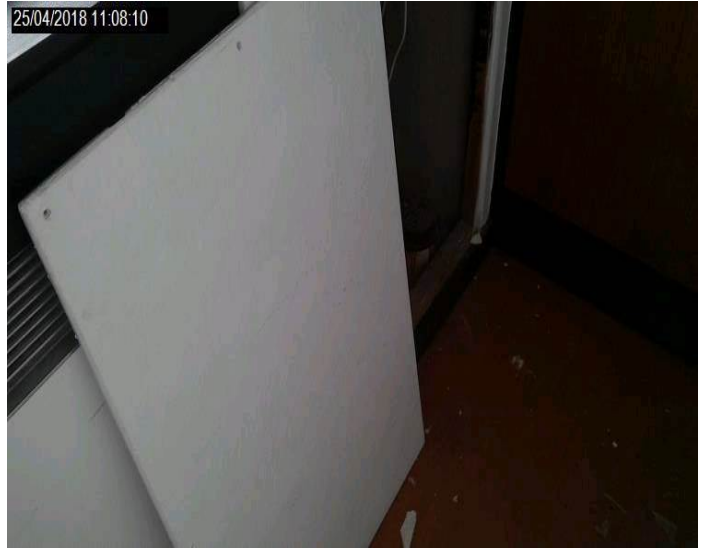
<b>Location:</b>	1.99A	<b>Block:</b>	Commercial	<b>Floor Level:</b> Ground Floor
<b>Sample No.:</b>	As DU001328	<b>Portal Ref No.:</b>	253

<b>Item:</b>	Insulating board panel to riser			
<b>Asbestos Content:</b>		<b>Result Based on:</b>		
No Asbestos Detected		Strongly presumed		
<b>Sample Analysed By:</b>	Not applicable	<b>Extent:</b>	3 m <sup>2</sup>	
<b>Comments:</b> 1 x riser

<b>Material Assessment Total Score: 0</b>		<b>Likelihood of Disturbance Assessment Total Score: 0</b>		<b>Management Assessment</b>  <b>Licensable:</b> Yes  <b>Recommendations:</b> Not Applicable  <b>Reinspection Interval:</b> Not Applicable  <b>Overall Risk Category:</b> E0
<b>Product Type:</b>	0 Not Applicable	<b>Location:</b>	0 Not Applicable	
<b>Condition:</b>	0 Not Applicable	<b>Accessibility:</b>	0 Not Applicable	
<b>Surface Treatment:</b>	0 Not Applicable			
<b>Asbestos Type:</b>	0 Not Applicable	<b>Extent Score:</b>	0 Not Applicable

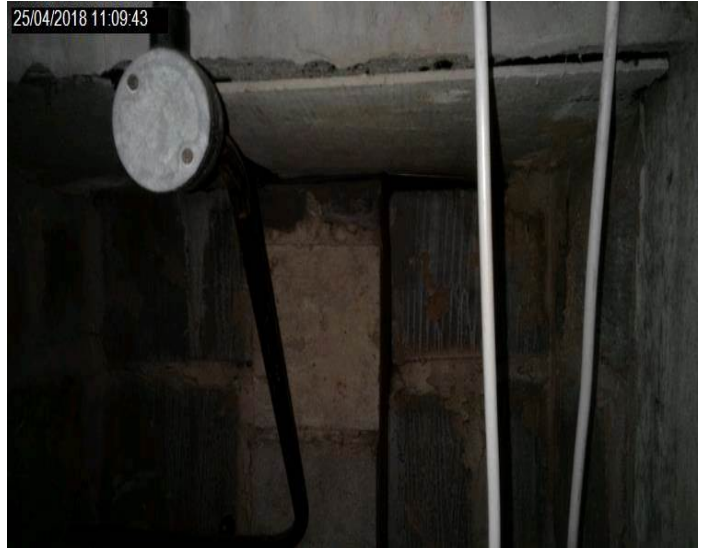
<b>Location:</b>	1.99A	<b>Block:</b>	Commercial	<b>Floor Level:</b> Ground Floor
<b>Sample No.:</b>	As DU001330	<b>Portal Ref No.:</b>	255

<b>Item:</b>	Asbestos Cement shuttering			
<b>Asbestos Content:</b>	<b>Result Based on:</b>			
Chrysotile	Strongly presumed			
<b>Sample Analysed By:</b>	Not applicable	<b>Extent:</b>	3 m <sup>2</sup>	
<b>Comments:</b> To ceiling of heater wall void to external wall perimeter

<b>Material Assessment Total Score: 4</b>		<b>Likelihood of Disturbance Assessment Total Score: 3</b>		<b>Management Assessment</b>  <b>Licensable:</b> No  <b>Recommendations:</b> Program removal  <b>Reinspection Interval:</b> Not Applicable  <b>Overall Risk Category:</b> C7
<b>Product Type:</b>	1 (Asbestos cement)	<b>Location:</b>	2 (Rooms up to 100 sq m)	
<b>Condition:</b>	1 (Minor scratches)	<b>Accessibility:</b>	0 (Usually inaccessible or unlikely to be disturbed)	
<b>Surface Treatment:</b>	1 (Encapsulated asbestos cement)			
<b>Asbestos Type:</b>	1 (Chrysotile)	<b>Extent Score:</b>	1 (<10 sq m or 10m pipe run)

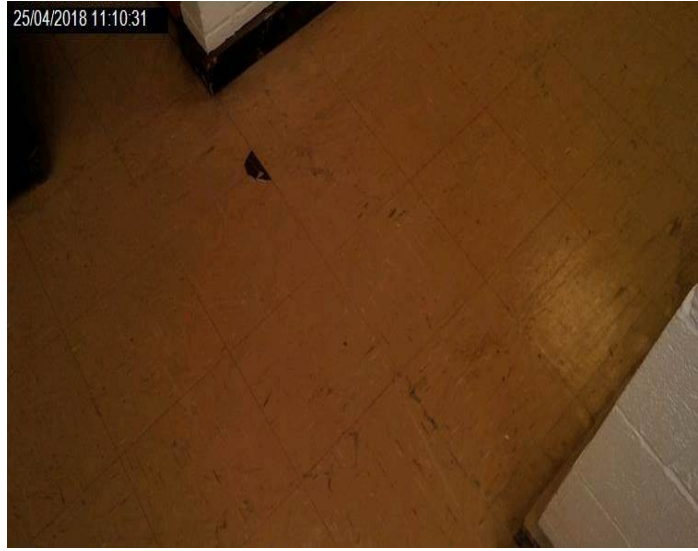
<b>Location:</b>	1.99A	<b>Block:</b>	Commercial	<b>Floor Level:</b> Ground Floor
<b>Sample No.:</b>	DU001335	<b>Portal Ref No.:</b>	256

<b>Item:</b>	Thermoplastic floor tiles with bitumen adhesive			
<b>Asbestos Content:</b>		<b>Result Based on:</b>		
No Asbestos Detected		Analysis of sample using PLM		
<b>Sample Analysed By:</b>	Reg 13(1)	<b>Extent:</b>	18 m <sup>2</sup>	
<b>Comments:</b>

<b>Material Assessment Total Score: 0</b>		<b>Likelihood of Disturbance Assessment Total Score: 0</b>		<b>Management Assessment</b>  <b>Licensable:</b> No  <b>Recommendations:</b> Not Applicable  <b>Reinspection Interval:</b> Not Applicable  <b>Overall Risk Category:</b> E0
<b>Product Type:</b>	0 Not Applicable	<b>Location:</b>	0 Not Applicable	
<b>Condition:</b>	0 Not Applicable	<b>Accessibility:</b>	0 Not Applicable	
<b>Surface Treatment:</b>	0 Not Applicable			
<b>Asbestos Type:</b>	0 Not Applicable	<b>Extent Score:</b>	0 Not Applicable

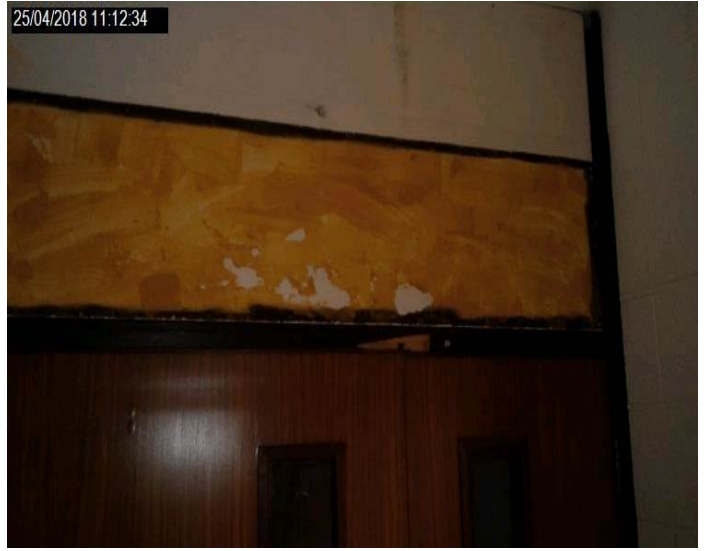
<b>Location:</b>	1.99A	<b>Block:</b>	Commercial	<b>Floor Level:</b> Ground Floor
<b>Sample No.:</b>	DU001336	<b>Portal Ref No.:</b>	257

<b>Item:</b>	Insulating board door header panels			
<b>Asbestos Content:</b>		<b>Result Based on:</b>		
No Asbestos Detected		Analysis of sample using PLM		
<b>Sample Analysed By:</b>	Reg 13(1)	<b>Extent:</b>	8 m <sup>2</sup>	
<b>Comments:</b> Leading to rooms 1.38, 1.37, leading to corridor 1.99B and stairwell 1.00

<b>Material Assessment Total Score: 0</b>		<b>Likelihood of Disturbance Assessment Total Score: 0</b>		<b>Management Assessment</b>  <b>Licensable:</b> Yes  <b>Recommendations:</b> Not Applicable  <b>Reinspection Interval:</b> Not Applicable  <b>Overall Risk Category:</b> E0
<b>Product Type:</b>	0 Not Applicable	<b>Location:</b>	0 Not Applicable	
<b>Condition:</b>	0 Not Applicable	<b>Accessibility:</b>	0 Not Applicable	
<b>Surface Treatment:</b>	0 Not Applicable			
<b>Asbestos Type:</b>	0 Not Applicable	<b>Extent Score:</b>	0 Not Applicable

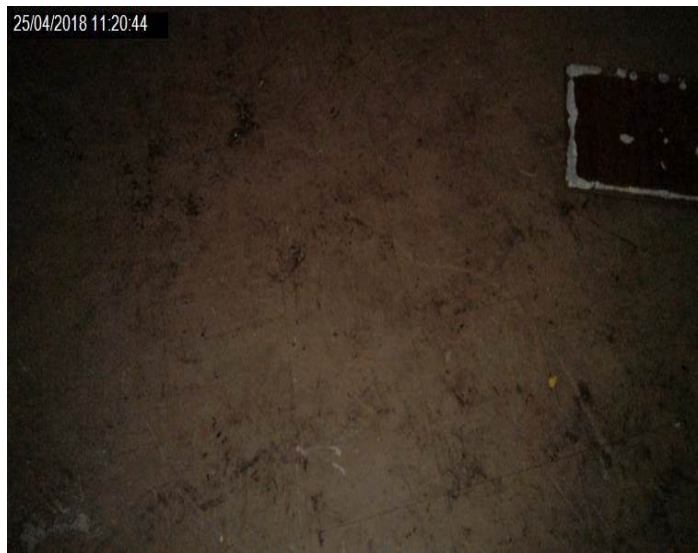
<b>Location:</b>	1.38	<b>Block:</b>	Commercial	<b>Floor Level:</b> Ground Floor
<b>Sample No.:</b>	DU001338	<b>Portal Ref No.:</b>	260

<b>Item:</b>	Asbestos Thermoplastic floor tiles with bitumen adhesive			
<b>Asbestos Content:</b>	Result Based on:			
Chrysotile in adhesive only	Analysis of sample using PLM			
<b>Sample Analysed By:</b> Reg 13(1)	<b>Extent:</b>	12 m <sup>2</sup>		
<b>Comments:</b>

<b>Material Assessment Total Score: 3</b>		<b>Likelihood of Disturbance Assessment Total Score: 7</b>		<b>Management Assessment</b>  <b>Licensable:</b> No  <b>Recommendations:</b> Program removal  <b>Reinspection Interval:</b> Not Applicable  <b>Overall Risk Category:</b> C10
<b>Product Type:</b>	1 (Asbestos thermoplastic)	<b>Location:</b>	2 (Rooms up to 100 sq m)	
<b>Condition:</b>	1 (Minor scratches)	<b>Accessibility:</b>	3 (Routinely disturbed)	
<b>Surface Treatment:</b>	0 (Composite material)			
<b>Asbestos Type:</b>	1 (Chrysotile)	<b>Extent Score:</b>	2 (>10 - <50 sq m or >10m - <50m pipe run)

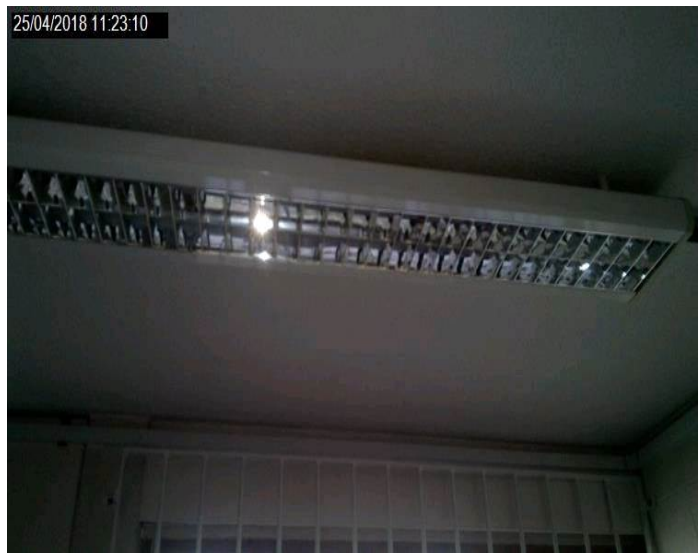
<b>Location:</b>	1.36	<b>Block:</b>	Commercial	<b>Floor Level:</b> Ground Floor
<b>Sample No.:</b>	As DU001337	<b>Portal Ref No.:</b>	261

<b>Item:</b>	Asbestos Textured coating to concrete			
<b>Asbestos Content:</b>	<b>Result Based on:</b>			
Chrysotile	Strongly presumed			
<b>Sample Analysed By:</b>	Not applicable	<b>Extent:</b>	12 m <sup>2</sup>	
<b>Comments:</b>

<b>Material Assessment Total Score: 3</b>		<b>Likelihood of Disturbance Assessment Total Score: 5</b>		<b>Management Assessment</b>  <b>Licensable:</b> No  <b>Recommendations:</b> Program removal  <b>Reinspection Interval:</b> Not Applicable  <b>Overall Risk Category:</b> C8
<b>Product Type:</b>	1 (Asbestos textured coating)	<b>Location:</b>	2 (Rooms up to 100 sq m)	
<b>Condition:</b>	1 (Minor scratches)	<b>Accessibility:</b>	1 (Occasionally likely to be disturbed)	
<b>Surface Treatment:</b>	0 (Composite material)			
<b>Asbestos Type:</b>	1 (Chrysotile)	<b>Extent Score:</b>	2 (>10 - <50 sq m or >10m - <50m pipe run)

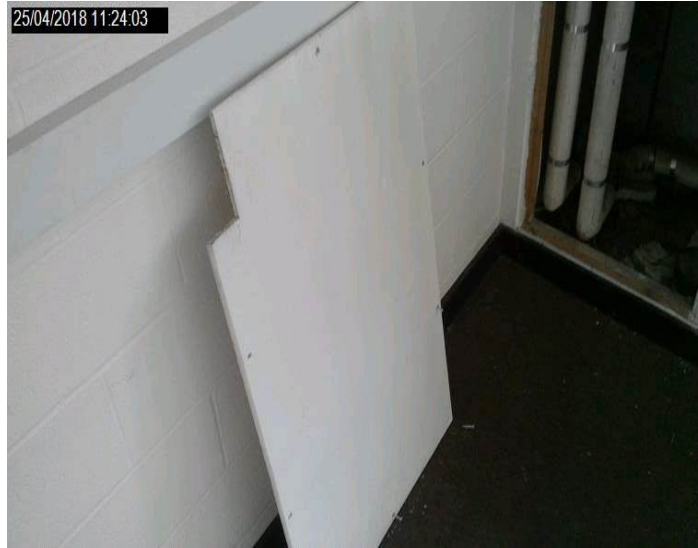
<b>Location:</b>	1.36	<b>Block:</b>	Commercial	<b>Floor Level:</b> Ground Floor
<b>Sample No.:</b>	As DU001328	<b>Portal Ref No.:</b>	262

<b>Item:</b>	Insulating board panel to riser			
<b>Asbestos Content:</b>		<b>Result Based on:</b>		
No Asbestos Detected		Strongly presumed		
<b>Sample Analysed By:</b>	Not applicable	<b>Extent:</b>	3 m <sup>2</sup>	
<b>Comments:</b> 1 x riser

<b>Material Assessment Total Score: 0</b>		<b>Likelihood of Disturbance Assessment Total Score: 0</b>		<b>Management Assessment</b>  <b>Licensable:</b> Yes  <b>Recommendations:</b> Not Applicable  <b>Reinspection Interval:</b> Not Applicable  <b>Overall Risk Category:</b> E0
<b>Product Type:</b>	0 Not Applicable	<b>Location:</b>	0 Not Applicable	
<b>Condition:</b>	0 Not Applicable	<b>Accessibility:</b>	0 Not Applicable	
<b>Surface Treatment:</b>	0 Not Applicable			
<b>Asbestos Type:</b>	0 Not Applicable	<b>Extent Score:</b>	0 Not Applicable

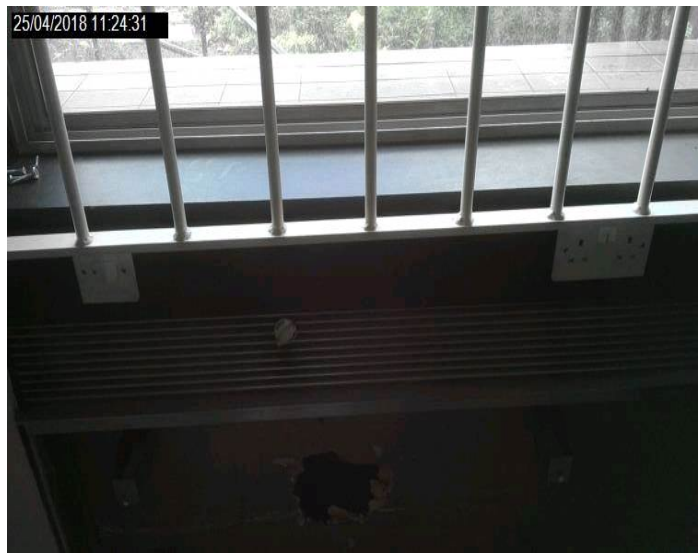
<b>Location:</b>	1.36	<b>Block:</b>	Commercial	<b>Floor Level:</b> Ground Floor
<b>Sample No.:</b>	As DU001329	<b>Portal Ref No.:</b>	263

<b>Item:</b>	Asbestos Cement window sill			
<b>Asbestos Content:</b>	<b>Result Based on:</b>			
Chrysotile	Strongly presumed			
<b>Sample Analysed By:</b>	Not applicable	<b>Extent:</b>	3 linear metres	
<b>Comments:</b>

<b>Material Assessment Total Score: 4</b>		<b>Likelihood of Disturbance Assessment Total Score: 4</b>		<b>Management Assessment</b>  <b>Licensable:</b> No  <b>Recommendations:</b> Program removal  <b>Reinspection Interval:</b> Not Applicable  <b>Overall Risk Category:</b> C8
<b>Product Type:</b>	1 (Asbestos cement)	<b>Location:</b>	2 (Rooms up to 100 sq m)	
<b>Condition:</b>	1 (Minor scratches)	<b>Accessibility:</b>	1 (Occasionally likely to be disturbed)	
<b>Surface Treatment:</b>	1 (Encapsulated asbestos cement)			
<b>Asbestos Type:</b>	1 (Chrysotile)	<b>Extent Score:</b>	1 (<10 sq m or 10m pipe run)

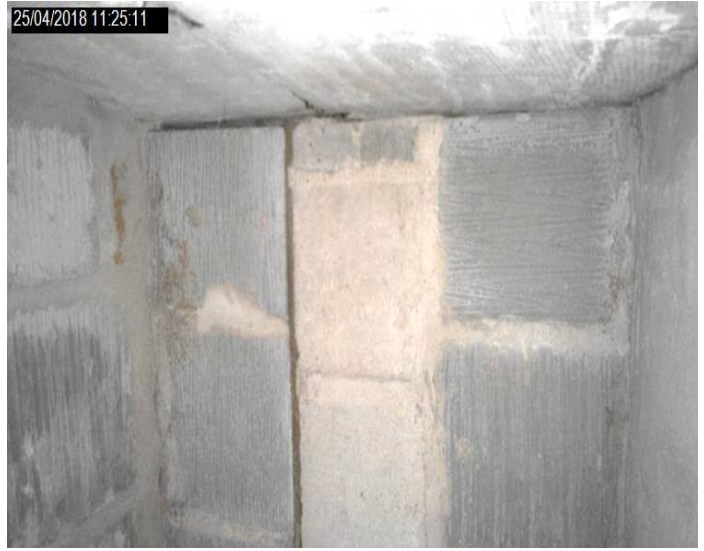
<b>Location:</b>	1.36	<b>Block:</b>	Commercial	<b>Floor Level:</b> Ground Floor
<b>Sample No.:</b>	As DU001330	<b>Portal Ref No.:</b>	264

<b>Item:</b>	Asbestos Cement shuttering			
<b>Asbestos Content:</b>	<b>Result Based on:</b>			
Chrysotile	Strongly presumed			
<b>Sample Analysed By:</b>	Not applicable	<b>Extent:</b>	3 m <sup>2</sup>	
<b>Comments:</b> To the ceiling of wall void to the heating system

<b>Material Assessment Total Score: 4</b>		<b>Likelihood of Disturbance Assessment Total Score: 4</b>		<b>Management Assessment</b>  <b>Licensable:</b> No  <b>Recommendations:</b> Program removal  <b>Reinspection Interval:</b> Not Applicable  <b>Overall Risk Category:</b> C8
<b>Product Type:</b>	1 (Asbestos cement)	<b>Location:</b>	2 (Rooms up to 100 sq m)	
<b>Condition:</b>	1 (Minor scratches)	<b>Accessibility:</b>	1 (Occasionally likely to be disturbed)	
<b>Surface Treatment:</b>	1 (Encapsulated asbestos cement)			
<b>Asbestos Type:</b>	1 (Chrysotile)	<b>Extent Score:</b>	1 (<10 sq m or 10m pipe run)

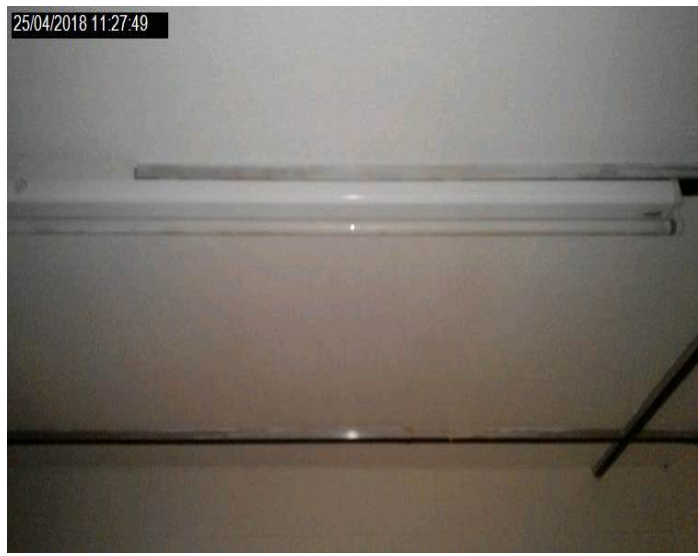
<b>Location:</b>	1.37	<b>Block:</b>	Commercial	<b>Floor Level:</b> Ground Floor
<b>Sample No.:</b>	As DU001337	<b>Portal Ref No.:</b>	265

<b>Item:</b>	Asbestos Textured coating to concrete			
<b>Asbestos Content:</b>	<b>Result Based on:</b>			
Chrysotile	Strongly presumed			
<b>Sample Analysed By:</b>	Not applicable	<b>Extent:</b>	10 m <sup>2</sup>	
<b>Comments:</b>

<b>Material Assessment Total Score: 3</b>		<b>Likelihood of Disturbance Assessment Total Score: 4</b>		<b>Management Assessment</b>  <b>Licensable:</b> No  <b>Recommendations:</b> Program removal  <b>Reinspection Interval:</b> Not Applicable  <b>Overall Risk Category:</b> C7
<b>Product Type:</b>	1 (Asbestos textured coating)	<b>Location:</b>	2 (Rooms up to 100 sq m)	
<b>Condition:</b>	1 (Minor scratches)	<b>Accessibility:</b>	1 (Occasionally likely to be disturbed)	
<b>Surface Treatment:</b>	0 (Composite material)			
<b>Asbestos Type:</b>	1 (Chrysotile)	<b>Extent Score:</b>	1 (<10 sq m or 10m pipe run)

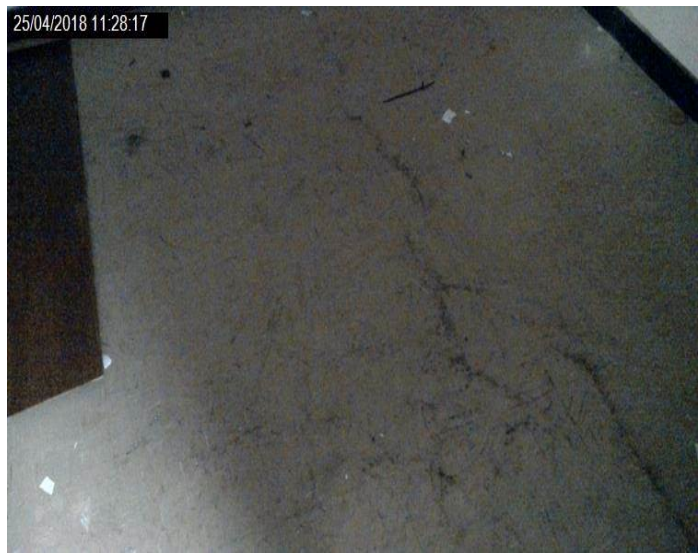
<b>Location:</b>	1.37	<b>Block:</b>	Commercial	<b>Floor Level:</b> Ground Floor
<b>Sample No.:</b>	As DU001338	<b>Portal Ref No.:</b>	266

<b>Item:</b>	Asbestos Thermoplastic floor tiles with bitumen adhesive			
<b>Asbestos Content:</b>	<b>Result Based on:</b>			
Chrysotile in adhesive only	Strongly presumed			
<b>Sample Analysed By:</b>	Not applicable	<b>Extent:</b>	10 m <sup>2</sup>	
<b>Comments:</b>

<b>Material Assessment Total Score: 3</b>		<b>Likelihood of Disturbance Assessment Total Score: 6</b>		<b>Management Assessment</b>  <b>Licensable:</b> No  <b>Recommendations:</b> Program removal  <b>Reinspection Interval:</b> Not Applicable  <b>Overall Risk Category:</b> C9
<b>Product Type:</b>	1 (Asbestos thermoplastic)	<b>Location:</b>	2 (Rooms up to 100 sq m)	
<b>Condition:</b>	1 (Minor scratches)	<b>Accessibility:</b>	3 (Routinely disturbed)	
<b>Surface Treatment:</b>	0 (Composite material)			
<b>Asbestos Type:</b>	1 (Chrysotile)	<b>Extent Score:</b>	1 (<10 sq m or 10m pipe run)

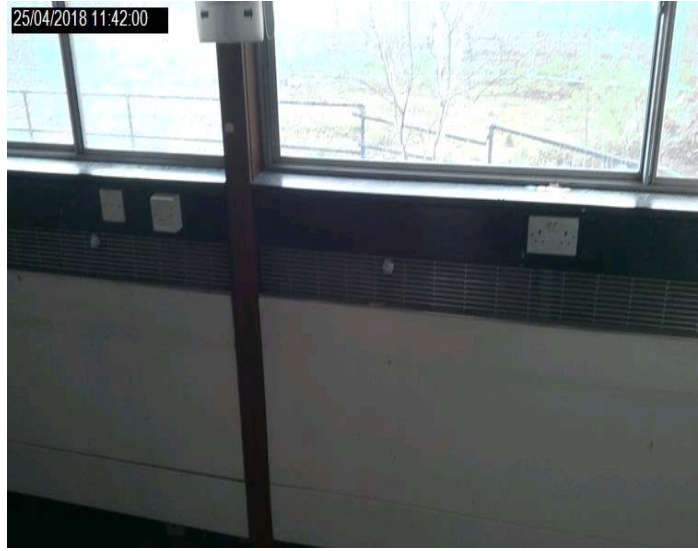
<b>Location:</b>	1.31	<b>Block:</b>	Commercial	<b>Floor Level:</b> Ground Floor
<b>Sample No.:</b>	DU001339	<b>Portal Ref No.:</b>	270

<b>Item:</b>	Asbestos Cement window sill			
<b>Asbestos Content:</b>	Result Based on:			
Chrysotile	Analysis of sample using PLM			
<b>Sample Analysed By:</b> Reg 13(1)	<b>Extent:</b>	4 linear metres		
<b>Comments:</b>

<b>Material Assessment Total Score: 4</b>		<b>Likelihood of Disturbance Assessment Total Score: 4</b>		<b>Management Assessment</b>  <b>Licensable:</b> No  <b>Recommendations:</b> Program removal  <b>Reinspection Interval:</b> Not Applicable  <b>Overall Risk Category:</b> C8
<b>Product Type:</b>	1 (Asbestos cement)	<b>Location:</b>	2 (Rooms up to 100 sq m)	
<b>Condition:</b>	1 (Minor scratches)	<b>Accessibility:</b>	1 (Occasionally likely to be disturbed)	
<b>Surface Treatment:</b>	1 (Encapsulated asbestos cement)			
<b>Asbestos Type:</b>	1 (Chrysotile)	<b>Extent Score:</b>	1 (<10 sq m or 10m pipe run)

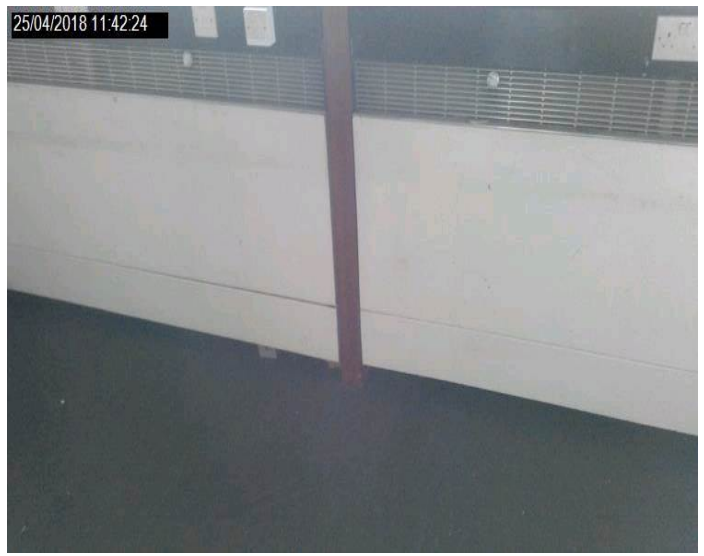
<b>Location:</b>	1.31	<b>Block:</b>	Commercial	<b>Floor Level:</b> Ground Floor
<b>Sample No.:</b>	DU001340	<b>Portal Ref No.:</b>	271

<b>Item:</b>	Asbestos Cement shuttering			
<b>Asbestos Content:</b>	Result Based on:			
Chrysotile	Analysis of sample using PLM			
<b>Sample Analysed By:</b> Reg 13(1)	<b>Extent:</b>	4 m <sup>2</sup>		
<b>Comments:</b> To the ceiling of wall void to the heating system

<b>Material Assessment Total Score: 4</b>		<b>Likelihood of Disturbance Assessment Total Score: 3</b>		<b>Management Assessment</b>  <b>Licensable:</b> No  <b>Recommendations:</b> Program removal  <b>Reinspection Interval:</b> Not Applicable  <b>Overall Risk Category:</b> C7
<b>Product Type:</b>	1 (Asbestos cement)	<b>Location:</b>	2 (Rooms up to 100 sq m)	
<b>Condition:</b>	1 (Minor scratches)	<b>Accessibility:</b>	0 (Usually inaccessible or unlikely to be disturbed)	
<b>Surface Treatment:</b>	1 (Unencapsulated asbestos cement)			
<b>Asbestos Type:</b>	1 (Chrysotile)	<b>Extent Score:</b>	1 (<10 sq m or 10m pipe run)

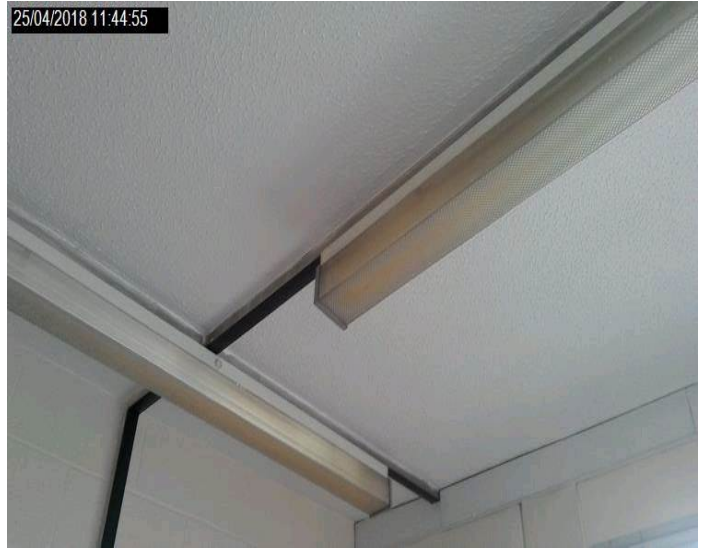
<b>Location:</b>	1.30	<b>Block:</b>	Commercial	<b>Floor Level:</b> Ground Floor
<b>Sample No.:</b>	As DU001337	<b>Portal Ref No.:</b>	272

<b>Item:</b>	Asbestos Textured coating to concrete			
<b>Asbestos Content:</b>	<b>Result Based on:</b>			
Chrysotile	Strongly presumed			
<b>Sample Analysed By:</b>	Not applicable	<b>Extent:</b>	8 m <sup>2</sup>	
<b>Comments:</b>

<b>Material Assessment Total Score: 3</b>		<b>Likelihood of Disturbance Assessment Total Score: 4</b>		<b>Management Assessment</b>  <b>Licensable:</b> No  <b>Recommendations:</b> Program removal  <b>Reinspection Interval:</b> Not Applicable  <b>Overall Risk Category:</b> C7
<b>Product Type:</b>	1 (Asbestos textured coating)	<b>Location:</b>	2 (Rooms up to 100 sq m)	
<b>Condition:</b>	1 (Minor scratches)	<b>Accessibility:</b>	1 (Occasionally likely to be disturbed)	
<b>Surface Treatment:</b>	0 (Composite material)			
<b>Asbestos Type:</b>	1 (Chrysotile)	<b>Extent Score:</b>	1 (<10 sq m or 10m pipe run)

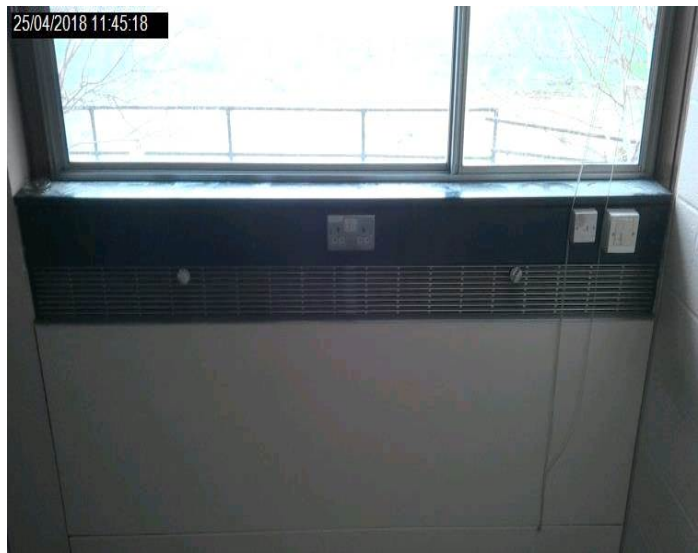
<b>Location:</b>	1.30	<b>Block:</b>	Commercial	<b>Floor Level:</b> Ground Floor
<b>Sample No.:</b>	As DU001339	<b>Portal Ref No.:</b>	273

<b>Item:</b>	Asbestos Cement window sill			
<b>Asbestos Content:</b>	<b>Result Based on:</b>			
Chrysotile	Strongly presumed			
<b>Sample Analysed By:</b>	Not applicable	<b>Extent:</b>	2 linear metres	
<b>Comments:</b>

<b>Material Assessment Total Score: 4</b>		<b>Likelihood of Disturbance Assessment Total Score: 4</b>		<b>Management Assessment</b>  <b>Licensable:</b> No  <b>Recommendations:</b> Program removal  <b>Reinspection Interval:</b> Not Applicable  <b>Overall Risk Category:</b> C8
<b>Product Type:</b>	1 (Asbestos cement)	<b>Location:</b>	2 (Rooms up to 100 sq m)	
<b>Condition:</b>	1 (Minor scratches)	<b>Accessibility:</b>	1 (Occasionally likely to be disturbed)	
<b>Surface Treatment:</b>	1 (Encapsulated asbestos cement)			
<b>Asbestos Type:</b>	1 (Chrysotile)	<b>Extent Score:</b>	1 (<10 sq m or 10m pipe run)

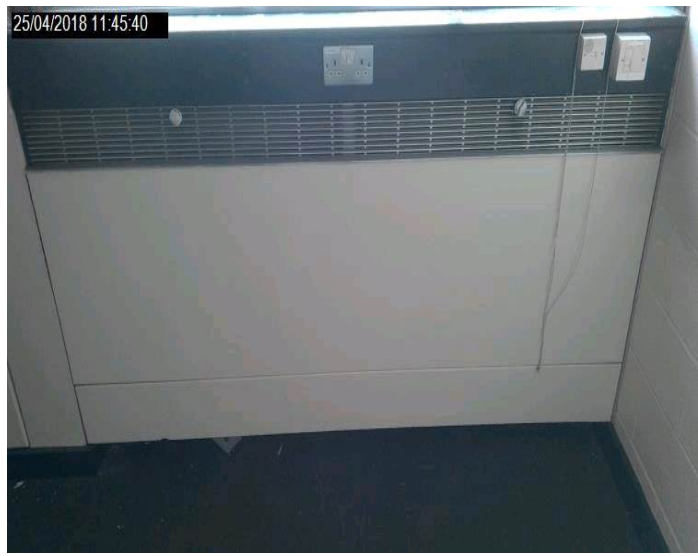
<b>Location:</b>	1.30	<b>Block:</b>	Commercial	<b>Floor Level:</b> Ground Floor
<b>Sample No.:</b>	As DU001340	<b>Portal Ref No.:</b>	274

<b>Item:</b>	Asbestos Cement shuttering			
<b>Asbestos Content:</b>	<b>Result Based on:</b>			
Chrysotile	Strongly presumed			
<b>Sample Analysed By:</b>	Not applicable	<b>Extent:</b>	3 m <sup>2</sup>	
<b>Comments:</b> To the ceiling of wall void to the heating system

<b>Material Assessment Total Score: 4</b>		<b>Likelihood of Disturbance Assessment Total Score: 3</b>		<b>Management Assessment</b>  <b>Licensable:</b> No  <b>Recommendations:</b> Program removal  <b>Reinspection Interval:</b> Not Applicable  <b>Overall Risk Category:</b> C7
<b>Product Type:</b>	1 (Asbestos cement)	<b>Location:</b>	2 (Rooms up to 100 sq m)	
<b>Condition:</b>	1 (Minor scratches)	<b>Accessibility:</b>	0 (Usually inaccessible or unlikely to be disturbed)	
<b>Surface Treatment:</b>	1 (Unencapsulated asbestos cement)			
<b>Asbestos Type:</b>	1 (Chrysotile)	<b>Extent Score:</b>	1 (<10 sq m or 10m pipe run)

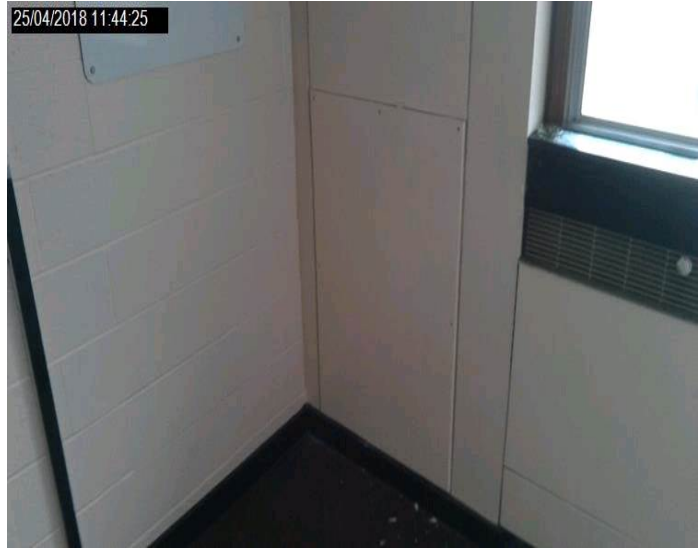
<b>Location:</b>	1.30	<b>Block:</b>	Commercial	<b>Floor Level:</b> Ground Floor
<b>Sample No.:</b>	DU001341	<b>Portal Ref No.:</b>	275

<b>Item:</b>	Insulating board to riser			
<b>Asbestos Content:</b>		<b>Result Based on:</b>		
No Asbestos Detected		Analysis of sample using PLM		
<b>Sample Analysed By:</b>	Reg 13(1)	<b>Extent:</b>	3 m <sup>2</sup>	
<b>Comments:</b> 1 x riser

<b>Material Assessment Total Score: 0</b>		<b>Likelihood of Disturbance Assessment Total Score: 0</b>		<b>Management Assessment</b>  <b>Licensable:</b> Yes  <b>Recommendations:</b> Not Applicable  <b>Reinspection Interval:</b> Not Applicable  <b>Overall Risk Category:</b> E0
<b>Product Type:</b>	0 Not Applicable	<b>Location:</b>	0 Not Applicable	
<b>Condition:</b>	0 Not Applicable	<b>Accessibility:</b>	0 Not Applicable	
<b>Surface Treatment:</b>	0 Not Applicable			
<b>Asbestos Type:</b>	0 Not Applicable	<b>Extent Score:</b>	0 Not Applicable

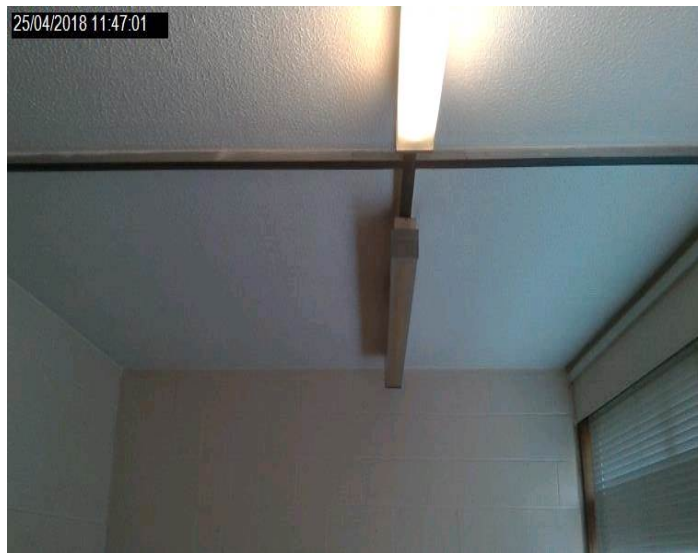
<b>Location:</b>	1.29	<b>Block:</b>	Commercial	<b>Floor Level:</b> Ground Floor
<b>Sample No.:</b>	As DU001337	<b>Portal Ref No.:</b>	276

<b>Item:</b>	Asbestos Textured coating to concrete			
<b>Asbestos Content:</b>	<b>Result Based on:</b>			
Chrysotile	Strongly presumed			
<b>Sample Analysed By:</b>	Not applicable	<b>Extent:</b>	14 m <sup>2</sup>	
<b>Comments:</b>

<b>Material Assessment Total Score: 3</b>		<b>Likelihood of Disturbance Assessment Total Score: 5</b>		<b>Management Assessment</b>  <b>Licensable:</b> No  <b>Recommendations:</b> Program removal  <b>Reinspection Interval:</b> Not Applicable  <b>Overall Risk Category:</b> C8
<b>Product Type:</b>	1 (Asbestos textured coating)	<b>Location:</b>	2 (Rooms up to 100 sq m)	
<b>Condition:</b>	1 (Minor scratches)	<b>Accessibility:</b>	1 (Occasionally likely to be disturbed)	
<b>Surface Treatment:</b>	0 (Composite material)			
<b>Asbestos Type:</b>	1 (Chrysotile)	<b>Extent Score:</b>	2 (>10 - <50 sq m or >10m - <50m pipe run)

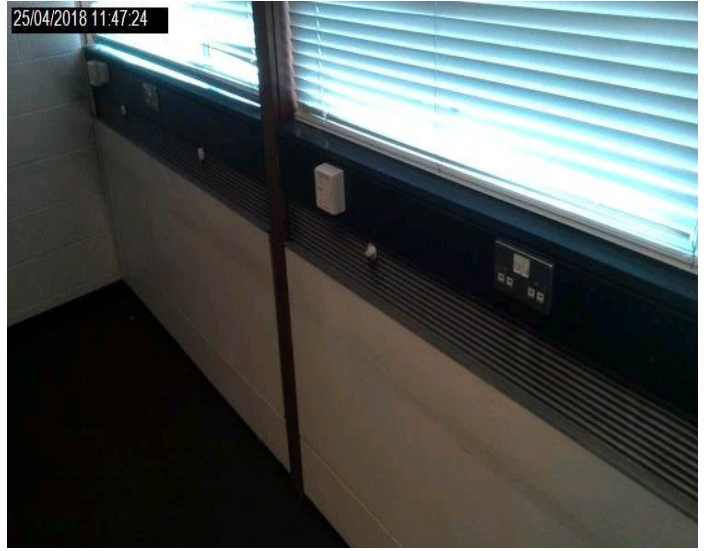
<b>Location:</b>	1.29	<b>Block:</b>	Commercial	<b>Floor Level:</b> Ground Floor
<b>Sample No.:</b>	As DU001339	<b>Portal Ref No.:</b>	277

<b>Item:</b>	Asbestos Cement window sill			
<b>Asbestos Content:</b>	<b>Result Based on:</b>			
Chrysotile	Strongly presumed			
<b>Sample Analysed By:</b>	Not applicable	<b>Extent:</b>	4 linear metres	
<b>Comments:</b>

<b>Material Assessment Total Score: 4</b>		<b>Likelihood of Disturbance Assessment Total Score: 4</b>		<b>Management Assessment</b>  <b>Licensable:</b> No  <b>Recommendations:</b> Program removal  <b>Reinspection Interval:</b> Not Applicable  <b>Overall Risk Category:</b> C8
<b>Product Type:</b>	1 (Asbestos cement)	<b>Location:</b>	2 (Rooms up to 100 sq m)	
<b>Condition:</b>	1 (Minor scratches)	<b>Accessibility:</b>	1 (Occasionally likely to be disturbed)	
<b>Surface Treatment:</b>	1 (Encapsulated asbestos cement)			
<b>Asbestos Type:</b>	1 (Chrysotile)	<b>Extent Score:</b>	1 (<10 sq m or 10m pipe run)

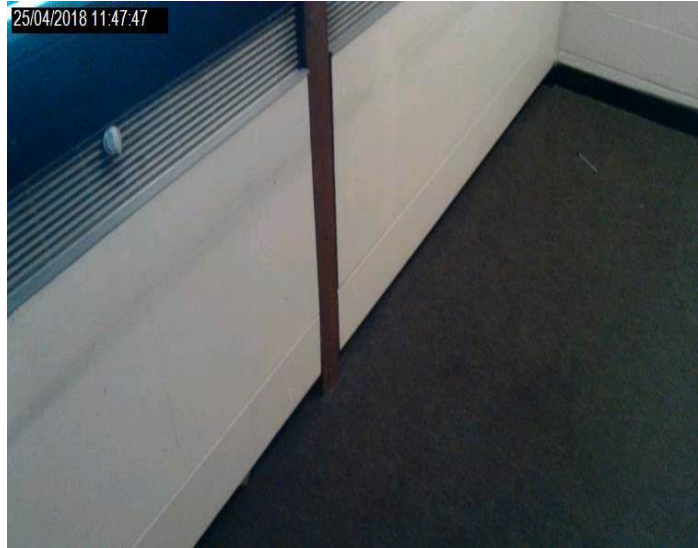
<b>Location:</b>	1.29	<b>Block:</b>	Commercial	<b>Floor Level:</b> Ground Floor
<b>Sample No.:</b>	As DU001340	<b>Portal Ref No.:</b>	278

<b>Item:</b>	Asbestos Cement shuttering			
<b>Asbestos Content:</b>	<b>Result Based on:</b>			
Chrysotile	Strongly presumed			
<b>Sample Analysed By:</b>	Not applicable	<b>Extent:</b>	4 m <sup>2</sup>	
<b>Comments:</b> To the ceiling of wall void to the heating system

<b>Material Assessment Total Score: 4</b>		<b>Likelihood of Disturbance Assessment Total Score: 3</b>		<b>Management Assessment</b>  <b>Licensable:</b> No  <b>Recommendations:</b> Program removal  <b>Reinspection Interval:</b> Not Applicable  <b>Overall Risk Category:</b> C7
<b>Product Type:</b>	1 (Asbestos cement)	<b>Location:</b>	2 (Rooms up to 100 sq m)	
<b>Condition:</b>	1 (Minor scratches)	<b>Accessibility:</b>	0 (Usually inaccessible or unlikely to be disturbed)	
<b>Surface Treatment:</b>	1 (Unencapsulated asbestos cement)			
<b>Asbestos Type:</b>	1 (Chrysotile)	<b>Extent Score:</b>	1 (<10 sq m or 10m pipe run)

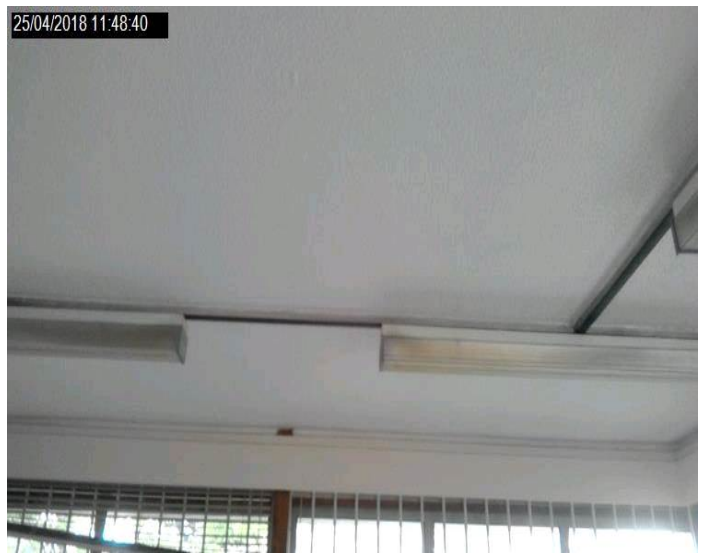
<b>Location:</b>	1.28	<b>Block:</b>	Commercial	<b>Floor Level:</b> Ground Floor
<b>Sample No.:</b>	As DU001337	<b>Portal Ref No.:</b>	279

<b>Item:</b>	Asbestos Textured coating to concrete			
<b>Asbestos Content:</b>	<b>Result Based on:</b>			
Chrysotile	Strongly presumed			
<b>Sample Analysed By:</b>	Not applicable	<b>Extent:</b>	16 m <sup>2</sup>	
<b>Comments:</b>

<b>Material Assessment Total Score: 3</b>		<b>Likelihood of Disturbance Assessment Total Score: 5</b>		<b>Management Assessment</b>  <b>Licensable:</b> No  <b>Recommendations:</b> Program removal  <b>Reinspection Interval:</b> Not Applicable  <b>Overall Risk Category:</b> C8
<b>Product Type:</b>	1 (Asbestos textured coating)	<b>Location:</b>	2 (Rooms up to 100 sq m)	
<b>Condition:</b>	1 (Minor scratches)	<b>Accessibility:</b>	1 (Occasionally likely to be disturbed)	
<b>Surface Treatment:</b>	0 (Composite material)			
<b>Asbestos Type:</b>	1 (Chrysotile)	<b>Extent Score:</b>	2 (>10 - <50 sq m or >10m - <50m pipe run)
