**Report No.:** J094042  
**Nature of Work:** Demolition Survey  
**Issue Date:** 29/05/2018  
**Client Name:** WYG Engineering Ltd  
Geneva Building, Lake View Drive, Sherwood Business Park,  
Annesley, Nottingham, NG15 0ED  
**Site Address:** Cox Building, Former City North Campus, Birmingham City  
University, Perry Barr, B42 2US

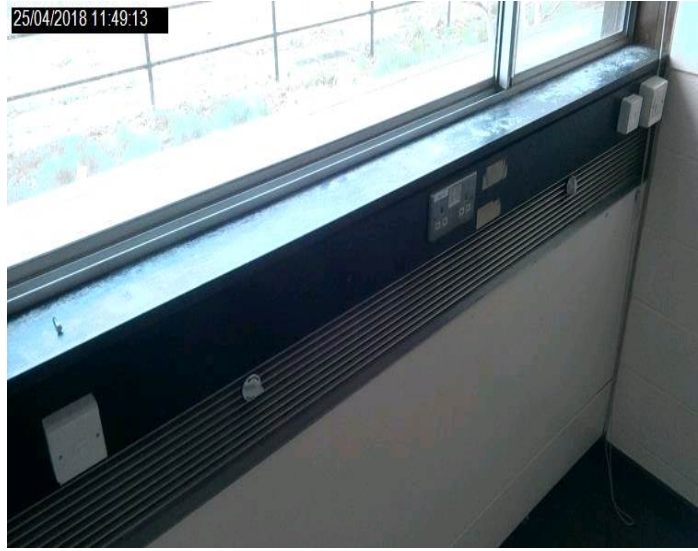
<b>Location:</b>	1.28	<b>Block:</b>	Commercial	<b>Floor Level:</b> Ground Floor
<b>Sample No.:</b>	As DU001339	<b>Portal Ref No.:</b>	280

<b>Item:</b>	Asbestos Cement window sill			
<b>Asbestos Content:</b>	<b>Result Based on:</b>			
Chrysotile	Strongly presumed			
<b>Sample Analysed By:</b>	Not applicable	<b>Extent:</b>	8 linear metres	
<b>Comments:</b>

<b>Material Assessment Total Score: 4</b>		<b>Likelihood of Disturbance Assessment Total Score: 4</b>		<b>Management Assessment</b>  <b>Licensable:</b> No  <b>Recommendations:</b> Program removal  <b>Reinspection Interval:</b> Not Applicable  <b>Overall Risk Category:</b> C8
<b>Product Type:</b>	1 (Asbestos cement)	<b>Location:</b>	2 (Rooms up to 100 sq m)	
<b>Condition:</b>	1 (Minor scratches)	<b>Accessibility:</b>	1 (Occasionally likely to be disturbed)	
<b>Surface Treatment:</b>	1 (Encapsulated asbestos cement)			
<b>Asbestos Type:</b>	1 (Chrysotile)	<b>Extent Score:</b>	1 (<10 sq m or 10m pipe run)

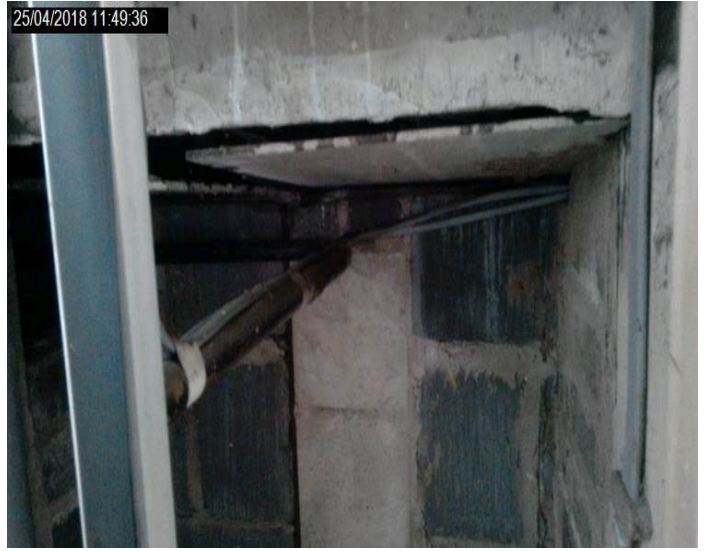
<b>Location:</b>	1.28	<b>Block:</b>	Commercial	<b>Floor Level:</b> Ground Floor
<b>Sample No.:</b>	As DU001340	<b>Portal Ref No.:</b>	281

<b>Item:</b>	Asbestos Cement shuttering			
<b>Asbestos Content:</b>	<b>Result Based on:</b>			
Chrysotile	Strongly presumed			
<b>Sample Analysed By:</b>	Not applicable	<b>Extent:</b>	8 m <sup>2</sup>	
<b>Comments:</b> To the ceiling of wall void to the heating system

<b>Material Assessment Total Score: 4</b>		<b>Likelihood of Disturbance Assessment Total Score: 3</b>		<b>Management Assessment</b>  <b>Licensable:</b> No  <b>Recommendations:</b> Program removal  <b>Reinspection Interval:</b> Not Applicable  <b>Overall Risk Category:</b> C7
<b>Product Type:</b>	1 (Asbestos cement)	<b>Location:</b>	2 (Rooms up to 100 sq m)	
<b>Condition:</b>	1 (Minor scratches)	<b>Accessibility:</b>	0 (Usually inaccessible or unlikely to be disturbed)	
<b>Surface Treatment:</b>	1 (Unencapsulated asbestos cement)			
<b>Asbestos Type:</b>	1 (Chrysotile)	<b>Extent Score:</b>	1 (<10 sq m or 10m pipe run)

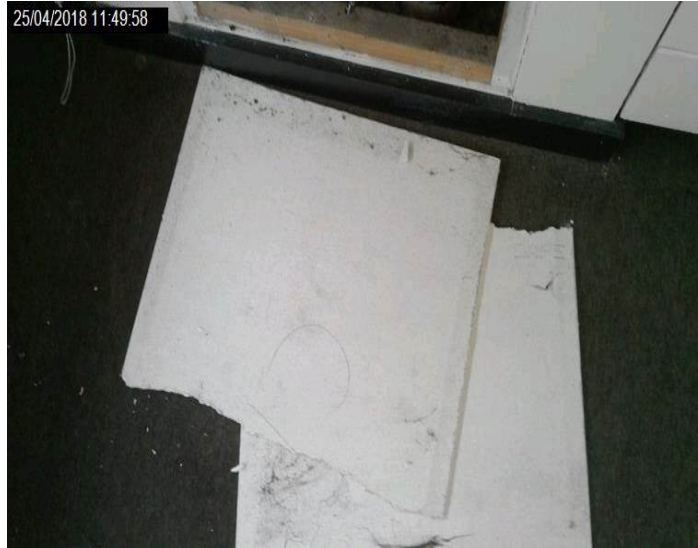
<b>Location:</b>	1.28	<b>Block:</b>	Commercial	<b>Floor Level:</b> Ground Floor
<b>Sample No.:</b>	As DU001341	<b>Portal Ref No.:</b>	282

<b>Item:</b>	Insulating board to riser			
<b>Asbestos Content:</b>		<b>Result Based on:</b>		
No Asbestos Detected		Strongly presumed		
<b>Sample Analysed By:</b>	Not applicable	<b>Extent:</b>	3 m <sup>2</sup>	
<b>Comments:</b> 1 x riser

<b>Material Assessment Total Score: 0</b>		<b>Likelihood of Disturbance Assessment Total Score: 0</b>		<b>Management Assessment</b>  <b>Licensable:</b> Yes  <b>Recommendations:</b> Not Applicable  <b>Reinspection Interval:</b> Not Applicable  <b>Overall Risk Category:</b> E0
<b>Product Type:</b>	0 Not Applicable	<b>Location:</b>	0 Not Applicable	
<b>Condition:</b>	0 Not Applicable	<b>Accessibility:</b>	0 Not Applicable	
<b>Surface Treatment:</b>	0 Not Applicable			
<b>Asbestos Type:</b>	0 Not Applicable	<b>Extent Score:</b>	0 Not Applicable

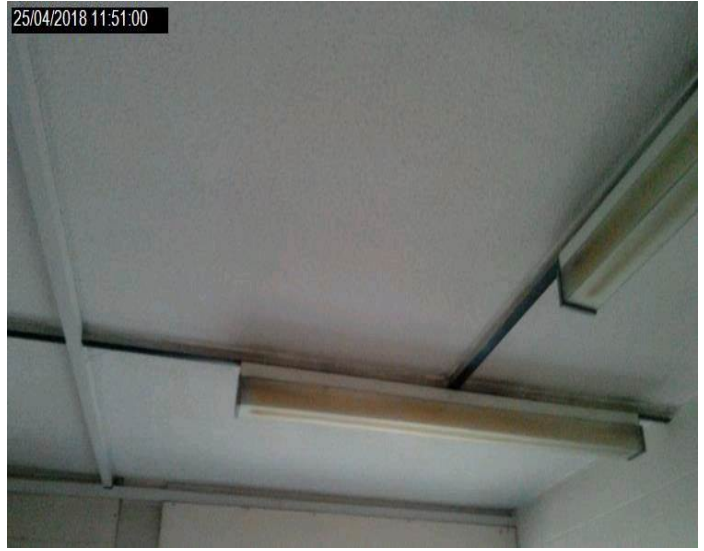
<b>Location:</b>	1.27	<b>Block:</b>	Commercial	<b>Floor Level:</b> Ground Floor
<b>Sample No.:</b>	As DU001337	<b>Portal Ref No.:</b>	283

<b>Item:</b>	Asbestos Textured coating to concrete			
<b>Asbestos Content:</b>	<b>Result Based on:</b>			
Chrysotile	Strongly presumed			
<b>Sample Analysed By:</b>	Not applicable	<b>Extent:</b>	12 m <sup>2</sup>	
<b>Comments:</b>

<b>Material Assessment Total Score: 3</b>		<b>Likelihood of Disturbance Assessment Total Score: 5</b>		<b>Management Assessment</b>  <b>Licensable:</b> No  <b>Recommendations:</b> Program removal  <b>Reinspection Interval:</b> Not Applicable  <b>Overall Risk Category:</b> C8
<b>Product Type:</b>	1 (Asbestos textured coating)	<b>Location:</b>	2 (Rooms up to 100 sq m)	
<b>Condition:</b>	1 (Minor scratches)	<b>Accessibility:</b>	1 (Occasionally likely to be disturbed)	
<b>Surface Treatment:</b>	0 (Composite material)			
<b>Asbestos Type:</b>	1 (Chrysotile)	<b>Extent Score:</b>	2 (>10 - <50 sq m or >10m - <50m pipe run)

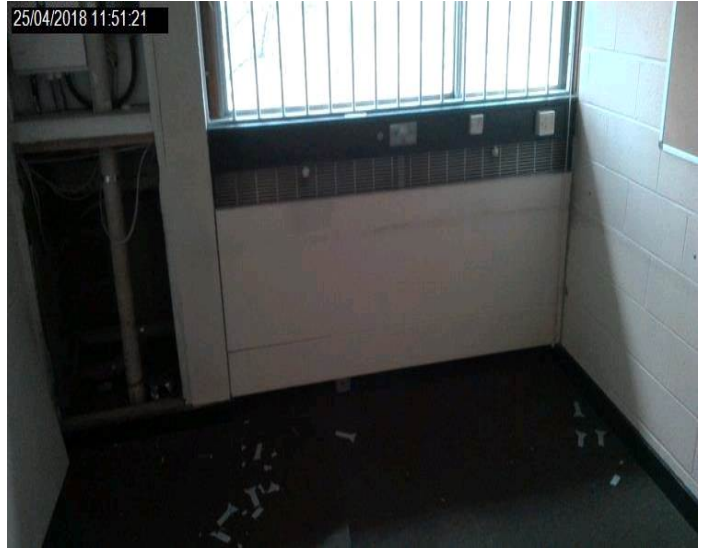
<b>Location:</b>	1.27	<b>Block:</b>	Commercial	<b>Floor Level:</b> Ground Floor
<b>Sample No.:</b>	As DU001339	<b>Portal Ref No.:</b>	284

<b>Item:</b>	Asbestos Cement window sill			
<b>Asbestos Content:</b>	<b>Result Based on:</b>			
Chrysotile	Strongly presumed			
<b>Sample Analysed By:</b>	Not applicable	<b>Extent:</b>	3 linear metres	
<b>Comments:</b>

<b>Material Assessment Total Score: 4</b>		<b>Likelihood of Disturbance Assessment Total Score: 4</b>		<b>Management Assessment</b>  <b>Licensable:</b> No  <b>Recommendations:</b> Program removal  <b>Reinspection Interval:</b> Not Applicable  <b>Overall Risk Category:</b> C8
<b>Product Type:</b>	1 (Asbestos cement)	<b>Location:</b>	2 (Rooms up to 100 sq m)	
<b>Condition:</b>	1 (Minor scratches)	<b>Accessibility:</b>	1 (Occasionally likely to be disturbed)	
<b>Surface Treatment:</b>	1 (Encapsulated asbestos cement)			
<b>Asbestos Type:</b>	1 (Chrysotile)	<b>Extent Score:</b>	1 (<10 sq m or 10m pipe run)

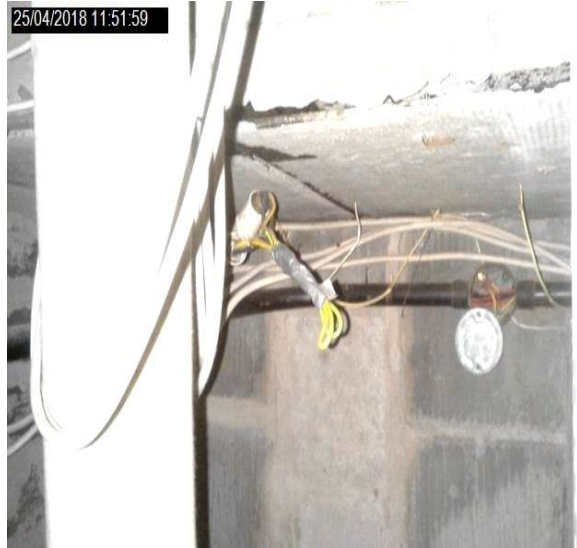
<b>Location:</b>	1.27	<b>Block:</b>	Commercial	<b>Floor Level:</b> Ground Floor
<b>Sample No.:</b>	As DU001340	<b>Portal Ref No.:</b>	285

<b>Item:</b>	Asbestos Cement shuttering			
<b>Asbestos Content:</b>	<b>Result Based on:</b>			
Chrysotile	Strongly presumed			
<b>Sample Analysed By:</b>	Not applicable	<b>Extent:</b>	4 m <sup>2</sup>	
<b>Comments:</b> To the ceiling of wall void to the heating system

<b>Material Assessment Total Score: 4</b>		<b>Likelihood of Disturbance Assessment Total Score: 3</b>		<b>Management Assessment</b>  <b>Licensable:</b> No  <b>Recommendations:</b> Program removal  <b>Reinspection Interval:</b> Not Applicable  <b>Overall Risk Category:</b> C7
<b>Product Type:</b>	1 (Asbestos cement)	<b>Location:</b>	2 (Rooms up to 100 sq m)	
<b>Condition:</b>	1 (Minor scratches)	<b>Accessibility:</b>	0 (Usually inaccessible or unlikely to be disturbed)	
<b>Surface Treatment:</b>	1 (Unencapsulated asbestos cement)			
<b>Asbestos Type:</b>	1 (Chrysotile)	<b>Extent Score:</b>	1 (<10 sq m or 10m pipe run)

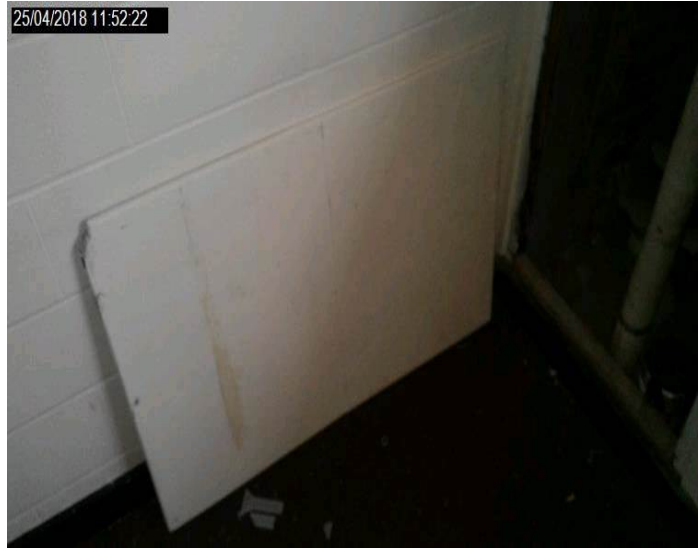
<b>Location:</b>	1.27	<b>Block:</b>	Commercial	<b>Floor Level:</b> Ground Floor
<b>Sample No.:</b>	As DU001341	<b>Portal Ref No.:</b>	286

<b>Item:</b>	Insulating board to riser			
<b>Asbestos Content:</b>		<b>Result Based on:</b>		
No Asbestos Detected		Strongly presumed		
<b>Sample Analysed By:</b>	Not applicable	<b>Extent:</b>	3 m <sup>2</sup>	
<b>Comments:</b> 1 x riser

<b>Material Assessment Total Score:</b> 0		<b>Likelihood of Disturbance Assessment Total Score:</b> 0		<b>Management Assessment</b>  <b>Licensable:</b> Yes  <b>Recommendations:</b> Not Applicable  <b>Reinspection Interval:</b> Not Applicable  <b>Overall Risk Category:</b> E0
<b>Product Type:</b>	0 Not Applicable	<b>Location:</b>	0 Not Applicable	
<b>Condition:</b>	0 Not Applicable	<b>Accessibility:</b>	0 Not Applicable	
<b>Surface Treatment:</b>	0 Not Applicable			
<b>Asbestos Type:</b>	0 Not Applicable	<b>Extent Score:</b>	0 Not Applicable

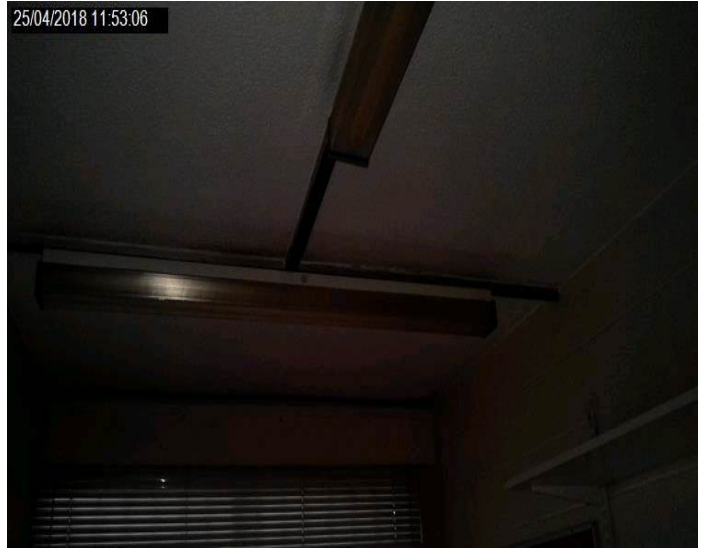
<b>Location:</b>	1.26	<b>Block:</b>	Commercial	<b>Floor Level:</b> Ground Floor
<b>Sample No.:</b>	As DU001337	<b>Portal Ref No.:</b>	287

<b>Item:</b>	Asbestos Textured coating to concrete			
<b>Asbestos Content:</b>	<b>Result Based on:</b>			
Chrysotile	Strongly presumed			
<b>Sample Analysed By:</b>	Not applicable	<b>Extent:</b>	8 m <sup>2</sup>	
<b>Comments:</b>

<b>Material Assessment Total Score: 3</b>		<b>Likelihood of Disturbance Assessment Total Score: 4</b>		<b>Management Assessment</b>  <b>Licensable:</b> No  <b>Recommendations:</b> Program removal  <b>Reinspection Interval:</b> Not Applicable  <b>Overall Risk Category:</b> C7
<b>Product Type:</b>	1 (Asbestos textured coating)	<b>Location:</b>	2 (Rooms up to 100 sq m)	
<b>Condition:</b>	1 (Minor scratches)	<b>Accessibility:</b>	1 (Occasionally likely to be disturbed)	
<b>Surface Treatment:</b>	0 (Composite material)			
<b>Asbestos Type:</b>	1 (Chrysotile)	<b>Extent Score:</b>	1 (<10 sq m or 10m pipe run)

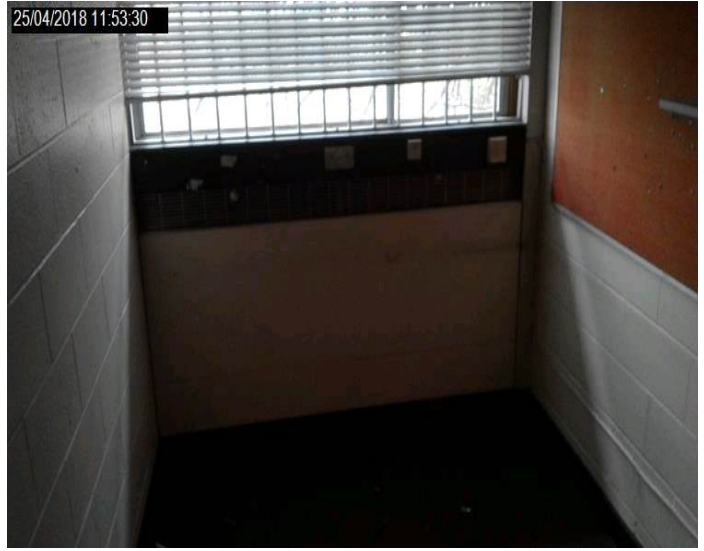
<b>Location:</b>	1.26	<b>Block:</b>	Commercial	<b>Floor Level:</b> Ground Floor
<b>Sample No.:</b>	As DU001339	<b>Portal Ref No.:</b>	288

<b>Item:</b>	Asbestos Cement window sill			
<b>Asbestos Content:</b>	<b>Result Based on:</b>			
Chrysotile	Strongly presumed			
<b>Sample Analysed By:</b>	Not applicable	<b>Extent:</b>	2 linear metres	
<b>Comments:</b>

<b>Material Assessment Total Score: 4</b>		<b>Likelihood of Disturbance Assessment Total Score: 4</b>		<b>Management Assessment</b>  <b>Licensable:</b> No  <b>Recommendations:</b> Program removal  <b>Reinspection Interval:</b> Not Applicable  <b>Overall Risk Category:</b> C8
<b>Product Type:</b>	1 (Asbestos cement)	<b>Location:</b>	2 (Rooms up to 100 sq m)	
<b>Condition:</b>	1 (Minor scratches)	<b>Accessibility:</b>	1 (Occasionally likely to be disturbed)	
<b>Surface Treatment:</b>	1 (Encapsulated asbestos cement)			
<b>Asbestos Type:</b>	1 (Chrysotile)	<b>Extent Score:</b>	1 (<10 sq m or 10m pipe run)

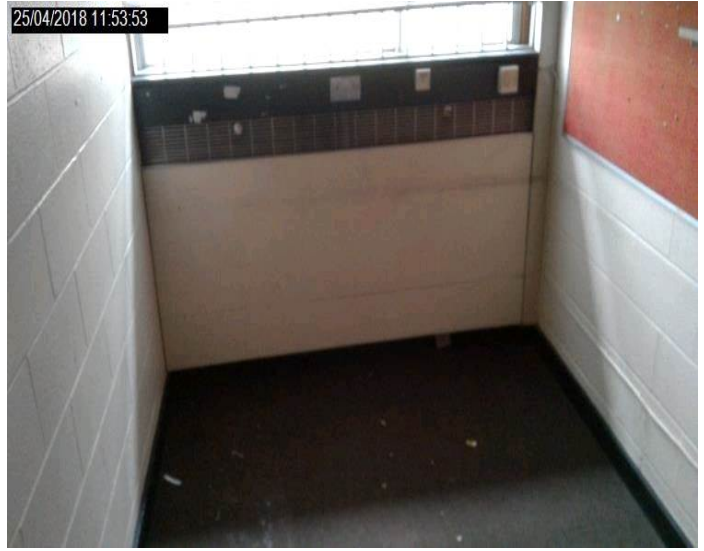
<b>Location:</b>	1.26	<b>Block:</b>	Commercial	<b>Floor Level:</b> Ground Floor
<b>Sample No.:</b>	As DU001340	<b>Portal Ref No.:</b>	289

<b>Item:</b>	Asbestos Cement shuttering			
<b>Asbestos Content:</b>	<b>Result Based on:</b>			
Chrysotile	Strongly presumed			
<b>Sample Analysed By:</b>	Not applicable	<b>Extent:</b>	2 m <sup>2</sup>	
<b>Comments:</b> To the ceiling of wall void to the heating system

<b>Material Assessment Total Score: 4</b>		<b>Likelihood of Disturbance Assessment Total Score: 3</b>		<b>Management Assessment</b>  <b>Licensable:</b> No  <b>Recommendations:</b> Program removal  <b>Reinspection Interval:</b> Not Applicable  <b>Overall Risk Category:</b> C7
<b>Product Type:</b>	1 (Asbestos cement)	<b>Location:</b>	2 (Rooms up to 100 sq m)	
<b>Condition:</b>	1 (Minor scratches)	<b>Accessibility:</b>	0 (Usually inaccessible or unlikely to be disturbed)	
<b>Surface Treatment:</b>	1 (Unencapsulated asbestos cement)			
<b>Asbestos Type:</b>	1 (Chrysotile)	<b>Extent Score:</b>	1 (<10 sq m or 10m pipe run)

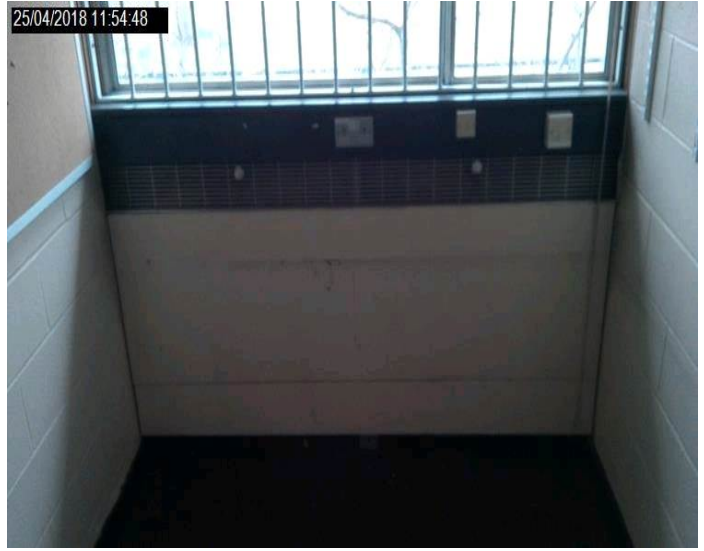
<b>Location:</b>	1.25	<b>Block:</b>	Commercial	<b>Floor Level:</b> Ground Floor
<b>Sample No.:</b>	As DU001339	<b>Portal Ref No.:</b>	291

<b>Item:</b>	Asbestos Cement window sill			
<b>Asbestos Content:</b>	<b>Result Based on:</b>			
Chrysotile	Strongly presumed			
<b>Sample Analysed By:</b>	Not applicable	<b>Extent:</b>	2 linear metres	
<b>Comments:</b>

<b>Material Assessment Total Score: 4</b>		<b>Likelihood of Disturbance Assessment Total Score: 4</b>		<b>Management Assessment</b>  <b>Licensable:</b> No  <b>Recommendations:</b> Program removal  <b>Reinspection Interval:</b> Not Applicable  <b>Overall Risk Category:</b> C8
<b>Product Type:</b>	1 (Asbestos cement)	<b>Location:</b>	2 (Rooms up to 100 sq m)	
<b>Condition:</b>	1 (Minor scratches)	<b>Accessibility:</b>	1 (Occasionally likely to be disturbed)	
<b>Surface Treatment:</b>	1 (Encapsulated asbestos cement)			
<b>Asbestos Type:</b>	1 (Chrysotile)	<b>Extent Score:</b>	1 (<10 sq m or 10m pipe run)

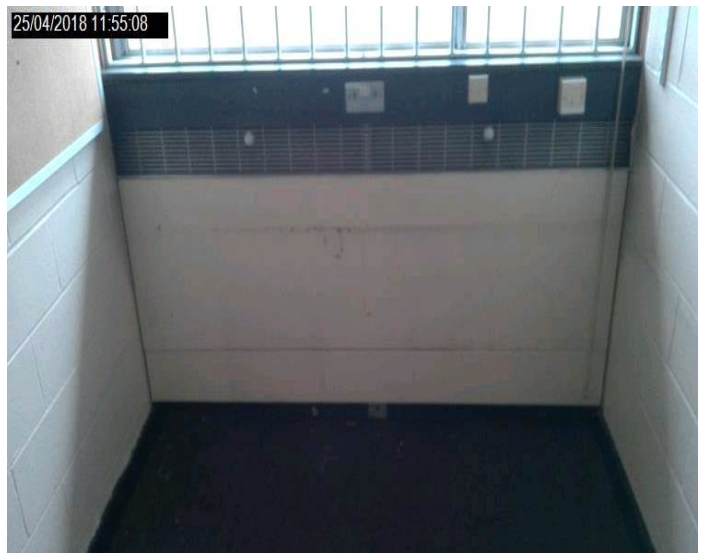
<b>Location:</b>	1.25	<b>Block:</b>	Commercial	<b>Floor Level:</b> Ground Floor
<b>Sample No.:</b>	As DU001340	<b>Portal Ref No.:</b>	292

<b>Item:</b>	Asbestos Cement shuttering			
<b>Asbestos Content:</b>	<b>Result Based on:</b>			
Chrysotile	Strongly presumed			
<b>Sample Analysed By:</b>	Not applicable	<b>Extent:</b>	2 m <sup>2</sup>	
<b>Comments:</b> To the ceiling of wall void to the heating system

<b>Material Assessment Total Score: 4</b>		<b>Likelihood of Disturbance Assessment Total Score: 3</b>		<b>Management Assessment</b>  <b>Licensable:</b> No  <b>Recommendations:</b> Program removal  <b>Reinspection Interval:</b> Not Applicable  <b>Overall Risk Category:</b> C7
<b>Product Type:</b>	1 (Asbestos cement)	<b>Location:</b>	2 (Rooms up to 100 sq m)	
<b>Condition:</b>	1 (Minor scratches)	<b>Accessibility:</b>	0 (Usually inaccessible or unlikely to be disturbed)	
<b>Surface Treatment:</b>	1 (Unencapsulated asbestos cement)			
<b>Asbestos Type:</b>	1 (Chrysotile)	<b>Extent Score:</b>	1 (<10 sq m or 10m pipe run)

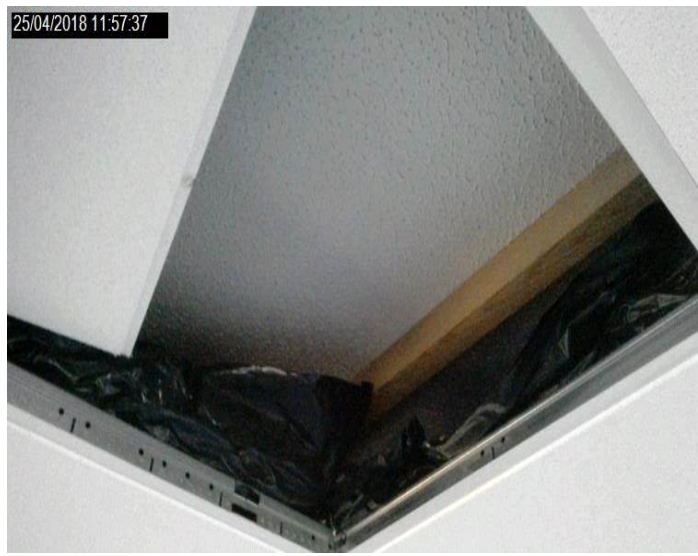
<b>Location:</b>	1.24	<b>Block:</b>	Commercial	<b>Floor Level:</b> Ground Floor
<b>Sample No.:</b>	As DU001337	<b>Portal Ref No.:</b>	293

<b>Item:</b>	Asbestos Textured coating to concrete			
<b>Asbestos Content:</b>	<b>Result Based on:</b>			
Chrysotile	Strongly presumed			
<b>Sample Analysed By:</b>	Not applicable	<b>Extent:</b>	50 m <sup>2</sup>	
<b>Comments:</b> Above suspended tiles

<b>Material Assessment Total Score: 3</b>		<b>Likelihood of Disturbance Assessment Total Score: 6</b>		<b>Management Assessment</b>  <b>Licensable:</b> No  <b>Recommendations:</b> Program removal  <b>Reinspection Interval:</b> Not Applicable  <b>Overall Risk Category:</b> C9
<b>Product Type:</b>	1 (Asbestos textured coating)	<b>Location:</b>	2 (Rooms up to 100 sq m)	
<b>Condition:</b>	1 (Minor scratches)	<b>Accessibility:</b>	1 (Occasionally likely to be disturbed)	
<b>Surface Treatment:</b>	0 (Composite material)			
<b>Asbestos Type:</b>	1 (Chrysotile)	<b>Extent Score:</b>	3 (>50 sq m or >50m pipe run)

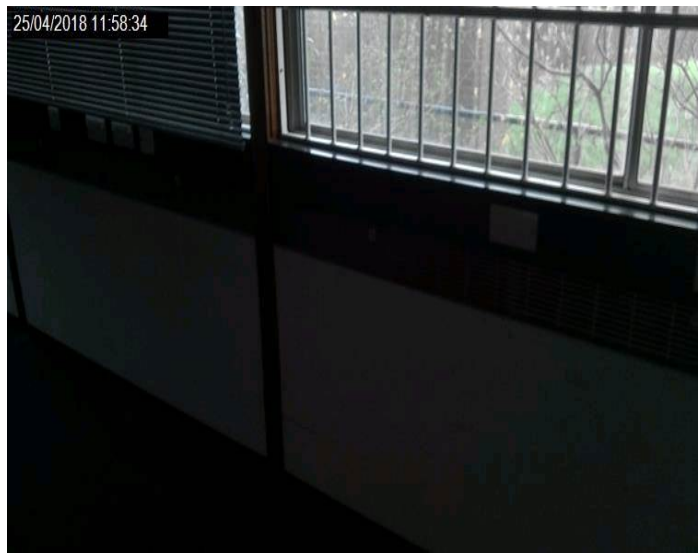
<b>Location:</b>	1.24	<b>Block:</b>	Commercial	<b>Floor Level:</b> Ground Floor
<b>Sample No.:</b>	As DU001339	<b>Portal Ref No.:</b>	294

<b>Item:</b>	Asbestos Cement window sill			
<b>Asbestos Content:</b>	<b>Result Based on:</b>			
Chrysotile	Strongly presumed			
<b>Sample Analysed By:</b>	Not applicable	<b>Extent:</b>	15 linear metres	
<b>Comments:</b>

<b>Material Assessment Total Score: 4</b>		<b>Likelihood of Disturbance Assessment Total Score: 5</b>		<b>Management Assessment</b>  <b>Licensable:</b> No  <b>Recommendations:</b> Program removal  <b>Reinspection Interval:</b> Not Applicable  <b>Overall Risk Category:</b> C9
<b>Product Type:</b>	1 (Asbestos cement)	<b>Location:</b>	2 (Rooms up to 100 sq m)	
<b>Condition:</b>	1 (Minor scratches)	<b>Accessibility:</b>	1 (Occasionally likely to be disturbed)	
<b>Surface Treatment:</b>	1 (Encapsulated asbestos cement)			
<b>Asbestos Type:</b>	1 (Chrysotile)	<b>Extent Score:</b>	2 (>10 - <50 sq m or >10m - <50m pipe run)

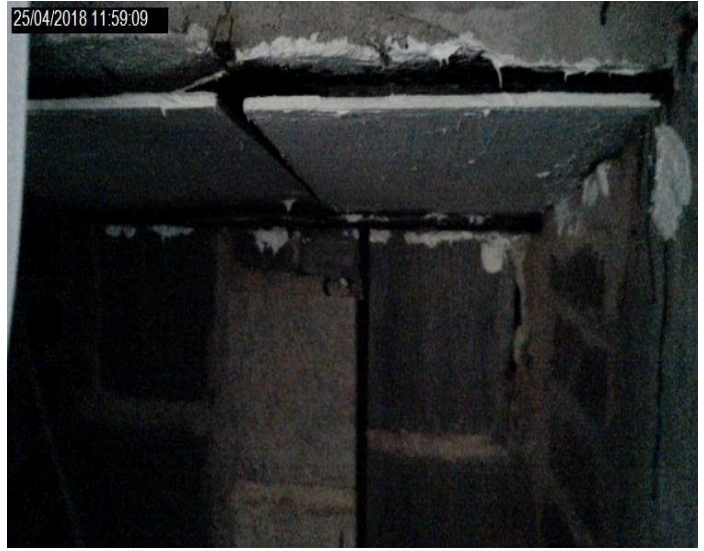
<b>Location:</b>	1.24	<b>Block:</b>	Commercial	<b>Floor Level:</b> Ground Floor
<b>Sample No.:</b>	As DU001340	<b>Portal Ref No.:</b>	295

<b>Item:</b>	Asbestos Cement shuttering			
<b>Asbestos Content:</b>	<b>Result Based on:</b>			
Chrysotile	Strongly presumed			
<b>Sample Analysed By:</b>	Not applicable	<b>Extent:</b>	15 m <sup>2</sup>	
<b>Comments:</b> To the ceiling of wall void to the heating system

<b>Material Assessment Total Score: 4</b>		<b>Likelihood of Disturbance Assessment Total Score: 4</b>		<b>Management Assessment</b>  <b>Licensable:</b> No  <b>Recommendations:</b> Program removal  <b>Reinspection Interval:</b> Not Applicable  <b>Overall Risk Category:</b> C8
<b>Product Type:</b>	1 (Asbestos cement)	<b>Location:</b>	2 (Rooms up to 100 sq m)	
<b>Condition:</b>	1 (Minor scratches)	<b>Accessibility:</b>	0 (Usually inaccessible or unlikely to be disturbed)	
<b>Surface Treatment:</b>	1 (Unencapsulated asbestos cement)			
<b>Asbestos Type:</b>	1 (Chrysotile)	<b>Extent Score:</b>	2 (>10 - <50 sq m or >10m - <50m pipe run)

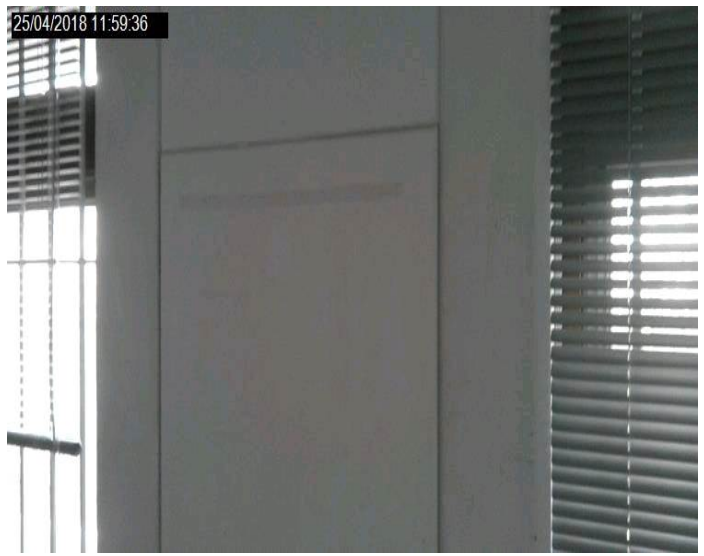
<b>Location:</b>	1.24	<b>Block:</b>	Commercial	<b>Floor Level:</b> Ground Floor
<b>Sample No.:</b>	As DU001341	<b>Portal Ref No.:</b>	296

<b>Item:</b>	Insulating board to riser			
<b>Asbestos Content:</b>		<b>Result Based on:</b>		
No Asbestos Detected		Strongly presumed		
<b>Sample Analysed By:</b>	Not applicable	<b>Extent:</b>	6 m <sup>2</sup>	
<b>Comments:</b> 2 x riser

<b>Material Assessment Total Score: 0</b>		<b>Likelihood of Disturbance Assessment Total Score: 0</b>		<b>Management Assessment</b>  <b>Licensable:</b> Yes  <b>Recommendations:</b> Not Applicable  <b>Reinspection Interval:</b> Not Applicable  <b>Overall Risk Category:</b> E0
<b>Product Type:</b>	0 Not Applicable	<b>Location:</b>	0 Not Applicable	
<b>Condition:</b>	0 Not Applicable	<b>Accessibility:</b>	0 Not Applicable	
<b>Surface Treatment:</b>	0 Not Applicable			
<b>Asbestos Type:</b>	0 Not Applicable	<b>Extent Score:</b>	0 Not Applicable

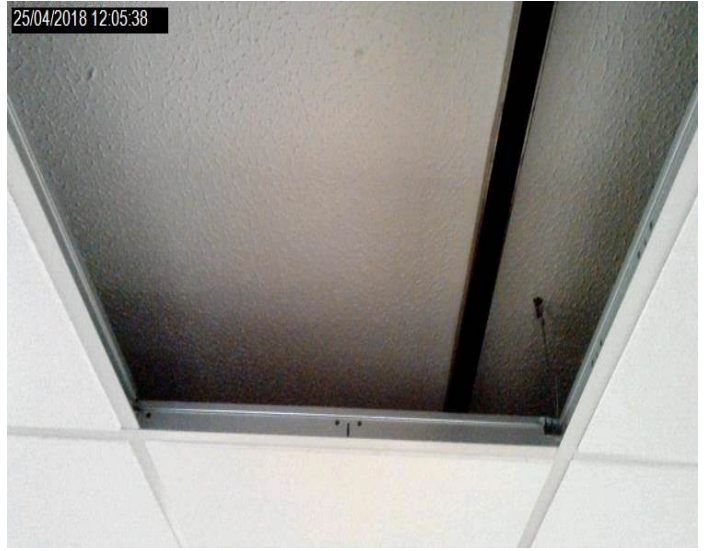
<b>Location:</b>	1.99B	<b>Block:</b>	Commercial	<b>Floor Level:</b> Ground Floor
<b>Sample No.:</b>	DU001342	<b>Portal Ref No.:</b>	298

<b>Item:</b>	Asbestos Textured coating to concrete			
<b>Asbestos Content:</b>	Result Based on:			
Chrysotile	Analysis of sample using PLM			
<b>Sample Analysed By:</b>	Reg 13(1)	<b>Extent:</b>	150 m <sup>2</sup>	
<b>Comments:</b>

<b>Material Assessment Total Score: 3</b>		<b>Likelihood of Disturbance Assessment Total Score: 6</b>		<b>Management Assessment</b>  <b>Licensable:</b> No  <b>Recommendations:</b> Program removal  <b>Reinspection Interval:</b> Not Applicable  <b>Overall Risk Category:</b> C9
<b>Product Type:</b>	1 (Asbestos textured coating)	<b>Location:</b>	2 (Rooms up to 100 sq m)	
<b>Condition:</b>	1 (Minor scratches)	<b>Accessibility:</b>	1 (Occasionally likely to be disturbed)	
<b>Surface Treatment:</b>	0 (Composite material)			
<b>Asbestos Type:</b>	1 (Chrysotile)	<b>Extent Score:</b>	3 (>50 sq m or >50m pipe run)

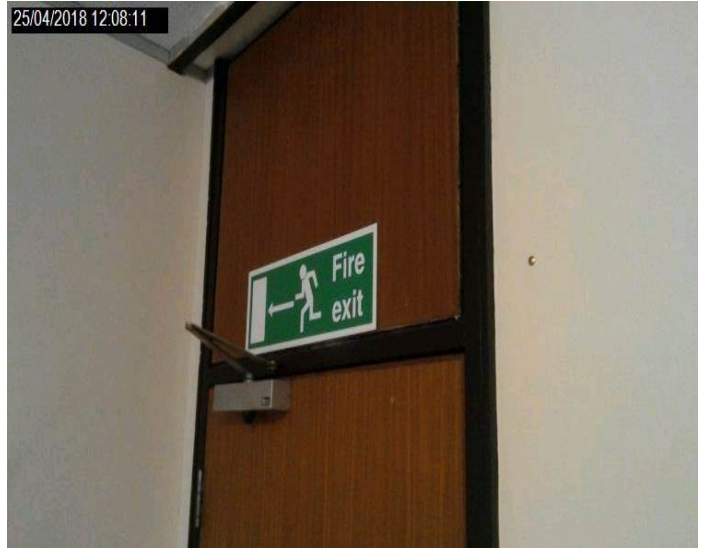
<b>Location:</b>	1.99B	<b>Block:</b>	Commercial	<b>Floor Level:</b> Ground Floor
<b>Sample No.:</b>	DU001343	<b>Portal Ref No.:</b>	299

<b>Item:</b>	Insulating board door header panels			
<b>Asbestos Content:</b>			<b>Result Based on:</b>	
No Asbestos Detected		Analysis of sample using PLM		
<b>Sample Analysed By:</b>	Reg 13(1)	<b>Extent:</b>	8 m <sup>2</sup>	
<b>Comments:</b> To rooms 1.19, 1.20, 1.25, 1.26, 1.27, 1.28, 1.29, 1.30 and 1.31

<b>Material Assessment Total Score: 0</b>		<b>Likelihood of Disturbance Assessment Total Score: 0</b>		<b>Management Assessment</b>  <b>Licensable:</b> Yes  <b>Recommendations:</b> Not Applicable  <b>Reinspection Interval:</b> Not Applicable  <b>Overall Risk Category:</b> E0
<b>Product Type:</b>	0 Not Applicable	<b>Location:</b>	0 Not Applicable	
<b>Condition:</b>	0 Not Applicable	<b>Accessibility:</b>	0 Not Applicable	
<b>Surface Treatment:</b>	0 Not Applicable			
<b>Asbestos Type:</b>	0 Not Applicable	<b>Extent Score:</b>	0 Not Applicable

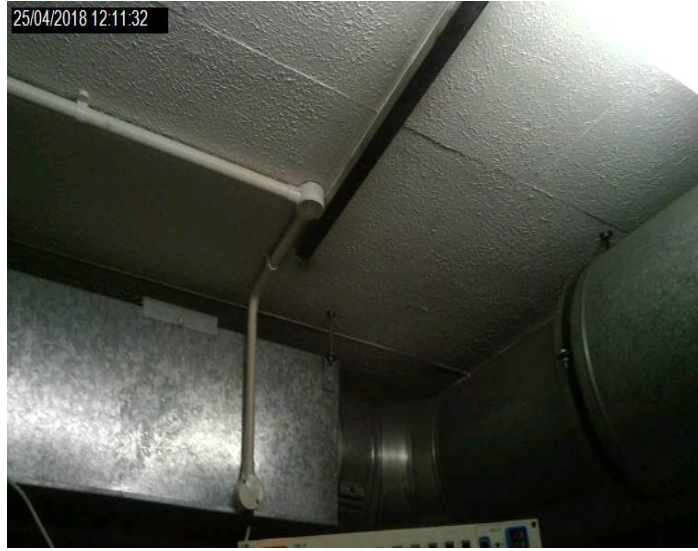
<b>Location:</b>	1.32	<b>Block:</b>	Commercial	<b>Floor Level:</b> Ground Floor
<b>Sample No.:</b>	As DU001342	<b>Portal Ref No.:</b>	301

<b>Item:</b>	Asbestos Textured coating to concrete			
<b>Asbestos Content:</b>	<b>Result Based on:</b>			
Chrysotile	Strongly presumed			
<b>Sample Analysed By:</b>	Not applicable	<b>Extent:</b>	8 m <sup>2</sup>	
<b>Comments:</b>

<b>Material Assessment Total Score: 3</b>		<b>Likelihood of Disturbance Assessment Total Score: 4</b>		<b>Management Assessment</b>  <b>Licensable:</b> No  <b>Recommendations:</b> Program removal  <b>Reinspection Interval:</b> Not Applicable  <b>Overall Risk Category:</b> C7
<b>Product Type:</b>	1 (Asbestos textured coating)	<b>Location:</b>	2 (Rooms up to 100 sq m)	
<b>Condition:</b>	1 (Minor scratches)	<b>Accessibility:</b>	1 (Occasionally likely to be disturbed)	
<b>Surface Treatment:</b>	0 (Composite material)			
<b>Asbestos Type:</b>	1 (Chrysotile)	<b>Extent Score:</b>	1 (<10 sq m or 10m pipe run)

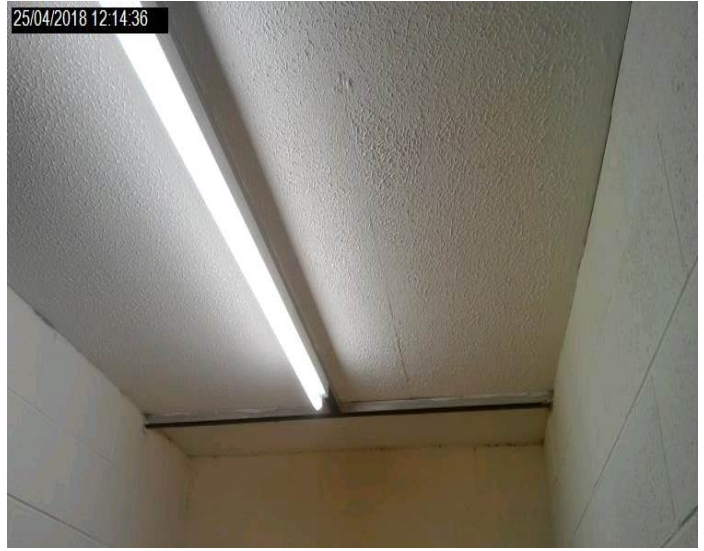
<b>Location:</b>	1.21	<b>Block:</b>	Commercial	<b>Floor Level:</b> Ground Floor
<b>Sample No.:</b>	As DU001342	<b>Portal Ref No.:</b>	302

<b>Item:</b>	Asbestos Textured coating to concrete			
<b>Asbestos Content:</b>	<b>Result Based on:</b>			
Chrysotile	Strongly presumed			
<b>Sample Analysed By:</b>	Not applicable	<b>Extent:</b>	6 m <sup>2</sup>	
<b>Comments:</b>

<b>Material Assessment Total Score: 3</b>		<b>Likelihood of Disturbance Assessment Total Score: 4</b>		<b>Management Assessment</b>  <b>Licensable:</b> No  <b>Recommendations:</b> Program removal  <b>Reinspection Interval:</b> Not Applicable  <b>Overall Risk Category:</b> C7
<b>Product Type:</b>	1 (Asbestos textured coating)	<b>Location:</b>	2 (Rooms up to 100 sq m)	
<b>Condition:</b>	1 (Minor scratches)	<b>Accessibility:</b>	1 (Occasionally likely to be disturbed)	
<b>Surface Treatment:</b>	0 (Composite material)			
<b>Asbestos Type:</b>	1 (Chrysotile)	<b>Extent Score:</b>	1 (<10 sq m or 10m pipe run)

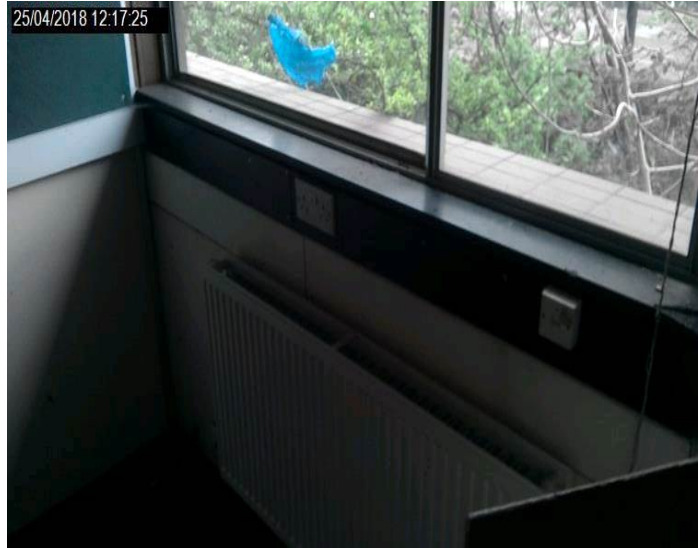
<b>Location:</b>	1.20	<b>Block:</b>	Commercial	<b>Floor Level:</b> Ground Floor
<b>Sample No.:</b>	DU001345	<b>Portal Ref No.:</b>	304

<b>Item:</b>	Asbestos Cement window sill			
<b>Asbestos Content:</b>	Result Based on:			
Chrysotile	Analysis of sample using PLM			
<b>Sample Analysed By:</b> Reg 13(1)	<b>Extent:</b>	2 linear metres		
<b>Comments:</b>

<b>Material Assessment Total Score: 4</b>		<b>Likelihood of Disturbance Assessment Total Score: 4</b>		<b>Management Assessment</b>  <b>Licensable:</b> No  <b>Recommendations:</b> Program removal  <b>Reinspection Interval:</b> Not Applicable  <b>Overall Risk Category:</b> C8
<b>Product Type:</b>	1 (Asbestos cement)	<b>Location:</b>	2 (Rooms up to 100 sq m)	
<b>Condition:</b>	1 (Minor scratches)	<b>Accessibility:</b>	1 (Occasionally likely to be disturbed)	
<b>Surface Treatment:</b>	1 (Encapsulated asbestos cement)			
<b>Asbestos Type:</b>	1 (Chrysotile)	<b>Extent Score:</b>	1 (<10 sq m or 10m pipe run)

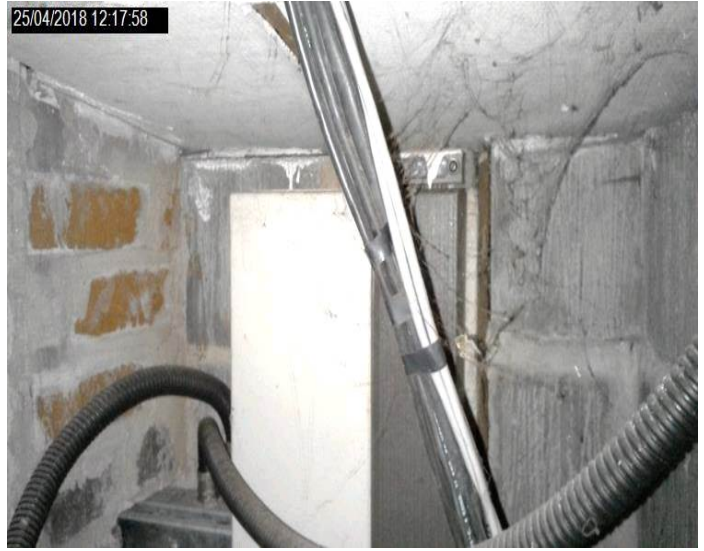
<b>Location:</b>	1.20	<b>Block:</b>	Commercial	<b>Floor Level:</b> Ground Floor
<b>Sample No.:</b>	DU001346	<b>Portal Ref No.:</b>	305

<b>Item:</b>	Asbestos Cement shuttering			
<b>Asbestos Content:</b>	Result Based on:			
Chrysotile	Analysis of sample using PLM			
<b>Sample Analysed By:</b> Reg 13(1)	<b>Extent:</b>	3 m <sup>2</sup>		
<b>Comments:</b> To the ceiling of wall void to the heating system

<b>Material Assessment Total Score: 4</b>		<b>Likelihood of Disturbance Assessment Total Score: 4</b>		<b>Management Assessment</b>  <b>Licensable:</b> No  <b>Recommendations:</b> Program removal  <b>Reinspection Interval:</b> Not Applicable  <b>Overall Risk Category:</b> C8
<b>Product Type:</b>	1 (Asbestos cement)	<b>Location:</b>	2 (Rooms up to 100 sq m)	
<b>Condition:</b>	1 (Minor scratches)	<b>Accessibility:</b>	1 (Occasionally likely to be disturbed)	
<b>Surface Treatment:</b>	1 (Encapsulated asbestos cement)			
<b>Asbestos Type:</b>	1 (Chrysotile)	<b>Extent Score:</b>	1 (<10 sq m or 10m pipe run)

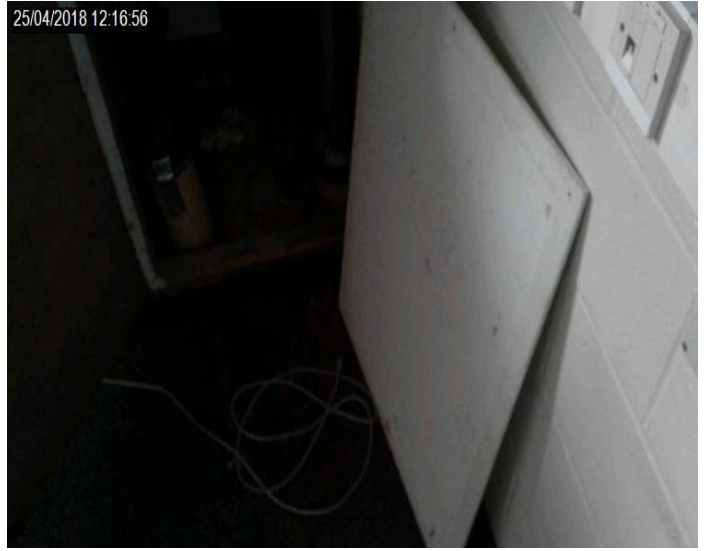
<b>Location:</b>	1.20	<b>Block:</b>	Commercial	<b>Floor Level:</b> Ground Floor
<b>Sample No.:</b>	DU001344	<b>Portal Ref No.:</b>	306

<b>Item:</b>	Insulating board to riser			
<b>Asbestos Content:</b>		<b>Result Based on:</b>		
No Asbestos Detected		Analysis of sample using PLM		
<b>Sample Analysed By:</b>	Reg 13(1)	<b>Extent:</b>	3 m <sup>2</sup>	
<b>Comments:</b> 1 x riser

<b>Material Assessment Total Score: 0</b>		<b>Likelihood of Disturbance Assessment Total Score: 0</b>		<b>Management Assessment</b>  <b>Licensable:</b> Yes  <b>Recommendations:</b> Not Applicable  <b>Reinspection Interval:</b> Not Applicable  <b>Overall Risk Category:</b> E0
<b>Product Type:</b>	0 Not Applicable	<b>Location:</b>	0 Not Applicable	
<b>Condition:</b>	0 Not Applicable	<b>Accessibility:</b>	0 Not Applicable	
<b>Surface Treatment:</b>	0 Not Applicable			
<b>Asbestos Type:</b>	0 Not Applicable	<b>Extent Score:</b>	0 Not Applicable

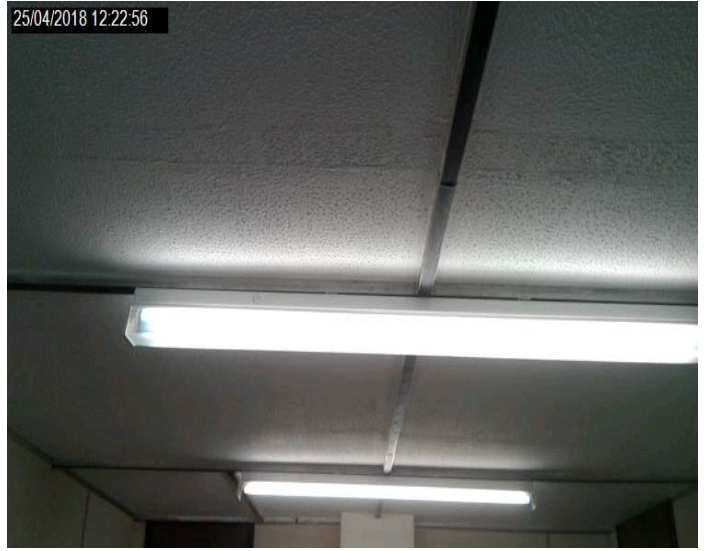
<b>Location:</b>	1.19	<b>Block:</b>	Commercial	<b>Floor Level:</b> Ground Floor
<b>Sample No.:</b>	As DU001342	<b>Portal Ref No.:</b>	307

<b>Item:</b>	Asbestos Textured coating to concrete			
<b>Asbestos Content:</b>	<b>Result Based on:</b>			
Chrysotile	Strongly presumed			
<b>Sample Analysed By:</b>	Not applicable	<b>Extent:</b>	25 m <sup>2</sup>	
<b>Comments:</b>

<b>Material Assessment Total Score: 3</b>		<b>Likelihood of Disturbance Assessment Total Score: 5</b>		<b>Management Assessment</b>  <b>Licensable:</b> No  <b>Recommendations:</b> Program removal  <b>Reinspection Interval:</b> Not Applicable  <b>Overall Risk Category:</b> C8
<b>Product Type:</b>	1 (Asbestos textured coating)	<b>Location:</b>	2 (Rooms up to 100 sq m)	
<b>Condition:</b>	1 (Minor scratches)	<b>Accessibility:</b>	1 (Occasionally likely to be disturbed)	
<b>Surface Treatment:</b>	0 (Composite material)			
<b>Asbestos Type:</b>	1 (Chrysotile)	<b>Extent Score:</b>	2 (>10 - <50 sq m or >10m - <50m pipe run)

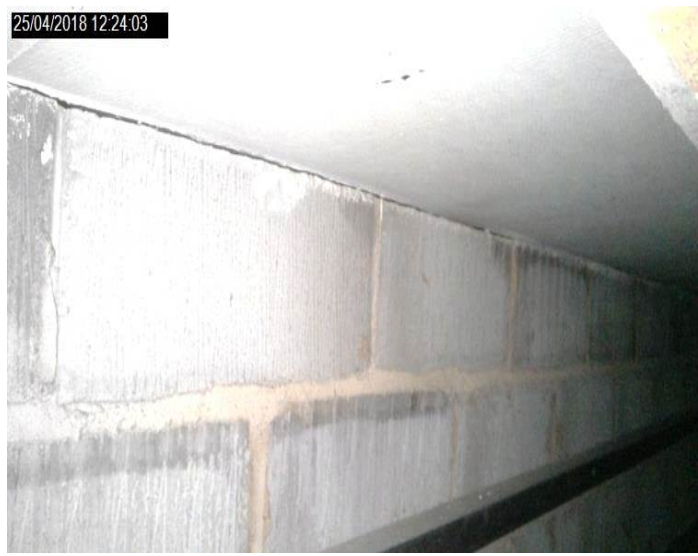
<b>Location:</b>	1.19	<b>Block:</b>	Commercial	<b>Floor Level:</b> Ground Floor
<b>Sample No.:</b>	As DU001346	<b>Portal Ref No.:</b>	309

<b>Item:</b>	Asbestos Cement shuttering			
<b>Asbestos Content:</b>	<b>Result Based on:</b>			
Chrysotile	Strongly presumed			
<b>Sample Analysed By:</b>	Not applicable	<b>Extent:</b>	5 m <sup>2</sup>	
<b>Comments:</b> To the ceiling of wall void to the heating system

<b>Material Assessment Total Score: 4</b>		<b>Likelihood of Disturbance Assessment Total Score: 4</b>		<b>Management Assessment</b>  <b>Licensable:</b> No  <b>Recommendations:</b> Program removal  <b>Reinspection Interval:</b> Not Applicable  <b>Overall Risk Category:</b> C8
<b>Product Type:</b>	1 (Asbestos cement)	<b>Location:</b>	2 (Rooms up to 100 sq m)	
<b>Condition:</b>	1 (Minor scratches)	<b>Accessibility:</b>	1 (Occasionally likely to be disturbed)	
<b>Surface Treatment:</b>	1 (Encapsulated asbestos cement)			
<b>Asbestos Type:</b>	1 (Chrysotile)	<b>Extent Score:</b>	1 (<10 sq m or 10m pipe run)

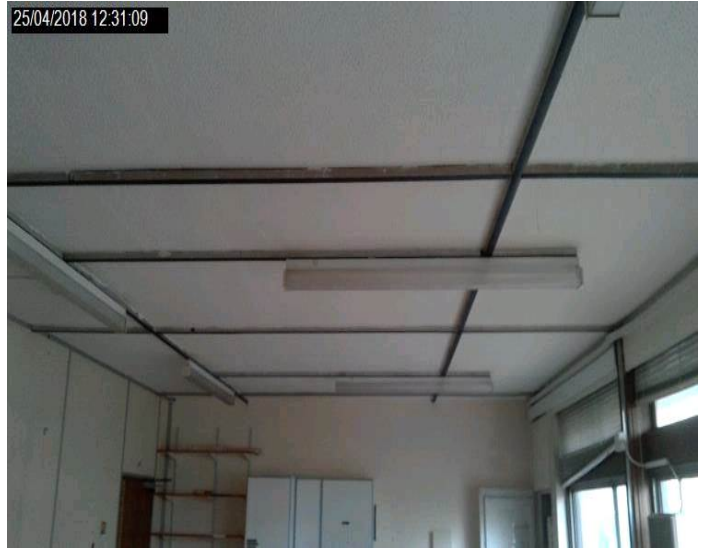
<b>Location:</b>	1.18	<b>Block:</b>	Commercial	<b>Floor Level:</b> Ground Floor
<b>Sample No.:</b>	As DU001342	<b>Portal Ref No.:</b>	311

<b>Item:</b>	Asbestos Textured coating to concrete			
<b>Asbestos Content:</b>	<b>Result Based on:</b>			
Chrysotile	Strongly presumed			
<b>Sample Analysed By:</b>	Not applicable	<b>Extent:</b>	40 m <sup>2</sup>	
<b>Comments:</b>

<b>Material Assessment Total Score: 3</b>		<b>Likelihood of Disturbance Assessment Total Score: 5</b>		<b>Management Assessment</b>  <b>Licensable:</b> No  <b>Recommendations:</b> Program removal  <b>Reinspection Interval:</b> Not Applicable  <b>Overall Risk Category:</b> C8
<b>Product Type:</b>	1 (Asbestos textured coating)	<b>Location:</b>	2 (Rooms up to 100 sq m)	
<b>Condition:</b>	1 (Minor scratches)	<b>Accessibility:</b>	1 (Occasionally likely to be disturbed)	
<b>Surface Treatment:</b>	0 (Composite material)			
<b>Asbestos Type:</b>	1 (Chrysotile)	<b>Extent Score:</b>	2 (>10 - <50 sq m or >10m - <50m pipe run)

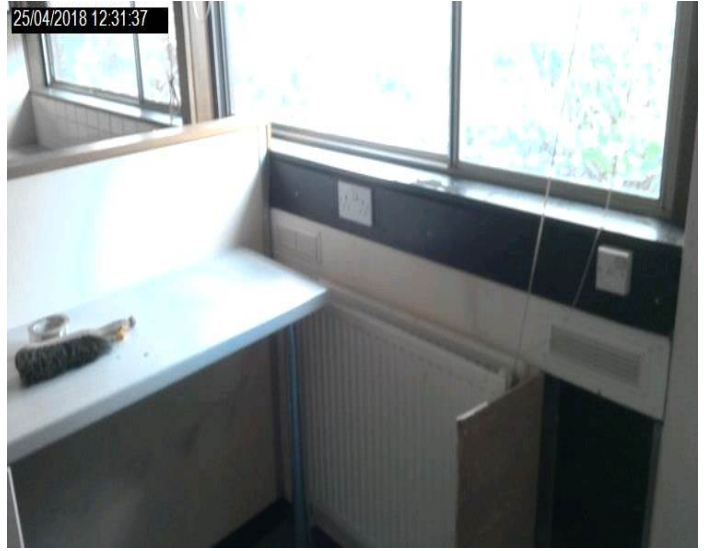
<b>Location:</b>	1.18	<b>Block:</b>	Commercial	<b>Floor Level:</b> Ground Floor
<b>Sample No.:</b>	As DU001345	<b>Portal Ref No.:</b>	312

<b>Item:</b>	Asbestos Cement window sill			
<b>Asbestos Content:</b>	<b>Result Based on:</b>			
Chrysotile	Strongly presumed			
<b>Sample Analysed By:</b>	Not applicable	<b>Extent:</b>	8 linear metres	
<b>Comments:</b>

<b>Material Assessment Total Score: 4</b>		<b>Likelihood of Disturbance Assessment Total Score: 4</b>		<b>Management Assessment</b>  <b>Licensable:</b> No  <b>Recommendations:</b> Program removal  <b>Reinspection Interval:</b> Not Applicable  <b>Overall Risk Category:</b> C8
<b>Product Type:</b>	1 (Asbestos cement)	<b>Location:</b>	2 (Rooms up to 100 sq m)	
<b>Condition:</b>	1 (Minor scratches)	<b>Accessibility:</b>	1 (Occasionally likely to be disturbed)	
<b>Surface Treatment:</b>	1 (Encapsulated asbestos cement)			
<b>Asbestos Type:</b>	1 (Chrysotile)	<b>Extent Score:</b>	1 (<10 sq m or 10m pipe run)

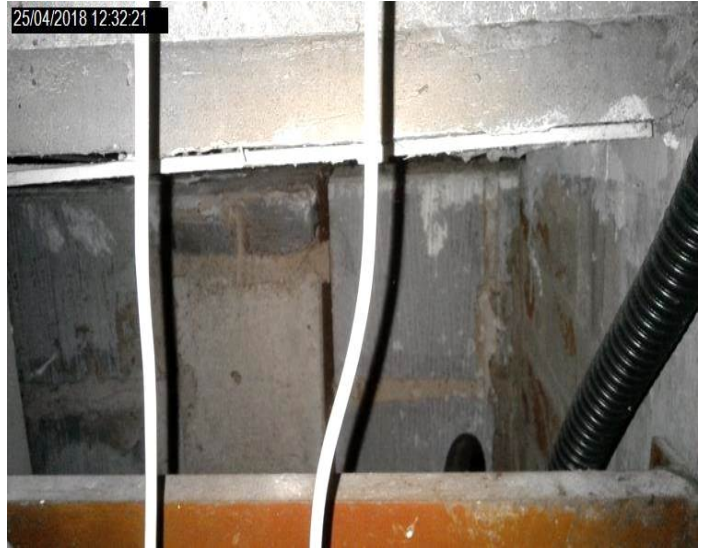
<b>Location:</b>	1.18	<b>Block:</b>	Commercial	<b>Floor Level:</b> Ground Floor
<b>Sample No.:</b>	As DU001346	<b>Portal Ref No.:</b>	313

<b>Item:</b>	Asbestos Cement shuttering			
<b>Asbestos Content:</b>	<b>Result Based on:</b>			
Chrysotile	Strongly presumed			
<b>Sample Analysed By:</b>	Not applicable	<b>Extent:</b>	8 m <sup>2</sup>	
<b>Comments:</b> To the ceiling of wall void to the heating system

<b>Material Assessment Total Score: 4</b>		<b>Likelihood of Disturbance Assessment Total Score: 4</b>		<b>Management Assessment</b>  <b>Licensable:</b> No  <b>Recommendations:</b> Program removal  <b>Reinspection Interval:</b> Not Applicable  <b>Overall Risk Category:</b> C8
<b>Product Type:</b>	1 (Asbestos cement)	<b>Location:</b>	2 (Rooms up to 100 sq m)	
<b>Condition:</b>	1 (Minor scratches)	<b>Accessibility:</b>	1 (Occasionally likely to be disturbed)	
<b>Surface Treatment:</b>	1 (Encapsulated asbestos cement)			
<b>Asbestos Type:</b>	1 (Chrysotile)	<b>Extent Score:</b>	1 (<10 sq m or 10m pipe run)

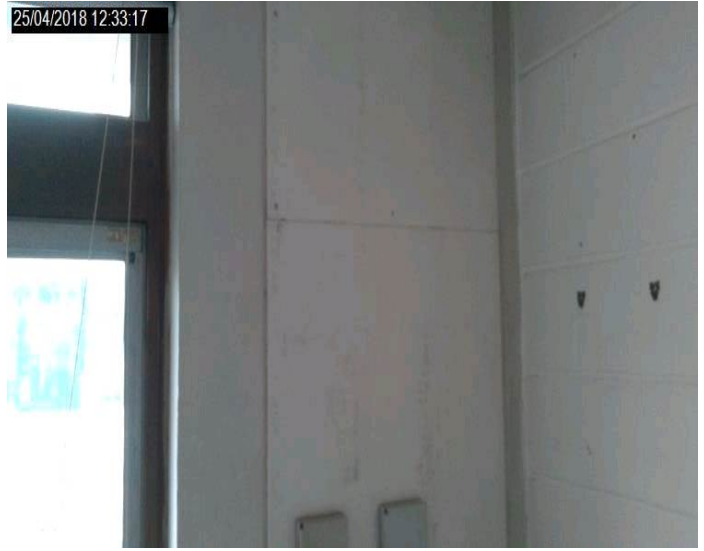
<b>Location:</b>	1.18	<b>Block:</b>	Commercial	<b>Floor Level:</b> Ground Floor
<b>Sample No.:</b>	As DU001344	<b>Portal Ref No.:</b>	314

<b>Item:</b>	Insulating board panel to riser			
<b>Asbestos Content:</b>		<b>Result Based on:</b>		
No Asbestos Detected		Strongly presumed		
<b>Sample Analysed By:</b>	Not applicable	<b>Extent:</b>	6 m <sup>2</sup>	
<b>Comments:</b> 2 x risers

<b>Material Assessment Total Score: 0</b>		<b>Likelihood of Disturbance Assessment Total Score: 0</b>		<b>Management Assessment</b>  <b>Licensable:</b> Yes  <b>Recommendations:</b> Not Applicable  <b>Reinspection Interval:</b> Not Applicable  <b>Overall Risk Category:</b> E0
<b>Product Type:</b>	0 Not Applicable	<b>Location:</b>	0 Not Applicable	
<b>Condition:</b>	0 Not Applicable	<b>Accessibility:</b>	0 Not Applicable	
<b>Surface Treatment:</b>	0 Not Applicable			
<b>Asbestos Type:</b>	0 Not Applicable	<b>Extent Score:</b>	0 Not Applicable

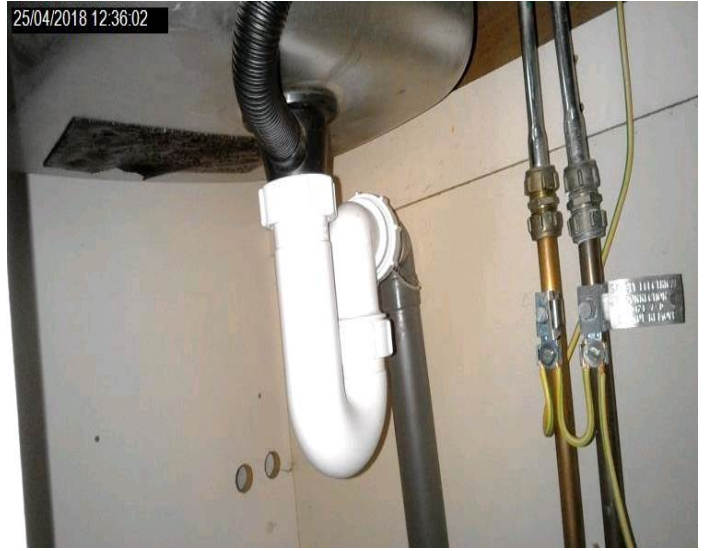
<b>Location:</b>	1.18	<b>Block:</b>	Commercial	<b>Floor Level:</b> Ground Floor
<b>Sample No.:</b>	DU001347	<b>Portal Ref No.:</b>	316

<b>Item:</b>	Bitumen sink pad			
<b>Asbestos Content:</b>		<b>Result Based on:</b>		
No Asbestos Detected		Analysis of sample using PLM		
<b>Sample Analysed By:</b>	Reg 13(1)	<b>Extent:</b>	4 units	
<b>Comments:</b> To sink and drainers

<b>Material Assessment Total Score: 0</b>		<b>Likelihood of Disturbance Assessment Total Score: 0</b>		<b>Management Assessment</b>  <b>Licensable:</b> No  <b>Recommendations:</b> Not Applicable  <b>Reinspection Interval:</b> Not Applicable  <b>Overall Risk Category:</b> E0
<b>Product Type:</b>	0 Not Applicable	<b>Location:</b>	0 Not Applicable	
<b>Condition:</b>	0 Not Applicable	<b>Accessibility:</b>	0 Not Applicable	
<b>Surface Treatment:</b>	0 Not Applicable			
<b>Asbestos Type:</b>	0 Not Applicable	<b>Extent Score:</b>	0 Not Applicable

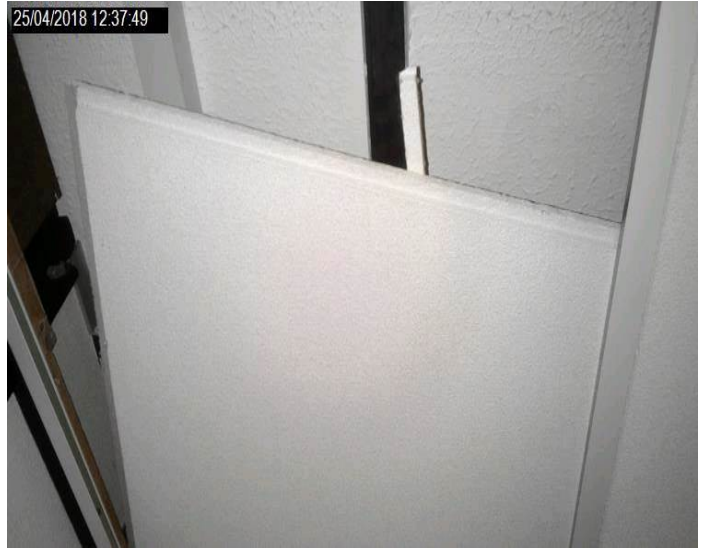
<b>Location:</b>	1.99C	<b>Block:</b>	Commercial	<b>Floor Level:</b> Ground Floor
<b>Sample No.:</b>	As DU001342	<b>Portal Ref No.:</b>	317

<b>Item:</b>	Asbestos Textured coating to concrete			
<b>Asbestos Content:</b>	<b>Result Based on:</b>			
Chrysotile	Strongly presumed			
<b>Sample Analysed By:</b>	Not applicable	<b>Extent:</b>	18 m <sup>2</sup>	
<b>Comments:</b> Above suspended ceiling tiles

<b>Material Assessment Total Score: 3</b>		<b>Likelihood of Disturbance Assessment Total Score: 5</b>		<b>Management Assessment</b>  <b>Licensable:</b> No  <b>Recommendations:</b> Program removal  <b>Reinspection Interval:</b> Not Applicable  <b>Overall Risk Category:</b> C8
<b>Product Type:</b>	1 (Asbestos textured coating)	<b>Location:</b>	2 (Rooms up to 100 sq m)	
<b>Condition:</b>	1 (Minor scratches)	<b>Accessibility:</b>	1 (Occasionally likely to be disturbed)	
<b>Surface Treatment:</b>	0 (Composite material)			
<b>Asbestos Type:</b>	1 (Chrysotile)	<b>Extent Score:</b>	2 (>10 - <50 sq m or >10m - <50m pipe run)

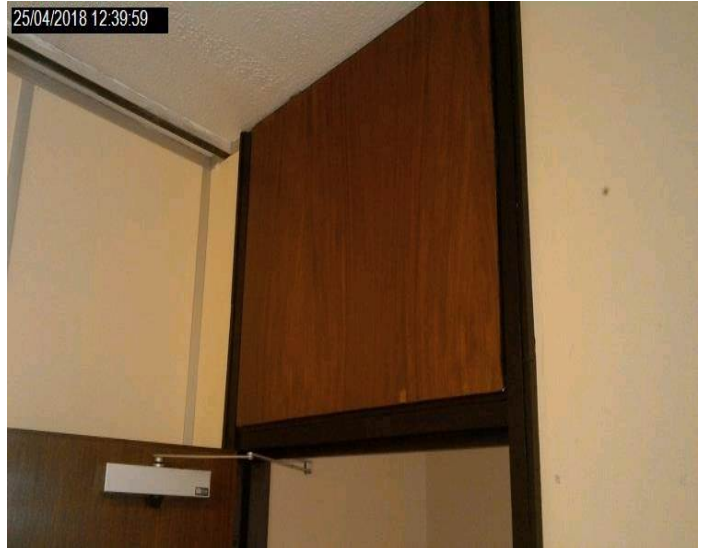
<b>Location:</b>	1.99C	<b>Block:</b>	Commercial	<b>Floor Level:</b> Ground Floor
<b>Sample No.:</b>	DU001348	<b>Portal Ref No.:</b>	318

<b>Item:</b>	Insulating board door header panels			
<b>Asbestos Content:</b>		<b>Result Based on:</b>		
No Asbestos Detected		Analysis of sample using PLM		
<b>Sample Analysed By:</b>	Reg 13(1)	<b>Extent:</b>	1 m <sup>2</sup>	
<b>Comments:</b> To rooms 1.19

<b>Material Assessment Total Score: 0</b>		<b>Likelihood of Disturbance Assessment Total Score: 0</b>		<b>Management Assessment</b>  <b>Licensable:</b> Yes  <b>Recommendations:</b> Not Applicable  <b>Reinspection Interval:</b> Not Applicable  <b>Overall Risk Category:</b> E0
<b>Product Type:</b>	0 Not Applicable	<b>Location:</b>	0 Not Applicable	
<b>Condition:</b>	0 Not Applicable	<b>Accessibility:</b>	0 Not Applicable	
<b>Surface Treatment:</b>	0 Not Applicable			
<b>Asbestos Type:</b>	0 Not Applicable	<b>Extent Score:</b>	0 Not Applicable

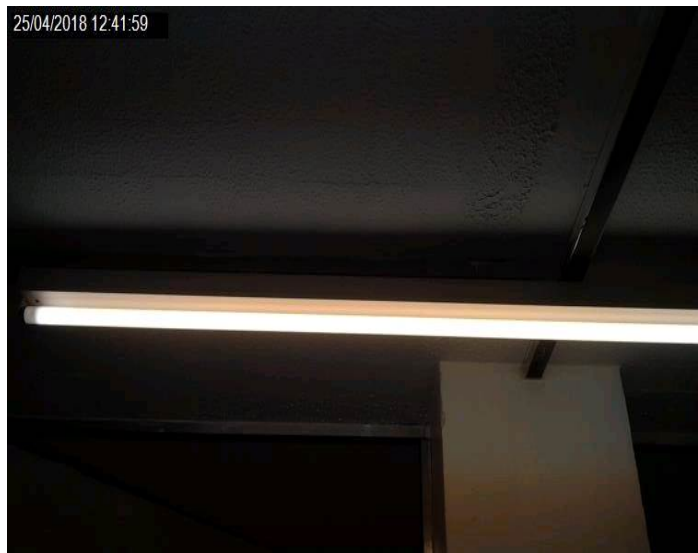
<b>Location:</b>	1.17	<b>Block:</b>	Commercial	<b>Floor Level:</b> Ground Floor
<b>Sample No.:</b>	As DU001342	<b>Portal Ref No.:</b>	319

<b>Item:</b>	Asbestos Textured coating to concrete			
<b>Asbestos Content:</b>	<b>Result Based on:</b>			
Chrysotile	Strongly presumed			
<b>Sample Analysed By:</b>	Not applicable	<b>Extent:</b>	8 m <sup>2</sup>	
<b>Comments:</b>

<b>Material Assessment Total Score: 3</b>		<b>Likelihood of Disturbance Assessment Total Score: 4</b>		<b>Management Assessment</b>  <b>Licensable:</b> No  <b>Recommendations:</b> Program removal  <b>Reinspection Interval:</b> Not Applicable  <b>Overall Risk Category:</b> C7
<b>Product Type:</b>	1 (Asbestos textured coating)	<b>Location:</b>	2 (Rooms up to 100 sq m)	
<b>Condition:</b>	1 (Minor scratches)	<b>Accessibility:</b>	1 (Occasionally likely to be disturbed)	
<b>Surface Treatment:</b>	0 (Composite material)			
<b>Asbestos Type:</b>	1 (Chrysotile)	<b>Extent Score:</b>	1 (<10 sq m or 10m pipe run)
