**Report No.:** J094042  
**Nature of Work:** Demolition Survey  
**Issue Date:** 29/05/2018  
**Client Name:** WYG Engineering Ltd  
Geneva Building, Lake View Drive, Sherwood Business Park,  
Annesley, Nottingham, NG15 0ED  
**Site Address:** Cox Building, Former City North Campus, Birmingham City  
University, Perry Barr, B42 2US

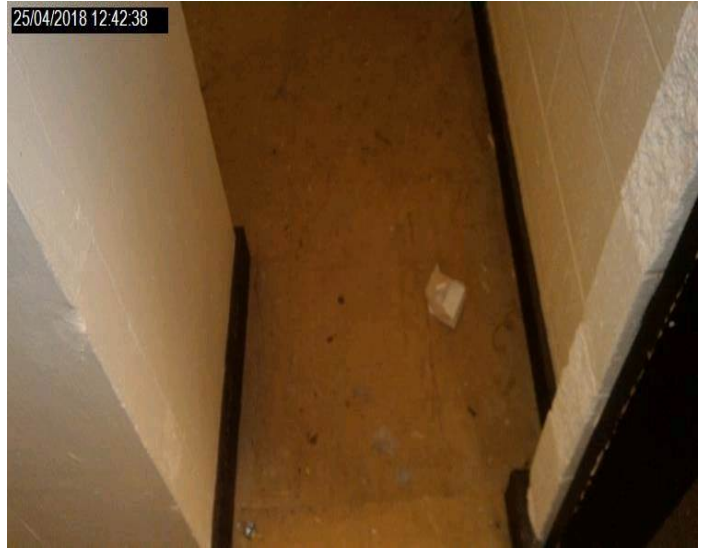
<b>Location:</b>	1.17	<b>Block:</b>	Commercial	<b>Floor Level:</b> Ground Floor
<b>Sample No.:</b>	DU001349	<b>Portal Ref No.:</b>	320

<b>Item:</b>	Asbestos Thermoplastic floor tiles with bitumen			
<b>Asbestos Content:</b>	Result Based on:			
Chrysotile in adhesive only	Analysis of sample using PLM			
<b>Sample Analysed By:</b> Reg 13(1)	<b>Extent:</b>	10 m <sup>2</sup>		
<b>Comments:</b>

<b>Material Assessment Total Score: 3</b>		<b>Likelihood of Disturbance Assessment Total Score: 4</b>		<b>Management Assessment</b>  <b>Licensable:</b> No  <b>Recommendations:</b> Program removal  <b>Reinspection Interval:</b> Not Applicable  <b>Overall Risk Category:</b> C7
<b>Product Type:</b>	1 (Asbestos thermoplastic)	<b>Location:</b>	2 (Rooms up to 100 sq m)	
<b>Condition:</b>	1 (Minor scratches)	<b>Accessibility:</b>	1 (Occasionally likely to be disturbed)	
<b>Surface Treatment:</b>	0 (Composite material)			
<b>Asbestos Type:</b>	1 (Chrysotile)	<b>Extent Score:</b>	1 (<10 sq m or 10m pipe run)

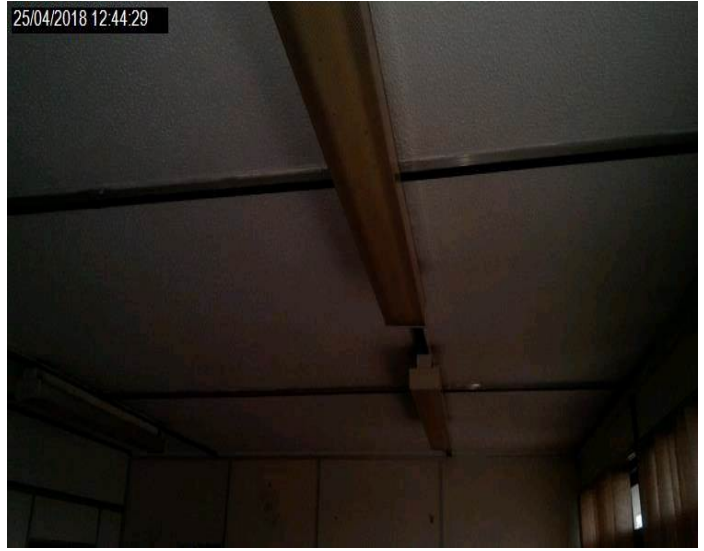
<b>Location:</b>	1.12	<b>Block:</b>	Commercial	<b>Floor Level:</b> Ground Floor
<b>Sample No.:</b>	As DU001342	<b>Portal Ref No.:</b>	321

<b>Item:</b>	Asbestos Textured coating to concrete			
<b>Asbestos Content:</b>	<b>Result Based on:</b>			
Chrysotile	Strongly presumed			
<b>Sample Analysed By:</b>	Not applicable	<b>Extent:</b>	25 m <sup>2</sup>	
<b>Comments:</b>

<b>Material Assessment Total Score: 3</b>		<b>Likelihood of Disturbance Assessment Total Score: 5</b>		<b>Management Assessment</b>  <b>Licensable:</b> No  <b>Recommendations:</b> Program removal  <b>Reinspection Interval:</b> Not Applicable  <b>Overall Risk Category:</b> C8
<b>Product Type:</b>	1 (Asbestos textured coating)	<b>Location:</b>	2 (Rooms up to 100 sq m)	
<b>Condition:</b>	1 (Minor scratches)	<b>Accessibility:</b>	1 (Occasionally likely to be disturbed)	
<b>Surface Treatment:</b>	0 (Composite material)			
<b>Asbestos Type:</b>	1 (Chrysotile)	<b>Extent Score:</b>	2 (>10 - <50 sq m or >10m - <50m pipe run)

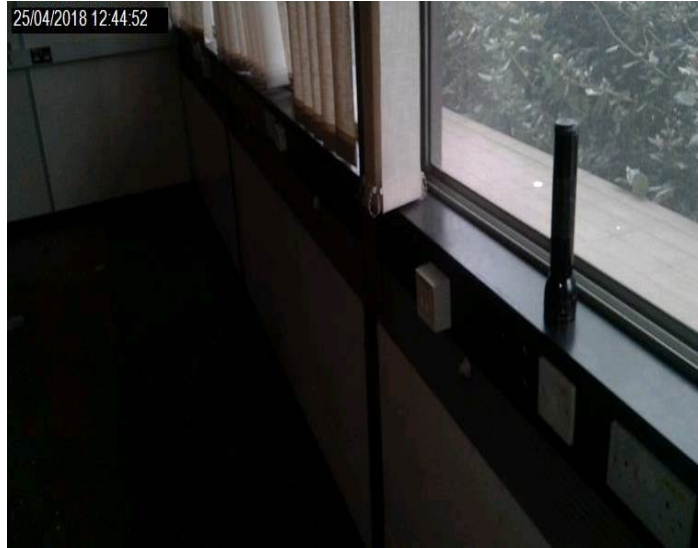
<b>Location:</b>	1.12	<b>Block:</b>	Commercial	<b>Floor Level:</b> Ground Floor
<b>Sample No.:</b>	As DU001345	<b>Portal Ref No.:</b>	322

<b>Item:</b>	Asbestos Cement window sill			
<b>Asbestos Content:</b>	<b>Result Based on:</b>			
Chrysotile	Strongly presumed			
<b>Sample Analysed By:</b>	Not applicable	<b>Extent:</b>	6 linear metres	
<b>Comments:</b>

<b>Material Assessment Total Score: 4</b>		<b>Likelihood of Disturbance Assessment Total Score: 4</b>		<b>Management Assessment</b>  <b>Licensable:</b> No  <b>Recommendations:</b> Program removal  <b>Reinspection Interval:</b> Not Applicable  <b>Overall Risk Category:</b> C8
<b>Product Type:</b>	1 (Asbestos cement)	<b>Location:</b>	2 (Rooms up to 100 sq m)	
<b>Condition:</b>	1 (Minor scratches)	<b>Accessibility:</b>	1 (Occasionally likely to be disturbed)	
<b>Surface Treatment:</b>	1 (Encapsulated asbestos cement)			
<b>Asbestos Type:</b>	1 (Chrysotile)	<b>Extent Score:</b>	1 (<10 sq m or 10m pipe run)

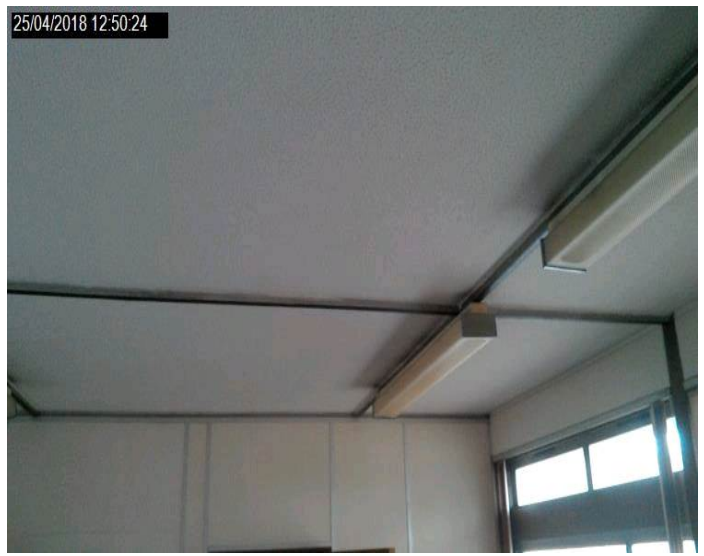
<b>Location:</b>	1.11	<b>Block:</b>	Commercial	<b>Floor Level:</b> Ground Floor
<b>Sample No.:</b>	As DU001342	<b>Portal Ref No.:</b>	324

<b>Item:</b>	Asbestos Textured coating to concrete			
<b>Asbestos Content:</b>	<b>Result Based on:</b>			
Chrysotile	Strongly presumed			
<b>Sample Analysed By:</b>	Not applicable	<b>Extent:</b>	20 m <sup>2</sup>	
<b>Comments:</b>

<b>Material Assessment Total Score: 3</b>		<b>Likelihood of Disturbance Assessment Total Score: 5</b>		<b>Management Assessment</b>  <b>Licensable:</b> No  <b>Recommendations:</b> Program removal  <b>Reinspection Interval:</b> Not Applicable  <b>Overall Risk Category:</b> C8
<b>Product Type:</b>	1 (Asbestos textured coating)	<b>Location:</b>	2 (Rooms up to 100 sq m)	
<b>Condition:</b>	1 (Minor scratches)	<b>Accessibility:</b>	1 (Occasionally likely to be disturbed)	
<b>Surface Treatment:</b>	0 (Composite material)			
<b>Asbestos Type:</b>	1 (Chrysotile)	<b>Extent Score:</b>	2 (>10 - <50 sq m or >10m - <50m pipe run)

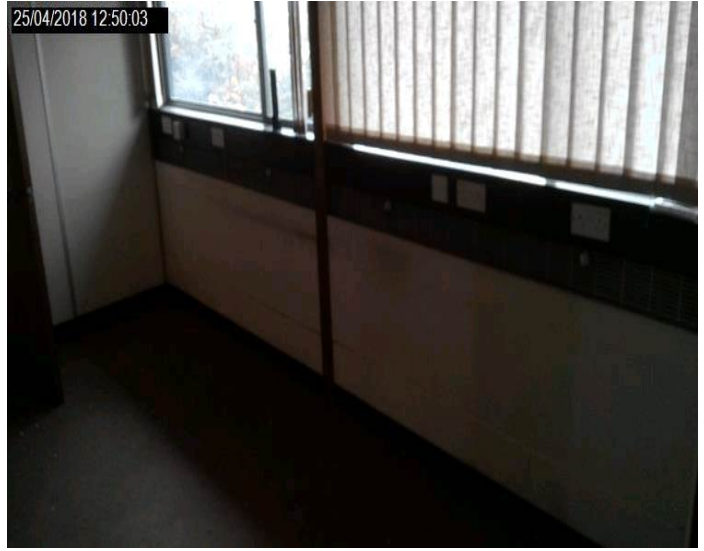
<b>Location:</b>	1.11	<b>Block:</b>	Commercial	<b>Floor Level:</b> Ground Floor
<b>Sample No.:</b>	As DU001345	<b>Portal Ref No.:</b>	325

<b>Item:</b>	Asbestos Cement window sill			
<b>Asbestos Content:</b>	<b>Result Based on:</b>			
Chrysotile	Strongly presumed			
<b>Sample Analysed By:</b>	Not applicable	<b>Extent:</b>	6 linear metres	
<b>Comments:</b>

<b>Material Assessment Total Score: 4</b>		<b>Likelihood of Disturbance Assessment Total Score: 4</b>		<b>Management Assessment</b>  <b>Licensable:</b> No  <b>Recommendations:</b> Program removal  <b>Reinspection Interval:</b> Not Applicable  <b>Overall Risk Category:</b> C8
<b>Product Type:</b>	1 (Asbestos cement)	<b>Location:</b>	2 (Rooms up to 100 sq m)	
<b>Condition:</b>	1 (Minor scratches)	<b>Accessibility:</b>	1 (Occasionally likely to be disturbed)	
<b>Surface Treatment:</b>	1 (Encapsulated asbestos cement)			
<b>Asbestos Type:</b>	1 (Chrysotile)	<b>Extent Score:</b>	1 (<10 sq m or 10m pipe run)

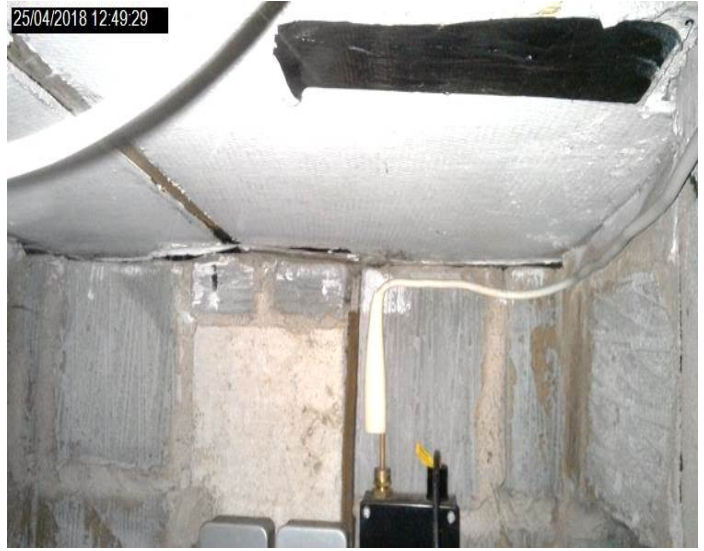
<b>Location:</b>	1.11	<b>Block:</b>	Commercial	<b>Floor Level:</b> Ground Floor
<b>Sample No.:</b>	As DU001346	<b>Portal Ref No.:</b>	326

<b>Item:</b>	Asbestos Cement shuttering			
<b>Asbestos Content:</b>	<b>Result Based on:</b>			
Chrysotile	Strongly presumed			
<b>Sample Analysed By:</b>	Not applicable	<b>Extent:</b>	6 m <sup>2</sup>	
<b>Comments:</b> To the ceiling of wall void to the heating system

<b>Material Assessment Total Score: 4</b>		<b>Likelihood of Disturbance Assessment Total Score: 4</b>		<b>Management Assessment</b>  <b>Licensable:</b> No  <b>Recommendations:</b> Program removal  <b>Reinspection Interval:</b> Not Applicable  <b>Overall Risk Category:</b> C8
<b>Product Type:</b>	1 (Asbestos cement)	<b>Location:</b>	2 (Rooms up to 100 sq m)	
<b>Condition:</b>	1 (Minor scratches)	<b>Accessibility:</b>	1 (Occasionally likely to be disturbed)	
<b>Surface Treatment:</b>	1 (Encapsulated asbestos cement)			
<b>Asbestos Type:</b>	1 (Chrysotile)	<b>Extent Score:</b>	1 (<10 sq m or 10m pipe run)

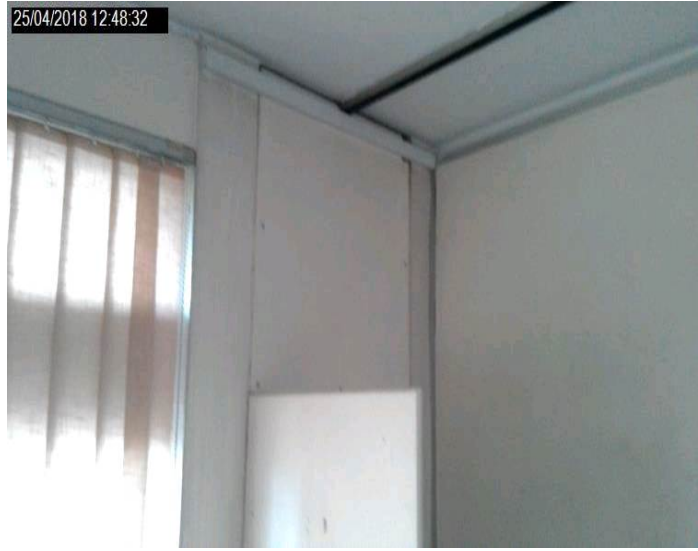
<b>Location:</b>	1.11	<b>Block:</b>	Commercial	<b>Floor Level:</b> Ground Floor
<b>Sample No.:</b>	As DU001344	<b>Portal Ref No.:</b>	327

<b>Item:</b>	Insulating board panel to riser			
<b>Asbestos Content:</b>		<b>Result Based on:</b>		
No Asbestos Detected		Strongly presumed		
<b>Sample Analysed By:</b>	Not applicable	<b>Extent:</b>	1 m <sup>2</sup>	
<b>Comments:</b> Top panel only

<b>Material Assessment Total Score: 0</b>		<b>Likelihood of Disturbance Assessment Total Score: 0</b>		<b>Management Assessment</b>  <b>Licensable:</b> Yes  <b>Recommendations:</b> Not Applicable  <b>Reinspection Interval:</b> Not Applicable  <b>Overall Risk Category:</b> E0
<b>Product Type:</b>	0 Not Applicable	<b>Location:</b>	0 Not Applicable	
<b>Condition:</b>	0 Not Applicable	<b>Accessibility:</b>	0 Not Applicable	
<b>Surface Treatment:</b>	0 Not Applicable			
<b>Asbestos Type:</b>	0 Not Applicable	<b>Extent Score:</b>	0 Not Applicable

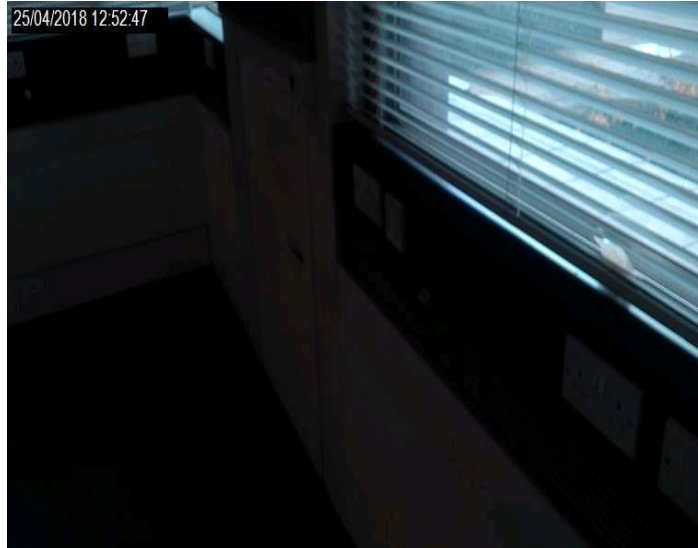
<b>Location:</b>	1.10	<b>Block:</b>	Commercial	<b>Floor Level:</b> Ground Floor
<b>Sample No.:</b>	As DU001345	<b>Portal Ref No.:</b>	329

<b>Item:</b>	Asbestos Cement window sill			
<b>Asbestos Content:</b>	<b>Result Based on:</b>			
Chrysotile	Strongly presumed			
<b>Sample Analysed By:</b>	Not applicable	<b>Extent:</b>	6 linear metres	
<b>Comments:</b>

<b>Material Assessment Total Score: 4</b>		<b>Likelihood of Disturbance Assessment Total Score: 4</b>		<b>Management Assessment</b>  <b>Licensable:</b> No  <b>Recommendations:</b> Program removal  <b>Reinspection Interval:</b> Not Applicable  <b>Overall Risk Category:</b> C8
<b>Product Type:</b>	1 (Asbestos cement)	<b>Location:</b>	2 (Rooms up to 100 sq m)	
<b>Condition:</b>	1 (Minor scratches)	<b>Accessibility:</b>	1 (Occasionally likely to be disturbed)	
<b>Surface Treatment:</b>	1 (Encapsulated asbestos cement)			
<b>Asbestos Type:</b>	1 (Chrysotile)	<b>Extent Score:</b>	1 (<10 sq m or 10m pipe run)

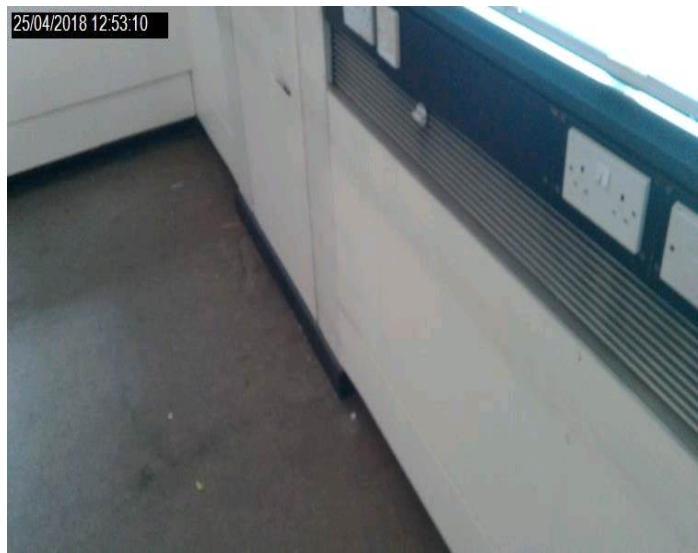
<b>Location:</b>	1.10	<b>Block:</b>	Commercial	<b>Floor Level:</b> Ground Floor
<b>Sample No.:</b>	As DU001346	<b>Portal Ref No.:</b>	330

<b>Item:</b>	Asbestos Cement shuttering			
<b>Asbestos Content:</b>	<b>Result Based on:</b>			
Chrysotile	Strongly presumed			
<b>Sample Analysed By:</b>	Not applicable	<b>Extent:</b>	6 m <sup>2</sup>	
<b>Comments:</b> To the ceiling of wall void to the heating system

<b>Material Assessment Total Score: 4</b>		<b>Likelihood of Disturbance Assessment Total Score: 4</b>		<b>Management Assessment</b>  <b>Licensable:</b> No  <b>Recommendations:</b> Program removal  <b>Reinspection Interval:</b> Not Applicable  <b>Overall Risk Category:</b> C8
<b>Product Type:</b>	1 (Asbestos cement)	<b>Location:</b>	2 (Rooms up to 100 sq m)	
<b>Condition:</b>	1 (Minor scratches)	<b>Accessibility:</b>	1 (Occasionally likely to be disturbed)	
<b>Surface Treatment:</b>	1 (Encapsulated asbestos cement)			
<b>Asbestos Type:</b>	1 (Chrysotile)	<b>Extent Score:</b>	1 (<10 sq m or 10m pipe run)

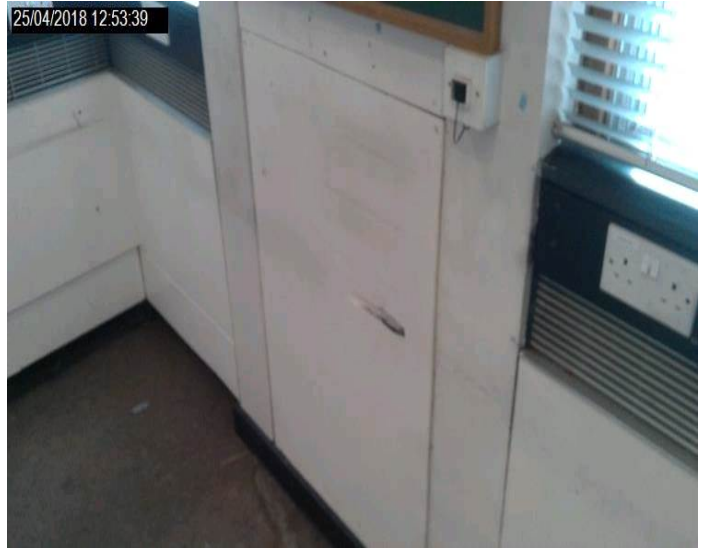
<b>Location:</b>	1.10	<b>Block:</b>	Commercial	<b>Floor Level:</b> Ground Floor
<b>Sample No.:</b>	As DU001344	<b>Portal Ref No.:</b>	331

<b>Item:</b>	Insulating board panel to riser			
<b>Asbestos Content:</b>		<b>Result Based on:</b>		
No Asbestos Detected		Strongly presumed		
<b>Sample Analysed By:</b>	Not applicable	<b>Extent:</b>	3 m <sup>2</sup>	
<b>Comments:</b> 1 x riser

<b>Material Assessment Total Score: 0</b>		<b>Likelihood of Disturbance Assessment Total Score: 0</b>		<b>Management Assessment</b>  <b>Licensable:</b> Yes  <b>Recommendations:</b> Not Applicable  <b>Reinspection Interval:</b> Not Applicable  <b>Overall Risk Category:</b> E0
<b>Product Type:</b>	0 Not Applicable	<b>Location:</b>	0 Not Applicable	
<b>Condition:</b>	0 Not Applicable	<b>Accessibility:</b>	0 Not Applicable	
<b>Surface Treatment:</b>	0 Not Applicable			
<b>Asbestos Type:</b>	0 Not Applicable	<b>Extent Score:</b>	0 Not Applicable

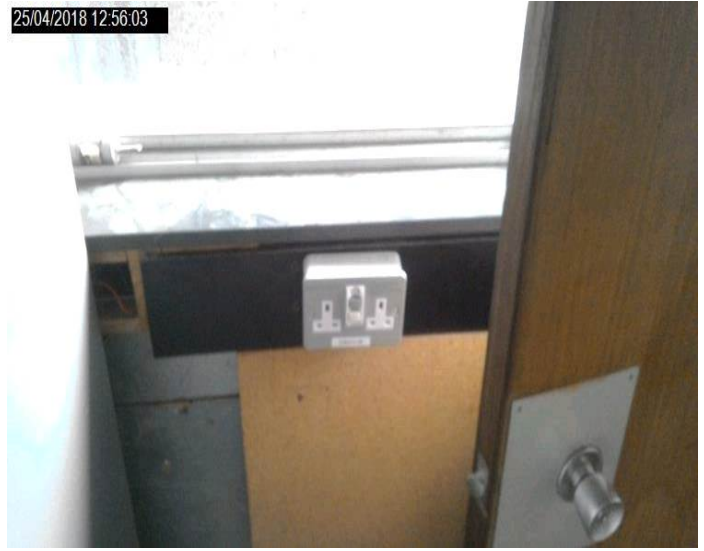
<b>Location:</b>	1.09	<b>Block:</b>	Commercial	<b>Floor Level:</b> Ground Floor
<b>Sample No.:</b>	As DU001345	<b>Portal Ref No.:</b>	333

<b>Item:</b>	Asbestos Cement window sill			
<b>Asbestos Content:</b>	<b>Result Based on:</b>			
Chrysotile	Strongly presumed			
<b>Sample Analysed By:</b>	Not applicable	<b>Extent:</b>	3 linear metres	
<b>Comments:</b>

<b>Material Assessment Total Score: 4</b>		<b>Likelihood of Disturbance Assessment Total Score: 4</b>		<b>Management Assessment</b>  <b>Licensable:</b> No  <b>Recommendations:</b> Program removal  <b>Reinspection Interval:</b> Not Applicable  <b>Overall Risk Category:</b> C8
<b>Product Type:</b>	1 (Asbestos cement)	<b>Location:</b>	2 (Rooms up to 100 sq m)	
<b>Condition:</b>	1 (Minor scratches)	<b>Accessibility:</b>	1 (Occasionally likely to be disturbed)	
<b>Surface Treatment:</b>	1 (Encapsulated asbestos cement)			
<b>Asbestos Type:</b>	1 (Chrysotile)	<b>Extent Score:</b>	1 (<10 sq m or 10m pipe run)

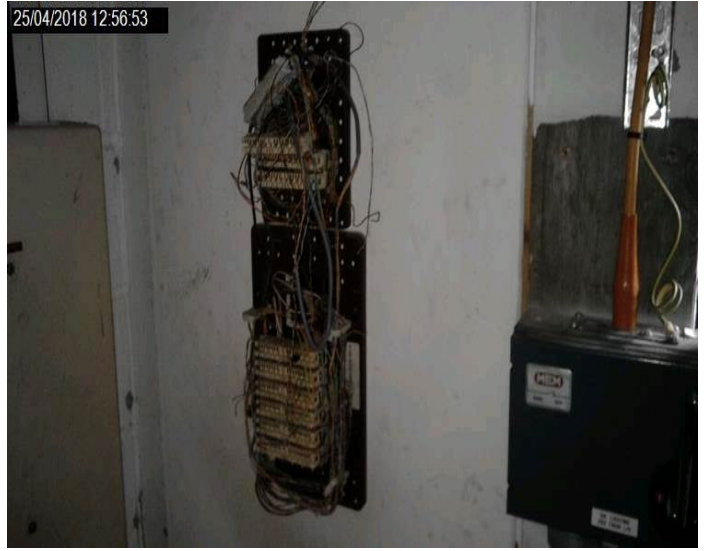
<b>Location:</b>	1.09	<b>Block:</b>	Commercial	<b>Floor Level:</b> Ground Floor
<b>Sample No.:</b>	As DU001344	<b>Portal Ref No.:</b>	335

<b>Item:</b>	Insulating board panel to riser			
<b>Asbestos Content:</b>		<b>Result Based on:</b>		
No Asbestos Detected		Strongly presumed		
<b>Sample Analysed By:</b>	Not applicable	<b>Extent:</b>	2 m <sup>2</sup>	
<b>Comments:</b> 1 x riser

<b>Material Assessment Total Score: 0</b>		<b>Likelihood of Disturbance Assessment Total Score: 0</b>		<b>Management Assessment</b>  <b>Licensable:</b> Yes  <b>Recommendations:</b> Not Applicable  <b>Reinspection Interval:</b> Not Applicable  <b>Overall Risk Category:</b> E0
<b>Product Type:</b>	0 Not Applicable	<b>Location:</b>	0 Not Applicable	
<b>Condition:</b>	0 Not Applicable	<b>Accessibility:</b>	0 Not Applicable	
<b>Surface Treatment:</b>	0 Not Applicable			
<b>Asbestos Type:</b>	0 Not Applicable	<b>Extent Score:</b>	0 Not Applicable

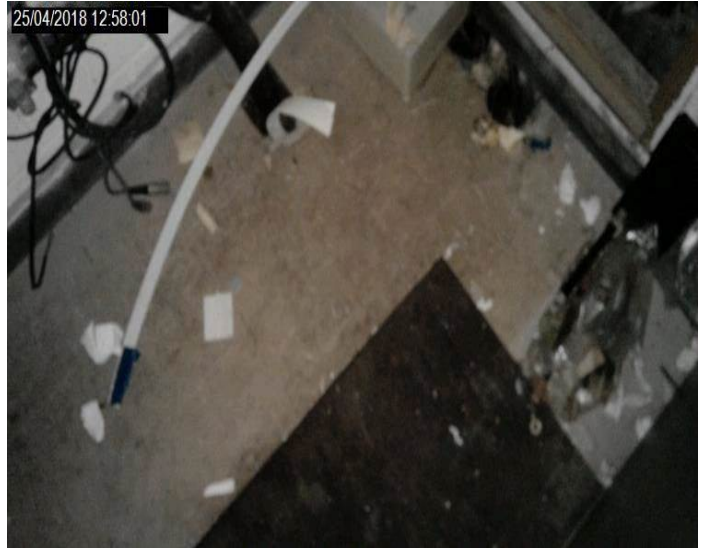
<b>Location:</b>	1.09	<b>Block:</b>	Commercial	<b>Floor Level:</b> Ground Floor
<b>Sample No.:</b>	DU001350	<b>Portal Ref No.:</b>	336

<b>Item:</b>	Asbestos Thermoplastic floor tiles with bitumen adhesive			
<b>Asbestos Content:</b>	Result Based on:			
Chrysotile in adhesive only	Analysis of sample using PLM			
<b>Sample Analysed By:</b> Reg 13(1)	<b>Extent:</b>	6 m <sup>2</sup>		
<b>Comments:</b>

<b>Material Assessment Total Score: 3</b>		<b>Likelihood of Disturbance Assessment Total Score: 6</b>		<b>Management Assessment</b>  <b>Licensable:</b> No  <b>Recommendations:</b> Program removal  <b>Reinspection Interval:</b> Not Applicable  <b>Overall Risk Category:</b> C9
<b>Product Type:</b>	1 (Asbestos thermoplastic)	<b>Location:</b>	2 (Rooms up to 100 sq m)	
<b>Condition:</b>	1 (Minor scratches)	<b>Accessibility:</b>	3 (Routinely disturbed)	
<b>Surface Treatment:</b>	0 (Composite material)			
<b>Asbestos Type:</b>	1 (Chrysotile)	<b>Extent Score:</b>	1 (<10 sq m or 10m pipe run)

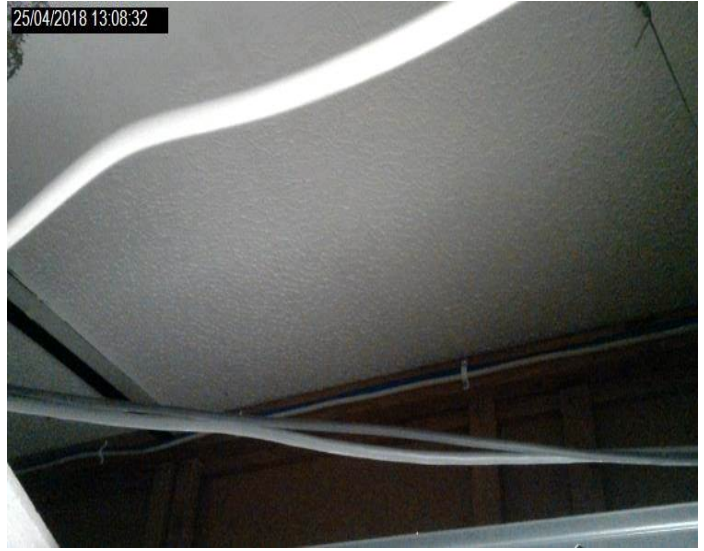
<b>Location:</b>	1.99D	<b>Block:</b>	Commercial	<b>Floor Level:</b> Ground Floor
<b>Sample No.:</b>	As DU001342	<b>Portal Ref No.:</b>	338

<b>Item:</b>	Asbestos Textured coating to concrete			
<b>Asbestos Content:</b>	<b>Result Based on:</b>			
Chrysotile	Strongly presumed			
<b>Sample Analysed By:</b>	Not applicable	<b>Extent:</b>	30 m <sup>2</sup>	
<b>Comments:</b> Above suspended ceiling tiles

<b>Material Assessment Total Score: 3</b>		<b>Likelihood of Disturbance Assessment Total Score: 5</b>		<b>Management Assessment</b>  <b>Licensable:</b> No  <b>Recommendations:</b> Program removal  <b>Reinspection Interval:</b> Not Applicable  <b>Overall Risk Category:</b> C8
<b>Product Type:</b>	1 (Asbestos textured coating)	<b>Location:</b>	2 (Rooms up to 100 sq m)	
<b>Condition:</b>	1 (Minor scratches)	<b>Accessibility:</b>	1 (Occasionally likely to be disturbed)	
<b>Surface Treatment:</b>	0 (Composite material)			
<b>Asbestos Type:</b>	1 (Chrysotile)	<b>Extent Score:</b>	2 (>10 - <50 sq m or >10m - <50m pipe run)

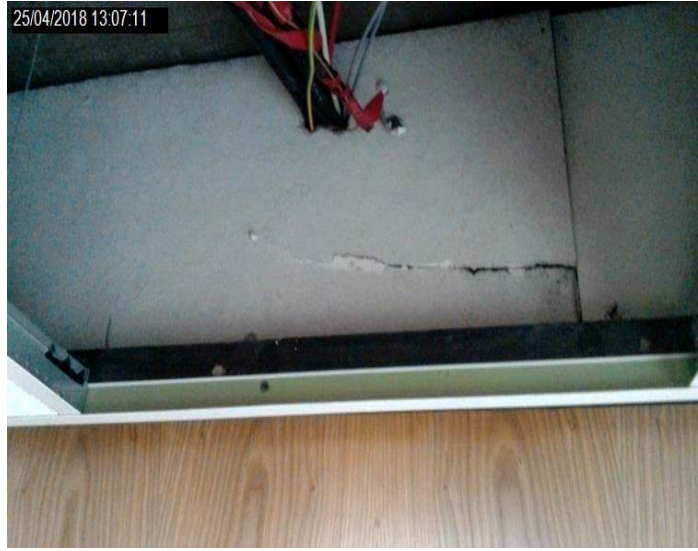
<b>Location:</b>	1.99D	<b>Block:</b>	Commercial	<b>Floor Level:</b> Ground Floor
<b>Sample No.:</b>	DU001352	<b>Portal Ref No.:</b>	339

<b>Item:</b>	Insulating board door header panels			
<b>Asbestos Content:</b>		<b>Result Based on:</b>		
No Asbestos Detected		Analysis of sample using PLM		
<b>Sample Analysed By:</b>	Reg 13(1)	<b>Extent:</b>	5 m <sup>2</sup>	
<b>Comments:</b> To rooms 1.14, 1.16 and above double doors leading to cox building

<b>Material Assessment Total Score: 0</b>		<b>Likelihood of Disturbance Assessment Total Score: 0</b>		<b>Management Assessment</b>  <b>Licensable:</b> Yes  <b>Recommendations:</b> Not Applicable  <b>Reinspection Interval:</b> Not Applicable  <b>Overall Risk Category:</b> E0
<b>Product Type:</b>	0 Not Applicable	<b>Location:</b>	0 Not Applicable	
<b>Condition:</b>	0 Not Applicable	<b>Accessibility:</b>	0 Not Applicable	
<b>Surface Treatment:</b>	0 Not Applicable			
<b>Asbestos Type:</b>	0 Not Applicable	<b>Extent Score:</b>	0 Not Applicable

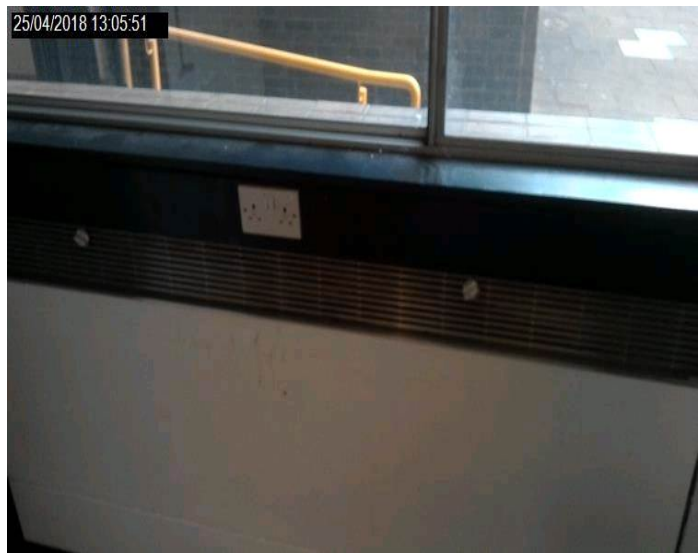
<b>Location:</b>	1.99D	<b>Block:</b>	Commercial	<b>Floor Level:</b> Ground Floor
<b>Sample No.:</b>	As DU001345	<b>Portal Ref No.:</b>	340

<b>Item:</b>	Asbestos Cement window sill			
<b>Asbestos Content:</b>	<b>Result Based on:</b>			
Chrysotile	Strongly presumed			
<b>Sample Analysed By:</b>	Not applicable	<b>Extent:</b>	3 linear metres	
<b>Comments:</b>

<b>Material Assessment Total Score: 4</b>		<b>Likelihood of Disturbance Assessment Total Score: 4</b>		<b>Management Assessment</b>  <b>Licensable:</b> No  <b>Recommendations:</b> Program removal  <b>Reinspection Interval:</b> Not Applicable  <b>Overall Risk Category:</b> C8
<b>Product Type:</b>	1 (Asbestos cement)	<b>Location:</b>	2 (Rooms up to 100 sq m)	
<b>Condition:</b>	1 (Minor scratches)	<b>Accessibility:</b>	1 (Occasionally likely to be disturbed)	
<b>Surface Treatment:</b>	1 (Encapsulated asbestos cement)			
<b>Asbestos Type:</b>	1 (Chrysotile)	<b>Extent Score:</b>	1 (<10 sq m or 10m pipe run)

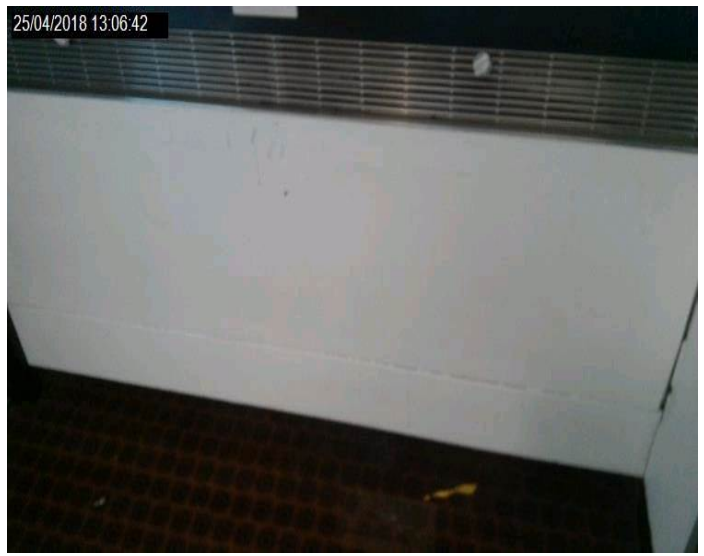
<b>Location:</b>	1.99D	<b>Block:</b>	Commercial	<b>Floor Level:</b> Ground Floor
<b>Sample No.:</b>	As DU001346	<b>Portal Ref No.:</b>	341

<b>Item:</b>	Asbestos Cement shuttering			
<b>Asbestos Content:</b>	<b>Result Based on:</b>			
Chrysotile	Strongly presumed			
<b>Sample Analysed By:</b>	Not applicable	<b>Extent:</b>	2 m <sup>2</sup>	
<b>Comments:</b> To the ceiling of wall void to the heating system

<b>Material Assessment Total Score: 4</b>		<b>Likelihood of Disturbance Assessment Total Score: 4</b>		<b>Management Assessment</b>  <b>Licensable:</b> No  <b>Recommendations:</b> Program removal  <b>Reinspection Interval:</b> Not Applicable  <b>Overall Risk Category:</b> C8
<b>Product Type:</b>	1 (Asbestos cement)	<b>Location:</b>	2 (Rooms up to 100 sq m)	
<b>Condition:</b>	1 (Minor scratches)	<b>Accessibility:</b>	1 (Occasionally likely to be disturbed)	
<b>Surface Treatment:</b>	1 (Encapsulated asbestos cement)			
<b>Asbestos Type:</b>	1 (Chrysotile)	<b>Extent Score:</b>	1 (<10 sq m or 10m pipe run)

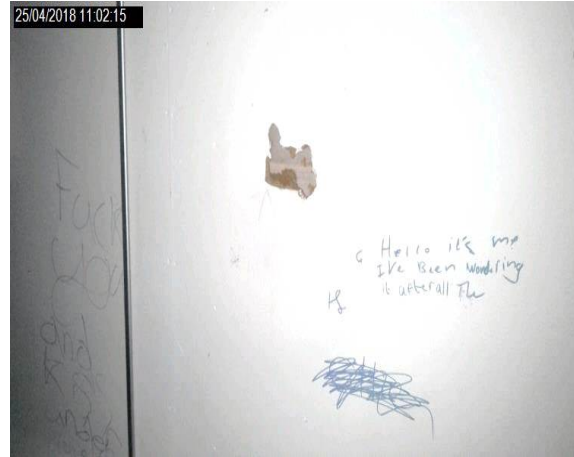
Intrusion 27 - Gyproc door header panel

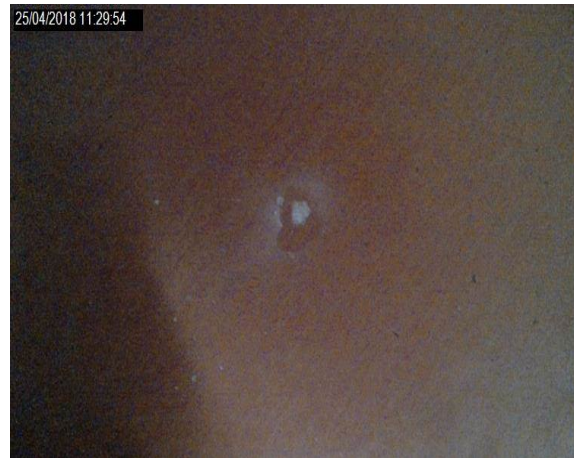
Intrusion 29 - Wall vent removed
