Report No.: J094099
Nature of Work: Demolition Survey
Issue Date: 11/06/2018
Client Name: WYG Engineering Ltd
Geneva Building, Lake View Drive, Sherwood Business Park,
Annesley, Nottingham, NG15 0ED
Site Address: Dawson building, Former City North Campus, Birmingham City
University, Perry Barr, B42 2US

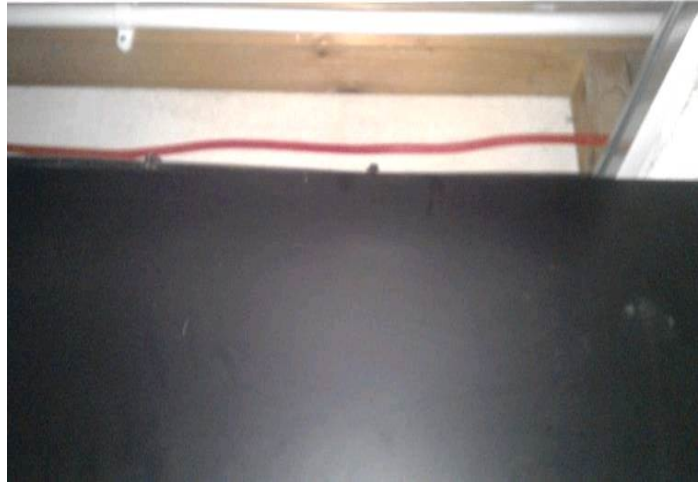
Location:	1.99	Block:	University	Floor Level: Ground Floor
Sample No.:	DU001354	Portal Ref No.:	1	27/04/2018 08:48:34
Item:	Insulating board fillet strip above sliding doors			
Asbestos Content:	Result Based on:

No Asbestos Detected	Analysis of sample using PLM			
Sample Analysed By: Reg 13(1)	Extent:	6 linear metres		
Comments: Both sliding doors parallel to Cox building entrance

Material Assessment Total Score: 0		Likelihood of Disturbance Assessment Total Score: 0		Management Assessment Licensable: Yes Recommendations: Not Applicable Reinspection Interval: Not Applicable Overall Risk Category: E0
Product Type:	0 Not Applicable	Location:	0 Not Applicable	
Condition:	0 Not Applicable	Accessibility:	0 Not Applicable	
Surface Treatment:	0 Not Applicable			
Asbestos Type:	0 Not Applicable	Extent Score:	0 Not Applicable

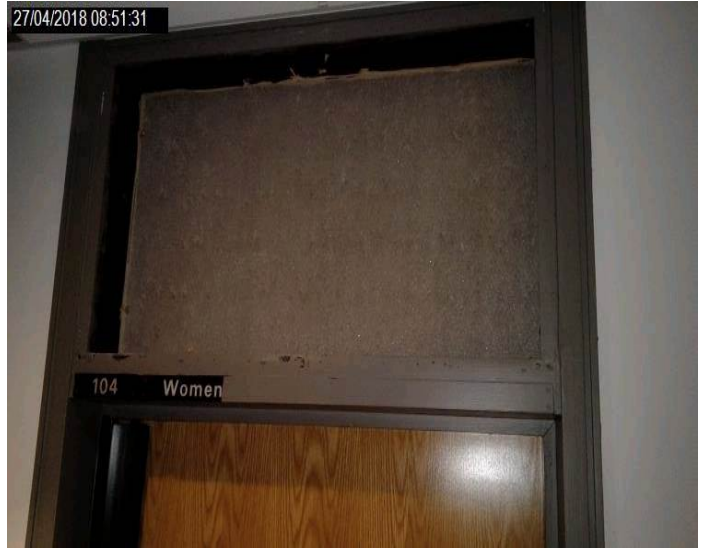
Location:	1.99	Block:	University	Floor Level: Ground Floor
Sample No.:	DU001355	Portal Ref No.:	3

Item:	Insulating board door header panels			
Asbestos Content:		Result Based on:		
No Asbestos Detected		Analysis of sample using PLM		
Sample Analysed By:	Reg 13(1)	Extent:	3 m ²	
Comments: Leading to rooms 1.02, 1.03 and 1.04

Material Assessment Total Score: 0		Likelihood of Disturbance Assessment Total Score: 0		Management Assessment Licensable: Yes Recommendations: Not Applicable Reinspection Interval: Not Applicable Overall Risk Category: E0
Product Type:	0 Not Applicable	Location:	0 Not Applicable	
Condition:	0 Not Applicable	Accessibility:	0 Not Applicable	
Surface Treatment:	0 Not Applicable			
Asbestos Type:	0 Not Applicable	Extent Score:	0 Not Applicable

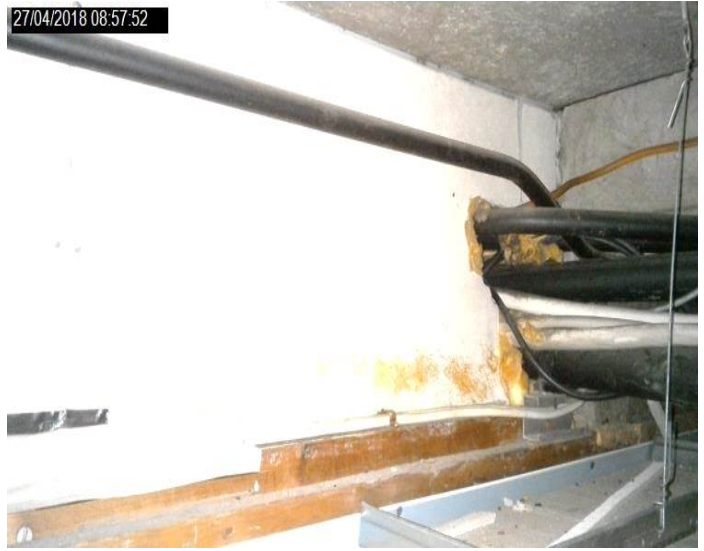
Location:	1.99	Block:	University	Floor Level: Ground Floor
Sample No.:	DU001357	Portal Ref No.:	6

Item:	Insulating board fillet above red sliding doors			
Asbestos Content:		Result Based on:		
No Asbestos Detected		Analysis of sample using PLM		
Sample Analysed By:	Reg 13(1)	Extent:	6 linear metres	
Comments: Both entrances to dawson building red sliding doors

Material Assessment Total Score: 0		Likelihood of Disturbance Assessment Total Score: 0		Management Assessment Licensable: Yes Recommendations: Not Applicable Reinspection Interval: Not Applicable Overall Risk Category: E0
Product Type:	0 Not Applicable	Location:	0 Not Applicable	
Condition:	0 Not Applicable	Accessibility:	0 Not Applicable	
Surface Treatment:	0 Not Applicable			
Asbestos Type:	0 Not Applicable	Extent Score:	0 Not Applicable

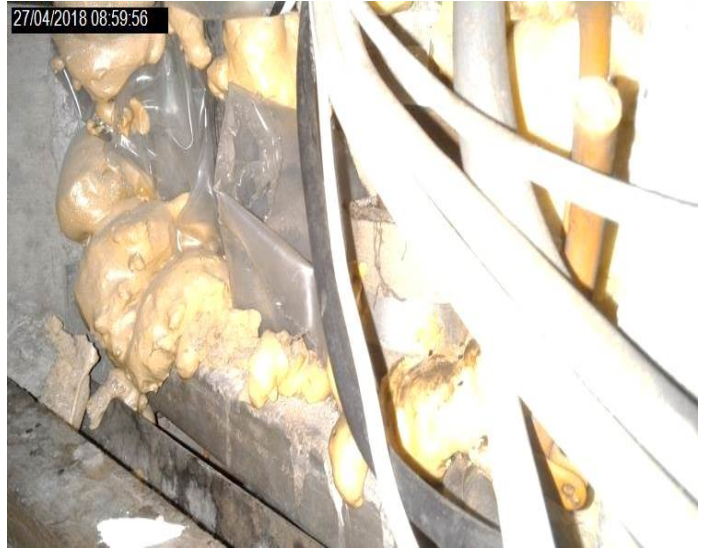
Location:	1.99	Block:	University	Floor Level: Ground Floor
Sample No.:	DU001358	Portal Ref No.:	7

Item:	Asbestos Insulating board debris within riser			
Asbestos Content:	Result Based on:			
Chrysotile Amosite	Analysis of sample using PLM			
Sample Analysed By: Reg 13(1)	Extent:	1 m ²		
Comments: Evidence of removal work taking place previously, potential for more insulating board to be present within the riser

Material Assessment Total Score: 9		Likelihood of Disturbance Assessment Total Score: 4		Management Assessment Licensable: Yes Recommendations: Program removal Reinspection Interval: Not Applicable Overall Risk Category: B13
Product Type:	2 (Asbestos insulating board)	Location:	2 (Rooms up to 100 sq m)	
Condition:	3 (Significant damage)	Accessibility:	1 (Occasionally likely to be disturbed)	
Surface Treatment:	2 (Unencapsulated asbestos insulating board)			
Asbestos Type:	2 (Chrysotile Amosite)	Extent Score:	1 (<10 sq m or 10m pipe run)

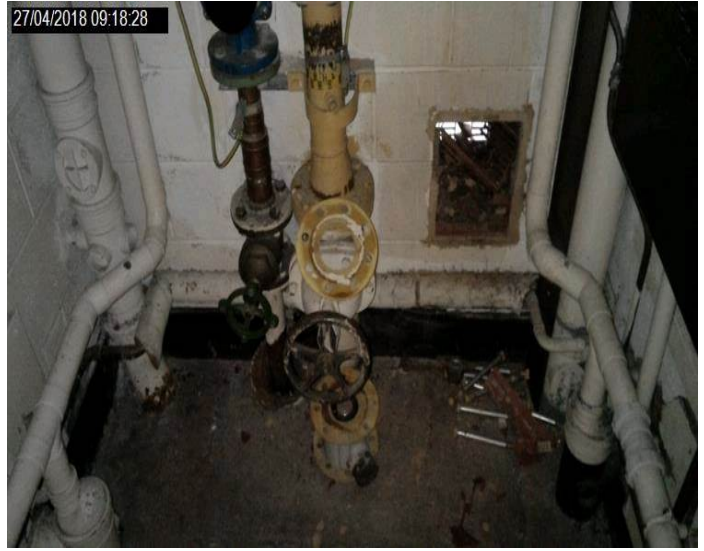
Location:	1.01A	Block:	University	Floor Level: Ground Floor
Sample No.:	DU001359	Portal Ref No.:	14

Item:	Compressed fibre gasket debris and to pipework			
Asbestos Content:		Result Based on:		
No Asbestos Detected		Analysis of sample using PLM		
Sample Analysed By:	Reg 13(1)	Extent:	6 units	
Comments: To gas pipework only

Material Assessment Total Score: 0		Likelihood of Disturbance Assessment Total Score: 0		Management Assessment Licensable: No Recommendations: Not Applicable Reinspection Interval: Not Applicable Overall Risk Category: E0
Product Type:	0 Not Applicable	Location:	0 Not Applicable	
Condition:	0 Not Applicable	Accessibility:	0 Not Applicable	
Surface Treatment:	0 Not Applicable			
Asbestos Type:	0 Not Applicable	Extent Score:	0 Not Applicable

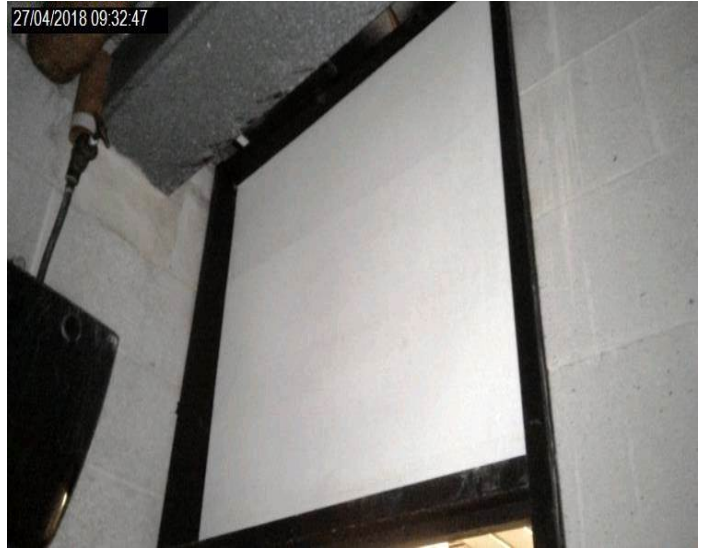
Location:	1.05	Block:	University	Floor Level: Ground Floor
Sample No.:	DU001361	Portal Ref No.:	20

Item:	Asbestos Insulating board door header panel			
Asbestos Content:	Result Based on:			
Amosite	Analysis of sample using PLM			
Sample Analysed By: Reg 13(1)	Extent:	1 m ²		
Comments: Board is loose

Material Assessment Total Score: 7		Likelihood of Disturbance Assessment Total Score: 5		Management Assessment Licensable: Yes Recommendations: Program removal Reinspection Interval: Not Applicable Overall Risk Category: B12
Product Type:	2 (Asbestos insulating board)	Location:	2 (Rooms up to 100 sq m)	
Condition:	1 (Minor scratches)	Accessibility:	2 (Easily disturbed)	
Surface Treatment:	2 (Unencapsulated asbestos insulating board)			
Asbestos Type:	2 (Amosite)	Extent Score:	1 (<10 sq m or 10m pipe run)

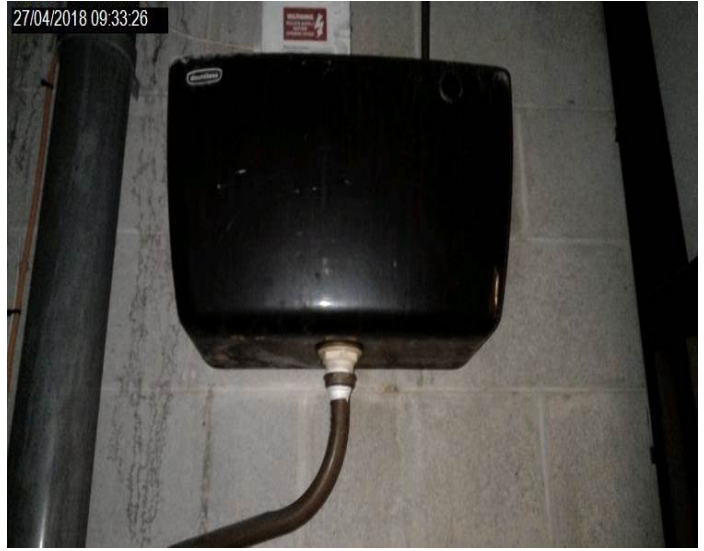
Location:	1.05	Block:	University	Floor Level: Ground Floor
Sample No.:	DU001362	Portal Ref No.:	21

Item:	Asbestos Reinforced plastic cistern			
Asbestos Content:	Result Based on:			
Amosite	Analysis of sample using PLM			
Sample Analysed By:	Reg 13(1)	Extent:	1 unit	
Comments:

Material Assessment Total Score: 4		Likelihood of Disturbance Assessment Total Score: 4		Management Assessment Licensable: No Recommendations: Program removal Reinspection Interval: Not Applicable Overall Risk Category: C8
Product Type:	1 (Asbestos reinforced plastic)	Location:	2 (Rooms up to 100 sq m)	
Condition:	1 (Minor scratches)	Accessibility:	1 (Occasionally likely to be disturbed)	
Surface Treatment:	0 (Composite material)			
Asbestos Type:	2 (Amosite)	Extent Score:	1 (<10 sq m or 10m pipe run)

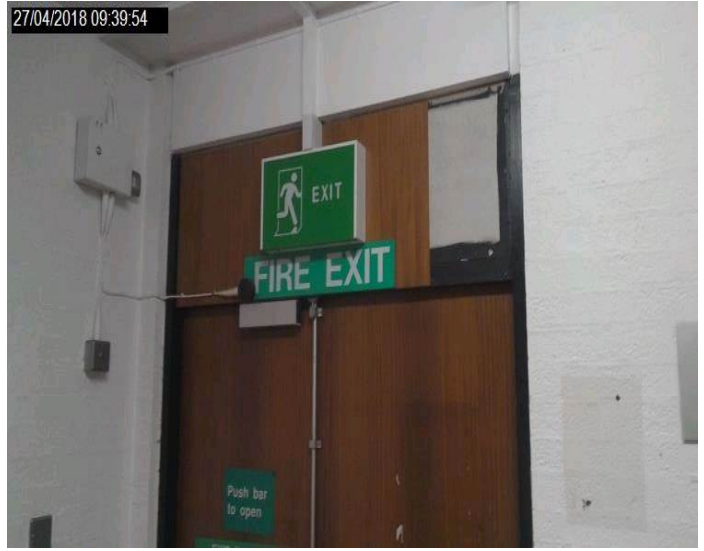
Location:	1.00	Block:	University	Floor Level: Ground Floor
Sample No.:	DU001363	Portal Ref No.:	23

Item:	Asbestos Insulating board door header panel			
Asbestos Content:	Result Based on:			
Chrysotile Amosite	Analysis of sample using PLM			
Sample Analysed By: Reg 13(1)	Extent:	4 m ²		
Comments: Double skin, to fire exit door

Material Assessment Total Score: 7		Likelihood of Disturbance Assessment Total Score: 4		Management Assessment Licensable: Yes Recommendations: Program removal Reinspection Interval: Not Applicable Overall Risk Category: B11
Product Type:	2 (Asbestos insulating board)	Location:	2 (Rooms up to 100 sq m)	
Condition:	1 (Minor scratches)	Accessibility:	1 (Occasionally likely to be disturbed)	
Surface Treatment:	2 (Unencapsulated asbestos insulating board)			
Asbestos Type:	2 (Chrysotile Amosite)	Extent Score:	1 (<10 sq m or 10m pipe run)

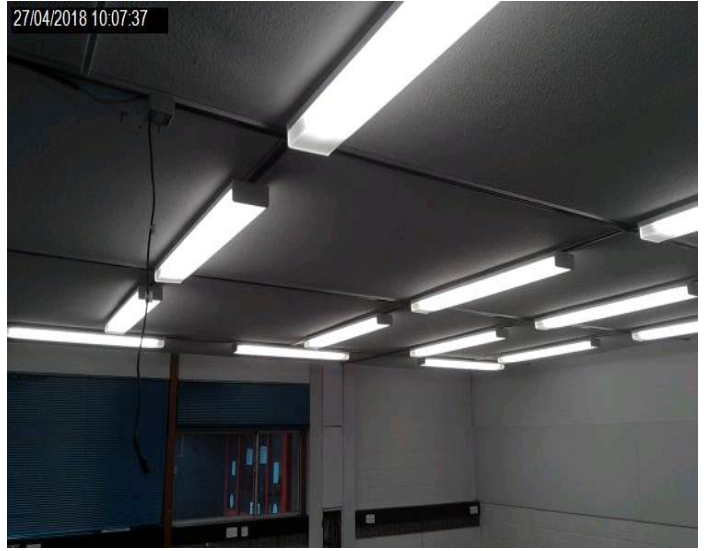
Location:	1.25	Block:	University	Floor Level: Ground Floor
Sample No.:	As DU001366	Portal Ref No.:	29

Item:	Asbestos Textured coating to concrete ceiling			
Asbestos Content:	Result Based on:			
Chrysotile	Strongly presumed			
Sample Analysed By:	Not applicable	Extent:	56 m ²	
Comments:

Material Assessment Total Score: 3		Likelihood of Disturbance Assessment Total Score: 6		Management Assessment Licensable: No Recommendations: Program removal Reinspection Interval: Not Applicable Overall Risk Category: C9
Product Type:	1 (Asbestos textured coating)	Location:	2 (Rooms up to 100 sq m)	
Condition:	1 (Minor scratches)	Accessibility:	1 (Occasionally likely to be disturbed)	
Surface Treatment:	0 (Composite material)			
Asbestos Type:	1 (Chrysotile)	Extent Score:	3 (>50 sq m or >50m pipe run)

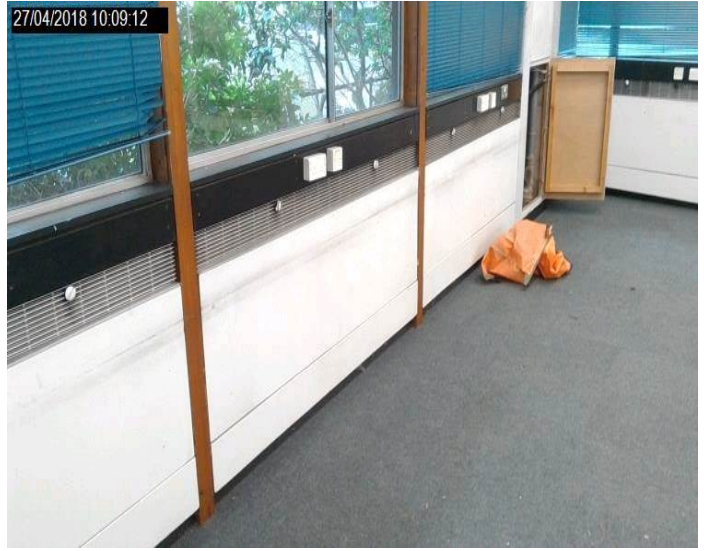
Location:	1.25	Block:	University	Floor Level: Ground Floor
Sample No.:	DU001368	Portal Ref No.:	31

Item:	Asbestos Cement window sill			
Asbestos Content:	Result Based on:			
Chrysotile	Analysis of sample using PLM			
Sample Analysed By: Reg 13(1)	Extent:	16 linear metres		
Comments:

Material Assessment Total Score: 4		Likelihood of Disturbance Assessment Total Score: 5		Management Assessment Licensable: No Recommendations: Program removal Reinspection Interval: Not Applicable Overall Risk Category: C9
Product Type:	1 (Asbestos cement)	Location:	2 (Rooms up to 100 sq m)	
Condition:	1 (Minor scratches)	Accessibility:	1 (Occasionally likely to be disturbed)	
Surface Treatment:	1 (Unencapsulated asbestos cement)			
Asbestos Type:	1 (Chrysotile)	Extent Score:	2 (>10 - <50 sq m or >10m - <50m pipe run)

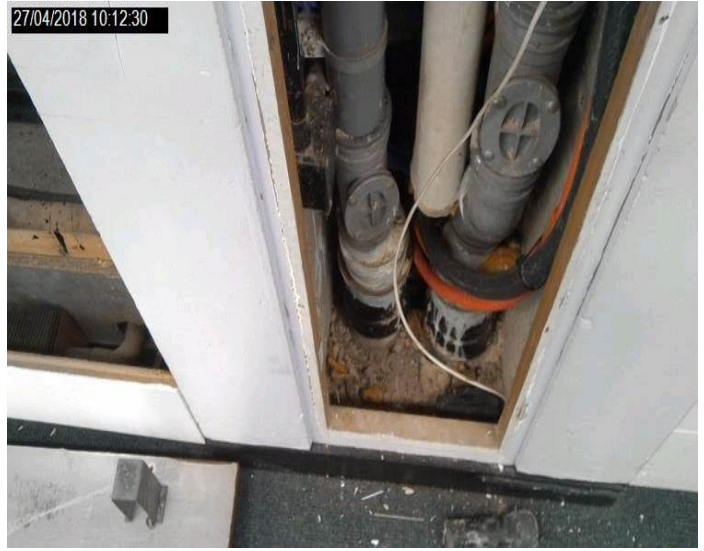
Location:	1.25	Block:	University	Floor Level: Ground Floor
Sample No.:	DU001370	Portal Ref No.:	33

Item:	Asbestos Insulating board debris to base of riser			
Asbestos Content:	Result Based on:			
Chrysotile Amosite	Analysis of sample using PLM			
Sample Analysed By: Reg 13(1)	Extent:	1 m ²		
Comments: The whole riser area should be presumed to be contaminated.

Material Assessment Total Score: 9		Likelihood of Disturbance Assessment Total Score: 4		Management Assessment Licensable: Yes Recommendations: Program removal Reinspection Interval: Not Applicable Overall Risk Category: B13
Product Type:	2 (Asbestos insulating board)	Location:	2 (Rooms up to 100 sq m)	
Condition:	3 (Significant damage)	Accessibility:	1 (Occasionally likely to be disturbed)	
Surface Treatment:	2 (Unencapsulated asbestos insulating board)			
Asbestos Type:	2 (Chrysotile Amosite)	Extent Score:	1 (<10 sq m or 10m pipe run)

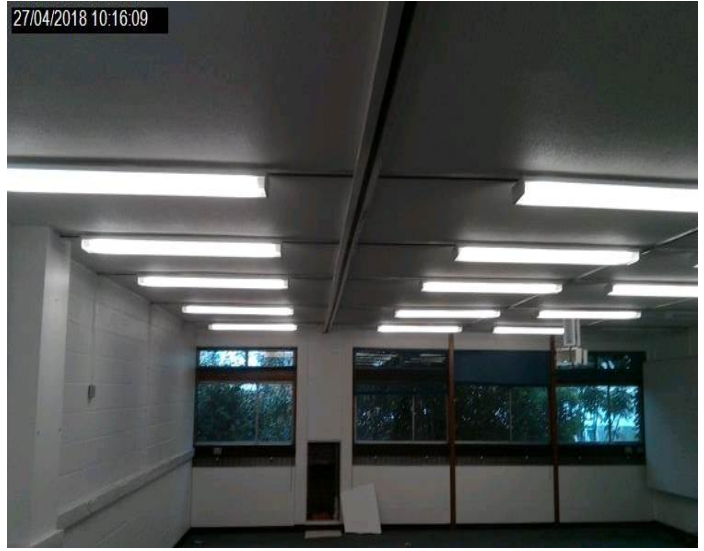
Location:	1.24	Block:	University	Floor Level: Ground Floor
Sample No.:	As DU001366	Portal Ref No.:	34

Item:	Asbestos Textured coating to concrete ceiling			
Asbestos Content:	Result Based on:			
Chrysotile	Strongly presumed			
Sample Analysed By:	Not applicable	Extent:	88 m ²	
Comments:

Material Assessment Total Score: 3		Likelihood of Disturbance Assessment Total Score: 6		Management Assessment Licensable: No Recommendations: Program removal Reinspection Interval: Not Applicable Overall Risk Category: C9
Product Type:	1 (Asbestos textured coating)	Location:	2 (Rooms up to 100 sq m)	
Condition:	1 (Minor scratches)	Accessibility:	1 (Occasionally likely to be disturbed)	
Surface Treatment:	0 (Composite material)			
Asbestos Type:	1 (Chrysotile)	Extent Score:	3 (>50 sq m or >50m pipe run)

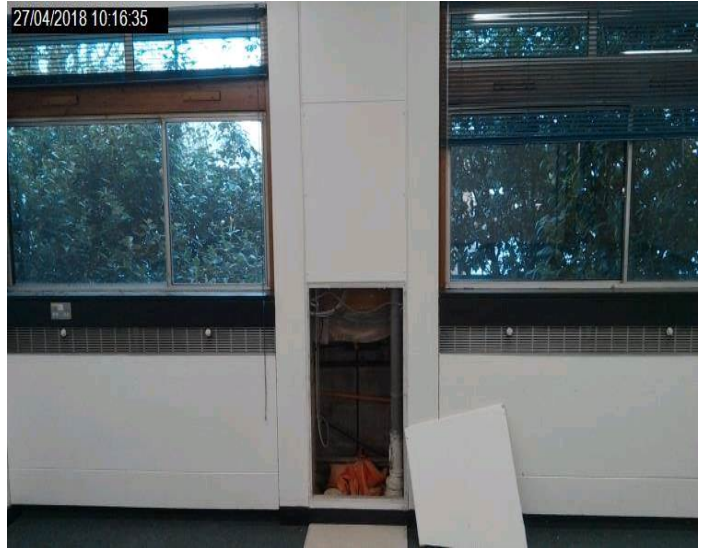
Location:	1.24	Block:	University	Floor Level: Ground Floor
Sample No.:	As DU001367	Portal Ref No.:	35

Item:	Insulating board panels to risers			
Asbestos Content:		Result Based on:		
No Asbestos Detected		Strongly presumed		
Sample Analysed By:	Not applicable	Extent:	3 m ²	
Comments: 1 x riser

Material Assessment Total Score: 0		Likelihood of Disturbance Assessment Total Score: 0		Management Assessment Licensable: Yes Recommendations: Not Applicable Reinspection Interval: Not Applicable Overall Risk Category: E0
Product Type:	0 Not Applicable	Location:	0 Not Applicable	
Condition:	0 Not Applicable	Accessibility:	0 Not Applicable	
Surface Treatment:	0 Not Applicable			
Asbestos Type:	0 Not Applicable	Extent Score:	0 Not Applicable

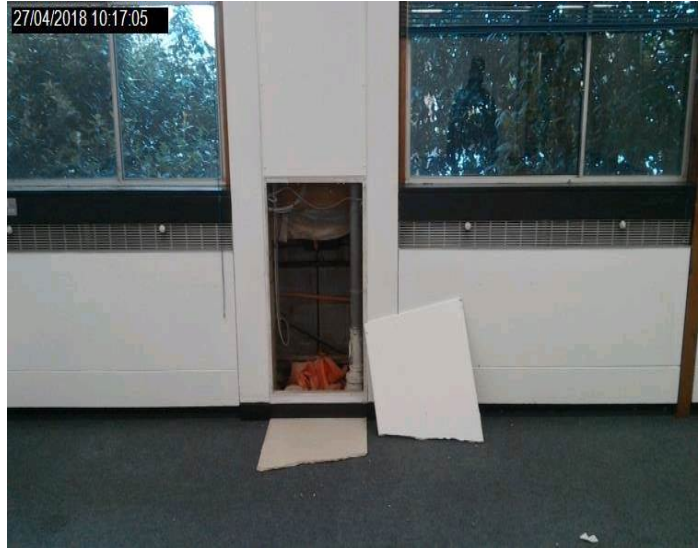
Location:	1.24	Block:	University	Floor Level: Ground Floor
Sample No.:	As DU001368	Portal Ref No.:	36

Item:	Asbestos Cement window sill			
Asbestos Content:	Result Based on:			
Chrysotile	Strongly presumed			
Sample Analysed By:	Not applicable	Extent:	8 linear metres	
Comments:

Material Assessment Total Score: 4		Likelihood of Disturbance Assessment Total Score: 4		Management Assessment Licensable: No Recommendations: Program removal Reinspection Interval: Not Applicable Overall Risk Category: C8
Product Type:	1 (Asbestos cement)	Location:	2 (Rooms up to 100 sq m)	
Condition:	1 (Minor scratches)	Accessibility:	1 (Occasionally likely to be disturbed)	
Surface Treatment:	1 (Unencapsulated asbestos cement)			
Asbestos Type:	1 (Chrysotile)	Extent Score:	1 (<10 sq m or 10m pipe run)

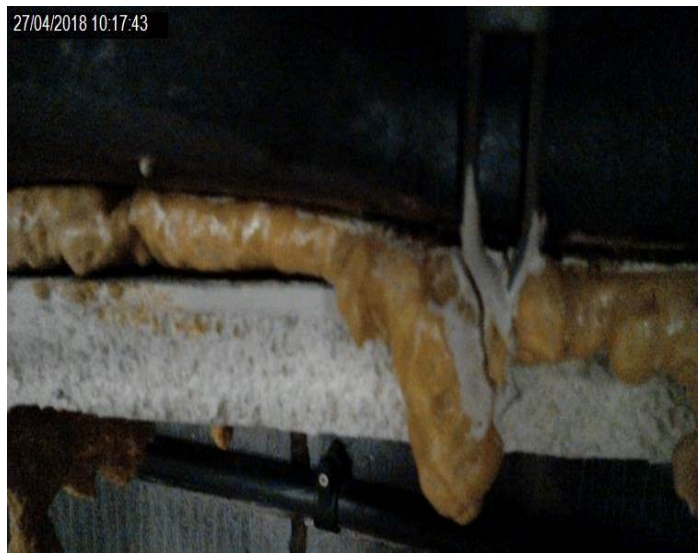
Location:	1.24	Block:	University	Floor Level: Ground Floor
Sample No.:	As DU001369	Portal Ref No.:	37

Item:	Asbestos Cement shuttering			
Asbestos Content:	Result Based on:			
Chrysotile	Strongly presumed			
Sample Analysed By:	Not applicable	Extent:	8 m ²	
Comments: To ceiling of wall void behind polystyrene sheets

Material Assessment Total Score: 4		Likelihood of Disturbance Assessment Total Score: 4		Management Assessment Licensable: No Recommendations: Program removal Reinspection Interval: Not Applicable Overall Risk Category: C8
Product Type:	1 (Asbestos cement)	Location:	2 (Rooms up to 100 sq m)	
Condition:	1 (Minor scratches)	Accessibility:	1 (Occasionally likely to be disturbed)	
Surface Treatment:	1 (Encapsulated asbestos cement)			
Asbestos Type:	1 (Chrysotile)	Extent Score:	1 (<10 sq m or 10m pipe run)

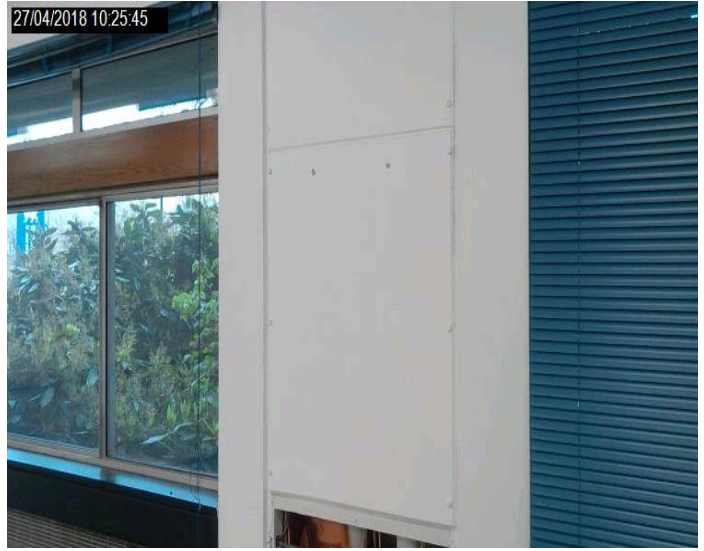
Location:	1.23	Block:	University	Floor Level: Ground Floor
Sample No.:	As DU001367	Portal Ref No.:	39

Item:	Insulating board panels to risers			
Asbestos Content:		Result Based on:		
No Asbestos Detected		Strongly presumed		
Sample Analysed By:	Not applicable	Extent:	3 m ²	
Comments: 1 x riser

Material Assessment Total Score: 0		Likelihood of Disturbance Assessment Total Score: 0		Management Assessment Licensable: Yes Recommendations: Not Applicable Reinspection Interval: Not Applicable Overall Risk Category: E0
Product Type:	0 Not Applicable	Location:	0 Not Applicable	
Condition:	0 Not Applicable	Accessibility:	0 Not Applicable	
Surface Treatment:	0 Not Applicable			
Asbestos Type:	0 Not Applicable	Extent Score:	0 Not Applicable

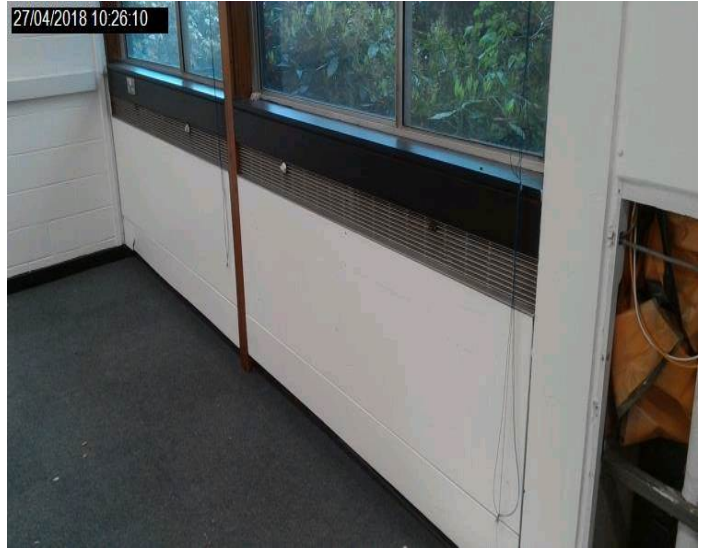
Location:	1.23	Block:	University	Floor Level: Ground Floor
Sample No.:	As DU001368	Portal Ref No.:	40

Item:	Asbestos Cement window sill			
Asbestos Content:	Result Based on:			
Chrysotile	Strongly presumed			
Sample Analysed By:	Not applicable	Extent:	8 linear metres	
Comments:

Material Assessment Total Score: 4		Likelihood of Disturbance Assessment Total Score: 4		Management Assessment Licensable: No Recommendations: Program removal Reinspection Interval: Not Applicable Overall Risk Category: C8
Product Type:	1 (Asbestos cement)	Location:	2 (Rooms up to 100 sq m)	
Condition:	1 (Minor scratches)	Accessibility:	1 (Occasionally likely to be disturbed)	
Surface Treatment:	1 (Unencapsulated asbestos cement)			
Asbestos Type:	1 (Chrysotile)	Extent Score:	1 (<10 sq m or 10m pipe run)

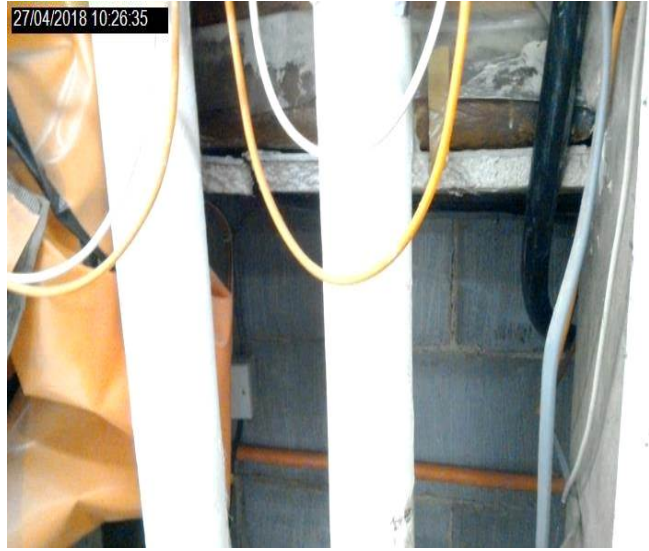
Location:	1.23	Block:	University	Floor Level: Ground Floor
Sample No.:	As DU001369	Portal Ref No.:	41

Item:	Asbestos Cement shuttering			
Asbestos Content:	Result Based on:			
Chrysotile	Strongly presumed			
Sample Analysed By:	Not applicable	Extent:	8 m ²	
Comments: To ceiling of wall void behind polystyrene sheets

Material Assessment Total Score: 4		Likelihood of Disturbance Assessment Total Score: 4		Management Assessment Licensable: No Recommendations: Program removal Reinspection Interval: Not Applicable Overall Risk Category: C8
Product Type:	1 (Asbestos cement)	Location:	2 (Rooms up to 100 sq m)	
Condition:	1 (Minor scratches)	Accessibility:	1 (Occasionally likely to be disturbed)	
Surface Treatment:	1 (Encapsulated asbestos cement)			
Asbestos Type:	1 (Chrysotile)	Extent Score:	1 (<10 sq m or 10m pipe run)

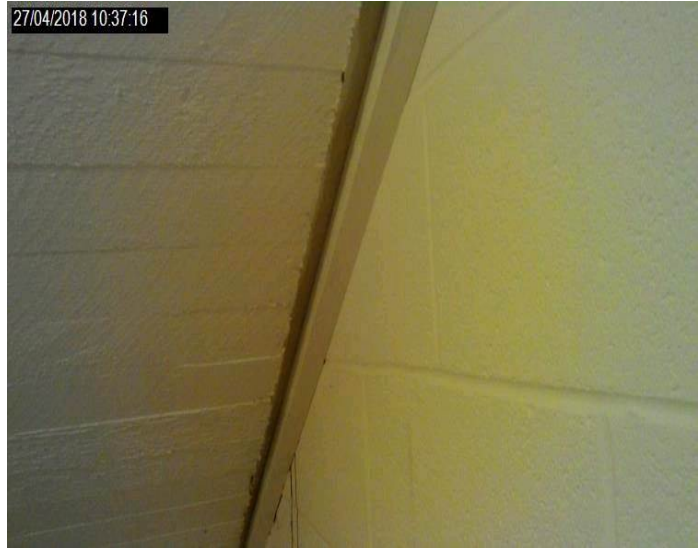
Location:	1.22A	Block:	University	Floor Level: Ground Floor
Sample No.:	DU001373	Portal Ref No.:	45

Item:	Insulating board infill to concrete stairs			
Asbestos Content:		Result Based on:		
No Asbestos Detected		Analysis of sample using PLM		
Sample Analysed By:	Reg 13(1)	Extent:	6 linear metres	
Comments: Both sides of stairs

Material Assessment Total Score: 0		Likelihood of Disturbance Assessment Total Score: 0		Management Assessment Licensable: Yes Recommendations: Not Applicable Reinspection Interval: Not Applicable Overall Risk Category: E0
Product Type:	0 Not Applicable	Location:	0 Not Applicable	
Condition:	0 Not Applicable	Accessibility:	0 Not Applicable	
Surface Treatment:	0 Not Applicable			
Asbestos Type:	0 Not Applicable	Extent Score:	0 Not Applicable

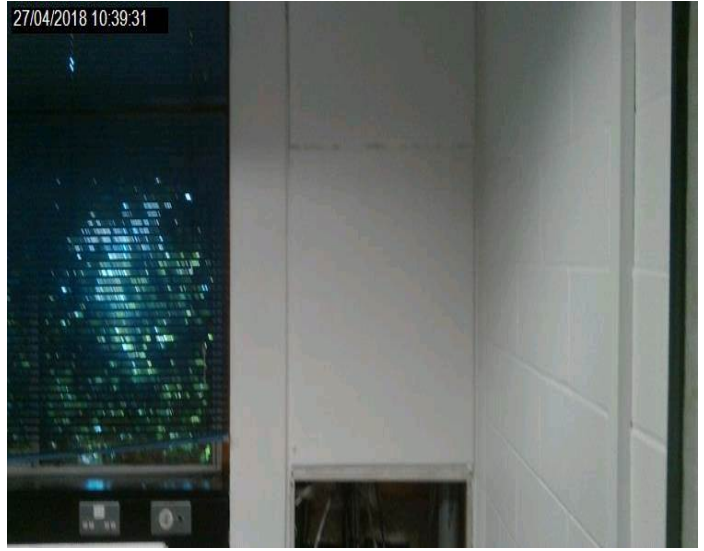
Location:	1.22	Block:	University	Floor Level: Ground Floor
Sample No.:	As DU001367	Portal Ref No.:	47

Item:	Insulating board panels to risers			
Asbestos Content:		Result Based on:		
No Asbestos Detected		Strongly presumed		
Sample Analysed By:	Not applicable	Extent:	3 m ²	
Comments: 1 x riser

Material Assessment Total Score: 0		Likelihood of Disturbance Assessment Total Score: 0		Management Assessment Licensable: Yes Recommendations: Not Applicable Reinspection Interval: Not Applicable Overall Risk Category: E0
Product Type:	0 Not Applicable	Location:	0 Not Applicable	
Condition:	0 Not Applicable	Accessibility:	0 Not Applicable	
Surface Treatment:	0 Not Applicable			
Asbestos Type:	0 Not Applicable	Extent Score:	0 Not Applicable

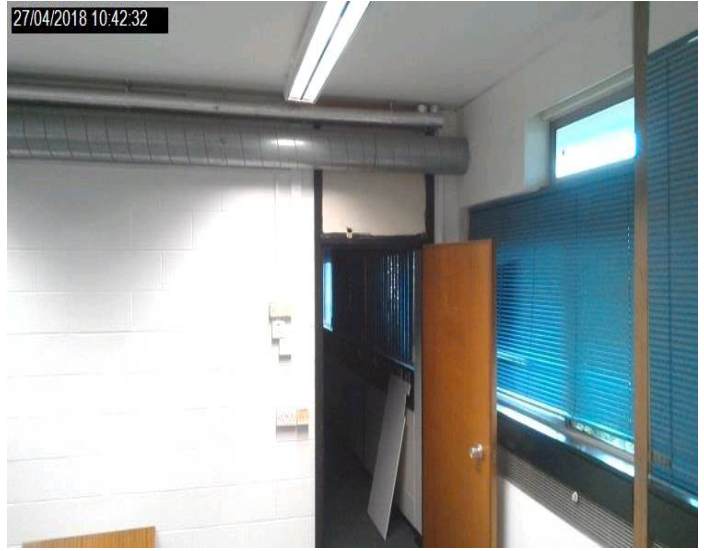
Location:	1.22	Block:	University	Floor Level: Ground Floor
Sample No.:	DU001375	Portal Ref No.:	51

Item:	Insulating board door header panel			
Asbestos Content:		Result Based on:		
No Asbestos Detected		Analysis of sample using PLM		
Sample Analysed By:	Reg 13(1)	Extent:	1 m ²	
Comments:

Material Assessment Total Score: 0		Likelihood of Disturbance Assessment Total Score: 0		Management Assessment Licensable: Yes Recommendations: Not Applicable Reinspection Interval: Not Applicable Overall Risk Category: E0
Product Type:	0 Not Applicable	Location:	0 Not Applicable	
Condition:	0 Not Applicable	Accessibility:	0 Not Applicable	
Surface Treatment:	0 Not Applicable			
Asbestos Type:	0 Not Applicable	Extent Score:	0 Not Applicable

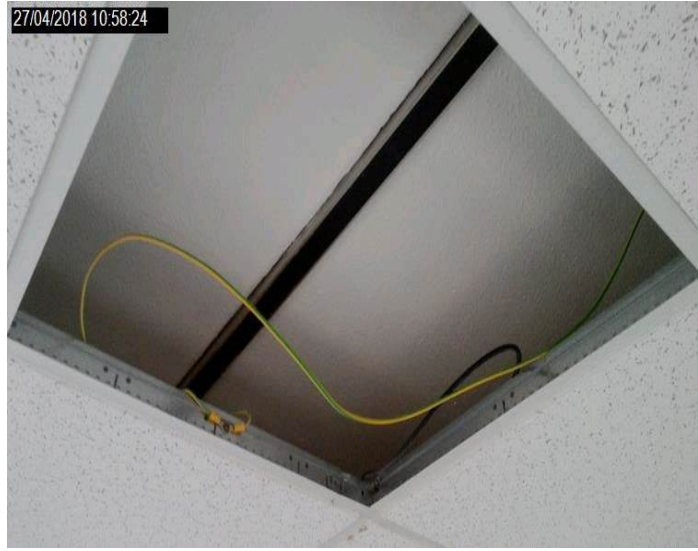
Location:	1.21	Block:	University	Floor Level: Ground Floor
Sample No.:	As DU001366	Portal Ref No.:	53

Item:	Asbestos Textured coating to concrete ceiling			
Asbestos Content:	Result Based on:			
Chrysotile	Strongly presumed			
Sample Analysed By:	Not applicable	Extent:	64 m ²	
Comments:

Material Assessment Total Score: 3		Likelihood of Disturbance Assessment Total Score: 6		Management Assessment Licensable: No Recommendations: Program removal Reinspection Interval: Not Applicable Overall Risk Category: C9
Product Type:	1 (Asbestos textured coating)	Location:	2 (Rooms up to 100 sq m)	
Condition:	1 (Minor scratches)	Accessibility:	1 (Occasionally likely to be disturbed)	
Surface Treatment:	0 (Composite material)			
Asbestos Type:	1 (Chrysotile)	Extent Score:	3 (>50 sq m or >50m pipe run)

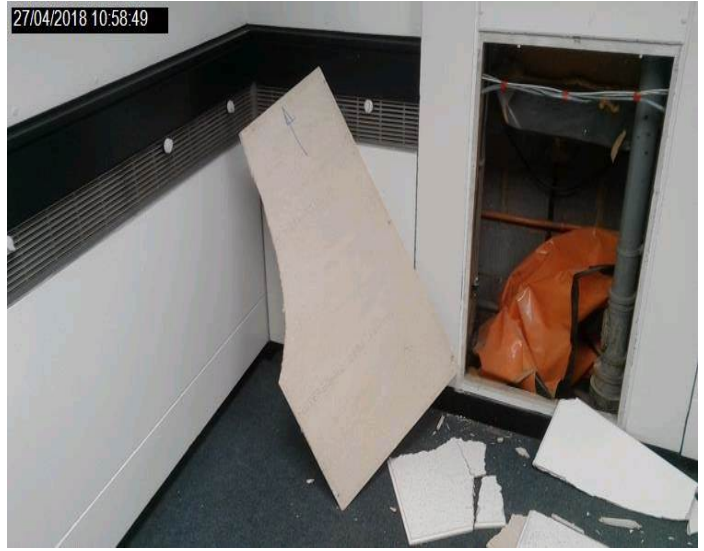
Location:	1.21	Block:	University	Floor Level: Ground Floor
Sample No.:	As DU001367	Portal Ref No.:	54

Item:	Insulating board panels to risers			
Asbestos Content:		Result Based on:		
No Asbestos Detected		Strongly presumed		
Sample Analysed By:	Not applicable	Extent:	5 m ²	
Comments: 2 x risers

Material Assessment Total Score: 0		Likelihood of Disturbance Assessment Total Score: 0		Management Assessment Licensable: Yes Recommendations: Not Applicable Reinspection Interval: Not Applicable Overall Risk Category: E0
Product Type:	0 Not Applicable	Location:	0 Not Applicable	
Condition:	0 Not Applicable	Accessibility:	0 Not Applicable	
Surface Treatment:	0 Not Applicable			
Asbestos Type:	0 Not Applicable	Extent Score:	0 Not Applicable

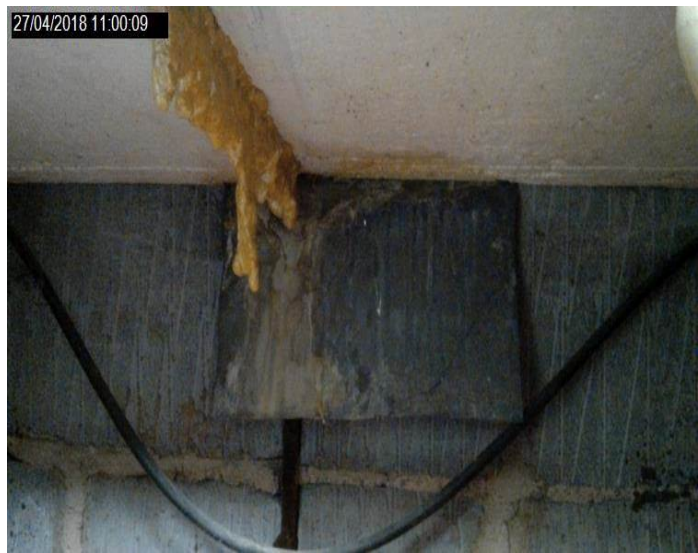
Location:	1.21	Block:	University	Floor Level: Ground Floor
Sample No.:	As DU001369	Portal Ref No.:	56

Item:	Asbestos Cement shuttering			
Asbestos Content:	Result Based on:			
Chrysotile	Strongly presumed			
Sample Analysed By:	Not applicable	Extent:	16 m ²	
Comments: To ceiling of wall void behind polystyrene sheets

Material Assessment Total Score: 4		Likelihood of Disturbance Assessment Total Score: 5		Management Assessment Licensable: No Recommendations: Program removal Reinspection Interval: Not Applicable Overall Risk Category: C9
Product Type:	1 (Asbestos cement)	Location:	2 (Rooms up to 100 sq m)	
Condition:	1 (Minor scratches)	Accessibility:	1 (Occasionally likely to be disturbed)	
Surface Treatment:	1 (Encapsulated asbestos cement)			
Asbestos Type:	1 (Chrysotile)	Extent Score:	2 (>10 - <50 sq m or >10m - <50m pipe run)

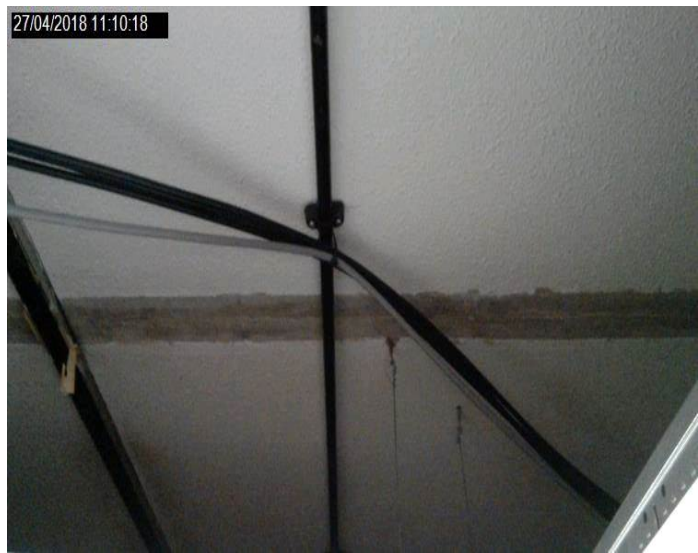
Location:	1.20B	Block:	University	Floor Level: Ground Floor
Sample No.:	DU001377	Portal Ref No.:	61

Item:	Asbestos Textured coating to concrete ceiling			
Asbestos Content:	Result Based on:			
Chrysotile	Analysis of sample using PLM			
Sample Analysed By:	Reg 13(1)	Extent:	25 m ²	
Comments:

Material Assessment Total Score: 3		Likelihood of Disturbance Assessment Total Score: 5		Management Assessment Licensable: No Recommendations: Program removal Reinspection Interval: Not Applicable Overall Risk Category: C8
Product Type:	1 (Asbestos textured coating)	Location:	2 (Rooms up to 100 sq m)	
Condition:	1 (Minor scratches)	Accessibility:	1 (Occasionally likely to be disturbed)	
Surface Treatment:	0 (Composite material)			
Asbestos Type:	1 (Chrysotile)	Extent Score:	2 (>10 - <50 sq m or >10m - <50m pipe run)

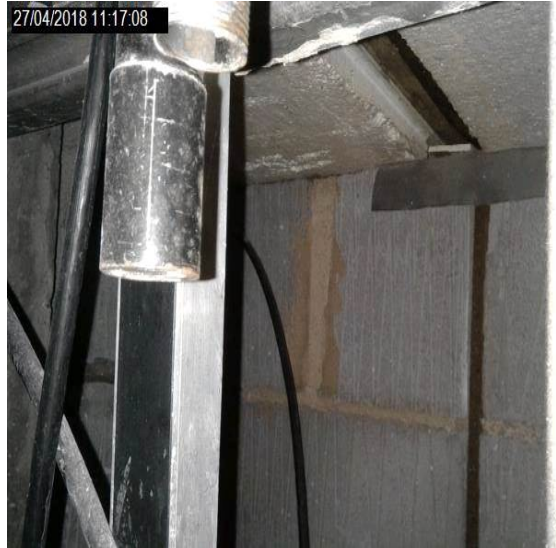
Location:	1.20B	Block:	University	Floor Level: Ground Floor
Sample No.:	DU001380	Portal Ref No.:	64

Item:	Asbestos Cement shuttering			
Asbestos Content:	Result Based on:			
Chrysotile	Analysis of sample using PLM			
Sample Analysed By: Reg 13(1)	Extent:	1 m ²		
Comments: Present within wall heater void

Material Assessment Total Score: 4		Likelihood of Disturbance Assessment Total Score: 4		Management Assessment Licensable: No Recommendations: Program removal Reinspection Interval: Not Applicable Overall Risk Category: C8
Product Type:	1 (Asbestos cement)	Location:	2 (Rooms up to 100 sq m)	
Condition:	1 (Minor scratches)	Accessibility:	1 (Occasionally likely to be disturbed)	
Surface Treatment:	1 (Unencapsulated asbestos cement)			
Asbestos Type:	1 (Chrysotile)	Extent Score:	1 (<10 sq m or 10m pipe run)

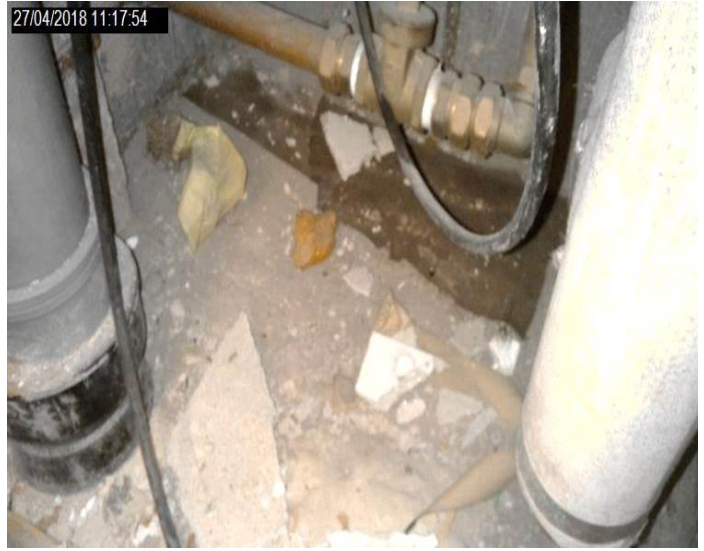
Location:	1.20B	Block:	University	Floor Level: Ground Floor
Sample No.:	DU001381	Portal Ref No.:	65

Item:	Bitumen damp proof course			
Asbestos Content:		Result Based on:		
No Asbestos Detected		Analysis of sample using PLM		
Sample Analysed By:	Reg 13(1)	Extent:	250 linear metres	
Comments: One sample representing the entire perimeter of the floor level, dpc present to the external wall of the wall void

Material Assessment Total Score: 0		Likelihood of Disturbance Assessment Total Score: 0		Management Assessment Licensable: No Recommendations: Not Applicable Reinspection Interval: Not Applicable Overall Risk Category: E0
Product Type:	0 Not Applicable	Location:	0 Not Applicable	
Condition:	0 Not Applicable	Accessibility:	0 Not Applicable	
Surface Treatment:	0 Not Applicable			
Asbestos Type:	0 Not Applicable	Extent Score:	0 Not Applicable

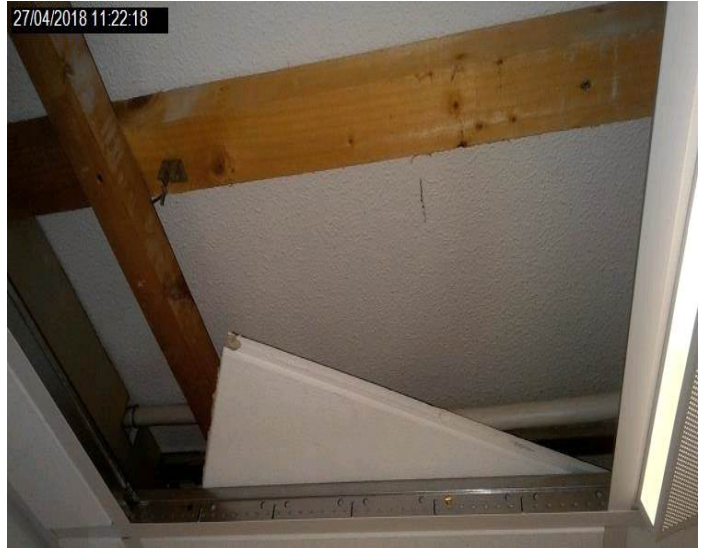
Location:	1.20A	Block:	University	Floor Level: Ground Floor
Sample No.:	As DU001377	Portal Ref No.:	67

Item:	Asbestos Textured coating to concrete ceiling			
Asbestos Content:	Result Based on:			
Chrysotile	Strongly presumed			
Sample Analysed By:	Not applicable	Extent:	4 m ²	
Comments: Present above suspended ceiling

Material Assessment Total Score: 3		Likelihood of Disturbance Assessment Total Score: 4		Management Assessment Licensable: No Recommendations: Program removal Reinspection Interval: Not Applicable Overall Risk Category: C7
Product Type:	1 (Asbestos textured coating)	Location:	2 (Rooms up to 100 sq m)	
Condition:	1 (Minor scratches)	Accessibility:	1 (Occasionally likely to be disturbed)	
Surface Treatment:	0 (Composite material)			
Asbestos Type:	1 (Chrysotile)	Extent Score:	1 (<10 sq m or 10m pipe run)

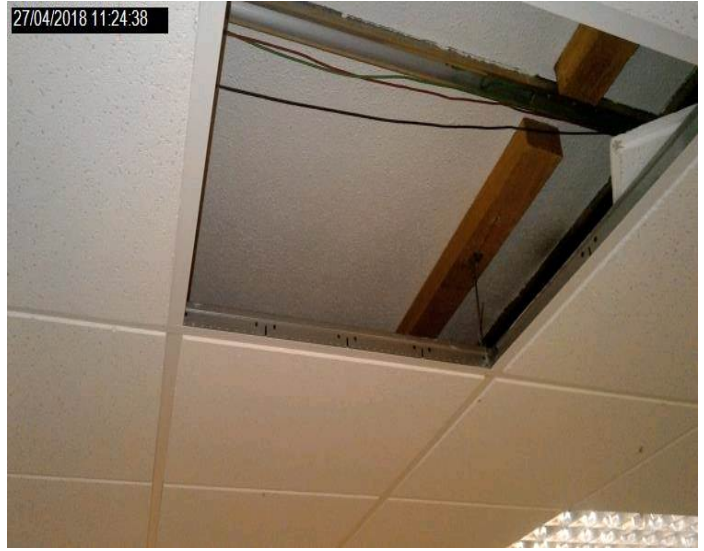
Location:	1.19	Block:	University	Floor Level: Ground Floor
Sample No.:	As DU001377	Portal Ref No.:	73

Item:	Asbestos Textured coating to concrete ceiling			
Asbestos Content:	Result Based on:			
Chrysotile	Strongly presumed			
Sample Analysed By:	Not applicable	Extent:	36 m ²	
Comments: Above suspended tiles

Material Assessment Total Score: 3		Likelihood of Disturbance Assessment Total Score: 5		Management Assessment Licensable: No Recommendations: Program removal Reinspection Interval: Not Applicable Overall Risk Category: C8
Product Type:	1 (Asbestos textured coating)	Location:	2 (Rooms up to 100 sq m)	
Condition:	1 (Minor scratches)	Accessibility:	1 (Occasionally likely to be disturbed)	
Surface Treatment:	0 (Composite material)			
Asbestos Type:	1 (Chrysotile)	Extent Score:	2 (>10 - <50 sq m or >10m - <50m pipe run)

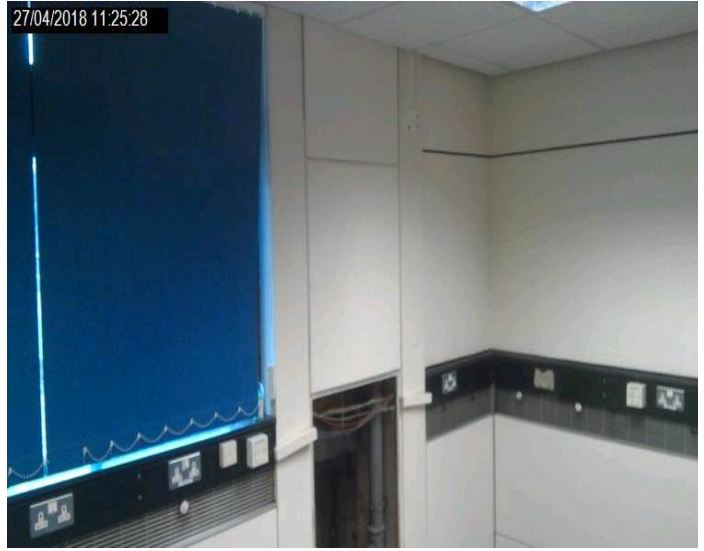
Location:	1.19	Block:	University	Floor Level: Ground Floor
Sample No.:	As DU001378	Portal Ref No.:	74

Item:	Insulating board panels to risers			
Asbestos Content:		Result Based on:		
No Asbestos Detected		Strongly presumed		
Sample Analysed By:	Not applicable	Extent:	6 m ²	
Comments: 2 x risers

Material Assessment Total Score: 0		Likelihood of Disturbance Assessment Total Score: 0		Management Assessment Licensable: Yes Recommendations: Not Applicable Reinspection Interval: Not Applicable Overall Risk Category: E0
Product Type:	0 Not Applicable	Location:	0 Not Applicable	
Condition:	0 Not Applicable	Accessibility:	0 Not Applicable	
Surface Treatment:	0 Not Applicable			
Asbestos Type:	0 Not Applicable	Extent Score:	0 Not Applicable

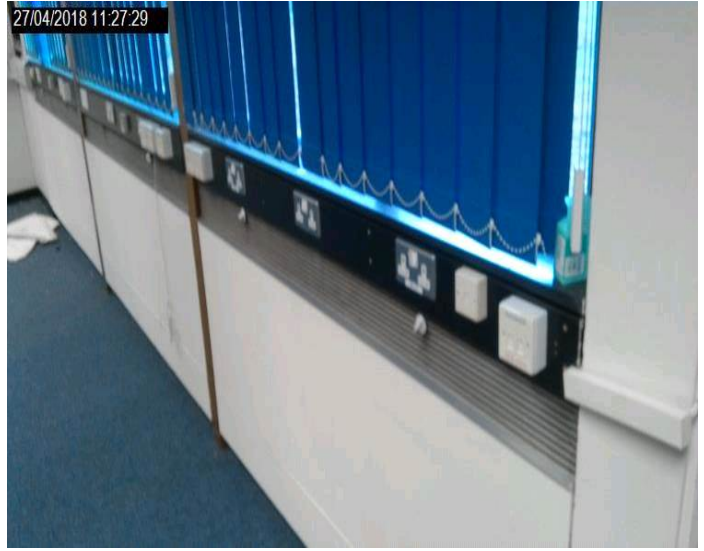
Location:	1.19	Block:	University	Floor Level: Ground Floor
Sample No.:	DU001382	Portal Ref No.:	75

Item:	Asbestos Cement window sill			
Asbestos Content:	Result Based on:			
Chrysotile	Analysis of sample using PLM			
Sample Analysed By:	Reg 13(1)	Extent:	12 linear metres	
Comments:

Material Assessment Total Score: 4		Likelihood of Disturbance Assessment Total Score: 5		Management Assessment Licensable: No Recommendations: Program removal Reinspection Interval: Not Applicable Overall Risk Category: C9
Product Type:	1 (Asbestos cement)	Location:	2 (Rooms up to 100 sq m)	
Condition:	1 (Minor scratches)	Accessibility:	1 (Occasionally likely to be disturbed)	
Surface Treatment:	1 (Unencapsulated asbestos cement)			
Asbestos Type:	1 (Chrysotile)	Extent Score:	2 (>10 - <50 sq m or >10m - <50m pipe run)

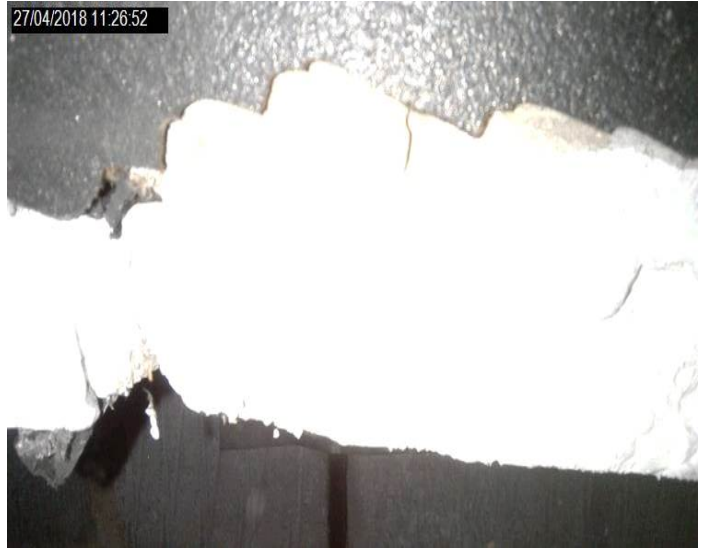
Location:	1.19	Block:	University	Floor Level: Ground Floor
Sample No.:	As DU001380	Portal Ref No.:	76

Item:	Asbestos Cement shuttering			
Asbestos Content:	Result Based on:			
Chrysotile	Strongly presumed			
Sample Analysed By:	Not applicable	Extent:	12 linear metres	
Comments: To ceiling of wall void behind polystyrene sheets

Material Assessment Total Score: 4		Likelihood of Disturbance Assessment Total Score: 5		Management Assessment Licensable: No Recommendations: Program removal Reinspection Interval: Not Applicable Overall Risk Category: C9
Product Type:	1 (Asbestos cement)	Location:	2 (Rooms up to 100 sq m)	
Condition:	1 (Minor scratches)	Accessibility:	1 (Occasionally likely to be disturbed)	
Surface Treatment:	1 (Encapsulated asbestos cement)			
Asbestos Type:	1 (Chrysotile)	Extent Score:	2 (>10 - <50 sq m or >10m - <50m pipe run)

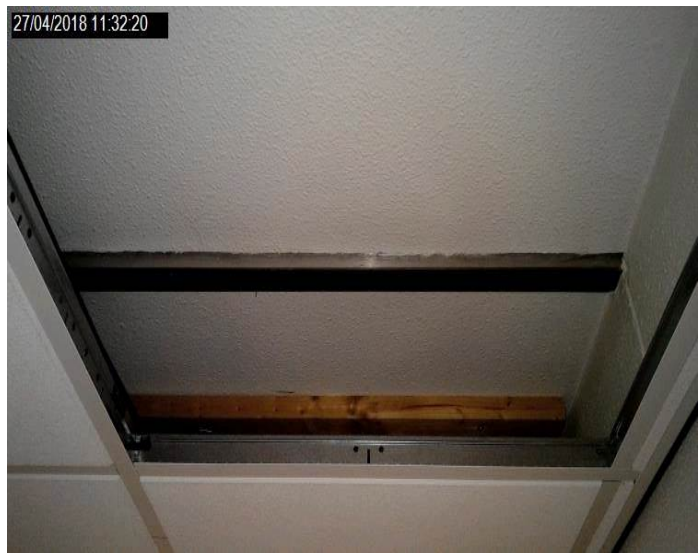
Location:	1.18B	Block:	University	Floor Level: Ground Floor
Sample No.:	As DU001377	Portal Ref No.:	81

Item:	Asbestos Textured coating to concrete ceiling			
Asbestos Content:	Result Based on:			
Chrysotile	Strongly presumed			
Sample Analysed By:	Not applicable	Extent:	12 m ²	
Comments: Present above suspended ceiling

Material Assessment Total Score: 3		Likelihood of Disturbance Assessment Total Score: 5		Management Assessment Licensable: No Recommendations: Program removal Reinspection Interval: Not Applicable Overall Risk Category: C8
Product Type:	1 (Asbestos textured coating)	Location:	2 (Rooms up to 100 sq m)	
Condition:	1 (Minor scratches)	Accessibility:	1 (Occasionally likely to be disturbed)	
Surface Treatment:	0 (Composite material)			
Asbestos Type:	1 (Chrysotile)	Extent Score:	2 (>10 - <50 sq m or >10m - <50m pipe run)

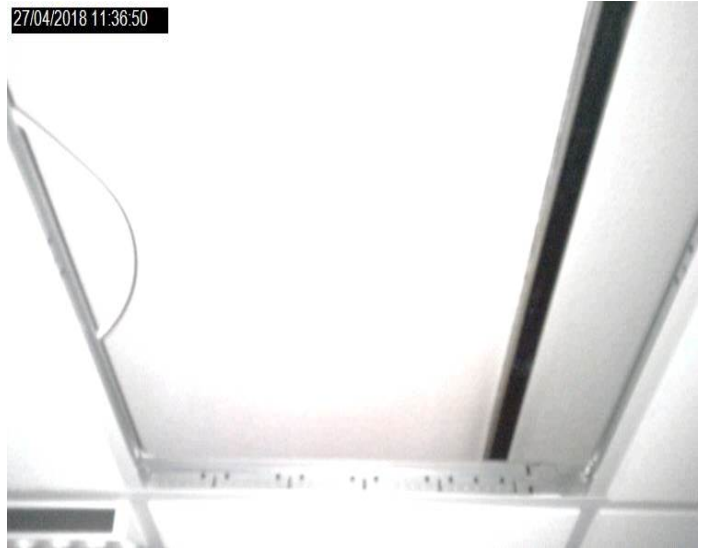
Location:	1.18	Block:	University	Floor Level: Ground Floor
Sample No.:	As DU001377	Portal Ref No.:	85

Item:	Asbestos Textured coating to concrete ceiling			
Asbestos Content:	Result Based on:			
Chrysotile	Strongly presumed			
Sample Analysed By:	Not applicable	Extent:	24 m ²	
Comments: Above suspended tiles

Material Assessment Total Score: 3		Likelihood of Disturbance Assessment Total Score: 5		Management Assessment Licensable: No Recommendations: Program removal Reinspection Interval: Not Applicable Overall Risk Category: C8
Product Type:	1 (Asbestos textured coating)	Location:	2 (Rooms up to 100 sq m)	
Condition:	1 (Minor scratches)	Accessibility:	1 (Occasionally likely to be disturbed)	
Surface Treatment:	0 (Composite material)			
Asbestos Type:	1 (Chrysotile)	Extent Score:	2 (>10 - <50 sq m or >10m - <50m pipe run)

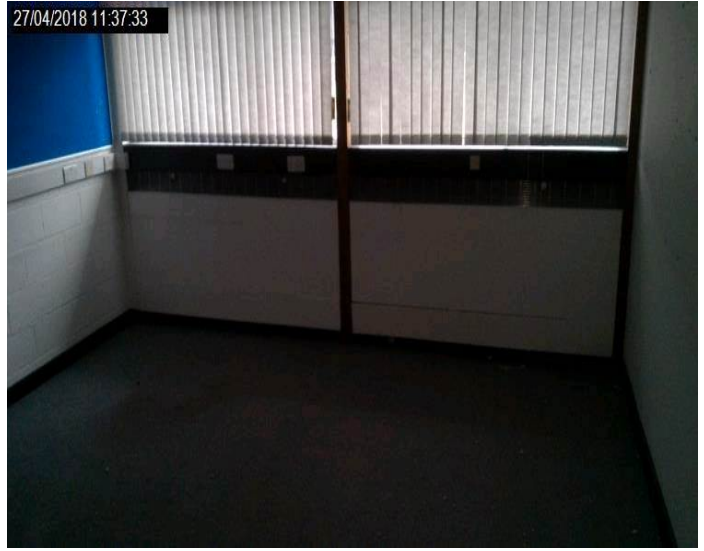
Location:	1.18	Block:	University	Floor Level: Ground Floor
Sample No.:	As DU001382	Portal Ref No.:	86

Item:	Asbestos Cement window sill			
Asbestos Content:	Result Based on:			
Chrysotile	Strongly presumed			
Sample Analysed By:	Not applicable	Extent:	4 linear metres	
Comments:

Material Assessment Total Score: 4		Likelihood of Disturbance Assessment Total Score: 4		Management Assessment Licensable: No Recommendations: Program removal Reinspection Interval: Not Applicable Overall Risk Category: C8
Product Type:	1 (Asbestos cement)	Location:	2 (Rooms up to 100 sq m)	
Condition:	1 (Minor scratches)	Accessibility:	1 (Occasionally likely to be disturbed)	
Surface Treatment:	1 (Unencapsulated asbestos cement)			
Asbestos Type:	1 (Chrysotile)	Extent Score:	1 (<10 sq m or 10m pipe run)

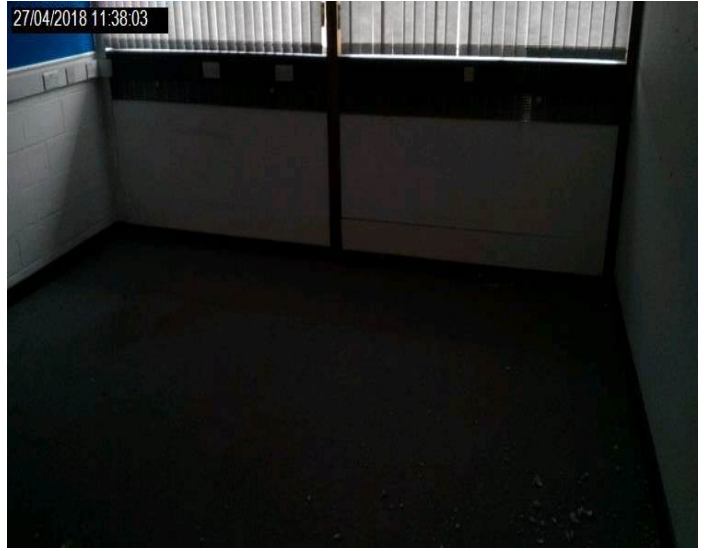
Location:	1.18	Block:	University	Floor Level: Ground Floor
Sample No.:	As DU001380	Portal Ref No.:	87

Item:	Asbestos Cement shuttering			
Asbestos Content:	Result Based on:			
Chrysotile	Strongly presumed			
Sample Analysed By:	Not applicable	Extent:	4 m ²	
Comments: To ceiling of wall void behind polystyrene

Material Assessment Total Score: 4		Likelihood of Disturbance Assessment Total Score: 4		Management Assessment Licensable: No Recommendations: Program removal Reinspection Interval: Not Applicable Overall Risk Category: C8
Product Type:	1 (Asbestos cement)	Location:	2 (Rooms up to 100 sq m)	
Condition:	1 (Minor scratches)	Accessibility:	1 (Occasionally likely to be disturbed)	
Surface Treatment:	1 (Encapsulated asbestos cement)			
Asbestos Type:	1 (Chrysotile)	Extent Score:	1 (<10 sq m or 10m pipe run)
