Report No.: J094099
Nature of Work: Demolition Survey
Issue Date: 11/06/2018
Client Name: WYG Engineering Ltd
Geneva Building, Lake View Drive, Sherwood Business Park,
Annesley, Nottingham, NG15 0ED
Site Address: Dawson building, Former City North Campus, Birmingham City
University, Perry Barr, B42 2US

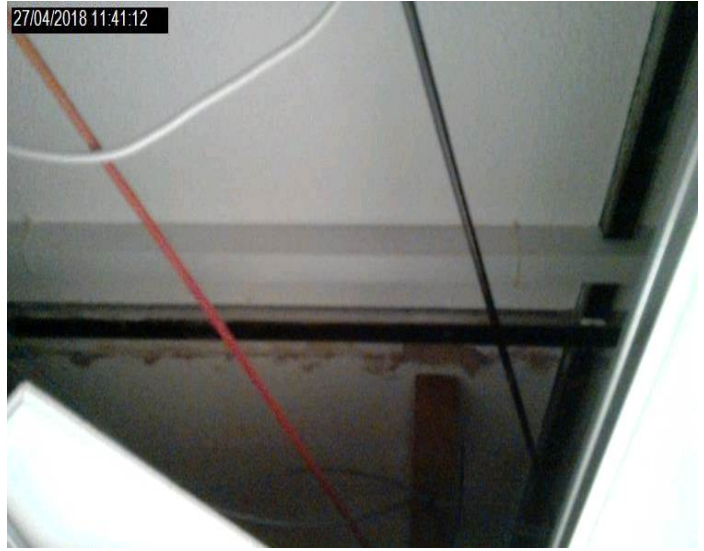
Location:	1.99C	Block:	University	Floor Level: Ground Floor
Sample No.:	As DU001377	Portal Ref No.:	89

Item:	Asbestos Textured coating to concrete ceiling			
Asbestos Content:	Result Based on:			
Chrysotile	Strongly presumed			
Sample Analysed By:	Not applicable	Extent:	6 m ²	
Comments: Present to small section of ceiling, above suspended ceiling tiles

Material Assessment Total Score: 3		Likelihood of Disturbance Assessment Total Score: 4		Management Assessment Licensable: No Recommendations: Program removal Reinspection Interval: Not Applicable Overall Risk Category: C7
Product Type:	1 (Asbestos textured coating)	Location:	2 (Rooms up to 100 sq m)	
Condition:	1 (Minor scratches)	Accessibility:	1 (Occasionally likely to be disturbed)	
Surface Treatment:	0 (Composite material)			
Asbestos Type:	1 (Chrysotile)	Extent Score:	1 (<10 sq m or 10m pipe run)

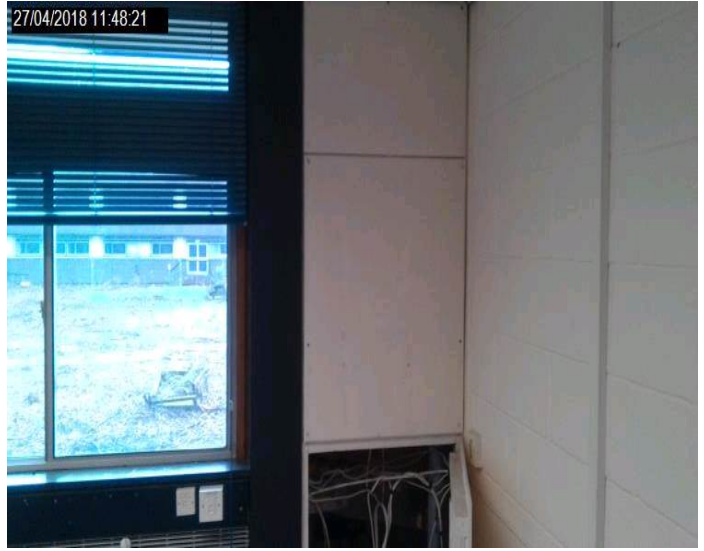
Location:	1.18A	Block:	University	Floor Level: Ground Floor
Sample No.:	DU001387	Portal Ref No.:	95

Item:	Insulating board panel to riser			
Asbestos Content:		Result Based on:		
No Asbestos Detected		Analysis of sample using PLM		
Sample Analysed By:	Reg 13(1)	Extent:	2 m ²	
Comments: 1 x riser top 2 panels

Material Assessment Total Score: 0		Likelihood of Disturbance Assessment Total Score: 0		Management Assessment Licensable: Yes Recommendations: Not Applicable Reinspection Interval: Not Applicable Overall Risk Category: E0
Product Type:	0 Not Applicable	Location:	0 Not Applicable	
Condition:	0 Not Applicable	Accessibility:	0 Not Applicable	
Surface Treatment:	0 Not Applicable			
Asbestos Type:	0 Not Applicable	Extent Score:	0 Not Applicable

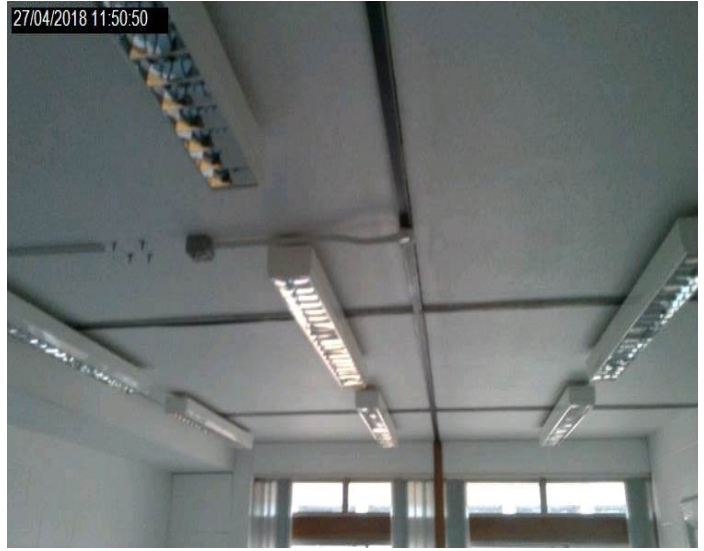
Location:	1.17B	Block:	University	Floor Level: Ground Floor
Sample No.:	As DU001384	Portal Ref No.:	97

Item:	Asbestos Textured coating to concrete ceiling			
Asbestos Content:	Result Based on:			
Chrysotile	Strongly presumed			
Sample Analysed By:	Not applicable	Extent:	25 m ²	
Comments:

Material Assessment Total Score: 3		Likelihood of Disturbance Assessment Total Score: 5		Management Assessment Licensable: No Recommendations: Program removal Reinspection Interval: Not Applicable Overall Risk Category: C8
Product Type:	1 (Asbestos textured coating)	Location:	2 (Rooms up to 100 sq m)	
Condition:	1 (Minor scratches)	Accessibility:	1 (Occasionally likely to be disturbed)	
Surface Treatment:	0 (Composite material)			
Asbestos Type:	1 (Chrysotile)	Extent Score:	2 (>10 - <50 sq m or >10m - <50m pipe run)

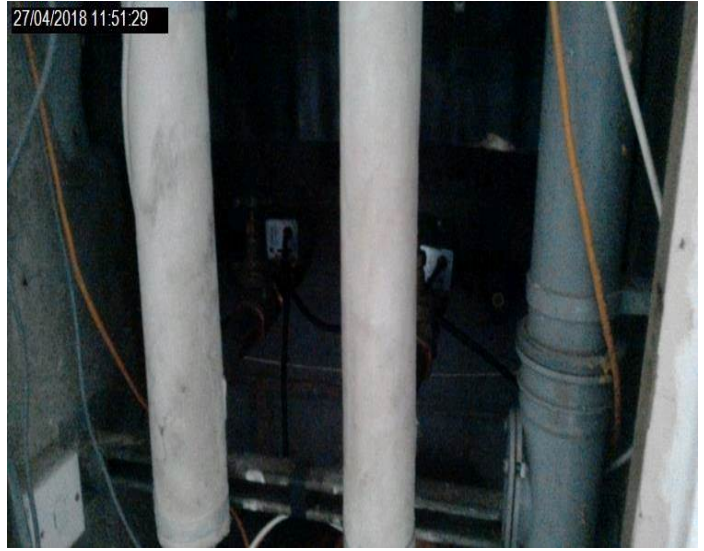
Location:	1.17B	Block:	University	Floor Level: Ground Floor
Sample No.:	As DU001386	Portal Ref No.:	98

Item:	Asbestos Cement shuttering			
Asbestos Content:	Result Based on:			
Chrysotile	Strongly presumed			
Sample Analysed By:	Not applicable	Extent:	4 m ²	
Comments: To ceiling of wall void behind polystyrene

Material Assessment Total Score: 4		Likelihood of Disturbance Assessment Total Score: 4		Management Assessment Licensable: No Recommendations: Program removal Reinspection Interval: Not Applicable Overall Risk Category: C8
Product Type:	1 (Asbestos cement)	Location:	2 (Rooms up to 100 sq m)	
Condition:	1 (Minor scratches)	Accessibility:	1 (Occasionally likely to be disturbed)	
Surface Treatment:	1 (Encapsulated asbestos cement)			
Asbestos Type:	1 (Chrysotile)	Extent Score:	1 (<10 sq m or 10m pipe run)

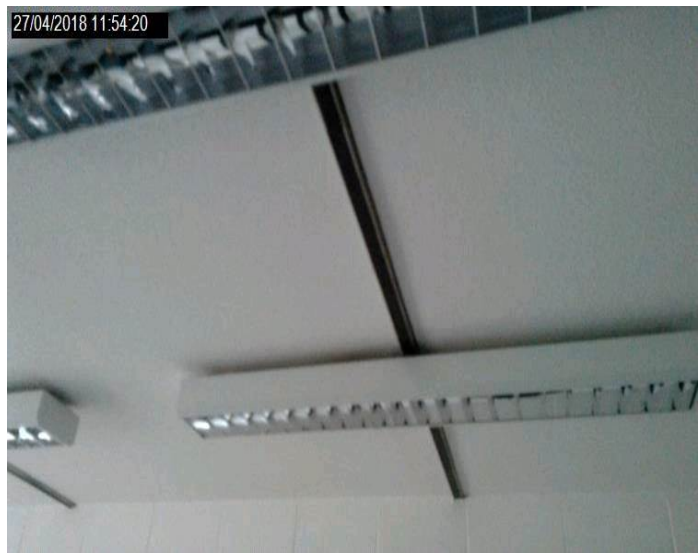
Location:	1.17A	Block:	University	Floor Level: Ground Floor
Sample No.:	As DU001384	Portal Ref No.:	102

Item:	Asbestos Textured coating to concrete ceiling			
Asbestos Content:	Result Based on:			
Chrysotile	Strongly presumed			
Sample Analysed By:	Not applicable	Extent:	24 m ²	
Comments:

Material Assessment Total Score: 3		Likelihood of Disturbance Assessment Total Score: 5		Management Assessment Licensable: No Recommendations: Program removal Reinspection Interval: Not Applicable Overall Risk Category: C8
Product Type:	1 (Asbestos textured coating)	Location:	2 (Rooms up to 100 sq m)	
Condition:	1 (Minor scratches)	Accessibility:	1 (Occasionally likely to be disturbed)	
Surface Treatment:	0 (Composite material)			
Asbestos Type:	1 (Chrysotile)	Extent Score:	2 (>10 - <50 sq m or >10m - <50m pipe run)

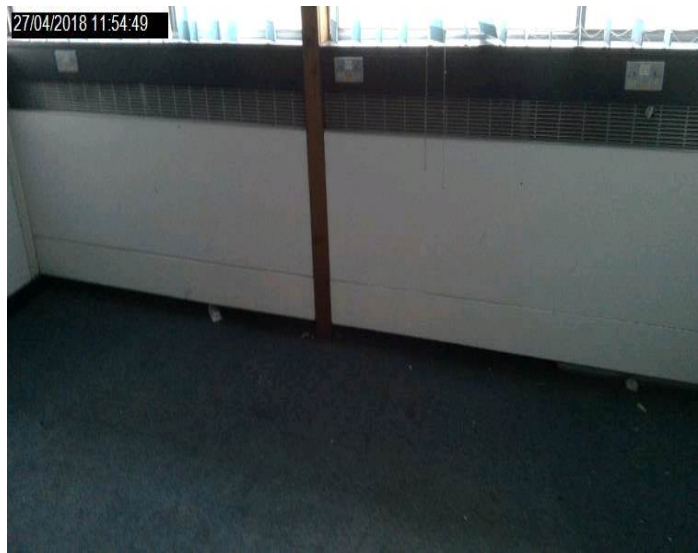
Location:	1.17A	Block:	University	Floor Level: Ground Floor
Sample No.:	As DU001386	Portal Ref No.:	103

Item:	Asbestos Cement shuttering			
Asbestos Content:	Result Based on:			
Chrysotile	Strongly presumed			
Sample Analysed By:	Not applicable	Extent:	4 m ²	
Comments: To ceiling of wall void behind polystyrene

Material Assessment Total Score: 4		Likelihood of Disturbance Assessment Total Score: 4		Management Assessment Licensable: No Recommendations: Program removal Reinspection Interval: Not Applicable Overall Risk Category: C8
Product Type:	1 (Asbestos cement)	Location:	2 (Rooms up to 100 sq m)	
Condition:	1 (Minor scratches)	Accessibility:	1 (Occasionally likely to be disturbed)	
Surface Treatment:	1 (Encapsulated asbestos cement)			
Asbestos Type:	1 (Chrysotile)	Extent Score:	1 (<10 sq m or 10m pipe run)

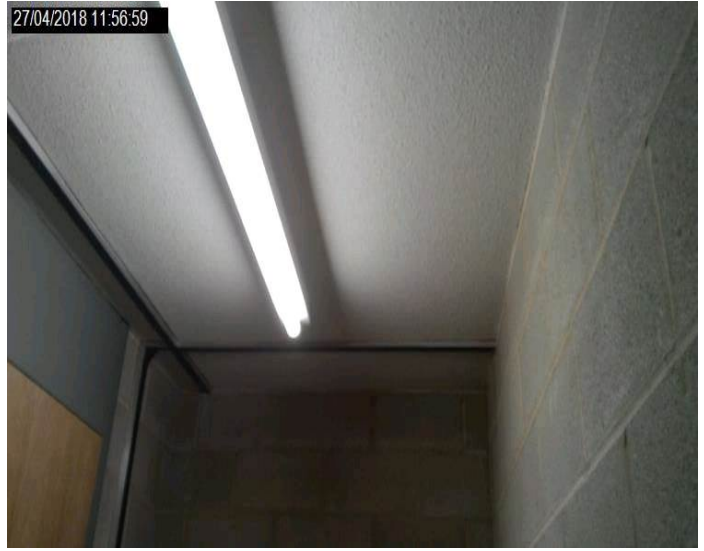
Location:	1.16	Block:	University	Floor Level: Ground Floor
Sample No.:	As DU001384	Portal Ref No.:	105

Item:	Asbestos Textured coating to concrete ceiling			
Asbestos Content:	Result Based on:			
Chrysotile	Strongly presumed			
Sample Analysed By:	Not applicable	Extent:	4 m ²	
Comments:

Material Assessment Total Score: 3		Likelihood of Disturbance Assessment Total Score: 4		Management Assessment Licensable: No Recommendations: Program removal Reinspection Interval: Not Applicable Overall Risk Category: C7
Product Type:	1 (Asbestos textured coating)	Location:	2 (Rooms up to 100 sq m)	
Condition:	1 (Minor scratches)	Accessibility:	1 (Occasionally likely to be disturbed)	
Surface Treatment:	0 (Composite material)			
Asbestos Type:	1 (Chrysotile)	Extent Score:	1 (<10 sq m or 10m pipe run)

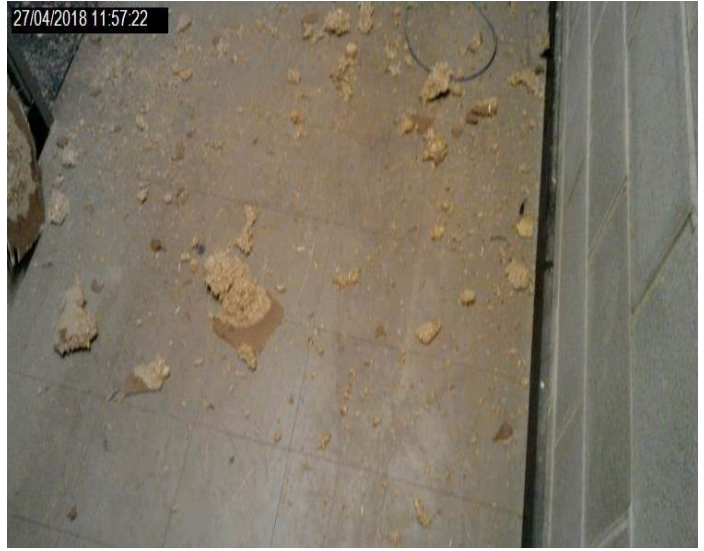
Location:	1.16	Block:	University	Floor Level: Ground Floor
Sample No.:	As DU001388	Portal Ref No.:	107

Item:	Asbestos Thermoplastic floor tiles with bitumen adhesive			
Asbestos Content:	Result Based on:			
Chrysotile in adhesive only	Strongly presumed			
Sample Analysed By:	Not applicable	Extent:	4 m ²	
Comments:

Material Assessment Total Score: 3		Likelihood of Disturbance Assessment Total Score: 4		Management Assessment Licensable: No Recommendations: Program removal Reinspection Interval: Not Applicable Overall Risk Category: C7
Product Type:	1 (Asbestos thermoplastic)	Location:	2 (Rooms up to 100 sq m)	
Condition:	1 (Minor scratches)	Accessibility:	1 (Occasionally likely to be disturbed)	
Surface Treatment:	0 (Composite material)			
Asbestos Type:	1 (Chrysotile)	Extent Score:	1 (<10 sq m or 10m pipe run)

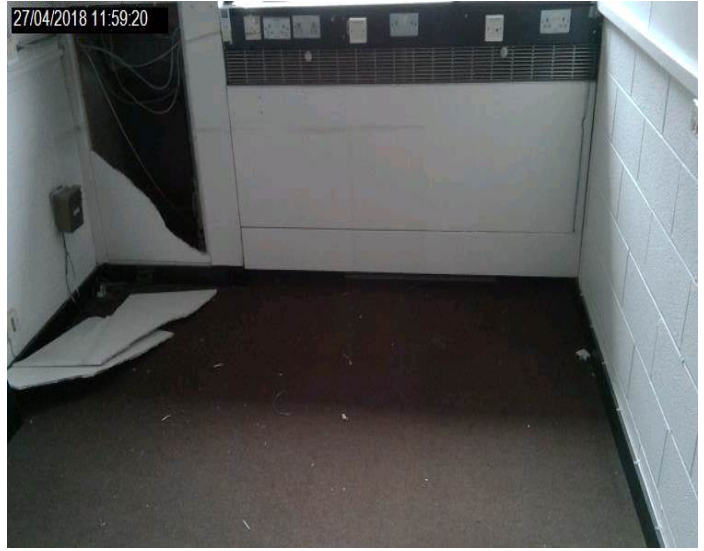
Location:	1.15	Block:	University	Floor Level: Ground Floor
Sample No.:	As DU001386	Portal Ref No.:	109

Item:	Asbestos Cement shuttering			
Asbestos Content:	Result Based on:			
Chrysotile	Strongly presumed			
Sample Analysed By:	Not applicable	Extent:	3 m ²	
Comments: To ceiling of wall void behind polystyrene

Material Assessment Total Score: 4		Likelihood of Disturbance Assessment Total Score: 4		Management Assessment Licensable: No Recommendations: Program removal Reinspection Interval: Not Applicable Overall Risk Category: C8
Product Type:	1 (Asbestos cement)	Location:	2 (Rooms up to 100 sq m)	
Condition:	1 (Minor scratches)	Accessibility:	1 (Occasionally likely to be disturbed)	
Surface Treatment:	1 (Encapsulated asbestos cement)			
Asbestos Type:	1 (Chrysotile)	Extent Score:	1 (<10 sq m or 10m pipe run)

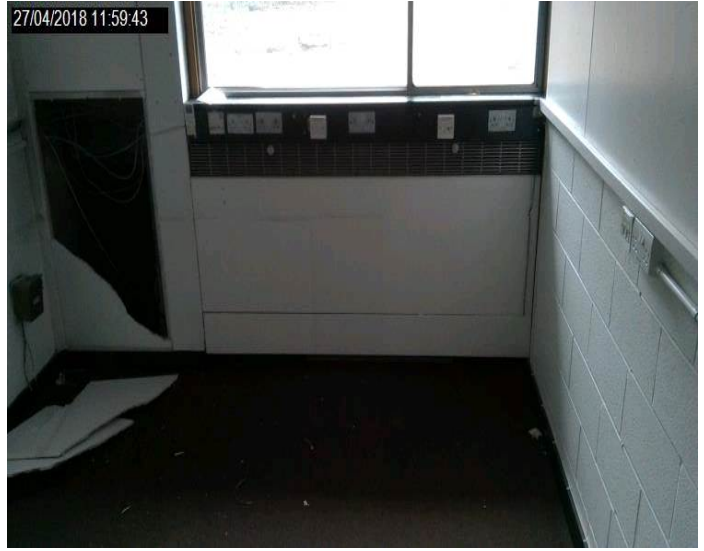
Location:	1.15	Block:	University	Floor Level: Ground Floor
Sample No.:	As DU001385	Portal Ref No.:	110

Item:	Asbestos Cement window sill			
Asbestos Content:	Result Based on:			
Chrysotile	Strongly presumed			
Sample Analysed By:	Not applicable	Extent:	2 linear metres	
Comments:

Material Assessment Total Score: 4		Likelihood of Disturbance Assessment Total Score: 4		Management Assessment Licensable: No Recommendations: Program removal Reinspection Interval: Not Applicable Overall Risk Category: C8
Product Type:	1 (Asbestos cement)	Location:	2 (Rooms up to 100 sq m)	
Condition:	1 (Minor scratches)	Accessibility:	1 (Occasionally likely to be disturbed)	
Surface Treatment:	1 (Unencapsulated asbestos cement)			
Asbestos Type:	1 (Chrysotile)	Extent Score:	1 (<10 sq m or 10m pipe run)

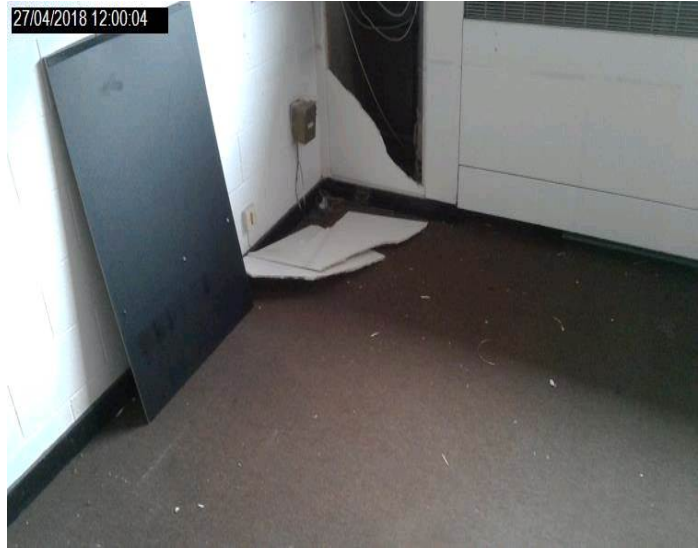
Location:	1.15	Block:	University	Floor Level: Ground Floor
Sample No.:	As DU001387	Portal Ref No.:	111

Item:	Insulating board panel to riser			
Asbestos Content:		Result Based on:		
No Asbestos Detected		Strongly presumed		
Sample Analysed By:	Not applicable	Extent:	3 m ²	
Comments: 1 x riser

Material Assessment Total Score: 0		Likelihood of Disturbance Assessment Total Score: 0		Management Assessment Licensable: Yes Recommendations: Not Applicable Reinspection Interval: Not Applicable Overall Risk Category: E0
Product Type:	0 Not Applicable	Location:	0 Not Applicable	
Condition:	0 Not Applicable	Accessibility:	0 Not Applicable	
Surface Treatment:	0 Not Applicable			
Asbestos Type:	0 Not Applicable	Extent Score:	0 Not Applicable

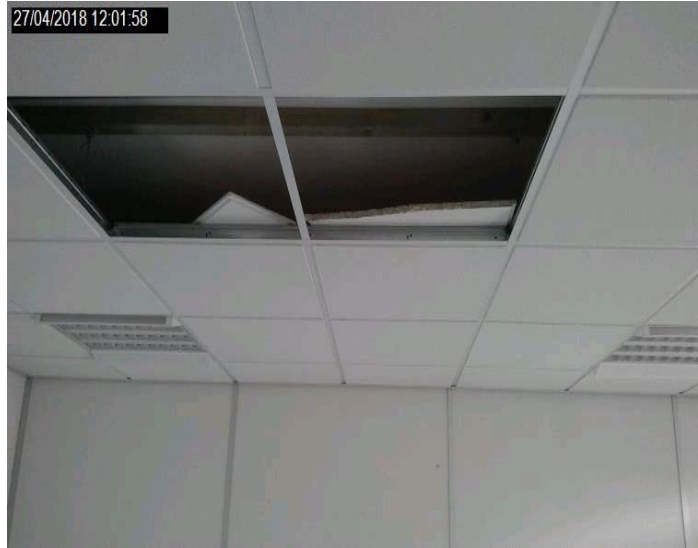
Location:	1.14	Block:	University	Floor Level: Ground Floor
Sample No.:	As DU001384	Portal Ref No.:	113

Item:	Asbestos Textured coating to concrete ceiling			
Asbestos Content:	Result Based on:			
Chrysotile	Strongly presumed			
Sample Analysed By:	Not applicable	Extent:	12 m ²	
Comments: Above suspended ceiling tiles

Material Assessment Total Score: 3		Likelihood of Disturbance Assessment Total Score: 5		Management Assessment Licensable: No Recommendations: Program removal Reinspection Interval: Not Applicable Overall Risk Category: C8
Product Type:	1 (Asbestos textured coating)	Location:	2 (Rooms up to 100 sq m)	
Condition:	1 (Minor scratches)	Accessibility:	1 (Occasionally likely to be disturbed)	
Surface Treatment:	0 (Composite material)			
Asbestos Type:	1 (Chrysotile)	Extent Score:	2 (>10 - <50 sq m or >10m - <50m pipe run)

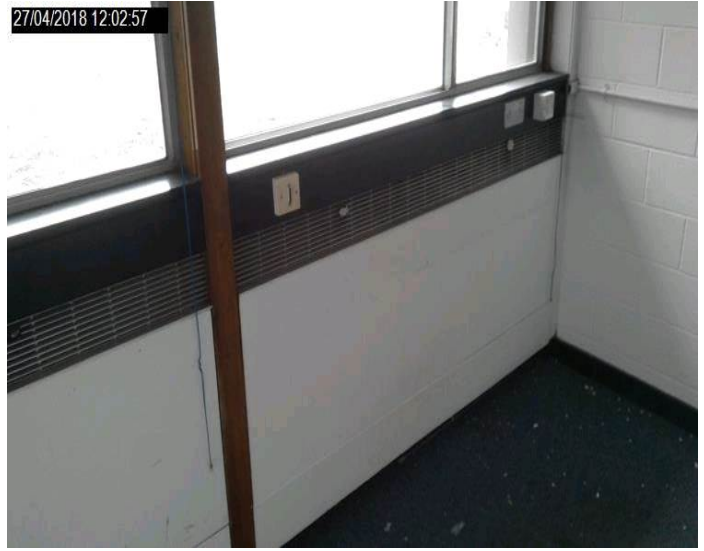
Location:	1.14	Block:	University	Floor Level: Ground Floor
Sample No.:	As DU001385	Portal Ref No.:	115

Item:	Asbestos Cement window sill			
Asbestos Content:	Result Based on:			
Chrysotile	Strongly presumed			
Sample Analysed By:	Not applicable	Extent:	4 linear metres	
Comments:

Material Assessment Total Score: 4		Likelihood of Disturbance Assessment Total Score: 4		Management Assessment Licensable: No Recommendations: Program removal Reinspection Interval: Not Applicable Overall Risk Category: C8
Product Type:	1 (Asbestos cement)	Location:	2 (Rooms up to 100 sq m)	
Condition:	1 (Minor scratches)	Accessibility:	1 (Occasionally likely to be disturbed)	
Surface Treatment:	1 (Unencapsulated asbestos cement)			
Asbestos Type:	1 (Chrysotile)	Extent Score:	1 (<10 sq m or 10m pipe run)

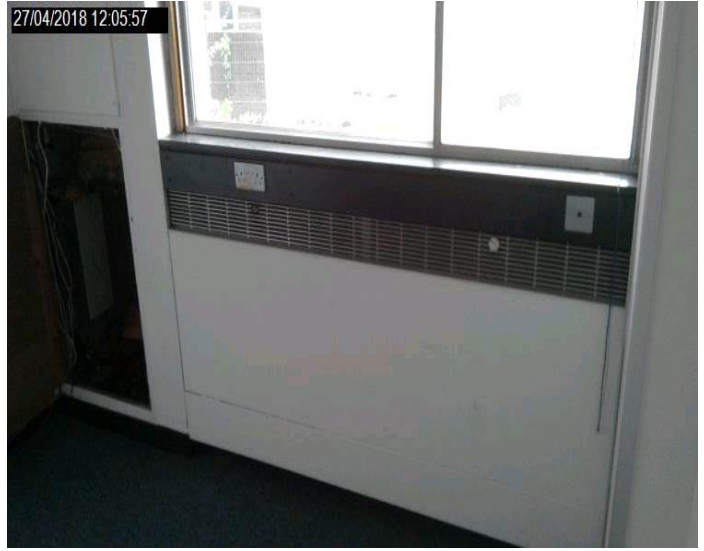
Location:	1.14A	Block:	University	Floor Level: Ground Floor
Sample No.:	As DU001385	Portal Ref No.:	119

Item:	Asbestos Cement window sill			
Asbestos Content:	Result Based on:			
Chrysotile	Strongly presumed			
Sample Analysed By:	Not applicable	Extent:	2 linear metres	
Comments:

Material Assessment Total Score: 4		Likelihood of Disturbance Assessment Total Score: 4		Management Assessment Licensable: No Recommendations: Program removal Reinspection Interval: Not Applicable Overall Risk Category: C8
Product Type:	1 (Asbestos cement)	Location:	2 (Rooms up to 100 sq m)	
Condition:	1 (Minor scratches)	Accessibility:	1 (Occasionally likely to be disturbed)	
Surface Treatment:	1 (Unencapsulated asbestos cement)			
Asbestos Type:	1 (Chrysotile)	Extent Score:	1 (<10 sq m or 10m pipe run)

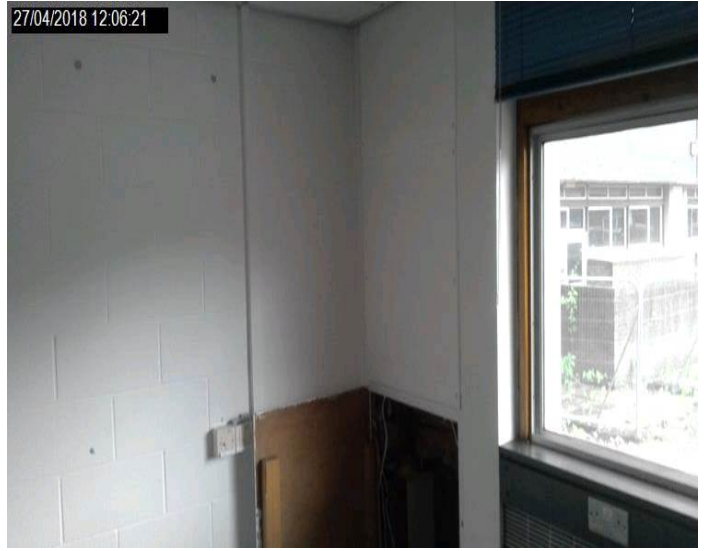
Location:	1.14A	Block:	University	Floor Level: Ground Floor
Sample No.:	As DU001387	Portal Ref No.:	120

Item:	Insulating board panel to riser			
Asbestos Content:		Result Based on:		
No Asbestos Detected		Strongly presumed		
Sample Analysed By:	Not applicable	Extent:	2 m ²	
Comments: Top two panels

Material Assessment Total Score: 0		Likelihood of Disturbance Assessment Total Score: 0		Management Assessment Licensable: Yes Recommendations: Not Applicable Reinspection Interval: Not Applicable Overall Risk Category: E0
Product Type:	0 Not Applicable	Location:	0 Not Applicable	
Condition:	0 Not Applicable	Accessibility:	0 Not Applicable	
Surface Treatment:	0 Not Applicable			
Asbestos Type:	0 Not Applicable	Extent Score:	0 Not Applicable

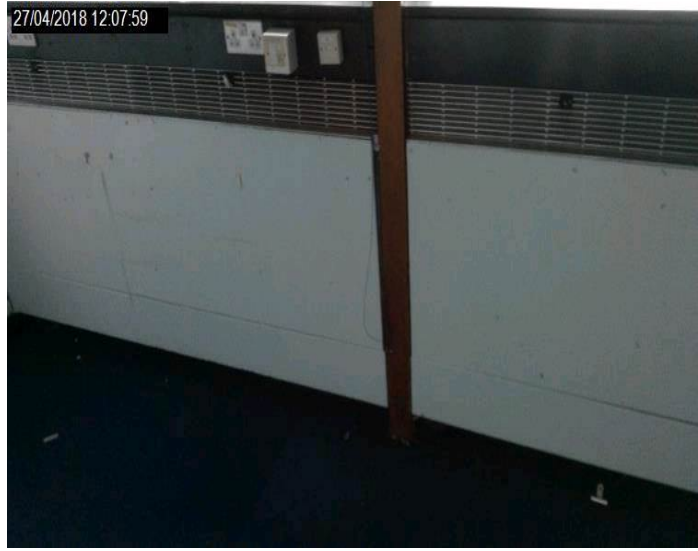
Location:	1.12	Block:	University	Floor Level: Ground Floor
Sample No.:	As DU001386	Portal Ref No.:	122

Item:	Asbestos Cement shuttering			
Asbestos Content:	Result Based on:			
Chrysotile	Strongly presumed			
Sample Analysed By:	Not applicable	Extent:	4 m ²	
Comments: To ceiling of wall void behind polystyrene

Material Assessment Total Score: 4		Likelihood of Disturbance Assessment Total Score: 4		Management Assessment Licensable: No Recommendations: Program removal Reinspection Interval: Not Applicable Overall Risk Category: C8
Product Type:	1 (Asbestos cement)	Location:	2 (Rooms up to 100 sq m)	
Condition:	1 (Minor scratches)	Accessibility:	1 (Occasionally likely to be disturbed)	
Surface Treatment:	1 (Encapsulated asbestos cement)			
Asbestos Type:	1 (Chrysotile)	Extent Score:	1 (<10 sq m or 10m pipe run)

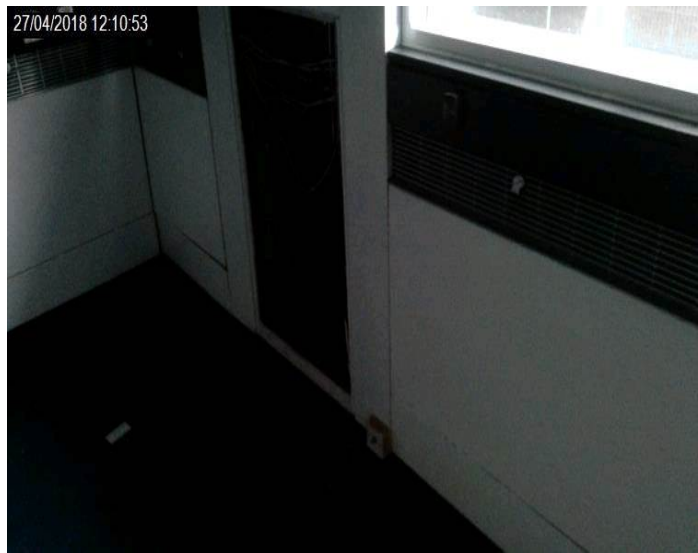
Location:	1.13	Block:	University	Floor Level: Ground Floor
Sample No.:	As DU001386	Portal Ref No.:	126

Item:	Asbestos Cement shuttering			
Asbestos Content:	Result Based on:			
Chrysotile	Strongly presumed			
Sample Analysed By:	Not applicable	Extent:	8 m ²	
Comments: To ceiling of wall void behind polystyrene

Material Assessment Total Score: 4		Likelihood of Disturbance Assessment Total Score: 4		Management Assessment Licensable: No Recommendations: Program removal Reinspection Interval: Not Applicable Overall Risk Category: C8
Product Type:	1 (Asbestos cement)	Location:	2 (Rooms up to 100 sq m)	
Condition:	1 (Minor scratches)	Accessibility:	1 (Occasionally likely to be disturbed)	
Surface Treatment:	1 (Encapsulated asbestos cement)			
Asbestos Type:	1 (Chrysotile)	Extent Score:	1 (<10 sq m or 10m pipe run)

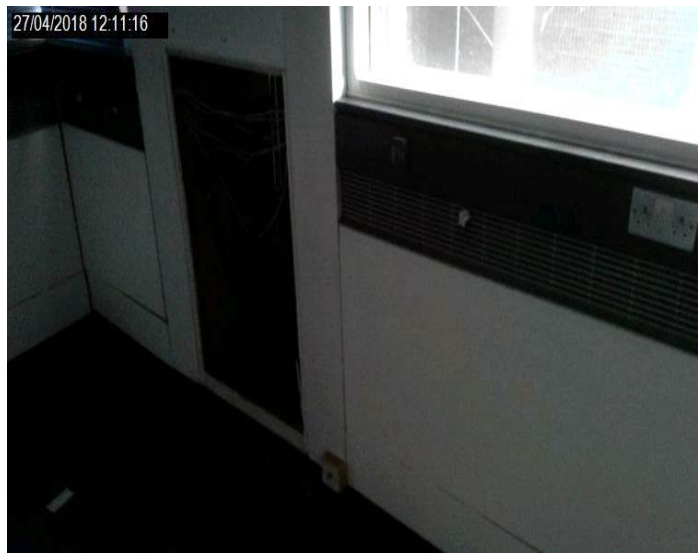
Location:	1.13	Block:	University	Floor Level: Ground Floor
Sample No.:	As DU001385	Portal Ref No.:	127

Item:	Asbestos Cement window sill			
Asbestos Content:	Result Based on:			
Chrysotile	Strongly presumed			
Sample Analysed By:	Not applicable	Extent:	8 linear metres	
Comments:

Material Assessment Total Score: 4		Likelihood of Disturbance Assessment Total Score: 4		Management Assessment Licensable: No Recommendations: Program removal Reinspection Interval: Not Applicable Overall Risk Category: C8
Product Type:	1 (Asbestos cement)	Location:	2 (Rooms up to 100 sq m)	
Condition:	1 (Minor scratches)	Accessibility:	1 (Occasionally likely to be disturbed)	
Surface Treatment:	1 (Unencapsulated asbestos cement)			
Asbestos Type:	1 (Chrysotile)	Extent Score:	1 (<10 sq m or 10m pipe run)

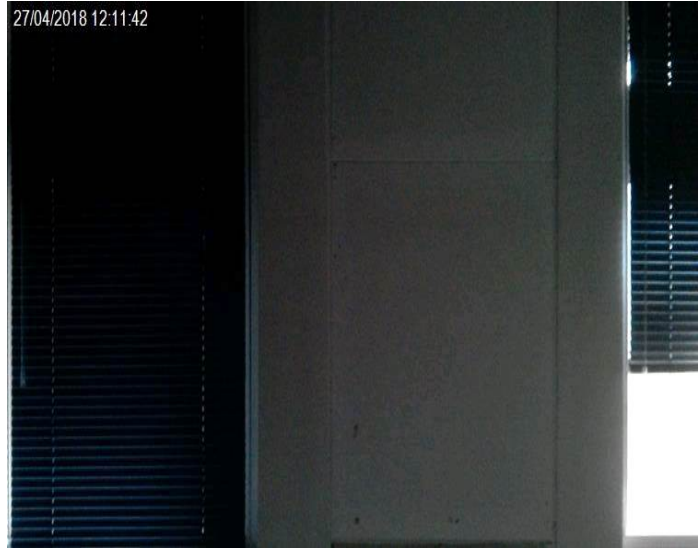
Location:	1.13	Block:	University	Floor Level: Ground Floor
Sample No.:	As DU001387	Portal Ref No.:	128

Item:	Insulating board panel to riser			
Asbestos Content:		Result Based on:		
No Asbestos Detected		Strongly presumed		
Sample Analysed By:	Not applicable	Extent:	2 m ²	
Comments: Top two panels

Material Assessment Total Score: 0		Likelihood of Disturbance Assessment Total Score: 0		Management Assessment Licensable: Yes Recommendations: Not Applicable Reinspection Interval: Not Applicable Overall Risk Category: E0
Product Type:	0 Not Applicable	Location:	0 Not Applicable	
Condition:	0 Not Applicable	Accessibility:	0 Not Applicable	
Surface Treatment:	0 Not Applicable			
Asbestos Type:	0 Not Applicable	Extent Score:	0 Not Applicable

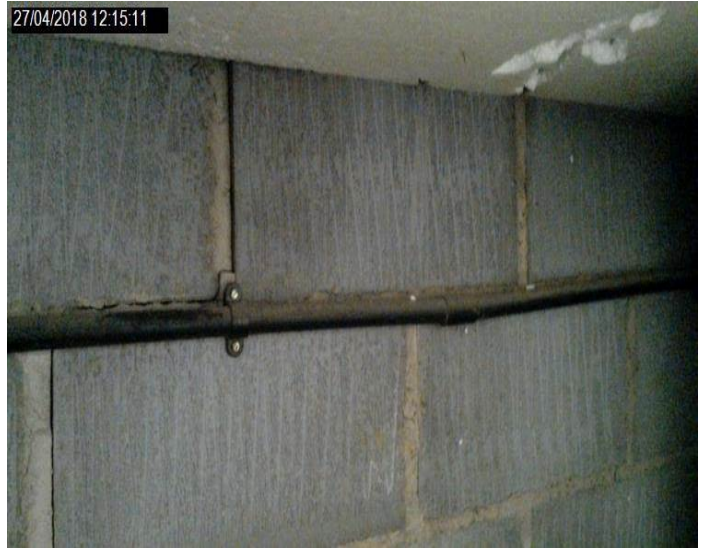
Location:	1.13A	Block:	University	Floor Level: Ground Floor
Sample No.:	As DU001386	Portal Ref No.:	130

Item:	Asbestos Cement shuttering			
Asbestos Content:	Result Based on:			
Chrysotile	Strongly presumed			
Sample Analysed By:	Not applicable	Extent:	3 m ²	
Comments: To ceiling of wall void behind polystyrene

Material Assessment Total Score: 4		Likelihood of Disturbance Assessment Total Score: 4		Management Assessment Licensable: No Recommendations: Program removal Reinspection Interval: Not Applicable Overall Risk Category: C8
Product Type:	1 (Asbestos cement)	Location:	2 (Rooms up to 100 sq m)	
Condition:	1 (Minor scratches)	Accessibility:	1 (Occasionally likely to be disturbed)	
Surface Treatment:	1 (Encapsulated asbestos cement)			
Asbestos Type:	1 (Chrysotile)	Extent Score:	1 (<10 sq m or 10m pipe run)

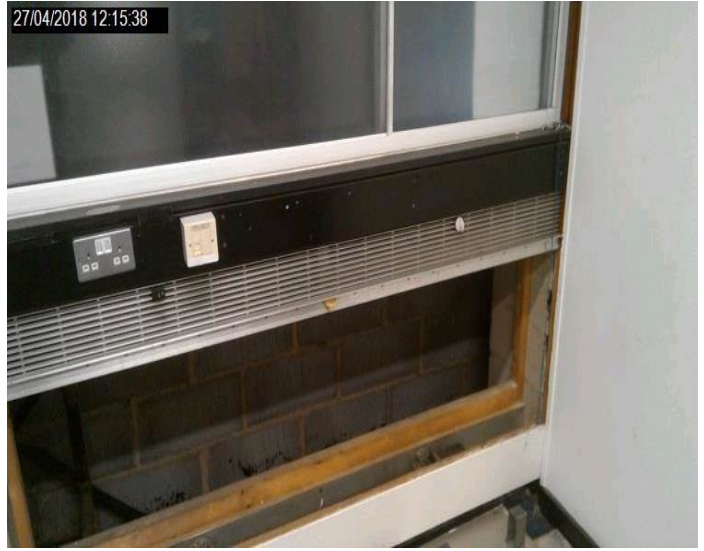
Location:	1.13A	Block:	University	Floor Level: Ground Floor
Sample No.:	As DU001385	Portal Ref No.:	131

Item:	Asbestos Cement window sill			
Asbestos Content:	Result Based on:			
Chrysotile	Strongly presumed			
Sample Analysed By:	Not applicable	Extent:	3 linear metres	
Comments:

Material Assessment Total Score: 4		Likelihood of Disturbance Assessment Total Score: 4		Management Assessment Licensable: No Recommendations: Program removal Reinspection Interval: Not Applicable Overall Risk Category: C8
Product Type:	1 (Asbestos cement)	Location:	2 (Rooms up to 100 sq m)	
Condition:	1 (Minor scratches)	Accessibility:	1 (Occasionally likely to be disturbed)	
Surface Treatment:	1 (Unencapsulated asbestos cement)			
Asbestos Type:	1 (Chrysotile)	Extent Score:	1 (<10 sq m or 10m pipe run)

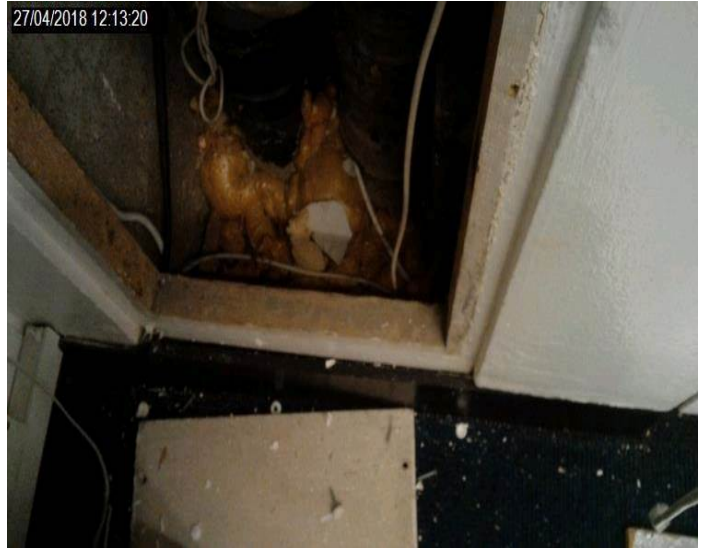
Location:	1.13A	Block:	University	Floor Level: Ground Floor
Sample No.:	DU001389	Portal Ref No.:	133

Item:	Asbestos Insulating board debris to base of riser			
Asbestos Content:	Result Based on:			
Amosite	Analysis of sample using PLM			
Sample Analysed By: Reg 13(1)	Extent:	1 m ²		
<p>Comments: The whole riser area should be presumed to be contaminated. Evidence of previous asbestos removal work remain within the riser.</p>

Material Assessment Total Score: 9		Likelihood of Disturbance Assessment Total Score: 4		<p>Management Assessment</p> <p>Licensable: Yes</p> <p>Recommendations: Program removal</p> <p>Reinspection Interval: Not Applicable</p> <p>Overall Risk Category: B13</p>
Product Type:	2 (Asbestos insulating board)	Location:	2 (Rooms up to 100 sq m)	
Condition:	3 (Significant damage)	Accessibility:	1 (Occasionally likely to be disturbed)	
Surface Treatment:	2 (Unencapsulated asbestos insulating board)			
Asbestos Type:	2 (Amosite)	Extent Score:	1 (<10 sq m or 10m pipe run)

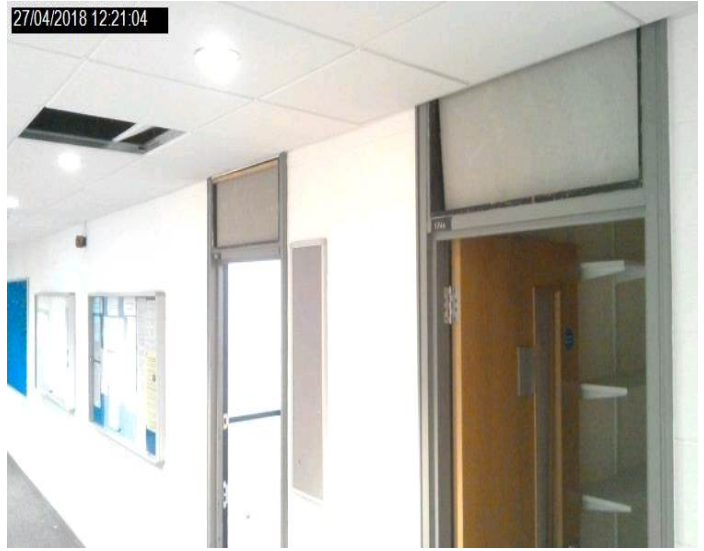
Location:	1.99D	Block:	University	Floor Level: Ground Floor
Sample No.:	DU001390	Portal Ref No.:	135

Item:	Insulating board door header panels			
Asbestos Content:	Result Based on:			
No Asbestos Detected	Analysis of sample using PLM			
Sample Analysed By: Reg 13(1)	Extent:	10 m ²		
Comments: Above doors leading to rooms 1.25, 1.24A, 1.24, 1.23, 1.17B, 1.18A, 1.14 and 1.15. The board is labelled PE Board

Material Assessment Total Score: 0		Likelihood of Disturbance Assessment Total Score: 0		Management Assessment Licensable: Yes Recommendations: Not Applicable Reinspection Interval: Not Applicable Overall Risk Category: E0
Product Type:	0 Not Applicable	Location:	0 Not Applicable	
Condition:	0 Not Applicable	Accessibility:	0 Not Applicable	
Surface Treatment:	0 Not Applicable			
Asbestos Type:	0 Not Applicable	Extent Score:	0 Not Applicable

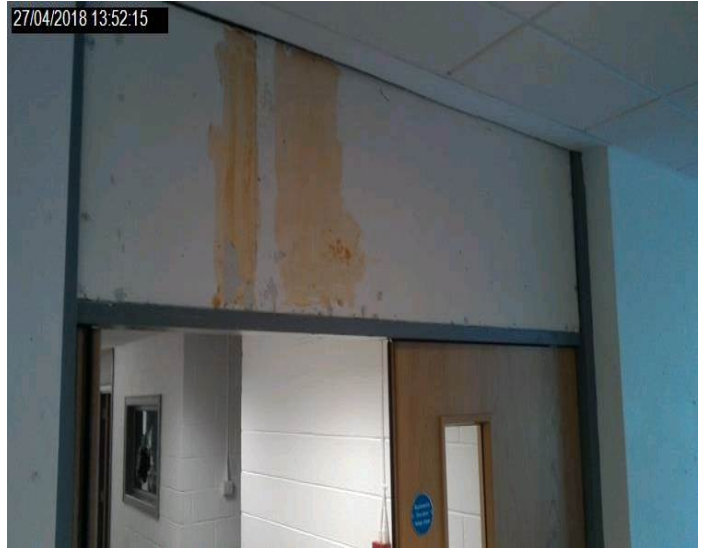
Location:	2.99	Block:	University	Floor Level: 1st Floor
Sample No.:	DU001393	Portal Ref No.:	138

Item:	Insulating board door header panels			
Asbestos Content:		Result Based on:		
No Asbestos Detected		Analysis of sample using PLM		
Sample Analysed By:	Reg 13(1)	Extent:	2 m ²	
Comments: Leading to corridor

Material Assessment Total Score: 0		Likelihood of Disturbance Assessment Total Score: 0		Management Assessment Licensable: Yes Recommendations: Not Applicable Reinspection Interval: Not Applicable Overall Risk Category: E0
Product Type:	0 Not Applicable	Location:	0 Not Applicable	
Condition:	0 Not Applicable	Accessibility:	0 Not Applicable	
Surface Treatment:	0 Not Applicable			
Asbestos Type:	0 Not Applicable	Extent Score:	0 Not Applicable

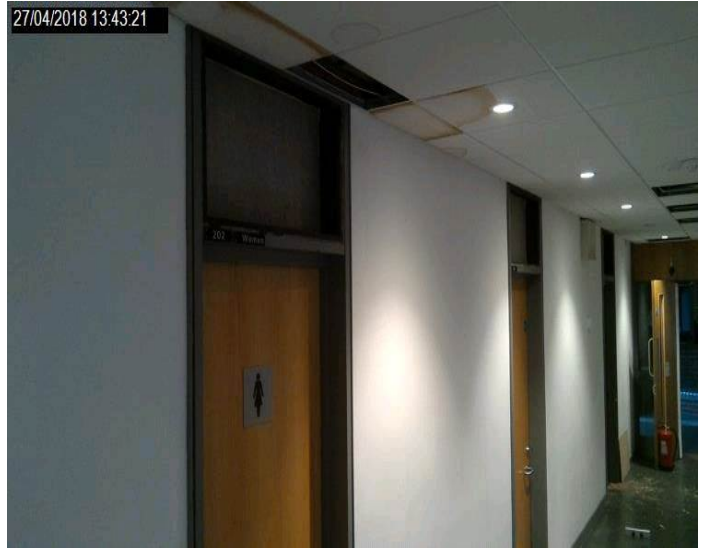
Location:	2.99	Block:	University	Floor Level: 1st Floor
Sample No.:	DU001392	Portal Ref No.:	140

Item:	Insulating board door header panels			
Asbestos Content:	Result Based on:			
No Asbestos Detected	Analysis of sample using PLM			
Sample Analysed By: Reg 13(1)	Extent:	4 m ²		
Comments: Above doors to room 2.01, 2.02, 2.03 and 2.04

Material Assessment Total Score: 0		Likelihood of Disturbance Assessment Total Score: 0		Management Assessment Licensable: Yes Recommendations: Not Applicable Reinspection Interval: Not Applicable Overall Risk Category: E0
Product Type:	0 Not Applicable	Location:	0 Not Applicable	
Condition:	0 Not Applicable	Accessibility:	0 Not Applicable	
Surface Treatment:	0 Not Applicable			
Asbestos Type:	0 Not Applicable	Extent Score:	0 Not Applicable

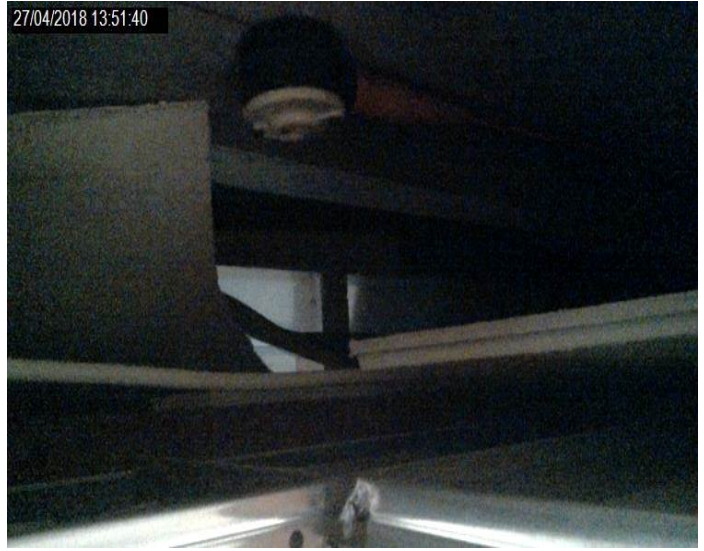
Location:	2.99	Block:	University	Floor Level: 1st Floor
Sample No.:	DU001391	Portal Ref No.:	141

Item:	Insulating board panel to room 2.11			
Asbestos Content:		Result Based on:		
No Asbestos Detected		Analysis of sample using PLM		
Sample Analysed By:	Reg 13(1)	Extent:	3 linear metres	
Comments: Above sliding doors leading to the balcony

Material Assessment Total Score: 0		Likelihood of Disturbance Assessment Total Score: 0		Management Assessment Licensable: Yes Recommendations: Not Applicable Reinspection Interval: Not Applicable Overall Risk Category: E0
Product Type:	0 Not Applicable	Location:	0 Not Applicable	
Condition:	0 Not Applicable	Accessibility:	0 Not Applicable	
Surface Treatment:	0 Not Applicable			
Asbestos Type:	0 Not Applicable	Extent Score:	0 Not Applicable

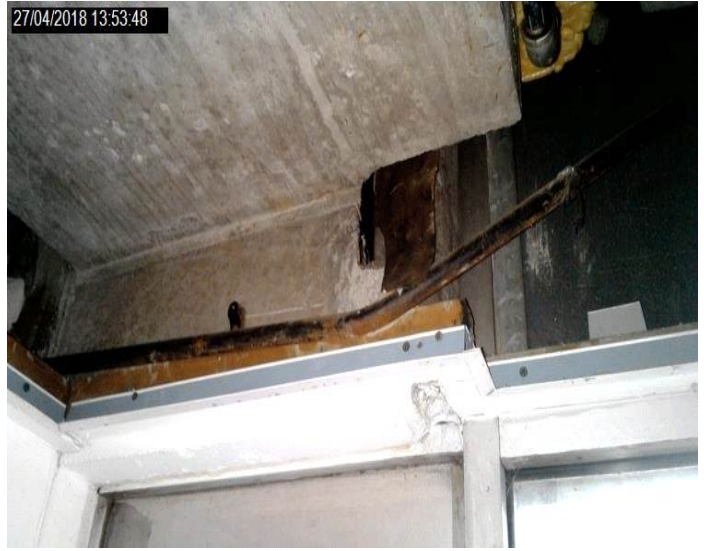
Location:	2.99	Block:	University	Floor Level: 1st Floor
Sample No.:	DU001394	Portal Ref No.:	142

Item:	Bitumen damp proof course			
Asbestos Content:		Result Based on:		
No Asbestos Detected		Analysis of sample using PLM		
Sample Analysed By:	Reg 13(1)	Extent:	7 linear metres	
Comments: To ceiling concrete level drops

Material Assessment Total Score: 0		Likelihood of Disturbance Assessment Total Score: 0		Management Assessment Licensable: No Recommendations: Not Applicable Reinspection Interval: Not Applicable Overall Risk Category: E0
Product Type:	0 Not Applicable	Location:	0 Not Applicable	
Condition:	0 Not Applicable	Accessibility:	0 Not Applicable	
Surface Treatment:	0 Not Applicable			
Asbestos Type:	0 Not Applicable	Extent Score:	0 Not Applicable

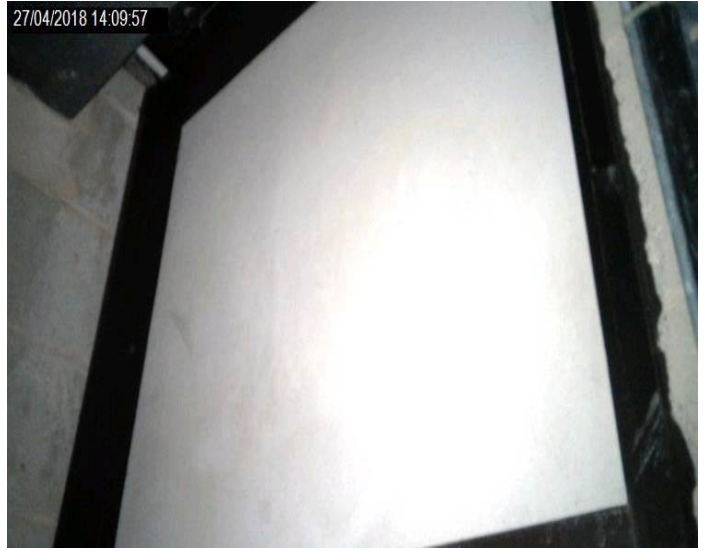
Location:	2.05	Block:	University	Floor Level: 1st Floor
Sample No.:	DU001397	Portal Ref No.:	150

Item:	Asbestos Insulating board door header panel			
Asbestos Content:	Result Based on:			
Chrysotile Amosite	Analysis of sample using PLM			
Sample Analysed By:	Reg 13(1)	Extent:	2 m ²	
Comments:

Material Assessment Total Score: 7		Likelihood of Disturbance Assessment Total Score: 4		Management Assessment Licensable: Yes Recommendations: Program removal Reinspection Interval: Not Applicable Overall Risk Category: B11
Product Type:	2 (Asbestos insulating board)	Location:	2 (Rooms up to 100 sq m)	
Condition:	1 (Minor scratches)	Accessibility:	1 (Occasionally likely to be disturbed)	
Surface Treatment:	2 (Unencapsulated asbestos insulating board)			
Asbestos Type:	2 (Chrysotile Amosite)	Extent Score:	1 (<10 sq m or 10m pipe run)

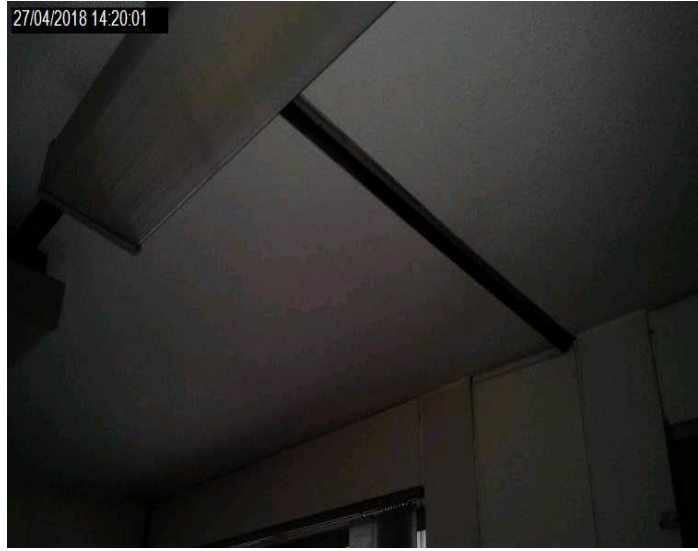
Location:	2.27C	Block:	University	Floor Level: 1st Floor
Sample No.:	DU001399	Portal Ref No.:	154

Item:	Asbestos Textured coating to concrete ceiling			
Asbestos Content:	Result Based on:			
Chrysotile	Analysis of sample using PLM			
Sample Analysed By: Reg 13(1)	Extent:	10 m ²		
Comments:

Material Assessment Total Score: 3		Likelihood of Disturbance Assessment Total Score: 5		Management Assessment Licensable: No Recommendations: Program removal Reinspection Interval: Not Applicable Overall Risk Category: C8
Product Type:	1 (Asbestos textured coating)	Location:	2 (Rooms up to 100 sq m)	
Condition:	1 (Minor scratches)	Accessibility:	1 (Occasionally likely to be disturbed)	
Surface Treatment:	0 (Composite material)			
Asbestos Type:	1 (Chrysotile)	Extent Score:	2 (>10 - <50 sq m or >10m - <50m pipe run)

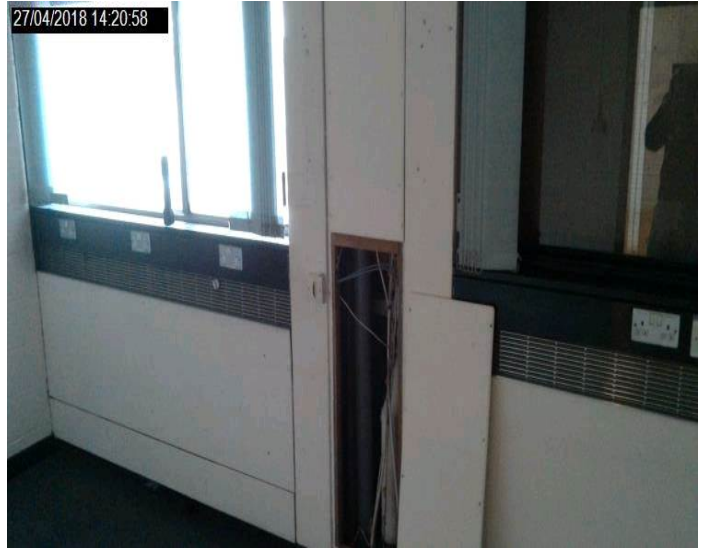
Location:	2.27C	Block:	University	Floor Level: 1st Floor
Sample No.:	DU001400	Portal Ref No.:	155

Item:	Insulating board panels to risers			
Asbestos Content:		Result Based on:		
No Asbestos Detected		Analysis of sample using PLM		
Sample Analysed By:	Reg 13(1)	Extent:	3 linear metres	
Comments: 1 x riser

Material Assessment Total Score: 0		Likelihood of Disturbance Assessment Total Score: 0		Management Assessment Licensable: Yes Recommendations: Not Applicable Reinspection Interval: Not Applicable Overall Risk Category: E0
Product Type:	0 Not Applicable	Location:	0 Not Applicable	
Condition:	0 Not Applicable	Accessibility:	0 Not Applicable	
Surface Treatment:	0 Not Applicable			
Asbestos Type:	0 Not Applicable	Extent Score:	0 Not Applicable

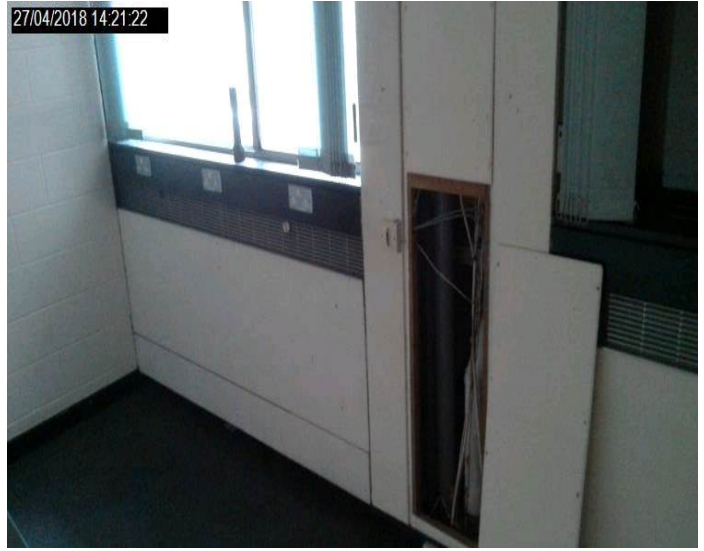
Location:	2.27C	Block:	University	Floor Level: 1st Floor
Sample No.:	DU001401	Portal Ref No.:	156

Item:	Asbestos Cement window sill			
Asbestos Content:	Result Based on:			
Chrysotile	Analysis of sample using PLM			
Sample Analysed By: Reg 13(1)	Extent:	4 linear metres		
Comments:

Material Assessment Total Score: 4		Likelihood of Disturbance Assessment Total Score: 4		Management Assessment Licensable: No Recommendations: Program removal Reinspection Interval: Not Applicable Overall Risk Category: C8
Product Type:	1 (Asbestos cement)	Location:	2 (Rooms up to 100 sq m)	
Condition:	1 (Minor scratches)	Accessibility:	1 (Occasionally likely to be disturbed)	
Surface Treatment:	1 (Unencapsulated asbestos cement)			
Asbestos Type:	1 (Chrysotile)	Extent Score:	1 (<10 sq m or 10m pipe run)

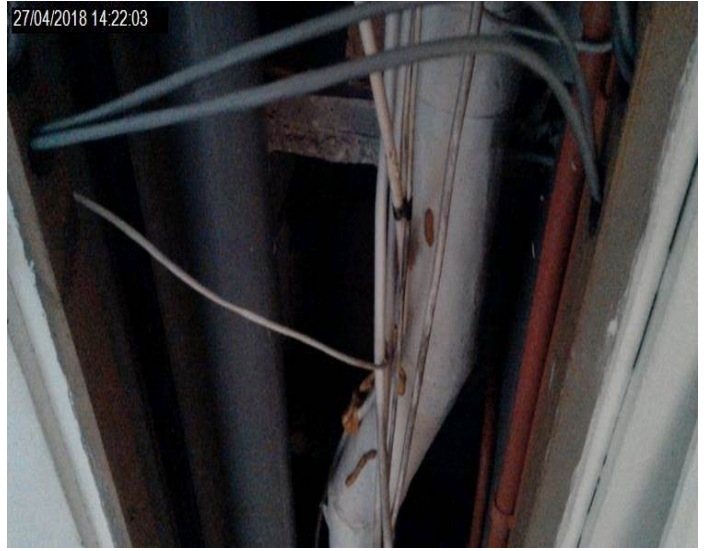
Location:	2.27C	Block:	University	Floor Level: 1st Floor
Sample No.:	DU001402	Portal Ref No.:	157

Item:	Asbestos Cement shuttering			
Asbestos Content:	Result Based on:			
Chrysotile	Analysis of sample using PLM			
Sample Analysed By: Reg 13(1)	Extent:	4 m ²		
Comments: To ceiling of wall void behind polystyrene sheets

Material Assessment Total Score: 4		Likelihood of Disturbance Assessment Total Score: 4		Management Assessment Licensable: No Recommendations: Program removal Reinspection Interval: Not Applicable Overall Risk Category: C8
Product Type:	1 (Asbestos cement)	Location:	2 (Rooms up to 100 sq m)	
Condition:	1 (Minor scratches)	Accessibility:	1 (Occasionally likely to be disturbed)	
Surface Treatment:	1 (Encapsulated asbestos cement)			
Asbestos Type:	1 (Chrysotile)	Extent Score:	1 (<10 sq m or 10m pipe run)

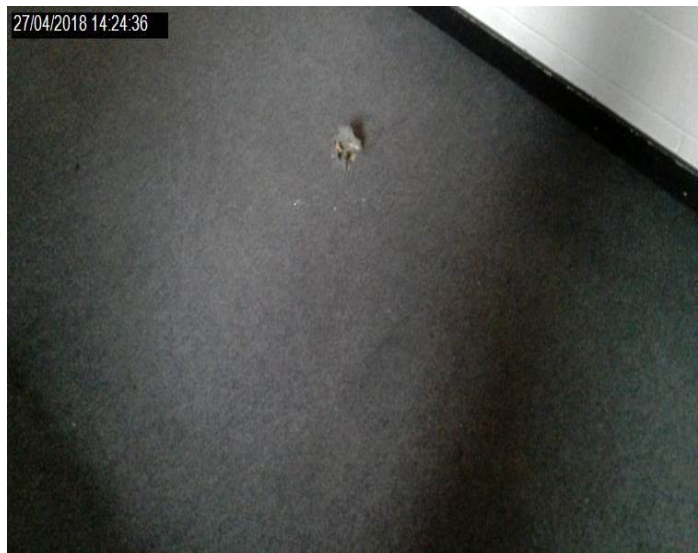
Location:	2.27C	Block:	University	Floor Level: 1st Floor
Sample No.:	DU001403	Portal Ref No.:	158

Item:	Asbestos Thermoplastic floor tiles with bitumen adhesive			
Asbestos Content:	Result Based on:			
Chrysotile in adhesive only		Analysis of sample using PLM		
Sample Analysed By:	Reg 13(1)	Extent:	10 m ²	
Comments: Present beneath carpet

Material Assessment Total Score: 3		Likelihood of Disturbance Assessment Total Score: 4		Management Assessment Licensable: No Recommendations: Program removal Reinspection Interval: Not Applicable Overall Risk Category: C7
Product Type:	1 (Asbestos thermoplastic)	Location:	2 (Rooms up to 100 sq m)	
Condition:	1 (Minor scratches)	Accessibility:	0 (Usually inaccessible or unlikely to be disturbed)	
Surface Treatment:	0 (Composite material)			
Asbestos Type:	1 (Chrysotile)	Extent Score:	2 (>10 - <50 sq m or >10m - <50m pipe run)

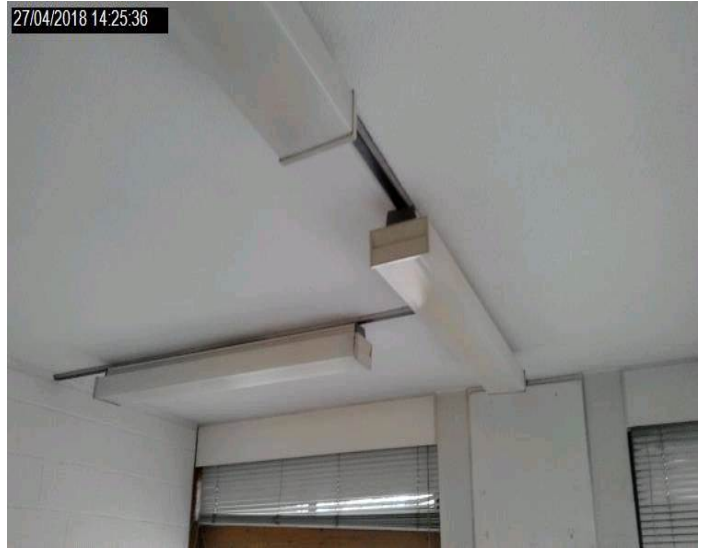
Location:	2.27B	Block:	University	Floor Level: 1st Floor
Sample No.:	As DU001399	Portal Ref No.:	159

Item:	Asbestos Textured coating to concrete ceiling			
Asbestos Content:	Result Based on:			
Chrysotile	Strongly presumed			
Sample Analysed By:	Not applicable	Extent:	14 m ²	
Comments:

Material Assessment Total Score: 3		Likelihood of Disturbance Assessment Total Score: 5		Management Assessment Licensable: No Recommendations: Program removal Reinspection Interval: Not Applicable Overall Risk Category: C8
Product Type:	1 (Asbestos textured coating)	Location:	2 (Rooms up to 100 sq m)	
Condition:	1 (Minor scratches)	Accessibility:	1 (Occasionally likely to be disturbed)	
Surface Treatment:	0 (Composite material)			
Asbestos Type:	1 (Chrysotile)	Extent Score:	2 (>10 - <50 sq m or >10m - <50m pipe run)	
Management Detail

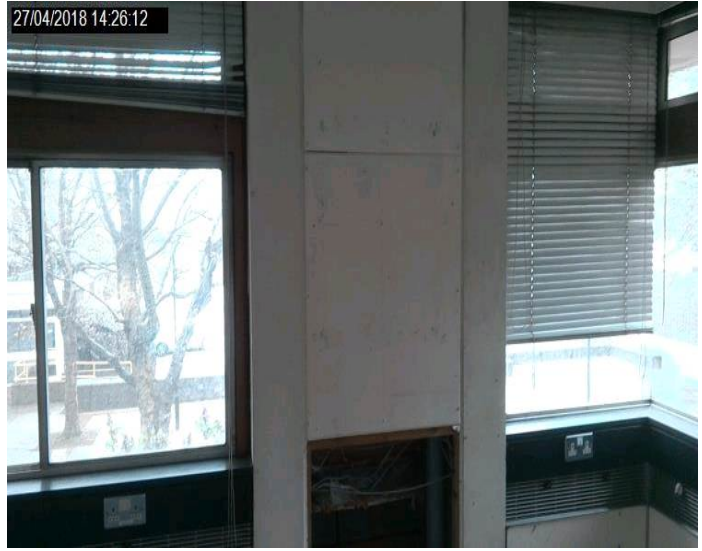
Location:	2.27B	Block:	University	Floor Level: 1st Floor
Sample No.:	As DU001400	Portal Ref No.:	160

Item:	Insulating board panels to risers			
Asbestos Content:		Result Based on:		
No Asbestos Detected		Strongly presumed		
Sample Analysed By:	Not applicable	Extent:	3 m ²	
Comments: 1 x riser

Material Assessment Total Score: 0		Likelihood of Disturbance Assessment Total Score: 0		Management Assessment Licensable: Yes Recommendations: Not Applicable Reinspection Interval: Not Applicable Overall Risk Category: E0
Product Type:	0 Not Applicable	Location:	0 Not Applicable	
Condition:	0 Not Applicable	Accessibility:	0 Not Applicable	
Surface Treatment:	0 Not Applicable			
Asbestos Type:	0 Not Applicable	Extent Score:	0 Not Applicable

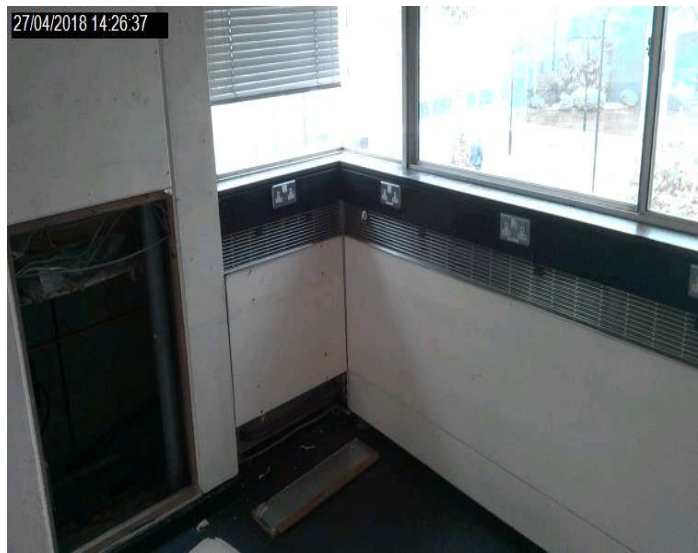
Location:	2.27B	Block:	University	Floor Level: 1st Floor
Sample No.:	As DU001401	Portal Ref No.:	161

Item:	Asbestos Cement window sill			
Asbestos Content:	Result Based on:			
Chrysotile	Strongly presumed			
Sample Analysed By:	Not applicable	Extent:	8 linear metres	
Comments:

Material Assessment Total Score: 4		Likelihood of Disturbance Assessment Total Score: 4		Management Assessment Licensable: No Recommendations: Program removal Reinspection Interval: Not Applicable Overall Risk Category: C8
Product Type:	1 (Asbestos cement)	Location:	2 (Rooms up to 100 sq m)	
Condition:	1 (Minor scratches)	Accessibility:	1 (Occasionally likely to be disturbed)	
Surface Treatment:	1 (Unencapsulated asbestos cement)			
Asbestos Type:	1 (Chrysotile)	Extent Score:	1 (<10 sq m or 10m pipe run)
