Report No.: J094099
Nature of Work: Demolition Survey
Issue Date: 11/06/2018
Client Name: WYG Engineering Ltd
Geneva Building, Lake View Drive, Sherwood Business Park,
Annesley, Nottingham, NG15 0ED
Site Address: Dawson building, Former City North Campus, Birmingham City
University, Perry Barr, B42 2US

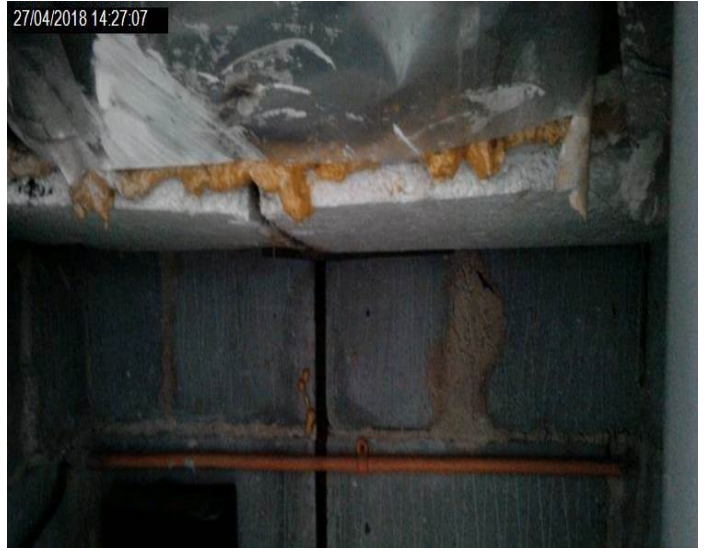
Location:	2.27B	Block:	University	Floor Level: 1st Floor
Sample No.:	As DU001402	Portal Ref No.:	162

Item:	Asbestos Cement shuttering			
Asbestos Content:	Result Based on:			
Chrysotile	Strongly presumed			
Sample Analysed By:	Not applicable	Extent:	8 m ²	
Comments: To ceiling of wall void behind polystyrene sheets

Material Assessment Total Score: 4		Likelihood of Disturbance Assessment Total Score: 4		Management Assessment Licensable: No Recommendations: Program removal Reinspection Interval: Not Applicable Overall Risk Category: C8
Product Type:	1 (Asbestos cement)	Location:	2 (Rooms up to 100 sq m)	
Condition:	1 (Minor scratches)	Accessibility:	1 (Occasionally likely to be disturbed)	
Surface Treatment:	1 (Encapsulated asbestos cement)			
Asbestos Type:	1 (Chrysotile)	Extent Score:	1 (<10 sq m or 10m pipe run)

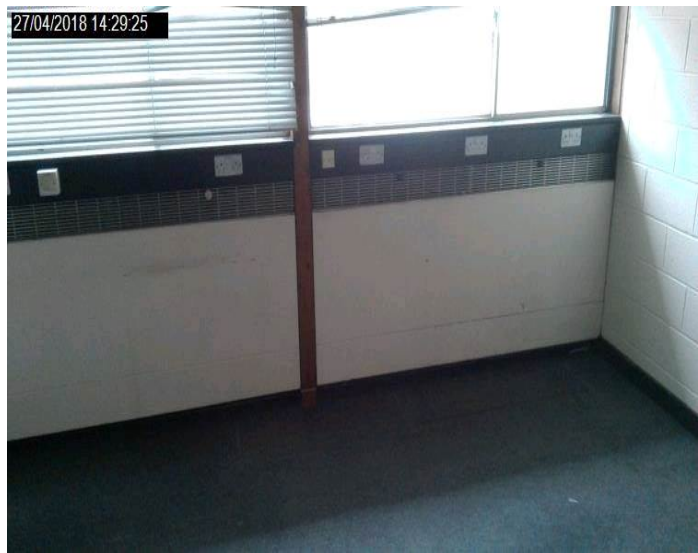
Location:	2.27A	Block:	University	Floor Level: 1st Floor
Sample No.:	As DU001401	Portal Ref No.:	166

Item:	Asbestos Cement window sill			
Asbestos Content:	Result Based on:			
Chrysotile	Strongly presumed			
Sample Analysed By:	Not applicable	Extent:	4 linear metres	
Comments:

Material Assessment Total Score: 4		Likelihood of Disturbance Assessment Total Score: 4		Management Assessment Licensable: No Recommendations: Program removal Reinspection Interval: Not Applicable Overall Risk Category: C8
Product Type:	1 (Asbestos cement)	Location:	2 (Rooms up to 100 sq m)	
Condition:	1 (Minor scratches)	Accessibility:	1 (Occasionally likely to be disturbed)	
Surface Treatment:	1 (Unencapsulated asbestos cement)			
Asbestos Type:	1 (Chrysotile)	Extent Score:	1 (<10 sq m or 10m pipe run)

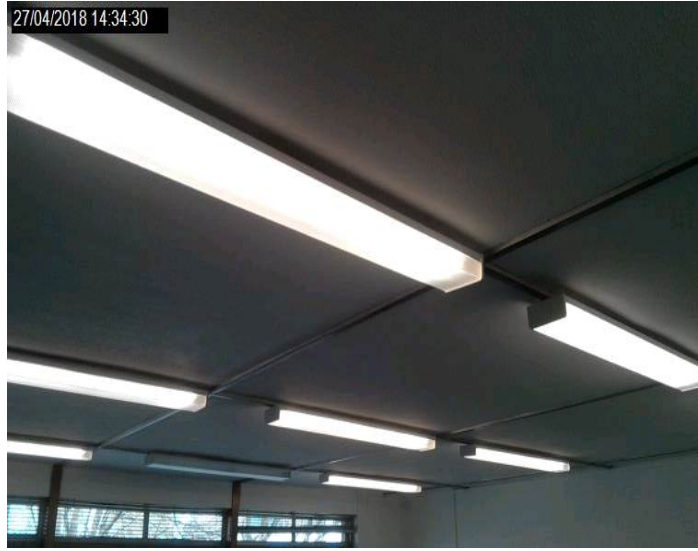
Location:	2.26	Block:	University	Floor Level: 1st Floor
Sample No.:	As DU001399	Portal Ref No.:	173

Item:	Asbestos Textured coating to concrete ceiling			
Asbestos Content:	Result Based on:			
Chrysotile	Strongly presumed			
Sample Analysed By:	Not applicable	Extent:	80 m ²	
Comments:

Material Assessment Total Score: 3		Likelihood of Disturbance Assessment Total Score: 6		Management Assessment Licensable: No Recommendations: Program removal Reinspection Interval: Not Applicable Overall Risk Category: C9
Product Type:	1 (Asbestos textured coating)	Location:	2 (Rooms up to 100 sq m)	
Condition:	1 (Minor scratches)	Accessibility:	1 (Occasionally likely to be disturbed)	
Surface Treatment:	0 (Composite material)			
Asbestos Type:	1 (Chrysotile)	Extent Score:	3 (>50 sq m or >50m pipe run)

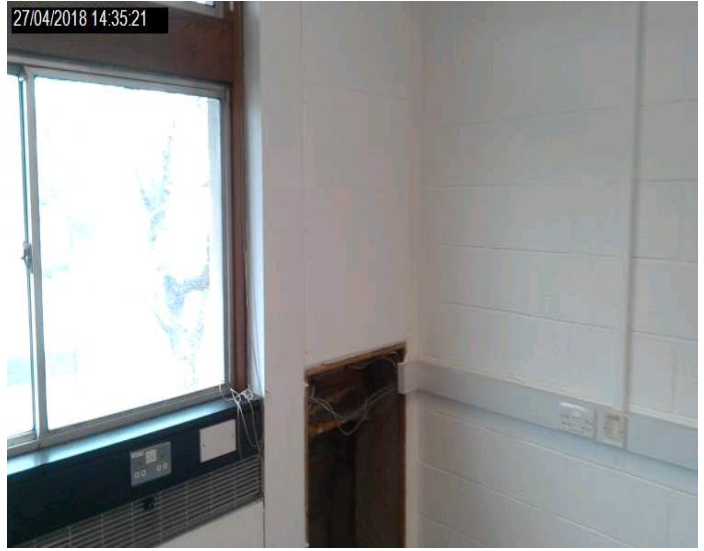
Location:	2.26	Block:	University	Floor Level: 1st Floor
Sample No.:	As DU001400	Portal Ref No.:	174

Item:	Insulating board panels to risers			
Asbestos Content:		Result Based on:		
No Asbestos Detected		Strongly presumed		
Sample Analysed By:	Not applicable	Extent:	6 m ²	
Comments: 2 x riser

Material Assessment Total Score: 0		Likelihood of Disturbance Assessment Total Score: 0		Management Assessment Licensable: Yes Recommendations: Not Applicable Reinspection Interval: Not Applicable Overall Risk Category: E0
Product Type:	0 Not Applicable	Location:	0 Not Applicable	
Condition:	0 Not Applicable	Accessibility:	0 Not Applicable	
Surface Treatment:	0 Not Applicable			
Asbestos Type:	0 Not Applicable	Extent Score:	0 Not Applicable

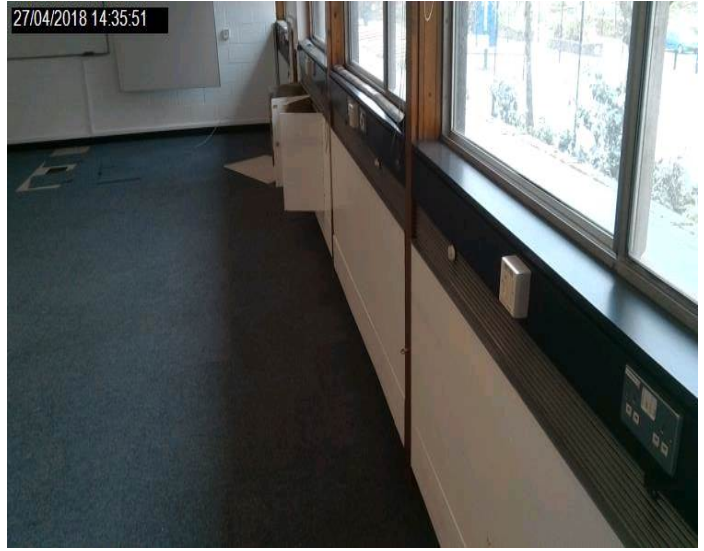
Location:	2.26	Block:	University	Floor Level: 1st Floor
Sample No.:	As DU001401	Portal Ref No.:	175

Item:	Asbestos Cement window sill			
Asbestos Content:	Result Based on:			
Chrysotile	Strongly presumed			
Sample Analysed By:	Not applicable	Extent:	8 linear metres	
Comments:

Material Assessment Total Score: 4		Likelihood of Disturbance Assessment Total Score: 4		Management Assessment Licensable: No Recommendations: Program removal Reinspection Interval: Not Applicable Overall Risk Category: C8
Product Type:	1 (Asbestos cement)	Location:	2 (Rooms up to 100 sq m)	
Condition:	1 (Minor scratches)	Accessibility:	1 (Occasionally likely to be disturbed)	
Surface Treatment:	1 (Unencapsulated asbestos cement)			
Asbestos Type:	1 (Chrysotile)	Extent Score:	1 (<10 sq m or 10m pipe run)

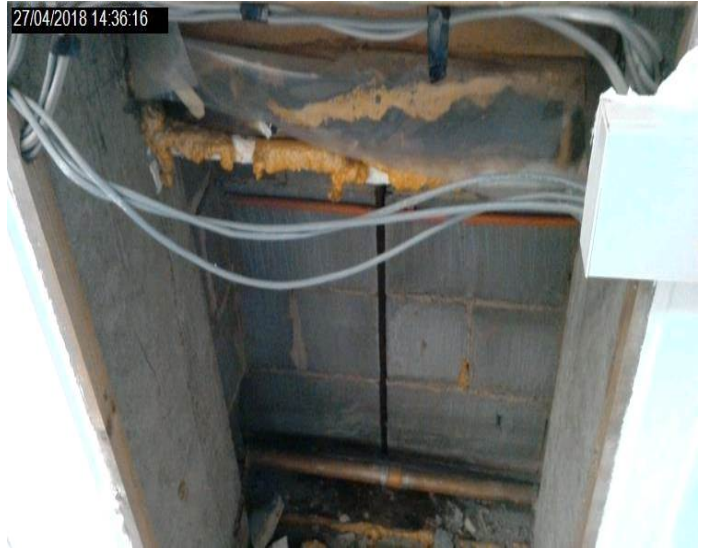
Location:	2.26	Block:	University	Floor Level: 1st Floor
Sample No.:	As DU001402	Portal Ref No.:	176

Item:	Asbestos Cement shuttering			
Asbestos Content:	Result Based on:			
Chrysotile	Strongly presumed			
Sample Analysed By:	Not applicable	Extent:	8 m ²	
Comments: To ceiling of wall void behind polystyrene sheets

Material Assessment Total Score: 4		Likelihood of Disturbance Assessment Total Score: 4		Management Assessment Licensable: No Recommendations: Program removal Reinspection Interval: Not Applicable Overall Risk Category: C8
Product Type:	1 (Asbestos cement)	Location:	2 (Rooms up to 100 sq m)	
Condition:	1 (Minor scratches)	Accessibility:	1 (Occasionally likely to be disturbed)	
Surface Treatment:	1 (Encapsulated asbestos cement)			
Asbestos Type:	1 (Chrysotile)	Extent Score:	1 (<10 sq m or 10m pipe run)

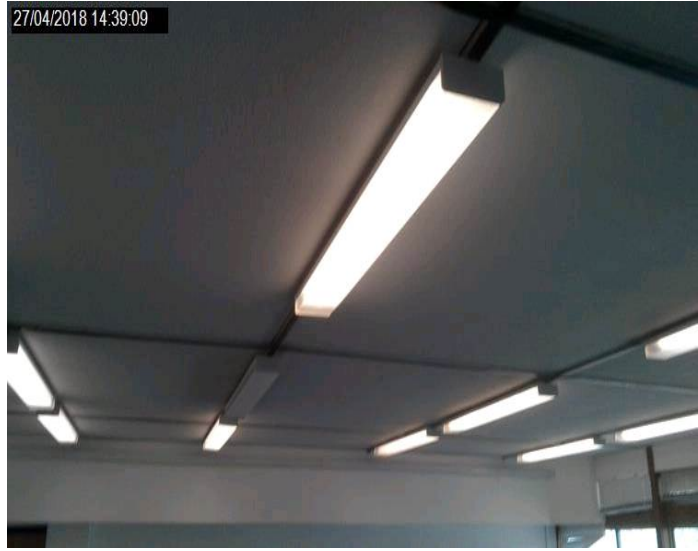
Location:	2.25	Block:	University	Floor Level: 1st Floor
Sample No.:	As DU001399	Portal Ref No.:	178

Item:	Asbestos Textured coating to concrete ceiling			
Asbestos Content:	Result Based on:			
Chrysotile	Strongly presumed			
Sample Analysed By:	Not applicable	Extent:	64 m ²	
Comments:

Material Assessment Total Score: 3		Likelihood of Disturbance Assessment Total Score: 6		Management Assessment Licensable: No Recommendations: Program removal Reinspection Interval: Not Applicable Overall Risk Category: C9
Product Type:	1 (Asbestos textured coating)	Location:	2 (Rooms up to 100 sq m)	
Condition:	1 (Minor scratches)	Accessibility:	1 (Occasionally likely to be disturbed)	
Surface Treatment:	0 (Composite material)			
Asbestos Type:	1 (Chrysotile)	Extent Score:	3 (>50 sq m or >50m pipe run)

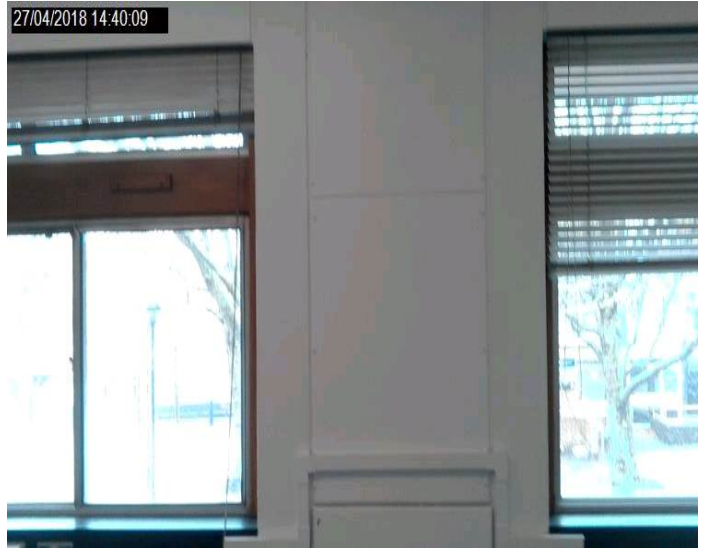
Location:	2.25	Block:	University	Floor Level: 1st Floor
Sample No.:	As DU001400	Portal Ref No.:	179

Item:	Insulating board panels to risers			
Asbestos Content:		Result Based on:		
No Asbestos Detected		Strongly presumed		
Sample Analysed By:	Not applicable	Extent:	2 m ²	
Comments: Top two panels

Material Assessment Total Score: 0		Likelihood of Disturbance Assessment Total Score: 0		Management Assessment Licensable: Yes Recommendations: Not Applicable Reinspection Interval: Not Applicable Overall Risk Category: E0
Product Type:	0 Not Applicable	Location:	0 Not Applicable	
Condition:	0 Not Applicable	Accessibility:	0 Not Applicable	
Surface Treatment:	0 Not Applicable			
Asbestos Type:	0 Not Applicable	Extent Score:	0 Not Applicable

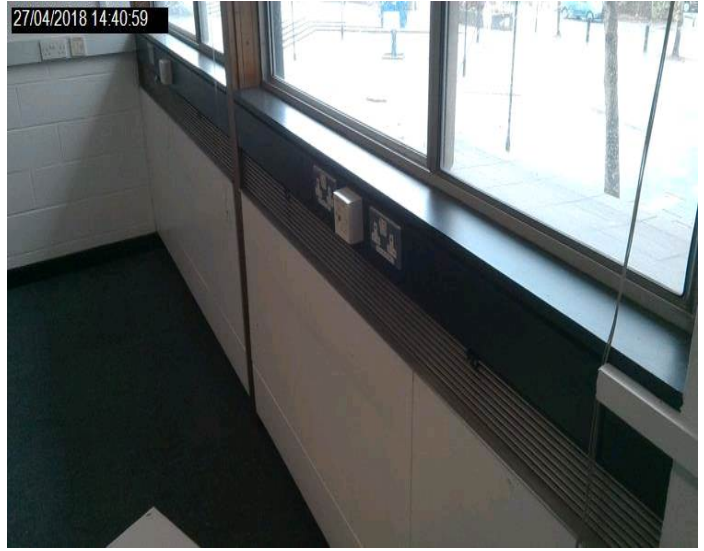
Location:	2.25	Block:	University	Floor Level: 1st Floor
Sample No.:	As DU001401	Portal Ref No.:	180

Item:	Asbestos Cement window sill			
Asbestos Content:	Result Based on:			
Chrysotile	Strongly presumed			
Sample Analysed By:	Not applicable	Extent:	8 linear metres	
Comments:

Material Assessment Total Score: 4		Likelihood of Disturbance Assessment Total Score: 4		Management Assessment Licensable: No Recommendations: Program removal Reinspection Interval: Not Applicable Overall Risk Category: C8
Product Type:	1 (Asbestos cement)	Location:	2 (Rooms up to 100 sq m)	
Condition:	1 (Minor scratches)	Accessibility:	1 (Occasionally likely to be disturbed)	
Surface Treatment:	1 (Unencapsulated asbestos cement)			
Asbestos Type:	1 (Chrysotile)	Extent Score:	1 (<10 sq m or 10m pipe run)

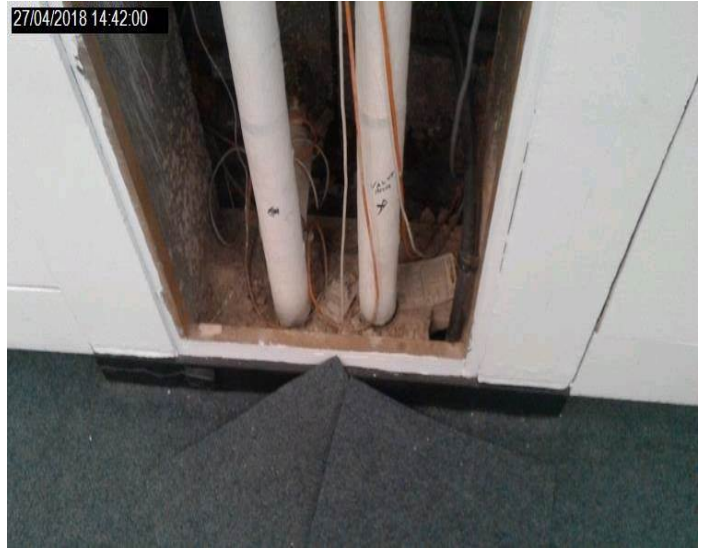
Location:	2.25	Block:	University	Floor Level: 1st Floor
Sample No.:	DU001404	Portal Ref No.:	182

Item:	Bitumen damp proof course			
Asbestos Content:		Result Based on:		
No Asbestos Detected		Analysis of sample using PLM		
Sample Analysed By:	Reg 13(1)	Extent:	250 linear metres	
Comments: To entire perimeter of floor level external wall of heater void

Material Assessment Total Score: 0		Likelihood of Disturbance Assessment Total Score: 0		Management Assessment Licensable: No Recommendations: Not Applicable Reinspection Interval: Not Applicable Overall Risk Category: E0
Product Type:	0 Not Applicable	Location:	0 Not Applicable	
Condition:	0 Not Applicable	Accessibility:	0 Not Applicable	
Surface Treatment:	0 Not Applicable			
Asbestos Type:	0 Not Applicable	Extent Score:	0 Not Applicable

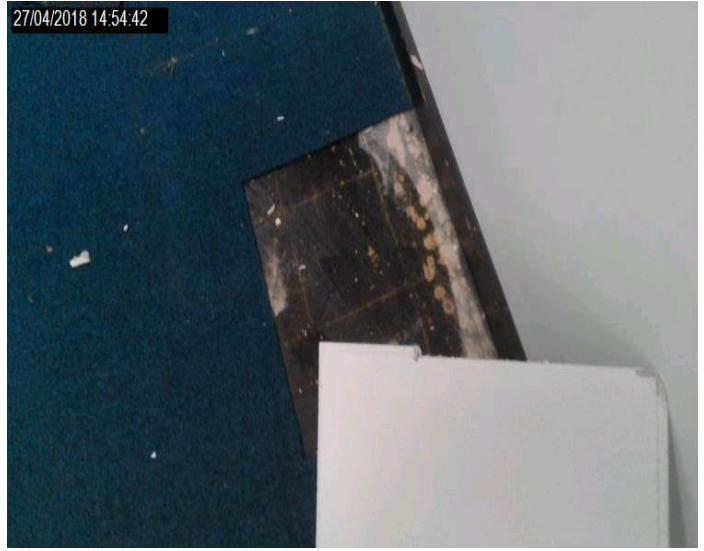
Location:	2.23C	Block:	University	Floor Level: 1st Floor
Sample No.:	DU001409	Portal Ref No.:	188

Item:	Asbestos Bitumen adhesive			
Asbestos Content:	Result Based on:			
Chrysotile	Analysis of sample using PLM			
Sample Analysed By:	Reg 13(1)	Extent:	15 m ²	
Comments: Present beneath carpet

Material Assessment Total Score: 3		Likelihood of Disturbance Assessment Total Score: 4		Management Assessment Licensable: No Recommendations: Program removal Reinspection Interval: Not Applicable Overall Risk Category: C7
Product Type:	1 (Asbestos bitumen)	Location:	2 (Rooms up to 100 sq m)	
Condition:	1 (Minor scratches)	Accessibility:	0 (Usually inaccessible or unlikely to be disturbed)	
Surface Treatment:	0 (Composite material)			
Asbestos Type:	1 (Chrysotile)	Extent Score:	2 (>10 - <50 sq m or >10m - <50m pipe run)

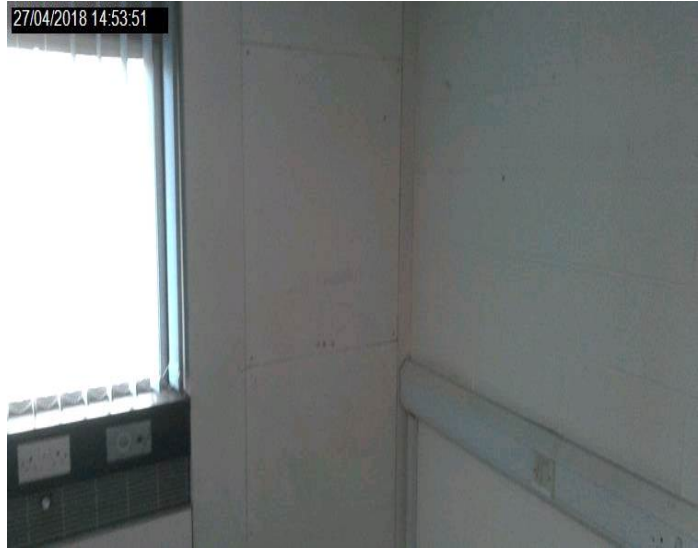
Location:	2.23C	Block:	University	Floor Level: 1st Floor
Sample No.:	DU001408	Portal Ref No.:	189

Item:	Insulating board panel to riser			
Asbestos Content:		Result Based on:		
No Asbestos Detected		Analysis of sample using PLM		
Sample Analysed By:	Reg 13(1)	Extent:	3 m ²	
Comments:

Material Assessment Total Score: 0		Likelihood of Disturbance Assessment Total Score: 0		Management Assessment Licensable: Yes Recommendations: Not Applicable Reinspection Interval: Not Applicable Overall Risk Category: E0
Product Type:	0 Not Applicable	Location:	0 Not Applicable	
Condition:	0 Not Applicable	Accessibility:	0 Not Applicable	
Surface Treatment:	0 Not Applicable			
Asbestos Type:	0 Not Applicable	Extent Score:	0 Not Applicable

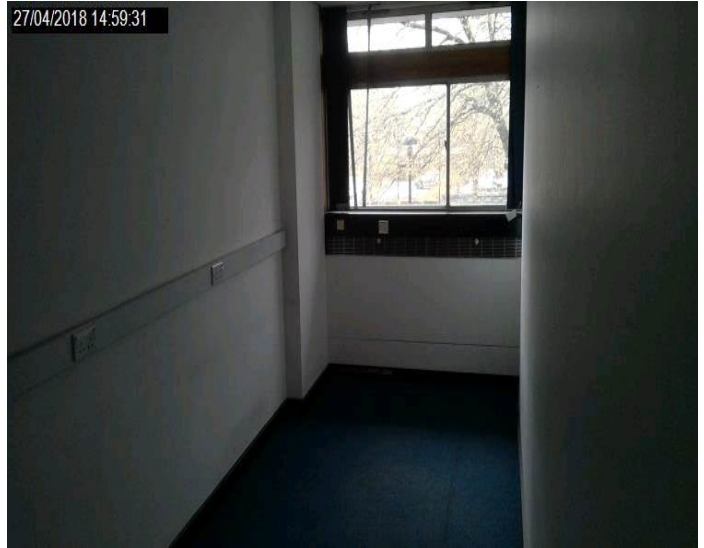
Location:	2.23A	Block:	University	Floor Level: 1st Floor
Sample No.:	As DU001406	Portal Ref No.:	195

Item:	Asbestos Cement window sill			
Asbestos Content:	Result Based on:			
Chrysotile	Strongly presumed			
Sample Analysed By:	Not applicable	Extent:	2 linear metres	
Comments:

Material Assessment Total Score: 4		Likelihood of Disturbance Assessment Total Score: 4		Management Assessment Licensable: No Recommendations: Program removal Reinspection Interval: Not Applicable Overall Risk Category: C8
Product Type:	1 (Asbestos cement)	Location:	2 (Rooms up to 100 sq m)	
Condition:	1 (Minor scratches)	Accessibility:	1 (Occasionally likely to be disturbed)	
Surface Treatment:	1 (Unencapsulated asbestos cement)			
Asbestos Type:	1 (Chrysotile)	Extent Score:	1 (<10 sq m or 10m pipe run)

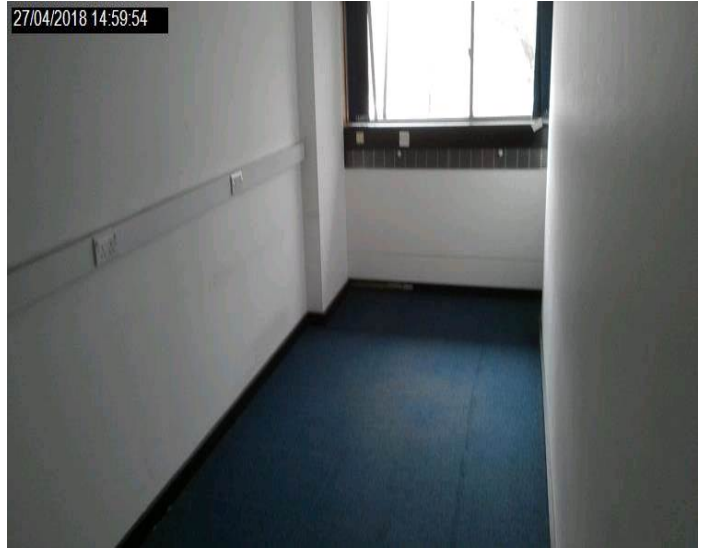
Location:	2.23A	Block:	University	Floor Level: 1st Floor
Sample No.:	As DU001407	Portal Ref No.:	196

Item:	Asbestos Cement shuttering			
Asbestos Content:	Result Based on:			
Chrysotile	Strongly presumed			
Sample Analysed By:	Not applicable	Extent:	2 m ²	
Comments: To ceiling of wall void behind polystyrene sheets

Material Assessment Total Score: 4		Likelihood of Disturbance Assessment Total Score: 4		Management Assessment Licensable: No Recommendations: Program removal Reinspection Interval: Not Applicable Overall Risk Category: C8
Product Type:	1 (Asbestos cement)	Location:	2 (Rooms up to 100 sq m)	
Condition:	1 (Minor scratches)	Accessibility:	1 (Occasionally likely to be disturbed)	
Surface Treatment:	1 (Encapsulated asbestos cement)			
Asbestos Type:	1 (Chrysotile)	Extent Score:	1 (<10 sq m or 10m pipe run)

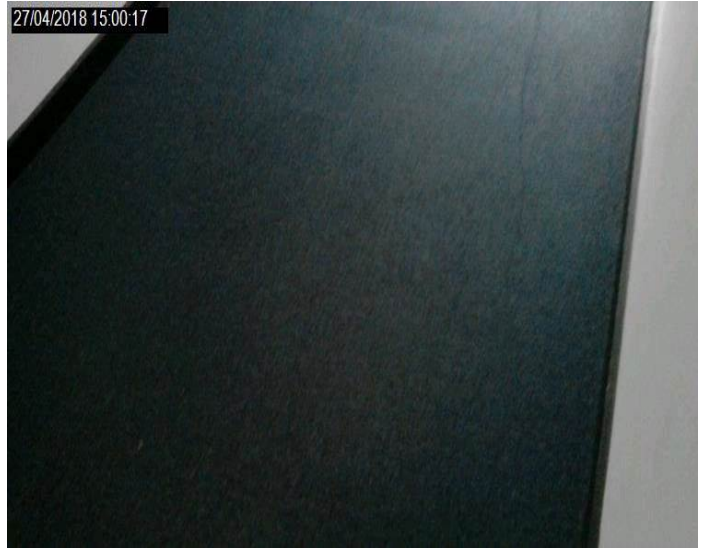
Location:	2.23A	Block:	University	Floor Level: 1st Floor
Sample No.:	As DU001409	Portal Ref No.:	197

Item:	Asbestos Bitumen adhesive			
Asbestos Content:	Result Based on:			
Chrysotile	Strongly presumed			
Sample Analysed By:	Not applicable	Extent:	12 m ²	
Comments: Present beneath carpet

Material Assessment Total Score: 3		Likelihood of Disturbance Assessment Total Score: 4		Management Assessment Licensable: No Recommendations: Program removal Reinspection Interval: Not Applicable Overall Risk Category: C7
Product Type:	1 (Asbestos bitumen)	Location:	2 (Rooms up to 100 sq m)	
Condition:	1 (Minor scratches)	Accessibility:	0 (Usually inaccessible or unlikely to be disturbed)	
Surface Treatment:	0 (Composite material)			
Asbestos Type:	1 (Chrysotile)	Extent Score:	2 (>10 - <50 sq m or >10m - <50m pipe run)

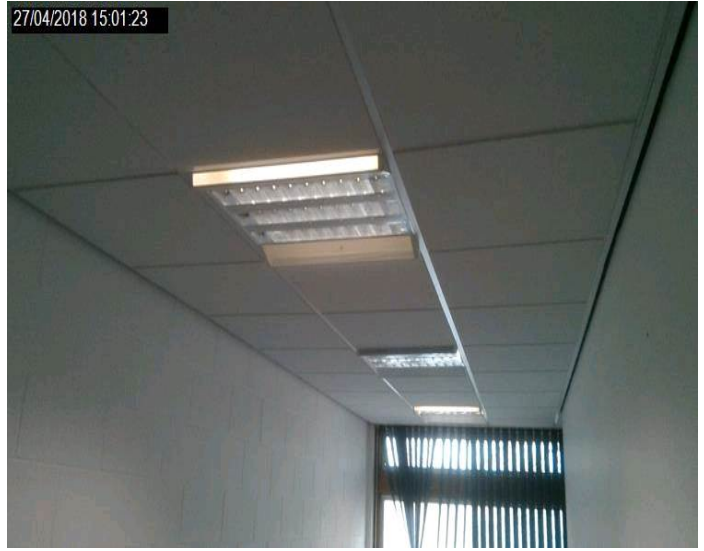
Location:	2.23	Block:	University	Floor Level: 1st Floor
Sample No.:	As DU001405	Portal Ref No.:	198

Item:	Asbestos Textured coating to concrete ceiling			
Asbestos Content:	Result Based on:			
Chrysotile	Strongly presumed			
Sample Analysed By:	Not applicable	Extent:	12 m ²	
Comments: Above suspended tiles

Material Assessment Total Score: 3		Likelihood of Disturbance Assessment Total Score: 5		Management Assessment Licensable: No Recommendations: Program removal Reinspection Interval: Not Applicable Overall Risk Category: C8
Product Type:	1 (Asbestos textured coating)	Location:	2 (Rooms up to 100 sq m)	
Condition:	1 (Minor scratches)	Accessibility:	1 (Occasionally likely to be disturbed)	
Surface Treatment:	0 (Composite material)			
Asbestos Type:	1 (Chrysotile)	Extent Score:	2 (>10 - <50 sq m or >10m - <50m pipe run)

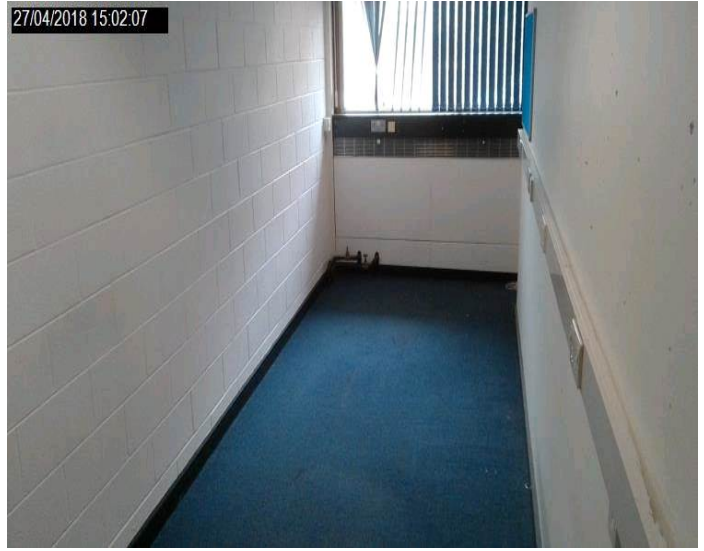
Location:	2.23	Block:	University	Floor Level: 1st Floor
Sample No.:	As DU001407	Portal Ref No.:	200

Item:	Asbestos Cement shuttering			
Asbestos Content:	Chrysotile			
Result Based on:	Strongly presumed			
Sample Analysed By:	Not applicable	Extent:	2 m ²	
Comments: To ceiling of wall void behind polystyrene sheets

Material Assessment Total Score: 4		Likelihood of Disturbance Assessment Total Score: 4		Management Assessment Licensable: No Recommendations: Program removal Reinspection Interval: Not Applicable Overall Risk Category: C8
Product Type:	1 (Asbestos cement)	Location:	2 (Rooms up to 100 sq m)	
Condition:	1 (Minor scratches)	Accessibility:	1 (Occasionally likely to be disturbed)	
Surface Treatment:	1 (Encapsulated asbestos cement)			
Asbestos Type:	1 (Chrysotile)	Extent Score:	1 (<10 sq m or 10m pipe run)

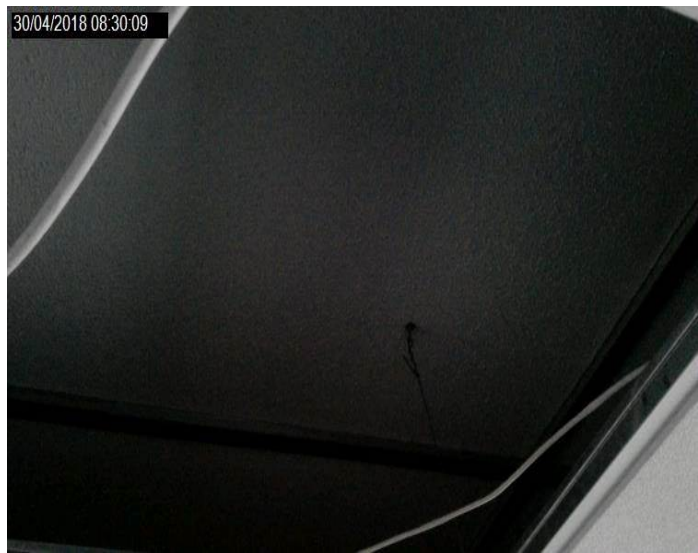
Location:	2.22	Block:	University	Floor Level: 1st Floor
Sample No.:	DU001410	Portal Ref No.:	202

Item:	Asbestos Textured coating to concrete ceiling			
Asbestos Content:	Result Based on:			
Chrysotile	Analysis of sample using PLM			
Sample Analysed By: Reg 13(1)	Extent:	25 m ²		
Comments: Above suspended tiles

Material Assessment Total Score: 3		Likelihood of Disturbance Assessment Total Score: 5		Management Assessment Licensable: No Recommendations: Program removal Reinspection Interval: Not Applicable Overall Risk Category: C8
Product Type:	1 (Asbestos textured coating)	Location:	2 (Rooms up to 100 sq m)	
Condition:	1 (Minor scratches)	Accessibility:	1 (Occasionally likely to be disturbed)	
Surface Treatment:	0 (Composite material)			
Asbestos Type:	1 (Chrysotile)	Extent Score:	2 (>10 - <50 sq m or >10m - <50m pipe run)

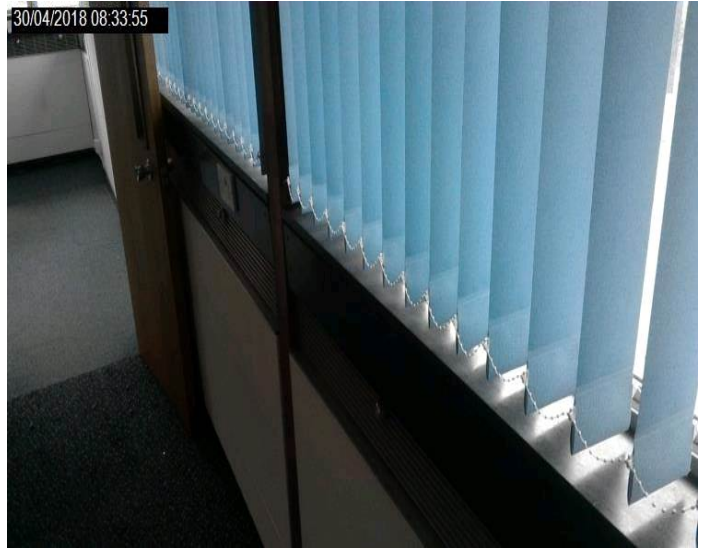
Location:	2.22	Block:	University	Floor Level: 1st Floor
Sample No.:	DU001412	Portal Ref No.:	203

Item:	Asbestos Cement window sill			
Asbestos Content:	Result Based on:			
Chrysotile	Analysis of sample using PLM			
Sample Analysed By:	Reg 13(1)	Extent:	4 linear metres	
Comments:

Material Assessment Total Score: 4		Likelihood of Disturbance Assessment Total Score: 4		Management Assessment Licensable: No Recommendations: Program removal Reinspection Interval: Not Applicable Overall Risk Category: C8
Product Type:	1 (Asbestos cement)	Location:	2 (Rooms up to 100 sq m)	
Condition:	1 (Minor scratches)	Accessibility:	1 (Occasionally likely to be disturbed)	
Surface Treatment:	1 (Unencapsulated asbestos cement)			
Asbestos Type:	1 (Chrysotile)	Extent Score:	1 (<10 sq m or 10m pipe run)

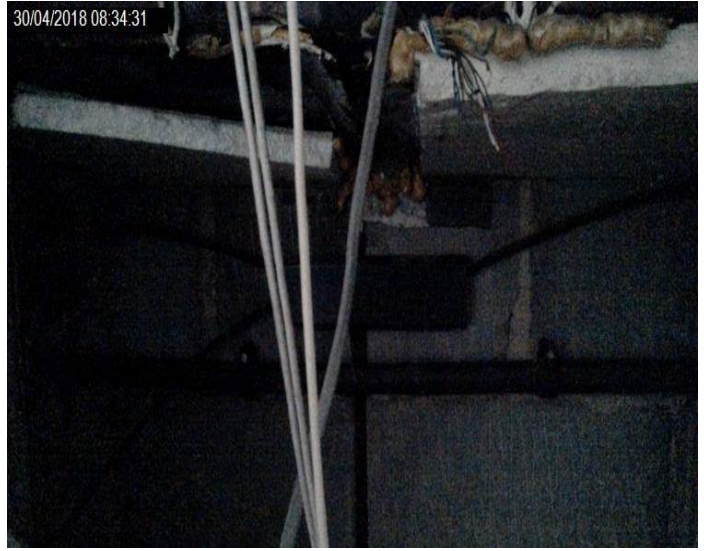
Location:	2.22	Block:	University	Floor Level: 1st Floor
Sample No.:	DU001413	Portal Ref No.:	204

Item:	Asbestos Cement shuttering			
Asbestos Content:	Result Based on:			
Chrysotile	Analysis of sample using PLM			
Sample Analysed By: Reg 13(1)	Extent:	5 m ²		
Comments: To ceiling of wall void behind polystyrene sheets

Material Assessment Total Score: 4		Likelihood of Disturbance Assessment Total Score: 4		Management Assessment Licensable: No Recommendations: Program removal Reinspection Interval: Not Applicable Overall Risk Category: C8
Product Type:	1 (Asbestos cement)	Location:	2 (Rooms up to 100 sq m)	
Condition:	1 (Minor scratches)	Accessibility:	1 (Occasionally likely to be disturbed)	
Surface Treatment:	1 (Encapsulated asbestos cement)			
Asbestos Type:	1 (Chrysotile)	Extent Score:	1 (<10 sq m or 10m pipe run)

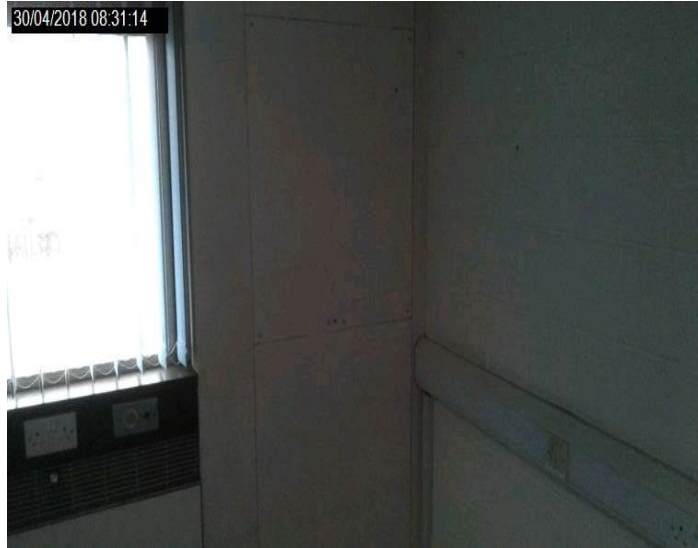
Location:	2.22	Block:	University	Floor Level: 1st Floor
Sample No.:	DU001411	Portal Ref No.:	206

Item:	Insulating board panels to riser			
Asbestos Content:	Result Based on:			
No Asbestos Detected	Analysis of sample using PLM			
Sample Analysed By: Reg 13(1)	Extent:	3 m ²		
Comments:

Material Assessment Total Score: 0		Likelihood of Disturbance Assessment Total Score: 0		Management Assessment Licensable: Yes Recommendations: Not Applicable Reinspection Interval: Not Applicable Overall Risk Category: E0
Product Type:	0 Not Applicable	Location:	0 Not Applicable	
Condition:	0 Not Applicable	Accessibility:	0 Not Applicable	
Surface Treatment:	0 Not Applicable			
Asbestos Type:	0 Not Applicable	Extent Score:	0 Not Applicable

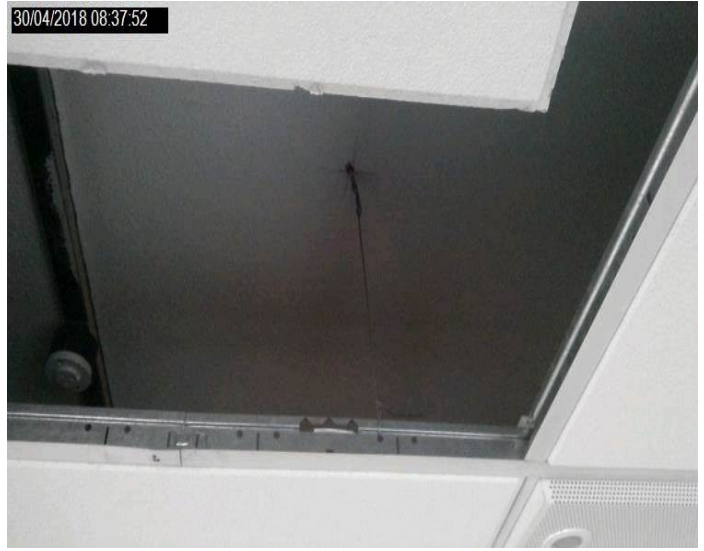
Location:	2.22A	Block:	University	Floor Level: 1st Floor
Sample No.:	As DU001410	Portal Ref No.:	207

Item:	Asbestos Textured coating to concrete ceiling			
Asbestos Content:	Result Based on:			
Chrysotile	Strongly presumed			
Sample Analysed By:	Not applicable	Extent:	16 m ²	
Comments: Above suspended tiles

Material Assessment Total Score: 3		Likelihood of Disturbance Assessment Total Score: 5		Management Assessment Licensable: No Recommendations: Program removal Reinspection Interval: Not Applicable Overall Risk Category: C8
Product Type:	1 (Asbestos textured coating)	Location:	2 (Rooms up to 100 sq m)	
Condition:	1 (Minor scratches)	Accessibility:	1 (Occasionally likely to be disturbed)	
Surface Treatment:	0 (Composite material)			
Asbestos Type:	1 (Chrysotile)	Extent Score:	2 (>10 - <50 sq m or >10m - <50m pipe run)

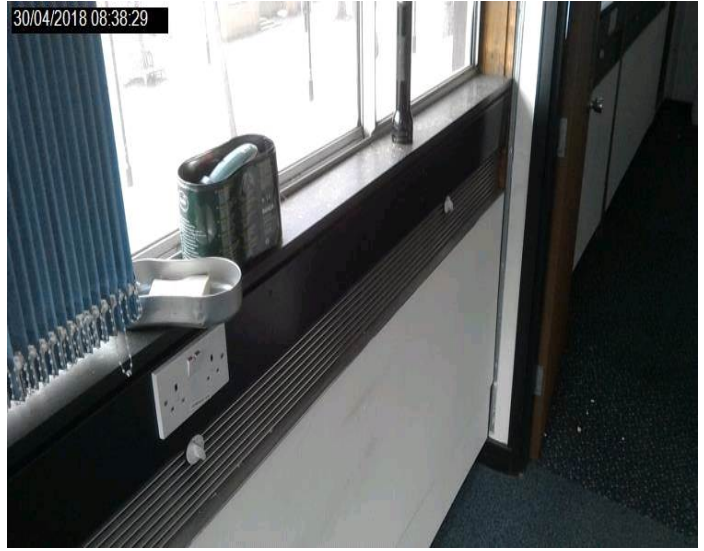
Location:	2.22A	Block:	University	Floor Level: 1st Floor
Sample No.:	As DU001412	Portal Ref No.:	208

Item:	Asbestos Cement window sill			
Asbestos Content:	Result Based on:			
Chrysotile	Strongly presumed			
Sample Analysed By:	Not applicable	Extent:	8 linear metres	
Comments:

Material Assessment Total Score: 4		Likelihood of Disturbance Assessment Total Score: 4		Management Assessment Licensable: No Recommendations: Program removal Reinspection Interval: Not Applicable Overall Risk Category: C8
Product Type:	1 (Asbestos cement)	Location:	2 (Rooms up to 100 sq m)	
Condition:	1 (Minor scratches)	Accessibility:	1 (Occasionally likely to be disturbed)	
Surface Treatment:	1 (Unencapsulated asbestos cement)			
Asbestos Type:	1 (Chrysotile)	Extent Score:	1 (<10 sq m or 10m pipe run)

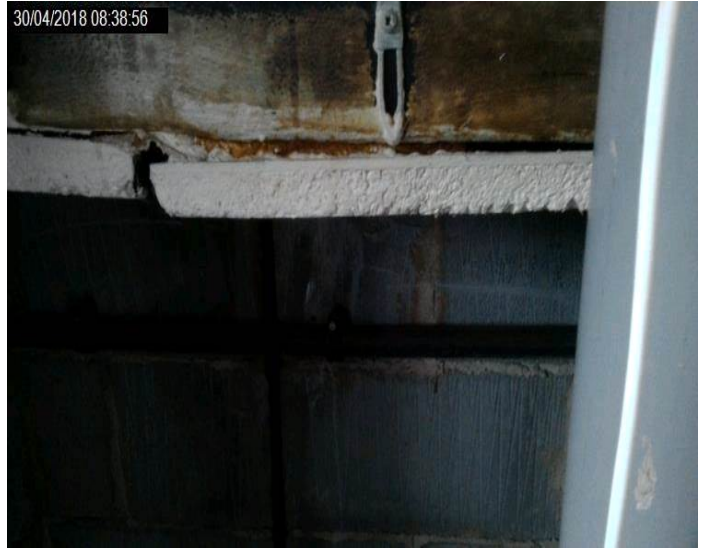
Location:	2.22A	Block:	University	Floor Level: 1st Floor
Sample No.:	As DU001413	Portal Ref No.:	209

Item:	Asbestos Cement shuttering			
Asbestos Content:	Result Based on:			
Chrysotile	Strongly presumed			
Sample Analysed By:	Not applicable	Extent:	8 m ²	
Comments: To ceiling of wall void behind polystyrene sheets

Material Assessment Total Score: 4		Likelihood of Disturbance Assessment Total Score: 4		Management Assessment Licensable: No Recommendations: Program removal Reinspection Interval: Not Applicable Overall Risk Category: C8
Product Type:	1 (Asbestos cement)	Location:	2 (Rooms up to 100 sq m)	
Condition:	1 (Minor scratches)	Accessibility:	1 (Occasionally likely to be disturbed)	
Surface Treatment:	1 (Encapsulated asbestos cement)			
Asbestos Type:	1 (Chrysotile)	Extent Score:	1 (<10 sq m or 10m pipe run)

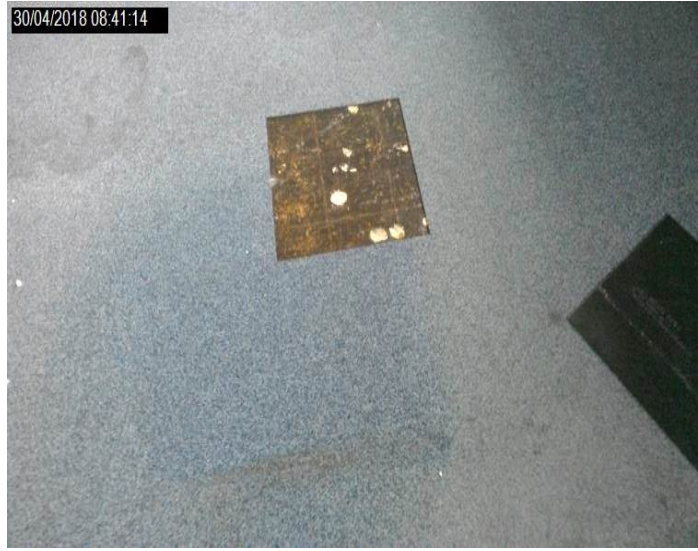
Location:	2.22A	Block:	University	Floor Level: 1st Floor
Sample No.:	As DU001414	Portal Ref No.:	210

Item:	Asbestos Bitumen adhesive			
Asbestos Content:	Result Based on:			
Chrysotile	Strongly presumed			
Sample Analysed By:	Not applicable	Extent:	16 m ²	
Comments: Present beneath carpet.

Material Assessment Total Score: 3		Likelihood of Disturbance Assessment Total Score: 4		Management Assessment Licensable: No Recommendations: Program removal Reinspection Interval: Not Applicable Overall Risk Category: C7
Product Type:	1 (Asbestos bitumen)	Location:	2 (Rooms up to 100 sq m)	
Condition:	1 (Minor scratches)	Accessibility:	0 (Usually inaccessible or unlikely to be disturbed)	
Surface Treatment:	0 (Composite material)			
Asbestos Type:	1 (Chrysotile)	Extent Score:	2 (>10 - <50 sq m or >10m - <50m pipe run)

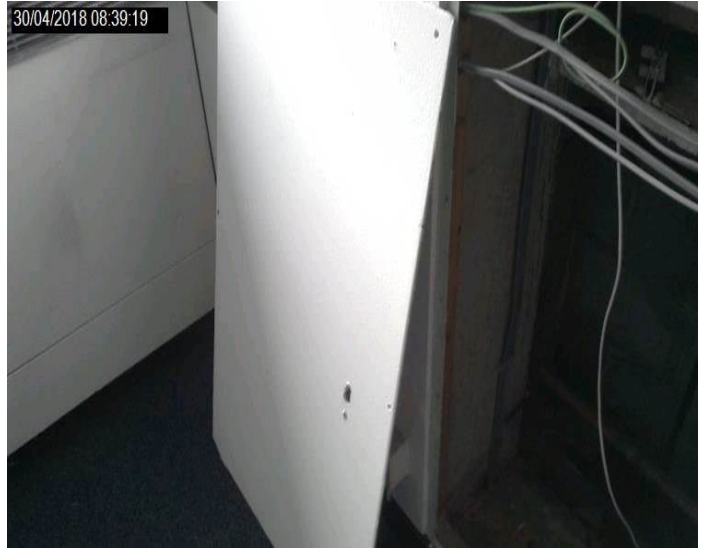
Location:	2.22A	Block:	University	Floor Level: 1st Floor
Sample No.:	As DU001411	Portal Ref No.:	211

Item:	Insulating board panels to riser			
Asbestos Content:		Result Based on:		
No Asbestos Detected		Strongly presumed		
Sample Analysed By:	Not applicable	Extent:	3 m ²	
Comments:

Material Assessment Total Score: 0		Likelihood of Disturbance Assessment Total Score: 0		Management Assessment Licensable: Yes Recommendations: Not Applicable Reinspection Interval: Not Applicable Overall Risk Category: E0
Product Type:	0 Not Applicable	Location:	0 Not Applicable	
Condition:	0 Not Applicable	Accessibility:	0 Not Applicable	
Surface Treatment:	0 Not Applicable			
Asbestos Type:	0 Not Applicable	Extent Score:	0 Not Applicable

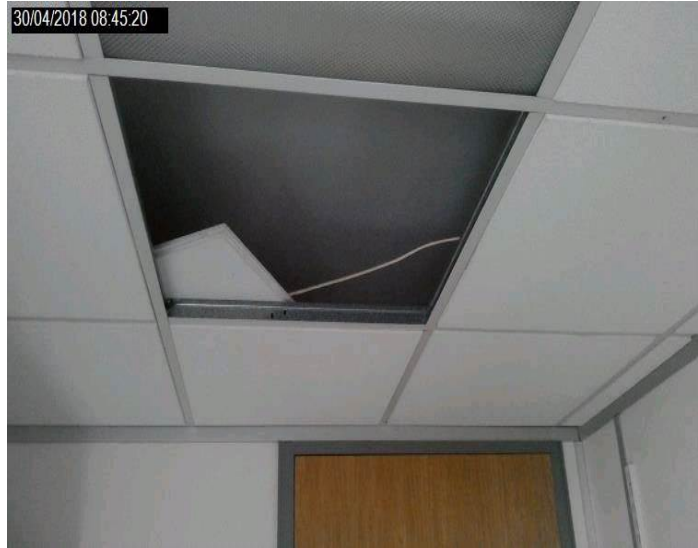
Location:	2.22B	Block:	University	Floor Level: 1st Floor
Sample No.:	As DU001410	Portal Ref No.:	213

Item:	Asbestos Textured coating to concrete ceiling			
Asbestos Content:	Result Based on:			
Chrysotile	Strongly presumed			
Sample Analysed By:	Not applicable	Extent:	6 m ²	
Comments: Above suspended tiles

Material Assessment Total Score: 3		Likelihood of Disturbance Assessment Total Score: 4		Management Assessment Licensable: No Recommendations: Program removal Reinspection Interval: Not Applicable Overall Risk Category: C7
Product Type:	1 (Asbestos textured coating)	Location:	2 (Rooms up to 100 sq m)	
Condition:	1 (Minor scratches)	Accessibility:	1 (Occasionally likely to be disturbed)	
Surface Treatment:	0 (Composite material)			
Asbestos Type:	1 (Chrysotile)	Extent Score:	1 (<10 sq m or 10m pipe run)

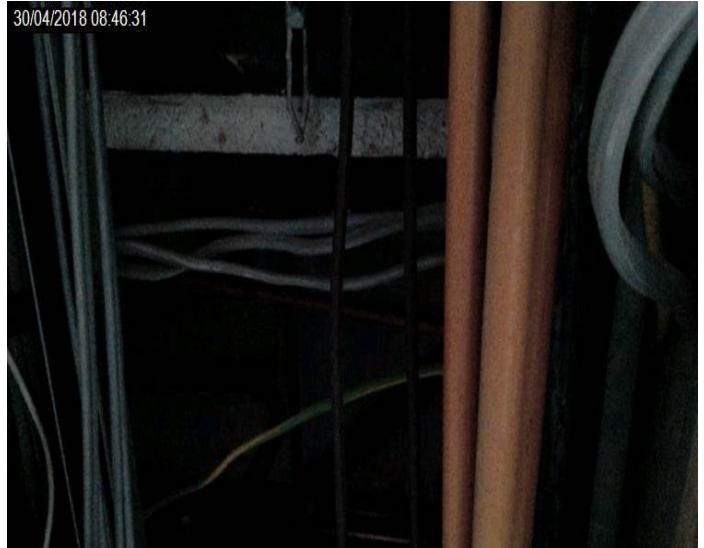
Location:	2.22B	Block:	University	Floor Level: 1st Floor
Sample No.:	As DU001413	Portal Ref No.:	215

Item:	Asbestos Cement shuttering			
Asbestos Content:	Result Based on:			
Chrysotile	Strongly presumed			
Sample Analysed By:	Not applicable	Extent:	2 m ²	
Comments: To ceiling of wall void behind polystyrene sheets

Material Assessment Total Score: 4		Likelihood of Disturbance Assessment Total Score: 4		Management Assessment Licensable: No Recommendations: Program removal Reinspection Interval: Not Applicable Overall Risk Category: C8
Product Type:	1 (Asbestos cement)	Location:	2 (Rooms up to 100 sq m)	
Condition:	1 (Minor scratches)	Accessibility:	1 (Occasionally likely to be disturbed)	
Surface Treatment:	1 (Encapsulated asbestos cement)			
Asbestos Type:	1 (Chrysotile)	Extent Score:	1 (<10 sq m or 10m pipe run)

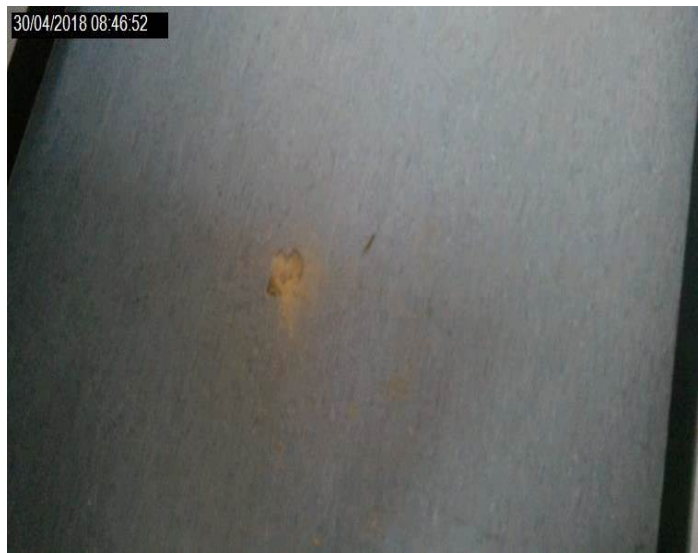
Location:	2.22B	Block:	University	Floor Level: 1st Floor
Sample No.:	As DU001414	Portal Ref No.:	216

Item:	Asbestos Bitumen adhesive			
Asbestos Content:	Result Based on:			
Chrysotile	Strongly presumed			
Sample Analysed By:	Not applicable	Extent:	6 m ²	
Comments: Present beneath modern vinyl

Material Assessment Total Score: 3		Likelihood of Disturbance Assessment Total Score: 3		Management Assessment Licensable: No Recommendations: Program removal Reinspection Interval: Not Applicable Overall Risk Category: D6
Product Type:	1 (Asbestos bitumen)	Location:	2 (Rooms up to 100 sq m)	
Condition:	1 (Minor scratches)	Accessibility:	0 (Usually inaccessible or unlikely to be disturbed)	
Surface Treatment:	0 (Composite material)			
Asbestos Type:	1 (Chrysotile)	Extent Score:	1 (<10 sq m or 10m pipe run)

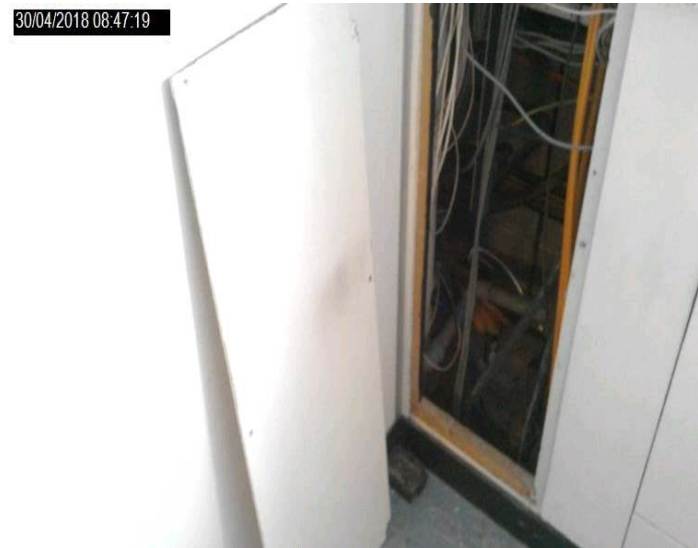
Location:	2.22B	Block:	University	Floor Level: 1st Floor
Sample No.:	As DU001411	Portal Ref No.:	217

<p>30/04/2018 08:47:19</p>
Item:	Insulating board panels to riser			
Asbestos Content:		Result Based on:		
No Asbestos Detected		Strongly presumed		
Sample Analysed By:	Not applicable	Extent:	2 m ²	
Comments:

Material Assessment Total Score: 0		Likelihood of Disturbance Assessment Total Score: 0		Management Assessment Licensable: Yes Recommendations: Not Applicable Reinspection Interval: Not Applicable Overall Risk Category: E0
Product Type:	0 Not Applicable	Location:	0 Not Applicable	
Condition:	0 Not Applicable	Accessibility:	0 Not Applicable	
Surface Treatment:	0 Not Applicable			
Asbestos Type:	0 Not Applicable	Extent Score:	0 Not Applicable

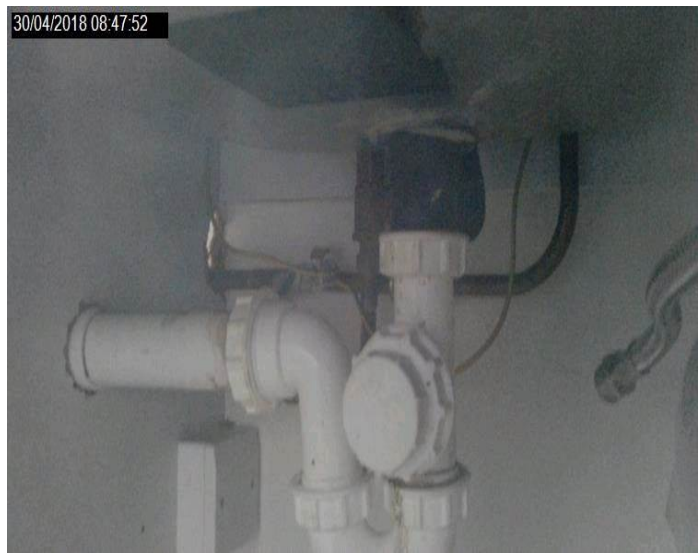
Location:	2.22B	Block:	University	Floor Level: 1st Floor
Sample No.:	DU001415	Portal Ref No.:	218

Item:	Bitumen sink pad			
Asbestos Content:		Result Based on:		
No Asbestos Detected		Analysis of sample using PLM		
Sample Analysed By:	Reg 13(1)	Extent:	2 units	
Comments:

Material Assessment Total Score: 0		Likelihood of Disturbance Assessment Total Score: 0		Management Assessment Licensable: No Recommendations: Not Applicable Reinspection Interval: Not Applicable Overall Risk Category: E0
Product Type:	0 Not Applicable	Location:	0 Not Applicable	
Condition:	0 Not Applicable	Accessibility:	0 Not Applicable	
Surface Treatment:	0 Not Applicable			
Asbestos Type:	0 Not Applicable	Extent Score:	0 Not Applicable

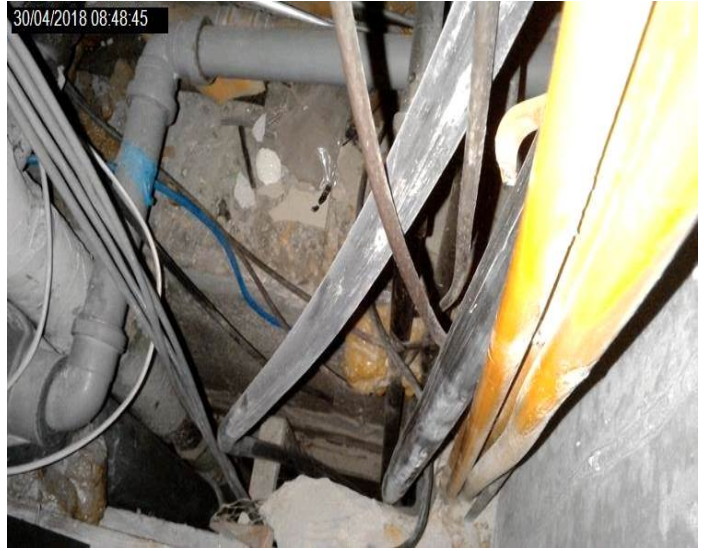
Location:	2.22B	Block:	University	Floor Level: 1st Floor
Sample No.:	DU001416	Portal Ref No.:	219

Item:	Asbestos Thermoplastic floor tile debris within riser			
Asbestos Content:	Result Based on:			
Chrysotile in adhesive only	Analysis of sample using PLM			
Sample Analysed By: Reg 13(1)	Extent:	<1 m ²		
Comments: One small piece

Material Assessment Total Score: 5		Likelihood of Disturbance Assessment Total Score: 4		Management Assessment Licensable: No Recommendations: Program removal Reinspection Interval: Not Applicable Overall Risk Category: C9
Product Type:	1 (Asbestos thermoplastic)	Location:	2 (Rooms up to 100 sq m)	
Condition:	3 (Significant damage)	Accessibility:	1 (Occasionally likely to be disturbed)	
Surface Treatment:	0 (Composite material)			
Asbestos Type:	1 (Chrysotile)	Extent Score:	1 (<10 sq m or 10m pipe run)

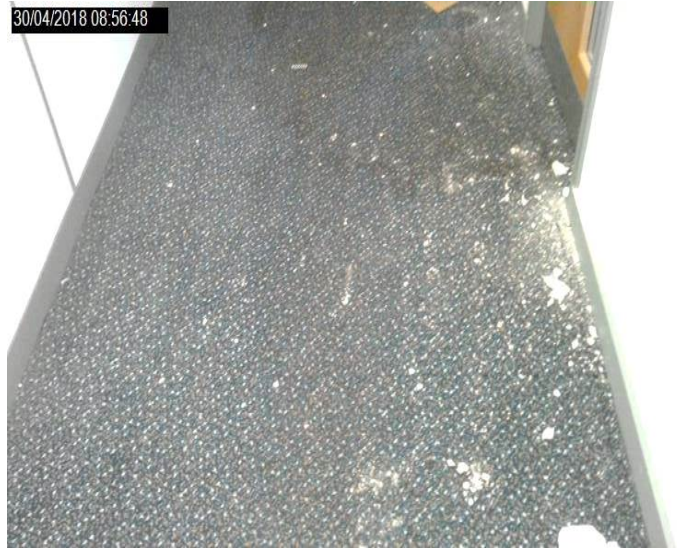
Location:	2.99A	Block:	University	Floor Level: 1st Floor
Sample No.:	As DU001414	Portal Ref No.:	221

Item:	Asbestos Bitumen adhesive to concrete			
Asbestos Content:	Result Based on:			
Chrysotile	Strongly presumed			
Sample Analysed By:	Not applicable	Extent:	10 m ²	
Comments: Present to section of the floor, beneath carpet.

Material Assessment Total Score: 3		Likelihood of Disturbance Assessment Total Score: 3		Management Assessment Licensable: No Recommendations: Program removal Reinspection Interval: Not Applicable Overall Risk Category: D6
Product Type:	1 (Asbestos bitumen)	Location:	2 (Rooms up to 100 sq m)	
Condition:	1 (Minor scratches)	Accessibility:	0 (Usually inaccessible or unlikely to be disturbed)	
Surface Treatment:	0 (Composite material)			
Asbestos Type:	1 (Chrysotile)	Extent Score:	1 (<10 sq m or 10m pipe run)

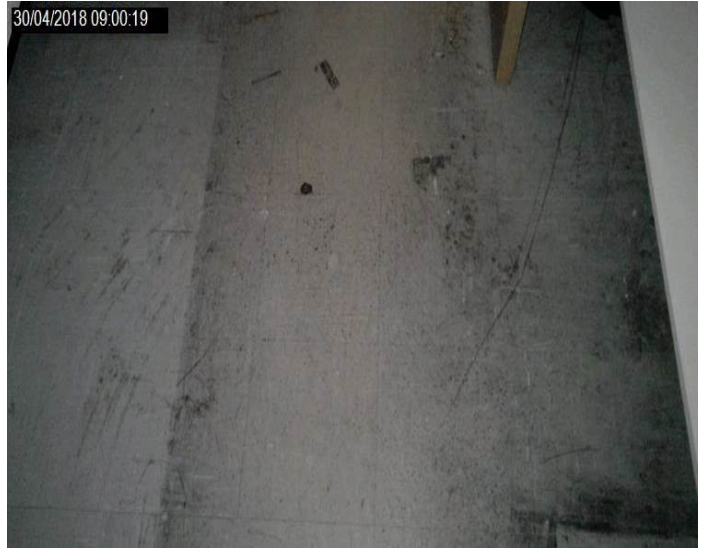
Location:	2.21C	Block:	University	Floor Level: 1st Floor
Sample No.:	As DU001417	Portal Ref No.:	223

Item:	Thermoplastic floor tiles			
Asbestos Content:		Result Based on:		
No Asbestos Detected		Strongly presumed		
Sample Analysed By:	Not applicable	Extent:	8 m ²	
Comments: Section of the corridor floor

Material Assessment Total Score: 0		Likelihood of Disturbance Assessment Total Score: 0		Management Assessment Licensable: No Recommendations: Not Applicable Reinspection Interval: Not Applicable Overall Risk Category: E0
Product Type:	0 Not Applicable	Location:	0 Not Applicable	
Condition:	0 Not Applicable	Accessibility:	0 Not Applicable	
Surface Treatment:	0 Not Applicable			
Asbestos Type:	0 Not Applicable	Extent Score:	0 Not Applicable

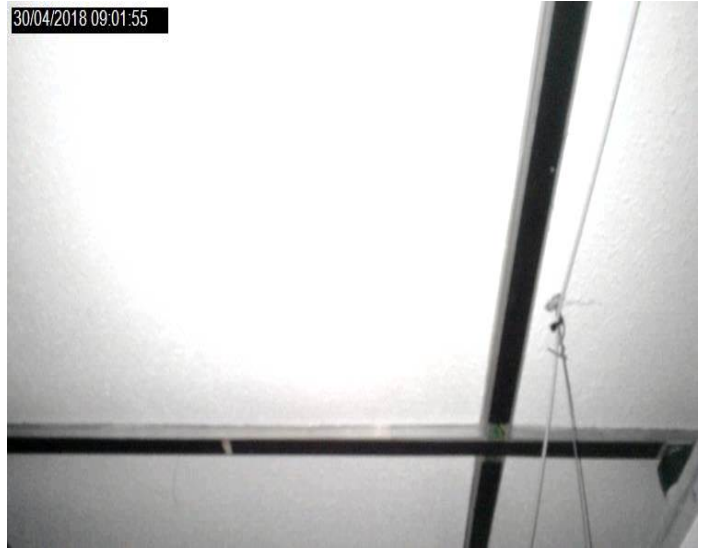
Location:	2.21	Block:	University	Floor Level: 1st Floor
Sample No.:	As DU001410	Portal Ref No.:	224

Item:	Asbestos Textured coating to concrete ceiling			
Asbestos Content:	Result Based on:			
Chrysotile	Strongly presumed			
Sample Analysed By:	Not applicable	Extent:	90 m ²	
Comments: Above suspended tiles

Material Assessment Total Score: 3		Likelihood of Disturbance Assessment Total Score: 6		Management Assessment Licensable: No Recommendations: Program removal Reinspection Interval: Not Applicable Overall Risk Category: C9
Product Type:	1 (Asbestos textured coating)	Location:	2 (Rooms up to 100 sq m)	
Condition:	1 (Minor scratches)	Accessibility:	1 (Occasionally likely to be disturbed)	
Surface Treatment:	0 (Composite material)			
Asbestos Type:	1 (Chrysotile)	Extent Score:	3 (>50 sq m or >50m pipe run)

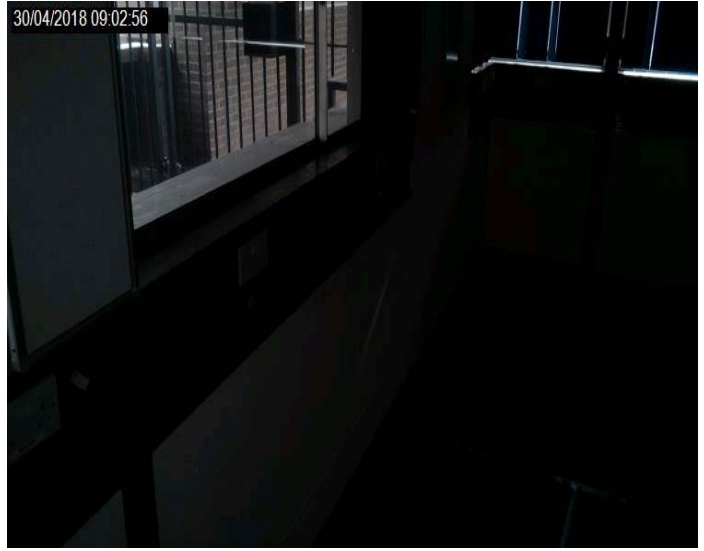
Location:	2.21	Block:	University	Floor Level: 1st Floor
Sample No.:	As DU001412	Portal Ref No.:	225

Item:	Asbestos Cement window sill			
Asbestos Content:	Result Based on:			
Chrysotile	Strongly presumed			
Sample Analysed By:	Not applicable	Extent:	15 linear metres	
Comments:

Material Assessment Total Score: 4		Likelihood of Disturbance Assessment Total Score: 5		Management Assessment Licensable: No Recommendations: Program removal Reinspection Interval: Not Applicable Overall Risk Category: C9
Product Type:	1 (Asbestos cement)	Location:	2 (Rooms up to 100 sq m)	
Condition:	1 (Minor scratches)	Accessibility:	1 (Occasionally likely to be disturbed)	
Surface Treatment:	1 (Unencapsulated asbestos cement)			
Asbestos Type:	1 (Chrysotile)	Extent Score:	2 (>10 - <50 sq m or >10m - <50m pipe run)
