Report No.: J094099
Nature of Work: Demolition Survey
Issue Date: 11/06/2018
Client Name: WYG Engineering Ltd
Geneva Building, Lake View Drive, Sherwood Business Park,
Annesley, Nottingham, NG15 0ED
Site Address: Dawson building, Former City North Campus, Birmingham City
University, Perry Barr, B42 2US

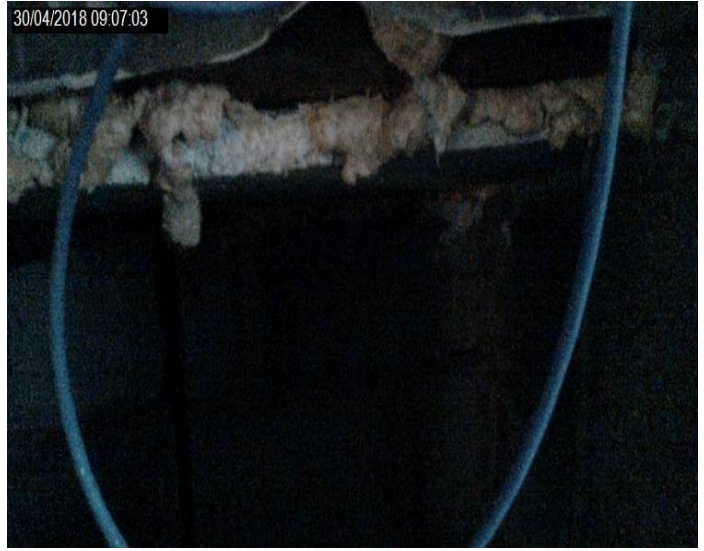
Location:	2.21	Block:	University	Floor Level: 1st Floor
Sample No.:	As DU001413	Portal Ref No.:	226

Item:	Asbestos Cement shuttering			
Asbestos Content:	Result Based on:			
Chrysotile	Strongly presumed			
Sample Analysed By:	Not applicable	Extent:	15 m ²	
Comments: To ceiling of wall void behind polystyrene sheets

Material Assessment Total Score: 4		Likelihood of Disturbance Assessment Total Score: 5		Management Assessment Licensable: No Recommendations: Program removal Reinspection Interval: Not Applicable Overall Risk Category: C9
Product Type:	1 (Asbestos cement)	Location:	2 (Rooms up to 100 sq m)	
Condition:	1 (Minor scratches)	Accessibility:	1 (Occasionally likely to be disturbed)	
Surface Treatment:	1 (Encapsulated asbestos cement)			
Asbestos Type:	1 (Chrysotile)	Extent Score:	2 (>10 - <50 sq m or >10m - <50m pipe run)

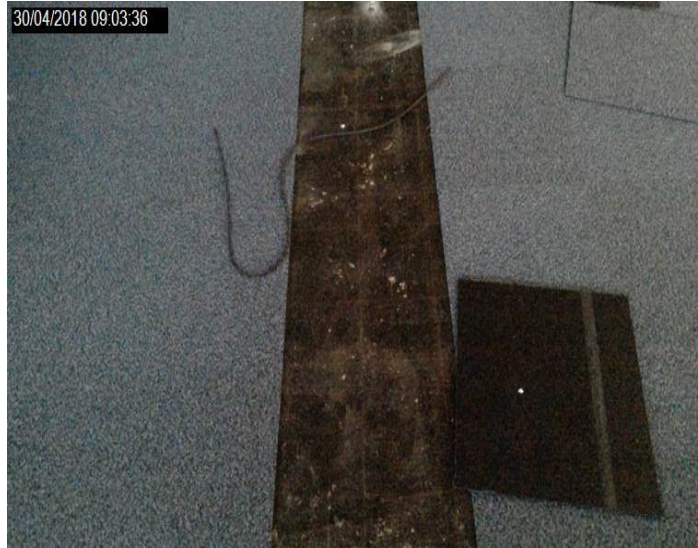
Location:	2.21	Block:	University	Floor Level: 1st Floor
Sample No.:	As DU001414	Portal Ref No.:	227

Item:	Asbestos Bitumen adhesive			
Asbestos Content:	Result Based on:			
Chrysotile	Strongly presumed			
Sample Analysed By:	Not applicable	Extent:	90 m ²	
Comments: Present beneath carpet

Material Assessment Total Score: 3		Likelihood of Disturbance Assessment Total Score: 5		Management Assessment Licensable: No Recommendations: Program removal Reinspection Interval: Not Applicable Overall Risk Category: C8
Product Type:	1 (Asbestos bitumen)	Location:	2 (Rooms up to 100 sq m)	
Condition:	1 (Minor scratches)	Accessibility:	0 (Usually inaccessible or unlikely to be disturbed)	
Surface Treatment:	0 (Composite material)			
Asbestos Type:	1 (Chrysotile)	Extent Score:	3 (>50 sq m or >50m pipe run)

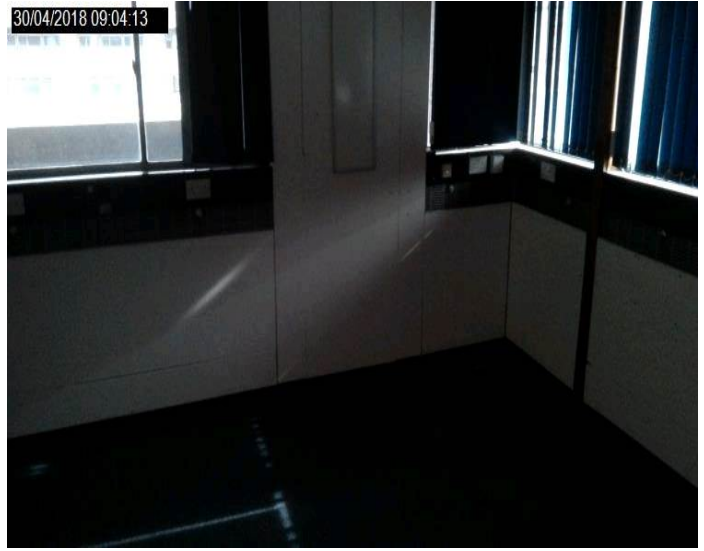
Location:	2.21	Block:	University	Floor Level: 1st Floor
Sample No.:	As DU001411	Portal Ref No.:	228

Item:	Insulating board panels to riser			
Asbestos Content:		Result Based on:		
No Asbestos Detected		Strongly presumed		
Sample Analysed By:	Not applicable	Extent:	7 m ²	
Comments: 3 x risers

Material Assessment Total Score: 0		Likelihood of Disturbance Assessment Total Score: 0		Management Assessment Licensable: Yes Recommendations: Not Applicable Reinspection Interval: Not Applicable Overall Risk Category: E0
Product Type:	0 Not Applicable	Location:	0 Not Applicable	
Condition:	0 Not Applicable	Accessibility:	0 Not Applicable	
Surface Treatment:	0 Not Applicable			
Asbestos Type:	0 Not Applicable	Extent Score:	0 Not Applicable

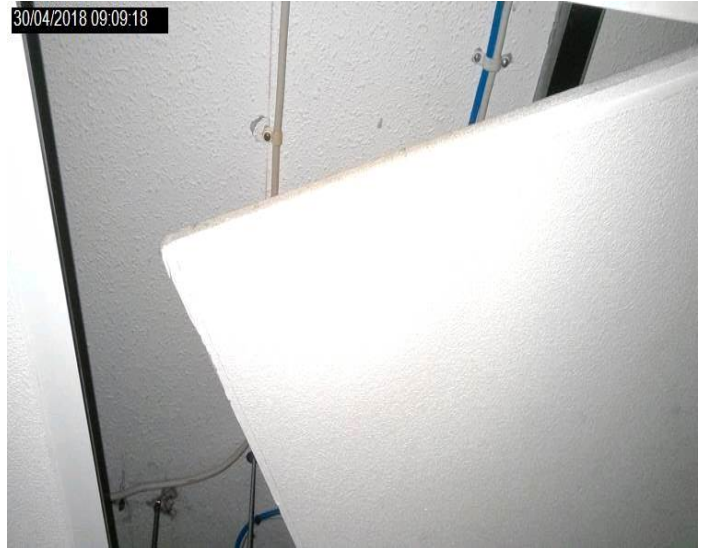
Location:	2.21B	Block:	University	Floor Level: 1st Floor
Sample No.:	As DU001410	Portal Ref No.:	229

Item:	Asbestos Textured coating to concrete ceiling			
Asbestos Content:	Result Based on:			
Chrysotile	Strongly presumed			
Sample Analysed By:	Not applicable	Extent:	10 m ²	
Comments: Above suspended tiles

Material Assessment Total Score: 3		Likelihood of Disturbance Assessment Total Score: 5		Management Assessment Licensable: No Recommendations: Program removal Reinspection Interval: Not Applicable Overall Risk Category: C8
Product Type:	1 (Asbestos textured coating)	Location:	2 (Rooms up to 100 sq m)	
Condition:	1 (Minor scratches)	Accessibility:	1 (Occasionally likely to be disturbed)	
Surface Treatment:	0 (Composite material)			
Asbestos Type:	1 (Chrysotile)	Extent Score:	2 (>10 - <50 sq m or >10m - <50m pipe run)

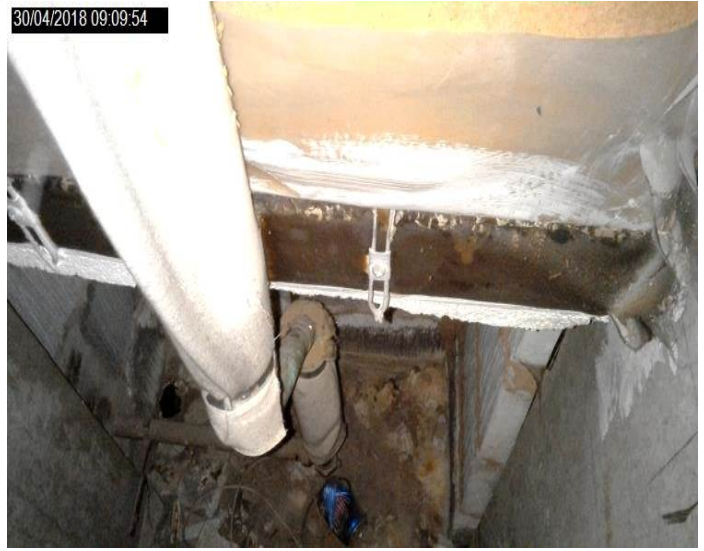
Location:	2.21B	Block:	University	Floor Level: 1st Floor
Sample No.:	As DU001413	Portal Ref No.:	231

Item:	Asbestos Cement shuttering			
Asbestos Content:	Result Based on:			
Chrysotile	Strongly presumed			
Sample Analysed By:	Not applicable	Extent:	2 m ²	
Comments: To ceiling of wall void behind polystyrene sheets

Material Assessment Total Score: 4		Likelihood of Disturbance Assessment Total Score: 4		Management Assessment Licensable: No Recommendations: Program removal Reinspection Interval: Not Applicable Overall Risk Category: C8
Product Type:	1 (Asbestos cement)	Location:	2 (Rooms up to 100 sq m)	
Condition:	1 (Minor scratches)	Accessibility:	1 (Occasionally likely to be disturbed)	
Surface Treatment:	1 (Encapsulated asbestos cement)			
Asbestos Type:	1 (Chrysotile)	Extent Score:	1 (<10 sq m or 10m pipe run)

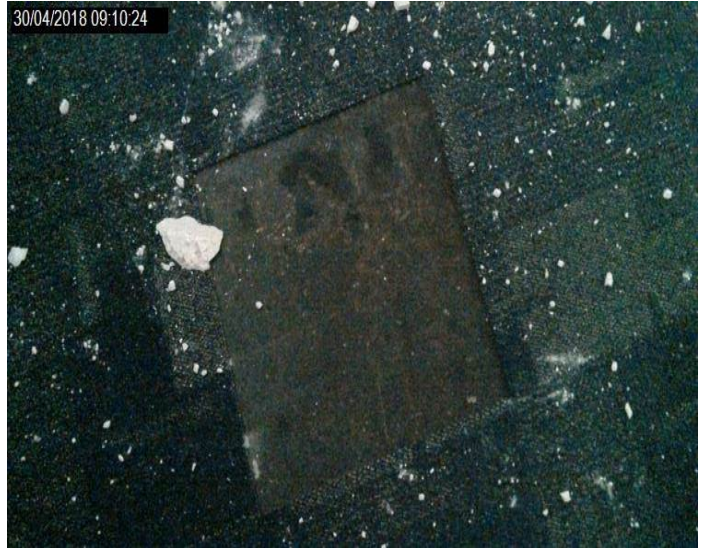
Location:	2.21B	Block:	University	Floor Level: 1st Floor
Sample No.:	As DU001414	Portal Ref No.:	232

Item:	Asbestos Bitumen adhesive			
Asbestos Content:	Result Based on:			
Chrysotile	Strongly presumed			
Sample Analysed By:	Not applicable	Extent:	10 m ²	
Comments: Present beneath carpet

Material Assessment Total Score: 3		Likelihood of Disturbance Assessment Total Score: 4		Management Assessment Licensable: No Recommendations: Program removal Reinspection Interval: Not Applicable Overall Risk Category: C7
Product Type:	1 (Asbestos bitumen)	Location:	2 (Rooms up to 100 sq m)	
Condition:	1 (Minor scratches)	Accessibility:	0 (Usually inaccessible or unlikely to be disturbed)	
Surface Treatment:	0 (Composite material)			
Asbestos Type:	1 (Chrysotile)	Extent Score:	2 (>10 - <50 sq m or >10m - <50m pipe run)

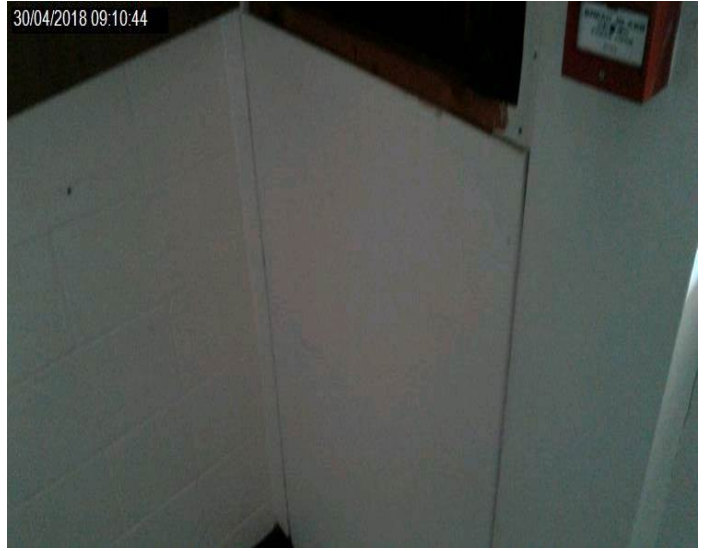
Location:	2.21B	Block:	University	Floor Level: 1st Floor
Sample No.:	As DU001411	Portal Ref No.:	233

Item:	Insulating board panels to riser			
Asbestos Content:		Result Based on:		
No Asbestos Detected		Strongly presumed		
Sample Analysed By:	Not applicable	Extent:	2 m ²	
Comments: bottom and top section

Material Assessment Total Score: 0		Likelihood of Disturbance Assessment Total Score: 0		Management Assessment Licensable: Yes Recommendations: Not Applicable Reinspection Interval: Not Applicable Overall Risk Category: E0
Product Type:	0 Not Applicable	Location:	0 Not Applicable	
Condition:	0 Not Applicable	Accessibility:	0 Not Applicable	
Surface Treatment:	0 Not Applicable			
Asbestos Type:	0 Not Applicable	Extent Score:	0 Not Applicable

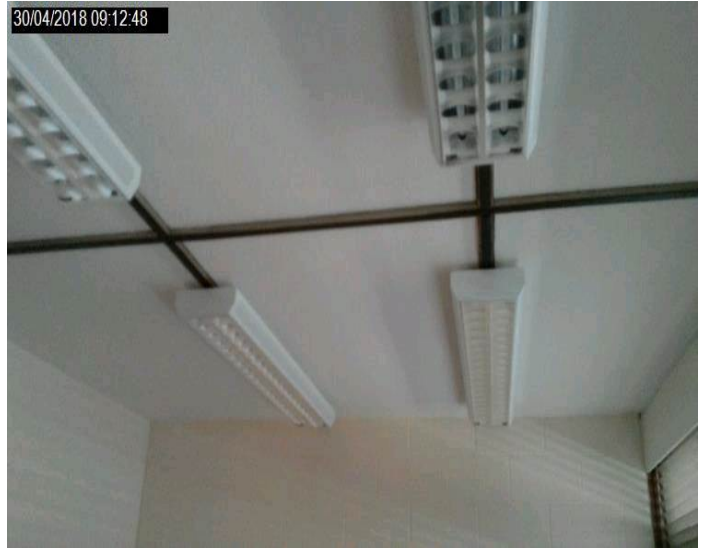
Location:	2.20	Block:	University	Floor Level: 1st Floor
Sample No.:	As DU001410	Portal Ref No.:	234

Item:	Asbestos Textured coating to concrete ceiling			
Asbestos Content:	Result Based on:			
Chrysotile	Strongly presumed			
Sample Analysed By:	Not applicable	Extent:	12 m ²	
Comments:

Material Assessment Total Score: 3		Likelihood of Disturbance Assessment Total Score: 5		Management Assessment Licensable: No Recommendations: Program removal Reinspection Interval: Not Applicable Overall Risk Category: C8
Product Type:	1 (Asbestos textured coating)	Location:	2 (Rooms up to 100 sq m)	
Condition:	1 (Minor scratches)	Accessibility:	1 (Occasionally likely to be disturbed)	
Surface Treatment:	0 (Composite material)			
Asbestos Type:	1 (Chrysotile)	Extent Score:	2 (>10 - <50 sq m or >10m - <50m pipe run)

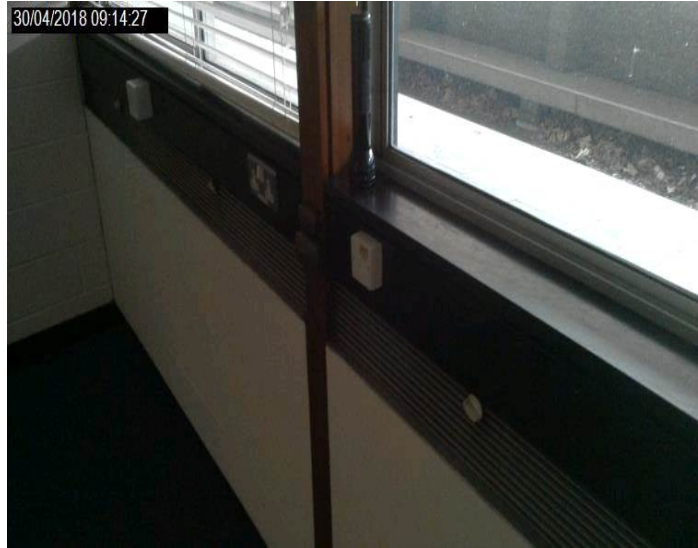
Location:	2.20	Block:	University	Floor Level: 1st Floor
Sample No.:	As DU001412	Portal Ref No.:	238

Item:	Asbestos Cement window sill			
Asbestos Content:	Result Based on:			
Chrysotile	Strongly presumed			
Sample Analysed By:	Not applicable	Extent:	4 linear metres	
Comments:

Material Assessment Total Score: 4		Likelihood of Disturbance Assessment Total Score: 4		Management Assessment Licensable: No Recommendations: Program removal Reinspection Interval: Not Applicable Overall Risk Category: C8
Product Type:	1 (Asbestos cement)	Location:	2 (Rooms up to 100 sq m)	
Condition:	1 (Minor scratches)	Accessibility:	1 (Occasionally likely to be disturbed)	
Surface Treatment:	1 (Unencapsulated asbestos cement)			
Asbestos Type:	1 (Chrysotile)	Extent Score:	1 (<10 sq m or 10m pipe run)

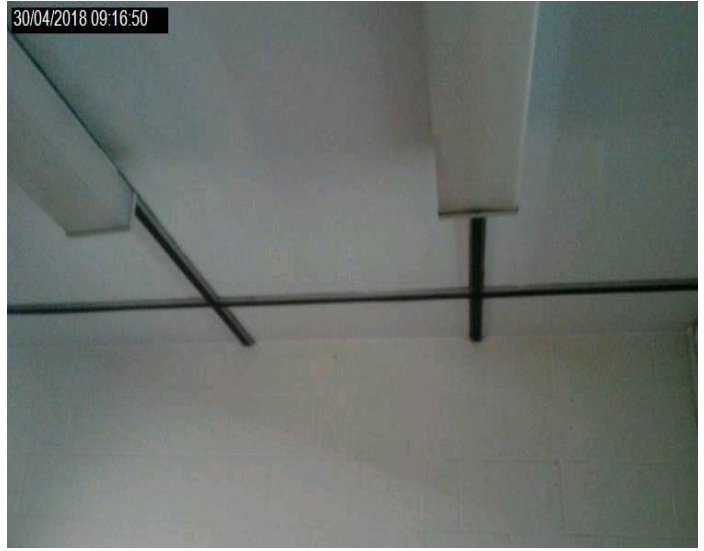
Location:	2.19	Block:	University	Floor Level: 1st Floor
Sample No.:	As DU001410	Portal Ref No.:	239

Item:	Asbestos Textured coating to concrete ceiling			
Asbestos Content:	Result Based on:			
Chrysotile	Strongly presumed			
Sample Analysed By:	Not applicable	Extent:	8 m ²	
Comments:

Material Assessment Total Score: 3		Likelihood of Disturbance Assessment Total Score: 4		Management Assessment Licensable: No Recommendations: Program removal Reinspection Interval: Not Applicable Overall Risk Category: C7
Product Type:	1 (Asbestos textured coating)	Location:	2 (Rooms up to 100 sq m)	
Condition:	1 (Minor scratches)	Accessibility:	1 (Occasionally likely to be disturbed)	
Surface Treatment:	0 (Composite material)			
Asbestos Type:	1 (Chrysotile)	Extent Score:	1 (<10 sq m or 10m pipe run)

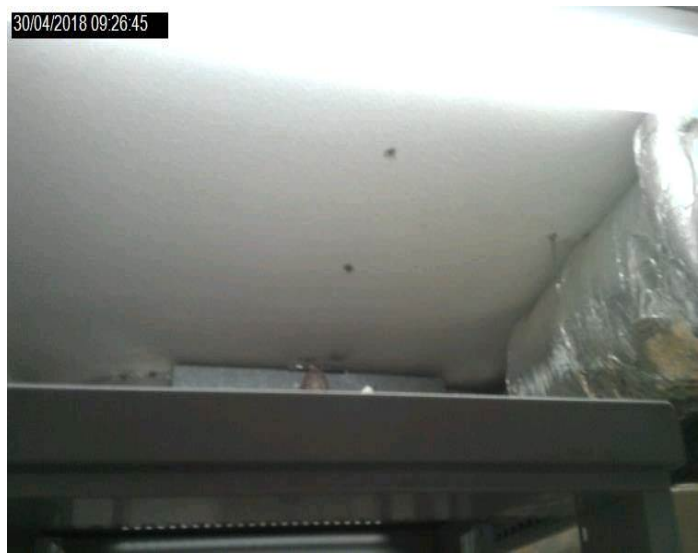
Location:	2.24A	Block:	University	Floor Level: 1st Floor
Sample No.:	As DU001410	Portal Ref No.:	248

Item:	Asbestos Textured coating to concrete ceiling			
Asbestos Content:	Result Based on:			
Chrysotile	Strongly presumed			
Sample Analysed By:	Not applicable	Extent:	8 m ²	
Comments:

Material Assessment Total Score: 3		Likelihood of Disturbance Assessment Total Score: 4		Management Assessment Licensable: No Recommendations: Program removal Reinspection Interval: Not Applicable Overall Risk Category: C7
Product Type:	1 (Asbestos textured coating)	Location:	2 (Rooms up to 100 sq m)	
Condition:	1 (Minor scratches)	Accessibility:	1 (Occasionally likely to be disturbed)	
Surface Treatment:	0 (Composite material)			
Asbestos Type:	1 (Chrysotile)	Extent Score:	1 (<10 sq m or 10m pipe run)

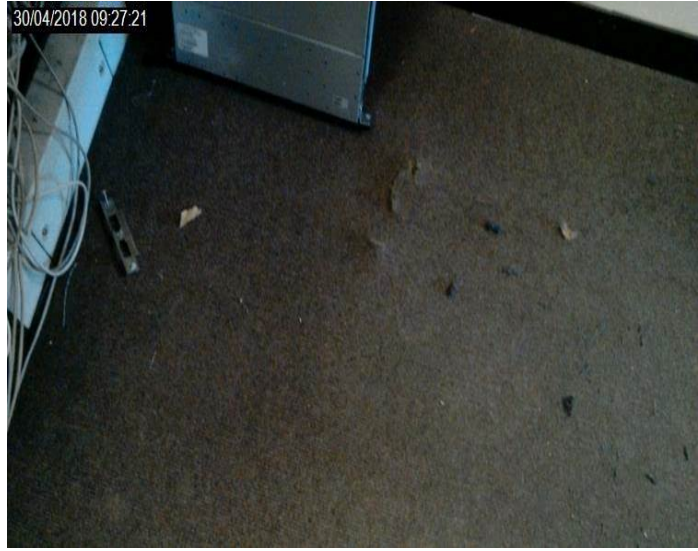
Location:	2.24A	Block:	University	Floor Level: 1st Floor
Sample No.:	DU001419	Portal Ref No.:	249

Item:	Asbestos Thermoplastic floor tiles with bitumen adhesive			
Asbestos Content:	Result Based on:			
Chrysotile in adhesive only	Analysis of sample using PLM			
Sample Analysed By: Reg 13(1)	Extent:	8 m ²		
Comments: Beneath carpet

Material Assessment Total Score: 3		Likelihood of Disturbance Assessment Total Score: 3		Management Assessment Licensable: No Recommendations: Program removal Reinspection Interval: Not Applicable Overall Risk Category: D6
Product Type:	1 (Asbestos thermoplastic)	Location:	2 (Rooms up to 100 sq m)	
Condition:	1 (Minor scratches)	Accessibility:	0 (Usually inaccessible or unlikely to be disturbed)	
Surface Treatment:	0 (Composite material)			
Asbestos Type:	1 (Chrysotile)	Extent Score:	1 (<10 sq m or 10m pipe run)

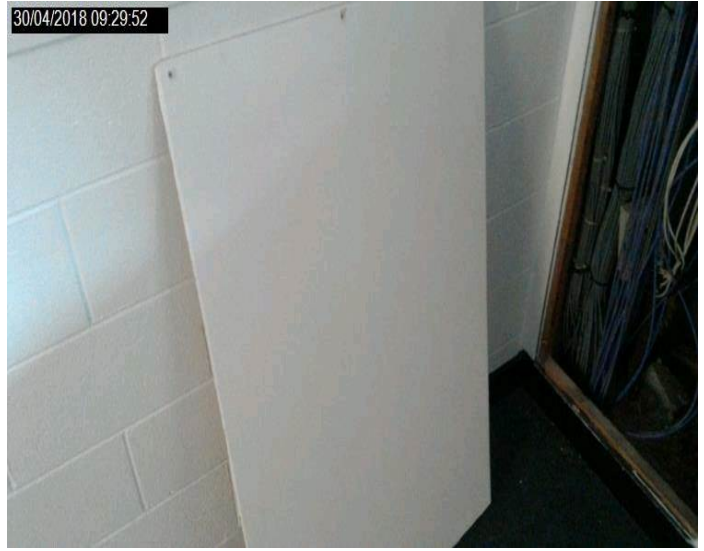
Location:	2.17	Block:	University	Floor Level: 1st Floor
Sample No.:	As DU001411	Portal Ref No.:	253

Item:	Insulating board panels to riser			
Asbestos Content:		Result Based on:		
No Asbestos Detected		Strongly presumed		
Sample Analysed By:	Not applicable	Extent:	3 m ²	
Comments:

Material Assessment Total Score: 0		Likelihood of Disturbance Assessment Total Score: 0		Management Assessment Licensable: Yes Recommendations: Not Applicable Reinspection Interval: Not Applicable Overall Risk Category: E0
Product Type:	0 Not Applicable	Location:	0 Not Applicable	
Condition:	0 Not Applicable	Accessibility:	0 Not Applicable	
Surface Treatment:	0 Not Applicable			
Asbestos Type:	0 Not Applicable	Extent Score:	0 Not Applicable

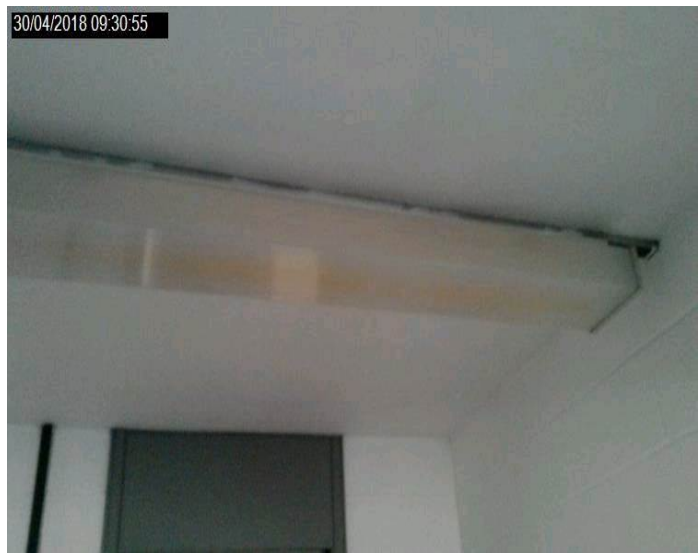
Location:	2.16	Block:	University	Floor Level: 1st Floor
Sample No.:	As DU001410	Portal Ref No.:	254

Item:	Asbestos Textured coating to concrete ceiling			
Asbestos Content:	Result Based on:			
Chrysotile	Strongly presumed			
Sample Analysed By:	Not applicable	Extent:	6 m ²	
Comments:

Material Assessment Total Score: 3		Likelihood of Disturbance Assessment Total Score: 4		Management Assessment Licensable: No Recommendations: Program removal Reinspection Interval: Not Applicable Overall Risk Category: C7
Product Type:	1 (Asbestos textured coating)	Location:	2 (Rooms up to 100 sq m)	
Condition:	1 (Minor scratches)	Accessibility:	1 (Occasionally likely to be disturbed)	
Surface Treatment:	0 (Composite material)			
Asbestos Type:	1 (Chrysotile)	Extent Score:	1 (<10 sq m or 10m pipe run)

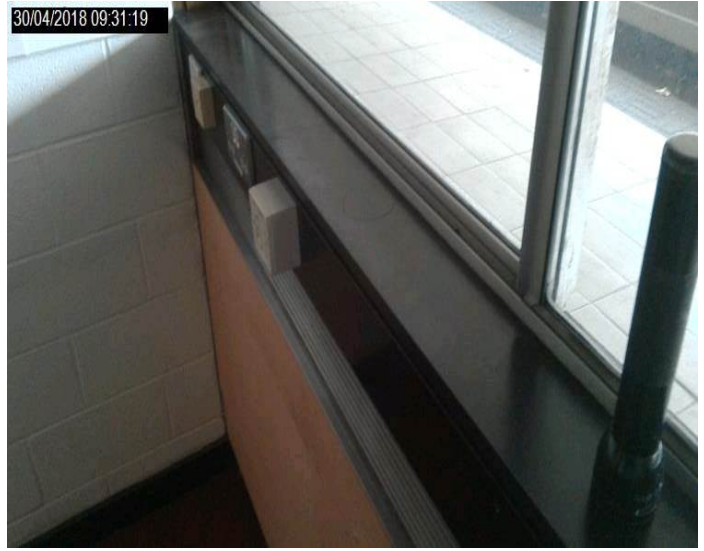
Location:	2.16	Block:	University	Floor Level: 1st Floor
Sample No.:	As DU001412	Portal Ref No.:	255

Item:	Asbestos Cement window sill			
Asbestos Content:	Result Based on:			
Chrysotile	Strongly presumed			
Sample Analysed By:	Not applicable	Extent:	2 linear metres	
Comments:

Material Assessment Total Score: 4		Likelihood of Disturbance Assessment Total Score: 4		Management Assessment Licensable: No Recommendations: Program removal Reinspection Interval: Not Applicable Overall Risk Category: C8
Product Type:	1 (Asbestos cement)	Location:	2 (Rooms up to 100 sq m)	
Condition:	1 (Minor scratches)	Accessibility:	1 (Occasionally likely to be disturbed)	
Surface Treatment:	1 (Unencapsulated asbestos cement)			
Asbestos Type:	1 (Chrysotile)	Extent Score:	1 (<10 sq m or 10m pipe run)

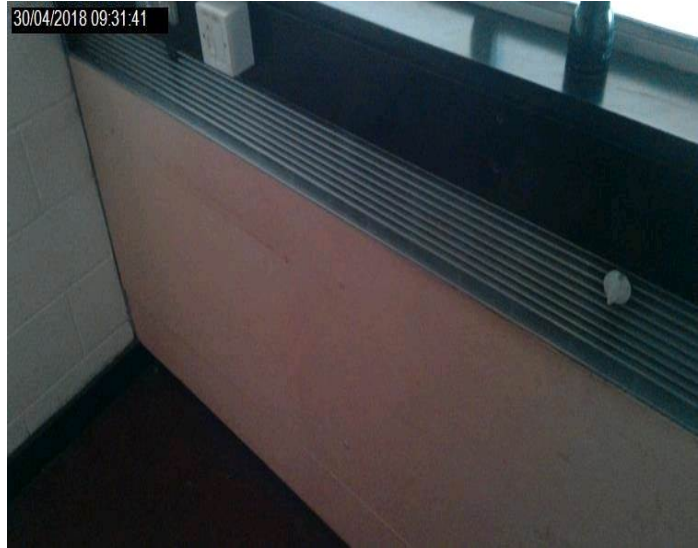
Location:	2.16	Block:	University	Floor Level: 1st Floor
Sample No.:	As DU001413	Portal Ref No.:	256

Item:	Asbestos Cement shuttering			
Asbestos Content:	Result Based on:			
Chrysotile	Strongly presumed			
Sample Analysed By:	Not applicable	Extent:	2 m ²	
Comments: To ceiling of wall void behind polystyrene sheets

Material Assessment Total Score: 4		Likelihood of Disturbance Assessment Total Score: 4		Management Assessment Licensable: No Recommendations: Program removal Reinspection Interval: Not Applicable Overall Risk Category: C8
Product Type:	1 (Asbestos cement)	Location:	2 (Rooms up to 100 sq m)	
Condition:	1 (Minor scratches)	Accessibility:	1 (Occasionally likely to be disturbed)	
Surface Treatment:	1 (Encapsulated asbestos cement)			
Asbestos Type:	1 (Chrysotile)	Extent Score:	1 (<10 sq m or 10m pipe run)

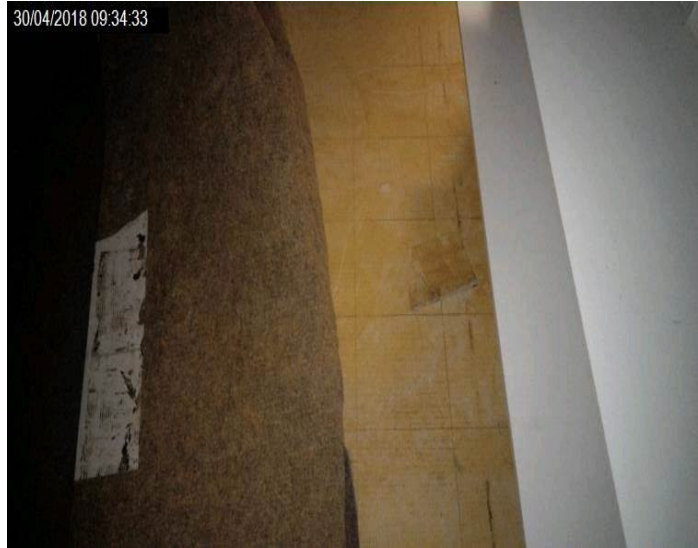
Location:	2.24	Block:	University	Floor Level: 1st Floor
Sample No.:	As DU001419	Portal Ref No.:	258

Item:	Asbestos Thermoplastic floor tiles with bitumen adhesive			
Asbestos Content:	Result Based on:			
Chrysotile in adhesive only	Strongly presumed			
Sample Analysed By:	Not applicable	Extent:	18 m ²	
Comments: Beneath carpet

Material Assessment Total Score: 3		Likelihood of Disturbance Assessment Total Score: 4		Management Assessment Licensable: No Recommendations: Program removal Reinspection Interval: Not Applicable Overall Risk Category: C7
Product Type:	1 (Asbestos thermoplastic)	Location:	2 (Rooms up to 100 sq m)	
Condition:	1 (Minor scratches)	Accessibility:	0 (Usually inaccessible or unlikely to be disturbed)	
Surface Treatment:	0 (Composite material)			
Asbestos Type:	1 (Chrysotile)	Extent Score:	2 (>10 - <50 sq m or >10m - <50m pipe run)

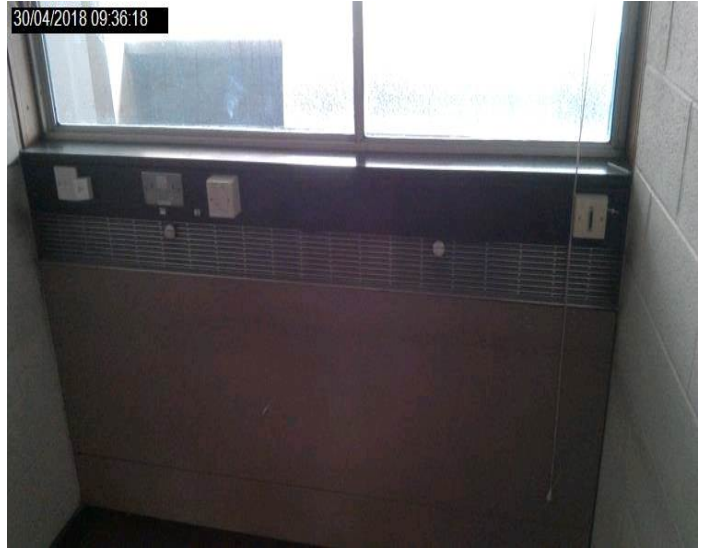
Location:	2.15	Block:	University	Floor Level: 1st Floor
Sample No.:	As DU001412	Portal Ref No.:	260

Item:	Asbestos Cement window sill			
Asbestos Content:	Result Based on:			
Chrysotile	Strongly presumed			
Sample Analysed By:	Not applicable	Extent:	2 linear metres	
Comments:

Material Assessment Total Score: 4		Likelihood of Disturbance Assessment Total Score: 4		Management Assessment Licensable: No Recommendations: Program removal Reinspection Interval: Not Applicable Overall Risk Category: C8
Product Type:	1 (Asbestos cement)	Location:	2 (Rooms up to 100 sq m)	
Condition:	1 (Minor scratches)	Accessibility:	1 (Occasionally likely to be disturbed)	
Surface Treatment:	1 (Unencapsulated asbestos cement)			
Asbestos Type:	1 (Chrysotile)	Extent Score:	1 (<10 sq m or 10m pipe run)

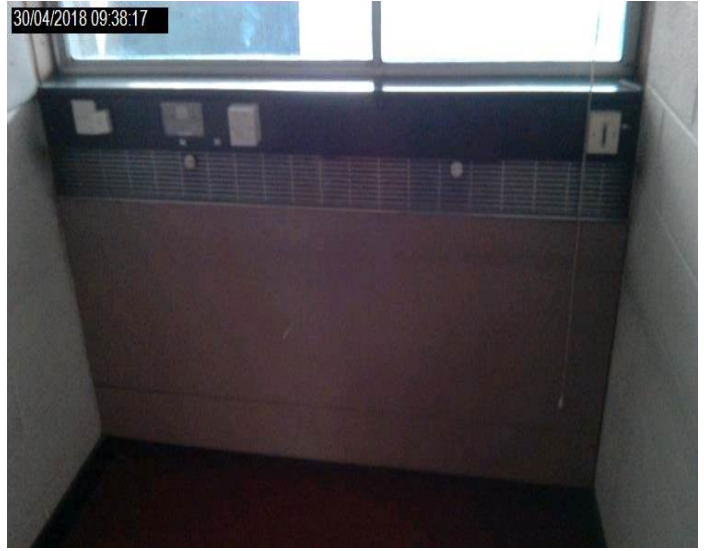
Location:	2.15	Block:	University	Floor Level: 1st Floor
Sample No.:	As DU001413	Portal Ref No.:	261

Item:	Asbestos Cement shuttering			
Asbestos Content:	Result Based on:			
Chrysotile	Strongly presumed			
Sample Analysed By:	Not applicable	Extent:	3 m ²	
Comments: To ceiling of wall void behind polystyrene sheets

Material Assessment Total Score: 4		Likelihood of Disturbance Assessment Total Score: 4		Management Assessment Licensable: No Recommendations: Program removal Reinspection Interval: Not Applicable Overall Risk Category: C8
Product Type:	1 (Asbestos cement)	Location:	2 (Rooms up to 100 sq m)	
Condition:	1 (Minor scratches)	Accessibility:	1 (Occasionally likely to be disturbed)	
Surface Treatment:	1 (Encapsulated asbestos cement)			
Asbestos Type:	1 (Chrysotile)	Extent Score:	1 (<10 sq m or 10m pipe run)

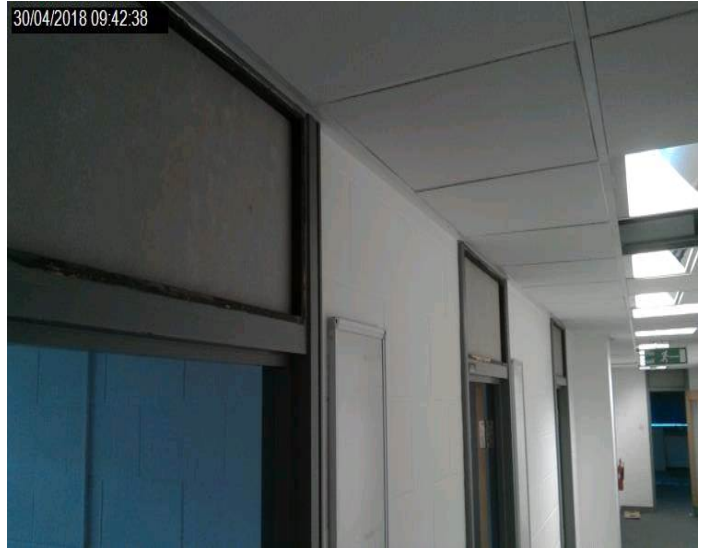
Location:	2.99B	Block:	University	Floor Level: 1st Floor
Sample No.:	DU001420	Portal Ref No.:	265

Item:	Insulating board door header panel			
Asbestos Content:		Result Based on:		
No Asbestos Detected		Analysis of sample using PLM		
Sample Analysed By:	Reg 13(1)	Extent:	7 m ²	
Comments: Visibly similar door header above doors to 2.15, 2.16, 2.17, 2.18, 2.20 and 2.21

Material Assessment Total Score: 0		Likelihood of Disturbance Assessment Total Score: 0		Management Assessment Licensable: Yes Recommendations: Not Applicable Reinspection Interval: Not Applicable Overall Risk Category: E0
Product Type:	0 Not Applicable	Location:	0 Not Applicable	
Condition:	0 Not Applicable	Accessibility:	0 Not Applicable	
Surface Treatment:	0 Not Applicable			
Asbestos Type:	0 Not Applicable	Extent Score:	0 Not Applicable

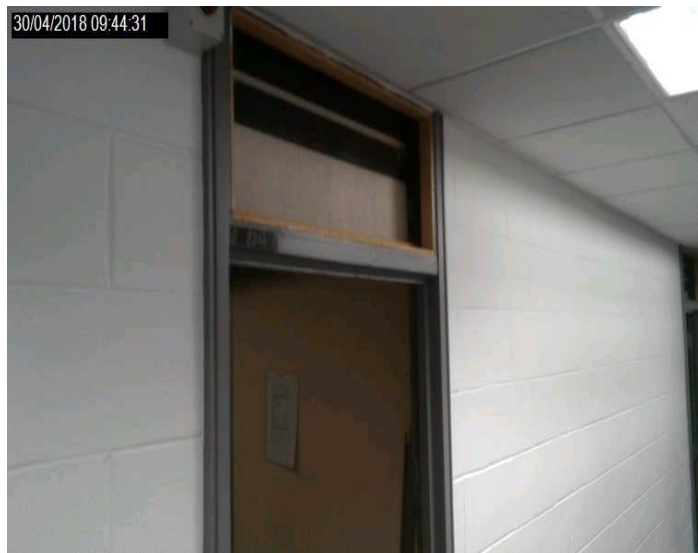
Location:	2.99B	Block:	University	Floor Level: 1st Floor
Sample No.:	DU001421	Portal Ref No.:	266

Item:	Insulating board door header panels			
Asbestos Content:		Result Based on:		
No Asbestos Detected		Analysis of sample using PLM		
Sample Analysed By:	Reg 13(1)	Extent:	4 m ²	
Comments: Visibly similar above doors to rooms 2.24A, 2.24 and leading to next corridor 2.99C

Material Assessment Total Score: 0		Likelihood of Disturbance Assessment Total Score: 0		Management Assessment Licensable: Yes Recommendations: Not Applicable Reinspection Interval: Not Applicable Overall Risk Category: E0
Product Type:	0 Not Applicable	Location:	0 Not Applicable	
Condition:	0 Not Applicable	Accessibility:	0 Not Applicable	
Surface Treatment:	0 Not Applicable			
Asbestos Type:	0 Not Applicable	Extent Score:	0 Not Applicable

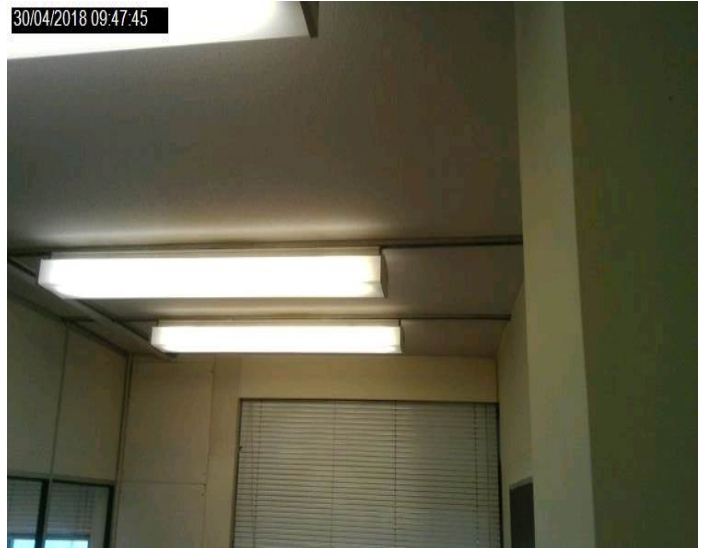
Location:	2.14B	Block:	University	Floor Level: 1st Floor
Sample No.:	DU001422	Portal Ref No.:	268

Item:	Asbestos Textured coating to concrete ceiling			
Asbestos Content:	Result Based on:			
Chrysotile	Analysis of sample using PLM			
Sample Analysed By: Reg 13(1)	Extent:	14 m ²		
Comments:

Material Assessment Total Score: 3		Likelihood of Disturbance Assessment Total Score: 5		Management Assessment Licensable: No Recommendations: Program removal Reinspection Interval: Not Applicable Overall Risk Category: C8
Product Type:	1 (Asbestos textured coating)	Location:	2 (Rooms up to 100 sq m)	
Condition:	1 (Minor scratches)	Accessibility:	1 (Occasionally likely to be disturbed)	
Surface Treatment:	0 (Composite material)			
Asbestos Type:	1 (Chrysotile)	Extent Score:	2 (>10 - <50 sq m or >10m - <50m pipe run)

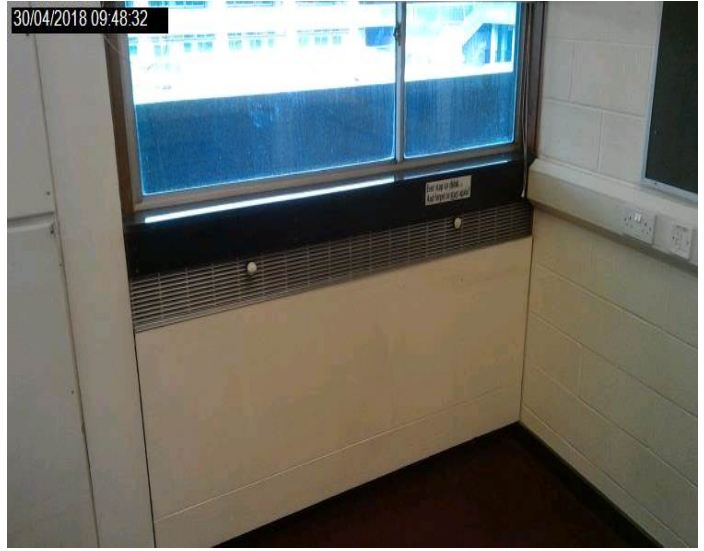
Location:	2.14B	Block:	University	Floor Level: 1st Floor
Sample No.:	DU001423	Portal Ref No.:	269

Item:	Asbestos Cement window sill			
Asbestos Content:	Result Based on:			
Chrysotile	Analysis of sample using PLM			
Sample Analysed By: Reg 13(1)	Extent:	2 linear metres		
Comments:

Material Assessment Total Score: 4		Likelihood of Disturbance Assessment Total Score: 4		Management Assessment Licensable: No Recommendations: Program removal Reinspection Interval: Not Applicable Overall Risk Category: C8
Product Type:	1 (Asbestos cement)	Location:	2 (Rooms up to 100 sq m)	
Condition:	1 (Minor scratches)	Accessibility:	1 (Occasionally likely to be disturbed)	
Surface Treatment:	1 (Unencapsulated asbestos cement)			
Asbestos Type:	1 (Chrysotile)	Extent Score:	1 (<10 sq m or 10m pipe run)

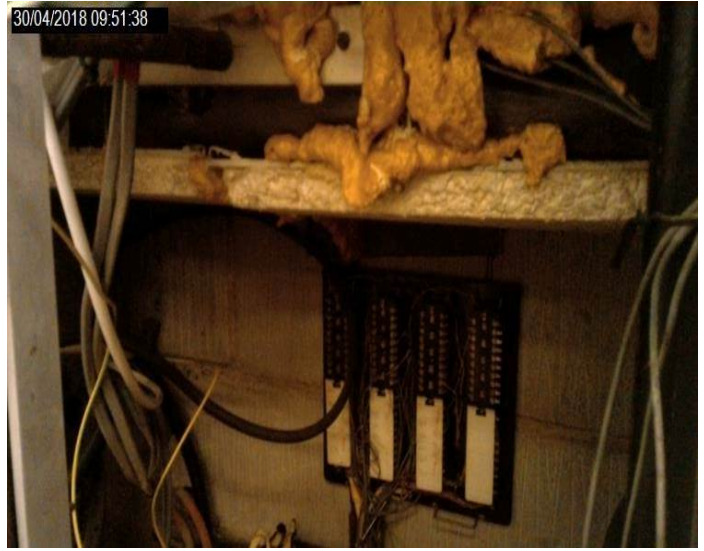
Location:	2.14B	Block:	University	Floor Level: 1st Floor
Sample No.:	DU001425	Portal Ref No.:	270

Item:	Asbestos Cement shuttering			
Asbestos Content:	Result Based on:			
Chrysotile	Analysis of sample using PLM			
Sample Analysed By: Reg 13(1)	Extent:	3 m ²		
Comments: To ceiling of wall void behind polystyrene sheets

Material Assessment Total Score: 4		Likelihood of Disturbance Assessment Total Score: 4		Management Assessment Licensable: No Recommendations: Program removal Reinspection Interval: Not Applicable Overall Risk Category: C8
Product Type:	1 (Asbestos cement)	Location:	2 (Rooms up to 100 sq m)	
Condition:	1 (Minor scratches)	Accessibility:	1 (Occasionally likely to be disturbed)	
Surface Treatment:	1 (Encapsulated asbestos cement)			
Asbestos Type:	1 (Chrysotile)	Extent Score:	1 (<10 sq m or 10m pipe run)

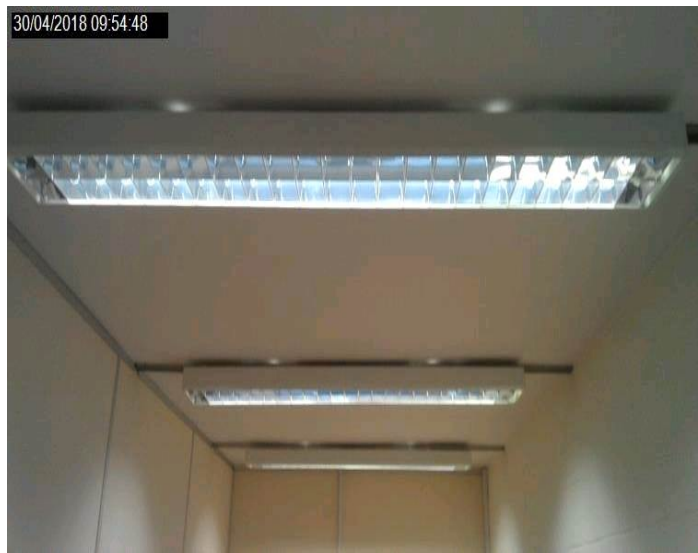
Location:	2.14A	Block:	University	Floor Level: 1st Floor
Sample No.:	As DU001422	Portal Ref No.:	273

Item:	Asbestos Textured coating to concrete ceiling			
Asbestos Content:	Result Based on:			
Chrysotile	Strongly presumed			
Sample Analysed By:	Not applicable	Extent:	10 m ²	
Comments:

Material Assessment Total Score: 3		Likelihood of Disturbance Assessment Total Score: 5		Management Assessment Licensable: No Recommendations: Program removal Reinspection Interval: Not Applicable Overall Risk Category: C8
Product Type:	1 (Asbestos textured coating)	Location:	2 (Rooms up to 100 sq m)	
Condition:	1 (Minor scratches)	Accessibility:	1 (Occasionally likely to be disturbed)	
Surface Treatment:	0 (Composite material)			
Asbestos Type:	1 (Chrysotile)	Extent Score:	2 (>10 - <50 sq m or >10m - <50m pipe run)

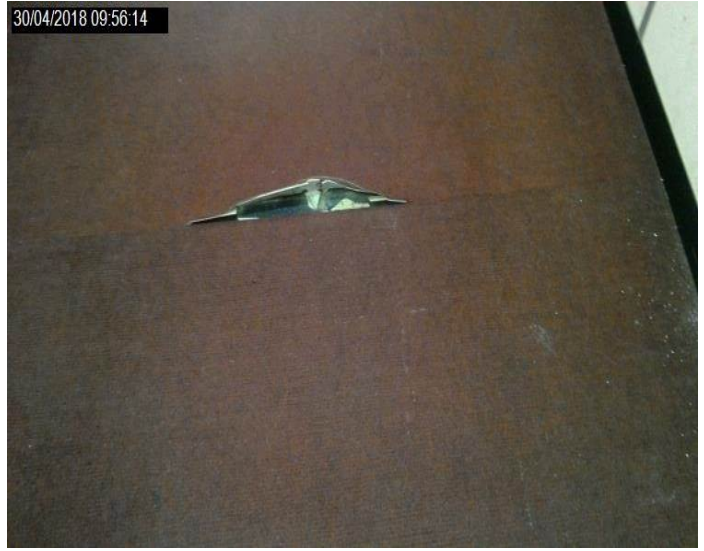
Location:	2.14A	Block:	University	Floor Level: 1st Floor
Sample No.:	As DU001426	Portal Ref No.:	277

Item:	Asbestos Thermoplastic floor tiles with bitumen adhesive			
Asbestos Content:	Result Based on:			
Chrysotile in adhesive only	Strongly presumed			
Sample Analysed By:	Not applicable	Extent:	10 m ²	
Comments: Beneath carpet

Material Assessment Total Score: 3		Likelihood of Disturbance Assessment Total Score: 4		Management Assessment Licensable: No Recommendations: Program removal Reinspection Interval: Not Applicable Overall Risk Category: C7
Product Type:	1 (Asbestos thermoplastic)	Location:	2 (Rooms up to 100 sq m)	
Condition:	1 (Minor scratches)	Accessibility:	0 (Usually inaccessible or unlikely to be disturbed)	
Surface Treatment:	0 (Composite material)			
Asbestos Type:	1 (Chrysotile)	Extent Score:	2 (>10 - <50 sq m or >10m - <50m pipe run)

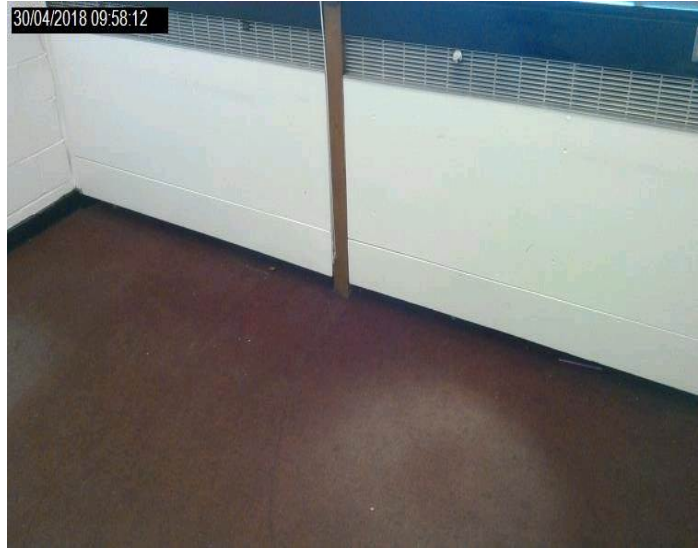
Location:	2.13	Block:	University	Floor Level: 1st Floor
Sample No.:	As DU001425	Portal Ref No.:	280

Item:	Asbestos Cement shuttering			
Asbestos Content:	Result Based on:			
Chrysotile	Strongly presumed			
Sample Analysed By:	Not applicable	Extent:	4 m ²	
Comments: To ceiling of wall void behind polystyrene sheets

Material Assessment Total Score: 4		Likelihood of Disturbance Assessment Total Score: 4		Management Assessment Licensable: No Recommendations: Program removal Reinspection Interval: Not Applicable Overall Risk Category: C8
Product Type:	1 (Asbestos cement)	Location:	2 (Rooms up to 100 sq m)	
Condition:	1 (Minor scratches)	Accessibility:	1 (Occasionally likely to be disturbed)	
Surface Treatment:	1 (Encapsulated asbestos cement)			
Asbestos Type:	1 (Chrysotile)	Extent Score:	1 (<10 sq m or 10m pipe run)

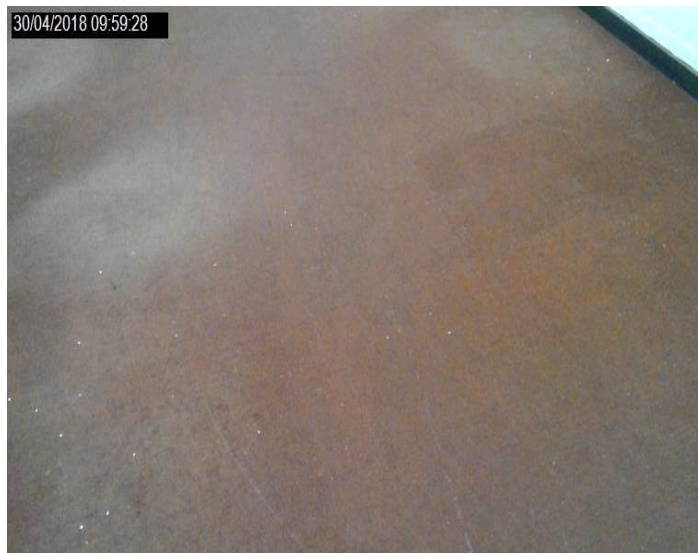
Location:	2.13	Block:	University	Floor Level: 1st Floor
Sample No.:	As DU001426	Portal Ref No.:	281

Item:	Asbestos Thermoplastic floor tiles with bitumen adhesive			
Asbestos Content:	Result Based on:			
Chrysotile in adhesive only	Strongly presumed			
Sample Analysed By:	Not applicable	Extent:	24 m ²	
Comments: Beneath carpet

Material Assessment Total Score: 3		Likelihood of Disturbance Assessment Total Score: 4		Management Assessment Licensable: No Recommendations: Program removal Reinspection Interval: Not Applicable Overall Risk Category: C7
Product Type:	1 (Asbestos thermoplastic)	Location:	2 (Rooms up to 100 sq m)	
Condition:	1 (Minor scratches)	Accessibility:	0 (Usually inaccessible or unlikely to be disturbed)	
Surface Treatment:	0 (Composite material)			
Asbestos Type:	1 (Chrysotile)	Extent Score:	2 (>10 - <50 sq m or >10m - <50m pipe run)

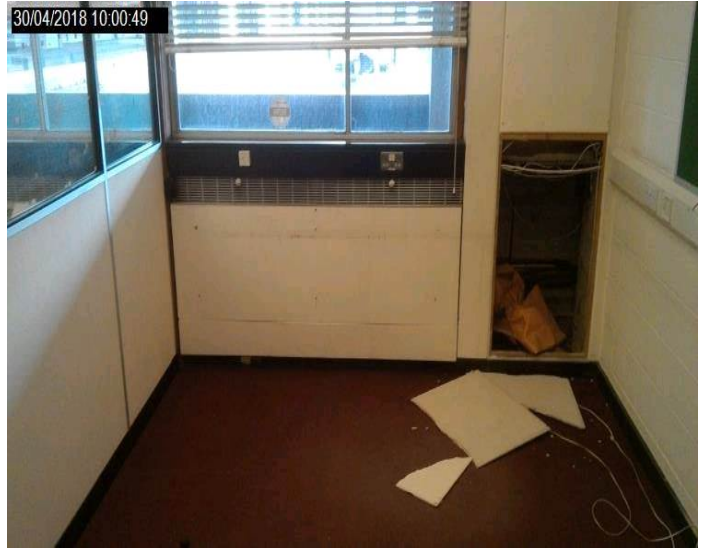
Location:	2.12B	Block:	University	Floor Level: 1st Floor
Sample No.:	As DU001423	Portal Ref No.:	283

Item:	Asbestos Cement window sill			
Asbestos Content:	Result Based on:			
Chrysotile	Strongly presumed			
Sample Analysed By:	Not applicable	Extent:	3 linear metres	
Comments:

Material Assessment Total Score: 4		Likelihood of Disturbance Assessment Total Score: 4		Management Assessment Licensable: No Recommendations: Program removal Reinspection Interval: Not Applicable Overall Risk Category: C8
Product Type:	1 (Asbestos cement)	Location:	2 (Rooms up to 100 sq m)	
Condition:	1 (Minor scratches)	Accessibility:	1 (Occasionally likely to be disturbed)	
Surface Treatment:	1 (Unencapsulated asbestos cement)			
Asbestos Type:	1 (Chrysotile)	Extent Score:	1 (<10 sq m or 10m pipe run)

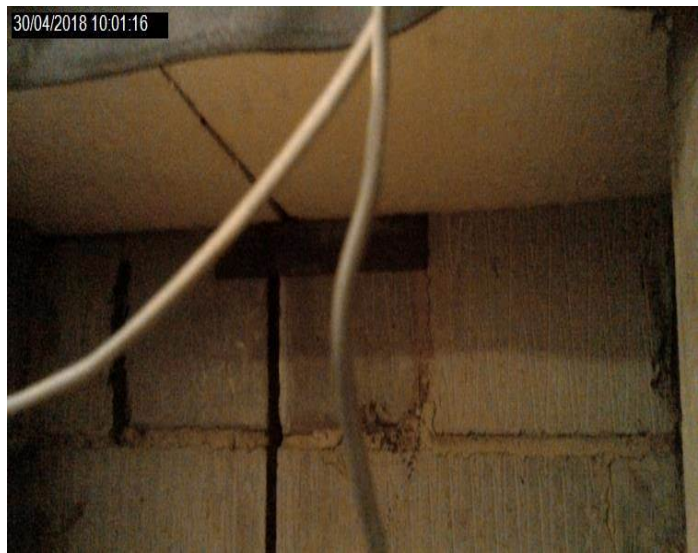
Location:	2.12B	Block:	University	Floor Level: 1st Floor
Sample No.:	As DU001425	Portal Ref No.:	284

Item:	Asbestos Cement shuttering			
Asbestos Content:	Result Based on:			
Chrysotile	Strongly presumed			
Sample Analysed By:	Not applicable	Extent:	3 m ²	
Comments: To ceiling of wall void behind polystyrene sheets

Material Assessment Total Score: 4		Likelihood of Disturbance Assessment Total Score: 4		Management Assessment Licensable: No Recommendations: Program removal Reinspection Interval: Not Applicable Overall Risk Category: C8
Product Type:	1 (Asbestos cement)	Location:	2 (Rooms up to 100 sq m)	
Condition:	1 (Minor scratches)	Accessibility:	1 (Occasionally likely to be disturbed)	
Surface Treatment:	1 (Encapsulated asbestos cement)			
Asbestos Type:	1 (Chrysotile)	Extent Score:	1 (<10 sq m or 10m pipe run)

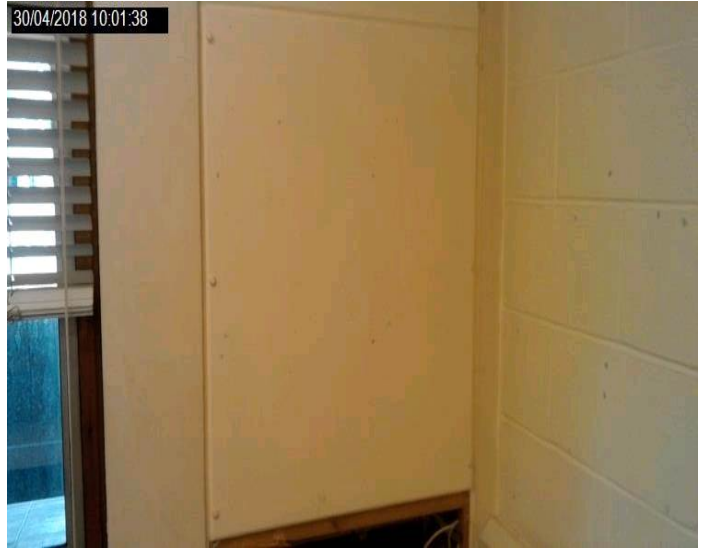
Location:	2.12B	Block:	University	Floor Level: 1st Floor
Sample No.:	As DU001424	Portal Ref No.:	285

Item:	Insulating board panels to riser			
Asbestos Content:		Result Based on:		
No Asbestos Detected		Strongly presumed		
Sample Analysed By:	Not applicable	Extent:	3 m ²	
Comments:

Material Assessment Total Score: 0		Likelihood of Disturbance Assessment Total Score: 0		Management Assessment Licensable: Yes Recommendations: Not Applicable Reinspection Interval: Not Applicable Overall Risk Category: E0
Product Type:	0 Not Applicable	Location:	0 Not Applicable	
Condition:	0 Not Applicable	Accessibility:	0 Not Applicable	
Surface Treatment:	0 Not Applicable			
Asbestos Type:	0 Not Applicable	Extent Score:	0 Not Applicable

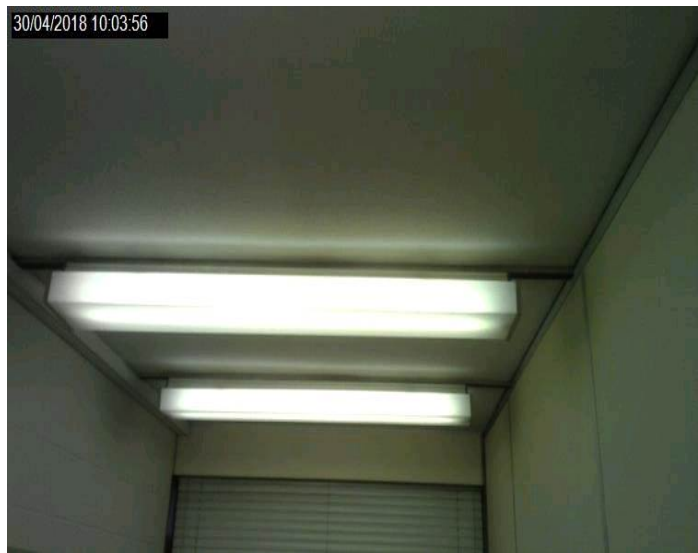
Location:	2.12A	Block:	University	Floor Level: 1st Floor
Sample No.:	As DU001422	Portal Ref No.:	287

Item:	Asbestos Textured coating to concrete ceiling			
Asbestos Content:	Result Based on:			
Chrysotile	Strongly presumed			
Sample Analysed By:	Not applicable	Extent:	10 m ²	
Comments:

Material Assessment Total Score: 3		Likelihood of Disturbance Assessment Total Score: 5		Management Assessment Licensable: No Recommendations: Program removal Reinspection Interval: Not Applicable Overall Risk Category: C8
Product Type:	1 (Asbestos textured coating)	Location:	2 (Rooms up to 100 sq m)	
Condition:	1 (Minor scratches)	Accessibility:	1 (Occasionally likely to be disturbed)	
Surface Treatment:	0 (Composite material)			
Asbestos Type:	1 (Chrysotile)	Extent Score:	2 (>10 - <50 sq m or >10m - <50m pipe run)

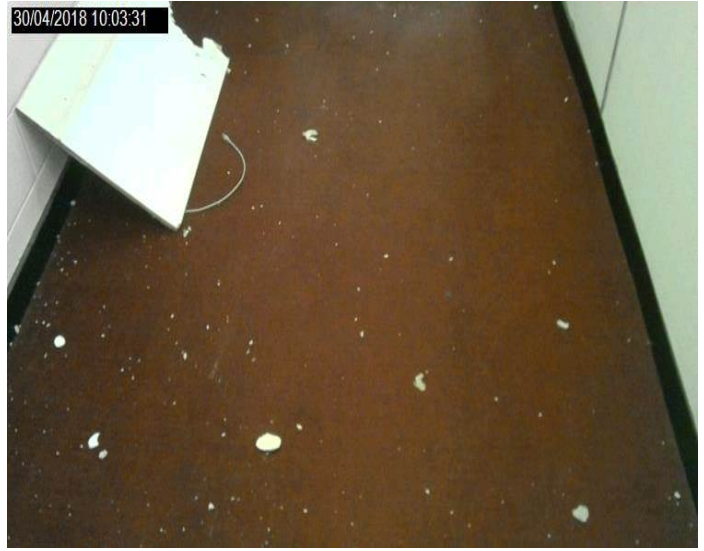
Location:	2.12A	Block:	University	Floor Level: 1st Floor
Sample No.:	As DU001427	Portal Ref No.:	290

Item:	Asbestos Thermoplastic floor tiles with bitumen adhesive			
Asbestos Content:	Result Based on:			
Chrysotile in adhesive only	Strongly presumed			
Sample Analysed By:	Not applicable	Extent:	10 m ²	
Comments: Beneath carpet

Material Assessment Total Score: 3		Likelihood of Disturbance Assessment Total Score: 4		Management Assessment Licensable: No Recommendations: Program removal Reinspection Interval: Not Applicable Overall Risk Category: C7
Product Type:	1 (Asbestos thermoplastic)	Location:	2 (Rooms up to 100 sq m)	
Condition:	1 (Minor scratches)	Accessibility:	0 (Usually inaccessible or unlikely to be disturbed)	
Surface Treatment:	0 (Composite material)			
Asbestos Type:	1 (Chrysotile)	Extent Score:	2 (>10 - <50 sq m or >10m - <50m pipe run)

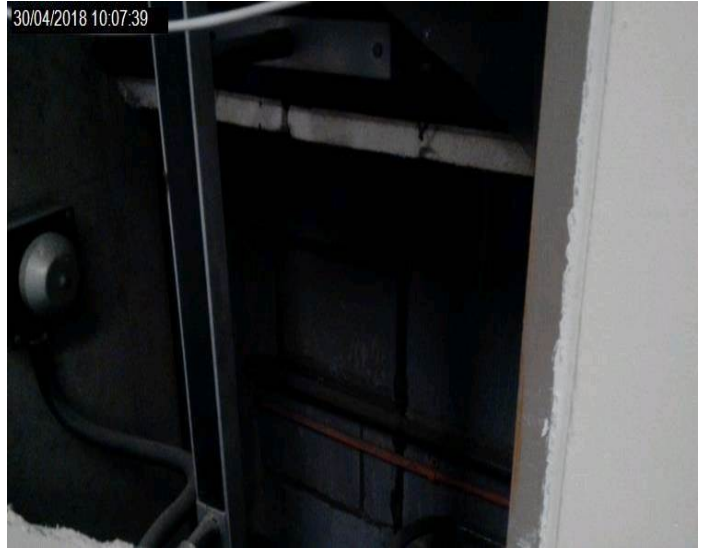
Location:	2.11	Block:	University	Floor Level: 1st Floor
Sample No.:	As DU001425	Portal Ref No.:	293

Item:	Asbestos Cement shuttering			
Asbestos Content:	Result Based on:			
Chrysotile	Strongly presumed			
Sample Analysed By:	Not applicable	Extent:	12 m ²	
Comments: To ceiling of wall void behind polystyrene sheets

Material Assessment Total Score: 4		Likelihood of Disturbance Assessment Total Score: 5		Management Assessment Licensable: No Recommendations: Program removal Reinspection Interval: Not Applicable Overall Risk Category: C9
Product Type:	1 (Asbestos cement)	Location:	2 (Rooms up to 100 sq m)	
Condition:	1 (Minor scratches)	Accessibility:	1 (Occasionally likely to be disturbed)	
Surface Treatment:	1 (Encapsulated asbestos cement)			
Asbestos Type:	1 (Chrysotile)	Extent Score:	2 (>10 - <50 sq m or >10m - <50m pipe run)

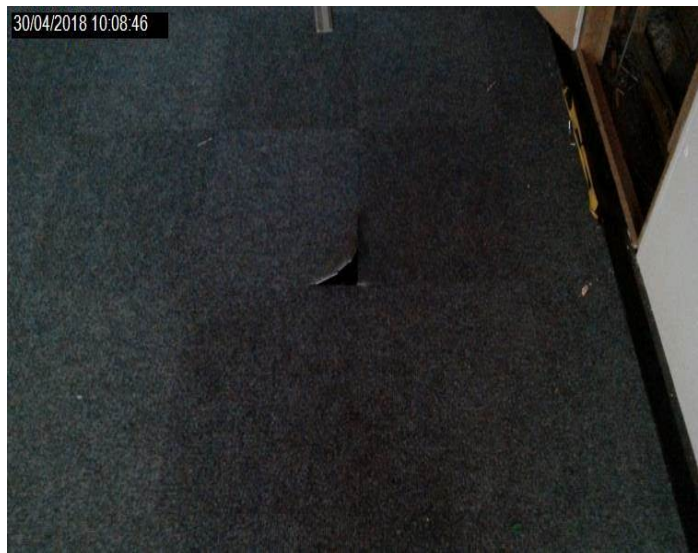
Location:	2.11	Block:	University	Floor Level: 1st Floor
Sample No.:	DU001428	Portal Ref No.:	295

Item:	Asbestos Thermoplastic floor tiles with bitumen adhesive			
Asbestos Content:	Result Based on:			
Chrysotile in adhesive only	Analysis of sample using PLM			
Sample Analysed By: Reg 13(1)	Extent:	28 m ²		
Comments: Beneath carpet

Material Assessment Total Score: 3		Likelihood of Disturbance Assessment Total Score: 4		Management Assessment Licensable: No Recommendations: Program removal Reinspection Interval: Not Applicable Overall Risk Category: C7
Product Type:	1 (Asbestos thermoplastic)	Location:	2 (Rooms up to 100 sq m)	
Condition:	1 (Minor scratches)	Accessibility:	0 (Usually inaccessible or unlikely to be disturbed)	
Surface Treatment:	0 (Composite material)			
Asbestos Type:	1 (Chrysotile)	Extent Score:	2 (>10 - <50 sq m or >10m - <50m pipe run)

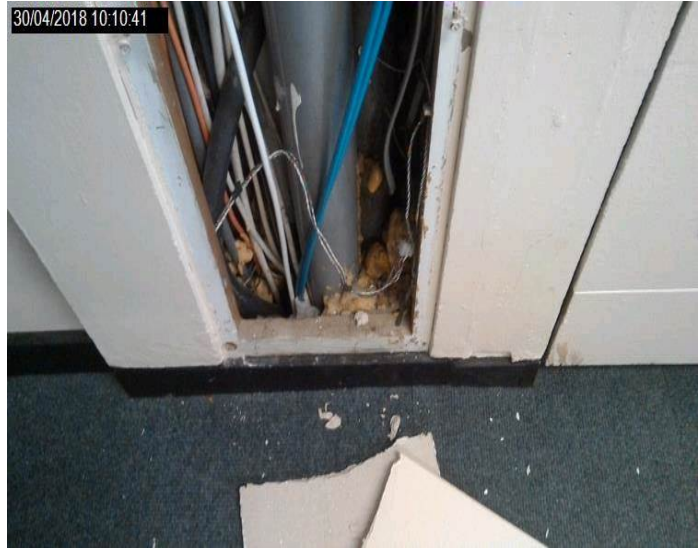
Location:	2.11	Block:	University	Floor Level: 1st Floor
Sample No.:	DU001429	Portal Ref No.:	296

Item:	Asbestos Insulating board debris within riser			
Asbestos Content:	Result Based on:			
Chrysotile Amosite	Analysis of sample using PLM			
Sample Analysed By: Reg 13(1)	Extent:	1 m ²		
Comments: Whole riser area should be presumed to be contaminated.

Material Assessment Total Score: 9		Likelihood of Disturbance Assessment Total Score: 4		Management Assessment Licensable: Yes Recommendations: Program removal Reinspection Interval: Not Applicable Overall Risk Category: B13
Product Type:	2 (Asbestos insulating board)	Location:	2 (Rooms up to 100 sq m)	
Condition:	3 (Significant damage)	Accessibility:	1 (Occasionally likely to be disturbed)	
Surface Treatment:	2 (Unencapsulated asbestos insulating board)			
Asbestos Type:	2 (Chrysotile Amosite)	Extent Score:	1 (<10 sq m or 10m pipe run)
