Report No.: J094099
Nature of Work: Demolition Survey
Issue Date: 11/06/2018
Client Name: WYG Engineering Ltd
Geneva Building, Lake View Drive, Sherwood Business Park,
Annesley, Nottingham, NG15 0ED
Site Address: Dawson building, Former City North Campus, Birmingham City
University, Perry Barr, B42 2US

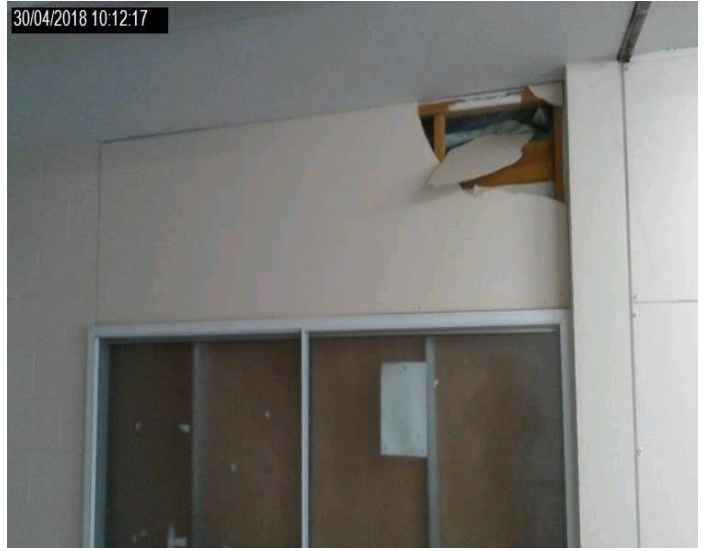
Location:	2.11	Block:	University	Floor Level: 1st Floor
Sample No.:	DU001430	Portal Ref No.:	297

Item:	Insulating board panel above window			
Asbestos Content:		Result Based on:		
No Asbestos Detected		Analysis of sample using PLM		
Sample Analysed By:	Reg 13(1)	Extent:	3 m ²	
Comments:

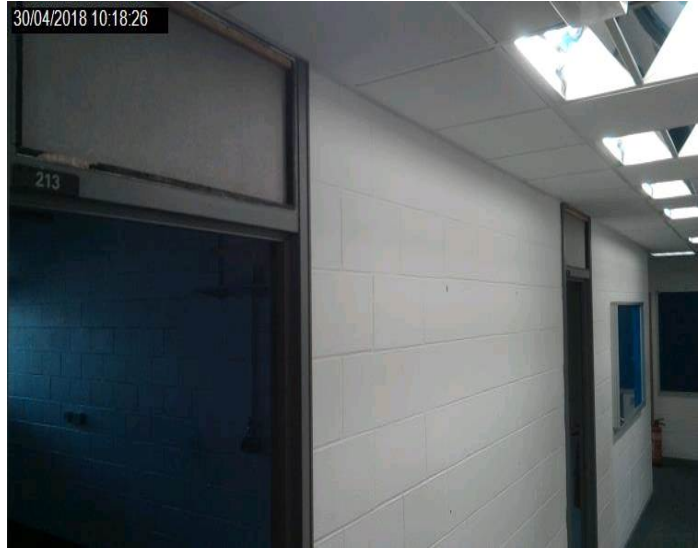
Location:	2.99C	Block:	University	Floor Level: 1st Floor
Sample No.:	DU001431	Portal Ref No.:	298

Item:	Insulating board door header panel			
Asbestos Content:		Result Based on:		
No Asbestos Detected		Analysis of sample using PLM		
Sample Analysed By:	Reg 13(1)	Extent:	6 m ²	
Comments: Visibly similar door header above doors to 2.25, 2.26, 2.14, 2.13, 2.12, 2.11 and 2.27

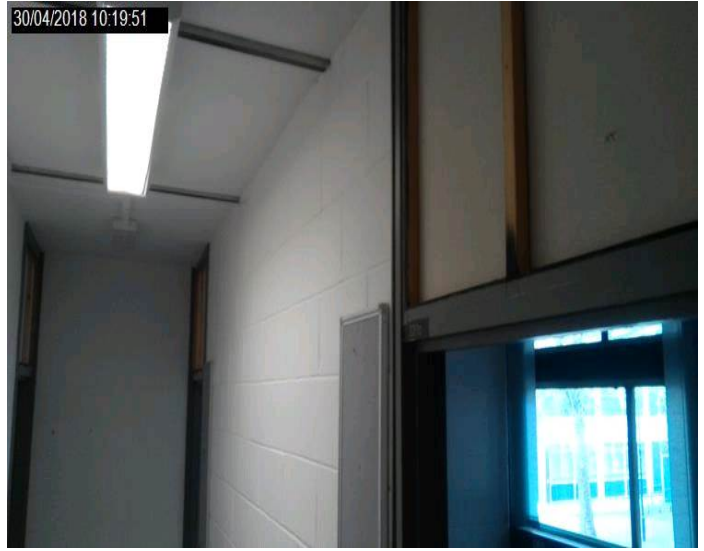
Location:	2.99C	Block:	University	Floor Level: 1st Floor
Sample No.:	DU001432	Portal Ref No.:	299

Item:	Insulating board door header panels			
Asbestos Content:	Result Based on:			
No Asbestos Detected	Analysis of sample using PLM			
Sample Analysed By: Reg 13(1)	Extent:	5 m ²		
Comments: Visibly similar above doors to rooms 2.27B, 2.27A, 2.27C and upstand to suspended ceiling leading to this section

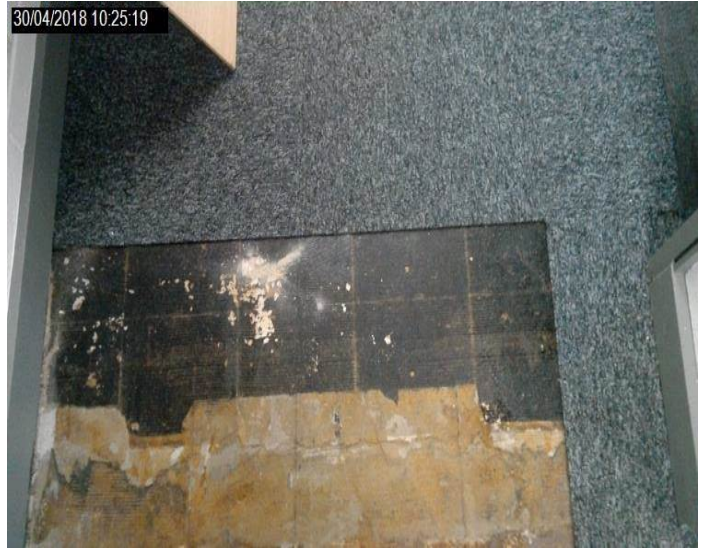
Location:	2.99C	Block:	University	Floor Level: 1st Floor
Sample No.:	DU001433	Portal Ref No.:	302

Item:	Asbestos Bitumen adhesive to concrete			
Asbestos Content:	Result Based on:			
Chrysotile	Analysis of sample using PLM			
Sample Analysed By: Reg 13(1)	Extent:	9 m ²		
Comments: To recess sections of main corridor only

Material Assessment Total Score: 3		Likelihood of Disturbance Assessment Total Score: 4		Management Assessment Licensable: No Recommendations: Program removal Reinspection Interval: Not Applicable Overall Risk Category: C7
Product Type:	1 (Asbestos bitumen)	Location:	2 (Rooms up to 100 sq m)	
Condition:	1 (Minor scratches)	Accessibility:	1 (Occasionally likely to be disturbed)	
Surface Treatment:	0 (Composite material)			
Asbestos Type:	1 (Chrysotile)	Extent Score:	1 (<10 sq m or 10m pipe run)

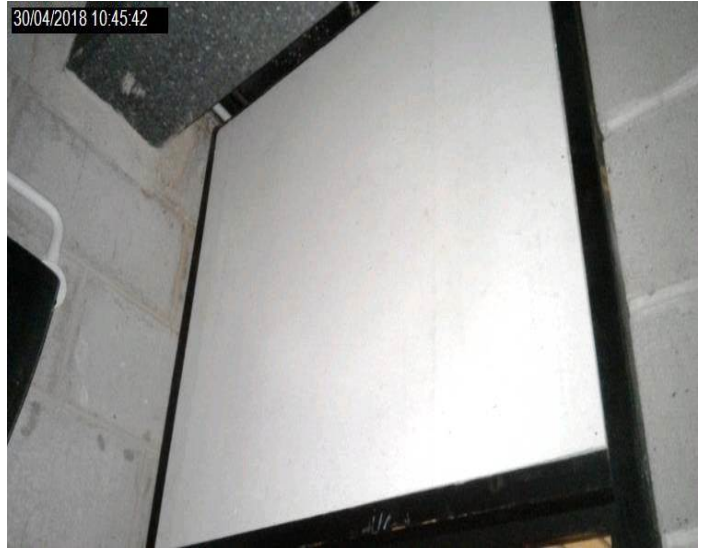
Location:	3.05	Block:	University	Floor Level: 2nd Floor
Sample No.:	DU001435	Portal Ref No.:	307

Item:	Asbestos Insulating board door header panel			
Asbestos Content:	Result Based on:			
Chrysotile Amosite	Analysis of sample using PLM			
Sample Analysed By: Reg 13(1)	Extent:	1 m ²		
Comments:

Material Assessment Total Score: 7		Likelihood of Disturbance Assessment Total Score: 4		Management Assessment Licensable: Yes Recommendations: Program removal Reinspection Interval: Not Applicable Overall Risk Category: B11
Product Type:	2 (Asbestos insulating board)	Location:	2 (Rooms up to 100 sq m)	
Condition:	1 (Minor scratches)	Accessibility:	1 (Occasionally likely to be disturbed)	
Surface Treatment:	2 (Unencapsulated asbestos insulating board)			
Asbestos Type:	2 (Chrysotile Amosite)	Extent Score:	1 (<10 sq m or 10m pipe run)

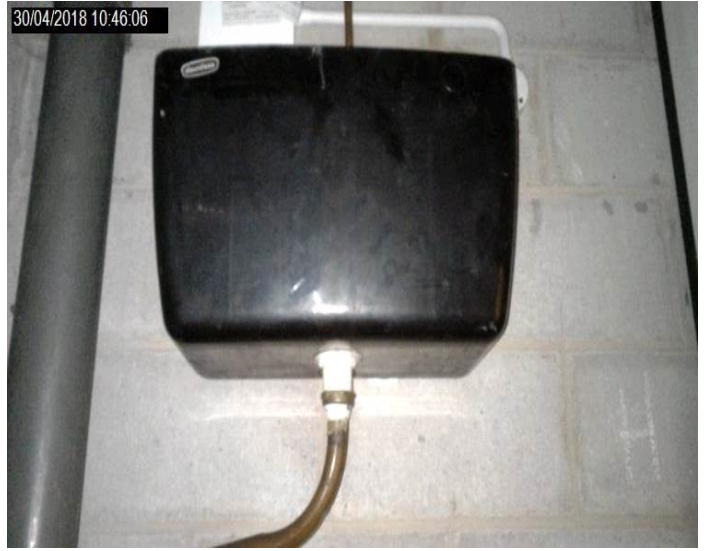
Location:	3.05	Block:	University	Floor Level: 2nd Floor
Sample No.:	DU001436	Portal Ref No.:	308

Item:	Asbestos Reinforced plastic cistern			
Asbestos Content:	Result Based on:			
Amosite	Analysis of sample using PLM			
Sample Analysed By: Reg 13(1)	Extent:	1 unit		
Comments:

Material Assessment Total Score: 4		Likelihood of Disturbance Assessment Total Score: 3		Management Assessment Licensable: No Recommendations: Program removal Reinspection Interval: Not Applicable Overall Risk Category: C7
Product Type:	1 (Asbestos reinforced plastic)	Location:	2 (Rooms up to 100 sq m)	
Condition:	1 (Minor scratches)	Accessibility:	1 (Occasionally likely to be disturbed)	
Surface Treatment:	0 (Composite material)			
Asbestos Type:	2 (Amosite)	Extent Score:	0 (Small amounts or items)

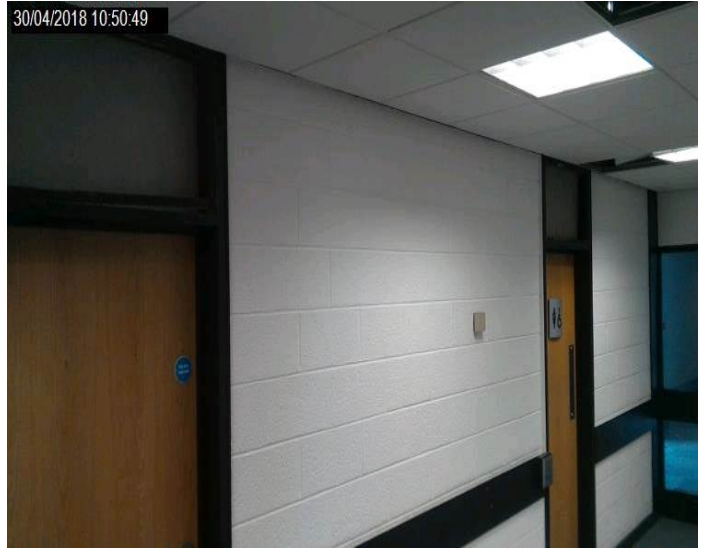
Location:	3.99	Block:	University	Floor Level: 2nd Floor
Sample No.:	DU001437	Portal Ref No.:	309

Item:	Insulating board door header panels			
Asbestos Content:		Result Based on:		
No Asbestos Detected		Analysis of sample using PLM		
Sample Analysed By:	Reg 13(1)	Extent:	4 m ²	
Comments: Leading to corridor

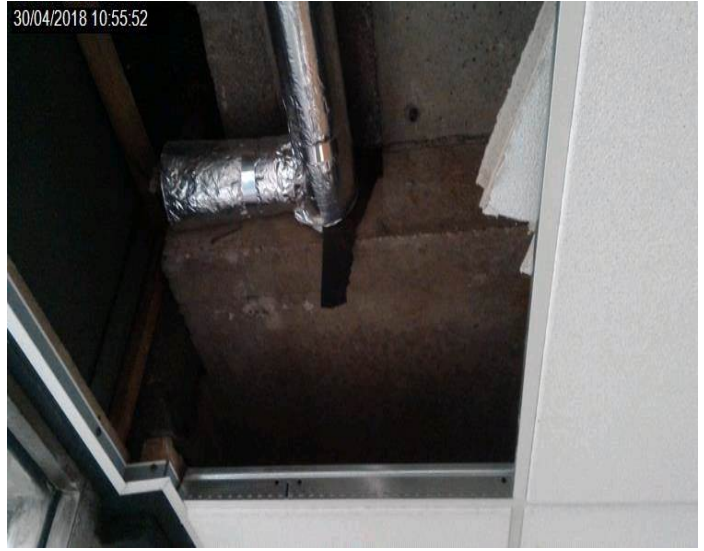
Location:	3.99	Block:	University	Floor Level: 2nd Floor
Sample No.:	DU001438	Portal Ref No.:	312

Item:	Bitumen damp proof course			
Asbestos Content:		Result Based on:		
No Asbestos Detected		Analysis of sample using PLM		
Sample Analysed By:	Reg 13(1)	Extent:	10 linear metres	
Comments: To ceiling concrete where level drops

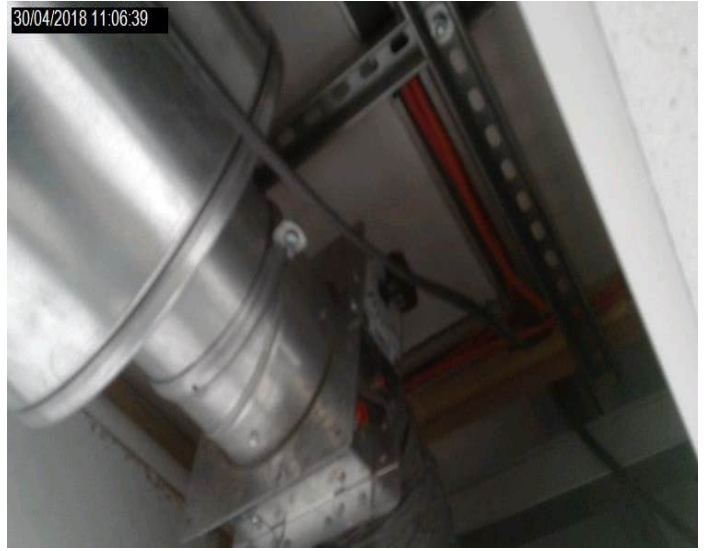
Location:	3.32A	Block:	University	Floor Level: 2nd Floor
Sample No.:	DU001439	Portal Ref No.:	313

Item:	Asbestos Textured coating to concrete ceiling			
Asbestos Content:	Result Based on:			
Chrysotile	Analysis of sample using PLM			
Sample Analysed By: Reg 13(1)	Extent:	6 m ²		
Comments: Above suspended tiles

Material Assessment Total Score: 3		Likelihood of Disturbance Assessment Total Score: 4		Management Assessment Licensable: No Recommendations: Program removal Reinspection Interval: Not Applicable Overall Risk Category: C7
Product Type:	1 (Asbestos textured coating)	Location:	2 (Rooms up to 100 sq m)	
Condition:	1 (Minor scratches)	Accessibility:	1 (Occasionally likely to be disturbed)	
Surface Treatment:	0 (Composite material)			
Asbestos Type:	1 (Chrysotile)	Extent Score:	1 (<10 sq m or 10m pipe run)

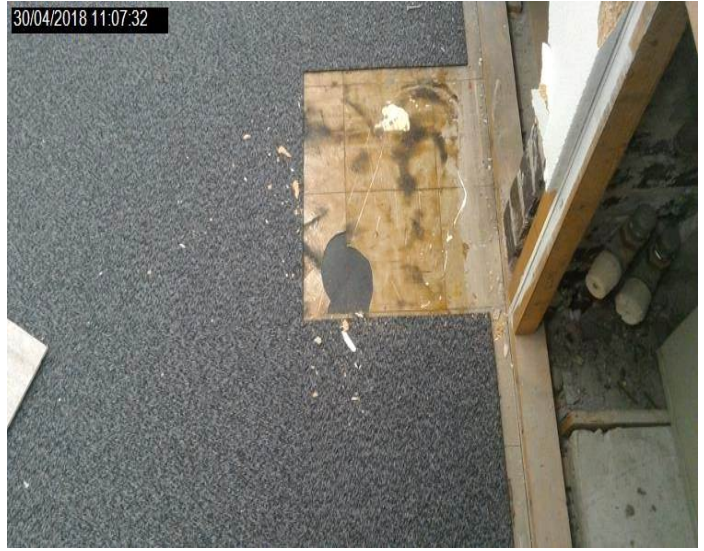
Location:	3.32A	Block:	University	Floor Level: 2nd Floor
Sample No.:	DU001440	Portal Ref No.:	314

Item:	Asbestos Thermoplastic floor tiles with bitumen adhesive			
Asbestos Content:	Result Based on:			
Chrysotile	Analysis of sample using PLM			
Sample Analysed By: Reg 13(1)	Extent:	6 m ²		
Comments: Present beneath carpet

Material Assessment Total Score: 3		Likelihood of Disturbance Assessment Total Score: 4		Management Assessment Licensable: No Recommendations: Program removal Reinspection Interval: Not Applicable Overall Risk Category: C7
Product Type:	1 (Asbestos thermoplastic)	Location:	2 (Rooms up to 100 sq m)	
Condition:	1 (Minor scratches)	Accessibility:	1 (Occasionally likely to be disturbed)	
Surface Treatment:	0 (Composite material)			
Asbestos Type:	1 (Chrysotile)	Extent Score:	1 (<10 sq m or 10m pipe run)

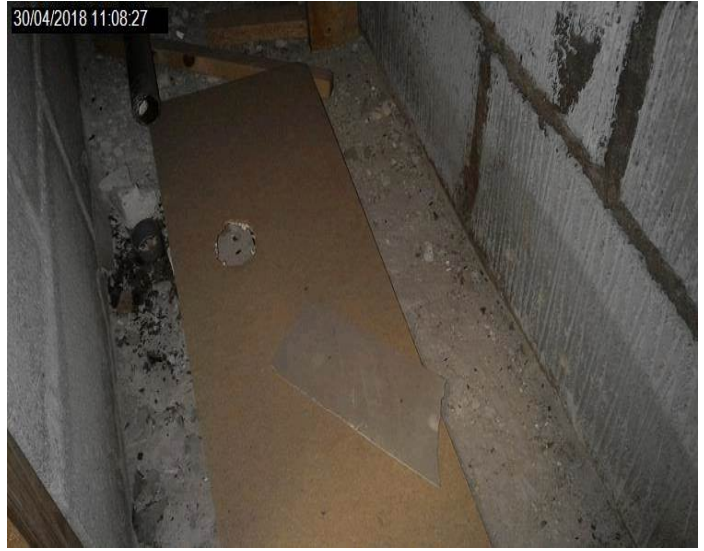
Location:	3.32A	Block:	University	Floor Level: 2nd Floor
Sample No.:	DU001441	Portal Ref No.:	315

Item:	Thermoplastic floor tile debris within wall void			
Asbestos Content:		Result Based on:		
No Asbestos Detected		Analysis of sample using PLM		
Sample Analysed By:	Reg 13(1)	Extent:	2 m ²	
Comments: Within left hand opening to wall voids

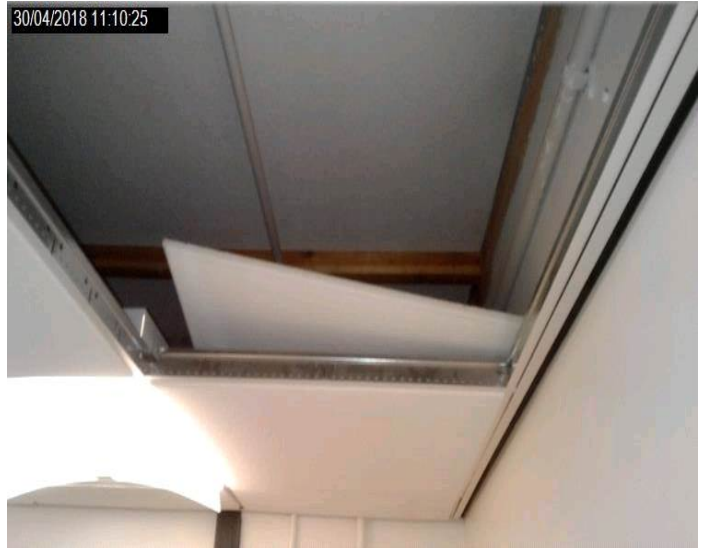
Location:	3.32	Block:	University	Floor Level: 2nd Floor
Sample No.:	As DU001439	Portal Ref No.:	317

Item:	Asbestos Textured coating to concrete ceiling			
Asbestos Content:	Result Based on:			
Chrysotile	Strongly presumed			
Sample Analysed By:	Not applicable	Extent:	6 m ²	
Comments: Above suspended tiles

Material Assessment Total Score: 3		Likelihood of Disturbance Assessment Total Score: 4		Management Assessment Licensable: No Recommendations: Program removal Reinspection Interval: Not Applicable Overall Risk Category: C7
Product Type:	1 (Asbestos textured coating)	Location:	2 (Rooms up to 100 sq m)	
Condition:	1 (Minor scratches)	Accessibility:	1 (Occasionally likely to be disturbed)	
Surface Treatment:	0 (Composite material)			
Asbestos Type:	1 (Chrysotile)	Extent Score:	1 (<10 sq m or 10m pipe run)

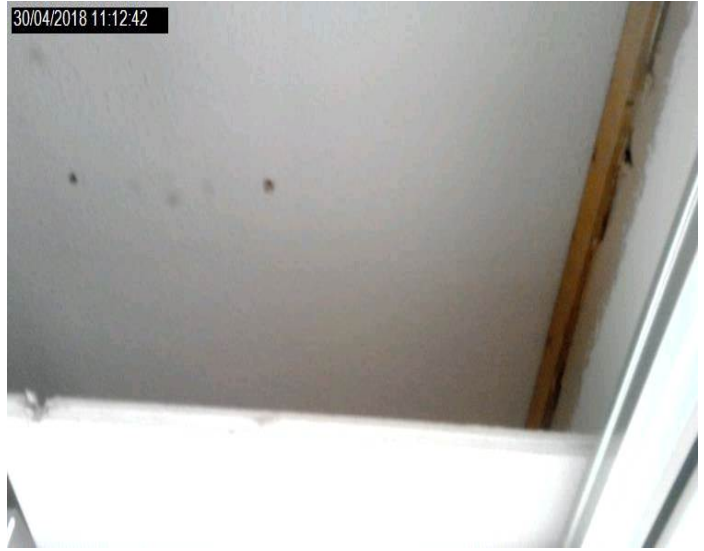
Location:	3.32B	Block:	University	Floor Level: 2nd Floor
Sample No.:	As DU001439	Portal Ref No.:	319

Item:	Asbestos Textured coating to concrete ceiling			
Asbestos Content:	Result Based on:			
Chrysotile	Strongly presumed			
Sample Analysed By:	Not applicable	Extent:	6 m ²	
Comments: Above suspended tiles

Material Assessment Total Score: 3		Likelihood of Disturbance Assessment Total Score: 4		Management Assessment Licensable: No Recommendations: Program removal Reinspection Interval: Not Applicable Overall Risk Category: C7
Product Type:	1 (Asbestos textured coating)	Location:	2 (Rooms up to 100 sq m)	
Condition:	1 (Minor scratches)	Accessibility:	1 (Occasionally likely to be disturbed)	
Surface Treatment:	0 (Composite material)			
Asbestos Type:	1 (Chrysotile)	Extent Score:	1 (<10 sq m or 10m pipe run)

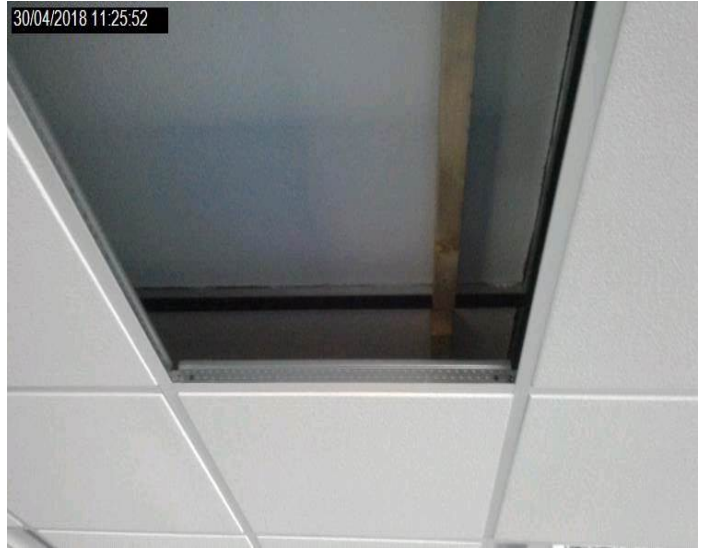
Location:	3.31	Block:	University	Floor Level: 2nd Floor
Sample No.:	As DU001439	Portal Ref No.:	321

Item:	Asbestos Textured coating to concrete ceiling			
Asbestos Content:	Result Based on:			
Chrysotile	Strongly presumed			
Sample Analysed By:	Not applicable	Extent:	60 m ²	
Comments: Present above suspended ceiling

Material Assessment Total Score: 3		Likelihood of Disturbance Assessment Total Score: 6		Management Assessment Licensable: No Recommendations: Program removal Reinspection Interval: Not Applicable Overall Risk Category: C9
Product Type:	1 (Asbestos textured coating)	Location:	2 (Rooms up to 100 sq m)	
Condition:	1 (Minor scratches)	Accessibility:	1 (Occasionally likely to be disturbed)	
Surface Treatment:	0 (Composite material)			
Asbestos Type:	1 (Chrysotile)	Extent Score:	3 (>50 sq m or >50m pipe run)

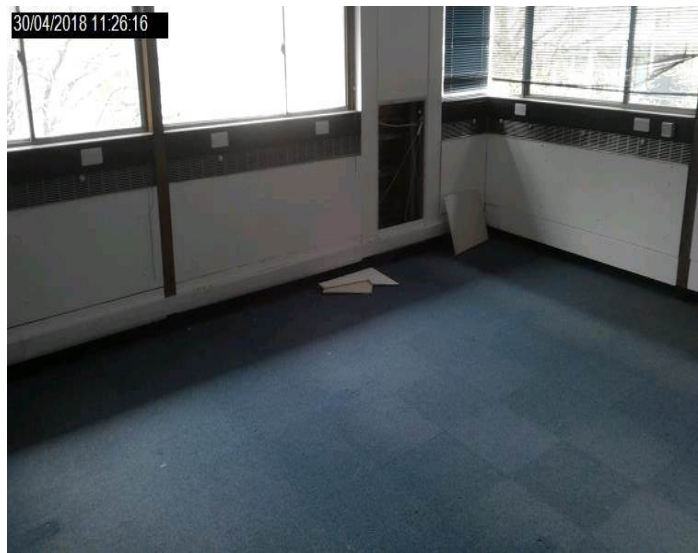
Location:	3.31	Block:	University	Floor Level: 2nd Floor
Sample No.:	DU001442	Portal Ref No.:	322

Item:	Asbestos Cement window sill			
Asbestos Content:	Result Based on:			
Chrysotile	Analysis of sample using PLM			
Sample Analysed By: Reg 13(1)	Extent:	15 linear metres		
Comments:

Material Assessment Total Score: 4		Likelihood of Disturbance Assessment Total Score: 5		Management Assessment Licensable: No Recommendations: Program removal Reinspection Interval: Not Applicable Overall Risk Category: C9
Product Type:	1 (Asbestos cement)	Location:	2 (Rooms up to 100 sq m)	
Condition:	1 (Minor scratches)	Accessibility:	1 (Occasionally likely to be disturbed)	
Surface Treatment:	1 (Unencapsulated asbestos cement)			
Asbestos Type:	1 (Chrysotile)	Extent Score:	2 (>10 - <50 sq m or >10m - <50m pipe run)

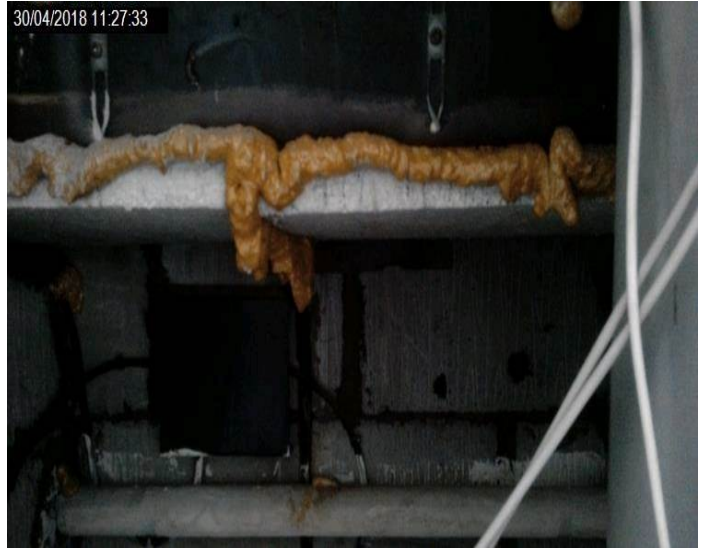
Location:	3.31	Block:	University	Floor Level: 2nd Floor
Sample No.:	DU001444	Portal Ref No.:	323

Item:	Asbestos Cement shuttering			
Asbestos Content:	Result Based on:			
Chrysotile Amosite	Analysis of sample using PLM			
Sample Analysed By: Reg 13(1)	Extent:	15 m ²		
Comments: To ceiling of wall void behind polystyrene sheets

Material Assessment Total Score: 5		Likelihood of Disturbance Assessment Total Score: 5		Management Assessment Licensable: No Recommendations: Program removal Reinspection Interval: Not Applicable Overall Risk Category: C10
Product Type:	1 (Asbestos cement)	Location:	2 (Rooms up to 100 sq m)	
Condition:	1 (Minor scratches)	Accessibility:	1 (Occasionally likely to be disturbed)	
Surface Treatment:	1 (Encapsulated asbestos cement)			
Asbestos Type:	2 (Chrysotile Amosite)	Extent Score:	2 (>10 - <50 sq m or >10m - <50m pipe run)

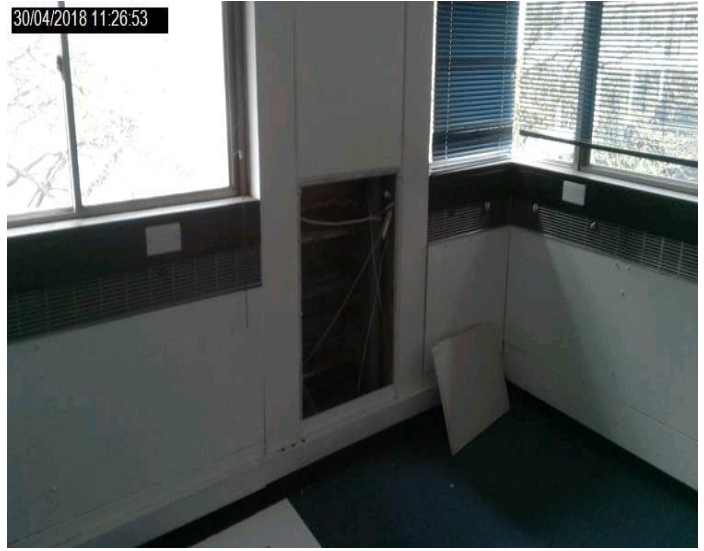
Location:	3.31	Block:	University	Floor Level: 2nd Floor
Sample No.:	DU001443	Portal Ref No.:	324

Item:	Insulating board panels to riser			
Asbestos Content:		Result Based on:		
No Asbestos Detected		Analysis of sample using PLM		
Sample Analysed By:	Reg 13(1)	Extent:	6 m ²	
Comments: 2 x risers

Material Assessment Total Score: 0		Likelihood of Disturbance Assessment Total Score: 0		Management Assessment Licensable: Yes Recommendations: Not Applicable Reinspection Interval: Not Applicable Overall Risk Category: E0
Product Type:	0 Not Applicable	Location:	0 Not Applicable	
Condition:	0 Not Applicable	Accessibility:	0 Not Applicable	
Surface Treatment:	0 Not Applicable			
Asbestos Type:	0 Not Applicable	Extent Score:	0 Not Applicable

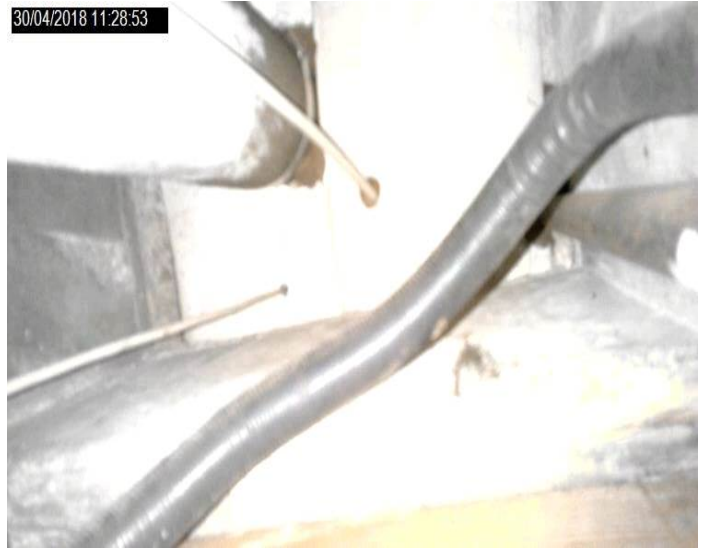
Location:	3.31	Block:	University	Floor Level: 2nd Floor
Sample No.:	DU001445	Portal Ref No.:	326

Item:	Asbestos Insulating board panel to ceiling of riser			
Asbestos Content:	Result Based on:			
Chrysotile Amosite	Analysis of sample using PLM			
Sample Analysed By: Reg 13(1)	Extent:	1 m ²		
Comments:

Material Assessment Total Score: 8		Likelihood of Disturbance Assessment Total Score: 4		Management Assessment Licensable: Yes Recommendations: Program removal Reinspection Interval: Not Applicable Overall Risk Category: B12
Product Type:	2 (Asbestos insulating board)	Location:	2 (Rooms up to 100 sq m)	
Condition:	2 (Local damage)	Accessibility:	1 (Occasionally likely to be disturbed)	
Surface Treatment:	2 (Unencapsulated asbestos insulating board)			
Asbestos Type:	2 (Chrysotile Amosite)	Extent Score:	1 (<10 sq m or 10m pipe run)

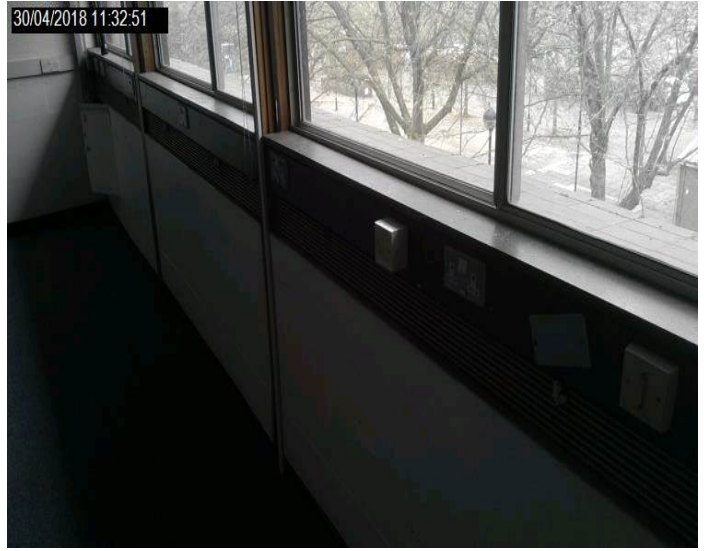
Location:	3.30	Block:	University	Floor Level: 2nd Floor
Sample No.:	As DU001442	Portal Ref No.:	328

Item:	Asbestos Cement window sill			
Asbestos Content:	Result Based on:			
Chrysotile	Strongly presumed			
Sample Analysed By:	Not applicable	Extent:	6 linear metres	
Comments:

Material Assessment Total Score: 4		Likelihood of Disturbance Assessment Total Score: 4		Management Assessment Licensable: No Recommendations: Program removal Reinspection Interval: Not Applicable Overall Risk Category: C8
Product Type:	1 (Asbestos cement)	Location:	2 (Rooms up to 100 sq m)	
Condition:	1 (Minor scratches)	Accessibility:	1 (Occasionally likely to be disturbed)	
Surface Treatment:	1 (Unencapsulated asbestos cement)			
Asbestos Type:	1 (Chrysotile)	Extent Score:	1 (<10 sq m or 10m pipe run)

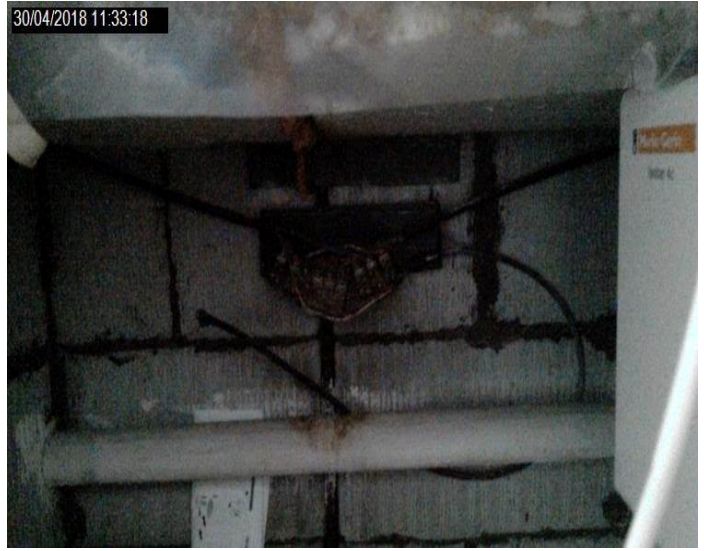
Location:	3.30	Block:	University	Floor Level: 2nd Floor
Sample No.:	As DU001444	Portal Ref No.:	329

Item:	Asbestos Cement shuttering			
Asbestos Content:	Result Based on:			
Chrysotile Amosite	Strongly presumed			
Sample Analysed By:	Not applicable	Extent:	6 m ²	
Comments: To ceiling of wall void behind polystyrene sheets

Material Assessment Total Score: 5		Likelihood of Disturbance Assessment Total Score: 4		Management Assessment Licensable: No Recommendations: Program removal Reinspection Interval: Not Applicable Overall Risk Category: C9
Product Type:	1 (Asbestos cement)	Location:	2 (Rooms up to 100 sq m)	
Condition:	1 (Minor scratches)	Accessibility:	1 (Occasionally likely to be disturbed)	
Surface Treatment:	1 (Encapsulated asbestos cement)			
Asbestos Type:	2 (Chrysotile Amosite)	Extent Score:	1 (<10 sq m or 10m pipe run)

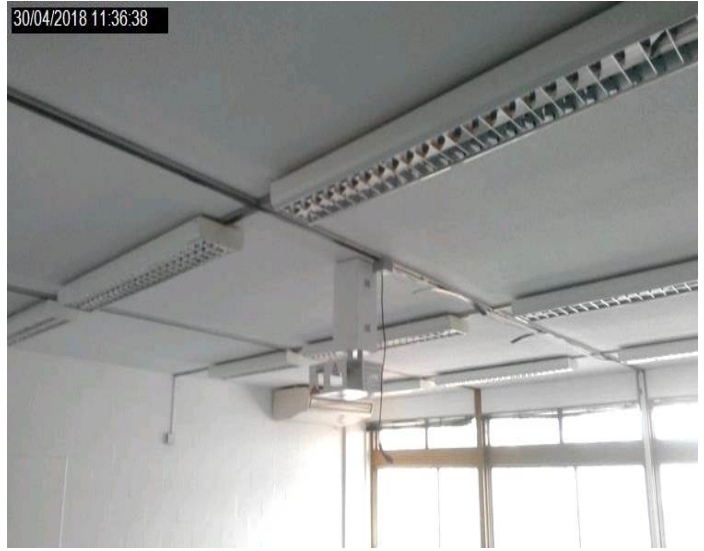
Location:	3.27	Block:	University	Floor Level: 2nd Floor
Sample No.:	As DU001439	Portal Ref No.:	331

Item:	Asbestos Textured coating to concrete ceiling			
Asbestos Content:	Result Based on:			
Chrysotile	Strongly presumed			
Sample Analysed By:	Not applicable	Extent:	50 m ²	
Comments:

Material Assessment Total Score: 3		Likelihood of Disturbance Assessment Total Score: 6		Management Assessment Licensable: No Recommendations: Program removal Reinspection Interval: Not Applicable Overall Risk Category: C9
Product Type:	1 (Asbestos textured coating)	Location:	2 (Rooms up to 100 sq m)	
Condition:	1 (Minor scratches)	Accessibility:	1 (Occasionally likely to be disturbed)	
Surface Treatment:	0 (Composite material)			
Asbestos Type:	1 (Chrysotile)	Extent Score:	3 (>50 sq m or >50m pipe run)

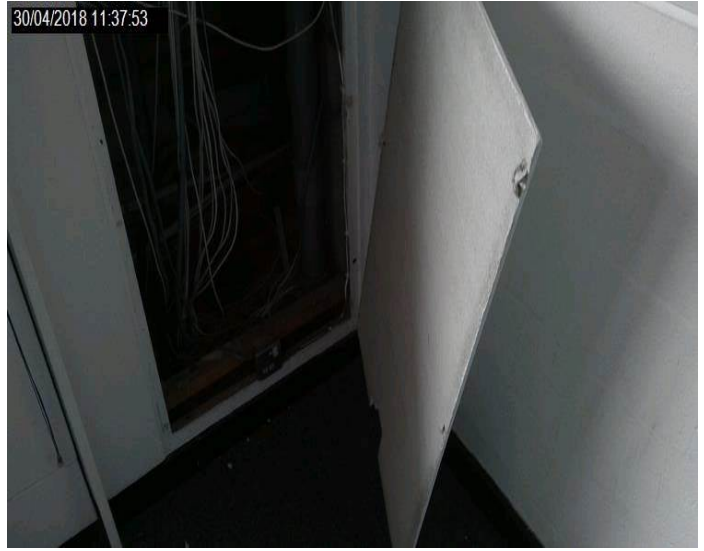
Location:	3.27	Block:	University	Floor Level: 2nd Floor
Sample No.:	As DU001443	Portal Ref No.:	334

Item:	Insulating board panels to riser			
Asbestos Content:		Result Based on:		
No Asbestos Detected		Strongly presumed		
Sample Analysed By:	Not applicable	Extent:	3 m ²	
Comments:

Material Assessment Total Score: 0		Likelihood of Disturbance Assessment Total Score: 0		Management Assessment Licensable: Yes Recommendations: Not Applicable Reinspection Interval: Not Applicable Overall Risk Category: E0
Product Type:	0 Not Applicable	Location:	0 Not Applicable	
Condition:	0 Not Applicable	Accessibility:	0 Not Applicable	
Surface Treatment:	0 Not Applicable			
Asbestos Type:	0 Not Applicable	Extent Score:	0 Not Applicable

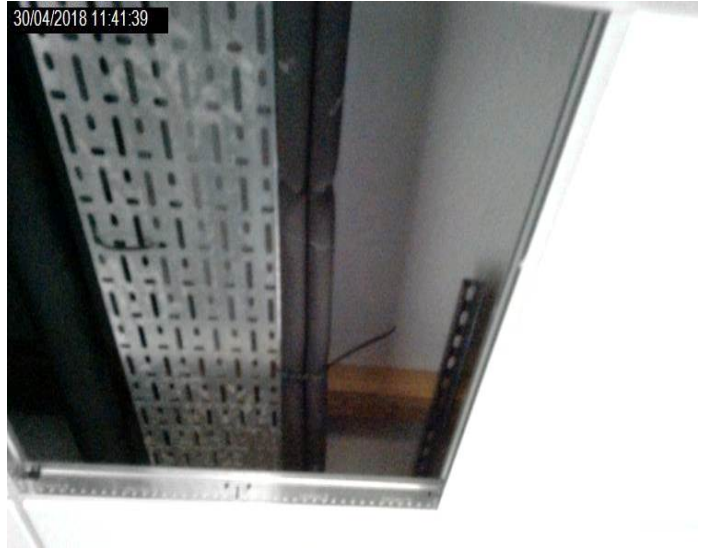
Location:	3.26	Block:	University	Floor Level: 2nd Floor
Sample No.:	As DU001439	Portal Ref No.:	336

Item:	Asbestos Textured coating to concrete ceiling			
Asbestos Content:	Result Based on:			
Chrysotile	Strongly presumed			
Sample Analysed By:	Not applicable	Extent:	54 m ²	
Comments: Present above suspended ceiling

Material Assessment Total Score: 3		Likelihood of Disturbance Assessment Total Score: 6		Management Assessment Licensable: No Recommendations: Program removal Reinspection Interval: Not Applicable Overall Risk Category: C9
Product Type:	1 (Asbestos textured coating)	Location:	2 (Rooms up to 100 sq m)	
Condition:	1 (Minor scratches)	Accessibility:	1 (Occasionally likely to be disturbed)	
Surface Treatment:	0 (Composite material)			
Asbestos Type:	1 (Chrysotile)	Extent Score:	3 (>50 sq m or >50m pipe run)

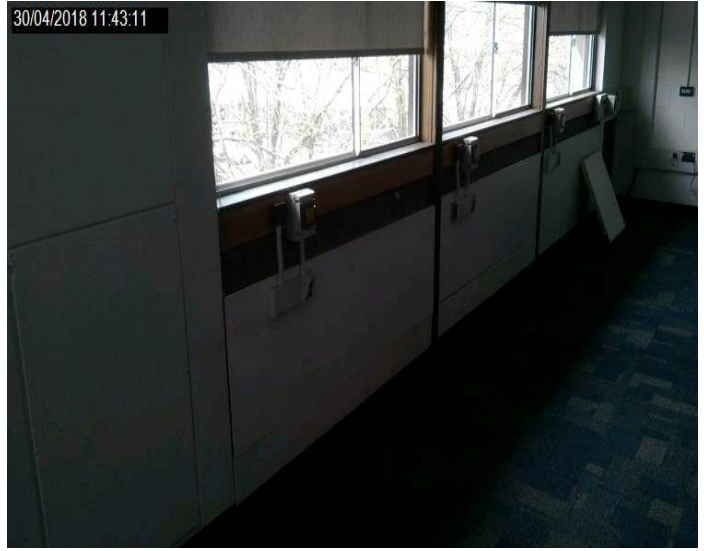
Location:	3.26	Block:	University	Floor Level: 2nd Floor
Sample No.:	As DU001442	Portal Ref No.:	337

Item:	Asbestos Cement window sill			
Asbestos Content:	Result Based on:			
Chrysotile	Strongly presumed			
Sample Analysed By:	Not applicable	Extent:	8 linear metres	
Comments:

Material Assessment Total Score: 4		Likelihood of Disturbance Assessment Total Score: 4		Management Assessment Licensable: No Recommendations: Program removal Reinspection Interval: Not Applicable Overall Risk Category: C8
Product Type:	1 (Asbestos cement)	Location:	2 (Rooms up to 100 sq m)	
Condition:	1 (Minor scratches)	Accessibility:	1 (Occasionally likely to be disturbed)	
Surface Treatment:	1 (Unencapsulated asbestos cement)			
Asbestos Type:	1 (Chrysotile)	Extent Score:	1 (<10 sq m or 10m pipe run)

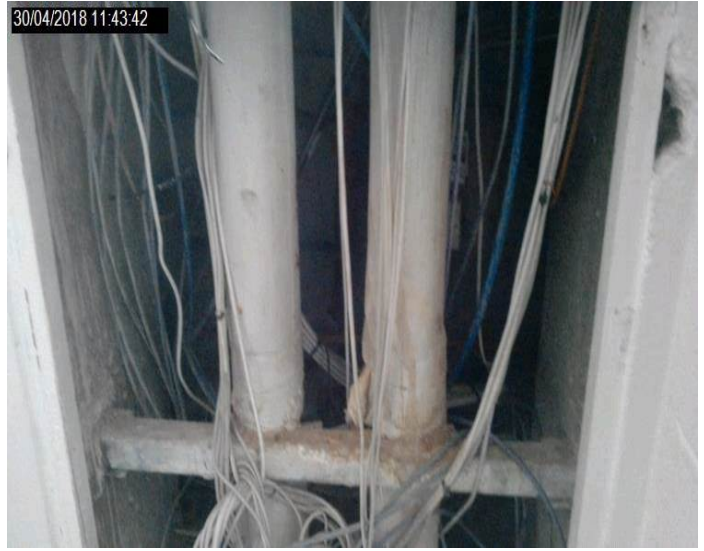
Location:	3.26	Block:	University	Floor Level: 2nd Floor
Sample No.:	As DU001444	Portal Ref No.:	338

Item:	Asbestos Cement shuttering			
Asbestos Content:	Result Based on:			
Chrysotile Amosite	Strongly presumed			
Sample Analysed By:	Not applicable	Extent:	9 m ²	
Comments: To ceiling of wall void behind polystyrene sheets

Material Assessment Total Score: 5		Likelihood of Disturbance Assessment Total Score: 4		Management Assessment Licensable: No Recommendations: Program removal Reinspection Interval: Not Applicable Overall Risk Category: C9
Product Type:	1 (Asbestos cement)	Location:	2 (Rooms up to 100 sq m)	
Condition:	1 (Minor scratches)	Accessibility:	1 (Occasionally likely to be disturbed)	
Surface Treatment:	1 (Encapsulated asbestos cement)			
Asbestos Type:	2 (Chrysotile Amosite)	Extent Score:	1 (<10 sq m or 10m pipe run)

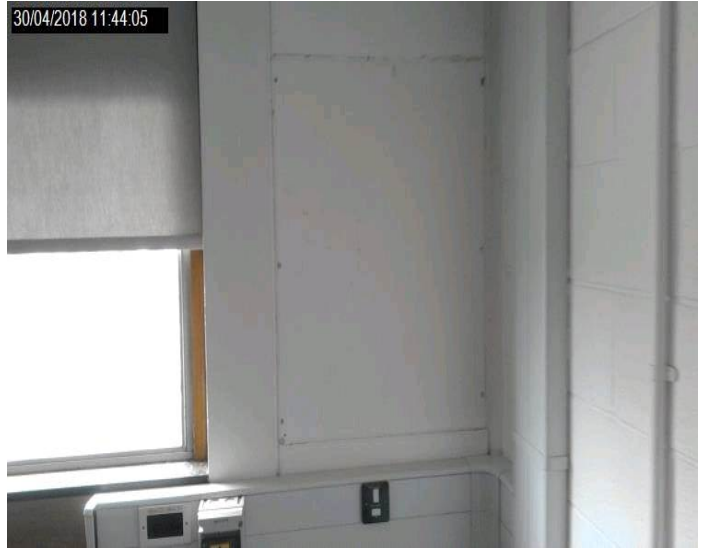
Location:	3.26	Block:	University	Floor Level: 2nd Floor
Sample No.:	As DU001443	Portal Ref No.:	339

Item:	Insulating board panels to riser			
Asbestos Content:		Result Based on:		
No Asbestos Detected		Strongly presumed		
Sample Analysed By:	Not applicable	Extent:	5 m ²	
Comments: 2 x risers

Material Assessment Total Score: 0		Likelihood of Disturbance Assessment Total Score: 0		Management Assessment Licensable: Yes Recommendations: Not Applicable Reinspection Interval: Not Applicable Overall Risk Category: E0
Product Type:	0 Not Applicable	Location:	0 Not Applicable	
Condition:	0 Not Applicable	Accessibility:	0 Not Applicable	
Surface Treatment:	0 Not Applicable			
Asbestos Type:	0 Not Applicable	Extent Score:	0 Not Applicable

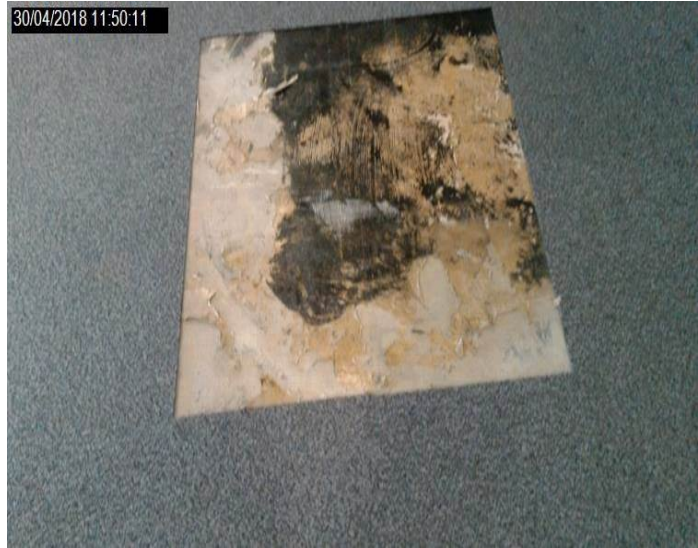
Location:	3.99A	Block:	University	Floor Level: 2nd Floor
Sample No.:	As DU001448	Portal Ref No.:	342

Item:	Asbestos Bitumen adhesive			
Asbestos Content:	Result Based on:			
Chrysotile	Strongly presumed			
Sample Analysed By:	Not applicable	Extent:	80 m ²	
Comments: Present beneath carpet

Material Assessment Total Score: 3		Likelihood of Disturbance Assessment Total Score: 5		Management Assessment Licensable: No Recommendations: Program removal Reinspection Interval: Not Applicable Overall Risk Category: C8
Product Type:	1 (Asbestos bitumen)	Location:	2 (Rooms up to 100 sq m)	
Condition:	1 (Minor scratches)	Accessibility:	0 (Usually inaccessible or unlikely to be disturbed)	
Surface Treatment:	0 (Composite material)			
Asbestos Type:	1 (Chrysotile)	Extent Score:	3 (>50 sq m or >50m pipe run)

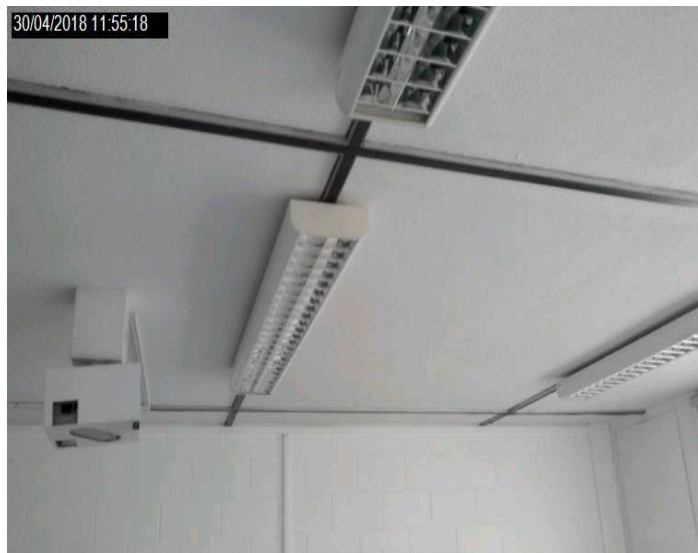
Location:	3.24	Block:	University	Floor Level: 2nd Floor
Sample No.:	DU001449	Portal Ref No.:	344

Item:	Asbestos Textured coating to concrete ceiling			
Asbestos Content:	Result Based on:			
Chrysotile	Analysis of sample using PLM			
Sample Analysed By:	Reg 13(1)	Extent:	25 m ²	
Comments:

Material Assessment Total Score: 3		Likelihood of Disturbance Assessment Total Score: 5		Management Assessment Licensable: No Recommendations: Program removal Reinspection Interval: Not Applicable Overall Risk Category: C8
Product Type:	1 (Asbestos textured coating)	Location:	2 (Rooms up to 100 sq m)	
Condition:	1 (Minor scratches)	Accessibility:	1 (Occasionally likely to be disturbed)	
Surface Treatment:	0 (Composite material)			
Asbestos Type:	1 (Chrysotile)	Extent Score:	2 (>10 - <50 sq m or >10m - <50m pipe run)

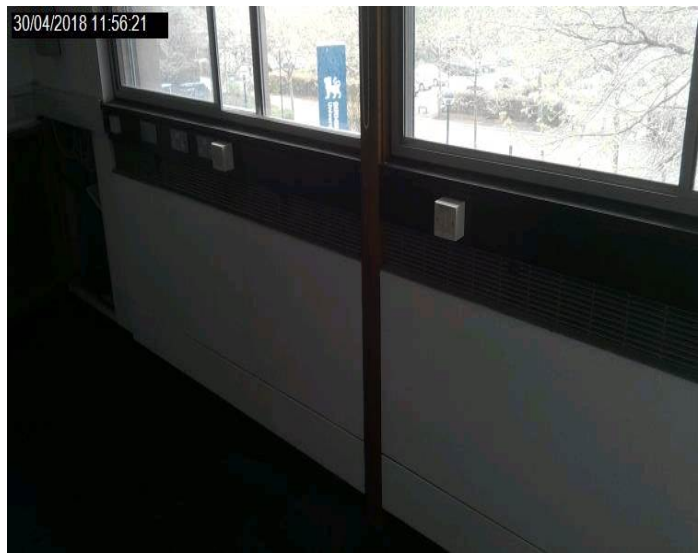
Location:	3.24	Block:	University	Floor Level: 2nd Floor
Sample No.:	DU001450	Portal Ref No.:	345

Item:	Asbestos Cement window sill			
Asbestos Content:	Result Based on:			
Chrysotile	Analysis of sample using PLM			
Sample Analysed By:	Reg 13(1)	Extent:	4 linear metres	
Comments:

Material Assessment Total Score: 4		Likelihood of Disturbance Assessment Total Score: 4		Management Assessment Licensable: No Recommendations: Program removal Reinspection Interval: Not Applicable Overall Risk Category: C8
Product Type:	1 (Asbestos cement)	Location:	2 (Rooms up to 100 sq m)	
Condition:	1 (Minor scratches)	Accessibility:	1 (Occasionally likely to be disturbed)	
Surface Treatment:	1 (Unencapsulated asbestos cement)			
Asbestos Type:	1 (Chrysotile)	Extent Score:	1 (<10 sq m or 10m pipe run)

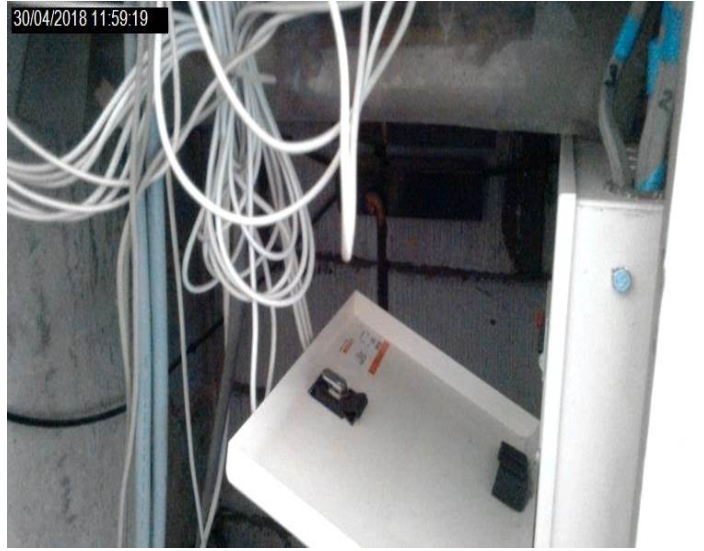
Location:	3.24	Block:	University	Floor Level: 2nd Floor
Sample No.:	DU001453	Portal Ref No.:	346

Item:	Asbestos Cement shuttering			
Asbestos Content:	Result Based on:			
Chrysotile Amosite	Analysis of sample using PLM			
Sample Analysed By: Reg 13(1)	Extent:	4 m ²		
Comments: To ceiling of wall void behind polystyrene sheets

Material Assessment Total Score: 5		Likelihood of Disturbance Assessment Total Score: 4		Management Assessment Licensable: No Recommendations: Program removal Reinspection Interval: Not Applicable Overall Risk Category: C9
Product Type:	1 (Asbestos cement)	Location:	2 (Rooms up to 100 sq m)	
Condition:	1 (Minor scratches)	Accessibility:	1 (Occasionally likely to be disturbed)	
Surface Treatment:	1 (Encapsulated asbestos cement)			
Asbestos Type:	2 (Chrysotile Amosite)	Extent Score:	1 (<10 sq m or 10m pipe run)

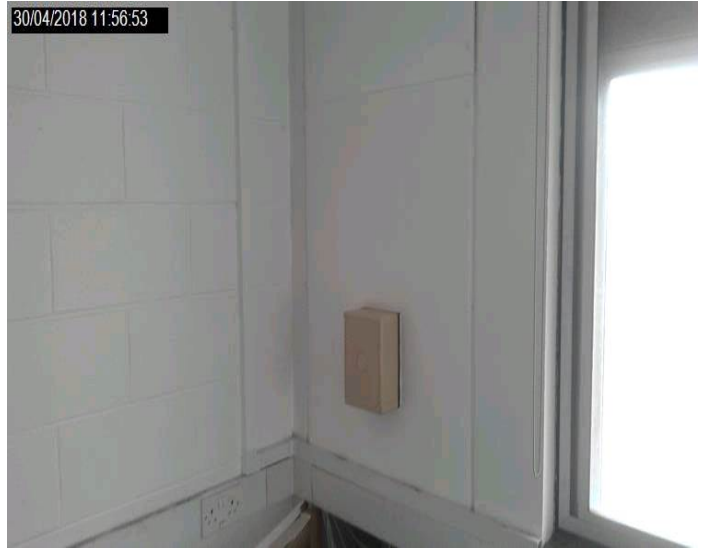
Location:	3.24	Block:	University	Floor Level: 2nd Floor
Sample No.:	DU001451	Portal Ref No.:	347

Item:	Insulating board panels to riser			
Asbestos Content:		Result Based on:		
No Asbestos Detected		Analysis of sample using PLM		
Sample Analysed By:	Reg 13(1)	Extent:	2 m ²	
Comments: Top two panels

Material Assessment Total Score: 0		Likelihood of Disturbance Assessment Total Score: 0		Management Assessment Licensable: Yes Recommendations: Not Applicable Reinspection Interval: Not Applicable Overall Risk Category: E0
Product Type:	0 Not Applicable	Location:	0 Not Applicable	
Condition:	0 Not Applicable	Accessibility:	0 Not Applicable	
Surface Treatment:	0 Not Applicable			
Asbestos Type:	0 Not Applicable	Extent Score:	0 Not Applicable

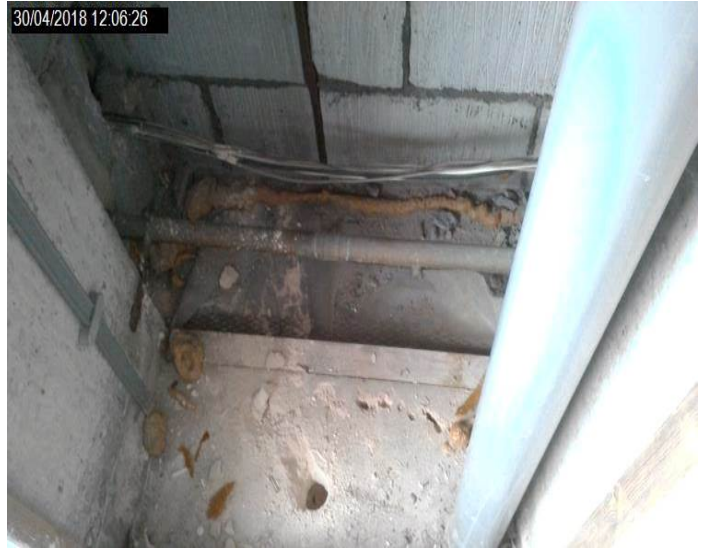
Location:	3.23	Block:	University	Floor Level: 2nd Floor
Sample No.:	DU001454	Portal Ref No.:	354

Item:	Bitumen damp proof course			
Asbestos Content:		Result Based on:		
No Asbestos Detected		Analysis of sample using PLM		
Sample Analysed By:	Reg 13(1)	Extent:	250 linear metres	
Comments: To entire perimeter of floor level to the external wall of the wall void

Material Assessment Total Score: 0		Likelihood of Disturbance Assessment Total Score: 0		Management Assessment Licensable: No Recommendations: Not Applicable Reinspection Interval: Not Applicable Overall Risk Category: E0
Product Type:	0 Not Applicable	Location:	0 Not Applicable	
Condition:	0 Not Applicable	Accessibility:	0 Not Applicable	
Surface Treatment:	0 Not Applicable			
Asbestos Type:	0 Not Applicable	Extent Score:	0 Not Applicable

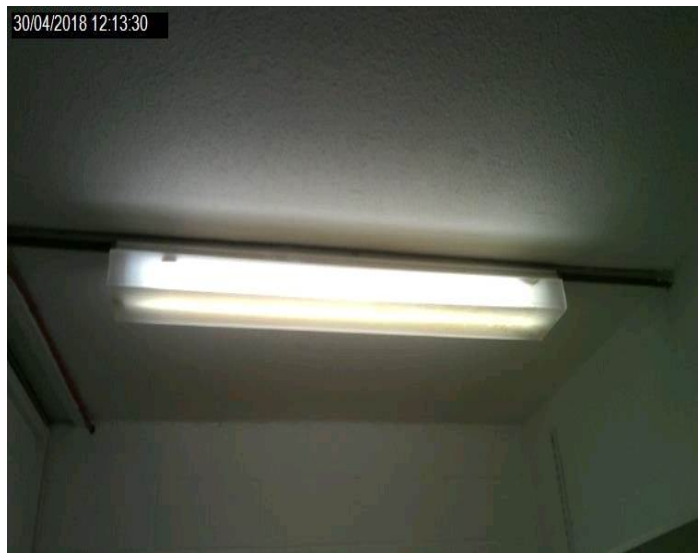
Location:	3.21	Block:	University	Floor Level: 2nd Floor
Sample No.:	As DU001449	Portal Ref No.:	355

Item:	Asbestos Textured coating to concrete ceiling			
Asbestos Content:	Result Based on:			
Chrysotile	Strongly presumed			
Sample Analysed By:	Not applicable	Extent:	8 m ²	
Comments:

Material Assessment Total Score: 3		Likelihood of Disturbance Assessment Total Score: 4		Management Assessment Licensable: No Recommendations: Program removal Reinspection Interval: Not Applicable Overall Risk Category: C7
Product Type:	1 (Asbestos textured coating)	Location:	2 (Rooms up to 100 sq m)	
Condition:	1 (Minor scratches)	Accessibility:	1 (Occasionally likely to be disturbed)	
Surface Treatment:	0 (Composite material)			
Asbestos Type:	1 (Chrysotile)	Extent Score:	1 (<10 sq m or 10m pipe run)

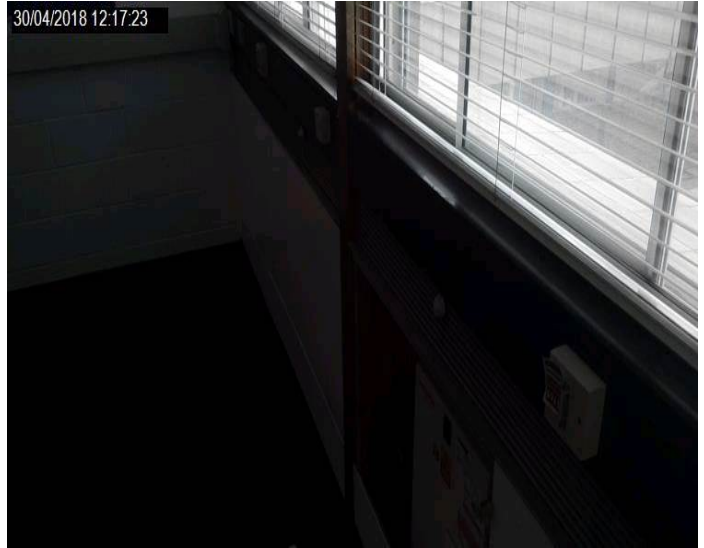
Location:	3.20	Block:	University	Floor Level: 2nd Floor
Sample No.:	As DU001450	Portal Ref No.:	358

Item:	Asbestos Cement window sill			
Asbestos Content:	Result Based on:			
Chrysotile	Strongly presumed			
Sample Analysed By:	Not applicable	Extent:	4 linear metres	
Comments:

Material Assessment Total Score: 4		Likelihood of Disturbance Assessment Total Score: 4		Management Assessment Licensable: No Recommendations: Program removal Reinspection Interval: Not Applicable Overall Risk Category: C8
Product Type:	1 (Asbestos cement)	Location:	2 (Rooms up to 100 sq m)	
Condition:	1 (Minor scratches)	Accessibility:	1 (Occasionally likely to be disturbed)	
Surface Treatment:	1 (Unencapsulated asbestos cement)			
Asbestos Type:	1 (Chrysotile)	Extent Score:	1 (<10 sq m or 10m pipe run)

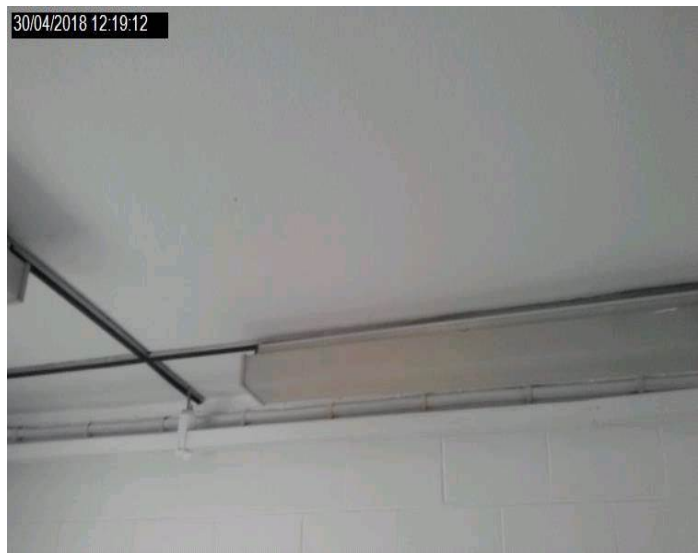
Location:	3.19	Block:	University	Floor Level: 2nd Floor
Sample No.:	As DU001449	Portal Ref No.:	360

Item:	Asbestos Textured coating to concrete ceiling			
Asbestos Content:	Result Based on:			
Chrysotile	Strongly presumed			
Sample Analysed By:	Not applicable	Extent:	12 m ²	
Comments:

Material Assessment Total Score: 3		Likelihood of Disturbance Assessment Total Score: 5		Management Assessment Licensable: No Recommendations: Program removal Reinspection Interval: Not Applicable Overall Risk Category: C8
Product Type:	1 (Asbestos textured coating)	Location:	2 (Rooms up to 100 sq m)	
Condition:	1 (Minor scratches)	Accessibility:	1 (Occasionally likely to be disturbed)	
Surface Treatment:	0 (Composite material)			
Asbestos Type:	1 (Chrysotile)	Extent Score:	2 (>10 - <50 sq m or >10m - <50m pipe run)

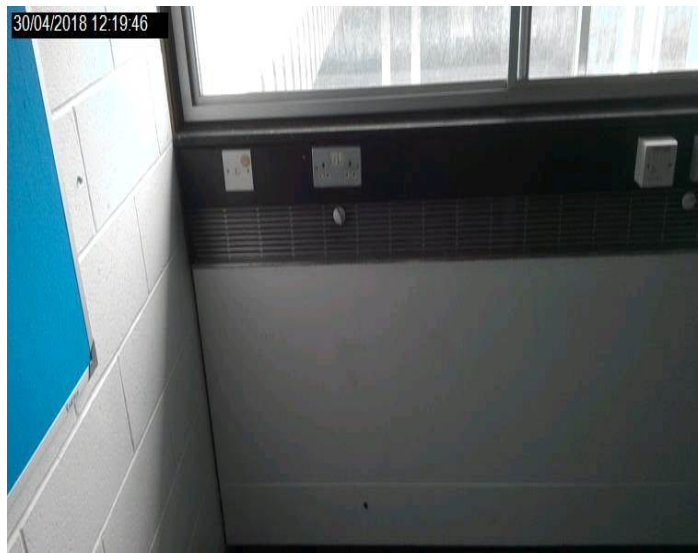
Location:	3.19	Block:	University	Floor Level: 2nd Floor
Sample No.:	As DU001450	Portal Ref No.:	361

Item:	Asbestos Cement window sill			
Asbestos Content:	Result Based on:			
Chrysotile	Strongly presumed			
Sample Analysed By:	Not applicable	Extent:	3 linear metres	
Comments:

Material Assessment Total Score: 4		Likelihood of Disturbance Assessment Total Score: 4		Management Assessment Licensable: No Recommendations: Program removal Reinspection Interval: Not Applicable Overall Risk Category: C8
Product Type:	1 (Asbestos cement)	Location:	2 (Rooms up to 100 sq m)	
Condition:	1 (Minor scratches)	Accessibility:	1 (Occasionally likely to be disturbed)	
Surface Treatment:	1 (Unencapsulated asbestos cement)			
Asbestos Type:	1 (Chrysotile)	Extent Score:	1 (<10 sq m or 10m pipe run)

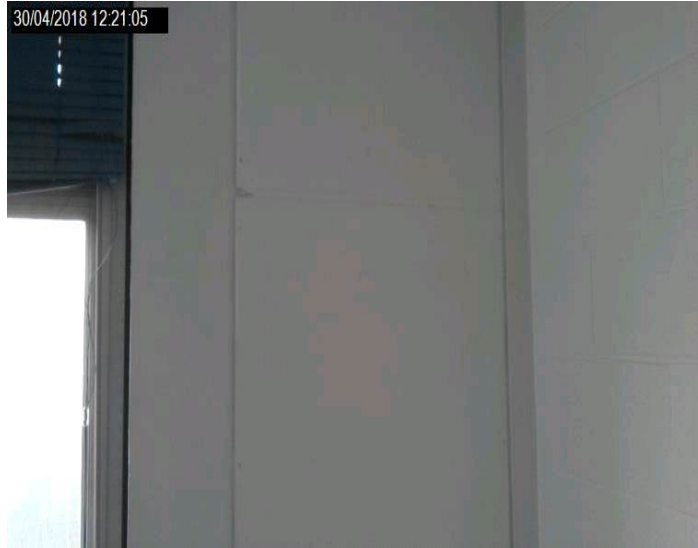
Location:	3.19	Block:	University	Floor Level: 2nd Floor
Sample No.:	As DU001451	Portal Ref No.:	363

Item:	Insulating board panels to riser			
Asbestos Content:		Result Based on:		
No Asbestos Detected		Strongly presumed		
Sample Analysed By:	Not applicable	Extent:	2 m ²	
Comments:

Material Assessment Total Score: 0		Likelihood of Disturbance Assessment Total Score: 0		Management Assessment Licensable: Yes Recommendations: Not Applicable Reinspection Interval: Not Applicable Overall Risk Category: E0
Product Type:	0 Not Applicable	Location:	0 Not Applicable	
Condition:	0 Not Applicable	Accessibility:	0 Not Applicable	
Surface Treatment:	0 Not Applicable			
Asbestos Type:	0 Not Applicable	Extent Score:	0 Not Applicable

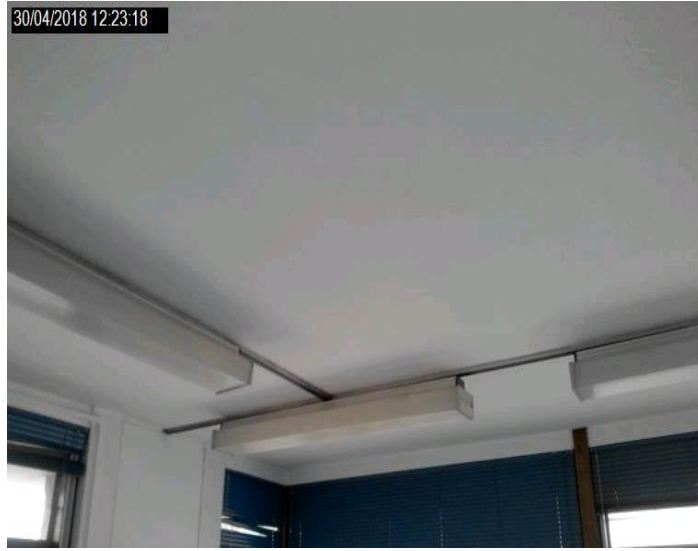
Location:	3.18	Block:	University	Floor Level: 2nd Floor
Sample No.:	As DU001449	Portal Ref No.:	364

Item:	Asbestos Textured coating to concrete ceiling			
Asbestos Content:	Result Based on:			
Chrysotile	Strongly presumed			
Sample Analysed By:	Not applicable	Extent:	25 m ²	
Comments:

Material Assessment Total Score: 3		Likelihood of Disturbance Assessment Total Score: 5		Management Assessment Licensable: No Recommendations: Program removal Reinspection Interval: Not Applicable Overall Risk Category: C8
Product Type:	1 (Asbestos textured coating)	Location:	2 (Rooms up to 100 sq m)	
Condition:	1 (Minor scratches)	Accessibility:	1 (Occasionally likely to be disturbed)	
Surface Treatment:	0 (Composite material)			
Asbestos Type:	1 (Chrysotile)	Extent Score:	2 (>10 - <50 sq m or >10m - <50m pipe run)
