Report No.: J094099
Nature of Work: Demolition Survey
Issue Date: 11/06/2018
Client Name: WYG Engineering Ltd
Geneva Building, Lake View Drive, Sherwood Business Park,
Annesley, Nottingham, NG15 0ED
Site Address: Dawson building, Former City North Campus, Birmingham City
University, Perry Barr, B42 2US

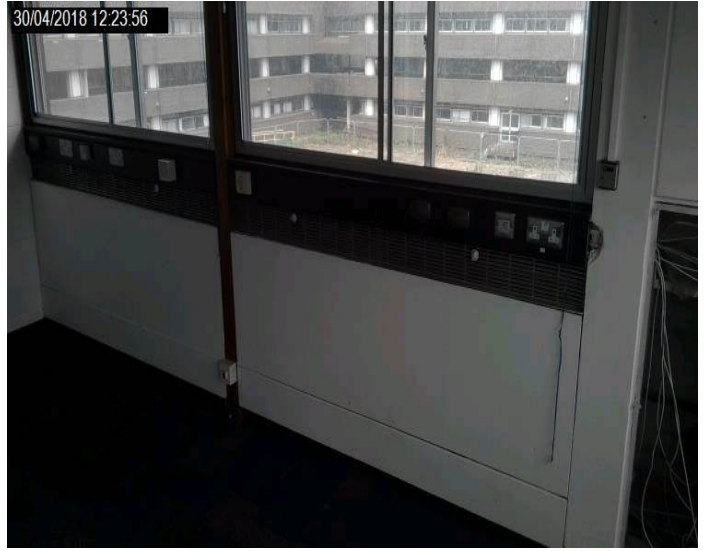
Location:	3.18	Block:	University	Floor Level: 2nd Floor
Sample No.:	As DU001450	Portal Ref No.:	365

Item:	Asbestos Cement window sill			
Asbestos Content:	Result Based on:			
Chrysotile	Strongly presumed			
Sample Analysed By:	Not applicable	Extent:	10 linear metres	
Comments:

Material Assessment Total Score: 4		Likelihood of Disturbance Assessment Total Score: 5		Management Assessment Licensable: No Recommendations: Program removal Reinspection Interval: Not Applicable Overall Risk Category: C9
Product Type:	1 (Asbestos cement)	Location:	2 (Rooms up to 100 sq m)	
Condition:	1 (Minor scratches)	Accessibility:	1 (Occasionally likely to be disturbed)	
Surface Treatment:	1 (Unencapsulated asbestos cement)			
Asbestos Type:	1 (Chrysotile)	Extent Score:	2 (>10 - <50 sq m or >10m - <50m pipe run)

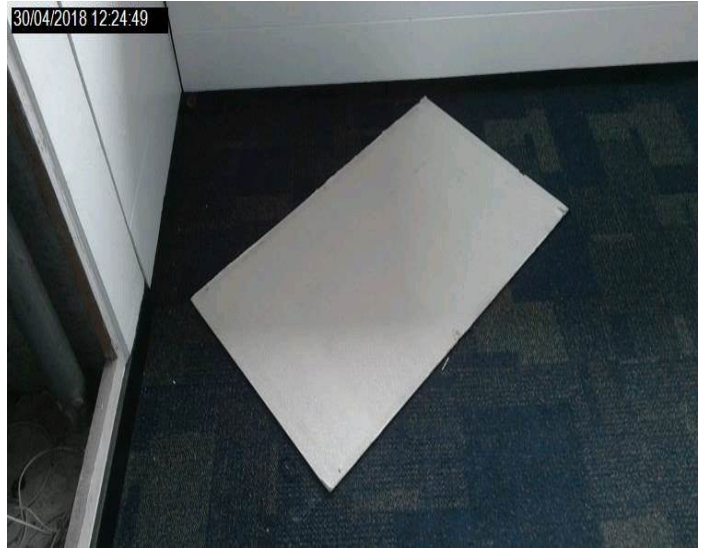
Location:	3.18	Block:	University	Floor Level: 2nd Floor
Sample No.:	As DU001451	Portal Ref No.:	367

Item:	Insulating board panels to riser			
Asbestos Content:		Result Based on:		
No Asbestos Detected		Strongly presumed		
Sample Analysed By:	Not applicable	Extent:	3 m ²	
Comments:

Material Assessment Total Score: 0		Likelihood of Disturbance Assessment Total Score: 0		Management Assessment Licensable: Yes Recommendations: Not Applicable Reinspection Interval: Not Applicable Overall Risk Category: E0
Product Type:	0 Not Applicable	Location:	0 Not Applicable	
Condition:	0 Not Applicable	Accessibility:	0 Not Applicable	
Surface Treatment:	0 Not Applicable			
Asbestos Type:	0 Not Applicable	Extent Score:	0 Not Applicable

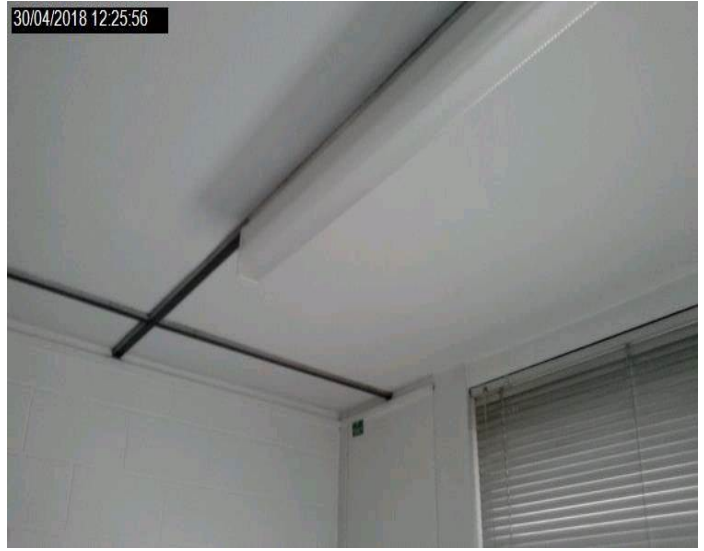
Location:	3.17	Block:	University	Floor Level: 2nd Floor
Sample No.:	As DU001449	Portal Ref No.:	368

Item:	Asbestos Textured coating to concrete ceiling			
Asbestos Content:	Result Based on:			
Chrysotile	Strongly presumed			
Sample Analysed By:	Not applicable	Extent:	12 m ²	
Comments:

Material Assessment Total Score: 3		Likelihood of Disturbance Assessment Total Score: 5		Management Assessment Licensable: No Recommendations: Program removal Reinspection Interval: Not Applicable Overall Risk Category: C8
Product Type:	1 (Asbestos textured coating)	Location:	2 (Rooms up to 100 sq m)	
Condition:	1 (Minor scratches)	Accessibility:	1 (Occasionally likely to be disturbed)	
Surface Treatment:	0 (Composite material)			
Asbestos Type:	1 (Chrysotile)	Extent Score:	2 (>10 - <50 sq m or >10m - <50m pipe run)

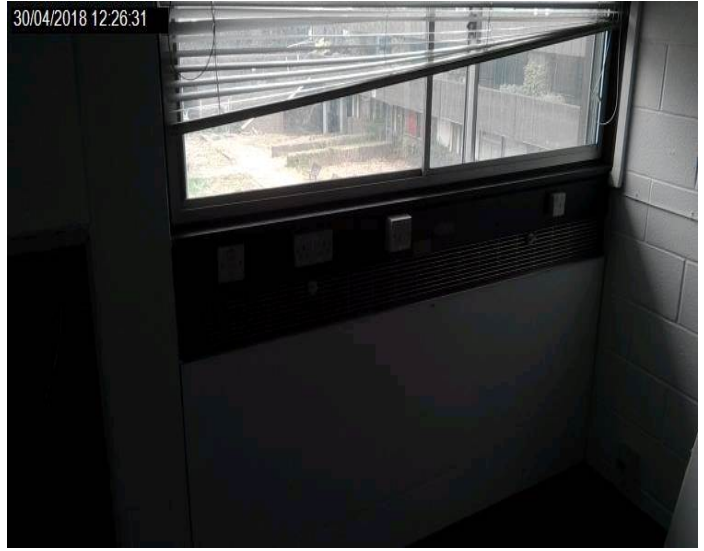
Location:	3.17	Block:	University	Floor Level: 2nd Floor
Sample No.:	As DU001450	Portal Ref No.:	369

Item:	Asbestos Cement window sill			
Asbestos Content:	Result Based on:			
Chrysotile	Strongly presumed			
Sample Analysed By:	Not applicable	Extent:	2 linear metres	
Comments:

Material Assessment Total Score: 4		Likelihood of Disturbance Assessment Total Score: 4		Management Assessment Licensable: No Recommendations: Program removal Reinspection Interval: Not Applicable Overall Risk Category: C8
Product Type:	1 (Asbestos cement)	Location:	2 (Rooms up to 100 sq m)	
Condition:	1 (Minor scratches)	Accessibility:	1 (Occasionally likely to be disturbed)	
Surface Treatment:	1 (Unencapsulated asbestos cement)			
Asbestos Type:	1 (Chrysotile)	Extent Score:	1 (<10 sq m or 10m pipe run)

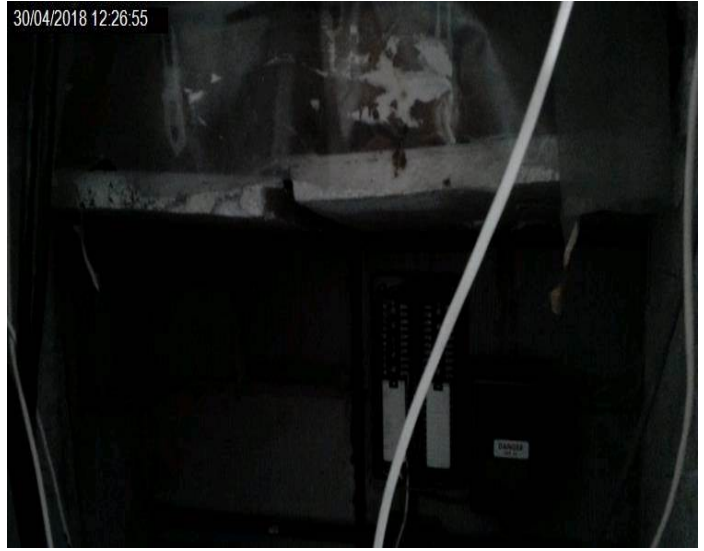
Location:	3.17	Block:	University	Floor Level: 2nd Floor
Sample No.:	As DU001453	Portal Ref No.:	370

Item:	Asbestos Cement shuttering			
Asbestos Content:	Result Based on:			
Chrysotile Amosite	Strongly presumed			
Sample Analysed By:	Not applicable	Extent:	3 m ²	
Comments: To ceiling of wall void behind polystyrene sheets

Material Assessment Total Score: 5		Likelihood of Disturbance Assessment Total Score: 4		Management Assessment Licensable: No Recommendations: Program removal Reinspection Interval: Not Applicable Overall Risk Category: C9
Product Type:	1 (Asbestos cement)	Location:	2 (Rooms up to 100 sq m)	
Condition:	1 (Minor scratches)	Accessibility:	1 (Occasionally likely to be disturbed)	
Surface Treatment:	1 (Encapsulated asbestos cement)			
Asbestos Type:	2 (Chrysotile Amosite)	Extent Score:	1 (<10 sq m or 10m pipe run)

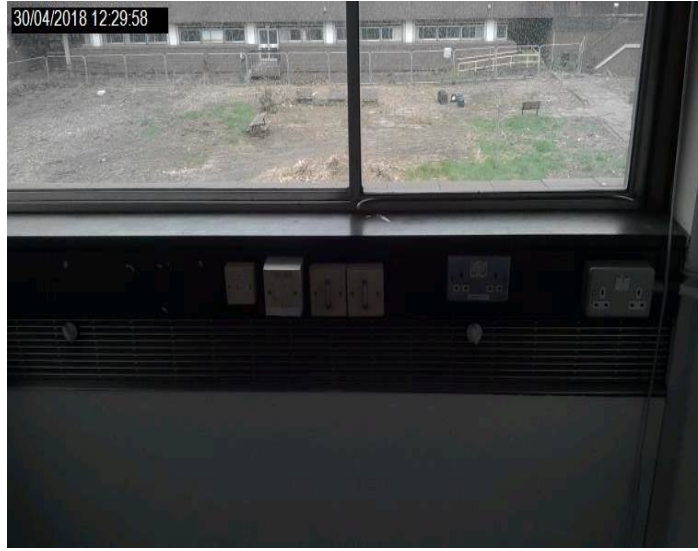
Location:	3.16	Block:	University	Floor Level: 2nd Floor
Sample No.:	As DU001450	Portal Ref No.:	373

Item:	Asbestos Cement window sill			
Asbestos Content:	Result Based on:			
Chrysotile	Strongly presumed			
Sample Analysed By:	Not applicable	Extent:	2 linear metres	
Comments:

Material Assessment Total Score: 4		Likelihood of Disturbance Assessment Total Score: 4		Management Assessment Licensable: No Recommendations: Program removal Reinspection Interval: Not Applicable Overall Risk Category: C8
Product Type:	1 (Asbestos cement)	Location:	2 (Rooms up to 100 sq m)	
Condition:	1 (Minor scratches)	Accessibility:	1 (Occasionally likely to be disturbed)	
Surface Treatment:	1 (Unencapsulated asbestos cement)			
Asbestos Type:	1 (Chrysotile)	Extent Score:	1 (<10 sq m or 10m pipe run)

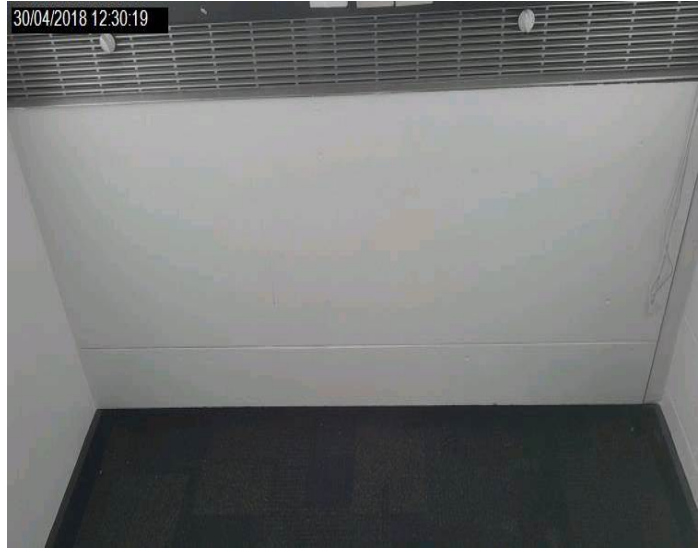
Location:	3.16	Block:	University	Floor Level: 2nd Floor
Sample No.:	As DU001453	Portal Ref No.:	374

Item:	Asbestos Cement shuttering			
Asbestos Content:	Result Based on:			
Chrysotile Amosite	Strongly presumed			
Sample Analysed By:	Not applicable	Extent:	2 m ²	
Comments: To ceiling of wall void behind polystyrene sheets

Material Assessment Total Score: 5		Likelihood of Disturbance Assessment Total Score: 4		Management Assessment Licensable: No Recommendations: Program removal Reinspection Interval: Not Applicable Overall Risk Category: C9
Product Type:	1 (Asbestos cement)	Location:	2 (Rooms up to 100 sq m)	
Condition:	1 (Minor scratches)	Accessibility:	1 (Occasionally likely to be disturbed)	
Surface Treatment:	1 (Encapsulated asbestos cement)			
Asbestos Type:	2 (Chrysotile Amosite)	Extent Score:	1 (<10 sq m or 10m pipe run)

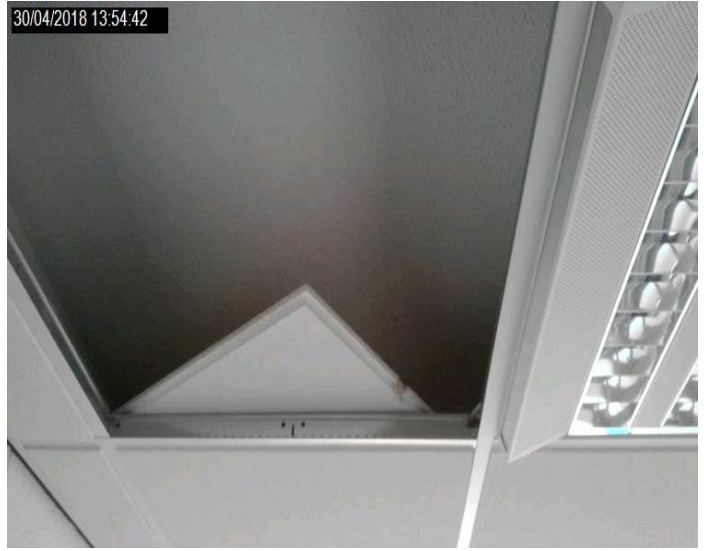
Location:	3.15A	Block:	University	Floor Level: 2nd Floor
Sample No.:	As DU001449	Portal Ref No.:	375

Item:	Asbestos Textured coating to concrete ceiling			
Asbestos Content:	Result Based on:			
Chrysotile	Strongly presumed			
Sample Analysed By:	Not applicable	Extent:	12 m ²	
Comments: Above ceiling tiles

Material Assessment Total Score: 3		Likelihood of Disturbance Assessment Total Score: 5		Management Assessment Licensable: No Recommendations: Program removal Reinspection Interval: Not Applicable Overall Risk Category: C8
Product Type:	1 (Asbestos textured coating)	Location:	2 (Rooms up to 100 sq m)	
Condition:	1 (Minor scratches)	Accessibility:	1 (Occasionally likely to be disturbed)	
Surface Treatment:	0 (Composite material)			
Asbestos Type:	1 (Chrysotile)	Extent Score:	2 (>10 - <50 sq m or >10m - <50m pipe run)

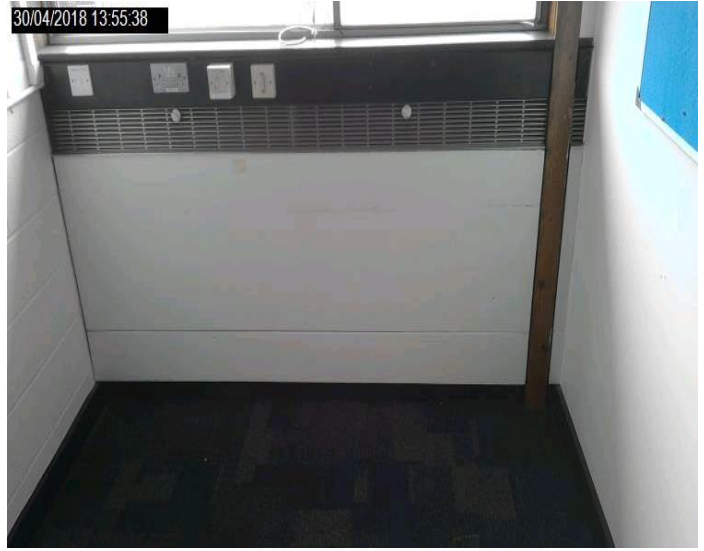
Location:	3.15A	Block:	University	Floor Level: 2nd Floor
Sample No.:	As DU001453	Portal Ref No.:	377

Item:	Asbestos Cement shuttering			
Asbestos Content:	Result Based on:			
Chrysotile Amosite	Strongly presumed			
Sample Analysed By:	Not applicable	Extent:	2 m ²	
Comments: To ceiling of wall void behind polystyrene sheets

Material Assessment Total Score: 5		Likelihood of Disturbance Assessment Total Score: 4		Management Assessment Licensable: No Recommendations: Program removal Reinspection Interval: Not Applicable Overall Risk Category: C9
Product Type:	1 (Asbestos cement)	Location:	2 (Rooms up to 100 sq m)	
Condition:	1 (Minor scratches)	Accessibility:	1 (Occasionally likely to be disturbed)	
Surface Treatment:	1 (Encapsulated asbestos cement)			
Asbestos Type:	2 (Chrysotile Amosite)	Extent Score:	1 (<10 sq m or 10m pipe run)

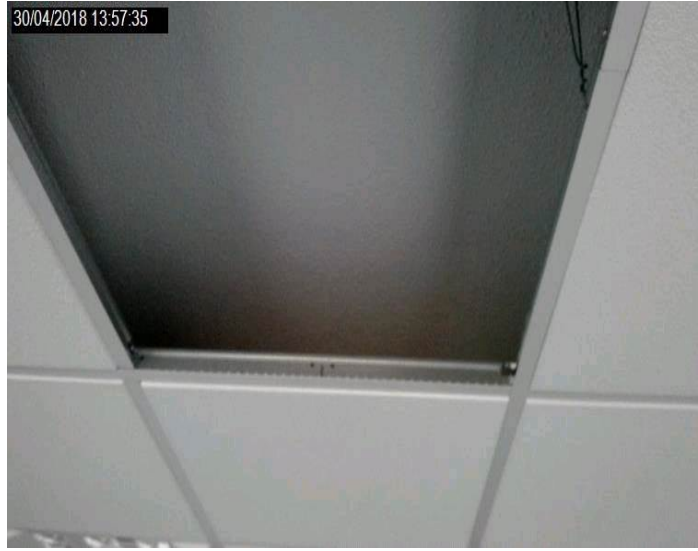
Location:	3.15	Block:	University	Floor Level: 2nd Floor
Sample No.:	As DU001449	Portal Ref No.:	378

Item:	Asbestos Textured coating to concrete ceiling			
Asbestos Content:	Result Based on:			
Chrysotile	Strongly presumed			
Sample Analysed By:	Not applicable	Extent:	18 m ²	
Comments:

Material Assessment Total Score: 3		Likelihood of Disturbance Assessment Total Score: 5		Management Assessment Licensable: No Recommendations: Program removal Reinspection Interval: Not Applicable Overall Risk Category: C8
Product Type:	1 (Asbestos textured coating)	Location:	2 (Rooms up to 100 sq m)	
Condition:	1 (Minor scratches)	Accessibility:	1 (Occasionally likely to be disturbed)	
Surface Treatment:	0 (Composite material)			
Asbestos Type:	1 (Chrysotile)	Extent Score:	2 (>10 - <50 sq m or >10m - <50m pipe run)

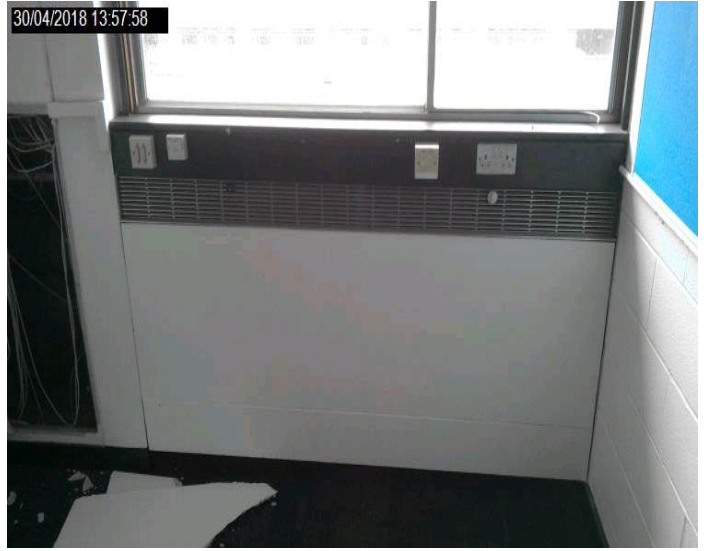
Location:	3.15	Block:	University	Floor Level: 2nd Floor
Sample No.:	As DU001450	Portal Ref No.:	379

Item:	Asbestos Cement window sill			
Asbestos Content:	Result Based on:			
Chrysotile	Strongly presumed			
Sample Analysed By:	Not applicable	Extent:	3 linear metres	
Comments:

Material Assessment Total Score: 4		Likelihood of Disturbance Assessment Total Score: 4		Management Assessment Licensable: No Recommendations: Program removal Reinspection Interval: Not Applicable Overall Risk Category: C8
Product Type:	1 (Asbestos cement)	Location:	2 (Rooms up to 100 sq m)	
Condition:	1 (Minor scratches)	Accessibility:	1 (Occasionally likely to be disturbed)	
Surface Treatment:	1 (Unencapsulated asbestos cement)			
Asbestos Type:	1 (Chrysotile)	Extent Score:	1 (<10 sq m or 10m pipe run)

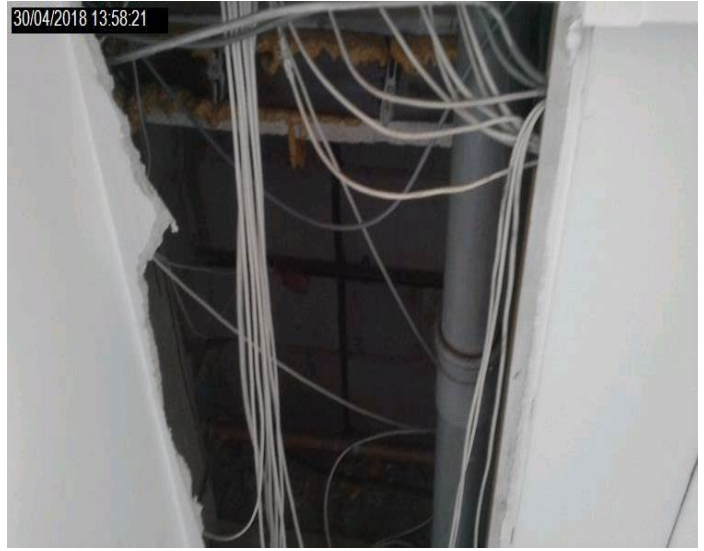
Location:	3.15	Block:	University	Floor Level: 2nd Floor
Sample No.:	As DU001453	Portal Ref No.:	380

Item:	Asbestos Cement shuttering			
Asbestos Content:	Result Based on:			
Chrysotile Amosite	Strongly presumed			
Sample Analysed By:	Not applicable	Extent:	3 m ²	
Comments: To ceiling of wall void behind polystyrene sheets

Material Assessment Total Score: 5		Likelihood of Disturbance Assessment Total Score: 4		Management Assessment Licensable: No Recommendations: Program removal Reinspection Interval: Not Applicable Overall Risk Category: C9
Product Type:	1 (Asbestos cement)	Location:	2 (Rooms up to 100 sq m)	
Condition:	1 (Minor scratches)	Accessibility:	1 (Occasionally likely to be disturbed)	
Surface Treatment:	1 (Encapsulated asbestos cement)			
Asbestos Type:	2 (Chrysotile Amosite)	Extent Score:	1 (<10 sq m or 10m pipe run)

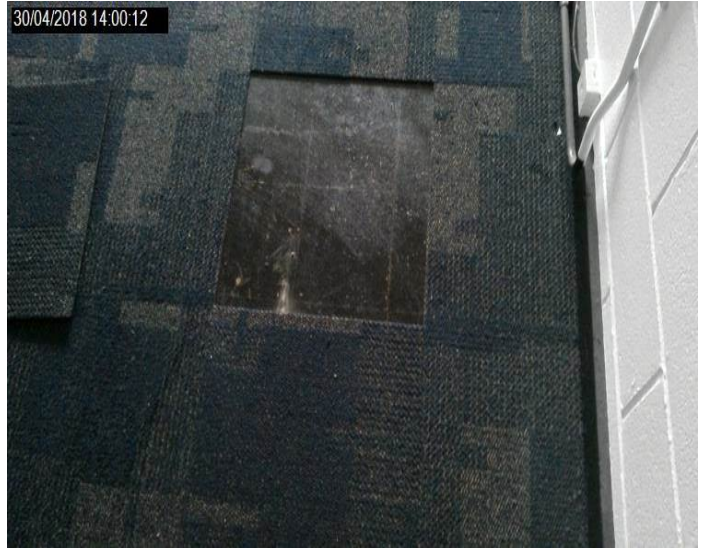
Location:	3.15	Block:	University	Floor Level: 2nd Floor
Sample No.:	DU001456	Portal Ref No.:	382

Item:	Asbestos Bitumen adhesive			
Asbestos Content:	Result Based on:			
Chrysotile	Analysis of sample using PLM			
Sample Analysed By: Reg 13(1)	Extent:	18 m ²		
Comments: Present beneath carpet

Material Assessment Total Score: 3		Likelihood of Disturbance Assessment Total Score: 5		Management Assessment Licensable: No Recommendations: Program removal Reinspection Interval: Not Applicable Overall Risk Category: C8
Product Type:	1 (Asbestos bitumen)	Location:	2 (Rooms up to 100 sq m)	
Condition:	1 (Minor scratches)	Accessibility:	1 (Occasionally likely to be disturbed)	
Surface Treatment:	0 (Composite material)			
Asbestos Type:	1 (Chrysotile)	Extent Score:	2 (>10 - <50 sq m or >10m - <50m pipe run)

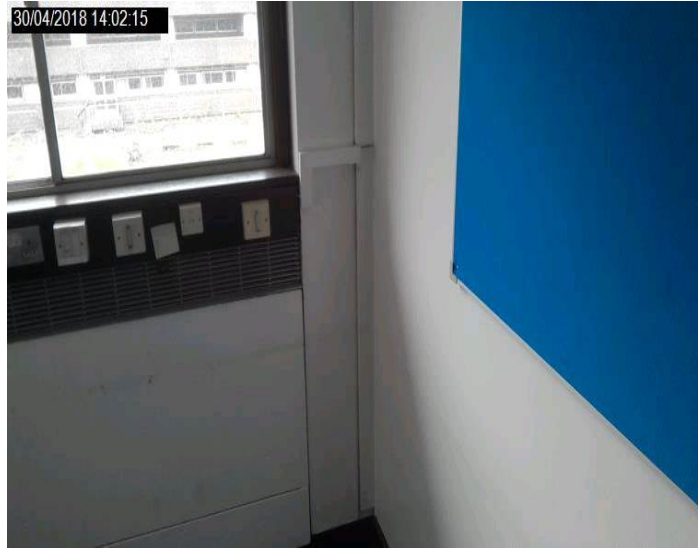
Location:	3.14A	Block:	University	Floor Level: 2nd Floor
Sample No.:	As DU001451	Portal Ref No.:	386

Item:	Insulating board panels to riser			
Asbestos Content:		Result Based on:		
No Asbestos Detected		Strongly presumed		
Sample Analysed By:	Not applicable	Extent:	3 linear metres	
Comments: Continuation from adjoining room

Material Assessment Total Score: 0		Likelihood of Disturbance Assessment Total Score: 0		Management Assessment Licensable: Yes Recommendations: Not Applicable Reinspection Interval: Not Applicable Overall Risk Category: E0
Product Type:	0 Not Applicable	Location:	0 Not Applicable	
Condition:	0 Not Applicable	Accessibility:	0 Not Applicable	
Surface Treatment:	0 Not Applicable			
Asbestos Type:	0 Not Applicable	Extent Score:	0 Not Applicable

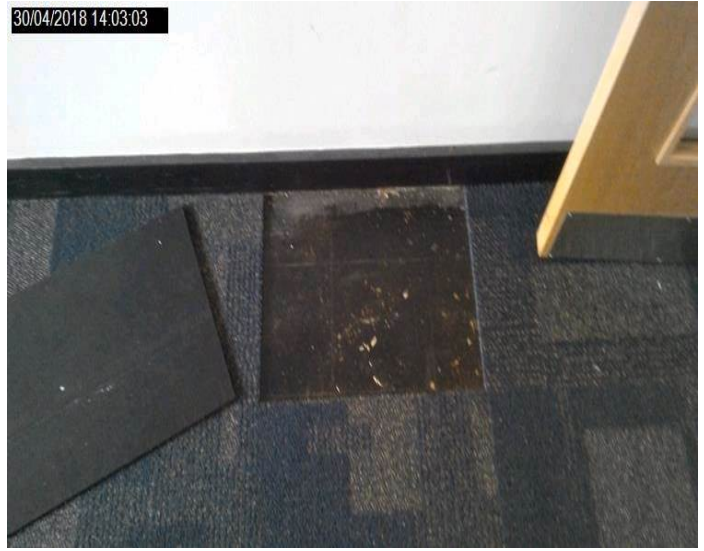
Location:	3.14A	Block:	University	Floor Level: 2nd Floor
Sample No.:	As DU001456	Portal Ref No.:	387

Item:	Asbestos Bitumen adhesive			
Asbestos Content:	Result Based on:			
Chrysotile	Strongly presumed			
Sample Analysed By:	Not applicable	Extent:	12 m ²	
Comments: Present beneath carpet

Material Assessment Total Score: 3		Likelihood of Disturbance Assessment Total Score: 5		Management Assessment Licensable: No Recommendations: Program removal Reinspection Interval: Not Applicable Overall Risk Category: C8
Product Type:	1 (Asbestos bitumen)	Location:	2 (Rooms up to 100 sq m)	
Condition:	1 (Minor scratches)	Accessibility:	1 (Occasionally likely to be disturbed)	
Surface Treatment:	0 (Composite material)			
Asbestos Type:	1 (Chrysotile)	Extent Score:	2 (>10 - <50 sq m or >10m - <50m pipe run)

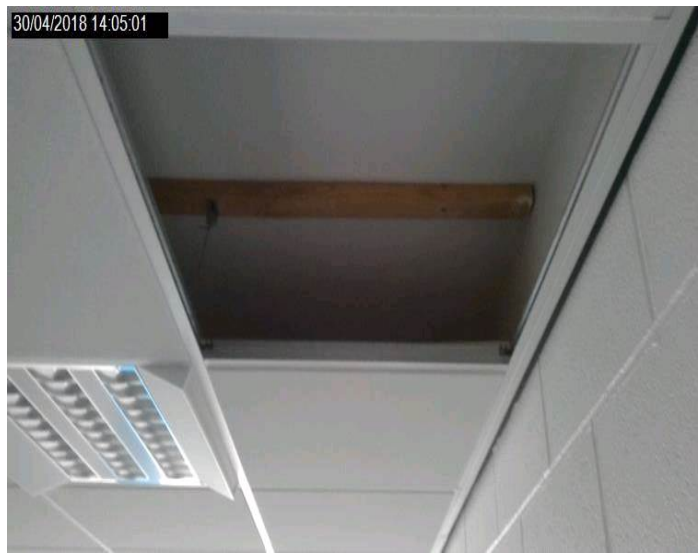
Location:	3.14	Block:	University	Floor Level: 2nd Floor
Sample No.:	As DU001449	Portal Ref No.:	388

Item:	Asbestos Textured coating to concrete ceiling			
Asbestos Content:	Result Based on:			
Chrysotile	Strongly presumed			
Sample Analysed By:	Not applicable	Extent:	12 m ²	
Comments: Present above suspended ceiling

Material Assessment Total Score: 3		Likelihood of Disturbance Assessment Total Score: 5		Management Assessment Licensable: No Recommendations: Program removal Reinspection Interval: Not Applicable Overall Risk Category: C8
Product Type:	1 (Asbestos textured coating)	Location:	2 (Rooms up to 100 sq m)	
Condition:	1 (Minor scratches)	Accessibility:	1 (Occasionally likely to be disturbed)	
Surface Treatment:	0 (Composite material)			
Asbestos Type:	1 (Chrysotile)	Extent Score:	2 (>10 - <50 sq m or >10m - <50m pipe run)

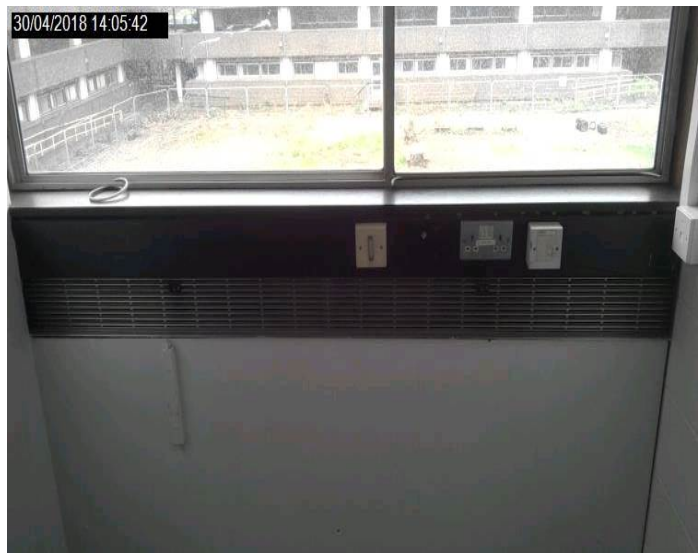
Location:	3.14	Block:	University	Floor Level: 2nd Floor
Sample No.:	As DU001450	Portal Ref No.:	389

Item:	Asbestos Cement window sill			
Asbestos Content:	Result Based on:			
Chrysotile	Strongly presumed			
Sample Analysed By:	Not applicable	Extent:	2 linear metres	
Comments:

Material Assessment Total Score: 4		Likelihood of Disturbance Assessment Total Score: 4		Management Assessment Licensable: No Recommendations: Program removal Reinspection Interval: Not Applicable Overall Risk Category: C8
Product Type:	1 (Asbestos cement)	Location:	2 (Rooms up to 100 sq m)	
Condition:	1 (Minor scratches)	Accessibility:	1 (Occasionally likely to be disturbed)	
Surface Treatment:	1 (Unencapsulated asbestos cement)			
Asbestos Type:	1 (Chrysotile)	Extent Score:	1 (<10 sq m or 10m pipe run)

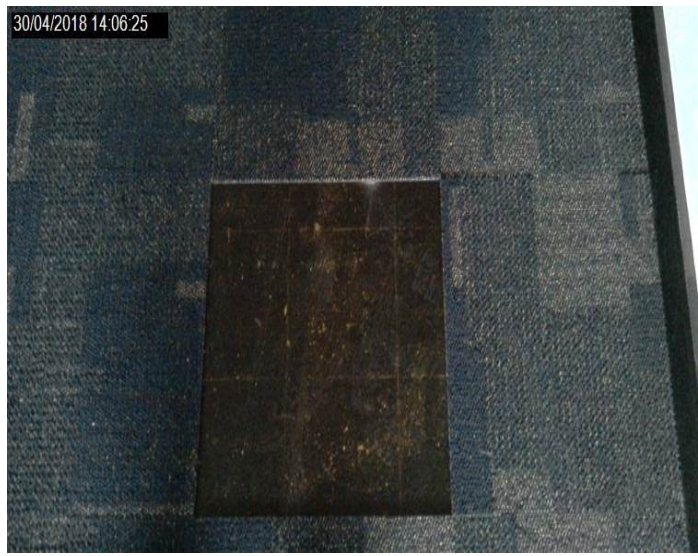
Location:	3.14	Block:	University	Floor Level: 2nd Floor
Sample No.:	As DU001456	Portal Ref No.:	392

Item:	Asbestos Bitumen adhesive			
Asbestos Content:	Result Based on:			
Chrysotile	Strongly presumed			
Sample Analysed By:	Not applicable	Extent:	12 m ²	
Comments: Present beneath carpet

Material Assessment Total Score: 3		Likelihood of Disturbance Assessment Total Score: 5		Management Assessment Licensable: No Recommendations: Program removal Reinspection Interval: Not Applicable Overall Risk Category: C8
Product Type:	1 (Asbestos bitumen)	Location:	2 (Rooms up to 100 sq m)	
Condition:	1 (Minor scratches)	Accessibility:	1 (Occasionally likely to be disturbed)	
Surface Treatment:	0 (Composite material)			
Asbestos Type:	1 (Chrysotile)	Extent Score:	2 (>10 - <50 sq m or >10m - <50m pipe run)

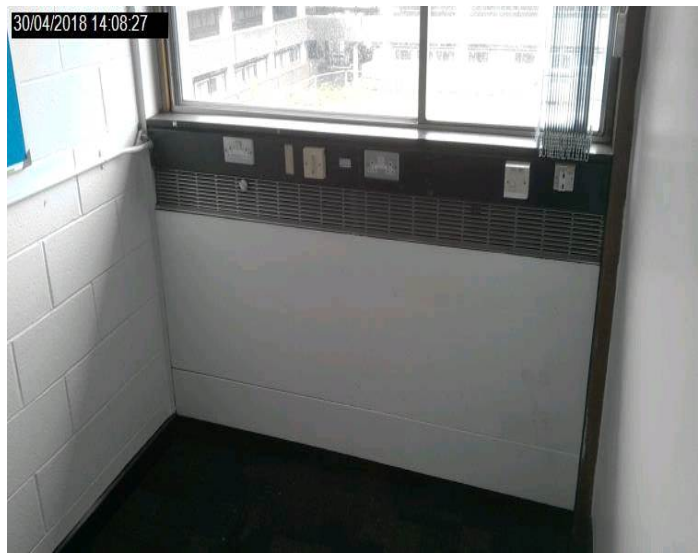
Location:	3.13A	Block:	University		Floor Level: 2nd Floor
Sample No.:	As DU001450	Portal Ref No.:	394		
Item:	Asbestos Cement window sill				
Asbestos Content:	Result Based on:

Chrysotile	Strongly presumed				
Sample Analysed By:	Not applicable	Extent:	2 linear metres		
Comments:

Material Assessment Total Score: 4		Likelihood of Disturbance Assessment Total Score: 4		Management Assessment Licensable: No Recommendations: Program removal Reinspection Interval: Not Applicable Overall Risk Category: C8
Product Type:	1 (Asbestos cement)	Location:	2 (Rooms up to 100 sq m)	
Condition:	1 (Minor scratches)	Accessibility:	1 (Occasionally likely to be disturbed)	
Surface Treatment:	1 (Unencapsulated asbestos cement)			
Asbestos Type:	1 (Chrysotile)	Extent Score:	1 (<10 sq m or 10m pipe run)

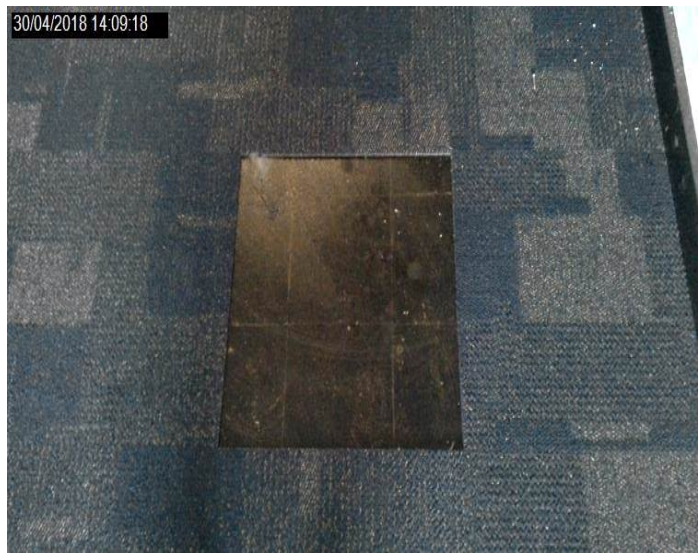
Location:	3.13A	Block:	University	Floor Level: 2nd Floor
Sample No.:	As DU001456	Portal Ref No.:	396

Item:	Asbestos Bitumen adhesive			
Asbestos Content:	Result Based on:			
Chrysotile	Strongly presumed			
Sample Analysed By:	Not applicable	Extent:	12 m ²	
Comments: Present beneath carpet

Material Assessment Total Score: 3		Likelihood of Disturbance Assessment Total Score: 5		Management Assessment Licensable: No Recommendations: Program removal Reinspection Interval: Not Applicable Overall Risk Category: C8
Product Type:	1 (Asbestos bitumen)	Location:	2 (Rooms up to 100 sq m)	
Condition:	1 (Minor scratches)	Accessibility:	1 (Occasionally likely to be disturbed)	
Surface Treatment:	0 (Composite material)			
Asbestos Type:	1 (Chrysotile)	Extent Score:	2 (>10 - <50 sq m or >10m - <50m pipe run)

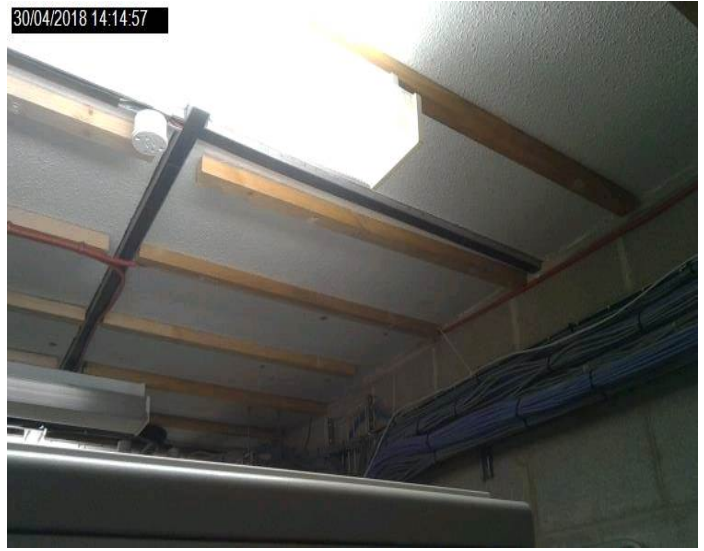
Location:	3.28	Block:	University	Floor Level: 2nd Floor
Sample No.:	DU001457	Portal Ref No.:	397

Item:	Asbestos Textured coating to concrete ceiling			
Asbestos Content:	Result Based on:			
Chrysotile	Analysis of sample using PLM			
Sample Analysed By:	Reg 13(1)	Extent:	12 m ²	
Comments:

Material Assessment Total Score: 3		Likelihood of Disturbance Assessment Total Score: 5		Management Assessment Licensable: No Recommendations: Program removal Reinspection Interval: Not Applicable Overall Risk Category: C8
Product Type:	1 (Asbestos textured coating)	Location:	2 (Rooms up to 100 sq m)	
Condition:	1 (Minor scratches)	Accessibility:	1 (Occasionally likely to be disturbed)	
Surface Treatment:	0 (Composite material)			
Asbestos Type:	1 (Chrysotile)	Extent Score:	2 (>10 - <50 sq m or >10m - <50m pipe run)

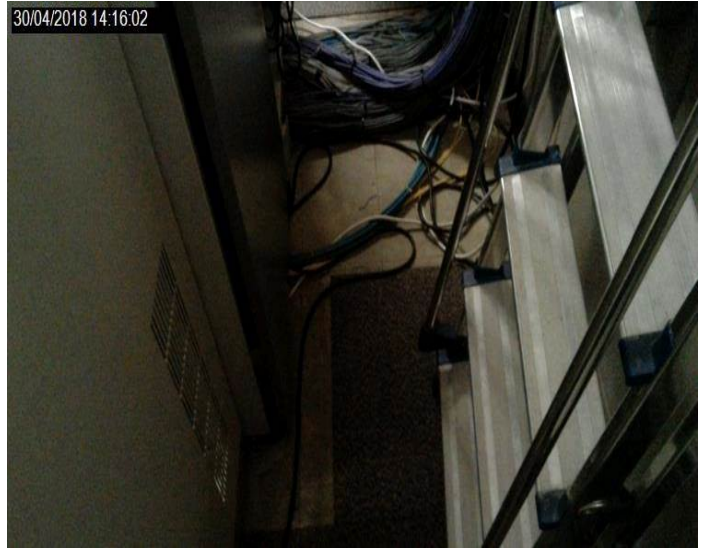
Location:	3.28	Block:	University	Floor Level: 2nd Floor
Sample No.:	DU001458	Portal Ref No.:	398

Item:	Asbestos Thermoplastic floor tiles with bitumen adhesive			
Asbestos Content:	Result Based on:			
Chrysotile	Analysis of sample using PLM			
Sample Analysed By:	Reg 13(1)	Extent:	12 m ²	
Comments:

Material Assessment Total Score: 3		Likelihood of Disturbance Assessment Total Score: 5		Management Assessment Licensable: No Recommendations: Program removal Reinspection Interval: Not Applicable Overall Risk Category: C8
Product Type:	1 (Asbestos thermoplastic)	Location:	2 (Rooms up to 100 sq m)	
Condition:	1 (Minor scratches)	Accessibility:	1 (Occasionally likely to be disturbed)	
Surface Treatment:	0 (Composite material)			
Asbestos Type:	1 (Chrysotile)	Extent Score:	2 (>10 - <50 sq m or >10m - <50m pipe run)

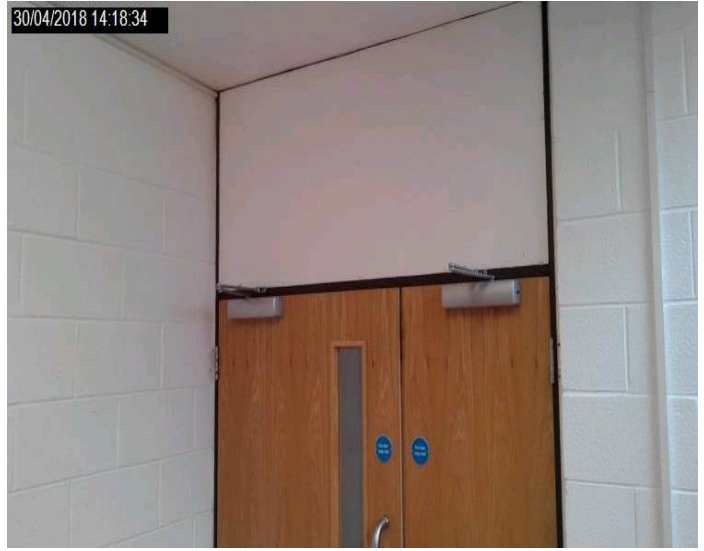
Location:	3.00A	Block:	University	Floor Level: 2nd Floor
Sample No.:	DU001459	Portal Ref No.:	399

Item:	Insulating board door header panel			
Asbestos Content:		Result Based on:		
No Asbestos Detected		Analysis of sample using PLM		
Sample Analysed By:	Reg 13(1)	Extent:	4 m ²	
Comments: Both doors leading to the stairwell

Material Assessment Total Score: 0		Likelihood of Disturbance Assessment Total Score: 0		Management Assessment Licensable: Yes Recommendations: Not Applicable Reinspection Interval: Not Applicable Overall Risk Category: E0
Product Type:	0 Not Applicable	Location:	0 Not Applicable	
Condition:	0 Not Applicable	Accessibility:	0 Not Applicable	
Surface Treatment:	0 Not Applicable			
Asbestos Type:	0 Not Applicable	Extent Score:	0 Not Applicable

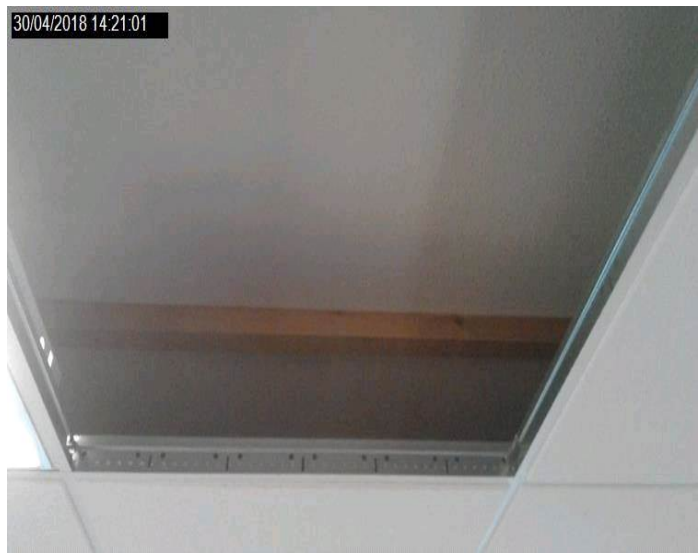
Location:	3.99B	Block:	University	Floor Level: 2nd Floor
Sample No.:	As DU001457	Portal Ref No.:	402

Item:	Asbestos Textured coating to concrete ceiling			
Asbestos Content:	Result Based on:			
Chrysotile	Strongly presumed			
Sample Analysed By:	Not applicable	Extent:	9 m ²	
Comments: Above suspended tiles

Material Assessment Total Score: 3		Likelihood of Disturbance Assessment Total Score: 4		Management Assessment Licensable: No Recommendations: Program removal Reinspection Interval: Not Applicable Overall Risk Category: C7
Product Type:	1 (Asbestos textured coating)	Location:	2 (Rooms up to 100 sq m)	
Condition:	1 (Minor scratches)	Accessibility:	1 (Occasionally likely to be disturbed)	
Surface Treatment:	0 (Composite material)			
Asbestos Type:	1 (Chrysotile)	Extent Score:	1 (<10 sq m or 10m pipe run)

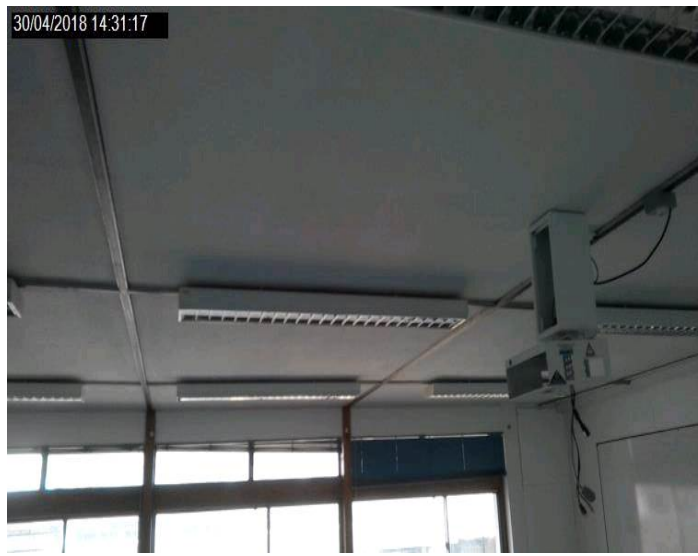
Location:	3.13	Block:	University	Floor Level: 2nd Floor
Sample No.:	As DU001457	Portal Ref No.:	403

Item:	Asbestos Textured coating to concrete ceiling			
Asbestos Content:	Result Based on:			
Chrysotile	Strongly presumed			
Sample Analysed By:	Not applicable	Extent:	40 m ²	
Comments:

Material Assessment Total Score: 3		Likelihood of Disturbance Assessment Total Score: 5		Management Assessment Licensable: No Recommendations: Program removal Reinspection Interval: Not Applicable Overall Risk Category: C8
Product Type:	1 (Asbestos textured coating)	Location:	2 (Rooms up to 100 sq m)	
Condition:	1 (Minor scratches)	Accessibility:	1 (Occasionally likely to be disturbed)	
Surface Treatment:	0 (Composite material)			
Asbestos Type:	1 (Chrysotile)	Extent Score:	2 (>10 - <50 sq m or >10m - <50m pipe run)

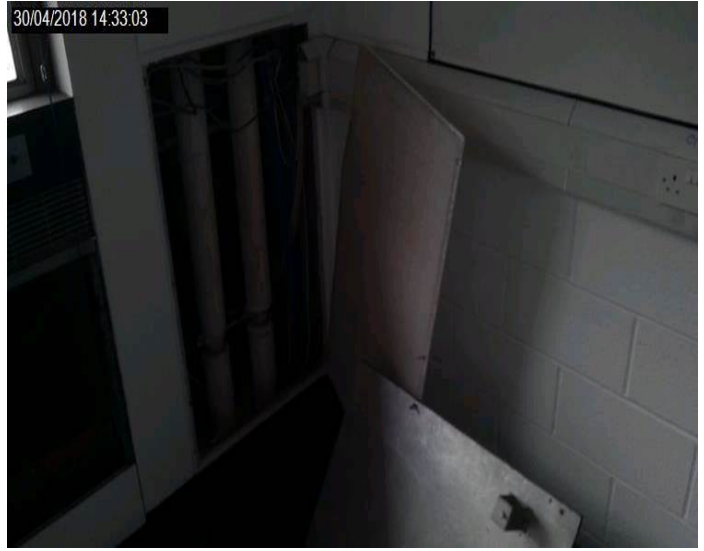
Location:	3.13	Block:	University	Floor Level: 2nd Floor
Sample No.:	DU001462	Portal Ref No.:	406

Item:	Insulating board panels to riser			
Asbestos Content:		Result Based on:		
No Asbestos Detected		Analysis of sample using PLM		
Sample Analysed By:	Reg 13(1)	Extent:	6 m ²	
Comments: 2 x risers

Material Assessment Total Score: 0		Likelihood of Disturbance Assessment Total Score: 0		Management Assessment Licensable: Yes Recommendations: Not Applicable Reinspection Interval: Not Applicable Overall Risk Category: E0
Product Type:	0 Not Applicable	Location:	0 Not Applicable	
Condition:	0 Not Applicable	Accessibility:	0 Not Applicable	
Surface Treatment:	0 Not Applicable			
Asbestos Type:	0 Not Applicable	Extent Score:	0 Not Applicable

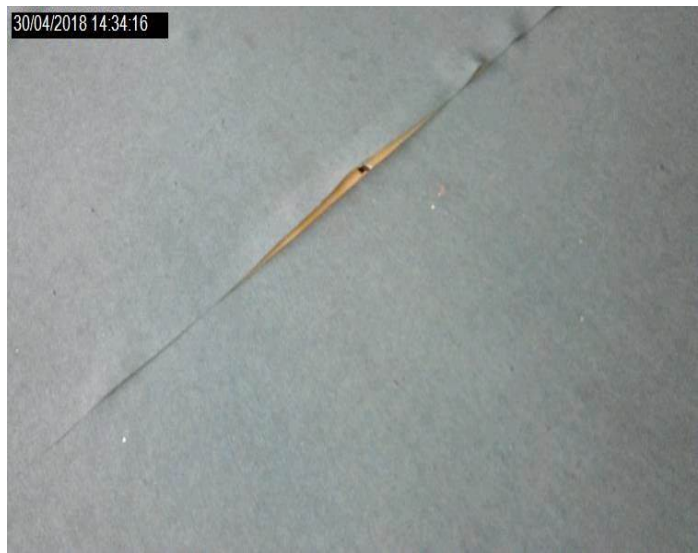
Location:	3.13	Block:	University	Floor Level: 2nd Floor
Sample No.:	DU001463	Portal Ref No.:	407

Item:	Asbestos Thermoplastic floor tiles with bitumen adhesive			
Asbestos Content:	Result Based on:			
Chrysotile	Analysis of sample using PLM			
Sample Analysed By: Reg 13(1)	Extent:	40 m ²		
Comments: Present beneath carpet

Material Assessment Total Score: 3		Likelihood of Disturbance Assessment Total Score: 5		Management Assessment Licensable: No Recommendations: Program removal Reinspection Interval: Not Applicable Overall Risk Category: C8
Product Type:	1 (Asbestos thermoplastic)	Location:	2 (Rooms up to 100 sq m)	
Condition:	1 (Minor scratches)	Accessibility:	1 (Occasionally likely to be disturbed)	
Surface Treatment:	0 (Composite material)			
Asbestos Type:	1 (Chrysotile)	Extent Score:	2 (>10 - <50 sq m or >10m - <50m pipe run)

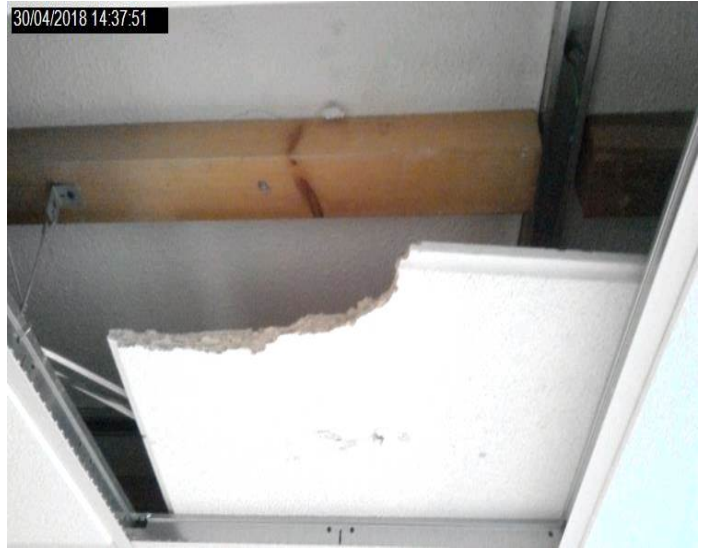
Location:	3.11	Block:	University	Floor Level: 2nd Floor
Sample No.:	As DU001457	Portal Ref No.:	408

Item:	Asbestos Textured coating to concrete ceiling			
Asbestos Content:	Result Based on:			
Chrysotile	Strongly presumed			
Sample Analysed By:	Not applicable	Extent:	12 m ²	
Comments: Present above suspended ceiling

Material Assessment Total Score: 3		Likelihood of Disturbance Assessment Total Score: 5		Management Assessment Licensable: No Recommendations: Program removal Reinspection Interval: Not Applicable Overall Risk Category: C8
Product Type:	1 (Asbestos textured coating)	Location:	2 (Rooms up to 100 sq m)	
Condition:	1 (Minor scratches)	Accessibility:	1 (Occasionally likely to be disturbed)	
Surface Treatment:	0 (Composite material)			
Asbestos Type:	1 (Chrysotile)	Extent Score:	2 (>10 - <50 sq m or >10m - <50m pipe run)

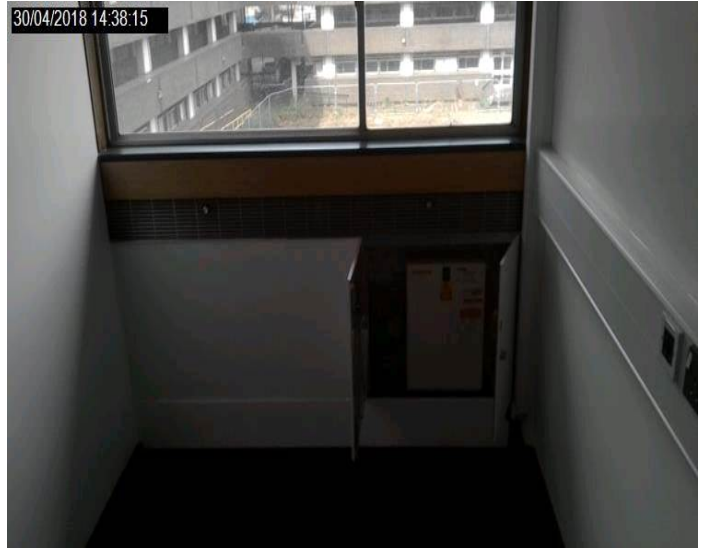
Location:	3.11	Block:	University	Floor Level: 2nd Floor
Sample No.:	As DU001460	Portal Ref No.:	409

Item:	Asbestos Cement window sill			
Asbestos Content:	Result Based on:			
Chrysotile	Strongly presumed			
Sample Analysed By:	Not applicable	Extent:	2 linear metres	
Comments:

Material Assessment Total Score: 4		Likelihood of Disturbance Assessment Total Score: 4		Management Assessment Licensable: No Recommendations: Program removal Reinspection Interval: Not Applicable Overall Risk Category: C8
Product Type:	1 (Asbestos cement)	Location:	2 (Rooms up to 100 sq m)	
Condition:	1 (Minor scratches)	Accessibility:	1 (Occasionally likely to be disturbed)	
Surface Treatment:	1 (Unencapsulated asbestos cement)			
Asbestos Type:	1 (Chrysotile)	Extent Score:	1 (<10 sq m or 10m pipe run)

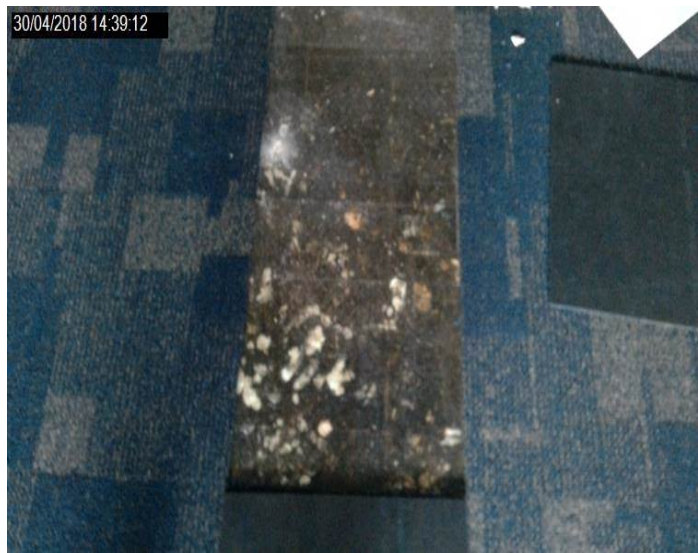
Location:	3.11	Block:	University	Floor Level: 2nd Floor
Sample No.:	DU001464	Portal Ref No.:	412

Item:	Asbestos Bitumen adhesive			
Asbestos Content:	Result Based on:			
Chrysotile	Analysis of sample using PLM			
Sample Analysed By: Reg 13(1)	Extent:	12 m ²		
Comments: Present beneath carpet

Material Assessment Total Score: 3		Likelihood of Disturbance Assessment Total Score: 5		Management Assessment Licensable: No Recommendations: Program removal Reinspection Interval: Not Applicable Overall Risk Category: C8
Product Type:	1 (Asbestos bitumen)	Location:	2 (Rooms up to 100 sq m)	
Condition:	1 (Minor scratches)	Accessibility:	1 (Occasionally likely to be disturbed)	
Surface Treatment:	0 (Composite material)			
Asbestos Type:	1 (Chrysotile)	Extent Score:	2 (>10 - <50 sq m or >10m - <50m pipe run)

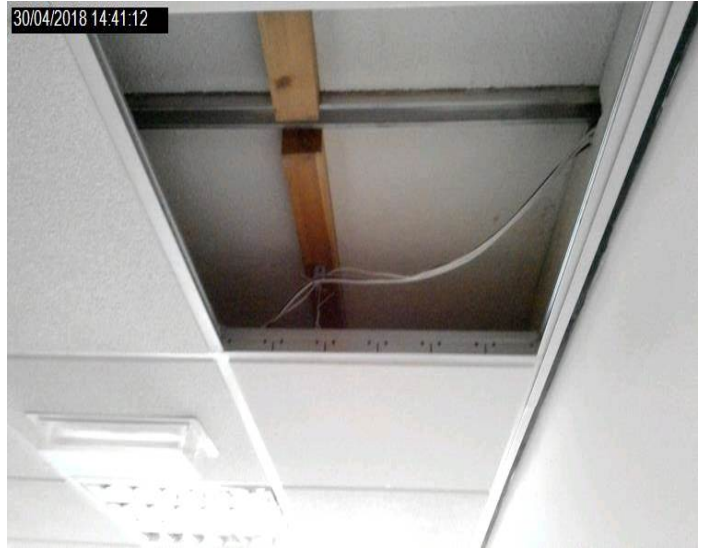
Location:	3.12	Block:	University	Floor Level: 2nd Floor
Sample No.:	As DU001457	Portal Ref No.:	413

Item:	Asbestos Textured coating to concrete ceiling			
Asbestos Content:	Result Based on:			
Chrysotile	Strongly presumed			
Sample Analysed By:	Not applicable	Extent:	12 m ²	
Comments: Present above suspended ceiling

Material Assessment Total Score: 3		Likelihood of Disturbance Assessment Total Score: 5		Management Assessment Licensable: No Recommendations: Program removal Reinspection Interval: Not Applicable Overall Risk Category: C8
Product Type:	1 (Asbestos textured coating)	Location:	2 (Rooms up to 100 sq m)	
Condition:	1 (Minor scratches)	Accessibility:	1 (Occasionally likely to be disturbed)	
Surface Treatment:	0 (Composite material)			
Asbestos Type:	1 (Chrysotile)	Extent Score:	2 (>10 - <50 sq m or >10m - <50m pipe run)

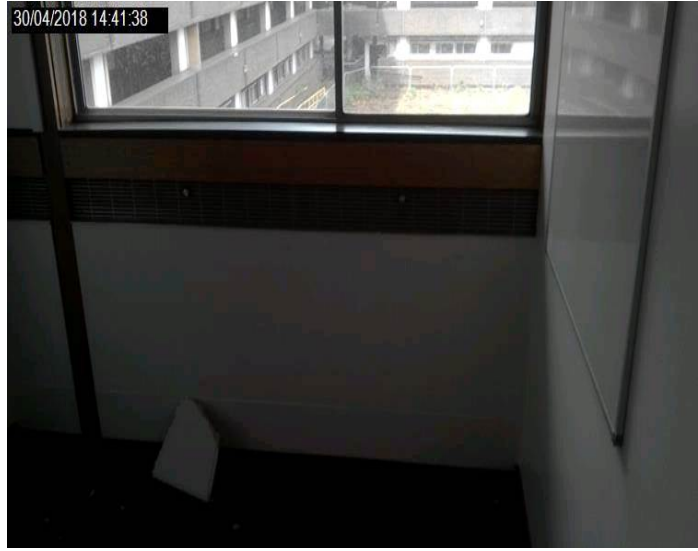
Location:	3.12	Block:	University	Floor Level: 2nd Floor
Sample No.:	As DU001460	Portal Ref No.:	414

Item:	Asbestos Cement window sill			
Asbestos Content:	Result Based on:			
Chrysotile	Strongly presumed			
Sample Analysed By:	Not applicable	Extent:	3 linear metres	
Comments:

Material Assessment Total Score: 4		Likelihood of Disturbance Assessment Total Score: 4		Management Assessment Licensable: No Recommendations: Program removal Reinspection Interval: Not Applicable Overall Risk Category: C8
Product Type:	1 (Asbestos cement)	Location:	2 (Rooms up to 100 sq m)	
Condition:	1 (Minor scratches)	Accessibility:	1 (Occasionally likely to be disturbed)	
Surface Treatment:	1 (Unencapsulated asbestos cement)			
Asbestos Type:	1 (Chrysotile)	Extent Score:	1 (<10 sq m or 10m pipe run)

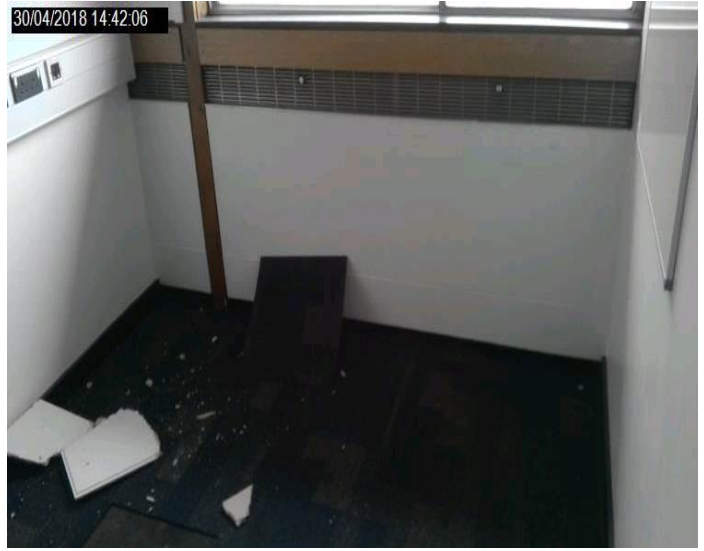
Location:	3.12	Block:	University	Floor Level: 2nd Floor
Sample No.:	As DU001461	Portal Ref No.:	415

Item:	Asbestos Cement shuttering			
Asbestos Content:	Result Based on:			
Chrysotile Amosite	Strongly presumed			
Sample Analysed By:	Not applicable	Extent:	3 m ²	
Comments: To ceiling of wall void behind polystyrene sheets

Material Assessment Total Score: 5		Likelihood of Disturbance Assessment Total Score: 4		Management Assessment Licensable: No Recommendations: Program removal Reinspection Interval: Not Applicable Overall Risk Category: C9
Product Type:	1 (Asbestos cement)	Location:	2 (Rooms up to 100 sq m)	
Condition:	1 (Minor scratches)	Accessibility:	1 (Occasionally likely to be disturbed)	
Surface Treatment:	1 (Encapsulated asbestos cement)			
Asbestos Type:	2 (Chrysotile Amosite)	Extent Score:	1 (<10 sq m or 10m pipe run)

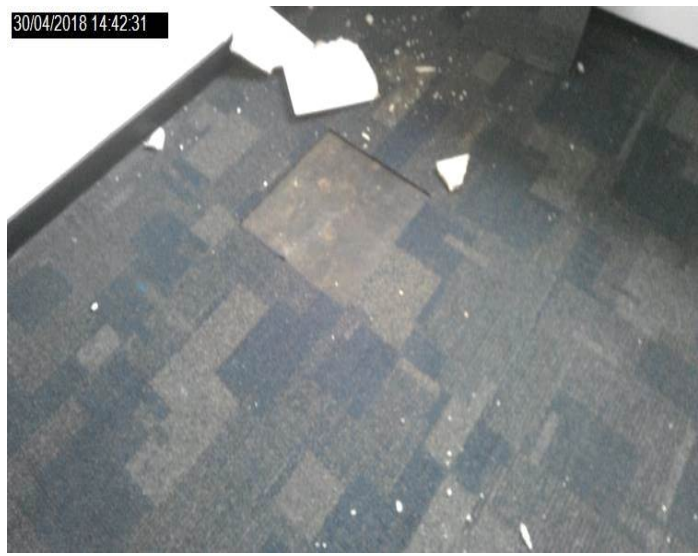
Location:	3.12	Block:	University	Floor Level: 2nd Floor
Sample No.:	As DU001464	Portal Ref No.:	416

Item:	Asbestos Bitumen adhesive			
Asbestos Content:	Result Based on:			
Chrysotile	Strongly presumed			
Sample Analysed By:	Not applicable	Extent:	12 m ²	
Comments: Present beneath carpet

Material Assessment Total Score: 3		Likelihood of Disturbance Assessment Total Score: 5		Management Assessment Licensable: No Recommendations: Program removal Reinspection Interval: Not Applicable Overall Risk Category: C8
Product Type:	1 (Asbestos bitumen)	Location:	2 (Rooms up to 100 sq m)	
Condition:	1 (Minor scratches)	Accessibility:	1 (Occasionally likely to be disturbed)	
Surface Treatment:	0 (Composite material)			
Asbestos Type:	1 (Chrysotile)	Extent Score:	2 (>10 - <50 sq m or >10m - <50m pipe run)

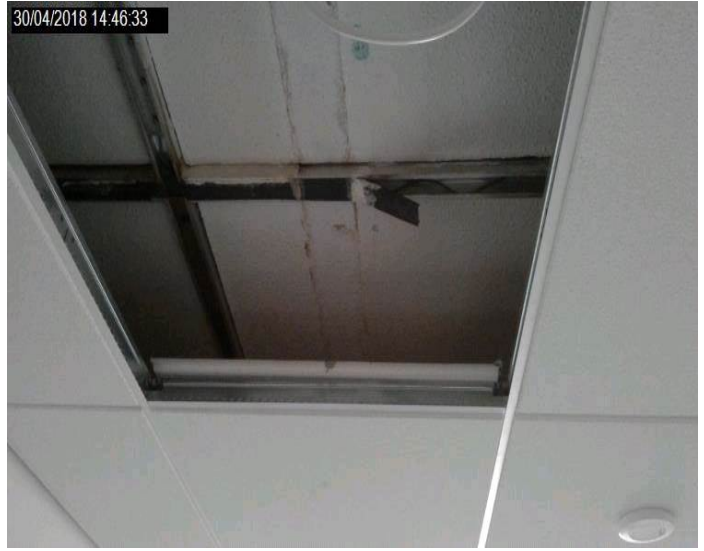
Location:	3.10A	Block:	University	Floor Level: 2nd Floor
Sample No.:	As DU001457	Portal Ref No.:	417

Item:	Asbestos Textured coating to concrete ceiling			
Asbestos Content:	Result Based on:			
Chrysotile	Strongly presumed			
Sample Analysed By:	Not applicable	Extent:	12 m ²	
Comments: Present above suspended ceiling

Material Assessment Total Score: 3		Likelihood of Disturbance Assessment Total Score: 5		Management Assessment Licensable: No Recommendations: Program removal Reinspection Interval: Not Applicable Overall Risk Category: C8
Product Type:	1 (Asbestos textured coating)	Location:	2 (Rooms up to 100 sq m)	
Condition:	1 (Minor scratches)	Accessibility:	1 (Occasionally likely to be disturbed)	
Surface Treatment:	0 (Composite material)			
Asbestos Type:	1 (Chrysotile)	Extent Score:	2 (>10 - <50 sq m or >10m - <50m pipe run)

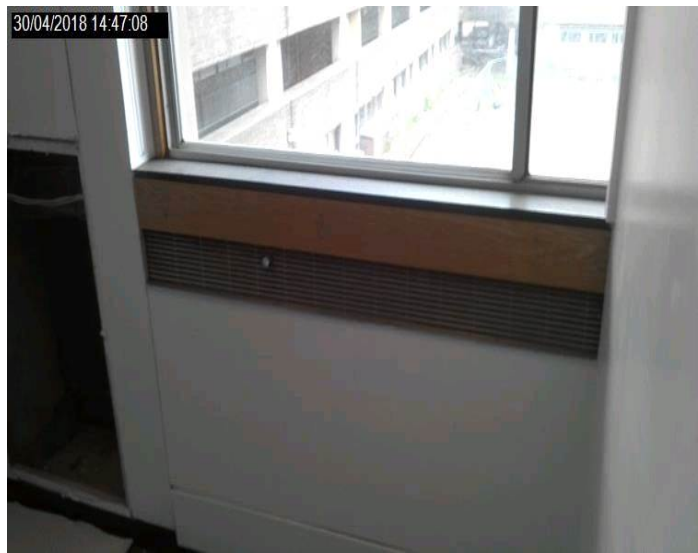
Location:	3.10A	Block:	University	Floor Level: 2nd Floor
Sample No.:	As DU001460	Portal Ref No.:	418

Item:	Asbestos Cement window sill			
Asbestos Content:	Result Based on:			
Chrysotile	Strongly presumed			
Sample Analysed By:	Not applicable	Extent:	2 linear metres	
Comments:

Material Assessment Total Score: 4		Likelihood of Disturbance Assessment Total Score: 4		Management Assessment Licensable: No Recommendations: Program removal Reinspection Interval: Not Applicable Overall Risk Category: C8
Product Type:	1 (Asbestos cement)	Location:	2 (Rooms up to 100 sq m)	
Condition:	1 (Minor scratches)	Accessibility:	1 (Occasionally likely to be disturbed)	
Surface Treatment:	1 (Unencapsulated asbestos cement)			
Asbestos Type:	1 (Chrysotile)	Extent Score:	1 (<10 sq m or 10m pipe run)
