Report No.: J094099
Nature of Work: Demolition Survey
Issue Date: 11/06/2018
Client Name: WYG Engineering Ltd
Geneva Building, Lake View Drive, Sherwood Business Park,
Annesley, Nottingham, NG15 0ED
Site Address: Dawson building, Former City North Campus, Birmingham City
University, Perry Barr, B42 2US

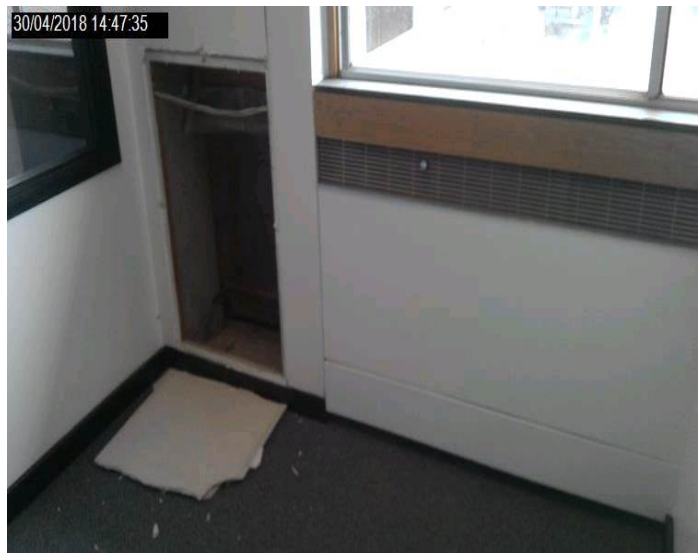
Location:	3.10A	Block:	University	Floor Level: 2nd Floor
Sample No.:	As DU001461	Portal Ref No.:	419

Item:	Asbestos Cement shuttering			
Asbestos Content:	Result Based on:			
Chrysotile Amosite	Strongly presumed			
Sample Analysed By:	Not applicable	Extent:	3 m ²	
Comments: To ceiling of wall void behind polystyrene sheets

Material Assessment Total Score: 5		Likelihood of Disturbance Assessment Total Score: 4		Management Assessment Licensable: No Recommendations: Program removal Reinspection Interval: Not Applicable Overall Risk Category: C9
Product Type:	1 (Asbestos cement)	Location:	2 (Rooms up to 100 sq m)	
Condition:	1 (Minor scratches)	Accessibility:	1 (Occasionally likely to be disturbed)	
Surface Treatment:	1 (Encapsulated asbestos cement)			
Asbestos Type:	2 (Chrysotile Amosite)	Extent Score:	1 (<10 sq m or 10m pipe run)

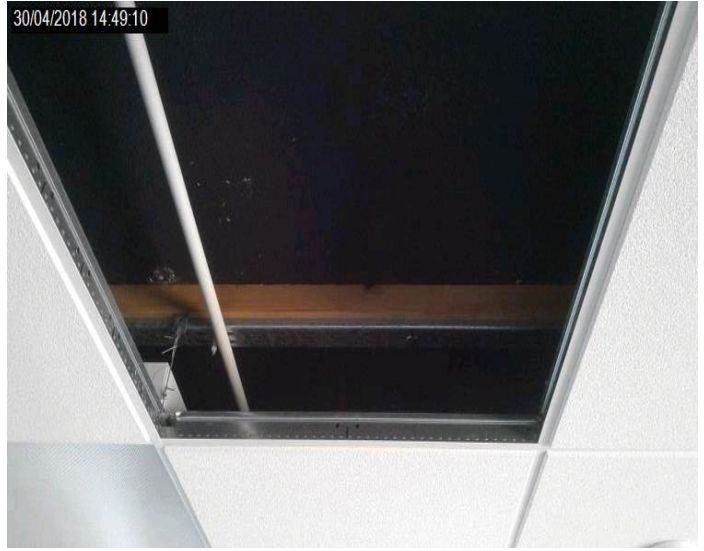
Location:	3.10	Block:	University	Floor Level: 2nd Floor
Sample No.:	As DU001457	Portal Ref No.:	421

Item:	Asbestos Textured coating to concrete ceiling			
Asbestos Content:	Result Based on:			
Chrysotile	Strongly presumed			
Sample Analysed By:	Not applicable	Extent:	49 m ²	
Comments: Present above suspended ceiling

Material Assessment Total Score: 3		Likelihood of Disturbance Assessment Total Score: 5		Management Assessment Licensable: No Recommendations: Program removal Reinspection Interval: Not Applicable Overall Risk Category: C8
Product Type:	1 (Asbestos textured coating)	Location:	2 (Rooms up to 100 sq m)	
Condition:	1 (Minor scratches)	Accessibility:	1 (Occasionally likely to be disturbed)	
Surface Treatment:	0 (Composite material)			
Asbestos Type:	1 (Chrysotile)	Extent Score:	2 (>10 - <50 sq m or >10m - <50m pipe run)

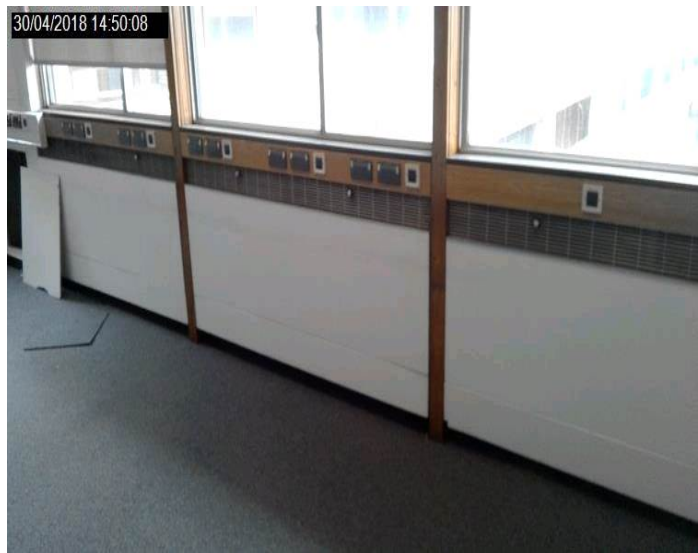
Location:	3.10	Block:	University	Floor Level: 2nd Floor
Sample No.:	As DU001460	Portal Ref No.:	422

Item:	Asbestos Cement window sill			
Asbestos Content:	Result Based on:			
Chrysotile	Strongly presumed			
Sample Analysed By:	Not applicable	Extent:	12 linear metres	
Comments:

Material Assessment Total Score: 4		Likelihood of Disturbance Assessment Total Score: 5		Management Assessment Licensable: No Recommendations: Program removal Reinspection Interval: Not Applicable Overall Risk Category: C9
Product Type:	1 (Asbestos cement)	Location:	2 (Rooms up to 100 sq m)	
Condition:	1 (Minor scratches)	Accessibility:	1 (Occasionally likely to be disturbed)	
Surface Treatment:	1 (Unencapsulated asbestos cement)			
Asbestos Type:	1 (Chrysotile)	Extent Score:	2 (>10 - <50 sq m or >10m - <50m pipe run)

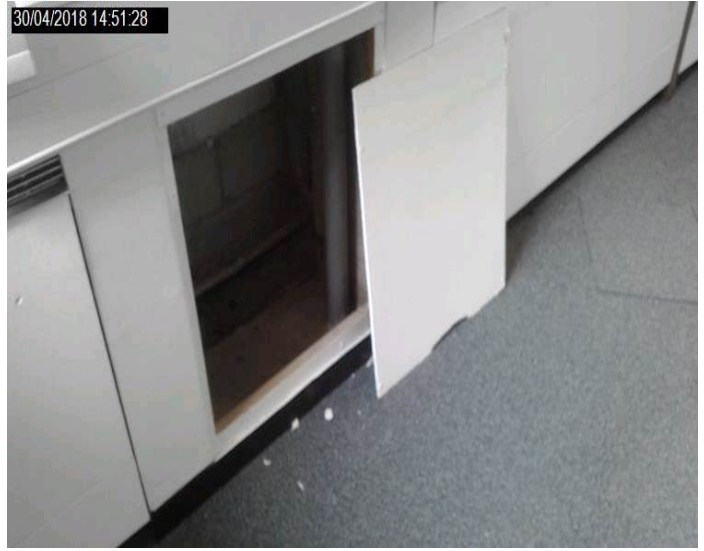
Location:	3.10	Block:	University	Floor Level: 2nd Floor
Sample No.:	As DU001462	Portal Ref No.:	424

Item:	Insulating board panels to riser			
Asbestos Content:		Result Based on:		
No Asbestos Detected		Strongly presumed		
Sample Analysed By:	Not applicable	Extent:	3 m ²	
Comments:

Material Assessment Total Score: 0		Likelihood of Disturbance Assessment Total Score: 0		Management Assessment Licensable: Yes Recommendations: Not Applicable Reinspection Interval: Not Applicable Overall Risk Category: E0
Product Type:	0 Not Applicable	Location:	0 Not Applicable	
Condition:	0 Not Applicable	Accessibility:	0 Not Applicable	
Surface Treatment:	0 Not Applicable			
Asbestos Type:	0 Not Applicable	Extent Score:	0 Not Applicable

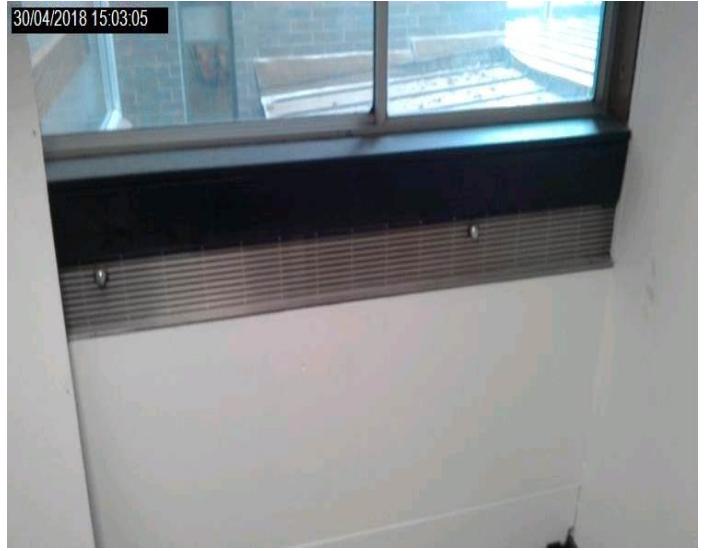
Location:	3.09	Block:	University	Floor Level: 2nd Floor
Sample No.:	As DU001460	Portal Ref No.:	426

Item:	Asbestos Cement window sill			
Asbestos Content:	Result Based on:			
Chrysotile	Strongly presumed			
Sample Analysed By:	Not applicable	Extent:	3 linear metres	
Comments:

Material Assessment Total Score: 4		Likelihood of Disturbance Assessment Total Score: 4		Management Assessment Licensable: No Recommendations: Program removal Reinspection Interval: Not Applicable Overall Risk Category: C8
Product Type:	1 (Asbestos cement)	Location:	2 (Rooms up to 100 sq m)	
Condition:	1 (Minor scratches)	Accessibility:	1 (Occasionally likely to be disturbed)	
Surface Treatment:	1 (Unencapsulated asbestos cement)			
Asbestos Type:	1 (Chrysotile)	Extent Score:	1 (<10 sq m or 10m pipe run)

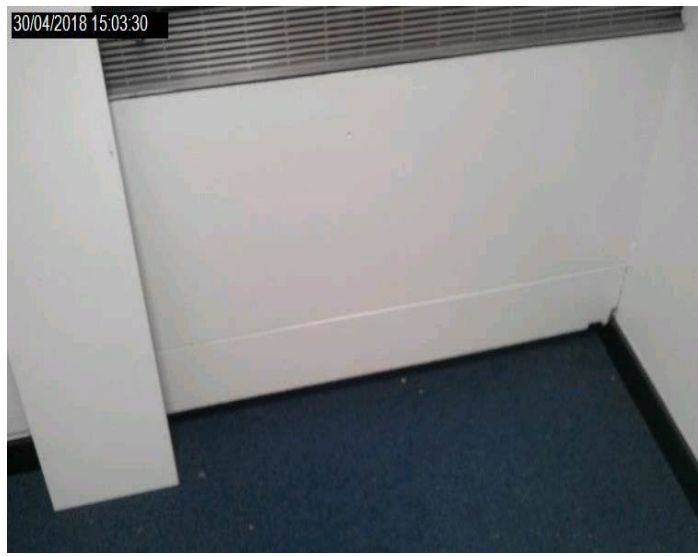
Location:	3.09	Block:	University	Floor Level: 2nd Floor
Sample No.:	As DU001461	Portal Ref No.:	427

Item:	Asbestos Cement shuttering			
Asbestos Content:	Result Based on:			
Chrysotile Amosite	Strongly presumed			
Sample Analysed By:	Not applicable	Extent:	2 m ²	
Comments: To ceiling of wall void behind polystyrene sheets

Material Assessment Total Score: 5		Likelihood of Disturbance Assessment Total Score: 4		Management Assessment Licensable: No Recommendations: Program removal Reinspection Interval: Not Applicable Overall Risk Category: C9
Product Type:	1 (Asbestos cement)	Location:	2 (Rooms up to 100 sq m)	
Condition:	1 (Minor scratches)	Accessibility:	1 (Occasionally likely to be disturbed)	
Surface Treatment:	1 (Encapsulated asbestos cement)			
Asbestos Type:	2 (Chrysotile Amosite)	Extent Score:	1 (<10 sq m or 10m pipe run)

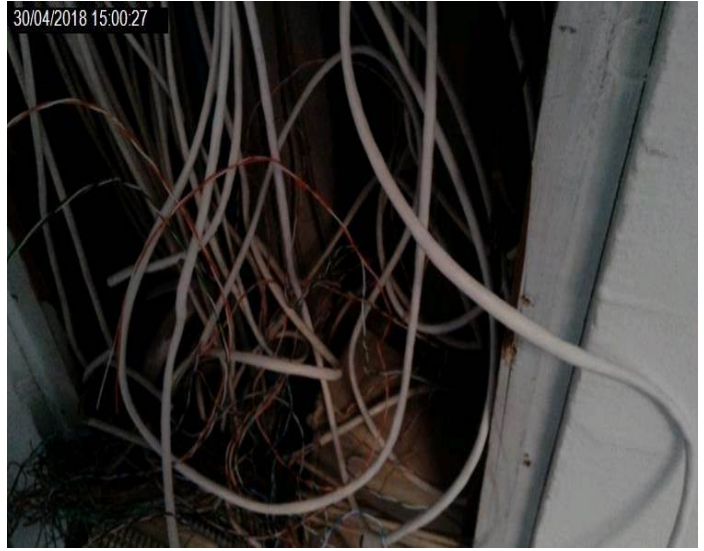
Location:	3.09	Block:	University	Floor Level: 2nd Floor
Sample No.:	DU001465	Portal Ref No.:	429

Item:	Asbestos Insulating board debris within riser			
Asbestos Content:	Result Based on:			
Chrysotile Amosite	Analysis of sample using PLM			
Sample Analysed By: Reg 13(1)	Extent:	1 m ²		
Comments: The riser area should be presumed to be contaminated.

Material Assessment Total Score: 9		Likelihood of Disturbance Assessment Total Score: 4		Management Assessment Licensable: Yes Recommendations: Program removal Reinspection Interval: Not Applicable Overall Risk Category: B13
Product Type:	2 (Asbestos insulating board)	Location:	2 (Rooms up to 100 sq m)	
Condition:	3 (Significant damage)	Accessibility:	1 (Occasionally likely to be disturbed)	
Surface Treatment:	2 (Unencapsulated asbestos insulating board)			
Asbestos Type:	2 (Chrysotile Amosite)	Extent Score:	1 (<10 sq m or 10m pipe run)

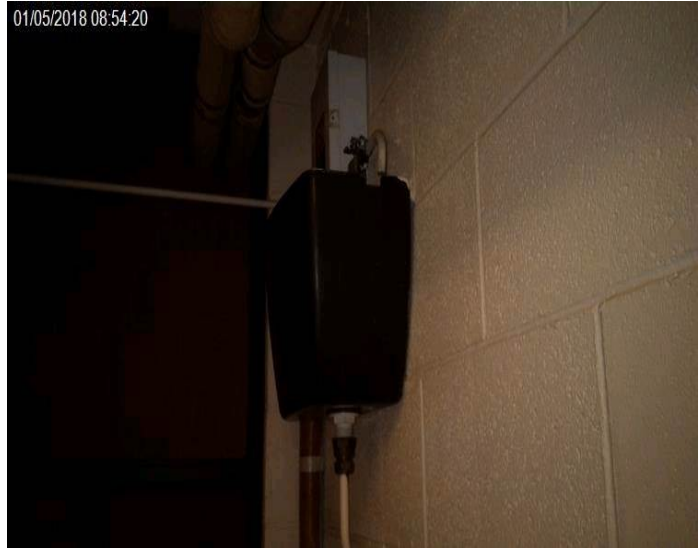
Location:	4.06	Block:	University	Floor Level: 3rd Floor
Sample No.:	DU001466	Portal Ref No.:	431

Item:	Reinforced plastic cistern			
Asbestos Content:		Result Based on:		
No Asbestos Detected		Analysis of sample using PLM		
Sample Analysed By:	Reg 13(1)	Extent:	1 unit	
Comments: Present at high level behind door

Material Assessment Total Score: 0		Likelihood of Disturbance Assessment Total Score: 0		Management Assessment Licensable: No Recommendations: Not Applicable Reinspection Interval: Not Applicable Overall Risk Category: E0
Product Type:	0 Not Applicable	Location:	0 Not Applicable	
Condition:	0 Not Applicable	Accessibility:	0 Not Applicable	
Surface Treatment:	0 Not Applicable			
Asbestos Type:	0 Not Applicable	Extent Score:	0 Not Applicable

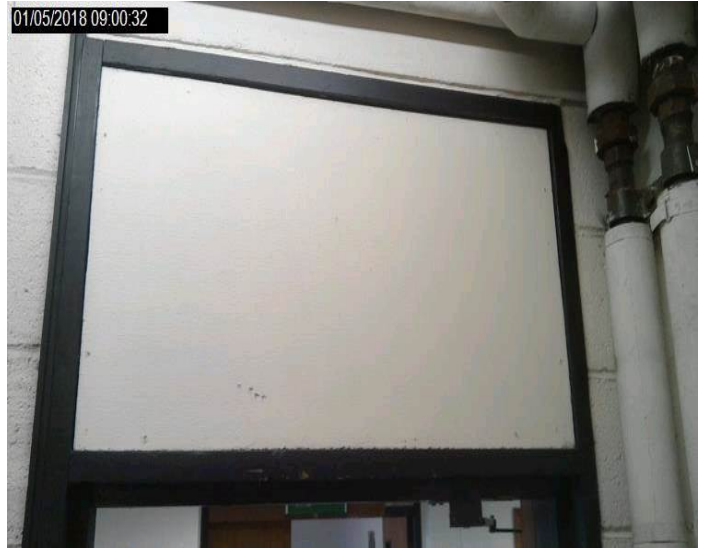
Location:	4.03	Block:	University	Floor Level: 3rd Floor
Sample No.:	DU001467	Portal Ref No.:	433

Item:	Asbestos Insulating board door header panel			
Asbestos Content:	Result Based on:			
Chrysotile Amosite	Analysis of sample using PLM			
Sample Analysed By: Reg 13(1)	Extent:	1 m ²		
Comments: Double skin

Material Assessment Total Score: 6		Likelihood of Disturbance Assessment Total Score: 4		Management Assessment Licensable: Yes Recommendations: Program removal Reinspection Interval: Not Applicable Overall Risk Category: C10
Product Type:	2 (Asbestos insulating board)	Location:	2 (Rooms up to 100 sq m)	
Condition:	1 (Minor scratches)	Accessibility:	1 (Occasionally likely to be disturbed)	
Surface Treatment:	1 (Encapsulated asbestos insulating board)			
Asbestos Type:	2 (Chrysotile Amosite)	Extent Score:	1 (<10 sq m or 10m pipe run)

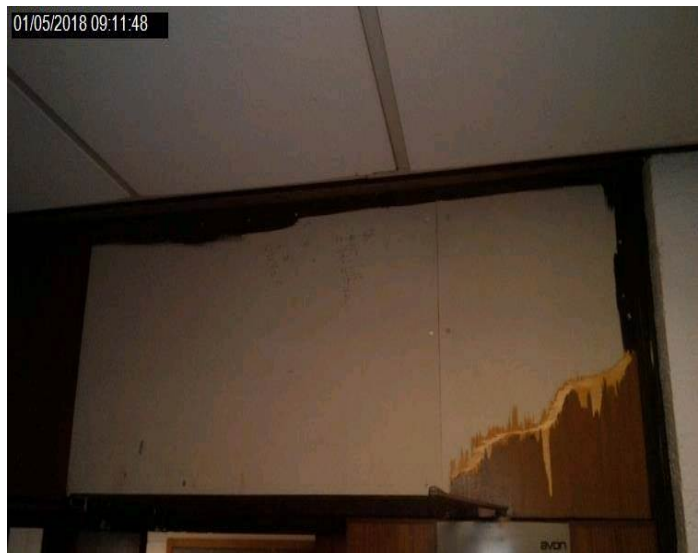
Location:	4.00	Block:	University	Floor Level: 3rd Floor
Sample No.:	DU001470	Portal Ref No.:	437

Item:	Asbestos Insulating board door header panel			
Asbestos Content:	Result Based on:			
Chrysotile Amosite	Analysis of sample using PLM			
Sample Analysed By: Reg 13(1)	Extent:	4 m ²		
Comments: Double skin

Material Assessment Total Score: 7		Likelihood of Disturbance Assessment Total Score: 4		Management Assessment Licensable: Yes Recommendations: Program removal Reinspection Interval: Not Applicable Overall Risk Category: B11
Product Type:	2 (Asbestos insulating board)	Location:	2 (Rooms up to 100 sq m)	
Condition:	1 (Minor scratches)	Accessibility:	1 (Occasionally likely to be disturbed)	
Surface Treatment:	2 (Unencapsulated asbestos insulating board)			
Asbestos Type:	2 (Chrysotile Amosite)	Extent Score:	1 (<10 sq m or 10m pipe run)

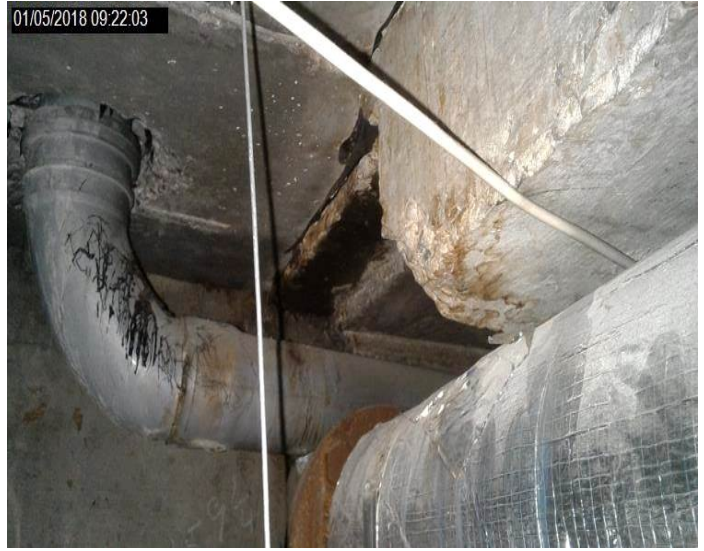
Location:	4.99	Block:	University	Floor Level: 3rd Floor
Sample No.:	DU001473	Portal Ref No.:	440

Item:	Bitumen damp proof course			
Asbestos Content:		Result Based on:		
No Asbestos Detected		Analysis of sample using PLM		
Sample Analysed By:	Reg 13(1)	Extent:	10 linear metres	
Comments: To ceiling concrete where level drops

Material Assessment Total Score: 0		Likelihood of Disturbance Assessment Total Score: 0		Management Assessment Licensable: No Recommendations: Not Applicable Reinspection Interval: Not Applicable Overall Risk Category: E0
Product Type:	0 Not Applicable	Location:	0 Not Applicable	
Condition:	0 Not Applicable	Accessibility:	0 Not Applicable	
Surface Treatment:	0 Not Applicable			
Asbestos Type:	0 Not Applicable	Extent Score:	0 Not Applicable

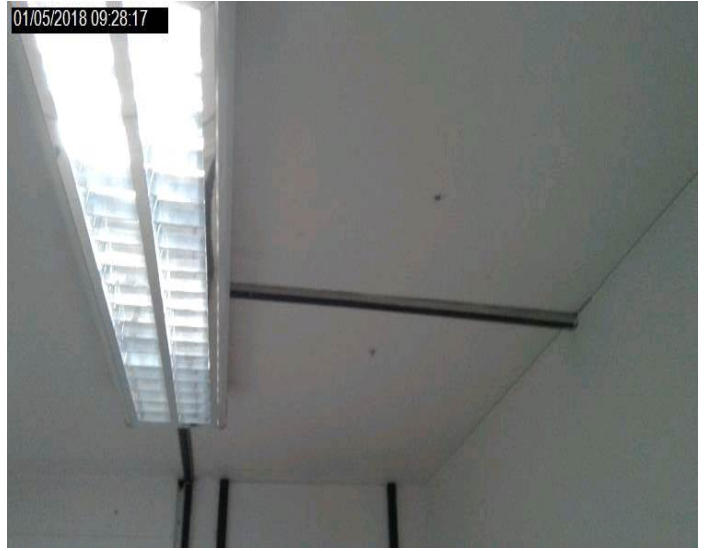
Location:	4.39	Block:	University	Floor Level: 3rd Floor
Sample No.:	DU001474	Portal Ref No.:	442

Item:	Asbestos Textured coating to concrete ceiling			
Asbestos Content:	Result Based on:			
Chrysotile	Analysis of sample using PLM			
Sample Analysed By:	Reg 13(1)	Extent:	6 m ²	
Comments:

Material Assessment Total Score: 3		Likelihood of Disturbance Assessment Total Score: 4		Management Assessment Licensable: No Recommendations: Program removal Reinspection Interval: Not Applicable Overall Risk Category: C7
Product Type:	1 (Asbestos textured coating)	Location:	2 (Rooms up to 100 sq m)	
Condition:	1 (Minor scratches)	Accessibility:	1 (Occasionally likely to be disturbed)	
Surface Treatment:	0 (Composite material)			
Asbestos Type:	1 (Chrysotile)	Extent Score:	1 (<10 sq m or 10m pipe run)

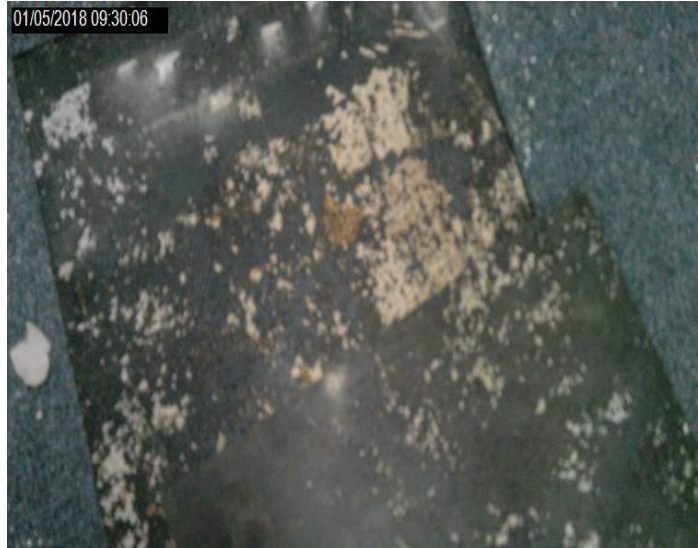
Location:	4.39	Block:	University	Floor Level: 3rd Floor
Sample No.:	DU001475	Portal Ref No.:	443

Item:	Asbestos Bitumen adhesive			
Asbestos Content:	Result Based on:			
Chrysotile	Analysis of sample using PLM			
Sample Analysed By: Reg 13(1)	Extent:	6 m ²		
Comments: Present beneath carpet

Material Assessment Total Score: 3		Likelihood of Disturbance Assessment Total Score: 4		Management Assessment Licensable: No Recommendations: Program removal Reinspection Interval: Not Applicable Overall Risk Category: C7
Product Type:	1 (Asbestos bitumen)	Location:	2 (Rooms up to 100 sq m)	
Condition:	1 (Minor scratches)	Accessibility:	1 (Occasionally likely to be disturbed)	
Surface Treatment:	0 (Composite material)			
Asbestos Type:	1 (Chrysotile)	Extent Score:	1 (<10 sq m or 10m pipe run)

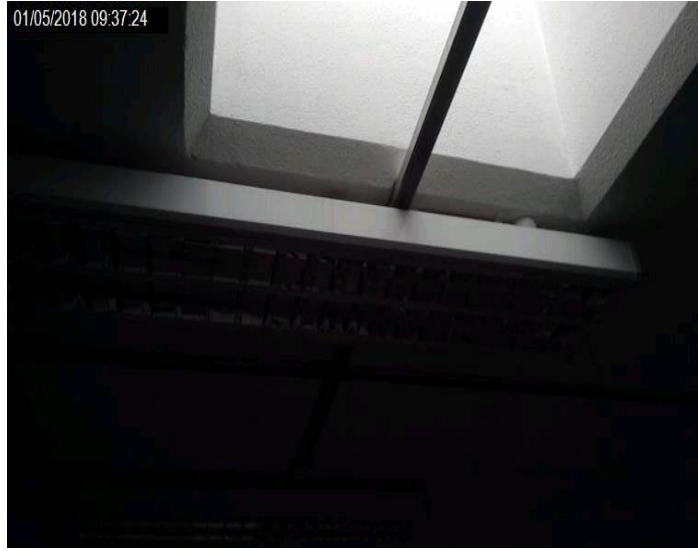
Location:	4.39A	Block:	University	Floor Level: 3rd Floor
Sample No.:	As DU001474	Portal Ref No.:	444

Item:	Asbestos Textured coating to concrete ceiling			
Asbestos Content:	Result Based on:			
Chrysotile	Strongly presumed			
Sample Analysed By:	Not applicable	Extent:	9 m ²	
Comments:

Material Assessment Total Score: 3		Likelihood of Disturbance Assessment Total Score: 4		Management Assessment Licensable: No Recommendations: Program removal Reinspection Interval: Not Applicable Overall Risk Category: C7
Product Type:	1 (Asbestos textured coating)	Location:	2 (Rooms up to 100 sq m)	
Condition:	1 (Minor scratches)	Accessibility:	1 (Occasionally likely to be disturbed)	
Surface Treatment:	0 (Composite material)			
Asbestos Type:	1 (Chrysotile)	Extent Score:	1 (<10 sq m or 10m pipe run)

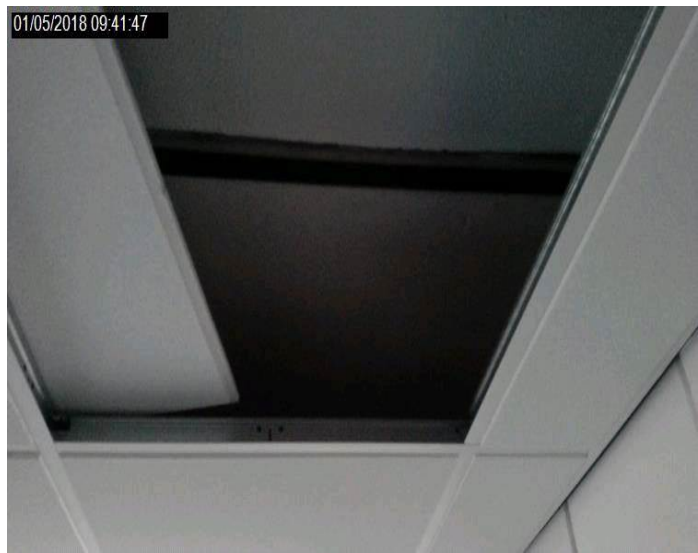
Location:	4.38A	Block:	University	Floor Level: 3rd Floor
Sample No.:	As DU001474	Portal Ref No.:	445

Item:	Asbestos Textured coating to concrete ceiling			
Asbestos Content:	Result Based on:			
Chrysotile	Strongly presumed			
Sample Analysed By:	Not applicable	Extent:	20 m ²	
Comments: Above suspended ceiling tiles

Material Assessment Total Score: 3		Likelihood of Disturbance Assessment Total Score: 5		Management Assessment Licensable: No Recommendations: Program removal Reinspection Interval: Not Applicable Overall Risk Category: C8
Product Type:	1 (Asbestos textured coating)	Location:	2 (Rooms up to 100 sq m)	
Condition:	1 (Minor scratches)	Accessibility:	1 (Occasionally likely to be disturbed)	
Surface Treatment:	0 (Composite material)			
Asbestos Type:	1 (Chrysotile)	Extent Score:	2 (>10 - <50 sq m or >10m - <50m pipe run)

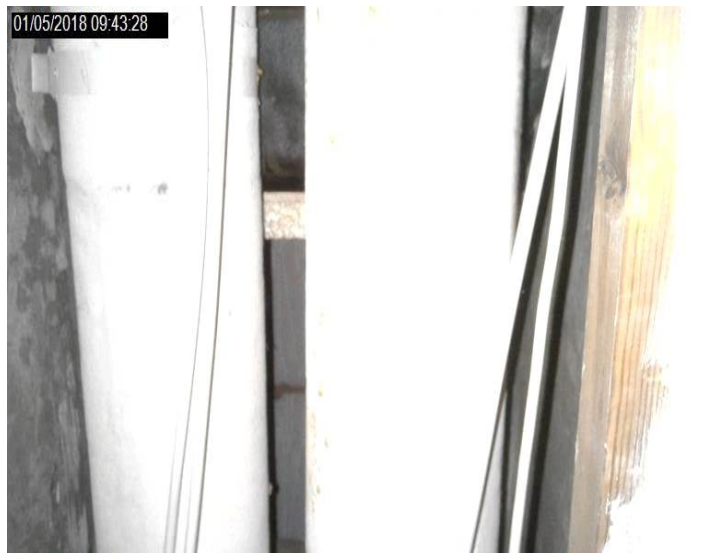
Location:	4.38A	Block:	University	Floor Level: 3rd Floor
Sample No.:	DU001477	Portal Ref No.:	447

Item:	Asbestos Cement shuttering			
Asbestos Content:	Result Based on:			
Chrysotile Amosite	Analysis of sample using PLM			
Sample Analysed By: Reg 13(1)	Extent:	4 m ²		
Comments: To ceiling of wall void behind polystyrene sheets

Material Assessment Total Score: 5		Likelihood of Disturbance Assessment Total Score: 4		Management Assessment Licensable: No Recommendations: Program removal Reinspection Interval: Not Applicable Overall Risk Category: C9
Product Type:	1 (Asbestos cement)	Location:	2 (Rooms up to 100 sq m)	
Condition:	1 (Minor scratches)	Accessibility:	1 (Occasionally likely to be disturbed)	
Surface Treatment:	1 (Encapsulated asbestos cement)			
Asbestos Type:	2 (Chrysotile Amosite)	Extent Score:	1 (<10 sq m or 10m pipe run)

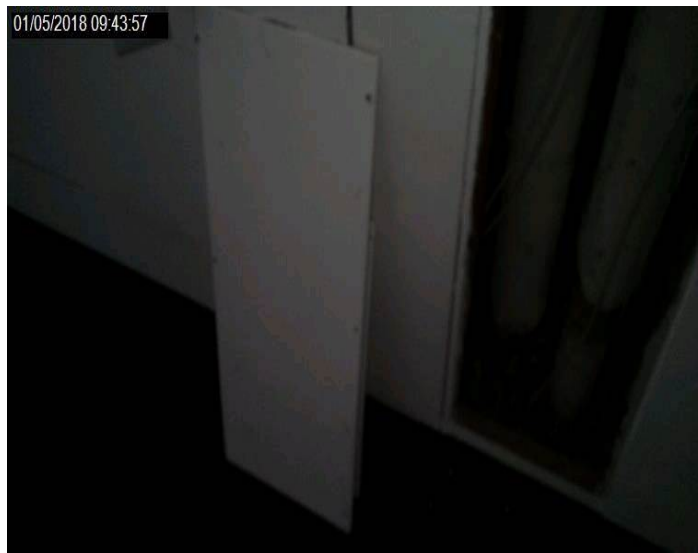
Location:	4.38A	Block:	University	Floor Level: 3rd Floor
Sample No.:	DU001478	Portal Ref No.:	448

Item:	Insulating board panels to riser			
Asbestos Content:	Result Based on:			
No Asbestos Detected	Analysis of sample using PLM			
Sample Analysed By: Reg 13(1)	Extent:	2 m ²		
Comments:

Material Assessment Total Score: 0		Likelihood of Disturbance Assessment Total Score: 0		Management Assessment Licensable: Yes Recommendations: Not Applicable Reinspection Interval: Not Applicable Overall Risk Category: E0
Product Type:	0 Not Applicable	Location:	0 Not Applicable	
Condition:	0 Not Applicable	Accessibility:	0 Not Applicable	
Surface Treatment:	0 Not Applicable			
Asbestos Type:	0 Not Applicable	Extent Score:	0 Not Applicable

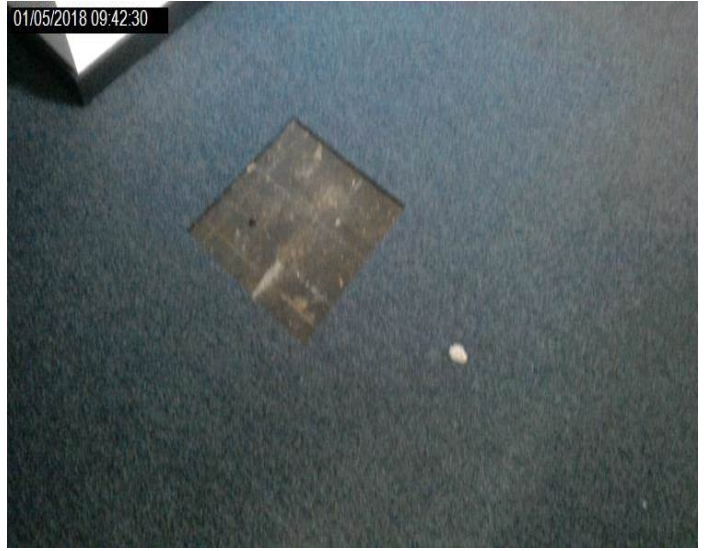
Location:	4.38A	Block:	University	Floor Level: 3rd Floor
Sample No.:	As DU001475	Portal Ref No.:	449

Item:	Asbestos Bitumen adhesive			
Asbestos Content:	Result Based on:			
Chrysotile	Strongly presumed			
Sample Analysed By:	Not applicable	Extent:	20 m ²	
Comments: Beneath carpet

Material Assessment Total Score: 3		Likelihood of Disturbance Assessment Total Score: 5		Management Assessment Licensable: No Recommendations: Program removal Reinspection Interval: Not Applicable Overall Risk Category: C8
Product Type:	1 (Asbestos bitumen)	Location:	2 (Rooms up to 100 sq m)	
Condition:	1 (Minor scratches)	Accessibility:	1 (Occasionally likely to be disturbed)	
Surface Treatment:	0 (Composite material)			
Asbestos Type:	1 (Chrysotile)	Extent Score:	2 (>10 - <50 sq m or >10m - <50m pipe run)

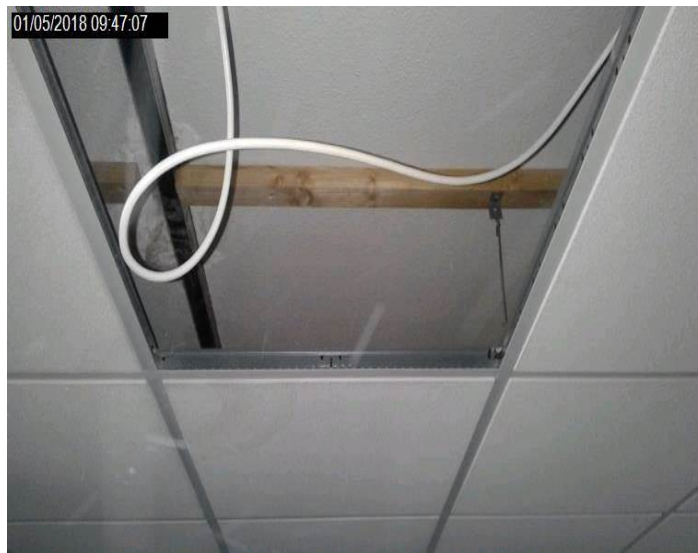
Location:	4.38B	Block:	University	Floor Level: 3rd Floor
Sample No.:	As DU001474	Portal Ref No.:	450

Item:	Asbestos Textured coating to concrete ceiling			
Asbestos Content:	Result Based on:			
Chrysotile	Strongly presumed			
Sample Analysed By:	Not applicable	Extent:	20 m ²	
Comments: Above suspended ceiling tiles

Material Assessment Total Score: 3		Likelihood of Disturbance Assessment Total Score: 5		Management Assessment Licensable: No Recommendations: Program removal Reinspection Interval: Not Applicable Overall Risk Category: C8
Product Type:	1 (Asbestos textured coating)	Location:	2 (Rooms up to 100 sq m)	
Condition:	1 (Minor scratches)	Accessibility:	1 (Occasionally likely to be disturbed)	
Surface Treatment:	0 (Composite material)			
Asbestos Type:	1 (Chrysotile)	Extent Score:	2 (>10 - <50 sq m or >10m - <50m pipe run)

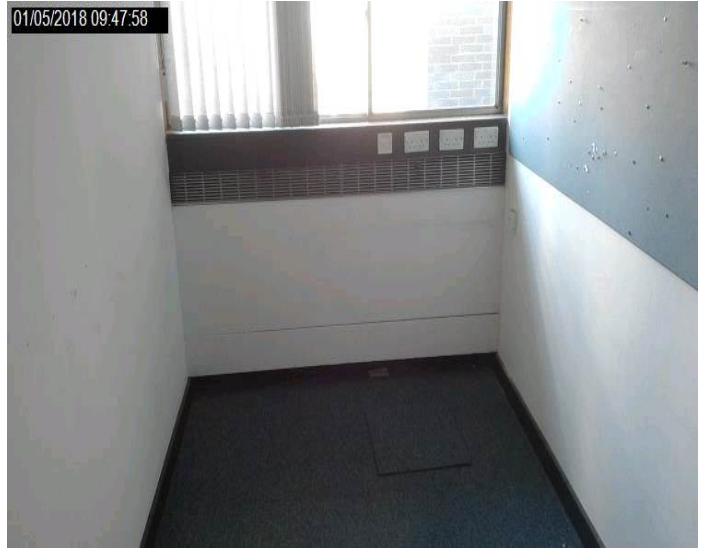
Location:	4.38B	Block:	University	Floor Level: 3rd Floor
Sample No.:	As DU001477	Portal Ref No.:	452

Item:	Asbestos Cement shuttering			
Asbestos Content:	Result Based on:			
Chrysotile Amosite	Strongly presumed			
Sample Analysed By:	Not applicable	Extent:	2 m ²	
Comments: To ceiling of wall void behind polystyrene sheets

Material Assessment Total Score: 5		Likelihood of Disturbance Assessment Total Score: 4		Management Assessment Licensable: No Recommendations: Program removal Reinspection Interval: Not Applicable Overall Risk Category: C9
Product Type:	1 (Asbestos cement)	Location:	2 (Rooms up to 100 sq m)	
Condition:	1 (Minor scratches)	Accessibility:	1 (Occasionally likely to be disturbed)	
Surface Treatment:	1 (Encapsulated asbestos cement)			
Asbestos Type:	2 (Chrysotile Amosite)	Extent Score:	1 (<10 sq m or 10m pipe run)

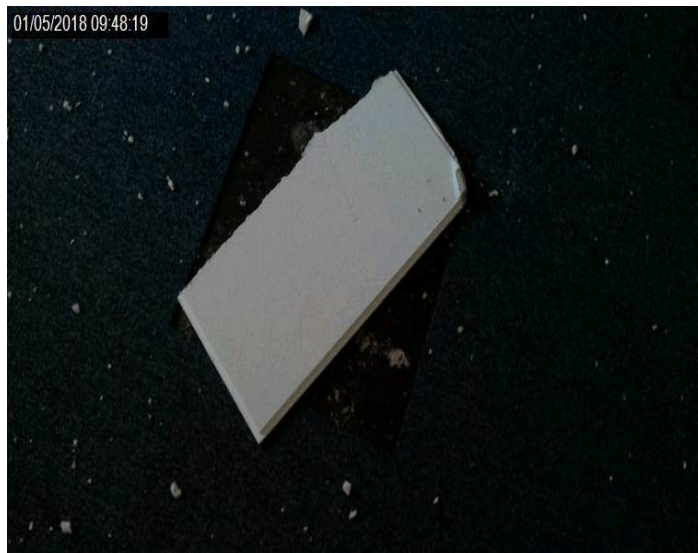
Location:	4.38B	Block:	University	Floor Level: 3rd Floor
Sample No.:	As DU001475	Portal Ref No.:	454

Item:	Asbestos Bitumen adhesive			
Asbestos Content:	Result Based on:			
Chrysotile	Strongly presumed			
Sample Analysed By:	Not applicable	Extent:	20 m ²	
Comments: Beneath carpet

Material Assessment Total Score: 3		Likelihood of Disturbance Assessment Total Score: 5		Management Assessment Licensable: No Recommendations: Program removal Reinspection Interval: Not Applicable Overall Risk Category: C8
Product Type:	1 (Asbestos bitumen)	Location:	2 (Rooms up to 100 sq m)	
Condition:	1 (Minor scratches)	Accessibility:	1 (Occasionally likely to be disturbed)	
Surface Treatment:	0 (Composite material)			
Asbestos Type:	1 (Chrysotile)	Extent Score:	2 (>10 - <50 sq m or >10m - <50m pipe run)

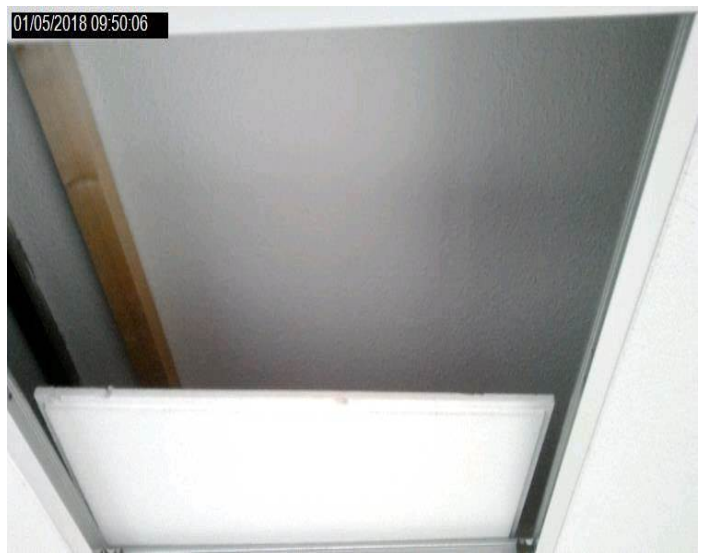
Location:	4.38C	Block:	University	Floor Level: 3rd Floor
Sample No.:	As DU001474	Portal Ref No.:	455

Item:	Asbestos Textured coating to concrete ceiling			
Asbestos Content:	Result Based on:			
Chrysotile	Strongly presumed			
Sample Analysed By:	Not applicable	Extent:	20 m ²	
Comments: Above suspended ceiling tiles

Material Assessment Total Score: 3		Likelihood of Disturbance Assessment Total Score: 5		Management Assessment Licensable: No Recommendations: Program removal Reinspection Interval: Not Applicable Overall Risk Category: C8
Product Type:	1 (Asbestos textured coating)	Location:	2 (Rooms up to 100 sq m)	
Condition:	1 (Minor scratches)	Accessibility:	1 (Occasionally likely to be disturbed)	
Surface Treatment:	0 (Composite material)			
Asbestos Type:	1 (Chrysotile)	Extent Score:	2 (>10 - <50 sq m or >10m - <50m pipe run)

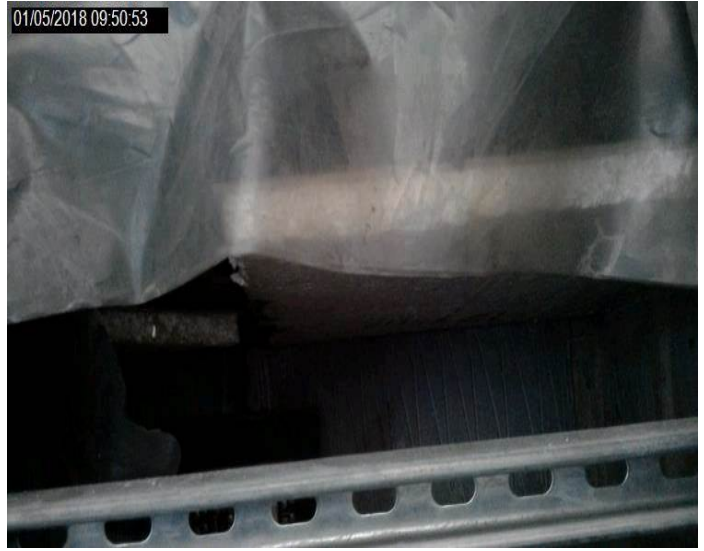
Location:	4.38C	Block:	University	Floor Level: 3rd Floor
Sample No.:	As DU001477	Portal Ref No.:	457

Item:	Asbestos Cement shuttering			
Asbestos Content:	Result Based on:			
Chrysotile Amosite	Strongly presumed			
Sample Analysed By:	Not applicable	Extent:	8 m ²	
Comments: To ceiling of wall void behind polystyrene sheets

Material Assessment Total Score: 5		Likelihood of Disturbance Assessment Total Score: 4		Management Assessment Licensable: No Recommendations: Program removal Reinspection Interval: Not Applicable Overall Risk Category: C9
Product Type:	1 (Asbestos cement)	Location:	2 (Rooms up to 100 sq m)	
Condition:	1 (Minor scratches)	Accessibility:	1 (Occasionally likely to be disturbed)	
Surface Treatment:	1 (Encapsulated asbestos cement)			
Asbestos Type:	2 (Chrysotile Amosite)	Extent Score:	1 (<10 sq m or 10m pipe run)

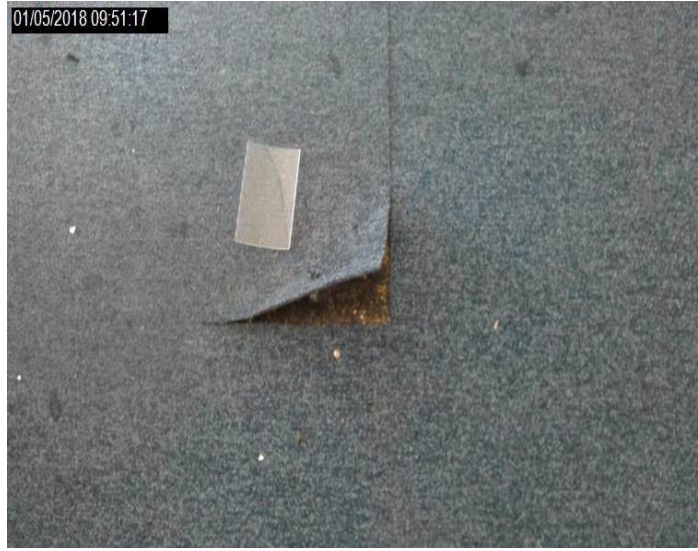
Location:	4.38C	Block:	University	Floor Level: 3rd Floor
Sample No.:	As DU001475	Portal Ref No.:	458

Item:	Asbestos Bitumen adhesive			
Asbestos Content:	Result Based on:			
Chrysotile	Strongly presumed			
Sample Analysed By:	Not applicable	Extent:	20 m ²	
Comments: Beneath carpet

Material Assessment Total Score: 3		Likelihood of Disturbance Assessment Total Score: 5		Management Assessment Licensable: No Recommendations: Program removal Reinspection Interval: Not Applicable Overall Risk Category: C8
Product Type:	1 (Asbestos bitumen)	Location:	2 (Rooms up to 100 sq m)	
Condition:	1 (Minor scratches)	Accessibility:	1 (Occasionally likely to be disturbed)	
Surface Treatment:	0 (Composite material)			
Asbestos Type:	1 (Chrysotile)	Extent Score:	2 (>10 - <50 sq m or >10m - <50m pipe run)

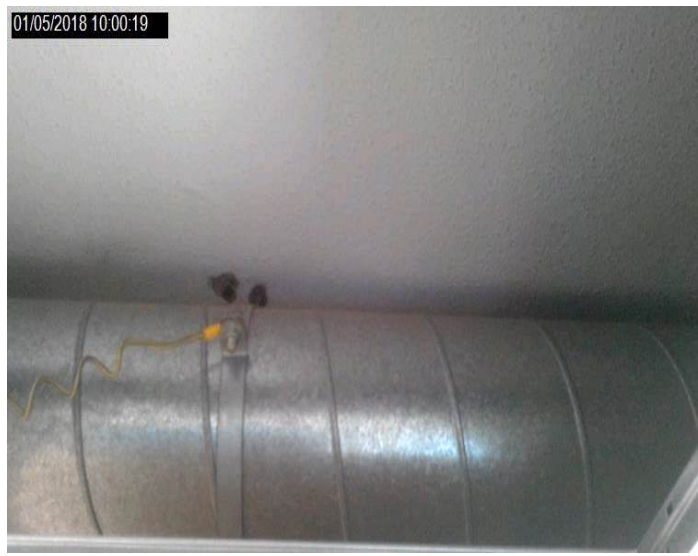
Location:	4.34	Block:	University	Floor Level: 3rd Floor
Sample No.:	As DU001474	Portal Ref No.:	459

Item:	Asbestos Textured coating to concrete ceiling			
Asbestos Content:	Result Based on:			
Chrysotile	Strongly presumed			
Sample Analysed By:	Not applicable	Extent:	70 m ²	
Comments: Above suspended ceiling tiles

Material Assessment Total Score: 3		Likelihood of Disturbance Assessment Total Score: 6		Management Assessment Licensable: No Recommendations: Program removal Reinspection Interval: Not Applicable Overall Risk Category: C9
Product Type:	1 (Asbestos textured coating)	Location:	2 (Rooms up to 100 sq m)	
Condition:	1 (Minor scratches)	Accessibility:	1 (Occasionally likely to be disturbed)	
Surface Treatment:	0 (Composite material)			
Asbestos Type:	1 (Chrysotile)	Extent Score:	3 (>50 sq m or >50m pipe run)

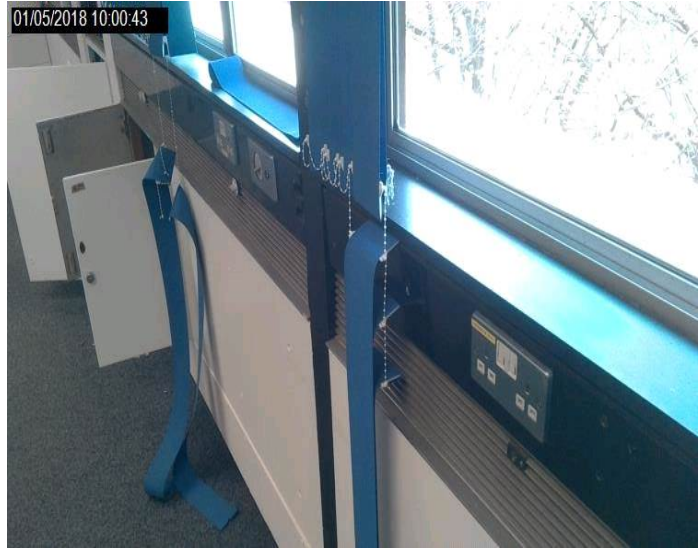
Location:	4.34	Block:	University	Floor Level: 3rd Floor
Sample No.:	As DU001476	Portal Ref No.:	460

Item:	Asbestos Cement window sill			
Asbestos Content:	Result Based on:			
Chrysotile	Strongly presumed			
Sample Analysed By:	Not applicable	Extent:	7 linear metres	
Comments:

Material Assessment Total Score: 4		Likelihood of Disturbance Assessment Total Score: 4		Management Assessment Licensable: No Recommendations: Program removal Reinspection Interval: Not Applicable Overall Risk Category: C8
Product Type:	1 (Asbestos cement)	Location:	2 (Rooms up to 100 sq m)	
Condition:	1 (Minor scratches)	Accessibility:	1 (Occasionally likely to be disturbed)	
Surface Treatment:	1 (Unencapsulated asbestos cement)			
Asbestos Type:	1 (Chrysotile)	Extent Score:	1 (<10 sq m or 10m pipe run)

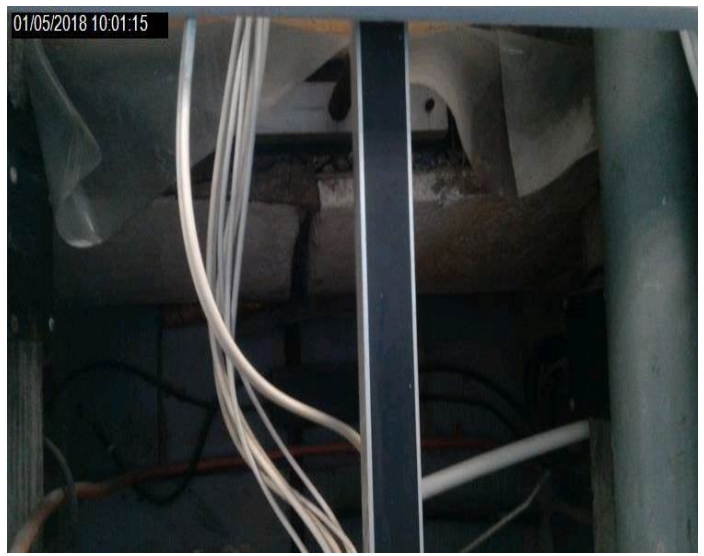
Location:	4.34	Block:	University	Floor Level: 3rd Floor
Sample No.:	As DU001477	Portal Ref No.:	461

Item:	Asbestos Cement shuttering			
Asbestos Content:	Result Based on:			
Chrysotile Amosite	Strongly presumed			
Sample Analysed By:	Not applicable	Extent:	7 m ²	
Comments: To ceiling of wall void behind polystyrene sheets

Material Assessment Total Score: 5		Likelihood of Disturbance Assessment Total Score: 4		Management Assessment Licensable: No Recommendations: Program removal Reinspection Interval: Not Applicable Overall Risk Category: C9
Product Type:	1 (Asbestos cement)	Location:	2 (Rooms up to 100 sq m)	
Condition:	1 (Minor scratches)	Accessibility:	1 (Occasionally likely to be disturbed)	
Surface Treatment:	1 (Encapsulated asbestos cement)			
Asbestos Type:	2 (Chrysotile Amosite)	Extent Score:	1 (<10 sq m or 10m pipe run)

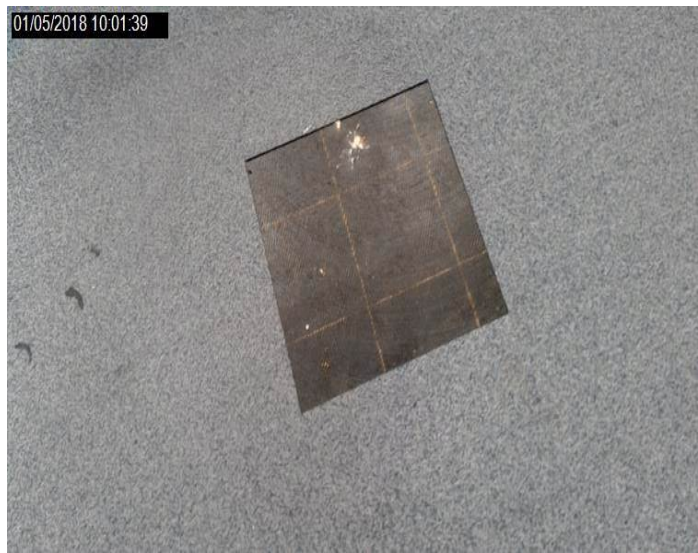
Location:	4.34	Block:	University	Floor Level: 3rd Floor
Sample No.:	As DU001475	Portal Ref No.:	463

Item:	Asbestos Bitumen adhesive			
Asbestos Content:	Result Based on:			
Chrysotile	Strongly presumed			
Sample Analysed By:	Not applicable	Extent:	70 m ²	
Comments: Beneath carpet

Material Assessment Total Score: 3		Likelihood of Disturbance Assessment Total Score: 6		Management Assessment Licensable: No Recommendations: Program removal Reinspection Interval: Not Applicable Overall Risk Category: C9
Product Type:	1 (Asbestos bitumen)	Location:	2 (Rooms up to 100 sq m)	
Condition:	1 (Minor scratches)	Accessibility:	1 (Occasionally likely to be disturbed)	
Surface Treatment:	0 (Composite material)			
Asbestos Type:	1 (Chrysotile)	Extent Score:	3 (>50 sq m or >50m pipe run)

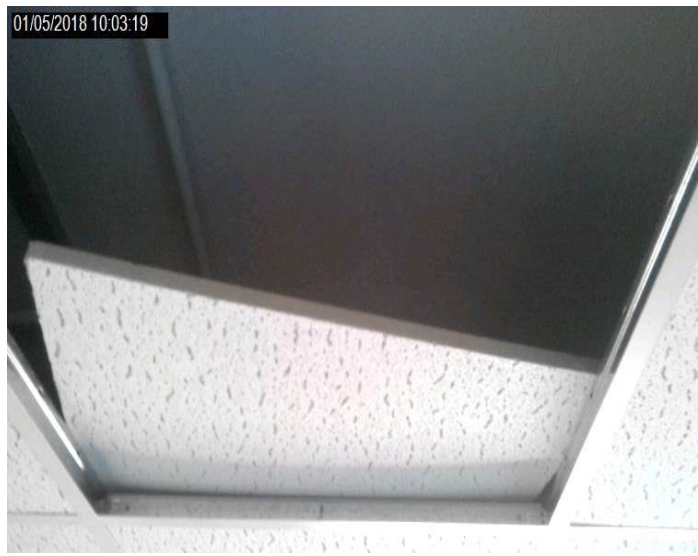
Location:	4.37	Block:	University	Floor Level: 3rd Floor
Sample No.:	As DU001474	Portal Ref No.:	464

Item:	Asbestos Textured coating to concrete ceiling			
Asbestos Content:	Result Based on:			
Chrysotile	Strongly presumed			
Sample Analysed By:	Not applicable	Extent:	15 m ²	
Comments: Above suspended ceiling tiles

Material Assessment Total Score: 3		Likelihood of Disturbance Assessment Total Score: 5		Management Assessment Licensable: No Recommendations: Program removal Reinspection Interval: Not Applicable Overall Risk Category: C8
Product Type:	1 (Asbestos textured coating)	Location:	2 (Rooms up to 100 sq m)	
Condition:	1 (Minor scratches)	Accessibility:	1 (Occasionally likely to be disturbed)	
Surface Treatment:	0 (Composite material)			
Asbestos Type:	1 (Chrysotile)	Extent Score:	2 (>10 - <50 sq m or >10m - <50m pipe run)

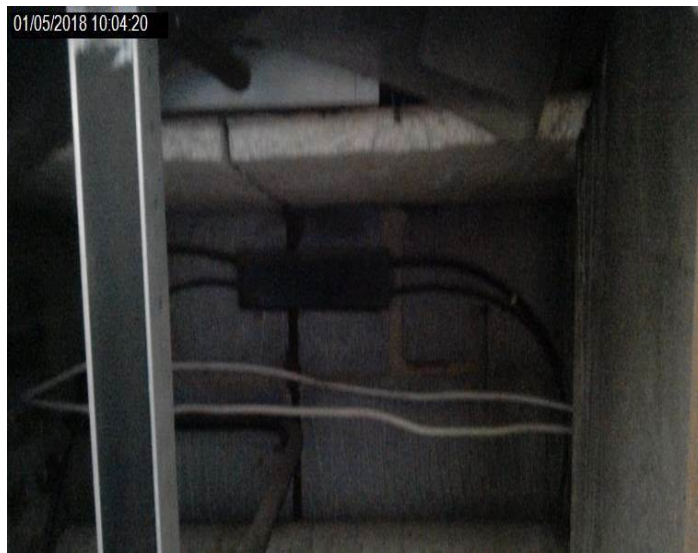
Location:	4.37	Block:	University	Floor Level: 3rd Floor
Sample No.:	As DU001477	Portal Ref No.:	466

Item:	Asbestos Cement shuttering			
Asbestos Content:	Result Based on:			
Chrysotile Amosite	Strongly presumed			
Sample Analysed By:	Not applicable	Extent:	3 m ²	
Comments: To ceiling of wall void behind polystyrene sheets

Material Assessment Total Score: 5		Likelihood of Disturbance Assessment Total Score: 4		Management Assessment Licensable: No Recommendations: Program removal Reinspection Interval: Not Applicable Overall Risk Category: C9
Product Type:	1 (Asbestos cement)	Location:	2 (Rooms up to 100 sq m)	
Condition:	1 (Minor scratches)	Accessibility:	1 (Occasionally likely to be disturbed)	
Surface Treatment:	1 (Encapsulated asbestos cement)			
Asbestos Type:	2 (Chrysotile Amosite)	Extent Score:	1 (<10 sq m or 10m pipe run)

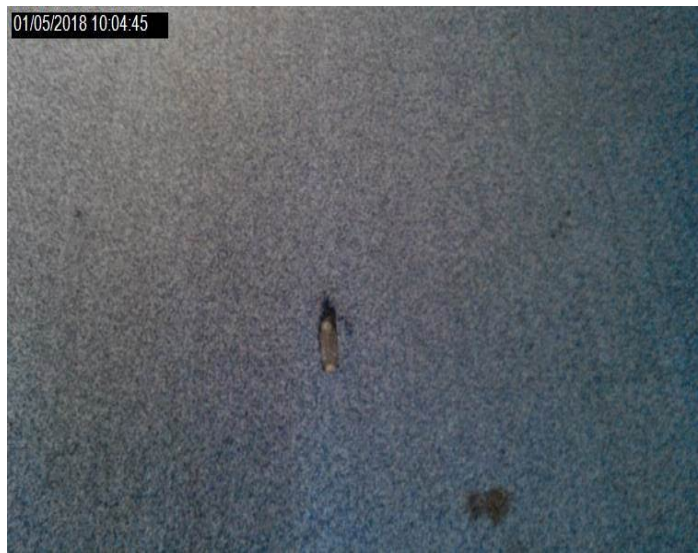
Location:	4.37	Block:	University	Floor Level: 3rd Floor
Sample No.:	As DU001475	Portal Ref No.:	467

Item:	Asbestos Bitumen adhesive			
Asbestos Content:	Result Based on:			
Chrysotile	Strongly presumed			
Sample Analysed By:	Not applicable	Extent:	15 m ²	
Comments: Beneath carpet

Material Assessment Total Score: 3		Likelihood of Disturbance Assessment Total Score: 5		Management Assessment Licensable: No Recommendations: Program removal Reinspection Interval: Not Applicable Overall Risk Category: C8
Product Type:	1 (Asbestos bitumen)	Location:	2 (Rooms up to 100 sq m)	
Condition:	1 (Minor scratches)	Accessibility:	1 (Occasionally likely to be disturbed)	
Surface Treatment:	0 (Composite material)			
Asbestos Type:	1 (Chrysotile)	Extent Score:	2 (>10 - <50 sq m or >10m - <50m pipe run)

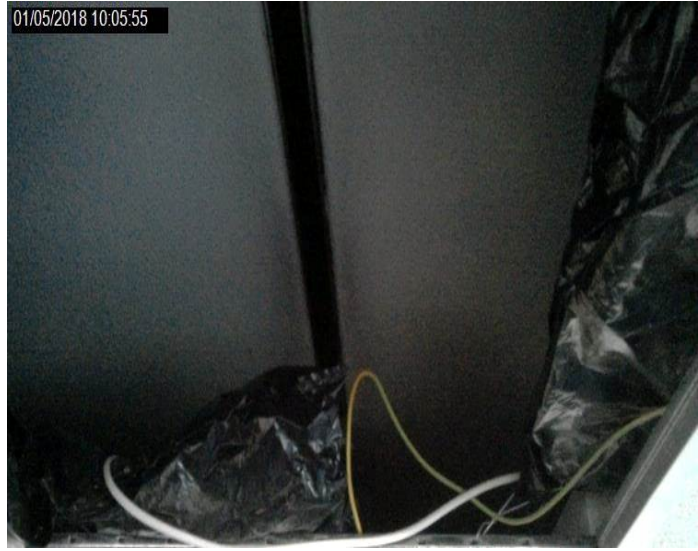
Location:	4.34A	Block:	University	Floor Level: 3rd Floor
Sample No.:	As DU001474	Portal Ref No.:	468

Item:	Asbestos Textured coating to concrete ceiling			
Asbestos Content:	Result Based on:			
Chrysotile	Strongly presumed			
Sample Analysed By:	Not applicable	Extent:	50 m ²	
Comments: Above suspended ceiling tiles

Material Assessment Total Score: 3		Likelihood of Disturbance Assessment Total Score: 6		Management Assessment Licensable: No Recommendations: Program removal Reinspection Interval: Not Applicable Overall Risk Category: C9
Product Type:	1 (Asbestos textured coating)	Location:	2 (Rooms up to 100 sq m)	
Condition:	1 (Minor scratches)	Accessibility:	1 (Occasionally likely to be disturbed)	
Surface Treatment:	0 (Composite material)			
Asbestos Type:	1 (Chrysotile)	Extent Score:	3 (>50 sq m or >50m pipe run)

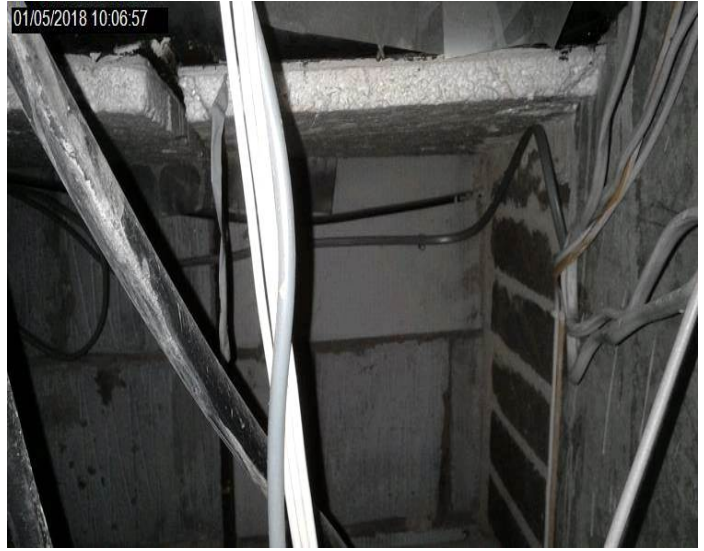
Location:	4.34A	Block:	University	Floor Level: 3rd Floor
Sample No.:	As DU001477	Portal Ref No.:	470

Item:	Asbestos Cement shuttering			
Asbestos Content:	Result Based on:			
Chrysotile Amosite	Strongly presumed			
Sample Analysed By:	Not applicable	Extent:	6 m ²	
Comments: To ceiling of wall void behind polystyrene sheets

Material Assessment Total Score: 5		Likelihood of Disturbance Assessment Total Score: 4		Management Assessment Licensable: No Recommendations: Program removal Reinspection Interval: Not Applicable Overall Risk Category: C9
Product Type:	1 (Asbestos cement)	Location:	2 (Rooms up to 100 sq m)	
Condition:	1 (Minor scratches)	Accessibility:	1 (Occasionally likely to be disturbed)	
Surface Treatment:	1 (Encapsulated asbestos cement)			
Asbestos Type:	2 (Chrysotile Amosite)	Extent Score:	1 (<10 sq m or 10m pipe run)

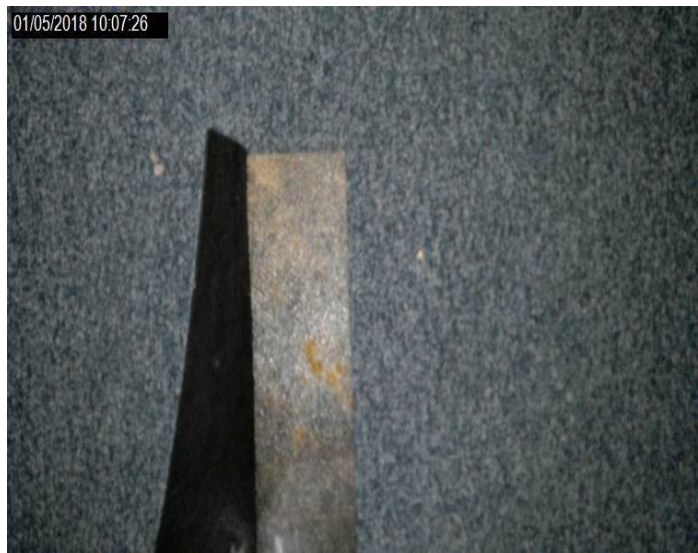
Location:	4.34A	Block:	University	Floor Level: 3rd Floor
Sample No.:	As DU001475	Portal Ref No.:	471

Item:	Asbestos Bitumen adhesive			
Asbestos Content:	Result Based on:			
Chrysotile	Strongly presumed			
Sample Analysed By:	Not applicable	Extent:	50 m ²	
Comments: Beneath carpet

Material Assessment Total Score: 3		Likelihood of Disturbance Assessment Total Score: 6		Management Assessment Licensable: No Recommendations: Program removal Reinspection Interval: Not Applicable Overall Risk Category: C9
Product Type:	1 (Asbestos bitumen)	Location:	2 (Rooms up to 100 sq m)	
Condition:	1 (Minor scratches)	Accessibility:	1 (Occasionally likely to be disturbed)	
Surface Treatment:	0 (Composite material)			
Asbestos Type:	1 (Chrysotile)	Extent Score:	3 (>50 sq m or >50m pipe run)

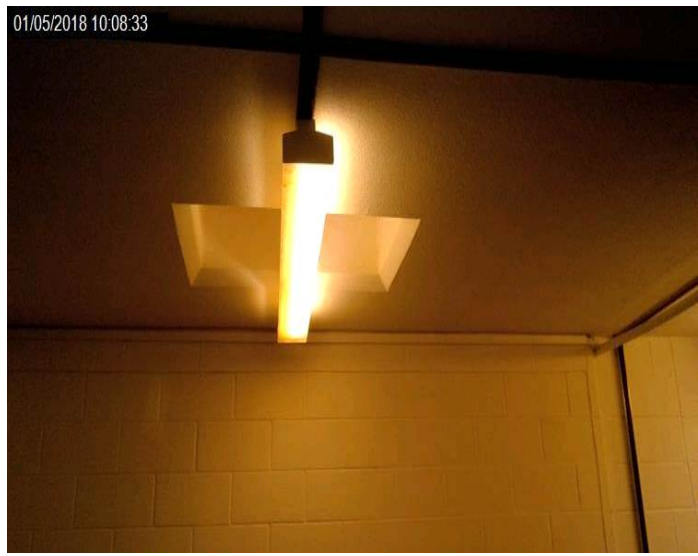
Location:	4.31	Block:	University	Floor Level: 3rd Floor
Sample No.:	As DU001474	Portal Ref No.:	472

Item:	Asbestos Textured coating to concrete ceiling			
Asbestos Content:	Result Based on:			
Chrysotile	Strongly presumed			
Sample Analysed By:	Not applicable	Extent:	20 m ²	
Comments:

Material Assessment Total Score: 3		Likelihood of Disturbance Assessment Total Score: 4		Management Assessment Licensable: No Recommendations: Program removal Reinspection Interval: Not Applicable Overall Risk Category: C7
Product Type:	1 (Asbestos textured coating)	Location:	2 (Rooms up to 100 sq m)	
Condition:	1 (Minor scratches)	Accessibility:	1 (Occasionally likely to be disturbed)	
Surface Treatment:	0 (Composite material)			
Asbestos Type:	1 (Chrysotile)	Extent Score:	1 (<10 sq m or 10m pipe run)

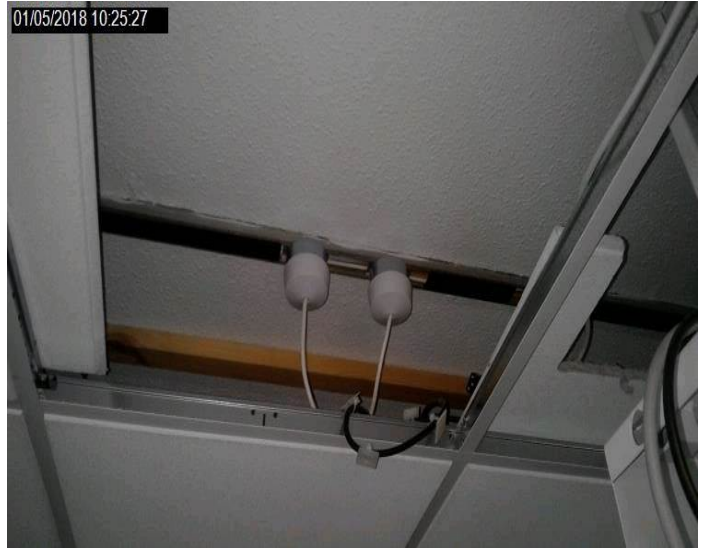
Location:	4.27	Block:	University	Floor Level: 3rd Floor
Sample No.:	As DU001474	Portal Ref No.:	473

Item:	Asbestos Textured coating to concrete ceiling			
Asbestos Content:	Result Based on:			
Chrysotile	Strongly presumed			
Sample Analysed By:	Not applicable	Extent:	48 m ²	
Comments: Above suspended ceiling tiles

Material Assessment Total Score: 3		Likelihood of Disturbance Assessment Total Score: 5		Management Assessment Licensable: No Recommendations: Program removal Reinspection Interval: Not Applicable Overall Risk Category: C8
Product Type:	1 (Asbestos textured coating)	Location:	2 (Rooms up to 100 sq m)	
Condition:	1 (Minor scratches)	Accessibility:	1 (Occasionally likely to be disturbed)	
Surface Treatment:	0 (Composite material)			
Asbestos Type:	1 (Chrysotile)	Extent Score:	2 (>10 - <50 sq m or >10m - <50m pipe run)
