Report No.: J094099
Nature of Work: Demolition Survey
Issue Date: 11/06/2018
Client Name: WYG Engineering Ltd
Geneva Building, Lake View Drive, Sherwood Business Park,
Annesley, Nottingham, NG15 0ED
Site Address: Dawson building, Former City North Campus, Birmingham City
University, Perry Barr, B42 2US

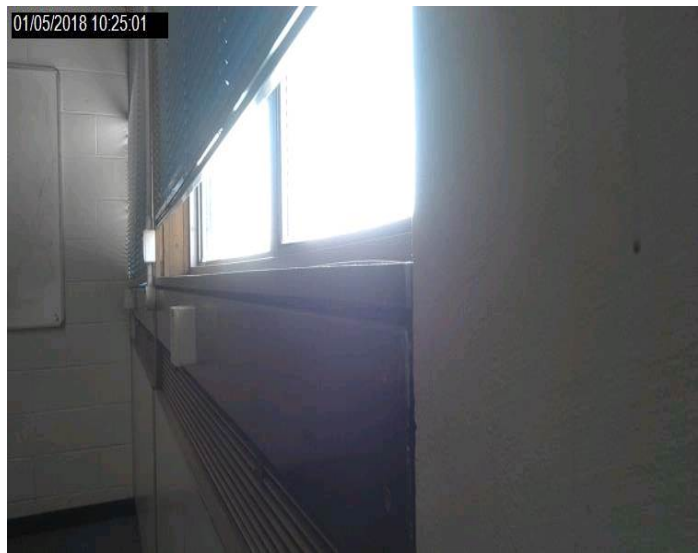
Location:	4.27	Block:	University	Floor Level: 3rd Floor
Sample No.:	As DU001476	Portal Ref No.:	474

Item:	Asbestos Cement window sill			
Asbestos Content:	Result Based on:			
Chrysotile	Strongly presumed			
Sample Analysed By:	Not applicable	Extent:	8 linear metres	
Comments:

Material Assessment Total Score: 4		Likelihood of Disturbance Assessment Total Score: 4		Management Assessment Licensable: No Recommendations: Program removal Reinspection Interval: Not Applicable Overall Risk Category: C8
Product Type:	1 (Asbestos cement)	Location:	2 (Rooms up to 100 sq m)	
Condition:	1 (Minor scratches)	Accessibility:	1 (Occasionally likely to be disturbed)	
Surface Treatment:	1 (Unencapsulated asbestos cement)			
Asbestos Type:	1 (Chrysotile)	Extent Score:	1 (<10 sq m or 10m pipe run)

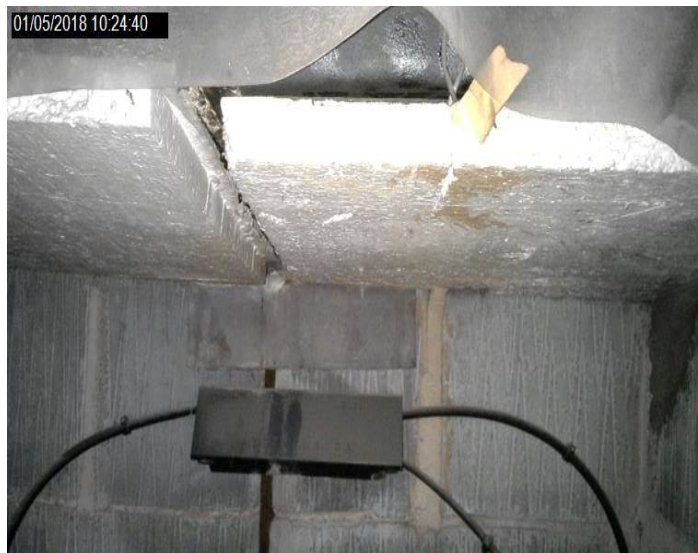
Location:	4.27	Block:	University	Floor Level: 3rd Floor
Sample No.:	As DU001477	Portal Ref No.:	475

Item:	Asbestos Cement shuttering			
Asbestos Content:	Result Based on:			
Chrysotile Amosite	Strongly presumed			
Sample Analysed By:	Not applicable	Extent:	8 m ²	
Comments: To ceiling of wall void behind polystyrene sheets

Material Assessment Total Score: 5		Likelihood of Disturbance Assessment Total Score: 4		Management Assessment Licensable: No Recommendations: Program removal Reinspection Interval: Not Applicable Overall Risk Category: C9
Product Type:	1 (Asbestos cement)	Location:	2 (Rooms up to 100 sq m)	
Condition:	1 (Minor scratches)	Accessibility:	1 (Occasionally likely to be disturbed)	
Surface Treatment:	1 (Encapsulated asbestos cement)			
Asbestos Type:	2 (Chrysotile Amosite)	Extent Score:	1 (<10 sq m or 10m pipe run)

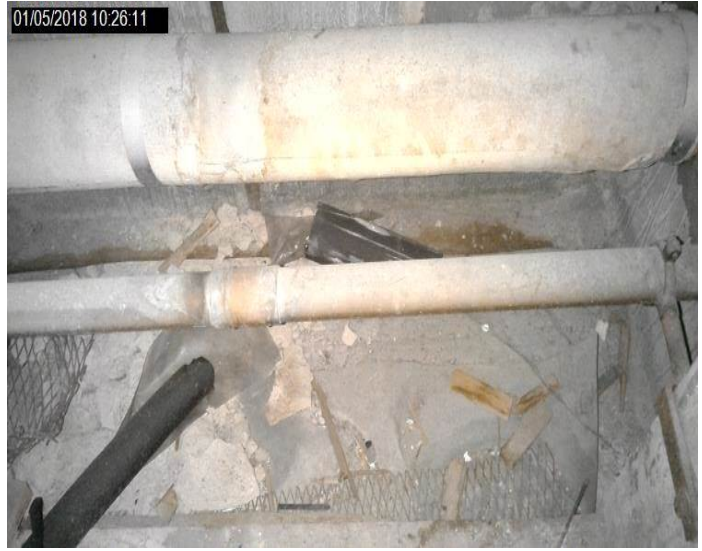
Location:	4.27	Block:	University	Floor Level: 3rd Floor
Sample No.:	DU001480	Portal Ref No.:	477

Item:	Bitumen damp proof course			
Asbestos Content:		Result Based on:		
No Asbestos Detected		Analysis of sample using PLM		
Sample Analysed By:	Reg 13(1)	Extent:	250 linear metres	
Comments: One sample for the entire perimeter of the floor level, item is to the external wall of the wall void

Material Assessment Total Score: 0		Likelihood of Disturbance Assessment Total Score: 0		Management Assessment Licensable: No Recommendations: Not Applicable Reinspection Interval: Not Applicable Overall Risk Category: E0
Product Type:	0 Not Applicable	Location:	0 Not Applicable	
Condition:	0 Not Applicable	Accessibility:	0 Not Applicable	
Surface Treatment:	0 Not Applicable			
Asbestos Type:	0 Not Applicable	Extent Score:	0 Not Applicable

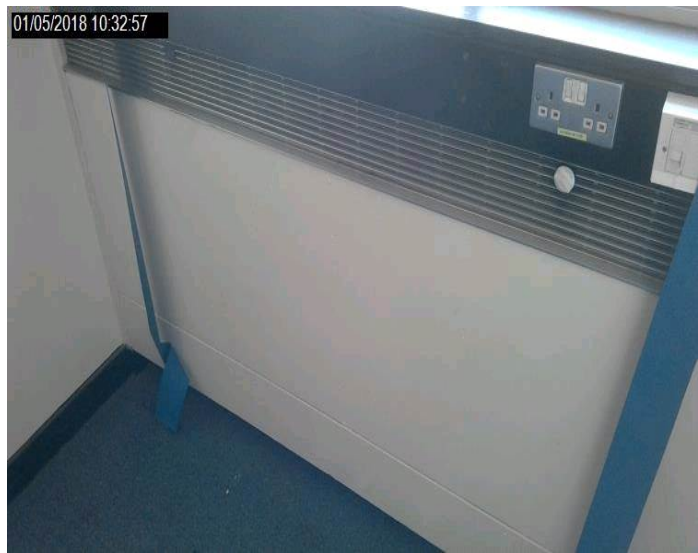
Location:	4.26	Block:	University	Floor Level: 3rd Floor
Sample No.:	DU001483	Portal Ref No.:	480

Item:	Asbestos Cement shuttering			
Asbestos Content:	Result Based on:			
Chrysotile	Analysis of sample using PLM			
Sample Analysed By: Reg 13(1)	Extent:	2 m ²		
Comments: To ceiling of wall void behind polystyrene sheets

Material Assessment Total Score: 4		Likelihood of Disturbance Assessment Total Score: 4		Management Assessment Licensable: No Recommendations: Program removal Reinspection Interval: Not Applicable Overall Risk Category: C8
Product Type:	1 (Asbestos cement)	Location:	2 (Rooms up to 100 sq m)	
Condition:	1 (Minor scratches)	Accessibility:	1 (Occasionally likely to be disturbed)	
Surface Treatment:	1 (Encapsulated asbestos cement)			
Asbestos Type:	1 (Chrysotile)	Extent Score:	1 (<10 sq m or 10m pipe run)

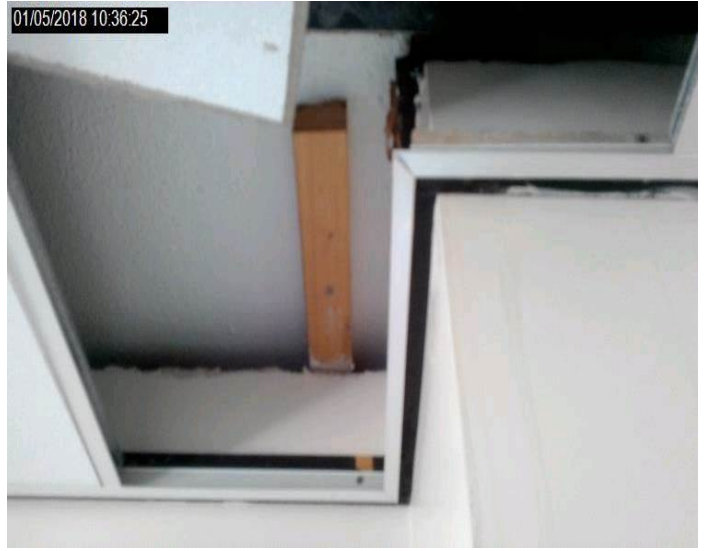
Location:	4.25	Block:	University	Floor Level: 3rd Floor
Sample No.:	As DU001481	Portal Ref No.:	482

Item:	Textured coating to concrete			
Asbestos Content:		Result Based on:		
No Asbestos Detected		Strongly presumed		
Sample Analysed By:	Not applicable	Extent:	8 m ²	
Comments: Above suspended ceiling tiles

Material Assessment Total Score: 0		Likelihood of Disturbance Assessment Total Score: 0		Management Assessment Licensable: No Recommendations: Not Applicable Reinspection Interval: Not Applicable Overall Risk Category: E0
Product Type:	0 Not Applicable	Location:	0 Not Applicable	
Condition:	0 Not Applicable	Accessibility:	0 Not Applicable	
Surface Treatment:	0 Not Applicable			
Asbestos Type:	0 Not Applicable	Extent Score:	0 Not Applicable

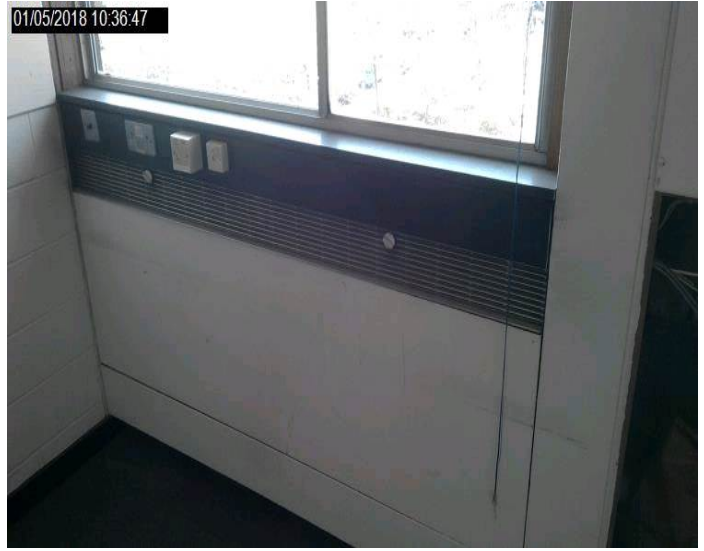
Location:	4.25	Block:	University	Floor Level: 3rd Floor
Sample No.:	As DU001482	Portal Ref No.:	483

Item:	Asbestos Cement window sill			
Asbestos Content:	Result Based on:			
Chrysotile	Strongly presumed			
Sample Analysed By:	Not applicable	Extent:	2 linear metres	
Comments:

Material Assessment Total Score: 4		Likelihood of Disturbance Assessment Total Score: 4		Management Assessment Licensable: No Recommendations: Program removal Reinspection Interval: Not Applicable Overall Risk Category: C8
Product Type:	1 (Asbestos cement)	Location:	2 (Rooms up to 100 sq m)	
Condition:	1 (Minor scratches)	Accessibility:	1 (Occasionally likely to be disturbed)	
Surface Treatment:	1 (Unencapsulated asbestos cement)			
Asbestos Type:	1 (Chrysotile)	Extent Score:	1 (<10 sq m or 10m pipe run)

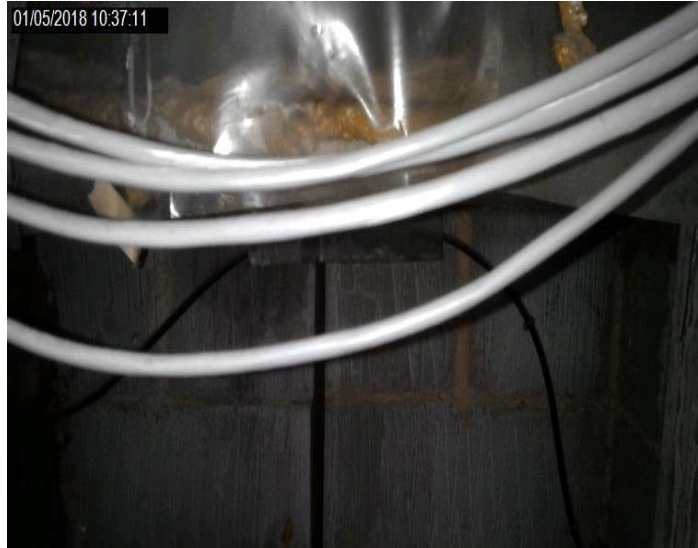
Location:	4.25	Block:	University	Floor Level: 3rd Floor
Sample No.:	As DU001483	Portal Ref No.:	484

Item:	Asbestos Cement shuttering			
Asbestos Content:	Result Based on:			
Chrysotile	Strongly presumed			
Sample Analysed By:	Not applicable	Extent:	3 m ²	
Comments: To ceiling of wall void behind polystyrene sheets

Material Assessment Total Score: 4		Likelihood of Disturbance Assessment Total Score: 4		Management Assessment Licensable: No Recommendations: Program removal Reinspection Interval: Not Applicable Overall Risk Category: C8
Product Type:	1 (Asbestos cement)	Location:	2 (Rooms up to 100 sq m)	
Condition:	1 (Minor scratches)	Accessibility:	1 (Occasionally likely to be disturbed)	
Surface Treatment:	1 (Encapsulated asbestos cement)			
Asbestos Type:	1 (Chrysotile)	Extent Score:	1 (<10 sq m or 10m pipe run)

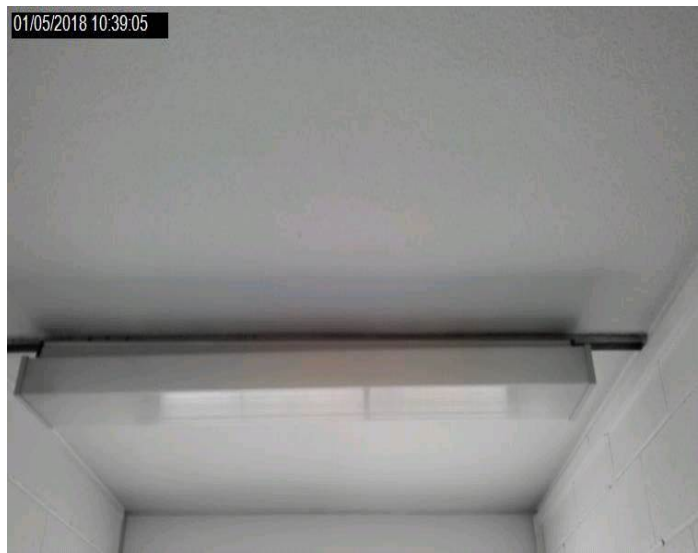
Location:	4.24	Block:	University	Floor Level: 3rd Floor
Sample No.:	As DU001481	Portal Ref No.:	486

Item:	Textured coating to concrete			
Asbestos Content:		Result Based on:		
No Asbestos Detected		Strongly presumed		
Sample Analysed By:	Not applicable	Extent:	6 m ²	
Comments:

Material Assessment Total Score: 0		Likelihood of Disturbance Assessment Total Score: 0		Management Assessment Licensable: No Recommendations: Not Applicable Reinspection Interval: Not Applicable Overall Risk Category: E0
Product Type:	0 Not Applicable	Location:	0 Not Applicable	
Condition:	0 Not Applicable	Accessibility:	0 Not Applicable	
Surface Treatment:	0 Not Applicable			
Asbestos Type:	0 Not Applicable	Extent Score:	0 Not Applicable

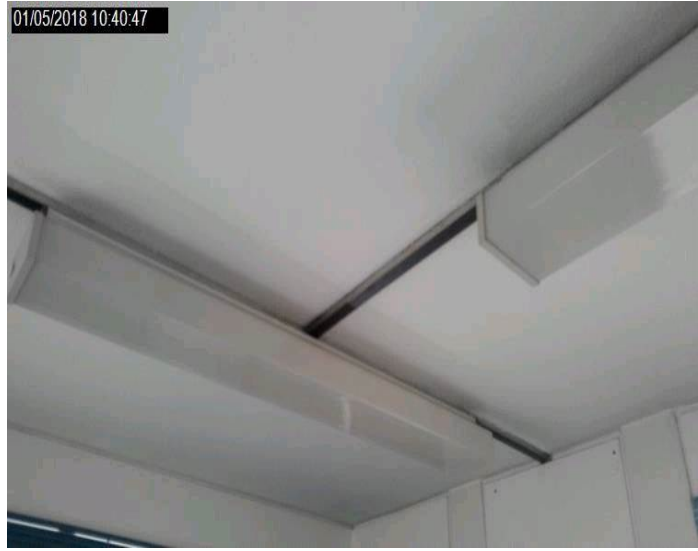
Location:	4.23	Block:	University	Floor Level: 3rd Floor
Sample No.:	As DU001481	Portal Ref No.:	489

Item:	Textured coating to concrete			
Asbestos Content:		Result Based on:		
No Asbestos Detected		Strongly presumed		
Sample Analysed By:	Not applicable	Extent:	12 m ²	
Comments:

Material Assessment Total Score: 0		Likelihood of Disturbance Assessment Total Score: 0		Management Assessment Licensable: No Recommendations: Not Applicable Reinspection Interval: Not Applicable Overall Risk Category: E0
Product Type:	0 Not Applicable	Location:	0 Not Applicable	
Condition:	0 Not Applicable	Accessibility:	0 Not Applicable	
Surface Treatment:	0 Not Applicable			
Asbestos Type:	0 Not Applicable	Extent Score:	0 Not Applicable

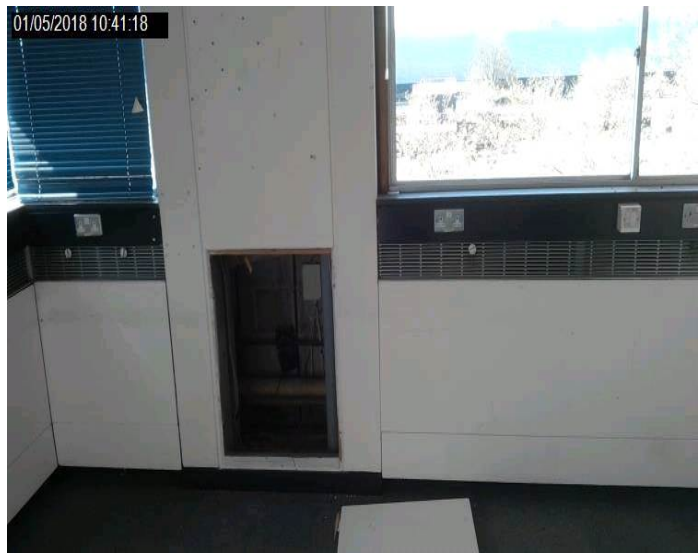
Location:	4.23	Block:	University	Floor Level: 3rd Floor
Sample No.:	As DU001482	Portal Ref No.:	490

Item:	Asbestos Cement window sill			
Asbestos Content:	Result Based on:			
Chrysotile	Strongly presumed			
Sample Analysed By:	Not applicable	Extent:	7 linear metres	
Comments:

Material Assessment Total Score: 4		Likelihood of Disturbance Assessment Total Score: 4		Management Assessment Licensable: No Recommendations: Program removal Reinspection Interval: Not Applicable Overall Risk Category: C8
Product Type:	1 (Asbestos cement)	Location:	2 (Rooms up to 100 sq m)	
Condition:	1 (Minor scratches)	Accessibility:	1 (Occasionally likely to be disturbed)	
Surface Treatment:	1 (Unencapsulated asbestos cement)			
Asbestos Type:	1 (Chrysotile)	Extent Score:	1 (<10 sq m or 10m pipe run)

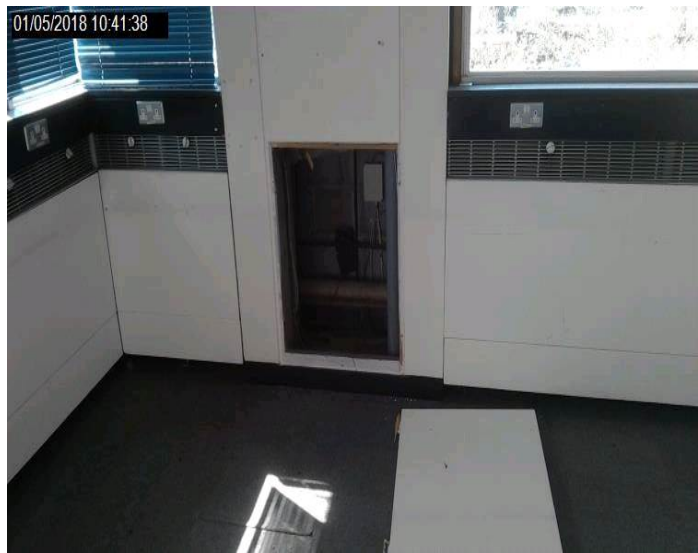
Location:	4.23	Block:	University	Floor Level: 3rd Floor
Sample No.:	As DU001483	Portal Ref No.:	491

Item:	Asbestos Cement shuttering			
Asbestos Content:	Result Based on:			
Chrysotile	Strongly presumed			
Sample Analysed By:	Not applicable	Extent:	7 m ²	
Comments: To ceiling of wall void behind polystyrene sheets

Material Assessment Total Score: 4		Likelihood of Disturbance Assessment Total Score: 4		Management Assessment Licensable: No Recommendations: Program removal Reinspection Interval: Not Applicable Overall Risk Category: C8
Product Type:	1 (Asbestos cement)	Location:	2 (Rooms up to 100 sq m)	
Condition:	1 (Minor scratches)	Accessibility:	1 (Occasionally likely to be disturbed)	
Surface Treatment:	1 (Encapsulated asbestos cement)			
Asbestos Type:	1 (Chrysotile)	Extent Score:	1 (<10 sq m or 10m pipe run)

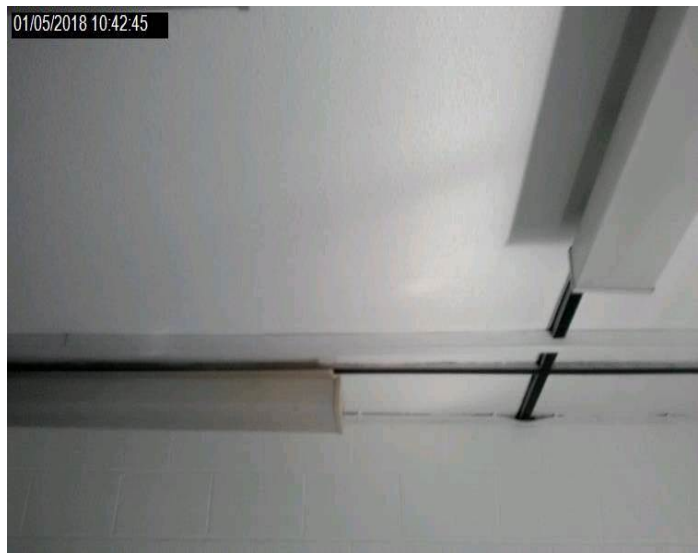
Location:	4.22	Block:	University	Floor Level: 3rd Floor
Sample No.:	As DU001481	Portal Ref No.:	492

Item:	Textured coating to concrete			
Asbestos Content:	Result Based on:			
No Asbestos Detected	Strongly presumed			
Sample Analysed By:	Not applicable	Extent:	10 m ²	
Comments:

Material Assessment Total Score: 0		Likelihood of Disturbance Assessment Total Score: 0		Management Assessment Licensable: No Recommendations: Not Applicable Reinspection Interval: Not Applicable Overall Risk Category: E0
Product Type:	0 Not Applicable	Location:	0 Not Applicable	
Condition:	0 Not Applicable	Accessibility:	0 Not Applicable	
Surface Treatment:	0 Not Applicable			
Asbestos Type:	0 Not Applicable	Extent Score:	0 Not Applicable

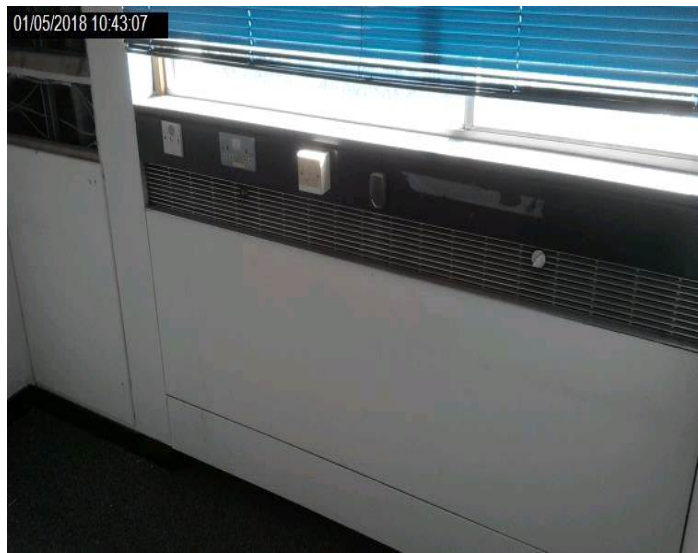
Location:	4.22	Block:	University	Floor Level: 3rd Floor
Sample No.:	As DU001482	Portal Ref No.:	493

Item:	Asbestos Cement window sill			
Asbestos Content:	Result Based on:			
Chrysotile	Strongly presumed			
Sample Analysed By:	Not applicable	Extent:	3 linear metres	
Comments:

Material Assessment Total Score: 4		Likelihood of Disturbance Assessment Total Score: 4		Management Assessment Licensable: No Recommendations: Program removal Reinspection Interval: Not Applicable Overall Risk Category: C8
Product Type:	1 (Asbestos cement)	Location:	2 (Rooms up to 100 sq m)	
Condition:	1 (Minor scratches)	Accessibility:	1 (Occasionally likely to be disturbed)	
Surface Treatment:	1 (Unencapsulated asbestos cement)			
Asbestos Type:	1 (Chrysotile)	Extent Score:	1 (<10 sq m or 10m pipe run)

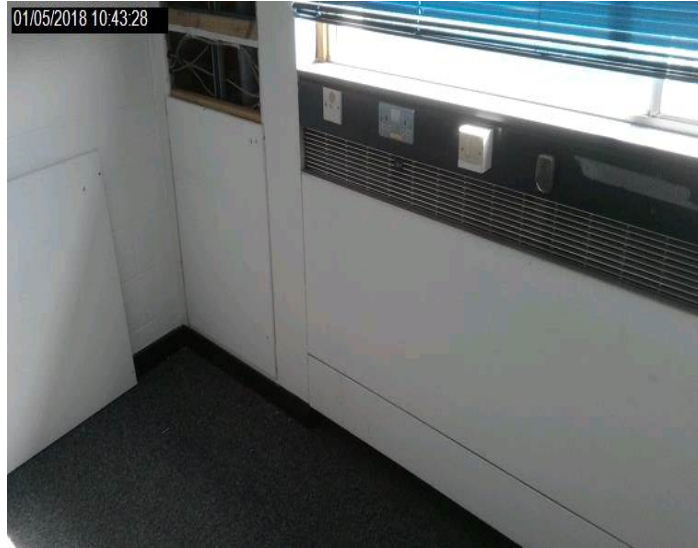
Location:	4.22	Block:	University	Floor Level: 3rd Floor
Sample No.:	As DU001483	Portal Ref No.:	494

Item:	Asbestos Cement shuttering			
Asbestos Content:	Result Based on:			
Chrysotile	Strongly presumed			
Sample Analysed By:	Not applicable	Extent:	3 m ²	
Comments: To ceiling of wall void behind polystyrene sheets

Material Assessment Total Score: 4		Likelihood of Disturbance Assessment Total Score: 4		Management Assessment Licensable: No Recommendations: Program removal Reinspection Interval: Not Applicable Overall Risk Category: C8
Product Type:	1 (Asbestos cement)	Location:	2 (Rooms up to 100 sq m)	
Condition:	1 (Minor scratches)	Accessibility:	1 (Occasionally likely to be disturbed)	
Surface Treatment:	1 (Encapsulated asbestos cement)			
Asbestos Type:	1 (Chrysotile)	Extent Score:	1 (<10 sq m or 10m pipe run)

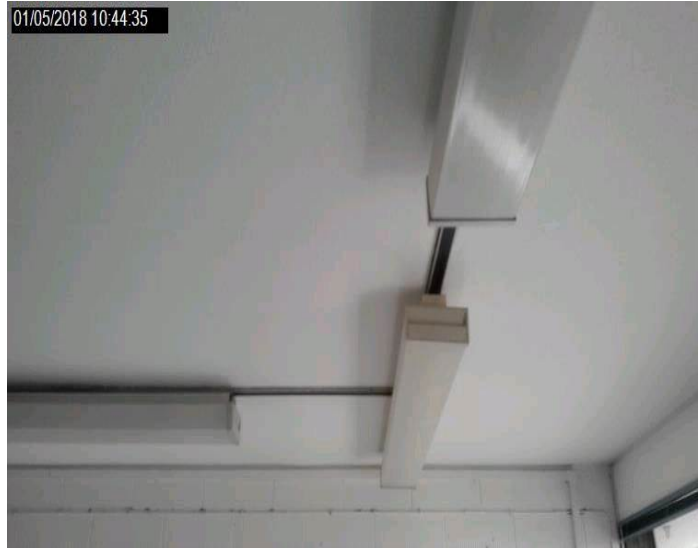
Location:	4.21	Block:	University	Floor Level: 3rd Floor
Sample No.:	As DU001481	Portal Ref No.:	496

Item:	Textured coating to concrete ceiling			
Asbestos Content:		Result Based on:		
No Asbestos Detected		Strongly presumed		
Sample Analysed By:	Not applicable	Extent:	16 m ²	
Comments:

Material Assessment Total Score: 0		Likelihood of Disturbance Assessment Total Score: 0		Management Assessment Licensable: No Recommendations: Not Applicable Reinspection Interval: Not Applicable Overall Risk Category: E0
Product Type:	0 Not Applicable	Location:	0 Not Applicable	
Condition:	0 Not Applicable	Accessibility:	0 Not Applicable	
Surface Treatment:	0 Not Applicable			
Asbestos Type:	0 Not Applicable	Extent Score:	0 Not Applicable

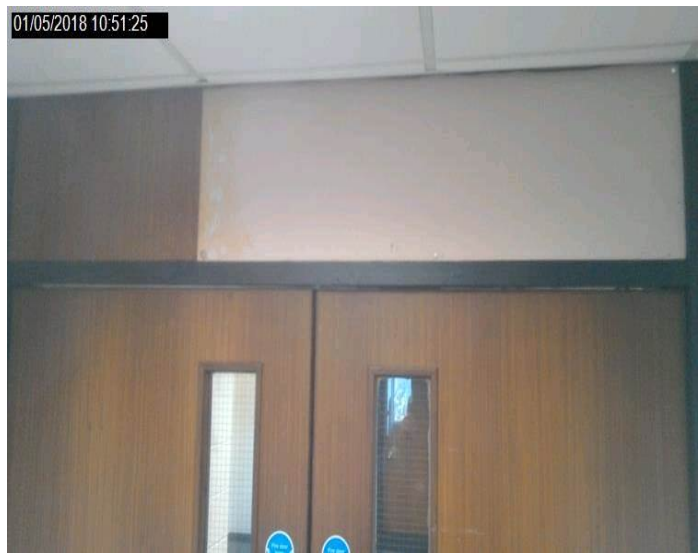
Location:	4.99A	Block:	University	Floor Level: 3rd Floor
Sample No.:	DU001485	Portal Ref No.:	500

Item:	Insulating board door header panel			
Asbestos Content:		Result Based on:		
No Asbestos Detected		Analysis of sample using PLM		
Sample Analysed By:	Reg 13(1)	Extent:	4 m ²	
Comments: Double skin, double doors leading to adjoining corridor

Material Assessment Total Score: 0		Likelihood of Disturbance Assessment Total Score: 0		Management Assessment Licensable: Yes Recommendations: Not Applicable Reinspection Interval: Not Applicable Overall Risk Category: E0
Product Type:	0 Not Applicable	Location:	0 Not Applicable	
Condition:	0 Not Applicable	Accessibility:	0 Not Applicable	
Surface Treatment:	0 Not Applicable			
Asbestos Type:	0 Not Applicable	Extent Score:	0 Not Applicable

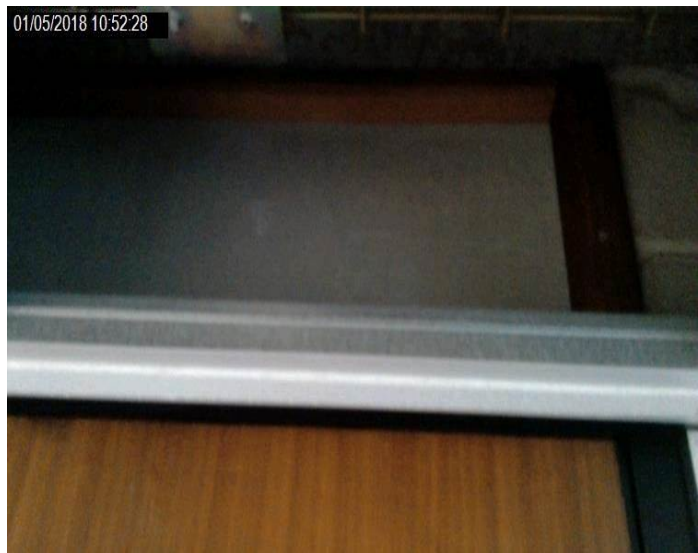
Location:	4.99A	Block:	University	Floor Level: 3rd Floor
Sample No.:	DU001486	Portal Ref No.:	501

Item:	Insulating board door header panels			
Asbestos Content:		Result Based on:		
No Asbestos Detected		Analysis of sample using PLM		
Sample Analysed By:	Reg 13(1)	Extent:	7 m ²	
Comments: Above doors leading to rooms, 4.21,22,23,25,26 and 4.27 visually similar product throughout

Material Assessment Total Score: 0		Likelihood of Disturbance Assessment Total Score: 0		Management Assessment Licensable: Yes Recommendations: Not Applicable Reinspection Interval: Not Applicable Overall Risk Category: E0
Product Type:	0 Not Applicable	Location:	0 Not Applicable	
Condition:	0 Not Applicable	Accessibility:	0 Not Applicable	
Surface Treatment:	0 Not Applicable			
Asbestos Type:	0 Not Applicable	Extent Score:	0 Not Applicable

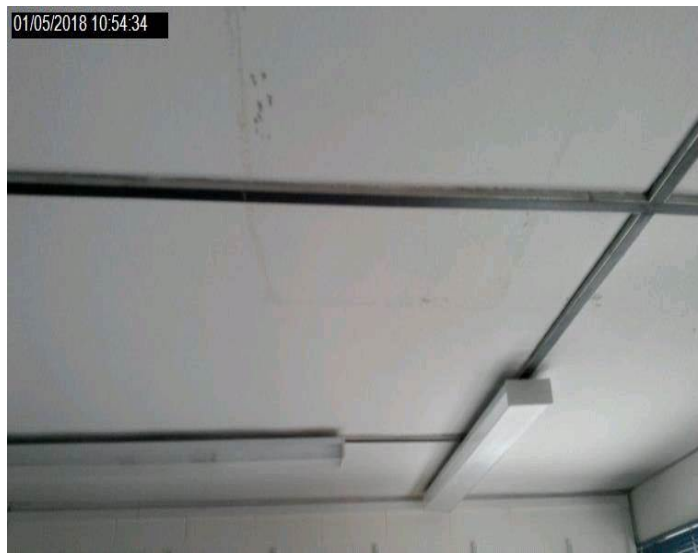
Location:	4.20	Block:	University	Floor Level: 3rd Floor
Sample No.:	As DU001481	Portal Ref No.:	502

Item:	Textured coating to concrete ceiling			
Asbestos Content:		Result Based on:		
No Asbestos Detected		Strongly presumed		
Sample Analysed By:	Not applicable	Extent:	16 m ²	
Comments:

Material Assessment Total Score: 0		Likelihood of Disturbance Assessment Total Score: 0		Management Assessment Licensable: No Recommendations: Not Applicable Reinspection Interval: Not Applicable Overall Risk Category: E0
Product Type:	0 Not Applicable	Location:	0 Not Applicable	
Condition:	0 Not Applicable	Accessibility:	0 Not Applicable	
Surface Treatment:	0 Not Applicable			
Asbestos Type:	0 Not Applicable	Extent Score:	0 Not Applicable

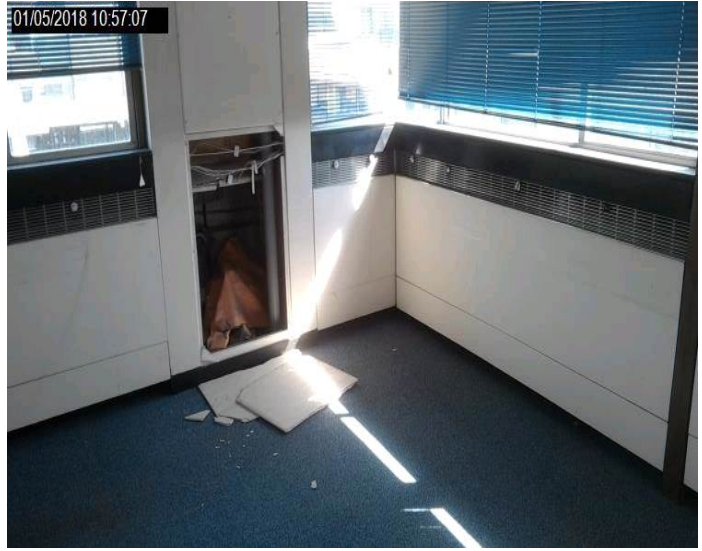
Location:	4.19	Block:	University	Floor Level: 3rd Floor
Sample No.:	As DU001482	Portal Ref No.:	506

Item:	Asbestos Cement window sill			
Asbestos Content:	Result Based on:			
Chrysotile	Strongly presumed			
Sample Analysed By:	Not applicable	Extent:	8 linear metres	
Comments:

Material Assessment Total Score: 4		Likelihood of Disturbance Assessment Total Score: 4		Management Assessment Licensable: No Recommendations: Program removal Reinspection Interval: Not Applicable Overall Risk Category: C8
Product Type:	1 (Asbestos cement)	Location:	2 (Rooms up to 100 sq m)	
Condition:	1 (Minor scratches)	Accessibility:	1 (Occasionally likely to be disturbed)	
Surface Treatment:	1 (Unencapsulated asbestos cement)			
Asbestos Type:	1 (Chrysotile)	Extent Score:	1 (<10 sq m or 10m pipe run)

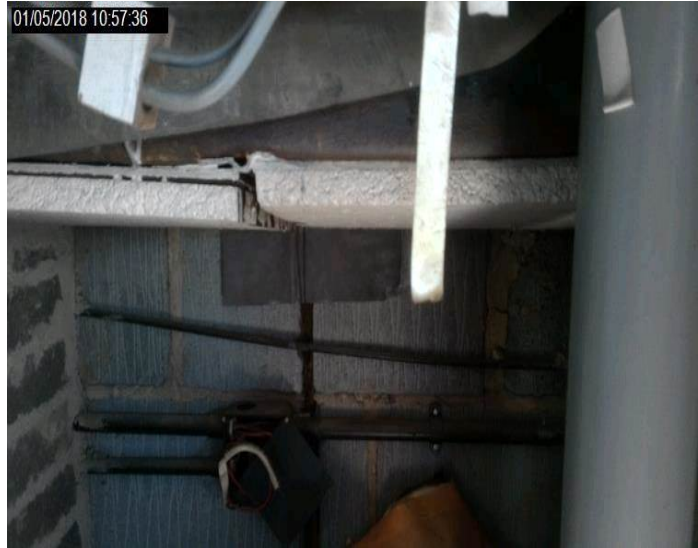
Location:	4.19	Block:	University	Floor Level: 3rd Floor
Sample No.:	As DU001483	Portal Ref No.:	507

Item:	Asbestos Cement shuttering			
Asbestos Content:	Result Based on:			
Chrysotile	Strongly presumed			
Sample Analysed By:	Not applicable	Extent:	8 m ²	
Comments: To ceiling of wall void behind polystyrene sheets

Material Assessment Total Score: 4		Likelihood of Disturbance Assessment Total Score: 4		Management Assessment Licensable: No Recommendations: Program removal Reinspection Interval: Not Applicable Overall Risk Category: C8
Product Type:	1 (Asbestos cement)	Location:	2 (Rooms up to 100 sq m)	
Condition:	1 (Minor scratches)	Accessibility:	1 (Occasionally likely to be disturbed)	
Surface Treatment:	1 (Encapsulated asbestos cement)			
Asbestos Type:	1 (Chrysotile)	Extent Score:	1 (<10 sq m or 10m pipe run)

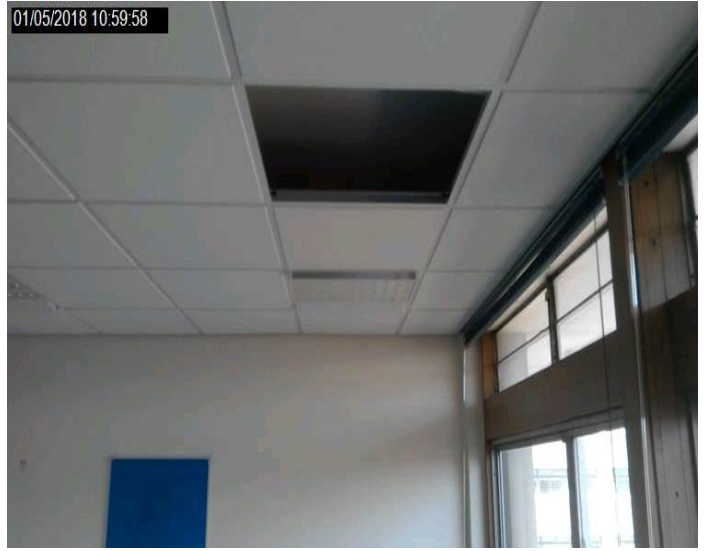
Location:	4.18	Block:	University	Floor Level: 3rd Floor
Sample No.:	As DU001481	Portal Ref No.:	509

Item:	Textured coating to concrete ceiling			
Asbestos Content:		Result Based on:		
No Asbestos Detected		Strongly presumed		
Sample Analysed By:	Not applicable	Extent:	12 m ²	
Comments: Above suspended ceiling tiles

Material Assessment Total Score: 0		Likelihood of Disturbance Assessment Total Score: 0		Management Assessment Licensable: No Recommendations: Not Applicable Reinspection Interval: Not Applicable Overall Risk Category: E0
Product Type:	0 Not Applicable	Location:	0 Not Applicable	
Condition:	0 Not Applicable	Accessibility:	0 Not Applicable	
Surface Treatment:	0 Not Applicable			
Asbestos Type:	0 Not Applicable	Extent Score:	0 Not Applicable

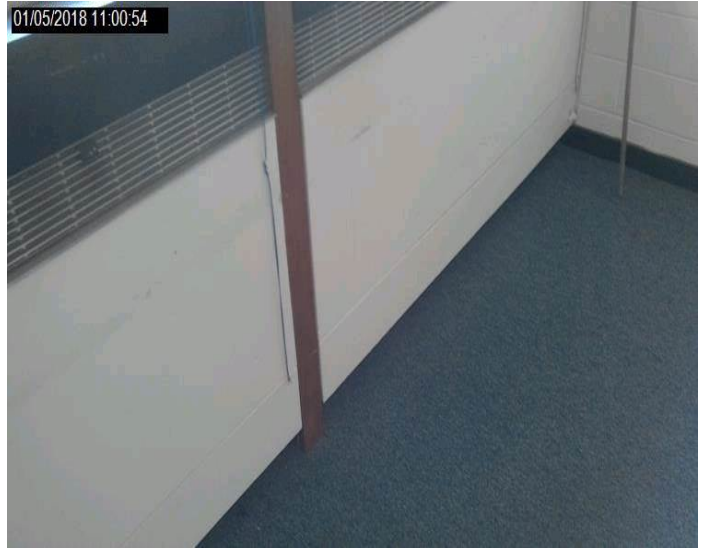
Location:	4.18	Block:	University	Floor Level: 3rd Floor
Sample No.:	As DU001483	Portal Ref No.:	511

Item:	Asbestos Cement shuttering			
Asbestos Content:	Result Based on:			
Chrysotile	Strongly presumed			
Sample Analysed By:	Not applicable	Extent:	4 m ²	
Comments: To ceiling of wall void behind polystyrene sheets

Material Assessment Total Score: 4		Likelihood of Disturbance Assessment Total Score: 4		Management Assessment Licensable: No Recommendations: Program removal Reinspection Interval: Not Applicable Overall Risk Category: C8
Product Type:	1 (Asbestos cement)	Location:	2 (Rooms up to 100 sq m)	
Condition:	1 (Minor scratches)	Accessibility:	1 (Occasionally likely to be disturbed)	
Surface Treatment:	1 (Encapsulated asbestos cement)			
Asbestos Type:	1 (Chrysotile)	Extent Score:	1 (<10 sq m or 10m pipe run)

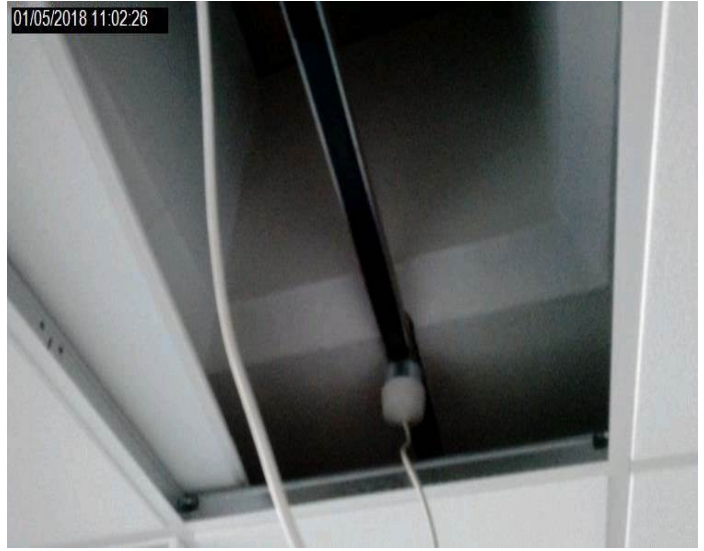
Location:	4.17	Block:	University	Floor Level: 3rd Floor
Sample No.:	As DU001481	Portal Ref No.:	512

Item:	Textured coating to concrete ceiling			
Asbestos Content:	Result Based on:			
No Asbestos Detected	Strongly presumed			
Sample Analysed By:	Not applicable	Extent:	16 m ²	
Comments:

Material Assessment Total Score: 0		Likelihood of Disturbance Assessment Total Score: 0		Management Assessment Licensable: No Recommendations: Not Applicable Reinspection Interval: Not Applicable Overall Risk Category: E0
Product Type:	0 Not Applicable	Location:	0 Not Applicable	
Condition:	0 Not Applicable	Accessibility:	0 Not Applicable	
Surface Treatment:	0 Not Applicable			
Asbestos Type:	0 Not Applicable	Extent Score:	0 Not Applicable

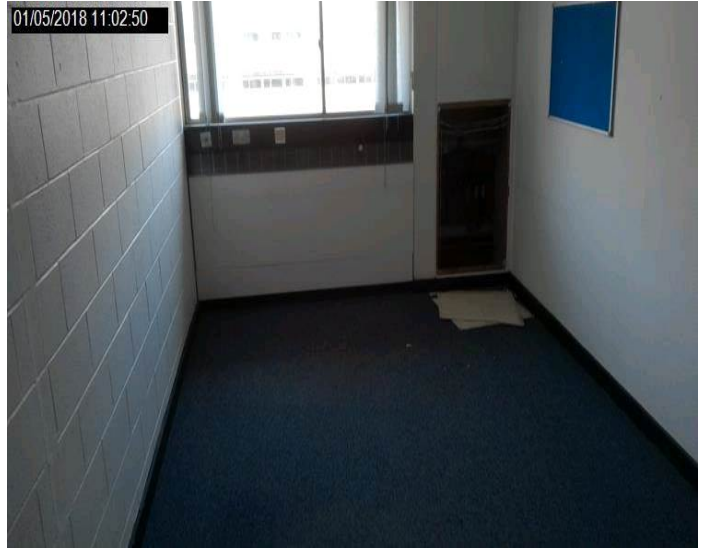
Location:	4.17	Block:	University	Floor Level: 3rd Floor
Sample No.:	As DU001482	Portal Ref No.:	513

Item:	Asbestos Cement window sill			
Asbestos Content:	Result Based on:			
Chrysotile	Strongly presumed			
Sample Analysed By:	Not applicable	Extent:	2 linear metres	
Comments:

Material Assessment Total Score: 4		Likelihood of Disturbance Assessment Total Score: 4		Management Assessment Licensable: No Recommendations: Program removal Reinspection Interval: Not Applicable Overall Risk Category: C8
Product Type:	1 (Asbestos cement)	Location:	2 (Rooms up to 100 sq m)	
Condition:	1 (Minor scratches)	Accessibility:	1 (Occasionally likely to be disturbed)	
Surface Treatment:	1 (Unencapsulated asbestos cement)			
Asbestos Type:	1 (Chrysotile)	Extent Score:	1 (<10 sq m or 10m pipe run)

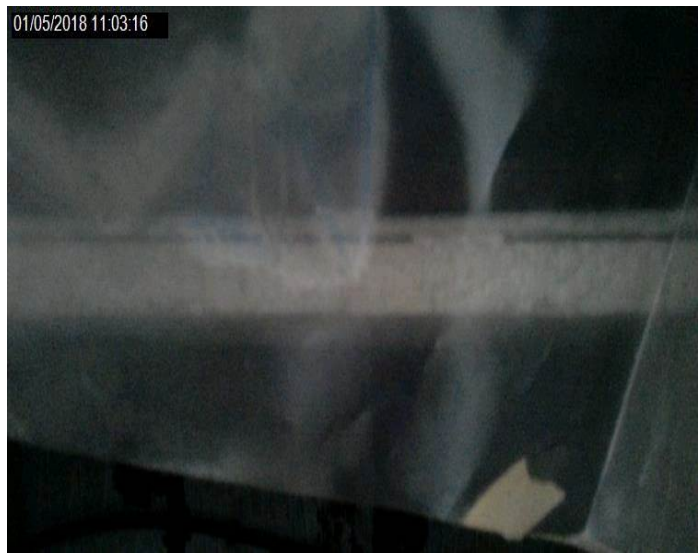
Location:	4.17	Block:	University	Floor Level: 3rd Floor
Sample No.:	As DU001483	Portal Ref No.:	514

Item:	Asbestos Cement shuttering			
Asbestos Content:	Result Based on:			
Chrysotile	Strongly presumed			
Sample Analysed By:	Not applicable	Extent:	3 m ²	
Comments: To ceiling of wall void behind polystyrene sheets

Material Assessment Total Score: 4		Likelihood of Disturbance Assessment Total Score: 4		Management Assessment Licensable: No Recommendations: Program removal Reinspection Interval: Not Applicable Overall Risk Category: C8
Product Type:	1 (Asbestos cement)	Location:	2 (Rooms up to 100 sq m)	
Condition:	1 (Minor scratches)	Accessibility:	1 (Occasionally likely to be disturbed)	
Surface Treatment:	1 (Encapsulated asbestos cement)			
Asbestos Type:	1 (Chrysotile)	Extent Score:	1 (<10 sq m or 10m pipe run)

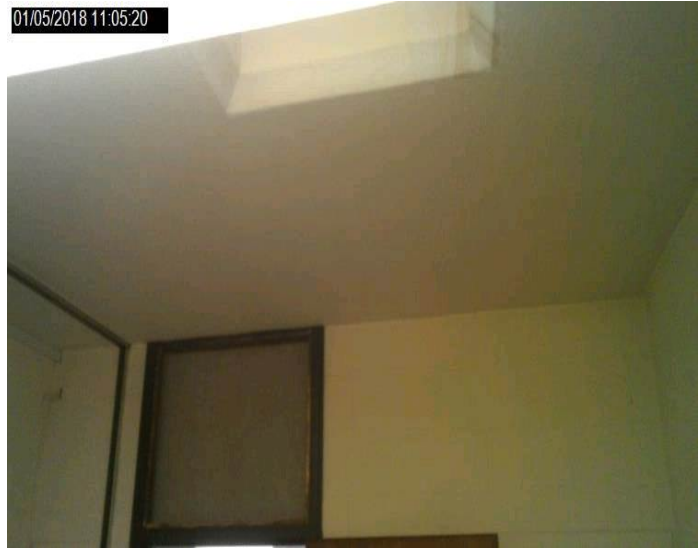
Location:	4.33	Block:	University	Floor Level: 3rd Floor
Sample No.:	As DU001481	Portal Ref No.:	516

Item:	Textured coating to concrete ceiling			
Asbestos Content:		Result Based on:		
No Asbestos Detected		Strongly presumed		
Sample Analysed By:	Not applicable	Extent:	12 m ²	
Comments:

Material Assessment Total Score: 0		Likelihood of Disturbance Assessment Total Score: 0		Management Assessment Licensable: No Recommendations: Not Applicable Reinspection Interval: Not Applicable Overall Risk Category: E0
Product Type:	0 Not Applicable	Location:	0 Not Applicable	
Condition:	0 Not Applicable	Accessibility:	0 Not Applicable	
Surface Treatment:	0 Not Applicable			
Asbestos Type:	0 Not Applicable	Extent Score:	0 Not Applicable

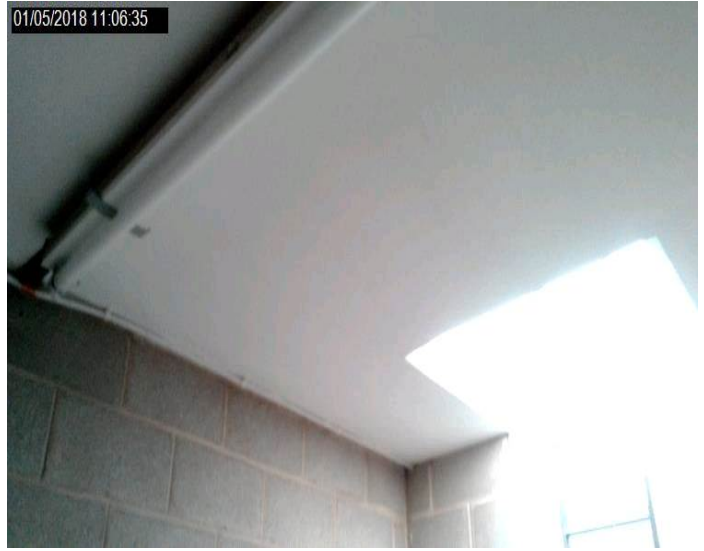
Location:	4.33A	Block:	University	Floor Level: 3rd Floor
Sample No.:	As DU001481	Portal Ref No.:	517

Item:	Textured coating to concrete ceiling			
Asbestos Content:		Result Based on:		
No Asbestos Detected		Strongly presumed		
Sample Analysed By:	Not applicable	Extent:	8 m ²	
Comments:

Material Assessment Total Score: 0		Likelihood of Disturbance Assessment Total Score: 0		Management Assessment Licensable: No Recommendations: Not Applicable Reinspection Interval: Not Applicable Overall Risk Category: E0
Product Type:	0 Not Applicable	Location:	0 Not Applicable	
Condition:	0 Not Applicable	Accessibility:	0 Not Applicable	
Surface Treatment:	0 Not Applicable			
Asbestos Type:	0 Not Applicable	Extent Score:	0 Not Applicable

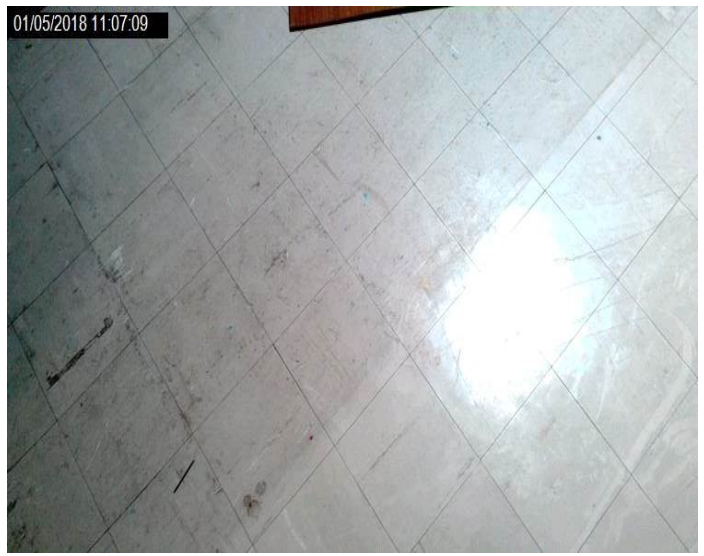
Location:	4.33A	Block:	University	Floor Level: 3rd Floor
Sample No.:	DU001488	Portal Ref No.:	518

Item:	Asbestos Thermoplastic floor tiles with bitumen adhesive			
Asbestos Content:	Result Based on:			
Chrysotile in adhesive only	Analysis of sample using PLM			
Sample Analysed By: Reg 13(1)	Extent:	8 m ²		
Comments:

Material Assessment Total Score: 3		Likelihood of Disturbance Assessment Total Score: 6		Management Assessment Licensable: No Recommendations: Program removal Reinspection Interval: Not Applicable Overall Risk Category: C9
Product Type:	1 (Asbestos thermoplastic)	Location:	2 (Rooms up to 100 sq m)	
Condition:	1 (Minor scratches)	Accessibility:	3 (Routinely disturbed)	
Surface Treatment:	0 (Composite material)			
Asbestos Type:	1 (Chrysotile)	Extent Score:	1 (<10 sq m or 10m pipe run)

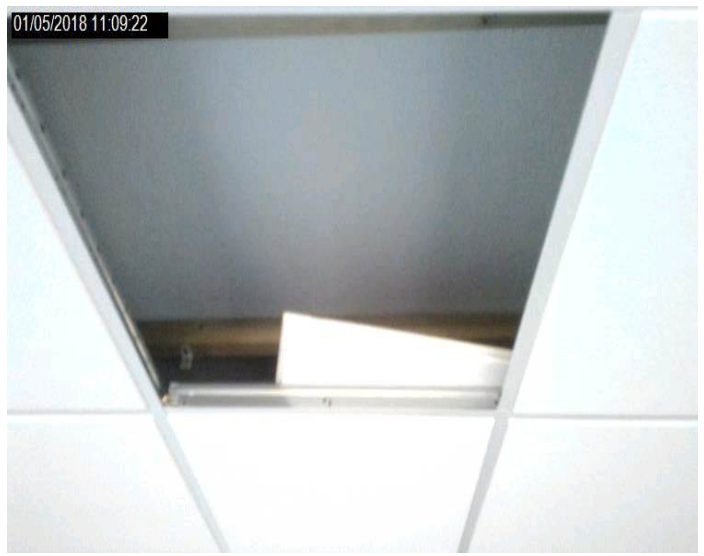
Location:	4.16	Block:	University	Floor Level: 3rd Floor
Sample No.:	As DU001481	Portal Ref No.:	519

Item:	Textured coating to concrete ceiling			
Asbestos Content:		Result Based on:		
No Asbestos Detected		Strongly presumed		
Sample Analysed By:	Not applicable	Extent:	12 m ²	
Comments: Above suspended ceiling tiles

Material Assessment Total Score: 0		Likelihood of Disturbance Assessment Total Score: 0		Management Assessment Licensable: No Recommendations: Not Applicable Reinspection Interval: Not Applicable Overall Risk Category: E0
Product Type:	0 Not Applicable	Location:	0 Not Applicable	
Condition:	0 Not Applicable	Accessibility:	0 Not Applicable	
Surface Treatment:	0 Not Applicable			
Asbestos Type:	0 Not Applicable	Extent Score:	0 Not Applicable

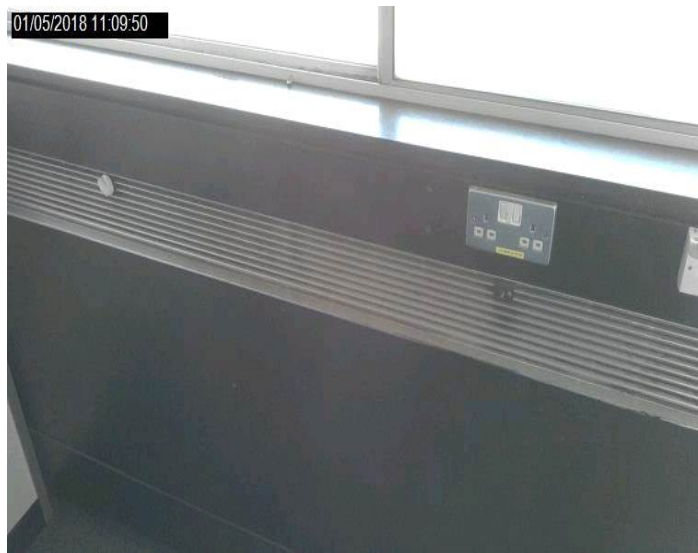
Location:	4.16	Block:	University	Floor Level: 3rd Floor
Sample No.:	As DU001482	Portal Ref No.:	520

Item:	Asbestos Cement window sill			
Asbestos Content:	Result Based on:			
Chrysotile	Strongly presumed			
Sample Analysed By:	Not applicable	Extent:	2 linear metres	
Comments:

Material Assessment Total Score: 4		Likelihood of Disturbance Assessment Total Score: 4		Management Assessment Licensable: No Recommendations: Program removal Reinspection Interval: Not Applicable Overall Risk Category: C8
Product Type:	1 (Asbestos cement)	Location:	2 (Rooms up to 100 sq m)	
Condition:	1 (Minor scratches)	Accessibility:	1 (Occasionally likely to be disturbed)	
Surface Treatment:	1 (Unencapsulated asbestos cement)			
Asbestos Type:	1 (Chrysotile)	Extent Score:	1 (<10 sq m or 10m pipe run)

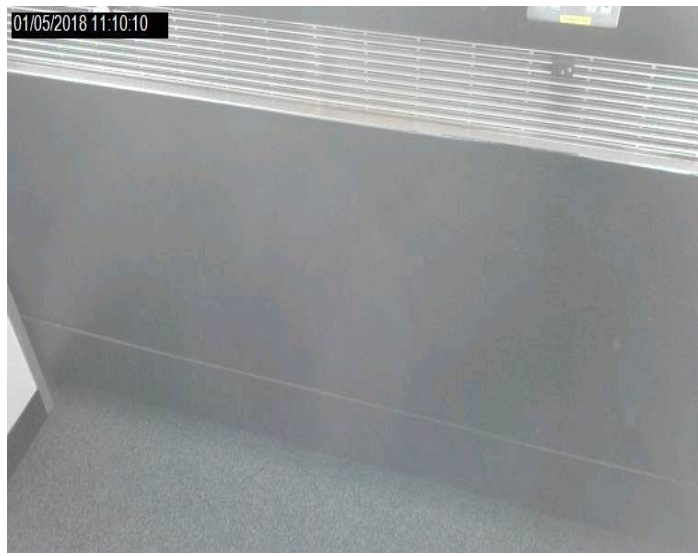
Location:	4.16	Block:	University	Floor Level: 3rd Floor
Sample No.:	As DU001483	Portal Ref No.:	521

Item:	Asbestos Cement shuttering			
Asbestos Content:	Result Based on:			
Chrysotile	Strongly presumed			
Sample Analysed By:	Not applicable	Extent:	2 m ²	
Comments: To ceiling of wall void behind polystyrene sheets

Material Assessment Total Score: 4		Likelihood of Disturbance Assessment Total Score: 4		Management Assessment Licensable: No Recommendations: Program removal Reinspection Interval: Not Applicable Overall Risk Category: C8
Product Type:	1 (Asbestos cement)	Location:	2 (Rooms up to 100 sq m)	
Condition:	1 (Minor scratches)	Accessibility:	1 (Occasionally likely to be disturbed)	
Surface Treatment:	1 (Encapsulated asbestos cement)			
Asbestos Type:	1 (Chrysotile)	Extent Score:	1 (<10 sq m or 10m pipe run)

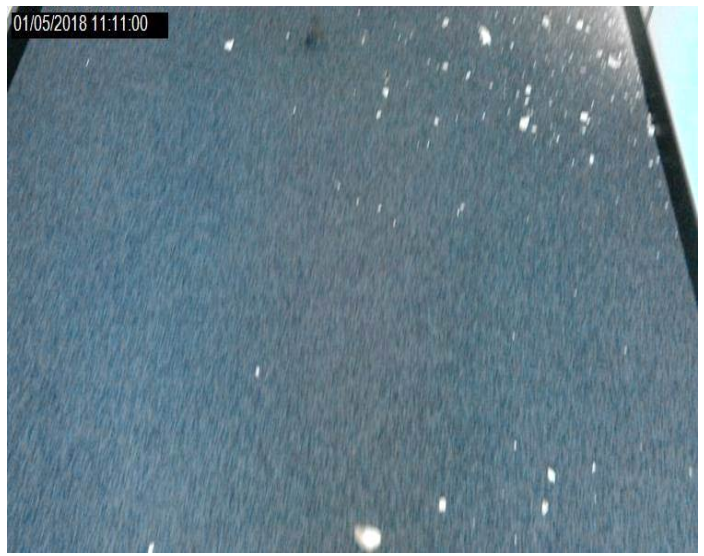
Location:	4.16	Block:	University	Floor Level: 3rd Floor
Sample No.:	As DU001488	Portal Ref No.:	522

Item:	Asbestos Thermoplastic floor tiles with bitumen adhesive			
Asbestos Content:	Result Based on:			
Chrysotile in adhesive only	Strongly presumed			
Sample Analysed By:	Not applicable	Extent:	12 m ²	
Comments: Beneath carpet

Material Assessment Total Score: 3		Likelihood of Disturbance Assessment Total Score: 4		Management Assessment Licensable: No Recommendations: Program removal Reinspection Interval: Not Applicable Overall Risk Category: C7
Product Type:	1 (Asbestos thermoplastic)	Location:	2 (Rooms up to 100 sq m)	
Condition:	1 (Minor scratches)	Accessibility:	0 (Usually inaccessible or unlikely to be disturbed)	
Surface Treatment:	0 (Composite material)			
Asbestos Type:	1 (Chrysotile)	Extent Score:	2 (>10 - <50 sq m or >10m - <50m pipe run)

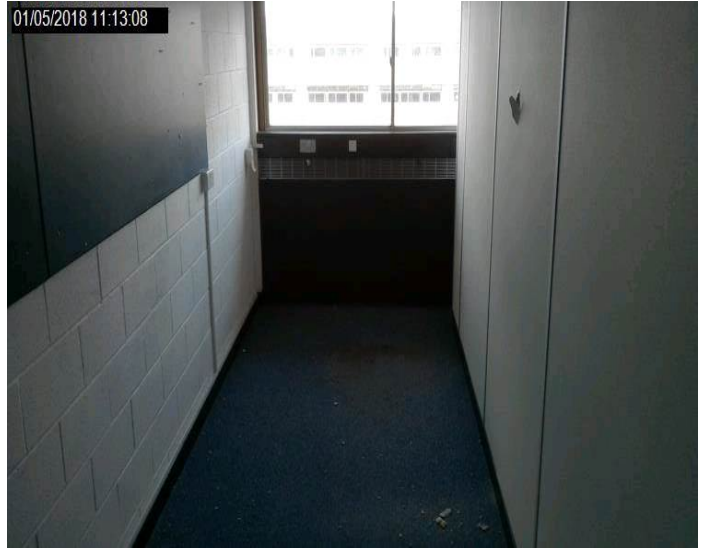
Location:	4.15A	Block:	University	Floor Level: 3rd Floor
Sample No.:	As DU001483	Portal Ref No.:	525

Item:	Asbestos Cement shuttering			
Asbestos Content:	Result Based on:			
Chrysotile	Strongly presumed			
Sample Analysed By:	Not applicable	Extent:	2 m ²	
Comments: To ceiling of wall void behind polystyrene sheets

Material Assessment Total Score: 4		Likelihood of Disturbance Assessment Total Score: 4		Management Assessment Licensable: No Recommendations: Program removal Reinspection Interval: Not Applicable Overall Risk Category: C8
Product Type:	1 (Asbestos cement)	Location:	2 (Rooms up to 100 sq m)	
Condition:	1 (Minor scratches)	Accessibility:	1 (Occasionally likely to be disturbed)	
Surface Treatment:	1 (Encapsulated asbestos cement)			
Asbestos Type:	1 (Chrysotile)	Extent Score:	1 (<10 sq m or 10m pipe run)

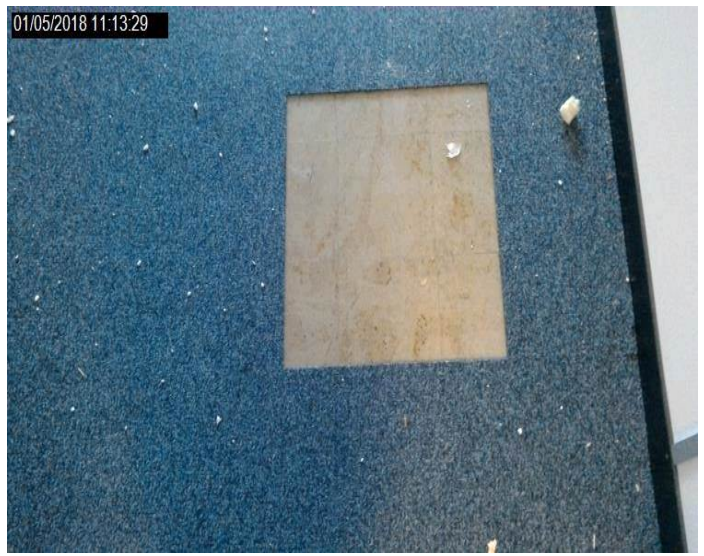
Location:	4.15A	Block:	University	Floor Level: 3rd Floor
Sample No.:	As DU001488	Portal Ref No.:	526

Item:	Asbestos Thermoplastic floor tiles with bitumen adhesive			
Asbestos Content:	Result Based on:			
Chrysotile in adhesive only	Strongly presumed			
Sample Analysed By:	Not applicable	Extent:	10 m ²	
Comments: Beneath carpet

Material Assessment Total Score: 3		Likelihood of Disturbance Assessment Total Score: 4		Management Assessment Licensable: No Recommendations: Program removal Reinspection Interval: Not Applicable Overall Risk Category: C7
Product Type:	1 (Asbestos thermoplastic)	Location:	2 (Rooms up to 100 sq m)	
Condition:	1 (Minor scratches)	Accessibility:	0 (Usually inaccessible or unlikely to be disturbed)	
Surface Treatment:	0 (Composite material)			
Asbestos Type:	1 (Chrysotile)	Extent Score:	2 (>10 - <50 sq m or >10m - <50m pipe run)

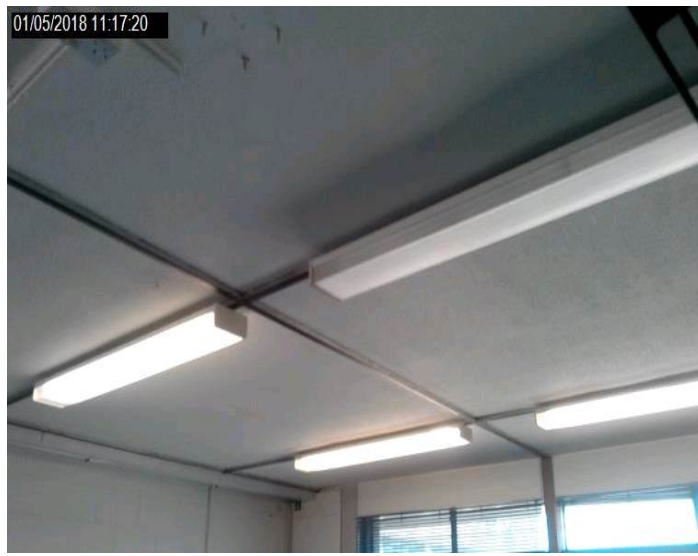
Location:	4.15	Block:	University	Floor Level: 3rd Floor
Sample No.:	As DU001481	Portal Ref No.:	527

Item:	Textured coating to concrete			
Asbestos Content:		Result Based on:		
No Asbestos Detected		Strongly presumed		
Sample Analysed By:	Not applicable	Extent:	50 m ²	
Comments: Above suspended ceiling tiles

Material Assessment Total Score: 0		Likelihood of Disturbance Assessment Total Score: 0		Management Assessment Licensable: No Recommendations: Not Applicable Reinspection Interval: Not Applicable Overall Risk Category: E0
Product Type:	0 Not Applicable	Location:	0 Not Applicable	
Condition:	0 Not Applicable	Accessibility:	0 Not Applicable	
Surface Treatment:	0 Not Applicable			
Asbestos Type:	0 Not Applicable	Extent Score:	0 Not Applicable

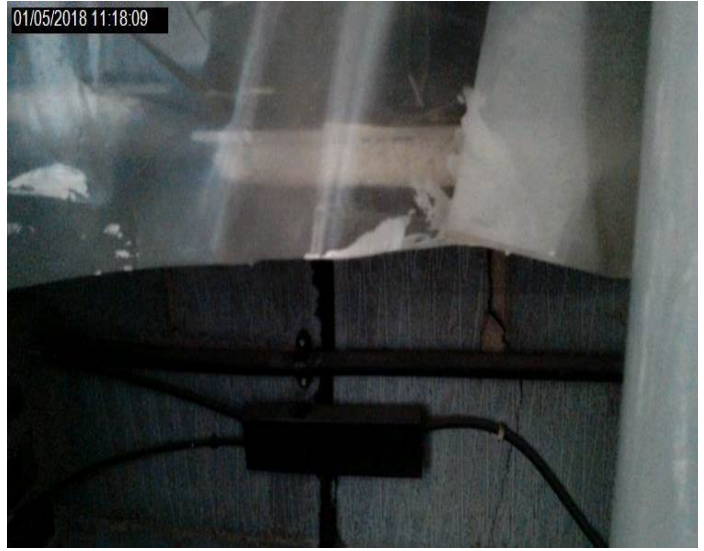
Location:	4.15	Block:	University	Floor Level: 3rd Floor
Sample No.:	As DU001483	Portal Ref No.:	529

Item:	Asbestos Cement shuttering			
Asbestos Content:	Result Based on:			
Chrysotile	Strongly presumed			
Sample Analysed By:	Not applicable	Extent:	7 m ²	
Comments: To ceiling of wall void behind polystyrene sheets

Material Assessment Total Score: 4		Likelihood of Disturbance Assessment Total Score: 4		Management Assessment Licensable: No Recommendations: Program removal Reinspection Interval: Not Applicable Overall Risk Category: C8
Product Type:	1 (Asbestos cement)	Location:	2 (Rooms up to 100 sq m)	
Condition:	1 (Minor scratches)	Accessibility:	1 (Occasionally likely to be disturbed)	
Surface Treatment:	1 (Encapsulated asbestos cement)			
Asbestos Type:	1 (Chrysotile)	Extent Score:	1 (<10 sq m or 10m pipe run)
