Report No.: J094099
Nature of Work: Demolition Survey
Issue Date: 11/06/2018
Client Name: WYG Engineering Ltd
Geneva Building, Lake View Drive, Sherwood Business Park,
Annesley, Nottingham, NG15 0ED
Site Address: Dawson building, Former City North Campus, Birmingham City
University, Perry Barr, B42 2US

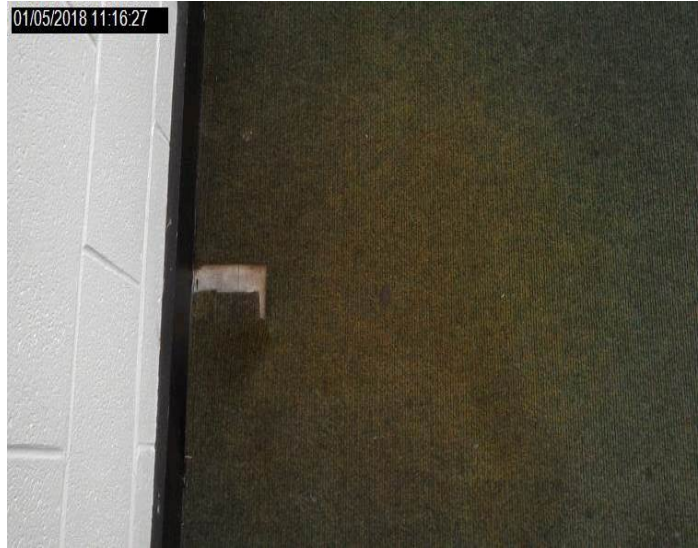
Location:	4.15	Block:	University	Floor Level: 3rd Floor
Sample No.:	DU001490	Portal Ref No.:	530

Item:	Asbestos Thermoplastic floor tiles with bitumen adhesive			
Asbestos Content:	Result Based on:			
Chrysotile in adhesive only	Analysis of sample using PLM			
Sample Analysed By: Reg 13(1)	Extent:	50 m ²		
Comments: Beneath carpet

Material Assessment Total Score: 3		Likelihood of Disturbance Assessment Total Score: 5		Management Assessment Licensable: No Recommendations: Program removal Reinspection Interval: Not Applicable Overall Risk Category: C8
Product Type:	1 (Asbestos thermoplastic)	Location:	2 (Rooms up to 100 sq m)	
Condition:	1 (Minor scratches)	Accessibility:	0 (Usually inaccessible or unlikely to be disturbed)	
Surface Treatment:	0 (Composite material)			
Asbestos Type:	1 (Chrysotile)	Extent Score:	3 (>50 sq m or >50m pipe run)

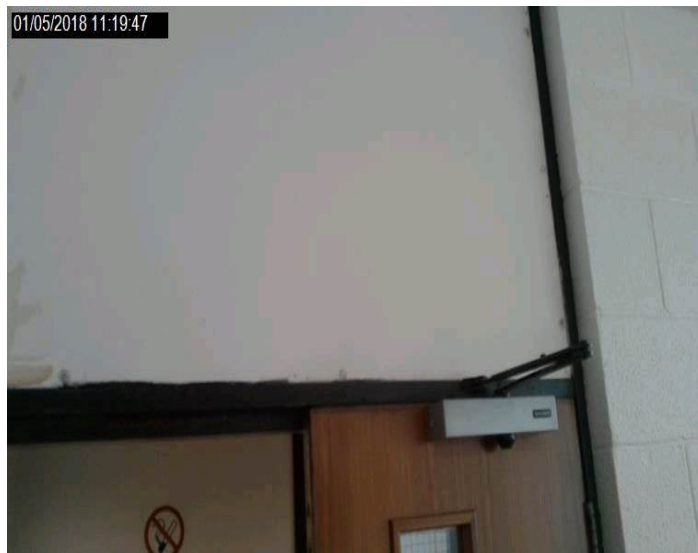
Location:	4.00A	Block:	University	Floor Level: 3rd Floor
Sample No.:	DU001491	Portal Ref No.:	532

Item:	Insulating board door header panel			
Asbestos Content:		Result Based on:		
No Asbestos Detected		Analysis of sample using PLM		
Sample Analysed By:	Reg 13(1)	Extent:	4 m ²	
Comments: Double skin, both double doors either side of the stairwell

Material Assessment Total Score: 0		Likelihood of Disturbance Assessment Total Score: 0		Management Assessment Licensable: Yes Recommendations: Not Applicable Reinspection Interval: Not Applicable Overall Risk Category: E0
Product Type:	0 Not Applicable	Location:	0 Not Applicable	
Condition:	0 Not Applicable	Accessibility:	0 Not Applicable	
Surface Treatment:	0 Not Applicable			
Asbestos Type:	0 Not Applicable	Extent Score:	0 Not Applicable

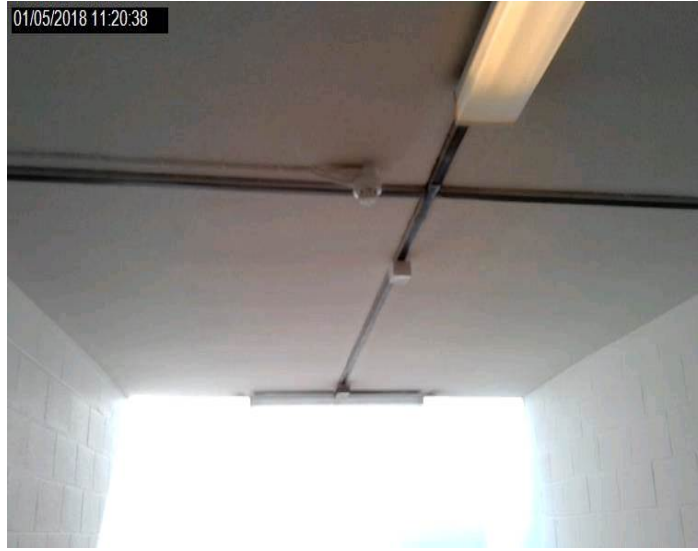
Location:	4.00A	Block:	University	Floor Level: 3rd Floor
Sample No.:	As DU001481	Portal Ref No.:	533

Item:	Textured coating to concrete ceiling			
Asbestos Content:		Result Based on:		
No Asbestos Detected		Strongly presumed		
Sample Analysed By:	Not applicable	Extent:	30 m ²	
Comments:

Material Assessment Total Score: 0		Likelihood of Disturbance Assessment Total Score: 0		Management Assessment Licensable: No Recommendations: Not Applicable Reinspection Interval: Not Applicable Overall Risk Category: E0
Product Type:	0 Not Applicable	Location:	0 Not Applicable	
Condition:	0 Not Applicable	Accessibility:	0 Not Applicable	
Surface Treatment:	0 Not Applicable			
Asbestos Type:	0 Not Applicable	Extent Score:	0 Not Applicable

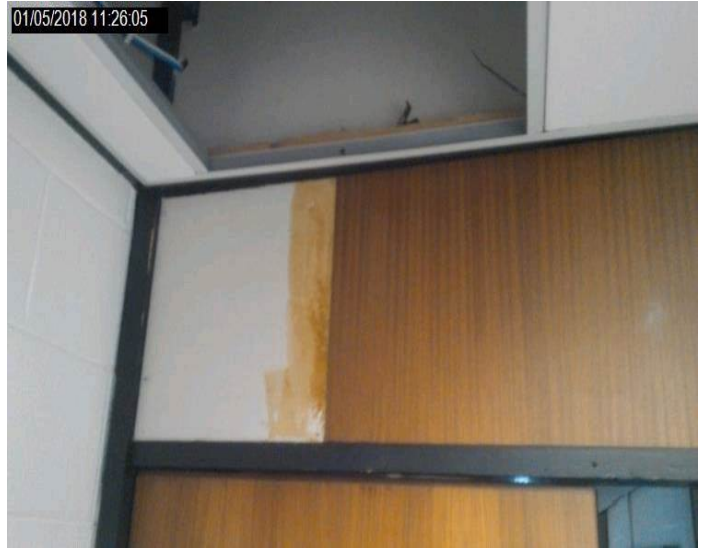
Location:	4.99B	Block:	University	Floor Level: 3rd Floor
Sample No.:	DU001493	Portal Ref No.:	535

Item:	Insulating board door header panel			
Asbestos Content:	Result Based on:			
No Asbestos Detected	Analysis of sample using PLM			
Sample Analysed By: Reg 13(1)	Extent:	4 m ²		
Comments: Above doors leading to adjoining corridor 4.99C, double skin

Material Assessment Total Score: 0		Likelihood of Disturbance Assessment Total Score: 0		Management Assessment Licensable: Yes Recommendations: Not Applicable Reinspection Interval: Not Applicable Overall Risk Category: E0
Product Type:	0 Not Applicable	Location:	0 Not Applicable	
Condition:	0 Not Applicable	Accessibility:	0 Not Applicable	
Surface Treatment:	0 Not Applicable			
Asbestos Type:	0 Not Applicable	Extent Score:	0 Not Applicable

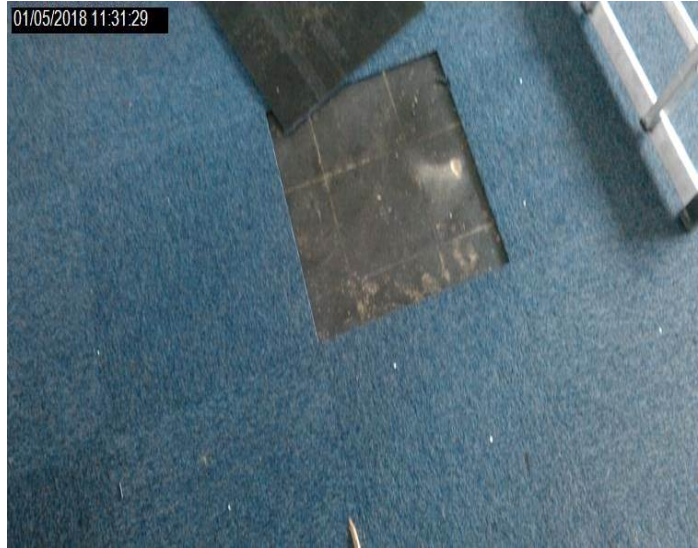
Location:	4.14	Block:	University	Floor Level: 3rd Floor
Sample No.:	DU001497	Portal Ref No.:	539

Item:	Asbestos Bitumen adhesive			
Asbestos Content:	Result Based on:			
Chrysotile	Analysis of sample using PLM			
Sample Analysed By: Reg 13(1)	Extent:	24 m ²		
Comments: Present beneath carpet

Material Assessment Total Score: 3		Likelihood of Disturbance Assessment Total Score: 4		Management Assessment Licensable: No Recommendations: Program removal Reinspection Interval: Not Applicable Overall Risk Category: C7
Product Type:	1 (Asbestos bitumen)	Location:	2 (Rooms up to 100 sq m)	
Condition:	1 (Minor scratches)	Accessibility:	0 (Usually inaccessible or unlikely to be disturbed)	
Surface Treatment:	0 (Composite material)			
Asbestos Type:	1 (Chrysotile)	Extent Score:	2 (>10 - <50 sq m or >10m - <50m pipe run)

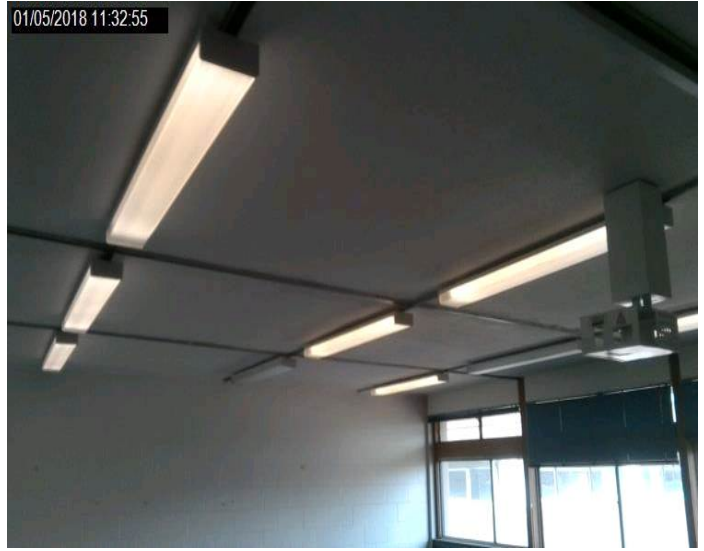
Location:	4.13	Block:	University	Floor Level: 3rd Floor
Sample No.:	As DU001494	Portal Ref No.:	540

Item:	Asbestos Textured coating to concrete			
Asbestos Content:	Result Based on:			
Chrysotile	Strongly presumed			
Sample Analysed By:	Not applicable	Extent:	50 m ²	
Comments:

Material Assessment Total Score: 3		Likelihood of Disturbance Assessment Total Score: 6		Management Assessment Licensable: No Recommendations: Program removal Reinspection Interval: Not Applicable Overall Risk Category: C9
Product Type:	1 (Asbestos textured coating)	Location:	2 (Rooms up to 100 sq m)	
Condition:	1 (Minor scratches)	Accessibility:	1 (Occasionally likely to be disturbed)	
Surface Treatment:	0 (Composite material)			
Asbestos Type:	1 (Chrysotile)	Extent Score:	3 (>50 sq m or >50m pipe run)

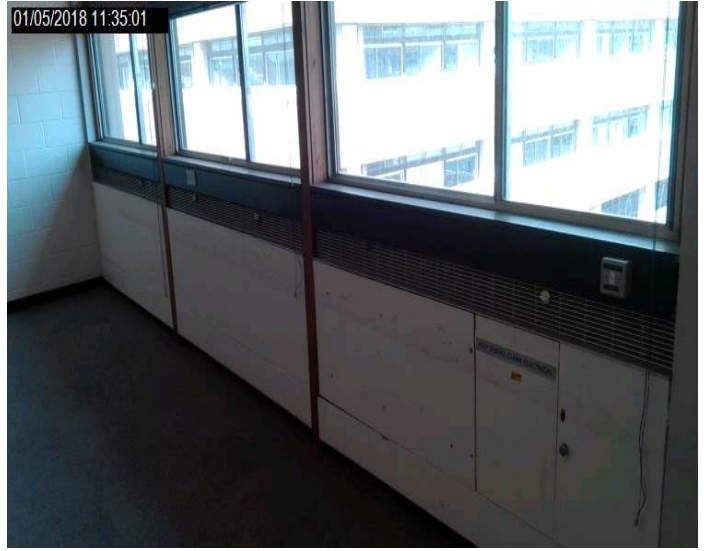
Location:	4.13	Block:	University	Floor Level: 3rd Floor
Sample No.:	As DU001495	Portal Ref No.:	541

Item:	Asbestos Cement window sill			
Asbestos Content:	Result Based on:			
Chrysotile	Strongly presumed			
Sample Analysed By:	Not applicable	Extent:	8 linear metres	
Comments:

Material Assessment Total Score: 4		Likelihood of Disturbance Assessment Total Score: 4		Management Assessment Licensable: No Recommendations: Program removal Reinspection Interval: Not Applicable Overall Risk Category: C8
Product Type:	1 (Asbestos cement)	Location:	2 (Rooms up to 100 sq m)	
Condition:	1 (Minor scratches)	Accessibility:	1 (Occasionally likely to be disturbed)	
Surface Treatment:	1 (Unencapsulated asbestos cement)			
Asbestos Type:	1 (Chrysotile)	Extent Score:	1 (<10 sq m or 10m pipe run)

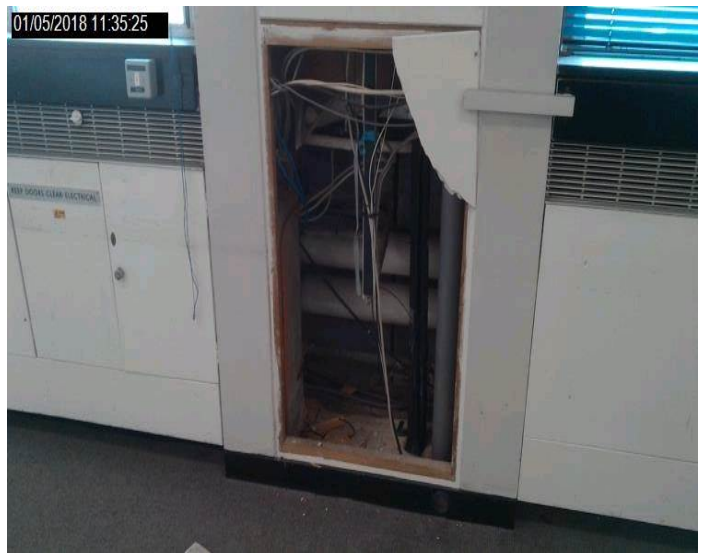
Location:	4.13	Block:	University	Floor Level: 3rd Floor
Sample No.:	As DU001496	Portal Ref No.:	542

Item:	Asbestos Cement shuttering			
Asbestos Content:	Result Based on:			
Chrysotile Amosite	Strongly presumed			
Sample Analysed By:	Not applicable	Extent:	8 m ²	
Comments: To ceiling of wall void behind polystyrene sheets

Material Assessment Total Score: 5		Likelihood of Disturbance Assessment Total Score: 4		Management Assessment Licensable: No Recommendations: Program removal Reinspection Interval: Not Applicable Overall Risk Category: C9
Product Type:	1 (Asbestos cement)	Location:	2 (Rooms up to 100 sq m)	
Condition:	1 (Minor scratches)	Accessibility:	1 (Occasionally likely to be disturbed)	
Surface Treatment:	1 (Encapsulated asbestos cement)			
Asbestos Type:	2 (Chrysotile Amosite)	Extent Score:	1 (<10 sq m or 10m pipe run)

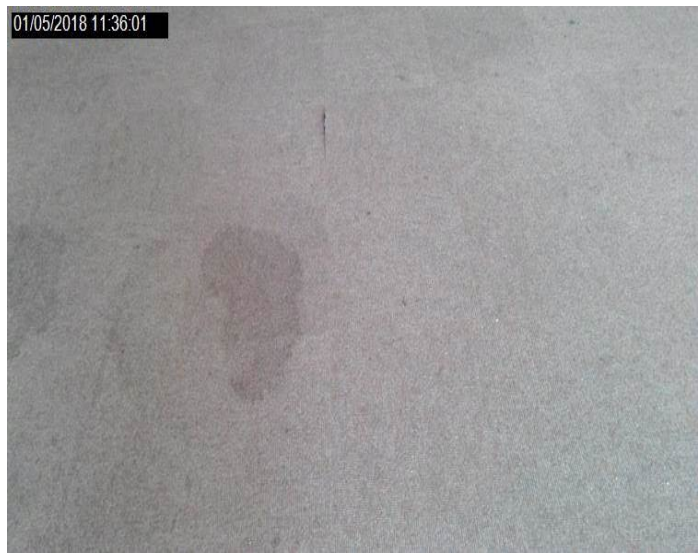
Location:	4.13	Block:	University	Floor Level: 3rd Floor
Sample No.:	DU001499	Portal Ref No.:	543

Item:	Asbestos Thermoplastic floor tiles with bitumen adhesive			
Asbestos Content:	Result Based on:			
Chrysotile	Analysis of sample using PLM			
Sample Analysed By: Reg 13(1)	Extent:	50 m ²		
Comments: Beneath carpet

Material Assessment Total Score: 3		Likelihood of Disturbance Assessment Total Score: 5		Management Assessment Licensable: No Recommendations: Program removal Reinspection Interval: Not Applicable Overall Risk Category: C8
Product Type:	1 (Asbestos thermoplastic)	Location:	2 (Rooms up to 100 sq m)	
Condition:	1 (Minor scratches)	Accessibility:	0 (Usually inaccessible or unlikely to be disturbed)	
Surface Treatment:	0 (Composite material)			
Asbestos Type:	1 (Chrysotile)	Extent Score:	3 (>50 sq m or >50m pipe run)

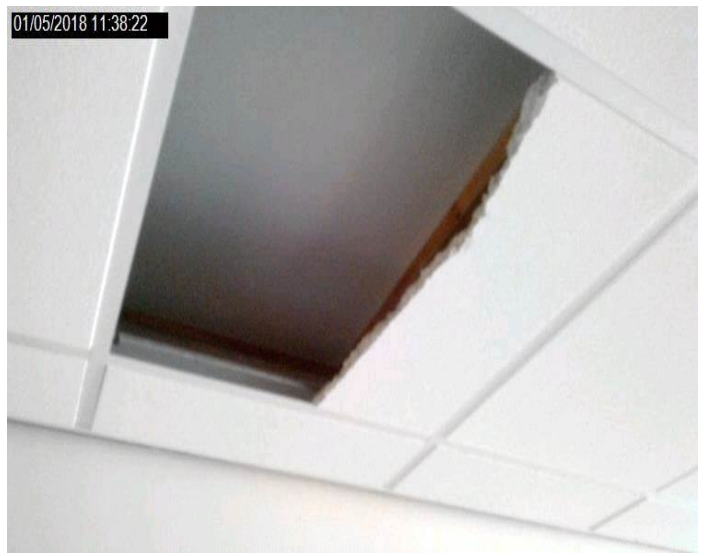
Location:	4.12	Block:	University	Floor Level: 3rd Floor
Sample No.:	As DU001494	Portal Ref No.:	545

Item:	Asbestos Textured coating to concrete ceiling			
Asbestos Content:	Result Based on:			
Chrysotile	Strongly presumed			
Sample Analysed By:	Not applicable	Extent:	16 m ²	
Comments: Above suspended ceiling tiles

Material Assessment Total Score: 3		Likelihood of Disturbance Assessment Total Score: 5		Management Assessment Licensable: No Recommendations: Program removal Reinspection Interval: Not Applicable Overall Risk Category: C8
Product Type:	1 (Asbestos textured coating)	Location:	2 (Rooms up to 100 sq m)	
Condition:	1 (Minor scratches)	Accessibility:	1 (Occasionally likely to be disturbed)	
Surface Treatment:	0 (Composite material)			
Asbestos Type:	1 (Chrysotile)	Extent Score:	2 (>10 - <50 sq m or >10m - <50m pipe run)

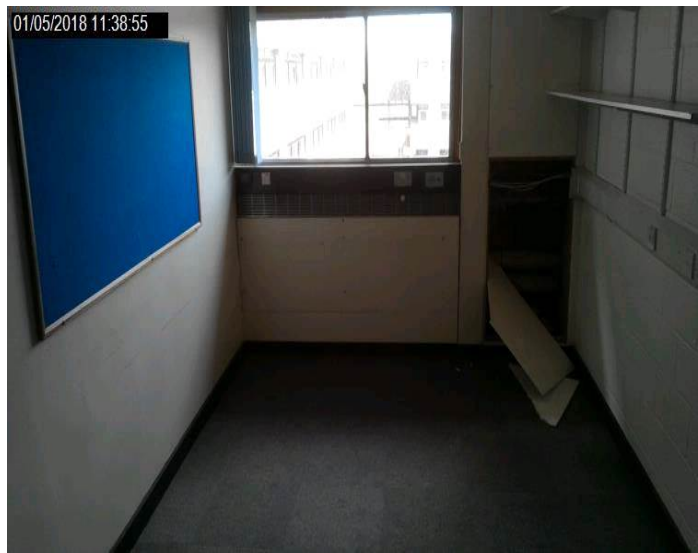
Location:	4.12	Block:	University	Floor Level: 3rd Floor
Sample No.:	As DU001495	Portal Ref No.:	546

Item:	Asbestos Cement window sill			
Asbestos Content:	Result Based on:			
Chrysotile	Strongly presumed			
Sample Analysed By:	Not applicable	Extent:	2 linear metres	
Comments:

Material Assessment Total Score: 4		Likelihood of Disturbance Assessment Total Score: 4		Management Assessment Licensable: No Recommendations: Program removal Reinspection Interval: Not Applicable Overall Risk Category: C8
Product Type:	1 (Asbestos cement)	Location:	2 (Rooms up to 100 sq m)	
Condition:	1 (Minor scratches)	Accessibility:	1 (Occasionally likely to be disturbed)	
Surface Treatment:	1 (Unencapsulated asbestos cement)			
Asbestos Type:	1 (Chrysotile)	Extent Score:	1 (<10 sq m or 10m pipe run)

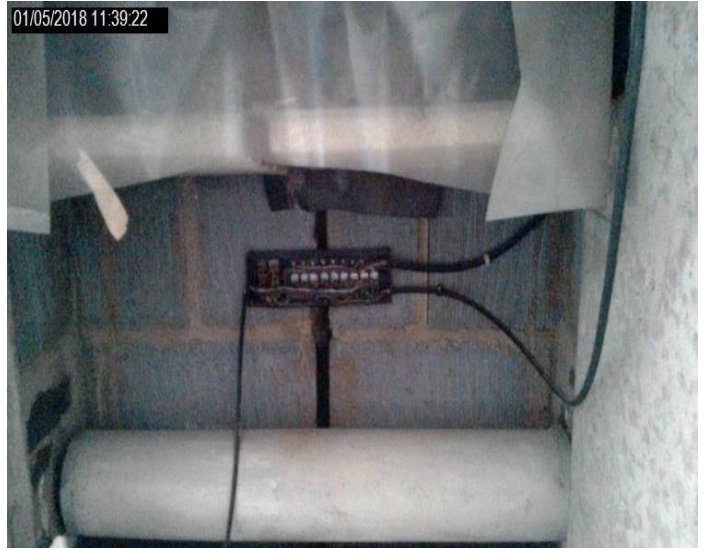
Location:	4.12	Block:	University	Floor Level: 3rd Floor
Sample No.:	As DU001496	Portal Ref No.:	547

Item:	Asbestos Cement shuttering			
Asbestos Content:	Result Based on:			
Chrysotile Amosite	Strongly presumed			
Sample Analysed By:	Not applicable	Extent:	3 m ²	
Comments: To ceiling of wall void behind polystyrene sheets

Material Assessment Total Score: 5		Likelihood of Disturbance Assessment Total Score: 4		Management Assessment Licensable: No Recommendations: Program removal Reinspection Interval: Not Applicable Overall Risk Category: C9
Product Type:	1 (Asbestos cement)	Location:	2 (Rooms up to 100 sq m)	
Condition:	1 (Minor scratches)	Accessibility:	1 (Occasionally likely to be disturbed)	
Surface Treatment:	1 (Encapsulated asbestos cement)			
Asbestos Type:	2 (Chrysotile Amosite)	Extent Score:	1 (<10 sq m or 10m pipe run)

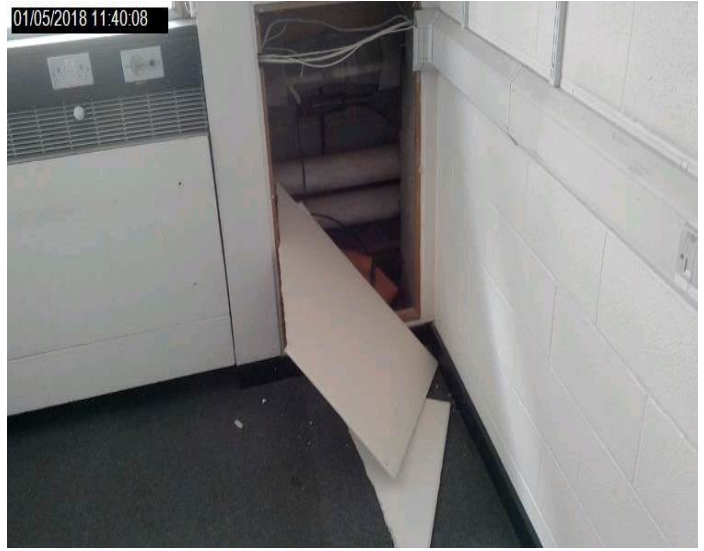
Location:	4.12	Block:	University	Floor Level: 3rd Floor
Sample No.:	As DU001498	Portal Ref No.:	549

Item:	Insulating board panel to riser			
Asbestos Content:		Result Based on:		
No Asbestos Detected		Strongly presumed		
Sample Analysed By:	Not applicable	Extent:	3 m ²	
Comments:

Material Assessment Total Score: 0		Likelihood of Disturbance Assessment Total Score: 0		Management Assessment Licensable: Yes Recommendations: Not Applicable Reinspection Interval: Not Applicable Overall Risk Category: E0
Product Type:	0 Not Applicable	Location:	0 Not Applicable	
Condition:	0 Not Applicable	Accessibility:	0 Not Applicable	
Surface Treatment:	0 Not Applicable			
Asbestos Type:	0 Not Applicable	Extent Score:	0 Not Applicable

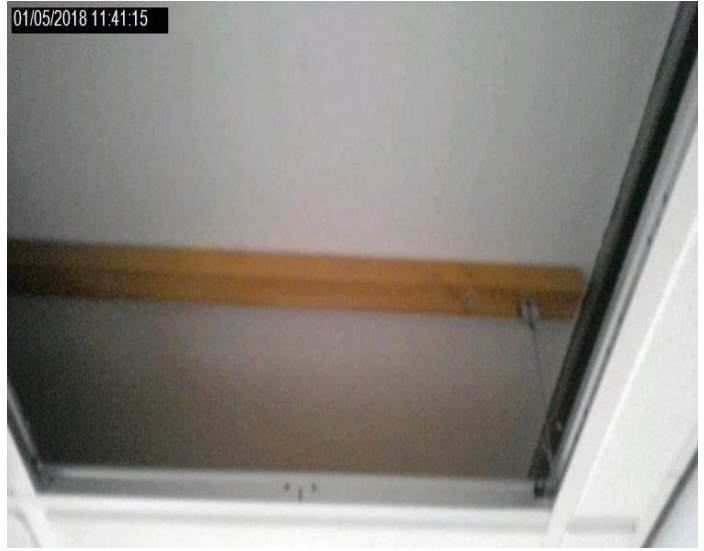
Location:	4.12A	Block:	University	Floor Level: 3rd Floor
Sample No.:	As DU001494	Portal Ref No.:	550

Item:	Asbestos Textured coating to concrete ceiling			
Asbestos Content:	Result Based on:			
Chrysotile	Strongly presumed			
Sample Analysed By:	Not applicable	Extent:	14 m ²	
Comments: Above suspended ceiling tiles

Material Assessment Total Score: 3		Likelihood of Disturbance Assessment Total Score: 5		Management Assessment Licensable: No Recommendations: Program removal Reinspection Interval: Not Applicable Overall Risk Category: C8
Product Type:	1 (Asbestos textured coating)	Location:	2 (Rooms up to 100 sq m)	
Condition:	1 (Minor scratches)	Accessibility:	1 (Occasionally likely to be disturbed)	
Surface Treatment:	0 (Composite material)			
Asbestos Type:	1 (Chrysotile)	Extent Score:	2 (>10 - <50 sq m or >10m - <50m pipe run)

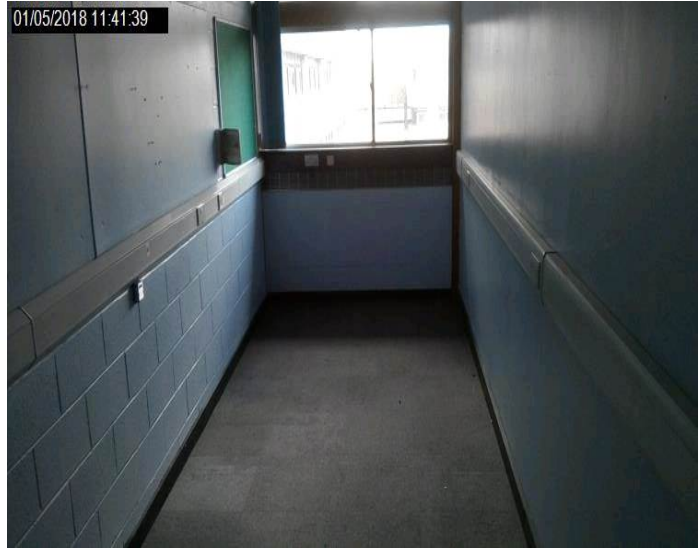
Location:	4.12A	Block:	University	Floor Level: 3rd Floor
Sample No.:	As DU001495	Portal Ref No.:	551

Item:	Asbestos Cement window sill			
Asbestos Content:	Result Based on:			
Chrysotile	Strongly presumed			
Sample Analysed By:	Not applicable	Extent:	2 linear metres	
Comments:

Material Assessment Total Score: 4		Likelihood of Disturbance Assessment Total Score: 4		Management Assessment Licensable: No Recommendations: Program removal Reinspection Interval: Not Applicable Overall Risk Category: C8
Product Type:	1 (Asbestos cement)	Location:	2 (Rooms up to 100 sq m)	
Condition:	1 (Minor scratches)	Accessibility:	1 (Occasionally likely to be disturbed)	
Surface Treatment:	1 (Unencapsulated asbestos cement)			
Asbestos Type:	1 (Chrysotile)	Extent Score:	1 (<10 sq m or 10m pipe run)

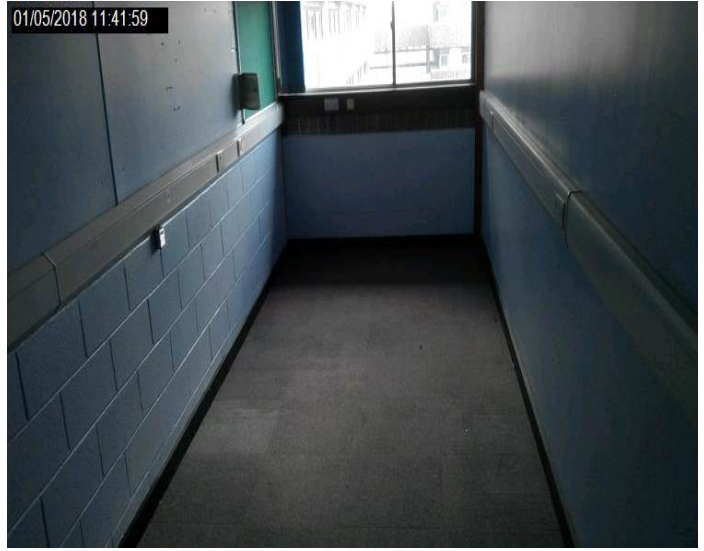
Location:	4.12A	Block:	University	Floor Level: 3rd Floor
Sample No.:	As DU001496	Portal Ref No.:	552

Item:	Asbestos Cement shuttering			
Asbestos Content:	Result Based on:			
Chrysotile Amosite	Strongly presumed			
Sample Analysed By:	Not applicable	Extent:	2 m ²	
Comments: To ceiling of wall void behind polystyrene sheets

Material Assessment Total Score: 5		Likelihood of Disturbance Assessment Total Score: 4		Management Assessment Licensable: No Recommendations: Program removal Reinspection Interval: Not Applicable Overall Risk Category: C9
Product Type:	1 (Asbestos cement)	Location:	2 (Rooms up to 100 sq m)	
Condition:	1 (Minor scratches)	Accessibility:	1 (Occasionally likely to be disturbed)	
Surface Treatment:	1 (Encapsulated asbestos cement)			
Asbestos Type:	2 (Chrysotile Amosite)	Extent Score:	1 (<10 sq m or 10m pipe run)

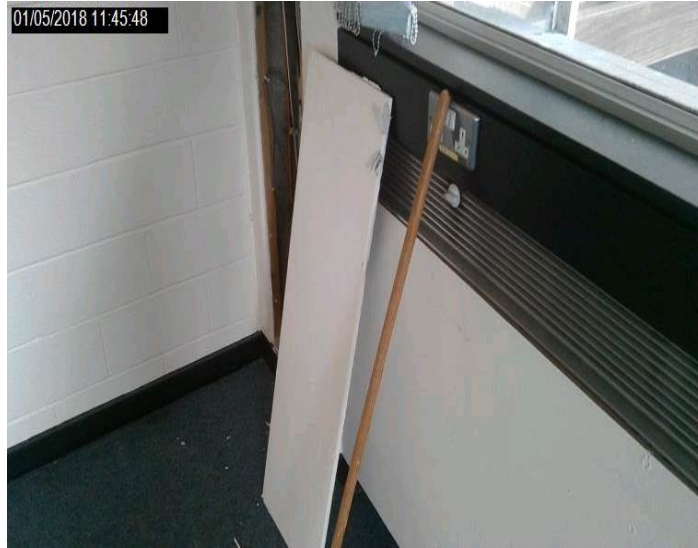
Location:	4.11	Block:	University	Floor Level: 3rd Floor
Sample No.:	As DU001498	Portal Ref No.:	558

Item:	Insulating board panel to riser			
Asbestos Content:		Result Based on:		
No Asbestos Detected		Strongly presumed		
Sample Analysed By:	Not applicable	Extent:	5 m ²	
Comments: 2 x risers

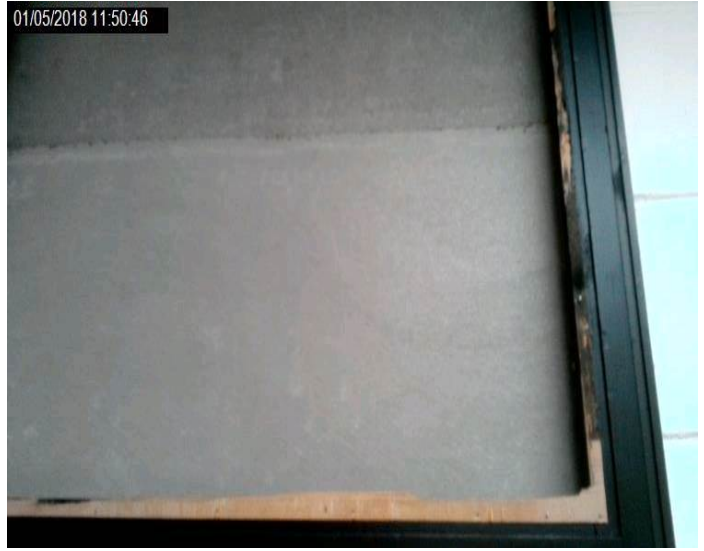
Location:	4.99C	Block:	University	Floor Level: 3rd Floor
Sample No.:	DU001500	Portal Ref No.:	559

Item:	Insulating board door header panel			
Asbestos Content:	Result Based on:			
No Asbestos Detected	Analysis of sample using PLM			
Sample Analysed By: Reg 13(1)	Extent:	6 m ²		
Comments: Above doors leading to rooms, 4.14, 4.13, 4.12, 4.11, 4.34 and 4.39A

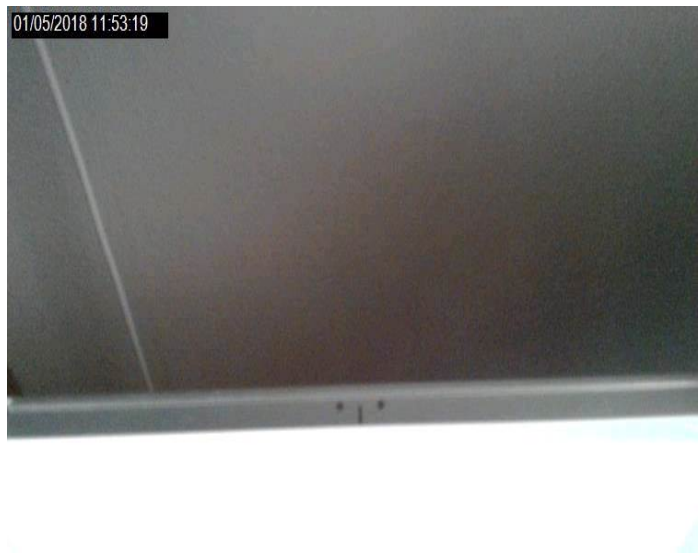
Location:	4.99C	Block:	University	Floor Level: 3rd Floor
Sample No.:	As DU001494	Portal Ref No.:	560

Item:	Asbestos Textured coating to concrete ceiling			
Asbestos Content:	Result Based on:			
Chrysotile	Strongly presumed			
Sample Analysed By:	Not applicable	Extent:	10 m ²	
Comments: Above suspended ceiling tiles to recess section of corridor only

Material Assessment Total Score: 3		Likelihood of Disturbance Assessment Total Score: 5		Management Assessment Licensable: No Recommendations: Program removal Reinspection Interval: Not Applicable Overall Risk Category: C8
Product Type:	1 (Asbestos textured coating)	Location:	2 (Rooms up to 100 sq m)	
Condition:	1 (Minor scratches)	Accessibility:	1 (Occasionally likely to be disturbed)	
Surface Treatment:	0 (Composite material)			
Asbestos Type:	1 (Chrysotile)	Extent Score:	2 (>10 - <50 sq m or >10m - <50m pipe run)

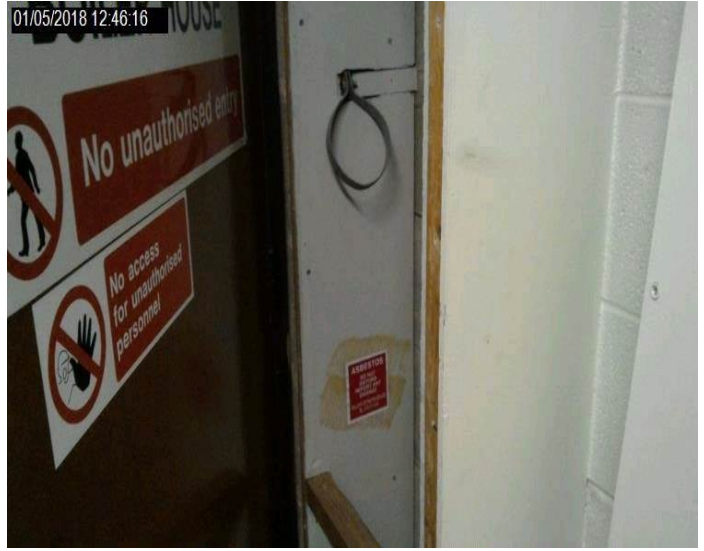
Location:	R.01	Block:	University		Floor Level: L - Loft
Sample No.:	DU001502	Portal Ref No.:	562

Item:	Asbestos Insulating board panel to rear of timber boxing				
Asbestos Content:	Result Based on:				
Chrysotile Amosite	Analysis of sample using PLM				
Sample Analysed By: Reg 13(1)	Extent:	4 linear metres			
Comments:

Material Assessment Total Score: 7		Likelihood of Disturbance Assessment Total Score: 4		Management Assessment Licensable: Yes Recommendations: Program removal Reinspection Interval: Not Applicable Overall Risk Category: B11
Product Type:	2 (Asbestos insulating board)	Location:	2 (Rooms up to 100 sq m)	
Condition:	1 (Minor scratches)	Accessibility:	1 (Occasionally likely to be disturbed)	
Surface Treatment:	2 (Unencapsulated asbestos insulating board)			
Asbestos Type:	2 (Chrysotile Amosite)	Extent Score:	1 (<10 sq m or 10m pipe run)

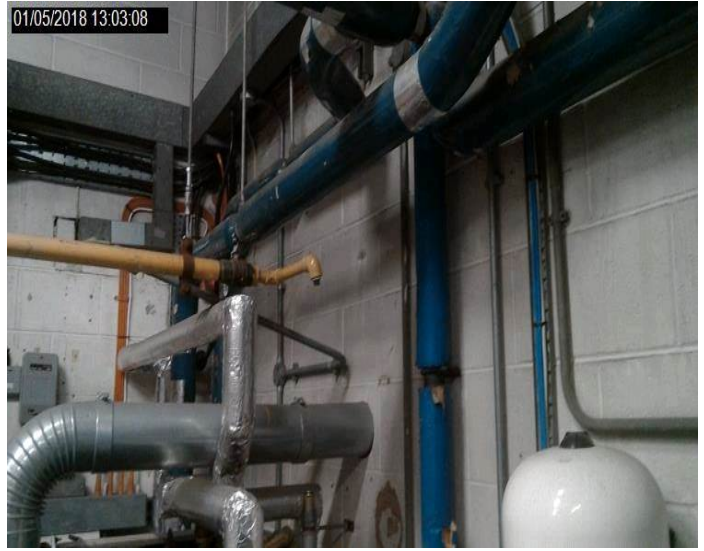
Location:	R.03	Block:	University	Floor Level: L - Loft
Sample No.:	DU001504	Portal Ref No.:	565

Item:	Insulation to pipework			
Asbestos Content:		Result Based on:		
No Asbestos Detected		Analysis of sample using PLM		
Sample Analysed By:	Reg 13(1)	Extent:	6 linear metres	
Comments:

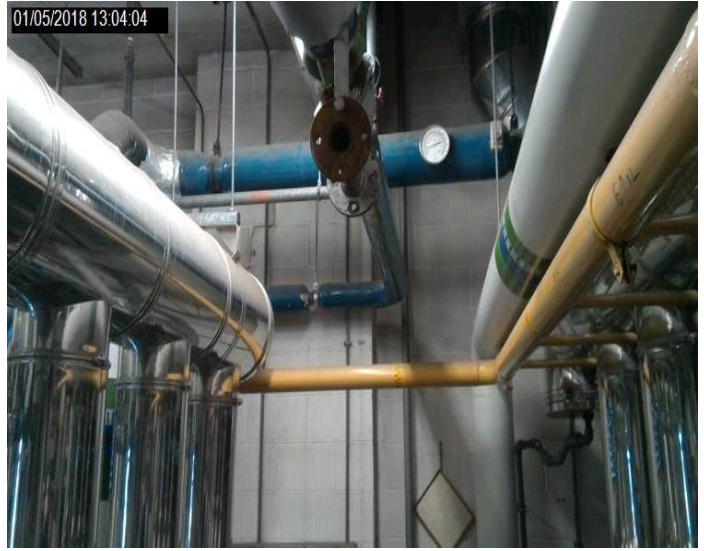
Location:	R.03	Block:	University	Floor Level: L - Loft
Sample No.:	DU001505	Portal Ref No.:	566

Item:	Insulation to pipework			
Asbestos Content:		Result Based on:		
No Asbestos Detected		Analysis of sample using PLM		
Sample Analysed By:	Reg 13(1)	Extent:	6 linear metres	
Comments:

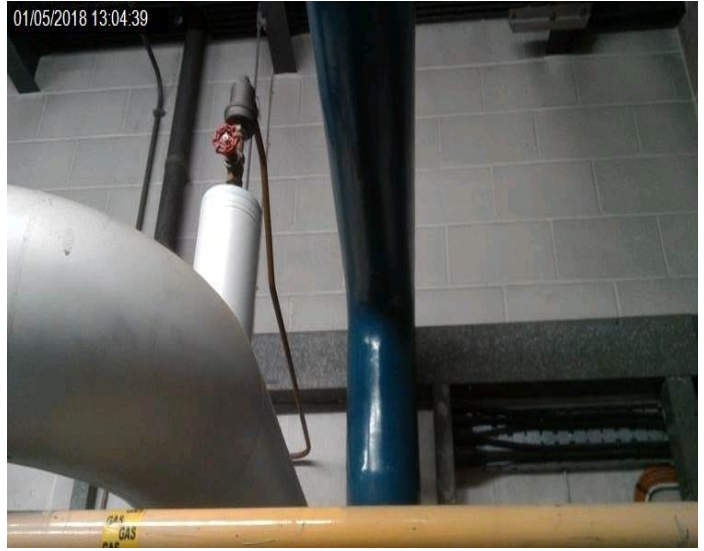
Location:	R.03	Block:	University	Floor Level: L - Loft
Sample No.:	DU001506	Portal Ref No.:	567

Item:	Insulation to pipework			
Asbestos Content:		Result Based on:		
No Asbestos Detected		Analysis of sample using PLM		
Sample Analysed By:	Reg 13(1)	Extent:	6 linear metres	
Comments:

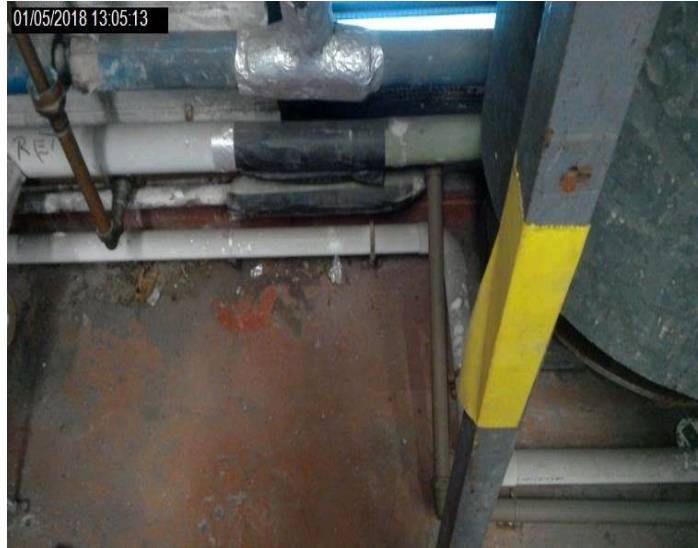
Location:	R.03	Block:	University	Floor Level: L - Loft
Sample No.:	DU001507	Portal Ref No.:	568

Item:	Insulation to pipework			
Asbestos Content:		Result Based on:		
No Asbestos Detected		Analysis of sample using PLM		
Sample Analysed By:	Reg 13(1)	Extent:	6 linear metres	
Comments:

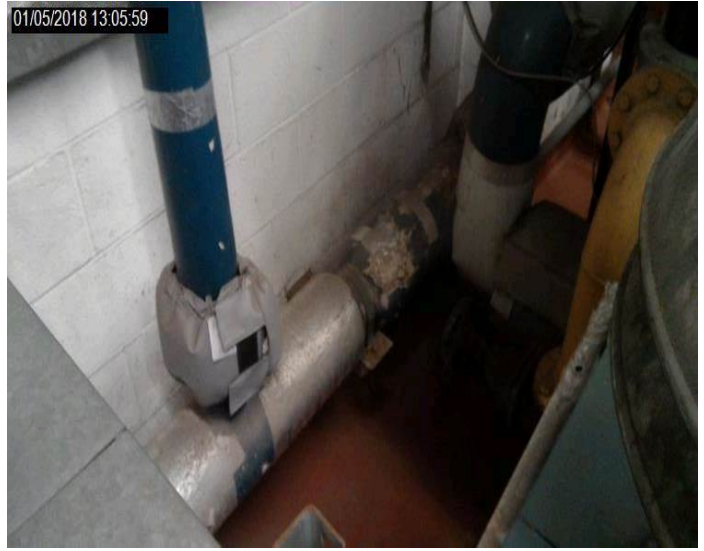
Location:	R.03	Block:	University	Floor Level: L - Loft
Sample No.:	DU001508	Portal Ref No.:	569

Item:	Insulation to pipework			
Asbestos Content:		Result Based on:		
No Asbestos Detected		Analysis of sample using PLM		
Sample Analysed By:	Reg 13(1)	Extent:	6 linear metres	
Comments:

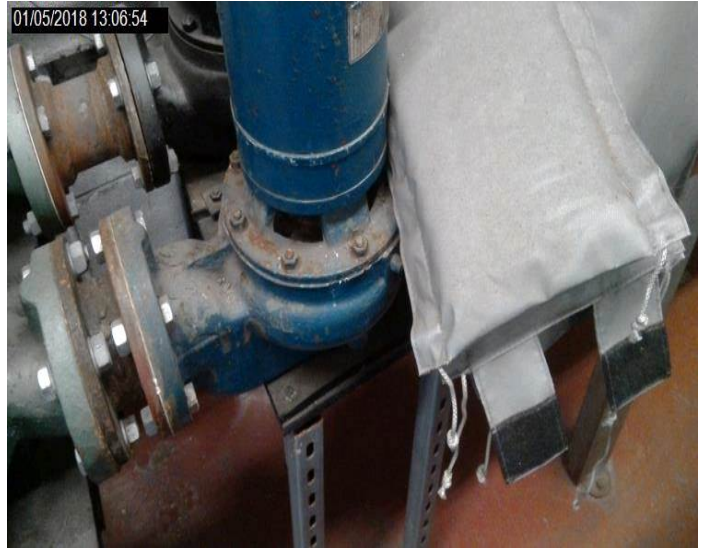
Location:	R.03	Block:	University	Floor Level: L - Loft
Sample No.:	DU001509	Portal Ref No.:	570

Item:	Asbestos Compressed fibre gasket			
Asbestos Content:	Result Based on:			
Chrysotile	Analysis of sample using PLM			
Sample Analysed By: Reg 13(1)	Extent:	2 units		
Comments: To blue and black pipework located behind boilers

Material Assessment Total Score: 5		Likelihood of Disturbance Assessment Total Score: 3		Management Assessment Licensable: No Recommendations: Program removal Reinspection Interval: Not Applicable Overall Risk Category: C8
Product Type:	2 (Compressed asbestos fibre)	Location:	2 (Rooms up to 100 sq m)	
Condition:	1 (Minor scratches)	Accessibility:	1 (Occasionally likely to be disturbed)	
Surface Treatment:	1 (Enclosed textile/paper)			
Asbestos Type:	1 (Chrysotile)	Extent Score:	0 (Small amounts or items)

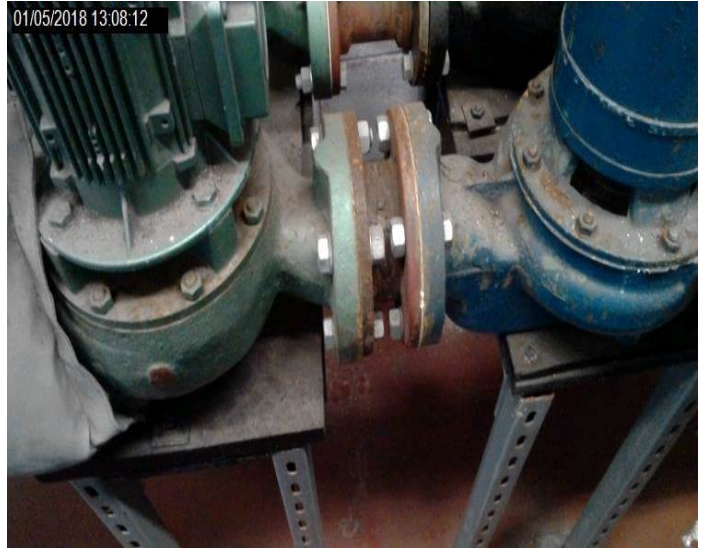
Location:	R.03	Block:	University	Floor Level: L - Loft
Sample No.:	DU001510	Portal Ref No.:	571

Item:	Compressed fibre gasket			
Asbestos Content:		Result Based on:		
No Asbestos Detected		Analysis of sample using PLM		
Sample Analysed By:	Reg 13(1)	Extent:	8 units	
Comments: To pipework flanges to rear of boilers

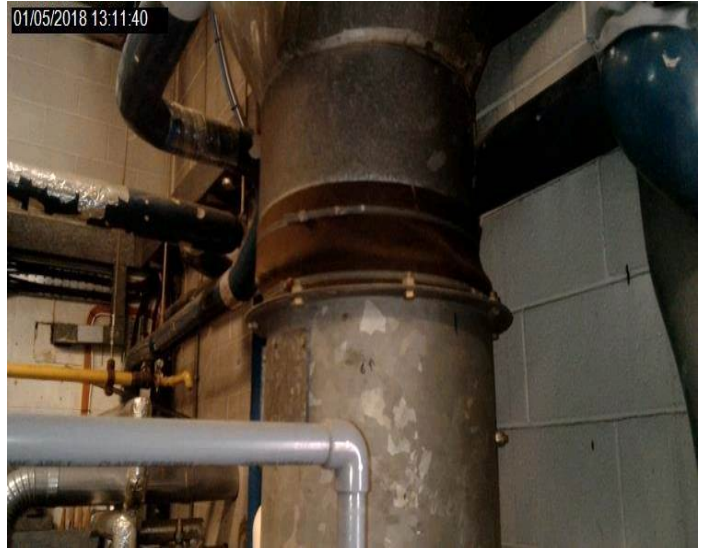
Location:	R.03	Block:	University	Floor Level: L - Loft
Sample No.:	DU001511	Portal Ref No.:	573

Item:	Textile seal to flue pipe			
Asbestos Content:		Result Based on:		
No Asbestos Detected		Analysis of sample using PLM		
Sample Analysed By:	Reg 13(1)	Extent:	2 linear metres	
Comments:

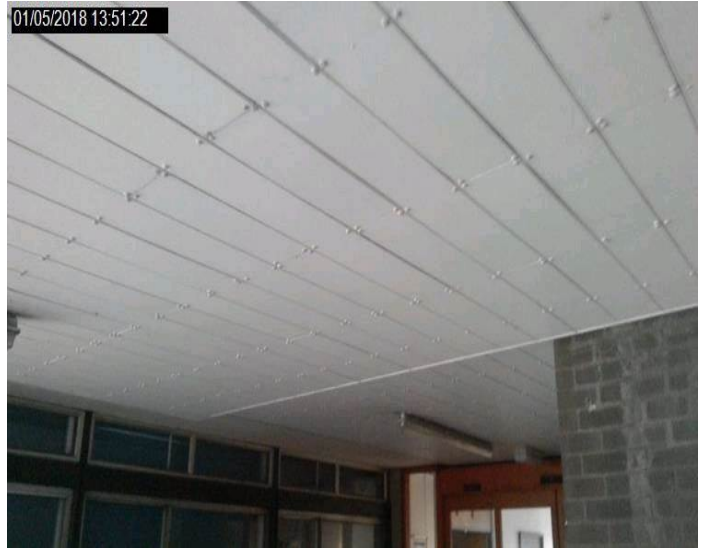
Location:	External	Block:	University	Floor Level: E - External
Sample No.:	DU001515	Portal Ref No.:	578

Item:	Insulating board canopy			
Asbestos Content:		Result Based on:		
No Asbestos Detected		Analysis of sample using PLM		
Sample Analysed By:	Reg 13(1)	Extent:	100 m ²	
Comments: To level 1 external

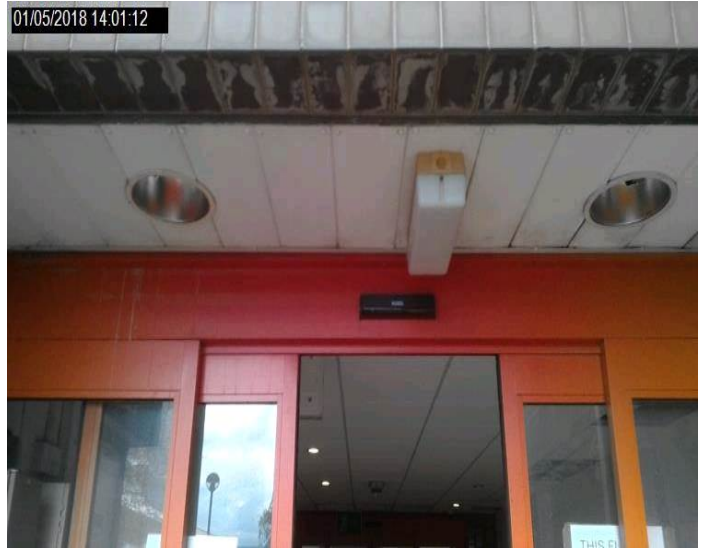
Location:	External	Block:	University	Floor Level: E - External
Sample No.:	DU001516	Portal Ref No.:	579

Item:	Insulating board canopy over front entrance			
Asbestos Content:		Result Based on:		
No Asbestos Detected		Analysis of sample using PLM		
Sample Analysed By:	Reg 13(1)	Extent:	4 m ²	
Comments:
