**Report No.:** J102747  
**Nature of Work:** Demolition Survey  
**Issue Date:** 26/09/2018  
**Client Name:** WYG Engineering Ltd  
Geneva Building, Lake View Drive, Sherwood Business Park,  
Annesley, Nottingham, NG15 0ED  
**Site Address:** Kenrick Building, Former City North Campus, Birmingham City  
University, Perry Barr, B42 2US

**Order Placed By:** Reg 13(1)  
**Site Contact:** Reg 13(1)  
**Date(s) of Work:** 20/08/2018 to 23/08/2018  
**Technical Manager:** Reg 13(1) (Asbestos)  
**Assistant Surveyor(s):** Reg 13(1)

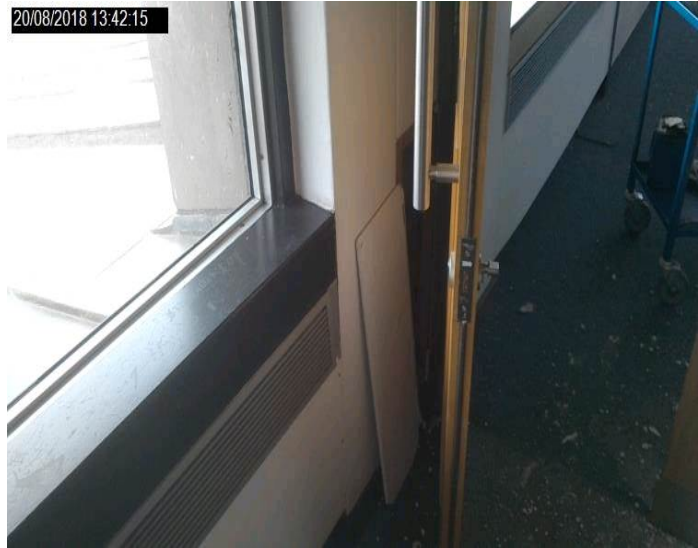
<b>Location:</b>	Stairs A	<b>Block:</b>	Birmingham City University	<b>Floor Level:</b> 4th Floor
<b>Sample No.:</b>	DU002103	<b>Portal Ref No.:</b>	12

<b>Item:</b>	Insulating board riser panels			
<b>Asbestos Content:</b>		<b>Result Based on:</b>		
No Asbestos Detected		Analysis of sample using PLM		
<b>Sample Analysed By:</b>	Reg 13(1)	<b>Extent:</b>	1 m <sup>2</sup>	
<b>Comments:</b> One riser

<b>Material Assessment Total Score: 0</b>		<b>Likelihood of Disturbance Assessment Total Score: 0</b>		<b>Management Assessment</b>  <b>Licensable:</b> Yes  <b>Recommendations:</b> Not Applicable  <b>Reinspection Interval:</b> Not Applicable  <b>Overall Risk Category:</b> E0
<b>Product Type:</b>	0 Not Applicable	<b>Location:</b>	0 Not Applicable	
<b>Condition:</b>	0 Not Applicable	<b>Accessibility:</b>	0 Not Applicable	
<b>Surface Treatment:</b>	0 Not Applicable			
<b>Asbestos Type:</b>	0 Not Applicable	<b>Extent Score:</b>	0 Not Applicable

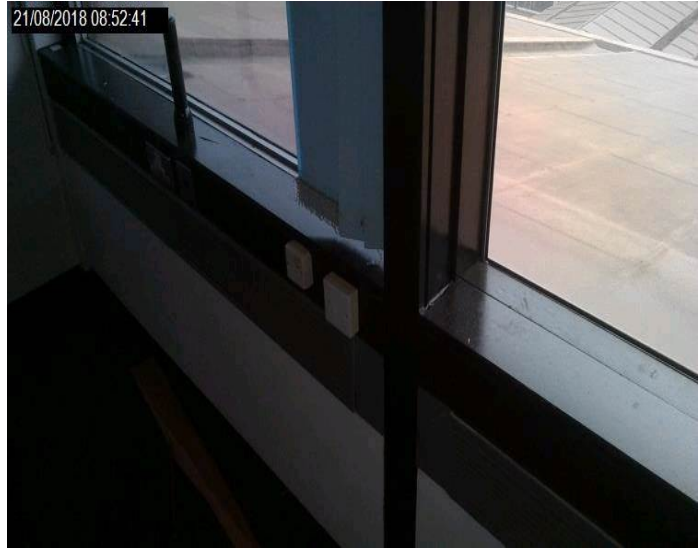
<b>Location:</b>	409	<b>Block:</b>	Birmingham City University	<b>Floor Level:</b> 4th Floor
<b>Sample No.:</b>	DU002109	<b>Portal Ref No.:</b>	29

<b>Item:</b>	Asbestos Cement window sill			
<b>Asbestos Content:</b>	Result Based on:			
Chrysotile	Analysis of sample using PLM			
<b>Sample Analysed By:</b>	Reg 13(1)	<b>Extent:</b>	4 linear metres	
<b>Comments:</b>

<b>Material Assessment Total Score: 4</b>		<b>Likelihood of Disturbance Assessment Total Score: 4</b>		<b>Management Assessment</b>  <b>Licensable:</b> No  <b>Recommendations:</b> Program removal  <b>Reinspection Interval:</b> Not Applicable  <b>Overall Risk Category:</b> C8
<b>Product Type:</b>	1 (Asbestos cement)	<b>Location:</b>	2 (Rooms up to 100 sq m)	
<b>Condition:</b>	1 (Minor scratches)	<b>Accessibility:</b>	1 (Occasionally likely to be disturbed)	
<b>Surface Treatment:</b>	1 (Unencapsulated asbestos cement)			
<b>Asbestos Type:</b>	1 (Chrysotile)	<b>Extent Score:</b>	1 (<10 sq m or 10m pipe run)

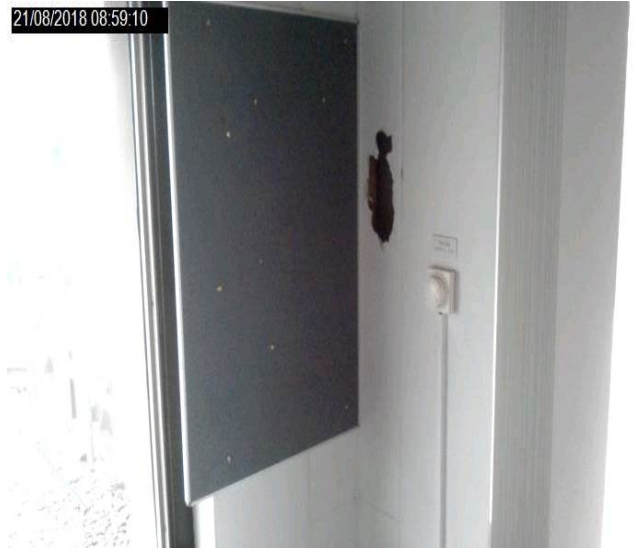
<b>Location:</b>	411	<b>Block:</b>	Birmingham City University	<b>Floor Level:</b> 4th Floor
<b>Sample No.:</b>	As DU002110	<b>Portal Ref No.:</b>	37

<b>Item:</b>	Insulating board riser panel			
<b>Asbestos Content:</b>		<b>Result Based on:</b>		
No Asbestos Detected		Strongly presumed		
<b>Sample Analysed By:</b>	Not applicable	<b>Extent:</b>	2 m <sup>2</sup>	
<b>Comments:</b> Riser in the corner

<b>Material Assessment Total Score: 0</b>		<b>Likelihood of Disturbance Assessment Total Score: 0</b>		<b>Management Assessment</b>  <b>Licensable:</b> Yes  <b>Recommendations:</b> Not Applicable  <b>Reinspection Interval:</b> Not Applicable  <b>Overall Risk Category:</b> E0
<b>Product Type:</b>	0 Not Applicable	<b>Location:</b>	0 Not Applicable	
<b>Condition:</b>	0 Not Applicable	<b>Accessibility:</b>	0 Not Applicable	
<b>Surface Treatment:</b>	0 Not Applicable			
<b>Asbestos Type:</b>	0 Not Applicable	<b>Extent Score:</b>	0 Not Applicable

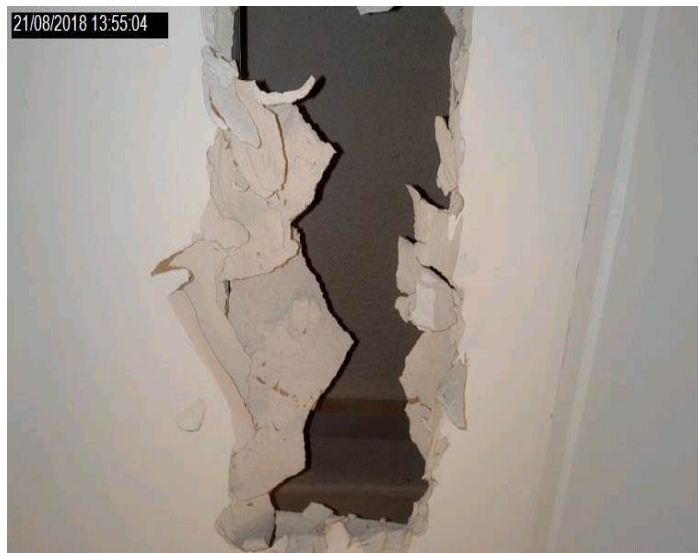
<b>Location:</b>	3.48	<b>Block:</b>	Birmingham City University	<b>Floor Level:</b> 3rd Floor
<b>Sample No.:</b>	DU002120	<b>Portal Ref No.:</b>	61

<b>Item:</b>	Textured coating to concrete			
<b>Asbestos Content:</b>		<b>Result Based on:</b>		
No Asbestos Detected		Analysis of sample using PLM		
<b>Sample Analysed By:</b>	Reg 13(1)	<b>Extent:</b>	6 m <sup>2</sup>	
<b>Comments:</b> Above plasterboard ceiling

<b>Material Assessment Total Score: 0</b>		<b>Likelihood of Disturbance Assessment Total Score: 0</b>		<b>Management Assessment</b>  <b>Licensable:</b> No  <b>Recommendations:</b> Not Applicable  <b>Reinspection Interval:</b> Not Applicable  <b>Overall Risk Category:</b> E0
<b>Product Type:</b>	0 Not Applicable	<b>Location:</b>	0 Not Applicable	
<b>Condition:</b>	0 Not Applicable	<b>Accessibility:</b>	0 Not Applicable	
<b>Surface Treatment:</b>	0 Not Applicable			
<b>Asbestos Type:</b>	0 Not Applicable	<b>Extent Score:</b>	0 Not Applicable

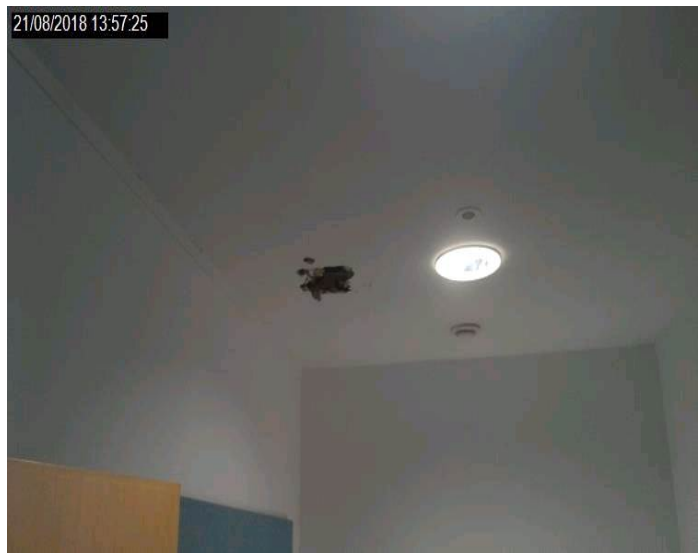
<b>Location:</b>	3.49	<b>Block:</b>	Birmingham City University	<b>Floor Level:</b> 3rd Floor
<b>Sample No.:</b>	As DU002120	<b>Portal Ref No.:</b>	63

<b>Item:</b>	Textured coating to concrete			
<b>Asbestos Content:</b>		<b>Result Based on:</b>		
No Asbestos Detected		Strongly presumed		
<b>Sample Analysed By:</b>	Not applicable	<b>Extent:</b>	6 m <sup>2</sup>	
<b>Comments:</b> Above plasterboard ceiling

<b>Material Assessment Total Score: 0</b>		<b>Likelihood of Disturbance Assessment Total Score: 0</b>		<b>Management Assessment</b>  <b>Licensable:</b> No  <b>Recommendations:</b> Not Applicable  <b>Reinspection Interval:</b> Not Applicable  <b>Overall Risk Category:</b> E0
<b>Product Type:</b>	0 Not Applicable	<b>Location:</b>	0 Not Applicable	
<b>Condition:</b>	0 Not Applicable	<b>Accessibility:</b>	0 Not Applicable	
<b>Surface Treatment:</b>	0 Not Applicable			
<b>Asbestos Type:</b>	0 Not Applicable	<b>Extent Score:</b>	0 Not Applicable

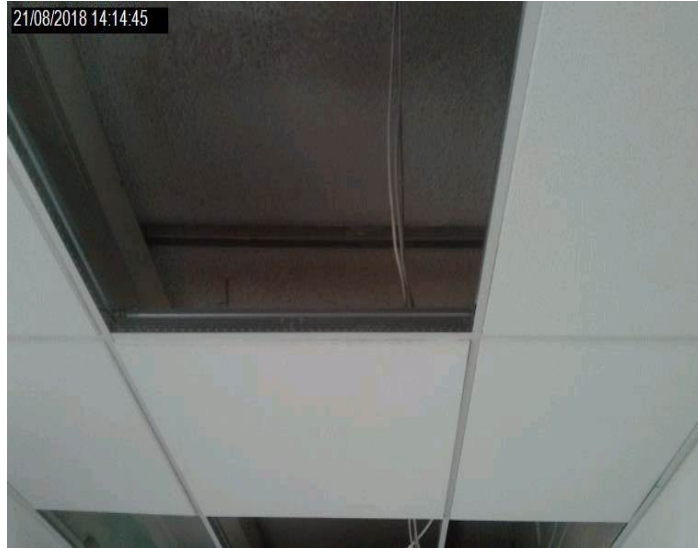
<b>Location:</b>	3.00B	<b>Block:</b>	Birmingham City University	<b>Floor Level:</b> 3rd Floor
<b>Sample No.:</b>	DU002121	<b>Portal Ref No.:</b>	67

<b>Item:</b>	Textured coating to concrete			
<b>Asbestos Content:</b>		<b>Result Based on:</b>		
No Asbestos Detected		Analysis of sample using PLM		
<b>Sample Analysed By:</b>	Reg 13(1)	<b>Extent:</b>	16 m <sup>2</sup>	
<b>Comments:</b> Above suspended tiles section of the ceiling not entire area

<b>Material Assessment Total Score: 0</b>		<b>Likelihood of Disturbance Assessment Total Score: 0</b>		<b>Management Assessment</b>  <b>Licensable:</b> No  <b>Recommendations:</b> Not Applicable  <b>Reinspection Interval:</b> Not Applicable  <b>Overall Risk Category:</b> E0
<b>Product Type:</b>	0 Not Applicable	<b>Location:</b>	0 Not Applicable	
<b>Condition:</b>	0 Not Applicable	<b>Accessibility:</b>	0 Not Applicable	
<b>Surface Treatment:</b>	0 Not Applicable			
<b>Asbestos Type:</b>	0 Not Applicable	<b>Extent Score:</b>	0 Not Applicable

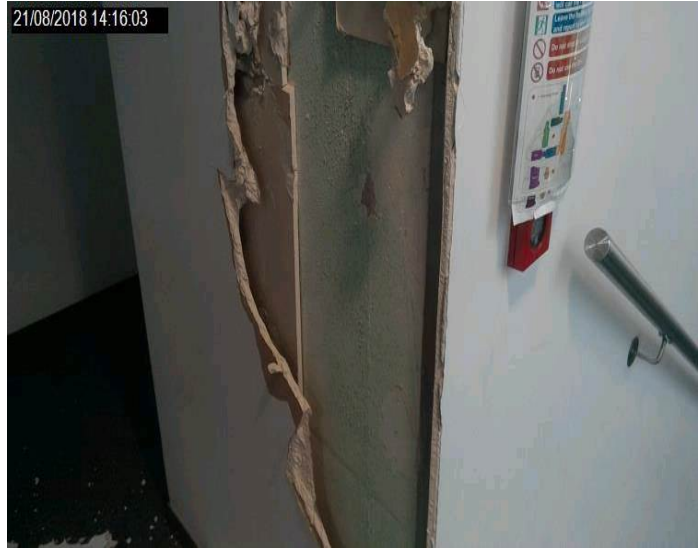
<b>Location:</b>	3.00B	<b>Block:</b>	Birmingham City University	<b>Floor Level:</b> 3rd Floor
<b>Sample No.:</b>	DU002122	<b>Portal Ref No.:</b>	68

<b>Item:</b>	Textured coating to concrete and block			
<b>Asbestos Content:</b>		<b>Result Based on:</b>		
No Asbestos Detected		Analysis of sample using PLM		
<b>Sample Analysed By:</b>	Reg 13(1)	<b>Extent:</b>	18 m <sup>2</sup>	
<b>Comments:</b> Behind plasterboard

<b>Material Assessment Total Score: 0</b>		<b>Likelihood of Disturbance Assessment Total Score: 0</b>		<b>Management Assessment</b>  <b>Licensable:</b> No  <b>Recommendations:</b> Not Applicable  <b>Reinspection Interval:</b> Not Applicable  <b>Overall Risk Category:</b> E0
<b>Product Type:</b>	0 Not Applicable	<b>Location:</b>	0 Not Applicable	
<b>Condition:</b>	0 Not Applicable	<b>Accessibility:</b>	0 Not Applicable	
<b>Surface Treatment:</b>	0 Not Applicable			
<b>Asbestos Type:</b>	0 Not Applicable	<b>Extent Score:</b>	0 Not Applicable

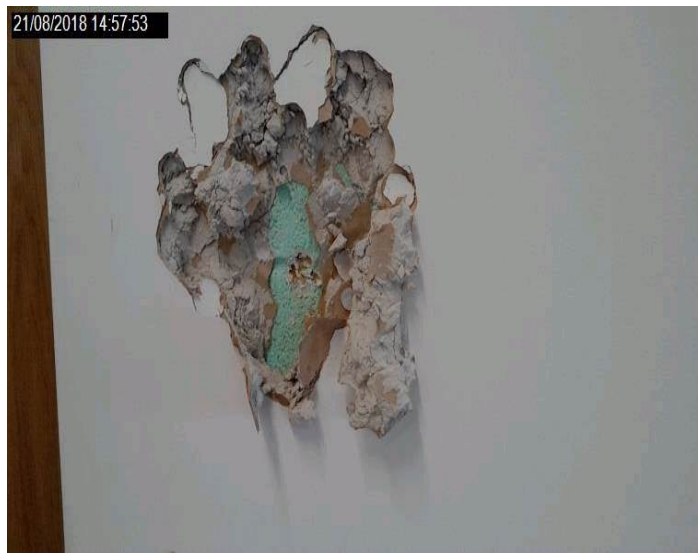
<b>Location:</b>	3.36B	<b>Block:</b>	Birmingham City University	<b>Floor Level:</b> 3rd Floor
<b>Sample No.:</b>	As DU002122	<b>Portal Ref No.:</b>	69

<b>Item:</b>	Textured coating to block			
<b>Asbestos Content:</b>		<b>Result Based on:</b>		
No Asbestos Detected		Strongly presumed		
<b>Sample Analysed By:</b>	Not applicable	<b>Extent:</b>	12 m <sup>2</sup>	
<b>Comments:</b> Behind plasterboard

<b>Material Assessment Total Score:</b> 0		<b>Likelihood of Disturbance Assessment Total Score:</b> 0		<b>Management Assessment</b>  <b>Licensable:</b> No  <b>Recommendations:</b> Not Applicable  <b>Reinspection Interval:</b> Not Applicable  <b>Overall Risk Category:</b> E0
<b>Product Type:</b>	0 Not Applicable	<b>Location:</b>	0 Not Applicable	
<b>Condition:</b>	0 Not Applicable	<b>Accessibility:</b>	0 Not Applicable	
<b>Surface Treatment:</b>	0 Not Applicable			
<b>Asbestos Type:</b>	0 Not Applicable	<b>Extent Score:</b>	0 Not Applicable

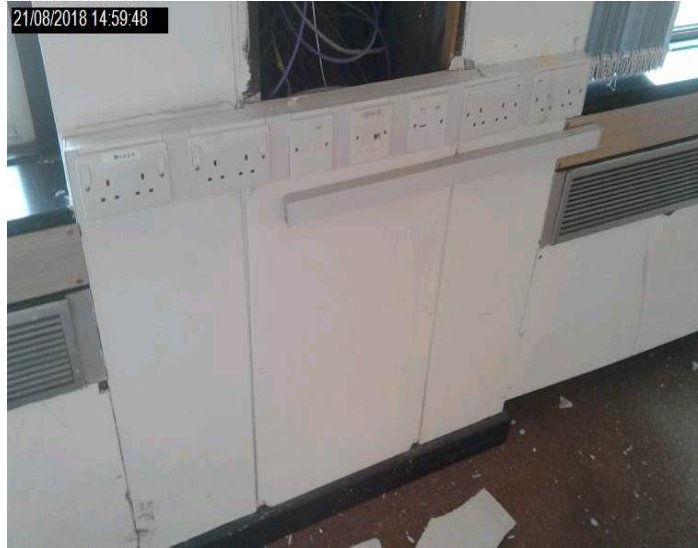
<b>Location:</b>	3.36B	<b>Block:</b>	Birmingham City University	<b>Floor Level:</b> 3rd Floor
<b>Sample No.:</b>	DU002124	<b>Portal Ref No.:</b>	71

<b>Item:</b>	Insulating board panel to riser			
<b>Asbestos Content:</b>		<b>Result Based on:</b>		
No Asbestos Detected		Analysis of sample using PLM		
<b>Sample Analysed By:</b>	Reg 13(1)	<b>Extent:</b>	2 m <sup>2</sup>	
<b>Comments:</b>

<b>Material Assessment Total Score: 0</b>		<b>Likelihood of Disturbance Assessment Total Score: 0</b>		<b>Management Assessment</b>  <b>Licensable:</b> Yes  <b>Recommendations:</b> Not Applicable  <b>Reinspection Interval:</b> Not Applicable  <b>Overall Risk Category:</b> E0
<b>Product Type:</b>	0 Not Applicable	<b>Location:</b>	0 Not Applicable	
<b>Condition:</b>	0 Not Applicable	<b>Accessibility:</b>	0 Not Applicable	
<b>Surface Treatment:</b>	0 Not Applicable			
<b>Asbestos Type:</b>	0 Not Applicable	<b>Extent Score:</b>	0 Not Applicable

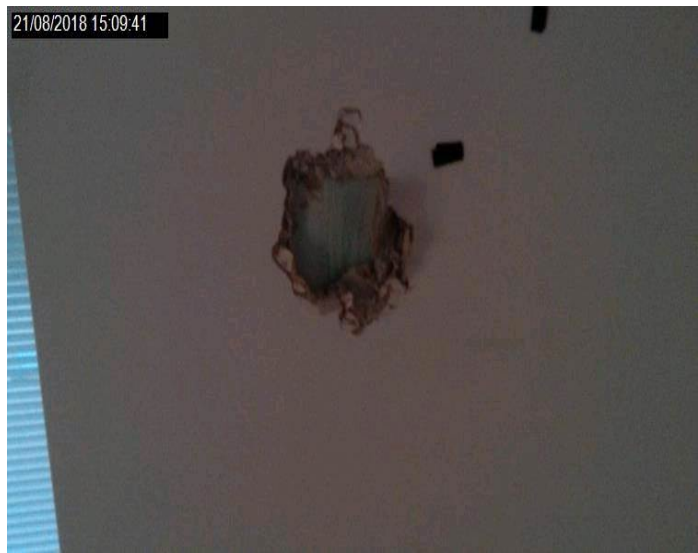
<b>Location:</b>	3.37C	<b>Block:</b>	Birmingham City University	<b>Floor Level:</b> 3rd Floor
<b>Sample No.:</b>	As DU002122	<b>Portal Ref No.:</b>	75

<b>Item:</b>	Textured coating to concrete wall			
<b>Asbestos Content:</b>		<b>Result Based on:</b>		
No Asbestos Detected		Strongly presumed		
<b>Sample Analysed By:</b>	Not applicable	<b>Extent:</b>	3 m <sup>2</sup>	
<b>Comments:</b> Behind plasterboard, adjacent to entrance

<b>Material Assessment Total Score: 0</b>		<b>Likelihood of Disturbance Assessment Total Score: 0</b>		<b>Management Assessment</b>  <b>Licensable:</b> No  <b>Recommendations:</b> Not Applicable  <b>Reinspection Interval:</b> Not Applicable  <b>Overall Risk Category:</b> E0
<b>Product Type:</b>	0 Not Applicable	<b>Location:</b>	0 Not Applicable	
<b>Condition:</b>	0 Not Applicable	<b>Accessibility:</b>	0 Not Applicable	
<b>Surface Treatment:</b>	0 Not Applicable			
<b>Asbestos Type:</b>	0 Not Applicable	<b>Extent Score:</b>	0 Not Applicable

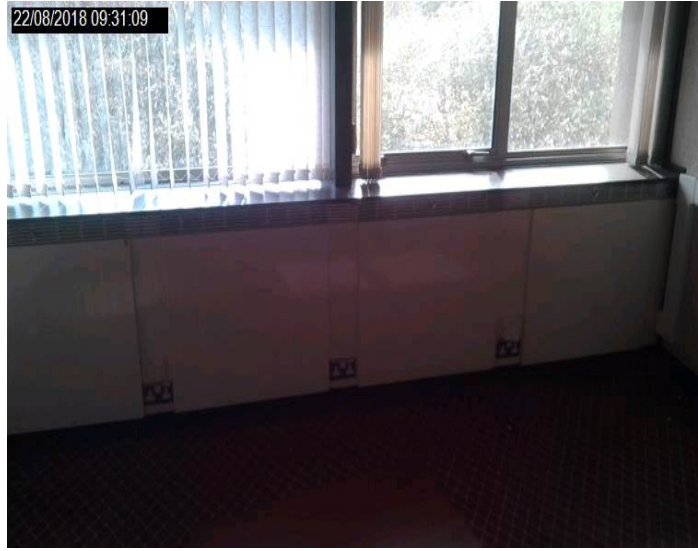
<b>Location:</b>	3.33	<b>Block:</b>	Birmingham City University	<b>Floor Level:</b> 3rd Floor
<b>Sample No.:</b>	As DU002123	<b>Portal Ref No.:</b>	87

<b>Item:</b>	Asbestos Cement window sill			
<b>Asbestos Content:</b>	<b>Result Based on:</b>			
Chrysotile	Strongly presumed			
<b>Sample Analysed By:</b>	Not applicable	<b>Extent:</b>	4 linear metres	
<b>Comments:</b>

<b>Material Assessment Total Score: 4</b>		<b>Likelihood of Disturbance Assessment Total Score: 5</b>		<b>Management Assessment</b>  <b>Licensable:</b> No  <b>Recommendations:</b> Program removal  <b>Reinspection Interval:</b> Not Applicable  <b>Overall Risk Category:</b> C9
<b>Product Type:</b>	1 (Asbestos cement)	<b>Location:</b>	2 (Rooms up to 100 sq m)	
<b>Condition:</b>	1 (Minor scratches)	<b>Accessibility:</b>	2 (Easily disturbed)	
<b>Surface Treatment:</b>	1 (Unencapsulated asbestos cement)			
<b>Asbestos Type:</b>	1 (Chrysotile)	<b>Extent Score:</b>	1 (<10 sq m or 10m pipe run)

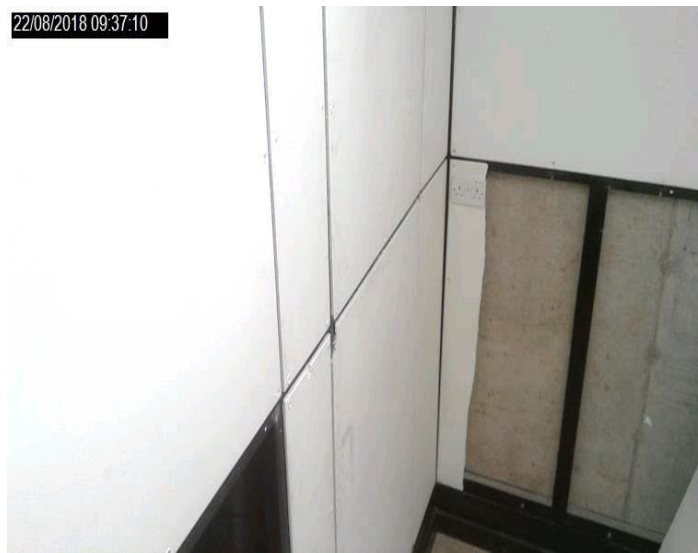
<b>Location:</b>	3.38	<b>Block:</b>	Birmingham City University	<b>Floor Level:</b> 3rd Floor
<b>Sample No.:</b>	DU002128	<b>Portal Ref No.:</b>	88

<b>Item:</b>	Insulating board wall panels			
<b>Asbestos Content:</b>		<b>Result Based on:</b>		
No Asbestos Detected		Analysis of sample using PLM		
<b>Sample Analysed By:</b>	Reg 13(1)	<b>Extent:</b>	12 m <sup>2</sup>	
<b>Comments:</b>

<b>Material Assessment Total Score: 0</b>		<b>Likelihood of Disturbance Assessment Total Score: 0</b>		<b>Management Assessment</b>  <b>Licensable:</b> Yes  <b>Recommendations:</b> Not Applicable  <b>Reinspection Interval:</b> Not Applicable  <b>Overall Risk Category:</b> E0
<b>Product Type:</b>	0 Not Applicable	<b>Location:</b>	0 Not Applicable	
<b>Condition:</b>	0 Not Applicable	<b>Accessibility:</b>	0 Not Applicable	
<b>Surface Treatment:</b>	0 Not Applicable			
<b>Asbestos Type:</b>	0 Not Applicable	<b>Extent Score:</b>	0 Not Applicable

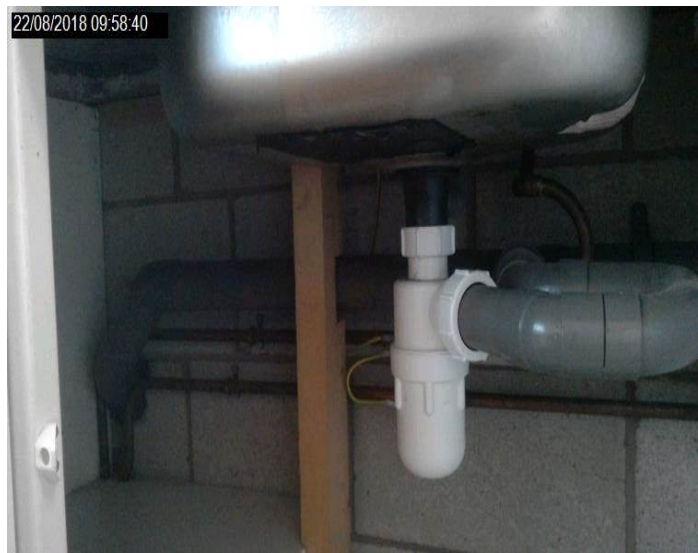
<b>Location:</b>	3.31	<b>Block:</b>	Birmingham City University	<b>Floor Level:</b> 3rd Floor
<b>Sample No.:</b>	DU002130	<b>Portal Ref No.:</b>	96

<b>Item:</b>	Bitumen sink pad			
<b>Asbestos Content:</b>		<b>Result Based on:</b>		
No Asbestos Detected		Analysis of sample using PLM		
<b>Sample Analysed By:</b>	Reg 13(1)	<b>Extent:</b>	2 units	
<b>Comments:</b>

<b>Material Assessment Total Score: 0</b>		<b>Likelihood of Disturbance Assessment Total Score: 0</b>		<b>Management Assessment</b>  <b>Licensable:</b> No  <b>Recommendations:</b> Not Applicable  <b>Reinspection Interval:</b> Not Applicable  <b>Overall Risk Category:</b> E0
<b>Product Type:</b>	0 Not Applicable	<b>Location:</b>	0 Not Applicable	
<b>Condition:</b>	0 Not Applicable	<b>Accessibility:</b>	0 Not Applicable	
<b>Surface Treatment:</b>	0 Not Applicable			
<b>Asbestos Type:</b>	0 Not Applicable	<b>Extent Score:</b>	0 Not Applicable

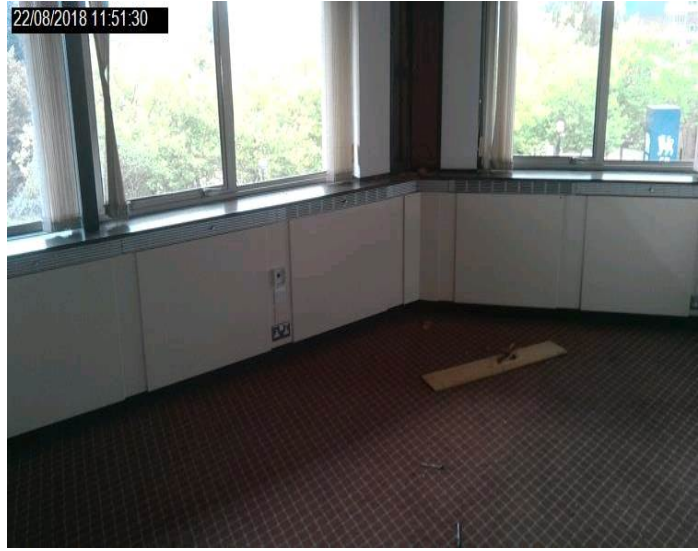
<b>Location:</b>	3.25A	<b>Block:</b>	Birmingham City University	<b>Floor Level:</b> 3rd Floor
<b>Sample No.:</b>	As DU002136	<b>Portal Ref No.:</b>	105

<b>Item:</b>	Asbestos Cement window sill			
<b>Asbestos Content:</b>	<b>Result Based on:</b>			
Chrysotile	Strongly presumed			
<b>Sample Analysed By:</b>	Not applicable	<b>Extent:</b>	7 linear metres	
<b>Comments:</b>

<b>Material Assessment Total Score: 4</b>		<b>Likelihood of Disturbance Assessment Total Score: 5</b>		<b>Management Assessment</b>  <b>Licensable:</b> No  <b>Recommendations:</b> Program removal  <b>Reinspection Interval:</b> Not Applicable  <b>Overall Risk Category:</b> C9
<b>Product Type:</b>	1 (Asbestos cement)	<b>Location:</b>	2 (Rooms up to 100 sq m)	
<b>Condition:</b>	1 (Minor scratches)	<b>Accessibility:</b>	2 (Easily disturbed)	
<b>Surface Treatment:</b>	1 (Unencapsulated asbestos cement)			
<b>Asbestos Type:</b>	1 (Chrysotile)	<b>Extent Score:</b>	1 (<10 sq m or 10m pipe run)

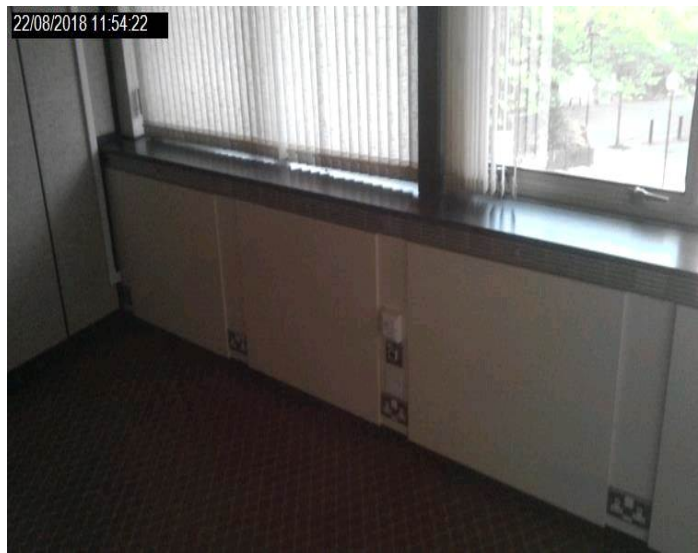
<b>Location:</b>	3.24	<b>Block:</b>	Birmingham City University	<b>Floor Level:</b> 3rd Floor
<b>Sample No.:</b>	As DU002136	<b>Portal Ref No.:</b>	107

<b>Item:</b>	Asbestos Cement window sill			
<b>Asbestos Content:</b>	<b>Result Based on:</b>			
Chrysotile	Strongly presumed			
<b>Sample Analysed By:</b>	Not applicable	<b>Extent:</b>	4 linear metres	
<b>Comments:</b>

<b>Material Assessment Total Score: 4</b>		<b>Likelihood of Disturbance Assessment Total Score: 5</b>		<b>Management Assessment</b>  <b>Licensable:</b> No  <b>Recommendations:</b> Program removal  <b>Reinspection Interval:</b> Not Applicable  <b>Overall Risk Category:</b> C9
<b>Product Type:</b>	1 (Asbestos cement)	<b>Location:</b>	2 (Rooms up to 100 sq m)	
<b>Condition:</b>	1 (Minor scratches)	<b>Accessibility:</b>	2 (Easily disturbed)	
<b>Surface Treatment:</b>	1 (Unencapsulated asbestos cement)			
<b>Asbestos Type:</b>	1 (Chrysotile)	<b>Extent Score:</b>	1 (<10 sq m or 10m pipe run)

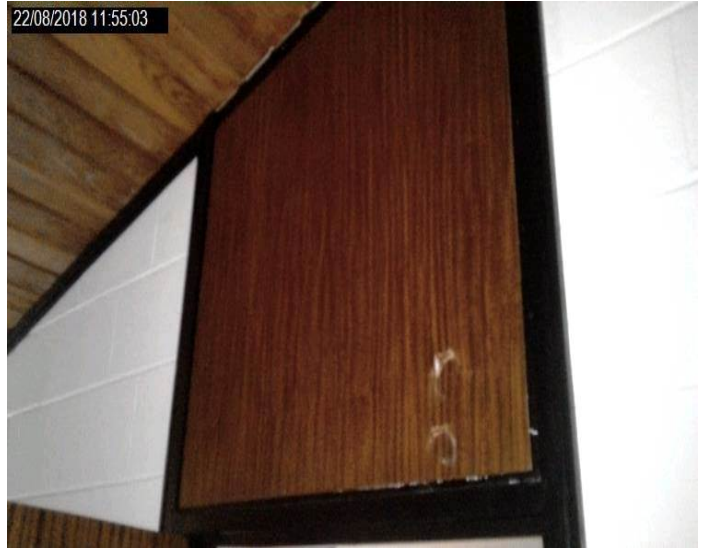
<b>Location:</b>	3.24	<b>Block:</b>	Birmingham City University	<b>Floor Level:</b> 3rd Floor
<b>Sample No.:</b>	As DU002137	<b>Portal Ref No.:</b>	108

<b>Item:</b>	Insulating board door header			
<b>Asbestos Content:</b>		<b>Result Based on:</b>		
No Asbestos Detected		Strongly presumed		
<b>Sample Analysed By:</b>	Not applicable	<b>Extent:</b>	2 m <sup>2</sup>	
<b>Comments:</b> Double skin

<b>Material Assessment Total Score: 0</b>		<b>Likelihood of Disturbance Assessment Total Score: 0</b>		<b>Management Assessment</b>  <b>Licensable:</b> Yes  <b>Recommendations:</b> Not Applicable  <b>Reinspection Interval:</b> Not Applicable  <b>Overall Risk Category:</b> E0
<b>Product Type:</b>	0 Not Applicable	<b>Location:</b>	0 Not Applicable	
<b>Condition:</b>	0 Not Applicable	<b>Accessibility:</b>	0 Not Applicable	
<b>Surface Treatment:</b>	0 Not Applicable			
<b>Asbestos Type:</b>	0 Not Applicable	<b>Extent Score:</b>	0 Not Applicable

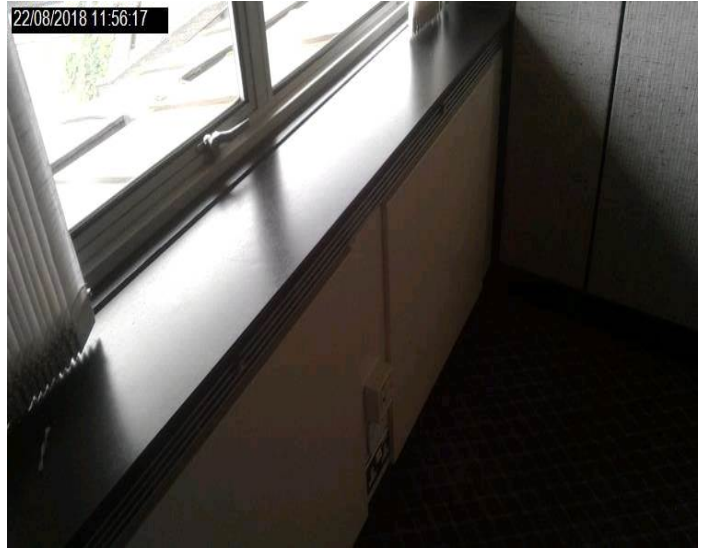
<b>Location:</b>	3.23	<b>Block:</b>	Birmingham City University	<b>Floor Level:</b> 3rd Floor
<b>Sample No.:</b>	As DU002136	<b>Portal Ref No.:</b>	109

<b>Item:</b>	Asbestos Cement window sill			
<b>Asbestos Content:</b>	<b>Result Based on:</b>			
Chrysotile	Strongly presumed			
<b>Sample Analysed By:</b>	Not applicable	<b>Extent:</b>	4 linear metres	
<b>Comments:</b>

<b>Material Assessment Total Score: 4</b>		<b>Likelihood of Disturbance Assessment Total Score: 5</b>		<b>Management Assessment</b>  <b>Licensable:</b> No  <b>Recommendations:</b> Program removal  <b>Reinspection Interval:</b> Not Applicable  <b>Overall Risk Category:</b> C9
<b>Product Type:</b>	1 (Asbestos cement)	<b>Location:</b>	2 (Rooms up to 100 sq m)	
<b>Condition:</b>	1 (Minor scratches)	<b>Accessibility:</b>	2 (Easily disturbed)	
<b>Surface Treatment:</b>	1 (Unencapsulated asbestos cement)			
<b>Asbestos Type:</b>	1 (Chrysotile)	<b>Extent Score:</b>	1 (<10 sq m or 10m pipe run)

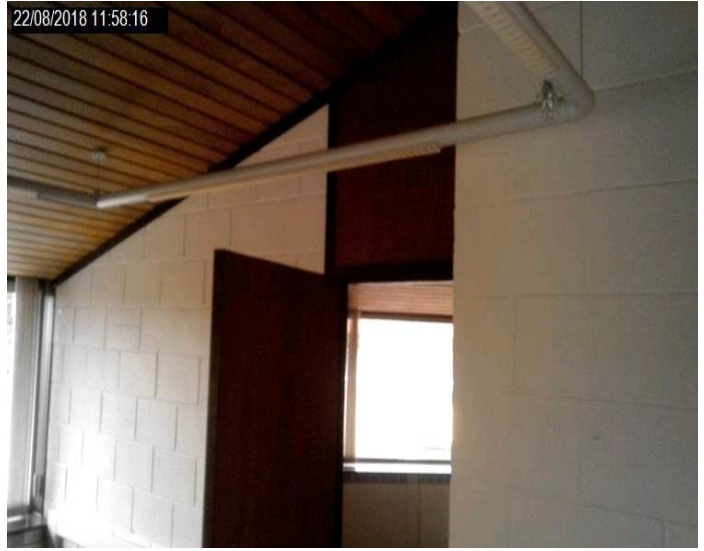
<b>Location:</b>	3.22	<b>Block:</b>	Birmingham City University	<b>Floor Level:</b> 3rd Floor
<b>Sample No.:</b>	As DU002137	<b>Portal Ref No.:</b>	111

<b>Item:</b>	Insulating board door header			
<b>Asbestos Content:</b>		<b>Result Based on:</b>		
No Asbestos Detected		Strongly presumed		
<b>Sample Analysed By:</b>	Not applicable	<b>Extent:</b>	2 m <sup>2</sup>	
<b>Comments:</b> Double skin

<b>Material Assessment Total Score: 0</b>		<b>Likelihood of Disturbance Assessment Total Score: 0</b>		<b>Management Assessment</b>  <b>Licensable:</b> Yes  <b>Recommendations:</b> Not Applicable  <b>Reinspection Interval:</b> Not Applicable  <b>Overall Risk Category:</b> E0
<b>Product Type:</b>	0 Not Applicable	<b>Location:</b>	0 Not Applicable	
<b>Condition:</b>	0 Not Applicable	<b>Accessibility:</b>	0 Not Applicable	
<b>Surface Treatment:</b>	0 Not Applicable			
<b>Asbestos Type:</b>	0 Not Applicable	<b>Extent Score:</b>	0 Not Applicable

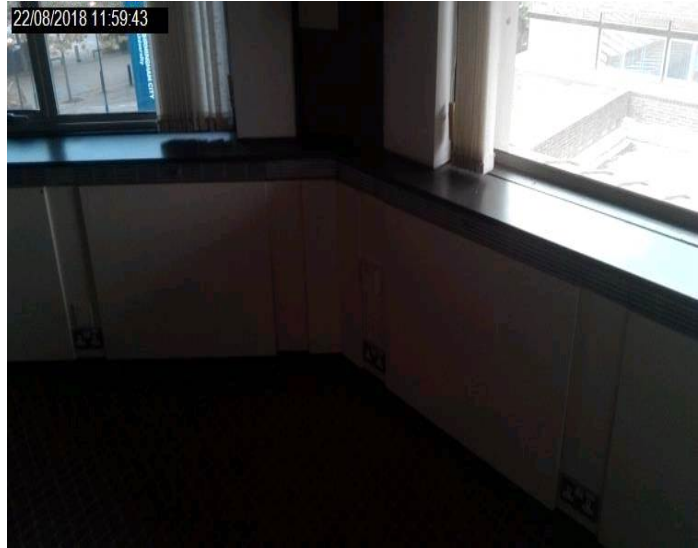
<b>Location:</b>	3.21	<b>Block:</b>	Birmingham City University	<b>Floor Level:</b> 3rd Floor
<b>Sample No.:</b>	As DU002136	<b>Portal Ref No.:</b>	112

<b>Item:</b>	Asbestos Cement window sill			
<b>Asbestos Content:</b>	<b>Result Based on:</b>			
Chrysotile	Strongly presumed			
<b>Sample Analysed By:</b>	Not applicable	<b>Extent:</b>	6 linear metres	
<b>Comments:</b>

<b>Material Assessment Total Score: 4</b>		<b>Likelihood of Disturbance Assessment Total Score: 4</b>		<b>Management Assessment</b>  <b>Licensable:</b> No  <b>Recommendations:</b> Program removal  <b>Reinspection Interval:</b> Not Applicable  <b>Overall Risk Category:</b> C8
<b>Product Type:</b>	1 (Asbestos cement)	<b>Location:</b>	2 (Rooms up to 100 sq m)	
<b>Condition:</b>	1 (Minor scratches)	<b>Accessibility:</b>	1 (Occasionally likely to be disturbed)	
<b>Surface Treatment:</b>	1 (Unencapsulated asbestos cement)			
<b>Asbestos Type:</b>	1 (Chrysotile)	<b>Extent Score:</b>	1 (<10 sq m or 10m pipe run)

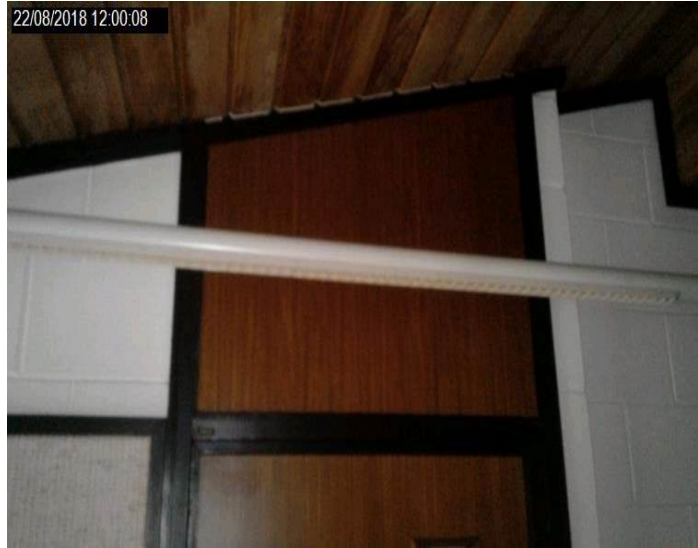
<b>Location:</b>	3.21	<b>Block:</b>	Birmingham City University	<b>Floor Level:</b> 3rd Floor
<b>Sample No.:</b>	As DU002137	<b>Portal Ref No.:</b>	113

<b>Item:</b>	Insulating board door header			
<b>Asbestos Content:</b>		<b>Result Based on:</b>		
No Asbestos Detected		Strongly presumed		
<b>Sample Analysed By:</b>	Not applicable	<b>Extent:</b>	2 m <sup>2</sup>	
<b>Comments:</b> Double skin

<b>Material Assessment Total Score: 0</b>		<b>Likelihood of Disturbance Assessment Total Score: 0</b>		<b>Management Assessment</b>  <b>Licensable:</b> Yes  <b>Recommendations:</b> Not Applicable  <b>Reinspection Interval:</b> Not Applicable  <b>Overall Risk Category:</b> E0
<b>Product Type:</b>	0 Not Applicable	<b>Location:</b>	0 Not Applicable	
<b>Condition:</b>	0 Not Applicable	<b>Accessibility:</b>	0 Not Applicable	
<b>Surface Treatment:</b>	0 Not Applicable			
<b>Asbestos Type:</b>	0 Not Applicable	<b>Extent Score:</b>	0 Not Applicable

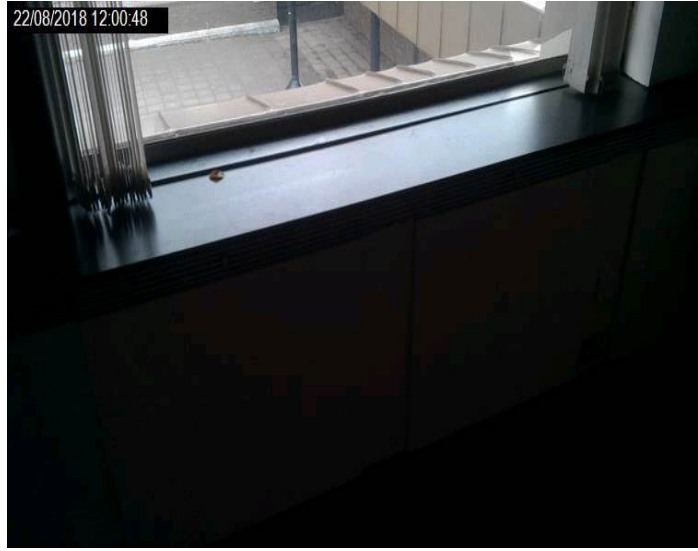
<b>Location:</b>	3.20	<b>Block:</b>	Birmingham City University	<b>Floor Level:</b> 3rd Floor
<b>Sample No.:</b>	As DU002136	<b>Portal Ref No.:</b>	114

<b>Item:</b>	Asbestos Cement window sill			
<b>Asbestos Content:</b>	<b>Result Based on:</b>			
Chrysotile	Strongly presumed			
<b>Sample Analysed By:</b>	Not applicable	<b>Extent:</b>	4 linear metres	
<b>Comments:</b>

<b>Material Assessment Total Score: 4</b>		<b>Likelihood of Disturbance Assessment Total Score: 5</b>		<b>Management Assessment</b>  <b>Licensable:</b> No  <b>Recommendations:</b> Program removal  <b>Reinspection Interval:</b> Not Applicable  <b>Overall Risk Category:</b> C9
<b>Product Type:</b>	1 (Asbestos cement)	<b>Location:</b>	2 (Rooms up to 100 sq m)	
<b>Condition:</b>	1 (Minor scratches)	<b>Accessibility:</b>	2 (Easily disturbed)	
<b>Surface Treatment:</b>	1 (Unencapsulated asbestos cement)			
<b>Asbestos Type:</b>	1 (Chrysotile)	<b>Extent Score:</b>	1 (<10 sq m or 10m pipe run)

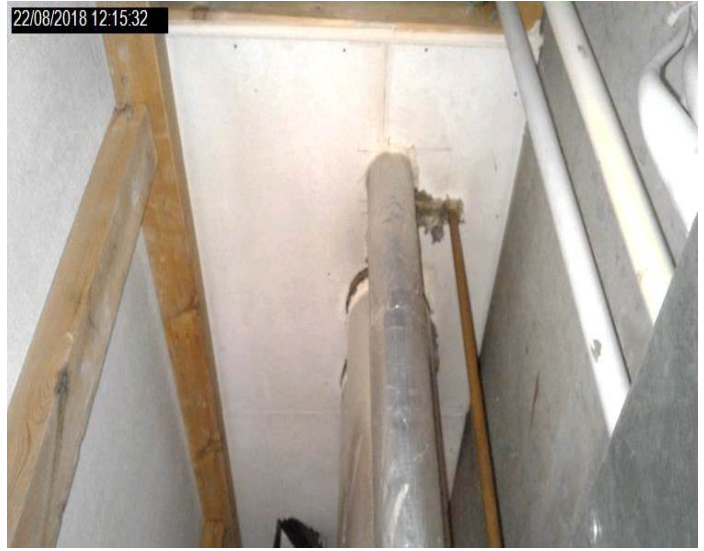
<b>Location:</b>	3.40A	<b>Block:</b>	Birmingham City University	<b>Floor Level:</b> 3rd Floor
<b>Sample No.:</b>	DU002139	<b>Portal Ref No.:</b>	117

<b>Item:</b>	Insulating board			
<b>Asbestos Content:</b>		<b>Result Based on:</b>		
No Asbestos Detected		Analysis of sample using PLM		
<b>Sample Analysed By:</b>	Reg 13(1)	<b>Extent:</b>	3 m <sup>2</sup>	
<b>Comments:</b> Ceiling of the room

<b>Material Assessment Total Score: 0</b>		<b>Likelihood of Disturbance Assessment Total Score: 0</b>		<b>Management Assessment</b>  <b>Licensable:</b> Yes  <b>Recommendations:</b> Not Applicable  <b>Reinspection Interval:</b> Not Applicable  <b>Overall Risk Category:</b> E0
<b>Product Type:</b>	0 Not Applicable	<b>Location:</b>	0 Not Applicable	
<b>Condition:</b>	0 Not Applicable	<b>Accessibility:</b>	0 Not Applicable	
<b>Surface Treatment:</b>	0 Not Applicable			
<b>Asbestos Type:</b>	0 Not Applicable	<b>Extent Score:</b>	0 Not Applicable

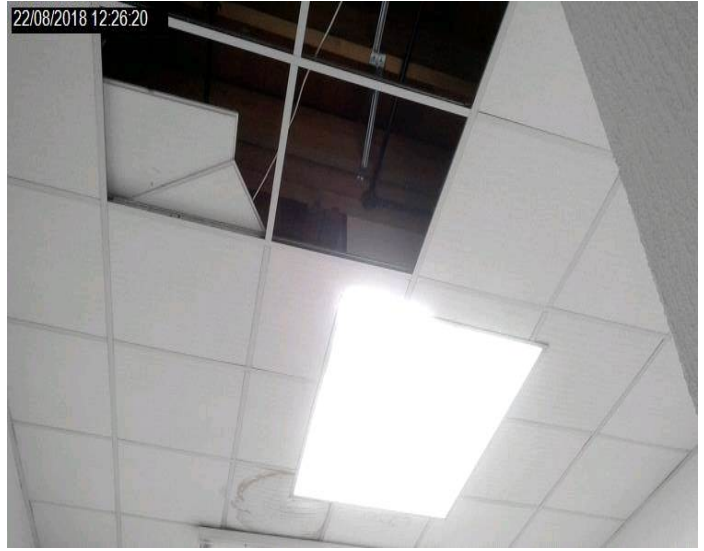
<b>Location:</b>	3.00C	<b>Block:</b>	Birmingham City University	<b>Floor Level:</b> 3rd Floor
<b>Sample No.:</b>	DU002141	<b>Portal Ref No.:</b>	119

<b>Item:</b>	Insulating board upstands to skylight			
<b>Asbestos Content:</b>		<b>Result Based on:</b>		
No Asbestos Detected		Analysis of sample using PLM		
<b>Sample Analysed By:</b>	Reg 13(1)	<b>Extent:</b>	6 m <sup>2</sup>	
<b>Comments:</b>

<b>Material Assessment Total Score: 0</b>		<b>Likelihood of Disturbance Assessment Total Score: 0</b>		<b>Management Assessment</b>  <b>Licensable:</b> Yes  <b>Recommendations:</b> Not Applicable  <b>Reinspection Interval:</b> Not Applicable  <b>Overall Risk Category:</b> E0
<b>Product Type:</b>	0 Not Applicable	<b>Location:</b>	0 Not Applicable	
<b>Condition:</b>	0 Not Applicable	<b>Accessibility:</b>	0 Not Applicable	
<b>Surface Treatment:</b>	0 Not Applicable			
<b>Asbestos Type:</b>	0 Not Applicable	<b>Extent Score:</b>	0 Not Applicable

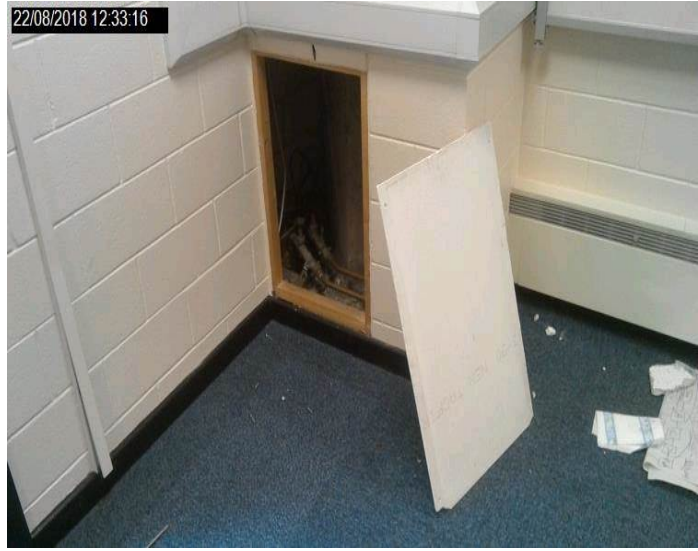
<b>Location:</b>	3.41	<b>Block:</b>	Birmingham City University	<b>Floor Level:</b> 3rd Floor
<b>Sample No.:</b>	DU002142	<b>Portal Ref No.:</b>	120

<b>Item:</b>	Insulating board panel			
<b>Asbestos Content:</b>		<b>Result Based on:</b>		
No Asbestos Detected		Analysis of sample using PLM		
<b>Sample Analysed By:</b>	Reg 13(1)	<b>Extent:</b>	3 m <sup>2</sup>	
<b>Comments:</b> To riser

<b>Material Assessment Total Score: 0</b>		<b>Likelihood of Disturbance Assessment Total Score: 0</b>		<b>Management Assessment</b>  <b>Licensable:</b> Yes  <b>Recommendations:</b> Not Applicable  <b>Reinspection Interval:</b> Not Applicable  <b>Overall Risk Category:</b> E0
<b>Product Type:</b>	0 Not Applicable	<b>Location:</b>	0 Not Applicable	
<b>Condition:</b>	0 Not Applicable	<b>Accessibility:</b>	0 Not Applicable	
<b>Surface Treatment:</b>	0 Not Applicable			
<b>Asbestos Type:</b>	0 Not Applicable	<b>Extent Score:</b>	0 Not Applicable

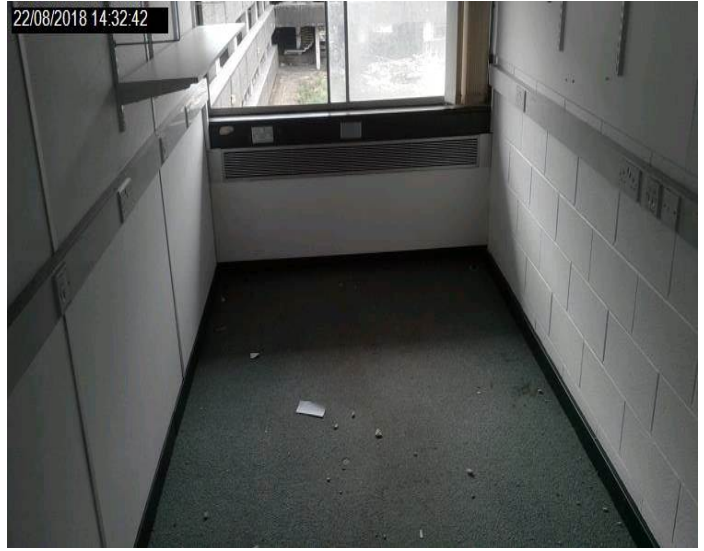
<b>Location:</b>	3.14	<b>Block:</b>	Birmingham City University	<b>Floor Level:</b> 3rd Floor
<b>Sample No.:</b>	As DU002136	<b>Portal Ref No.:</b>	123

<b>Item:</b>	Asbestos Cement window sill			
<b>Asbestos Content:</b>	<b>Result Based on:</b>			
Chrysotile	Strongly presumed			
<b>Sample Analysed By:</b>	Not applicable	<b>Extent:</b>	3 linear metres	
<b>Comments:</b>

<b>Material Assessment Total Score: 4</b>		<b>Likelihood of Disturbance Assessment Total Score: 5</b>		<b>Management Assessment</b>  <b>Licensable:</b> No  <b>Recommendations:</b> Program removal  <b>Reinspection Interval:</b> Not Applicable  <b>Overall Risk Category:</b> C9
<b>Product Type:</b>	1 (Asbestos cement)	<b>Location:</b>	2 (Rooms up to 100 sq m)	
<b>Condition:</b>	1 (Minor scratches)	<b>Accessibility:</b>	2 (Easily disturbed)	
<b>Surface Treatment:</b>	1 (Unencapsulated asbestos cement)			
<b>Asbestos Type:</b>	1 (Chrysotile)	<b>Extent Score:</b>	1 (<10 sq m or 10m pipe run)

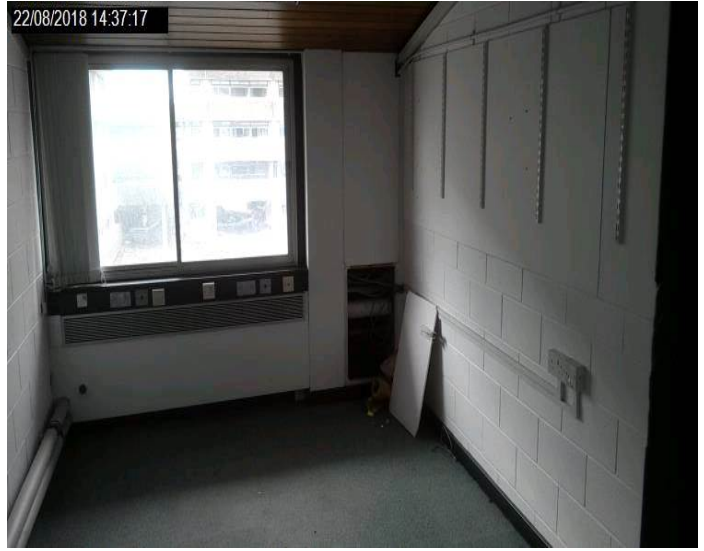
<b>Location:</b>	3.13	<b>Block:</b>	Birmingham City University	<b>Floor Level:</b> 3rd Floor
<b>Sample No.:</b>	DU002144	<b>Portal Ref No.:</b>	125

<b>Item:</b>	Insulating board panel to riser			
<b>Asbestos Content:</b>		<b>Result Based on:</b>		
No Asbestos Detected		Analysis of sample using PLM		
<b>Sample Analysed By:</b>	Reg 13(1)	<b>Extent:</b>	3 m <sup>2</sup>	
<b>Comments:</b>

<b>Material Assessment Total Score: 0</b>		<b>Likelihood of Disturbance Assessment Total Score: 0</b>		<b>Management Assessment</b>  <b>Licensable:</b> Yes  <b>Recommendations:</b> Not Applicable  <b>Reinspection Interval:</b> Not Applicable  <b>Overall Risk Category:</b> E0
<b>Product Type:</b>	0 Not Applicable	<b>Location:</b>	0 Not Applicable	
<b>Condition:</b>	0 Not Applicable	<b>Accessibility:</b>	0 Not Applicable	
<b>Surface Treatment:</b>	0 Not Applicable			
<b>Asbestos Type:</b>	0 Not Applicable	<b>Extent Score:</b>	0 Not Applicable

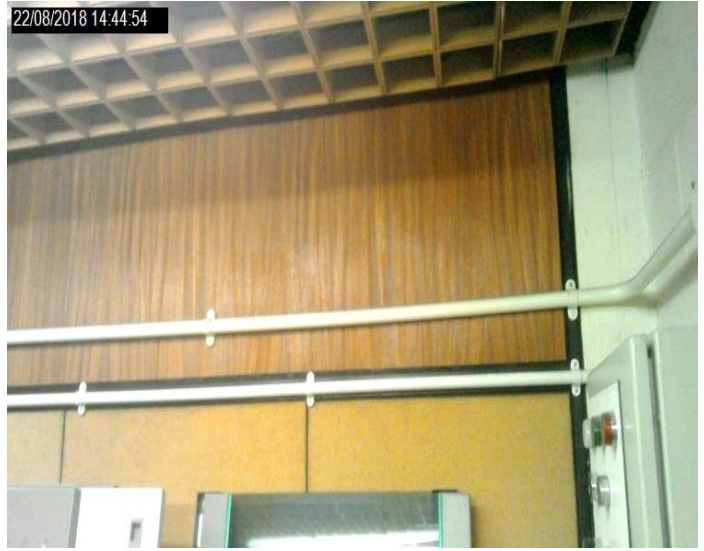
<b>Location:</b>	3.09	<b>Block:</b>	Birmingham City University	<b>Floor Level:</b> 3rd Floor
<b>Sample No.:</b>	DU002145	<b>Portal Ref No.:</b>	126

<b>Item:</b>	Insulating board upstand			
<b>Asbestos Content:</b>		<b>Result Based on:</b>		
No Asbestos Detected		Analysis of sample using PLM		
<b>Sample Analysed By:</b>	Reg 13(1)	<b>Extent:</b>	4 m <sup>2</sup>	
<b>Comments:</b> Double skin

<b>Material Assessment Total Score: 0</b>		<b>Likelihood of Disturbance Assessment Total Score: 0</b>		<b>Management Assessment</b>  <b>Licensable:</b> Yes  <b>Recommendations:</b> Not Applicable  <b>Reinspection Interval:</b> Not Applicable  <b>Overall Risk Category:</b> E0
<b>Product Type:</b>	0 Not Applicable	<b>Location:</b>	0 Not Applicable	
<b>Condition:</b>	0 Not Applicable	<b>Accessibility:</b>	0 Not Applicable	
<b>Surface Treatment:</b>	0 Not Applicable			
<b>Asbestos Type:</b>	0 Not Applicable	<b>Extent Score:</b>	0 Not Applicable

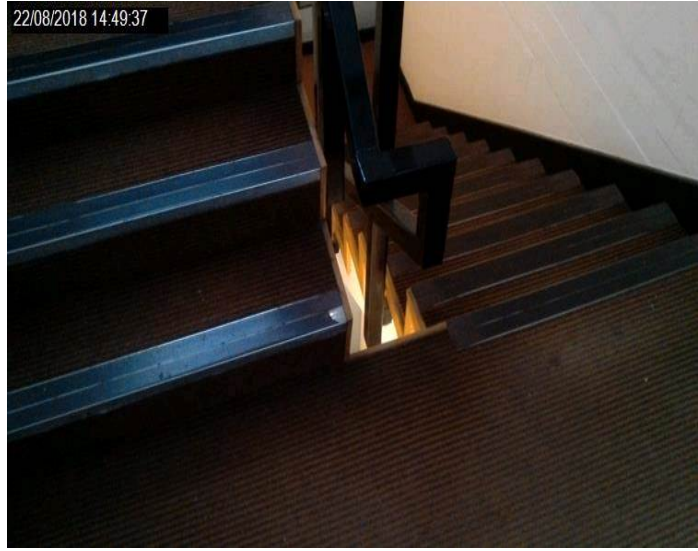
<b>Location:</b>	3.00D	<b>Block:</b>	Birmingham City University	<b>Floor Level:</b> 3rd Floor
<b>Sample No.:</b>	DU002146	<b>Portal Ref No.:</b>	127

<b>Item:</b>	Reinforced plastic stair nosing			
<b>Asbestos Content:</b>		<b>Result Based on:</b>		
No Asbestos Detected		Analysis of sample using PLM		
<b>Sample Analysed By:</b>	Reg 13(1)	<b>Extent:</b>	22 linear metres	
<b>Comments:</b>

<b>Material Assessment Total Score: 0</b>		<b>Likelihood of Disturbance Assessment Total Score: 0</b>		<b>Management Assessment</b>  <b>Licensable:</b> No  <b>Recommendations:</b> Not Applicable  <b>Reinspection Interval:</b> Not Applicable  <b>Overall Risk Category:</b> E0
<b>Product Type:</b>	0 Not Applicable	<b>Location:</b>	0 Not Applicable	
<b>Condition:</b>	0 Not Applicable	<b>Accessibility:</b>	0 Not Applicable	
<b>Surface Treatment:</b>	0 Not Applicable			
<b>Asbestos Type:</b>	0 Not Applicable	<b>Extent Score:</b>	0 Not Applicable

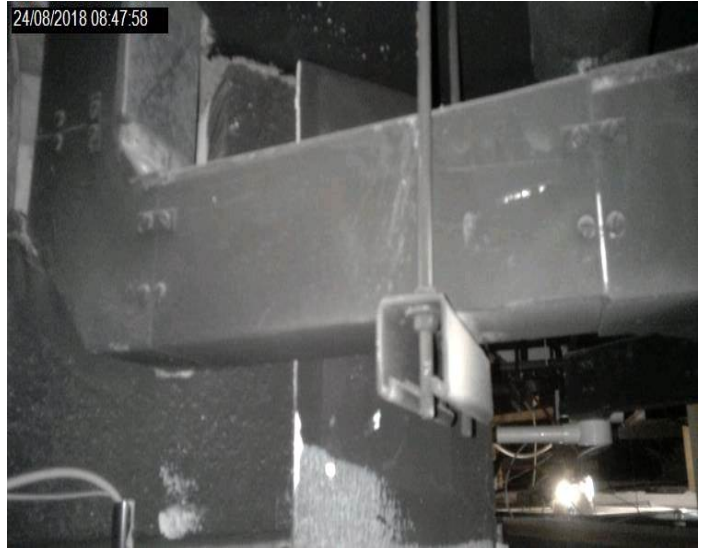
<b>Location:</b>	2.22	<b>Block:</b>	Birmingham City University	<b>Floor Level:</b> 2nd Floor
<b>Sample No.:</b>	DU002148	<b>Portal Ref No.:</b>	129

<b>Item:</b>	Insulating board panel			
<b>Asbestos Content:</b>		<b>Result Based on:</b>		
No Asbestos Detected		Analysis of sample using PLM		
<b>Sample Analysed By:</b>	Reg 13(1)	<b>Extent:</b>	1 m <sup>2</sup>	
<b>Comments:</b> Within ceiling void to corner of central pillar

<b>Material Assessment Total Score: 0</b>		<b>Likelihood of Disturbance Assessment Total Score: 0</b>		<b>Management Assessment</b>  <b>Licensable:</b> Yes  <b>Recommendations:</b> Not Applicable  <b>Reinspection Interval:</b> Not Applicable  <b>Overall Risk Category:</b> E0
<b>Product Type:</b>	0 Not Applicable	<b>Location:</b>	0 Not Applicable	
<b>Condition:</b>	0 Not Applicable	<b>Accessibility:</b>	0 Not Applicable	
<b>Surface Treatment:</b>	0 Not Applicable			
<b>Asbestos Type:</b>	0 Not Applicable	<b>Extent Score:</b>	0 Not Applicable

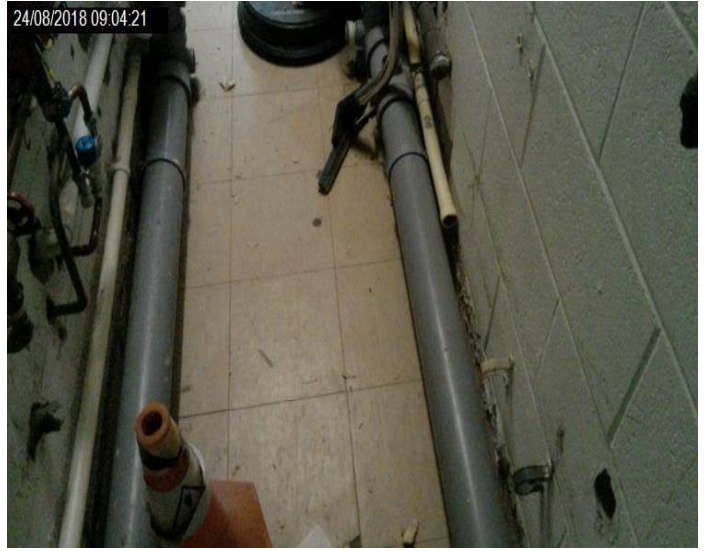
<b>Location:</b>	2.14	<b>Block:</b>	Birmingham City University	<b>Floor Level:</b> 2nd Floor
<b>Sample No.:</b>	DU002150	<b>Portal Ref No.:</b>	133

<b>Item:</b>	Thermoplastic floor tiles			
<b>Asbestos Content:</b>		<b>Result Based on:</b>		
No Asbestos Detected in tile or adhesive		Analysis of sample using PLM		
<b>Sample Analysed By:</b>	Reg 13(1)	<b>Extent:</b>	7 m <sup>2</sup>	
<b>Comments:</b>

<b>Material Assessment Total Score: 0</b>		<b>Likelihood of Disturbance Assessment Total Score: 0</b>		<b>Management Assessment</b>  <b>Licensable:</b> No  <b>Recommendations:</b> Not Applicable  <b>Reinspection Interval:</b> Not Applicable  <b>Overall Risk Category:</b> E0
<b>Product Type:</b>	0 Not Applicable	<b>Location:</b>	0 Not Applicable	
<b>Condition:</b>	0 Not Applicable	<b>Accessibility:</b>	0 Not Applicable	
<b>Surface Treatment:</b>	0 Not Applicable			
<b>Asbestos Type:</b>	0 Not Applicable	<b>Extent Score:</b>	0 Not Applicable

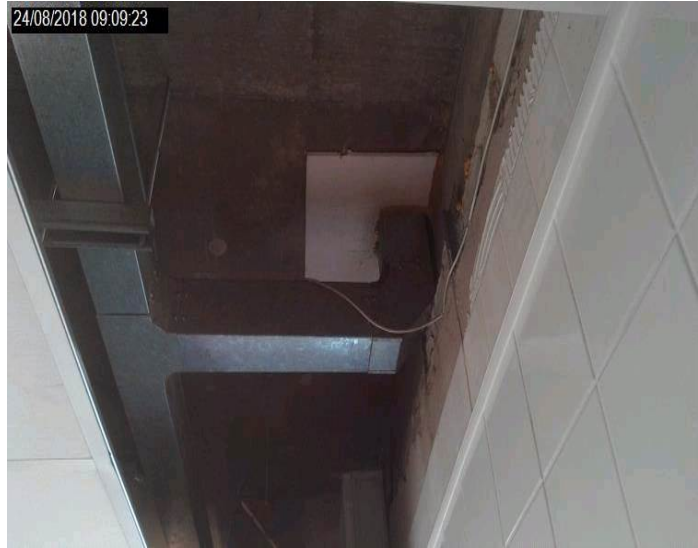
<b>Location:</b>	2.16	<b>Block:</b>	Birmingham City University	<b>Floor Level:</b> 2nd Floor
<b>Sample No.:</b>	DU002151	<b>Portal Ref No.:</b>	134

<b>Item:</b>	Insulating board			
<b>Asbestos Content:</b>		<b>Result Based on:</b>		
No Asbestos Detected		Analysis of sample using PLM		
<b>Sample Analysed By:</b>	Reg 13(1)	<b>Extent:</b>	1 m <sup>2</sup>	
<b>Comments:</b> Fire protection for metal ducting within ceiling void

<b>Material Assessment Total Score: 0</b>		<b>Likelihood of Disturbance Assessment Total Score: 0</b>		<b>Management Assessment</b>  <b>Licensable:</b> Yes  <b>Recommendations:</b> Not Applicable  <b>Reinspection Interval:</b> Not Applicable  <b>Overall Risk Category:</b> E0
<b>Product Type:</b>	0 Not Applicable	<b>Location:</b>	0 Not Applicable	
<b>Condition:</b>	0 Not Applicable	<b>Accessibility:</b>	0 Not Applicable	
<b>Surface Treatment:</b>	0 Not Applicable			
<b>Asbestos Type:</b>	0 Not Applicable	<b>Extent Score:</b>	0 Not Applicable

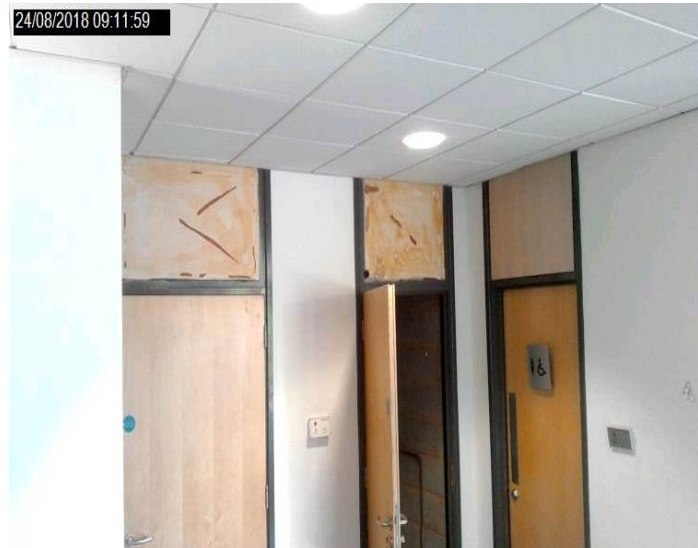
<b>Location:</b>	2.22A	<b>Block:</b>	Birmingham City University	<b>Floor Level:</b> 2nd Floor
<b>Sample No.:</b>	DU002152	<b>Portal Ref No.:</b>	135

<b>Item:</b>	Insulating board door headers			
<b>Asbestos Content:</b>	<b>Result Based on:</b>			
No Asbestos Detected	Analysis of sample using PLM			
<b>Sample Analysed By:</b> Reg 13(1)	<b>Extent:</b>	8 m <sup>2</sup>		
<b>Comments:</b> Above doors to rooms 2.12, 2.13, 2.14 2.16 double skin and above 2.00 stairs

<b>Material Assessment Total Score: 0</b>		<b>Likelihood of Disturbance Assessment Total Score: 0</b>		<b>Management Assessment</b>  <b>Licensable:</b> Yes  <b>Recommendations:</b> Not Applicable  <b>Reinspection Interval:</b> Not Applicable  <b>Overall Risk Category:</b> E0
<b>Product Type:</b>	0 Not Applicable	<b>Location:</b>	0 Not Applicable	
<b>Condition:</b>	0 Not Applicable	<b>Accessibility:</b>	0 Not Applicable	
<b>Surface Treatment:</b>	0 Not Applicable			
<b>Asbestos Type:</b>	0 Not Applicable	<b>Extent Score:</b>	0 Not Applicable

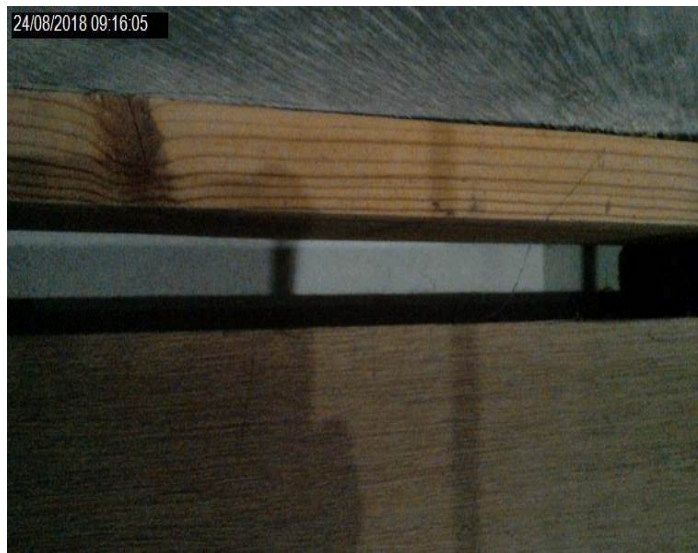
<b>Location:</b>	2.22A	<b>Block:</b>	Birmingham City University	<b>Floor Level:</b> 2nd Floor
<b>Sample No.:</b>	As DU002147	<b>Portal Ref No.:</b>	136

<b>Item:</b>	Insulating board panel			
<b>Asbestos Content:</b>		<b>Result Based on:</b>		
No Asbestos Detected		Strongly presumed		
<b>Sample Analysed By:</b>	Not applicable	<b>Extent:</b>	6 linear metres	
<b>Comments:</b> Within ceiling void to above sliding doors

<b>Material Assessment Total Score: 0</b>		<b>Likelihood of Disturbance Assessment Total Score: 0</b>		<b>Management Assessment</b>  <b>Licensable:</b> Yes  <b>Recommendations:</b> Not Applicable  <b>Reinspection Interval:</b> Not Applicable  <b>Overall Risk Category:</b> E0
<b>Product Type:</b>	0 Not Applicable	<b>Location:</b>	0 Not Applicable	
<b>Condition:</b>	0 Not Applicable	<b>Accessibility:</b>	0 Not Applicable	
<b>Surface Treatment:</b>	0 Not Applicable			
<b>Asbestos Type:</b>	0 Not Applicable	<b>Extent Score:</b>	0 Not Applicable

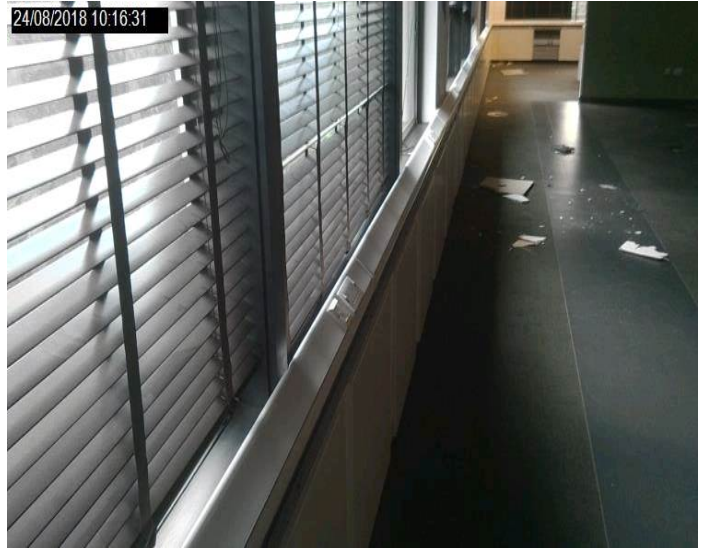
<b>Location:</b>	2.18	<b>Block:</b>	Birmingham City University	<b>Floor Level:</b> 2nd Floor
<b>Sample No.:</b>	As DU002153	<b>Portal Ref No.:</b>	141

<b>Item:</b>	Asbestos Cement window sill			
<b>Asbestos Content:</b>	<b>Result Based on:</b>			
Chrysotile	Strongly presumed			
<b>Sample Analysed By:</b>	Not applicable	<b>Extent:</b>	11 linear metres	
<b>Comments:</b>

<b>Material Assessment Total Score: 4</b>		<b>Likelihood of Disturbance Assessment Total Score: 5</b>		<b>Management Assessment</b>  <b>Licensable:</b> No  <b>Recommendations:</b> Program removal  <b>Reinspection Interval:</b> Not Applicable  <b>Overall Risk Category:</b> C9
<b>Product Type:</b>	1 (Asbestos cement)	<b>Location:</b>	2 (Rooms up to 100 sq m)	
<b>Condition:</b>	1 (Minor scratches)	<b>Accessibility:</b>	1 (Occasionally likely to be disturbed)	
<b>Surface Treatment:</b>	1 (Unencapsulated asbestos cement)			
<b>Asbestos Type:</b>	1 (Chrysotile)	<b>Extent Score:</b>	2 (>10 - <50 sq m or >10m - <50m pipe run)
