**Report No.:** J102747  
**Nature of Work:** Demolition Survey  
**Issue Date:** 26/09/2018  
**Client Name:** WYG Engineering Ltd  
Geneva Building, Lake View Drive, Sherwood Business Park,  
Annesley, Nottingham, NG15 0ED  
**Site Address:** Kenrick Building, Former City North Campus, Birmingham City  
University, Perry Barr, B42 2US

**Order Placed By:** Reg 13(1)  
**Site Contact:** Reg 13(1)  
**Date(s) of Work:** 20/08/2018 to 23/08/2018  
**Technical Manager:** Reg 13(1) (Asbestos)  
**Assistant Surveyor(s):** Reg 13(1)

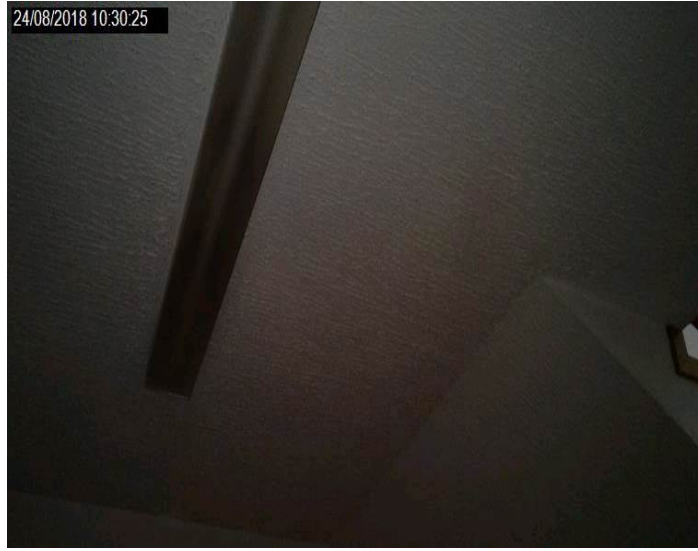
<b>Location:</b>	2.00	<b>Block:</b>	Birmingham City University	<b>Floor Level:</b> 2nd Floor
<b>Sample No.:</b>	DU002156	<b>Portal Ref No.:</b>	144

<b>Item:</b>	Textured coating to concrete ceiling			
<b>Asbestos Content:</b>		<b>Result Based on:</b>		
No Asbestos Detected		Analysis of sample using PLM		
<b>Sample Analysed By:</b>	Reg 13(1)	<b>Extent:</b>	20 m <sup>2</sup>	
<b>Comments:</b>

<b>Material Assessment Total Score: 0</b>		<b>Likelihood of Disturbance Assessment Total Score: 0</b>		<b>Management Assessment</b>  <b>Licensable:</b> No  <b>Recommendations:</b> Not Applicable  <b>Reinspection Interval:</b> Not Applicable  <b>Overall Risk Category:</b> E0
<b>Product Type:</b>	0 Not Applicable	<b>Location:</b>	0 Not Applicable	
<b>Condition:</b>	0 Not Applicable	<b>Accessibility:</b>	0 Not Applicable	
<b>Surface Treatment:</b>	0 Not Applicable			
<b>Asbestos Type:</b>	0 Not Applicable	<b>Extent Score:</b>	0 Not Applicable

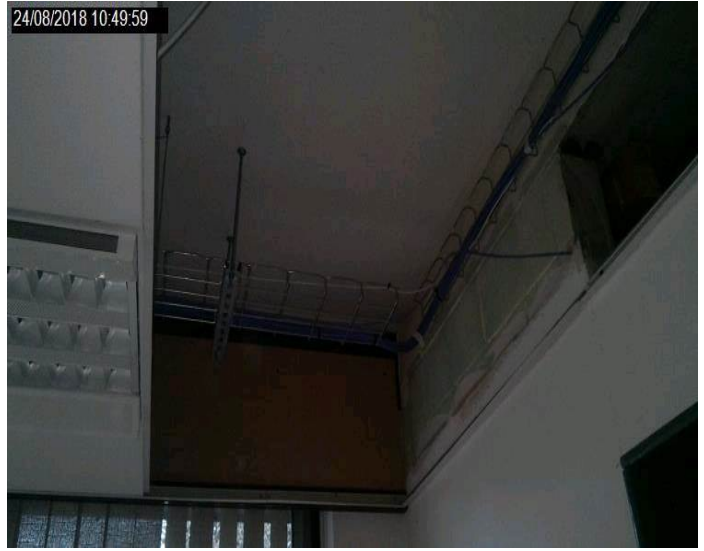
<b>Location:</b>	2.49	<b>Block:</b>	Birmingham City University	<b>Floor Level:</b> 2nd Floor
<b>Sample No.:</b>	DU002157	<b>Portal Ref No.:</b>	146

<b>Item:</b>	Textured coating to concrete			
<b>Asbestos Content:</b>	<b>Result Based on:</b>			
No Asbestos Detected	Analysis of sample using PLM			
<b>Sample Analysed By:</b>	Reg 13(1)	<b>Extent:</b>	60 m <sup>2</sup>	
<b>Comments:</b>

<b>Material Assessment Total Score: 0</b>		<b>Likelihood of Disturbance Assessment Total Score: 0</b>		<b>Management Assessment</b>  <b>Licensable:</b> No  <b>Recommendations:</b> Not Applicable  <b>Reinspection Interval:</b> Not Applicable  <b>Overall Risk Category:</b> E0
<b>Product Type:</b>	0 Not Applicable	<b>Location:</b>	0 Not Applicable	
<b>Condition:</b>	0 Not Applicable	<b>Accessibility:</b>	0 Not Applicable	
<b>Surface Treatment:</b>	0 Not Applicable			
<b>Asbestos Type:</b>	0 Not Applicable	<b>Extent Score:</b>	0 Not Applicable

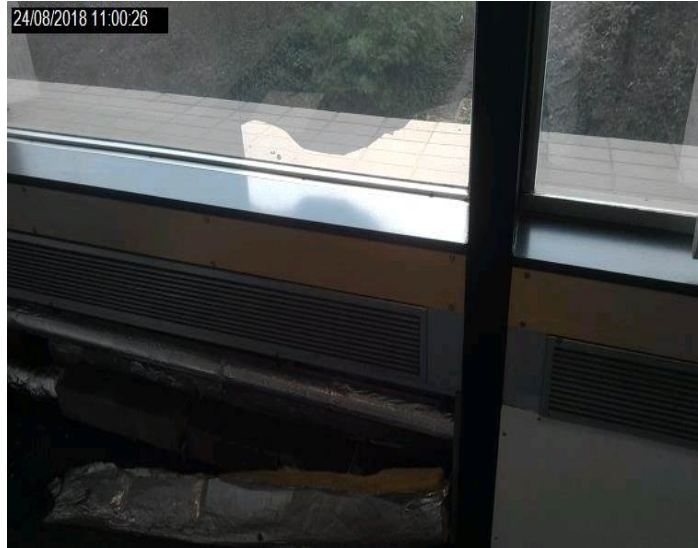
<b>Location:</b>	2.49	<b>Block:</b>	Birmingham City University	<b>Floor Level:</b> 2nd Floor
<b>Sample No.:</b>	As DU002153	<b>Portal Ref No.:</b>	147

<b>Item:</b>	Asbestos Cement window sill			
<b>Asbestos Content:</b>	<b>Result Based on:</b>			
Chrysotile	Strongly presumed			
<b>Sample Analysed By:</b>	Not applicable	<b>Extent:</b>	7 linear metres	
<b>Comments:</b>

<b>Material Assessment Total Score: 4</b>		<b>Likelihood of Disturbance Assessment Total Score: 4</b>		<b>Management Assessment</b>  <b>Licensable:</b> No  <b>Recommendations:</b> Program removal  <b>Reinspection Interval:</b> Not Applicable  <b>Overall Risk Category:</b> C8
<b>Product Type:</b>	1 (Asbestos cement)	<b>Location:</b>	2 (Rooms up to 100 sq m)	
<b>Condition:</b>	1 (Minor scratches)	<b>Accessibility:</b>	1 (Occasionally likely to be disturbed)	
<b>Surface Treatment:</b>	1 (Unencapsulated asbestos cement)			
<b>Asbestos Type:</b>	1 (Chrysotile)	<b>Extent Score:</b>	1 (<10 sq m or 10m pipe run)

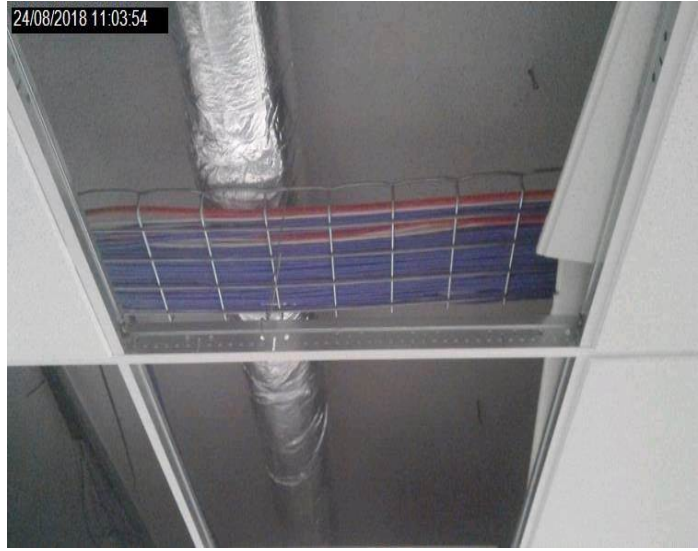
<b>Location:</b>	2.51	<b>Block:</b>	Birmingham City University	<b>Floor Level:</b> 2nd Floor
<b>Sample No.:</b>	As DU002157	<b>Portal Ref No.:</b>	149

<b>Item:</b>	Textured coating to concrete			
<b>Asbestos Content:</b>		<b>Result Based on:</b>		
No Asbestos Detected		Strongly presumed		
<b>Sample Analysed By:</b>	Not applicable	<b>Extent:</b>	35 m <sup>2</sup>	
<b>Comments:</b>

<b>Material Assessment Total Score: 0</b>		<b>Likelihood of Disturbance Assessment Total Score: 0</b>		<b>Management Assessment</b>  <b>Licensable:</b> No  <b>Recommendations:</b> Not Applicable  <b>Reinspection Interval:</b> Not Applicable  <b>Overall Risk Category:</b> E0
<b>Product Type:</b>	0 Not Applicable	<b>Location:</b>	0 Not Applicable	
<b>Condition:</b>	0 Not Applicable	<b>Accessibility:</b>	0 Not Applicable	
<b>Surface Treatment:</b>	0 Not Applicable			
<b>Asbestos Type:</b>	0 Not Applicable	<b>Extent Score:</b>	0 Not Applicable

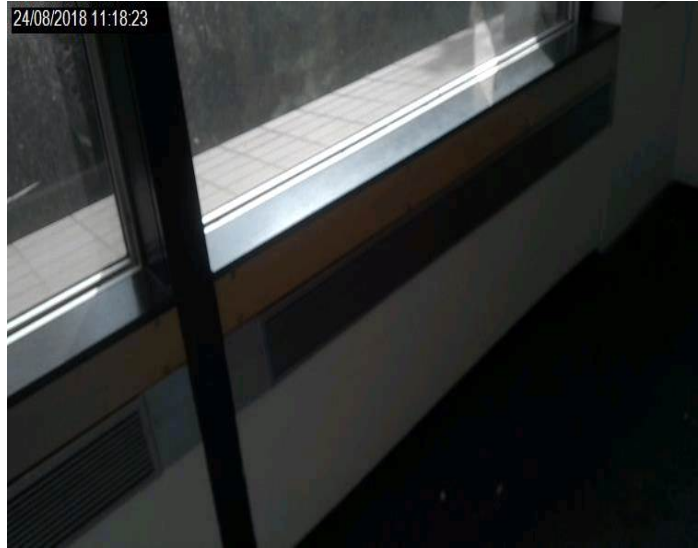
<b>Location:</b>	2.55	<b>Block:</b>	Birmingham City University	<b>Floor Level:</b> 2nd Floor
<b>Sample No.:</b>	DU002159	<b>Portal Ref No.:</b>	153

<b>Item:</b>	Asbestos Cement window sill			
<b>Asbestos Content:</b>	Result Based on:			
Chrysotile	Analysis of sample using PLM			
<b>Sample Analysed By:</b>	Reg 13(1)	<b>Extent:</b>	5 linear metres	
<b>Comments:</b>

<b>Material Assessment Total Score: 4</b>		<b>Likelihood of Disturbance Assessment Total Score: 4</b>		<b>Management Assessment</b>  <b>Licensable:</b> No  <b>Recommendations:</b> Program removal  <b>Reinspection Interval:</b> Not Applicable  <b>Overall Risk Category:</b> C8
<b>Product Type:</b>	1 (Asbestos cement)	<b>Location:</b>	2 (Rooms up to 100 sq m)	
<b>Condition:</b>	1 (Minor scratches)	<b>Accessibility:</b>	1 (Occasionally likely to be disturbed)	
<b>Surface Treatment:</b>	1 (Unencapsulated asbestos cement)			
<b>Asbestos Type:</b>	1 (Chrysotile)	<b>Extent Score:</b>	1 (<10 sq m or 10m pipe run)

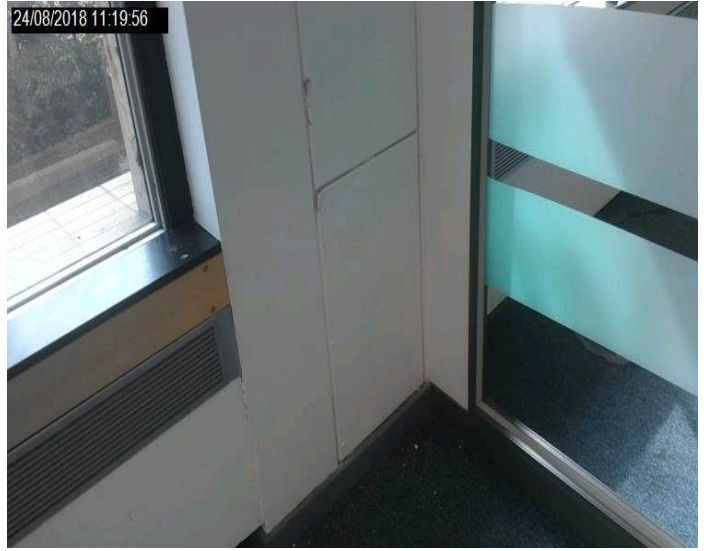
<b>Location:</b>	2.55	<b>Block:</b>	Birmingham City University	<b>Floor Level:</b> 2nd Floor
<b>Sample No.:</b>	DU002160	<b>Portal Ref No.:</b>	154

<b>Item:</b>	Insulating board panel to riser			
<b>Asbestos Content:</b>		<b>Result Based on:</b>		
No Asbestos Detected		Analysis of sample using PLM		
<b>Sample Analysed By:</b>	Reg 13(1)	<b>Extent:</b>	3 m <sup>2</sup>	
<b>Comments:</b>

<b>Material Assessment Total Score: 0</b>		<b>Likelihood of Disturbance Assessment Total Score: 0</b>		<b>Management Assessment</b>  <b>Licensable:</b> Yes  <b>Recommendations:</b> Not Applicable  <b>Reinspection Interval:</b> Not Applicable  <b>Overall Risk Category:</b> E0
<b>Product Type:</b>	0 Not Applicable	<b>Location:</b>	0 Not Applicable	
<b>Condition:</b>	0 Not Applicable	<b>Accessibility:</b>	0 Not Applicable	
<b>Surface Treatment:</b>	0 Not Applicable			
<b>Asbestos Type:</b>	0 Not Applicable	<b>Extent Score:</b>	0 Not Applicable

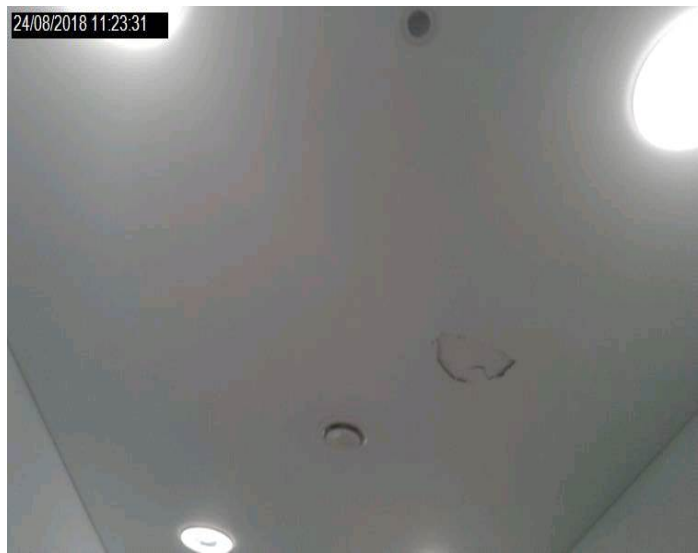
<b>Location:</b>	2.56	<b>Block:</b>	Birmingham City University	<b>Floor Level:</b> 2nd Floor
<b>Sample No.:</b>	As DU002158	<b>Portal Ref No.:</b>	155

<b>Item:</b>	Textured coating to concrete			
<b>Asbestos Content:</b>		<b>Result Based on:</b>		
No Asbestos Detected		Strongly presumed		
<b>Sample Analysed By:</b>	Not applicable	<b>Extent:</b>	8 m <sup>2</sup>	
<b>Comments:</b> Above plasterboard

<b>Material Assessment Total Score: 0</b>		<b>Likelihood of Disturbance Assessment Total Score: 0</b>		<b>Management Assessment</b>  <b>Licensable:</b> No  <b>Recommendations:</b> Not Applicable  <b>Reinspection Interval:</b> Not Applicable  <b>Overall Risk Category:</b> E0
<b>Product Type:</b>	0 Not Applicable	<b>Location:</b>	0 Not Applicable	
<b>Condition:</b>	0 Not Applicable	<b>Accessibility:</b>	0 Not Applicable	
<b>Surface Treatment:</b>	0 Not Applicable			
<b>Asbestos Type:</b>	0 Not Applicable	<b>Extent Score:</b>	0 Not Applicable

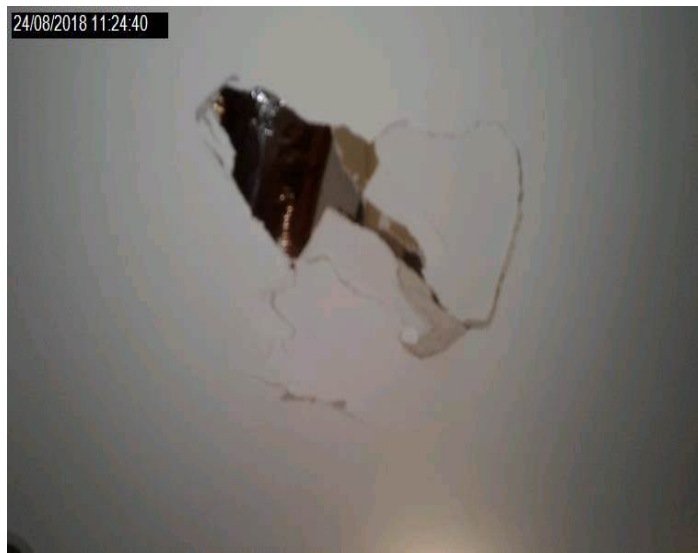
<b>Location:</b>	2.57	<b>Block:</b>	Birmingham City University	<b>Floor Level:</b> 2nd Floor
<b>Sample No.:</b>	As DU002158	<b>Portal Ref No.:</b>	157

<b>Item:</b>	Textured coating to concrete			
<b>Asbestos Content:</b>		<b>Result Based on:</b>		
No Asbestos Detected		Strongly presumed		
<b>Sample Analysed By:</b>	Not applicable	<b>Extent:</b>	5 m <sup>2</sup>	
<b>Comments:</b> Above plasterboard

<b>Material Assessment Total Score: 0</b>		<b>Likelihood of Disturbance Assessment Total Score: 0</b>		<b>Management Assessment</b>  <b>Licensable:</b> No  <b>Recommendations:</b> Not Applicable  <b>Reinspection Interval:</b> Not Applicable  <b>Overall Risk Category:</b> E0
<b>Product Type:</b>	0 Not Applicable	<b>Location:</b>	0 Not Applicable	
<b>Condition:</b>	0 Not Applicable	<b>Accessibility:</b>	0 Not Applicable	
<b>Surface Treatment:</b>	0 Not Applicable			
<b>Asbestos Type:</b>	0 Not Applicable	<b>Extent Score:</b>	0 Not Applicable

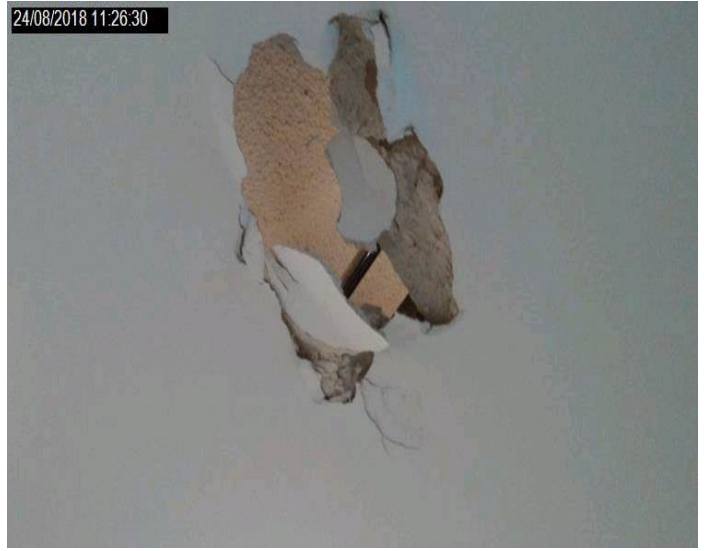
<b>Location:</b>	2.58	<b>Block:</b>	Birmingham City University	<b>Floor Level:</b> 2nd Floor
<b>Sample No.:</b>	As DU002158	<b>Portal Ref No.:</b>	159

<b>Item:</b>	Textured coating to concrete			
<b>Asbestos Content:</b>		<b>Result Based on:</b>		
No Asbestos Detected		Strongly presumed		
<b>Sample Analysed By:</b>	Not applicable	<b>Extent:</b>	5 m <sup>2</sup>	
<b>Comments:</b> Above plasterboard

<b>Material Assessment Total Score: 0</b>		<b>Likelihood of Disturbance Assessment Total Score: 0</b>		<b>Management Assessment</b>  <b>Licensable:</b> No  <b>Recommendations:</b> Not Applicable  <b>Reinspection Interval:</b> Not Applicable  <b>Overall Risk Category:</b> E0
<b>Product Type:</b>	0 Not Applicable	<b>Location:</b>	0 Not Applicable	
<b>Condition:</b>	0 Not Applicable	<b>Accessibility:</b>	0 Not Applicable	
<b>Surface Treatment:</b>	0 Not Applicable			
<b>Asbestos Type:</b>	0 Not Applicable	<b>Extent Score:</b>	0 Not Applicable

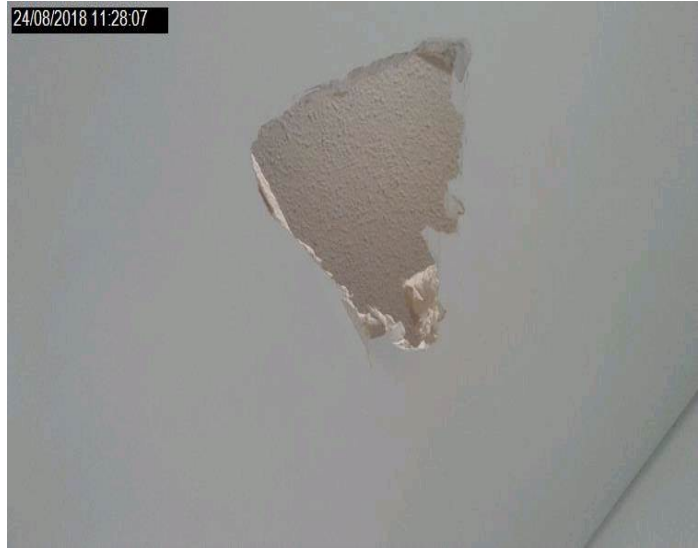
<b>Location:</b>	2.59	<b>Block:</b>	Birmingham City University	<b>Floor Level:</b> 2nd Floor
<b>Sample No.:</b>	As DU002158	<b>Portal Ref No.:</b>	161

<b>Item:</b>	Textured coating to concrete			
<b>Asbestos Content:</b>		<b>Result Based on:</b>		
No Asbestos Detected		Strongly presumed		
<b>Sample Analysed By:</b>	Not applicable	<b>Extent:</b>	5 m <sup>2</sup>	
<b>Comments:</b> Above plasterboard

<b>Material Assessment Total Score: 0</b>		<b>Likelihood of Disturbance Assessment Total Score: 0</b>		<b>Management Assessment</b>  <b>Licensable:</b> No  <b>Recommendations:</b> Not Applicable  <b>Reinspection Interval:</b> Not Applicable  <b>Overall Risk Category:</b> E0
<b>Product Type:</b>	0 Not Applicable	<b>Location:</b>	0 Not Applicable	
<b>Condition:</b>	0 Not Applicable	<b>Accessibility:</b>	0 Not Applicable	
<b>Surface Treatment:</b>	0 Not Applicable			
<b>Asbestos Type:</b>	0 Not Applicable	<b>Extent Score:</b>	0 Not Applicable

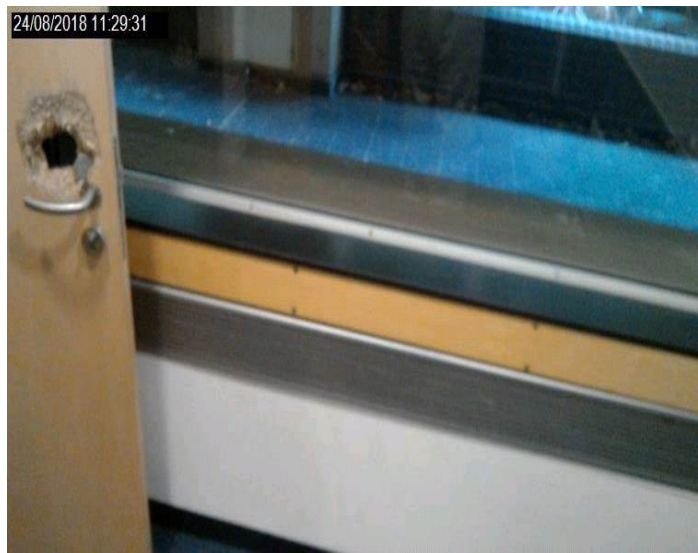
<b>Location:</b>	2.60	<b>Block:</b>	Birmingham City University	<b>Floor Level:</b> 2nd Floor
<b>Sample No.:</b>	As DU002159	<b>Portal Ref No.:</b>	164

<b>Item:</b>	Asbestos Cement window sill			
<b>Asbestos Content:</b>	<b>Result Based on:</b>			
Chrysotile	Strongly presumed			
<b>Sample Analysed By:</b>	Not applicable	<b>Extent:</b>	2 linear metres	
<b>Comments:</b>

<b>Material Assessment Total Score: 4</b>		<b>Likelihood of Disturbance Assessment Total Score: 4</b>		<b>Management Assessment</b>  <b>Licensable:</b> No  <b>Recommendations:</b> Program removal  <b>Reinspection Interval:</b> Not Applicable  <b>Overall Risk Category:</b> C8
<b>Product Type:</b>	1 (Asbestos cement)	<b>Location:</b>	2 (Rooms up to 100 sq m)	
<b>Condition:</b>	1 (Minor scratches)	<b>Accessibility:</b>	1 (Occasionally likely to be disturbed)	
<b>Surface Treatment:</b>	1 (Unencapsulated asbestos cement)			
<b>Asbestos Type:</b>	1 (Chrysotile)	<b>Extent Score:</b>	1 (<10 sq m or 10m pipe run)

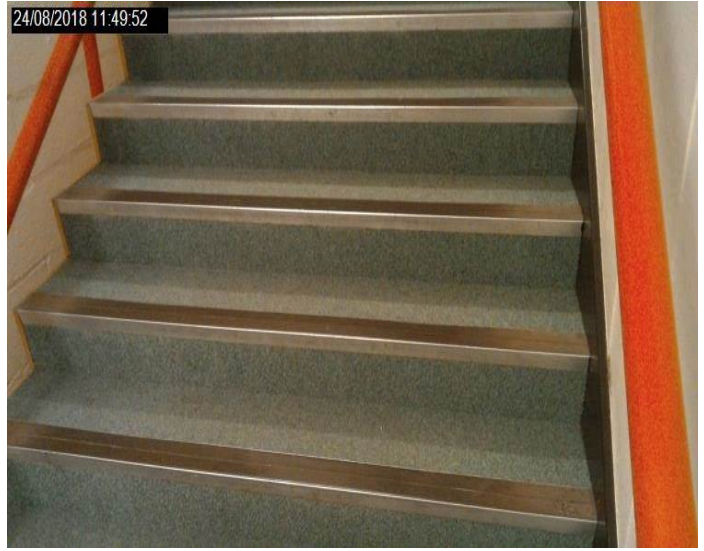
<b>Location:</b>	2.99	<b>Block:</b>	Birmingham City University	<b>Floor Level:</b> 2nd Floor
<b>Sample No.:</b>	DU002161	<b>Portal Ref No.:</b>	165

<b>Item:</b>	Reinforced plastic stair nosing			
<b>Asbestos Content:</b>		<b>Result Based on:</b>		
No Asbestos Detected		Analysis of sample using PLM		
<b>Sample Analysed By:</b>	Reg 13(1)	<b>Extent:</b>	22 linear metres	
<b>Comments:</b>

<b>Material Assessment Total Score: 0</b>		<b>Likelihood of Disturbance Assessment Total Score: 0</b>		<b>Management Assessment</b>  <b>Licensable:</b> No  <b>Recommendations:</b> Not Applicable  <b>Reinspection Interval:</b> Not Applicable  <b>Overall Risk Category:</b> E0
<b>Product Type:</b>	0 Not Applicable	<b>Location:</b>	0 Not Applicable	
<b>Condition:</b>	0 Not Applicable	<b>Accessibility:</b>	0 Not Applicable	
<b>Surface Treatment:</b>	0 Not Applicable			
<b>Asbestos Type:</b>	0 Not Applicable	<b>Extent Score:</b>	0 Not Applicable

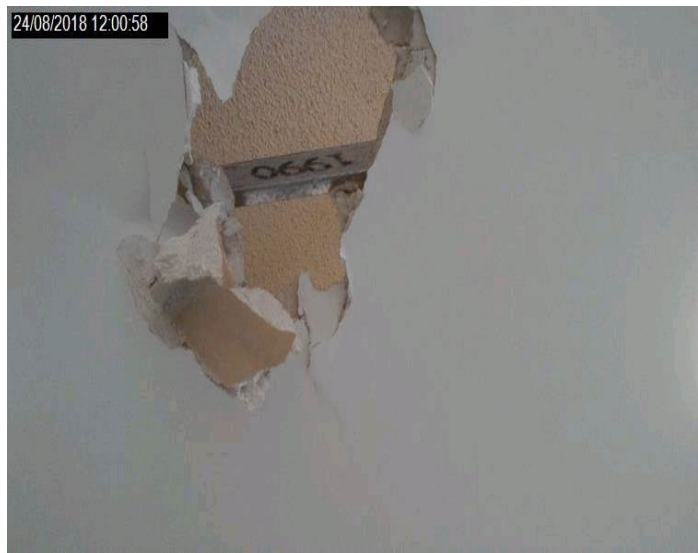
<b>Location:</b>	2.62	<b>Block:</b>	Birmingham City University	<b>Floor Level:</b> 2nd Floor
<b>Sample No.:</b>	As DU002158	<b>Portal Ref No.:</b>	168

<b>Item:</b>	Textured coating to concrete			
<b>Asbestos Content:</b>		<b>Result Based on:</b>		
No Asbestos Detected		Strongly presumed		
<b>Sample Analysed By:</b>	Not applicable	<b>Extent:</b>	8 m <sup>2</sup>	
<b>Comments:</b> Above plasterboard

<b>Material Assessment Total Score: 0</b>		<b>Likelihood of Disturbance Assessment Total Score: 0</b>		<b>Management Assessment</b>  <b>Licensable:</b> No  <b>Recommendations:</b> Not Applicable  <b>Reinspection Interval:</b> Not Applicable  <b>Overall Risk Category:</b> E0
<b>Product Type:</b>	0 Not Applicable	<b>Location:</b>	0 Not Applicable	
<b>Condition:</b>	0 Not Applicable	<b>Accessibility:</b>	0 Not Applicable	
<b>Surface Treatment:</b>	0 Not Applicable			
<b>Asbestos Type:</b>	0 Not Applicable	<b>Extent Score:</b>	0 Not Applicable

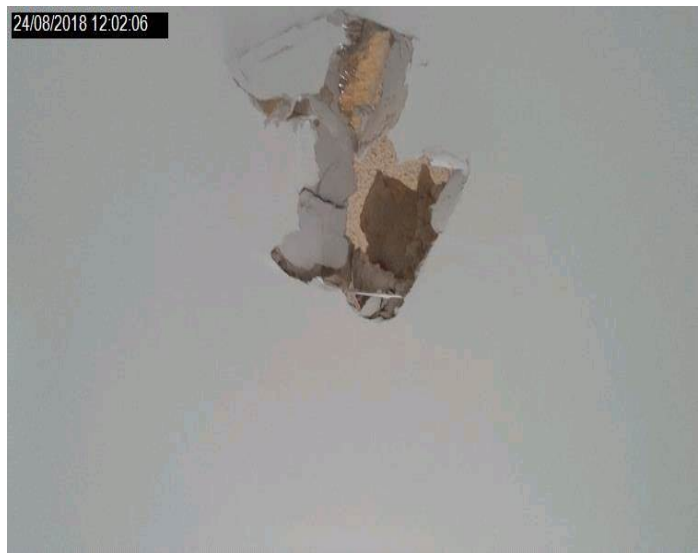
<b>Location:</b>	2.63	<b>Block:</b>	Birmingham City University	<b>Floor Level:</b> 2nd Floor
<b>Sample No.:</b>	As DU002158	<b>Portal Ref No.:</b>	170

<b>Item:</b>	Textured coating to concrete			
<b>Asbestos Content:</b>		<b>Result Based on:</b>		
No Asbestos Detected		Strongly presumed		
<b>Sample Analysed By:</b>	Not applicable	<b>Extent:</b>	8 m <sup>2</sup>	
<b>Comments:</b> Above plasterboard

<b>Material Assessment Total Score: 0</b>		<b>Likelihood of Disturbance Assessment Total Score: 0</b>		<b>Management Assessment</b>  <b>Licensable:</b> No  <b>Recommendations:</b> Not Applicable  <b>Reinspection Interval:</b> Not Applicable  <b>Overall Risk Category:</b> E0
<b>Product Type:</b>	0 Not Applicable	<b>Location:</b>	0 Not Applicable	
<b>Condition:</b>	0 Not Applicable	<b>Accessibility:</b>	0 Not Applicable	
<b>Surface Treatment:</b>	0 Not Applicable			
<b>Asbestos Type:</b>	0 Not Applicable	<b>Extent Score:</b>	0 Not Applicable

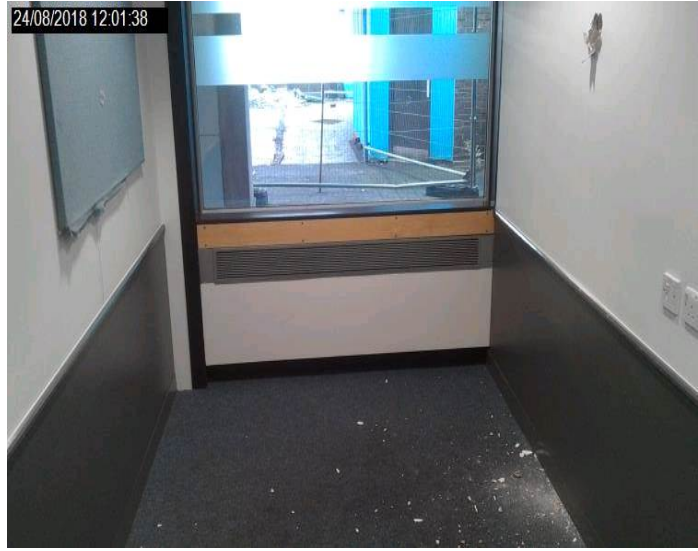
<b>Location:</b>	2.63	<b>Block:</b>	Birmingham City University	<b>Floor Level:</b> 2nd Floor
<b>Sample No.:</b>	As DU002159	<b>Portal Ref No.:</b>	171

<b>Item:</b>	Asbestos Cement window sill			
<b>Asbestos Content:</b>	<b>Result Based on:</b>			
Chrysotile	Strongly presumed			
<b>Sample Analysed By:</b>	Not applicable	<b>Extent:</b>	2 linear metres	
<b>Comments:</b>

<b>Material Assessment Total Score: 4</b>		<b>Likelihood of Disturbance Assessment Total Score: 4</b>		<b>Management Assessment</b>  <b>Licensable:</b> No  <b>Recommendations:</b> Program removal  <b>Reinspection Interval:</b> Not Applicable  <b>Overall Risk Category:</b> C8
<b>Product Type:</b>	1 (Asbestos cement)	<b>Location:</b>	2 (Rooms up to 100 sq m)	
<b>Condition:</b>	1 (Minor scratches)	<b>Accessibility:</b>	1 (Occasionally likely to be disturbed)	
<b>Surface Treatment:</b>	1 (Unencapsulated asbestos cement)			
<b>Asbestos Type:</b>	1 (Chrysotile)	<b>Extent Score:</b>	1 (<10 sq m or 10m pipe run)

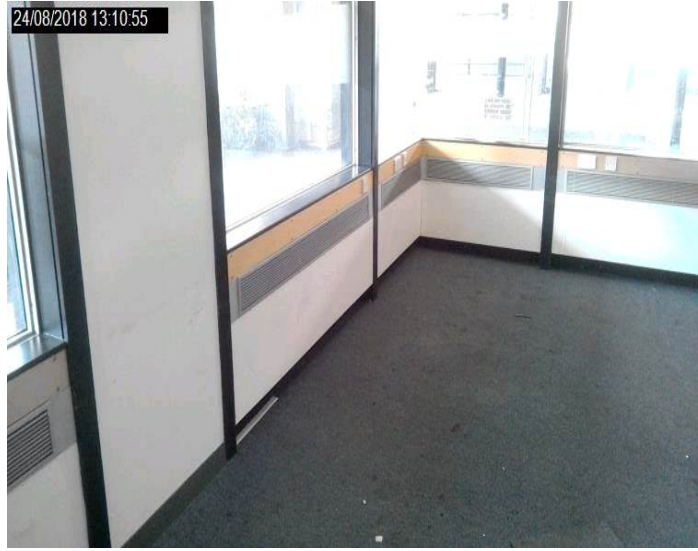
<b>Location:</b>	2.64	<b>Block:</b>	Birmingham City University	<b>Floor Level:</b> 2nd Floor
<b>Sample No.:</b>	DU002163	<b>Portal Ref No.:</b>	173

<b>Item:</b>	Asbestos Cement window sill			
<b>Asbestos Content:</b>	<b>Result Based on:</b>			
Chrysotile	Analysis of sample using PLM			
<b>Sample Analysed By:</b>	Reg 13(1)	<b>Extent:</b>	10 linear metres	
<b>Comments:</b>

<b>Material Assessment Total Score: 4</b>		<b>Likelihood of Disturbance Assessment Total Score: 4</b>		<b>Management Assessment</b>  <b>Licensable:</b> No  <b>Recommendations:</b> Program removal  <b>Reinspection Interval:</b> Not Applicable  <b>Overall Risk Category:</b> C8
<b>Product Type:</b>	1 (Asbestos cement)	<b>Location:</b>	2 (Rooms up to 100 sq m)	
<b>Condition:</b>	1 (Minor scratches)	<b>Accessibility:</b>	1 (Occasionally likely to be disturbed)	
<b>Surface Treatment:</b>	1 (Unencapsulated asbestos cement)			
<b>Asbestos Type:</b>	1 (Chrysotile)	<b>Extent Score:</b>	1 (<10 sq m or 10m pipe run)

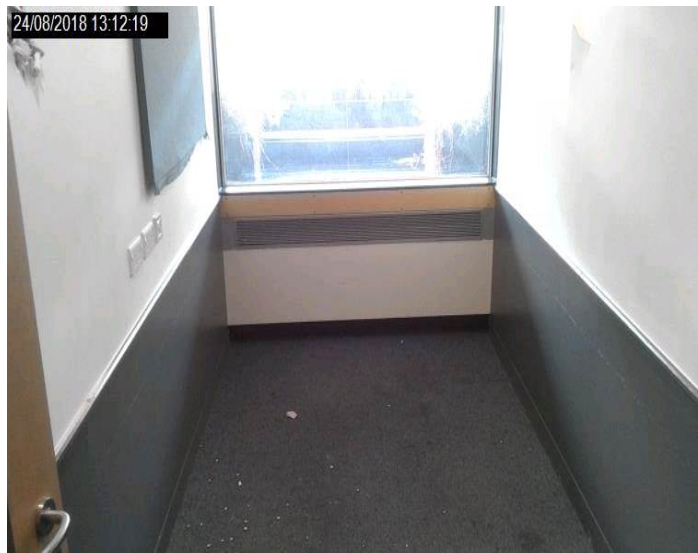
<b>Location:</b>	2.65	<b>Block:</b>	Birmingham City University	<b>Floor Level:</b> 2nd Floor
<b>Sample No.:</b>	As DU002163	<b>Portal Ref No.:</b>	175

<b>Item:</b>	Asbestos Cement window sill			
<b>Asbestos Content:</b>	<b>Result Based on:</b>			
Chrysotile	Strongly presumed			
<b>Sample Analysed By:</b>	Not applicable	<b>Extent:</b>	2 linear metres	
<b>Comments:</b>

<b>Material Assessment Total Score: 4</b>		<b>Likelihood of Disturbance Assessment Total Score: 4</b>		<b>Management Assessment</b>  <b>Licensable:</b> No  <b>Recommendations:</b> Program removal  <b>Reinspection Interval:</b> Not Applicable  <b>Overall Risk Category:</b> C8
<b>Product Type:</b>	1 (Asbestos cement)	<b>Location:</b>	2 (Rooms up to 100 sq m)	
<b>Condition:</b>	1 (Minor scratches)	<b>Accessibility:</b>	1 (Occasionally likely to be disturbed)	
<b>Surface Treatment:</b>	1 (Unencapsulated asbestos cement)			
<b>Asbestos Type:</b>	1 (Chrysotile)	<b>Extent Score:</b>	1 (<10 sq m or 10m pipe run)

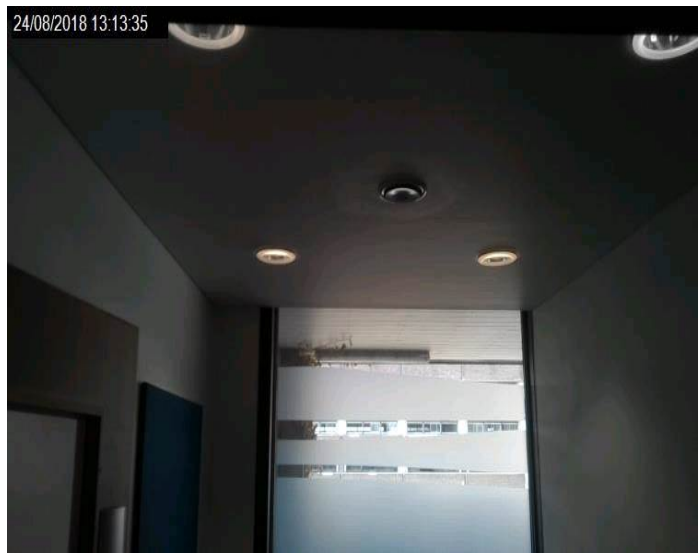
<b>Location:</b>	2.66	<b>Block:</b>	Birmingham City University	<b>Floor Level:</b> 2nd Floor
<b>Sample No.:</b>	As DU002162	<b>Portal Ref No.:</b>	176

<b>Item:</b>	Textured coating to concrete			
<b>Asbestos Content:</b>		<b>Result Based on:</b>		
No Asbestos Detected		Strongly presumed		
<b>Sample Analysed By:</b>	Not applicable	<b>Extent:</b>	8 m <sup>2</sup>	
<b>Comments:</b> Above plasterboard

<b>Material Assessment Total Score: 0</b>		<b>Likelihood of Disturbance Assessment Total Score: 0</b>		<b>Management Assessment</b>  <b>Licensable:</b> No  <b>Recommendations:</b> Not Applicable  <b>Reinspection Interval:</b> Not Applicable  <b>Overall Risk Category:</b> E0
<b>Product Type:</b>	0 Not Applicable	<b>Location:</b>	0 Not Applicable	
<b>Condition:</b>	0 Not Applicable	<b>Accessibility:</b>	0 Not Applicable	
<b>Surface Treatment:</b>	0 Not Applicable			
<b>Asbestos Type:</b>	0 Not Applicable	<b>Extent Score:</b>	0 Not Applicable

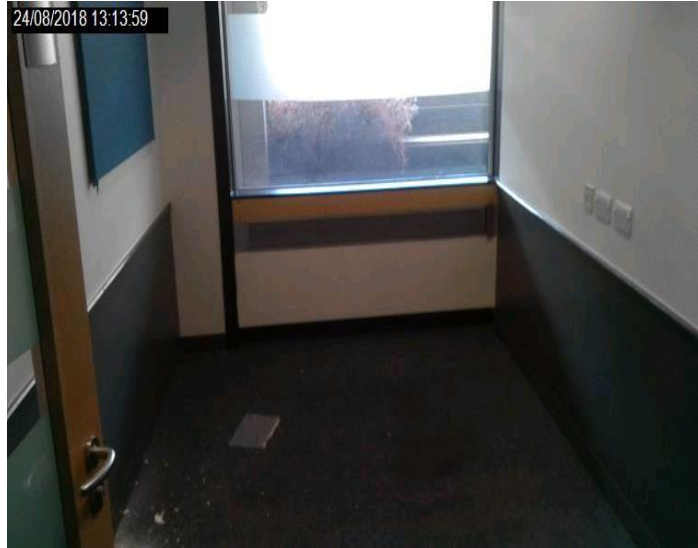
<b>Location:</b>	2.66	<b>Block:</b>	Birmingham City University	<b>Floor Level:</b> 2nd Floor
<b>Sample No.:</b>	As DU002163	<b>Portal Ref No.:</b>	177

<b>Item:</b>	Asbestos Cement window sill			
<b>Asbestos Content:</b>	<b>Result Based on:</b>			
Chrysotile	Strongly presumed			
<b>Sample Analysed By:</b>	Not applicable	<b>Extent:</b>	2 linear metres	
<b>Comments:</b>

<b>Material Assessment Total Score: 4</b>		<b>Likelihood of Disturbance Assessment Total Score: 4</b>		<b>Management Assessment</b>  <b>Licensable:</b> No  <b>Recommendations:</b> Program removal  <b>Reinspection Interval:</b> Not Applicable  <b>Overall Risk Category:</b> C8
<b>Product Type:</b>	1 (Asbestos cement)	<b>Location:</b>	2 (Rooms up to 100 sq m)	
<b>Condition:</b>	1 (Minor scratches)	<b>Accessibility:</b>	1 (Occasionally likely to be disturbed)	
<b>Surface Treatment:</b>	1 (Unencapsulated asbestos cement)			
<b>Asbestos Type:</b>	1 (Chrysotile)	<b>Extent Score:</b>	1 (<10 sq m or 10m pipe run)

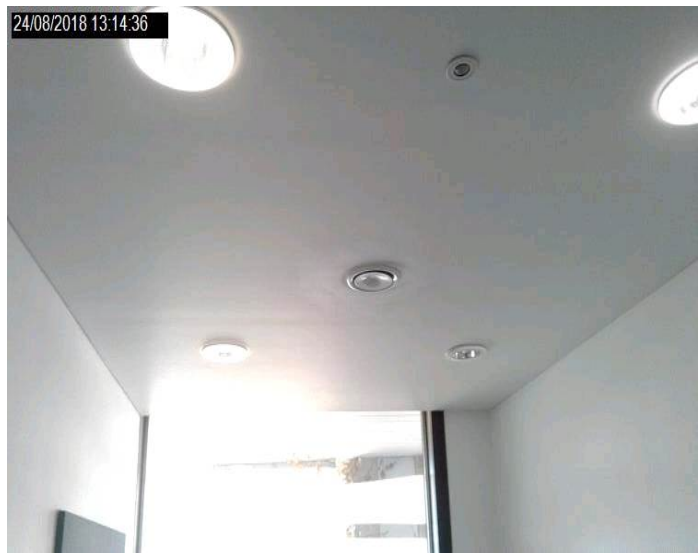
<b>Location:</b>	2.67	<b>Block:</b>	Birmingham City University	<b>Floor Level:</b> 2nd Floor
<b>Sample No.:</b>	As DU002162	<b>Portal Ref No.:</b>	178

<b>Item:</b>	Textured coating to concrete			
<b>Asbestos Content:</b>		<b>Result Based on:</b>		
No Asbestos Detected		Strongly presumed		
<b>Sample Analysed By:</b>	Not applicable	<b>Extent:</b>	8 m <sup>2</sup>	
<b>Comments:</b> Above plasterboard

<b>Material Assessment Total Score: 0</b>		<b>Likelihood of Disturbance Assessment Total Score: 0</b>		<b>Management Assessment</b>  <b>Licensable:</b> No  <b>Recommendations:</b> Not Applicable  <b>Reinspection Interval:</b> Not Applicable  <b>Overall Risk Category:</b> E0
<b>Product Type:</b>	0 Not Applicable	<b>Location:</b>	0 Not Applicable	
<b>Condition:</b>	0 Not Applicable	<b>Accessibility:</b>	0 Not Applicable	
<b>Surface Treatment:</b>	0 Not Applicable			
<b>Asbestos Type:</b>	0 Not Applicable	<b>Extent Score:</b>	0 Not Applicable

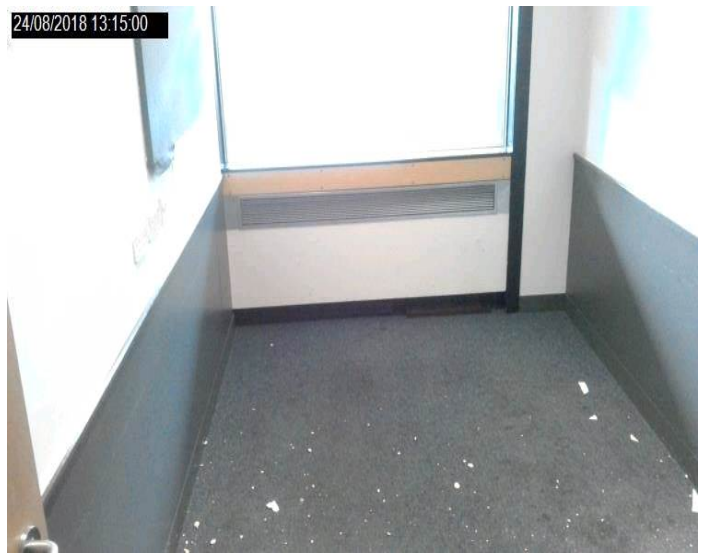
<b>Location:</b>	2.67	<b>Block:</b>	Birmingham City University	<b>Floor Level:</b> 2nd Floor
<b>Sample No.:</b>	As DU002163	<b>Portal Ref No.:</b>	179

<b>Item:</b>	Asbestos Cement window sill			
<b>Asbestos Content:</b>	<b>Result Based on:</b>			
Chrysotile	Strongly presumed			
<b>Sample Analysed By:</b>	Not applicable	<b>Extent:</b>	2 linear metres	
<b>Comments:</b>

<b>Material Assessment Total Score: 4</b>		<b>Likelihood of Disturbance Assessment Total Score: 4</b>		<b>Management Assessment</b>  <b>Licensable:</b> No  <b>Recommendations:</b> Program removal  <b>Reinspection Interval:</b> Not Applicable  <b>Overall Risk Category:</b> C8
<b>Product Type:</b>	1 (Asbestos cement)	<b>Location:</b>	2 (Rooms up to 100 sq m)	
<b>Condition:</b>	1 (Minor scratches)	<b>Accessibility:</b>	1 (Occasionally likely to be disturbed)	
<b>Surface Treatment:</b>	1 (Unencapsulated asbestos cement)			
<b>Asbestos Type:</b>	1 (Chrysotile)	<b>Extent Score:</b>	1 (<10 sq m or 10m pipe run)

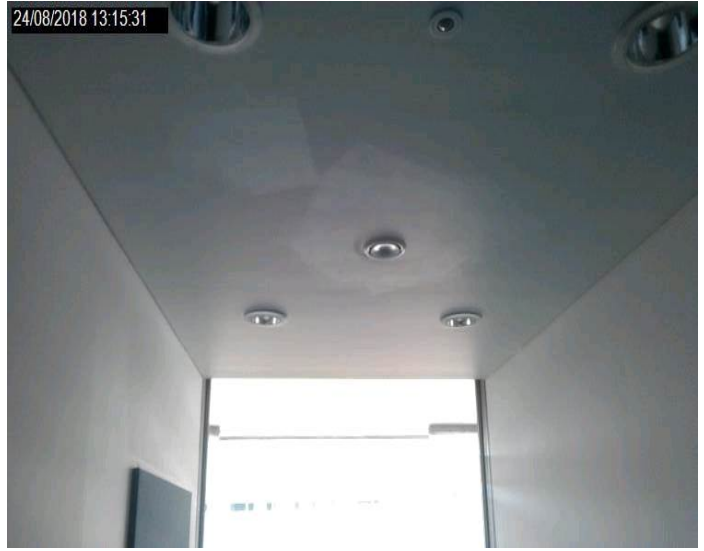
<b>Location:</b>	2.68	<b>Block:</b>	Birmingham City University	<b>Floor Level:</b> 2nd Floor
<b>Sample No.:</b>	As DU002162	<b>Portal Ref No.:</b>	180

<b>Item:</b>	Textured coating to concrete			
<b>Asbestos Content:</b>		<b>Result Based on:</b>		
No Asbestos Detected		Strongly presumed		
<b>Sample Analysed By:</b>	Not applicable	<b>Extent:</b>	8 m <sup>2</sup>	
<b>Comments:</b> Above plasterboard

<b>Material Assessment Total Score: 0</b>		<b>Likelihood of Disturbance Assessment Total Score: 0</b>		<b>Management Assessment</b>  <b>Licensable:</b> No  <b>Recommendations:</b> Not Applicable  <b>Reinspection Interval:</b> Not Applicable  <b>Overall Risk Category:</b> E0
<b>Product Type:</b>	0 Not Applicable	<b>Location:</b>	0 Not Applicable	
<b>Condition:</b>	0 Not Applicable	<b>Accessibility:</b>	0 Not Applicable	
<b>Surface Treatment:</b>	0 Not Applicable			
<b>Asbestos Type:</b>	0 Not Applicable	<b>Extent Score:</b>	0 Not Applicable

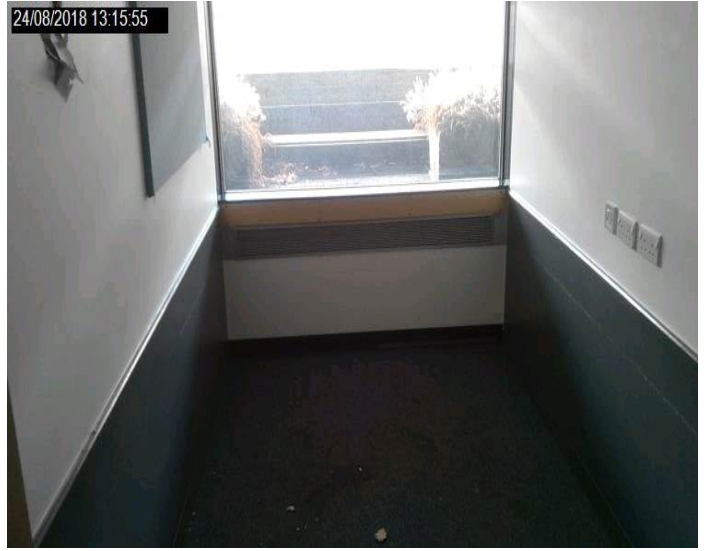
<b>Location:</b>	2.68	<b>Block:</b>	Birmingham City University	<b>Floor Level:</b> 2nd Floor
<b>Sample No.:</b>	As DU002163	<b>Portal Ref No.:</b>	181

<b>Item:</b>	Asbestos Cement window sill			
<b>Asbestos Content:</b>	<b>Result Based on:</b>			
Chrysotile	Strongly presumed			
<b>Sample Analysed By:</b>	Not applicable	<b>Extent:</b>	2 linear metres	
<b>Comments:</b>

<b>Material Assessment Total Score: 4</b>		<b>Likelihood of Disturbance Assessment Total Score: 4</b>		<b>Management Assessment</b>  <b>Licensable:</b> No  <b>Recommendations:</b> Program removal  <b>Reinspection Interval:</b> Not Applicable  <b>Overall Risk Category:</b> C8
<b>Product Type:</b>	1 (Asbestos cement)	<b>Location:</b>	2 (Rooms up to 100 sq m)	
<b>Condition:</b>	1 (Minor scratches)	<b>Accessibility:</b>	1 (Occasionally likely to be disturbed)	
<b>Surface Treatment:</b>	1 (Unencapsulated asbestos cement)			
<b>Asbestos Type:</b>	1 (Chrysotile)	<b>Extent Score:</b>	1 (<10 sq m or 10m pipe run)

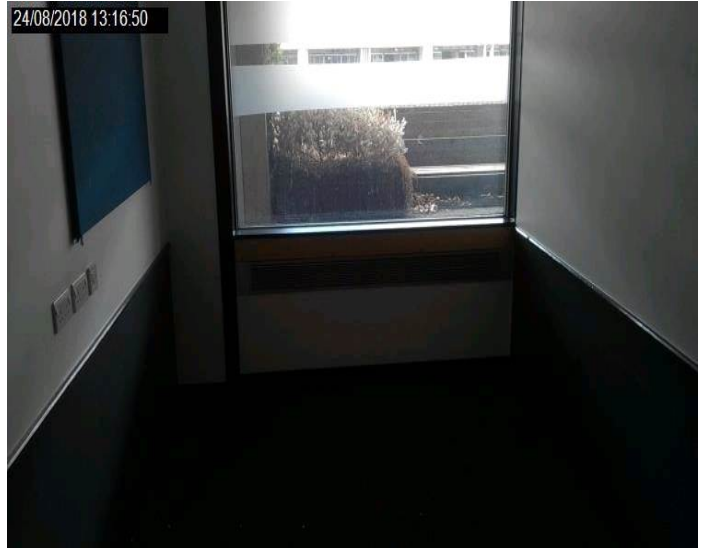
<b>Location:</b>	2.69	<b>Block:</b>	Birmingham City University	<b>Floor Level:</b> 2nd Floor
<b>Sample No.:</b>	As DU002163	<b>Portal Ref No.:</b>	183

<b>Item:</b>	Asbestos Cement window sill			
<b>Asbestos Content:</b>	<b>Result Based on:</b>			
Chrysotile	Strongly presumed			
<b>Sample Analysed By:</b>	Not applicable	<b>Extent:</b>	2 linear metres	
<b>Comments:</b>

<b>Material Assessment Total Score: 4</b>		<b>Likelihood of Disturbance Assessment Total Score: 4</b>		<b>Management Assessment</b>  <b>Licensable:</b> No  <b>Recommendations:</b> Program removal  <b>Reinspection Interval:</b> Not Applicable  <b>Overall Risk Category:</b> C8
<b>Product Type:</b>	1 (Asbestos cement)	<b>Location:</b>	2 (Rooms up to 100 sq m)	
<b>Condition:</b>	1 (Minor scratches)	<b>Accessibility:</b>	1 (Occasionally likely to be disturbed)	
<b>Surface Treatment:</b>	1 (Unencapsulated asbestos cement)			
<b>Asbestos Type:</b>	1 (Chrysotile)	<b>Extent Score:</b>	1 (<10 sq m or 10m pipe run)

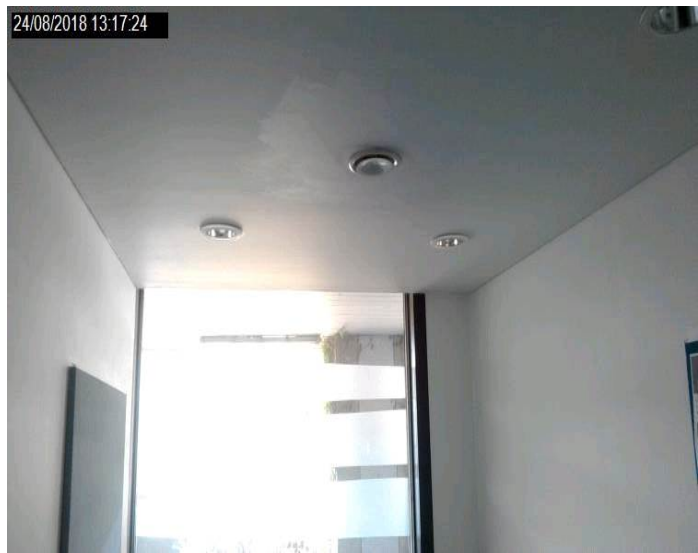
<b>Location:</b>	2.70	<b>Block:</b>	Birmingham City University	<b>Floor Level:</b> 2nd Floor
<b>Sample No.:</b>	As DU002162	<b>Portal Ref No.:</b>	184

<b>Item:</b>	Textured coating to concrete			
<b>Asbestos Content:</b>		<b>Result Based on:</b>		
No Asbestos Detected		Strongly presumed		
<b>Sample Analysed By:</b>	Not applicable	<b>Extent:</b>	8 m <sup>2</sup>	
<b>Comments:</b> Above plasterboard

<b>Material Assessment Total Score: 0</b>		<b>Likelihood of Disturbance Assessment Total Score: 0</b>		<b>Management Assessment</b>  <b>Licensable:</b> No  <b>Recommendations:</b> Not Applicable  <b>Reinspection Interval:</b> Not Applicable  <b>Overall Risk Category:</b> E0
<b>Product Type:</b>	0 Not Applicable	<b>Location:</b>	0 Not Applicable	
<b>Condition:</b>	0 Not Applicable	<b>Accessibility:</b>	0 Not Applicable	
<b>Surface Treatment:</b>	0 Not Applicable			
<b>Asbestos Type:</b>	0 Not Applicable	<b>Extent Score:</b>	0 Not Applicable

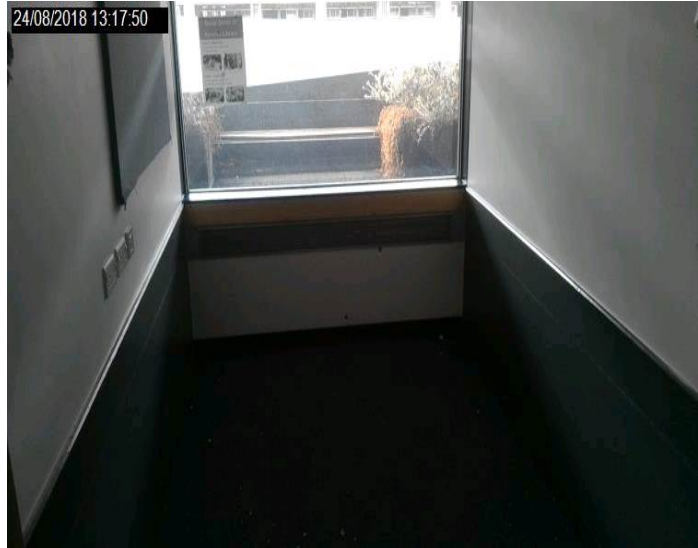
<b>Location:</b>	2.70	<b>Block:</b>	Birmingham City University	<b>Floor Level:</b> 2nd Floor
<b>Sample No.:</b>	As DU002163	<b>Portal Ref No.:</b>	185

<b>Item:</b>	Asbestos Cement window sill			
<b>Asbestos Content:</b>	<b>Result Based on:</b>			
Chrysotile	Strongly presumed			
<b>Sample Analysed By:</b>	Not applicable	<b>Extent:</b>	2 linear metres	
<b>Comments:</b>

<b>Material Assessment Total Score: 4</b>		<b>Likelihood of Disturbance Assessment Total Score: 4</b>		<b>Management Assessment</b>  <b>Licensable:</b> No  <b>Recommendations:</b> Program removal  <b>Reinspection Interval:</b> Not Applicable  <b>Overall Risk Category:</b> C8
<b>Product Type:</b>	1 (Asbestos cement)	<b>Location:</b>	2 (Rooms up to 100 sq m)	
<b>Condition:</b>	1 (Minor scratches)	<b>Accessibility:</b>	1 (Occasionally likely to be disturbed)	
<b>Surface Treatment:</b>	1 (Unencapsulated asbestos cement)			
<b>Asbestos Type:</b>	1 (Chrysotile)	<b>Extent Score:</b>	1 (<10 sq m or 10m pipe run)

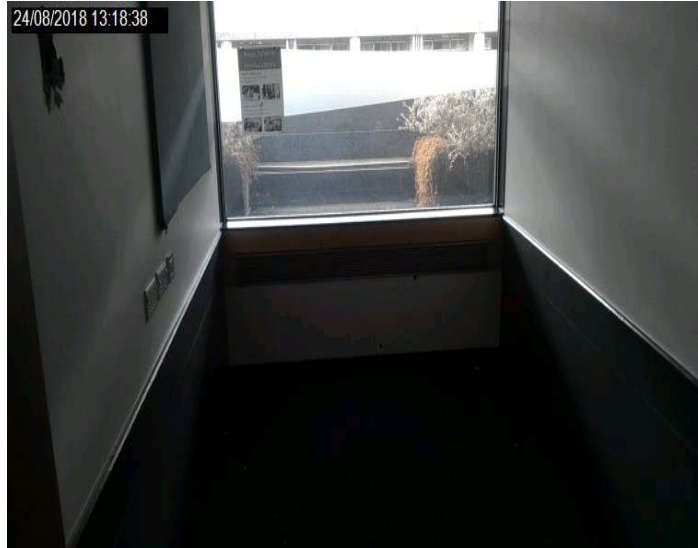
<b>Location:</b>	2.71	<b>Block:</b>	Birmingham City University	<b>Floor Level:</b> 2nd Floor
<b>Sample No.:</b>	As DU002163	<b>Portal Ref No.:</b>	187

<b>Item:</b>	Asbestos Cement window sill			
<b>Asbestos Content:</b>	<b>Result Based on:</b>			
Chrysotile	Strongly presumed			
<b>Sample Analysed By:</b>	Not applicable	<b>Extent:</b>	2 linear metres	
<b>Comments:</b>

<b>Material Assessment Total Score: 4</b>		<b>Likelihood of Disturbance Assessment Total Score: 4</b>		<b>Management Assessment</b>  <b>Licensable:</b> No  <b>Recommendations:</b> Program removal  <b>Reinspection Interval:</b> Not Applicable  <b>Overall Risk Category:</b> C8
<b>Product Type:</b>	1 (Asbestos cement)	<b>Location:</b>	2 (Rooms up to 100 sq m)	
<b>Condition:</b>	1 (Minor scratches)	<b>Accessibility:</b>	1 (Occasionally likely to be disturbed)	
<b>Surface Treatment:</b>	1 (Unencapsulated asbestos cement)			
<b>Asbestos Type:</b>	1 (Chrysotile)	<b>Extent Score:</b>	1 (<10 sq m or 10m pipe run)

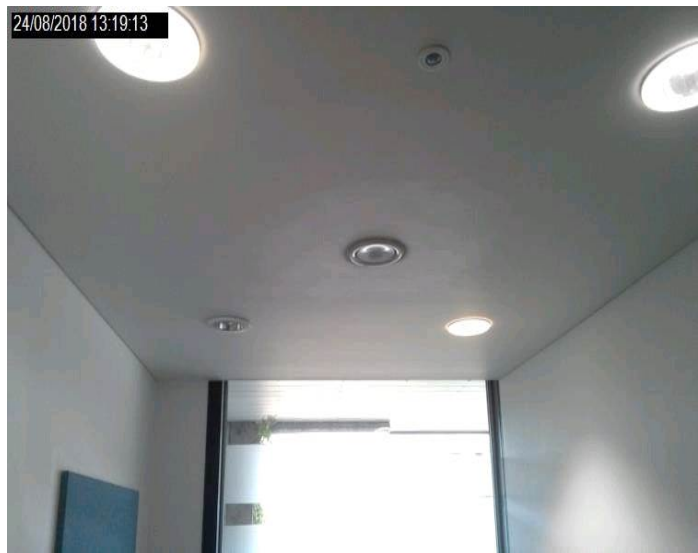
<b>Location:</b>	2.72	<b>Block:</b>	Birmingham City University	<b>Floor Level:</b> 2nd Floor
<b>Sample No.:</b>	As DU002162	<b>Portal Ref No.:</b>	188

<b>Item:</b>	Textured coating to concrete			
<b>Asbestos Content:</b>		<b>Result Based on:</b>		
No Asbestos Detected		Strongly presumed		
<b>Sample Analysed By:</b>	Not applicable	<b>Extent:</b>	8 m <sup>2</sup>	
<b>Comments:</b> Above plasterboard

<b>Material Assessment Total Score:</b> 0		<b>Likelihood of Disturbance Assessment Total Score:</b> 0		<b>Management Assessment</b>  <b>Licensable:</b> No  <b>Recommendations:</b> Not Applicable  <b>Reinspection Interval:</b> Not Applicable  <b>Overall Risk Category:</b> E0
<b>Product Type:</b>	0 Not Applicable	<b>Location:</b>	0 Not Applicable	
<b>Condition:</b>	0 Not Applicable	<b>Accessibility:</b>	0 Not Applicable	
<b>Surface Treatment:</b>	0 Not Applicable			
<b>Asbestos Type:</b>	0 Not Applicable	<b>Extent Score:</b>	0 Not Applicable

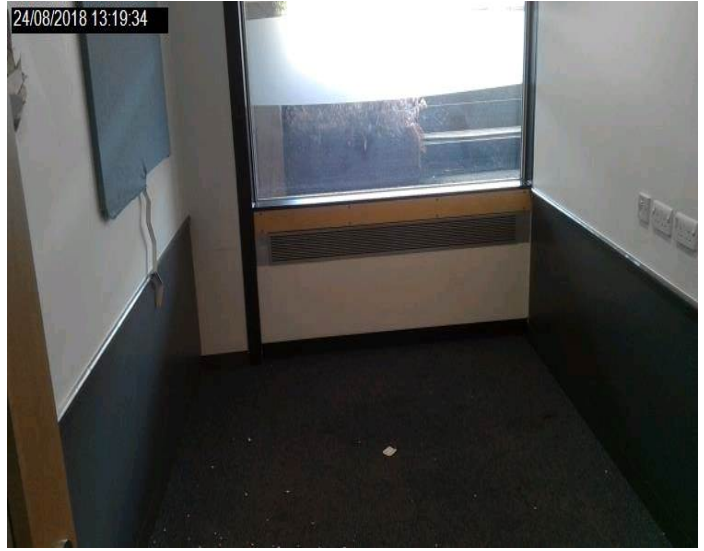
<b>Location:</b>	2.72	<b>Block:</b>	Birmingham City University	<b>Floor Level:</b> 2nd Floor
<b>Sample No.:</b>	As DU002163	<b>Portal Ref No.:</b>	189

<b>Item:</b>	Asbestos Cement window sill			
<b>Asbestos Content:</b>	<b>Result Based on:</b>			
Chrysotile	Strongly presumed			
<b>Sample Analysed By:</b>	Not applicable	<b>Extent:</b>	2 linear metres	
<b>Comments:</b>

<b>Material Assessment Total Score: 4</b>		<b>Likelihood of Disturbance Assessment Total Score: 4</b>		<b>Management Assessment</b>  <b>Licensable:</b> No  <b>Recommendations:</b> Program removal  <b>Reinspection Interval:</b> Not Applicable  <b>Overall Risk Category:</b> C8
<b>Product Type:</b>	1 (Asbestos cement)	<b>Location:</b>	2 (Rooms up to 100 sq m)	
<b>Condition:</b>	1 (Minor scratches)	<b>Accessibility:</b>	1 (Occasionally likely to be disturbed)	
<b>Surface Treatment:</b>	1 (Unencapsulated asbestos cement)			
<b>Asbestos Type:</b>	1 (Chrysotile)	<b>Extent Score:</b>	1 (<10 sq m or 10m pipe run)

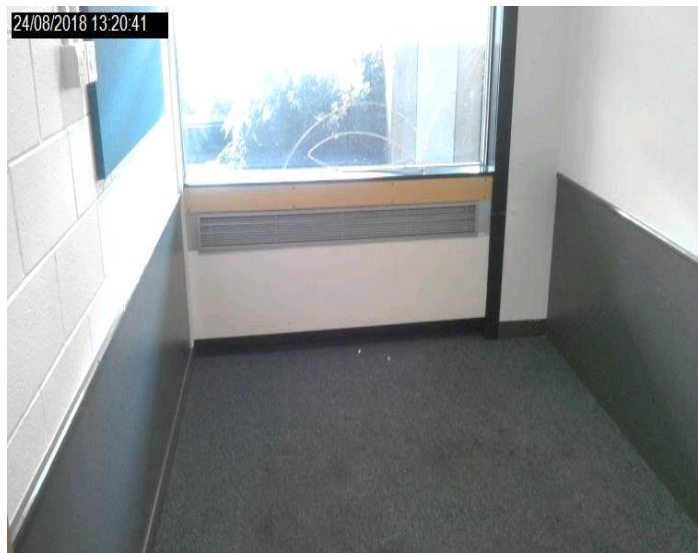
<b>Location:</b>	2.73	<b>Block:</b>	Birmingham City University	<b>Floor Level:</b> 2nd Floor
<b>Sample No.:</b>	As DU002163	<b>Portal Ref No.:</b>	191

<b>Item:</b>	Asbestos Cement window sill			
<b>Asbestos Content:</b>	<b>Result Based on:</b>			
Chrysotile	Strongly presumed			
<b>Sample Analysed By:</b>	Not applicable	<b>Extent:</b>	2 linear metres	
<b>Comments:</b>

<b>Material Assessment Total Score: 4</b>		<b>Likelihood of Disturbance Assessment Total Score: 4</b>		<b>Management Assessment</b>  <b>Licensable:</b> No  <b>Recommendations:</b> Program removal  <b>Reinspection Interval:</b> Not Applicable  <b>Overall Risk Category:</b> C8
<b>Product Type:</b>	1 (Asbestos cement)	<b>Location:</b>	2 (Rooms up to 100 sq m)	
<b>Condition:</b>	1 (Minor scratches)	<b>Accessibility:</b>	1 (Occasionally likely to be disturbed)	
<b>Surface Treatment:</b>	1 (Unencapsulated asbestos cement)			
<b>Asbestos Type:</b>	1 (Chrysotile)	<b>Extent Score:</b>	1 (<10 sq m or 10m pipe run)

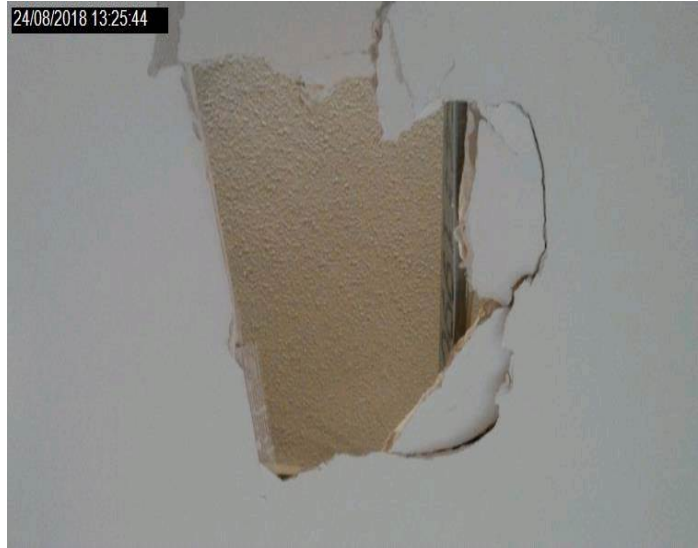
<b>Location:</b>	2.15	<b>Block:</b>	Birmingham City University	<b>Floor Level:</b> 2nd Floor
<b>Sample No.:</b>	As DU002162	<b>Portal Ref No.:</b>	192

<b>Item:</b>	Textured coating to concrete			
<b>Asbestos Content:</b>		<b>Result Based on:</b>		
No Asbestos Detected		Strongly presumed		
<b>Sample Analysed By:</b>	Not applicable	<b>Extent:</b>	16 m <sup>2</sup>	
<b>Comments:</b> Above plasterboard

<b>Material Assessment Total Score: 0</b>		<b>Likelihood of Disturbance Assessment Total Score: 0</b>		<b>Management Assessment</b>  <b>Licensable:</b> No  <b>Recommendations:</b> Not Applicable  <b>Reinspection Interval:</b> Not Applicable  <b>Overall Risk Category:</b> E0
<b>Product Type:</b>	0 Not Applicable	<b>Location:</b>	0 Not Applicable	
<b>Condition:</b>	0 Not Applicable	<b>Accessibility:</b>	0 Not Applicable	
<b>Surface Treatment:</b>	0 Not Applicable			
<b>Asbestos Type:</b>	0 Not Applicable	<b>Extent Score:</b>	0 Not Applicable

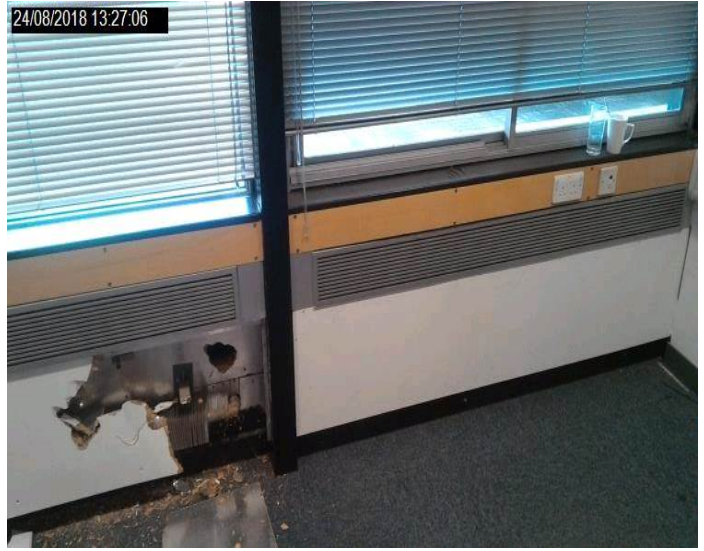
<b>Location:</b>	2.15	<b>Block:</b>	Birmingham City University	<b>Floor Level:</b> 2nd Floor
<b>Sample No.:</b>	As DU002163	<b>Portal Ref No.:</b>	193

<b>Item:</b>	Asbestos Cement window sill			
<b>Asbestos Content:</b>	<b>Result Based on:</b>			
Chrysotile	Strongly presumed			
<b>Sample Analysed By:</b>	Not applicable	<b>Extent:</b>	4 linear metres	
<b>Comments:</b>

<b>Material Assessment Total Score: 4</b>		<b>Likelihood of Disturbance Assessment Total Score: 4</b>		<b>Management Assessment</b>  <b>Licensable:</b> No  <b>Recommendations:</b> Program removal  <b>Reinspection Interval:</b> Not Applicable  <b>Overall Risk Category:</b> C8
<b>Product Type:</b>	1 (Asbestos cement)	<b>Location:</b>	2 (Rooms up to 100 sq m)	
<b>Condition:</b>	1 (Minor scratches)	<b>Accessibility:</b>	1 (Occasionally likely to be disturbed)	
<b>Surface Treatment:</b>	1 (Unencapsulated asbestos cement)			
<b>Asbestos Type:</b>	1 (Chrysotile)	<b>Extent Score:</b>	1 (<10 sq m or 10m pipe run)

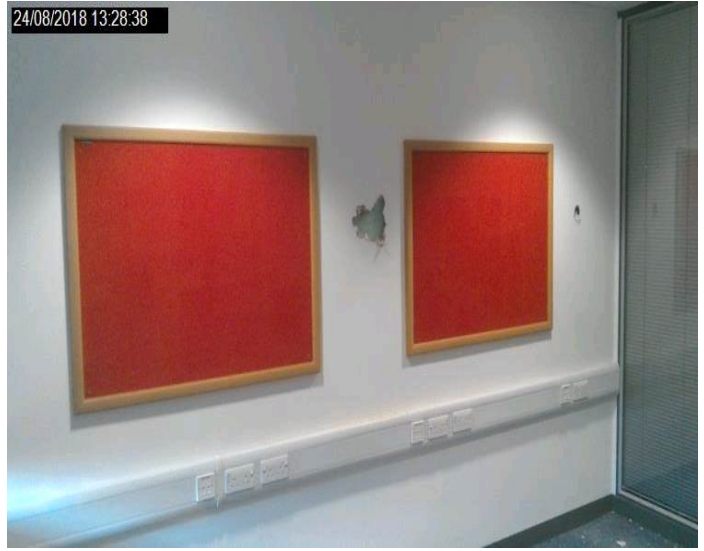
<b>Location:</b>	2.15	<b>Block:</b>	Birmingham City University	<b>Floor Level:</b> 2nd Floor
<b>Sample No.:</b>	DU002164	<b>Portal Ref No.:</b>	194

<b>Item:</b>	Textured coating to block			
<b>Asbestos Content:</b>		<b>Result Based on:</b>		
No Asbestos Detected		Analysis of sample using PLM		
<b>Sample Analysed By:</b>	Reg 13(1)	<b>Extent:</b>	24 m <sup>2</sup>	
<b>Comments:</b> Green both sides of the room

<b>Material Assessment Total Score: 0</b>		<b>Likelihood of Disturbance Assessment Total Score: 0</b>		<b>Management Assessment</b>  <b>Licensable:</b> No  <b>Recommendations:</b> Not Applicable  <b>Reinspection Interval:</b> Not Applicable  <b>Overall Risk Category:</b> E0
<b>Product Type:</b>	0 Not Applicable	<b>Location:</b>	0 Not Applicable	
<b>Condition:</b>	0 Not Applicable	<b>Accessibility:</b>	0 Not Applicable	
<b>Surface Treatment:</b>	0 Not Applicable			
<b>Asbestos Type:</b>	0 Not Applicable	<b>Extent Score:</b>	0 Not Applicable

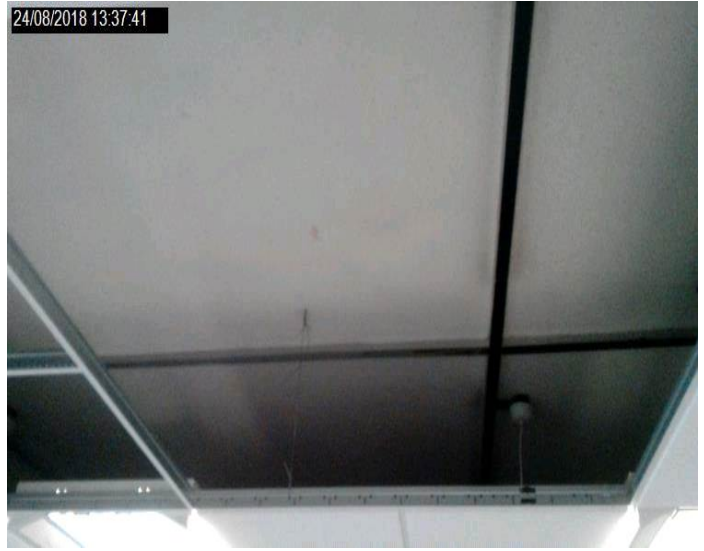
<b>Location:</b>	2.01	<b>Block:</b>	Birmingham City University	<b>Floor Level:</b> 2nd Floor
<b>Sample No.:</b>	DU002165	<b>Portal Ref No.:</b>	195

<b>Item:</b>	Textured coating to concrete			
<b>Asbestos Content:</b>	<b>Result Based on:</b>			
No Asbestos Detected	Analysis of sample using PLM			
<b>Sample Analysed By:</b> Reg 13(1)	<b>Extent:</b>	750 m <sup>2</sup>		
<b>Comments:</b>

<b>Material Assessment Total Score: 0</b>		<b>Likelihood of Disturbance Assessment Total Score: 0</b>		<b>Management Assessment</b>  <b>Licensable:</b> No  <b>Recommendations:</b> Not Applicable  <b>Reinspection Interval:</b> Not Applicable  <b>Overall Risk Category:</b> E0
<b>Product Type:</b>	0 Not Applicable	<b>Location:</b>	0 Not Applicable	
<b>Condition:</b>	0 Not Applicable	<b>Accessibility:</b>	0 Not Applicable	
<b>Surface Treatment:</b>	0 Not Applicable			
<b>Asbestos Type:</b>	0 Not Applicable	<b>Extent Score:</b>	0 Not Applicable
