**Report No.:** J102747  
**Nature of Work:** Demolition Survey  
**Issue Date:** 26/09/2018  
**Client Name:** WYG Engineering Ltd  
Geneva Building, Lake View Drive, Sherwood Business Park,  
Annesley, Nottingham, NG15 0ED  
**Site Address:** Kenrick Building, Former City North Campus, Birmingham City  
University, Perry Barr, B42 2US

**Order Placed By:** Reg 13(1)  
**Site Contact:** Reg 13(1)  
**Date(s) of Work:** 20/08/2018 to 23/08/2018  
**Technical Manager:** Reg 13(1) (Asbestos)  
**Assistant Surveyor(s):** Reg 13(1)

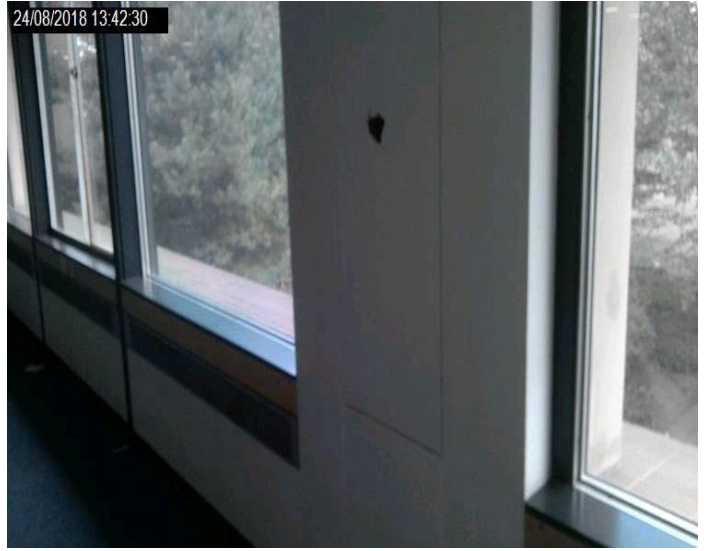
<b>Location:</b>	2.01	<b>Block:</b>	Birmingham City University	<b>Floor Level:</b> 2nd Floor
<b>Sample No.:</b>	DU002167	<b>Portal Ref No.:</b>	197

<b>Item:</b>	Insulating board panel to riser			
<b>Asbestos Content:</b>		<b>Result Based on:</b>		
No Asbestos Detected		Analysis of sample using PLM		
<b>Sample Analysed By:</b>	Reg 13(1)	<b>Extent:</b>	3 m <sup>2</sup>	
<b>Comments:</b> Centre panel and bottom panels to electric riser

<b>Material Assessment Total Score: 0</b>		<b>Likelihood of Disturbance Assessment Total Score: 0</b>		<b>Management Assessment</b>  <b>Licensable:</b> Yes  <b>Recommendations:</b> Not Applicable  <b>Reinspection Interval:</b> Not Applicable  <b>Overall Risk Category:</b> E0
<b>Product Type:</b>	0 Not Applicable	<b>Location:</b>	0 Not Applicable	
<b>Condition:</b>	0 Not Applicable	<b>Accessibility:</b>	0 Not Applicable	
<b>Surface Treatment:</b>	0 Not Applicable			
<b>Asbestos Type:</b>	0 Not Applicable	<b>Extent Score:</b>	0 Not Applicable

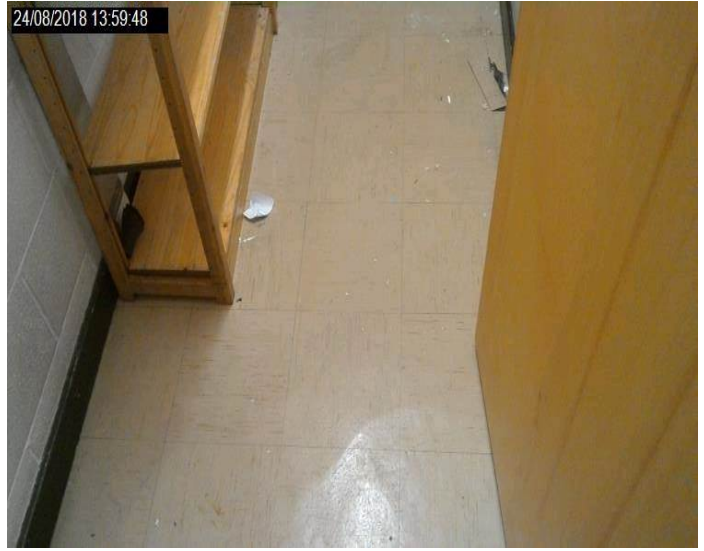
<b>Location:</b>	2.07	<b>Block:</b>	Birmingham City University	<b>Floor Level:</b> 2nd Floor
<b>Sample No.:</b>	DU002169	<b>Portal Ref No.:</b>	199

<b>Item:</b>	Asbestos Thermoplastic floor tiles			
<b>Asbestos Content:</b>	Result Based on:			
Chrysotile in adhesive only	Analysis of sample using PLM			
<b>Sample Analysed By:</b> Reg 13(1)	<b>Extent:</b>	3 m <sup>2</sup>		
<b>Comments:</b>

<b>Material Assessment Total Score: 3</b>		<b>Likelihood of Disturbance Assessment Total Score: 5</b>		<b>Management Assessment</b>  <b>Licensable:</b> No  <b>Recommendations:</b> Program removal  <b>Reinspection Interval:</b> Not Applicable  <b>Overall Risk Category:</b> C8
<b>Product Type:</b>	1 (Asbestos thermoplastic)	<b>Location:</b>	2 (Rooms up to 100 sq m)	
<b>Condition:</b>	1 (Minor scratches)	<b>Accessibility:</b>	2 (Easily disturbed)	
<b>Surface Treatment:</b>	0 (Composite material)			
<b>Asbestos Type:</b>	1 (Chrysotile)	<b>Extent Score:</b>	1 (<10 sq m or 10m pipe run)

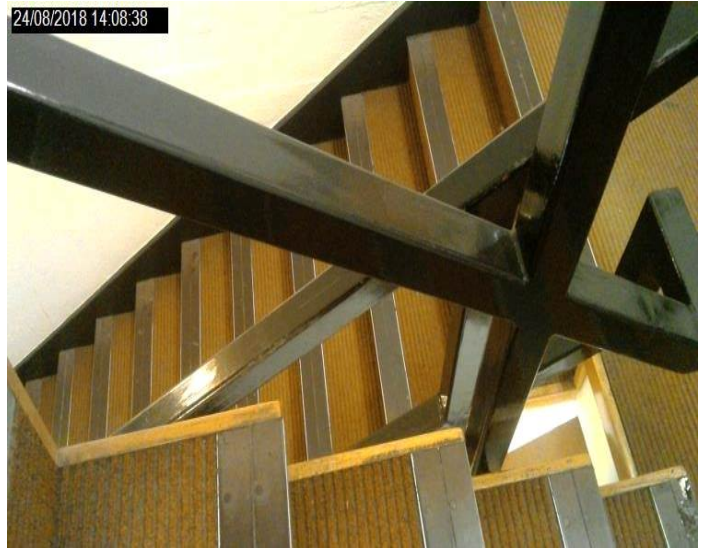
<b>Location:</b>	2.00C	<b>Block:</b>	Birmingham City University	<b>Floor Level:</b> 2nd Floor
<b>Sample No.:</b>	DU002170	<b>Portal Ref No.:</b>	200

<b>Item:</b>	Reinforced plastic stair nosing			
<b>Asbestos Content:</b>		<b>Result Based on:</b>		
No Asbestos Detected		Analysis of sample using PLM		
<b>Sample Analysed By:</b>	Reg 13(1)	<b>Extent:</b>	22 linear metres	
<b>Comments:</b>

<b>Material Assessment Total Score: 0</b>		<b>Likelihood of Disturbance Assessment Total Score: 0</b>		<b>Management Assessment</b>  <b>Licensable:</b> No  <b>Recommendations:</b> Not Applicable  <b>Reinspection Interval:</b> Not Applicable  <b>Overall Risk Category:</b> E0
<b>Product Type:</b>	0 Not Applicable	<b>Location:</b>	0 Not Applicable	
<b>Condition:</b>	0 Not Applicable	<b>Accessibility:</b>	0 Not Applicable	
<b>Surface Treatment:</b>	0 Not Applicable			
<b>Asbestos Type:</b>	0 Not Applicable	<b>Extent Score:</b>	0 Not Applicable

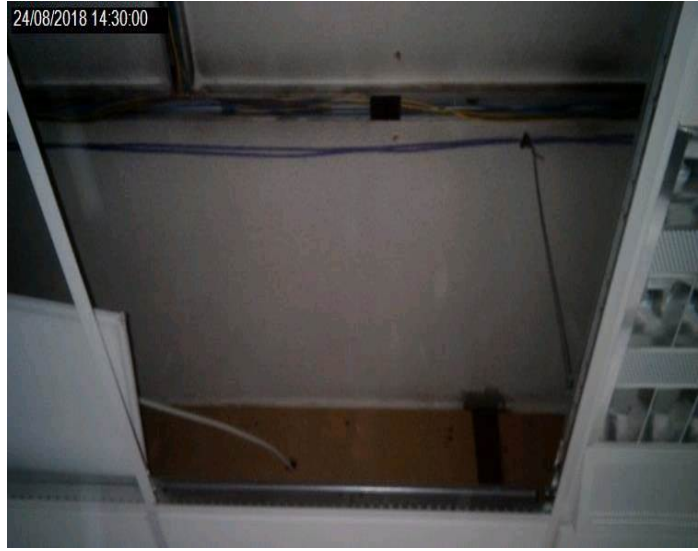
<b>Location:</b>	2.11	<b>Block:</b>	Birmingham City University	<b>Floor Level:</b> 2nd Floor
<b>Sample No.:</b>	As DU002162	<b>Portal Ref No.:</b>	201

<b>Item:</b>	Textured coating to concrete			
<b>Asbestos Content:</b>			<b>Result Based on:</b>	
No Asbestos Detected		Strongly presumed		
<b>Sample Analysed By:</b>	Not applicable	<b>Extent:</b>	10 m <sup>2</sup>	
<b>Comments:</b>

<b>Material Assessment Total Score: 0</b>		<b>Likelihood of Disturbance Assessment Total Score: 0</b>		<b>Management Assessment</b>  <b>Licensable:</b> No  <b>Recommendations:</b> Not Applicable  <b>Reinspection Interval:</b> Not Applicable  <b>Overall Risk Category:</b> E0
<b>Product Type:</b>	0 Not Applicable	<b>Location:</b>	0 Not Applicable	
<b>Condition:</b>	0 Not Applicable	<b>Accessibility:</b>	0 Not Applicable	
<b>Surface Treatment:</b>	0 Not Applicable			
<b>Asbestos Type:</b>	0 Not Applicable	<b>Extent Score:</b>	0 Not Applicable

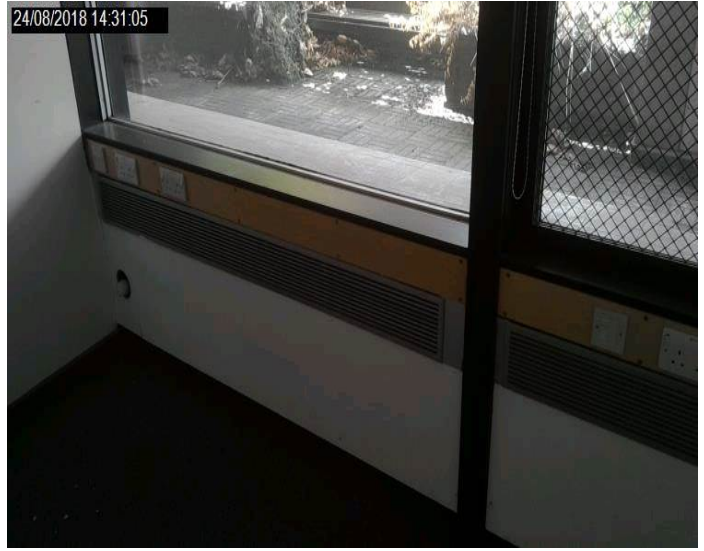
<b>Location:</b>	2.11	<b>Block:</b>	Birmingham City University	<b>Floor Level:</b> 2nd Floor
<b>Sample No.:</b>	As DU002163	<b>Portal Ref No.:</b>	202

<b>Item:</b>	Asbestos Cement window sill			
<b>Asbestos Content:</b>	<b>Result Based on:</b>			
Chrysotile	Strongly presumed			
<b>Sample Analysed By:</b>	Not applicable	<b>Extent:</b>	4 linear metres	
<b>Comments:</b>

<b>Material Assessment Total Score: 4</b>		<b>Likelihood of Disturbance Assessment Total Score: 4</b>		<b>Management Assessment</b>  <b>Licensable:</b> No  <b>Recommendations:</b> Program removal  <b>Reinspection Interval:</b> Not Applicable  <b>Overall Risk Category:</b> C8
<b>Product Type:</b>	1 (Asbestos cement)	<b>Location:</b>	2 (Rooms up to 100 sq m)	
<b>Condition:</b>	1 (Minor scratches)	<b>Accessibility:</b>	1 (Occasionally likely to be disturbed)	
<b>Surface Treatment:</b>	1 (Unencapsulated asbestos cement)			
<b>Asbestos Type:</b>	1 (Chrysotile)	<b>Extent Score:</b>	1 (<10 sq m or 10m pipe run)

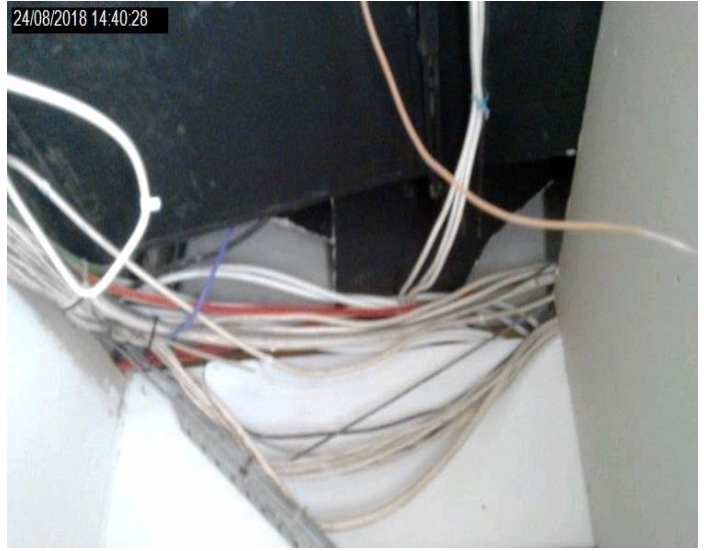
<b>Location:</b>	2.09A	<b>Block:</b>	Birmingham City University	<b>Floor Level:</b> 2nd Floor
<b>Sample No.:</b>	DU002171	<b>Portal Ref No.:</b>	204

<b>Item:</b>	Insulating board			
<b>Asbestos Content:</b>		<b>Result Based on:</b>		
No Asbestos Detected		Analysis of sample using PLM		
<b>Sample Analysed By:</b>	Reg 13(1)	<b>Extent:</b>	2 m <sup>2</sup>	
<b>Comments:</b> Double skin

<b>Material Assessment Total Score: 0</b>		<b>Likelihood of Disturbance Assessment Total Score: 0</b>		<b>Management Assessment</b>  <b>Licensable:</b> Yes  <b>Recommendations:</b> Not Applicable  <b>Reinspection Interval:</b> Not Applicable  <b>Overall Risk Category:</b> E0
<b>Product Type:</b>	0 Not Applicable	<b>Location:</b>	0 Not Applicable	
<b>Condition:</b>	0 Not Applicable	<b>Accessibility:</b>	0 Not Applicable	
<b>Surface Treatment:</b>	0 Not Applicable			
<b>Asbestos Type:</b>	0 Not Applicable	<b>Extent Score:</b>	0 Not Applicable

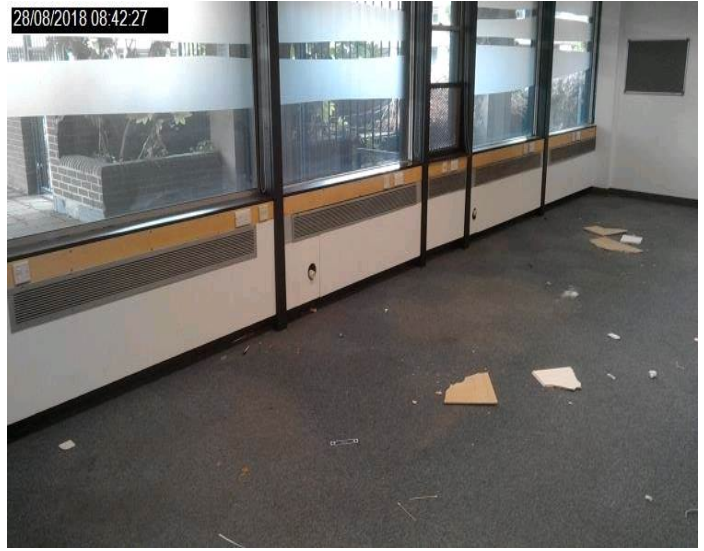
<b>Location:</b>	2.20	<b>Block:</b>	Birmingham City University	<b>Floor Level:</b> 2nd Floor
<b>Sample No.:</b>	As DU002163	<b>Portal Ref No.:</b>	205

<b>Item:</b>	Asbestos Cement window sill			
<b>Asbestos Content:</b>	<b>Result Based on:</b>			
Chrysotile	Strongly presumed			
<b>Sample Analysed By:</b>	Not applicable	<b>Extent:</b>	11 linear metres	
<b>Comments:</b>

<b>Material Assessment Total Score: 4</b>		<b>Likelihood of Disturbance Assessment Total Score: 5</b>		<b>Management Assessment</b>  <b>Licensable:</b> No  <b>Recommendations:</b> Program removal  <b>Reinspection Interval:</b> Not Applicable  <b>Overall Risk Category:</b> C9
<b>Product Type:</b>	1 (Asbestos cement)	<b>Location:</b>	2 (Rooms up to 100 sq m)	
<b>Condition:</b>	1 (Minor scratches)	<b>Accessibility:</b>	1 (Occasionally likely to be disturbed)	
<b>Surface Treatment:</b>	1 (Unencapsulated asbestos cement)			
<b>Asbestos Type:</b>	1 (Chrysotile)	<b>Extent Score:</b>	2 (>10 - <50 sq m or >10m - <50m pipe run)

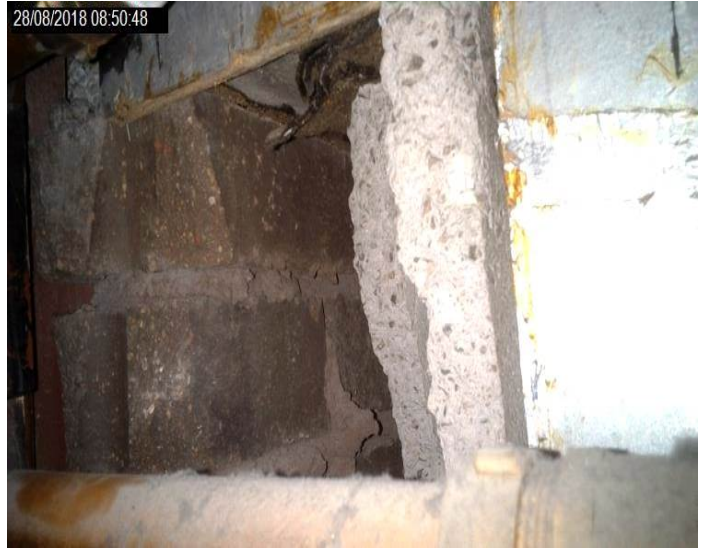
<b>Location:</b>	2.20	<b>Block:</b>	Birmingham City University	<b>Floor Level:</b> 2nd Floor
<b>Sample No.:</b>	DU002172	<b>Portal Ref No.:</b>	206

<b>Item:</b>	Bitumen damp proof course			
<b>Asbestos Content:</b>		<b>Result Based on:</b>		
No Asbestos Detected		Analysis of sample using PLM		
<b>Sample Analysed By:</b>	Reg 13(1)	<b>Extent:</b>	1 linear metres	
<b>Comments:</b> Within wall void top of blockwork divide

<b>Material Assessment Total Score:</b> 0		<b>Likelihood of Disturbance Assessment Total Score:</b> 0		<b>Management Assessment</b>  <b>Licensable:</b> No  <b>Recommendations:</b> Not Applicable  <b>Reinspection Interval:</b> Not Applicable  <b>Overall Risk Category:</b> E0
<b>Product Type:</b>	0 Not Applicable	<b>Location:</b>	0 Not Applicable	
<b>Condition:</b>	0 Not Applicable	<b>Accessibility:</b>	0 Not Applicable	
<b>Surface Treatment:</b>	0 Not Applicable			
<b>Asbestos Type:</b>	0 Not Applicable	<b>Extent Score:</b>	0 Not Applicable

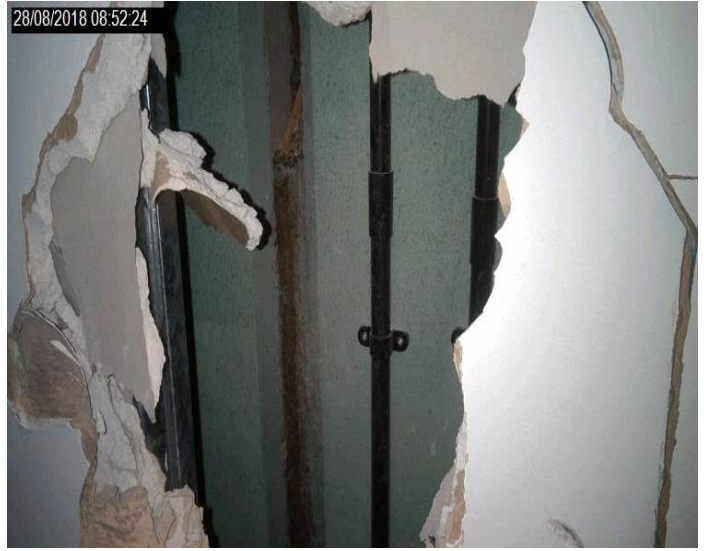
<b>Location:</b>	2.20	<b>Block:</b>	Birmingham City University	<b>Floor Level:</b> 2nd Floor
<b>Sample No.:</b>	DU002173	<b>Portal Ref No.:</b>	207

<b>Item:</b>	Textured coating to concrete column			
<b>Asbestos Content:</b>		<b>Result Based on:</b>		
No Asbestos Detected		Analysis of sample using PLM		
<b>Sample Analysed By:</b>	Reg 13(1)	<b>Extent:</b>	36 m <sup>2</sup>	
<b>Comments:</b> To each column, green in colour

<b>Material Assessment Total Score: 0</b>		<b>Likelihood of Disturbance Assessment Total Score: 0</b>		<b>Management Assessment</b>  <b>Licensable:</b> No  <b>Recommendations:</b> Not Applicable  <b>Reinspection Interval:</b> Not Applicable  <b>Overall Risk Category:</b> E0
<b>Product Type:</b>	0 Not Applicable	<b>Location:</b>	0 Not Applicable	
<b>Condition:</b>	0 Not Applicable	<b>Accessibility:</b>	0 Not Applicable	
<b>Surface Treatment:</b>	0 Not Applicable			
<b>Asbestos Type:</b>	0 Not Applicable	<b>Extent Score:</b>	0 Not Applicable

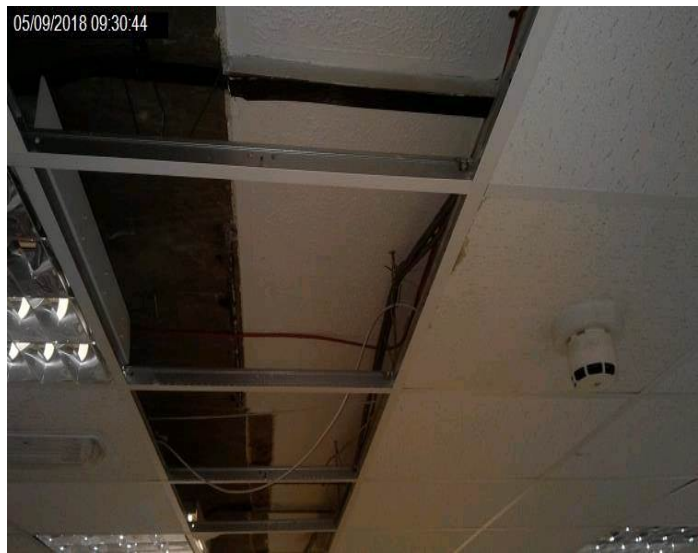
<b>Location:</b>	Mezz.158	<b>Block:</b>	Birmingham City University	<b>Floor Level:</b> M - Mezzanine
<b>Sample No.:</b>	DU002252	<b>Portal Ref No.:</b>	208

<b>Item:</b>	Textured coating to concrete			
<b>Asbestos Content:</b>		<b>Result Based on:</b>		
No Asbestos Detected		Analysis of sample using PLM		
<b>Sample Analysed By:</b>	Reg 13(1)	<b>Extent:</b>	36 m <sup>2</sup>	
<b>Comments:</b> To half the ceiling area of the room

<b>Material Assessment Total Score: 0</b>		<b>Likelihood of Disturbance Assessment Total Score: 0</b>		<b>Management Assessment</b>  <b>Licensable:</b> No  <b>Recommendations:</b> Not Applicable  <b>Reinspection Interval:</b> Not Applicable  <b>Overall Risk Category:</b> E0
<b>Product Type:</b>	0 Not Applicable	<b>Location:</b>	0 Not Applicable	
<b>Condition:</b>	0 Not Applicable	<b>Accessibility:</b>	0 Not Applicable	
<b>Surface Treatment:</b>	0 Not Applicable			
<b>Asbestos Type:</b>	0 Not Applicable	<b>Extent Score:</b>	0 Not Applicable

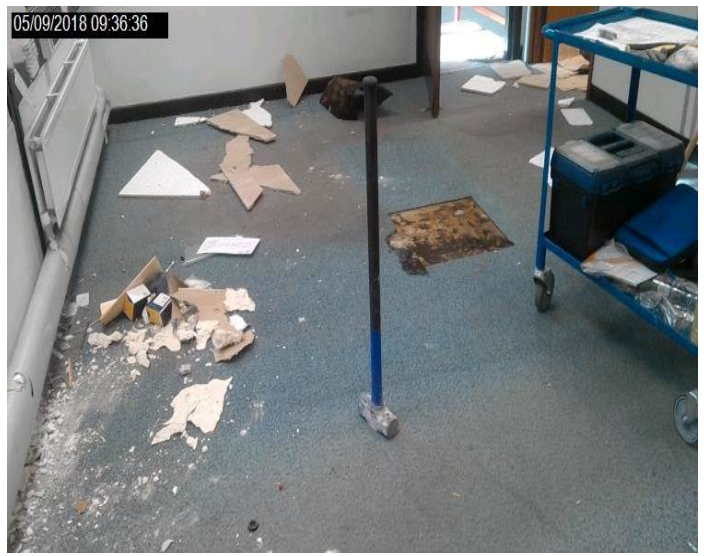
<b>Location:</b>	Mezz.158	<b>Block:</b>	Birmingham City University	<b>Floor Level:</b> M - Mezzanine
<b>Sample No.:</b>	DU002254	<b>Portal Ref No.:</b>	210

<b>Item:</b>	Thermoplastic floor tiles			
<b>Asbestos Content:</b>		<b>Result Based on:</b>		
No Asbestos Detected in tile or adhesive		Analysis of sample using PLM		
<b>Sample Analysed By:</b>	Reg 13(1)	<b>Extent:</b>	70 m <sup>2</sup>	
<b>Comments:</b>

<b>Material Assessment Total Score: 0</b>		<b>Likelihood of Disturbance Assessment Total Score: 0</b>		<b>Management Assessment</b>  <b>Licensable:</b> No  <b>Recommendations:</b> Not Applicable  <b>Reinspection Interval:</b> Not Applicable  <b>Overall Risk Category:</b> E0
<b>Product Type:</b>	0 Not Applicable	<b>Location:</b>	0 Not Applicable	
<b>Condition:</b>	0 Not Applicable	<b>Accessibility:</b>	0 Not Applicable	
<b>Surface Treatment:</b>	0 Not Applicable			
<b>Asbestos Type:</b>	0 Not Applicable	<b>Extent Score:</b>	0 Not Applicable

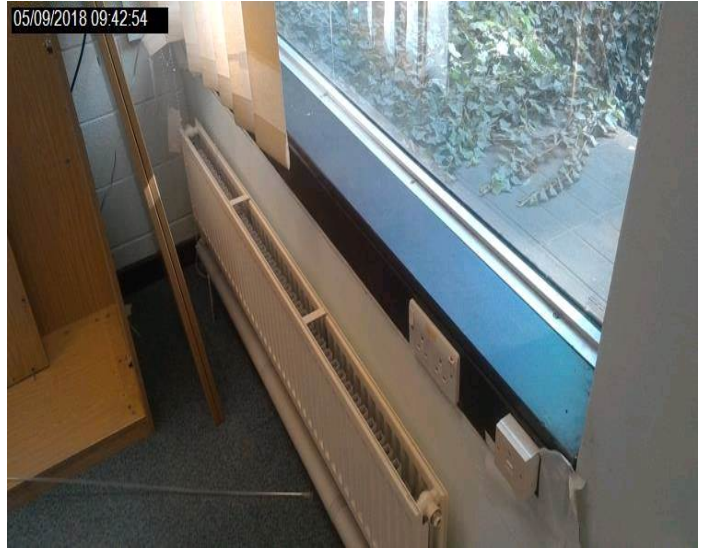
<b>Location:</b>	Mezz.158	<b>Block:</b>	Birmingham City University	<b>Floor Level:</b> M - Mezzanine
<b>Sample No.:</b>	DU002255	<b>Portal Ref No.:</b>	211

<b>Item:</b>	Asbestos Cement window sill			
<b>Asbestos Content:</b>	Result Based on:			
Chrysotile	Analysis of sample using PLM			
<b>Sample Analysed By:</b> Reg 13(1)	<b>Extent:</b>	2 linear metres		
<b>Comments:</b> Left hand section to external window

<b>Material Assessment Total Score: 4</b>		<b>Likelihood of Disturbance Assessment Total Score: 4</b>		<b>Management Assessment</b>  <b>Licensable:</b> No  <b>Recommendations:</b> Program removal  <b>Reinspection Interval:</b> Not Applicable  <b>Overall Risk Category:</b> C8
<b>Product Type:</b>	1 (Asbestos cement)	<b>Location:</b>	2 (Rooms up to 100 sq m)	
<b>Condition:</b>	1 (Minor scratches)	<b>Accessibility:</b>	1 (Occasionally likely to be disturbed)	
<b>Surface Treatment:</b>	1 (Unencapsulated asbestos cement)			
<b>Asbestos Type:</b>	1 (Chrysotile)	<b>Extent Score:</b>	1 (<10 sq m or 10m pipe run)

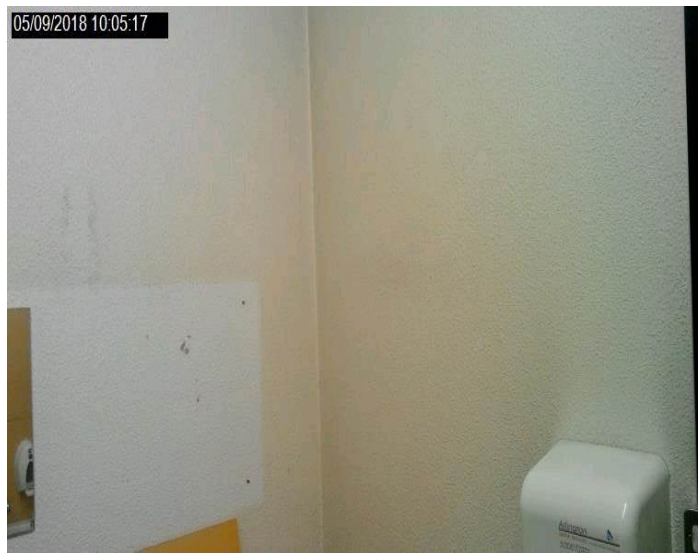
<b>Location:</b>	Mezz.155	<b>Block:</b>	Birmingham City University	<b>Floor Level:</b> M - Mezzanine
<b>Sample No.:</b>	DU002258	<b>Portal Ref No.:</b>	218

<b>Item:</b>	Textured coating to concrete walls			
<b>Asbestos Content:</b>			<b>Result Based on:</b>	
No Asbestos Detected		Analysis of sample using PLM		
<b>Sample Analysed By:</b>	Reg 13(1)	<b>Extent:</b>	24 m <sup>2</sup>	
<b>Comments:</b>

<b>Material Assessment Total Score: 0</b>		<b>Likelihood of Disturbance Assessment Total Score: 0</b>		<b>Management Assessment</b>  <b>Licensable:</b> No  <b>Recommendations:</b> Not Applicable  <b>Reinspection Interval:</b> Not Applicable  <b>Overall Risk Category:</b> E0
<b>Product Type:</b>	0 Not Applicable	<b>Location:</b>	0 Not Applicable	
<b>Condition:</b>	0 Not Applicable	<b>Accessibility:</b>	0 Not Applicable	
<b>Surface Treatment:</b>	0 Not Applicable			
<b>Asbestos Type:</b>	0 Not Applicable	<b>Extent Score:</b>	0 Not Applicable

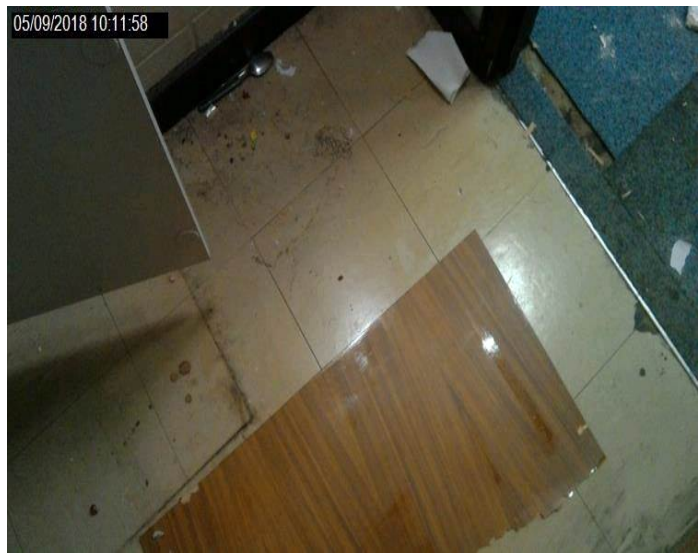
<b>Location:</b>	Mezz.154	<b>Block:</b>	Birmingham City University	<b>Floor Level:</b> M - Mezzanine
<b>Sample No.:</b>	DU002259	<b>Portal Ref No.:</b>	219

<b>Item:</b>	Asbestos Thermoplastic floor tiles			
<b>Asbestos Content:</b>	Result Based on:			
Chrysotile in tile and adhesive		Analysis of sample using PLM		
<b>Sample Analysed By:</b>	Reg 13(1)	<b>Extent:</b>	2 m <sup>2</sup>	
<b>Comments:</b>

<b>Material Assessment Total Score: 3</b>		<b>Likelihood of Disturbance Assessment Total Score: 6</b>		<b>Management Assessment</b>  <b>Licensable:</b> No  <b>Recommendations:</b> Program removal  <b>Reinspection Interval:</b> Not Applicable  <b>Overall Risk Category:</b> C9
<b>Product Type:</b>	1 (Asbestos thermoplastic)	<b>Location:</b>	2 (Rooms up to 100 sq m)	
<b>Condition:</b>	1 (Minor scratches)	<b>Accessibility:</b>	3 (Routinely disturbed)	
<b>Surface Treatment:</b>	0 (Composite material)			
<b>Asbestos Type:</b>	1 (Chrysotile)	<b>Extent Score:</b>	1 (<10 sq m or 10m pipe run)

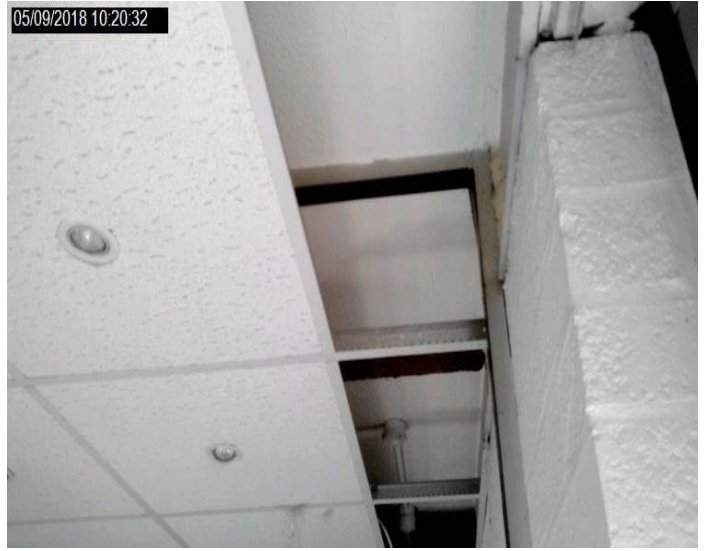
<b>Location:</b>	Mezz.153	<b>Block:</b>	Birmingham City University	<b>Floor Level:</b> M - Mezzanine
<b>Sample No.:</b>	As DU002252	<b>Portal Ref No.:</b>	220

<b>Item:</b>	Textured coating to concrete			
<b>Asbestos Content:</b>		<b>Result Based on:</b>		
No Asbestos Detected		Strongly presumed		
<b>Sample Analysed By:</b>	Not applicable	<b>Extent:</b>	14 m <sup>2</sup>	
<b>Comments:</b>

<b>Material Assessment Total Score: 0</b>		<b>Likelihood of Disturbance Assessment Total Score: 0</b>		<b>Management Assessment</b>  <b>Licensable:</b> No  <b>Recommendations:</b> Not Applicable  <b>Reinspection Interval:</b> Not Applicable  <b>Overall Risk Category:</b> E0
<b>Product Type:</b>	0 Not Applicable	<b>Location:</b>	0 Not Applicable	
<b>Condition:</b>	0 Not Applicable	<b>Accessibility:</b>	0 Not Applicable	
<b>Surface Treatment:</b>	0 Not Applicable			
<b>Asbestos Type:</b>	0 Not Applicable	<b>Extent Score:</b>	0 Not Applicable	
<b>Management Detail</b>

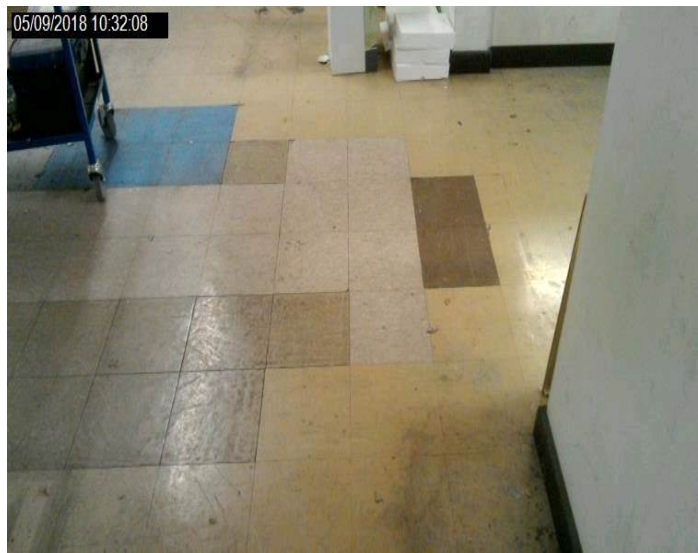
<b>Location:</b>	1.60	<b>Block:</b>	Birmingham City University	<b>Floor Level:</b> 1st Floor
<b>Sample No.:</b>	DU002261	<b>Portal Ref No.:</b>	223

<b>Item:</b>	Asbestos Thermoplastic floor tiles			
<b>Asbestos Content:</b>	Result Based on:			
Chrysotile in adhesive only	Analysis of sample using PLM			
<b>Sample Analysed By:</b> Reg 13(1)	<b>Extent:</b>	65 m <sup>2</sup>		
<b>Comments:</b>

<b>Material Assessment Total Score: 3</b>		<b>Likelihood of Disturbance Assessment Total Score: 8</b>		<b>Management Assessment</b>  <b>Licensable:</b> No  <b>Recommendations:</b> Program removal  <b>Reinspection Interval:</b> Not Applicable  <b>Overall Risk Category:</b> B11
<b>Product Type:</b>	1 (Asbestos thermoplastic)	<b>Location:</b>	2 (Rooms up to 100 sq m)	
<b>Condition:</b>	1 (Minor scratches)	<b>Accessibility:</b>	3 (Routinely disturbed)	
<b>Surface Treatment:</b>	0 (Composite material)			
<b>Asbestos Type:</b>	1 (Chrysotile)	<b>Extent Score:</b>	3 (>50 sq m or >50m pipe run)

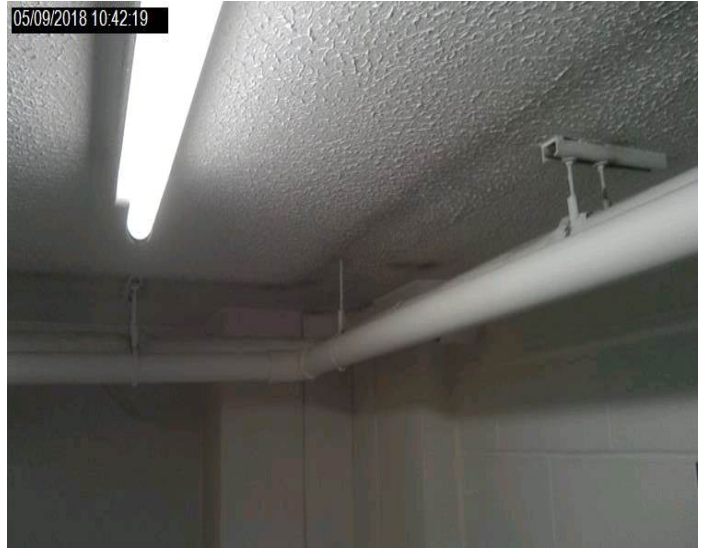
<b>Location:</b>	1.61	<b>Block:</b>	Birmingham City University	<b>Floor Level:</b> 1st Floor
<b>Sample No.:</b>	As DU002260	<b>Portal Ref No.:</b>	226

<b>Item:</b>	Textured coating to concrete			
<b>Asbestos Content:</b>		<b>Result Based on:</b>		
No Asbestos Detected		Strongly presumed		
<b>Sample Analysed By:</b>	Not applicable	<b>Extent:</b>	8 m <sup>2</sup>	
<b>Comments:</b>

<b>Material Assessment Total Score: 0</b>		<b>Likelihood of Disturbance Assessment Total Score: 0</b>		<b>Management Assessment</b>  <b>Licensable:</b> No  <b>Recommendations:</b> Not Applicable  <b>Reinspection Interval:</b> Not Applicable  <b>Overall Risk Category:</b> E0
<b>Product Type:</b>	0 Not Applicable	<b>Location:</b>	0 Not Applicable	
<b>Condition:</b>	0 Not Applicable	<b>Accessibility:</b>	0 Not Applicable	
<b>Surface Treatment:</b>	0 Not Applicable			
<b>Asbestos Type:</b>	0 Not Applicable	<b>Extent Score:</b>	0 Not Applicable

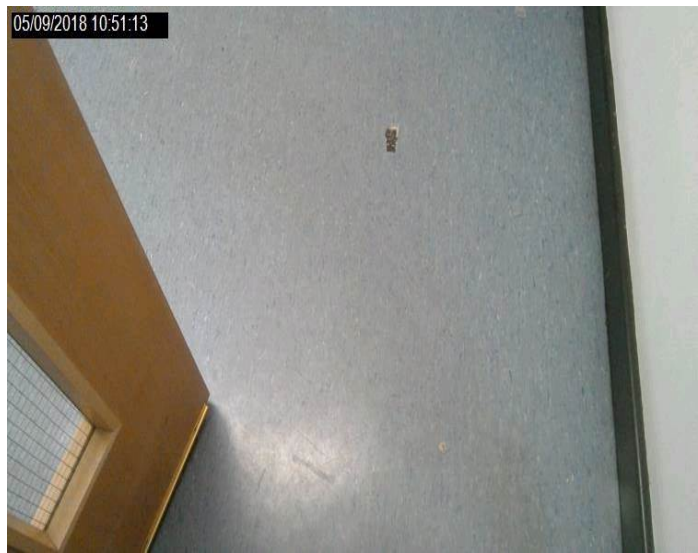
<b>Location:</b>	1.61	<b>Block:</b>	Birmingham City University	<b>Floor Level:</b> 1st Floor
<b>Sample No.:</b>	DU002263	<b>Portal Ref No.:</b>	229

<b>Item:</b>	Asbestos Vinyl floor covering			
<b>Asbestos Content:</b>	<b>Result Based on:</b>			
Chrysotile in adhesive only	Analysis of sample using PLM			
<b>Sample Analysed By:</b> Reg 13(1)	<b>Extent:</b>	8 m <sup>2</sup>		
<b>Comments:</b> 2nd layer

<b>Material Assessment Total Score: 3</b>		<b>Likelihood of Disturbance Assessment Total Score: 4</b>		<b>Management Assessment</b>  <b>Licensable:</b> No  <b>Recommendations:</b> Program removal  <b>Reinspection Interval:</b> Not Applicable  <b>Overall Risk Category:</b> C7
<b>Product Type:</b>	1 (Asbestos vinyl)	<b>Location:</b>	2 (Rooms up to 100 sq m)	
<b>Condition:</b>	1 (Minor scratches)	<b>Accessibility:</b>	1 (Occasionally likely to be disturbed)	
<b>Surface Treatment:</b>	0 (Composite material)			
<b>Asbestos Type:</b>	1 (Chrysotile)	<b>Extent Score:</b>	1 (<10 sq m or 10m pipe run)

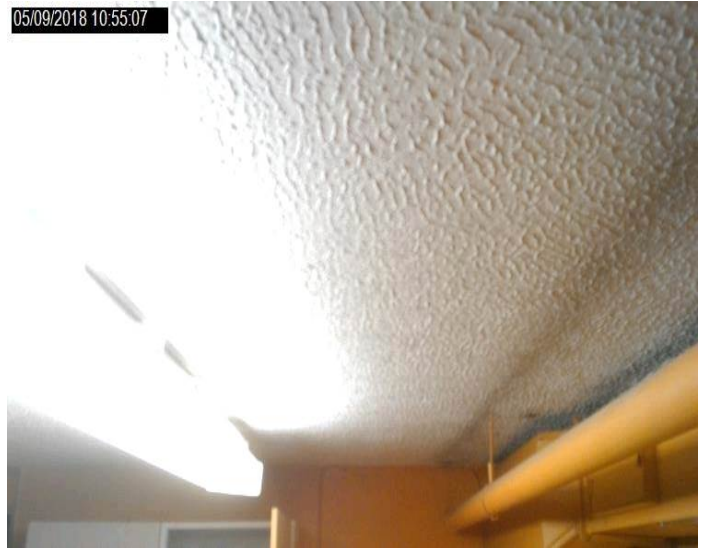
<b>Location:</b>	1.58	<b>Block:</b>	Birmingham City University	<b>Floor Level:</b> 1st Floor
<b>Sample No.:</b>	As DU002260	<b>Portal Ref No.:</b>	230

<b>Item:</b>	Textured coating to concrete			
<b>Asbestos Content:</b>		<b>Result Based on:</b>		
No Asbestos Detected		Strongly presumed		
<b>Sample Analysed By:</b>	Not applicable	<b>Extent:</b>	6 m <sup>2</sup>	
<b>Comments:</b>

<b>Material Assessment Total Score: 0</b>		<b>Likelihood of Disturbance Assessment Total Score: 0</b>		<b>Management Assessment</b>  <b>Licensable:</b> No  <b>Recommendations:</b> Not Applicable  <b>Reinspection Interval:</b> Not Applicable  <b>Overall Risk Category:</b> E0
<b>Product Type:</b>	0 Not Applicable	<b>Location:</b>	0 Not Applicable	
<b>Condition:</b>	0 Not Applicable	<b>Accessibility:</b>	0 Not Applicable	
<b>Surface Treatment:</b>	0 Not Applicable			
<b>Asbestos Type:</b>	0 Not Applicable	<b>Extent Score:</b>	0 Not Applicable

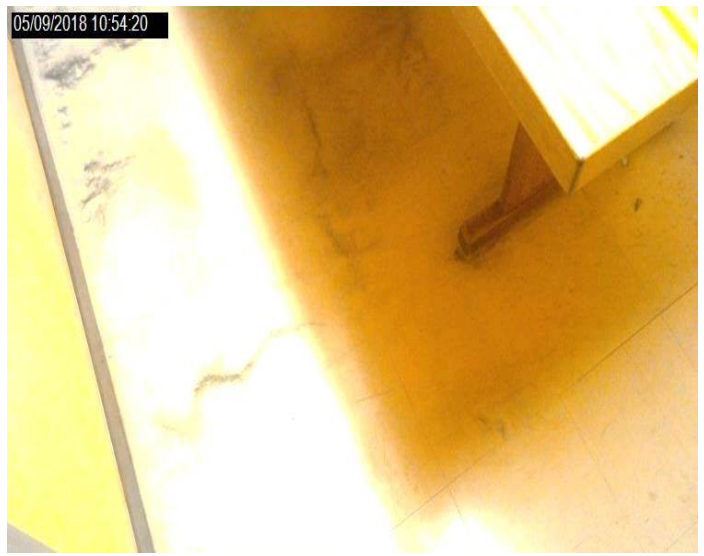
<b>Location:</b>	1.58	<b>Block:</b>	Birmingham City University	<b>Floor Level:</b> 1st Floor
<b>Sample No.:</b>	As DU002261	<b>Portal Ref No.:</b>	231

<b>Item:</b>	Asbestos Thermoplastic floor tiles			
<b>Asbestos Content:</b>	<b>Result Based on:</b>			
Chrysotile in adhesive only	Strongly presumed			
<b>Sample Analysed By:</b>	Not applicable	<b>Extent:</b>	6 m <sup>2</sup>	
<b>Comments:</b>

<b>Material Assessment Total Score: 3</b>		<b>Likelihood of Disturbance Assessment Total Score: 6</b>		<b>Management Assessment</b>  <b>Licensable:</b> No  <b>Recommendations:</b> Program removal  <b>Reinspection Interval:</b> Not Applicable  <b>Overall Risk Category:</b> C9
<b>Product Type:</b>	1 (Asbestos thermoplastic)	<b>Location:</b>	2 (Rooms up to 100 sq m)	
<b>Condition:</b>	1 (Minor scratches)	<b>Accessibility:</b>	3 (Routinely disturbed)	
<b>Surface Treatment:</b>	0 (Composite material)			
<b>Asbestos Type:</b>	1 (Chrysotile)	<b>Extent Score:</b>	1 (<10 sq m or 10m pipe run)

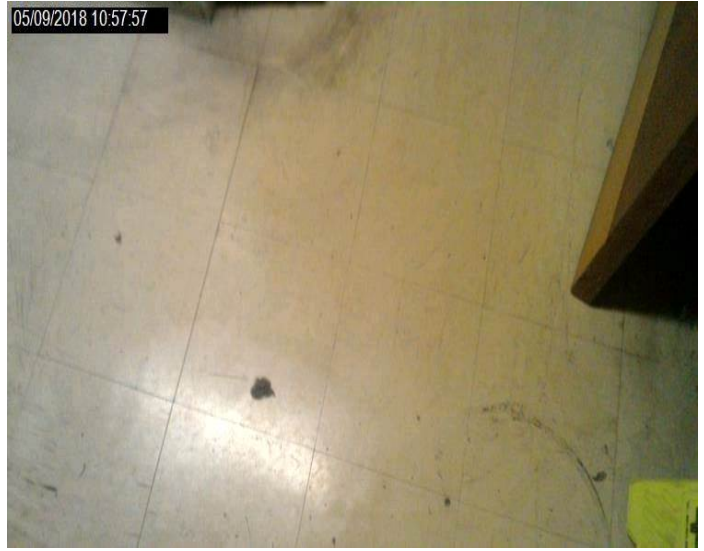
<b>Location:</b>	1.57	<b>Block:</b>	Birmingham City University	<b>Floor Level:</b> 1st Floor
<b>Sample No.:</b>	As DU002261	<b>Portal Ref No.:</b>	233

<b>Item:</b>	Asbestos Thermoplastic floor tiles			
<b>Asbestos Content:</b>	<b>Result Based on:</b>			
Chrysotile in adhesive only	Strongly presumed			
<b>Sample Analysed By:</b>	Not applicable	<b>Extent:</b>	6 m <sup>2</sup>	
<b>Comments:</b>

<b>Material Assessment Total Score: 3</b>		<b>Likelihood of Disturbance Assessment Total Score: 6</b>		<b>Management Assessment</b>  <b>Licensable:</b> No  <b>Recommendations:</b> Program removal  <b>Reinspection Interval:</b> Not Applicable  <b>Overall Risk Category:</b> C9
<b>Product Type:</b>	1 (Asbestos thermoplastic)	<b>Location:</b>	2 (Rooms up to 100 sq m)	
<b>Condition:</b>	1 (Minor scratches)	<b>Accessibility:</b>	3 (Routinely disturbed)	
<b>Surface Treatment:</b>	0 (Composite material)			
<b>Asbestos Type:</b>	1 (Chrysotile)	<b>Extent Score:</b>	1 (<10 sq m or 10m pipe run)

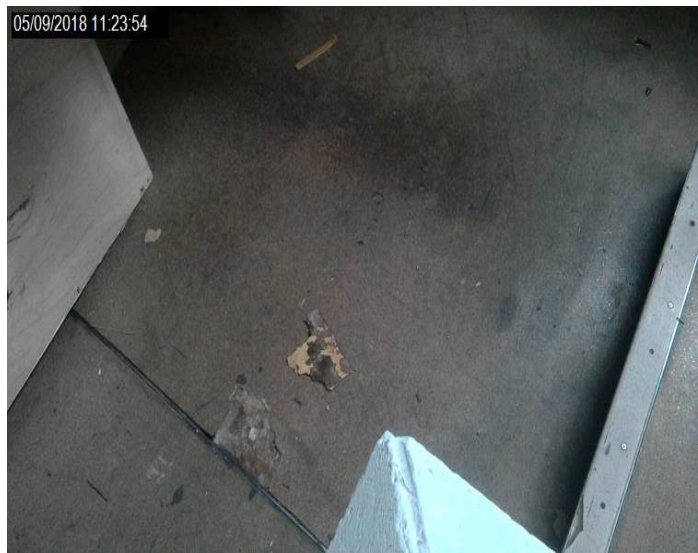
<b>Location:</b>	1.00	<b>Block:</b>	Birmingham City University	<b>Floor Level:</b> 1st Floor
<b>Sample No.:</b>	DU002264	<b>Portal Ref No.:</b>	234

<b>Item:</b>	Asbestos Bitumen adhesive to concrete			
<b>Asbestos Content:</b>	Result Based on:			
Chrysotile	Analysis of sample using PLM			
<b>Sample Analysed By:</b> Reg 13(1)	<b>Extent:</b>	15 m <sup>2</sup>		
<b>Comments:</b> Beneath modern vinyl flooring

<b>Material Assessment Total Score: 3</b>		<b>Likelihood of Disturbance Assessment Total Score: 4</b>		<b>Management Assessment</b>  <b>Licensable:</b> No  <b>Recommendations:</b> Program removal  <b>Reinspection Interval:</b> Not Applicable  <b>Overall Risk Category:</b> C7
<b>Product Type:</b>	1 (Asbestos bitumen)	<b>Location:</b>	2 (Rooms up to 100 sq m)	
<b>Condition:</b>	1 (Minor scratches)	<b>Accessibility:</b>	0 (Usually inaccessible or unlikely to be disturbed)	
<b>Surface Treatment:</b>	0 (Composite material)			
<b>Asbestos Type:</b>	1 (Chrysotile)	<b>Extent Score:</b>	2 (>10 - <50 sq m or >10m - <50m pipe run)

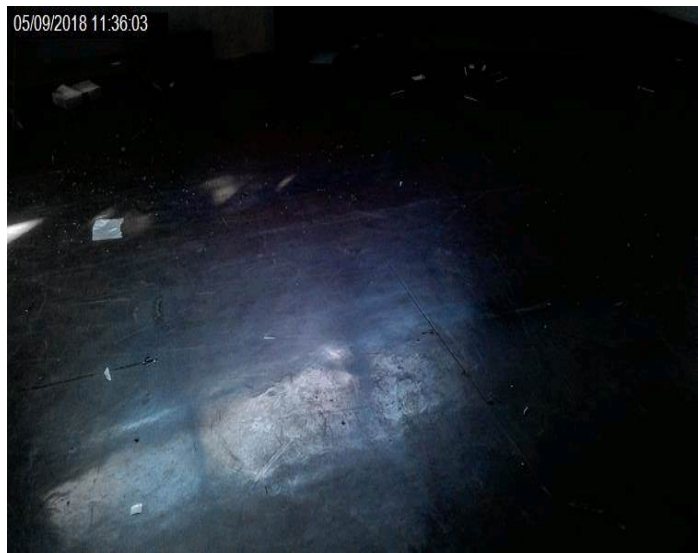
<b>Location:</b>	1.55	<b>Block:</b>	Birmingham City University	<b>Floor Level:</b> 1st Floor
<b>Sample No.:</b>	DU002265	<b>Portal Ref No.:</b>	236

<b>Item:</b>	Vinyl			
<b>Asbestos Content:</b>		<b>Result Based on:</b>		
No Asbestos Detected		Analysis of sample using PLM		
<b>Sample Analysed By:</b>	Reg 13(1)	<b>Extent:</b>	70 m <sup>2</sup>	
<b>Comments:</b>

<b>Material Assessment Total Score: 0</b>		<b>Likelihood of Disturbance Assessment Total Score: 0</b>		<b>Management Assessment</b>  <b>Licensable:</b> No  <b>Recommendations:</b> Not Applicable  <b>Reinspection Interval:</b> Not Applicable  <b>Overall Risk Category:</b> E0
<b>Product Type:</b>	0 Not Applicable	<b>Location:</b>	0 Not Applicable	
<b>Condition:</b>	0 Not Applicable	<b>Accessibility:</b>	0 Not Applicable	
<b>Surface Treatment:</b>	0 Not Applicable			
<b>Asbestos Type:</b>	0 Not Applicable	<b>Extent Score:</b>	0 Not Applicable

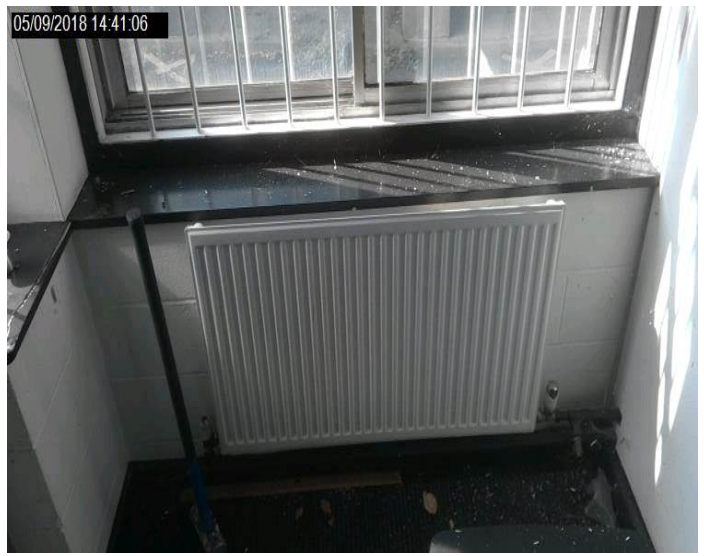
<b>Location:</b>	1.44	<b>Block:</b>	Birmingham City University	<b>Floor Level:</b> 1st Floor
<b>Sample No.:</b>	DU002266	<b>Portal Ref No.:</b>	239

<b>Item:</b>	Asbestos Cement window sill			
<b>Asbestos Content:</b>	Result Based on:			
Chrysotile	Analysis of sample using PLM			
<b>Sample Analysed By:</b>	Reg 13(1)	<b>Extent:</b>	2 linear metres	
<b>Comments:</b>

<b>Material Assessment Total Score: 4</b>		<b>Likelihood of Disturbance Assessment Total Score: 4</b>		<b>Management Assessment</b>  <b>Licensable:</b> No  <b>Recommendations:</b> Program removal  <b>Reinspection Interval:</b> Not Applicable  <b>Overall Risk Category:</b> C8
<b>Product Type:</b>	1 (Asbestos cement)	<b>Location:</b>	2 (Rooms up to 100 sq m)	
<b>Condition:</b>	1 (Minor scratches)	<b>Accessibility:</b>	1 (Occasionally likely to be disturbed)	
<b>Surface Treatment:</b>	1 (Unencapsulated asbestos cement)			
<b>Asbestos Type:</b>	1 (Chrysotile)	<b>Extent Score:</b>	1 (<10 sq m or 10m pipe run)

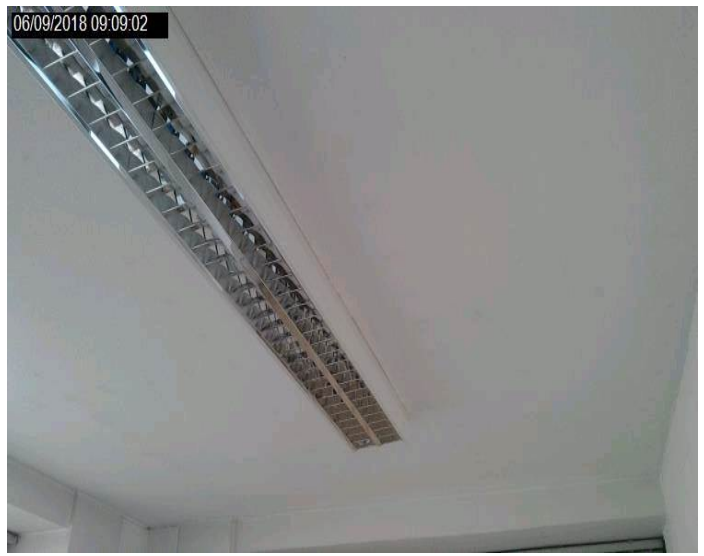
<b>Location:</b>	1.03	<b>Block:</b>	Birmingham City University	<b>Floor Level:</b> 1st Floor
<b>Sample No.:</b>	DU002267	<b>Portal Ref No.:</b>	240

<b>Item:</b>	Textured coating to plasterboard			
<b>Asbestos Content:</b>		<b>Result Based on:</b>		
No Asbestos Detected		Analysis of sample using PLM		
<b>Sample Analysed By:</b>	Reg 13(1)	<b>Extent:</b>	12 m <sup>2</sup>	
<b>Comments:</b>

<b>Material Assessment Total Score: 0</b>		<b>Likelihood of Disturbance Assessment Total Score: 0</b>		<b>Management Assessment</b>  <b>Licensable:</b> No  <b>Recommendations:</b> Not Applicable  <b>Reinspection Interval:</b> Not Applicable  <b>Overall Risk Category:</b> E0
<b>Product Type:</b>	0 Not Applicable	<b>Location:</b>	0 Not Applicable	
<b>Condition:</b>	0 Not Applicable	<b>Accessibility:</b>	0 Not Applicable	
<b>Surface Treatment:</b>	0 Not Applicable			
<b>Asbestos Type:</b>	0 Not Applicable	<b>Extent Score:</b>	0 Not Applicable

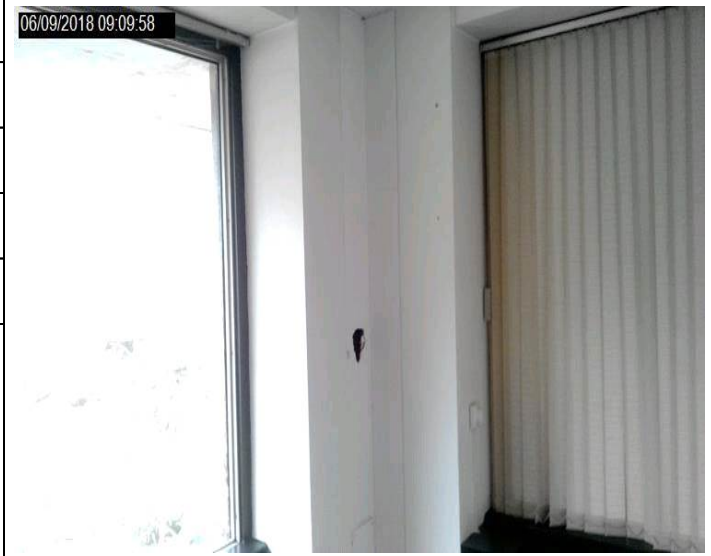
<b>Location:</b>	1.03	<b>Block:</b>	Birmingham City University	<b>Floor Level:</b> 1st Floor
<b>Sample No.:</b>	DU002268	<b>Portal Ref No.:</b>	241

<b>Item:</b>	Insulating board panel			
<b>Asbestos Content:</b>		<b>Result Based on:</b>		
No Asbestos Detected		Analysis of sample using PLM		
<b>Sample Analysed By:</b>	Reg 13(1)	<b>Extent:</b>	2 m <sup>2</sup>	
<b>Comments:</b>

<b>Material Assessment Total Score: 0</b>		<b>Likelihood of Disturbance Assessment Total Score: 0</b>		<b>Management Assessment</b>  <b>Licensable:</b> Yes  <b>Recommendations:</b> Not Applicable  <b>Reinspection Interval:</b> Not Applicable  <b>Overall Risk Category:</b> E0
<b>Product Type:</b>	0 Not Applicable	<b>Location:</b>	0 Not Applicable	
<b>Condition:</b>	0 Not Applicable	<b>Accessibility:</b>	0 Not Applicable	
<b>Surface Treatment:</b>	0 Not Applicable			
<b>Asbestos Type:</b>	0 Not Applicable	<b>Extent Score:</b>	0 Not Applicable

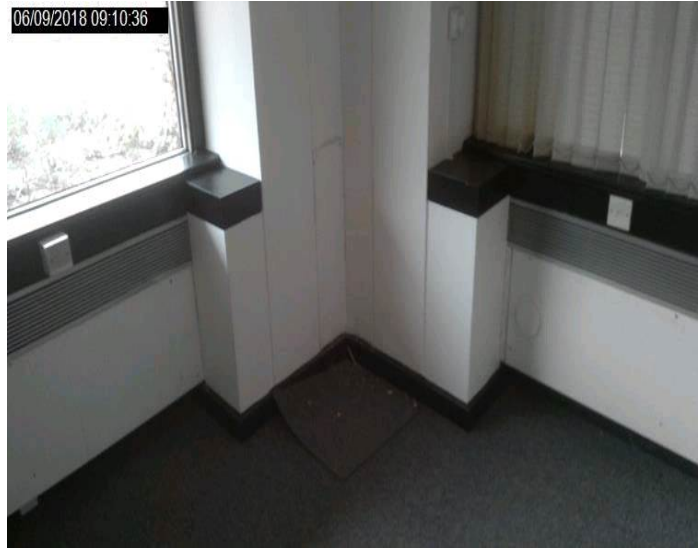
<b>Location:</b>	1.03	<b>Block:</b>	Birmingham City University	<b>Floor Level:</b> 1st Floor
<b>Sample No.:</b>	DU002269	<b>Portal Ref No.:</b>	242

<b>Item:</b>	Asbestos Cement window sill			
<b>Asbestos Content:</b>	Result Based on:			
Chrysotile	Analysis of sample using PLM			
<b>Sample Analysed By:</b>	Reg 13(1)	<b>Extent:</b>	7 linear metres	
<b>Comments:</b>

<b>Material Assessment Total Score: 4</b>		<b>Likelihood of Disturbance Assessment Total Score: 4</b>		<b>Management Assessment</b>  <b>Licensable:</b> No  <b>Recommendations:</b> Program removal  <b>Reinspection Interval:</b> Not Applicable  <b>Overall Risk Category:</b> C8
<b>Product Type:</b>	1 (Asbestos cement)	<b>Location:</b>	2 (Rooms up to 100 sq m)	
<b>Condition:</b>	1 (Minor scratches)	<b>Accessibility:</b>	1 (Occasionally likely to be disturbed)	
<b>Surface Treatment:</b>	1 (Unencapsulated asbestos cement)			
<b>Asbestos Type:</b>	1 (Chrysotile)	<b>Extent Score:</b>	1 (<10 sq m or 10m pipe run)

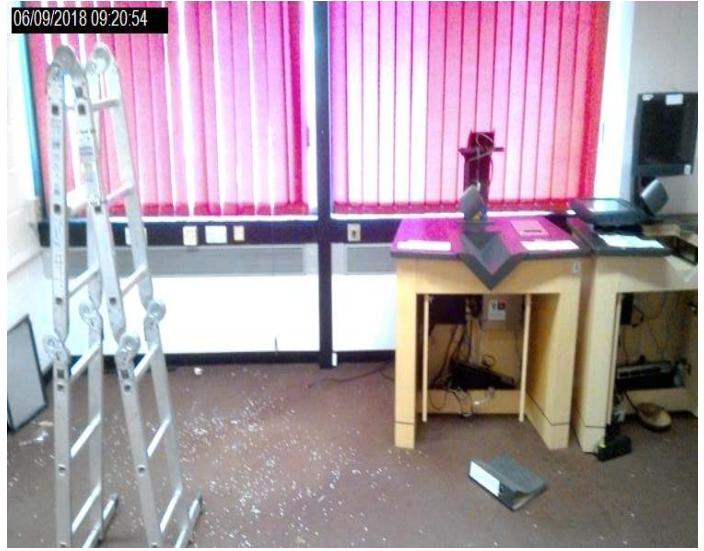
<b>Location:</b>	1.02	<b>Block:</b>	Birmingham City University	<b>Floor Level:</b> 1st Floor
<b>Sample No.:</b>	As DU002269	<b>Portal Ref No.:</b>	246

<b>Item:</b>	Asbestos Cement window sill			
<b>Asbestos Content:</b>	<b>Result Based on:</b>			
Chrysotile	Strongly presumed			
<b>Sample Analysed By:</b>	Not applicable	<b>Extent:</b>	4 linear metres	
<b>Comments:</b>

<b>Material Assessment Total Score: 4</b>		<b>Likelihood of Disturbance Assessment Total Score: 4</b>		<b>Management Assessment</b>  <b>Licensable:</b> No  <b>Recommendations:</b> Program removal  <b>Reinspection Interval:</b> Not Applicable  <b>Overall Risk Category:</b> C8
<b>Product Type:</b>	1 (Asbestos cement)	<b>Location:</b>	2 (Rooms up to 100 sq m)	
<b>Condition:</b>	1 (Minor scratches)	<b>Accessibility:</b>	1 (Occasionally likely to be disturbed)	
<b>Surface Treatment:</b>	1 (Unencapsulated asbestos cement)			
<b>Asbestos Type:</b>	1 (Chrysotile)	<b>Extent Score:</b>	1 (<10 sq m or 10m pipe run)

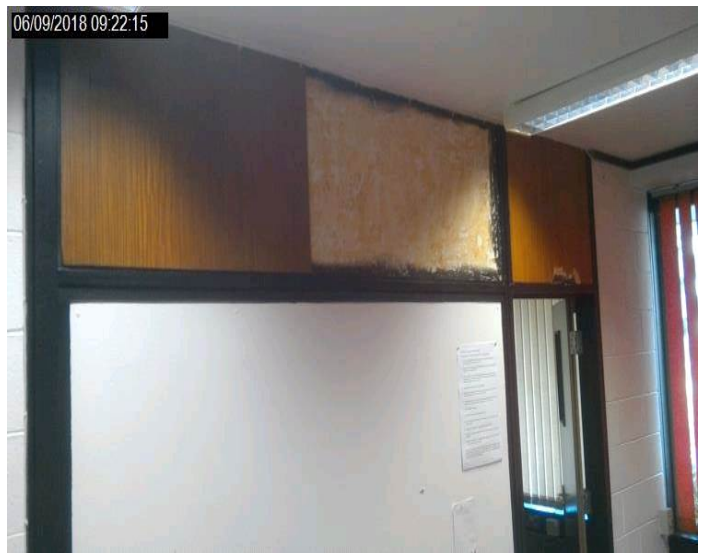
<b>Location:</b>	1.02	<b>Block:</b>	Birmingham City University	<b>Floor Level:</b> 1st Floor
<b>Sample No.:</b>	DU002270	<b>Portal Ref No.:</b>	247

<b>Item:</b>	Insulating board door header			
<b>Asbestos Content:</b>	<b>Result Based on:</b>			
No Asbestos Detected	Analysis of sample using PLM			
<b>Sample Analysed By:</b> Reg 13(1)	<b>Extent:</b>	6 m <sup>2</sup>		
<b>Comments:</b> Double skin to dividing wall

<b>Material Assessment Total Score: 0</b>		<b>Likelihood of Disturbance Assessment Total Score: 0</b>		<b>Management Assessment</b>  <b>Licensable:</b> Yes  <b>Recommendations:</b> Not Applicable  <b>Reinspection Interval:</b> Not Applicable  <b>Overall Risk Category:</b> E0
<b>Product Type:</b>	0 Not Applicable	<b>Location:</b>	0 Not Applicable	
<b>Condition:</b>	0 Not Applicable	<b>Accessibility:</b>	0 Not Applicable	
<b>Surface Treatment:</b>	0 Not Applicable			
<b>Asbestos Type:</b>	0 Not Applicable	<b>Extent Score:</b>	0 Not Applicable

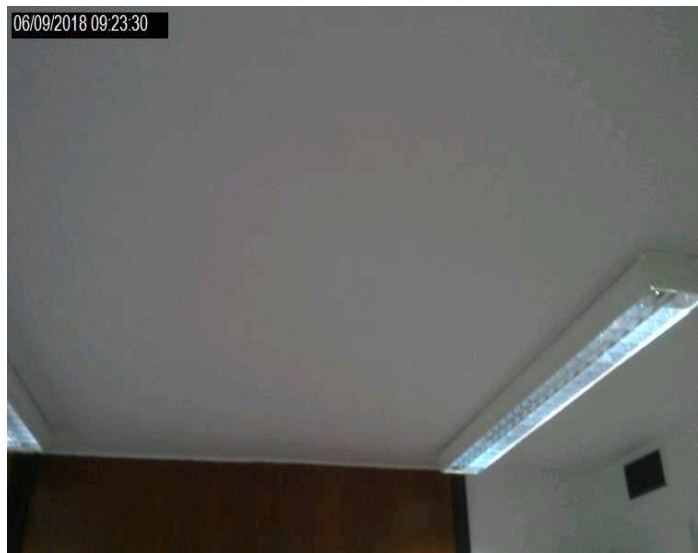
<b>Location:</b>	1.01	<b>Block:</b>	Birmingham City University	<b>Floor Level:</b> 1st Floor
<b>Sample No.:</b>	As DU002267	<b>Portal Ref No.:</b>	248

<b>Item:</b>	Textured coating to plasterboard			
<b>Asbestos Content:</b>		<b>Result Based on:</b>		
No Asbestos Detected		Strongly presumed		
<b>Sample Analysed By:</b>	Not applicable	<b>Extent:</b>	20 m <sup>2</sup>	
<b>Comments:</b>

<b>Material Assessment Total Score: 0</b>		<b>Likelihood of Disturbance Assessment Total Score: 0</b>		<b>Management Assessment</b>  <b>Licensable:</b> No  <b>Recommendations:</b> Not Applicable  <b>Reinspection Interval:</b> Not Applicable  <b>Overall Risk Category:</b> E0
<b>Product Type:</b>	0 Not Applicable	<b>Location:</b>	0 Not Applicable	
<b>Condition:</b>	0 Not Applicable	<b>Accessibility:</b>	0 Not Applicable	
<b>Surface Treatment:</b>	0 Not Applicable			
<b>Asbestos Type:</b>	0 Not Applicable	<b>Extent Score:</b>	0 Not Applicable

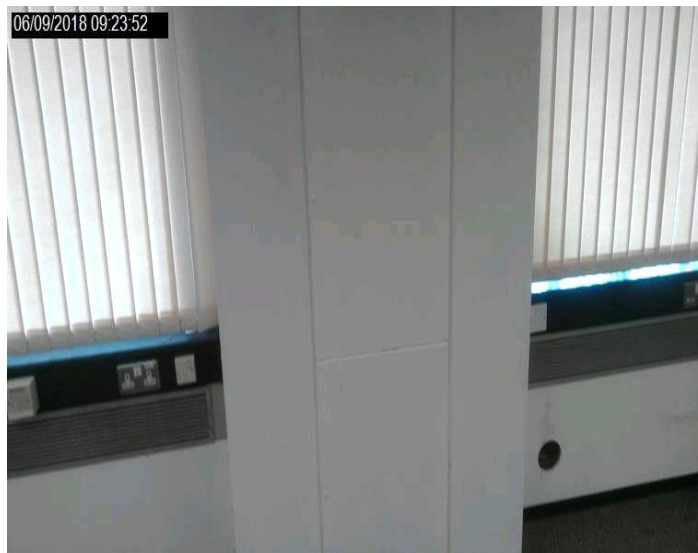
<b>Location:</b>	1.01	<b>Block:</b>	Birmingham City University		<b>Floor Level:</b> 1st Floor
<b>Sample No.:</b>	As DU002268	<b>Portal Ref No.:</b>	249

<b>Item:</b>	Insulating board panel				
<b>Asbestos Content:</b>		<b>Result Based on:</b>			
No Asbestos Detected		Strongly presumed			
<b>Sample Analysed By:</b>	Not applicable	<b>Extent:</b>	3 m <sup>2</sup>		
<b>Comments:</b> To riser

<b>Material Assessment Total Score:</b> 0		<b>Likelihood of Disturbance Assessment Total Score:</b> 0		<b>Management Assessment</b>  <b>Licensable:</b> Yes  <b>Recommendations:</b> Not Applicable  <b>Reinspection Interval:</b> Not Applicable  <b>Overall Risk Category:</b> E0
<b>Product Type:</b>	0 Not Applicable	<b>Location:</b>	0 Not Applicable	
<b>Condition:</b>	0 Not Applicable	<b>Accessibility:</b>	0 Not Applicable	
<b>Surface Treatment:</b>	0 Not Applicable			
<b>Asbestos Type:</b>	0 Not Applicable	<b>Extent Score:</b>	0 Not Applicable

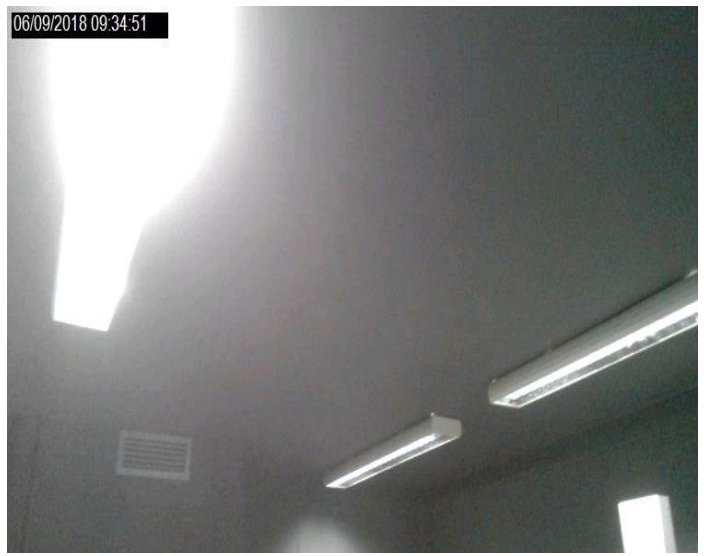
<b>Location:</b>	1.05	<b>Block:</b>	Birmingham City University	<b>Floor Level:</b> 1st Floor
<b>Sample No.:</b>	As DU002267	<b>Portal Ref No.:</b>	252

<b>Item:</b>	Textured coating to plasterboard			
<b>Asbestos Content:</b>		<b>Result Based on:</b>		
No Asbestos Detected		Strongly presumed		
<b>Sample Analysed By:</b>	Not applicable	<b>Extent:</b>	25 m <sup>2</sup>	
<b>Comments:</b>

<b>Material Assessment Total Score: 0</b>		<b>Likelihood of Disturbance Assessment Total Score: 0</b>		<b>Management Assessment</b>  <b>Licensable:</b> No  <b>Recommendations:</b> Not Applicable  <b>Reinspection Interval:</b> Not Applicable  <b>Overall Risk Category:</b> E0
<b>Product Type:</b>	0 Not Applicable	<b>Location:</b>	0 Not Applicable	
<b>Condition:</b>	0 Not Applicable	<b>Accessibility:</b>	0 Not Applicable	
<b>Surface Treatment:</b>	0 Not Applicable			
<b>Asbestos Type:</b>	0 Not Applicable	<b>Extent Score:</b>	0 Not Applicable

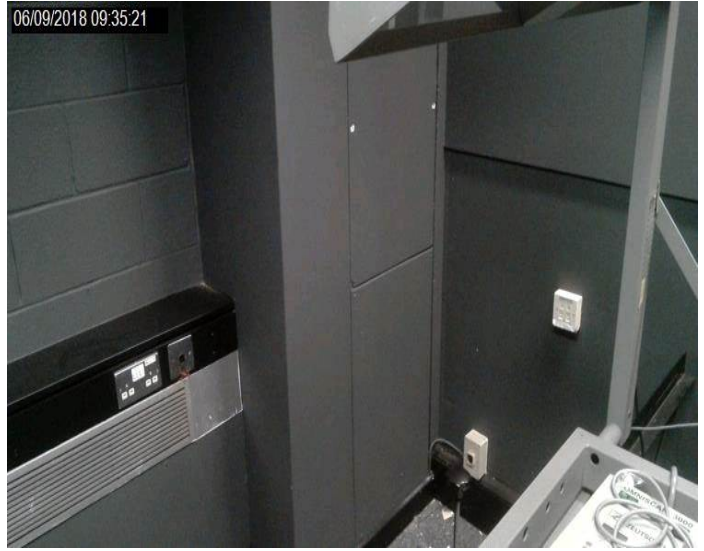
<b>Location:</b>	1.05	<b>Block:</b>	Birmingham City University	<b>Floor Level:</b> 1st Floor
<b>Sample No.:</b>	As DU002268	<b>Portal Ref No.:</b>	253

<b>Item:</b>	Insulating board panel			
<b>Asbestos Content:</b>		<b>Result Based on:</b>		
No Asbestos Detected		Strongly presumed		
<b>Sample Analysed By:</b>	Not applicable	<b>Extent:</b>	3 m <sup>2</sup>	
<b>Comments:</b> To riser

<b>Material Assessment Total Score:</b> 0		<b>Likelihood of Disturbance Assessment Total Score:</b> 0		<b>Management Assessment</b>  <b>Licensable:</b> Yes  <b>Recommendations:</b> Not Applicable  <b>Reinspection Interval:</b> Not Applicable  <b>Overall Risk Category:</b> E0
<b>Product Type:</b>	0 Not Applicable	<b>Location:</b>	0 Not Applicable	
<b>Condition:</b>	0 Not Applicable	<b>Accessibility:</b>	0 Not Applicable	
<b>Surface Treatment:</b>	0 Not Applicable			
<b>Asbestos Type:</b>	0 Not Applicable	<b>Extent Score:</b>	0 Not Applicable
